SIMEC Mining:  
**Tahmoor South  
Longwalls S1A to S7A**

Management Plan for potential impacts to Wollondilly Shire Council Infrastructure

Date	Report No.	Rev	Comments
Sep-22	MSEC1193-02	A	Draft for submission to Wollondilly Shire Council
Oct-22	MSEC1193-02	B	Final for submission following review by Bridge Technical Committee
Oct-22	MSEC1193-02	C	Final following review by Wollondilly Shire Council
Aug-25	MSEC1193-02	D	Draft for LW S1A-S7A

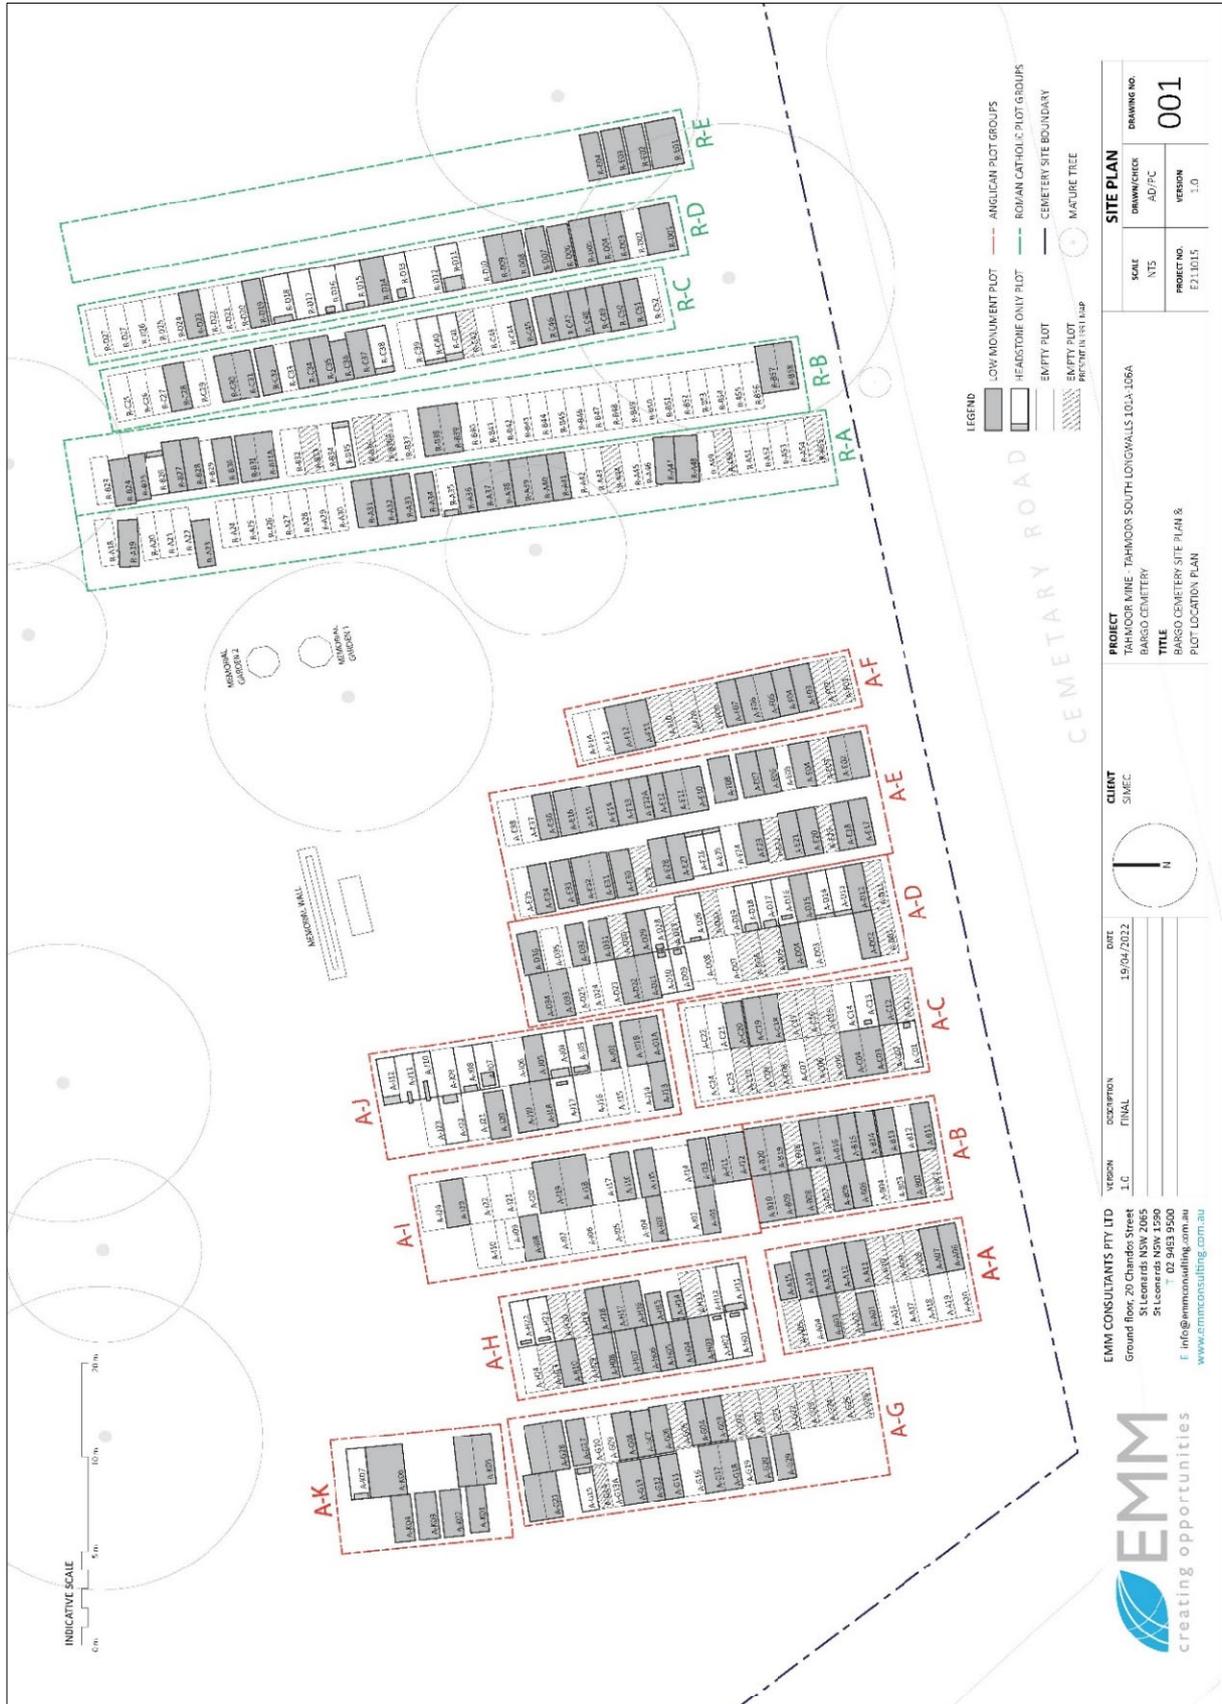
Fig. 3.65 Bargo Cemetery plan

The Bargo Cemetery is managed by Wollondilly Shire Council's Cemetery Operations Officer. It is located at the northern end of Great Southern Road directly above the south-eastern ends of LW S4A and S5A, as shown in Fig. 3.64. As the Cemetery is located above the ends of the longwall panels, it is predicted to experience vertical subsidence between 20 mm and 50 mm due to the extraction of LW S4A. The majority of predicted subsidence movements are expected to occur during the extraction of LW S5A. The Cemetery is predicted to experience vertical subsidence between 80 mm and 1100 mm due to the extraction of LW S1A-S7A. Non-conventional subsidence movements may also develop at the cemetery.
