## **SIMEC Mining – Tahmoor Coal**

**Management Plan for extraction of Tahmoor South LW S1A-S7A  
beneath the Main Southern Railway**

**Revision D**

**Prepared by Mine Subsidence Engineering Consultants  
on behalf of  
the ARTC / Tahmoor Coal  
Rail Management Group**

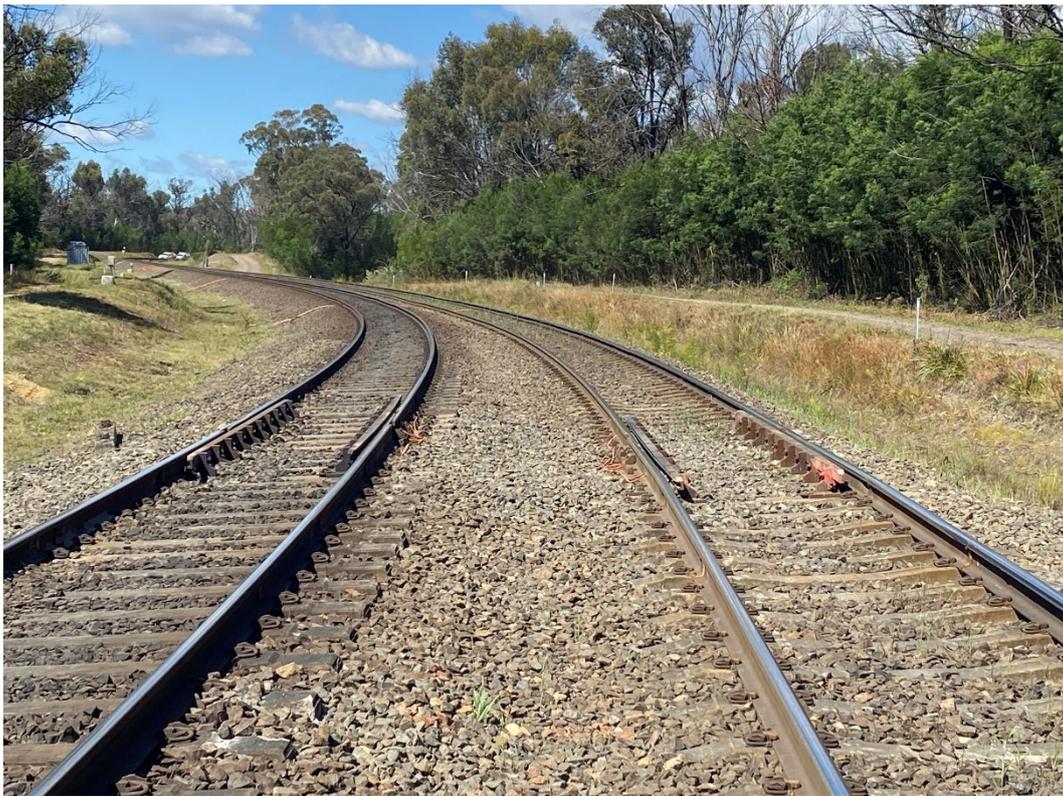
**Fig. 3.5 Expansion switches installed at 98.560 km (ES2) prior to influence of LW S1A**

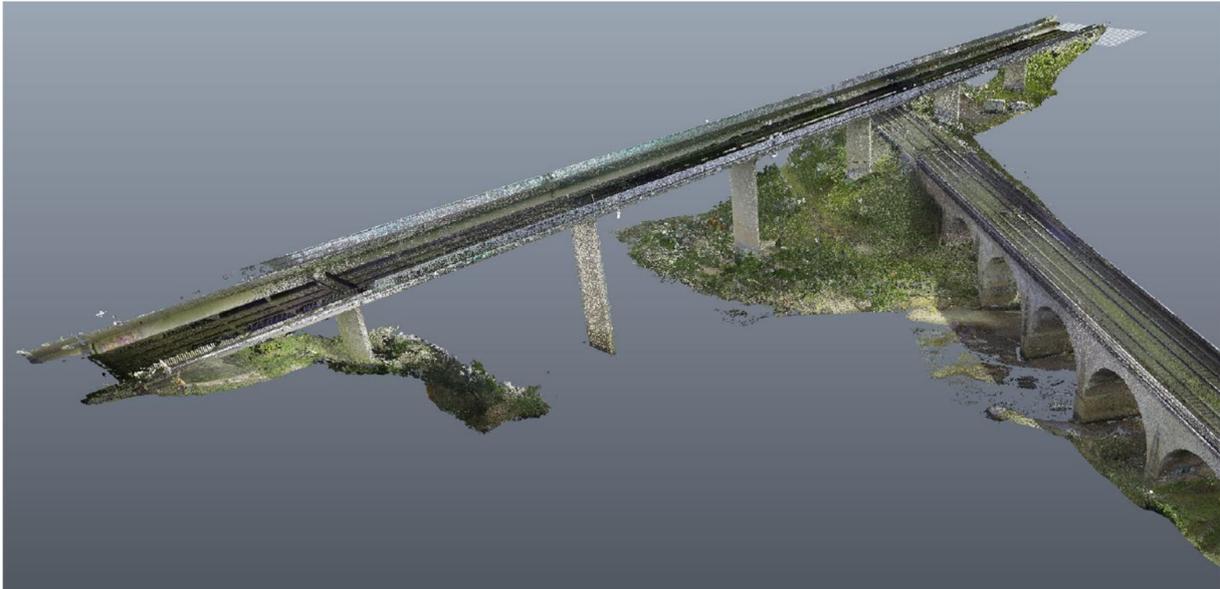
**Fig. 3.29 Image produced from laser scan (Precision Measurement, 2022)**

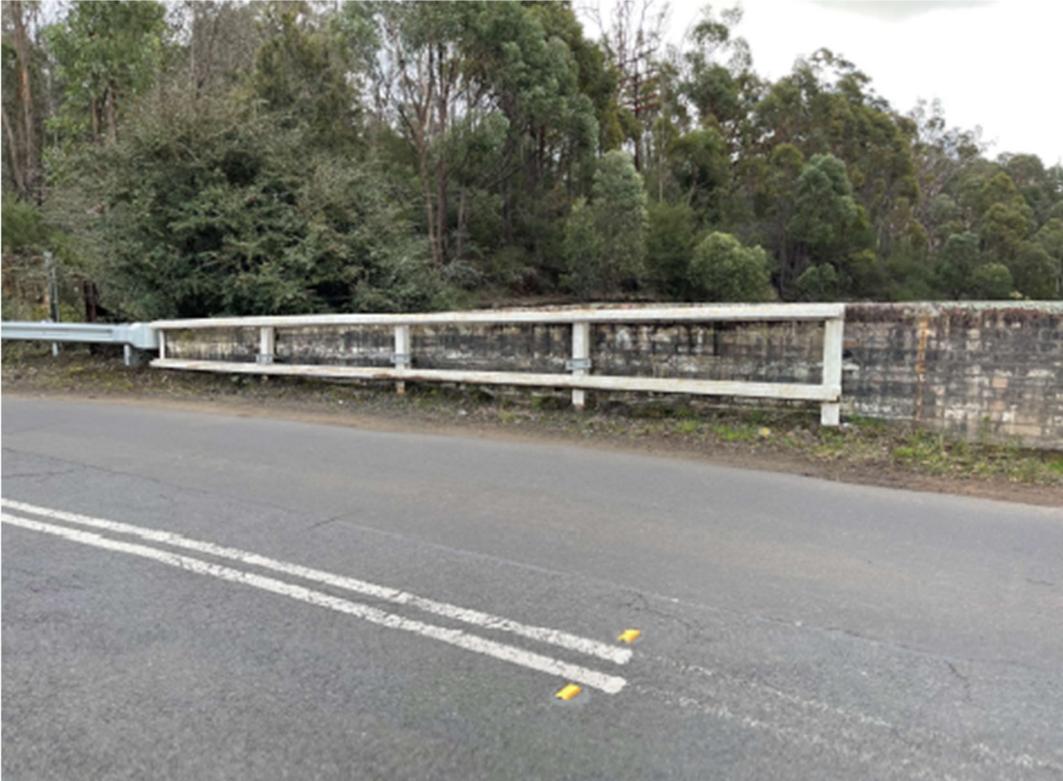
**Fig. 3.35 Bargo River Road pavement on Overbridge**

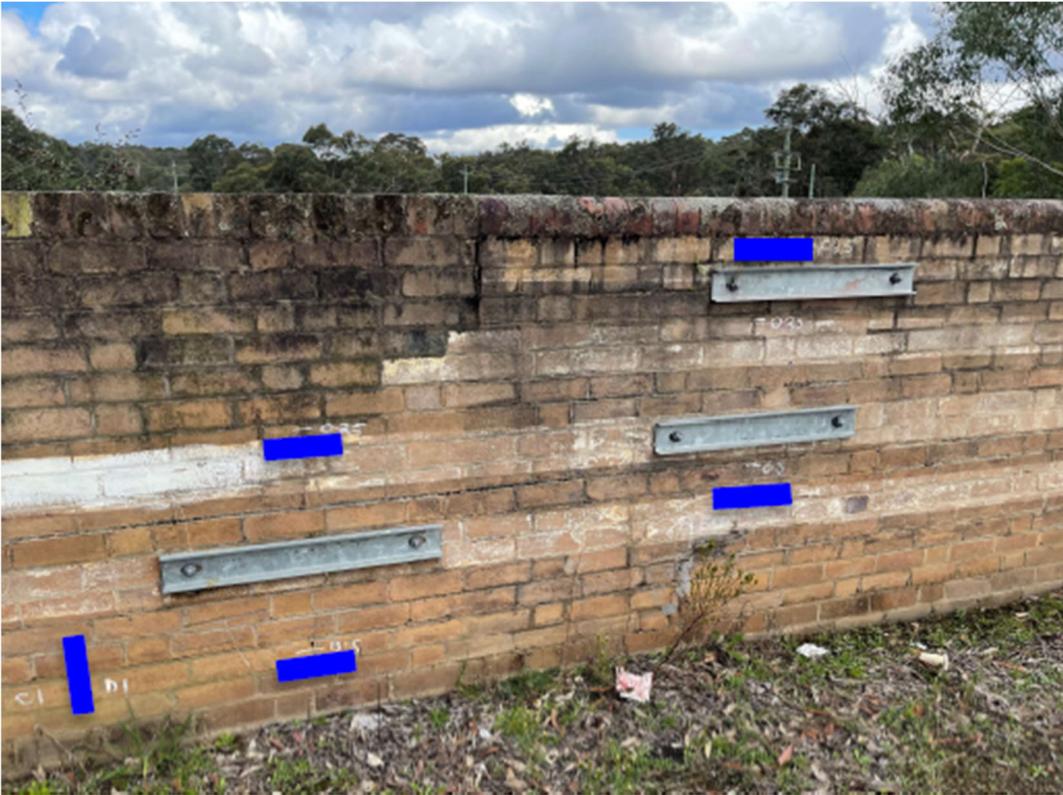
Photograph courtesy JMA Solutions (2022c) with blue lines where crack gauges are recommended

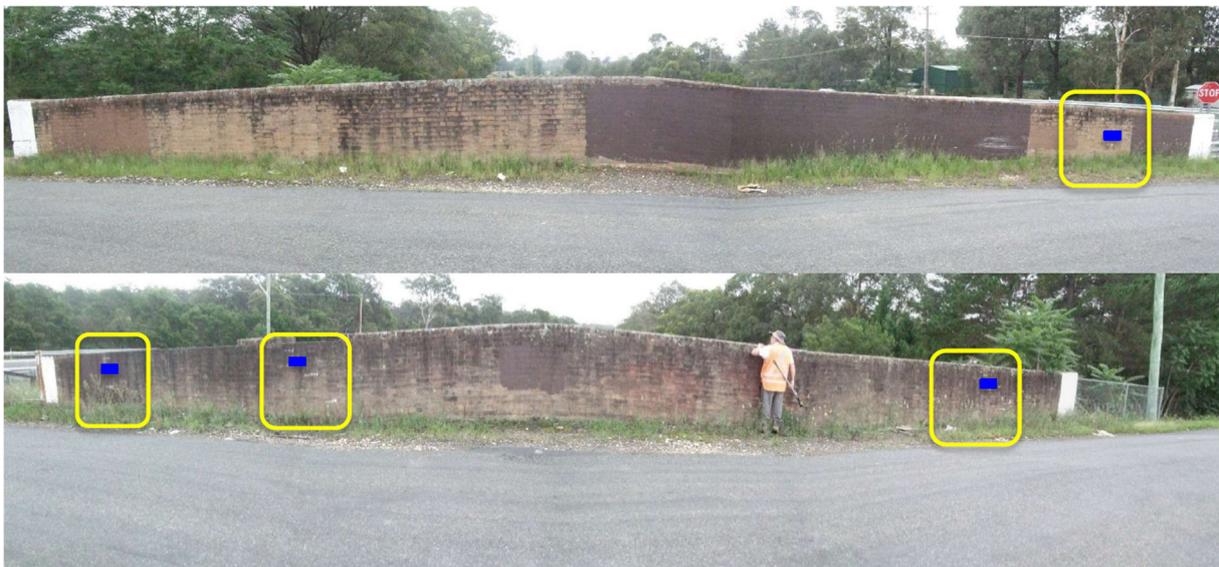
*Photograph courtesy JMA Solutions (2022d) with blue lines where crack gauges are recommended*

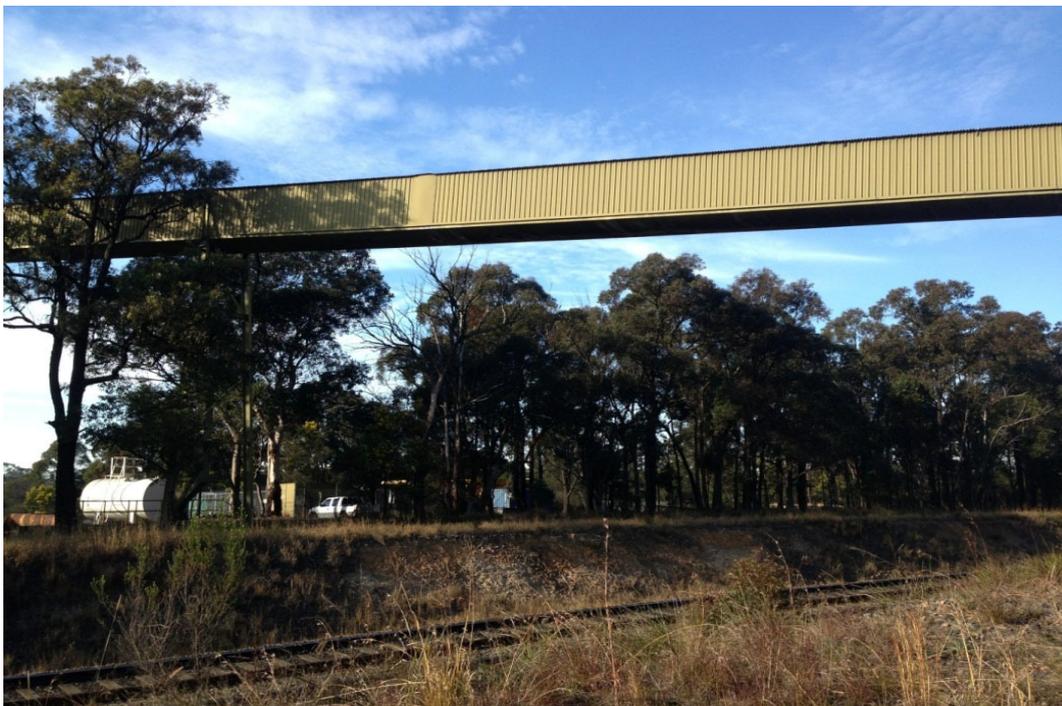
**Fig. 3.43 Tahmoor Mine overhead coal conveyor 3R over the Main Southern Railway near 98.160 km**
