SIMEC Mining:  
**Tahmoor South  
Longwalls S1A to S7A**

Management Plan for potential impacts to Wollondilly Shire Council Infrastructure

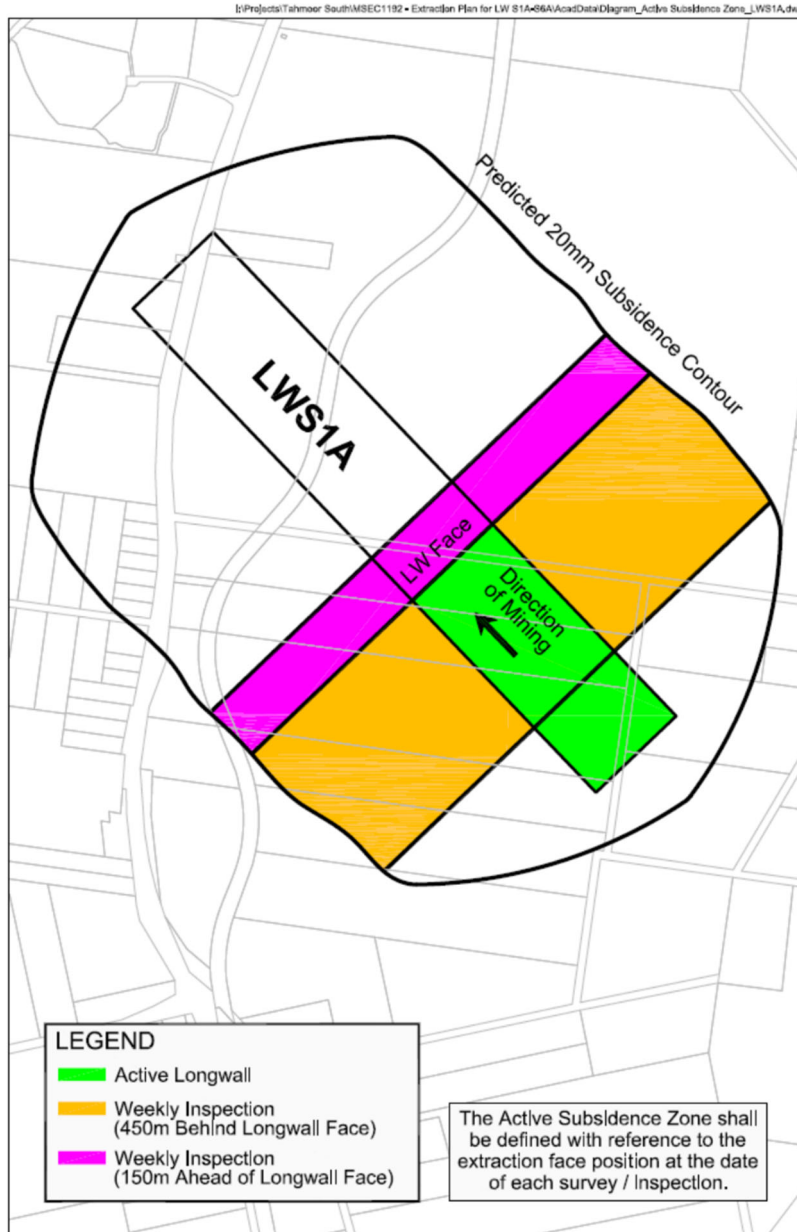
Fig. 1.1 Diagrammatic Representation of Active Subsidence Zone

This is termed the “active subsidence zone” for the purposes of this Management Plan, where surface monitoring is generally conducted. The active subsidence zone for each longwall is defined by the area bounded by the predicted 20 mm subsidence contour for the active longwall and a distance of 150 metres in front and 450 metres behind the active longwall face, as shown by Fig. 1.1.

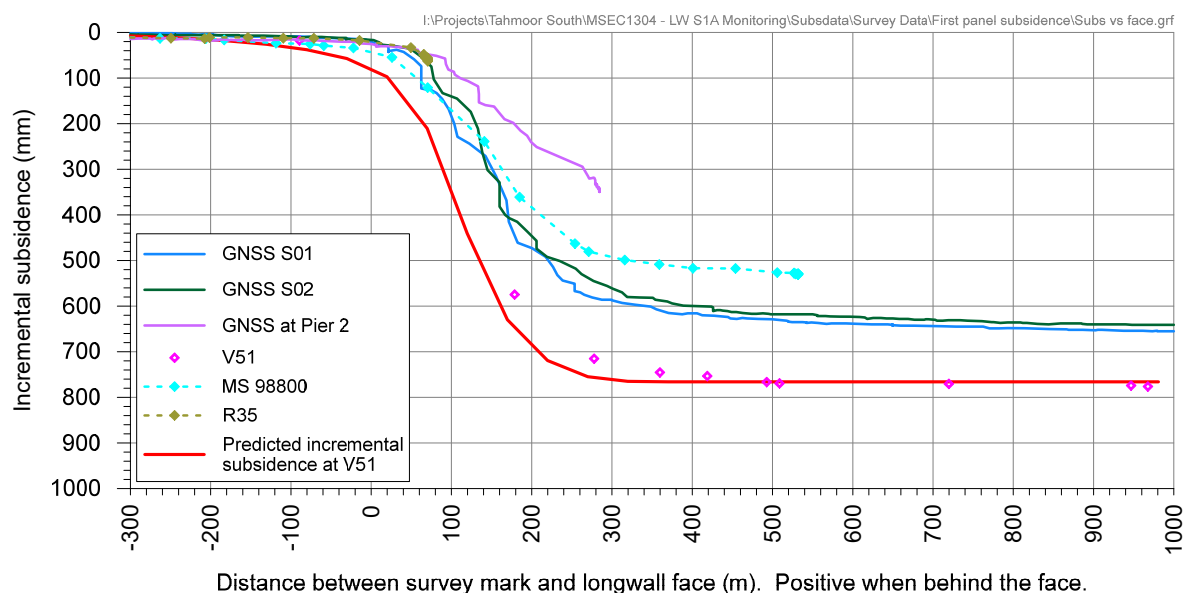
**Fig. 3.1 Comparison between predicted and observed subsidence above centreline of LW S1A**

As shown in Fig. 3.1, observed subsidence at Peg V51 was slightly greater than predicted but within the accuracy of the prediction model of  $\pm 15\%$  (Reports Nos. MSEC1123 and MSEC1192). Observed total subsidence at Peg V51 after the mining of LW S3A is less than predicted, as shown in Fig. 3.4. Observed subsidence values at other locations above LW S1A were less than predicted.

Extensive monitoring has been undertaken by Tahmoor Coal during the mining of LW S1A-S3A. Observed incremental subsidence due to the extraction of LW S1A has correlated reasonably well with predictions, as shown in Fig. 3.1 to Fig. 3.6.

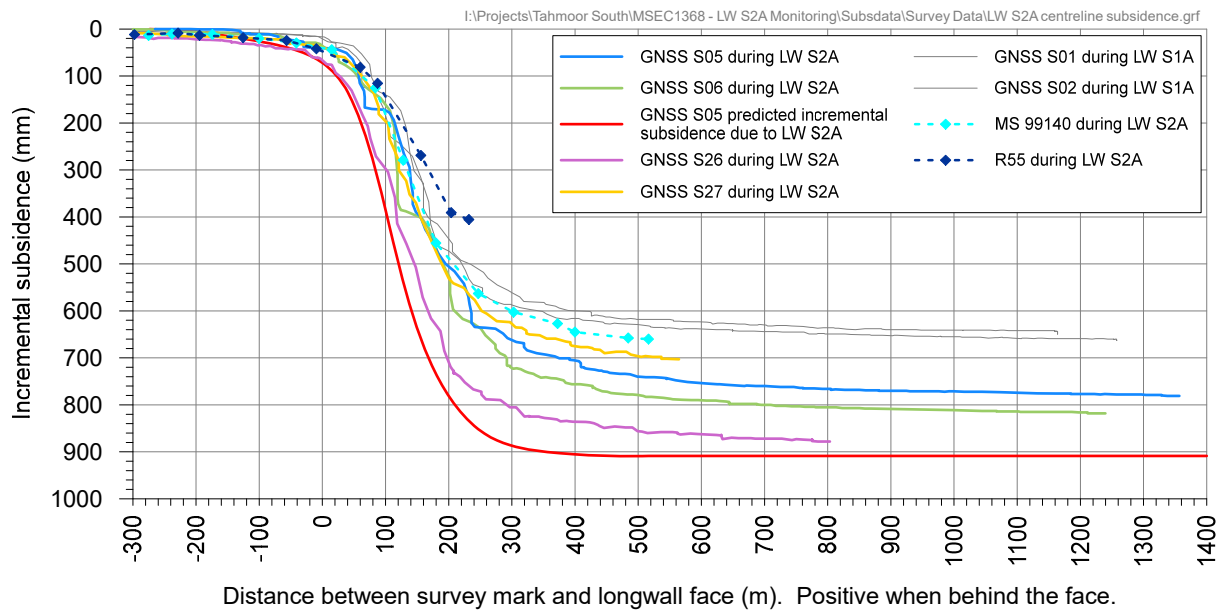
**Fig. 3.2 Comparison between predicted and observed subsidence above centreline of LW S2A**

Monitoring during the mining of LW S2A measured subsidence movements within predictions, as shown in Fig. 3.2. Whilst observed subsidence along Remembrance Drive has been less than predicted, increased compressive strains have been observed at two locations, as shown in Fig. 3.6. Wollondilly Shire Council and Tahmoor Coal have managed potential impacts at these two locations in accordance with this Management Plan, and the previously agreed Revision C of this Management Plan.

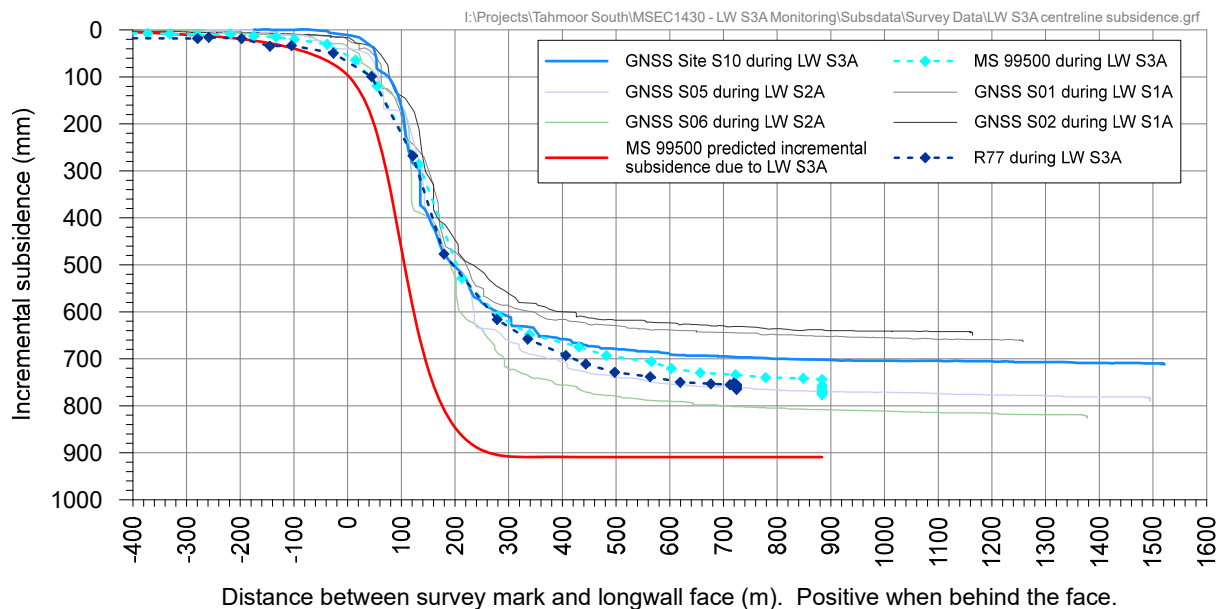
**Fig. 3.3 Comparison between predicted and observed subsidence above centreline of LW S3A**

Monitoring during the mining of LW S3A measured subsidence movements within predictions, as shown in Fig. 3.3. Maximum subsidence was measured at Peg MS99500 which is located along the Main Southern Railway and above the centreline of LW S3A. Whilst observed subsidence along the Main Southern Railway has been less than predicted, a bump was observed in the subsidence profile along with a corresponding increased compressive strain at one location, as shown in Fig. 3.5.

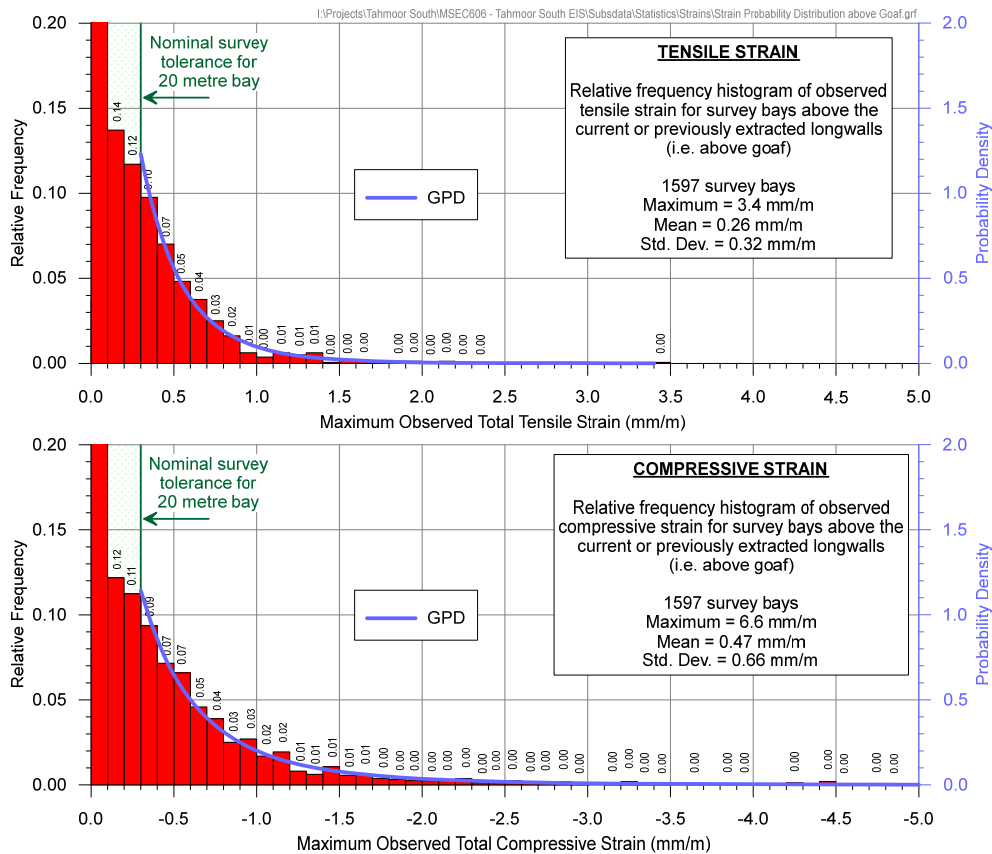
**Fig. 3.7 Distributions of the maximum measured tensile and compressive strains for survey bays located above goaf at Tahmoor, Appin and West Cliff Collieries**

A histogram of the maximum observed total tensile and compressive strains measured in survey bays above goaf, for monitoring lines at Tahmoor, Appin and West Cliff Collieries is provided in Fig. 3.7. Probability distribution functions, based on fitted *Generalised Pareto Distributions* (GPDs), have also been shown in this figure.

The 95 % confidence levels for the maximum total strains that the individual survey bays *above goaf* experienced at any time during mining at Tahmoor, Appin and West Cliff Collieries were 0.9 mm/m tensile and 1.6 mm/m compressive. The strains for the proposed longwalls are predicted to be 20 % to 40 % greater than those previously observed at these collieries and, therefore, it is expected that 95 % of the strains measured *above goaf* would be less than 1.3 mm/m tensile and 2.2 mm/m compressive.

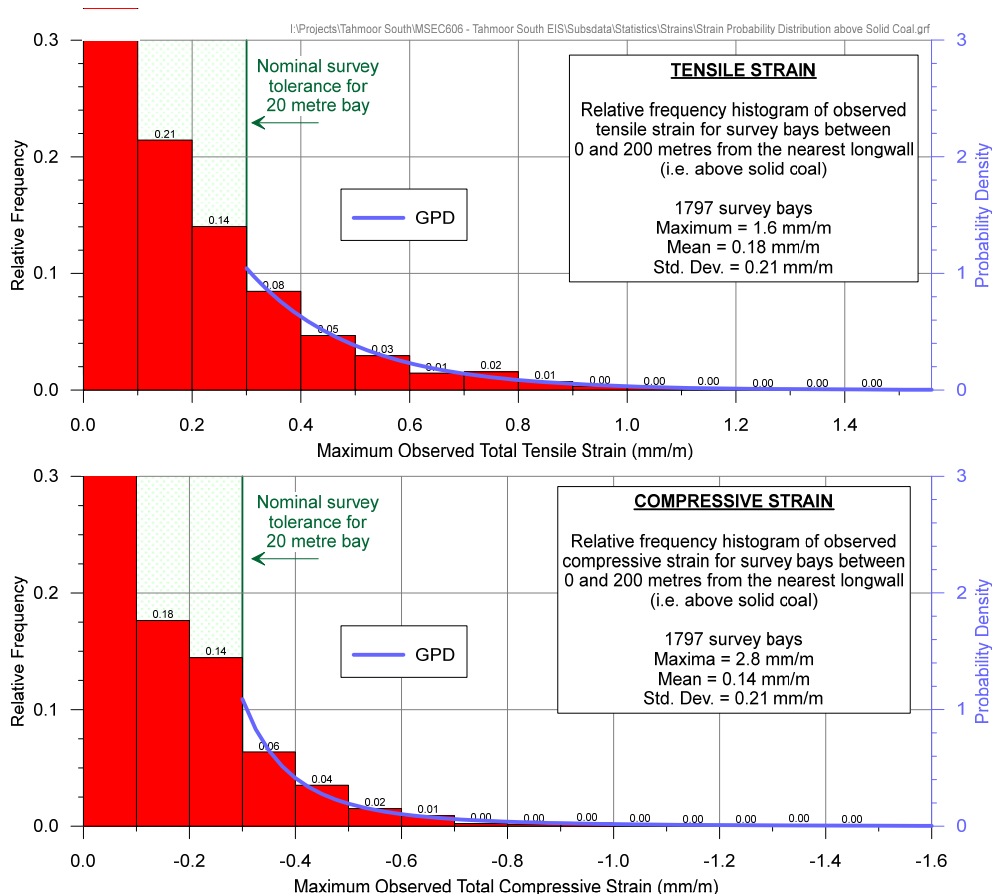
**Fig. 3.8 Distributions of the maximum measured tensile and compressive strains for survey bays located above solid coal at Tahmoor, Appin and West Cliff Collieries**

A histogram of the maximum observed tensile and compressive strains measured in survey bays above solid coal, for monitoring lines at Tahmoor, Appin and West Cliff Collieries is provided in Fig. 3.8. The probability distribution functions, based on the fitted GPDs, have also been shown in this figure.

The 95 % confidence levels for the maximum total strains that the individual survey bays *above solid coal* experienced at any time during mining at Tahmoor, Appin and West Cliff Collieries were 0.6 mm/m tensile and 0.5 mm/m compressive. The strains for the proposed longwalls are predicted to be 20 % to 40 % greater than those previously observed at these collieries and, therefore, it is expected that 95 % of the strains measured *above solid coal* would be less than 1.0 mm/m tensile and compressive.

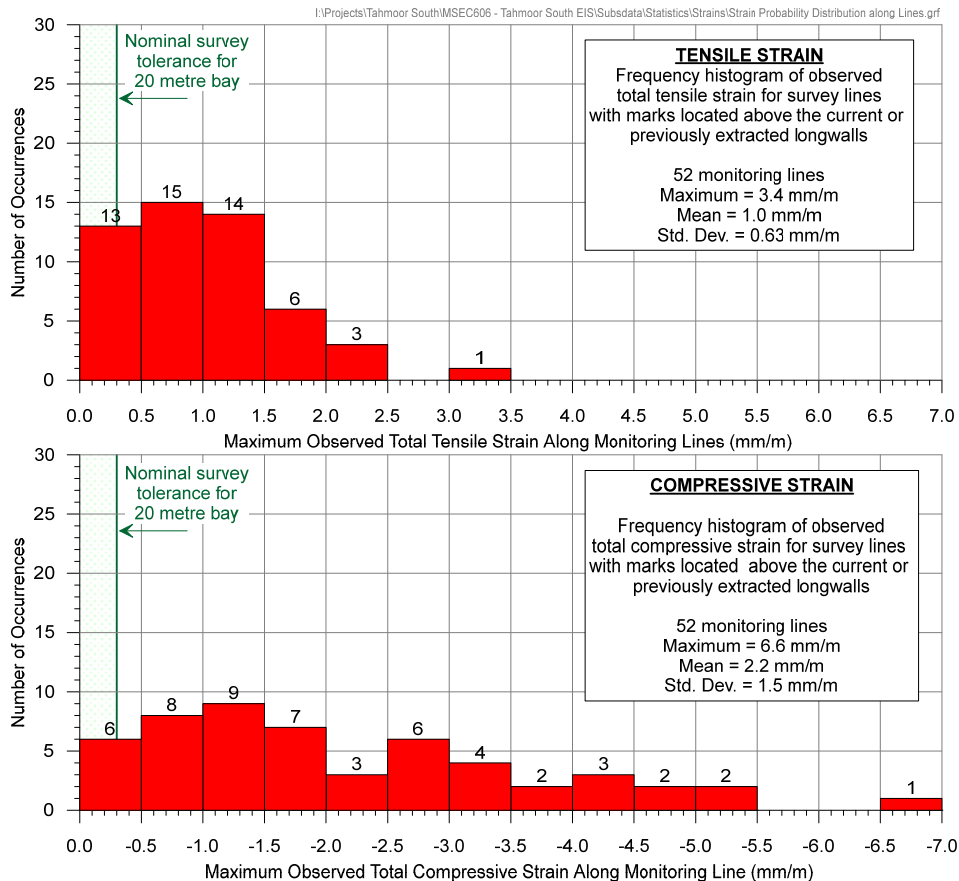
**Fig. 3.9 Distributions of measured maximum tensile and compressive strains anywhere along the monitoring lines at Tahmoor, Appin and West Cliff Collieries**

A histogram of maximum observed total tensile and compressive strains measured anywhere along the monitoring lines, at any time during or after the extraction of the previous longwalls Tahmoor, Appin and West Cliff Collieries, is provided in Fig. 3.9.

The road is a linear feature and, therefore, the most relevant distribution of strain is the maximum strains measured along whole monitoring lines above previous longwall mining. The analysis of strains along whole monitoring lines during the mining of previous longwalls in the Southern Coalfield is discussed in Section 3.3.2 and the results are provided in Fig. 3.9.

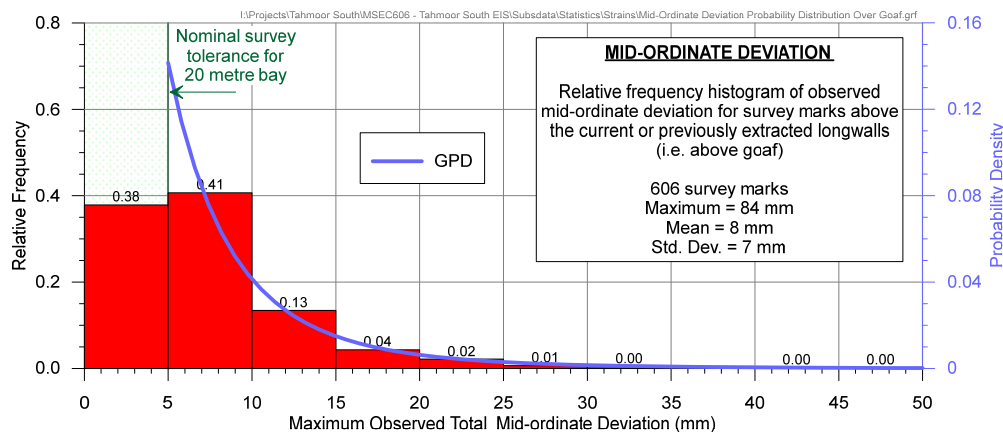
**Fig. 3.10 Distribution of measured maximum mid-ordinate deviation during the extraction of previous longwalls in the Southern Coalfield for marks located above goaf**

The frequency distribution of the maximum total horizontal mid-ordinate deviations measured at survey marks above goaf, for previously extracted longwalls in the Southern Coalfield, is provided in Fig. 3.10. As the typical survey bay length was 20 metres, the calculated mid-ordinate deviations were over a chord length of 40 metres. The probability distribution function, based on the fitted GPD, has also been shown in this figure.

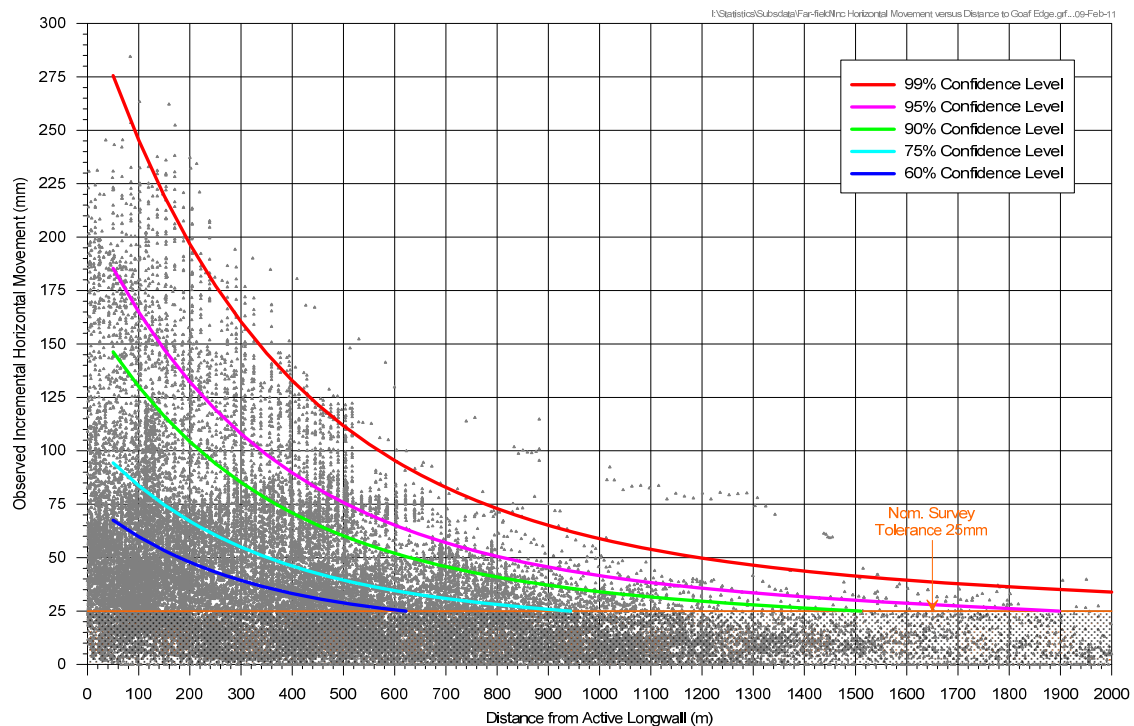
**Fig. 3.11 Observed incremental far-field horizontal movements above goaf or solid coal**

As successive longwalls within a series of longwalls are mined, the magnitudes of the incremental far-field horizontal movements decrease. The total far-field horizontal movement may be less, therefore, than the sum of the incremental far-field horizontal movements for the individual longwalls.

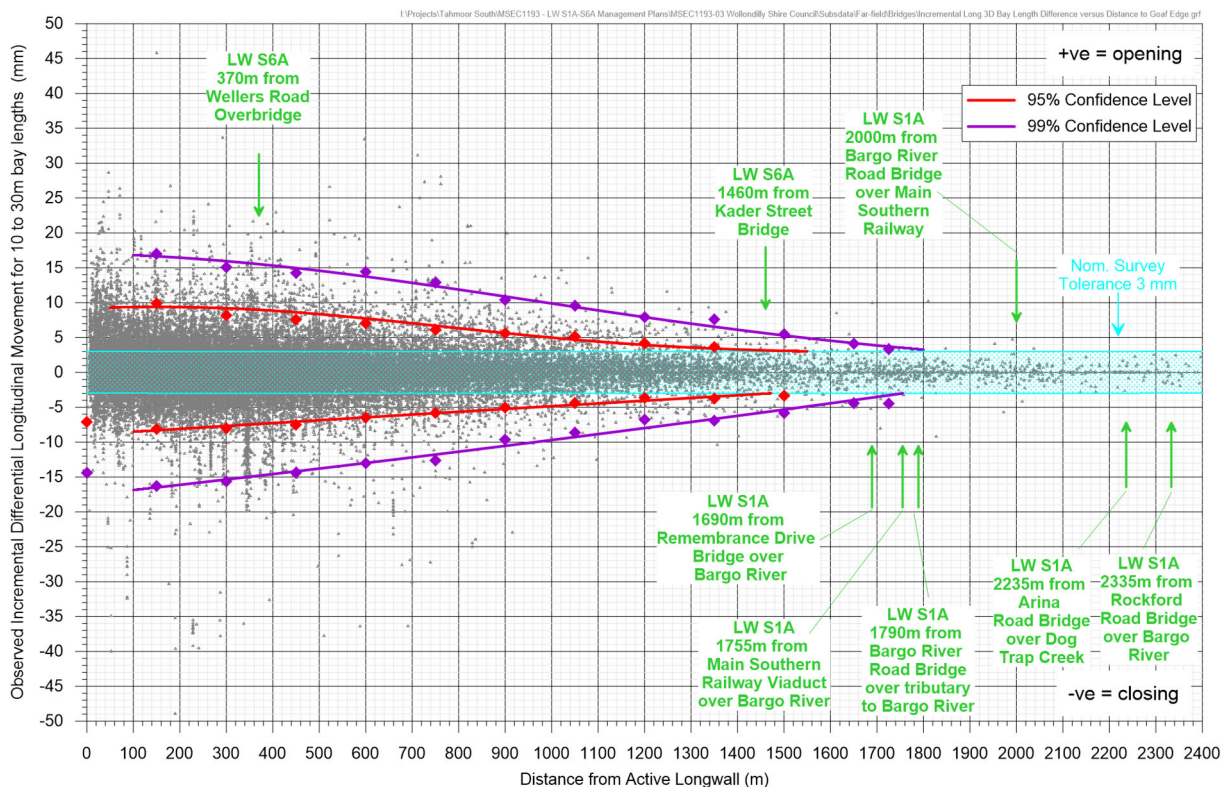
**Fig. 3.13 Observed incremental differential longitudinal horizontal movements versus distance from active longwall for marks spaced between 10 and 30 metres**

The potential for impacts on the bridges do not result from absolute far-field horizontal movements, but rather from differential horizontal movements over the length of the structure. It can be seen from Fig. 3.13 that structures located well away from active longwalls are likely to experience relatively small differential horizontal movements, particularly given that a large proportion of the measured variations are within survey tolerance. Statistical analyses were not conducted for offset distances greater than 1800 metres as there are insufficient measurements beyond the nominal survey tolerance of 3 mm.

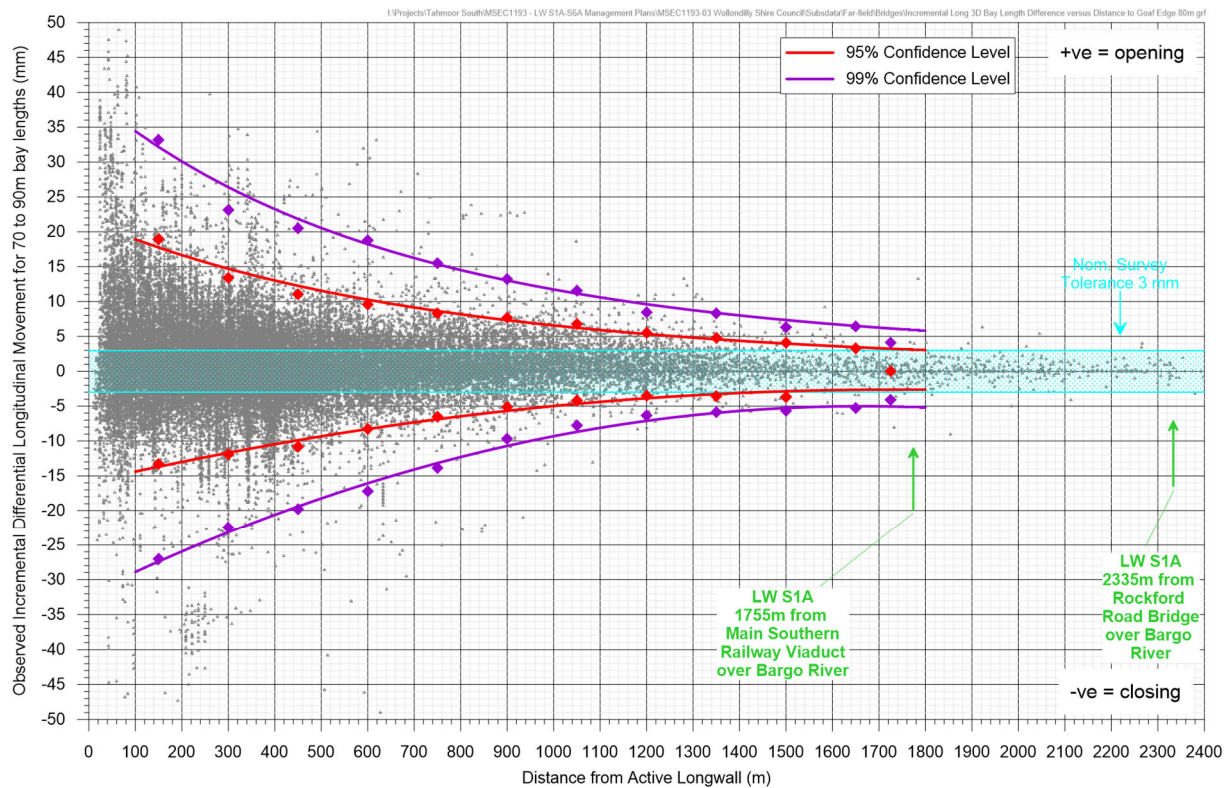
**Fig. 3.14** Observed incremental differential longitudinal horizontal movements versus distance from active longwall for marks spaced between 70 and 90 metres

The Rockford Road Bridge has an overall length of approximately 80 metres. Observed changes in horizontal distances for survey marks spaced between 70 and 90 metres are shown in Fig. 3.14. Statistical analyses were not conducted for offset distances greater than 1800 metres as there are insufficient measurements beyond the nominal survey tolerance of 3 mm.

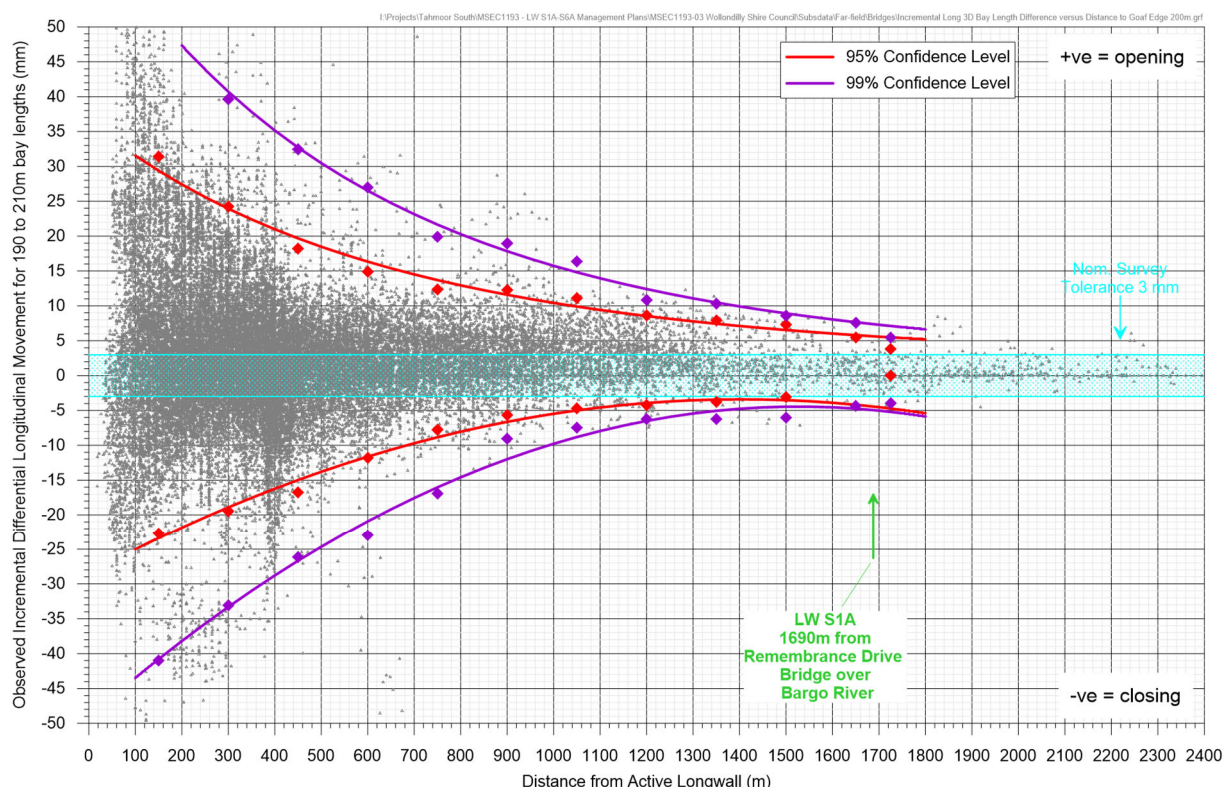
**Fig. 3.15 Observed incremental differential longitudinal horizontal movements versus distance from active longwall for marks spaced between 190 and 210 metres**

The Remembrance Drive Bridge over the Bargo River has an overall length of approximately 195 metres. Observed changes in horizontal distances for survey marks spaced between 190 and 210 metres are shown in Statistical analyses were not conducted for offset distances greater than 1800 metres as there are insufficient measurements beyond the nominal survey tolerance of 3 mm.

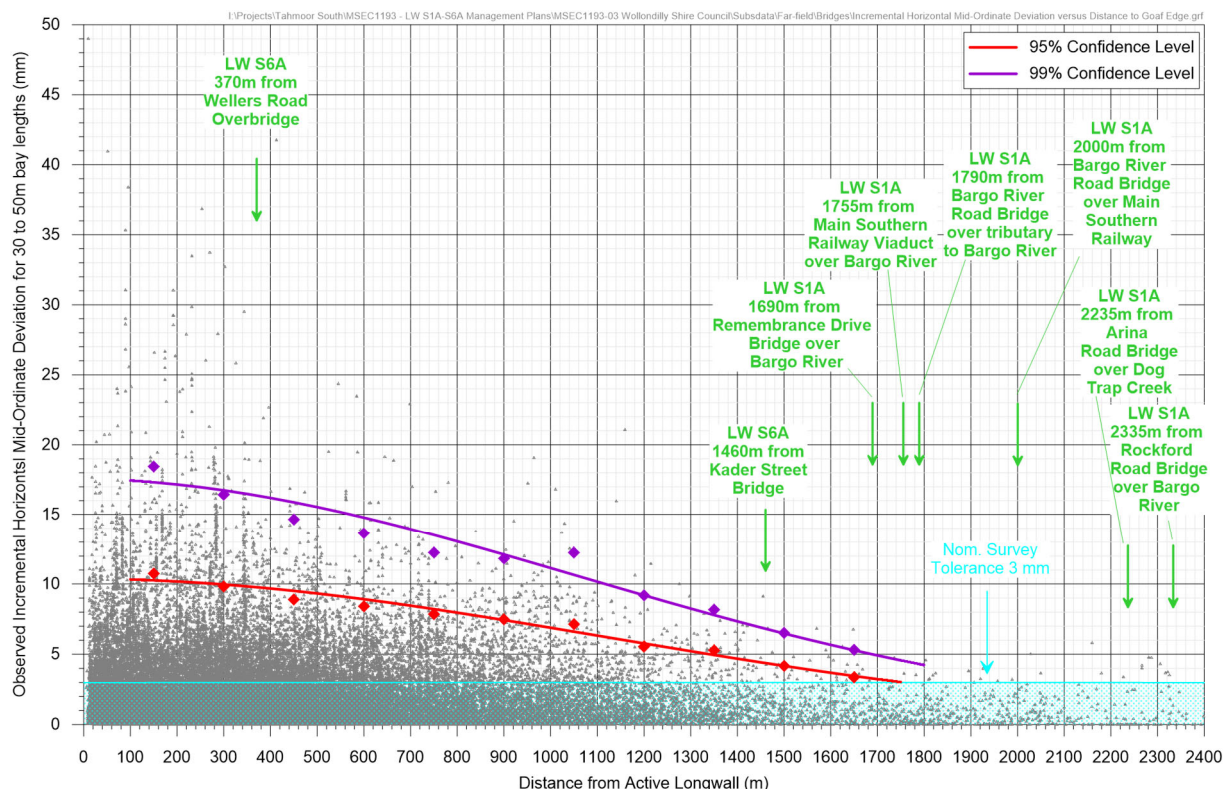
**Fig. 3.16 Observed incremental differential horizontal mid-ordinate deviation versus distance from active longwall for marks spaced between 30 and 50 metres**

It is possible that the bridges could experience shear deformations as a result of differential far field movements. In this report, horizontal mid-ordinate deviation has been used as the measure for shear deformation, which is defined as the differential horizontal movement of each survey mark, perpendicular to a line drawn between two adjacent survey marks. The frequency distribution of the maximum total horizontal mid-ordinate deviations measured at survey marks above solid coal, for previously extracted longwalls in the Southern Coalfield, is provided in Fig. 3.15.

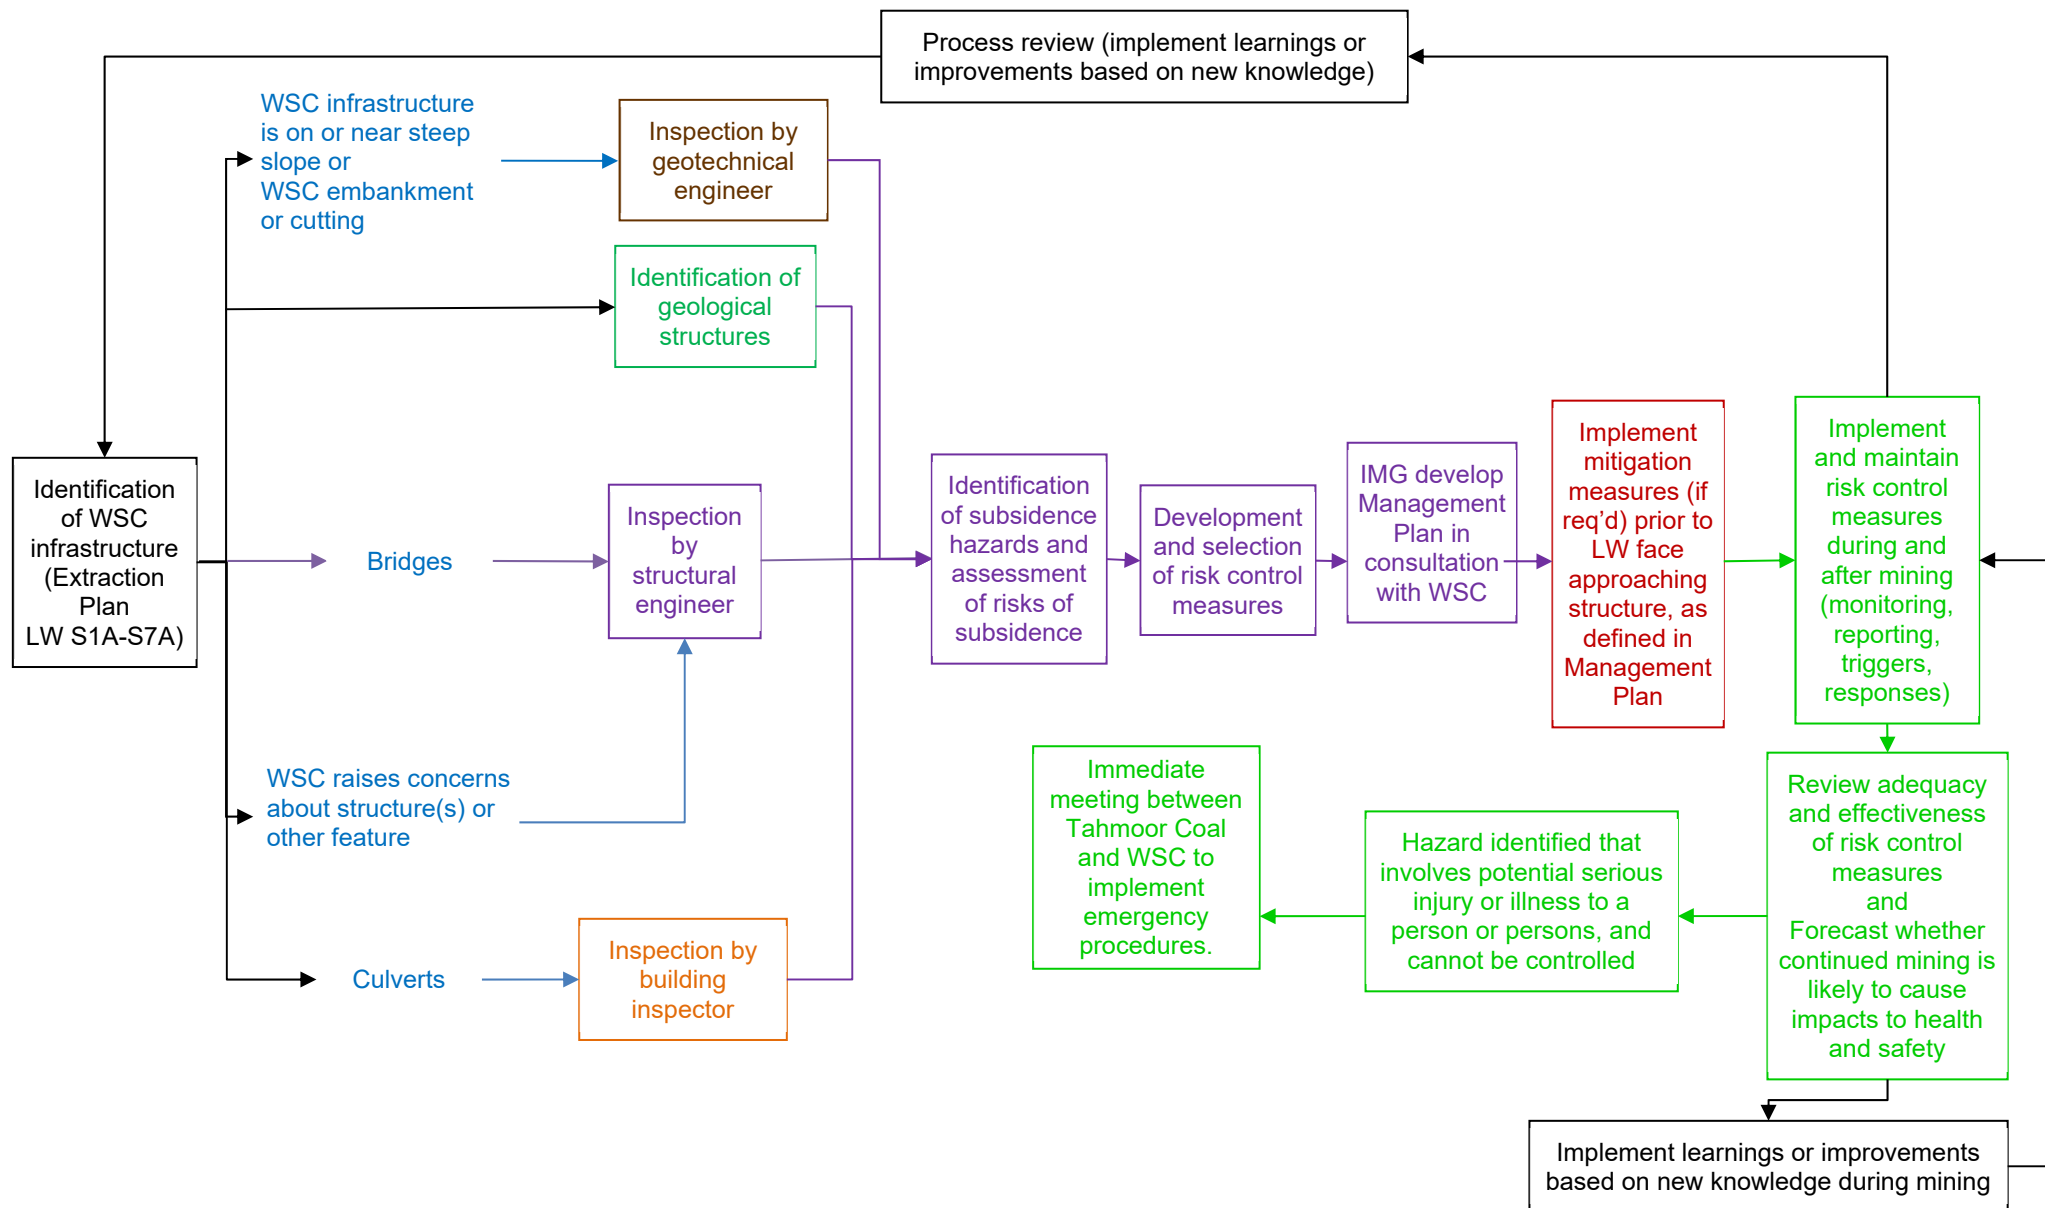
**Fig. 3.17 Flowchart for Subsidence Impact Management Process**

A flowchart illustrating the subsidence impact management process prior to, during and after Wollondilly Shire Council infrastructure experiences mine subsidence movements is shown in Fig. 3.17.

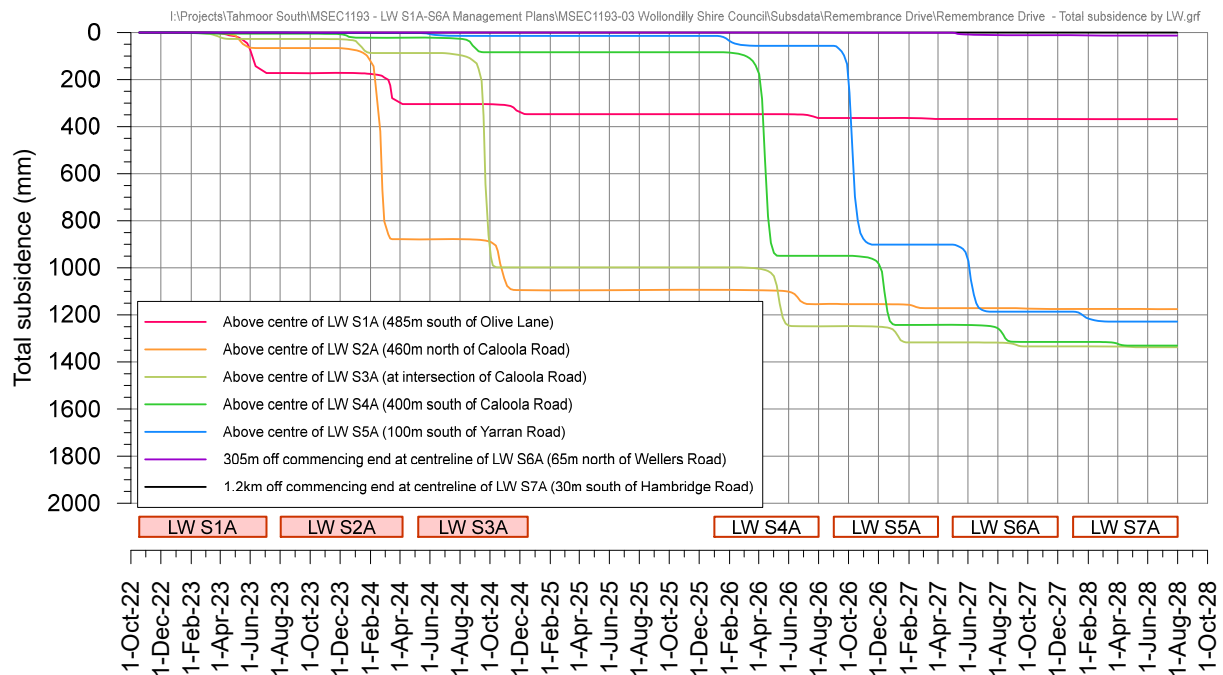
**Fig. 3.20 Predicted development of vertical subsidence at selected points along Remembrance Driveway over time during the mining of LW S1A-S7A**

To illustrate the above, the predicted development of subsidence over time for sections of pavement that are located directly above or adjacent to the centrelines of LW S1A-S7A are shown in Fig. 3.20. The timing of the periods of active subsidence at each point is based on the current mining schedule, assuming that the longwall face is extracted at a uniform rate from start to finish. As discussed in Section 1.7, the longwall schedule may vary depending on a variety of factors and the predicted timing of subsidence at each point may change.

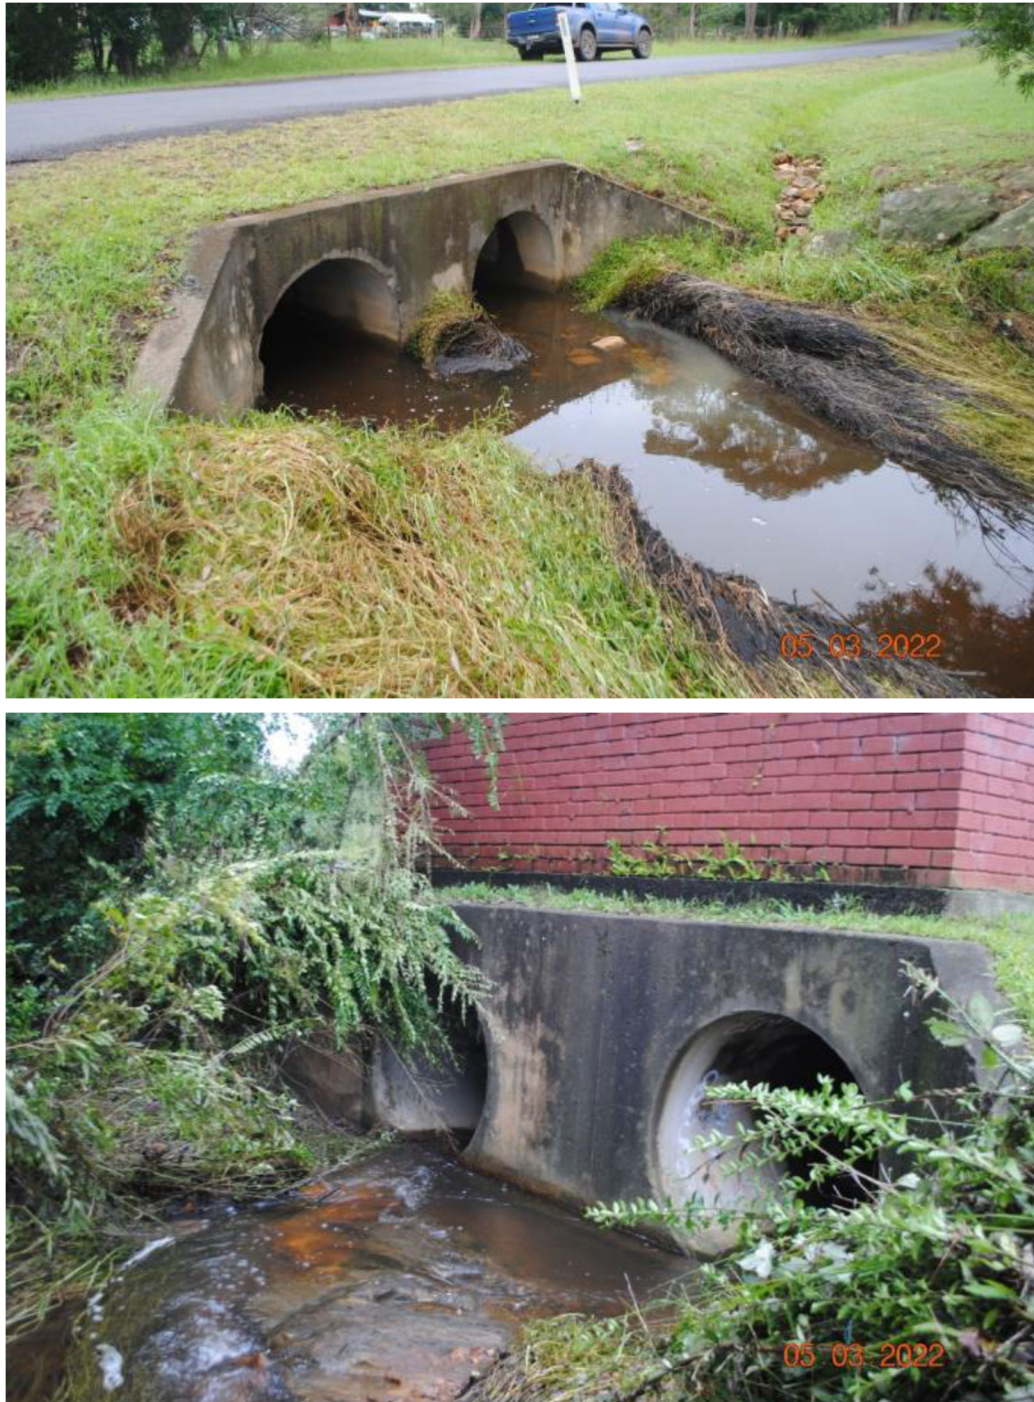
Teatree Hollow crosses between Remembrance Drive at the intersection with Caloola Road. The stream flows under Caloola Road via twin 1.2 metre diameter reinforced concrete culverts, which connect to twin, 1.35 metre diameter reinforced concrete culverts beneath bus stop at the end of Caloola Road. Photographs of both culverts are shown in Fig. 3.25. The culvert carries the pavement over Teatree Hollow and continues beneath Remembrance Drive.

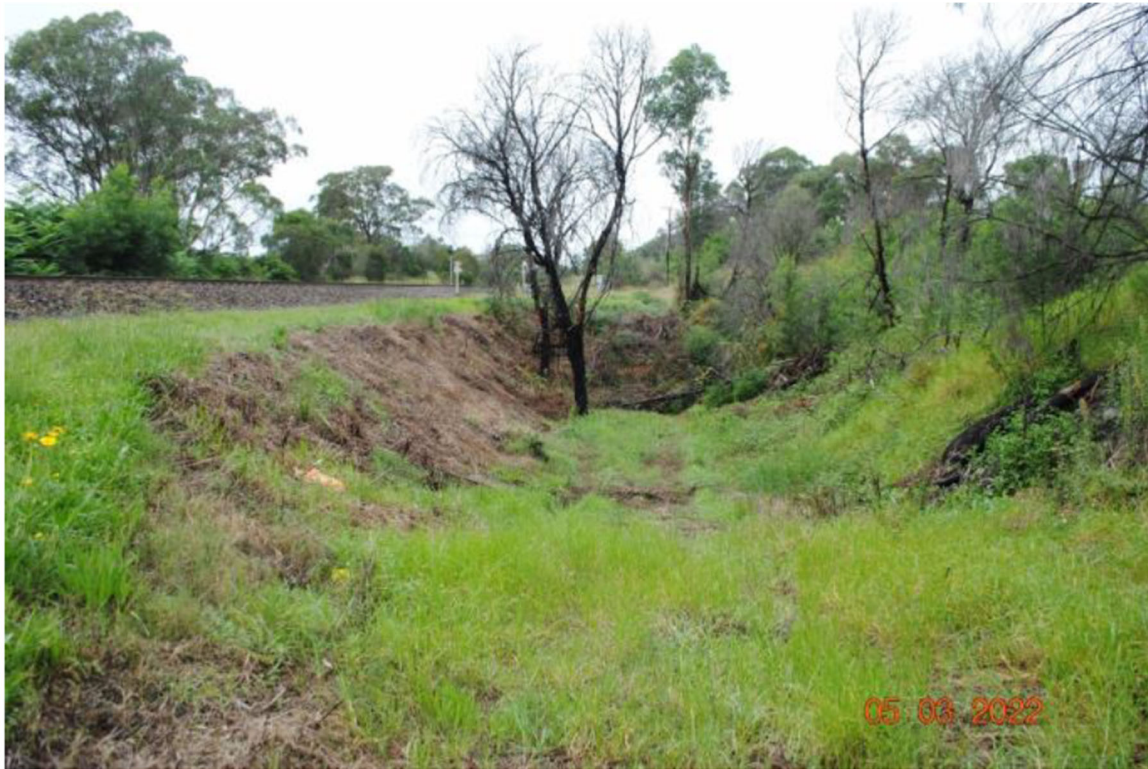
Two culverts are located in close proximity at the intersection between Remembrance Drive, Yarran Road and the Main Southern Railway. The 1800 mm RCP culvert beneath Remembrance Drive drains into a small parcel of privately owned land and a 2000 mm diameter brick arch culvert beneath the Main Southern Railway.

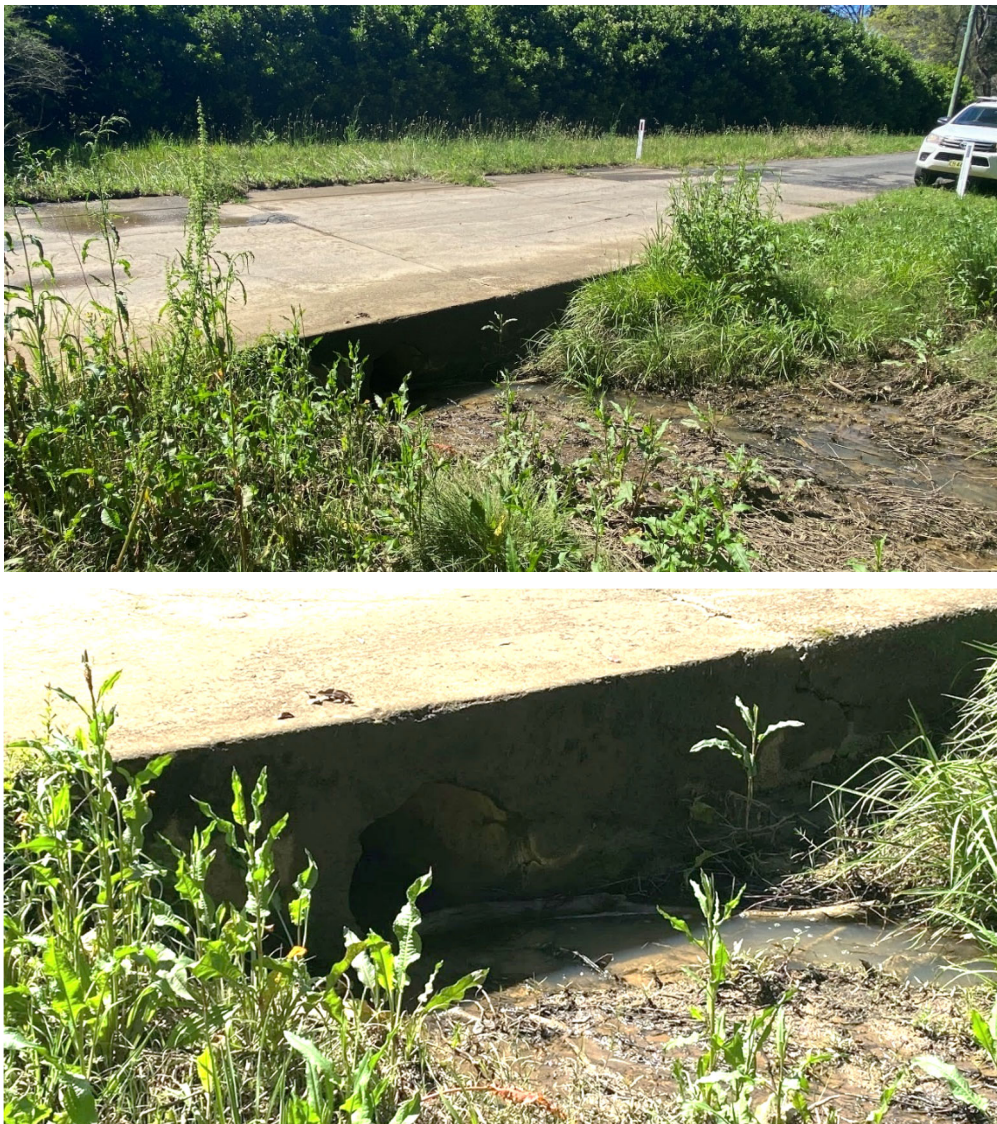
**Fig. 3.27 Causeway on Government Road**

The Causeway consists of a concrete pavement that is approximately 18 metres long, with a 450 mm diameter pipe directly beneath it. A photograph is shown in Fig. 3.27.

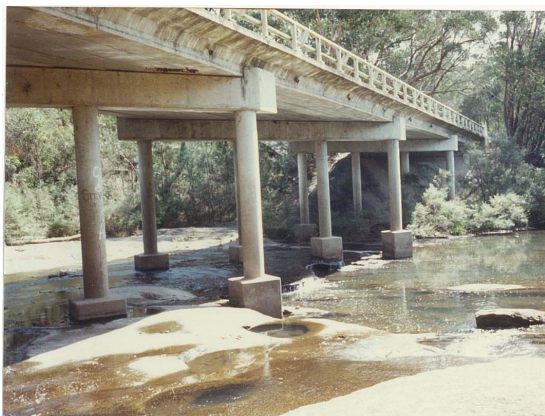
Original Bridge (1966)

The Rockford Road crosses the Bargo River between Tahmoor and Pheasants Nest. The six-span dual lane Bridge was constructed in 1966 and comprises reinforced concrete abutments, with intermediate reinforced concrete piers on pad footings, founded in sandstone (JMA, 2022c). The Bridge was modified in 1994 prior to the mining of Tahmoor Longwalls 12 and 13. A photograph of the original and modified Bridge is shown in Fig. 3.43.

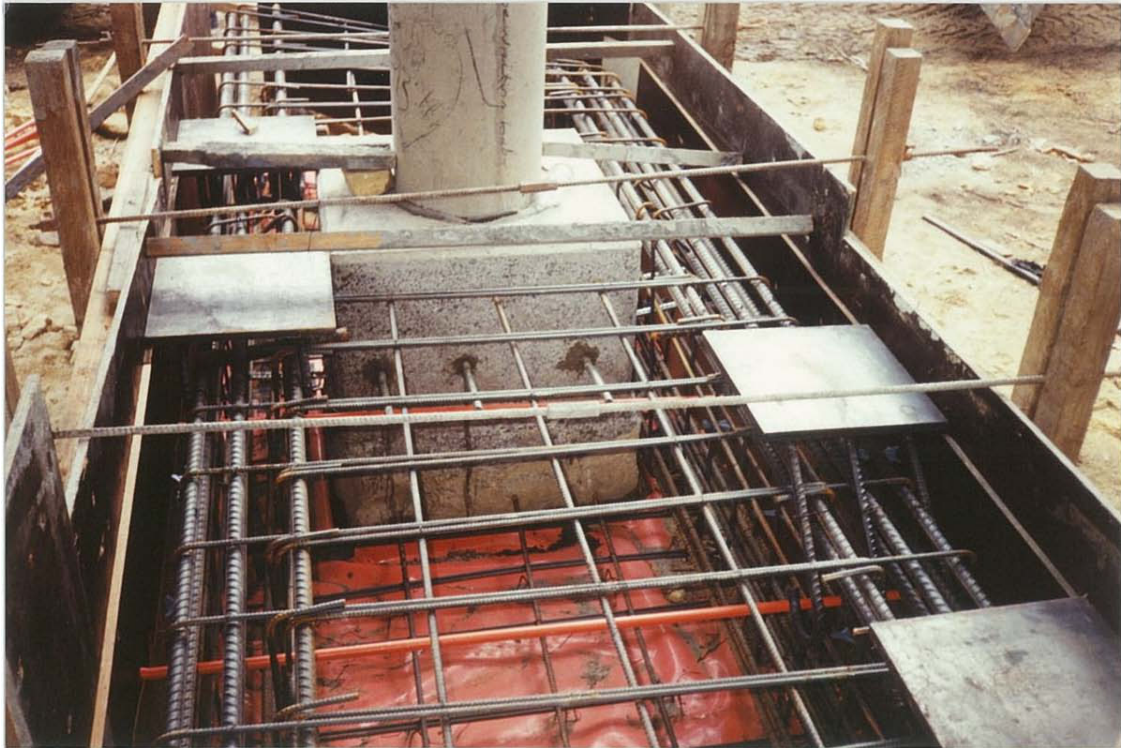
**Fig. 3.44** Pad footings tied together at Rockford Road Bridge prior to mining of LW12

Photographs of the bridge modification and jacking works prior to the mining of Longwalls 12 and 13 are shown in Fig. 3.44 to Fig. 3.47. Current photographs of the Bridge are shown in Fig. 3.48 and Fig. 3.49.

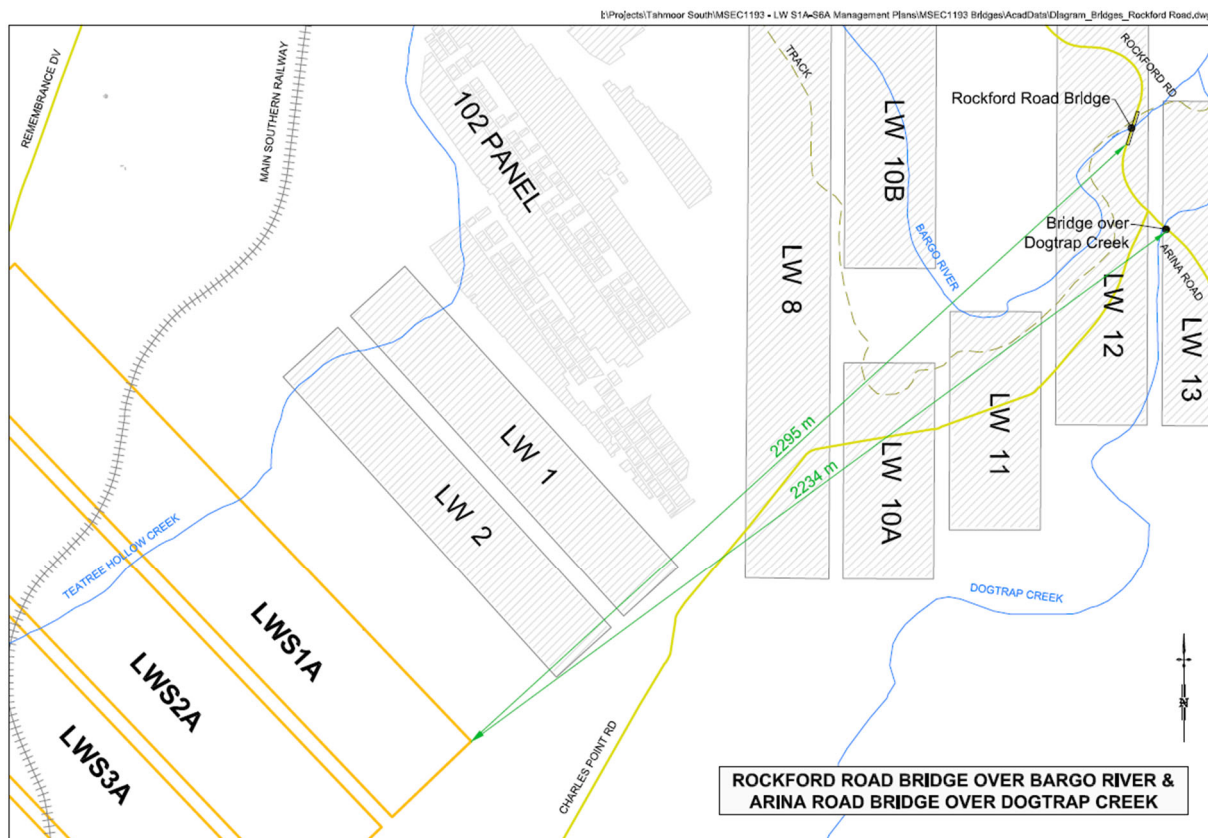
**Fig. 3.50 Location of Rockford Road Bridge over Bargo River and Arina Road Bridge over Dog Trap Creek relative to mine layout**

Tahmoor Mine has extracted Longwall 12 directly beneath the Rockford Road Bridge, as shown in Fig. 3.50. Tahmoor South LWs S1A to S7A are located in the southwest corner of the map below, with the closest distance of 2,295 metres to the Bridge.
