Appendix E – Myrtle Creek Rehabilitation Report

TAH5179A_Rev1

UPDATE OF REMEDIATION OUTCOMES AT POOL 23 ON MYRTLE CREEK

Please find herein an update of remediation outcomes at Pool 23 on Myrtle Creek following Stage 1 of the Corrective Management Action Plan (CMAP) for Myrtle Creek.

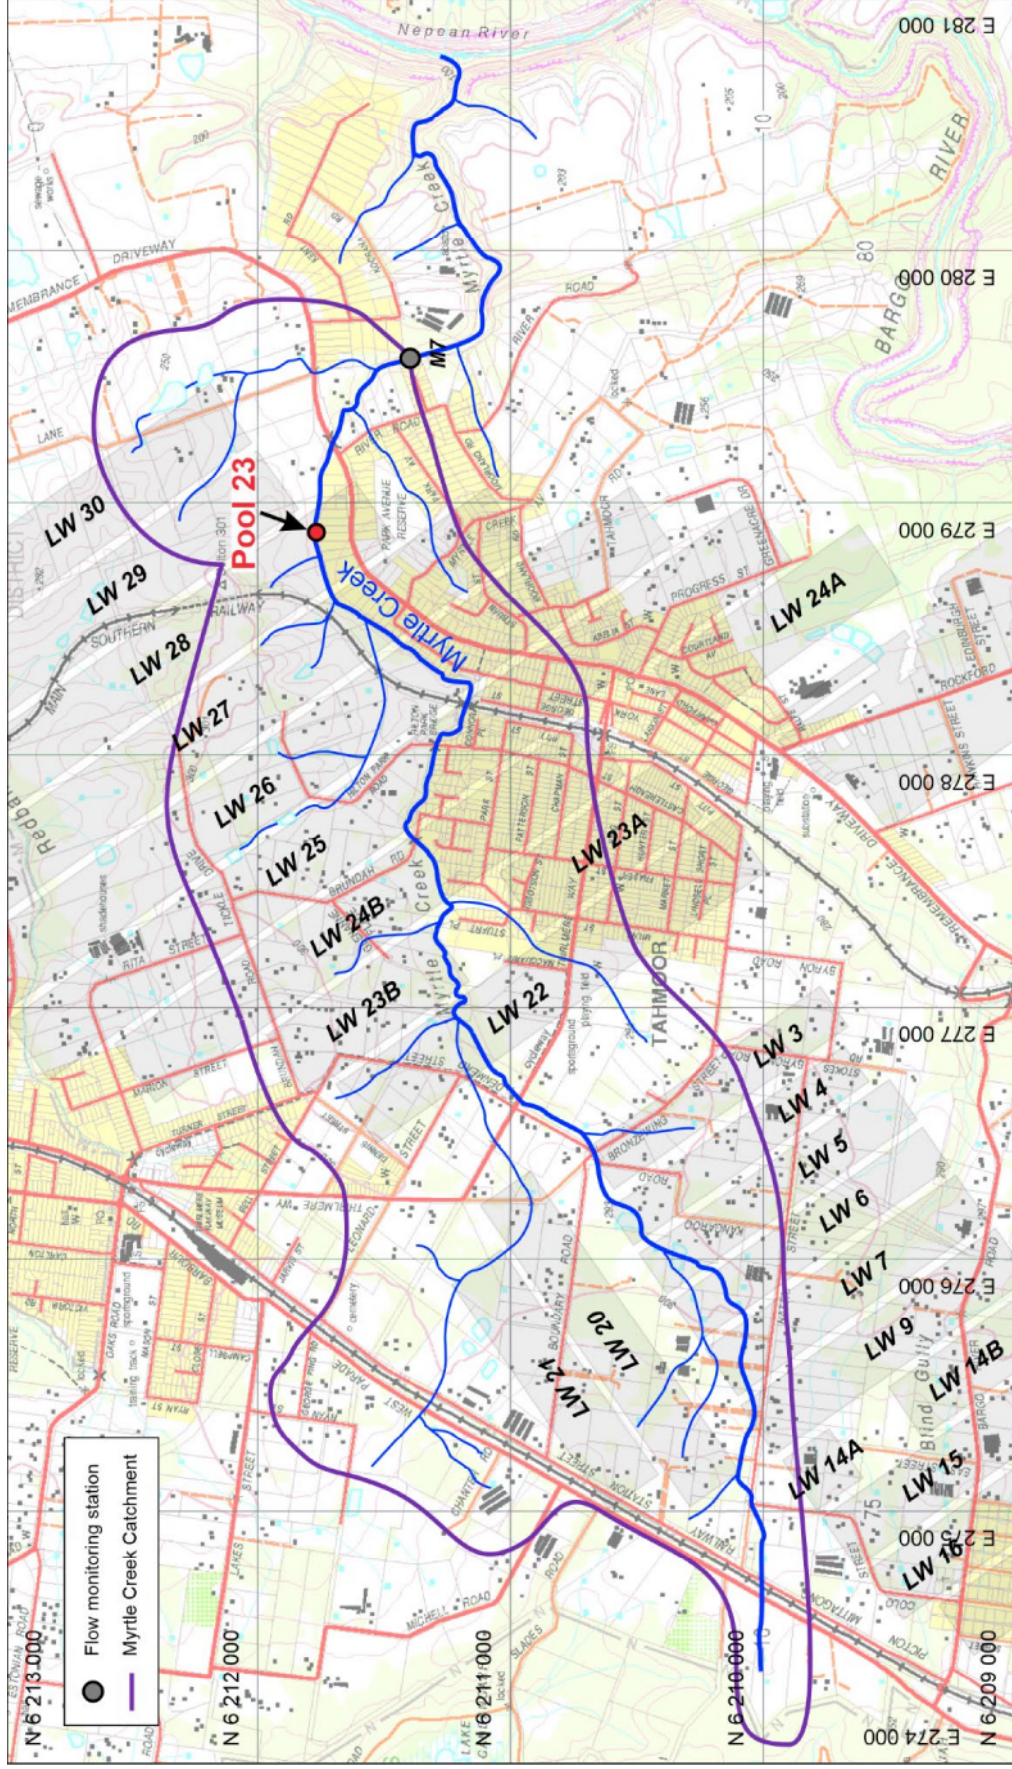
Figure 2 shows a plan of Myrtle Creek and the location of Pool 23 superimposed onto a 1:25,000 topographic series map of the area. The catchment upstream of the site is approximately 7km² in area. Average rainfall between 2004 and 2016 is approximately 760mm/yr.

Figure 2: Site plan showing Myrtle Creek catchment and location of Pool 23 relative to longwall panels superimposed on a 1:25,000 topographic series base.

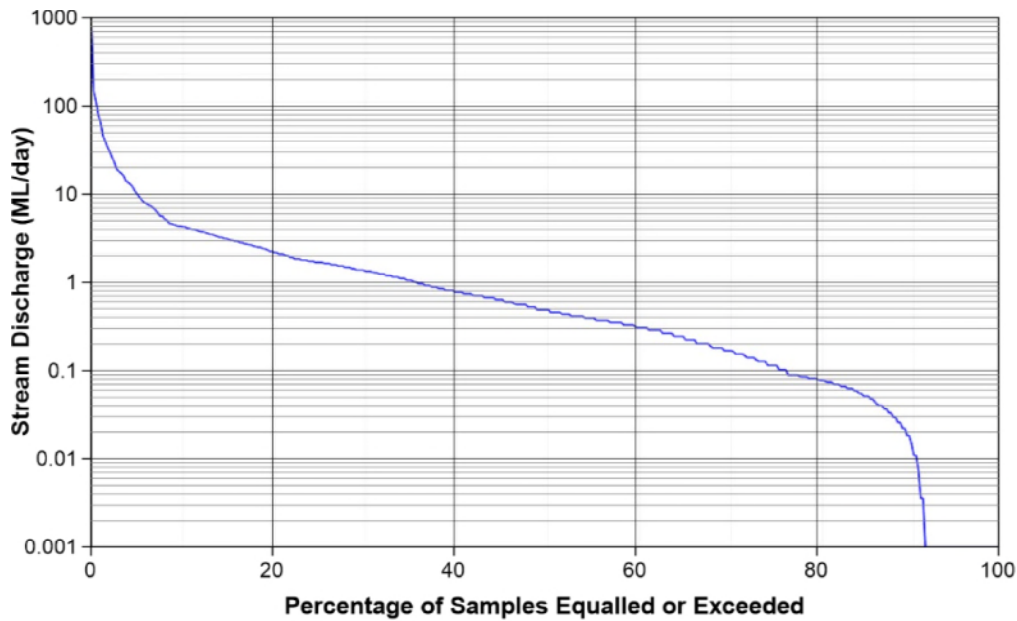
There is a flow station known as M7 located approximately 520m downstream of Remembrance Drive at CH1909m. This station has been in operation since 2010 and provides a near continuous record of the flow in the creek at this point. The catchment area above M7 is approximately 8km² in area. Figure 3 shows the time weighted stream discharge duration curve for Myrtle Creek. This plot shows that natural flow in Myrtle Creek averages approximately 1Ml/day but is less than 0.1Ml/day for approximately 15% of the time.

Figure 3: Time weighted stream discharge duration curve (after Hydrometric Consulting Services 2020).
