Report on
Geotechnical Assessment
Longwalls W3 and W4, Picton

Prepared for
Tahmoor Coal Pty Ltd

Project 89541.06
March 2021

Longwalls W3 and W4, Picton

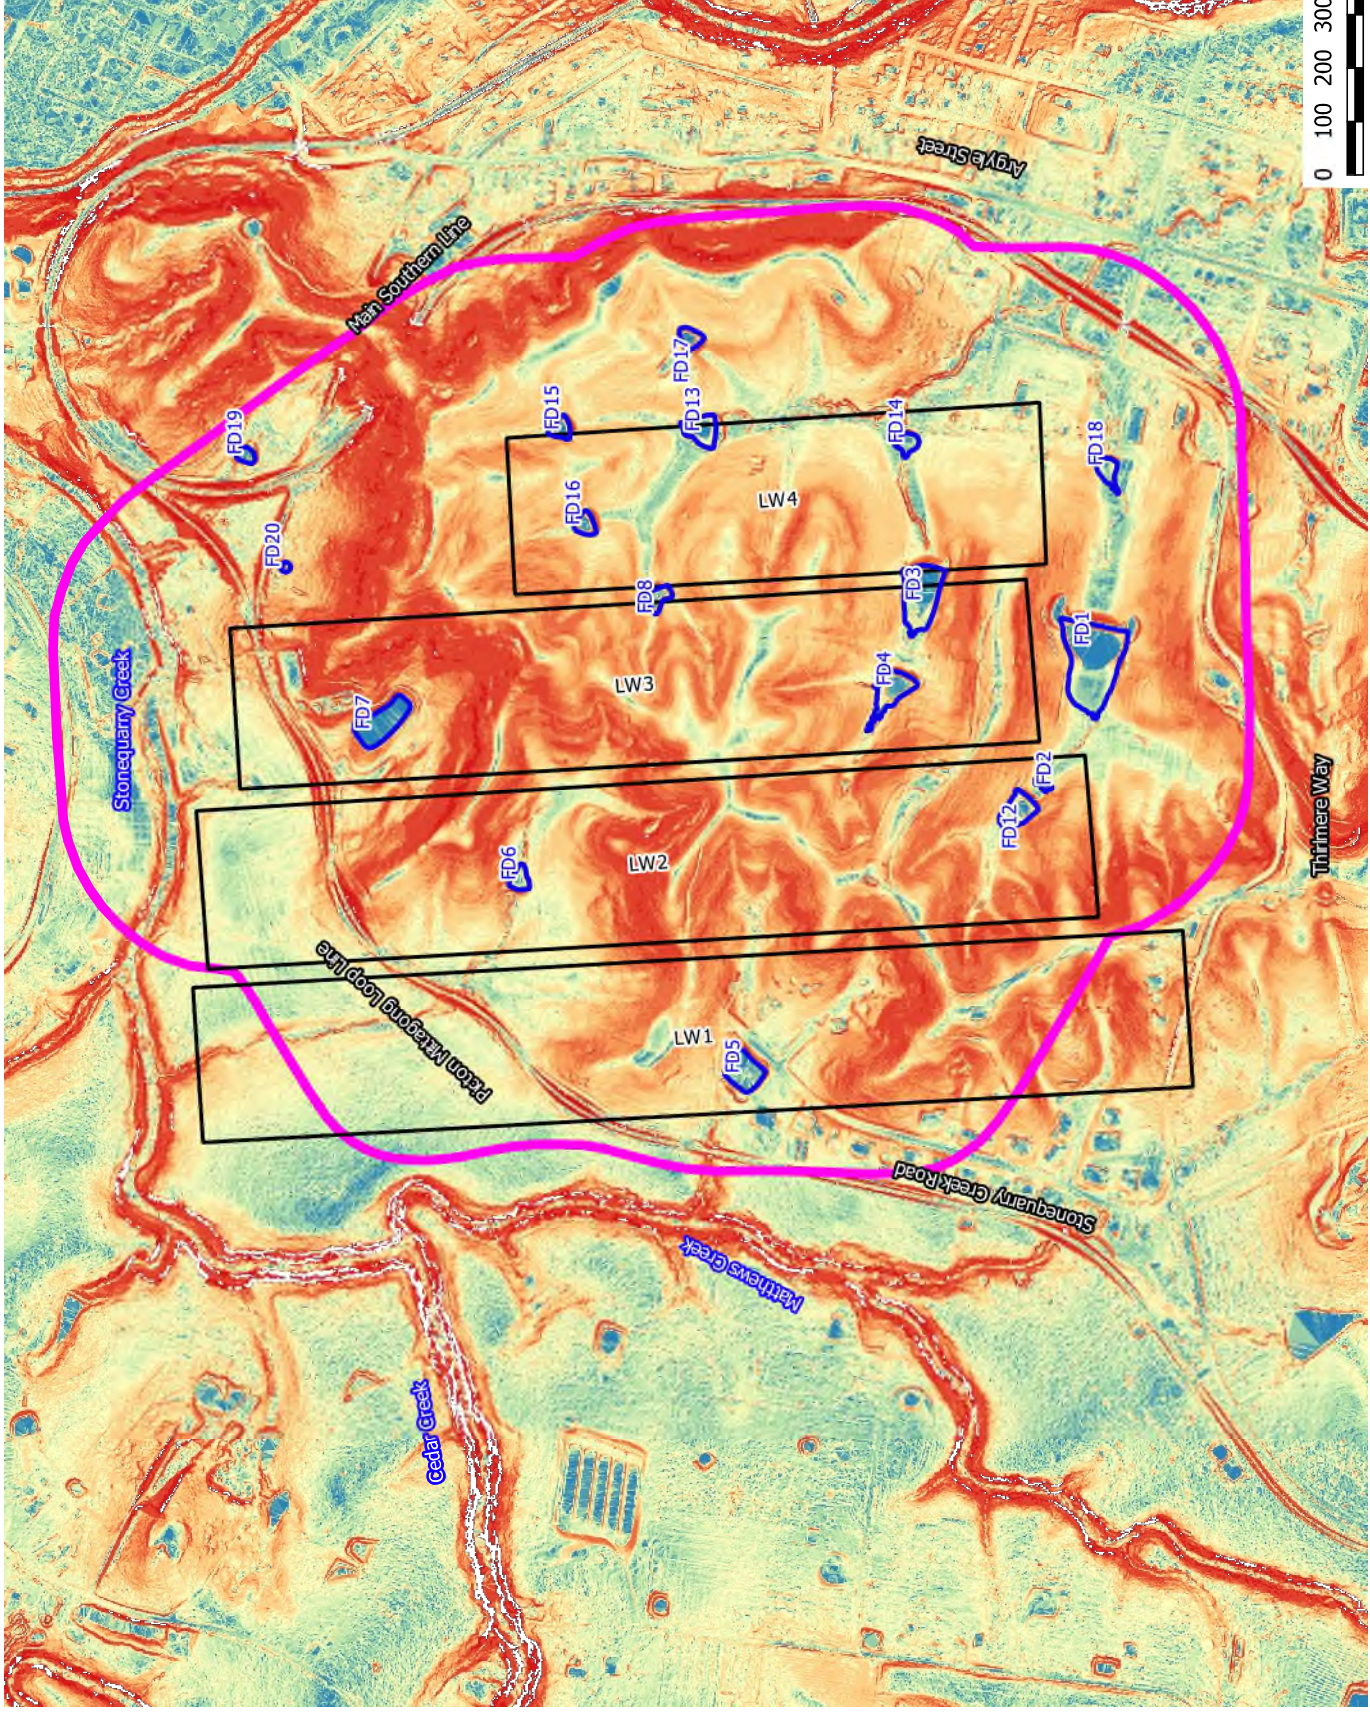
FD6 has a large slot through the centre of the embankment from a previous failure. The slot is estimated to be up to 2.5 m high and up to 1.5 m wide. While there is still limited water storage capacity in the dam, its capacity has been drastically reduced. Anecdotal information provided by a farmer that runs cattle on the site indicates a wombat hole was previously located in the embankment. There were no signs of a wombat hole during the current inspection. Review of historic aerial photography on Metromap.com.au indicates that the slot in the embankment was present in July 2018 (ie prior to the mining of Longwall W1) and the embankment was intact in December 2016, however, there are signs of erosion of the embankment in the vicinity of the slot, probably from overtopping. In its current state the damage to the existing farm dam is not considered to increase the risk to the Picton Mittagong Loop Line downslope. It is expected that erosion of the embankment will continue, over time, that will result in the total loss of storage capacity.

Loose material has been placed in front of the face of FD13. The grass in the loose material was lush and green, indicating potential seepage through the face. The material may also indicate buttressing of a previous failure in the downstream face.
