**CENTENNIAL TAHMOOR
LONGWALL PANELS 22, 23A and 23B
SURFACE WATER, DAMS & GROUNDWATER
END OF PANEL MONITORING REPORT
Tahmoor, NSW**

TA5-R1
15 JANUARY, 2007

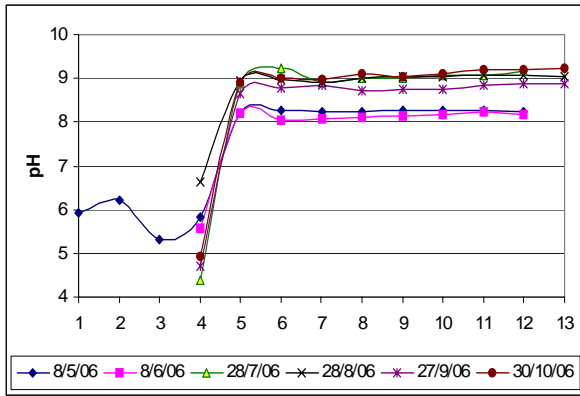
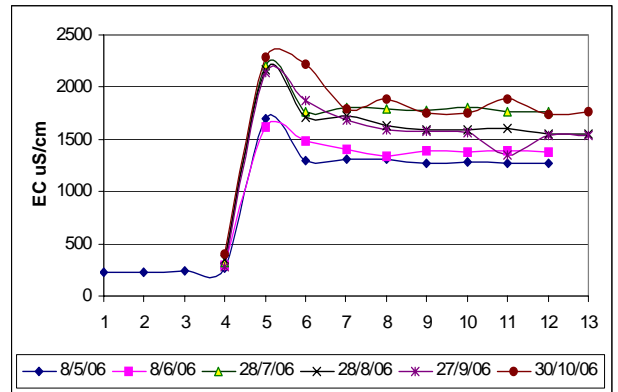
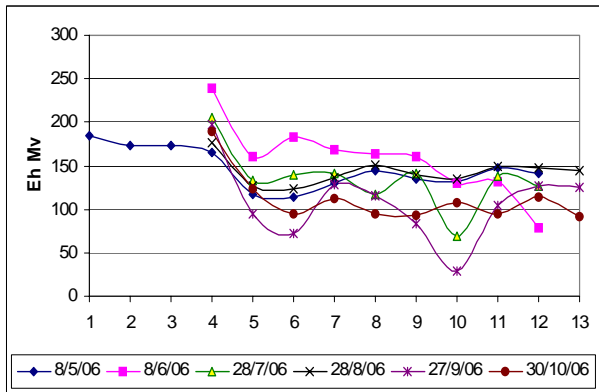
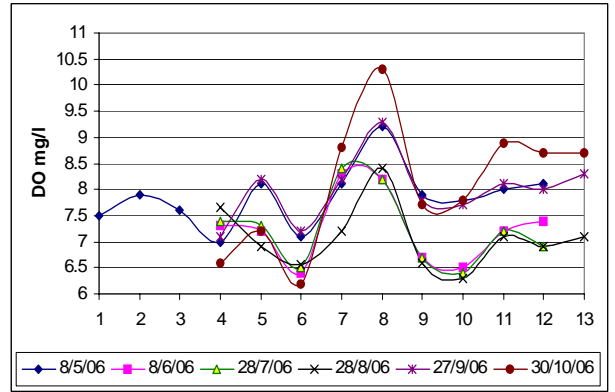
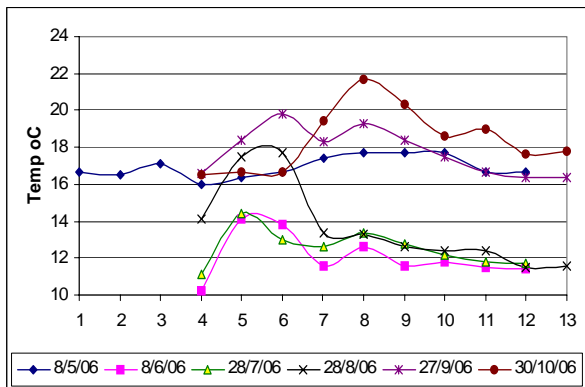
FIGURE 2 BARGO RIVER FIELD WATER QUALITY

Water quality in the Bargo as shown in **Figures 2 to 4** changes significantly downstream of the confluence with Teatree Hollow by becoming more alkaline (pH 4 - 5 to pH 8 - 9) and more saline (EC 250 μ S/cm to 1250 - 2250 μ S/cm), although there is no notable change in river water oxidation / reduction potential or dissolved oxygen levels. Temperature readings indicate a slight rise of up to 4°C downstream of Teatree Hollow with the current 6 months of monthly data.

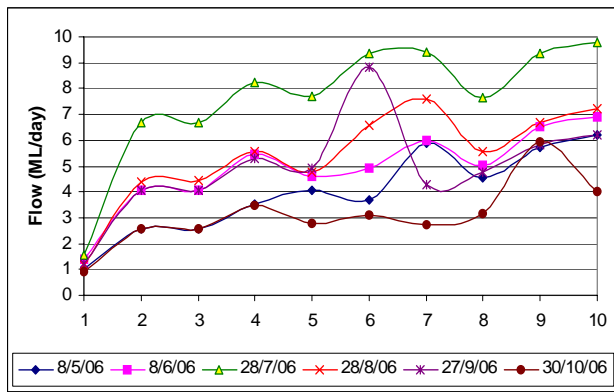
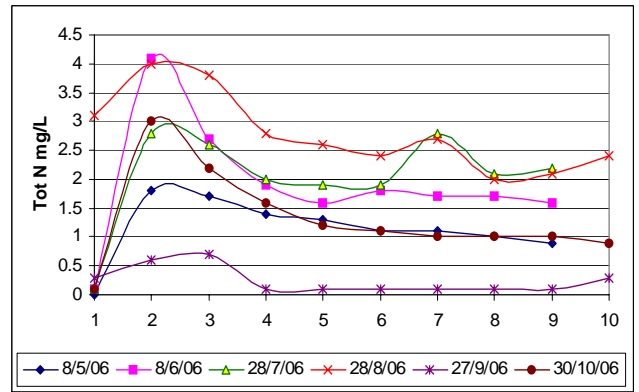
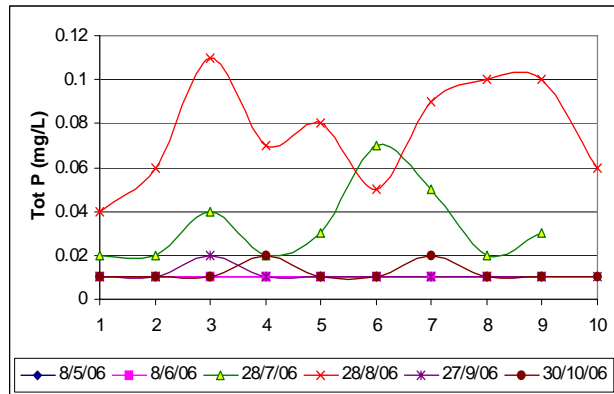
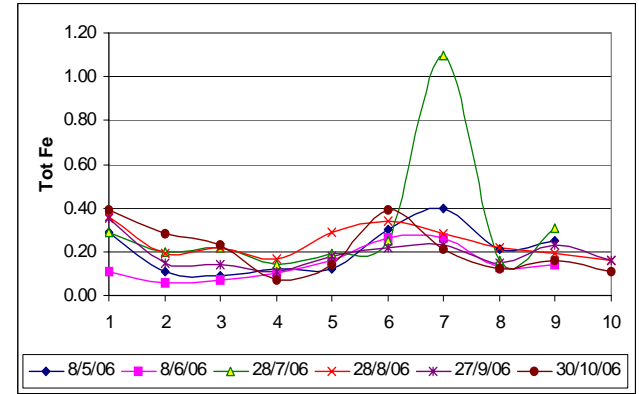
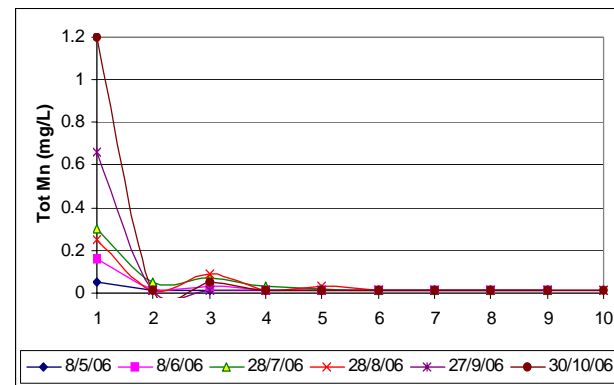
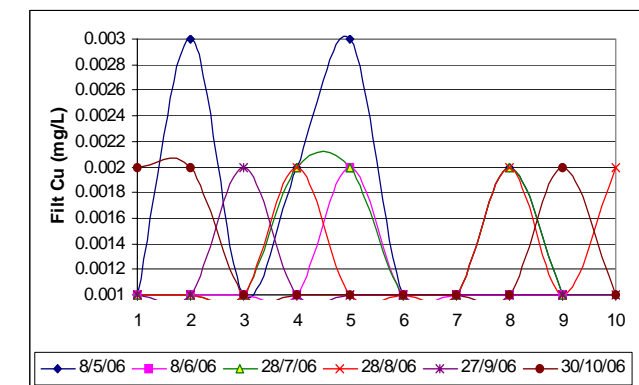
FIGURE 3 BARGO RIVER WATER QUALITY ANALYSES

Under the current dry flow conditions, with Teatree Hollow dominating the river flow, the river progresses from HCO₃-Cl dominant immediately downstream of Bargo Weir, through Na-Cl dominant to the confluence with Teatree Hollow, after which it becomes Na-HCO₃ dominant through the main Panel 22 to 26 study area, then slightly altering to Na-HCO₃-Cl dominant toward the confluence with the Nepean River.

Significant rises of up to 4mg/L for Total Nitrogen downstream of Teatree Hollow are also noted, whilst Total Phosphorous does not indicate a definitive rise due to inflow from Teatree Hollow.

Filterable copper does not show a distinctive rise with inflow from Teatree Hollow and zinc has a small rise which tapers off with distance downstream in the river.

Filterable nickel shows a distinctive rise downstream of the Teatree Hollow inflow by up to 0.08mg/L, which does not notably taper off with flow downstream, whilst arsenic, with rises by up to 0.05mg/L tapers off with flow downstream of the mine discharge.

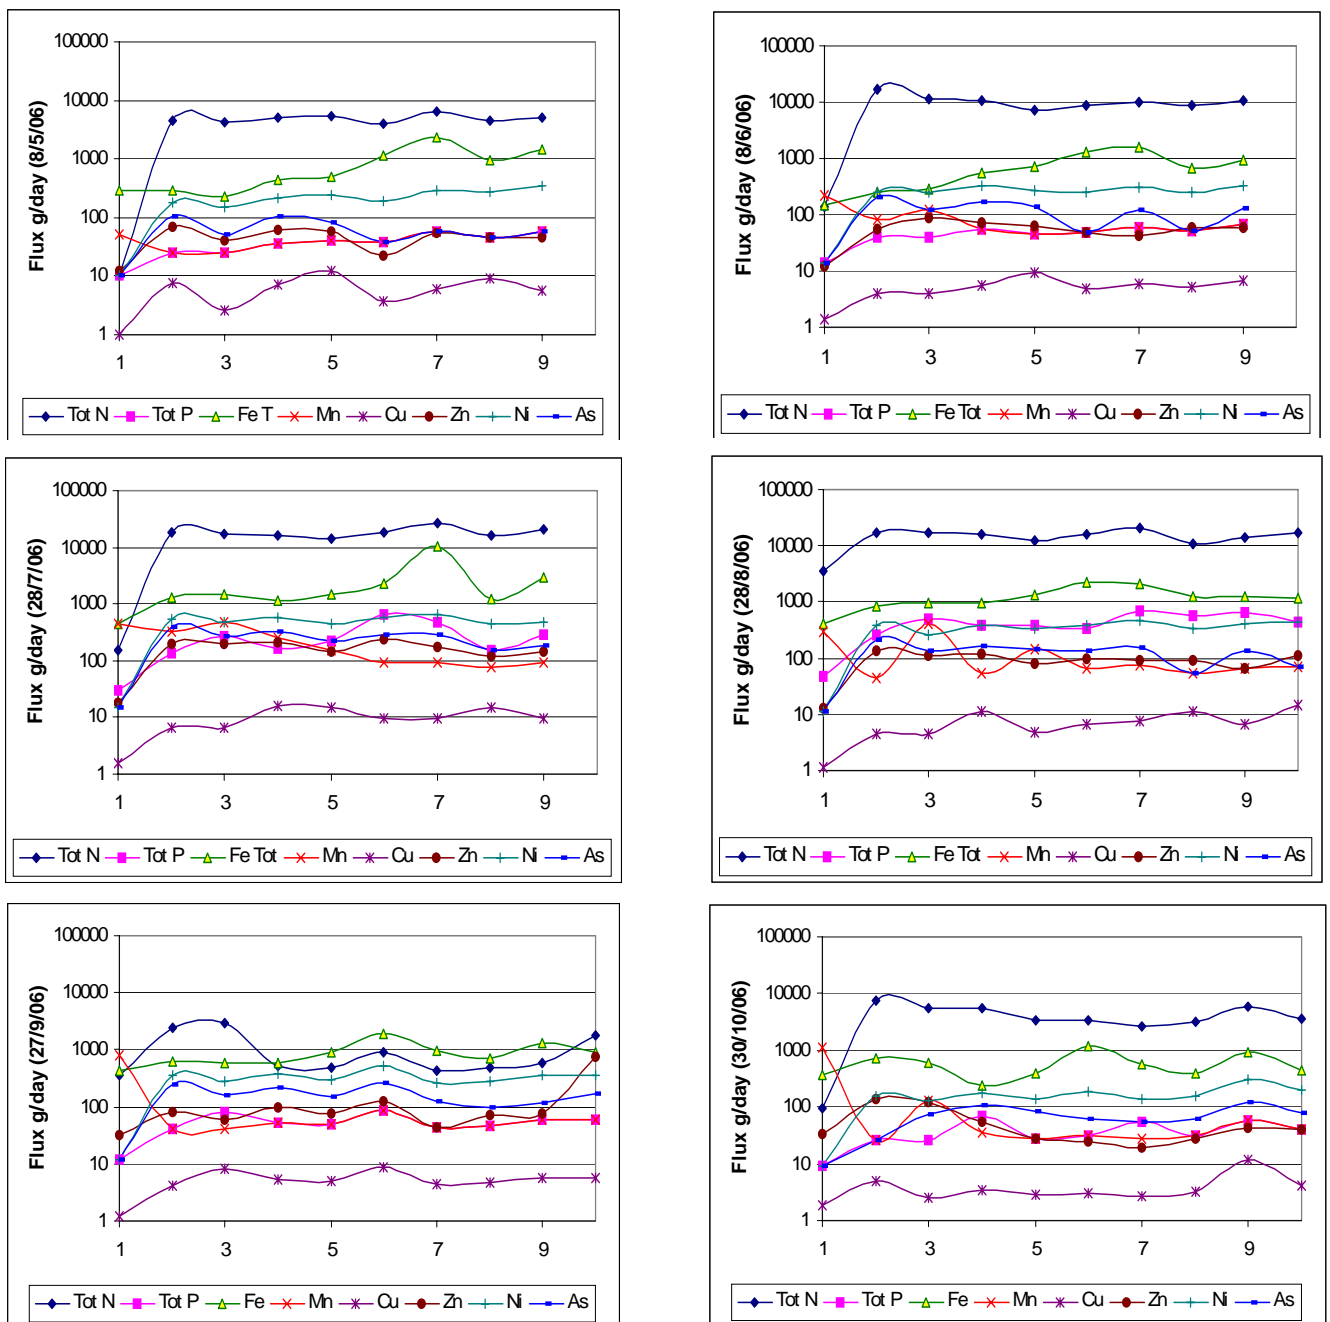
FIGURE 5 BARGO RIVER WATER PARAMETER FLUX

Total flux of selected parameters in the river shown in **Figure 5** was derived by multiplying the monitored or interpreted river flow at selected points in the gorge (HCS, in prep) with the relevant laboratory analysis.

Based on the calculated data, the main input from the mine discharge is Total Nitrogen, with a rise downstream of Teatree Hollow of up to almost 3 orders of magnitude, followed by nickel with a 1 to 2 order of magnitude rise and arsenic with a rise of over 1 order of magnitude.

It should be noted that where analyses were below the lower detection limit (LDL), the LDL was used in the calculations, thereby enhancing the actual flux of that reading.

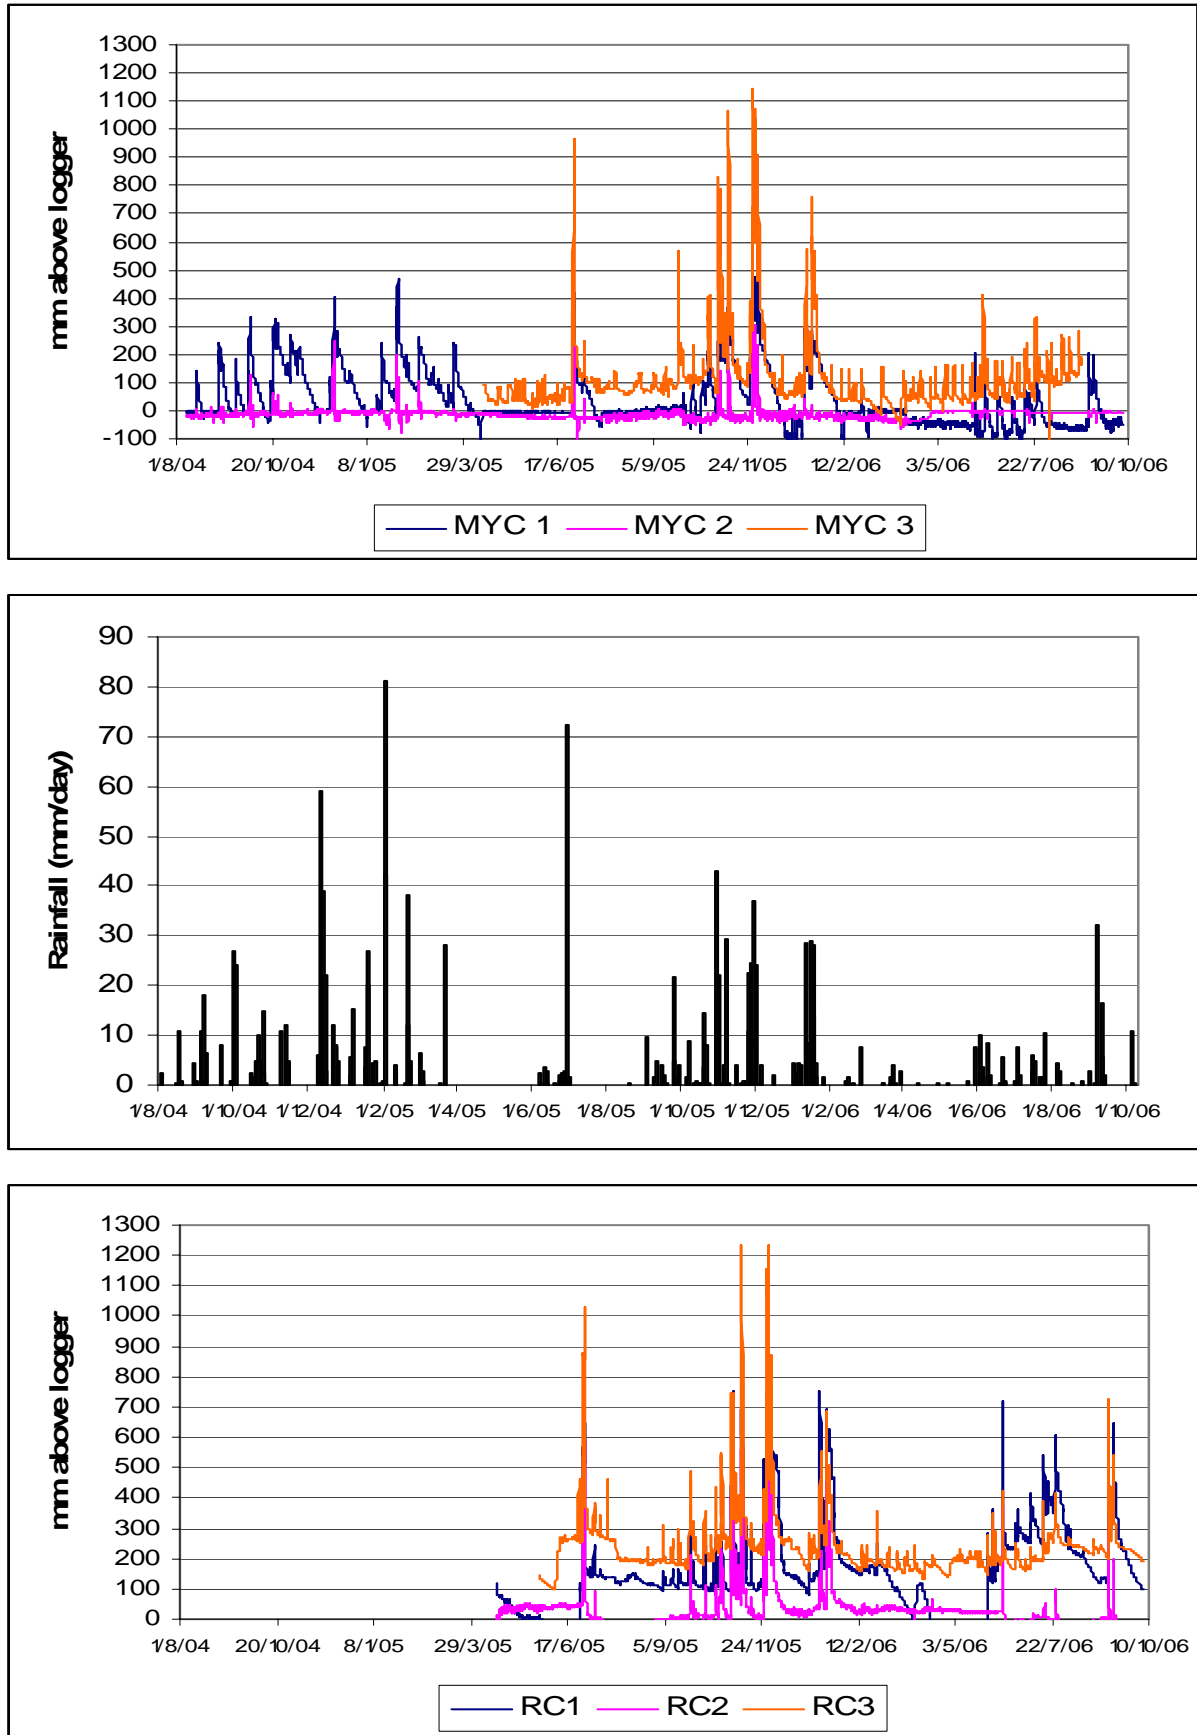
FIGURE 6 Stream Water Depth in Myrtle and Redbank Creeks

No change in stream flow has been observed within Myrtle Creek or Redbank Creek during or after extraction of Panels 22, 23A and 23B, with creek flow at selected locations shown in **Figure 6**.

Cracking has been observed in Myrtle Creek over Panels 22 and 23B, however the effect on stream flow, water quality, ponding or flow reversal have not been directly measured within the Panel 22, 23A and 23B 20mm subsidence zone as the creek has been essentially dry during the monitoring period.

Redbank Creek has also been essentially dry throughout the monitoring period, within the potential subsidence zone, however it has not been undermined as yet by longwall extraction.

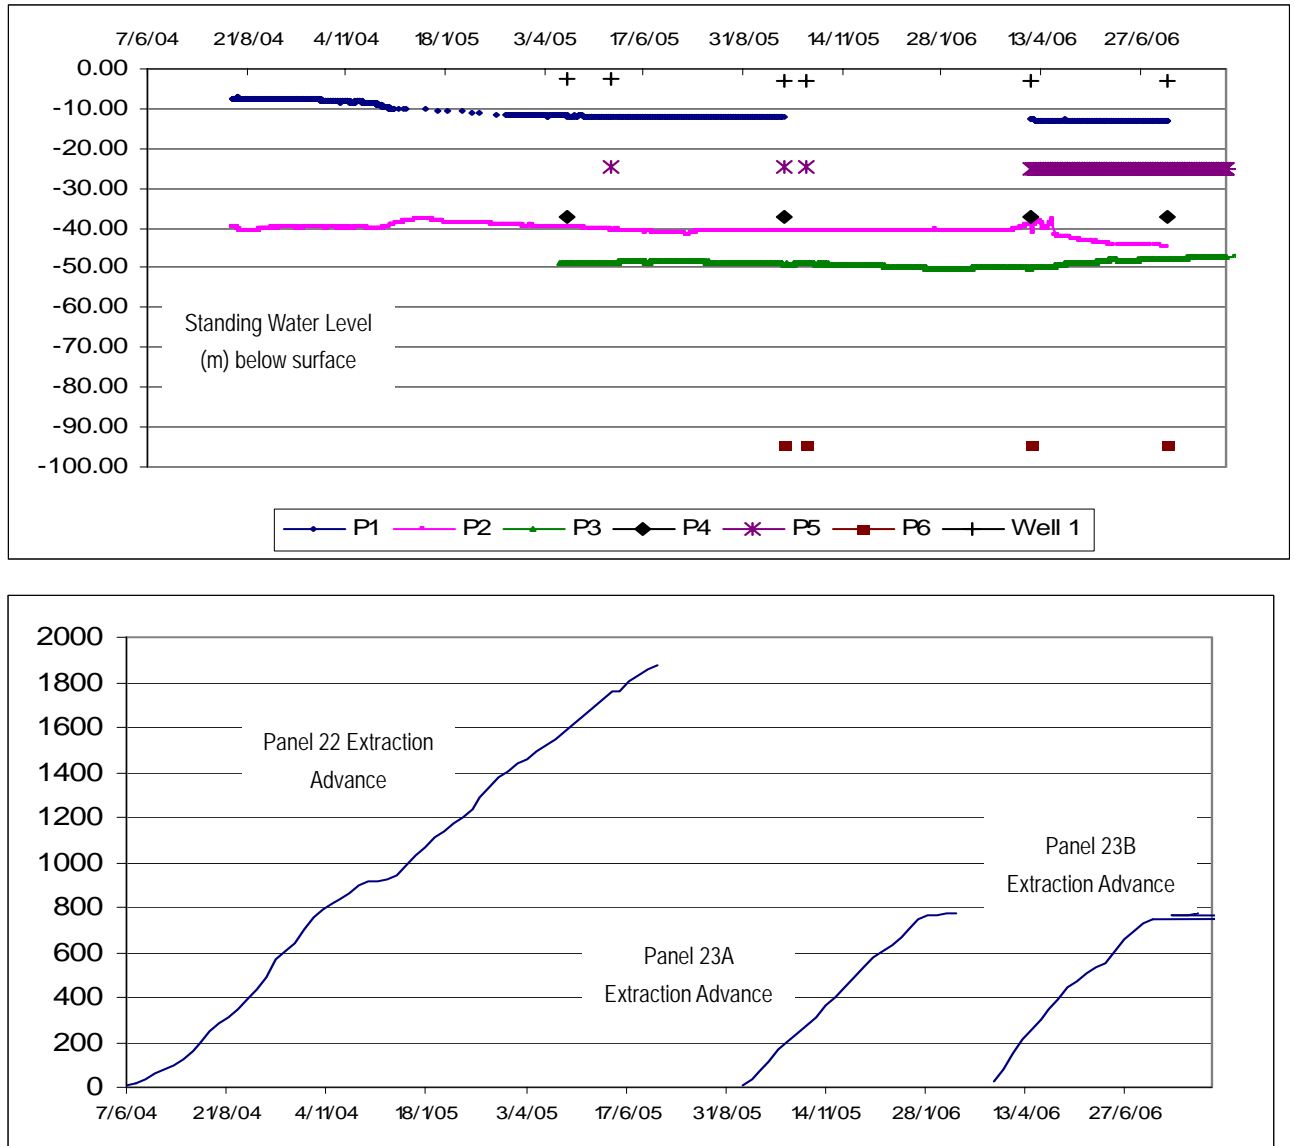
FIGURE 7 Standing Water Levels and Panel Extraction

The post subsidence reduction in groundwater levels is anticipated to be temporary, until such time that sufficient rainfall and infiltration occurs to replenish the groundwater system. Permanent post mining water level reduction is not anticipated as none of the bores are located close to the Bargo River gorge for new enhanced flow paths to be generate and allow additional groundwater to drain to the river.

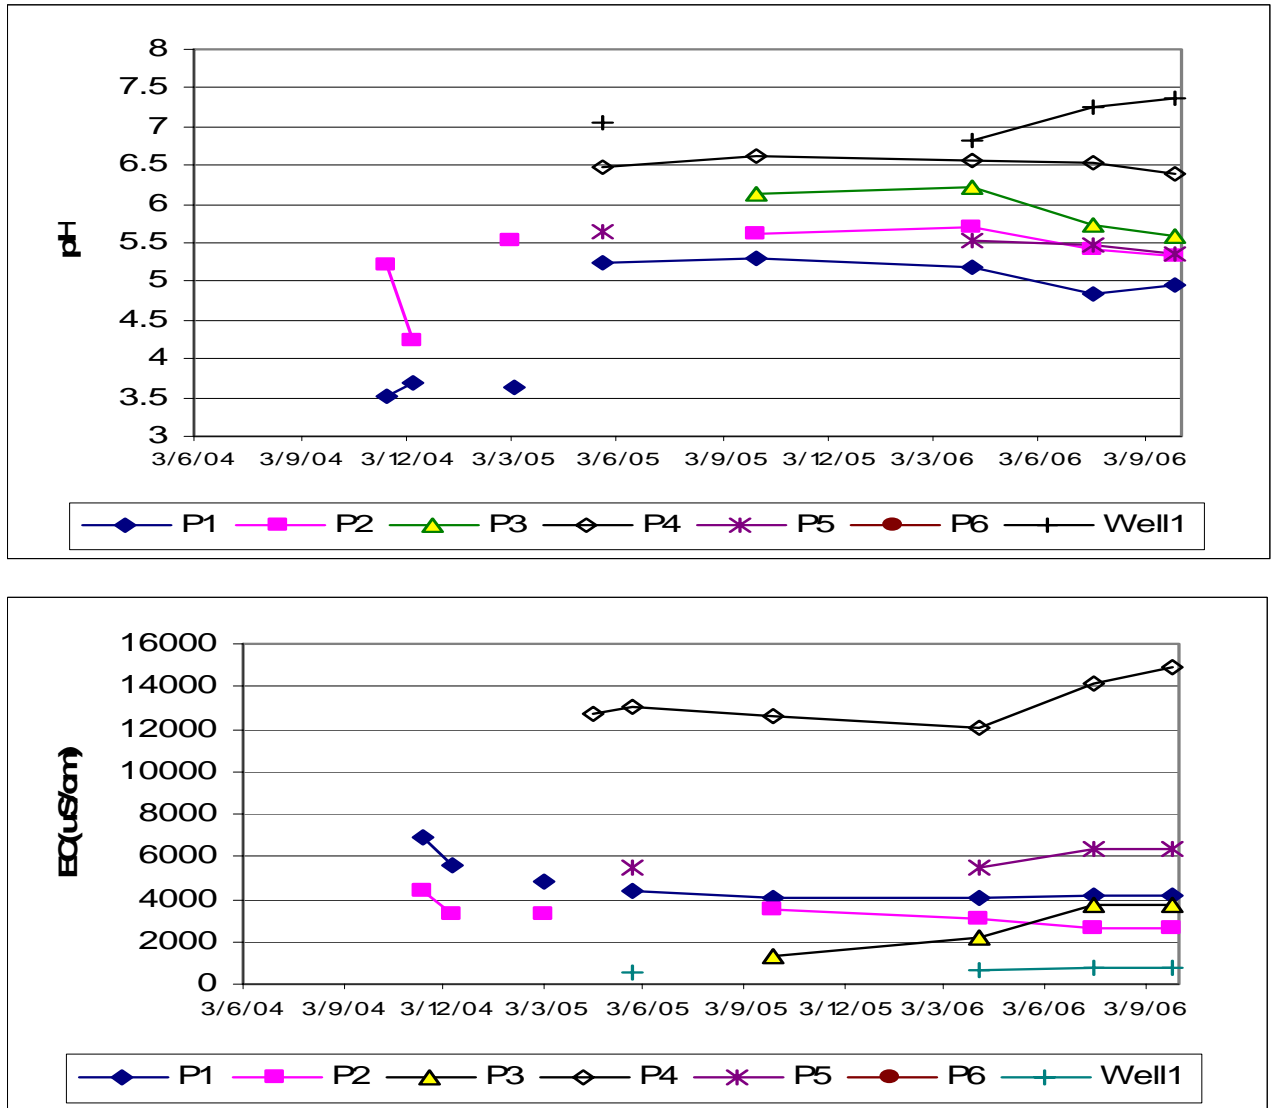
FIGURE 8 Field Groundwater Quality

Groundwater in the study area has generally brackish salinity (564 μ S/cm to 14,940 μ S/cm) with acid to circum-neutral pH (3.53 to 7.36) as shown in **Figure 8**.

Adverse changes to groundwater quality of the subsided bores has not been observed, with no distinctive increase in dissolved total iron or salinity and no distinctive lowering of pH.
