# **TAHMOOR COLLIERY LONGWALL 24A**

**END OF PANEL  
SUBSIDENCE MONITORING REPORT  
FOR LONGWALL 24A  
AT TAHMOOR COLLIERY**

**REPORT NO. MSEC335**

**January 2009**

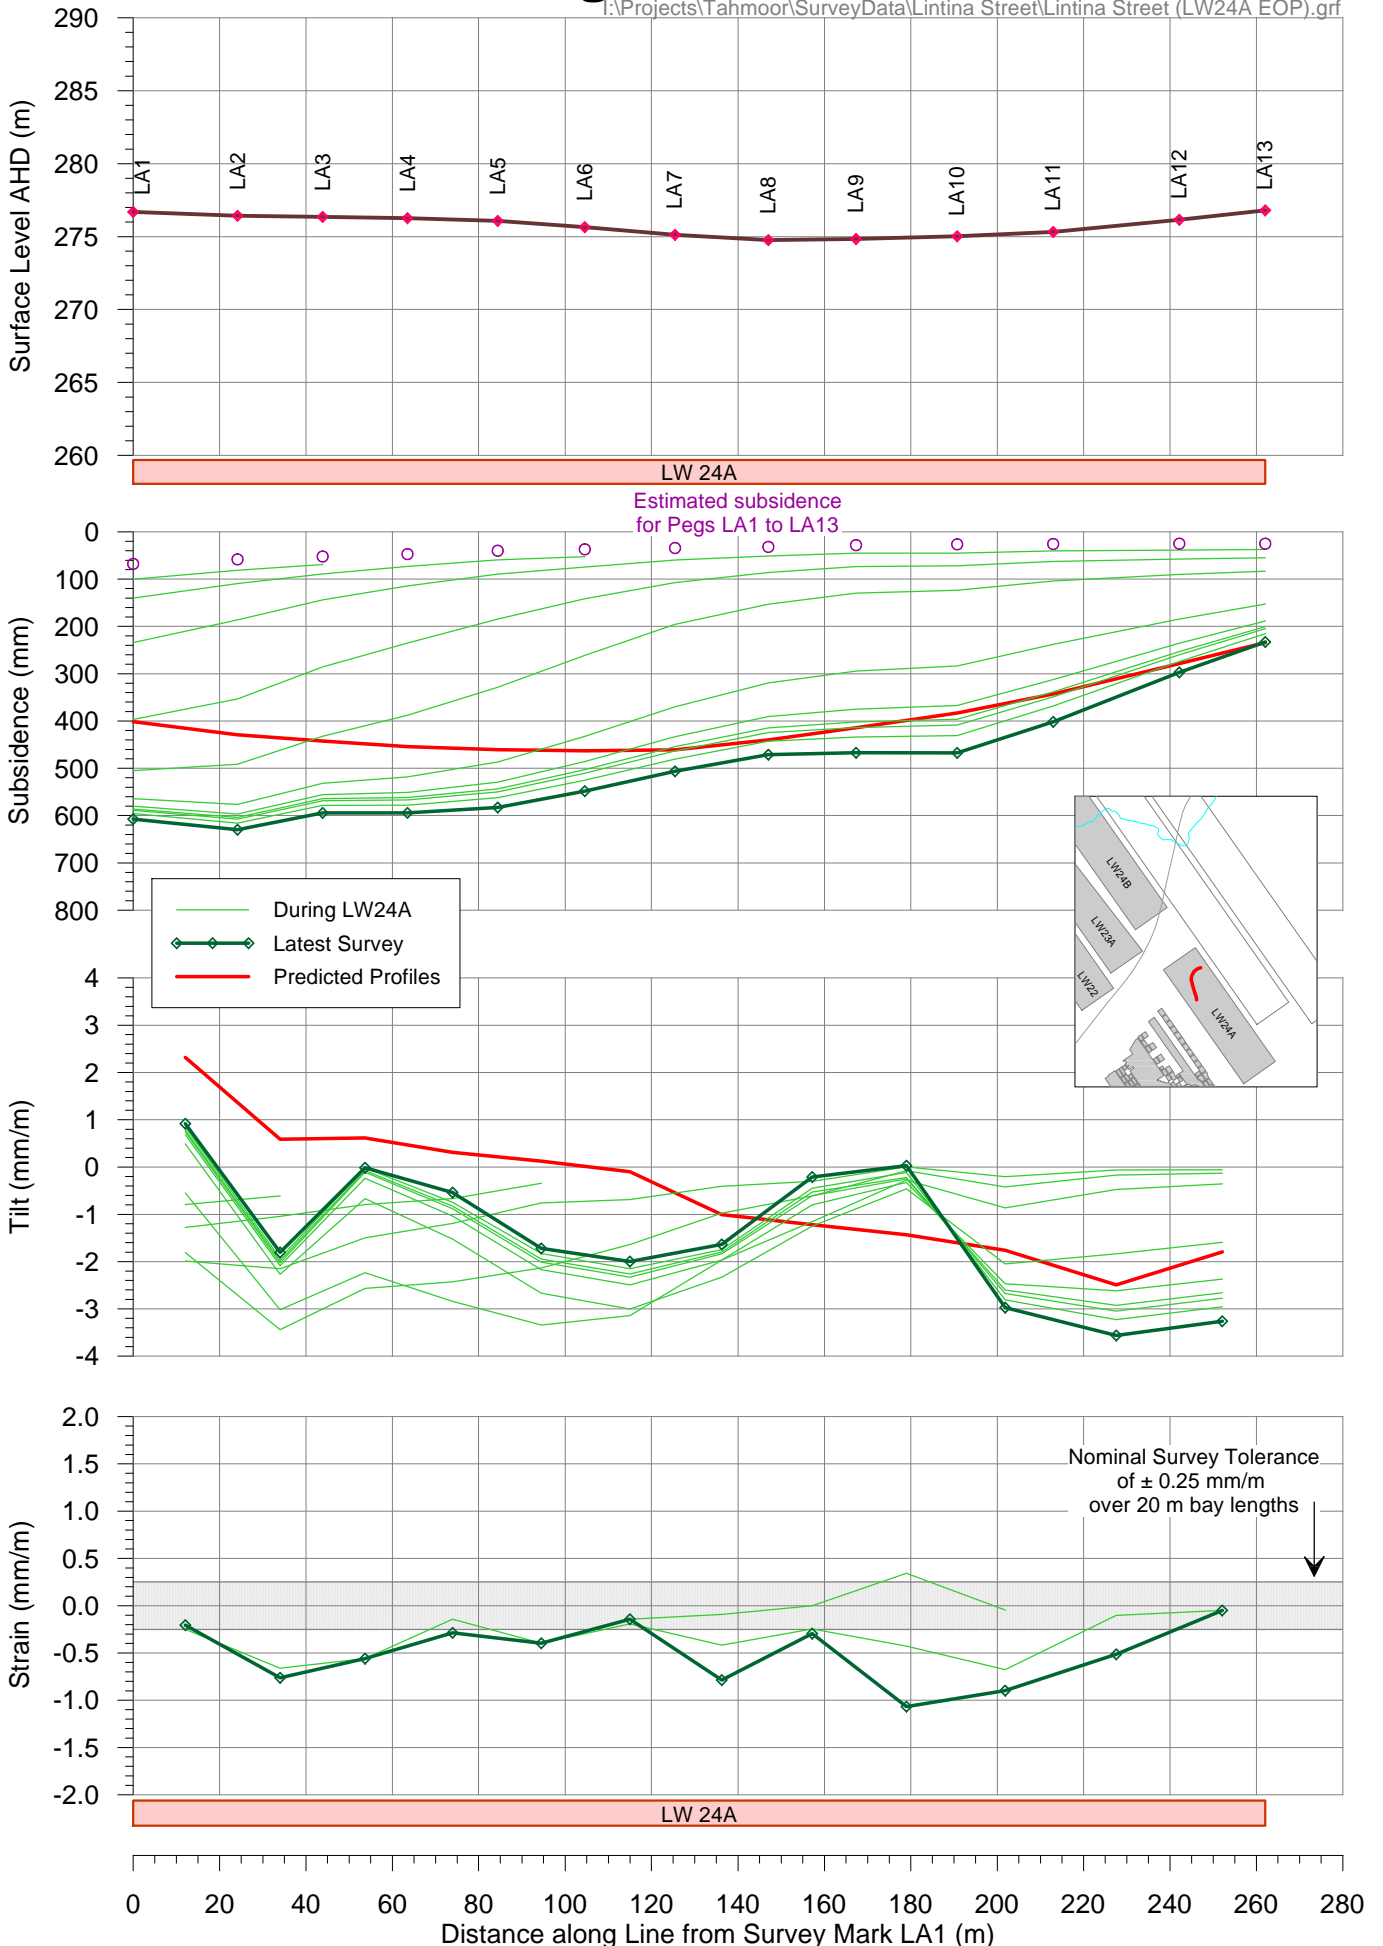
# Tahmoor Colliery - Total Subsidence Profiles along Lintina Street

One of these impact sites, located on Lintina Street above Longwall 24A, was substantially greater than the other 11 impact sites. A selection of photographs is provided in Figure 4.1. The impacts on Lintina Street were repaired twice as the longwall progressed.

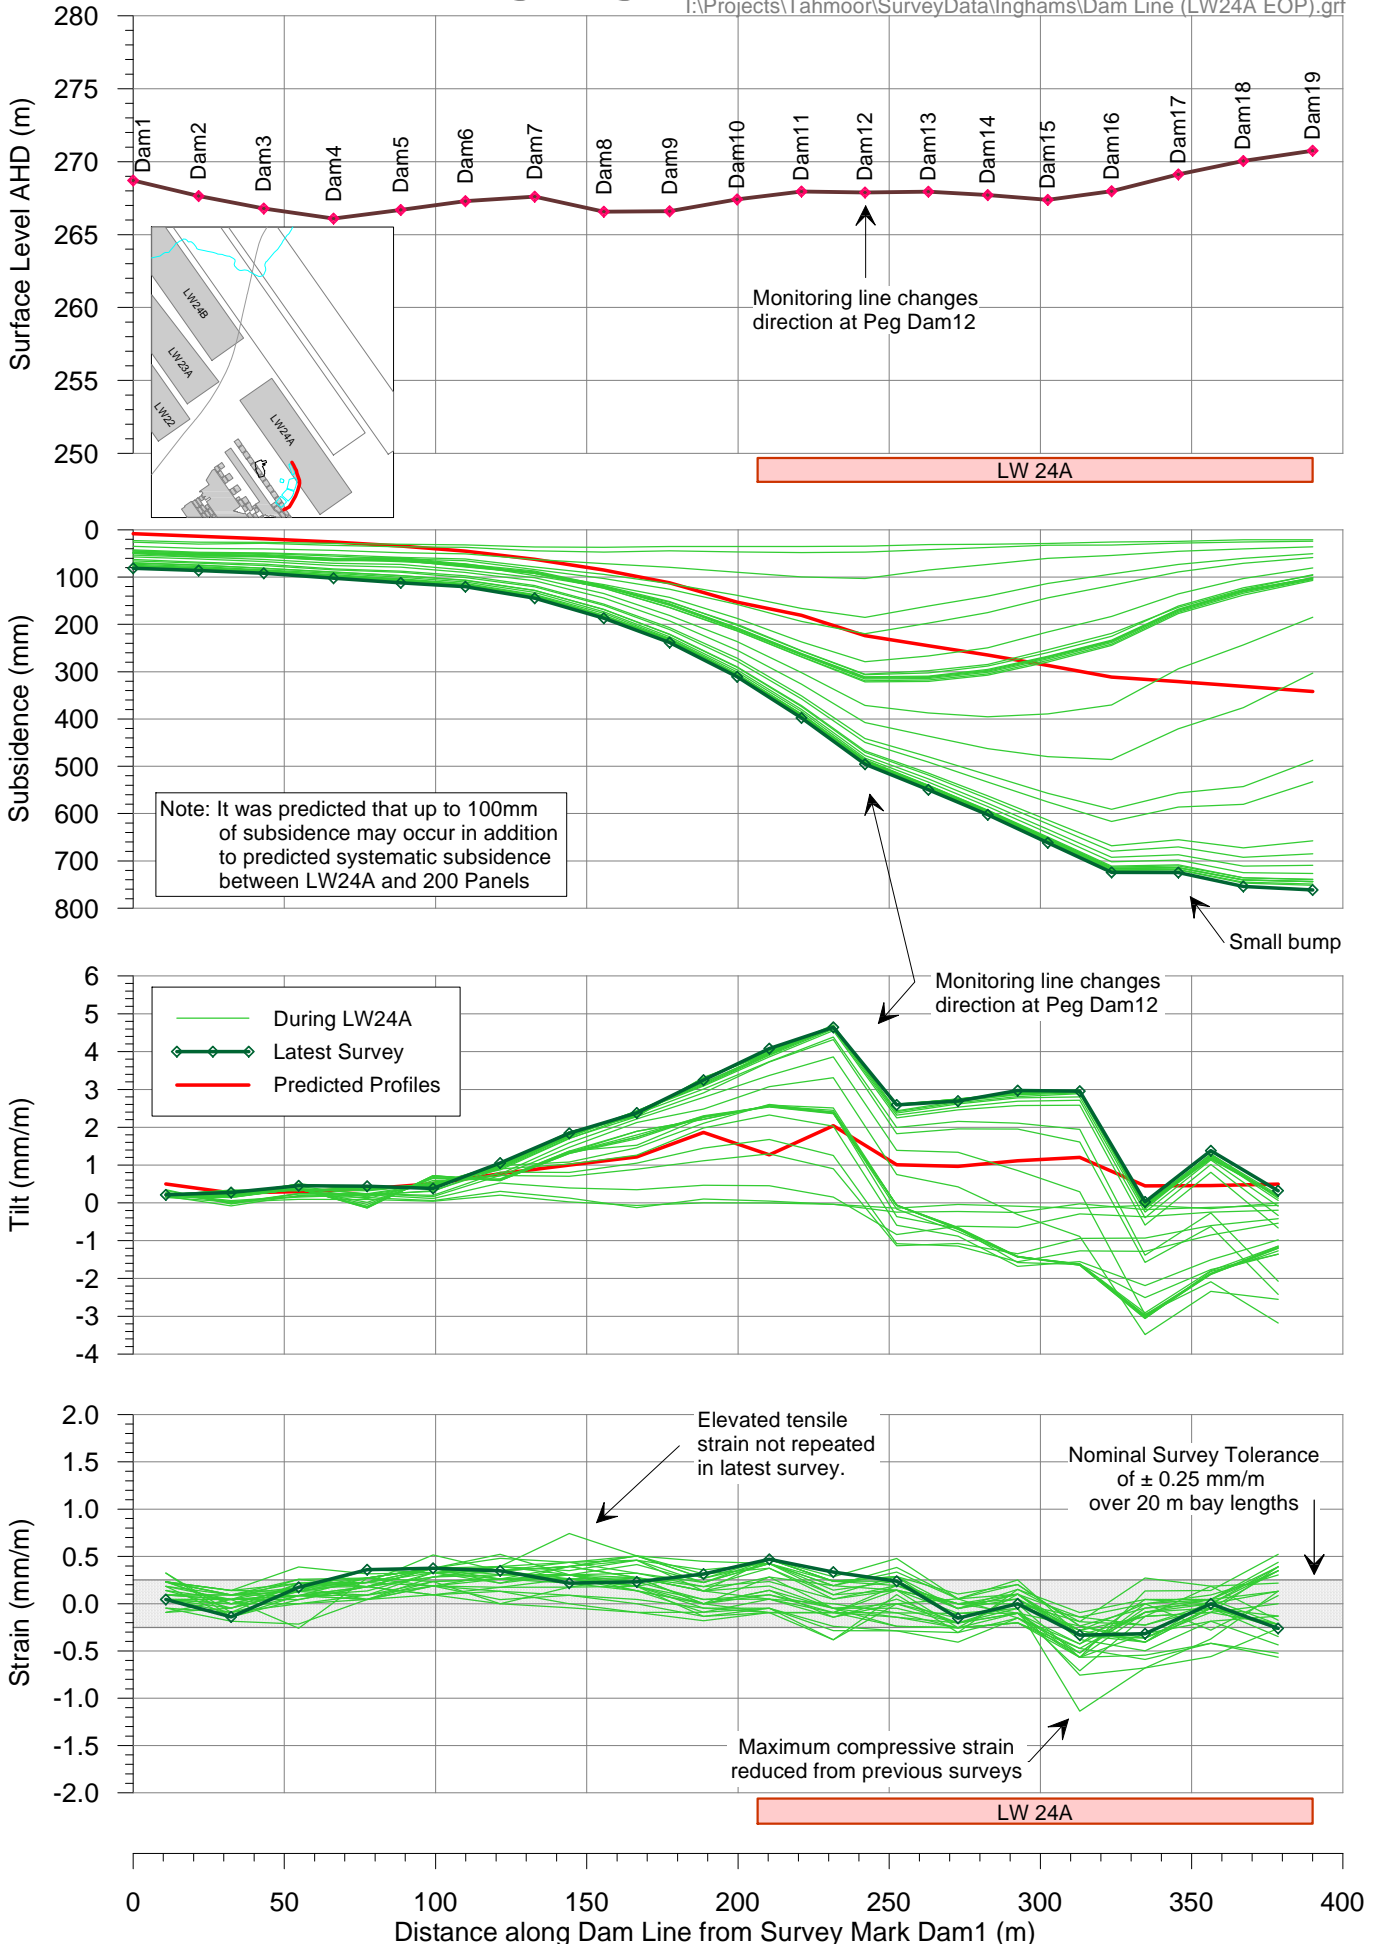
# Tahmoor Colliery - Total Subsidence Profiles along Inghams Dam Line

While subsidence developed as expected at the Plant, increased subsidence was observed at the dams. This was not predicted.

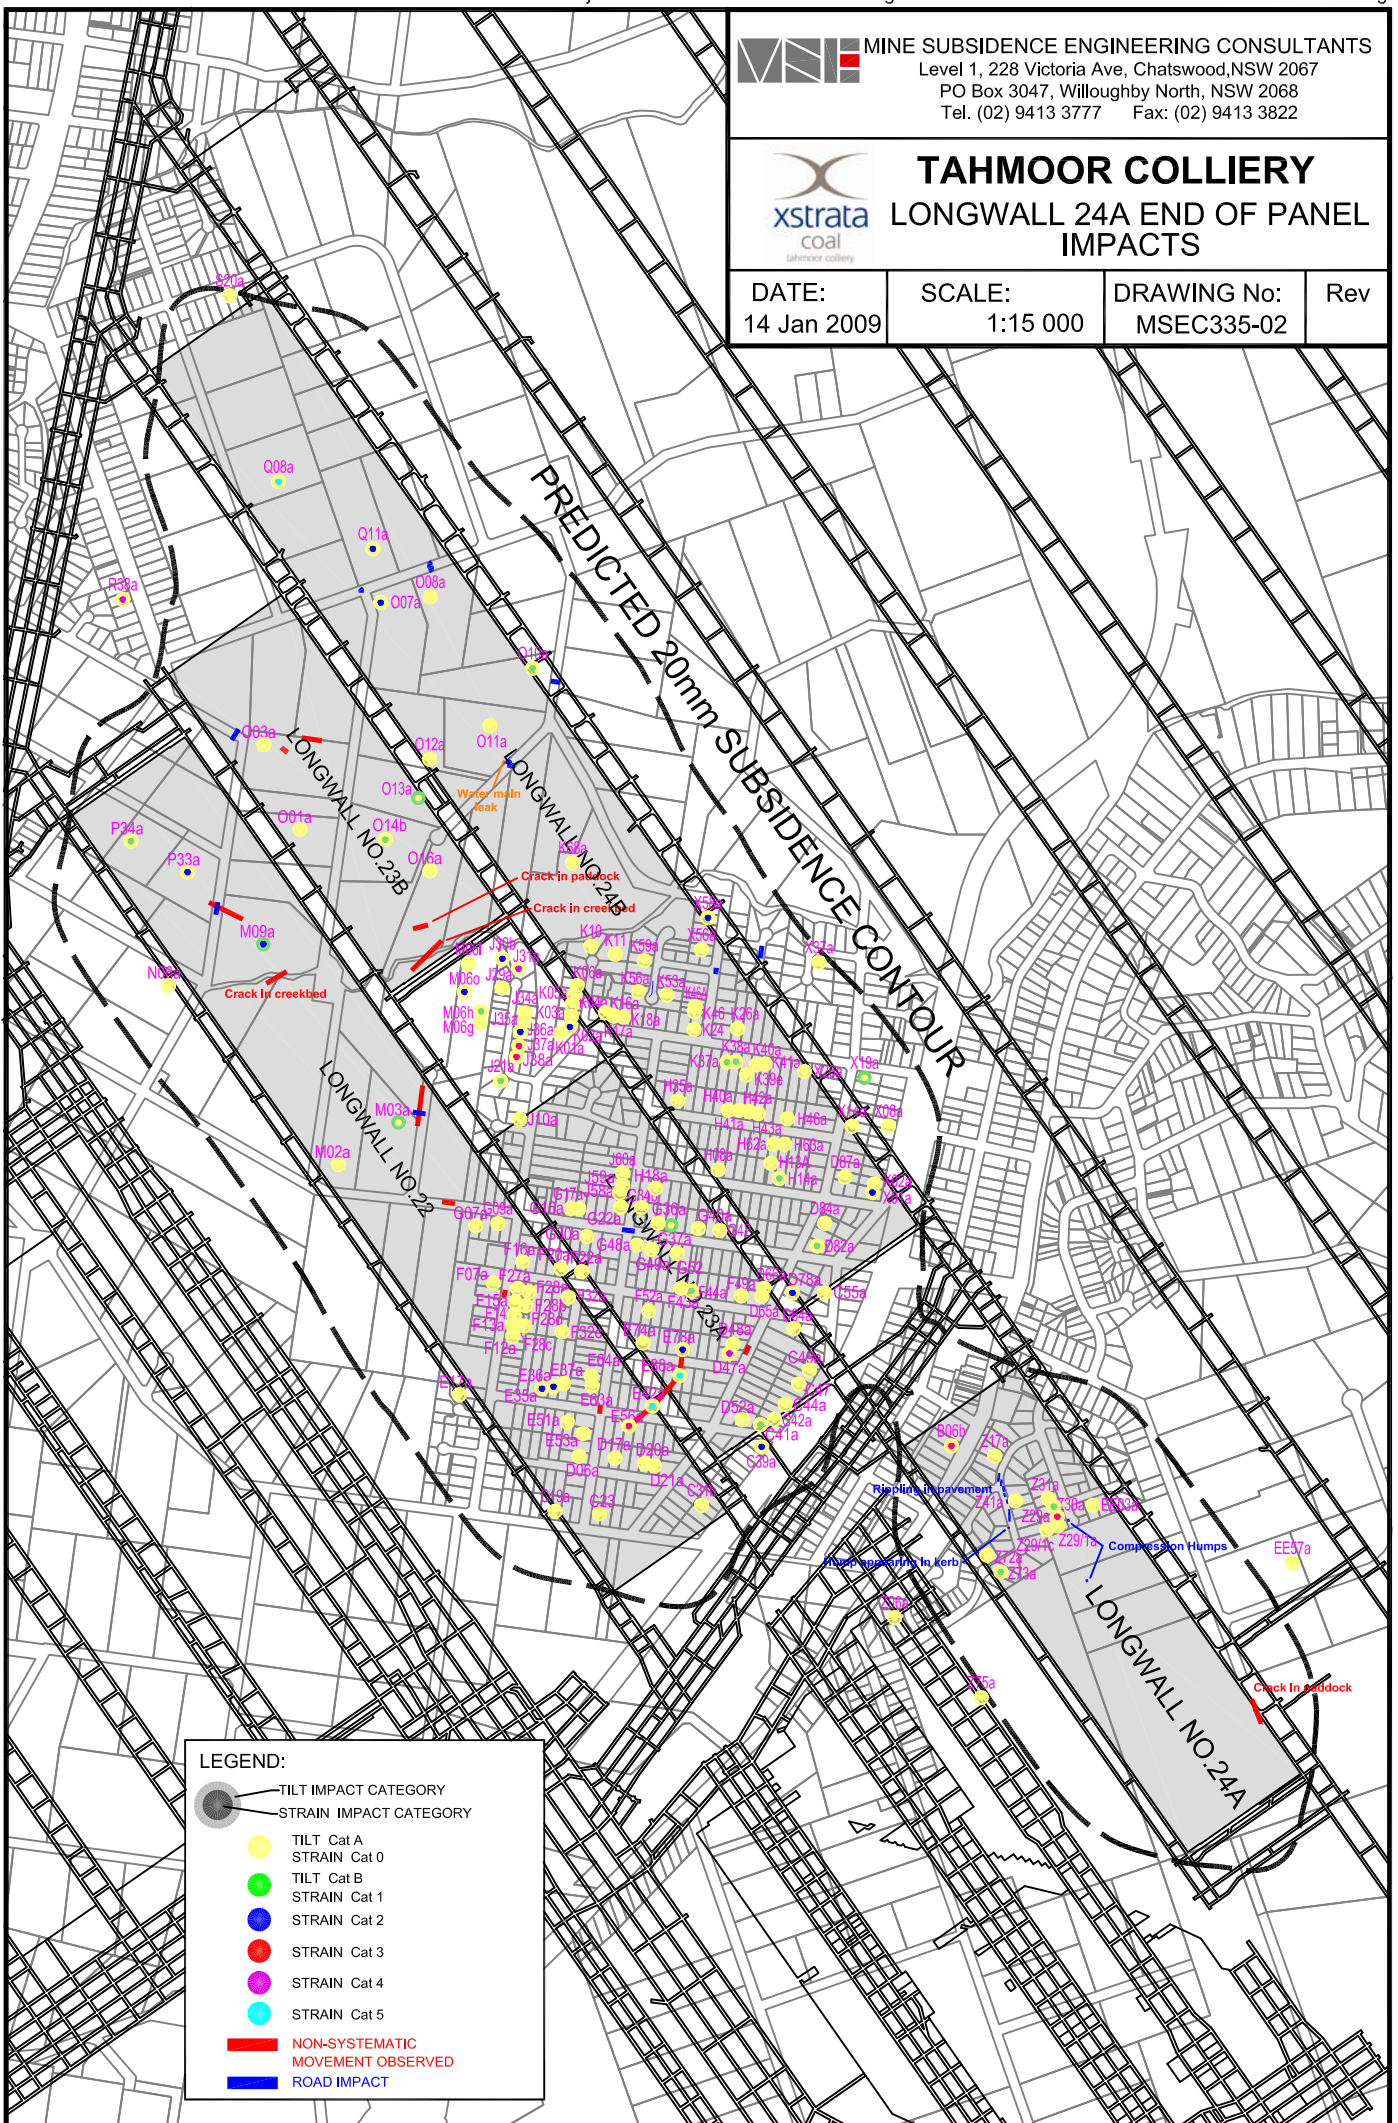
DATE: 14 Jan 2009	SCALE: 1:15 000	DRAWING No: MSEC335-02	Rev
----------------------	--------------------	---------------------------	-----

## LONGWALL 24A END OF PANEL IMPACTS
