**XSTRATA COAL – TAHMOOR COLLIERY
END OF LONGWALL 24A
SURFACE WATER, DAMS & GROUNDWATER
MONITORING REPORT
Tahmoor, NSW**

TA8-R2
16 JANUARY 2009

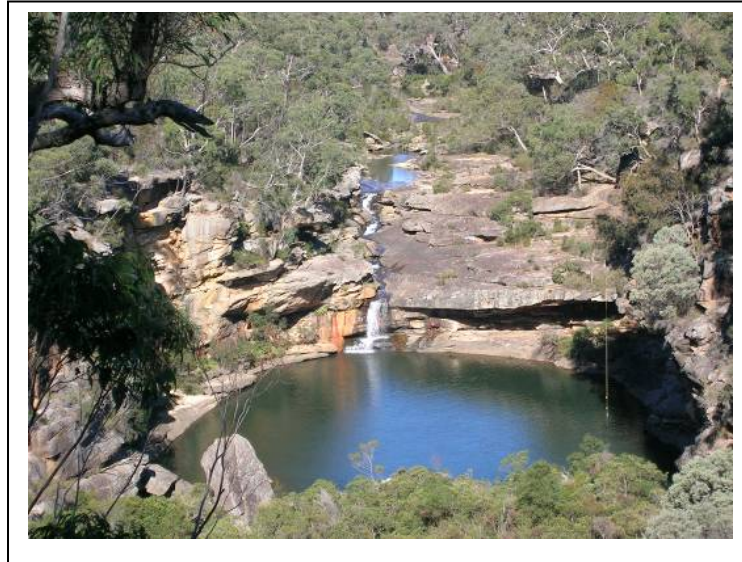
PHOTOGRAPH 7 Mermaid Pool

Mermaid Pool is approximately 1km south and upstream of longwalls 22 to 26 and is upstream of the 20mm subsidence zone.

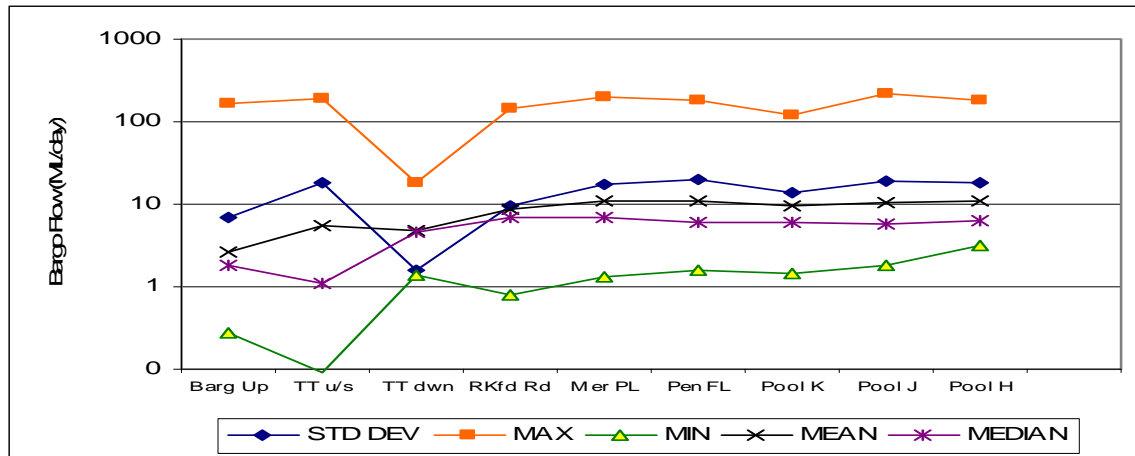
FIGURE 3 Bargo River Flow Summary (31/1/06 - 29/9/08)

Some anomalous maximum flow data from upstream of Teatree Hollow upstream is also present in the data base supplied by HCS Pty Ltd, however the minimum, mean and median flow data shows a minor increase in flows down the gorge as shown in **Figure 3**.

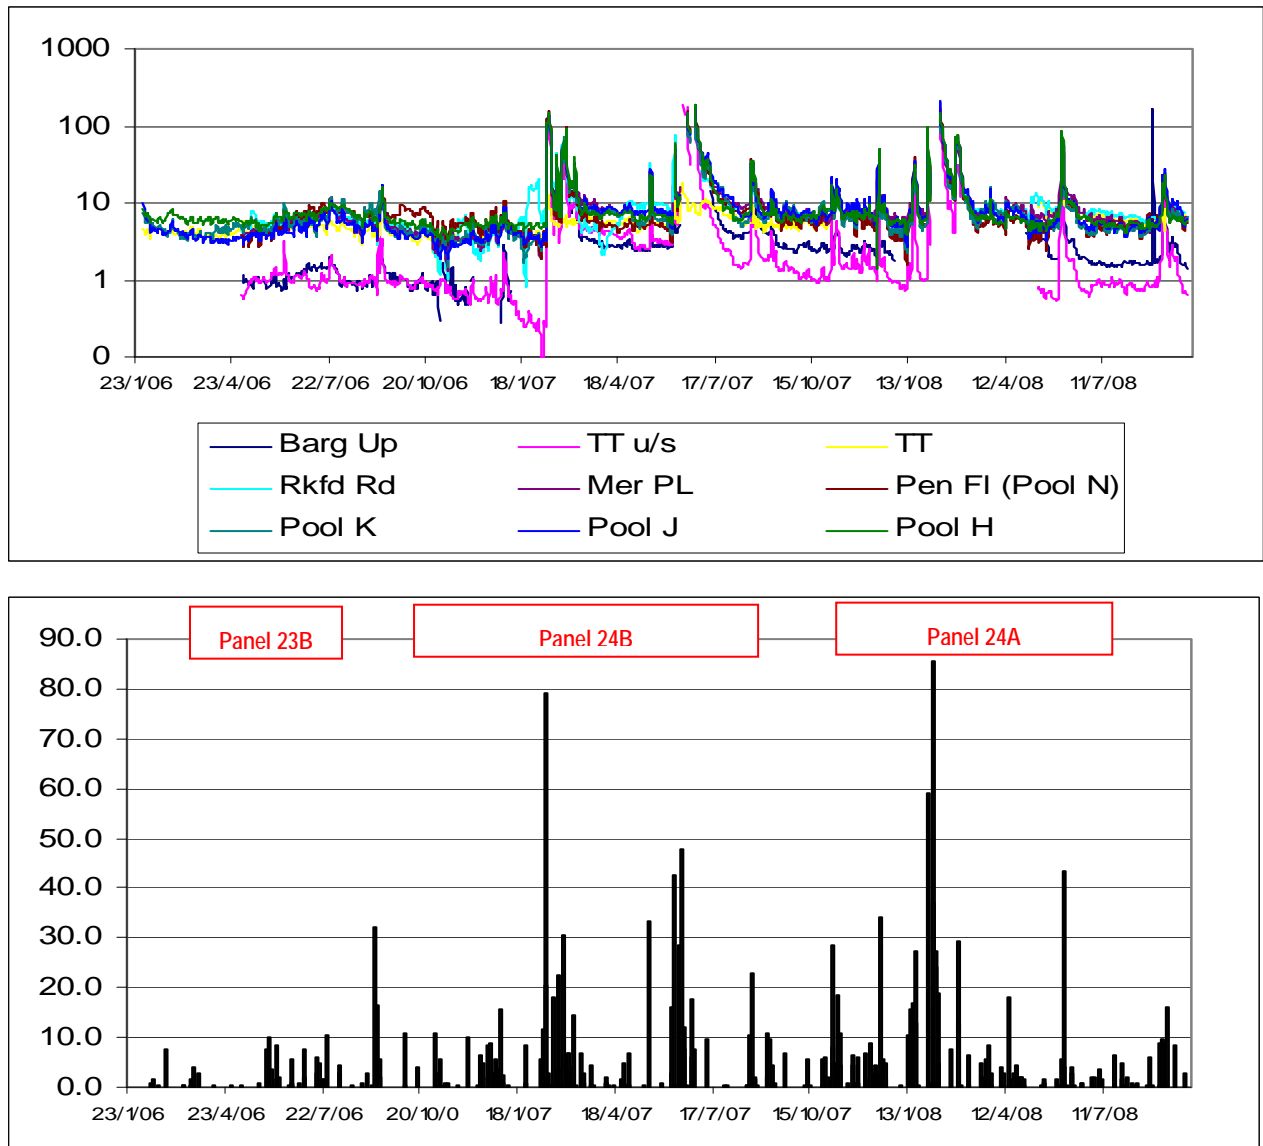
FIGURE 4 Bargo River Flows and Rainfall

Maximum daily rainfall during the monitoring period has been up to 86mm/day (5/2/08). The pre Panel 24A period had a significantly higher average (mean) daily rainfall compared to the period after Panel 24A started extraction (6.02 versus 2.33mm/day). The drought runoff regime that was evident in the early period of monitoring subsequently reverted to flows more dominated by surface runoff baseflow and bank storage depletion after approximately early February 2007, with a lesser proportional contribution from groundwater seepage and the Teatree Hollow licensed discharge after around early February 2007 as shown in **Figure 4**.

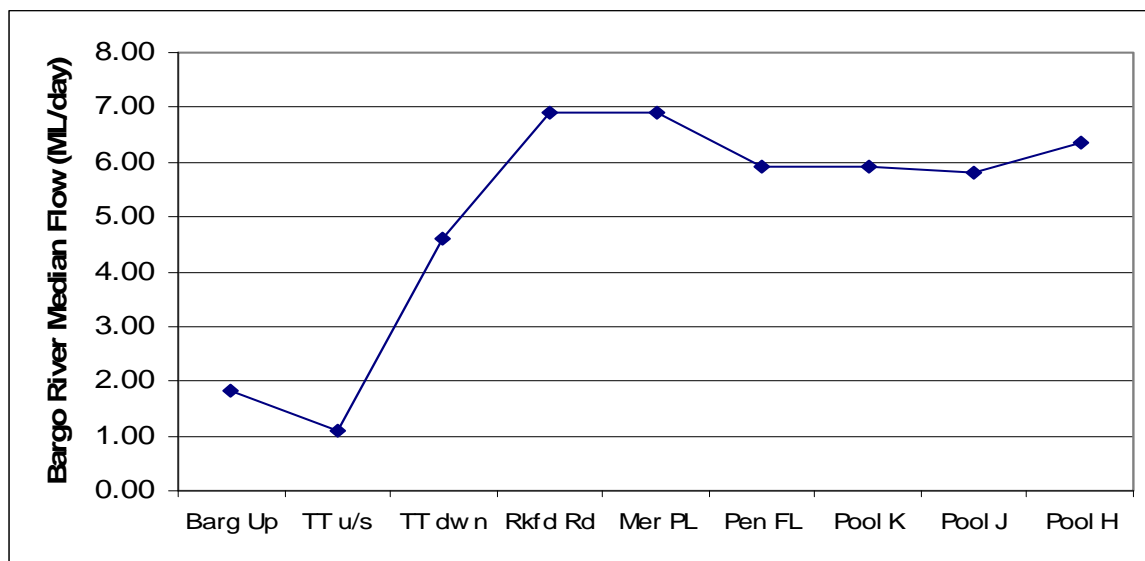
FIGURE 5 Median Flow Rates (31/1/06 - 29/9/08)

Flows downstream of Teatree Hollow are primarily affected by the quantum of daily release from the mine's licensed discharge, as well as catchment runoff and groundwater seeps. A plot of the calculated median flow rates in **Figure 5** indicates that the licensed discharge from the colliery into Teatree Hollow generally contributes around 5.1ML/day (ranging from 1.4ML/day to 18.4ML/day) into the Bargo River.

Figure 5 indicates, that, based on median flows, there is an essentially equivalent overland flow between Rockford Road Bridge and Pencil Falls (Pool N), with a loss of around 1.0ML/day of overland flow between Pencil Falls and Pool J, which resurfaces at Pool H. The area where the loss of overland flow occurs equates to the steeper gradient section of the river shown in **Figure 1**, where the density of boulder fields and bedrock throughflow increases.

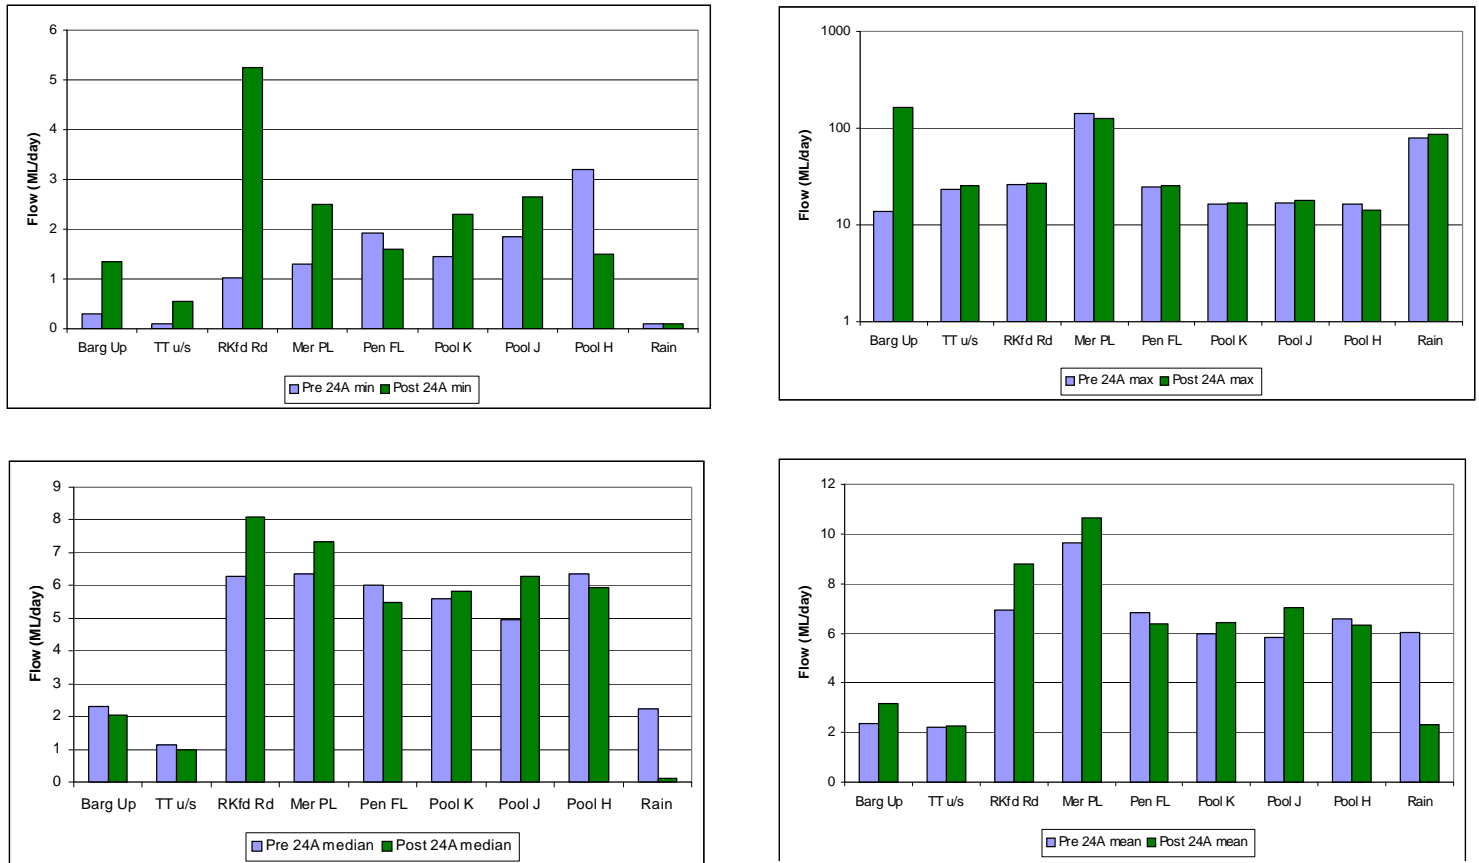
FIGURE 6 Bargo River Flow Before / After the Start of Panel 24A

As shown in **Figure 6**, within the SMP area, the Pre Panel 24A flow regime in the Bargo River shows a reduction in the minimum flow of 0.48ML/day between Pencil Falls (Pool N) and Pool K, with a subsequent rise of 0.4ML/day between Pool K and Pool J, then 1.36ML/day a rise between Pool J and Pool H. Following the start of Panel 24A, the trend is one of a 1.05ML/day rise in flow between Pool N and Pool J, then a 1.16ML/day reduction in flow between Pool J and Pool H.

Prior to the start of Panel 24A, the median (or most commonly occurring) stream flow reduced by 1.1ML/day between Pool N and Pool J, then rose by 1.43ML/day between Pool J and Pool H. After the start of Panel 24A, flow between Pool N and Pool J rose by 0.8ML/day the fell by 0.35ML/day between Pool J and Pool H.

The mean (or average) flow illustrated a 1.0ML/day flow reduction between Pool N and Pool J, then a rise of 0.74ML/day between Pool J and Pool H. Following the start of Panel 24A, the mean flow rose by 0.65ML/day between Pool N and Pool J, then a reduction of 0.72ML/day between Pool J and Pool H as shown in **Figure 6** and **Table 10**.

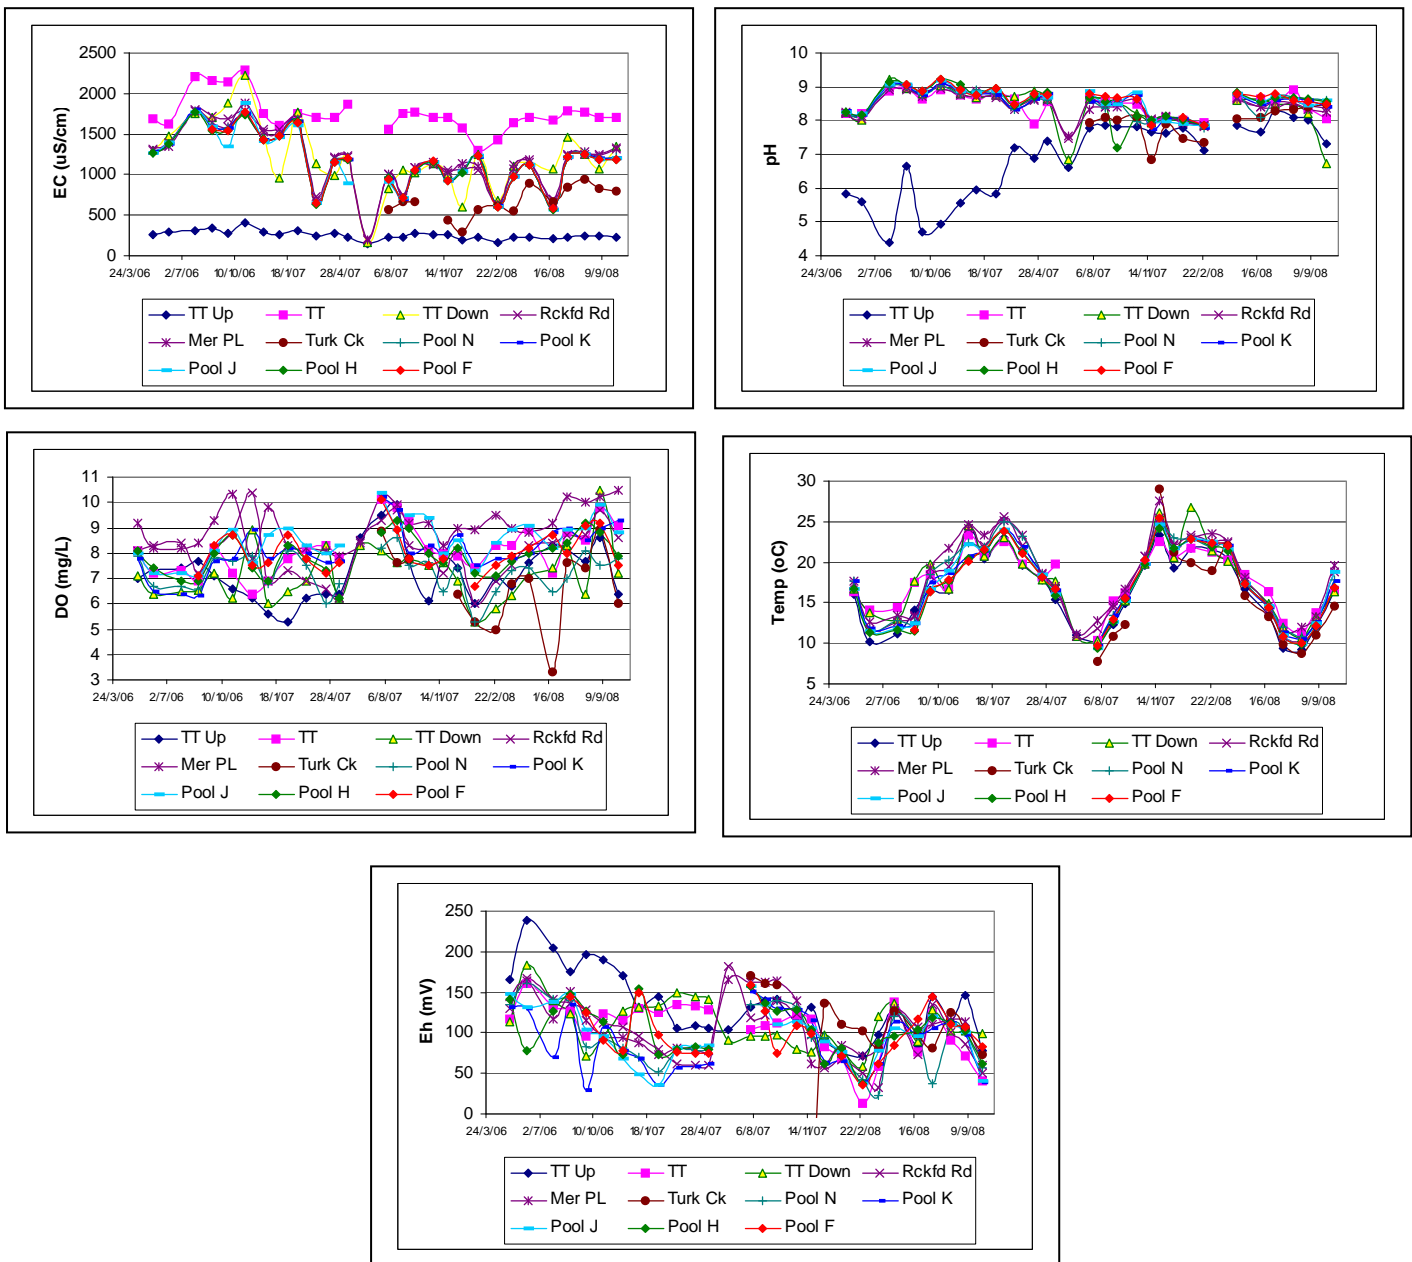
FIGURE 7 Bargo River Field Water Chemistry

Field monitored water quality in the Bargo River as shown in **Figure 7** during the earlier stage of monitoring, initially changed from around pH 4.4 to 5.8, upstream of Teatree Hollow, to pH 8.2 to 8.9 downstream of Teatree Hollow. In the latter phase of monitoring, the disparity between upstream and downstream pH has reduced as a higher proportion of rainfall runoff compared to groundwater baseflow is entering the river, with the upstream / downstream change now being from pH 7.8 to 8.5. With flow down the gorge pH becomes slightly more acidic, with a notable acidification during the June 2007 runoff event due to the higher dominance of runoff from the sandstone dominated catchment and the lower proportional contribution from the alkaline Tea Tree Hollow discharge .

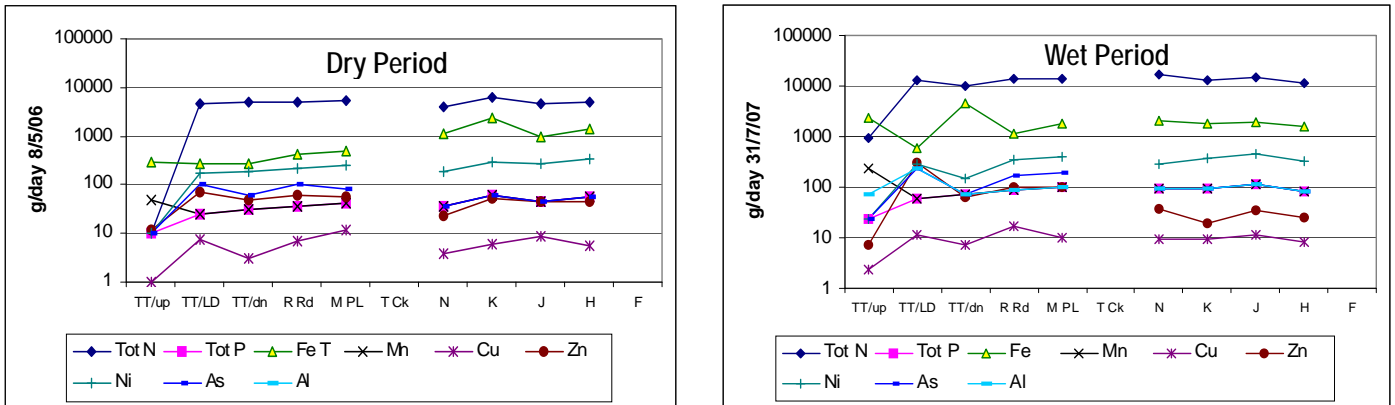
FIGURE 11 Bargo River Analyte Flux

Total flux of selected parameters in the river shown for a selected “dry” and “wet” sampling event in **Figure 11** was derived by multiplying the monitored / interpreted river flow at selected points in the gorge with the relevant laboratory analysis. Based on the calculated data (which is primarily reliant on the accuracy of the measured flow data), the main input from the mine discharge is

- total nitrogen, with a rise downstream of Teatree Hollow of up to almost 3 orders of magnitude in the dry and 2 in the wet period, followed by;
- nickel with a 1 to 2 order of magnitude rise, then;
- zinc and arsenic with a rise of over 1 order of magnitude.

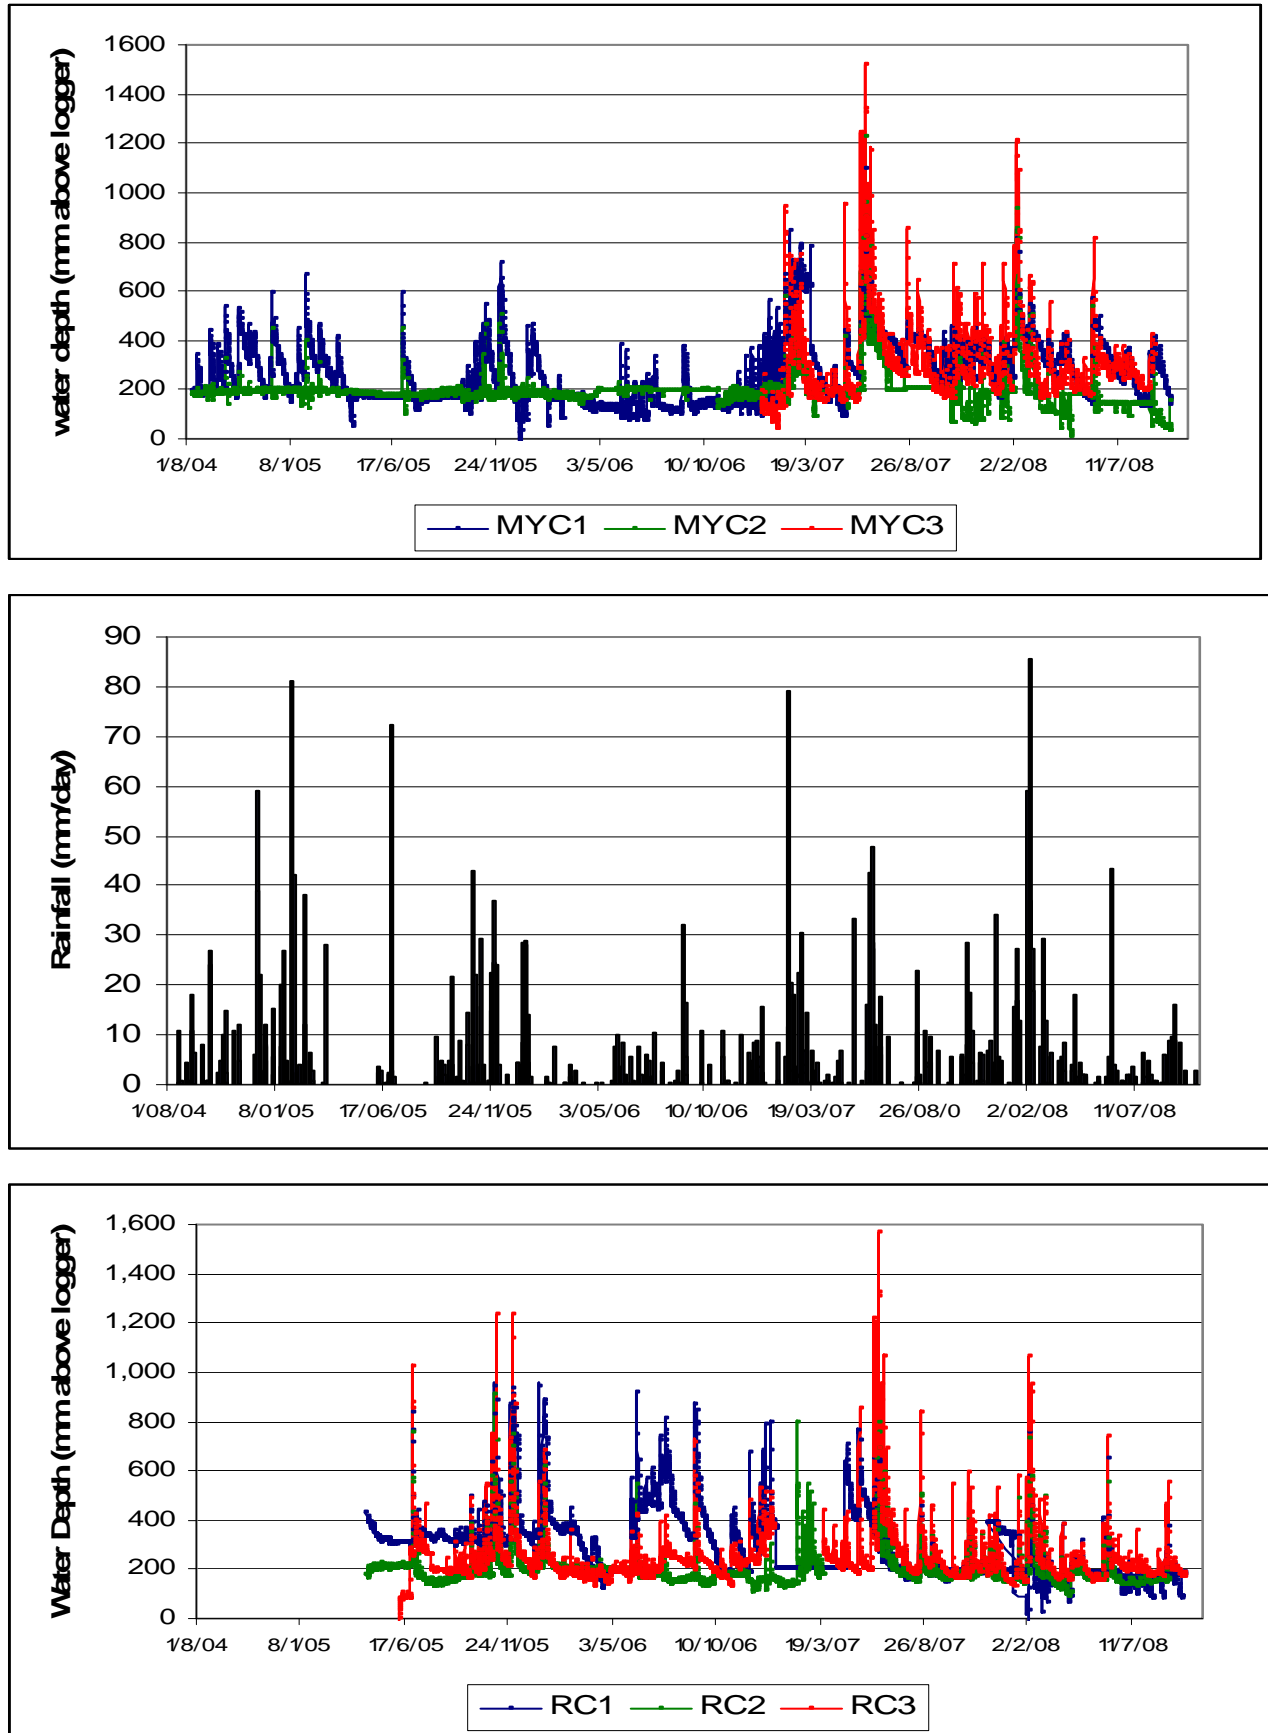
FIGURE 12 Stream Water Depth in Myrtle and Redbank Creeks

No change in stream flow has been observed within Myrtle Creek or Redbank Creek during or after extraction of Panels 22 to 24B, with creek flow at monitored locations shown in **Figure 12**.

Long standing pools are noted to occur at locations MYC3, RC2 and RC3, however it should be noted that these are in currently unsubsidised areas, and are naturally occurring.

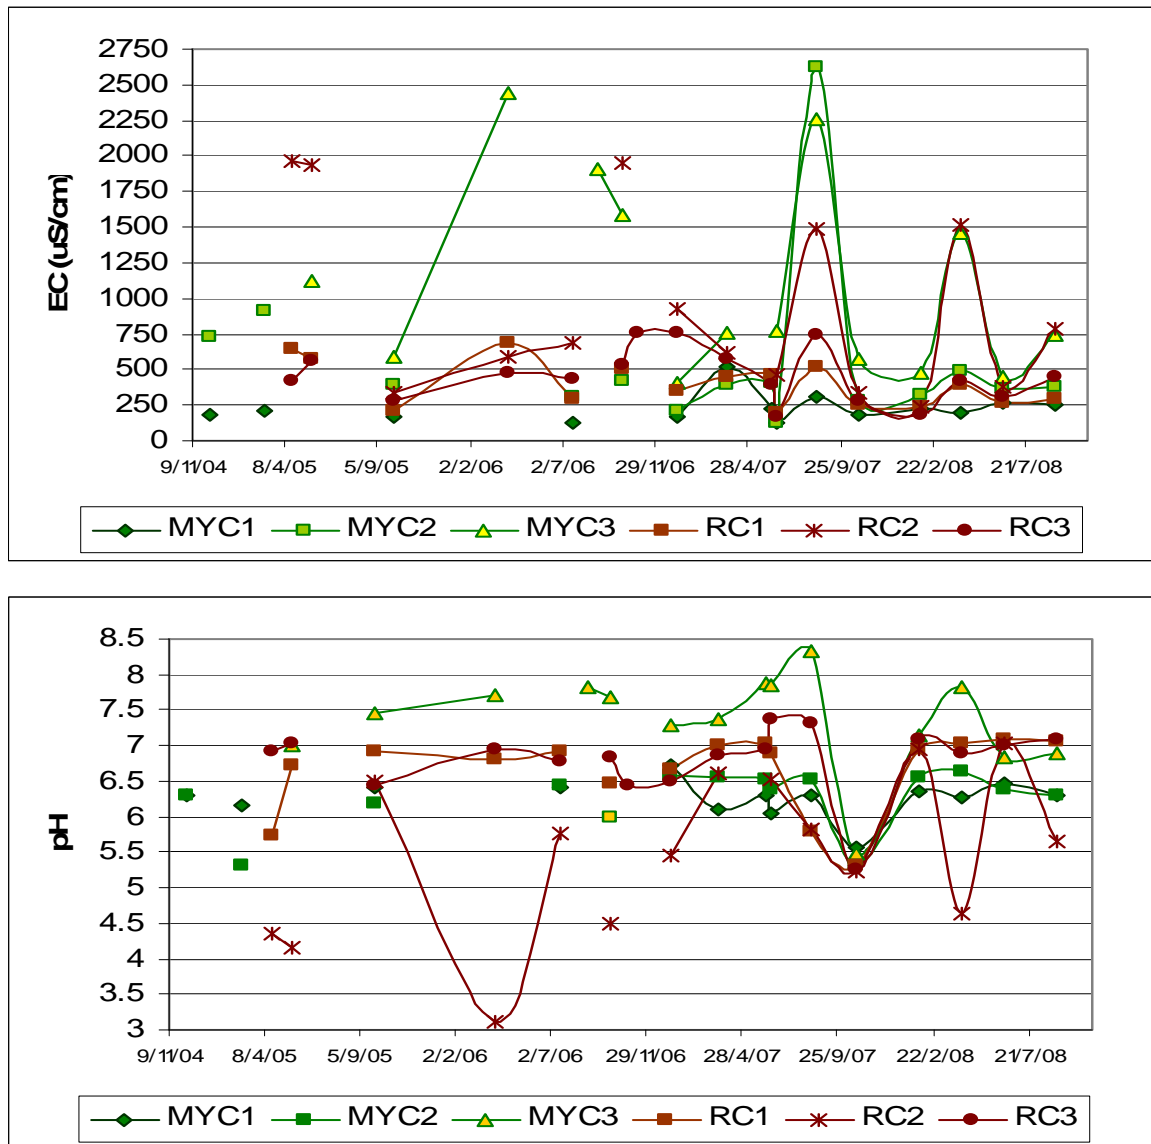
FIGURE 13 Upland Stream Field Water Quality

Prior to the February 2007 rains, Myrtle Creek has been generally dry at MYC1, however MYC2 and MYC3 are generally ponded. Myrtle Creek has a pH range between 5.31 and 8.34, with EC between 125uS/cm and 2630uS/cm, with the creek becoming more alkaline and saline downstream as shown in **Figure 13**.

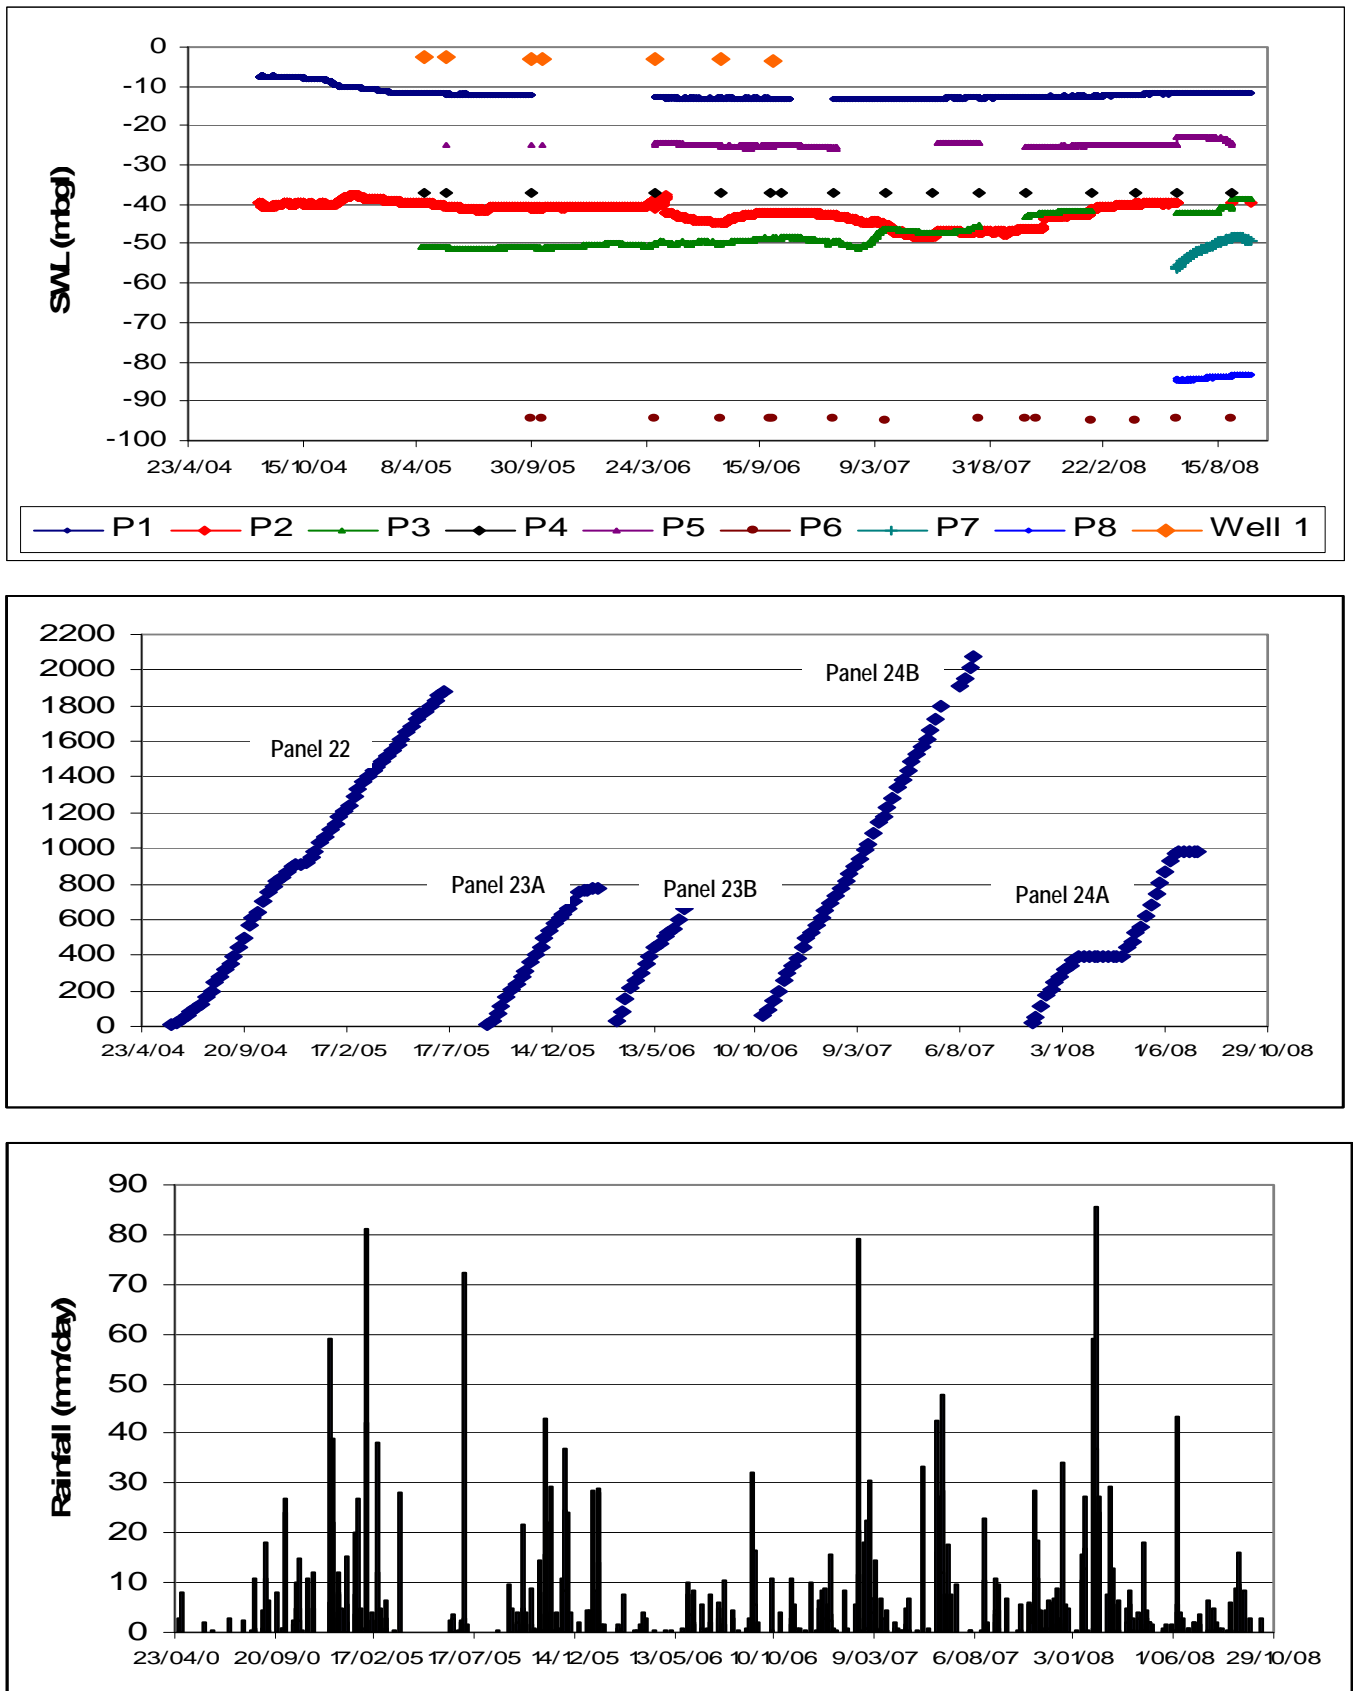
FIGURE 14 Standing Water Levels and Panel Extraction

A plot of water levels shown in **Figure 14**, with manual readings listed in **Appendix C**, indicates that the groundwater level in P1, which is 450m south of Panel 22, fell by approximately 4.3m due to extraction of Panel 22 over 7 months between mid / late November 2004 to early / mid December 2004. This was superimposed on a gradual, drought related decline of around 0.1mm / month, which existed both before and after extraction of Panels 22, 23A and 23B. Piezometer P1 then continued to fall a further 1.63m over 24 months to mid June 2007. The P1 water levels began to recover after June 2007 to around 4.1m beneath the earliest recorded standing water level in August 2004.

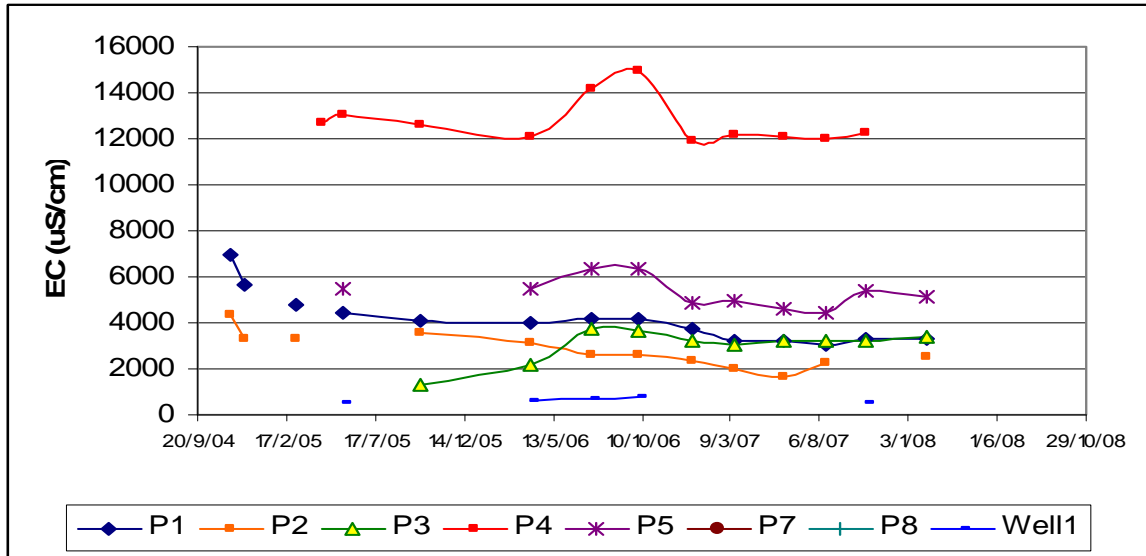
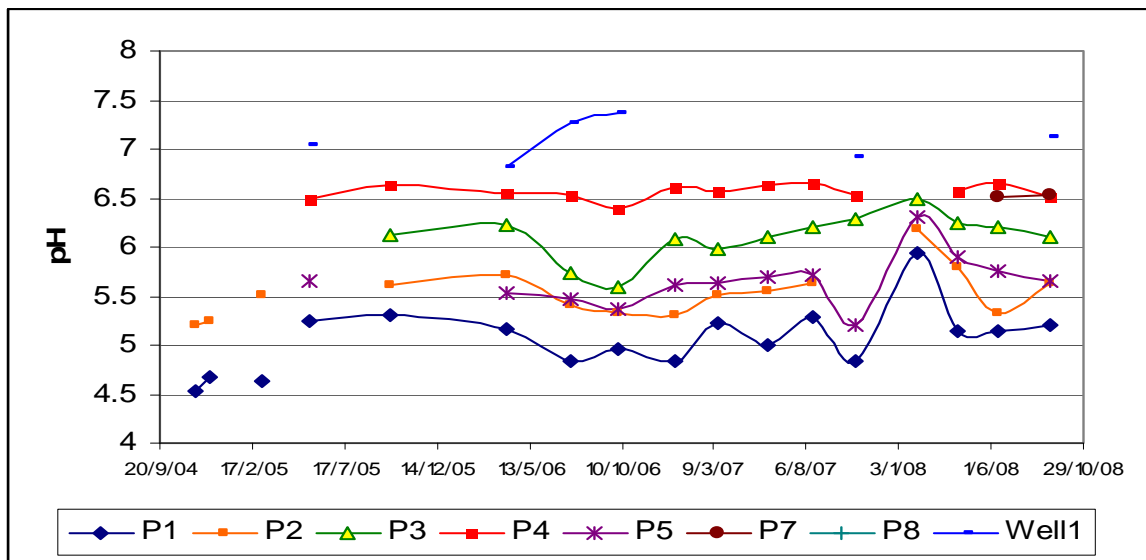
FIGURE 15 Field Groundwater Quality

Groundwater in the study area has generally brackish salinity (564 μ S/cm to 14,940 μ S/cm) with acid to circum-neutral pH (3.53 to 7.36) as shown in **Figure 15**.

No adverse changes to groundwater quality of the subsided bores has been observed, with no distinctive increase in dissolved total iron or salinity and no distinctive lowering of pH.
