TAHMOOR COLLIERY LONGWALL 24B

**END OF PANEL
SUBSIDENCE MONITORING REPORT
FOR LONGWALL 24B
AT TAHMOOR COLLIERY**

REPORT NO. MSEC272-06

February 2008

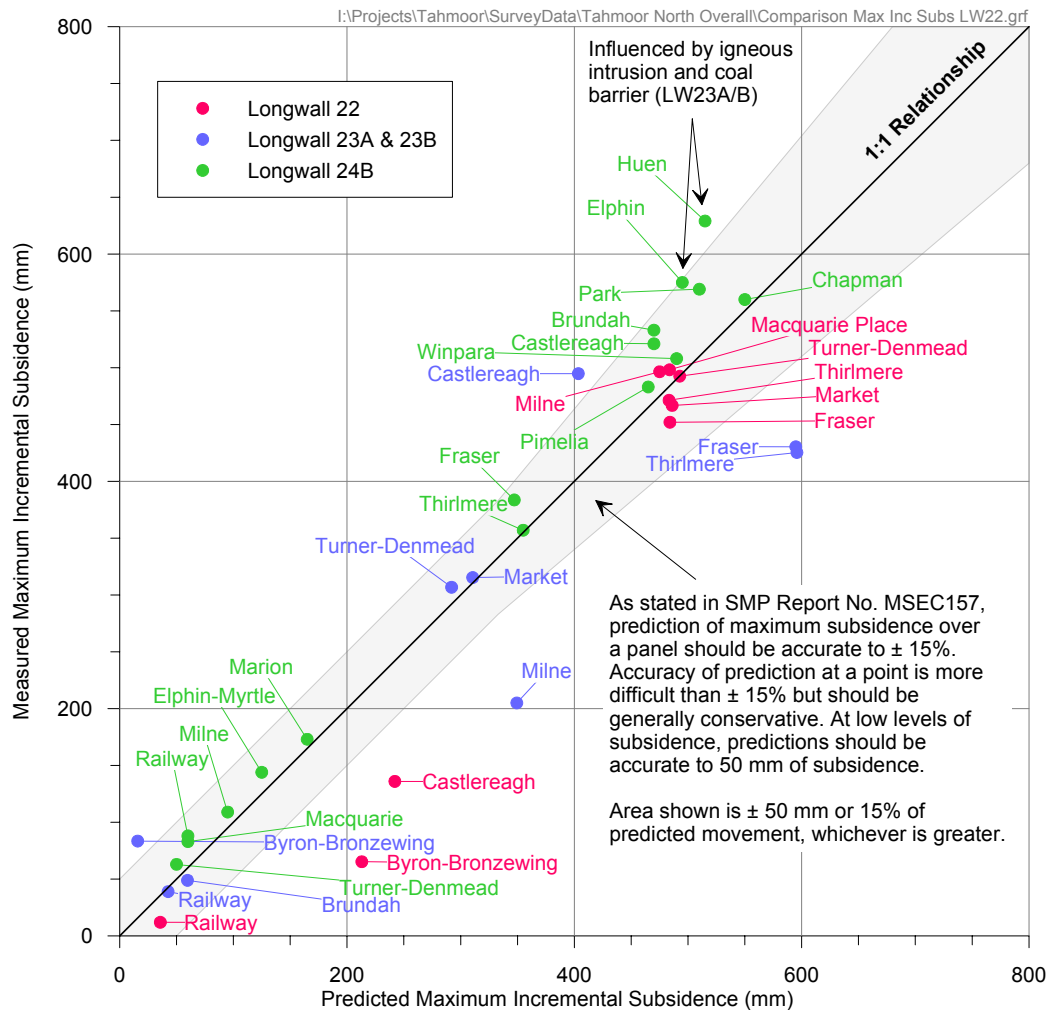
Fig. 2.1 Comparison between Measured and Predicted Maximum Incremental Subsidence above Longwalls 22 to 24B at Tahmoor Colliery

It can be seen from Fig. 2.1 and Table 2.2 that observed maximum incremental subsidence is greater than predicted maximum incremental subsidence for all monitoring lines. Where subsidence is predicted at points beyond the goaf edge, which are likely to experience very low values of subsidence, the predictions should generally be accurate to within 50 mm of subsidence, which has been observed here. When compared to the experience from previous longwalls, observed subsidence has been comparatively greater, though the difference is still within $\pm 15\%$ in the majority of cases. Considering that the extracted height was up to 23% greater than the seam thickness adopted for the predictions in the SMP Report, this comparison indicates that the predicted subsidence values are generally reasonable.

As shown in Fig. 2.1 and Figs. MSEC272-01 to MSEC272-30, a very good correlation between observed and predicted incremental subsidence was observed on many monitoring lines. These include Thirlmere Way, Chapman Street, Fraser Street, Pimelia Street, Winpara Close and Turner-Denmead and Marion Street. While the correlation between observed and predicted subsidence was exceptional for these monitoring lines, we would prefer, in principle, to provide predictions that are more conservative than observed subsidence.

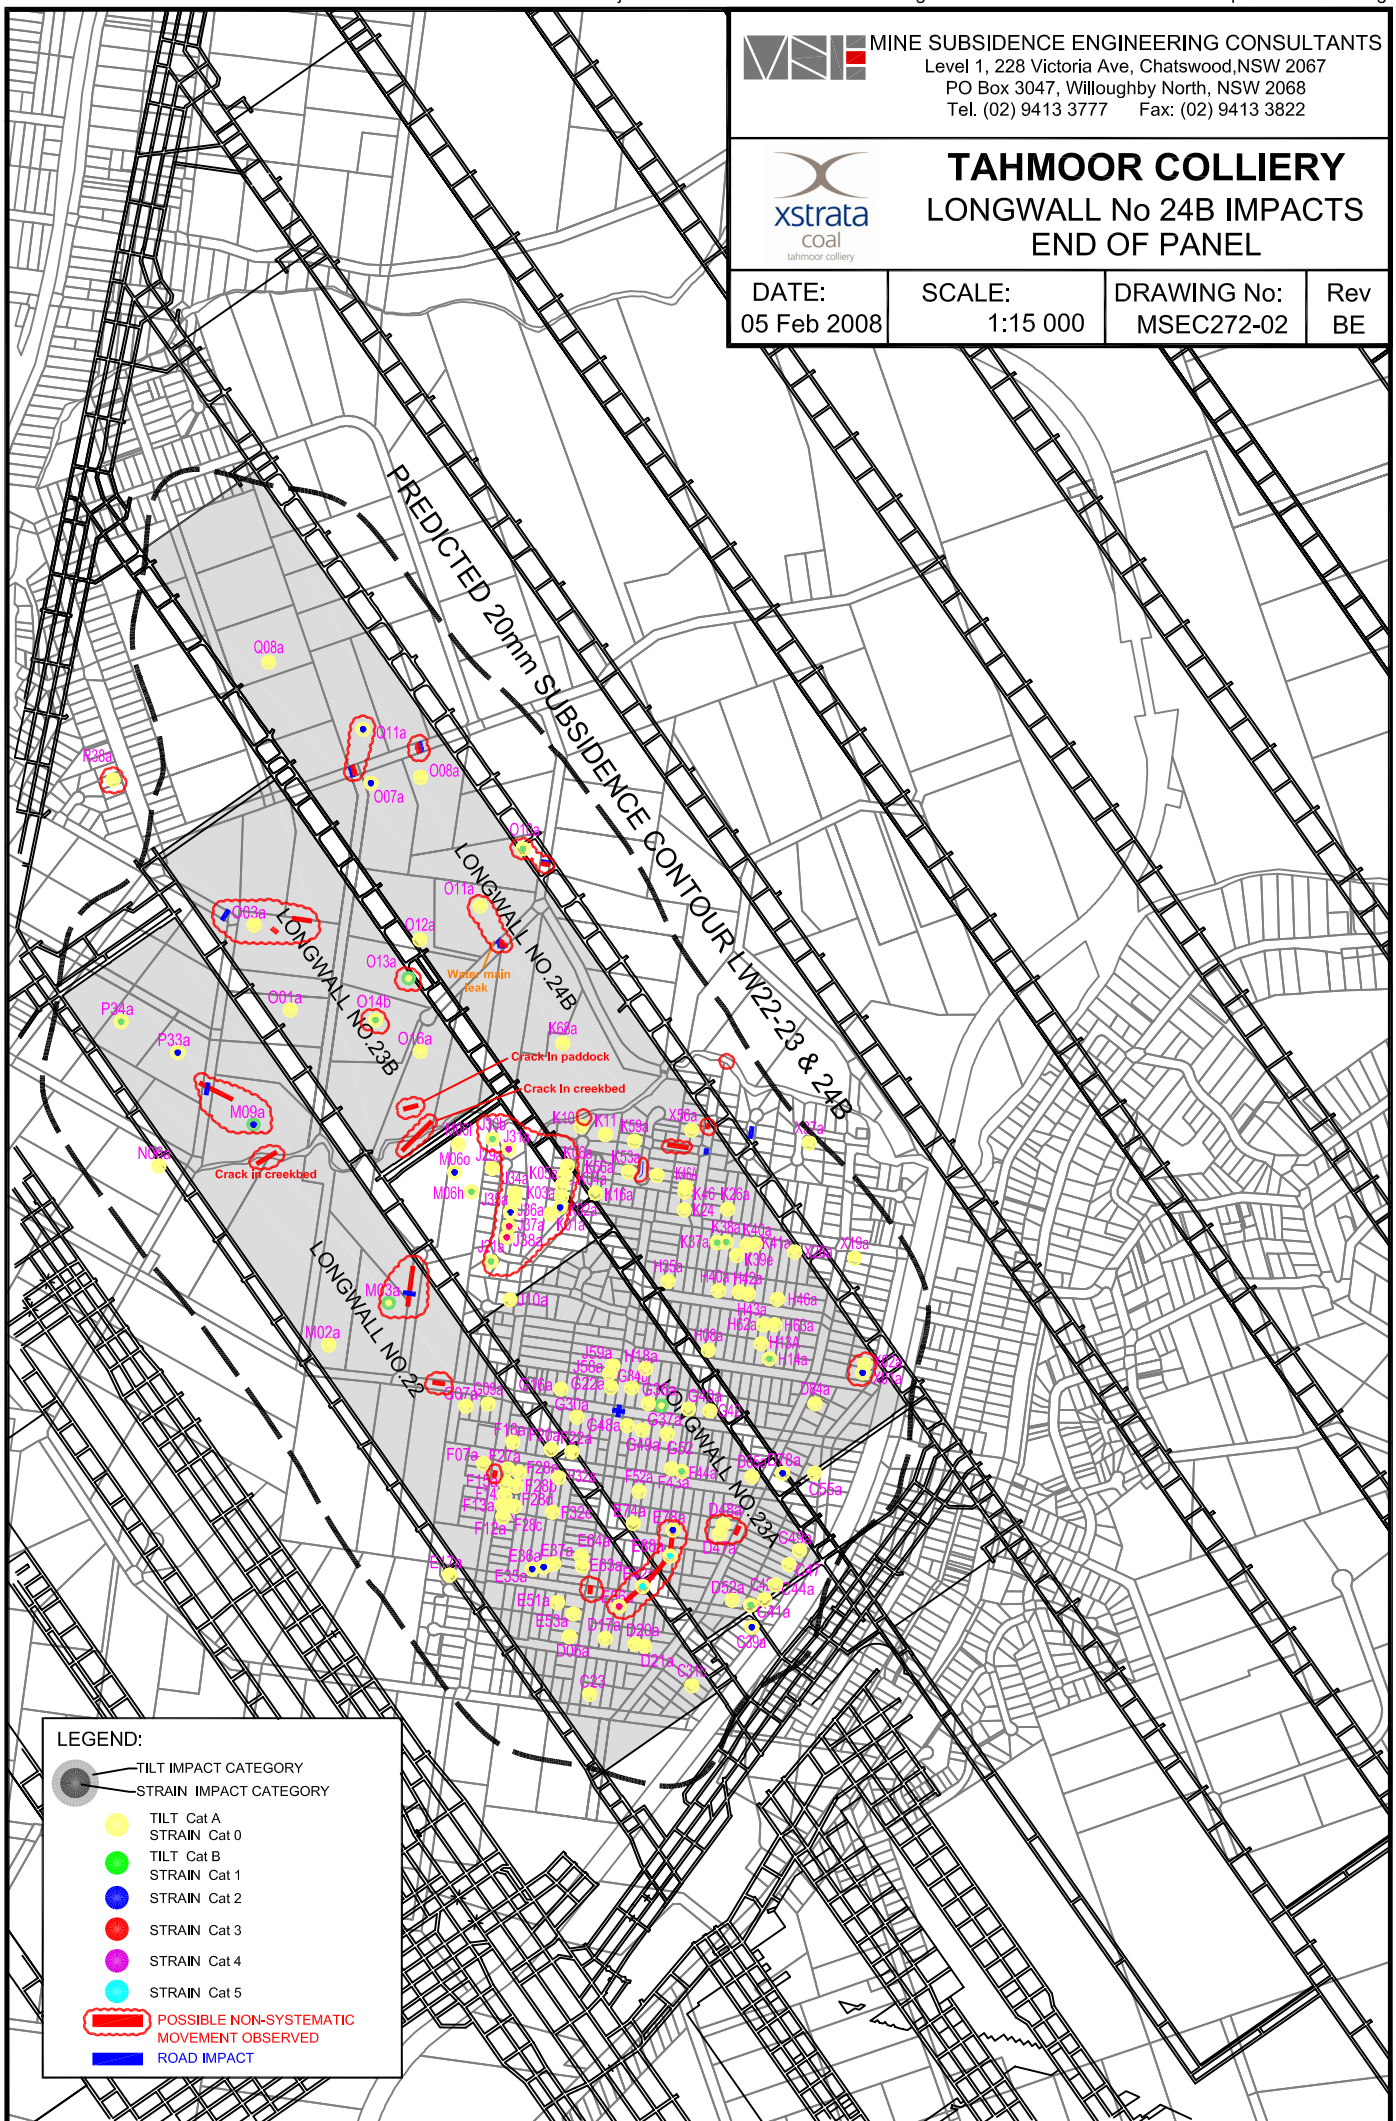
DRAWING No:
MSEC272-02

The locations of all sites where it is considered that observed non-systematic movements have occurred are shown in Drawing No. MSEC272-02.

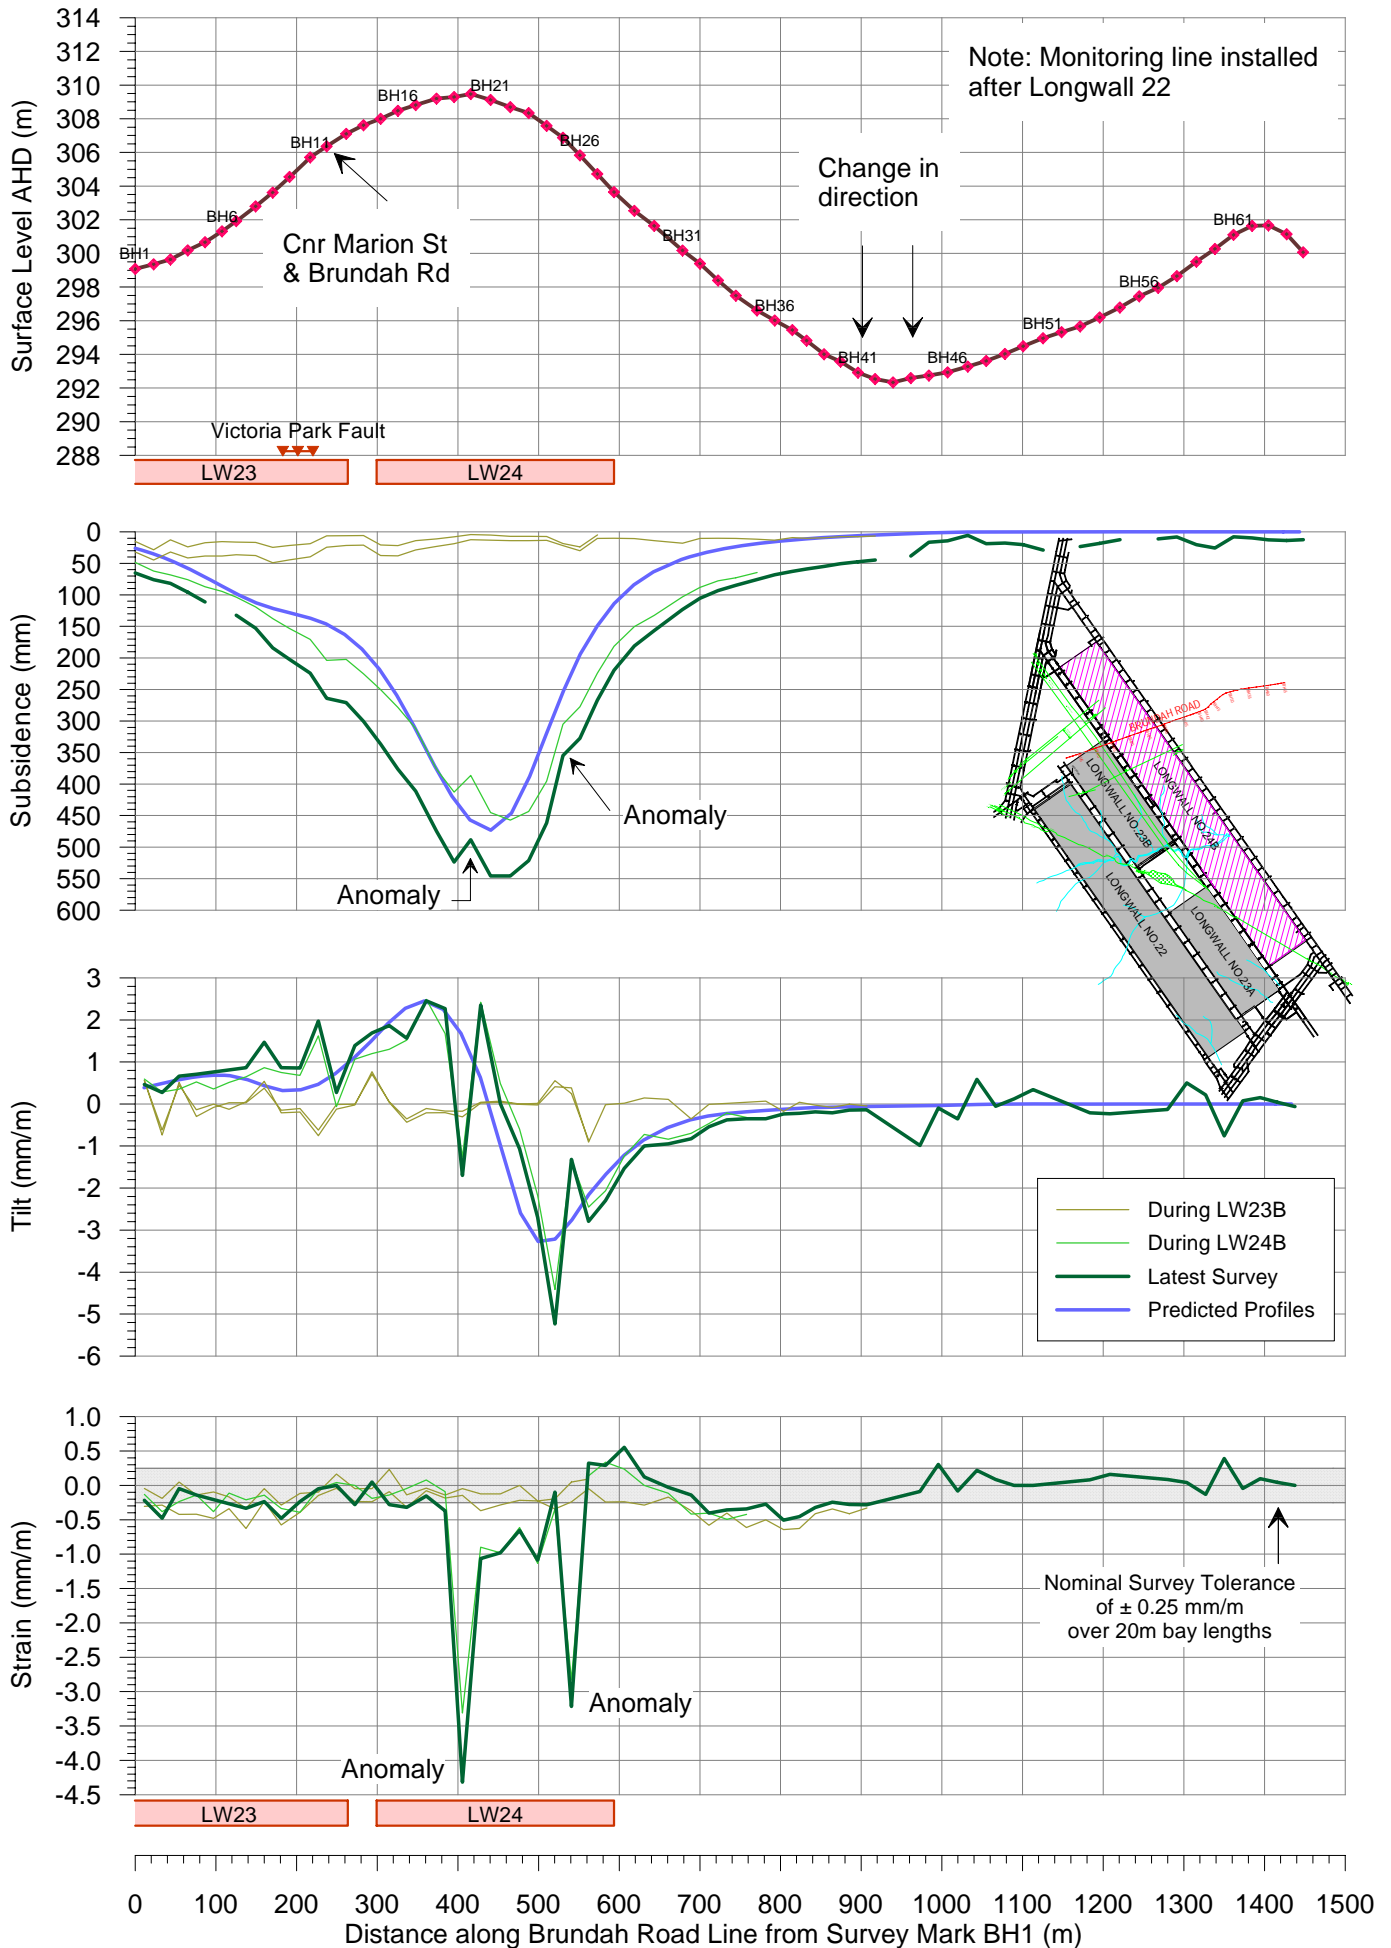
Tahmoor Colliery - Incremental Subsidence Profiles along Brundah Road Line during LW24B

These exceedences would have been reduced if the minimum extraction heights of 2.05 metres or the design cutting height of 2.15 metres had been adopted for the SMP predictions. For example, observed maximum subsidence along Brundah Road exceeded predictions by approximately 13.4% and the seam thickness directly below this monitoring line was approximately 1.8 metres. If the actual extracted height was 2.05m, we would add 13.9% additional subsidence to the predictions. If the actual extracted height was the design cut of 2.15m, we would add 19.4% to the predictions.

Maximum predicted incremental systematic tilt for Longwall 24B was predicted to be 4.7 mm/m. As shown in Figs. MSEC272-01 to MSEC272-30, observed tilt was less than predicted maximum tilt along all of the monitoring lines where systematic subsidence has occurred. Maximum observed incremental systematic tilt was approximately 4.3 mm/m, which occurred along Chapman Street. Maximum observed tilt exceeded the prediction maximum systematic tilt in one instance along the monitoring lines, and this occurred along Brundah Road (5.7 mm/m), where non-systematic movement had clearly occurred.

Maximum predicted incremental systematic radii of curvature for Longwall 24B were predicted to be 0.1 km^{-1} sagging and 0.05 km^{-1} hogging. While not shown graphically in this report, observed curvature was equal to or less than predicted maximum curvature along all of the monitoring lines where systematic subsidence has occurred. Maximum observed incremental systematic curvature was approximately 0.08 km^{-1} sagging and 0.05 km^{-1} hogging, which occurred along Chapman Street. In all instances where maximum observed strain exceeded the predicted maxima, non-systematic movement had occurred. Maximum observed non-systematic incremental curvature of 0.18 km^{-1} sagging and 0.19 km^{-1} hogging occurred on Brundah Road.
