XSTRATA COAL:
Tahmoor Colliery - Longwall 25

End of Panel Subsidence Monitoring Report for Tahmoor Longwall 25

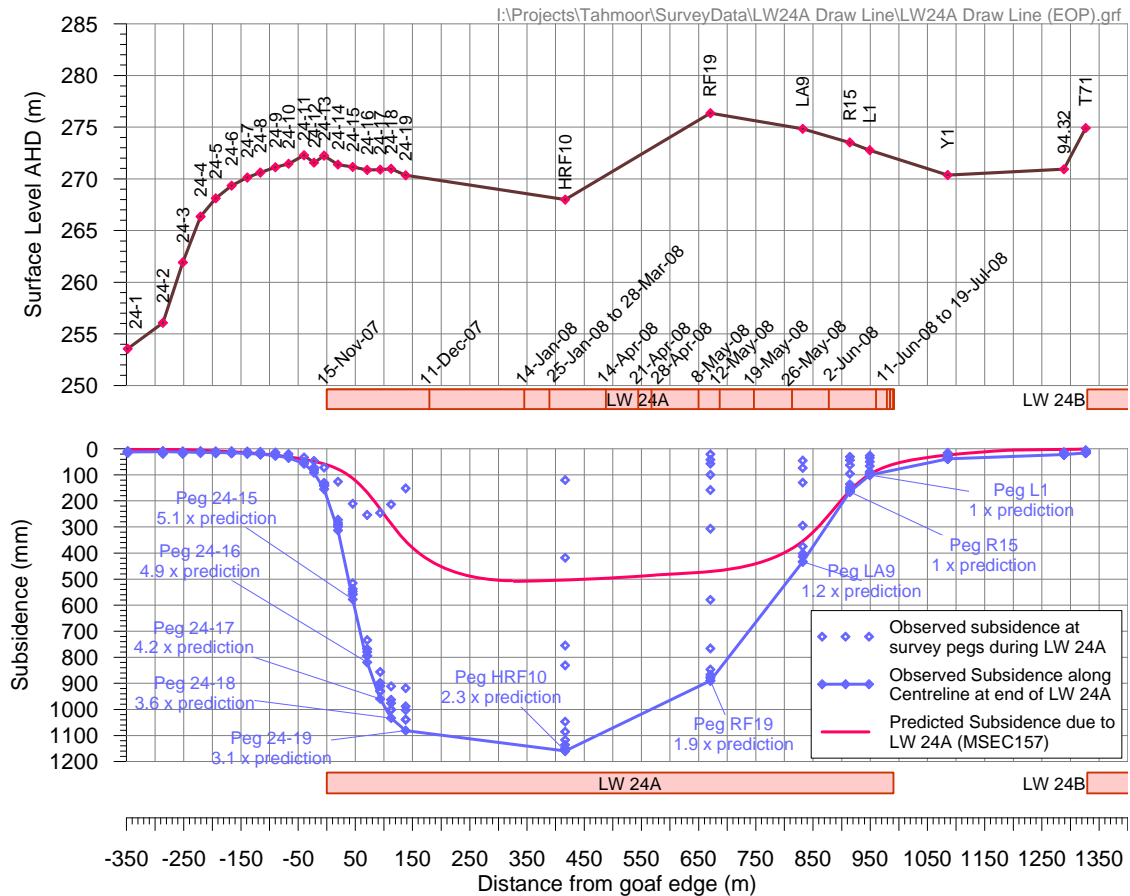
Fig. 2.1 Observed Subsidence along Centreline of Longwall 24A

It can be seen from Fig. 2.1 that observed subsidence was more than twice the predicted maximum value, reaching to a maximum of 1169 mm at Peg HRF10. It is possible that the actual maximum subsidence developed somewhere between Pegs HRF10 and RF19, though this was not measured. Observed subsidence was similar to prediction near Peg R15 on Remembrance Drive. Survey pegs RF19 and LA9 were located within a transition zone where subsidence gradually reduced from areas of maximum increased subsidence to areas of normal subsidence.

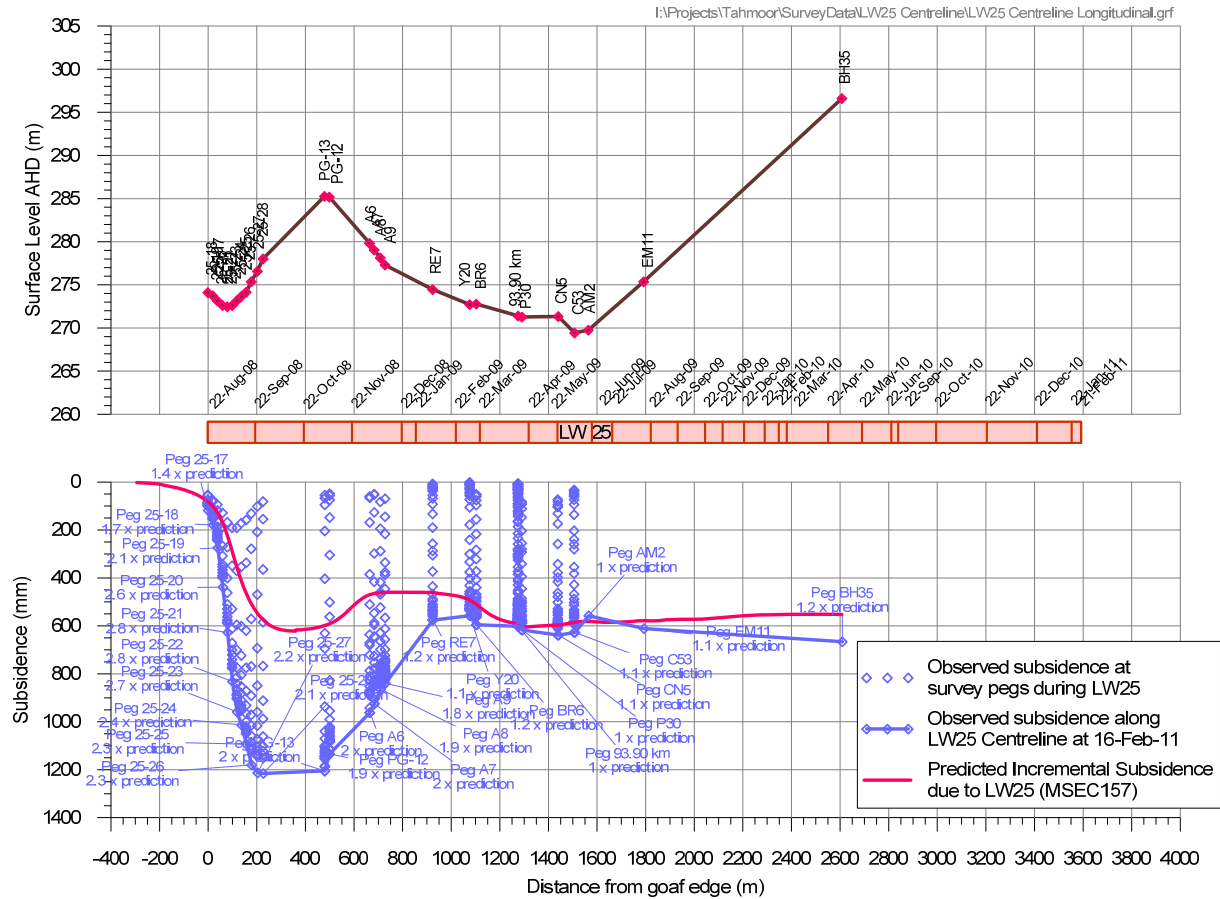
Fig. 2.2 Observed Subsidence along Centreline of Longwall 25

It can be seen from Fig. 2.2 that observed subsidence was approximately twice the predicted maximum value, with maximum subsidence of 1168 mm at Peg 25-28 and 1187 mm at Peg PG13. .

Observed subsidence was similar to but slightly more than predicted at Peg RE7 and was similar to prediction at Peg Y20 and at all pegs located further along the panel. Survey pegs A6, A7, A8 and A9 are located within a transition zone where subsidence has gradually reduced from areas of maximum increased subsidence to areas of normal subsidence.

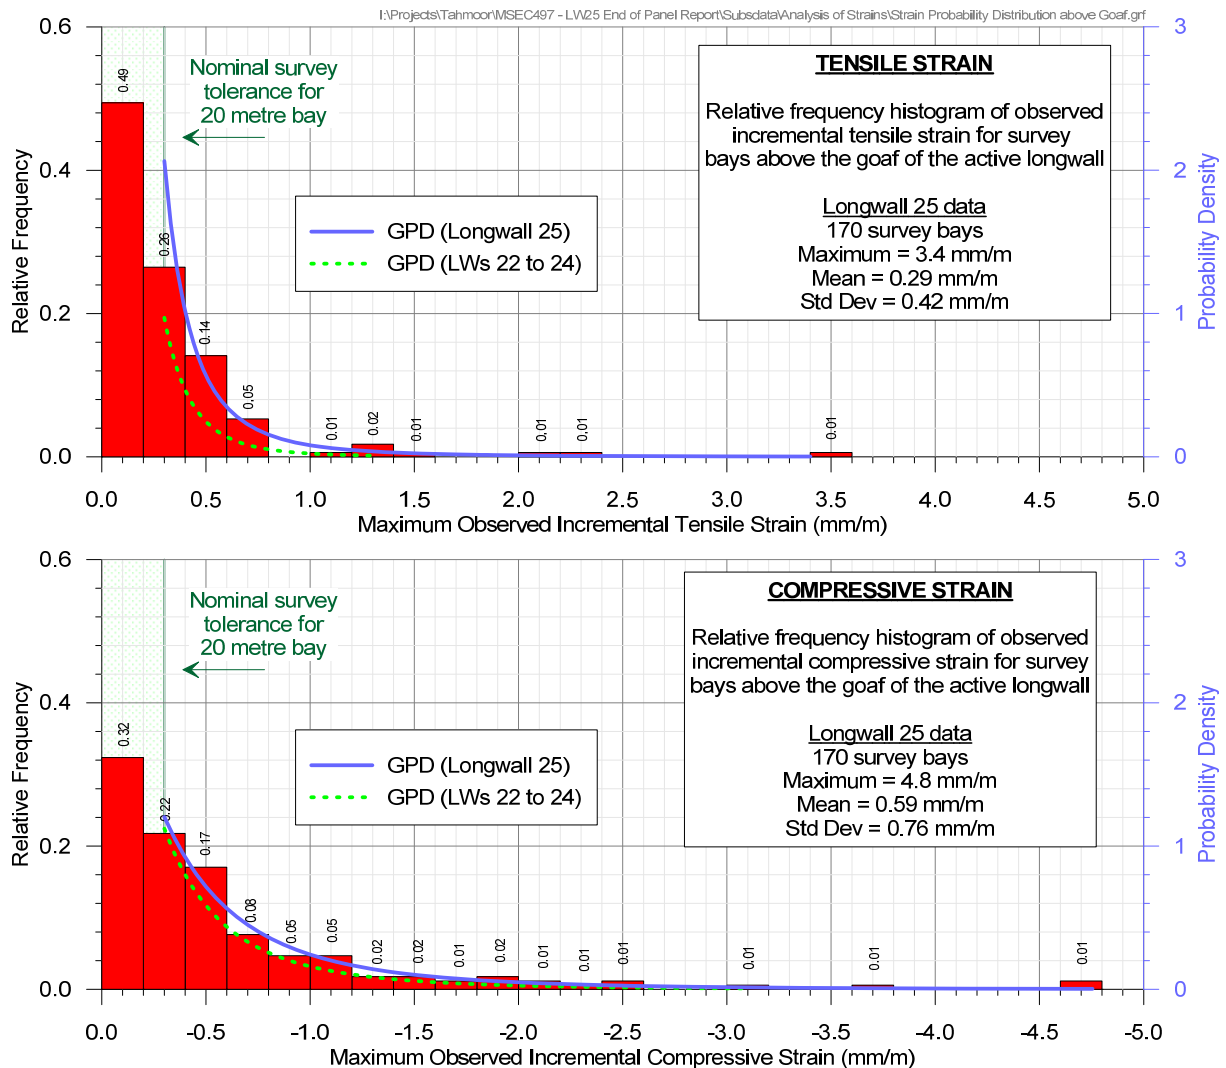
Fig. 2.3 Observed Incremental Strain for Survey Bays above Goaf resulting from the Extraction of Longwall 25

A number of probability distribution functions were fitted to the empirical data. It was found that a *Generalised Pareto Distribution (GPD)* provided a good fit to the raw strain data for Longwall 25, which are shown as the blue lines.

The probability distribution functions for previous monitoring during the mining of Longwalls 22 to 24 are also shown in this figure, as the dashed green lines. It can be seen from these comparisons, that the overall distribution of strain resulting from the extraction of Longwall 25 was greater in magnitude when compared with those observed during the mining of Longwalls 22 to 24.

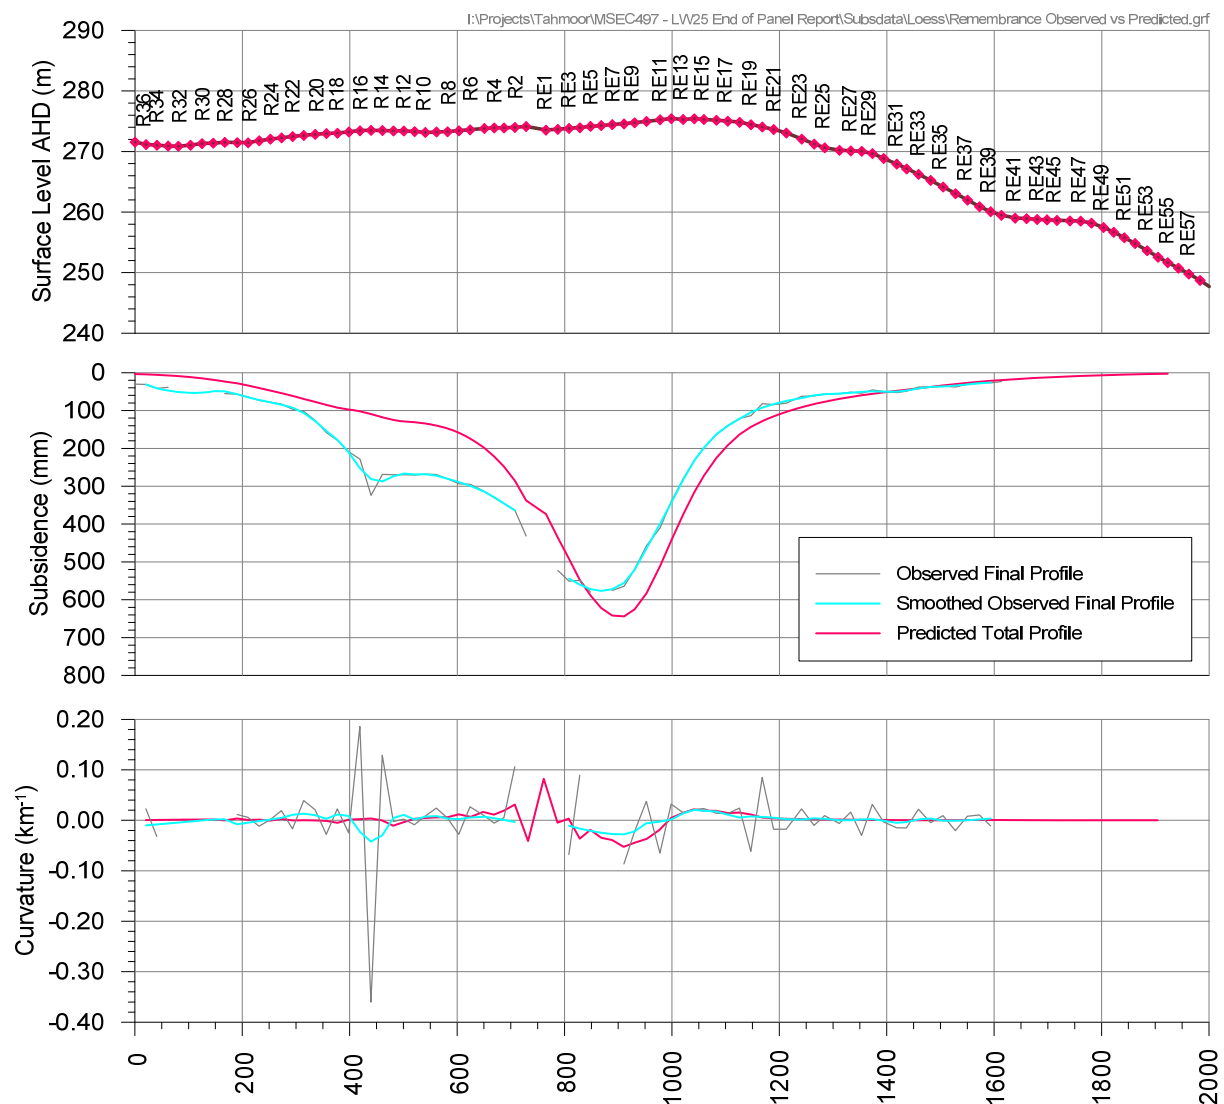
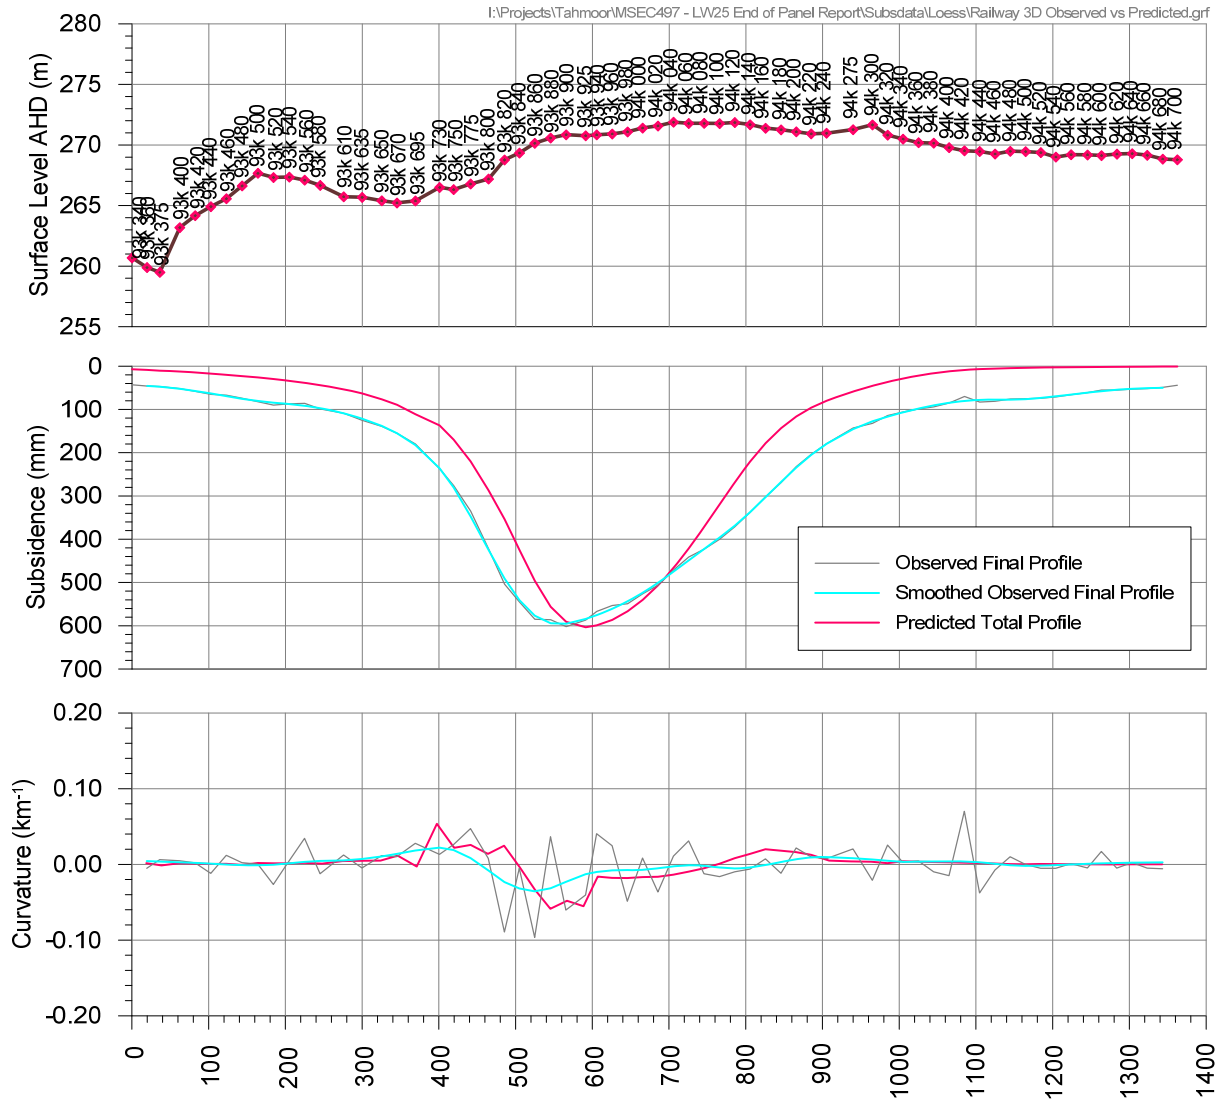
Fig. 2.4 Observed Curvature derived from Smoothed Subsidence and Predicted Curvature along Remembrance Drive resulting from the extraction of Longwall 25

Fig. 2.5 Observed Curvature derived from Smoothed Subsidence and Predicted Curvature along the Main Southern Railway Resulting from the Extraction of Longwall 25

It can be seen from these figures, that the maximum observed curvatures derived from smoothed subsidence profiles along these monitoring are reasonably similar to the maximum predicted curvatures. Also, the observed locations of hogging (i.e. convex) curvature and sagging (i.e. concave) curvature reasonably match the locations predicted along Remembrance Drive and the Main Southern Railway.

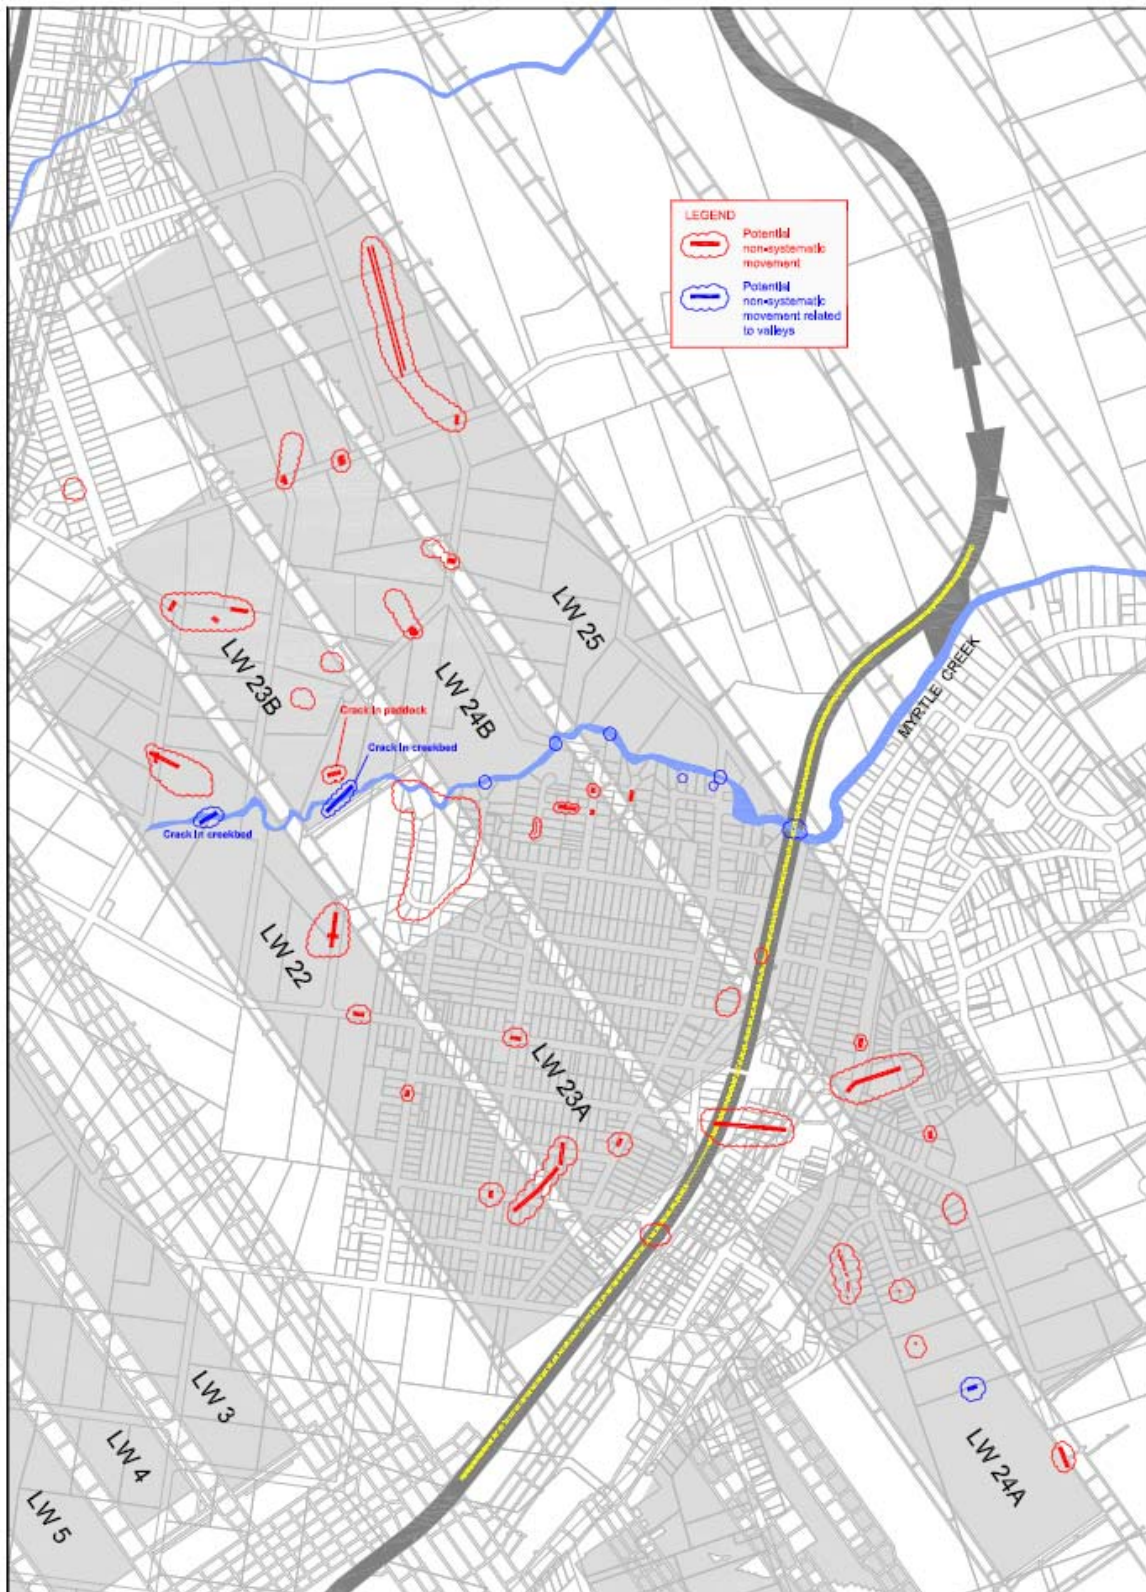
Fig. 2.6 Map of Locations of Potential Non-Systematic Movements

A plan showing the locations of observed non-systematic movements at Tahmoor is shown in Fig. 2.6. The locations were selected based on ground monitoring results or observed impacts that appear to have been caused by non-systematic movement. A total of approximately 36 locations (not including valleys) have been identified over the extracted Longwalls 22 to 25, of which 6 locations are above Longwall 25.

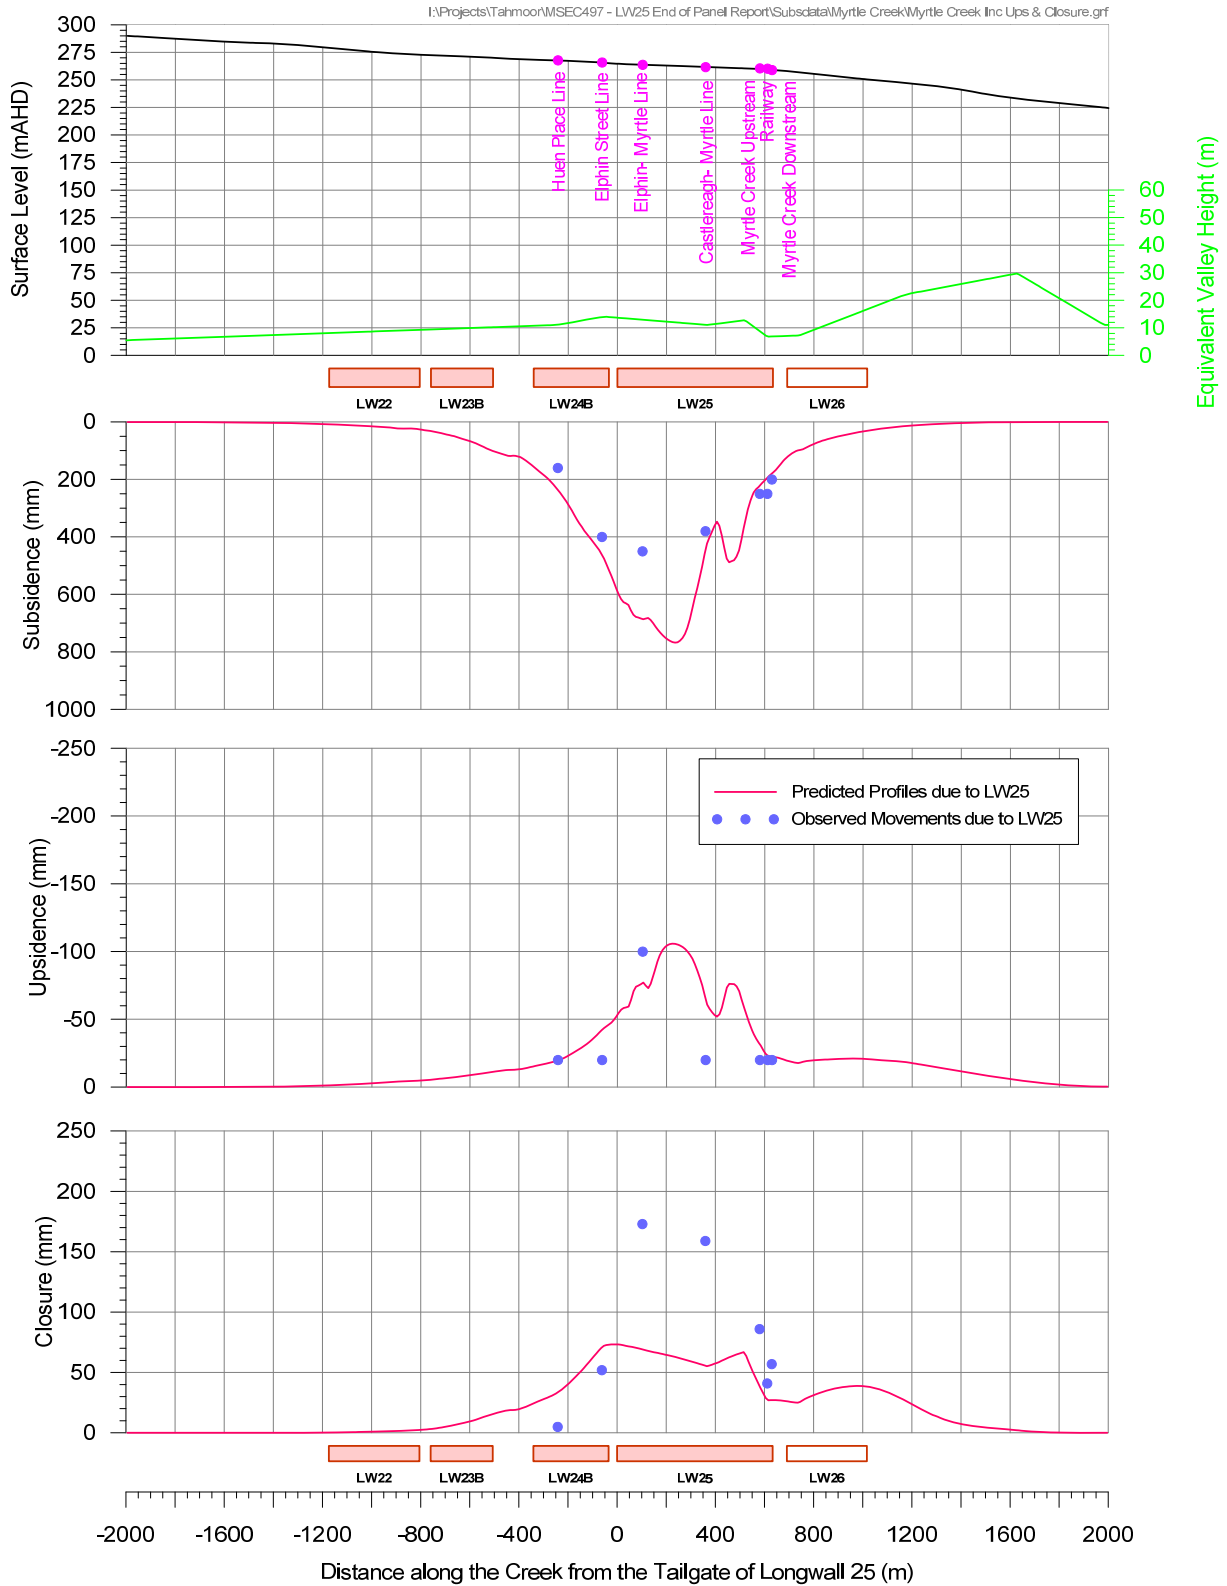
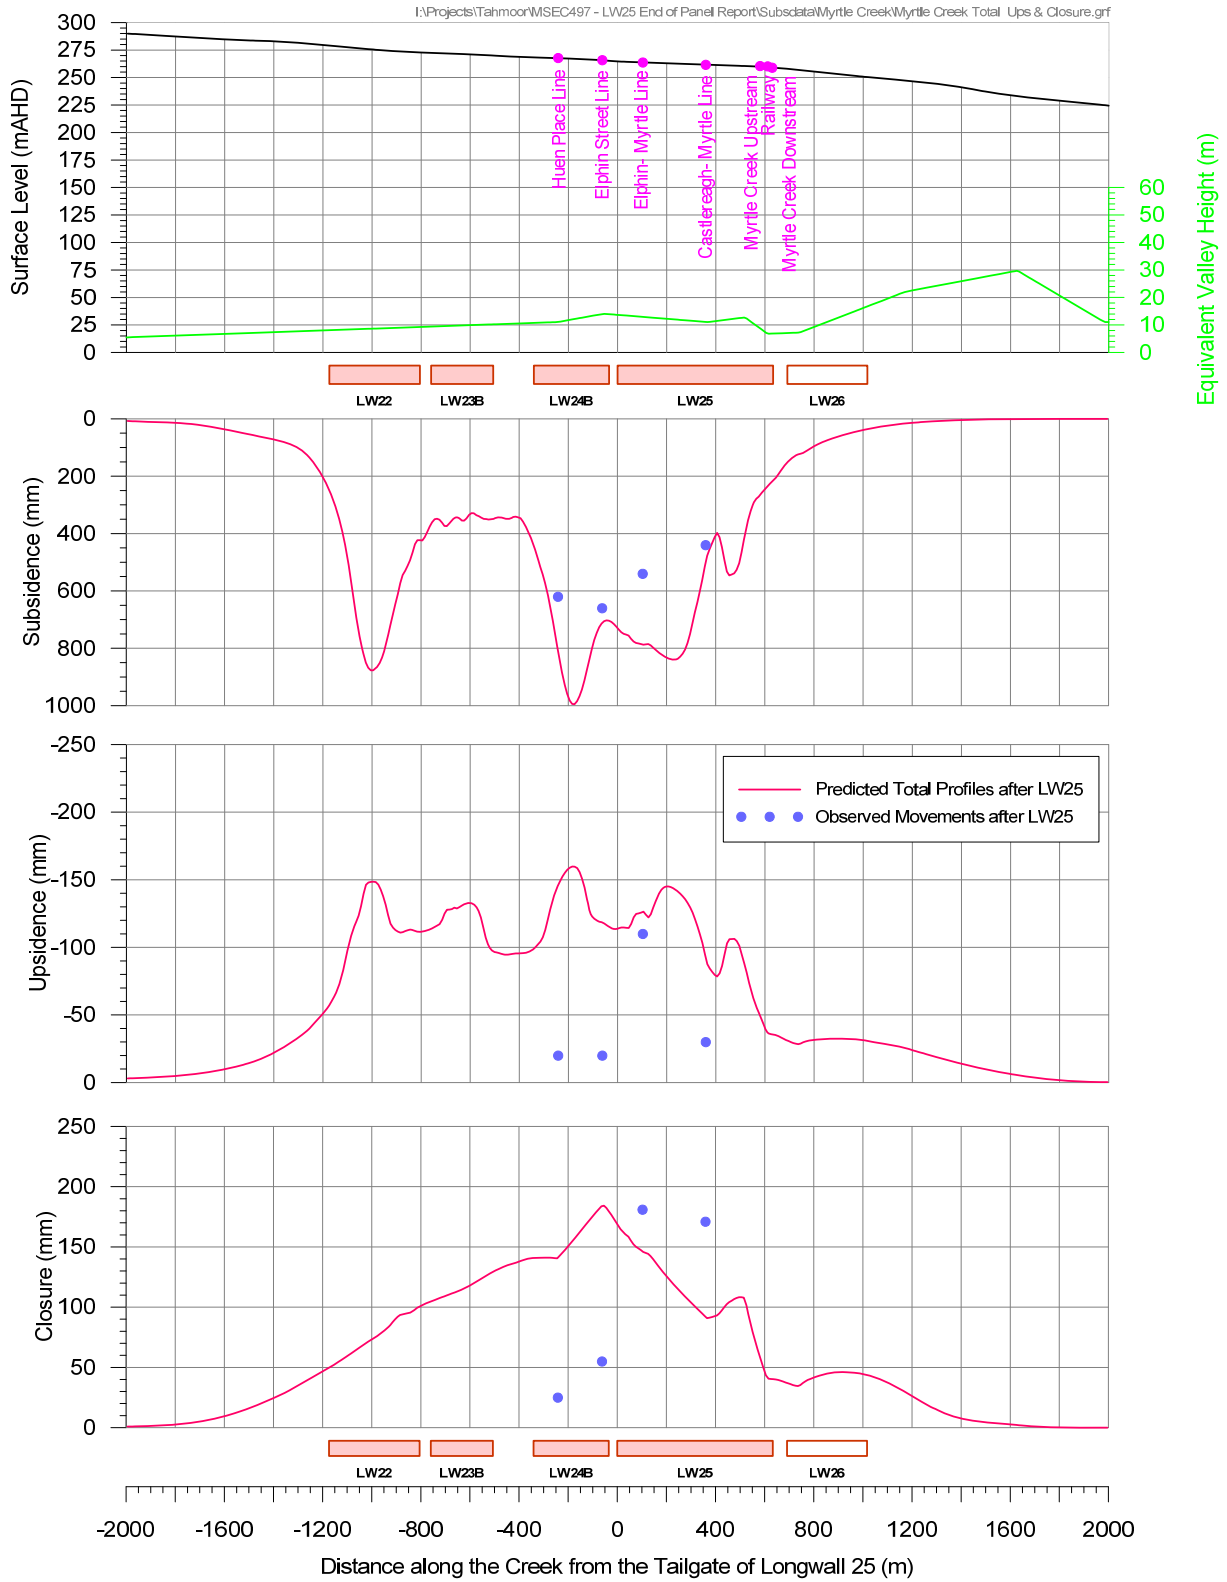
Fig. 2.8 Observed and Predicted Incremental Subsidence, Upsidence and Closure along Myrtle Creek due to the mining of Longwall 25

Fig. 2.9 Observed and Predicted Total Subsidence, Upsidence and Closure along Myrtle Creek due to the mining of Longwalls 22 to 25

It can be seen from the above comparison that observed incremental valley closure movements due to the mining of Longwall 25 have exceeded predictions, particularly along the Elphin-Myrtle and Castlereagh-Myrtle monitoring lines. Observed upsidence is generally less than prediction, with substantial upsidence only detected along the Elphin-Myrtle monitoring line.

While the exceedances of the predicted incremental closure during the mining of Longwall 25 are large, it can be seen from Fig. 2.9 that observed total closures are much closer to prediction.

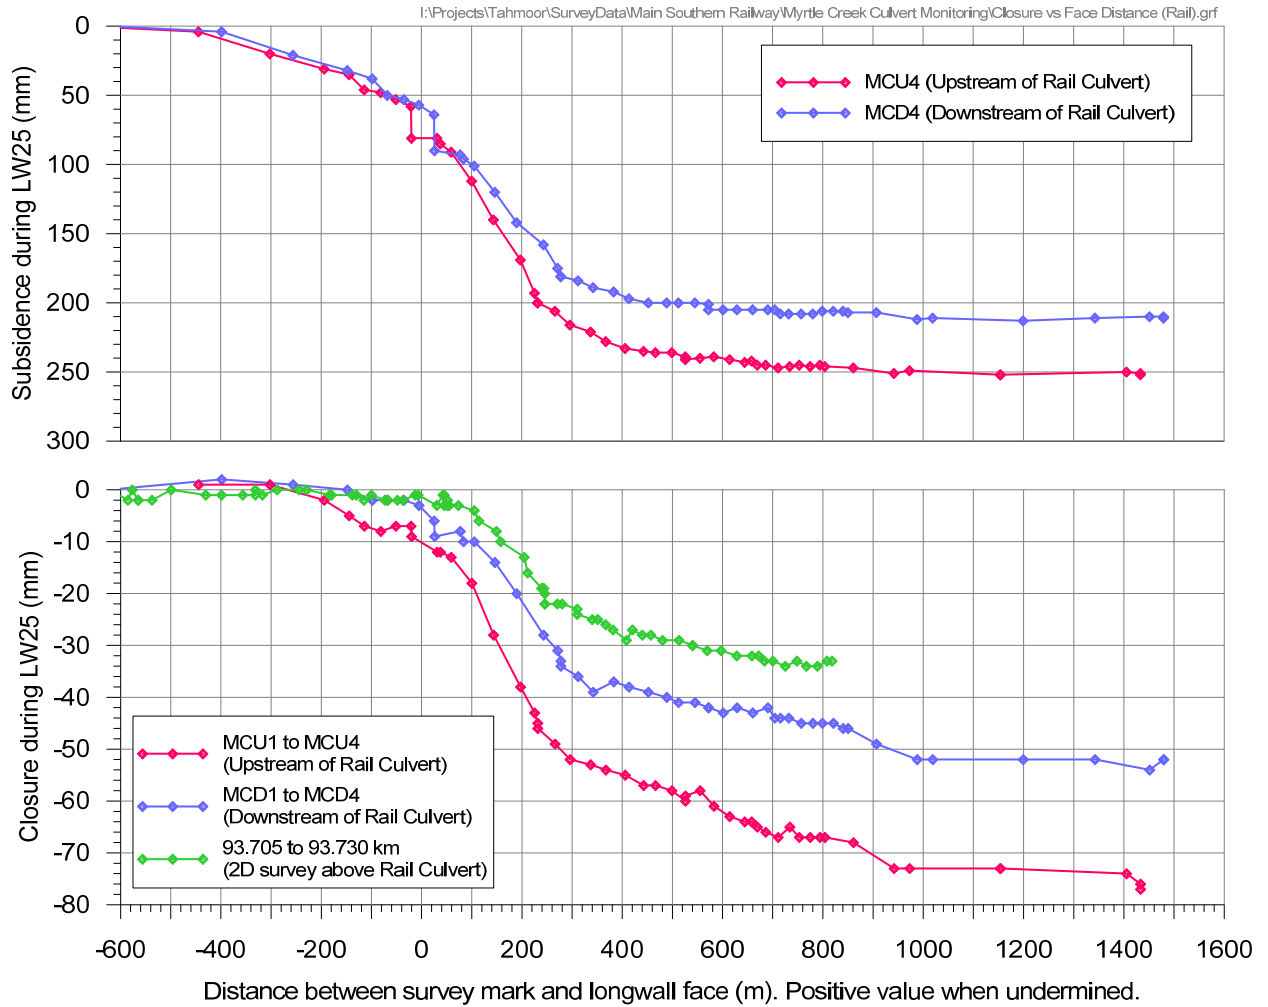
Fig. 2.10 Observed development of Valley Closure across Myrtle Creek at Main Southern Railway during the mining of Longwall 25

Subsidence movements across Myrtle Creek were observed along three monitoring lines during the mining of Longwall 25: the Main Southern Railway line, and lines upstream and downstream of Myrtle Creek Culvert. While none or very little valley upsidence was observed, valley closure was observed across Myrtle Creek. A graph showing the development of valley closure along the three monitoring lines is shown in Fig. 2.10.

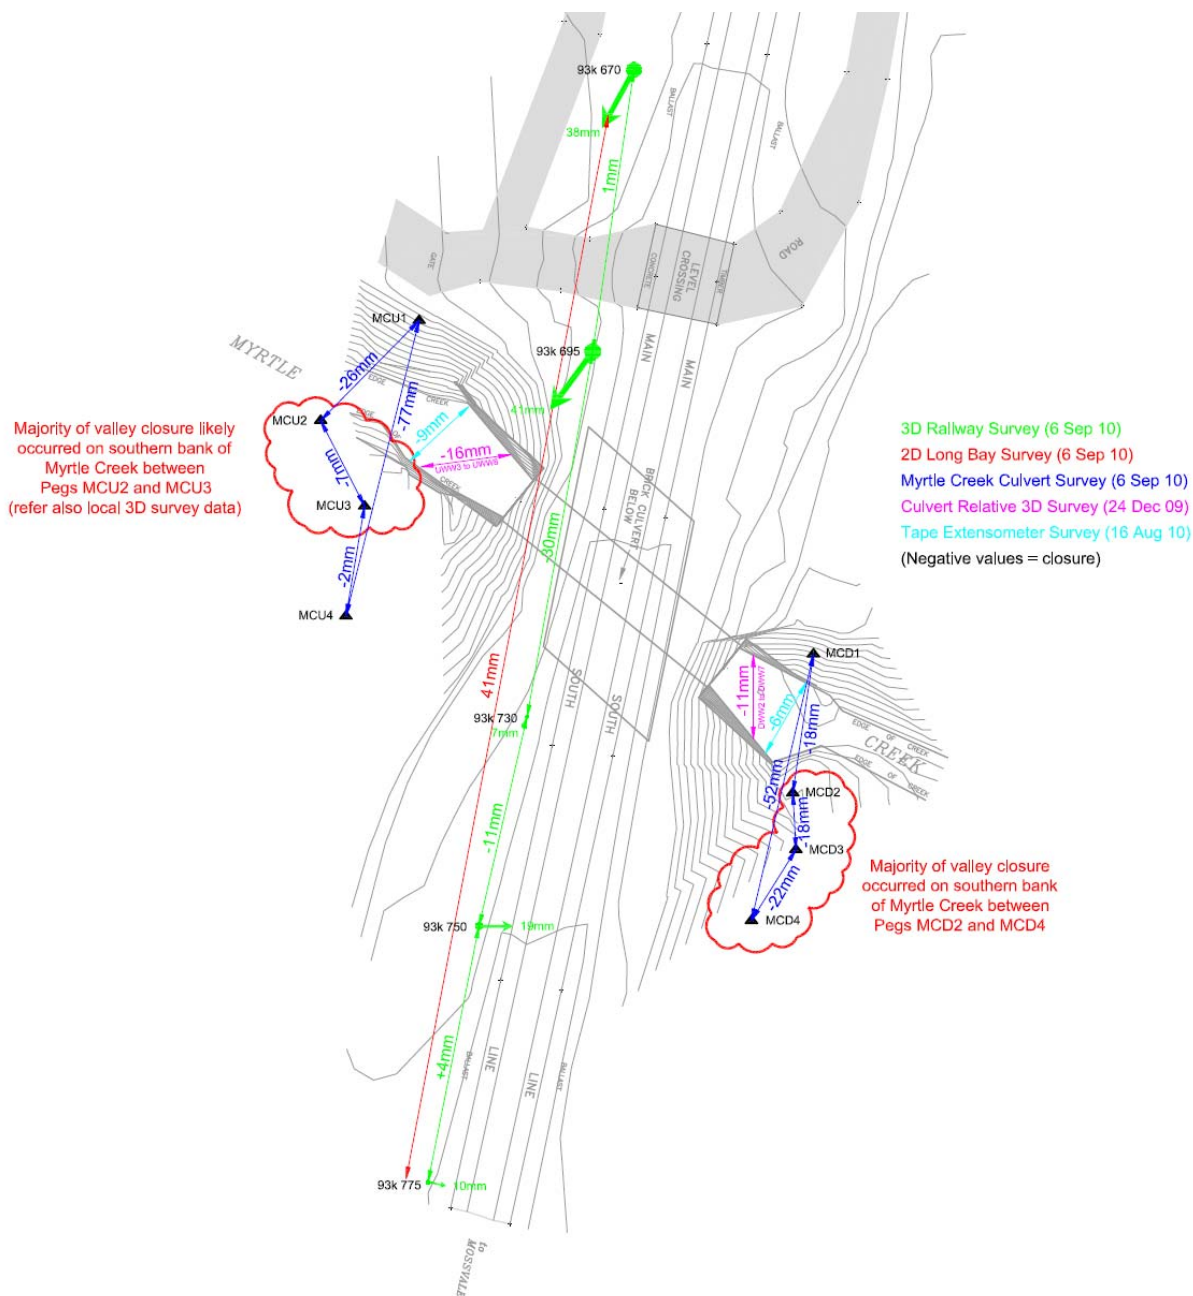
Fig. 2.11 Observed Changes in Horizontal Distance between Survey Points at Myrtle Creek Culvert due to the mining of Longwall 25

It can be seen from Fig. 2.11 that the observed movements along the railway line were less than those across the upstream and downstream monitoring lines.

The upstream and downstream monitoring lines were surveyed in local, relative 3D and reported in 2D, as required in the Management Plan. It can be seen from the representation of 2D data in Fig. 2.11 that the sum of the changes in horizontal movement between the pegs is substantially less than the overall total closure that was measured across the banks. This is particularly the case with the upstream monitoring line.

The reason for the discrepancy can be explained by the bend in the monitoring line, particularly between Pegs MCU2 and MCU3. The monitoring data suggests that the majority of the valley closure was focussed between these pegs, but in a direction normal to the monitoring line. A similar result is observed along the downstream line, where the majority of valley closure movements appear to have been focussed between Pegs MCD2 and MCD4.

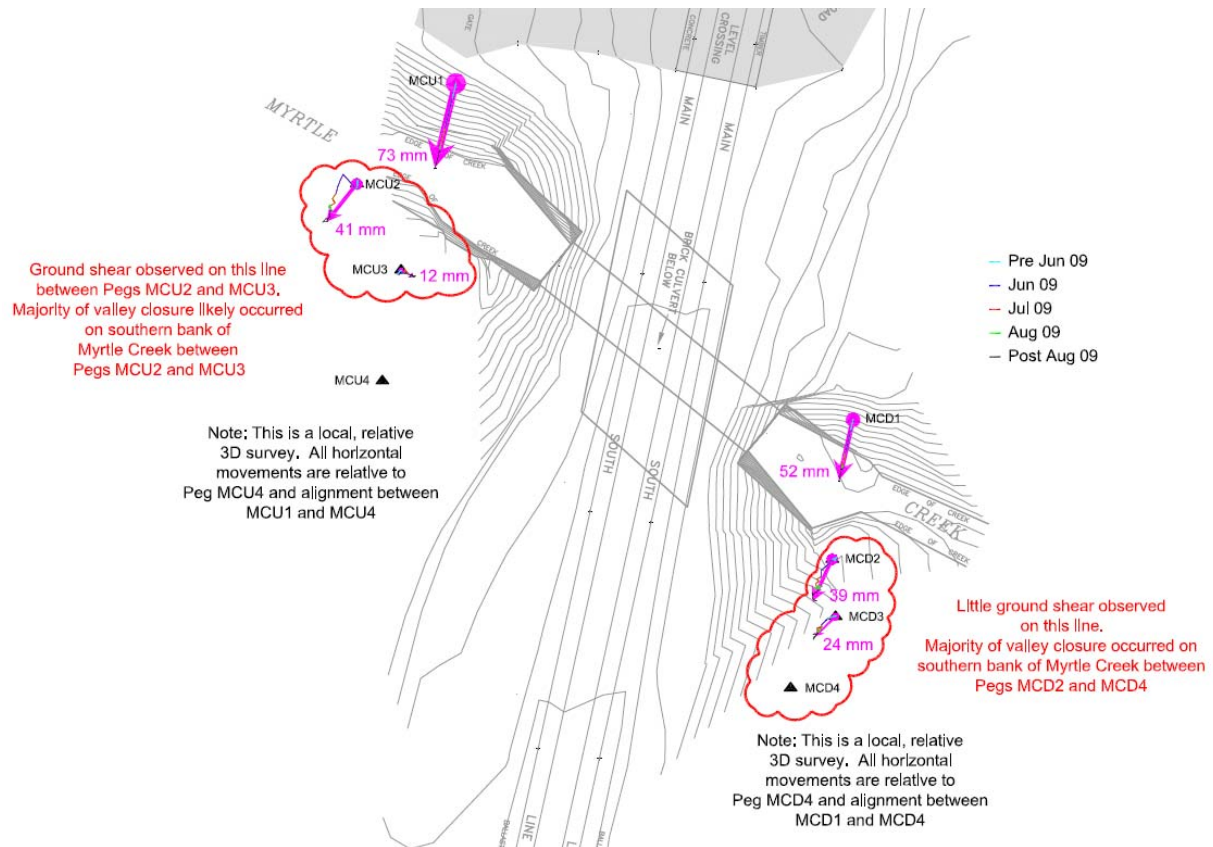
Fig. 2.12 Observed Horizontal Movement of Survey Pegs along Upstream and Downstream Monitoring lines across Myrtle Creek during the mining of Longwall 25

The above results show that horizontal ground shearing has developed on the upstream monitoring line between Pegs MCU2 and MCU3, with less ground shear apparent across the downstream monitoring line. Approximately 30 mm of closure has been observed across the base of the culvert between Pegs MCU1 and MCU2 by both 2D and 3D survey. Given that 41 mm of closure can be inferred from the 3D survey to have developed between Pegs MCU2 and MCU3, the majority of the valley closure movements appear to have focussed between two pegs.

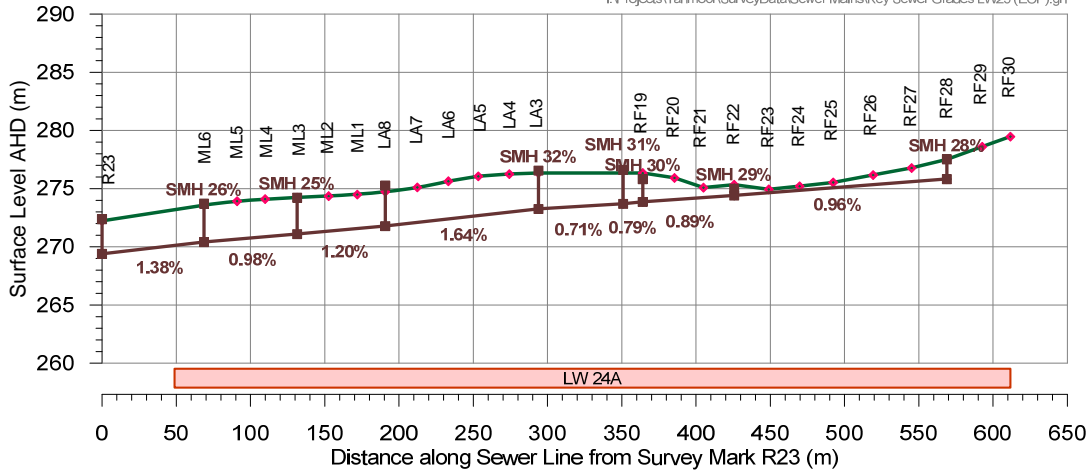
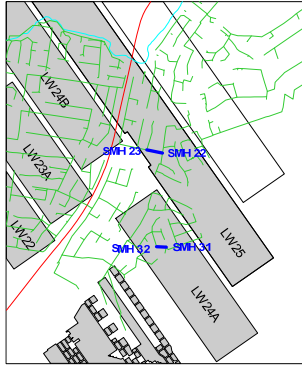
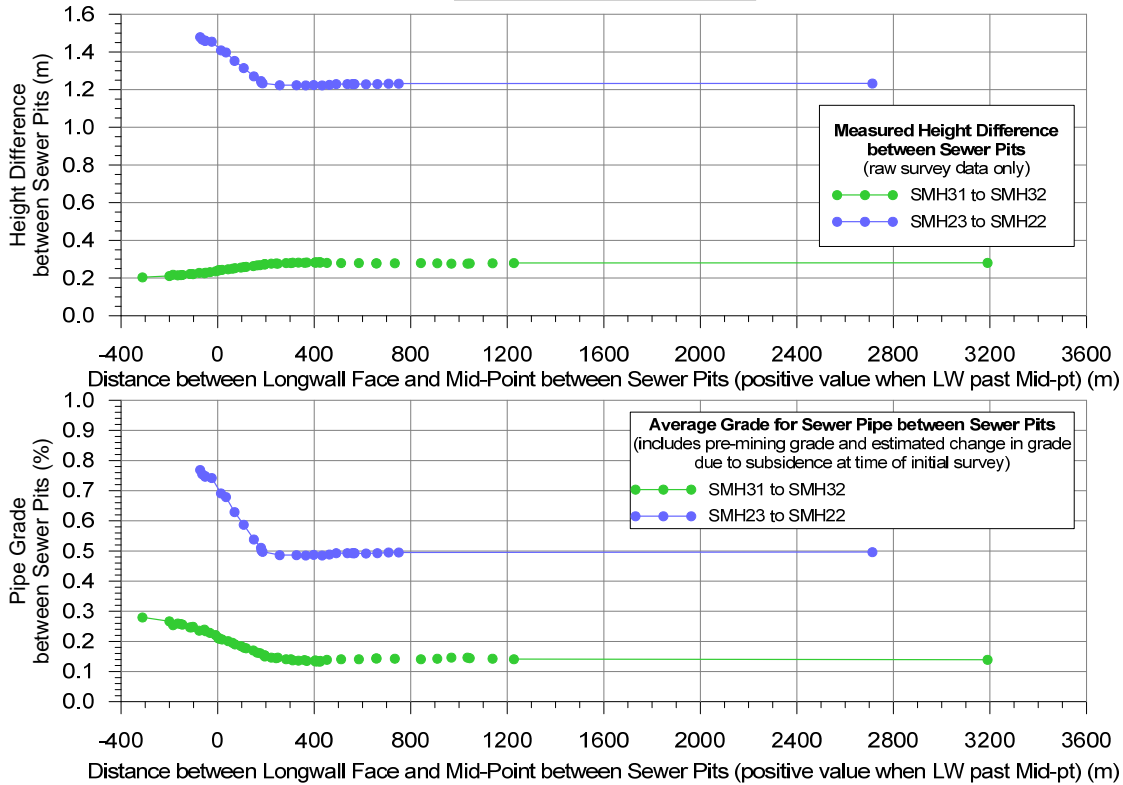
Fig. 2.13 Observed Changes in Grade between selected Sewer Pits

Relative height differences between the sewer pit lids were measured up to three times a week in accordance with an agreed management plan with Sydney Water. A total of 57 surveys were conducted between SMH31 and SMH32, and a total of 28 surveys were conducted between SMH23 and SMH22 during the mining of Longwall 25. A plot of observed height differences and changes in grade is provided in Fig. 2.13.

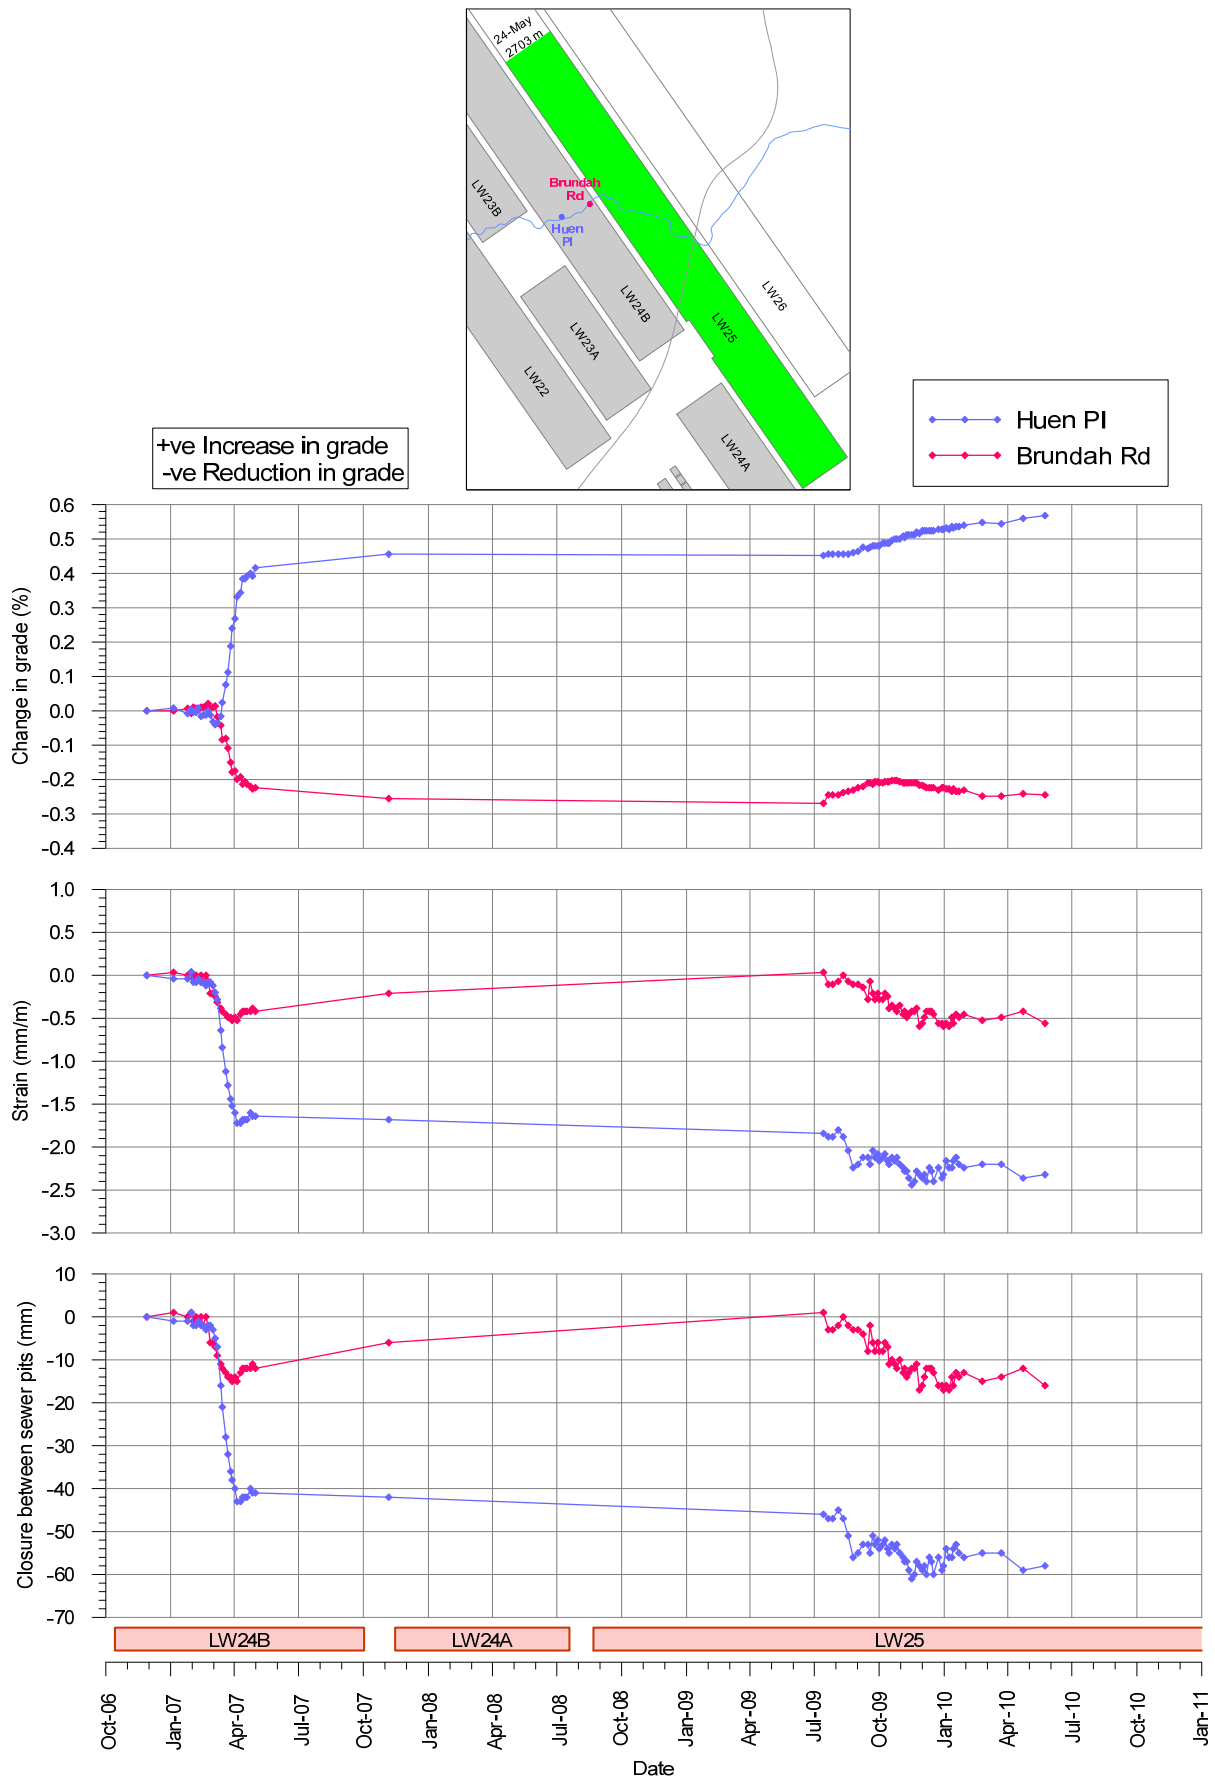
Fig. 2.14 Observed Total Change in Grade, Strain and Closure along Sewer Pipes that cross Myrtle Creek during the mining of Longwalls 24B to 25

It can be seen that very little change was observed across the Brundah Road crossing during the mining of Longwall 25 and an additional 20 mm closure developed across the Huen Place crossing.

In accordance with the management plan, daily visual inspections and CCTV inspections were conducted. No impacts were observed to the sewer pipes during the mining of Longwall 25. Comfort is drawn from CCTV observations, which did not detect changes at pipe joints.
