XSTRATA COAL:
Tahmoor Colliery - Longwall 25

End of Panel Subsidence Monitoring Report for Tahmoor Longwall 25

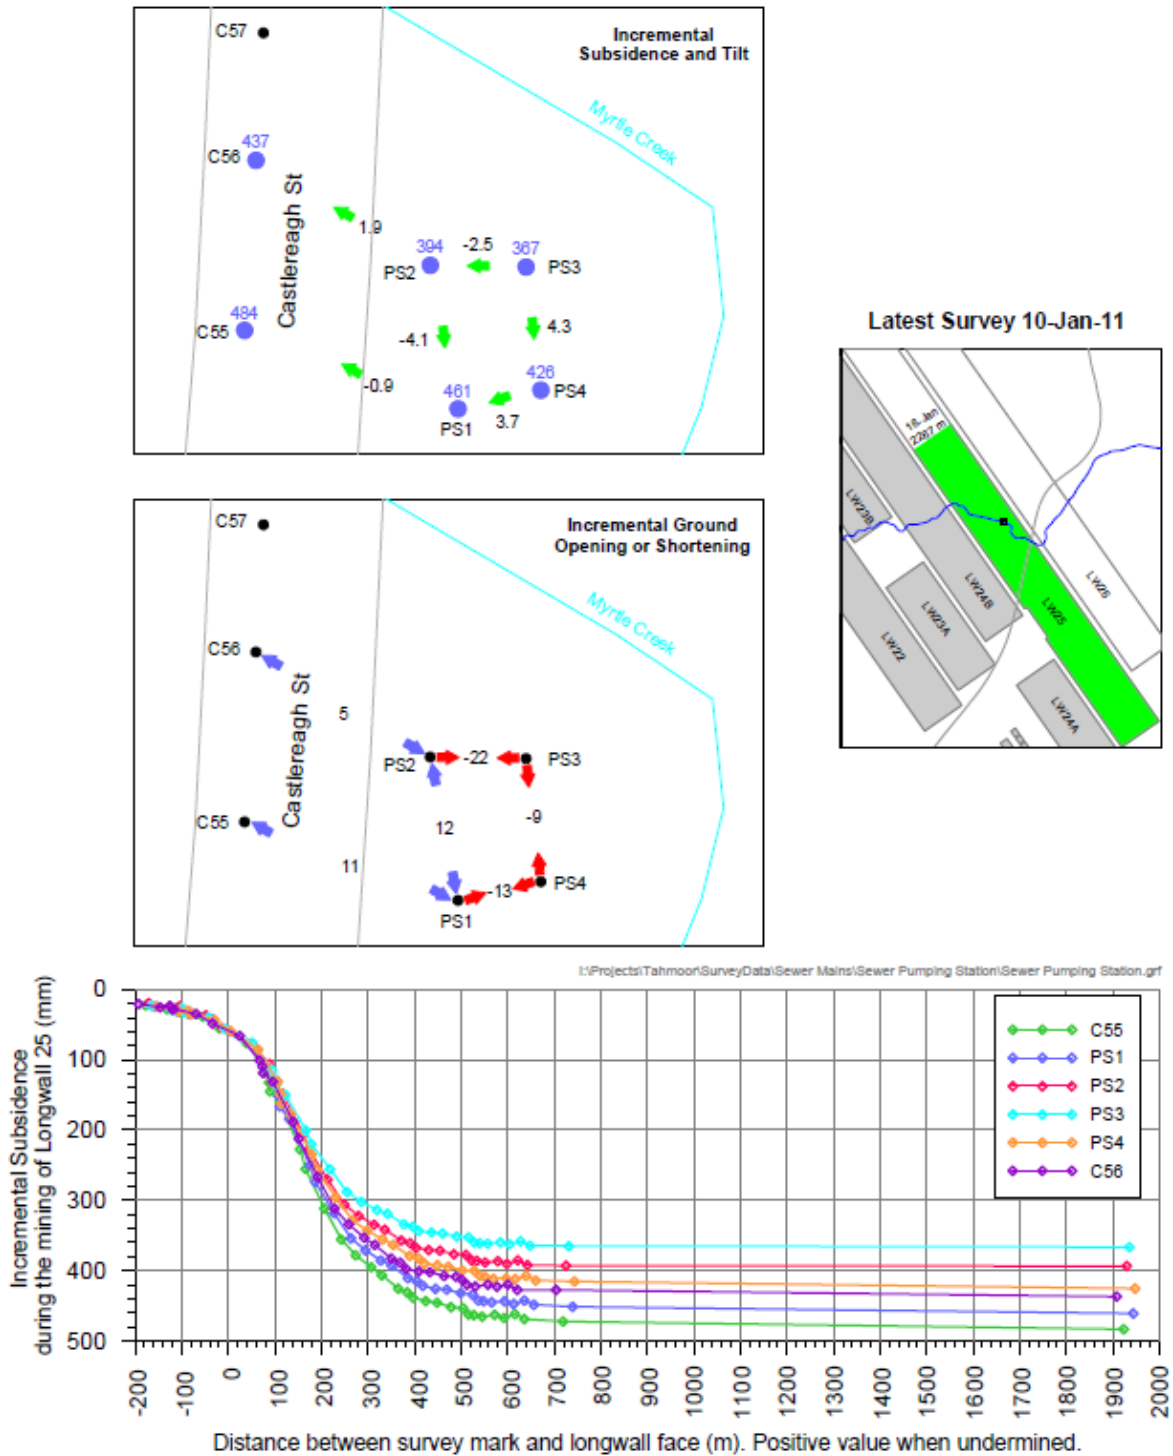
Fig. 2.15 Sewer Pumping Station Monitoring during Longwall 25

Ground monitoring around the pumping station during the mining of Longwall 25 showed that the pumping station subsided approximately 400 mm, as shown in Fig. 2.15. Observed tilts were within expectations. The majority of ground strains around the pumping station were relatively small, with the exception of strain between Pegs PS2 and PS3 on the northern or downslope side. Compressive strain between the pegs was 2.2 mm/m in January 2010, with a maximum of 3.4 mm/m observed in December 2009.

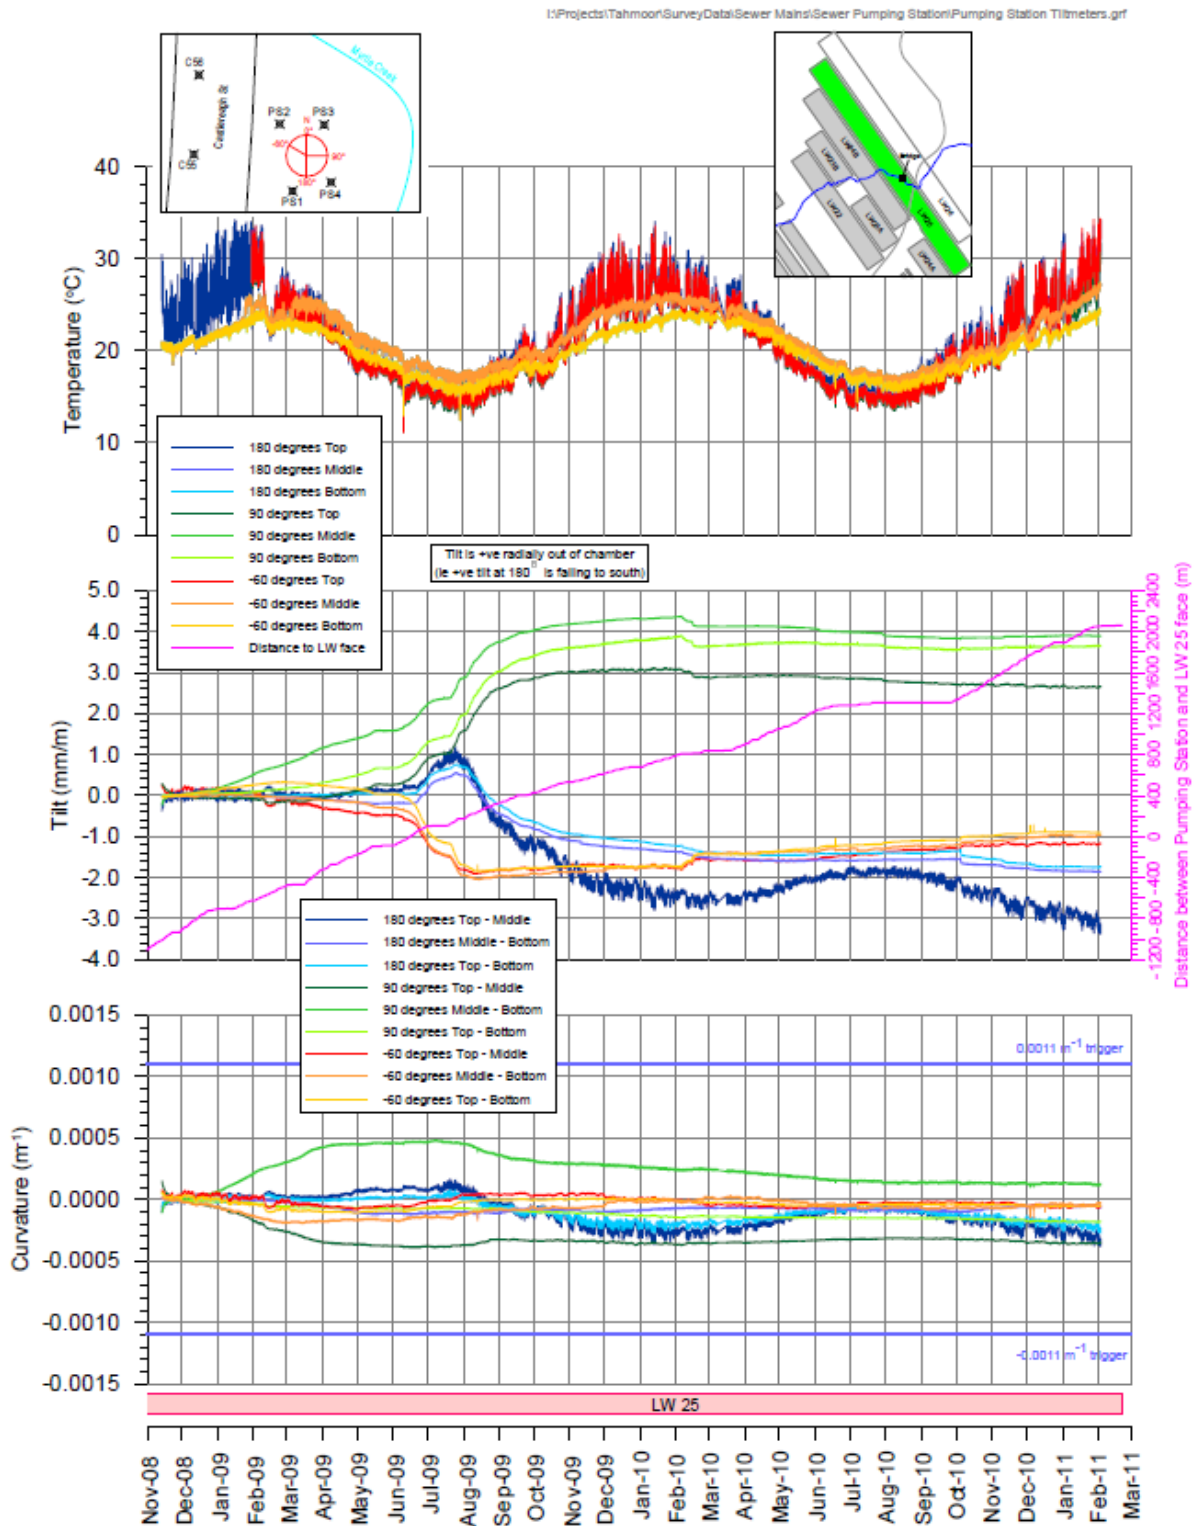
Fig. 2.16 Sewer Pumping Station Tiltmeters during Longwall 25

Automated continuous tiltmeters monitored changes in tilt in 3 vertical lines, placed at the top, base and mid-point on the internal face of the chamber wall. As shown in Fig. 2.16, observed curvatures are well within trigger levels as defined under the Management Plan.

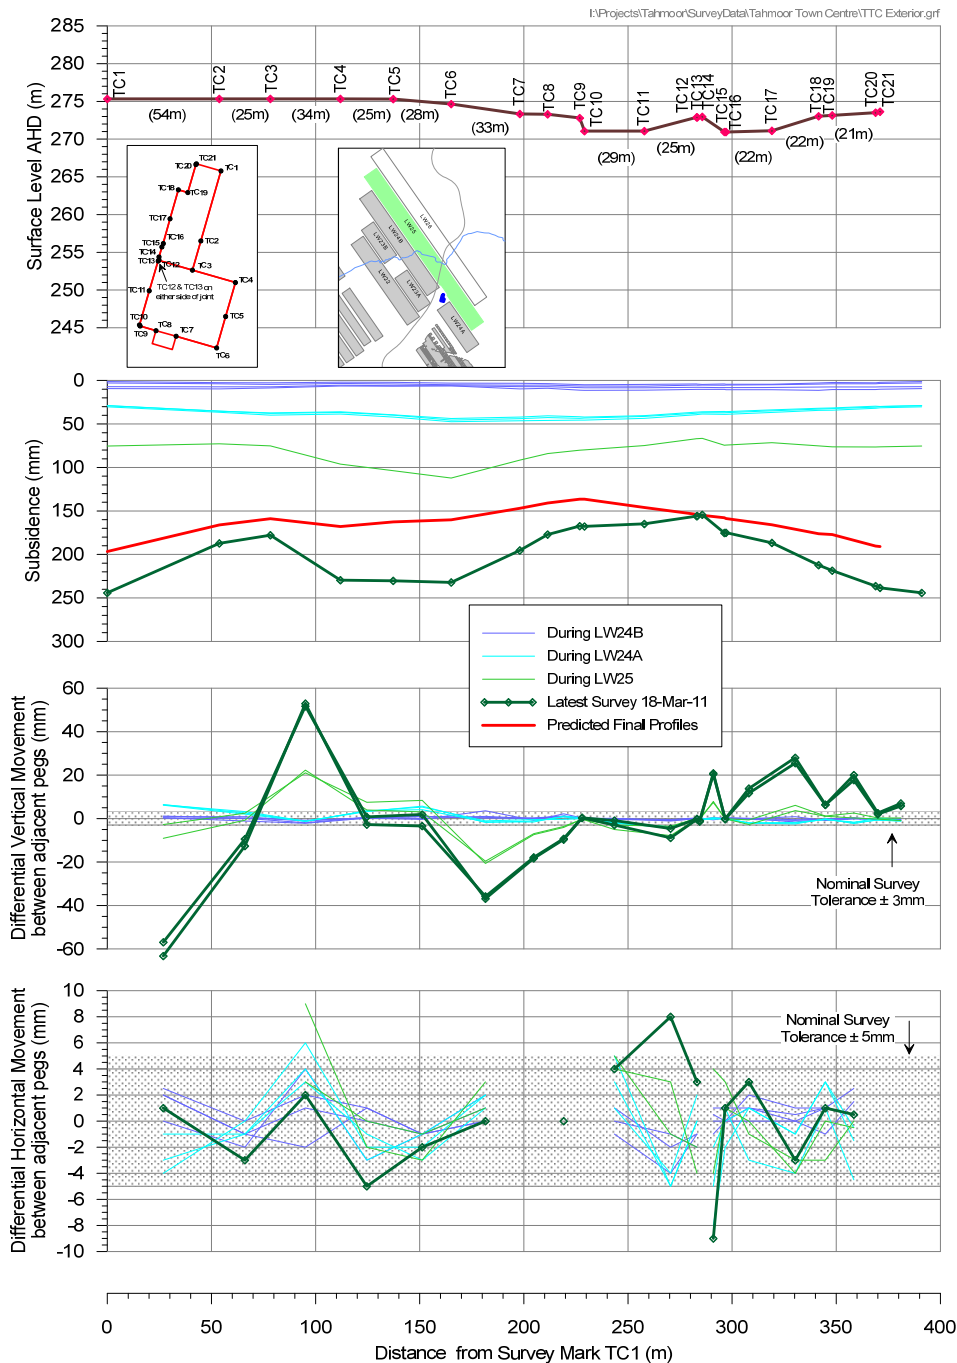
Fig. 2.17 Observed Profiles along Tahmoor Town Centre Exterior Line after Longwall 25

A total of 52 detailed surveys of the Tahmoor Town Centre and basement carpark were undertaken in accordance with the conditions of SMP Approval by the Department of Primary Industries and management plan with Tahmoor Town Centre. Maximum observed incremental subsidence due to the mining of Longwall 25 was 214 mm at the north-east corner of the complex. Maximum observed total subsidence after the mining of Longwall 25 was approximately 244 mm since the commencement of Longwall 24B. Observed profiles along the Exterior line after Longwall 25 are shown in Fig. 2.17 below.

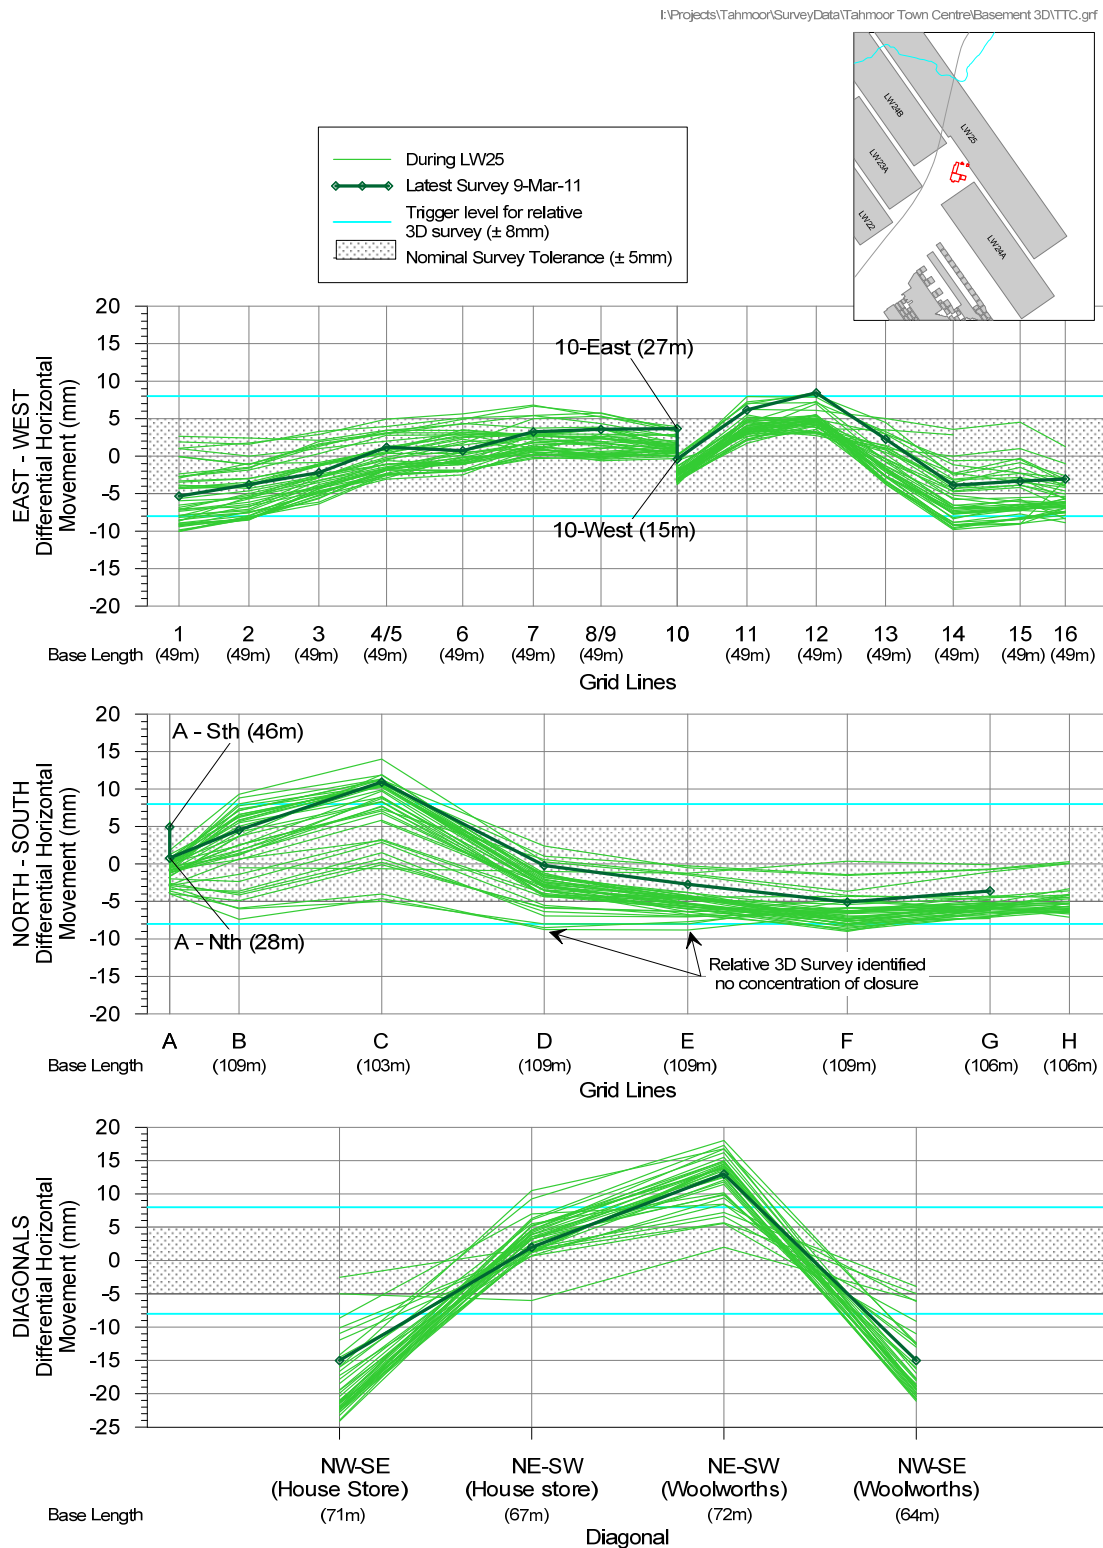
Fig. 2.18 Basement Width and Length Surveys during Longwall 25

The distances across the width and length of the TTC basement were measured on a weekly basis during mining. The results indicate small movements in the North-South and East-West directions, slightly greater closure movement across the diagonal NW/SE direction and small opening movements in the NE/SW direction.

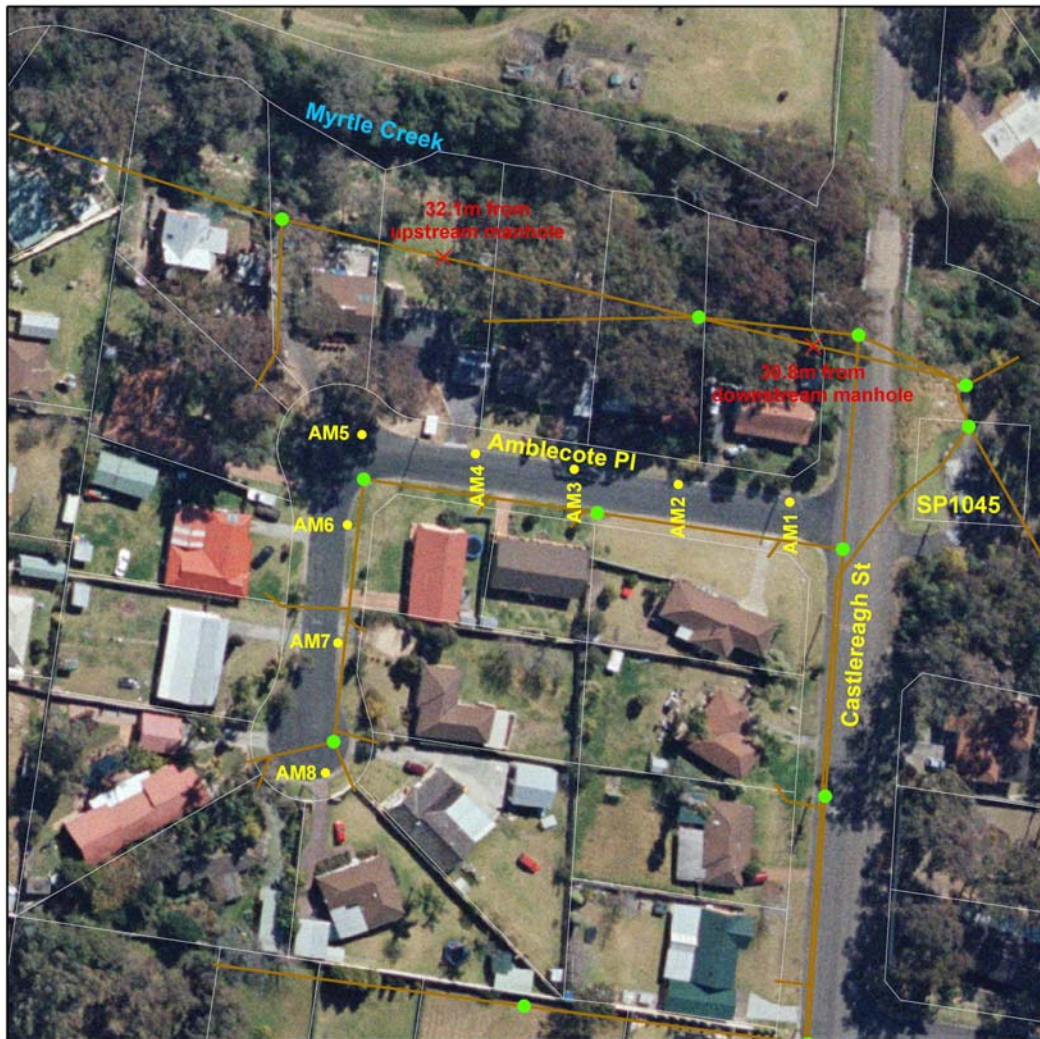
Fig. 4.3 Location of Sewer Impacts along Horizontal Bore near Amblecote Place

- Crushing and vertical bending of the 225 mm diameter horizontal bore between Amblecote Place and Myrtle Creek, at the location shown in Fig. 4.3. There is no monitoring line above this bore.

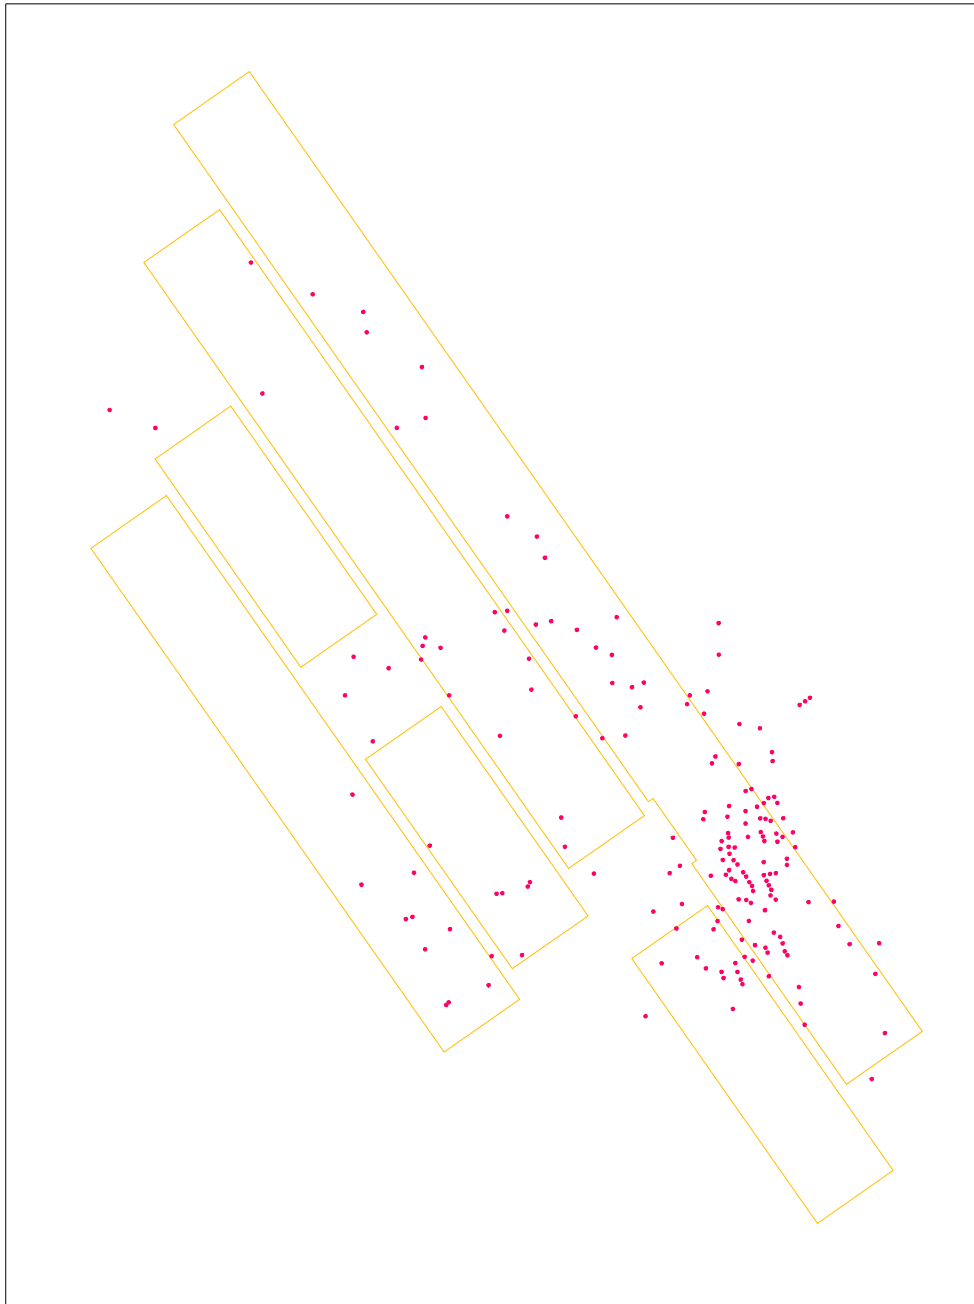
Fig. 4.4 Locations of Impacts Reported during the Mining of Longwall 25

This is illustrated by a spatial plot of locations of impacts reported during the mining of Longwall 25 in Fig. 4.4. A total of 59 of 182 claims related to the mining of Longwalls 22 to 24A, rather than the active Longwall 25.
