GLENCORE:
Tahmoor Colliery - Longwall 27

End of Panel Subsidence Monitoring Report for Tahmoor Longwall 27

This report has been prepared by Mine Subsidence Engineering Consultants (MSEC) for Glencore Tahmoor Colliery to comply with conditions of the SMP Approval set by the NSW Department of Trade and Investment, Regional Infrastructure and Services, Division of Resources and Energy (DTIRIS).

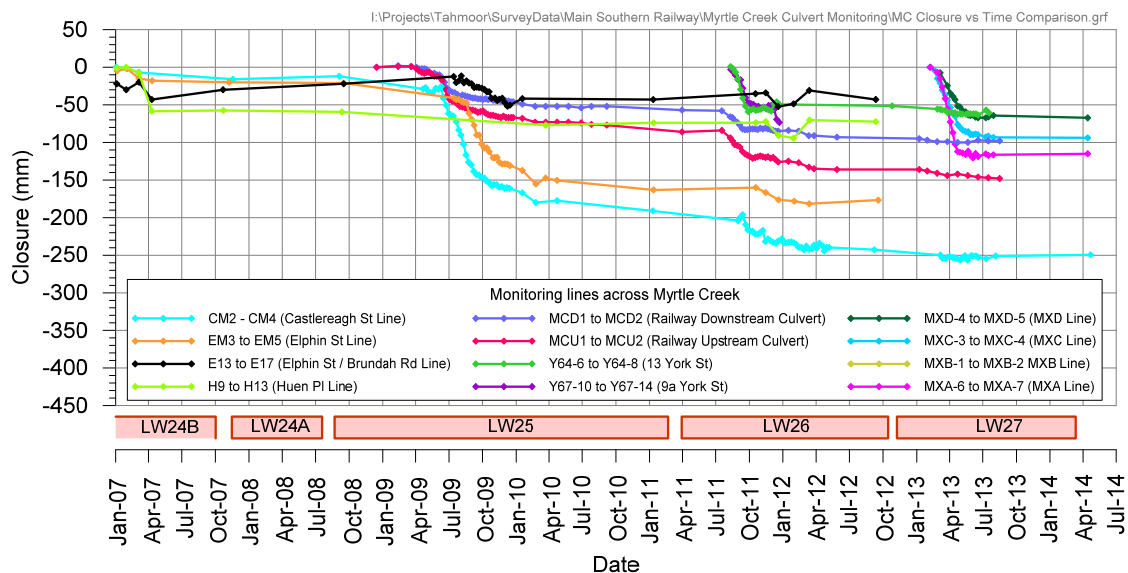
Fig. 2.9 Development of closure across Myrtle Creek during the mining of Longwalls 24B to 27

It can be seen that during the mining of Longwall 25, observed valley closure had substantially exceeded predictions at the Castlereagh Street crossing, at the crossing of the Elphin-Myrtle monitoring line and to a lesser extent the crossing of the Main Southern Railway. It is considered that the reason for the differences in observations may be linked to the change in orientation of Myrtle Creek as the three above-mentioned monitoring lines are located along the same stretch of Myrtle Creek. It is noted, however, that substantially less closure has developed at Castlereagh Street than predicted during the mining of Longwall 27.

Observed valley closure across Myrtle Creek where it flows directly above Longwall 27 (MXA to MXC lines) have been less than predictions, but greater in magnitude across monitoring lines above previously extracted longwalls. This was expected because the valley is deeper compared to sections further upstream.

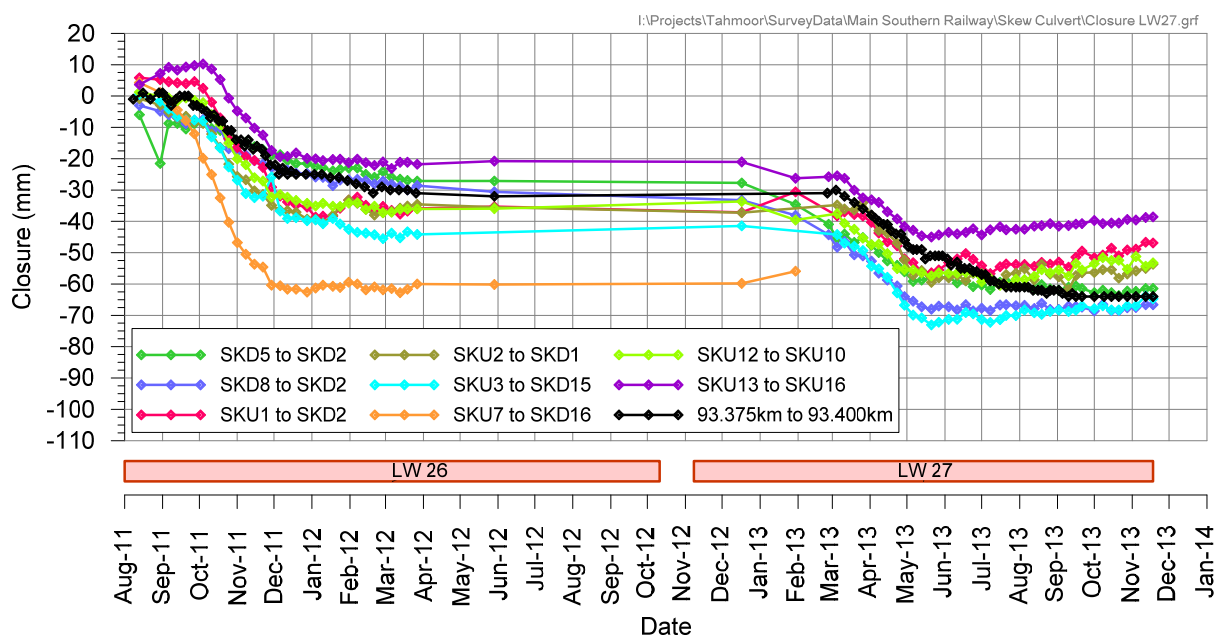
Fig. 2.11 Development of closure across Skew Culvert during the mining of Longwall 27

Observed valley closure across the creek at the Skew Culvert has also slightly exceeded predictions, where the differences between predicted and observed closure are relatively small for most cross sections.

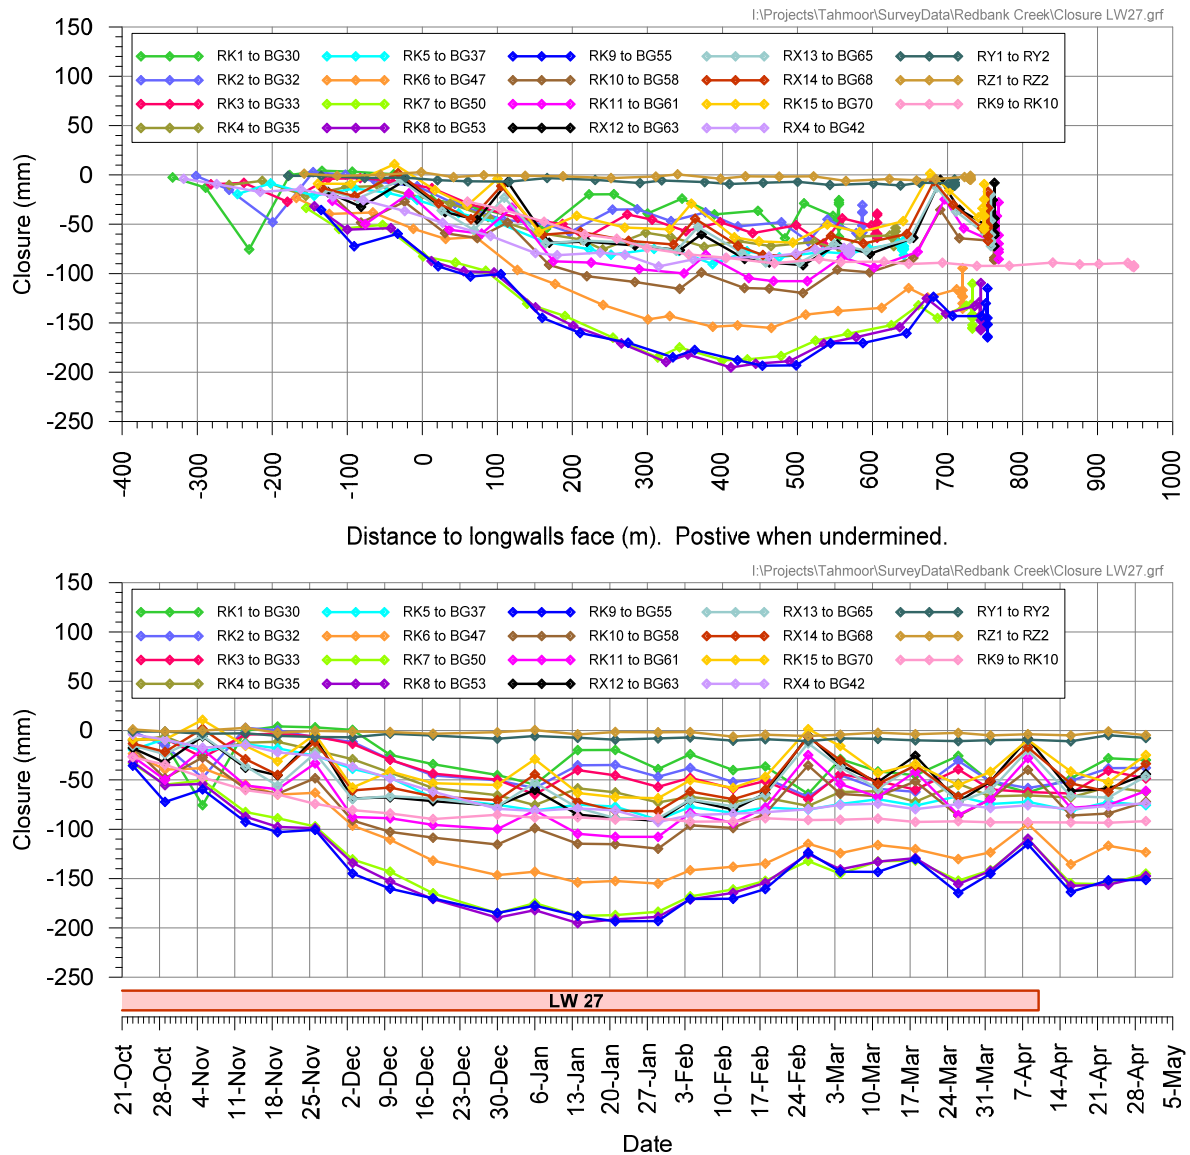
Fig. 2.13 Observed development of closure across Redbank Creek

It can be seen from Fig. 2.13 that valley closure was greater for a temporary period of time, when the transient effects of the subsidence travelling wave passing through the valley. As the longwall face moved away from Redbank Creek by more than 400 metres, the additional compressive strains from the travelling wave reduced. It can also be seen that very little change in valley closure since early March 2014.

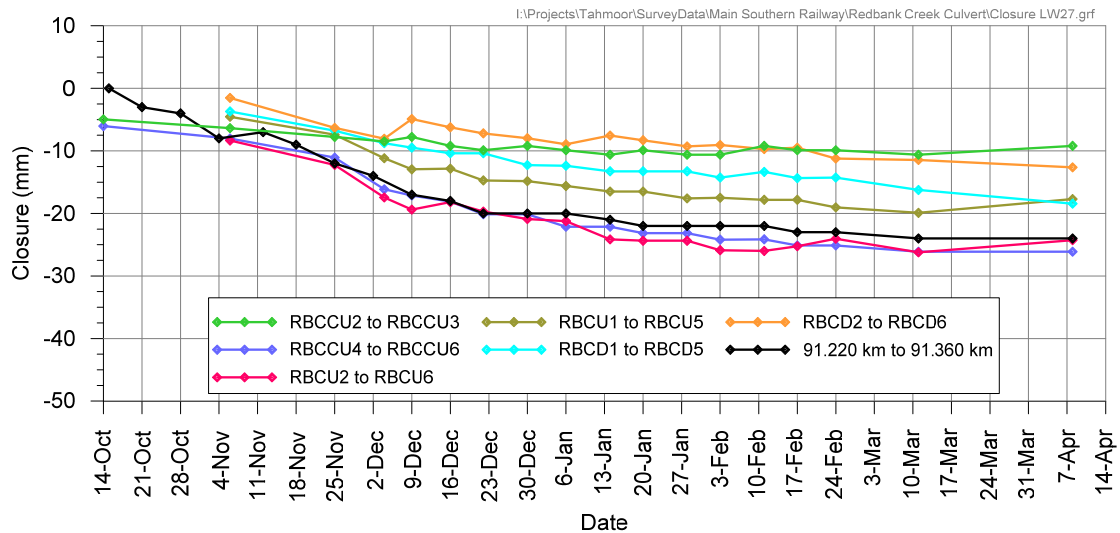
Fig. 2.15 Observed Valley Closure over time across Redbank Creek Culvert at Main Southern Railway

This ground survey has shown 5 mm of closure across the upstream end of the Redbank Creek Culvert wingwalls. The changes were cross checked with tape extensometer measurements by GHD Geotechnics and only sub millimetre changes have been observed. Measured changes in horizontal distances are within survey tolerances across the remainder of the survey points on the wingwalls, headwalls and culvert barrel, and along the length of the culvert.

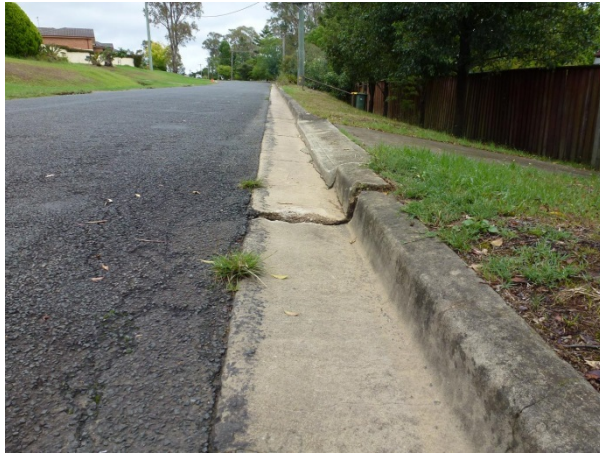
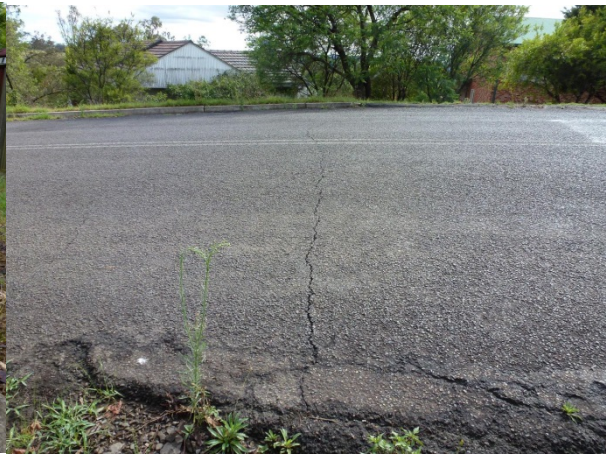
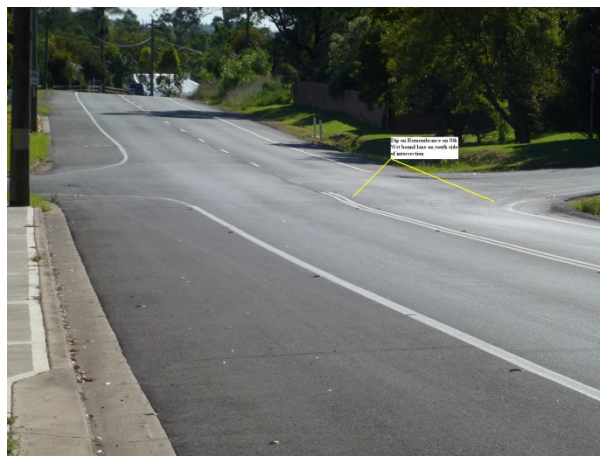
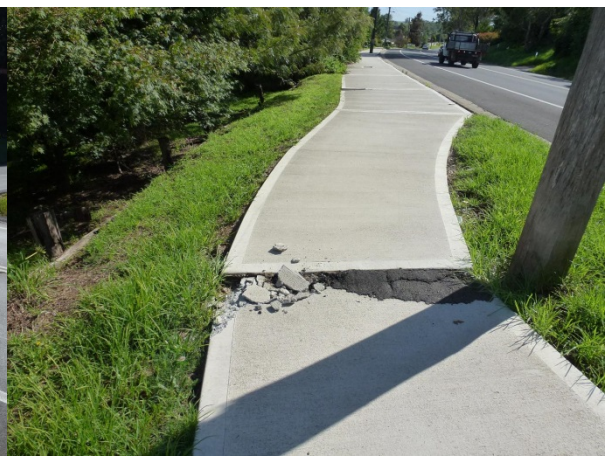
Approximately 24.5 kilometres of asphaltic pavement lie directly above the extracted longwalls and a total of 46 impact sites have been observed. The observed rate of impact equates to an average of one impact for every 533 metres of pavement. The impacts were minor and did not present a public safety risk.

Fig. 4.1 Photographs of Impacts to Road Pavements and Kerbs during Longwall 27

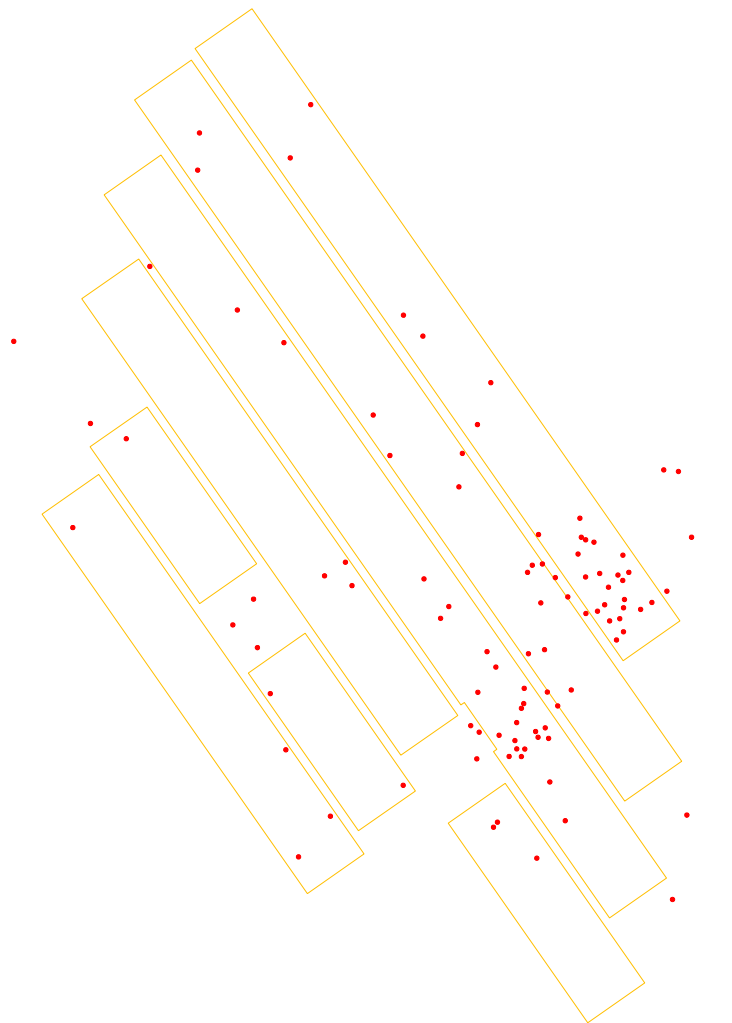
Fig. 4.2 Locations of Impacts Reported during the Mining of Longwall 27

This is illustrated by a spatial plot of locations of impacts reported during the mining of Longwall 27 in Fig. 4.2. A total of 67 of 101 claims related to the mining of Longwalls 22 to 26, rather than the active Longwall 27.

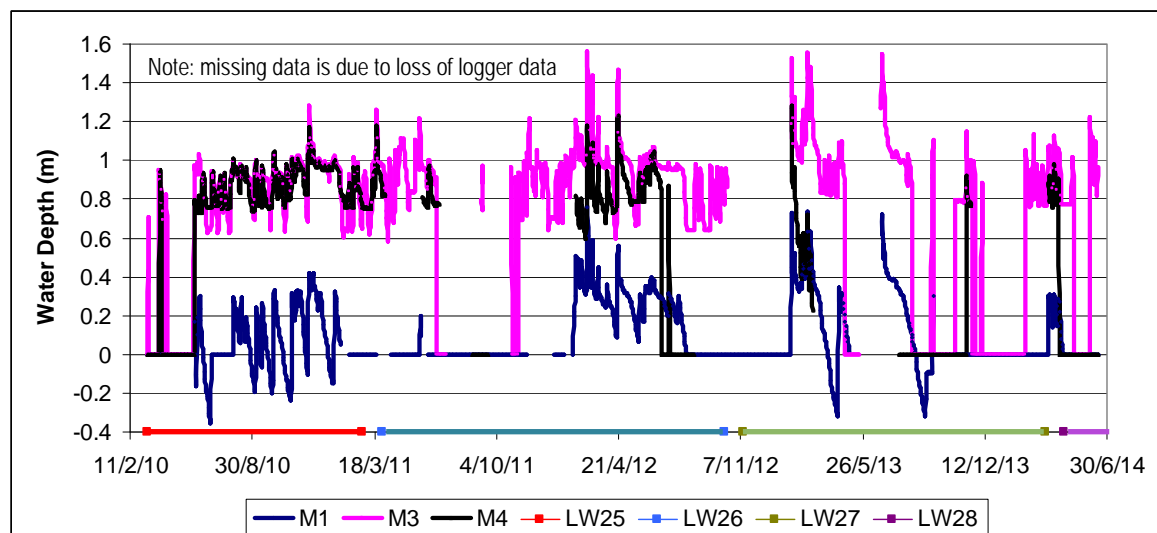
Figure 2 Myrtle Creek Depth Upstream of LW27

M3 is located immediately downstream of the Longwall 25 / 26 chain pillar and shows subsidence effects on its pool holding capacity due to subsidence associated with Longwall 26, and subsequent additional cracking associated with extraction of Longwall 27.

M4 is located over the chain pillar between Longwall 26 and 27 and also shows a reduction in pool holding capacity due to extraction of Longwall 26 and subsequently Longwall 27.

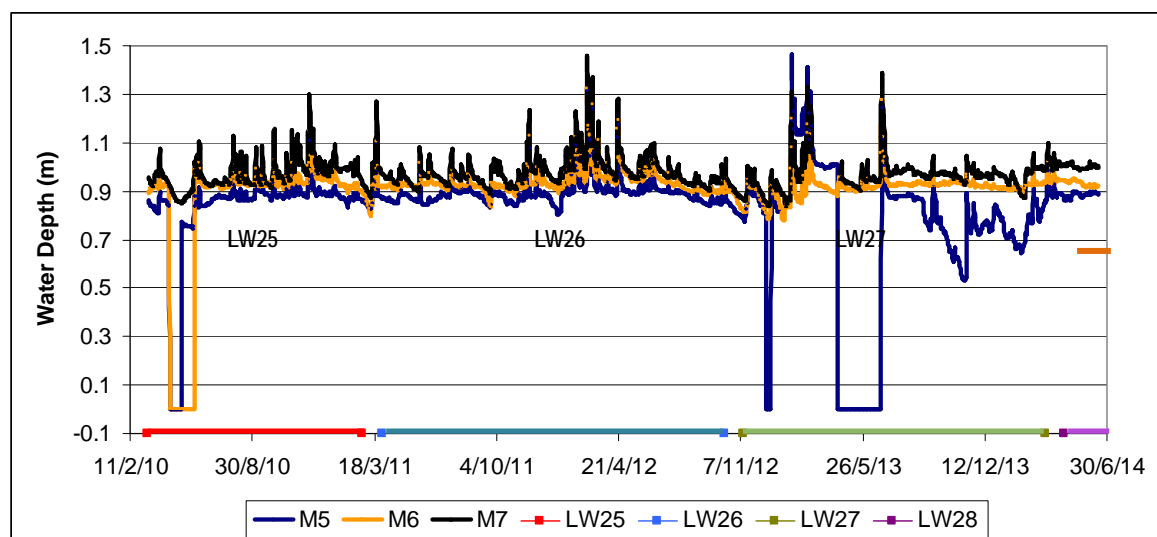
Figure 3 Myrtle Creek Depth Over and Downstream of LW27

Site M5 is located over the central to main gate section of Longwall 28 and showed no effects on its pool holding capacity due to extraction of Longwalls 22 to 27.

Sites M6 and M7 are located downstream of Longwall 28 and show no subsidence effects on their pool holding capacity.

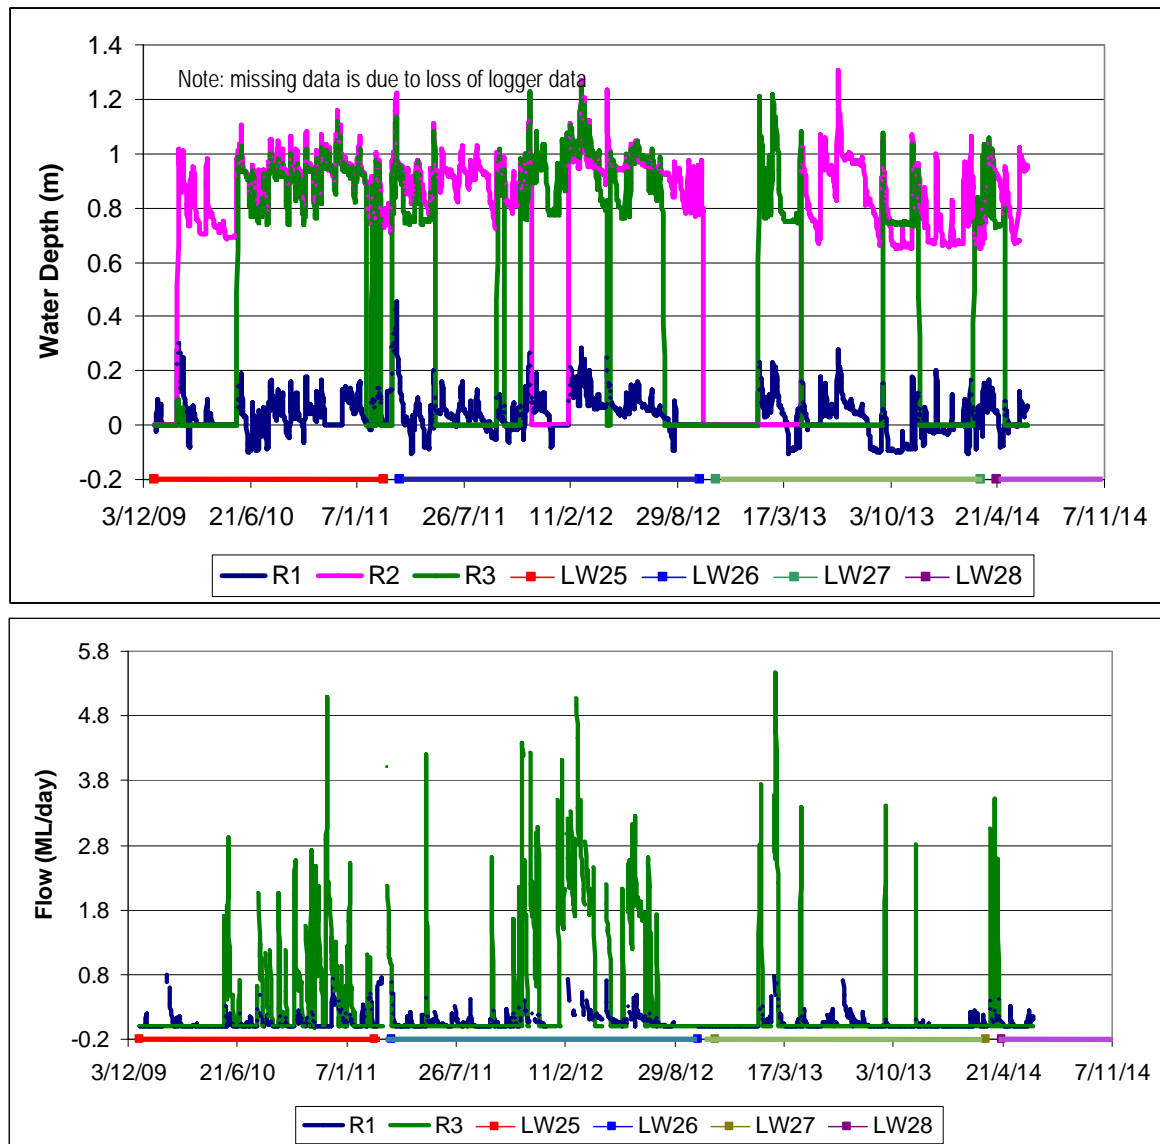
Figure 4 Redbank Creek Depth and Flow Upstream of Longwall 27

Pool R2, on the north eastern upstream corner of Longwall 25, and upstream of Longwall 26, ceased on 17 October 2012 because the pool ran dry due to lack of rainfall in the catchment. Since then, the pool has dried out on two occasions during and after extraction of Longwall 26.

Pool R3, located at the northern western end of Longwall 25 and upstream of Longwall 26, has dried out on numerous occasions since and after extraction of Longwall 25.

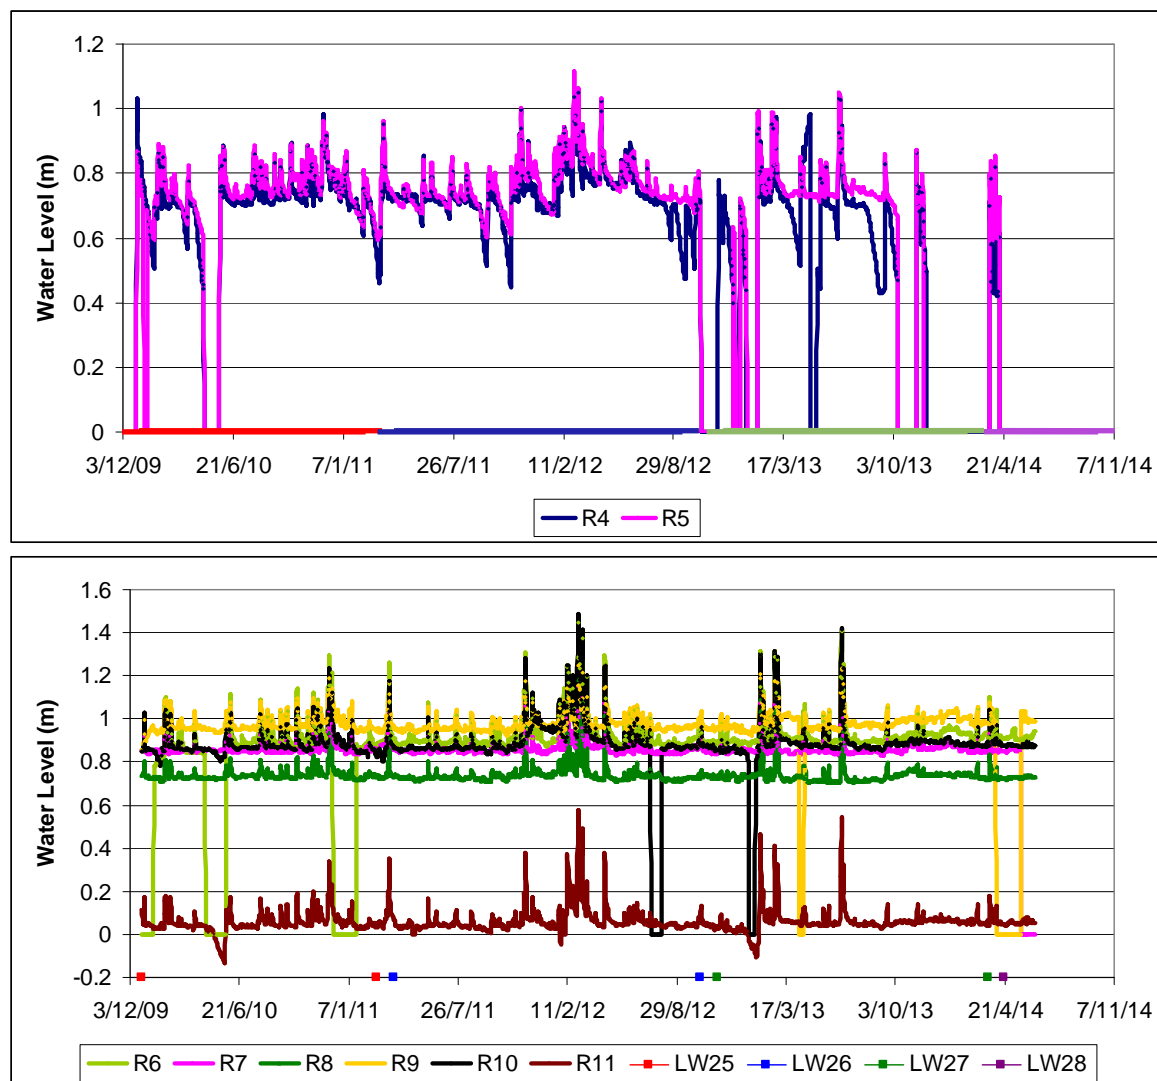
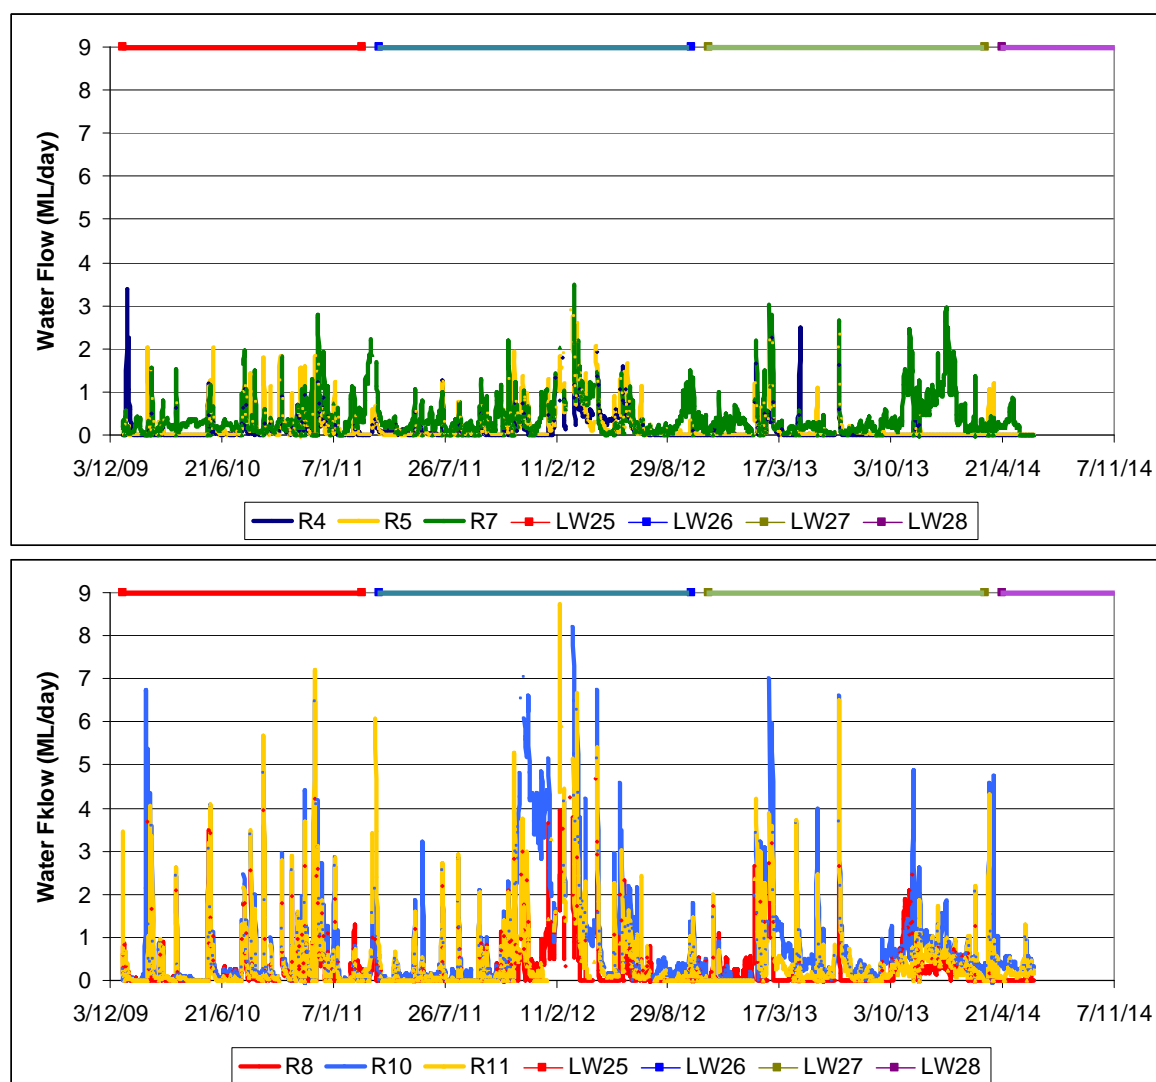
Pool R4, which is located over Longwall 27 did not dry out until it was undermined by Longwall 27, as shown in **Figures 5 and 6**.

Pool R6, which is located over the middle of Longwall 29 and contains the permanently ferruginous pool RC2, dried up on three occasions during extraction of Longwall 25, but has not dried up since then.

Pools 7 and 8 have not dried up in the monitoring period, whilst Pool 9 has dried up on two occasions during extraction of Longwall 27 and Pool 10 dried up on two occasions during extraction of the end of Longwall 26 and the beginning of Longwall 27.

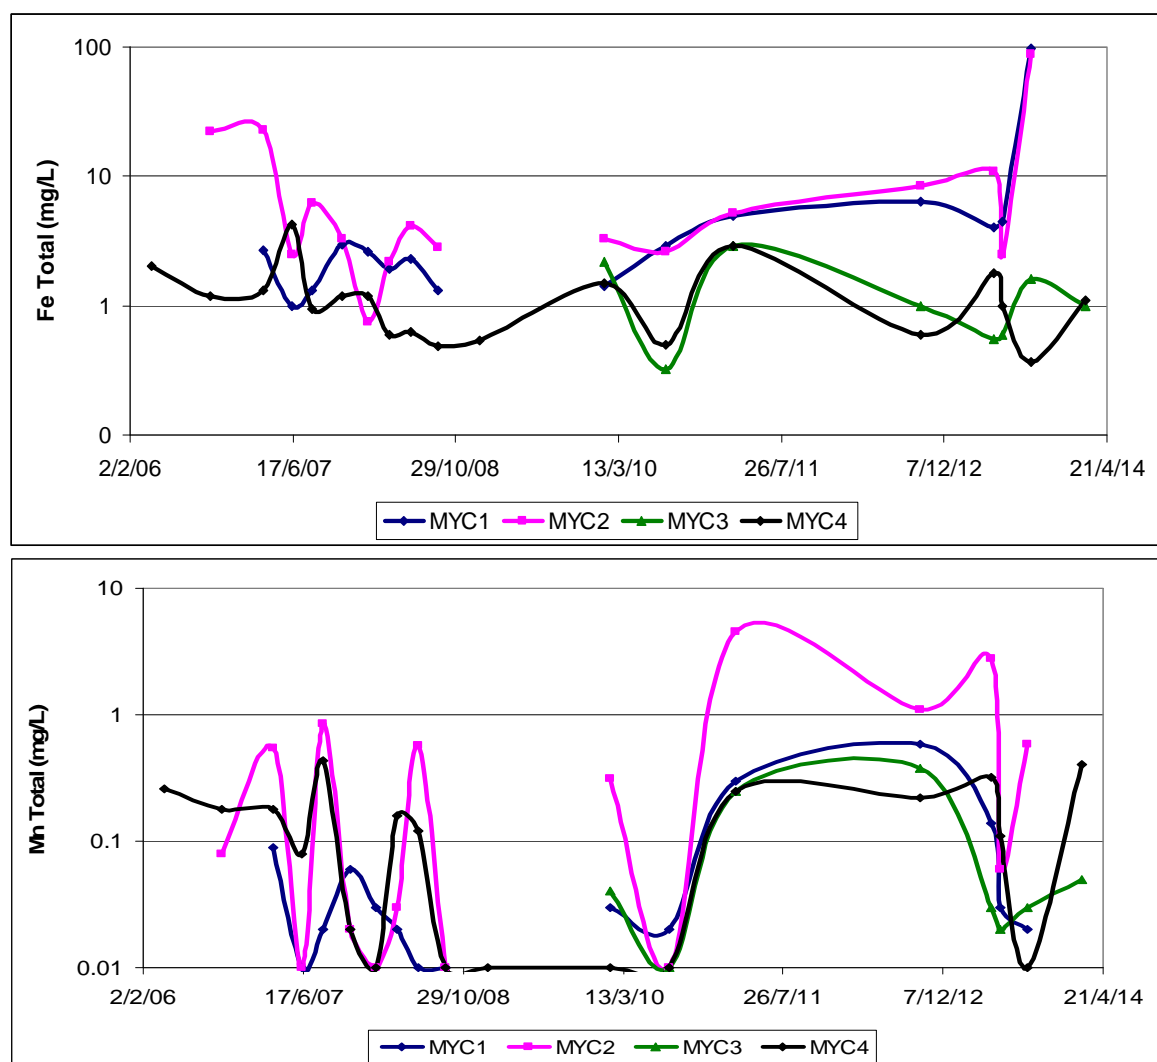
Figure 9 Myrtle Creek Iron and Manganese

Iron and manganese levels are generally not elevated in Myrtle Creek, apart from an isolated occasion at MYC1 and MYC2 during extraction of Longwall 27, with no long term trend or increase over subsided areas as shown in **Figure 9**.

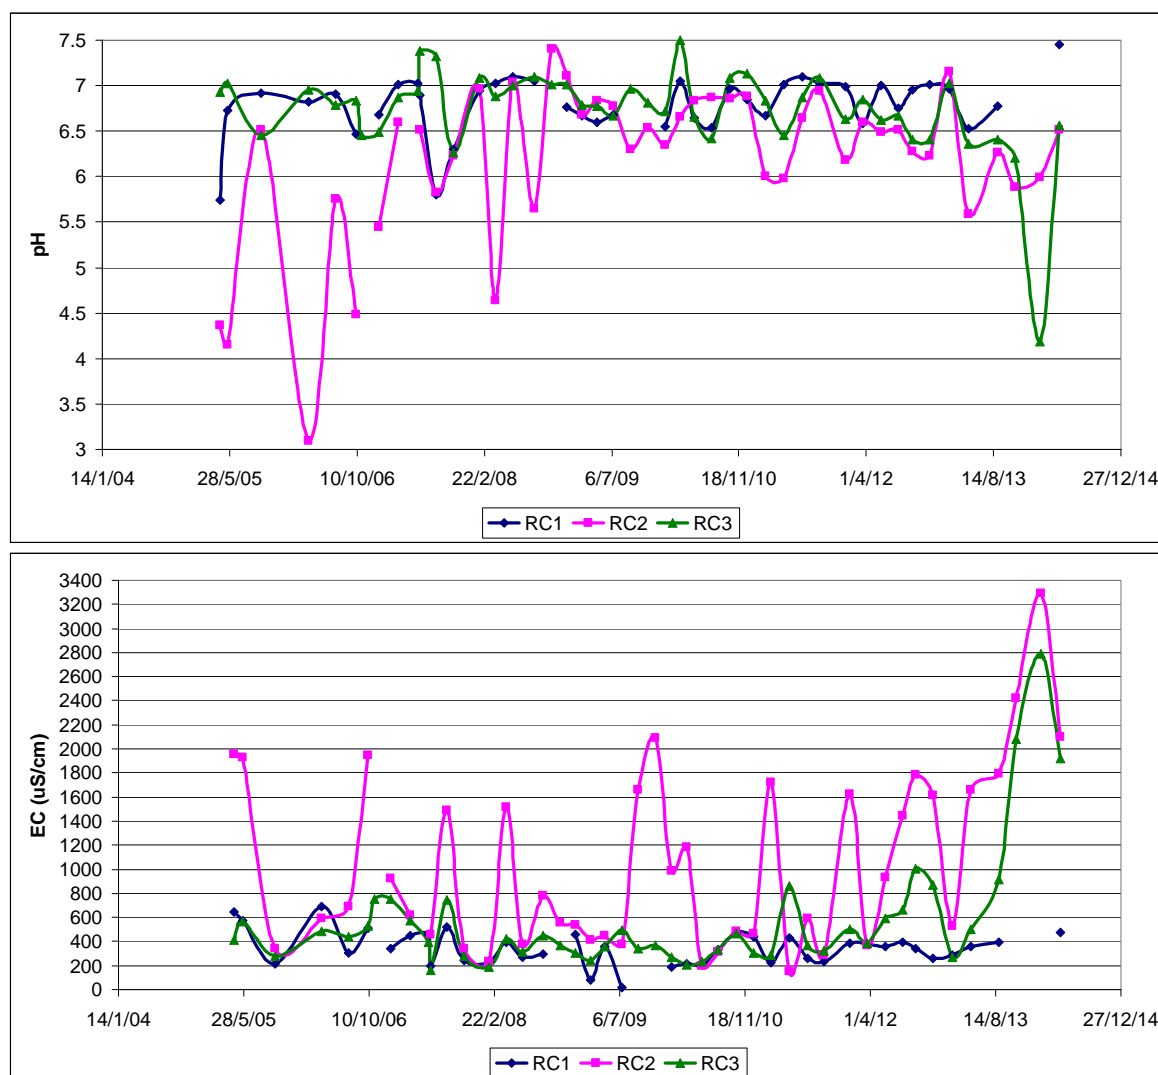
Figure 12 Redbank Creek Field Water Quality

Redbank Creek has an EC range from 22 - 3290uS/cm, and pH was between 3.10 and 7.50, with the creek generally being more acidic and saline at RC2 as shown in **Figure 12** and **Appendix B**.

During the Longwall 27 mining period, Redbank Creek pH trended to being slightly more acidic at RC2, and more acidic at RC3, whilst salinity peaked at around 3290uS/cm at RC2 and 2790uS/cm at RC3, which are both significantly above previous salinity levels.

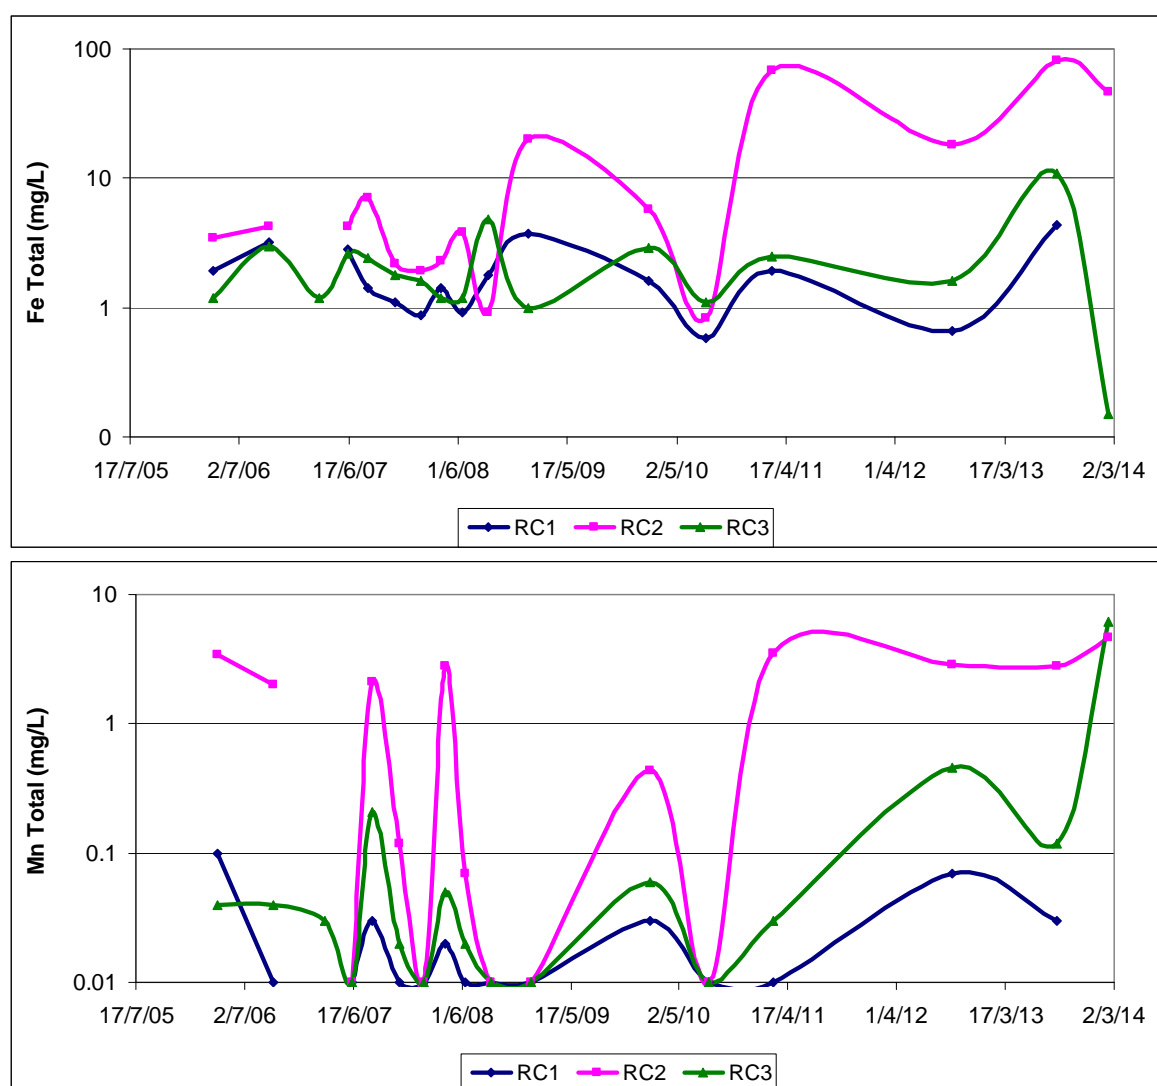
Figure 13 Redbank Creek Iron and Manganese

Redbank Creek generally contains elevated iron and, occasionally, above ANZECC 2000 Protection of 95% of Freshwater Aquatic Species manganese trigger levels in the creek at RC2 in association with the upstream tributary seepage as shown in **Figure 13** and **Appendix B**.

The stream reach at RC2 (a.k.a. Site 37) has had a definitive ferruginous hydroxide precipitate in the standing pool since monitoring was started in early 2005 which is present due to upwelling and re-oxygenation of chemically reduced waters in the creek between sites 30 to 35, as well as a groundwater seep in a tributary entering Redbank Creek downstream of the railway tunnel at Site 36.

The iron and manganese levels tend to vary with rainfall in the catchment, with lower concentrations after wetter periods, however a definitive rise in iron and manganese has been observed at RC2 since Longwall 27 undermined Redbank Creek

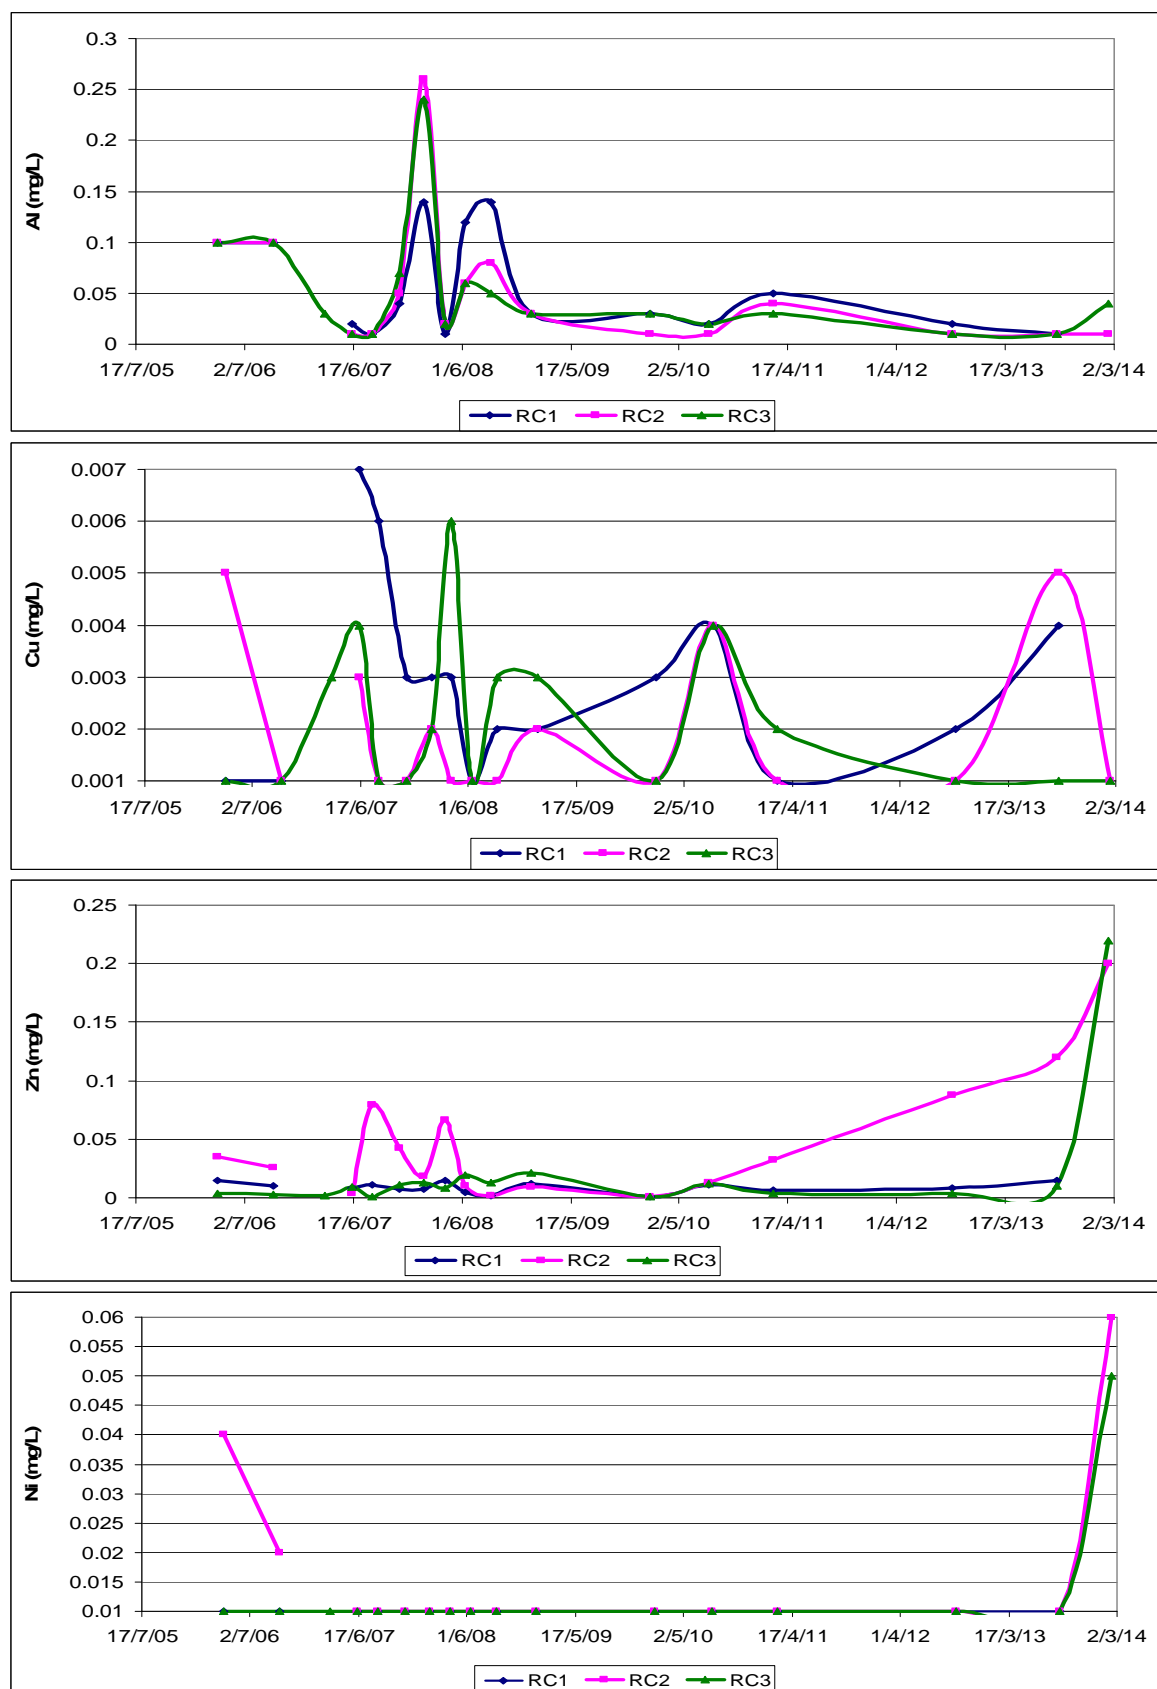
**Figure 15 Redbank Creek Metals**

Copper can reach up to 0.007mg/L at the three water quality monitoring sites, however no definitive increase downstream of Longwall 27 is observed as shown in **Figure 15** and **Appendix B**.

Zinc can reach up to 0.088mg/L as shown in **Figure 15** and **Appendix B**, with its concentration being observed to rise at RC2 since late 2010, and since August 2013 at RC3

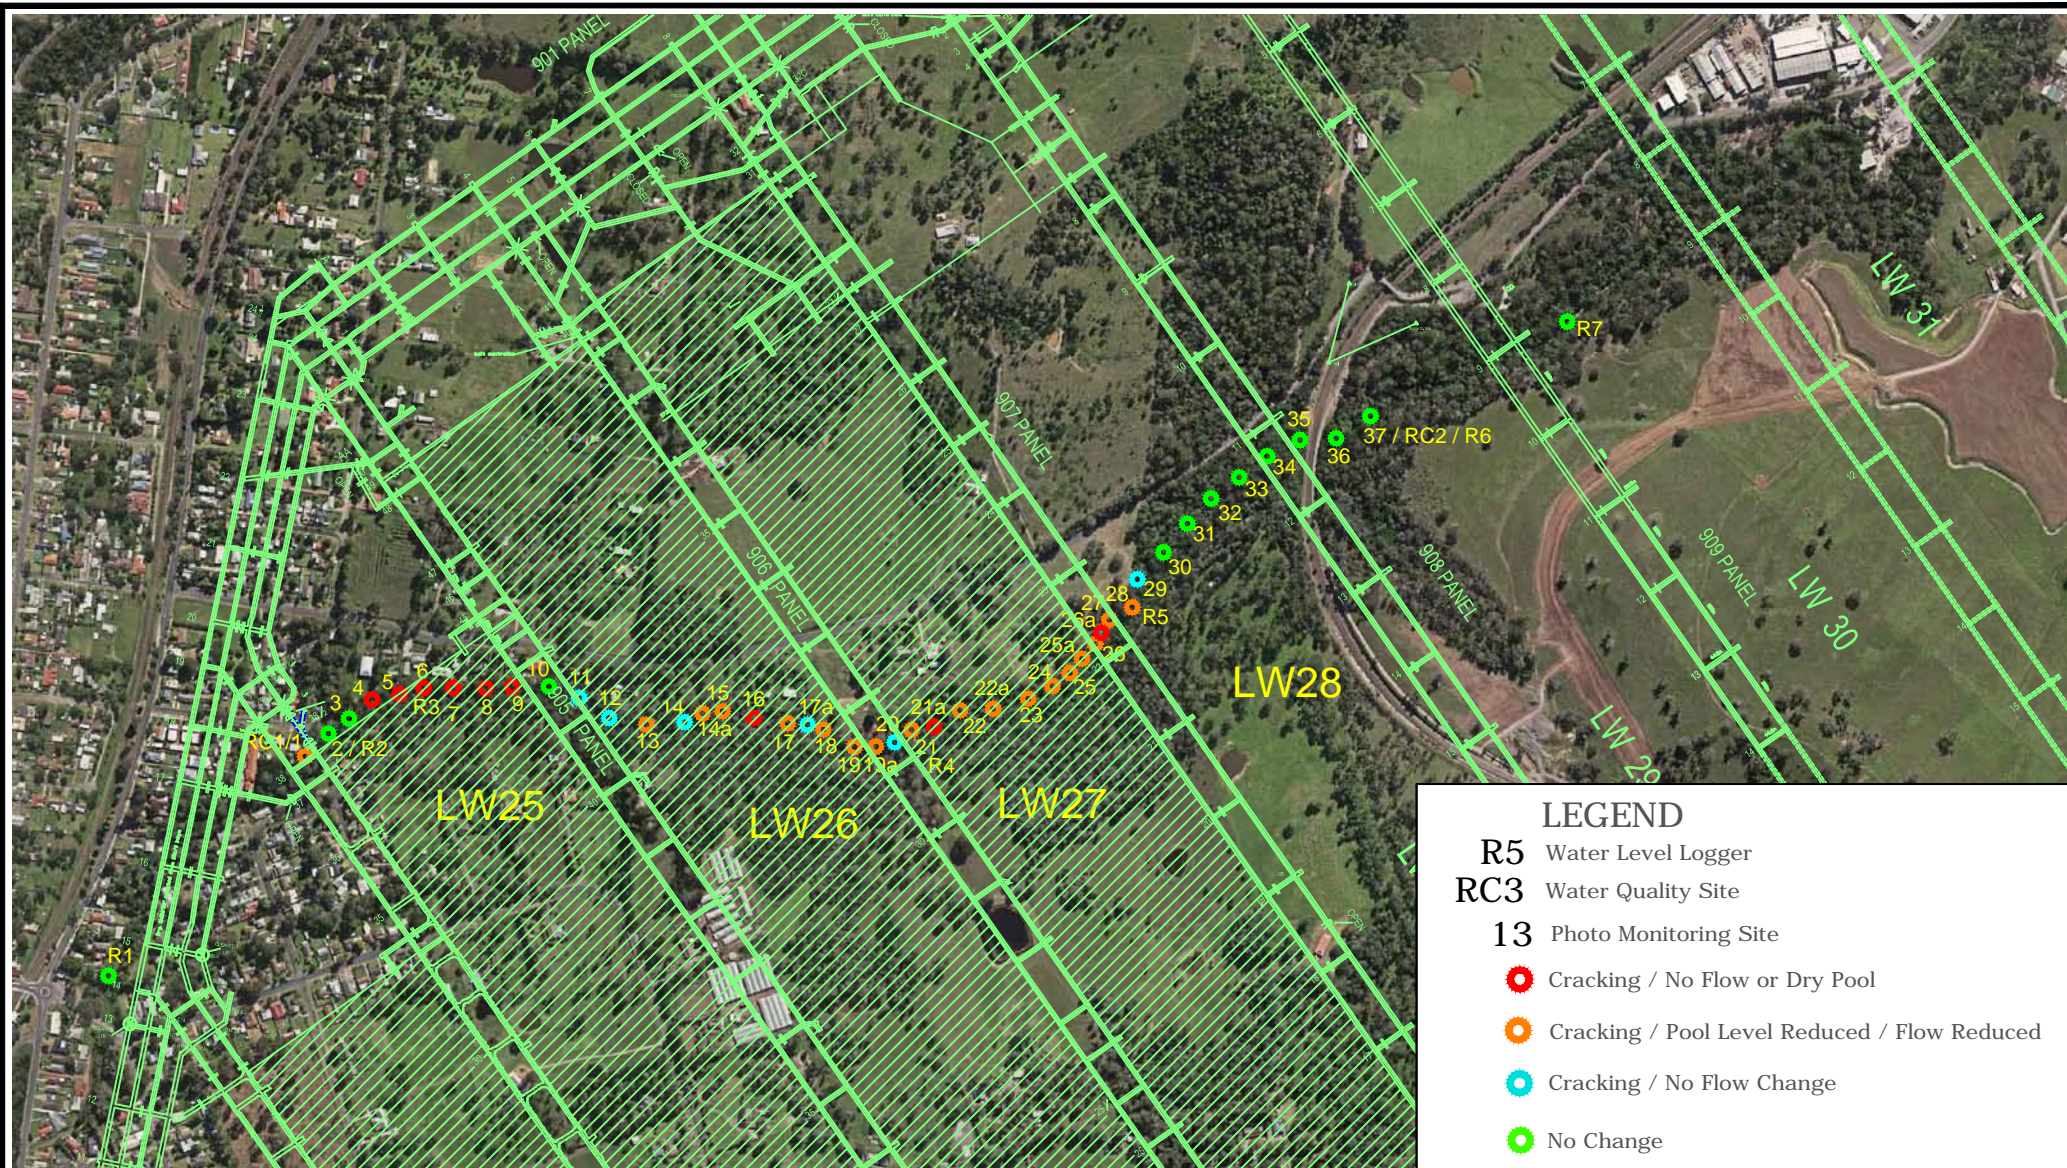
DRAWING 3

During undermining by Longwall 27, Myrtle Creek was observed to have undergone subsidence effects as summarised in **Table 10** and shown in **Drawing 3**.

Sites	Relative Location in the Panel	Effect	Date Observed	TARP Triggered
Over Longwall 26				
4	central / tailgate	additional cracking and dry pool continuation	during LW26 & 22/3/13	10/5/13
5	central / maingate	continuation of dry pool due to cracking	during LW26	10/5/13
6	central / maingate	continuation of dry pool due to cracking	during LW26	10/5/13
7	central / maingate	continuation of dry pool due to cracking	during LW26	10/5/13
8	maingate	continuation of dry pool due to cracking	during LW26	10/5/13
9	maingate	additional cracking and dry pool continuation	during LW26 & 13/6/13	10/5/13
10	maingate	continuation of dry pool (no obvious cracking)	during LW26	10/5/13
11	LW26 / 27 chain pillar	continuation of dry pool (no obvious cracking)	during LW26	10/5/13
Over Longwall 27				
12	tailgate	additional cracking, dry pool and fallen tree	22/3/13	23/5/13
12A	central / tailgate	pool level reduction and cracks in rock bar	during LW26	no

13 – 13A	central	additional cracking and dry pool continuation	during LW26 & 5/4/13	10/5/13
14	central	continuation of dry pool due to cracking	during LW26	10/5/13
15	central	additional cracking and dry pool	during LW26 & 28/3/13	10/5/13
16	central / maingate	additional cracking and dry pool / race	during LW26 & 11/4/13	12/6/13
17	maingate	additional cracking and dry pool	during LW26 & 26/4/13	27/6/13
18	maingate	dry pool (no obvious cracking)	22/3/13	23/5/13
19	LW27 / 28 chain pillar	additional cracking of rock shelf, no overland flow	during LW26 & 26/4/13	27/6/13
21	tailgate / central	continuation of dry rock shelf due to cracking	during LW26	10/5/13
Over Longwall 28				
23	central - maingate	new cracks and pool dry	19/4/13	no
24	maingate	No flow, strong iron hydroxide developed	10/5/14	no
