GLENCORE:
Tahmoor Colliery - Longwall 27

End of Panel Subsidence Monitoring Report for Tahmoor Longwall 27

This report has been prepared by Mine Subsidence Engineering Consultants (MSEC) for Glencore Tahmoor Colliery to comply with conditions of the SMP Approval set by the NSW Department of Trade and Investment, Regional Infrastructure and Services, Division of Resources and Energy (DTIRIS).

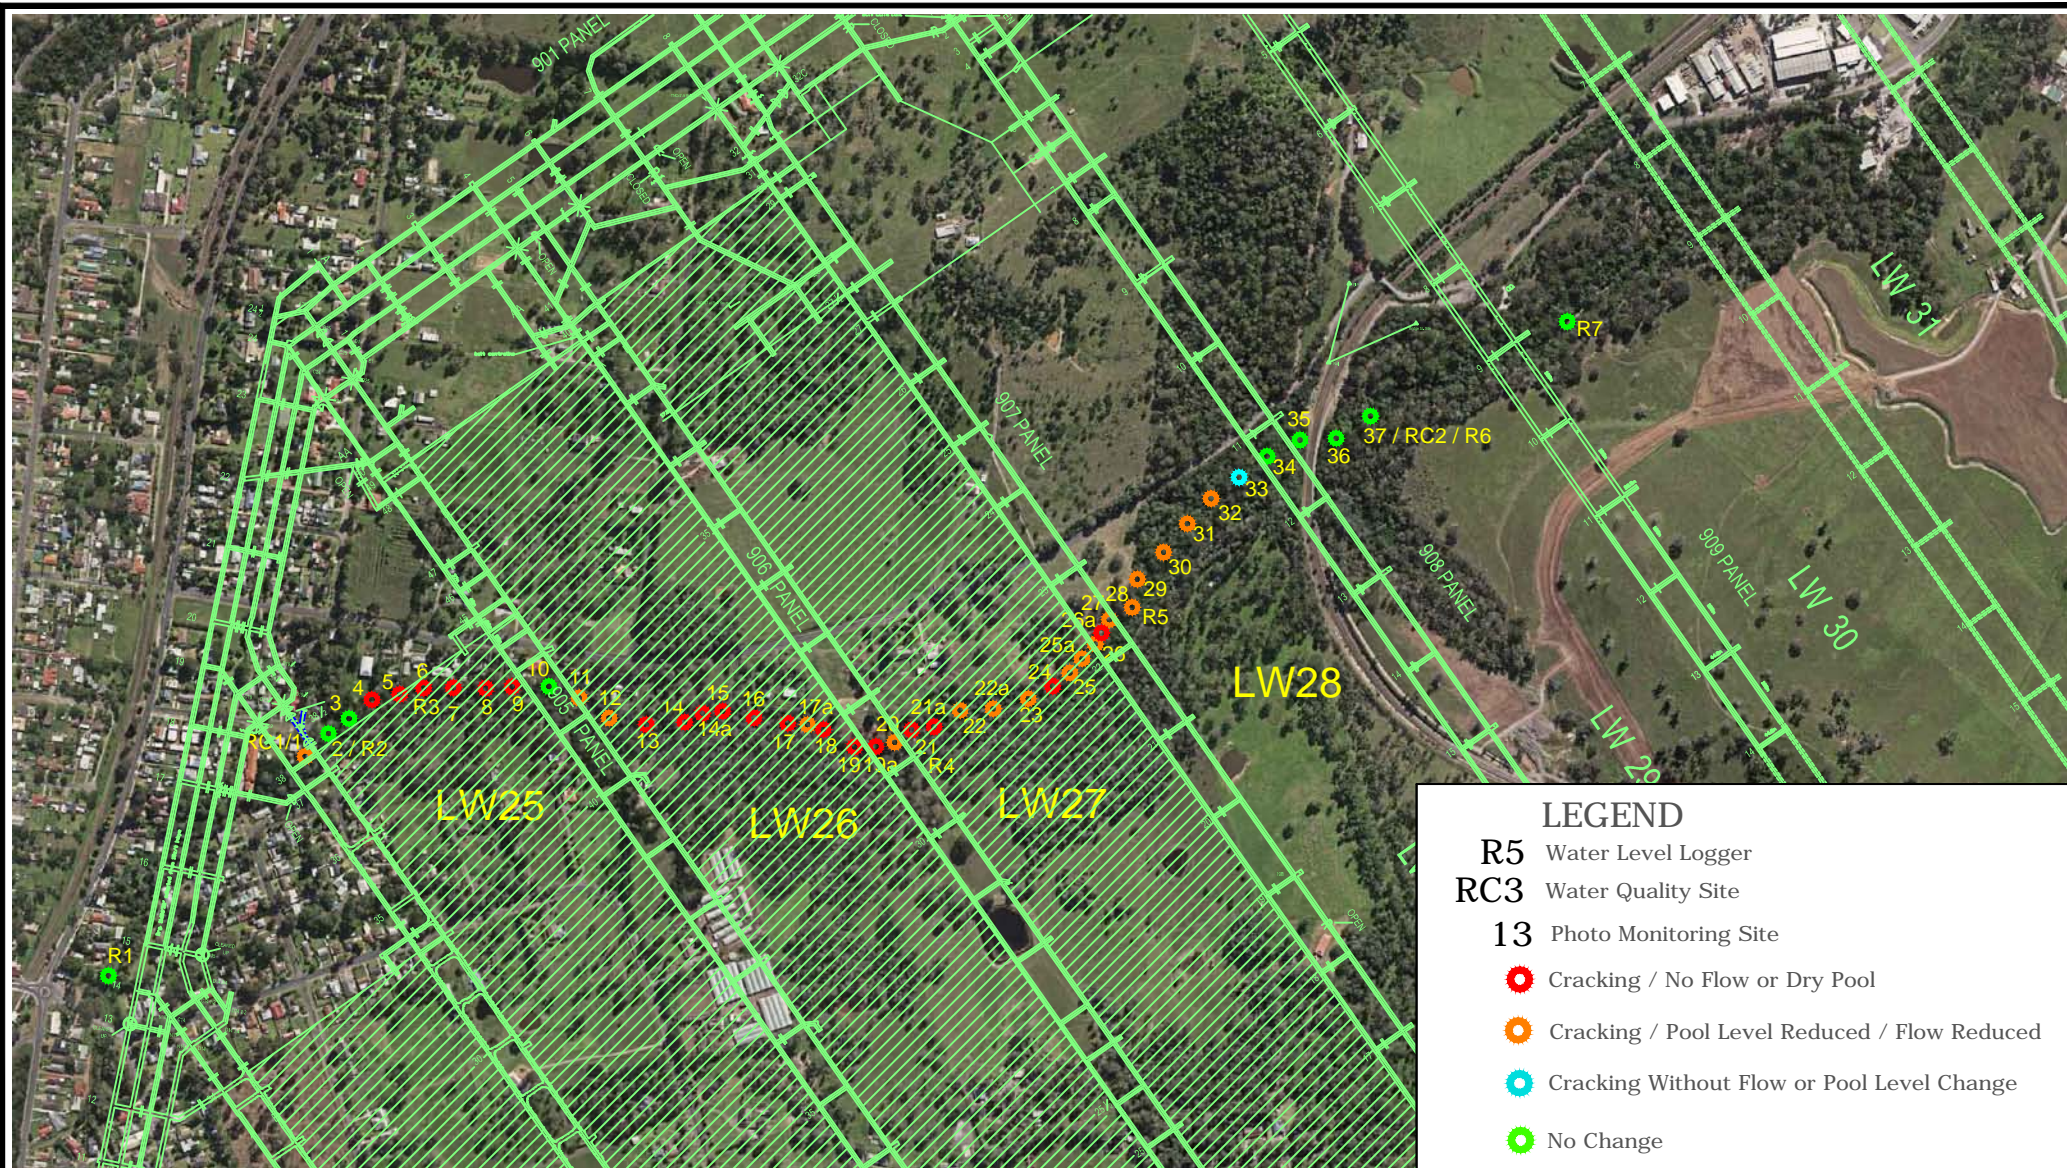
<p>GeoTerra</p>
<p>DRAWING 4</p>

As shown in **Drawing 4**, subsidence effects observed due to extraction of Longwall 26 (i.e. prior to extraction of Longwall 27) at the following sites included;

- 12 to 13 – sandstone stream bed cracking, with no obvious effect on pool holding capacity;
- 14 to 14a - pool desiccation in a cobble / sandstone based section;
- 15 to 17 - pool desiccation in sandstone based pools; and

- 21 to 21a - pool desiccation in sandstone based pools;
- 22 - pool desiccation in a cobble / sandstone based section;
- 22a to 23 – significant cracking and pool desiccation in sandstone based pools;
- 24 to 25 – pool desiccation with significant iron hydroxide in cobble / sandstone based pools;
- 25a to 26 - significant cracking and pool desiccation in sandstone based pools;
- 26a to 28 - pool desiccation in sandstone based pools, and
- 29 – reduced flow over sandstone rock shelf.

Although creek bed cracking was observed due to extraction of Longwall 26, no adverse effects were observed on the stream bed or bank stability or water quality during the monitoring period.

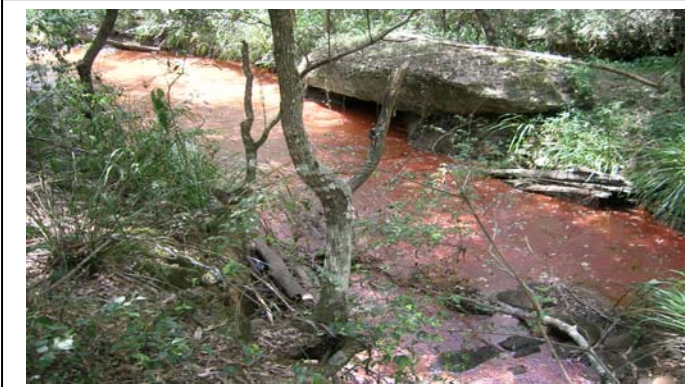
Redbank Creek Site 37 (1/11/13)

- the TARP trigger in relation to reduced water quality (specifically zinc) was observed at Site 37 (RC2), downstream of Longwall 27 in Redbank Creek, in association with drying out of pools and lack of stream connectivity over Longwall 27, with subsequent re-emergence of the under-flow back into the stream and enhanced ferruginous hydroxide precipitation over Longwall 28;
