# **Tahmoor Colliery - Longwall 29**

End of Panel Subsidence Monitoring Report for Tahmoor Longwall 29

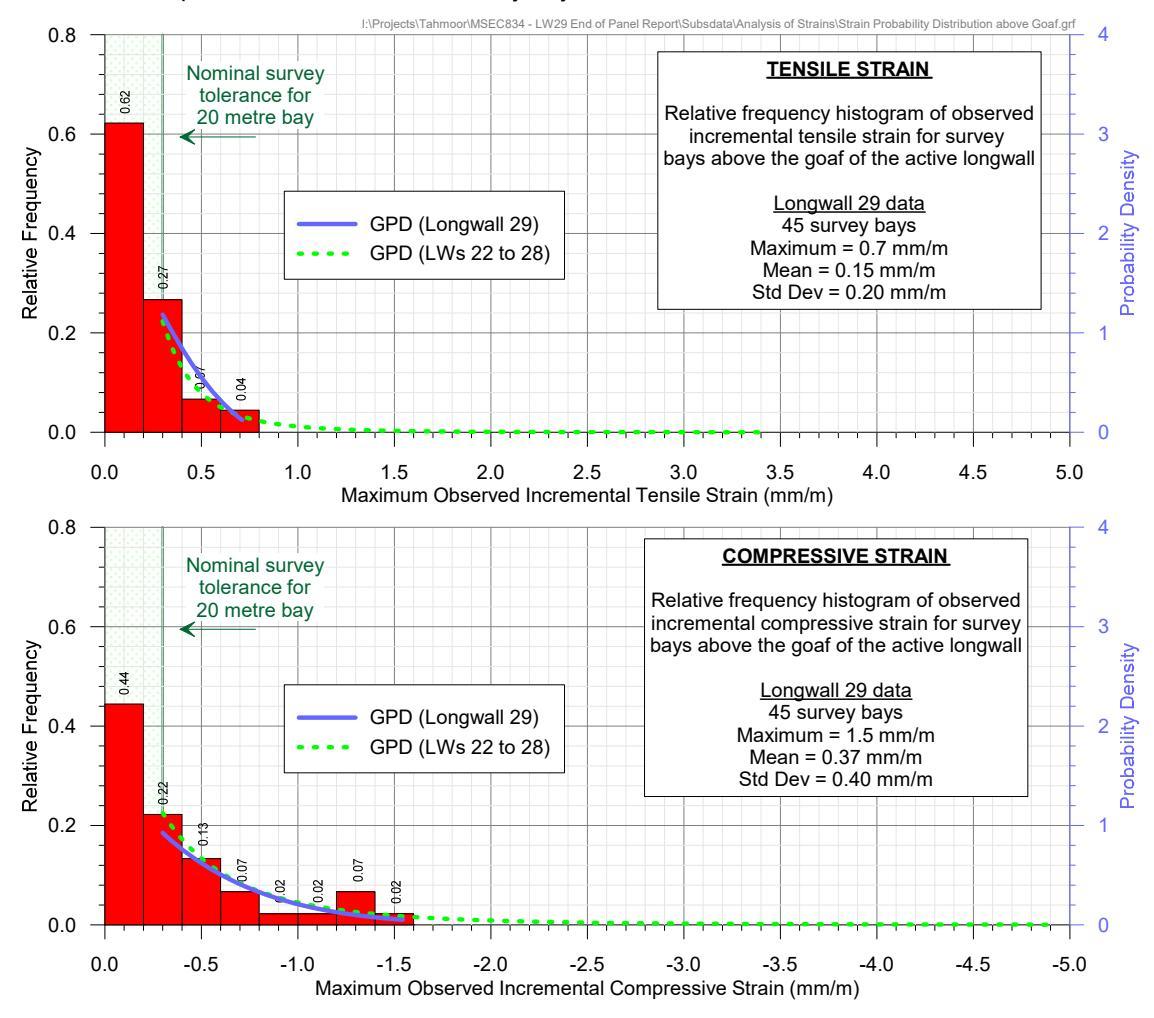
Fig. 2.1 Observed Incremental Strain for Survey Bays above Goaf resulting from the Extraction of Longwall 29

A Generalised Pareto Distribution (GPD) has been fitted to the raw strain data for Longwall 29, as shown in the blue lines.

The probability distribution functions for previous monitoring during the mining of Longwalls 22 to 28 are also shown in this figure, as the dashed green lines. It can be seen from these comparisons, that the overall distribution of tensile and compressive strain resulting from the extraction of Longwall 29 was similar to or less than the magnitude of that observed during the mining of Longwalls 22 to 28.

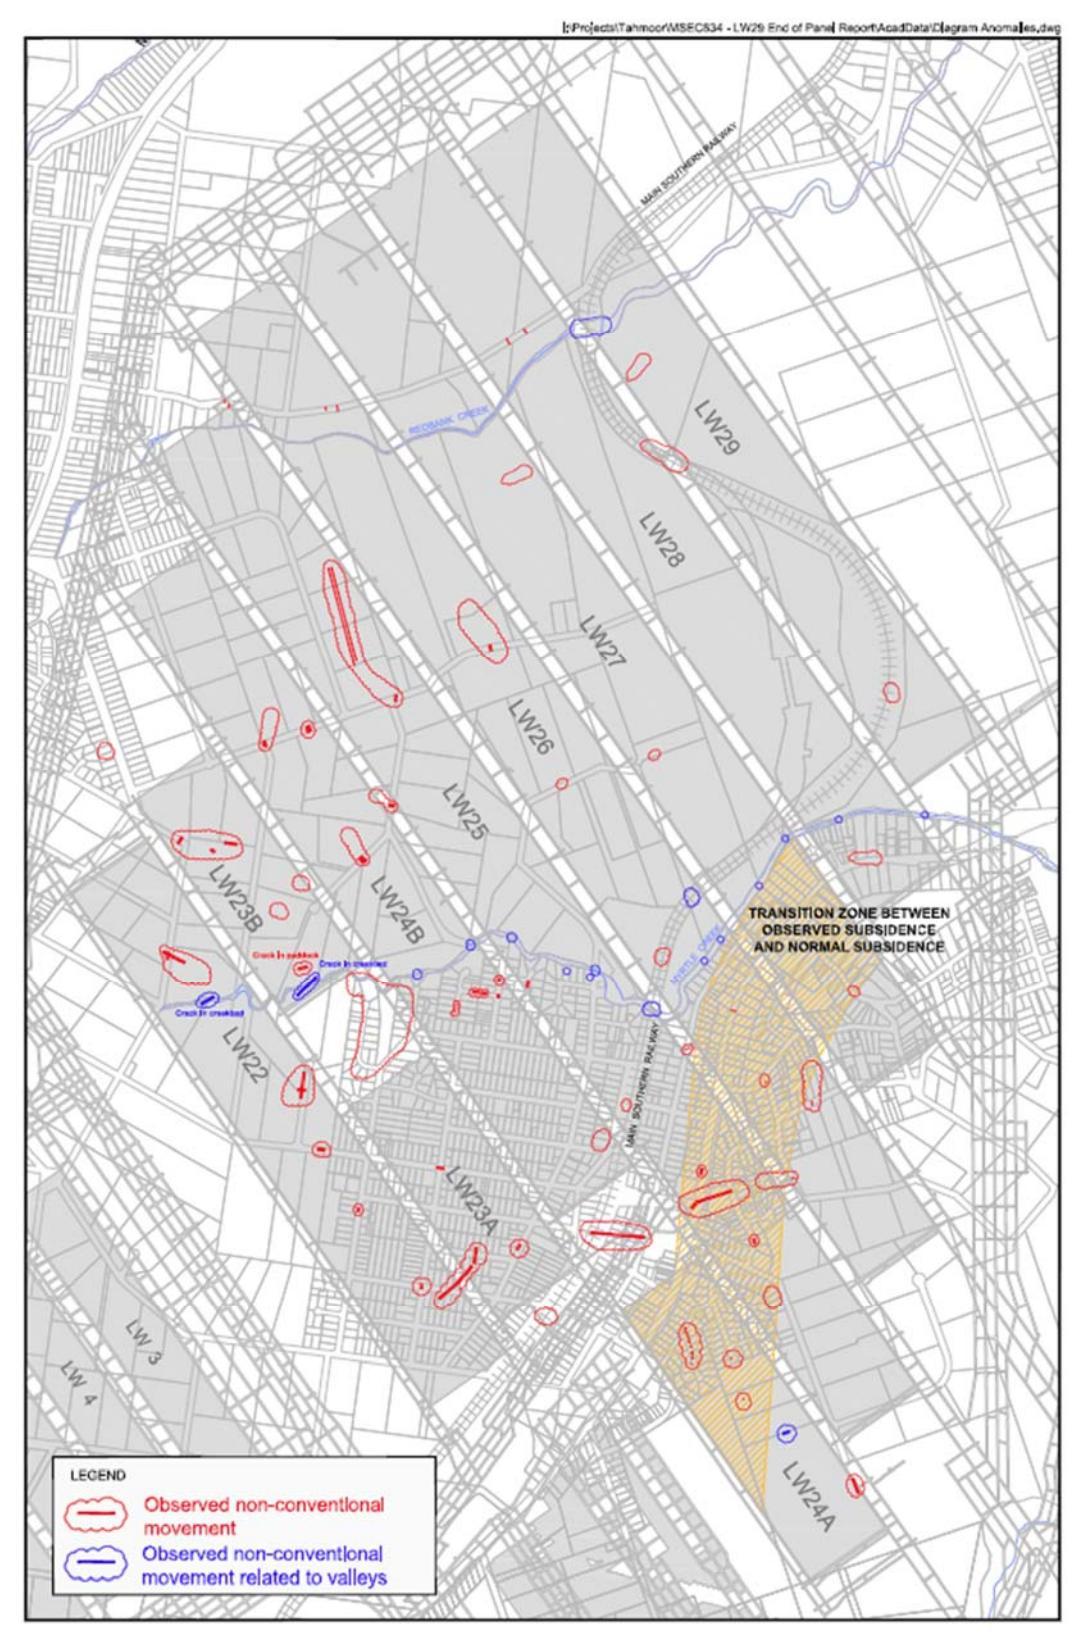
Fig. 2.2 Map of Locations of Potential Non-Systematic Movements

A plan showing the locations of observed non-systematic movements at Tahmoor is shown in Fig. 2.2. The locations were selected based on ground monitoring results or observed impacts that appear to have been caused by non-systematic movement. A total of approximately 51 locations (not including valleys) have been identified over the extracted Longwalls 22 to 28, of which 2 new locations were observed during the mining of Longwall 29.

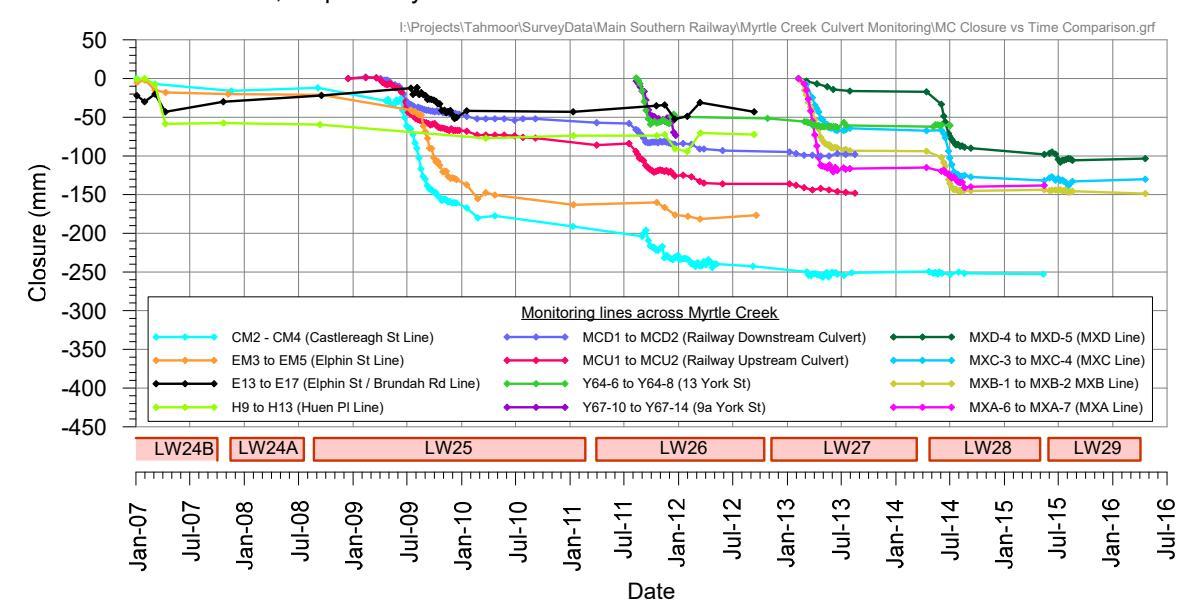
Fig. 2.4 Development of closure across Myrtle Creek during the mining of Longwalls 24B to 29

A summary graph showing the development of valley closure across Myrtle Creek at each monitoring line is shown in Fig. 2.4. It can be seen that very little additional, incremental valley closure was experienced during the mining of Longwall 29. The maximum measured incremental closure was 10 mm across the MXD Line due to the extraction of Longwall 29, with an additional 5 mm and 7 mm measured across the MXB Line and MXC Line, respectively.

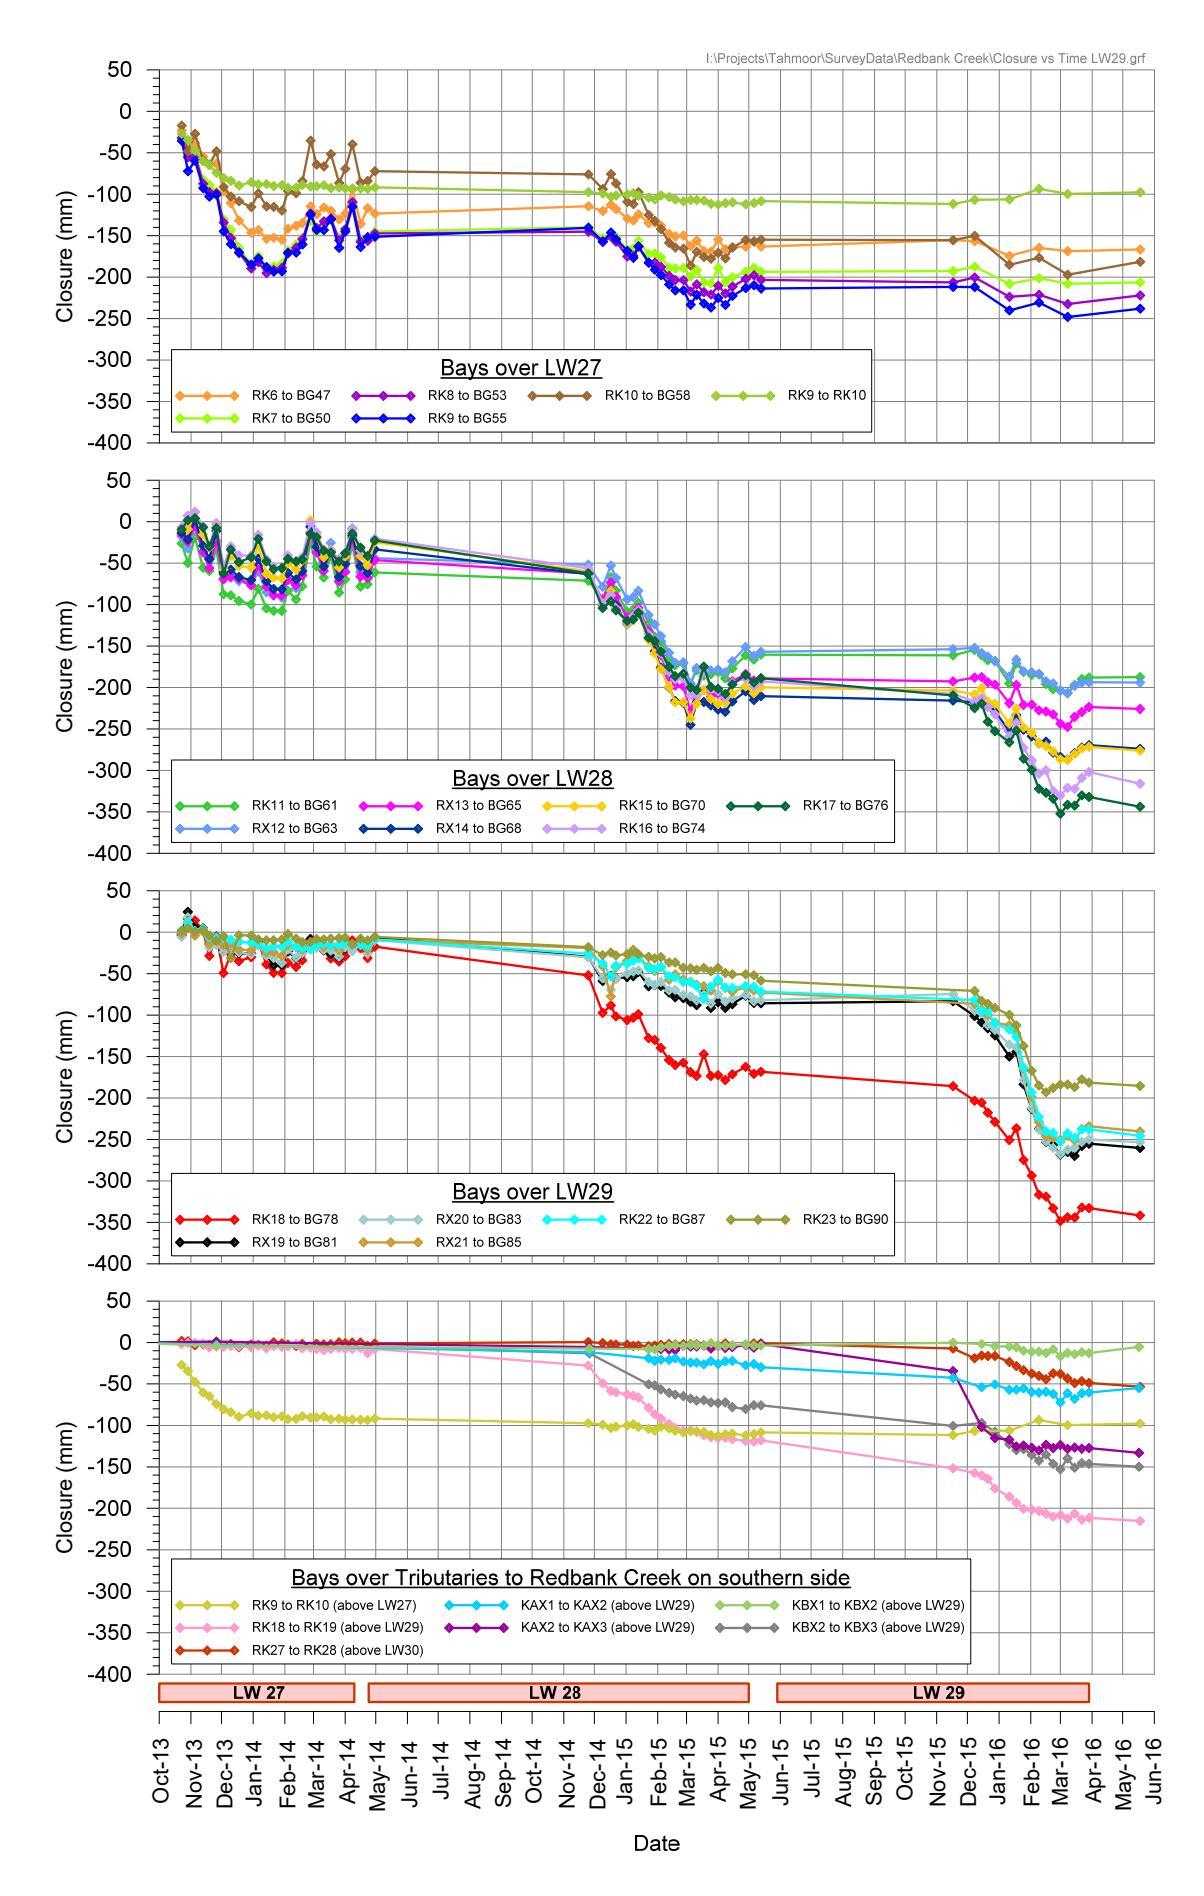
Fig. 2.6 Observed development of closure across tributaries to Redbank Creek over time

- It can be seen from Fig. 2.6 that valley closure was slightly greater for a temporary period of time, when the transient effects of the subsidence travelling wave passed through the valley.
- Maximum observed closure above Longwall 29 was greater than above Longwalls 27 and 28. This was predicted as the valley is deeper and more incised above Longwall 29.

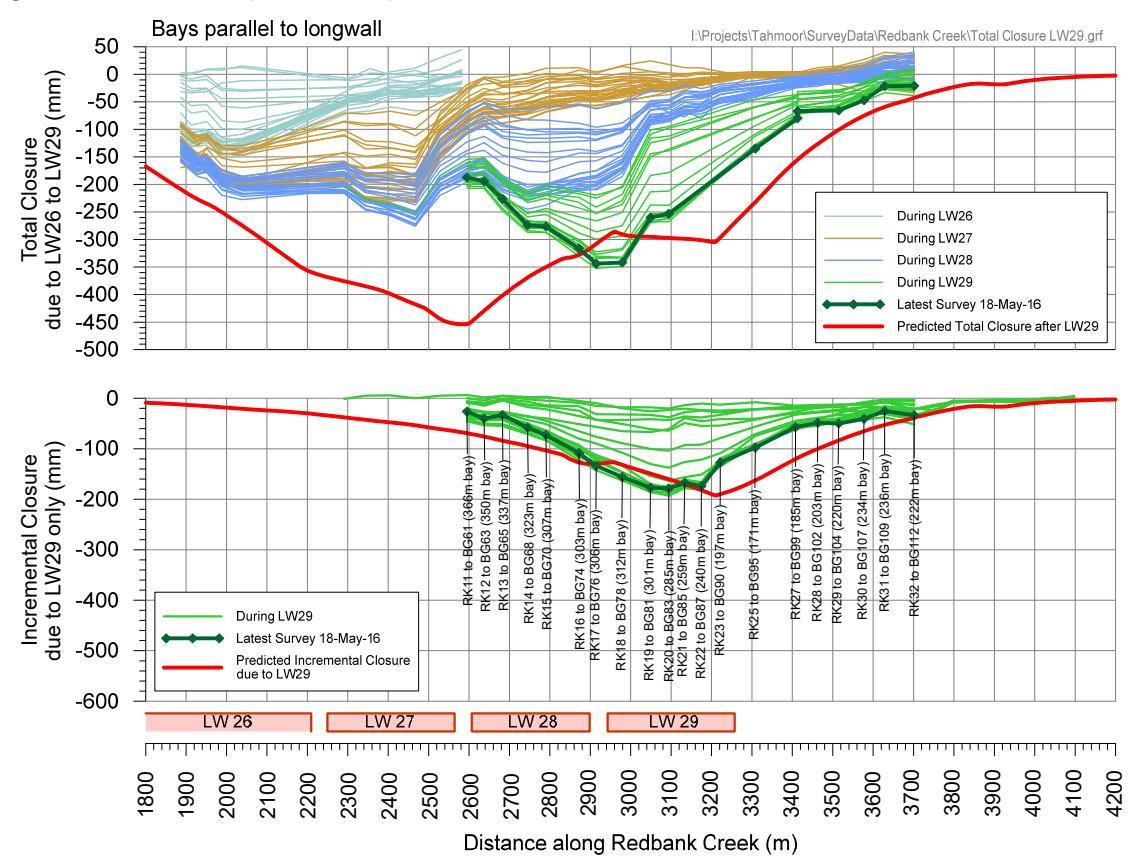
Fig. 2.7 Comparison between observed and predicted valley closure along Redbank Creek

A comparison between observed and predicted valley closure along Redbank Creek is shown in Fig. 2.7. A number of observations are made from the monitoring data.

- There has been a reasonable correlation between predicted and observed closure at the completion of Longwall 29.
- Observed total closure from the mining of Longwalls 26, 27, 28 and 29 is less than predicted.

Maximum predicted valley closure due to extraction of Longwall 29 was 200 mm. As shown in the bottom graph of Fig. 2.7, observed maximum incremental valley closure at the completion of Longwall 29 was 179 mm. It can also be seen, from the top graph of Fig. 2.7 that observed total closure from the mining of Longwalls 26 to 29 is less than predicted.

Observed total closure is also less than the predicted total closure of 450 mm due to the mining of Longwalls 22 to 29, as reported in Report No. MSEC355.

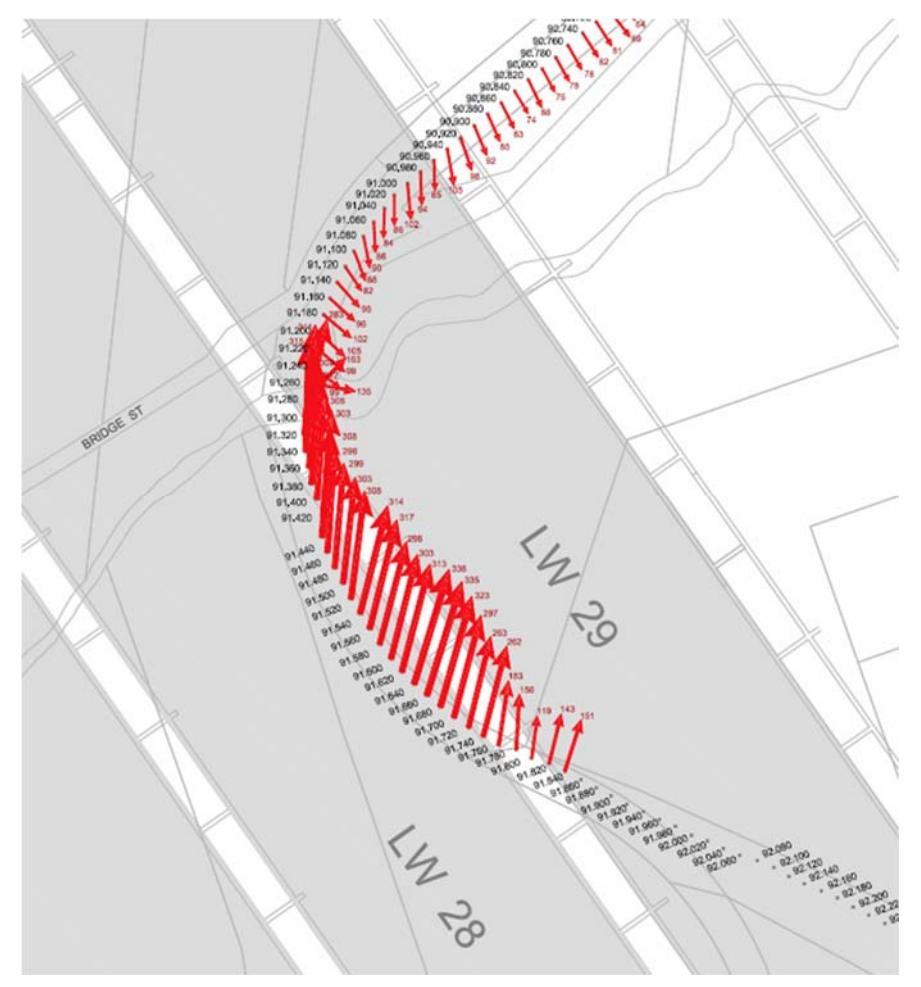
Fig. 2.8 Observed total horizontal movement along Main Southern Railway during the mining of Longwalls 27 to 29 as at 24 May 2016

Observed absolute horizontal movements along the Main Southern Railway are shown in Fig. 2.8. It can be seen that the rockmass on the Sydney side of the Culvert has moved substantially relative to the Country side. When observed in conjunction with the relative 3D surveys, as shown in Drawing No. MSEC834-03, it is clear that the boundaries of the rockmass are approximately Redbank Creek and the tributary, with ground strains relatively small in the plateau areas.

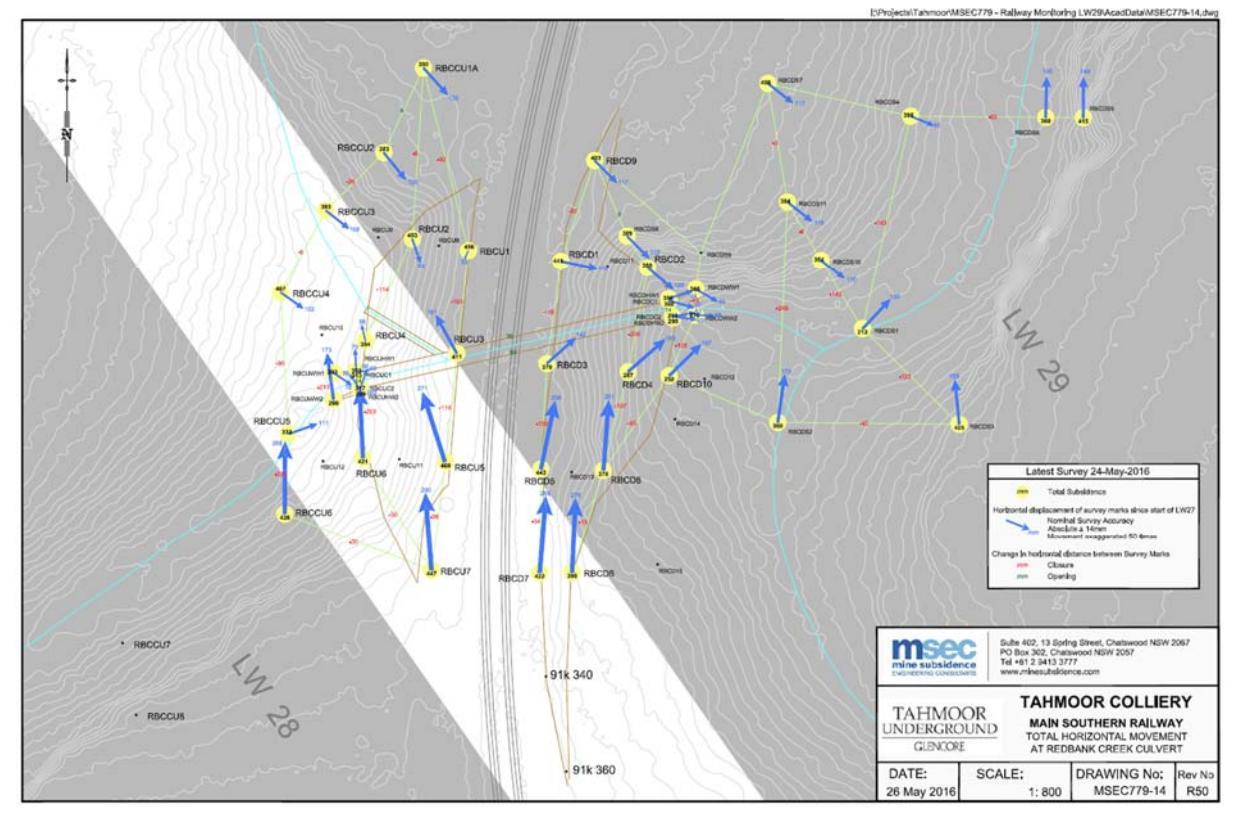
Fig. 2.9 Observed total horizontal movement at Redbank Creek Culvert and embankment during the mining of Longwalls 27, 28 and 29

Observed incremental subsidence and horizontal movement of survey marks in the immediate of the culvert and embankment are shown in Fig. 2.9. The results show that boundaries of the rockmass in the south-western quadrant intersect with the country side of the culvert. The corner of the rockmass is approximately aligned with midpoint of the culvert, which correlates well with observed detailed closure measurements inside the culvert itself.

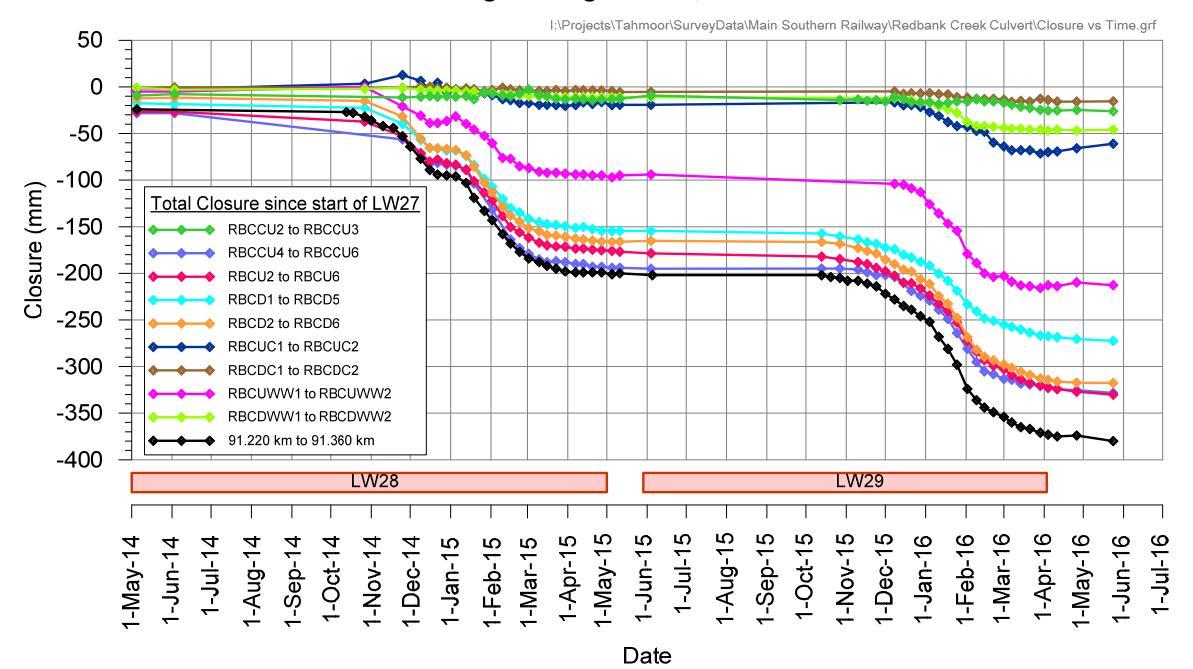
Fig. 2.10 Observed Total Valley Closure over time across Redbank Creek Culvert at Main Southern Railway during the mining of Longwall 29 (includes closure from Longwalls 27 and 28)

The observed gradual development with time of differential horizontal movements between selected pegs at the culvert and embankment are shown in Fig. 2.10. Maximum observed closure was measured between the long bay survey pegs on the track at 91.220 km and 91.360 km, though a similar result was observed

between Pegs RBCCU4 and RBCCU6, which are located in the base of the embankment across the upstream inlet. This suggests that closure across the valley of Redbank Creek and its tributary, were focussed at the culvert. This was confirmed at greater detail from additional detailed surveys in the culvert, which are discussed later.

Whilst the ends of the wingwall on the upstream end closed by 213 mm, the culvert barrel at the inlet opened by 14 mm. Very little closure was observed across the culvert barrel or wingwalls at the downstream inlet.

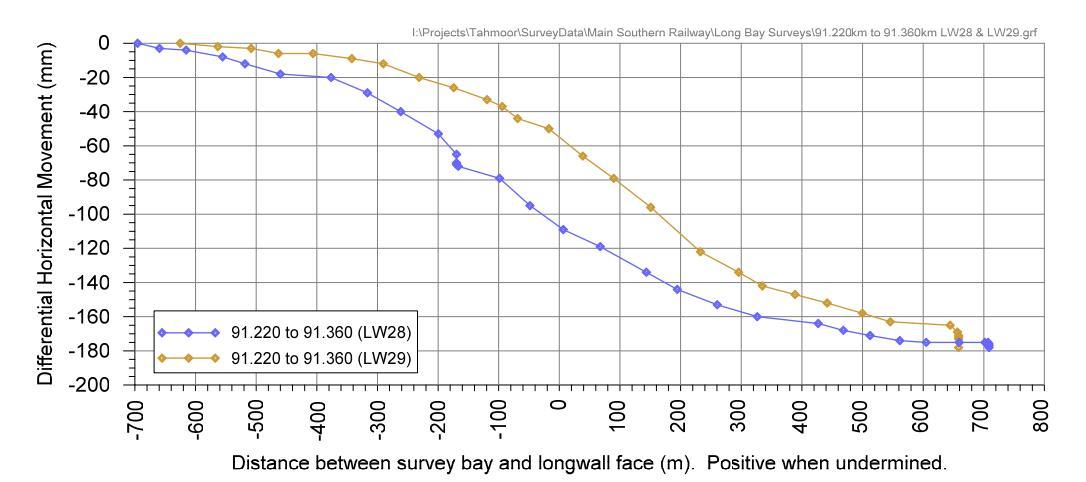
# Fig. 2.11 Observed Incremental Valley Closure as measured by long bay survey, relative to face distance across Redbank Creek Culvert at Main Southern Railway during the mining of Longwall 29 (includes incremental closure from Longwall 28)

It can be seen from Fig. 2.11 that the majority of valley closure movements occurred from when the longwall face had approached within 300 metres of the culvert, until the longwall face had passed the culvert by approximately 300 metres.

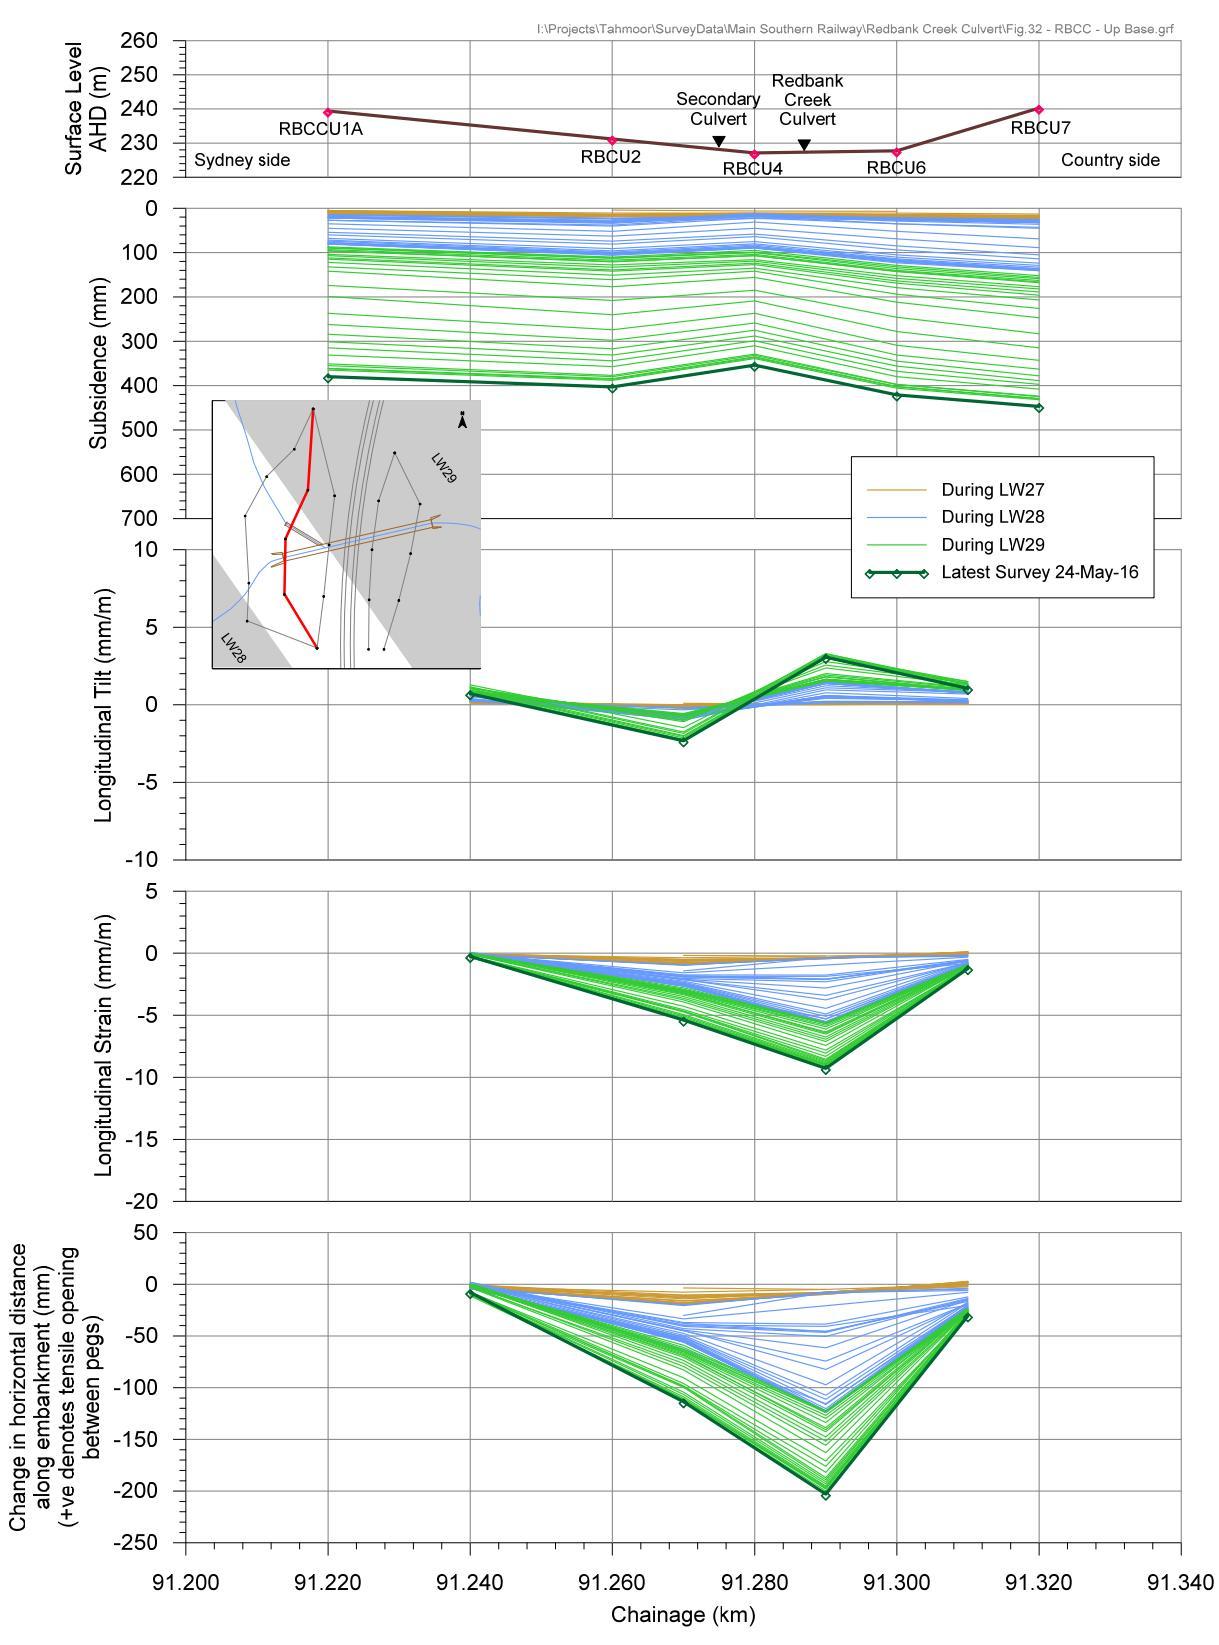
Fig. 2.12 Observed total subsidence, tilt and strain across the upstream base of Redbank Creek Culvert due to the mining of Longwalls 27 to 29 as at 24 May 2016

Observed subsidence along the base of the embankment on the upstream side is shown in Fig. 2.12. The results show valley closure focussing between Pegs RBCCU4 and RBCCU6, with upsidence observed at Peg RBCCU4.

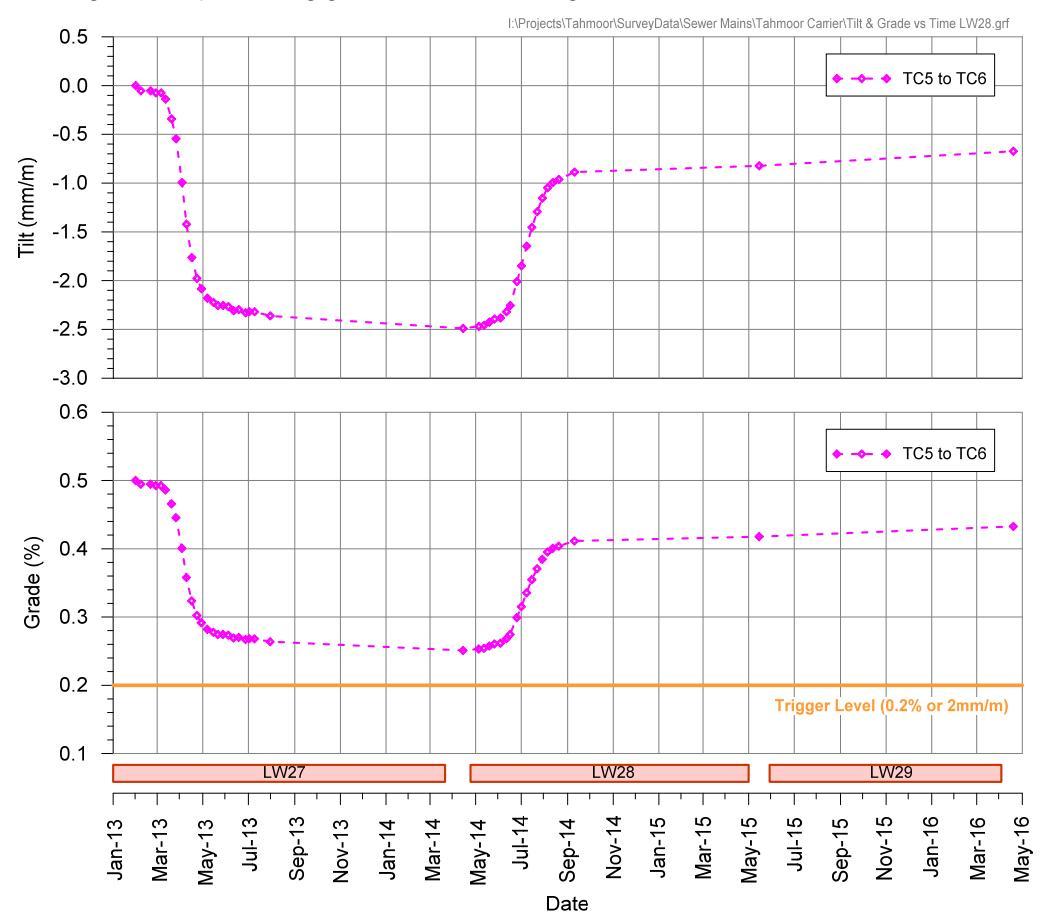
# Fig. 2.13 Observed changes in mining-induced tilt and sewer grade at Tahmoor Carrier between Pegs TC5 and TC6

The Tahmoor Carrier is the main branch servicing the majority of Tahmoor township. One survey was undertaken along the Tahmoor Carrier at the completion of Longwall 29. One area of focus was changes in grade between Pegs TC5 and TC6, where pipe grades were predicted and observed to reduce during the mining of Longwall 27. As expected, the mining of Longwall 29 increased the predicted grade in this area almost returning it to the pre-mining grade, as shown in Fig. 2.13.

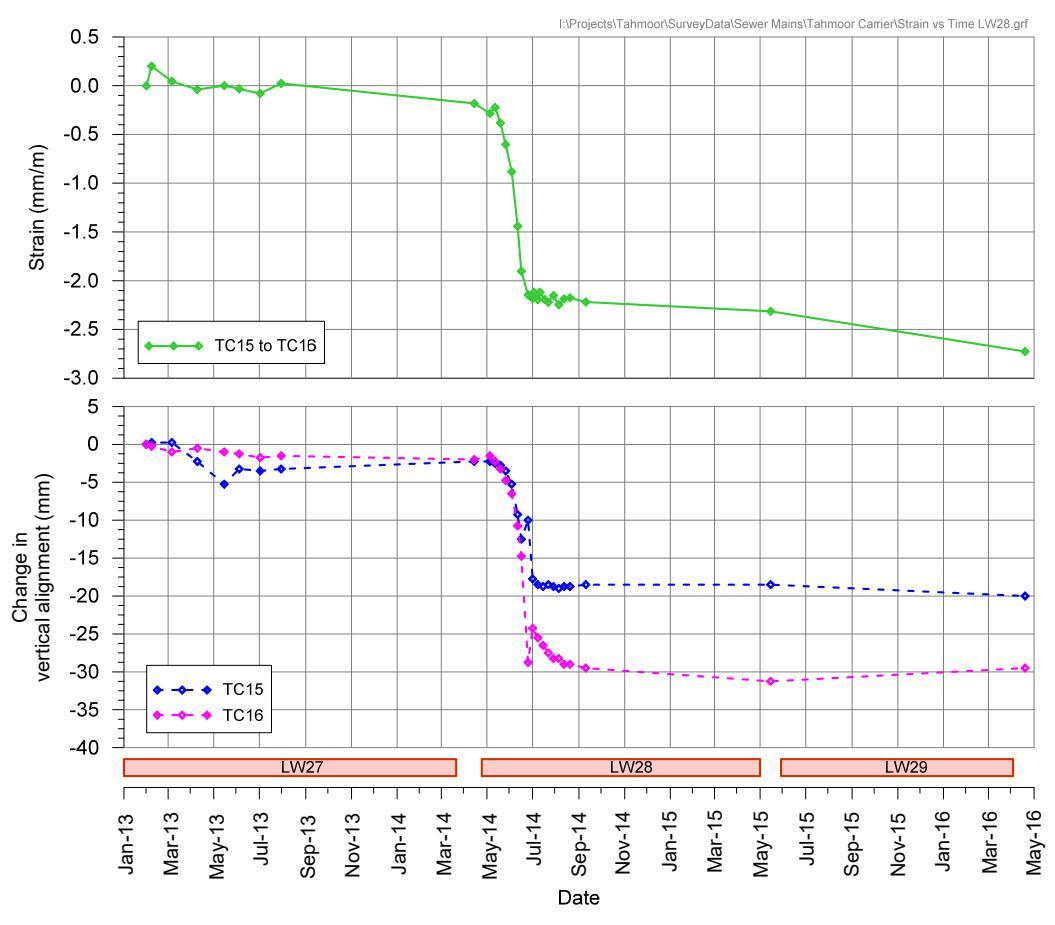
Fig. 2.14 Observed changes in strain and vertical alignment at Tahmoor Carrier between Pegs TC15 and TC16

As shown in Fig. A.25, a small change in compressive ground strain was observed between Pegs TC15 and TC16 during Longwall 29, and observed changes are shown in Fig. 2.14.

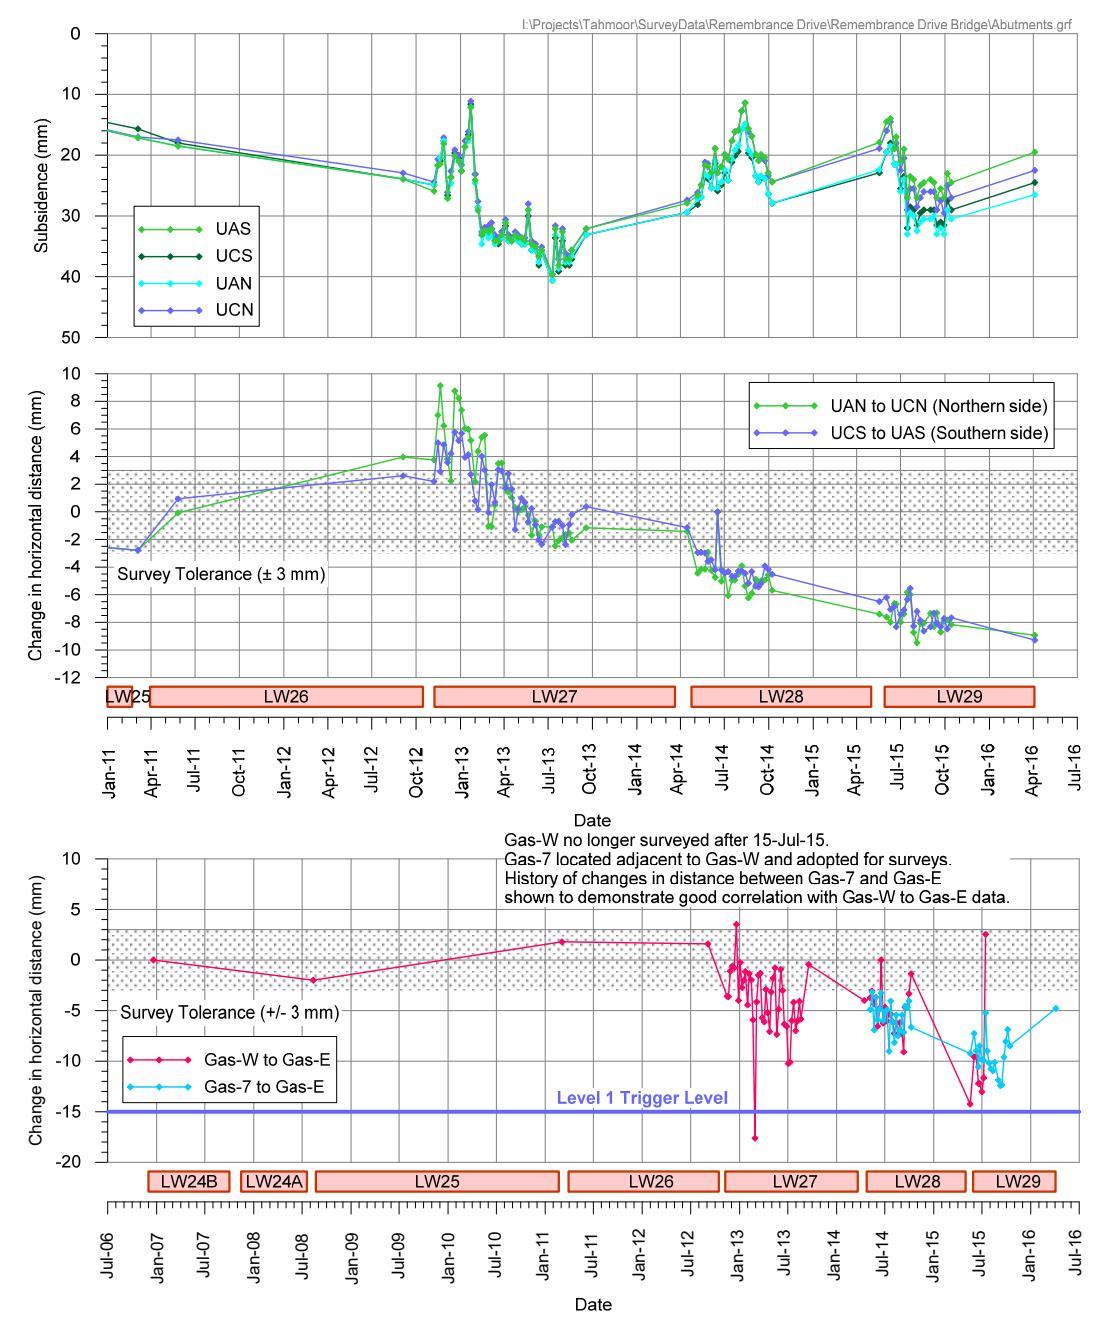
Fig. 2.16 Observed subsidence and changes in horizontal distances across the abutment and gas pipe supports at Remembrance Drive (Myrtle Creek) Road Bridge

Survey marks were installed on the Remembrance Drive Road Bridge prior to the extraction of Longwall 24A. While the Bridge has experienced approximately 40 mm of subsidence, measured changes in horizontal distances between the abutments are small. Minor closure has been measured, as shown in Fig. 2.16. This includes the measured changes in horizontal distances across the gas pipe supports. Vertical subsidence is relatively consistent across all survey marks, indicating that no measureable upsidence has occurred to date.

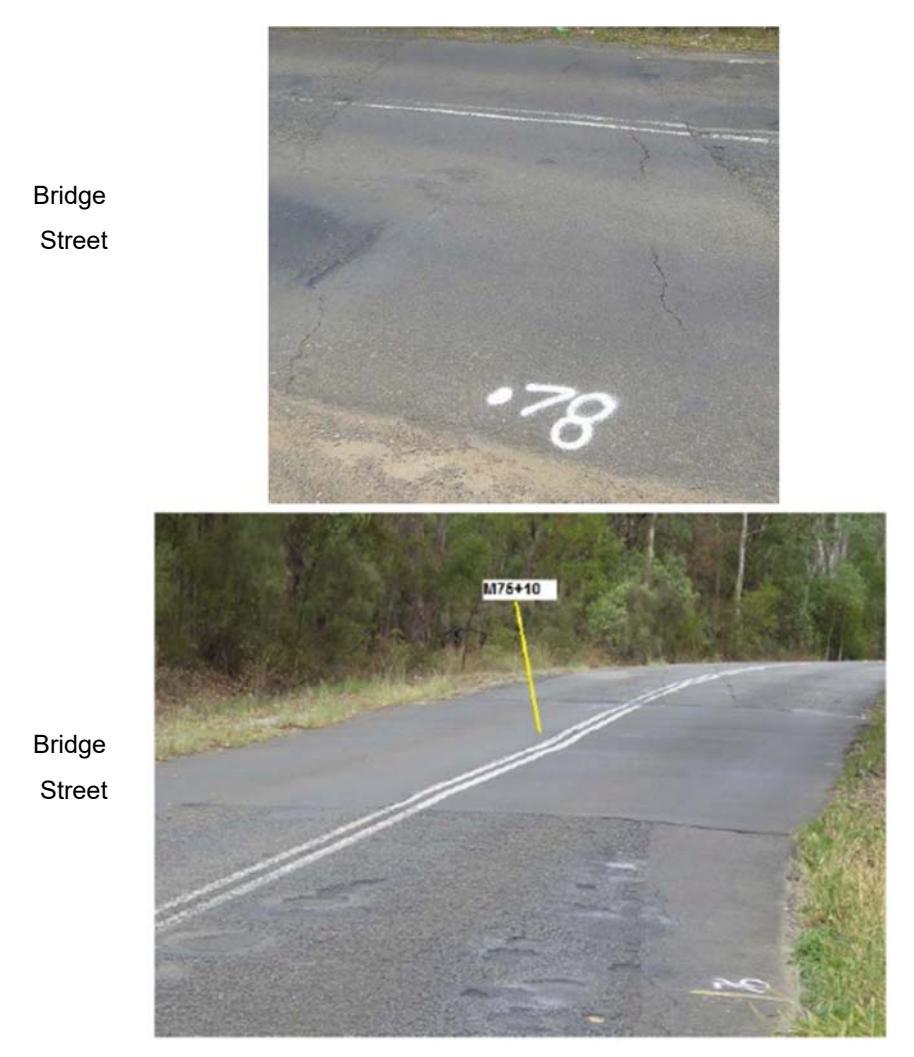
Fig. 4.1 Photographs of Impacts to Road Pavements and Kerbs during Longwall 29

Approximately 25.5 kilometres of asphaltic pavement lie directly above the extracted longwalls and a total of 49 impact sites have been observed. The observed rate of impact equates to an average of one impact for every 520 metres of pavement. The impacts were minor and did not present a public safety risk. A collection of photographs of impacts is provided in Fig. 4.1.

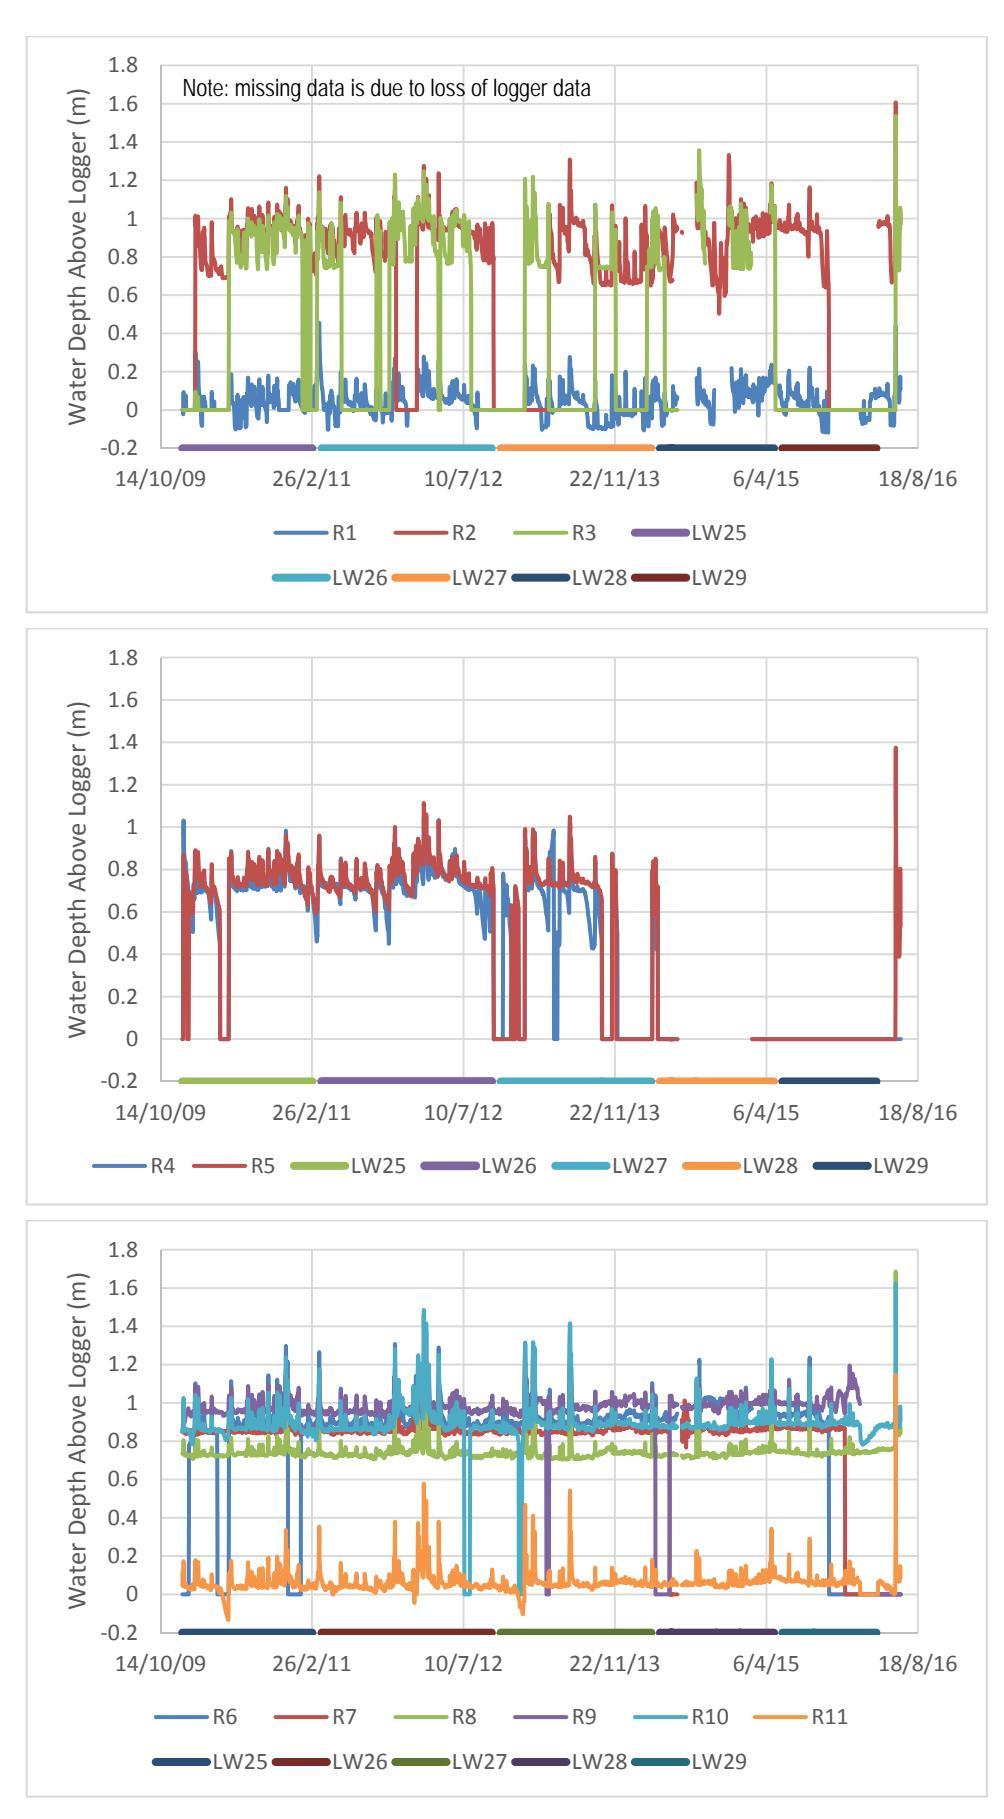
Figure 2 Redbank Creek Pool Depth

Sites R2, 3, 4, 5, 6 and R7, which overlie Longwalls 25 to 29, show evidence of subsidence related pool holding capacity effects, whilst R8 to 11 do not, as shown in **Figure 2**.

Observation of weekly monitoring sites 19 to 37 and between RR2 to RR19 (over Longwalls 27 to 31) were monitored during extraction of Longwall 29 indicate that stream flow and pool depths have been significantly affected by subsidence associated with Longwalls 26 to 29 between Sites 19 - 37 and between RR2 to RR11, which overlie Longwalls 27 and 30 as shown in **Drawing 2**.

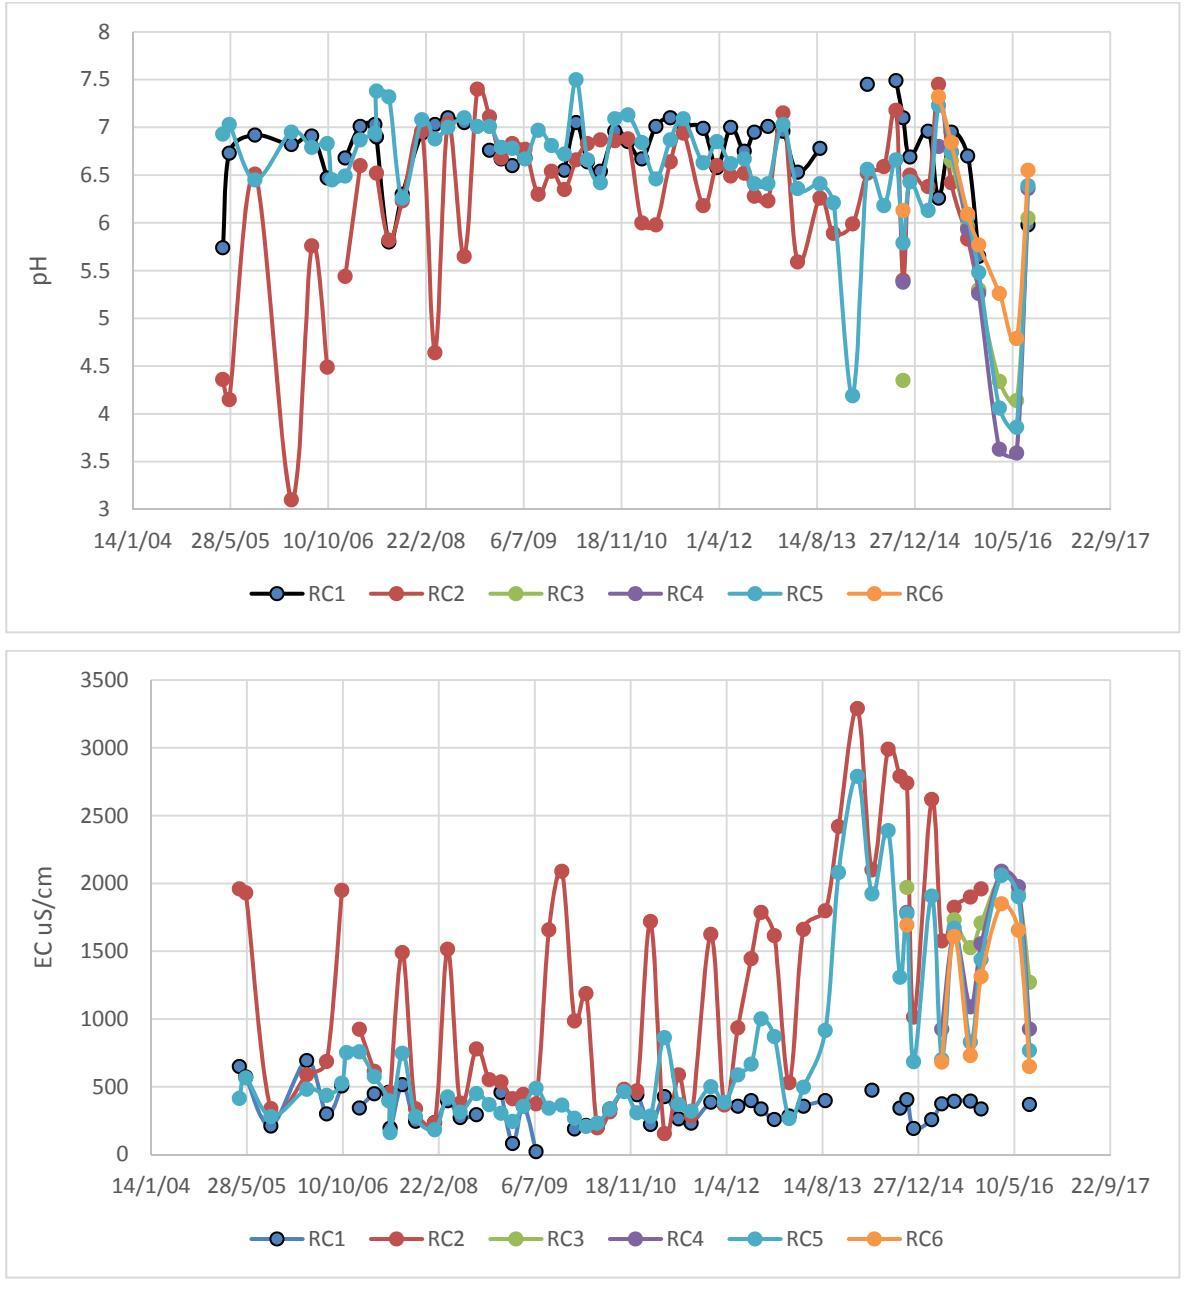
Figure 3 Redbank Creek Field Water Quality

Redbank Creek has an EC range from 22 - 3290uS/cm, and pH was between 3.10 and 7.50, with the creek generally being more acidic and saline at RC2 as shown in **Figure 3**.

During extraction of Longwall 29, pH in Redbank Creek distinctly acidified at all monitored sites, whilst salinity did not show a specific trend, except for higher salinity during low flow periods.

Enhanced salinity and lower pH is predominantly associated with the more ferruginous seeps in the stream.
