# **Tahmoor Colliery - Longwall 29**

End of Panel Subsidence Monitoring Report for Tahmoor Longwall 29

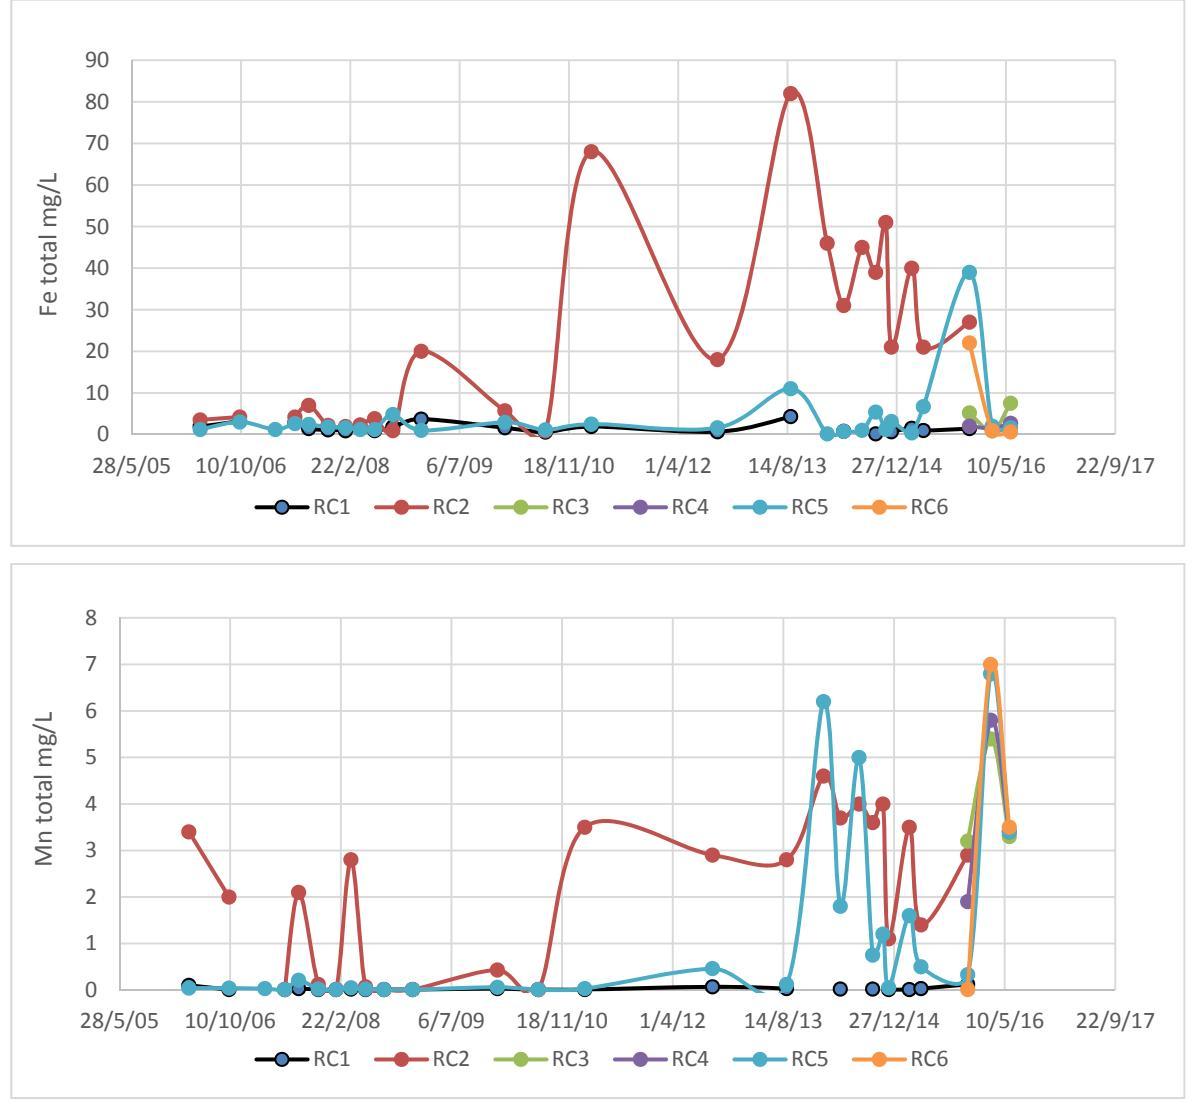
Figure 4 Redbank Creek Iron and Manganese

Redbank Creek generally contains elevated iron and, occasionally, above ANZECC 2000 Protection of 95% of Freshwater Aquatic Species trigger level manganese at RC2 in association with the upstream tributary seepage as shown in **Figure 4**.

The stream reach at RC2 (a.k.a. Site 37) has had a definitive ferruginous hydroxide precipitate in the standing pool since monitoring was started in early 2005 which is present due to upwelling and re-oxygenation of chemically reduced waters in the creek between sites 30 to 35, as well as a groundwater seep in a tributary entering Redbank Creek downstream of the railway tunnel at Site 36, as well as sites RC37, RR2, RB3-6, RR7-10, RRS12, RW13, RB14 and RR15 -19.

The iron and manganese levels vary with rainfall in the catchment, with lower concentrations after wetter periods, however a definitive rise in iron has been observed at RC2 and for manganese at RC2 and RC5 since Longwall 27 and Longwall 28 undermined Redbank Creek. Manganese also rose distinctly during extraction of Longwall 29 at Sites RC3-6 (at which time RC1 and RC2 were dry).

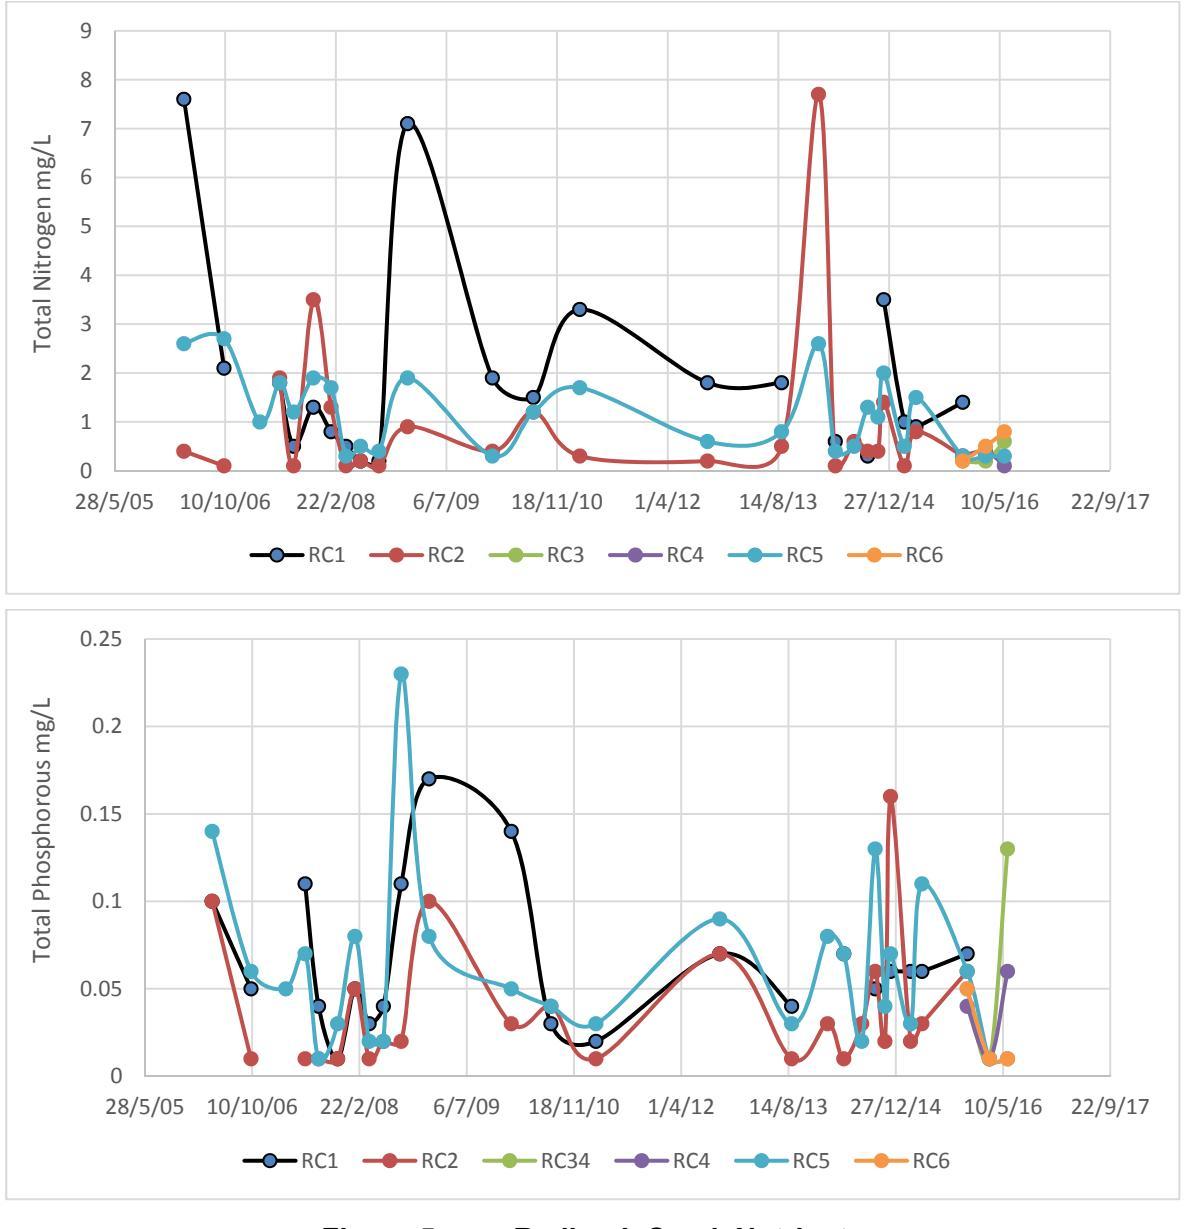
Figure 5 Redbank Creek Nutrients

The creek can have total nitrogen up to 7.6mg/L and total phosphorous up to 0.23mg/L, which can be above the ANZECC 2000 SE Australian Upland Stream criteria at all monitored sites as shown in **Figure 5**.

The above criteria nutrients are present in the creek due to urban and rural / residential runoff in the catchment from house gardens, market gardens, as well as properties with poultry and stock, and are not related to mining influences.

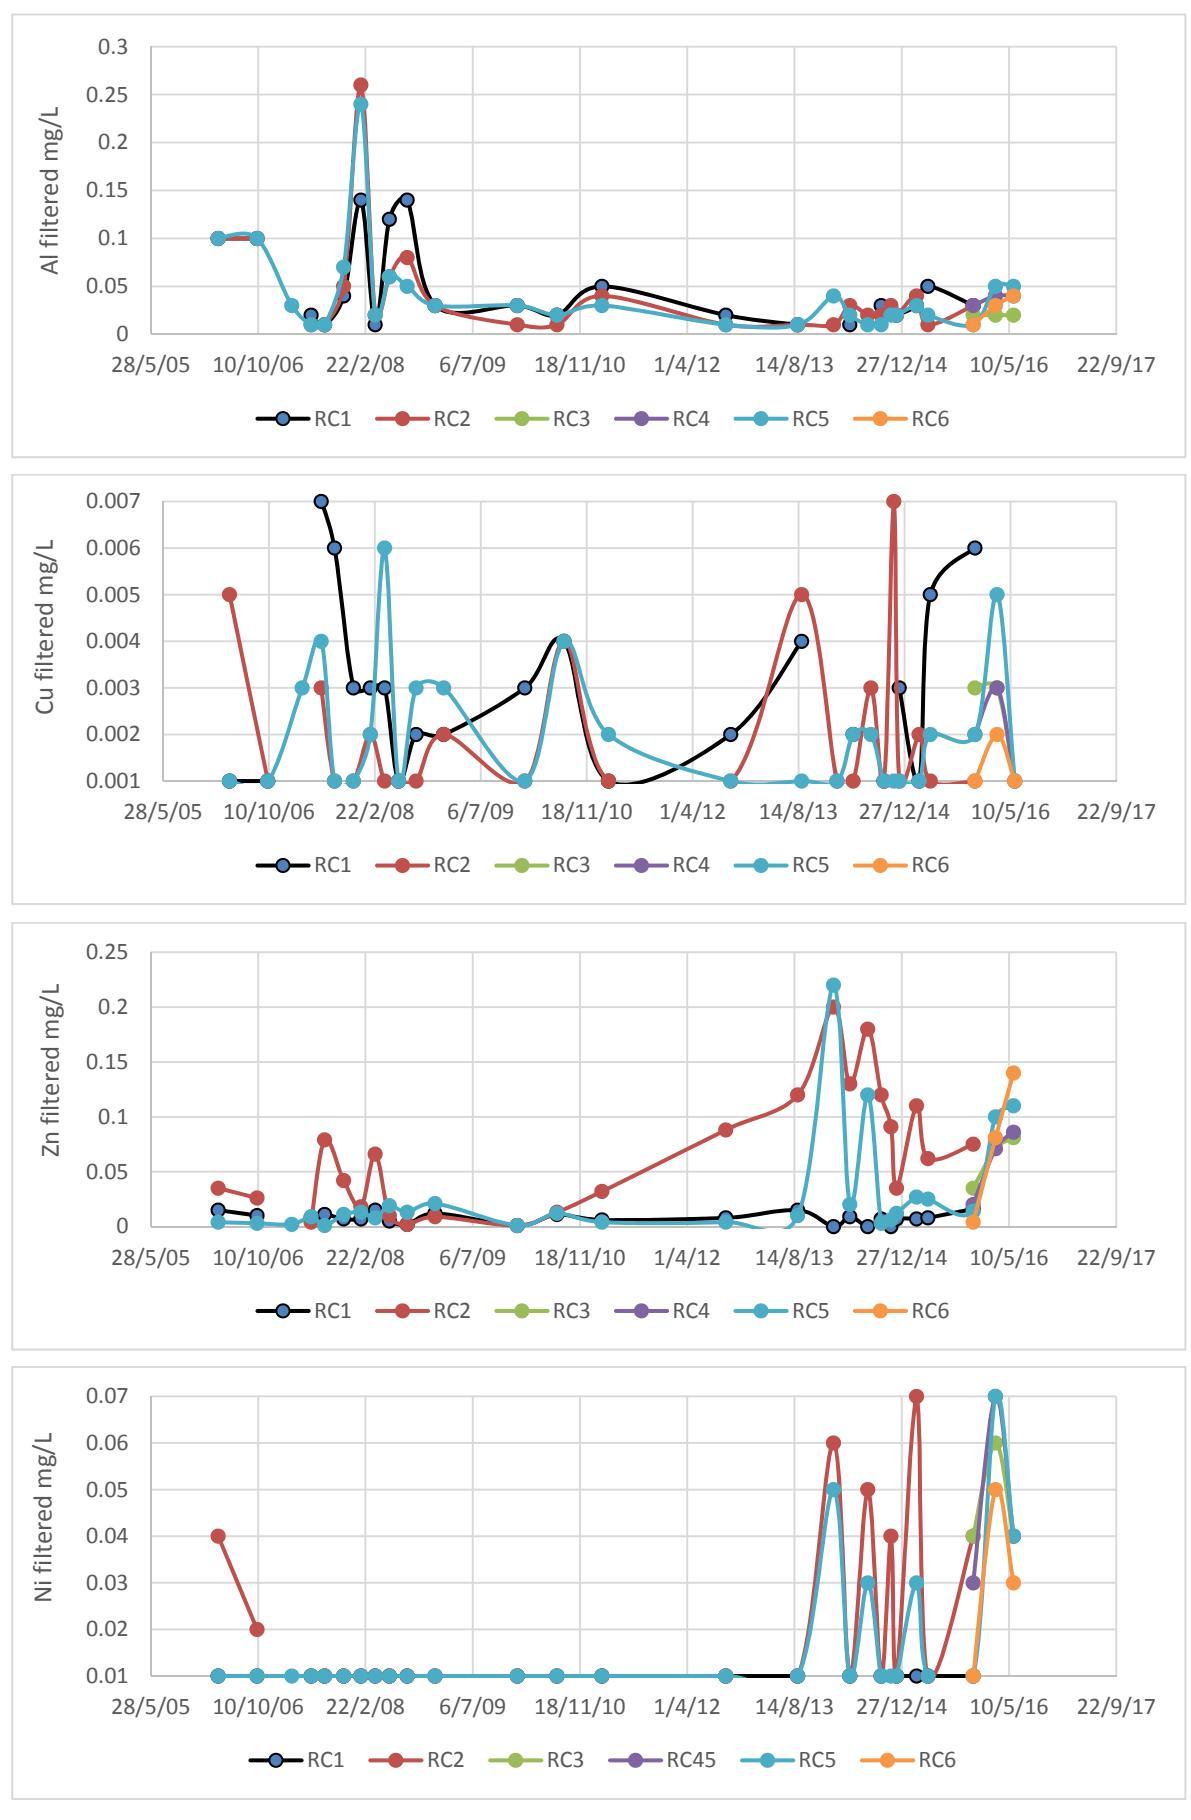
Redbank Creek can also exceed the ANZECC 2000 trigger levels for filterable aluminium (<0.26mg/L), although the peak levels occurred during late 2007 and early 2008, with no observable increase above background levels during the Longwall 26 to 28 mining period.

Copper can reach up to 0.007mg/L at RC1 and RC2, however no sustained increase as a result of Longwall 28 or Longwall 29 is observed as shown in **Figure 6**.

Zinc can reach up to 0.22mg/L as shown in **Figure 6**, with its concentration being observed to rise at RC2 since late 2010, and since August 2013 at RC3 with an erratic, although generalised reduction since February 2014 and subsequent rise after extraction of Longwall 29.

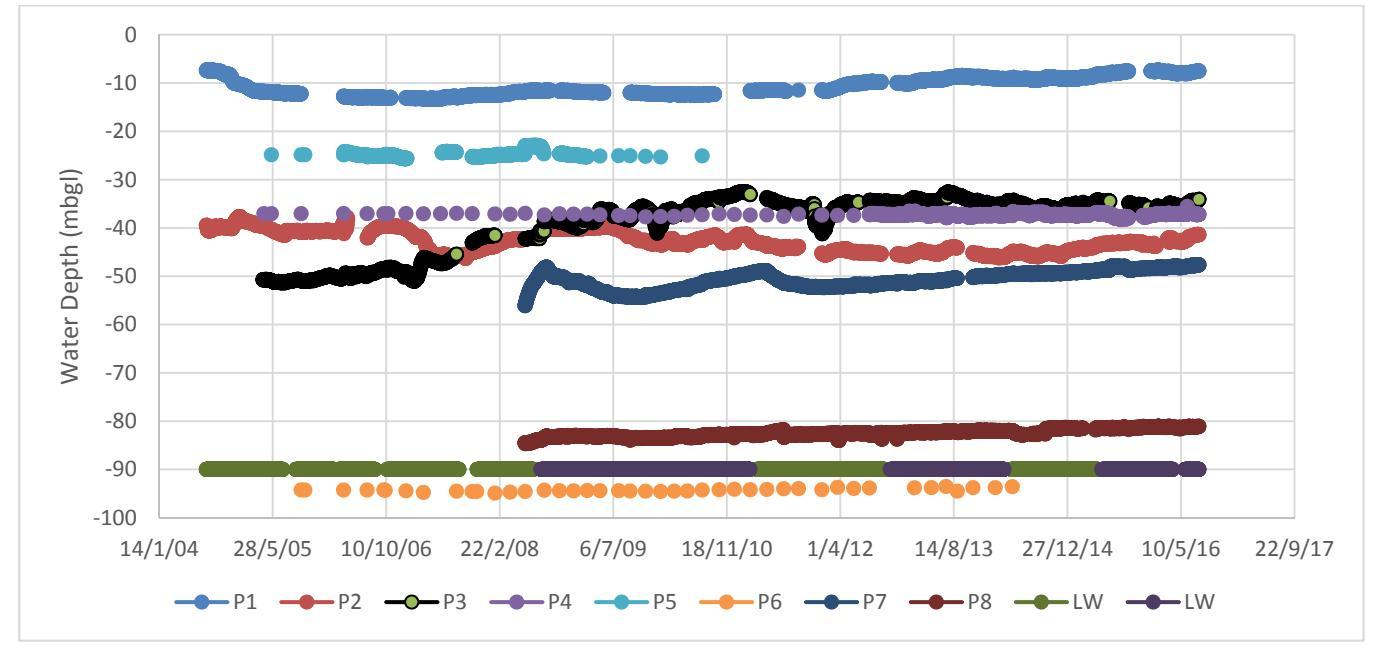
Figure 7Standing Water Levels and Panel Extraction

No open standpipe piezometer water level reduction in response to Longwall 29 has been observed, and no complaints of adverse effects on private bore water levels or yield were received by the Colliery during extraction of Longwall 29.

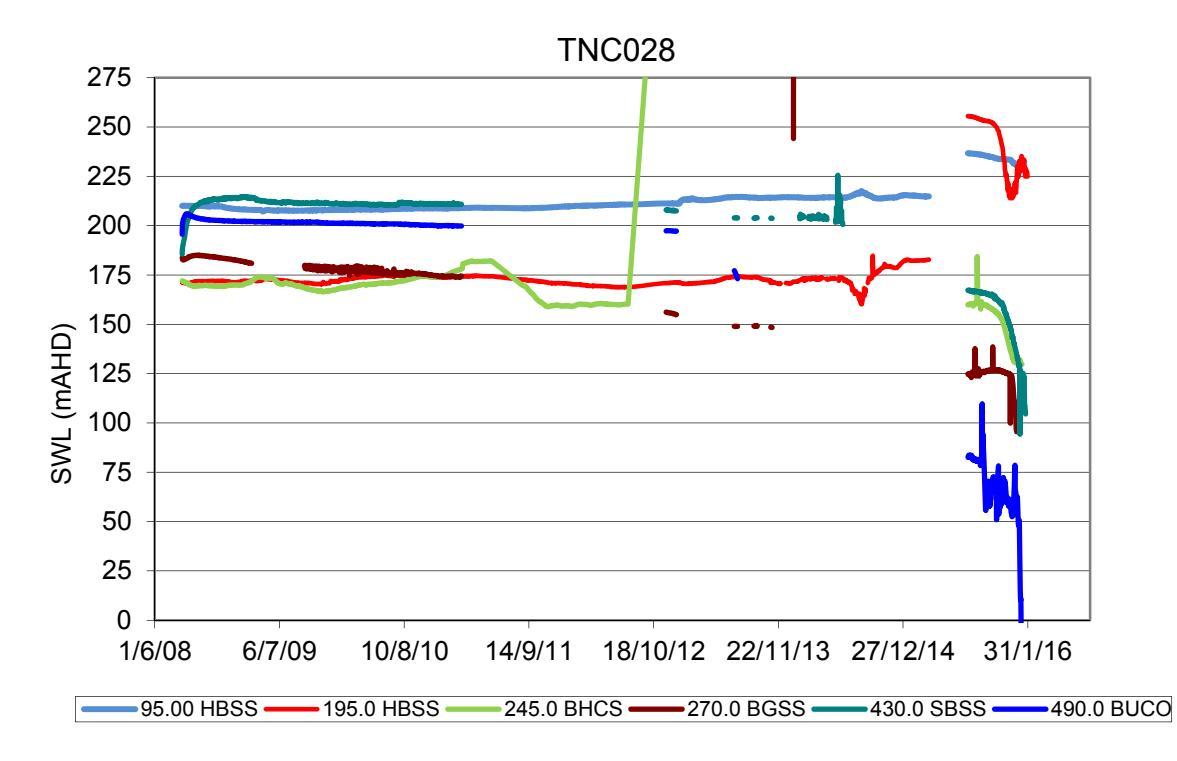
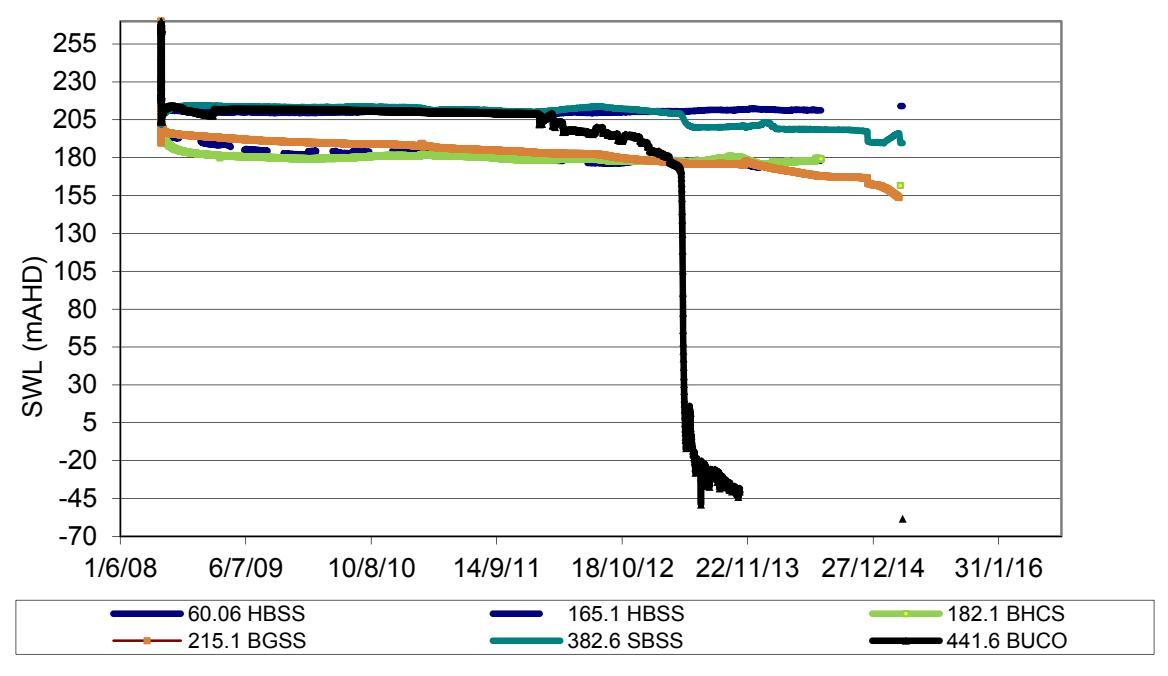
Figure 8 Vibrating Wire Piezometer TNC28 and 29 Groundwater Levels

The available data from the open standpipe piezometers, coal exploration and private bores, as well as the piezometric head monitoring in TNC28 and TNC29 have not indicated any adverse breaching or interconnection between the Hawkesbury Sandstone and Bulgo Sandstone, or through the Bald Hill Claystone.

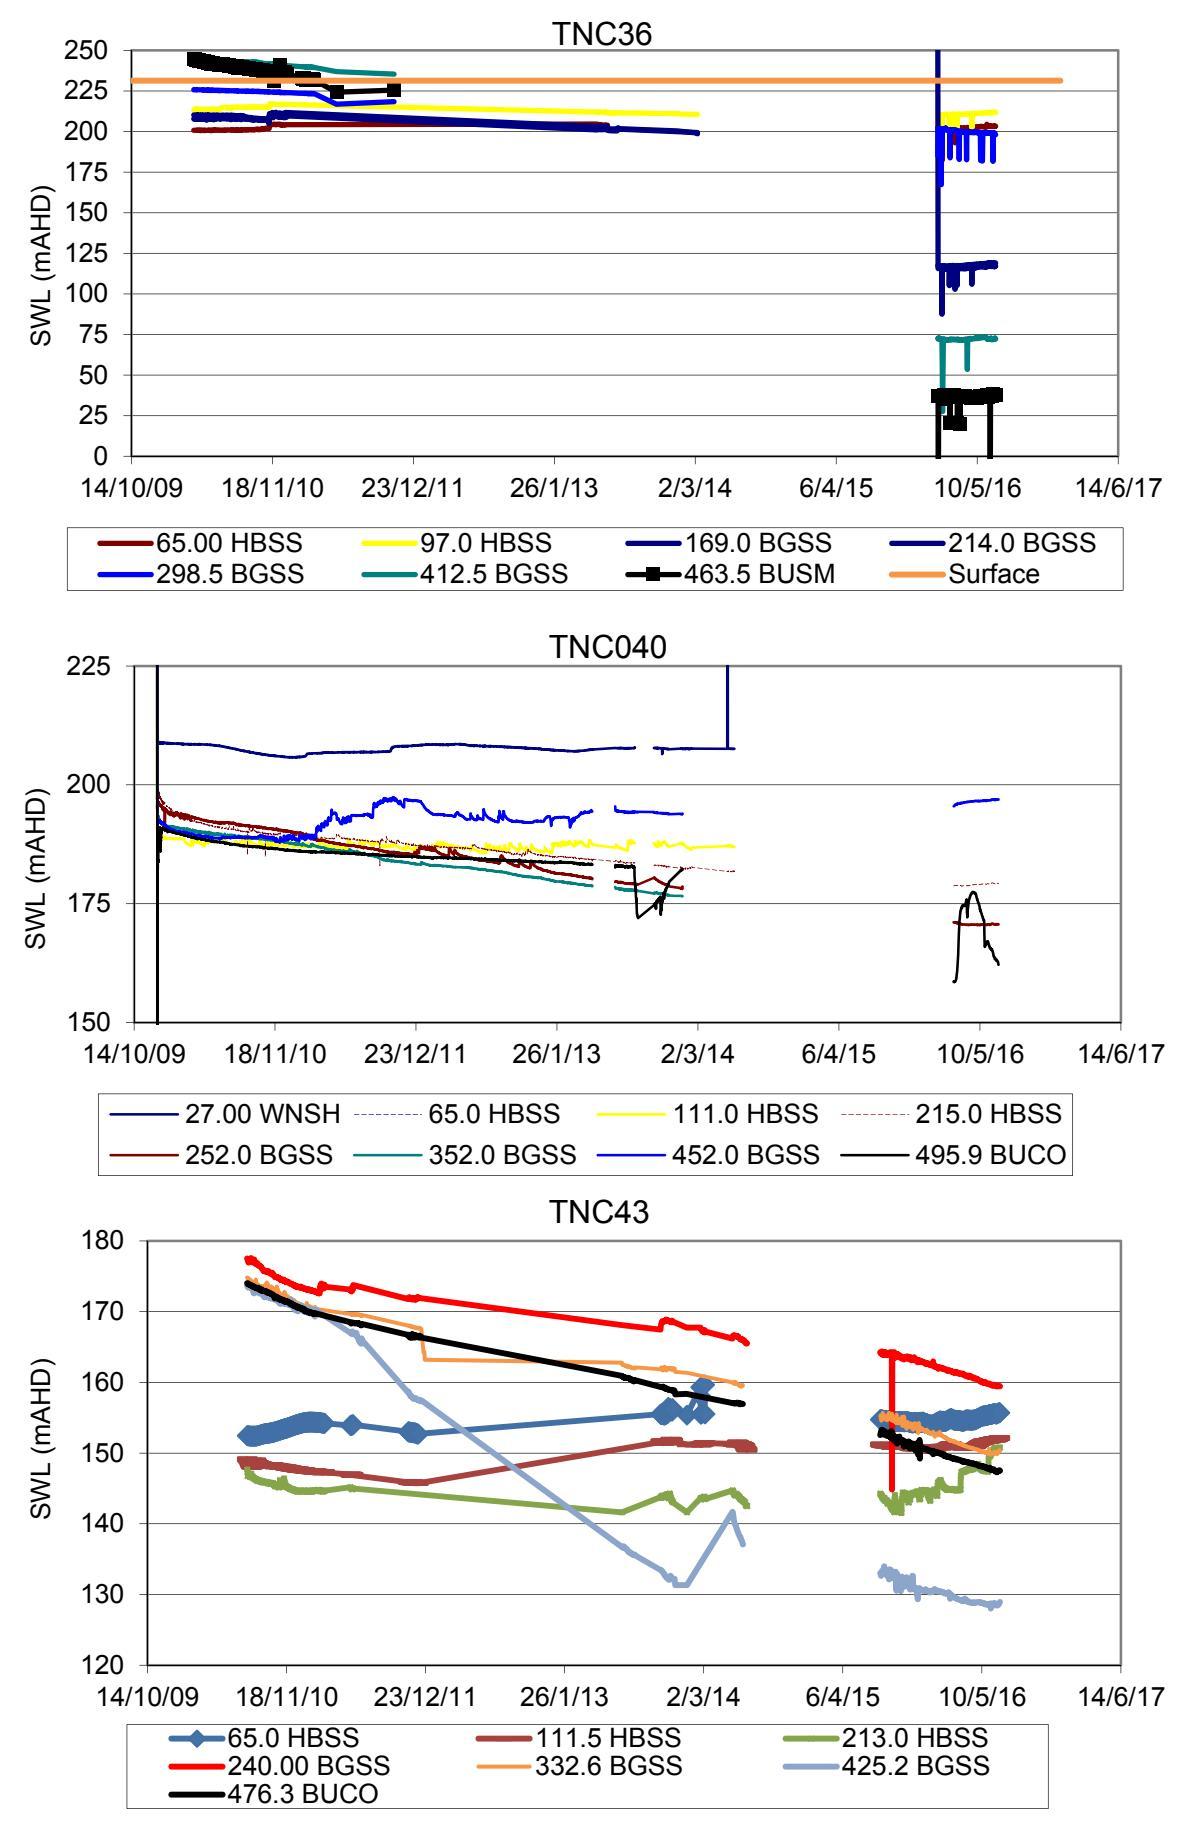
Figure 9 Vibrating Wire Piezometer TNC36, 40 and 43 Groundwater Levels

Partial depressurisation is observed in the Hawkesbury Sandstone at 97mbgl as well as in the Bulgo Sandstone (at 169 / 214 / 299mbgl) and the Bulli Seam in TNC36.

Partial depressurisation is also observed in the Hawkesbury Sandstone (213mbgl) as well as in the Bulgo Sandstone (at 240 / 333 / 425mbgl) and Bulli Seam in TNC43.

TNC36 is located approximately 1600m north of Longwall 29, whilst TNC40 is located approximately 1300m north east and TNC43 is approximately 1050m north east of Longwall 29.

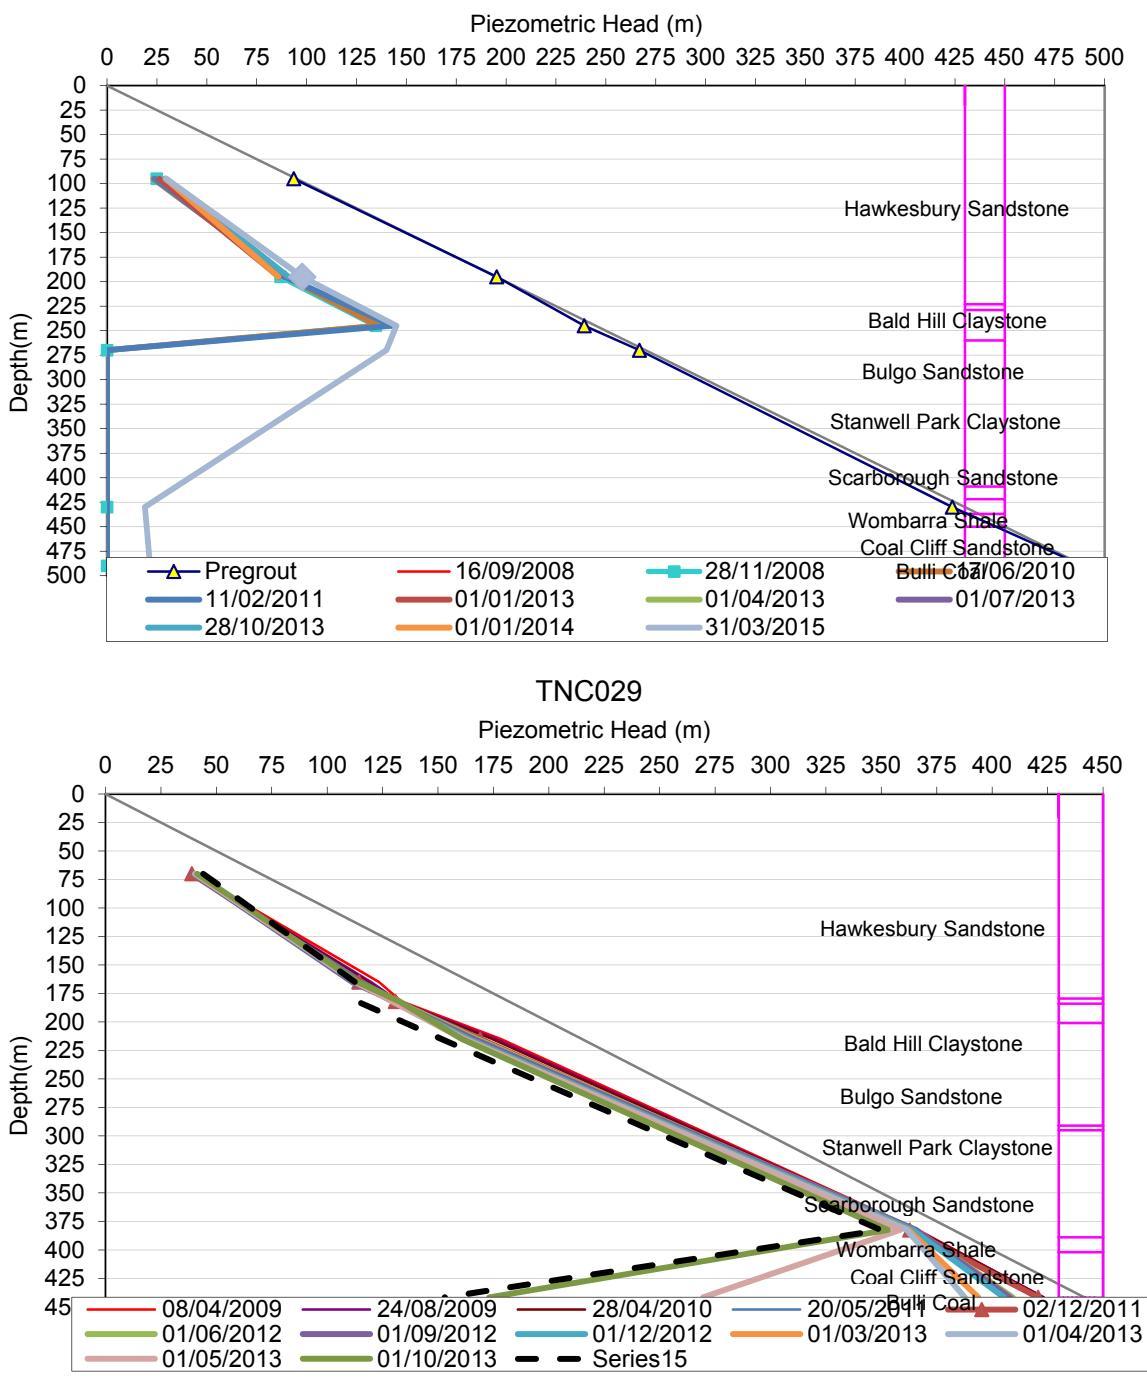
Figure 10 Vibrating Wire Piezometer Head vs Depth

Hydraulic connection has been instigated between the Bald Hill Claystone and Bulgo Sandstone in TNC28 as well as between the base of the Scarborough Sandstone and the Wombarra Shale in TNC29 during extraction of Longwalls 22 to 28 as shown in **Figure 10**.

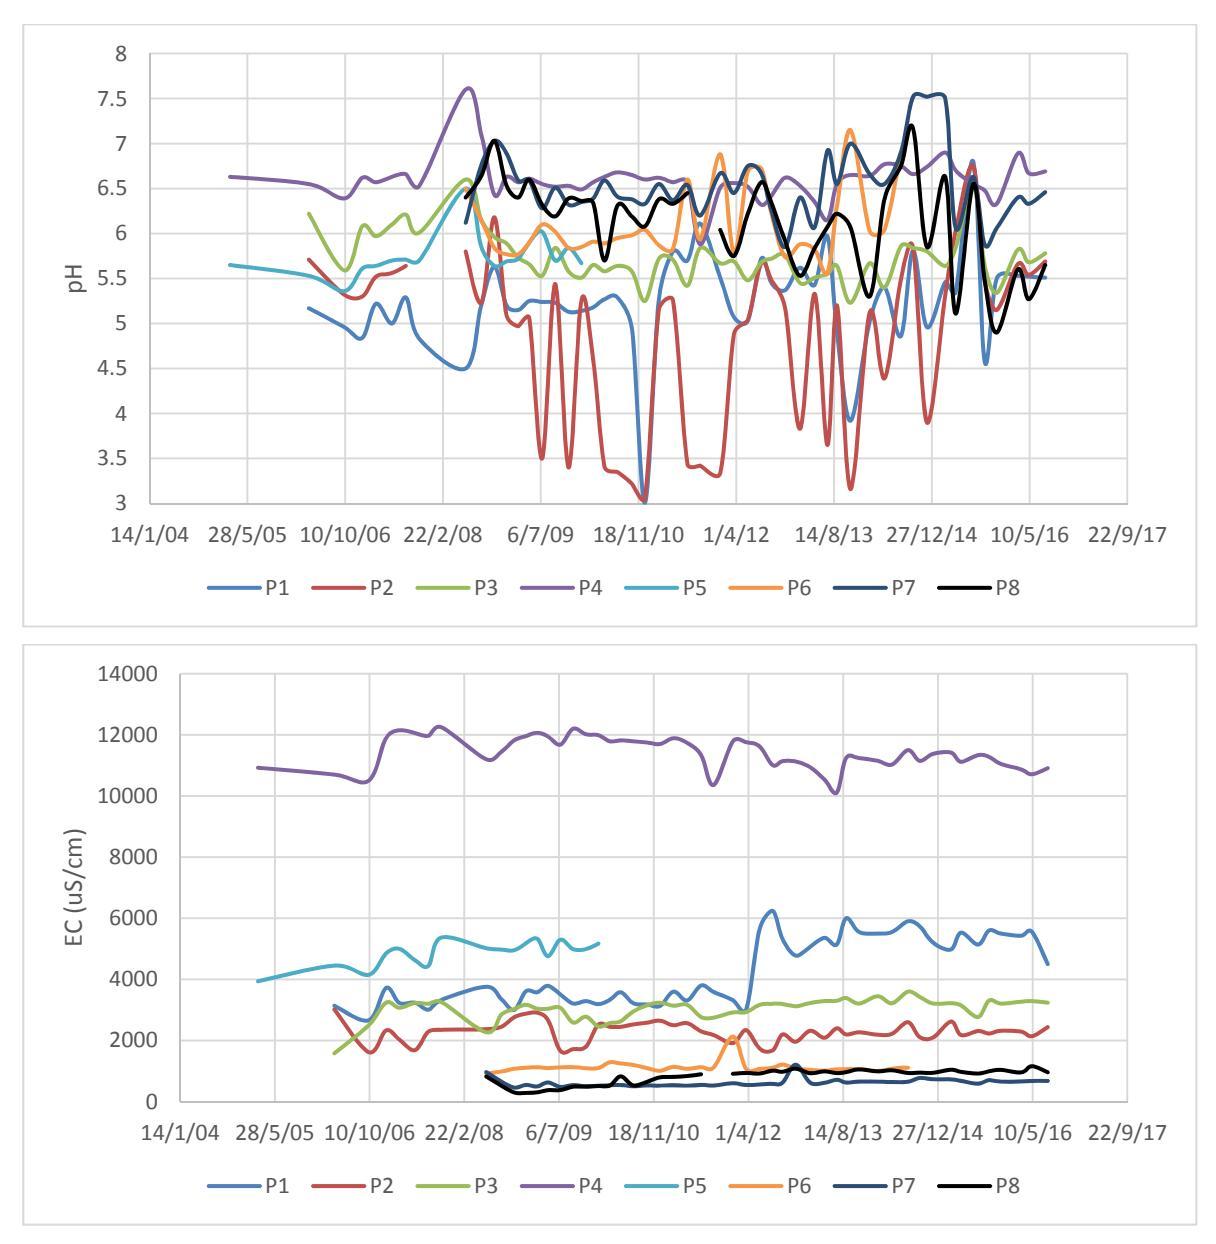
Figure 11 Field Groundwater Quality

Groundwater in the study area has generally brackish salinity ( $459\mu$ S/cm to  $12,250\mu$ S/cm) with acid to circum-neutral pH (3.06 to 7.6) as shown in **Figure 11**.

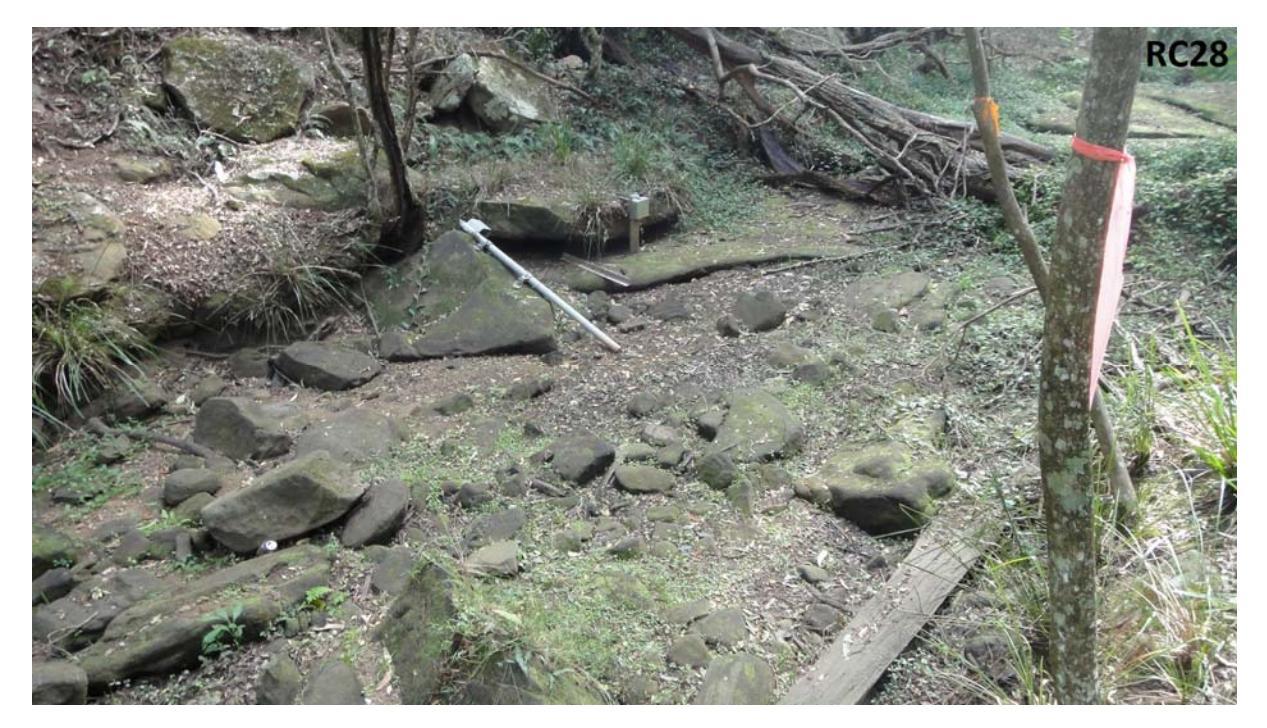
Site 28 (flow Monitoring Site R5) dry pool

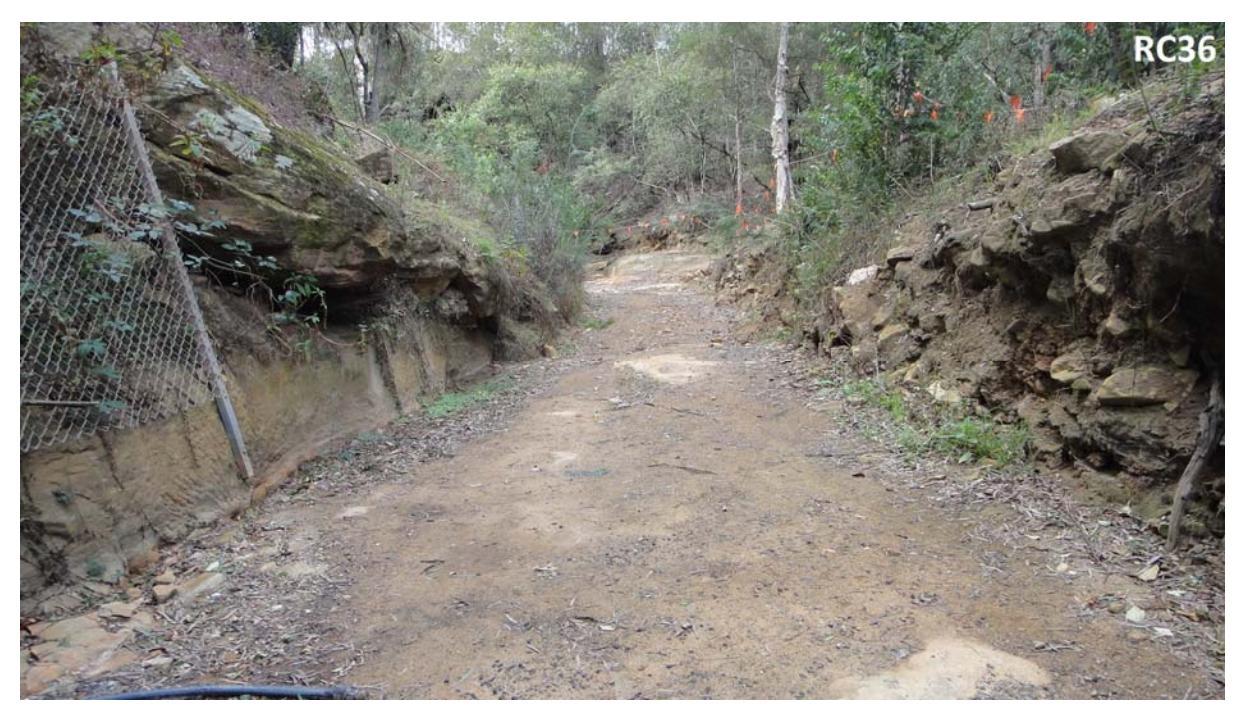
Site 36 (downstream of railway culvert tunnel) dry reach

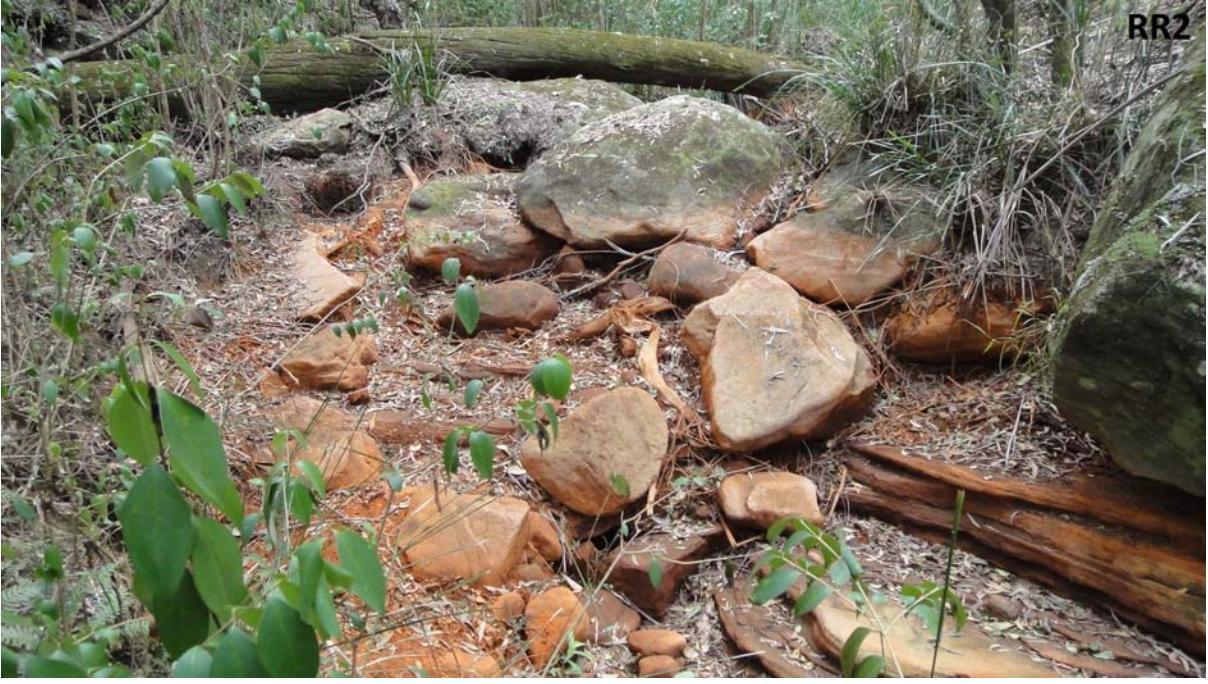
Site RR2 dry pool

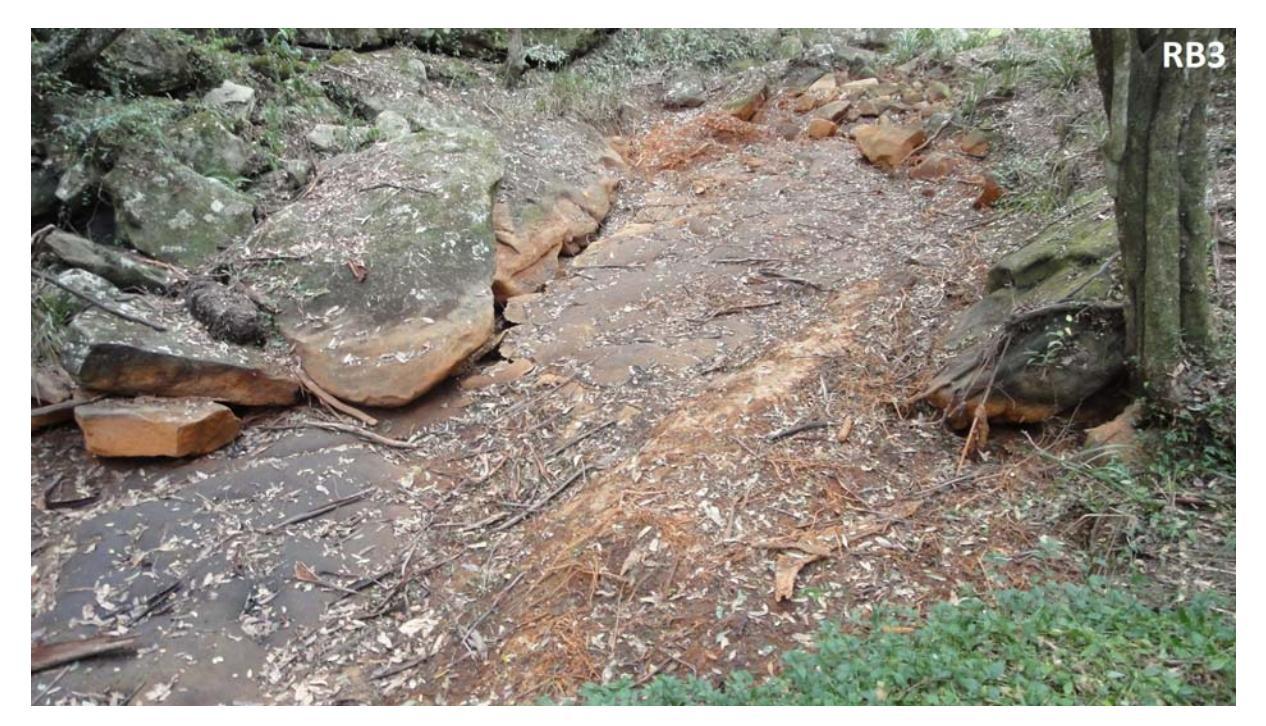
Site RB3 dry pool

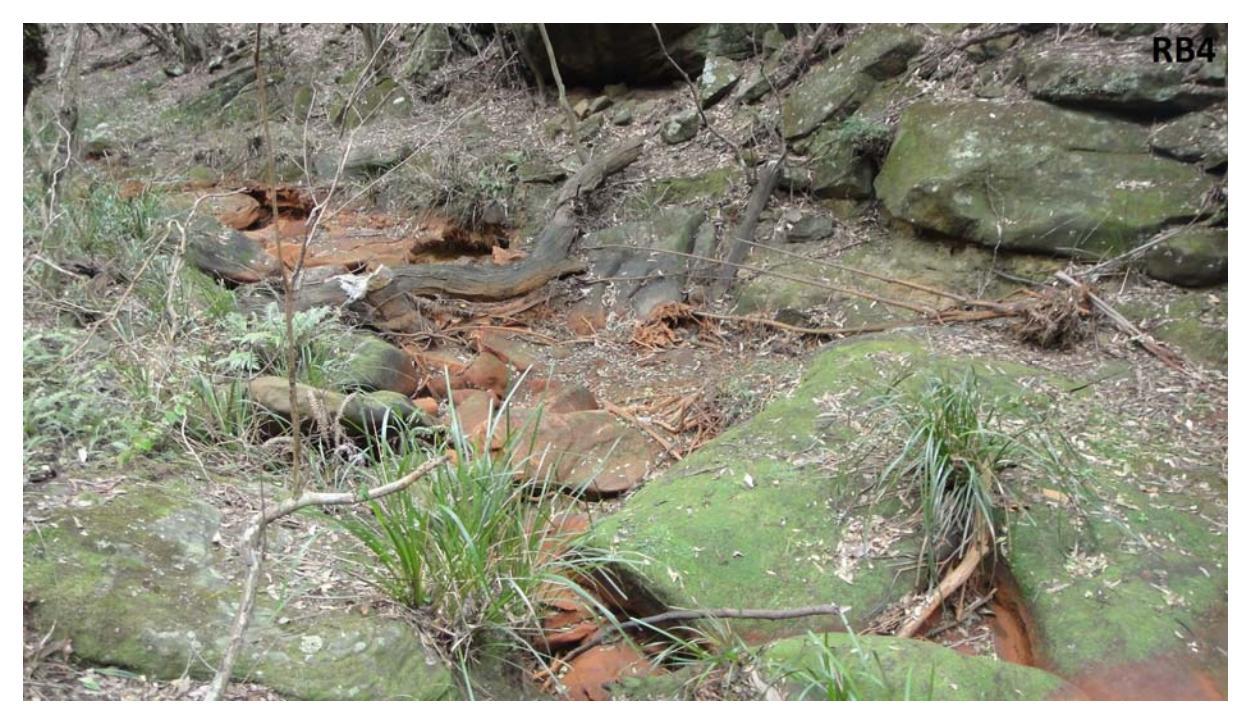
Site RB4 dry pool

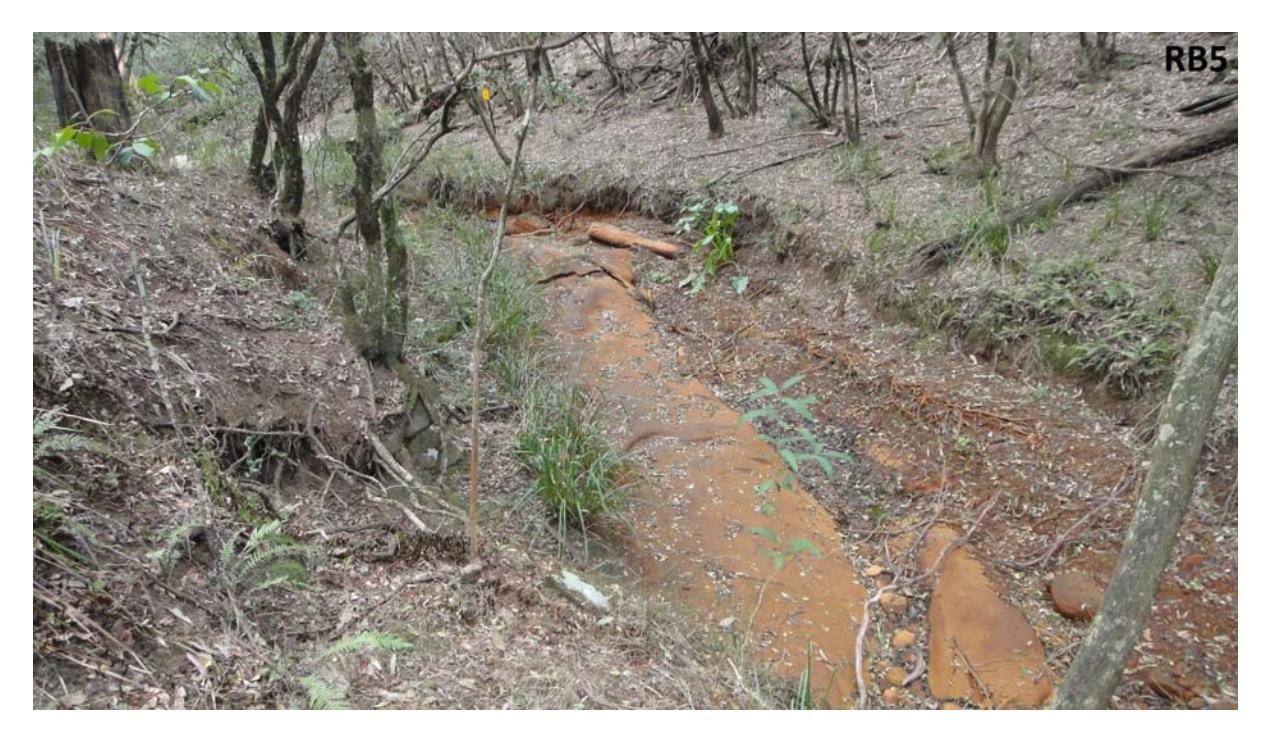
Site RB5 dry pool

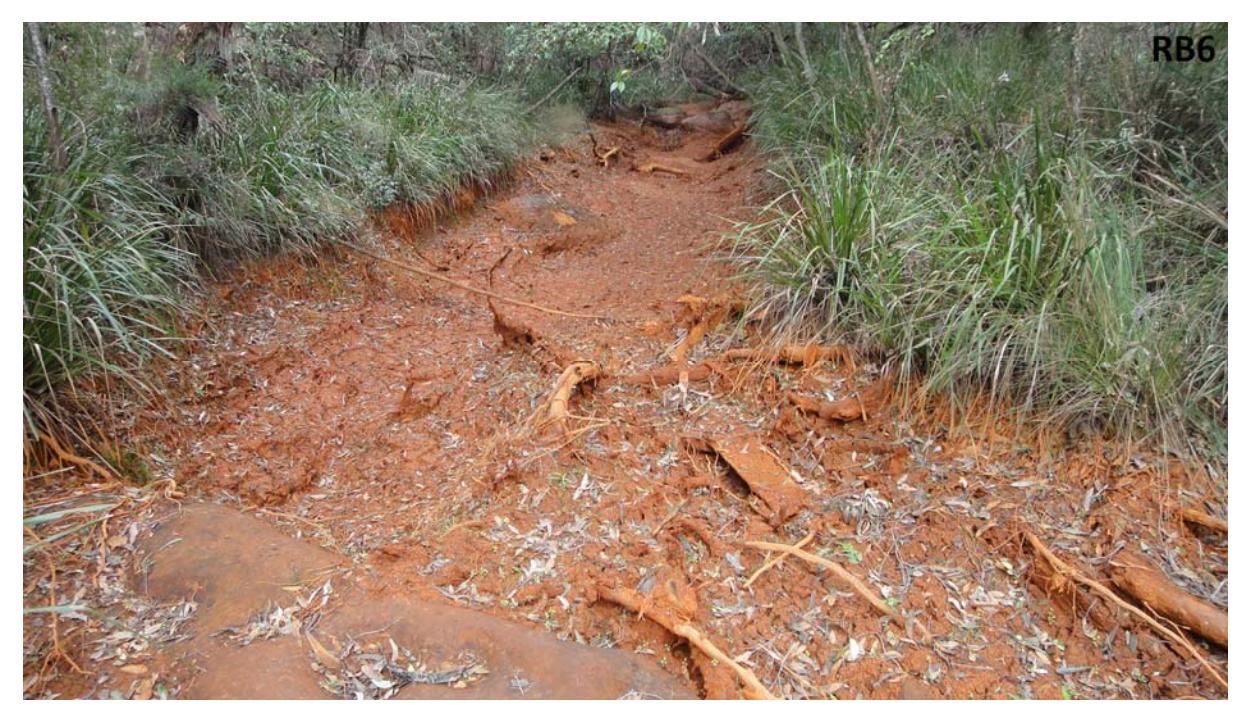
Site RB6 dry pool

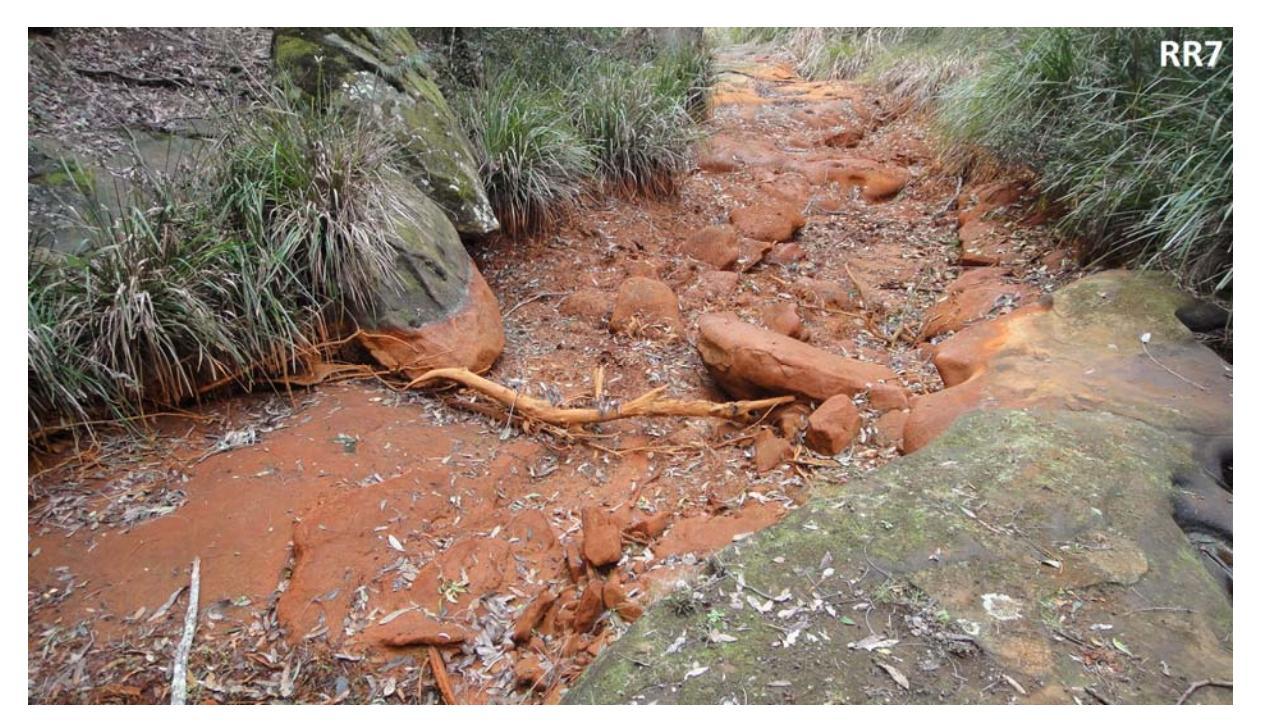
Site RR7 dry pool

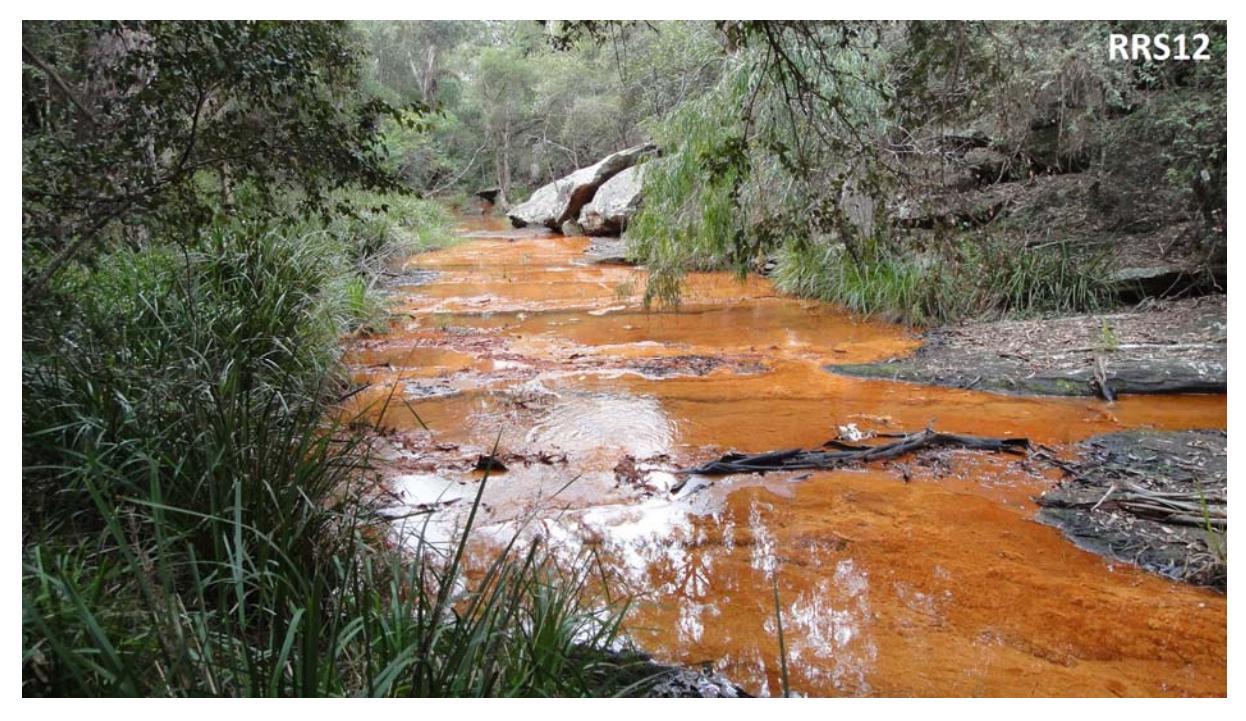
Site RRS12 highly ferruginous flow over the rock shelf. (All sites downstream of here contain full pools or overland flow)

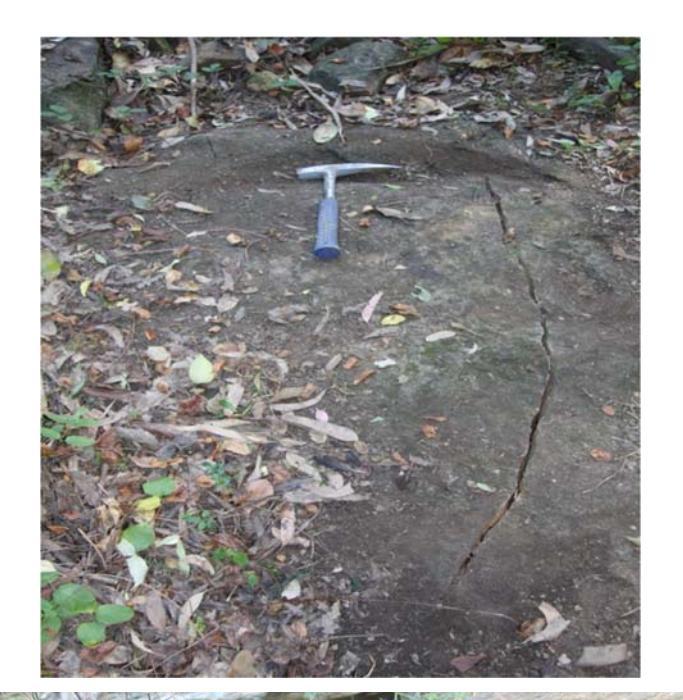
Figure 3 Cracking over Longwall 25

Three areas of isolated cracking of exposed sandstone in the base or sides of generally dry pools occurred after the completion of Longwall 25 as summarised in **Table 6** and shown in **Figure 3**.
