# **Tahmoor Colliery - Longwall 29**

End of Panel Subsidence Monitoring Report for Tahmoor Longwall 29

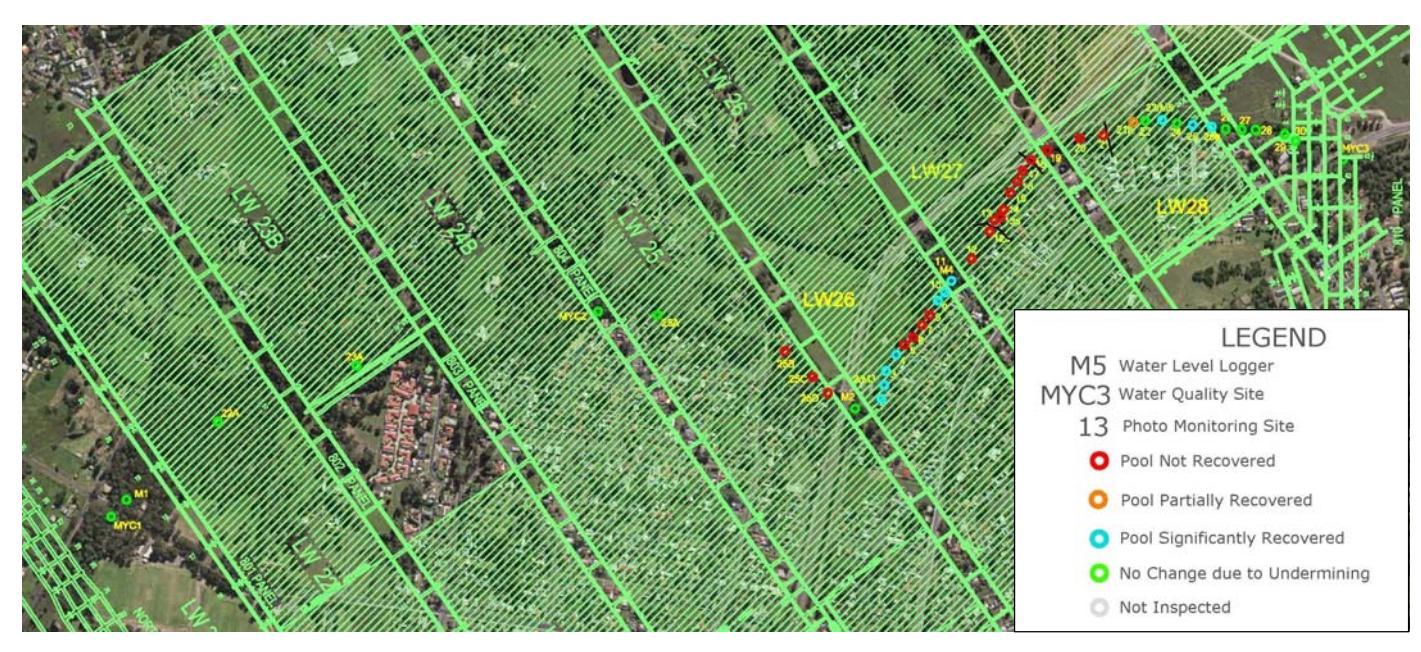
Figure 14 Subsidence Effects After Longwalls 29 and 30 (ongoing) Extraction

A summary of the observed subsidence effects during the period of Longwall 30 extraction is shown in **Figure 14**.

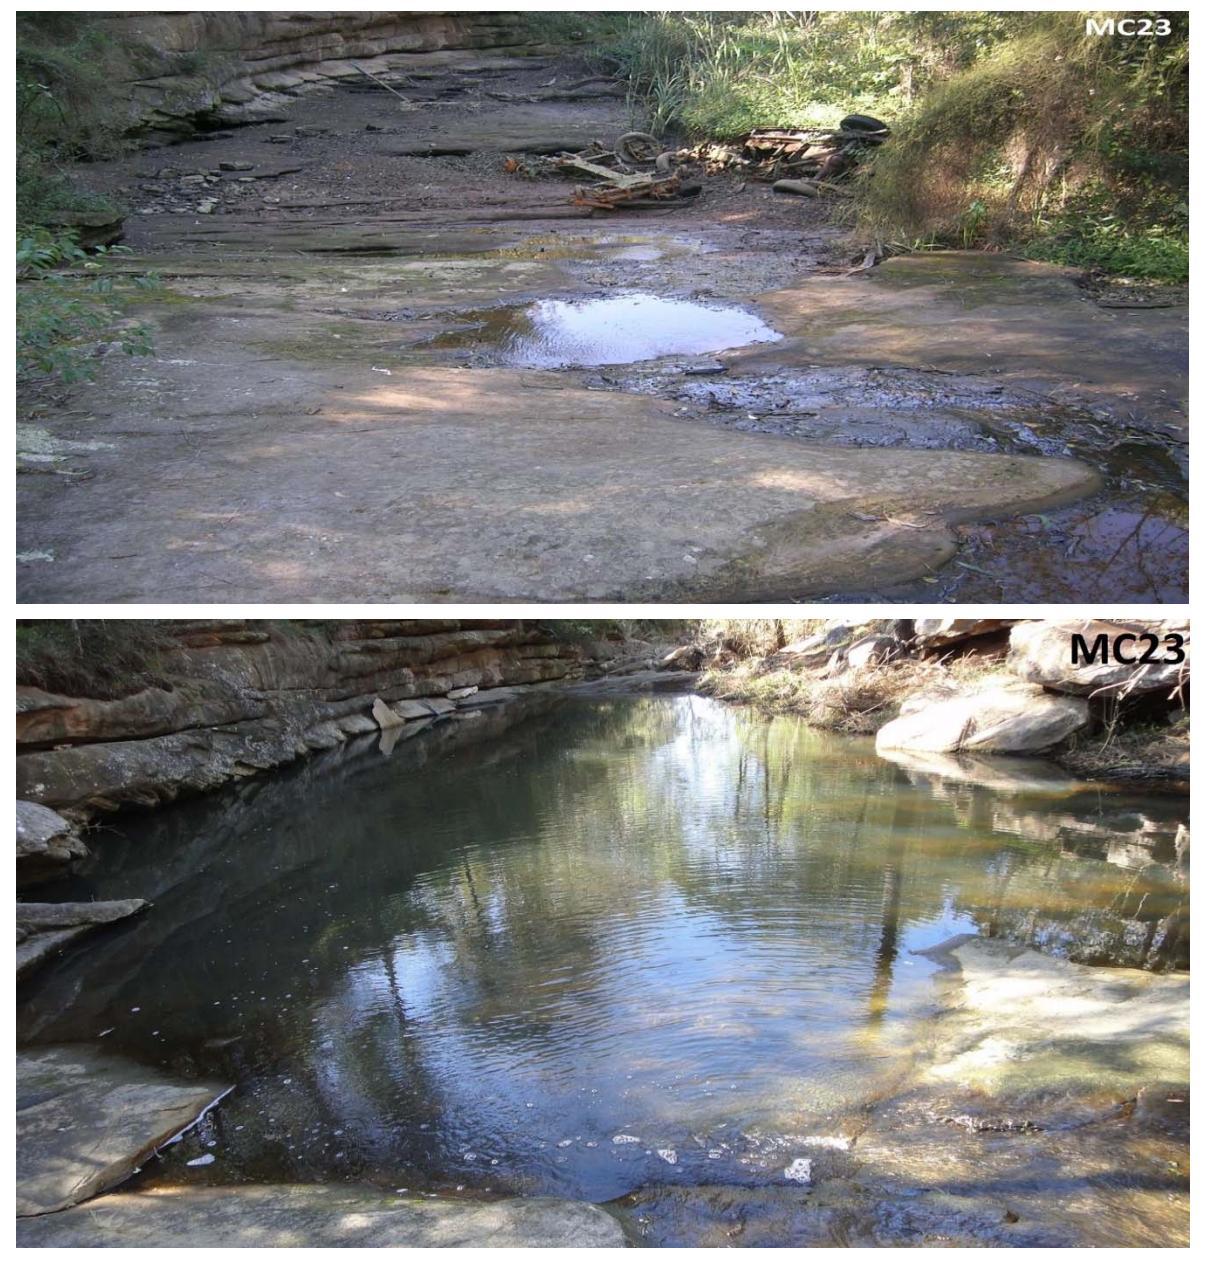
Figure 26 Site 23 (02/07/14 and 29/07/16)

In the case of the large pool at Site 23, which had been essentially totally dry after mid-April 2013, and contained 2 old car bodies, the car bodies were washed downstream of Site 30 in early June 2016 and haven't yet been located. The two photos below (02/07/2014) and (29/07/2016) show the pool when it was totally dry, and after the June 2016 storm.

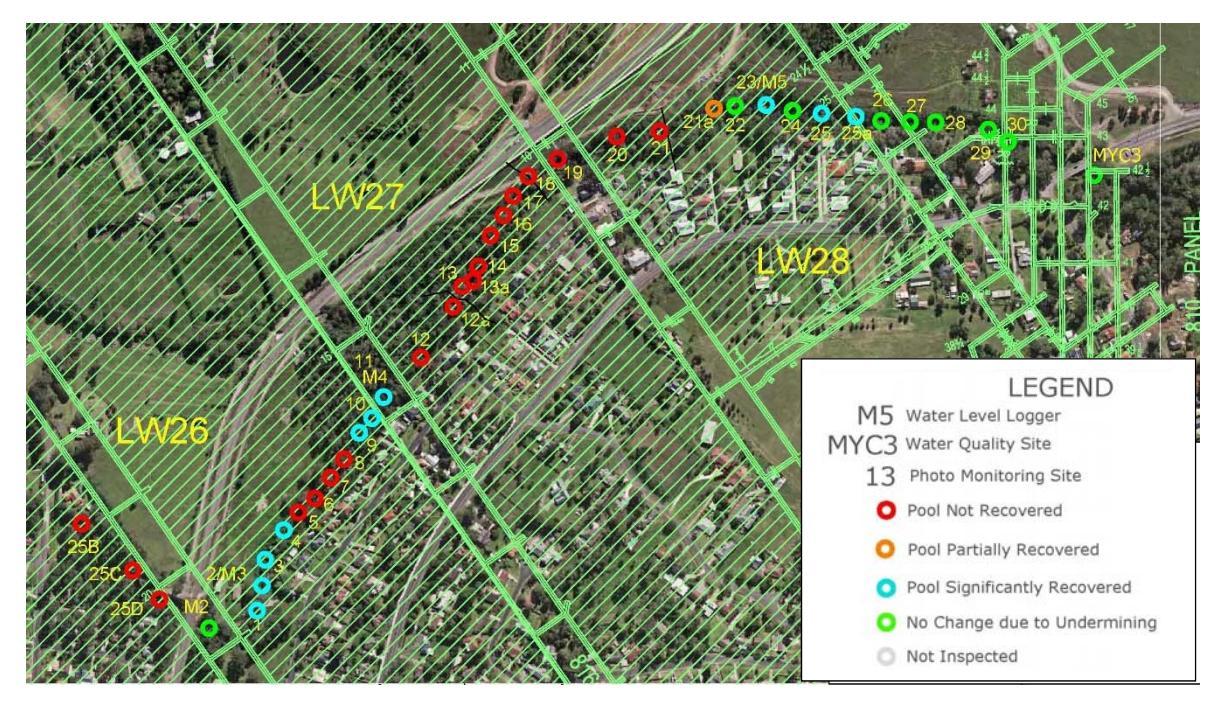
Figure 27 Status of Pools over and Downstream of Longwalls 25 to 28 as of August 2016

- Significantly dried out pools or sandstone shelves are located at Sites 25B,C and 25D over Longwall 25, Sites 5 to 8 over Longwall 26 and Sites 12 to 21 over Longwalls 27 and 28;
- Pools showing signs of recovery or those that were not significantly adversely affected are located at Sites 2 to 4 11 over Longwall 26, as well as Sites 23 to 30 over and downstream of Longwall 28, whilst;
- The pool at Site 22 was not affected at all by subsidence.
