SIMEC Mining:

Tahmoor Coking Coal Operations - Longwall 31

End of Panel Subsidence Monitoring Report for Longwall 31

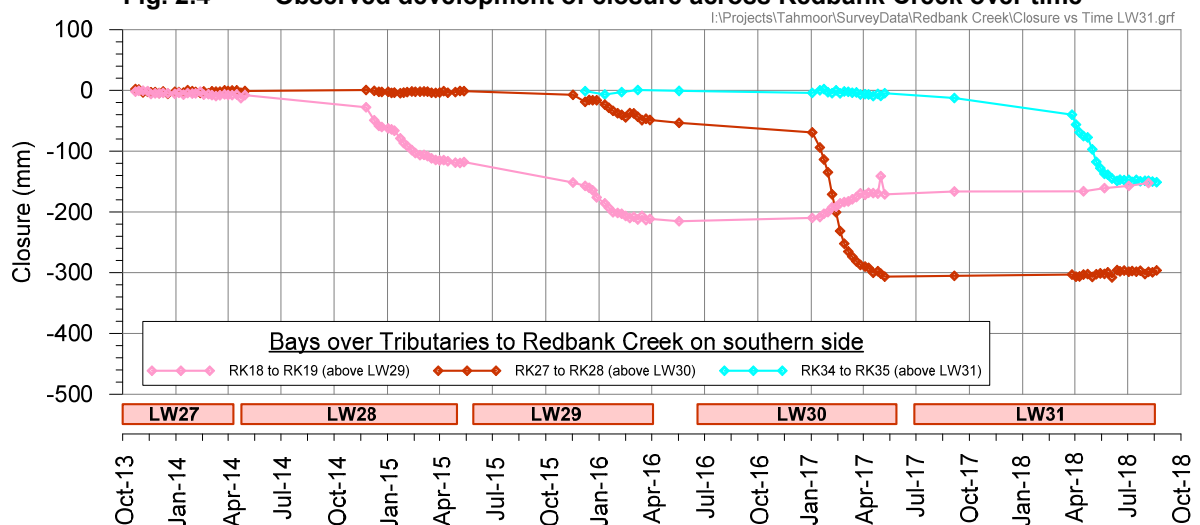
Fig. 2.5 Observed development of closure across tributaries to Redbank Creek over time

A number of observations are made from the monitoring data:

- It can be seen from Fig. 2.4 that valley closure was slightly greater for a temporary period of time, when the transient effects of the subsidence travelling wave passed through the valley.
- Maximum observed closure above Longwall 31 was similar to maximum observed closure above Longwall 30 and less than maximum observed closure above Longwall 29. This was predicted as the valley is deeper and more incised above Longwall 29.

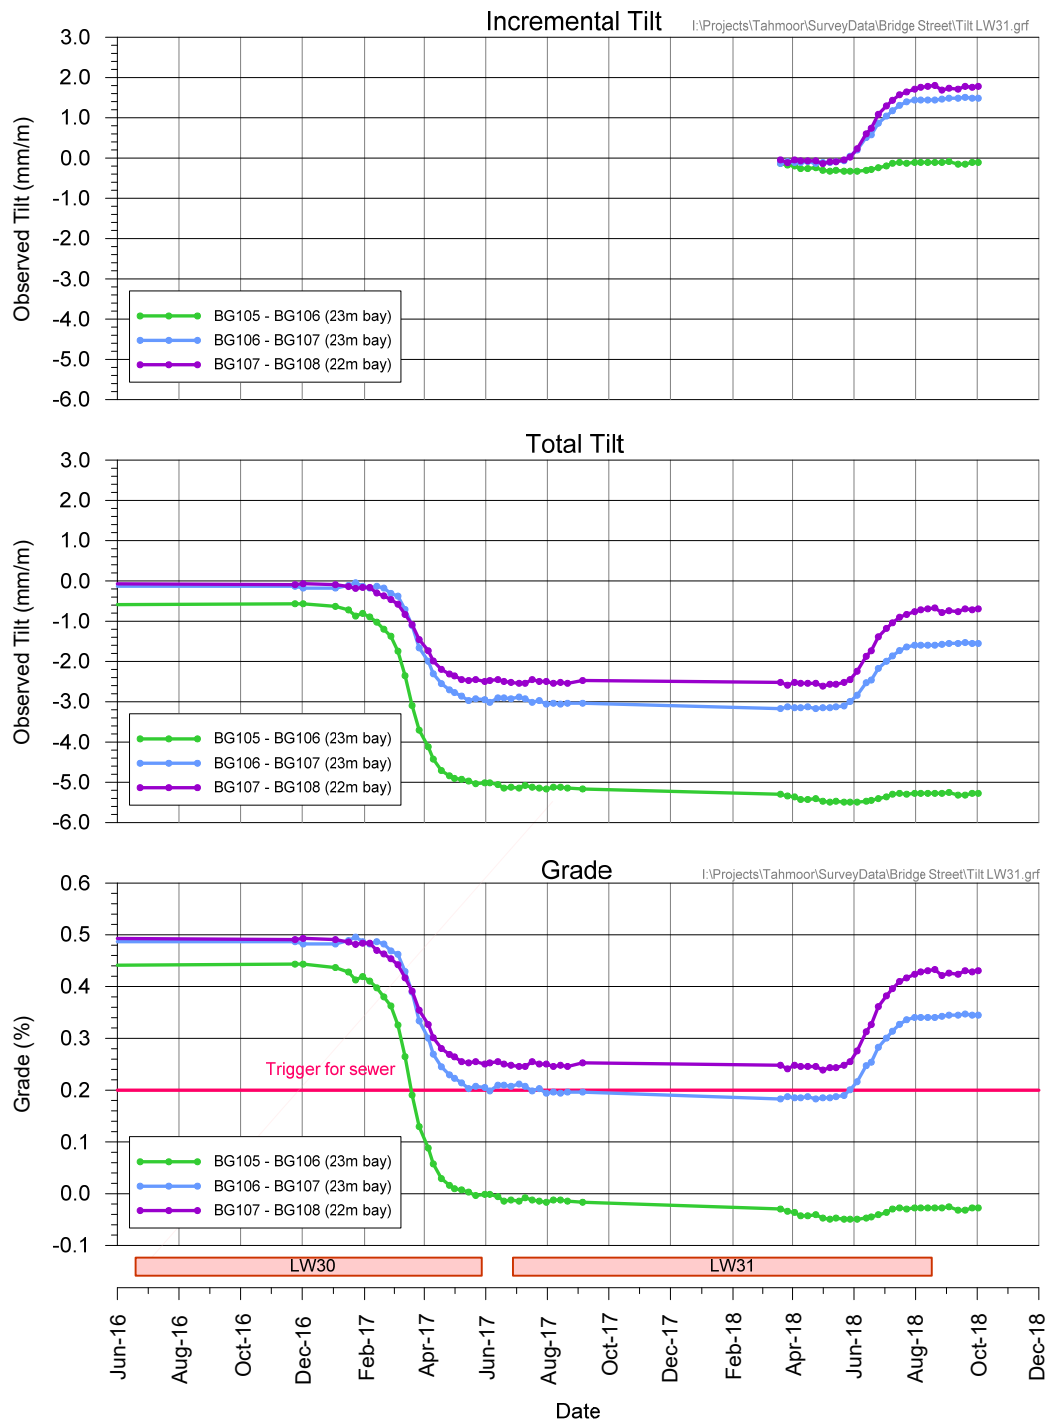
Fig. 2.12 Development of tilt on Bridge Street between pegs BG105 and BG108

The Thirlmere Carrier is the main branch servicing the majority of Thirlmere township. A total of 24 surveys were undertaken along the Thirlmere Carrier during the mining of Longwall 31. Small improvements in sewer grade were observed above the eastern edge of previously extracted Longwall 30 between Pegs BG106 and BG108, as expected. An improvement in grade was not observed between Pegs BG105 and BG106. An invert level survey was completed on 6 September to improve understanding of current levels along the pipe. The survey confirmed a reversal of grade at the Pits Nos. 3186019 and 3186018, which are located opposite Pegs BH105 and BH106, respectively. While good flows continue to be observed, the replacement pipe will be laid to re-establish a positive grade.

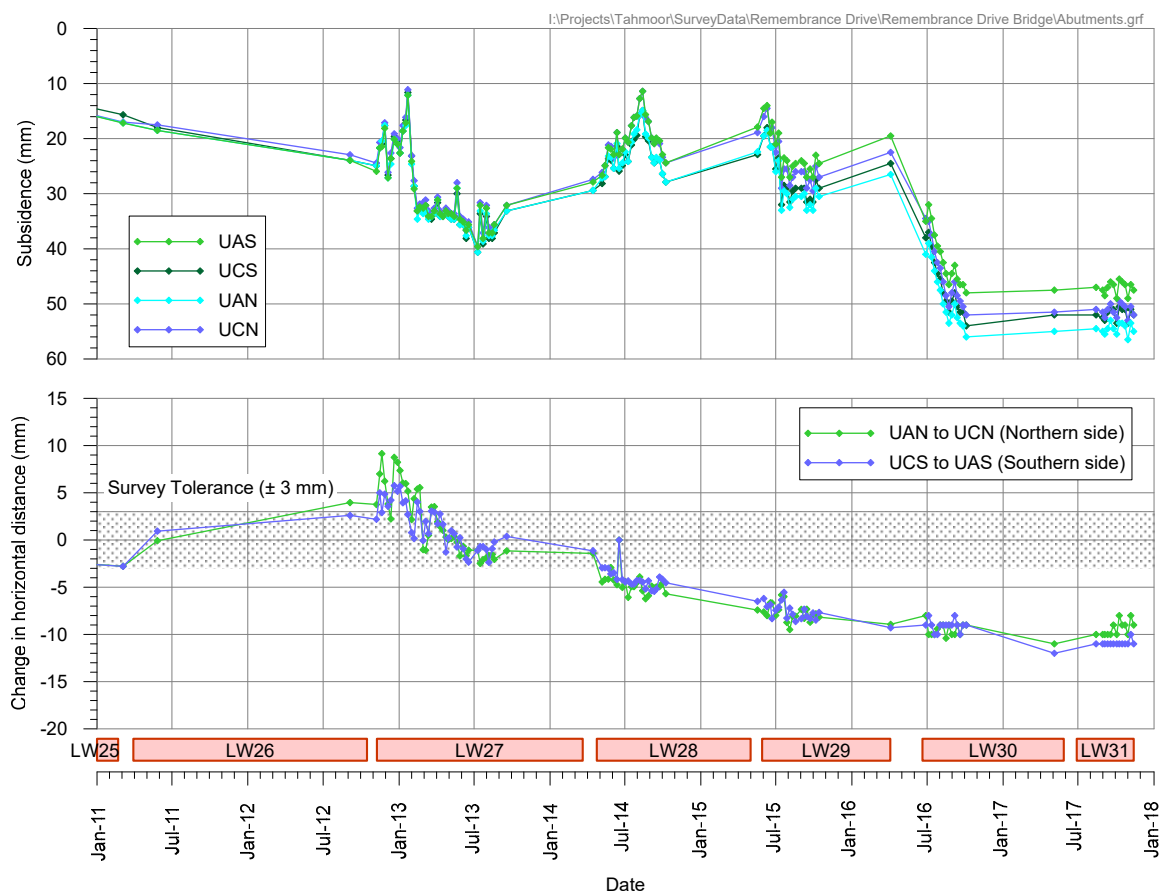
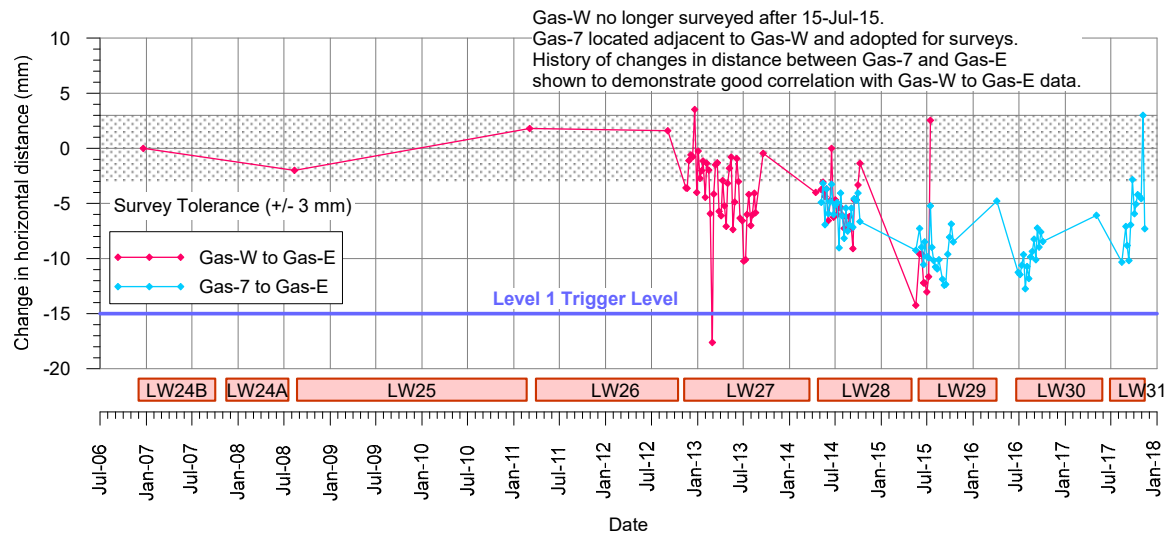
Fig. 2.13 Observed subsidence and changes in horizontal distances across the abutment and gas pipe supports at Remembrance Drive (Myrtle Creek) Road Bridge

Survey marks were installed on the Remembrance Drive Road Bridge prior to the extraction of Longwall 24A. While the Bridge has experienced approximately 60 mm of subsidence, measured changes in horizontal distances between the abutments are small. Minor closure has been measured, as shown in Fig. 2.13. This includes the measured changes in horizontal distances across the gas pipe supports.

Vertical subsidence is relatively consistent across all survey marks, indicating that no measurable upsidence has occurred to date.

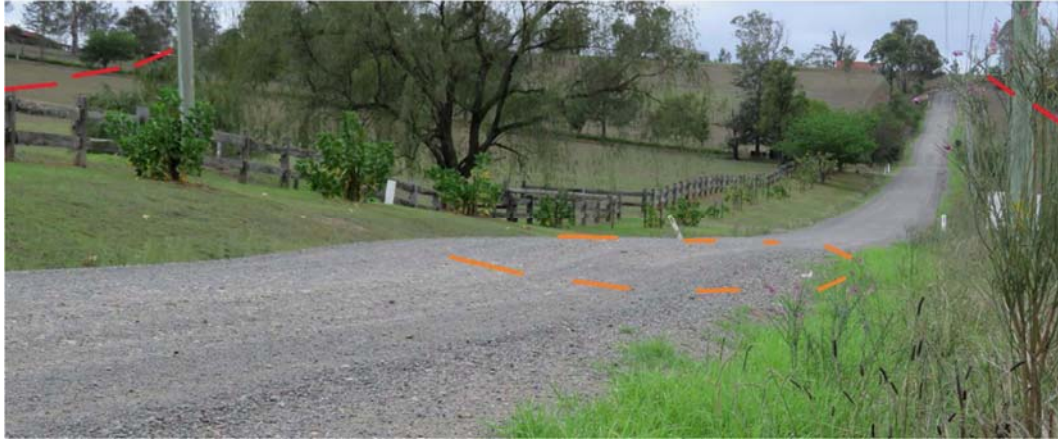
Stilton Lane

Approximately 28 kilometres of asphaltic pavement lie directly above the extracted longwalls and a total of 54 impact sites have been observed. The observed rate of impact equates to an average of one impact for every 520 metres of pavement. The impacts were minor and did not present a public safety risk. A collection of photographs of impacts is provided in Fig. 4.1.

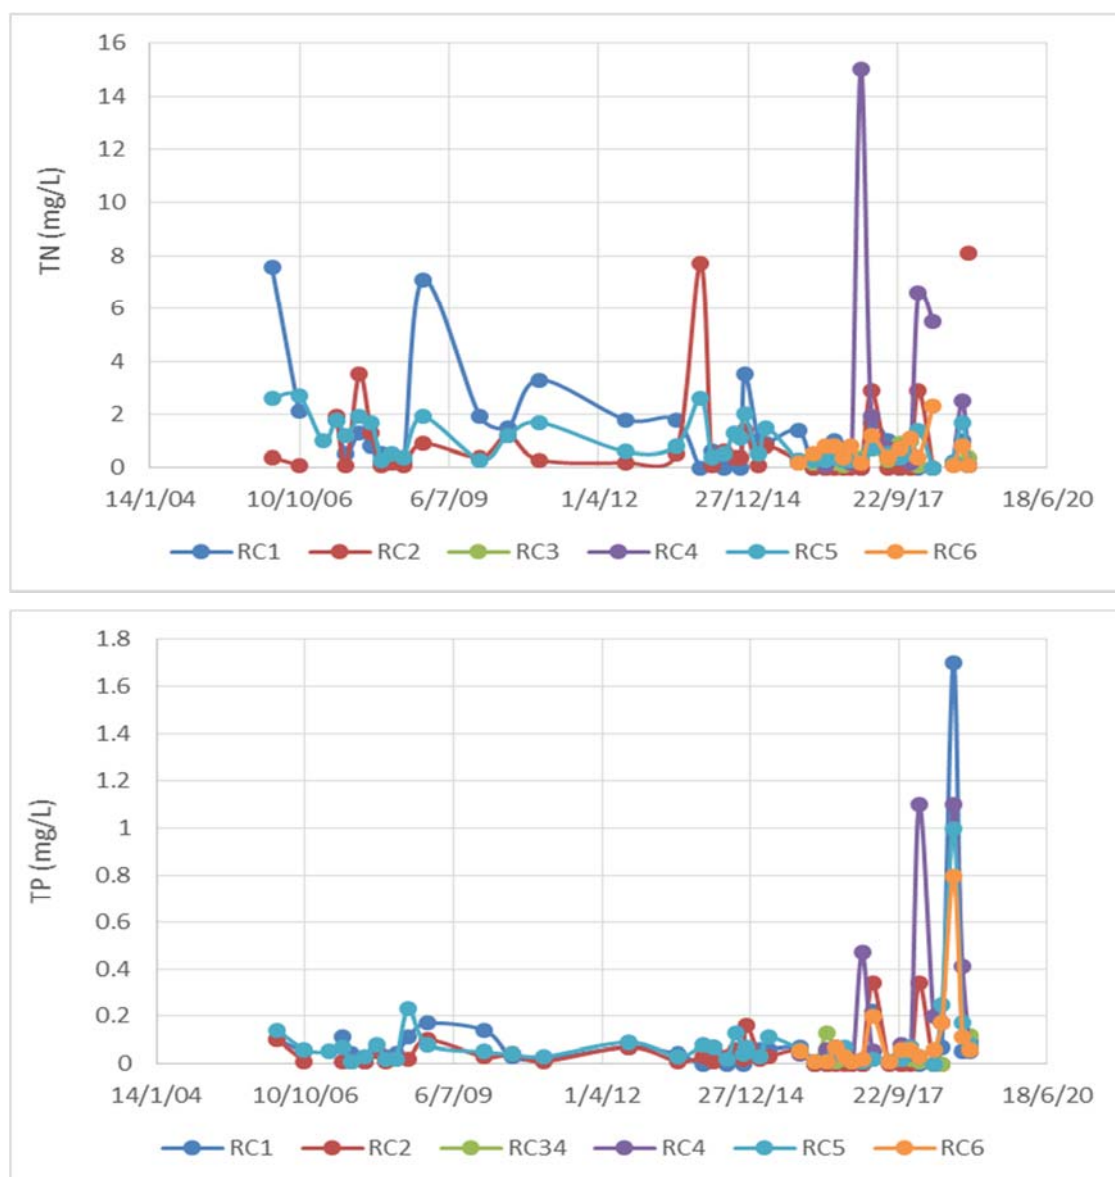
Figure 5 Redbank Creek Nutrients

The creek can have total nitrogen (TN) up to 15mg/L and total phosphorous (TP) up to 0.47mg/L, which can be above the ANZECC 2000 SE Australian Upland Stream criteria at all monitored sites as shown in **Figure 5**.

The above criteria nutrients are present in the creek due to urban, rural / residential and industrial runoff in the catchment, and are not related to mining influences.

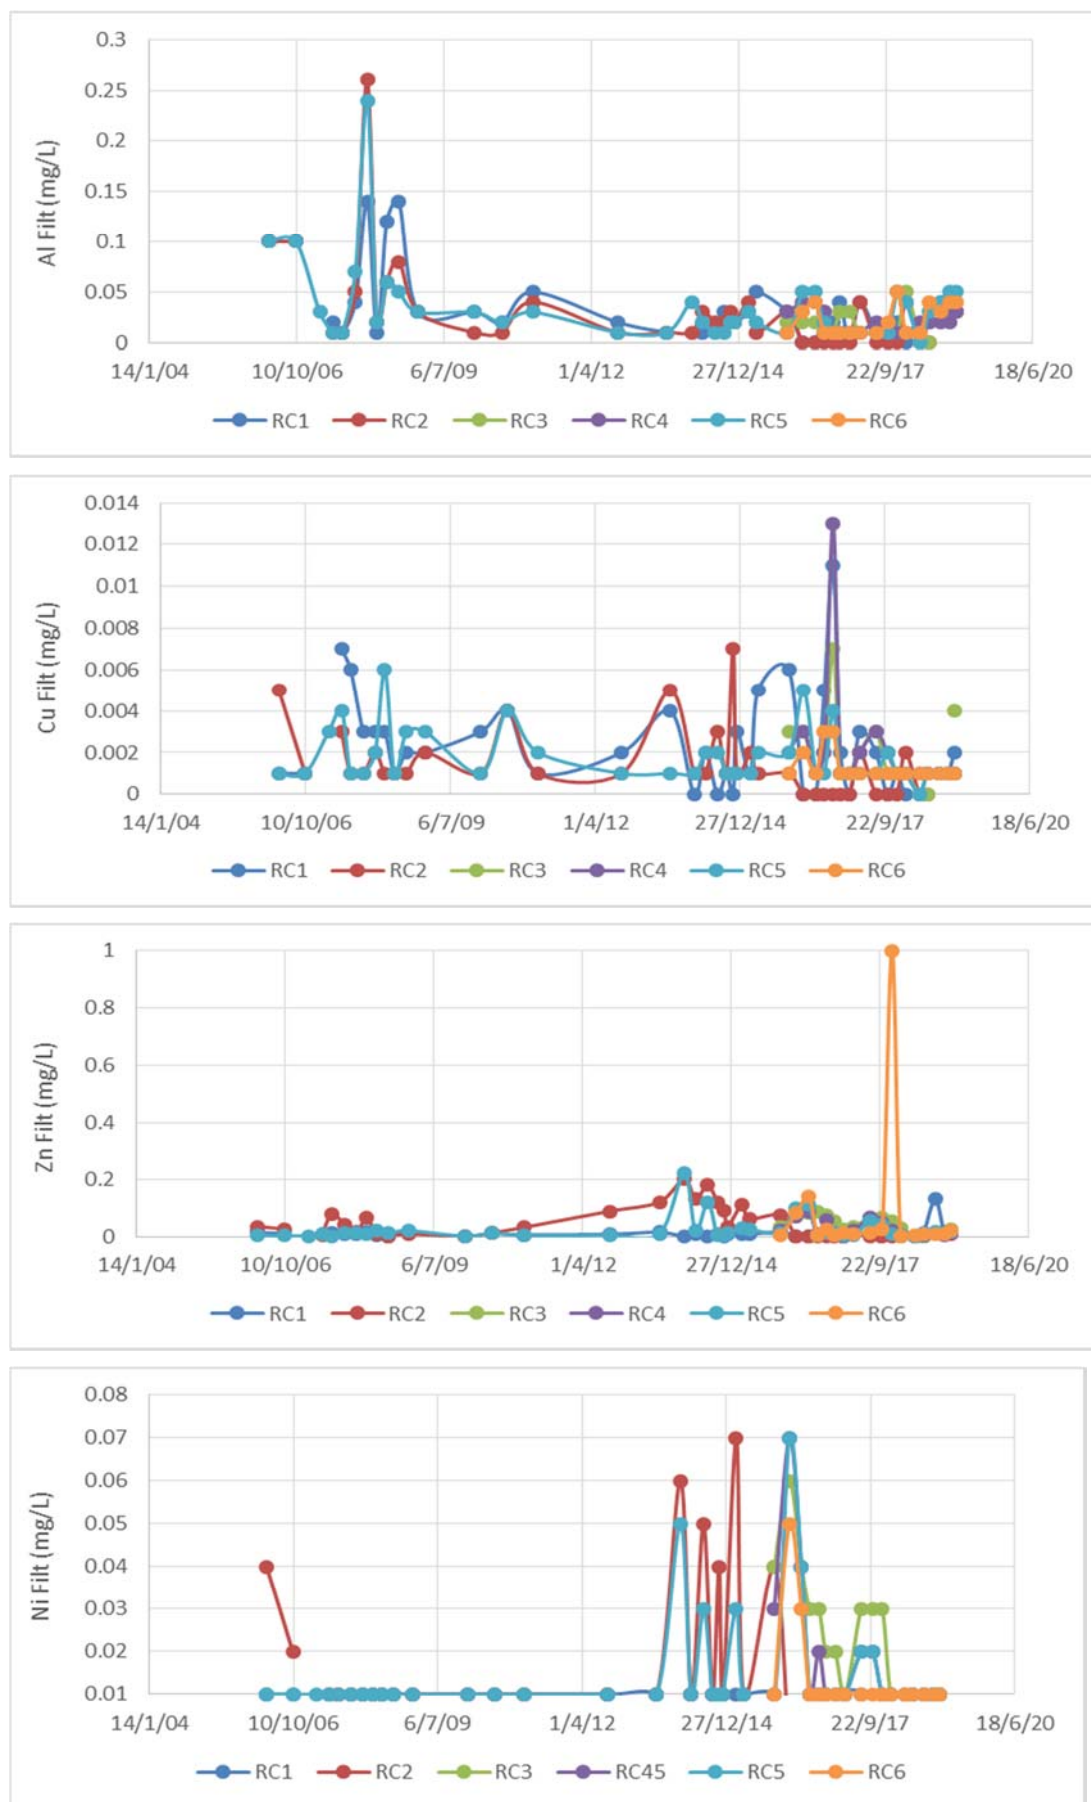
Figure 6 Redbank Creek Metals

Copper can reach up to 0.013mg/L , however no sustained increase as a result of Longwalls 28 to 30 is observed as shown in **Figure 6**.

Zinc can reach up to 1.0mg/L as shown in **Figure 6**, with its concentration being observed to rise at RC2 since late 2010, and since August 2013 at RC3 with an erratic, although generalised reduction since February 2014 and subsequent rise after extraction of Longwall 29 and after Longwall 31.

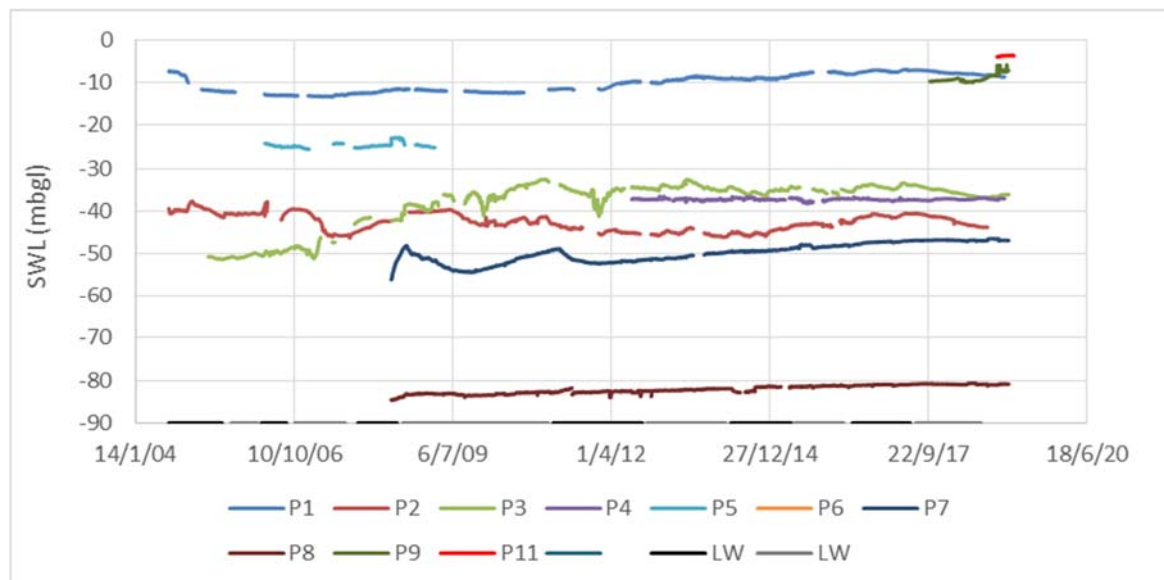
Figure 7 Standing Water Levels and Panel Extraction

All piezometers and bores are located as shown in **Drawing 1** whilst the monitored groundwater levels are shown in **Figure 7**.

No significant open standpipe piezometer water level reduction occurred during the Longwall 31 extraction period (except for the P9 series as discussed further in Section 3.7.5), and no complaints of adverse effects on private bore water levels or yield were received by the Colliery during extraction of Longwall 31.

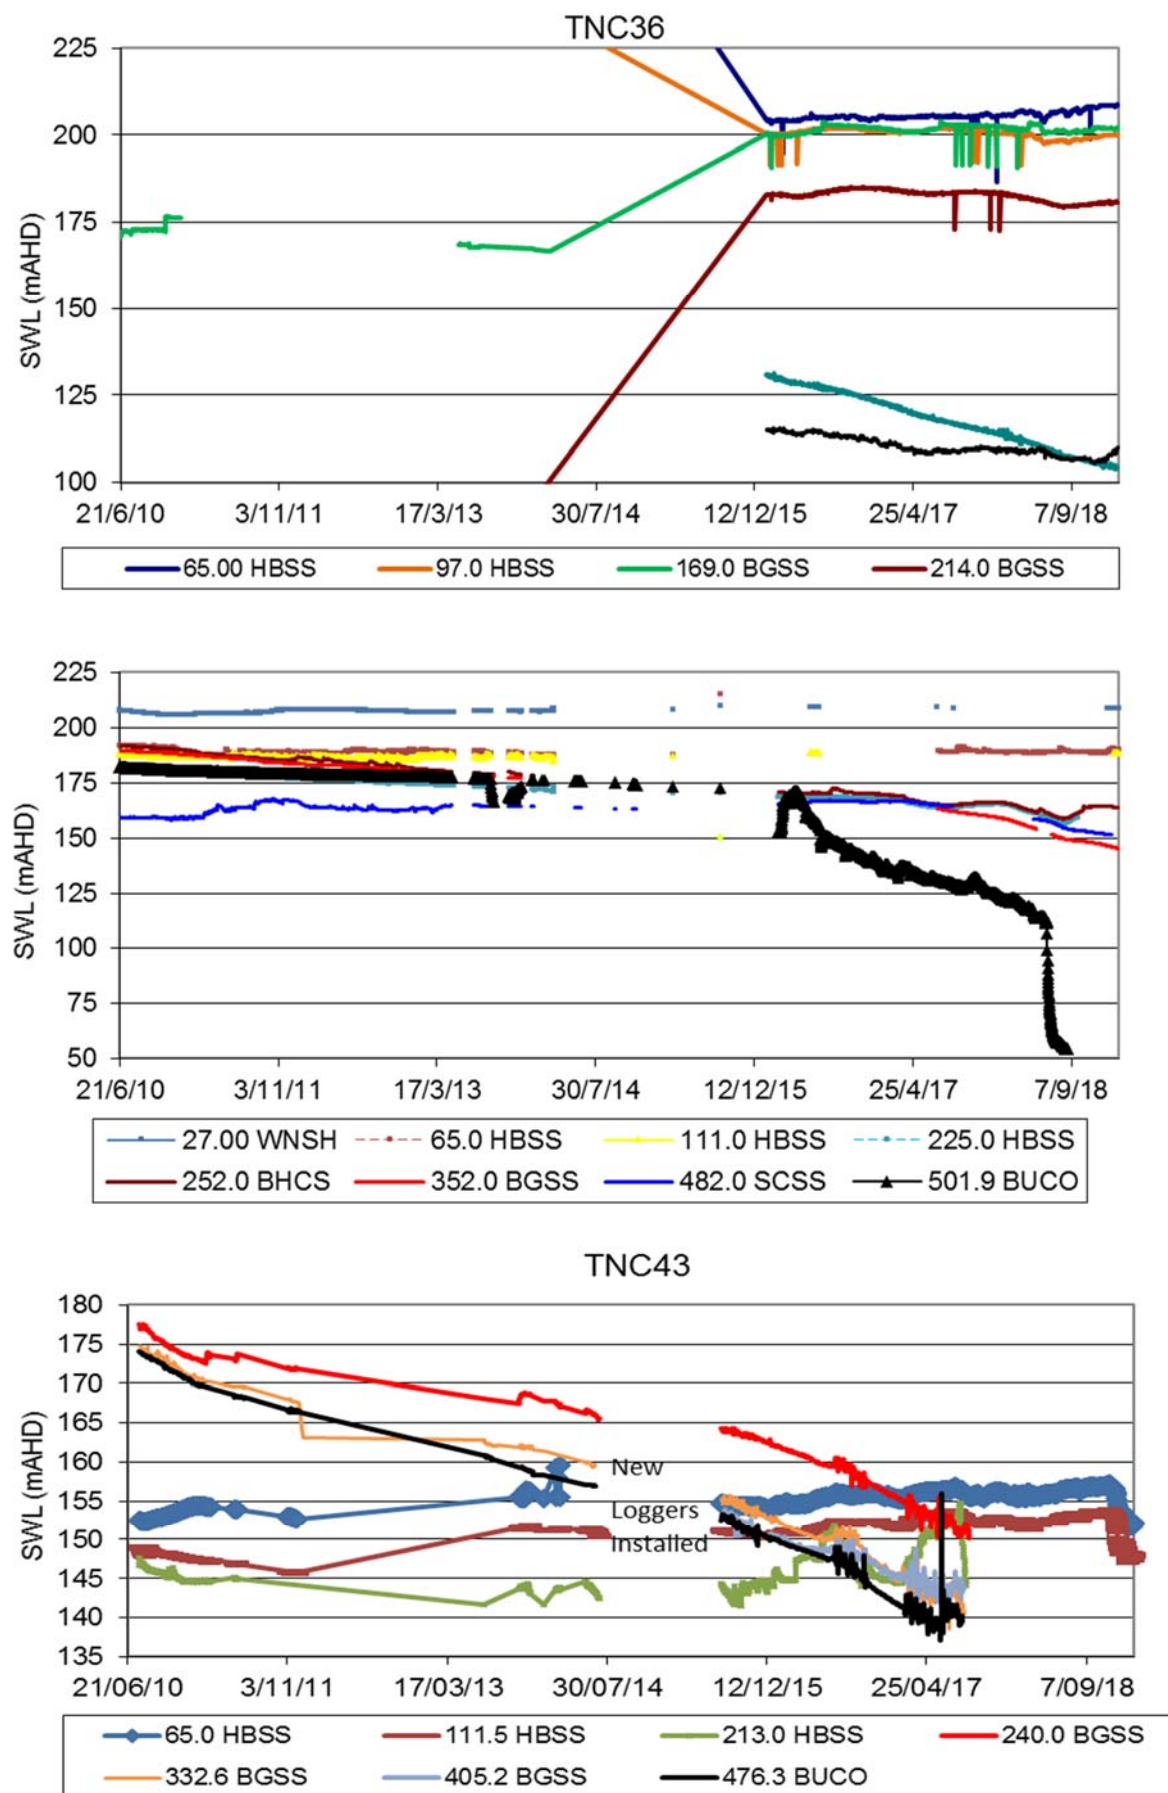
Figure 8 Vibrating Wire Piezometer TNC36, 40 and 43 Groundwater Levels

Ongoing monitoring at VWPs TNC36, 40 and 43 are shown in **Figure 8**.

None of the above depressurisation observations exceeded the TARP trigger level (*10m water level reduction for greater than 2 months*) as they do not exceed predictions outlined in the groundwater model prepared for the Environmental Application (EA) for the deeper strata and the Bulli Coal Seam, where depressurisation greater than 10m was predicted.

No shallow strata exceeded the Longwall 31 TARP Trigger during the Longwall 31 extraction period.

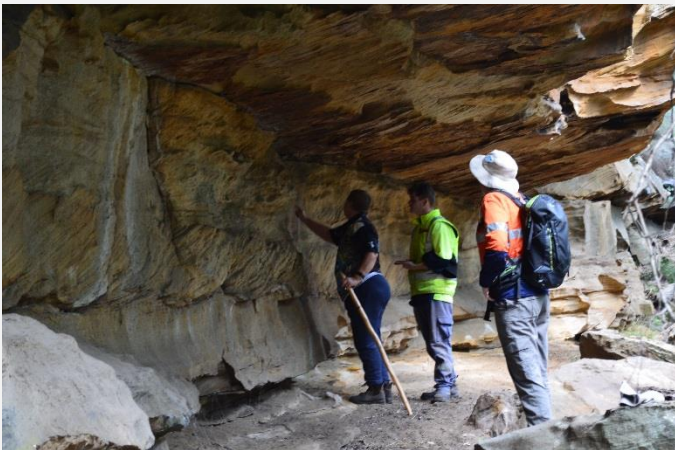
AHIMS Site #	Site Name	Results of Inspection	Photos
52-2-3254	Redbank Creek-1	<p>The condition of the site has not changed due to mining related impacts since the Niche 2014 condition assessment of the site.</p> <p>The floor and back wall of the shelter however have suffered some damage as a result of wild goats living in the shelter. Seepage and mould growth are evident to the lower levels of the shelter</p>

<p>Plate 1: View of Redbank Creek-1, photograph taken facing north</p>

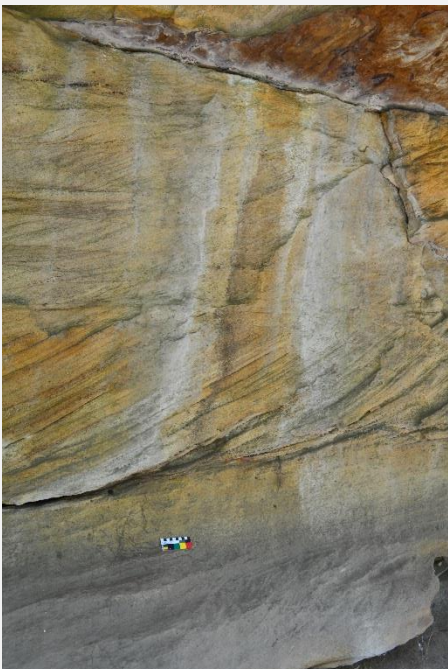
<p>Plate 3: Naturally occurring mineral that was identified previously when monitored.</p>

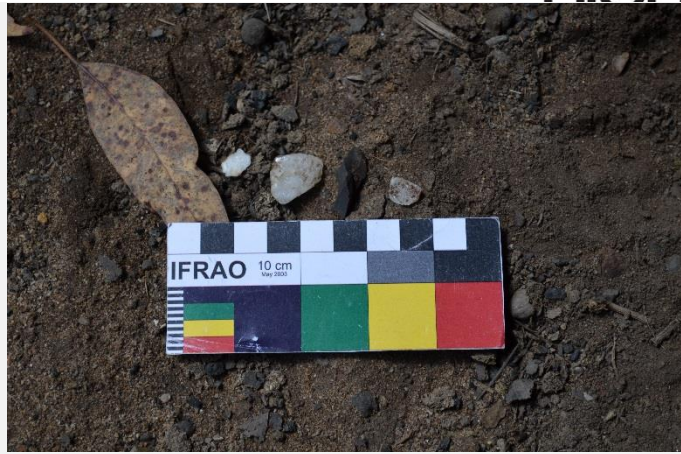
Plate 5: Overview of artefacts found within the shelter dripline.
