SIMEC Mining:  
**Tahmoor Coal - Longwall 32**

End of Panel Subsidence Monitoring Report for Longwall 32

This report has been prepared by Mine Subsidence Engineering Consultants (MSEC) for Tahmoor Coal to comply with conditions of the SMP Approval for Tahmoor Longwall 32 dated 14 September 2018.

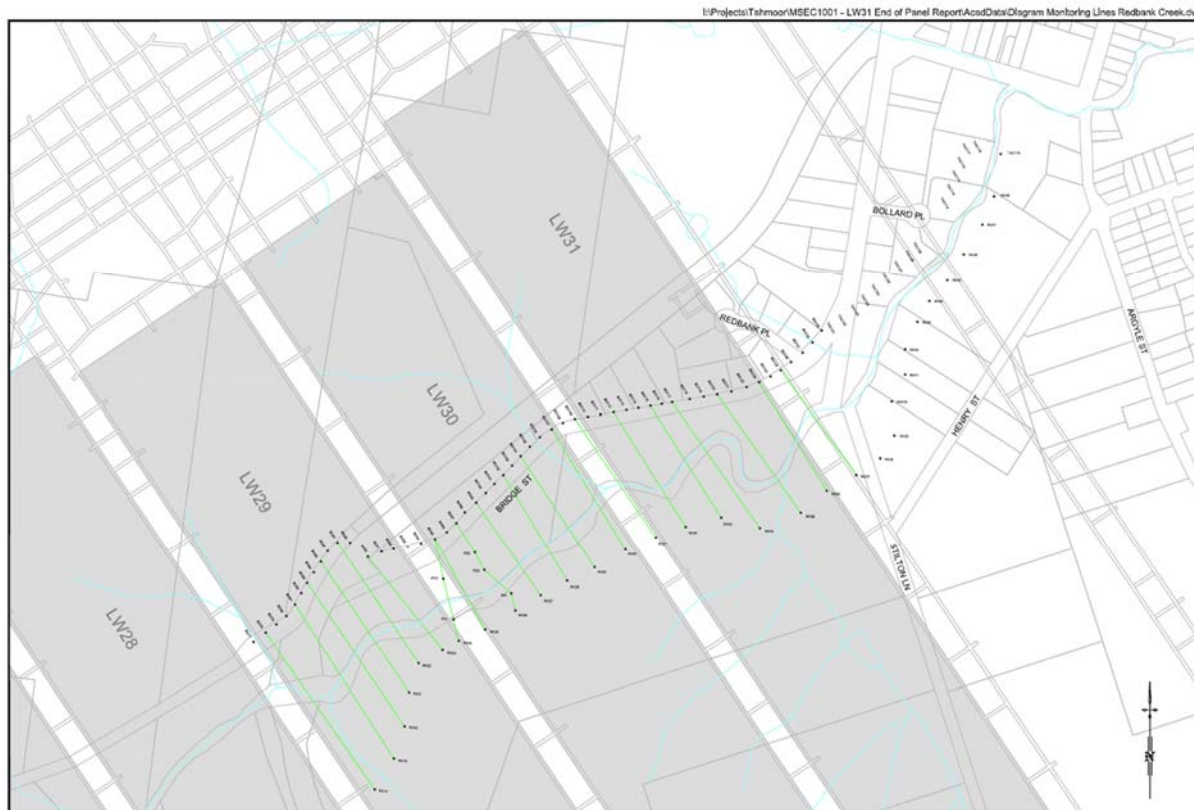
**Fig. 2.5 Location of survey marks across Redbank Creek**

Survey pegs were, however installed across the sewer aqueduct crossing of Redbank Creek between Pegs THC18 and THC19, which is located approximately 200 metres to the side of the longwall panel. No measurable valley closure was observed during the mining of Longwall 32. Additional marks were installed on the aqueduct structure itself, with no measurable changes observed.

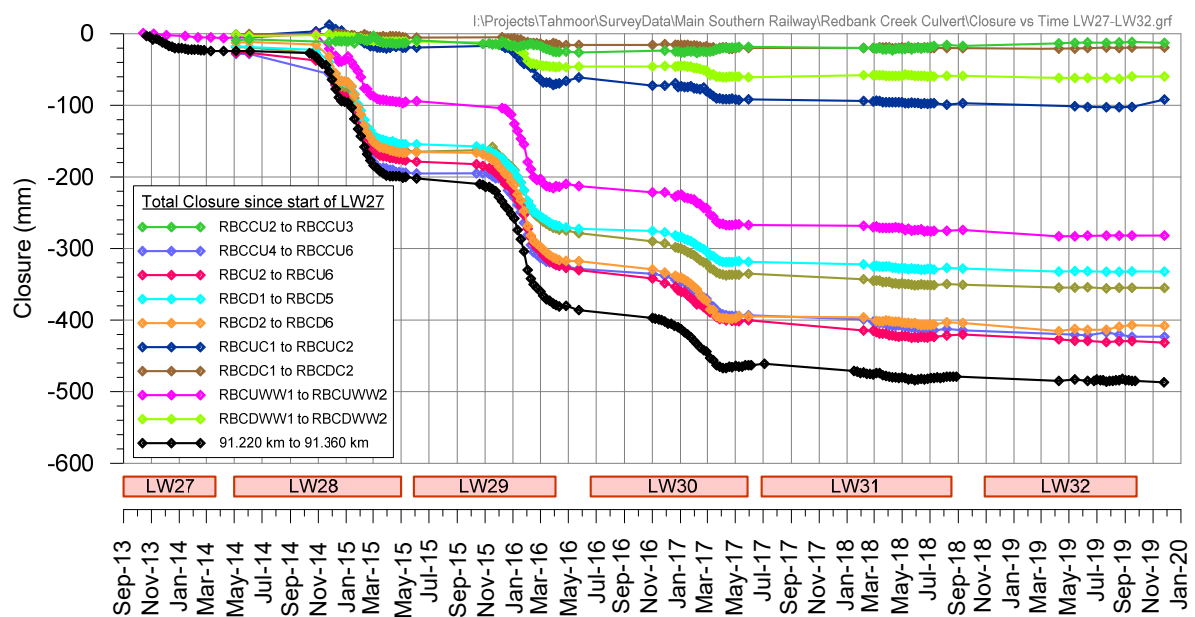
**Fig. 2.8** Observed total valley closure over time across Redbank Creek Culvert at Main Southern Railway during the mining of Longwall 32 (includes closure from Longwalls 27 to 31)

The observed gradual development with time of differential horizontal movements between selected pegs at the culvert and embankment are shown in Fig. 2.8. Maximum observed closure was measured between the long bay survey pegs on the track at 91.220 km and 91.360 km, though a similar result was observed between Pegs RBCCU4 and RBCCU6, RBCU4 and RBCU6, and between RBCD2 and RBCD6, which are located in the base of the embankment across the upstream inlet. This suggests that closure across the valley of Redbank Creek and its tributary, were focussed at the culvert. This was confirmed at greater detail from additional detailed surveys in the culvert, which are discussed later.

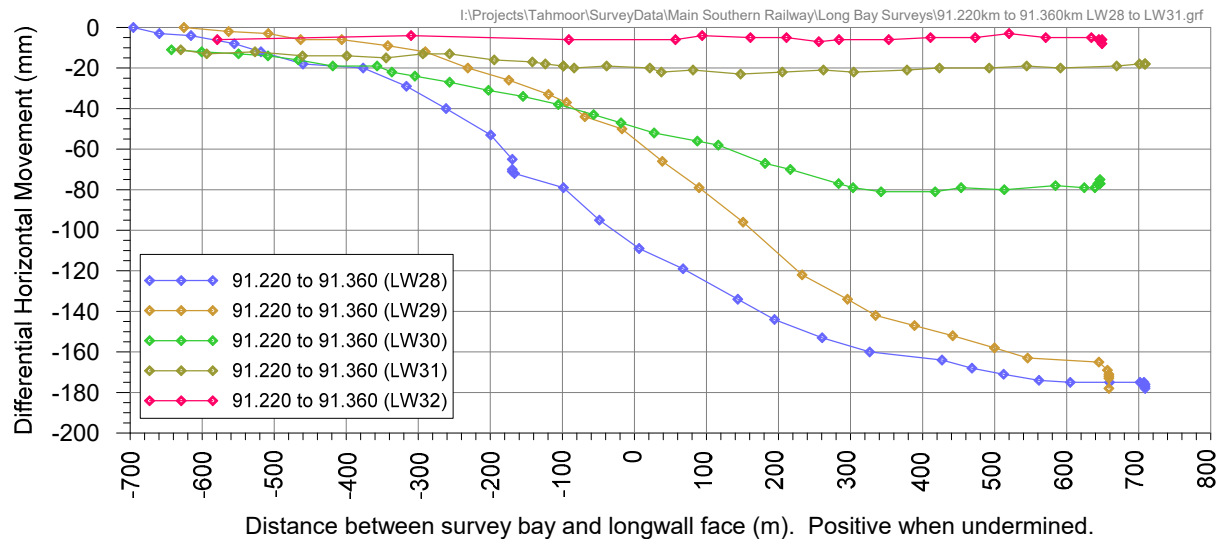
**Fig. 2.9 Observed incremental valley closure as measured by long bay survey, relative to face distance, across Redbank Creek Culvert at Main Southern Railway during the mining of Longwalls 28 to 32**

It can be seen from Fig. 2.9 that no measurable valley closure movements occurred during Longwall 32.

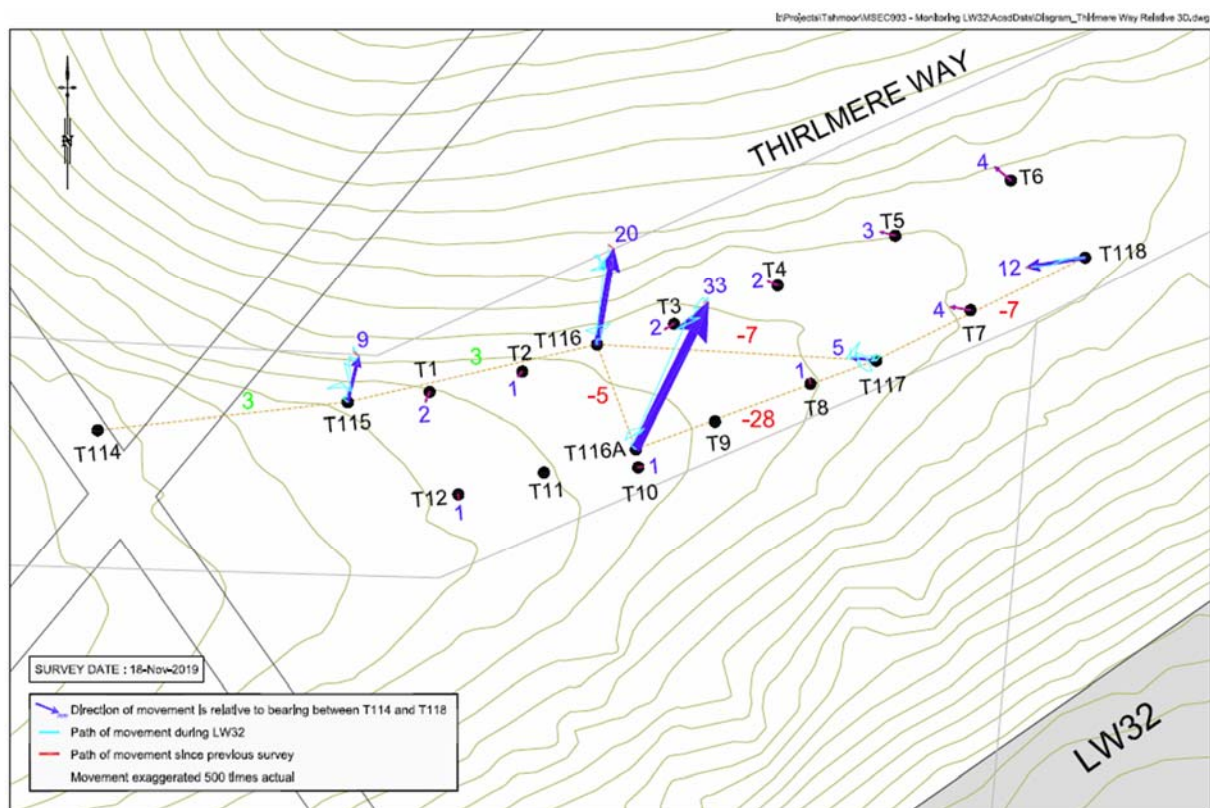
**Fig. 2.13 Relative horizontal movements along Thirlmere Way between Pegs T114 and T118**

It can be seen from Fig. 2.13 that a lateral rotation and shearing has developed over time at Pegs T116 / T116A, with a clear change in displacements at Peg T117. The movements have, however, developed very gradually over a period of 18 months.

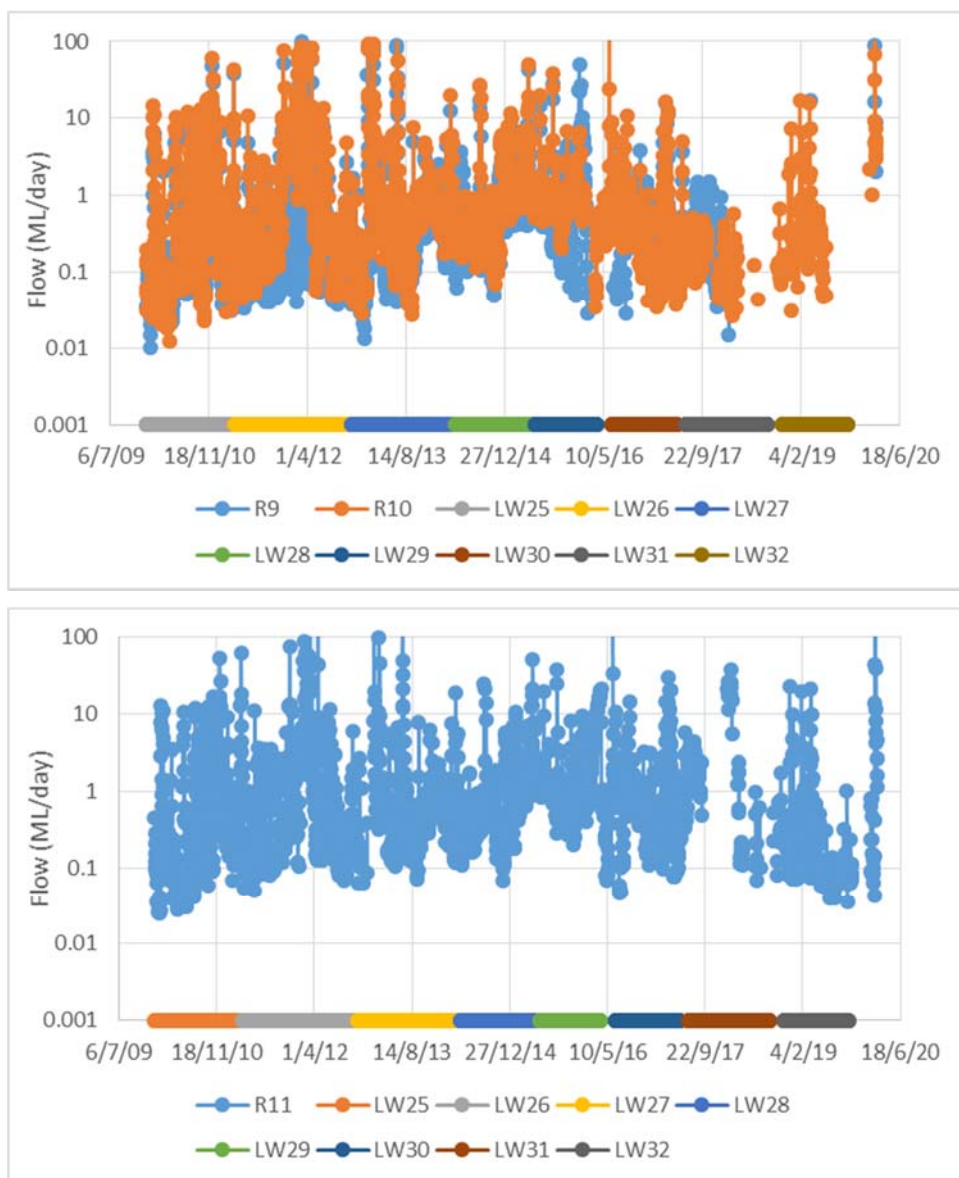
**Figure 2** Redbank Creek Flow

The majority of pools over and downstream of Longwalls 25 to 32 showed evidence of subsidence related pool holding capacity impacts. Site R11 also showed drying out of the pool, however this was considered to be primarily due to the extended drought in the catchment, rather than purely subsidence impacts, as shown in **Figure 2**.

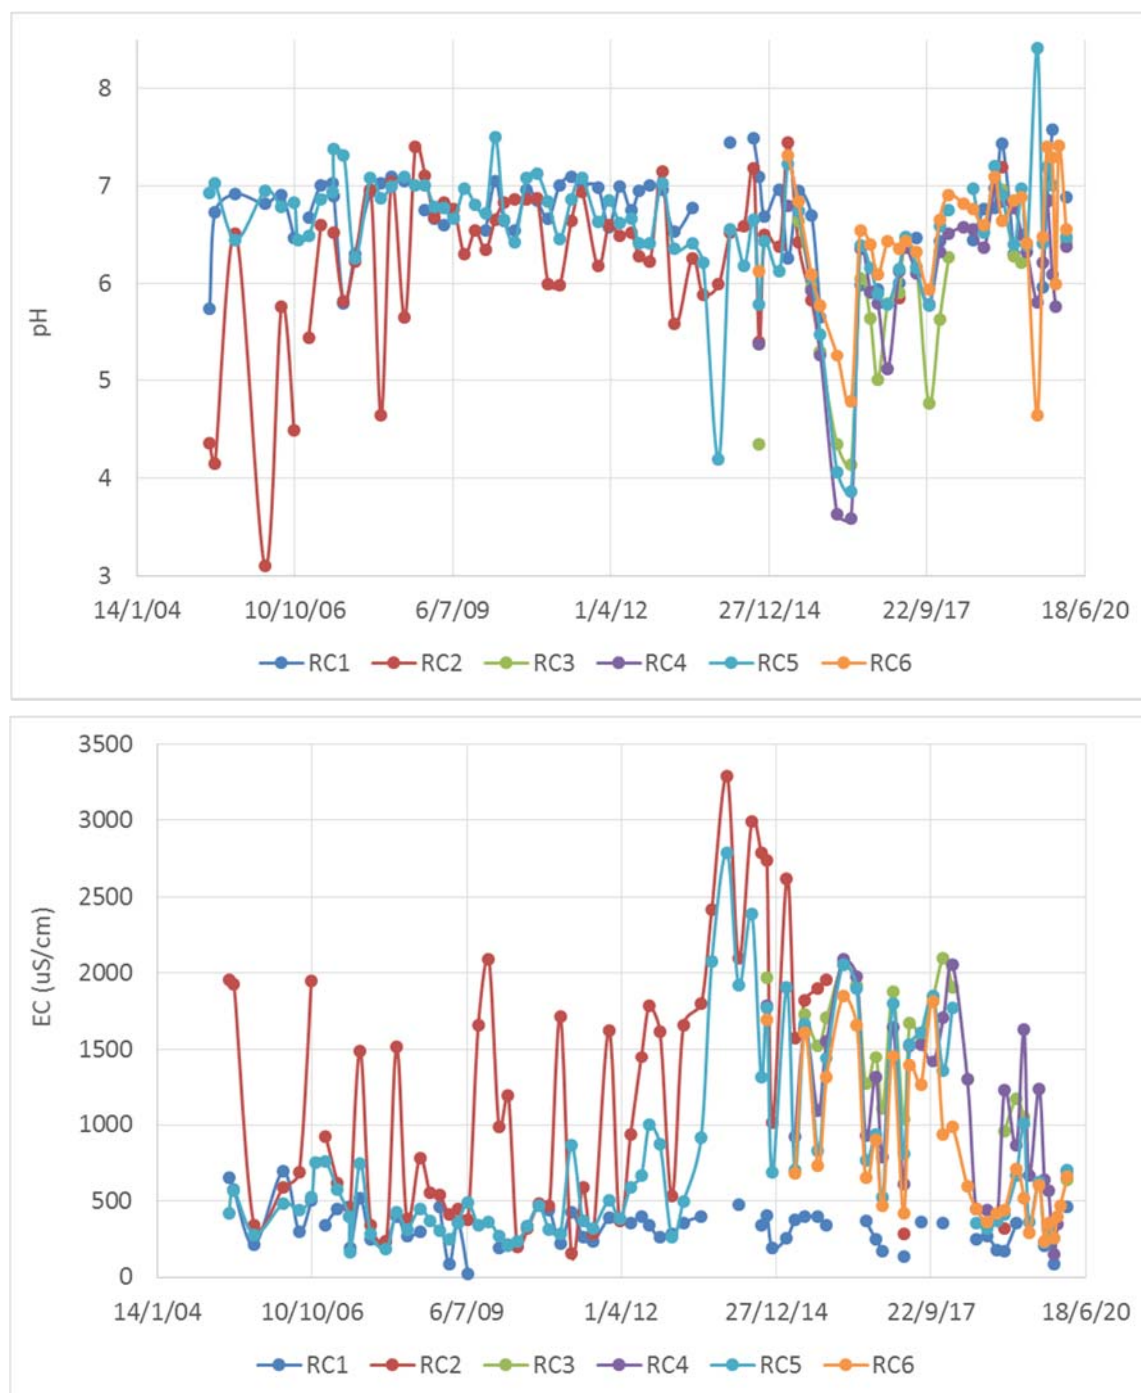
**Figure 3 Redbank Creek Field Water Quality**

Redbank Creek has had an electrical conductivity (EC) range of 22 – 3,290  $\mu\text{S}/\text{cm}$  and pH between 3.10 and 7.50, with the creek generally being more acidic and saline at Site RC2 as shown in **Figure 3**.

During extraction of Longwall 32, pH in Redbank Creek distinctly acidified at all monitored sites, whilst salinity did not show a specific trend, except for higher salinity during low flow / drought periods.

Enhanced salinity and lower pH is predominantly associated with the more ferruginous seeps in the stream.

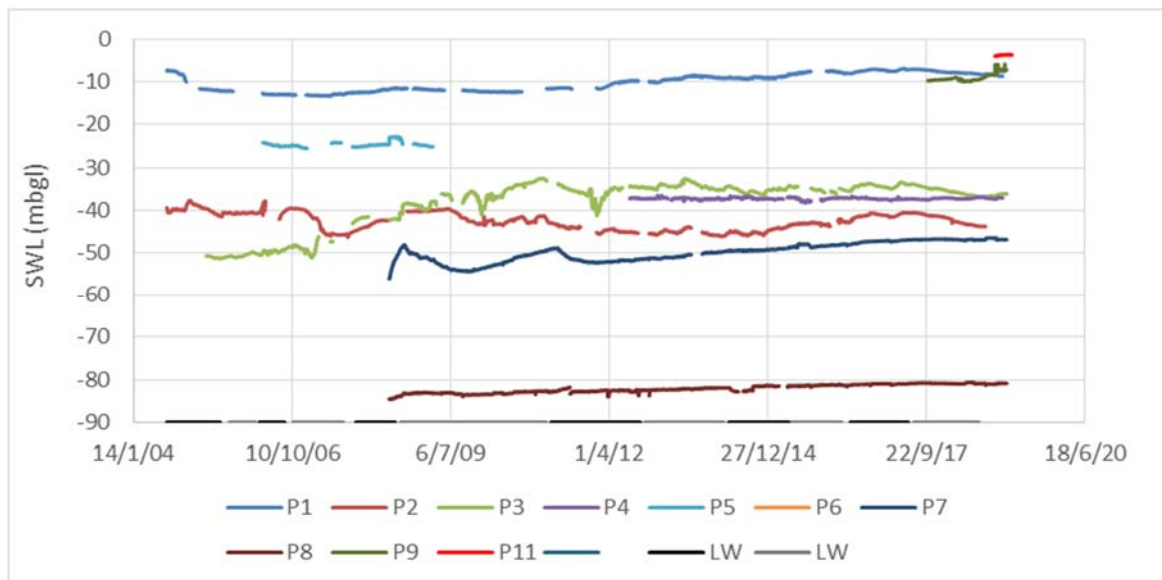
**Figure 7 Standing Water Levels and Panel Extraction**

No significant open standpipe piezometer water level reduction occurred during the Longwall 31 extraction period (except for the P9 series as discussed further in Section 3.7.5), and no complaints of adverse effects on private bore water levels or yield were received by the Colliery during extraction of Longwall 31.

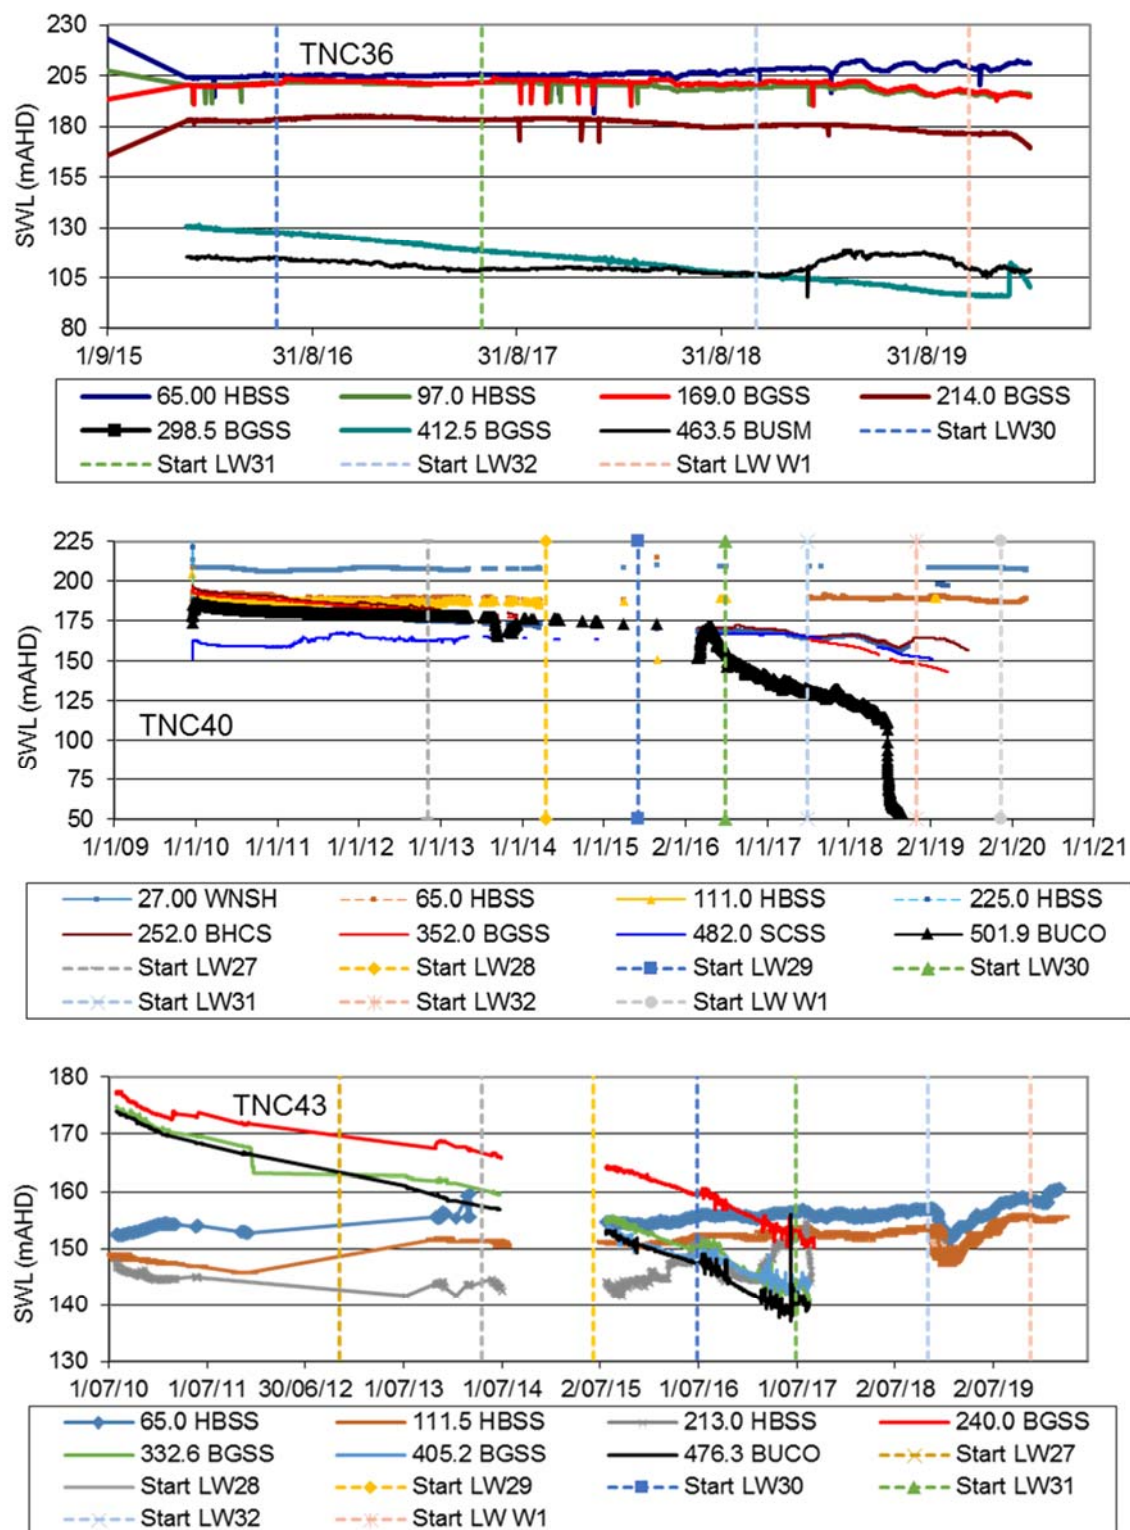
**Figure 8** Vibrating Wire Piezometer TNC36, 40 and 43 Groundwater Levels

Partial depressurisation is observed in the Hawkesbury Sandstone at 97mbgl as well as in the Bulgo Sandstone (at 169 / 214 / 299mbgl) and the Bulli Seam in TNC36.

Gradual depressurisation was observed in the Hawkesbury Sandstone (213mbgl) as well as in the Bulgo Sandstone (at 240 / 333 / 425mbgl) and Bulli Seam in TNC43.

No significant depressurisation step changes have yet been observed in TNC36.

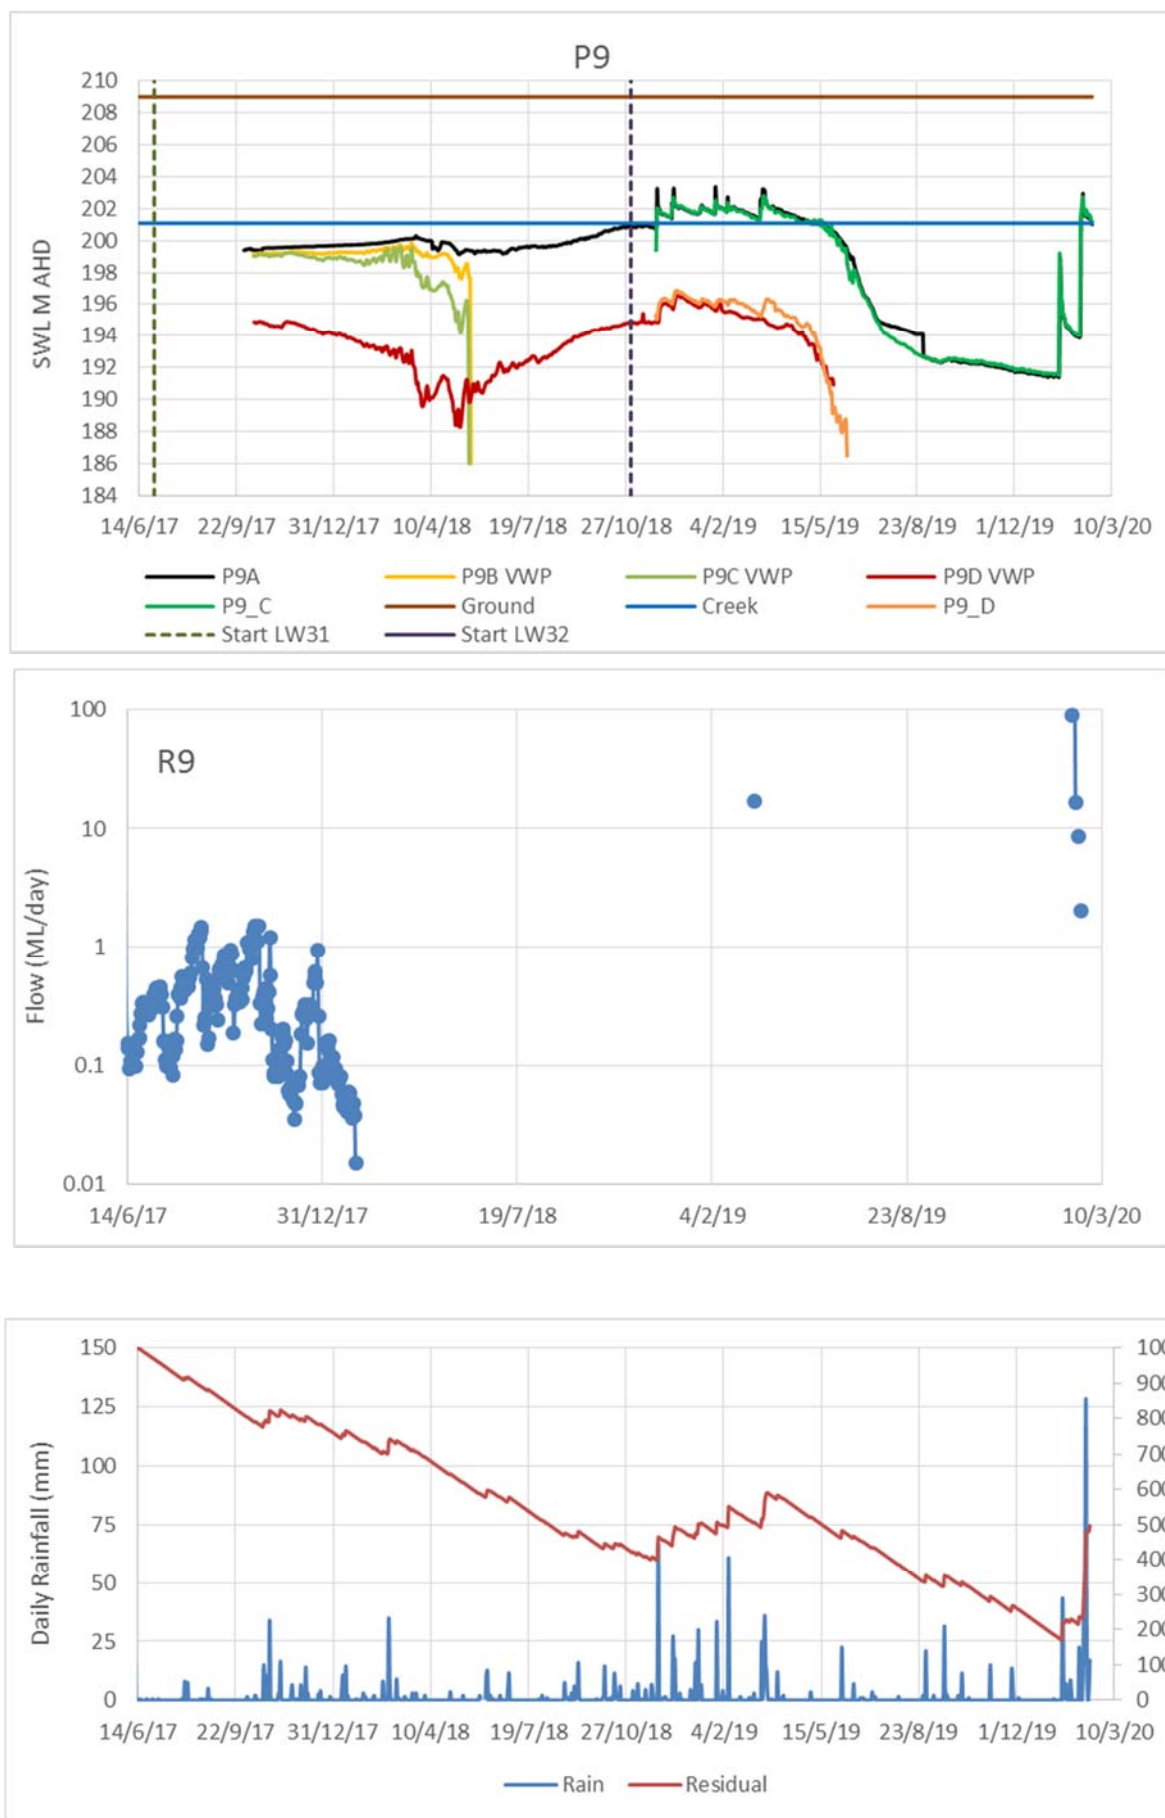
**Figure 10 P9 Series Groundwater Levels, Pool R9 Water Level and Rainfall**

A definitive reduction in pool depth and downstream overland connective flow occurred within Redbank Creek in the concrete weir based pool (R9 / RC3) on and after 10/3/18 as shown in **Figure 10**, when Longwall 31 was approximately 140m south of the creek bed.

Both VWP intakes at 38mbgl and 48mbgl (P9B and P9C) failed to record any further readings after 19 May 2018, when they sheared off.

P9B and P9C were replaced with open standpipe piezometers on 28/11/2018. After that time they have both shown a heightened response to rainfall in the catchment and recharge of pools in Redbank Creek, compared to before they were undermined.

Observation of the P9 piezometers, pool levels in Redbank Creek and rainfall indicates undermining of the creek and P9 piezometers by Longwall 31 increased the fracture connection with the creek and enables a heightened recharge / discharge response after rain events within the shallow strata.

It has also been observed that the pre-undermining separation of the four individual hydrographs has modified so that the upper two intakes are at an equivalent elevation, whilst the two deeper intakes are also at an equivalent, deeper elevation.

The separation between the two post undermining systems occurs at around 10.5m below surface.

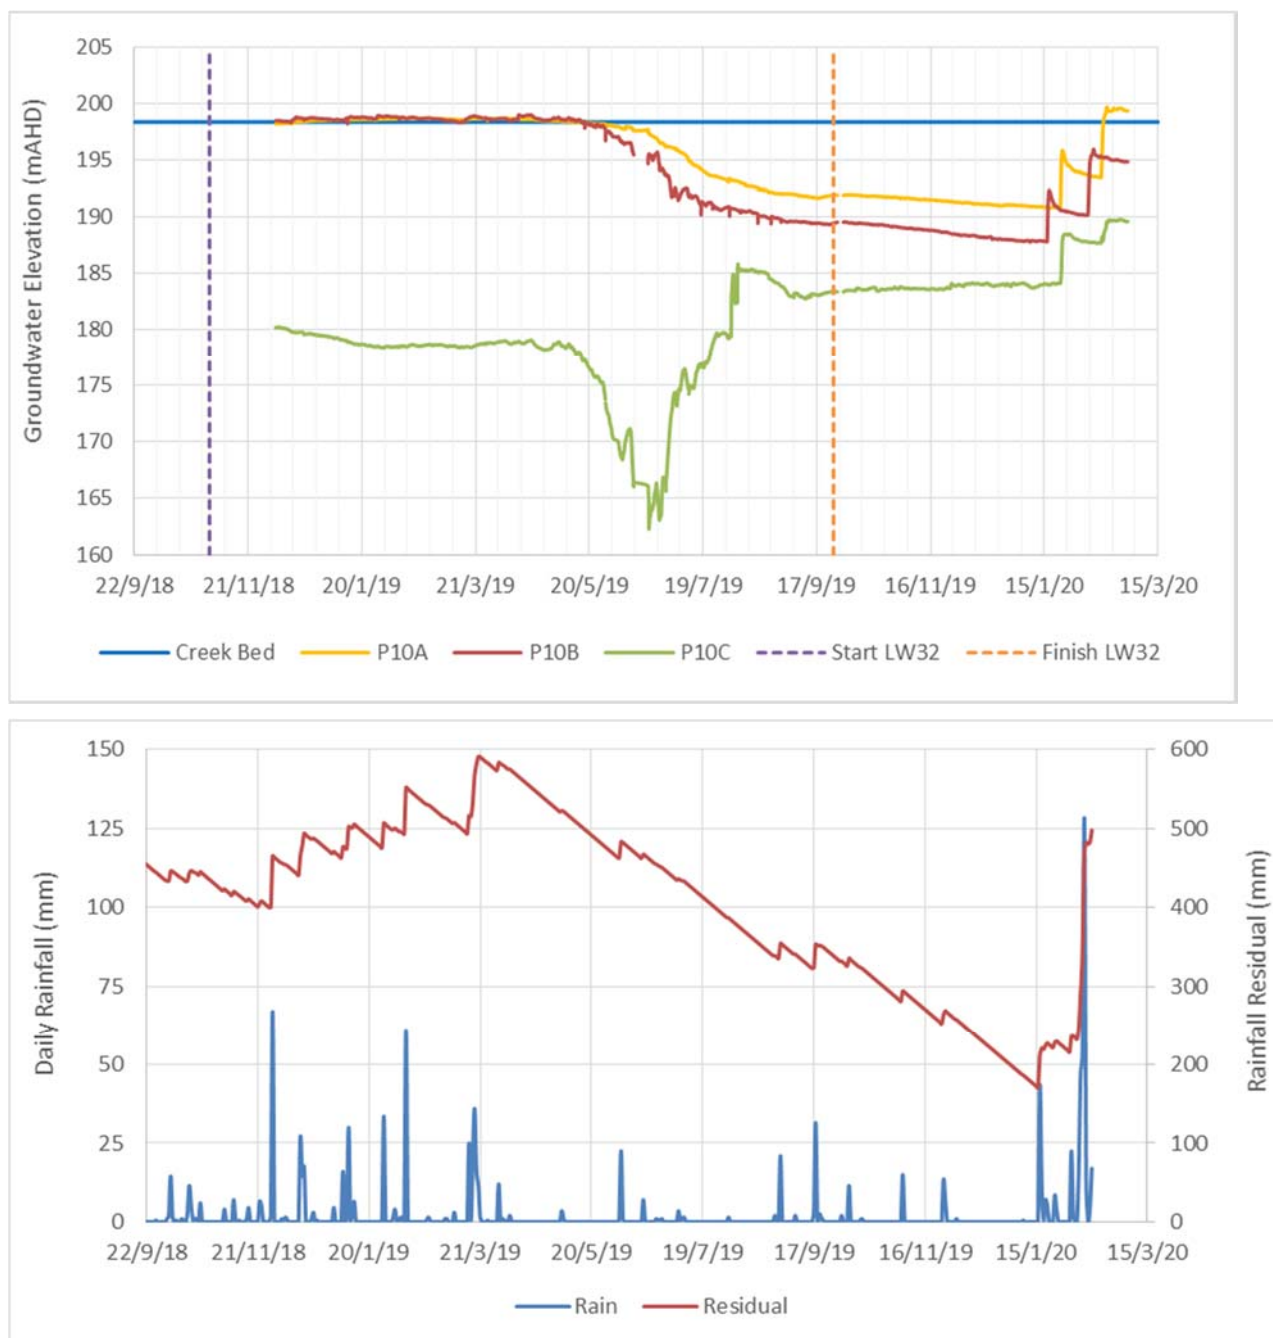
**Figure 11 P10 Groundwater Levels and Rainfall**

As shown in **Figure 11**, the P10 piezometers showed a definitive water level reduction in all three open standpipe piezometer intakes before the piezometer was undermined in late May 2019.

Following significant rain in January and early February the deepest intake rose a further 5.5m.

Observation of the P10 piezometers, pool levels in Redbank Creek and rainfall indicates undermining of the creek and P10 by Longwall 32 increased the fracture connection with the creek and now enables a heightened recharge / discharge response after rain events within the shallow strata.

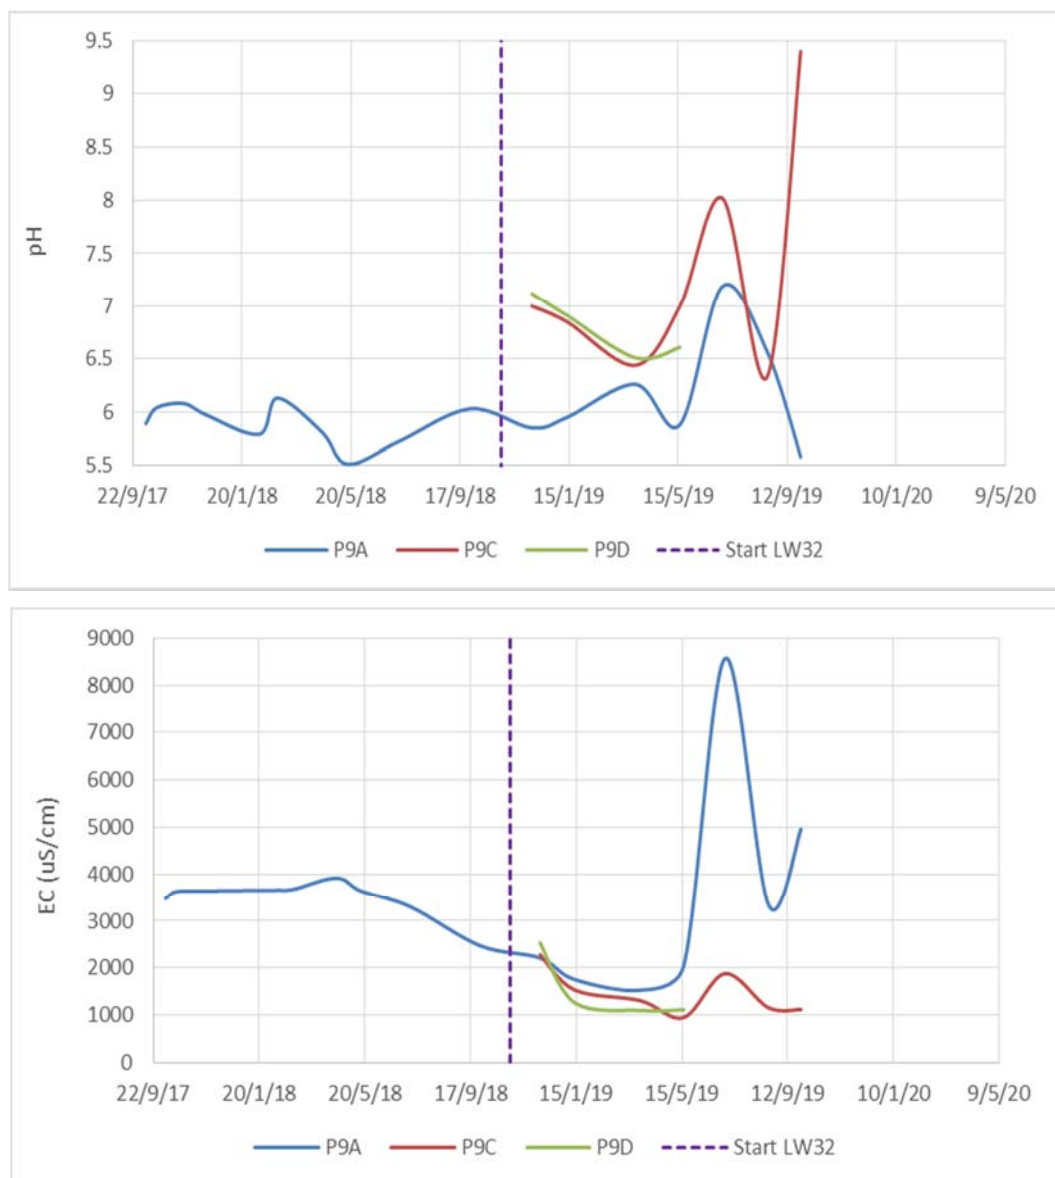
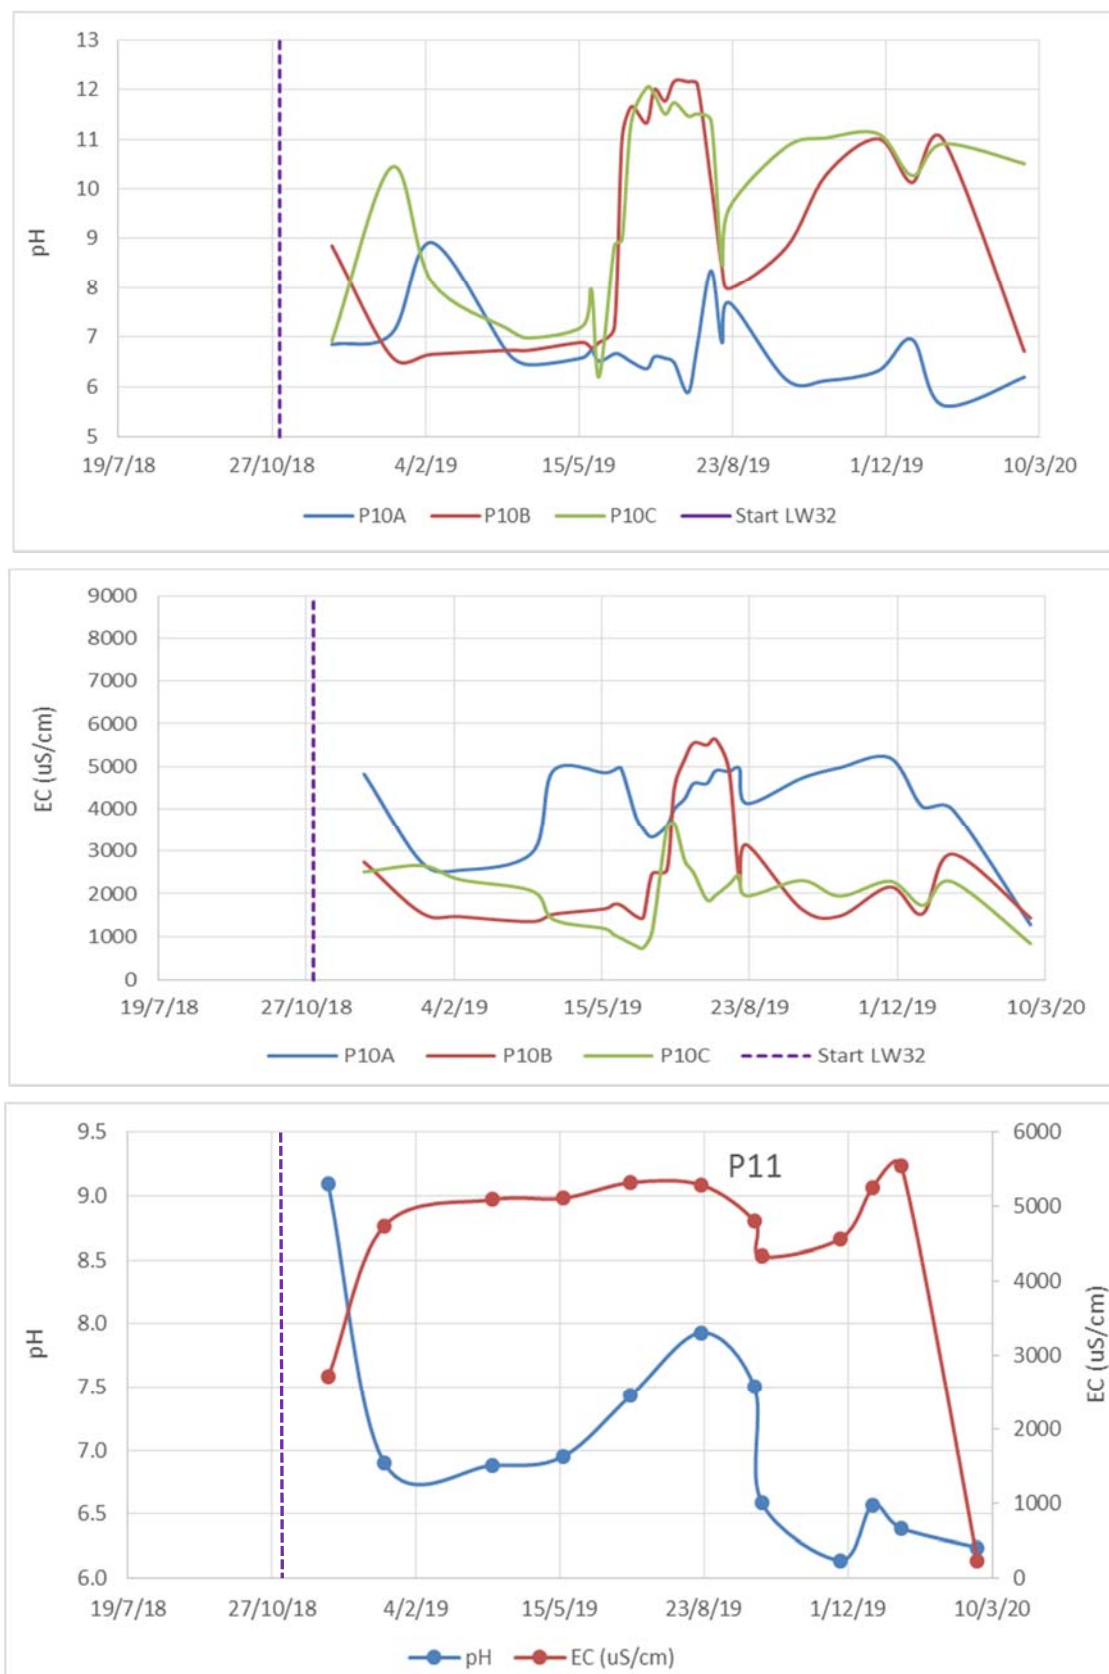
Groundwater in the study area has generally brackish salinity (459 $\mu$ S/cm to 12,250 $\mu$ S/cm) with acid to circum-neutral pH (3.06 to 7.6) as shown in **Figures 12 and 13**.

No adverse change to groundwater quality in the subsided bores has been observed, along with no distinctive increase in salinity, iron or manganese.

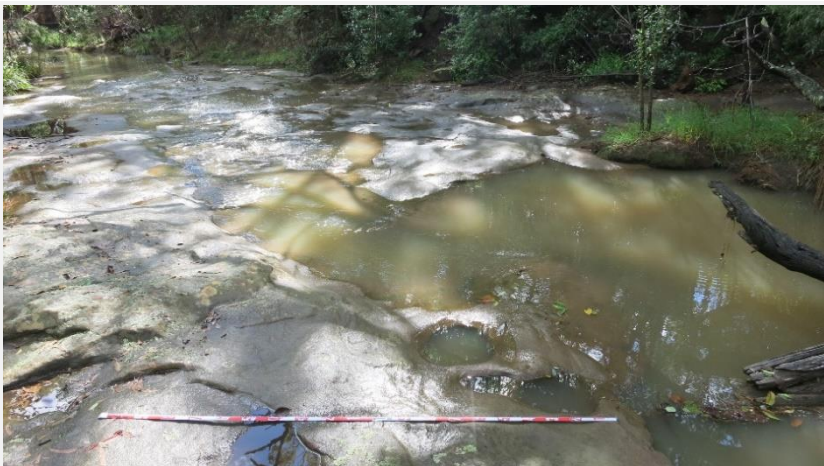
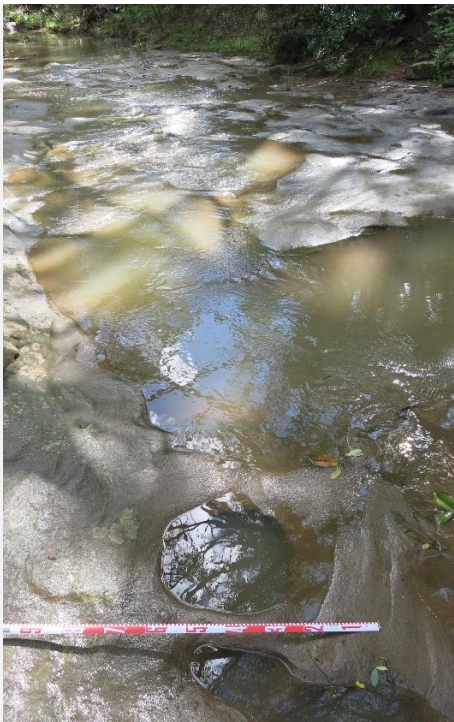
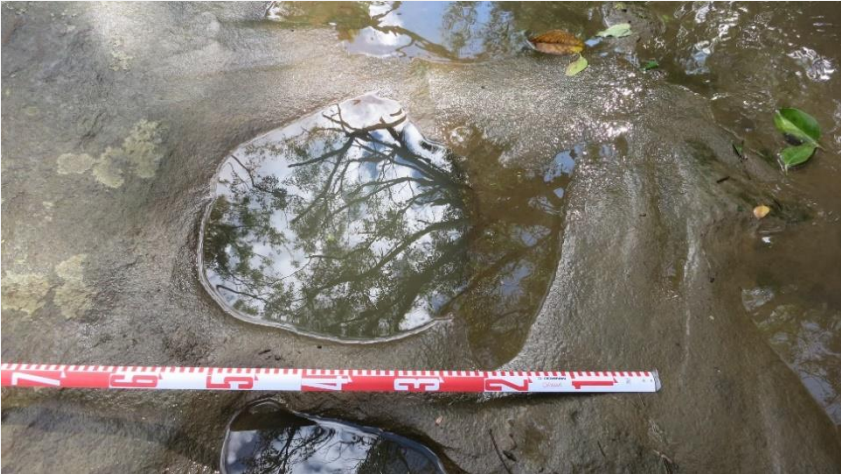
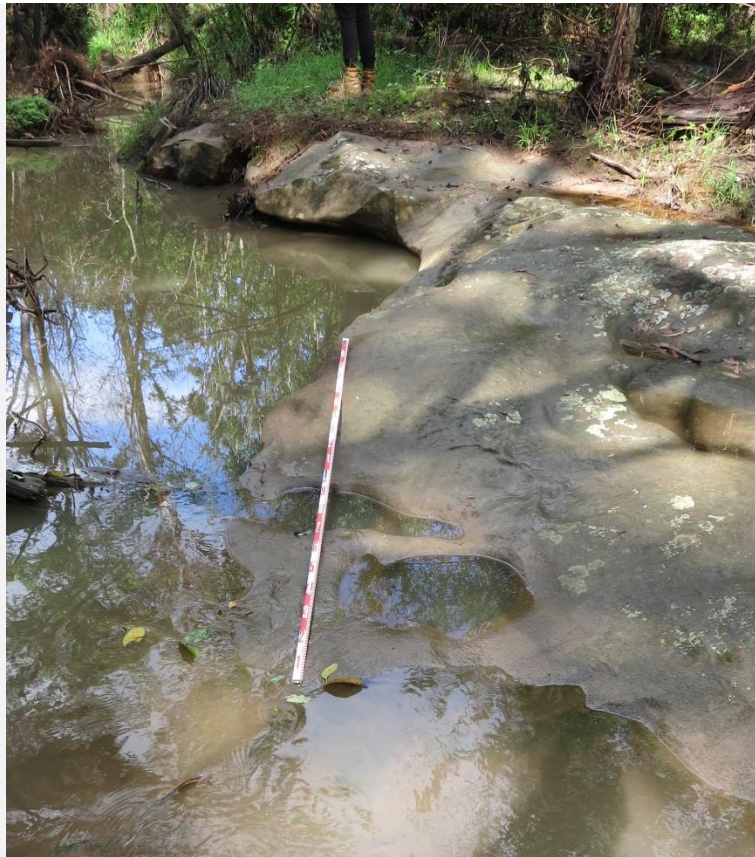
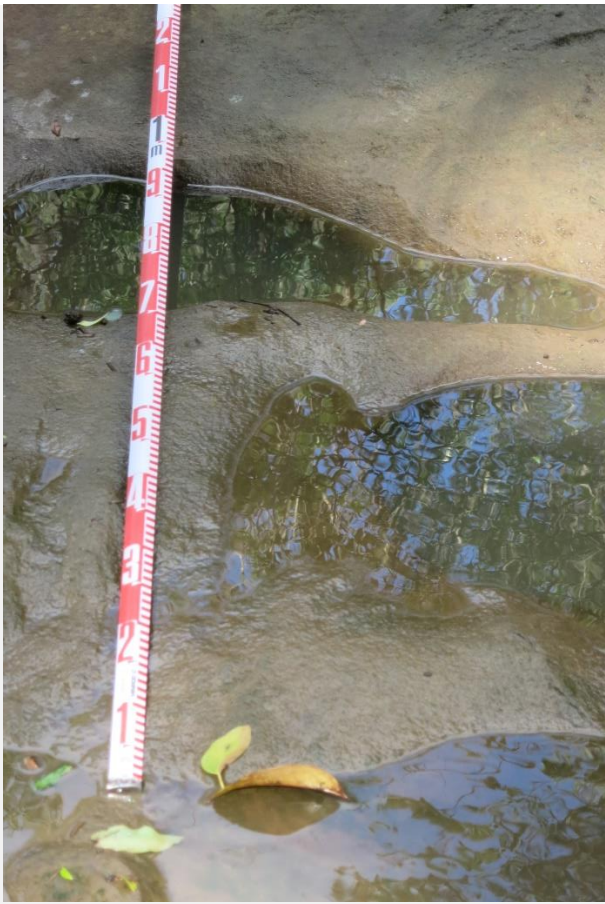
AHIMS Site #	Site Name	Results of Inspection	Photos
52-2-2082	Redbank Creek-4	The condition of the site has not changed due to mining related impacts since the original recording in 1998.
