**Tahmoor Coal Pty Ltd**

# **SIX MONTHLY SUBSIDENCE IMPACT REPORT**

**Western Domain Longwalls West 1 – West 4**

**Report 5 – June 2022**

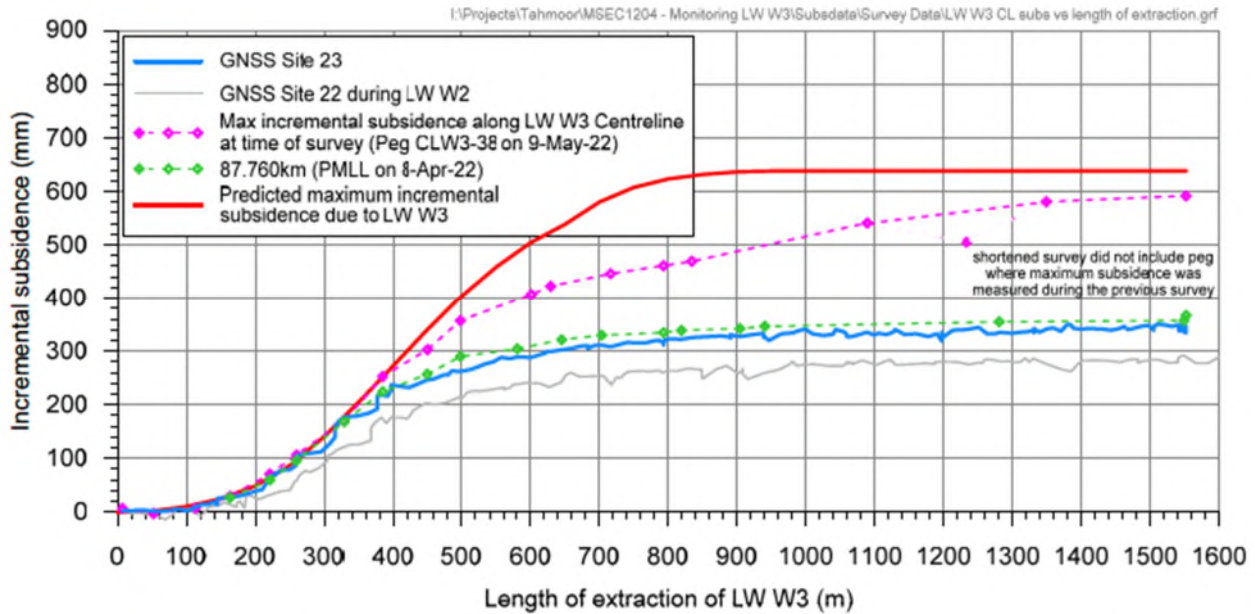
Figure 4-2 Development of subsidence along centreline of LW W3 (source: MSEC, Subsidence Monitoring Report 27, Appendix A)

The development of subsidence at pegs and GNSS units located on the LW W3 centreline that have been mined directly beneath by LW W3 are illustrated in **Figure 4-2**. This figure shows that subsidence currently observed along the centreline of LW W3, as well as that observed at GNSS Site 23 and 87.760 km on the Picton Mittagong Loop Line, was less than predicted.

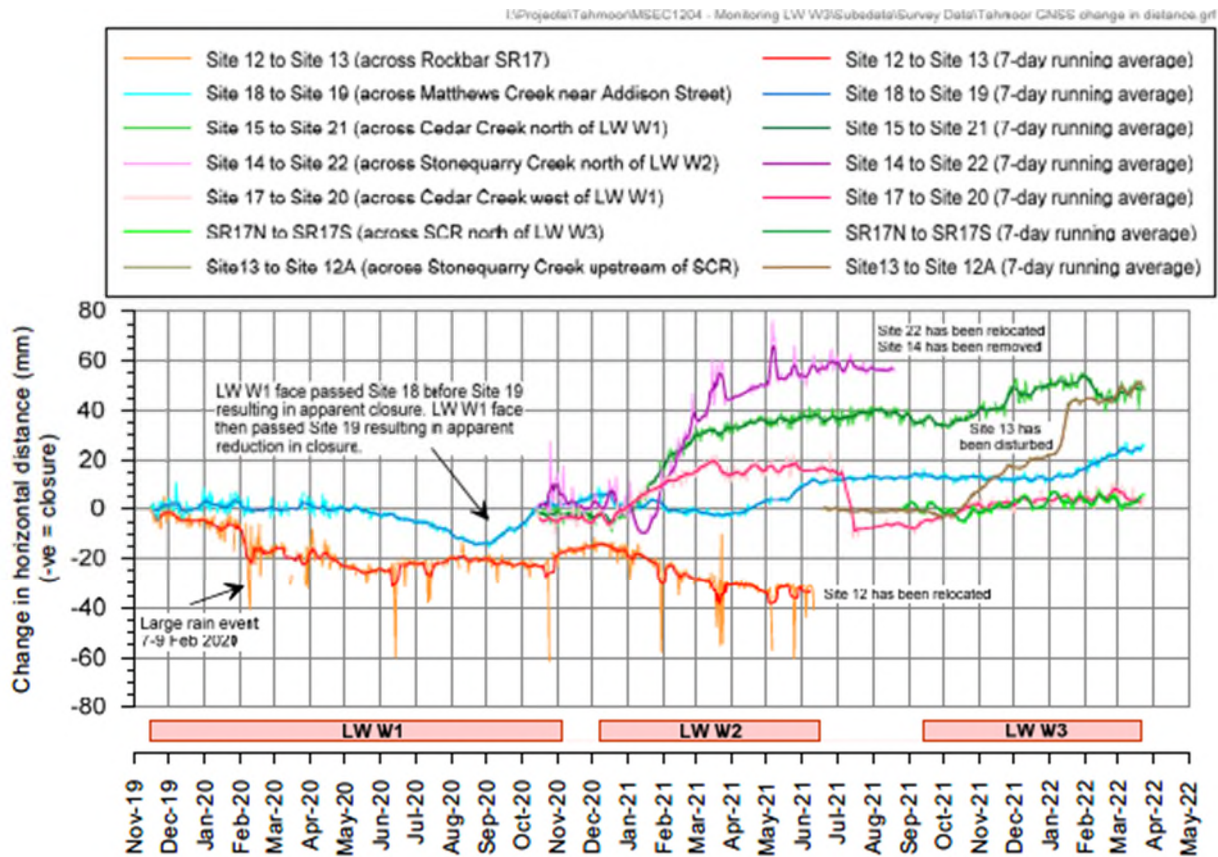
Figure 4-3 Observed changes in horizontal distances between GNSS units during LW W1-W3 extraction (source: MSEC, Subsidence Monitoring Report 27, Appendix A).

Changes in horizontal distances between GNSS units stationed near each other and on opposite sides of a waterway as a result of the extraction of LW W1-W3 are shown in **Figure 4-3**. During LW W3 extraction, only minor changes have been observed between the GNSS units.

The GNSS unit at Site 14 has been removed at the request of the landowner. The last reading was on 4 November 2021. The GNSS unit at Site 13 has been confirmed as disturbed in January, likely during removal of the surrounding fencing. Minor changes have been observed since this time. The unit was relocated on 28 March and results normalised.

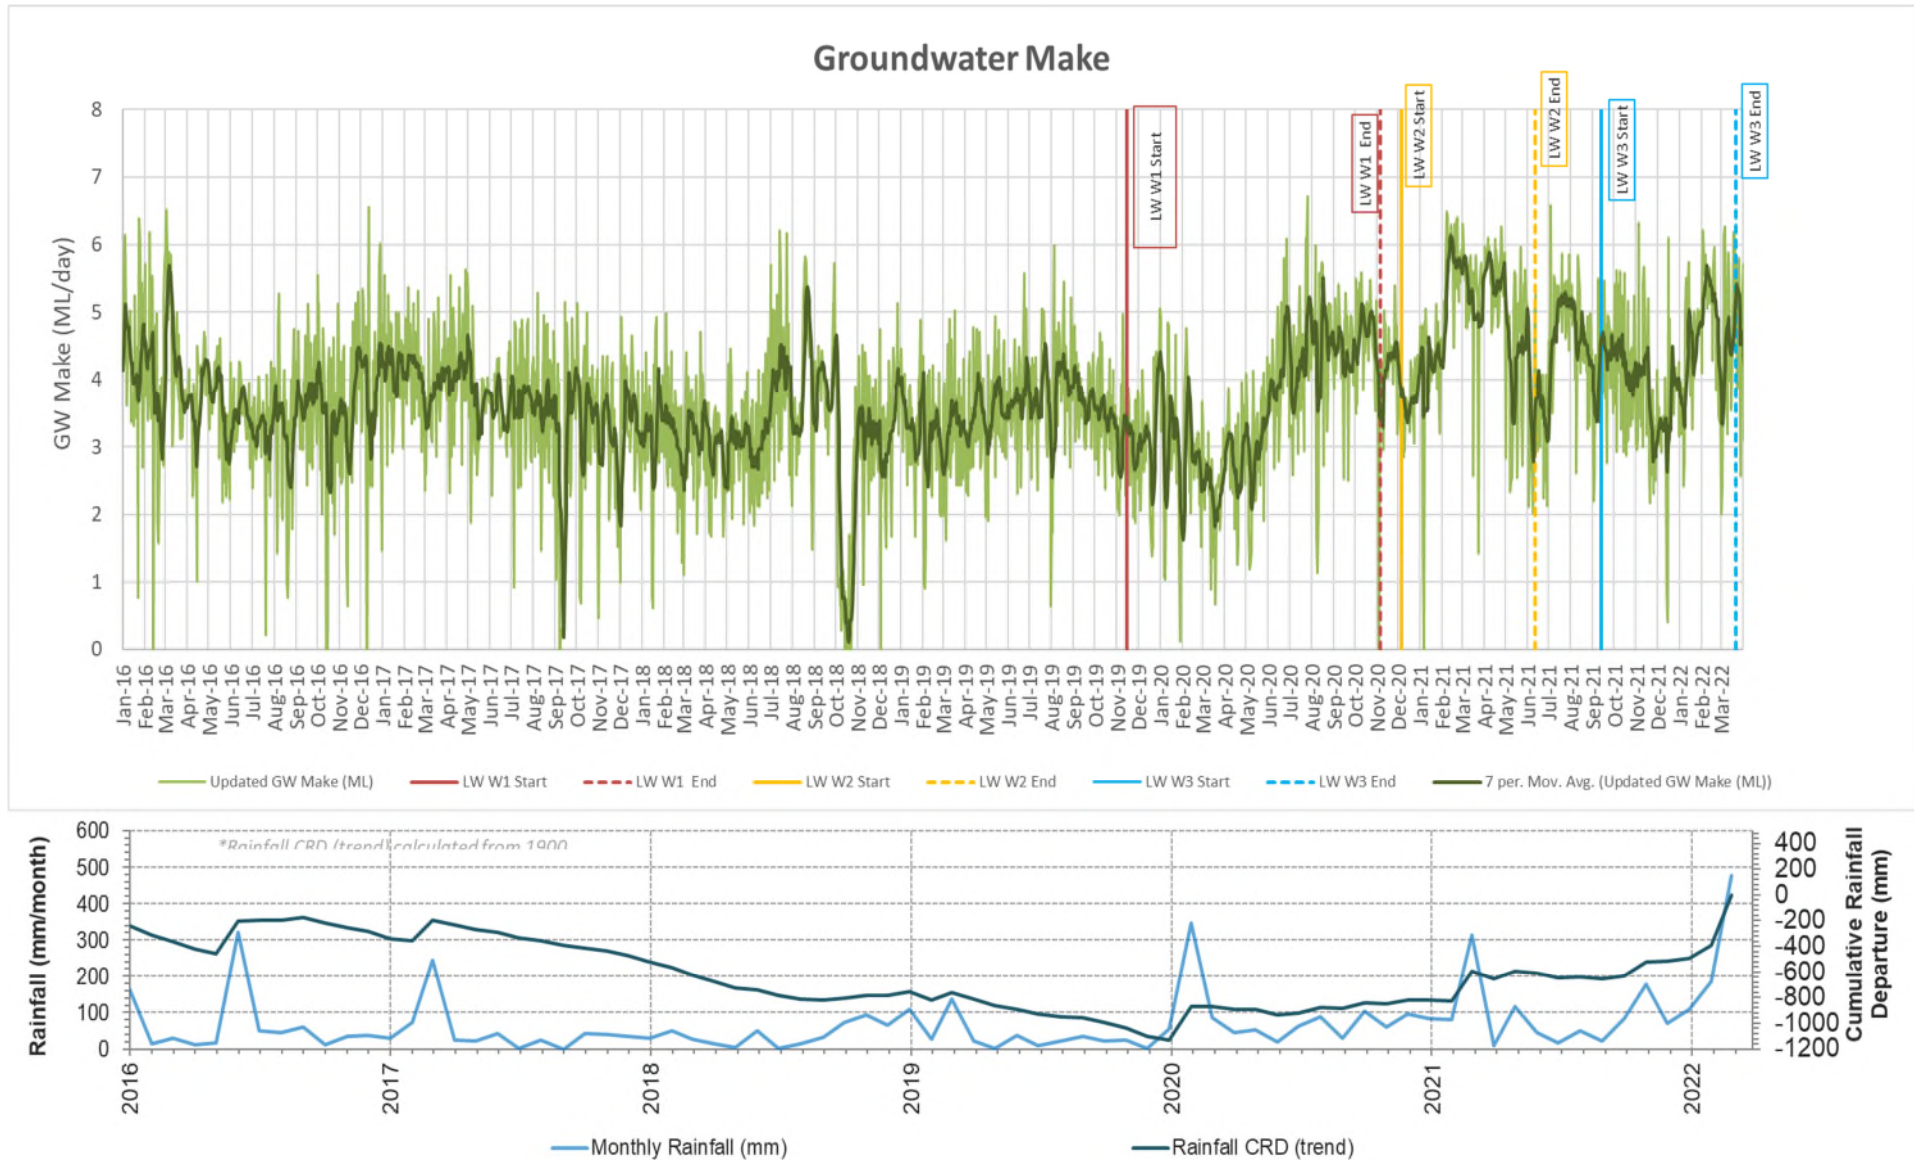
Figure 4-7 Historical record of inflows at Tahmoor Mine (source SLR, Groundwater Monitoring Report, Appendix C)

The period between mid-2020 shows an increase in inflows to greater than 5 ML/day at the end of July 2020 likely due to the extraction of LW W1. Inflows declined in late 2020, before rising in February 2021 (early in LW W2), with the recent peak at marginally over 6 ML/d in March and April 2021 (**Figure 4-7**). Inflows to the Western Domain are not metered in isolation from other parts of Tahmoor North but were estimated to be greater than 2.5 ML/d in early 2021 (based on advice from Tahmoor Coal staff in early 2021).

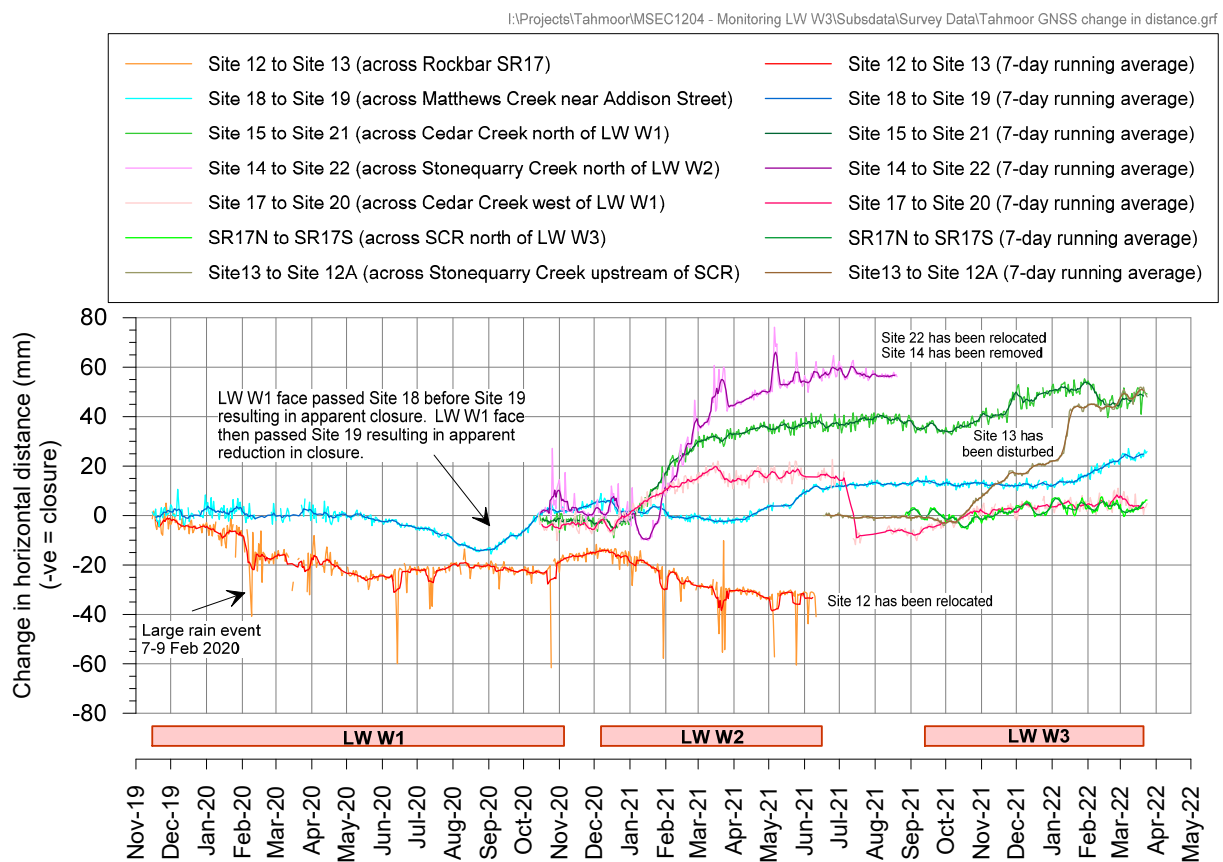
**Figure D** Observed changes in horizontal distances between GNSS units

The GNSS unit at Site 14 has been removed at the request of the landowner. The last reading was on 4 November 2021.

The GNSS unit at Site 13 has been confirmed as disturbed in January, likely during removal of the surrounding fencing. Minor changes have been observed since this time. The unit was relocated on 28 March and results normalised.

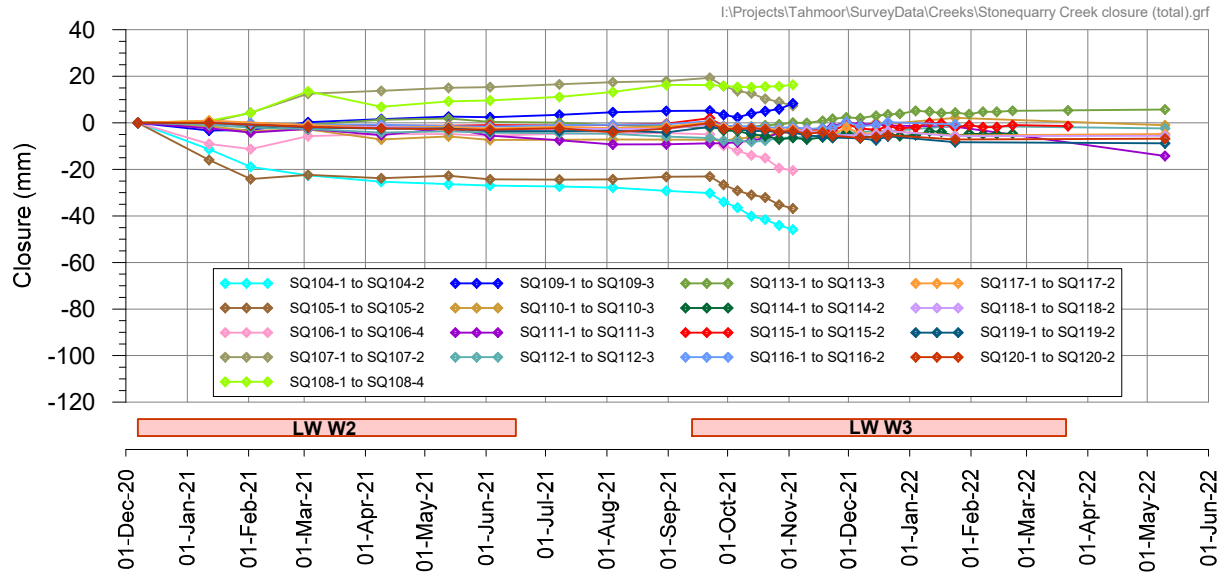
**Figure E Development of observed valley closure along Stonequarry Creek (new closure marks)**

Valley closure has been measured to develop across Stonequarry Creek at SQ104 and SQ105, which are located near the confluence of Stonequarry Creek and Cedar Creek. Minor closure was developing across SQ104, SQ105, SQ106 and SQ107 up to 3 November. The survey pegs for SQ101 to SQ109 were removed following the survey on 3 November, as requested by the landowner. Results are shown in Figure E.

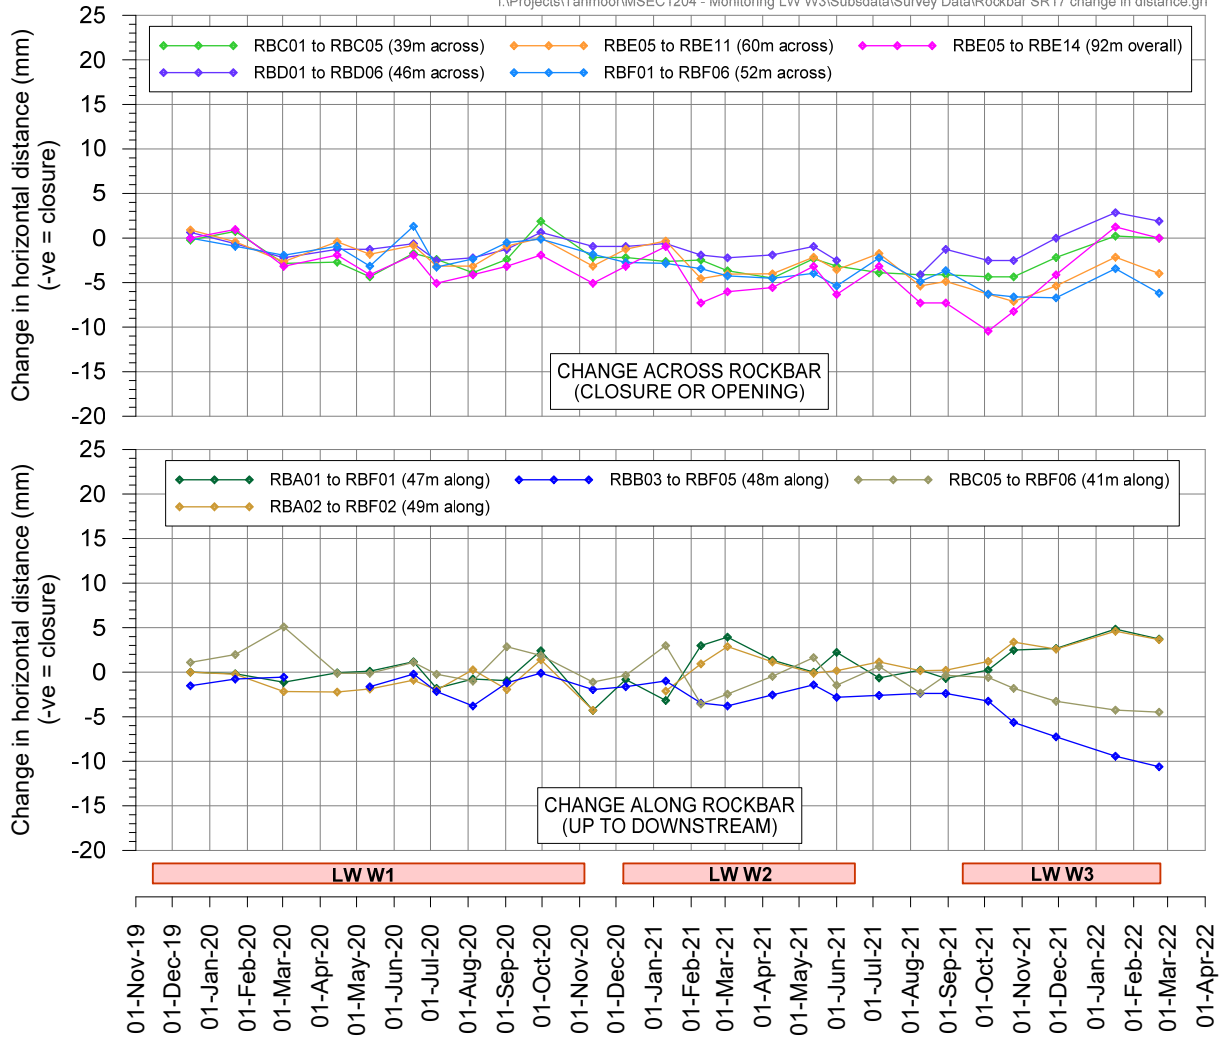
**Figure F Changes in distance across and along Rockbar SR17 during LW W1-W3**

The most recent monthly survey for Rockbar SR17 was on 22 February. Small changes in horizontal distances were observed both along and across the rockbar, as shown in Figure F. Minor ground shortening is observed in the southeast corner of the rockbar, which is captured by measurements at Marks RBE11, RBF05 and RBF06.

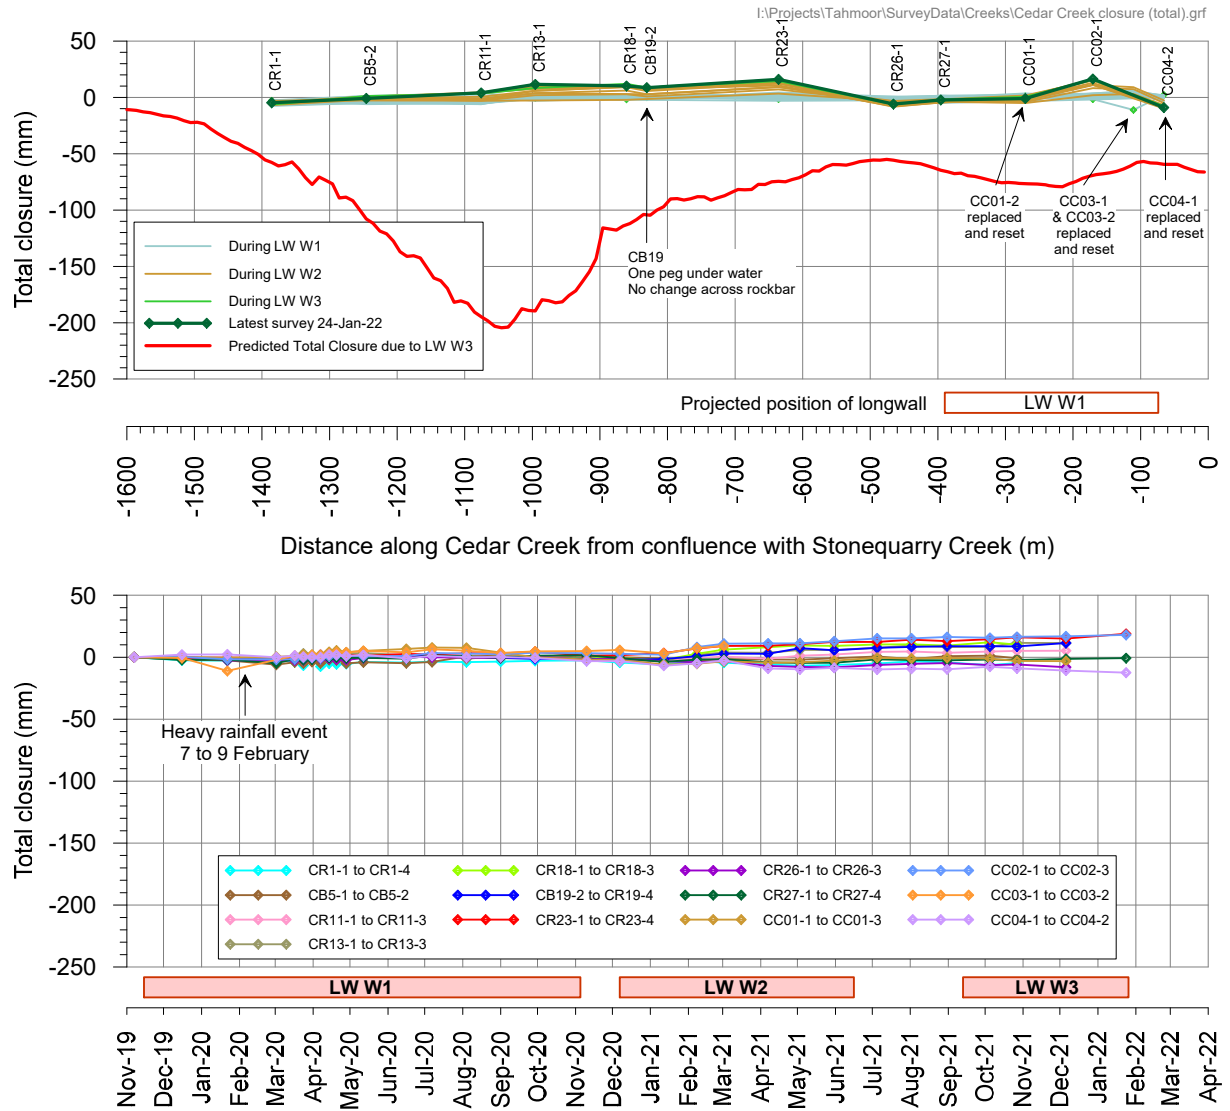
**Figure G** Comparison between observed and predicted valley closure along Cedar Creek

A comparison between observed and predicted valley closure along Cedar Creek is shown in Figure G. Very little change in closure was observed during the mining of LW W3. The most recent survey was on 24 January, with minor changes observed.

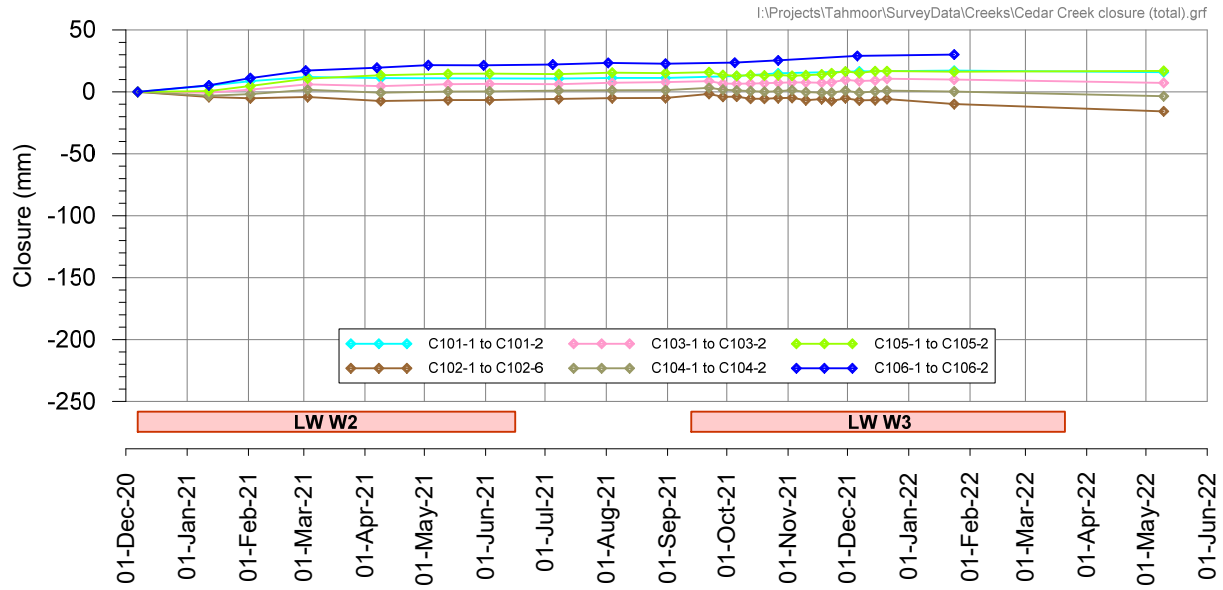
Figure H Development of observed valley closure along Cedar Creek (new closure marks)

Surveys across the newly installed closure marks are shown in Figure H. The most recent survey was on 10 May with minor changes observed.

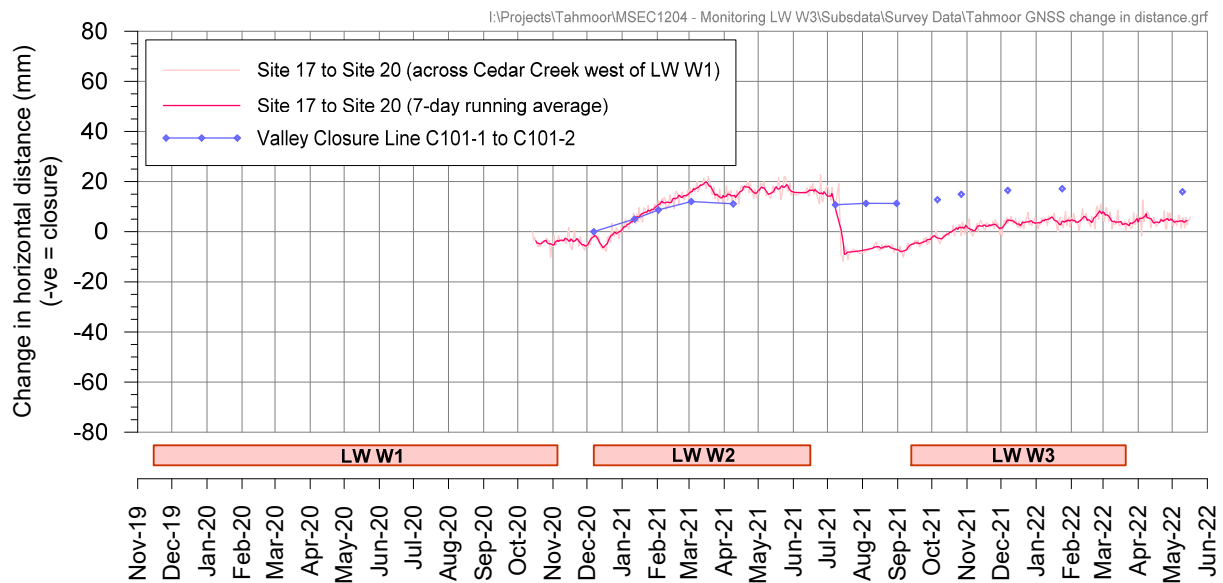
Figure I Development of observed valley closure along and across Cedar Creek

Survey pegs C101-1 and C101-2 are aligned with GNSS sites 17 and 20. A reasonable comparison in measured changes in distance between the two survey sites is shown in Figure I, though one of the GNSS units appears to have been disturbed in July 2021 between the completion of LW W2 and commencement of LW W3.

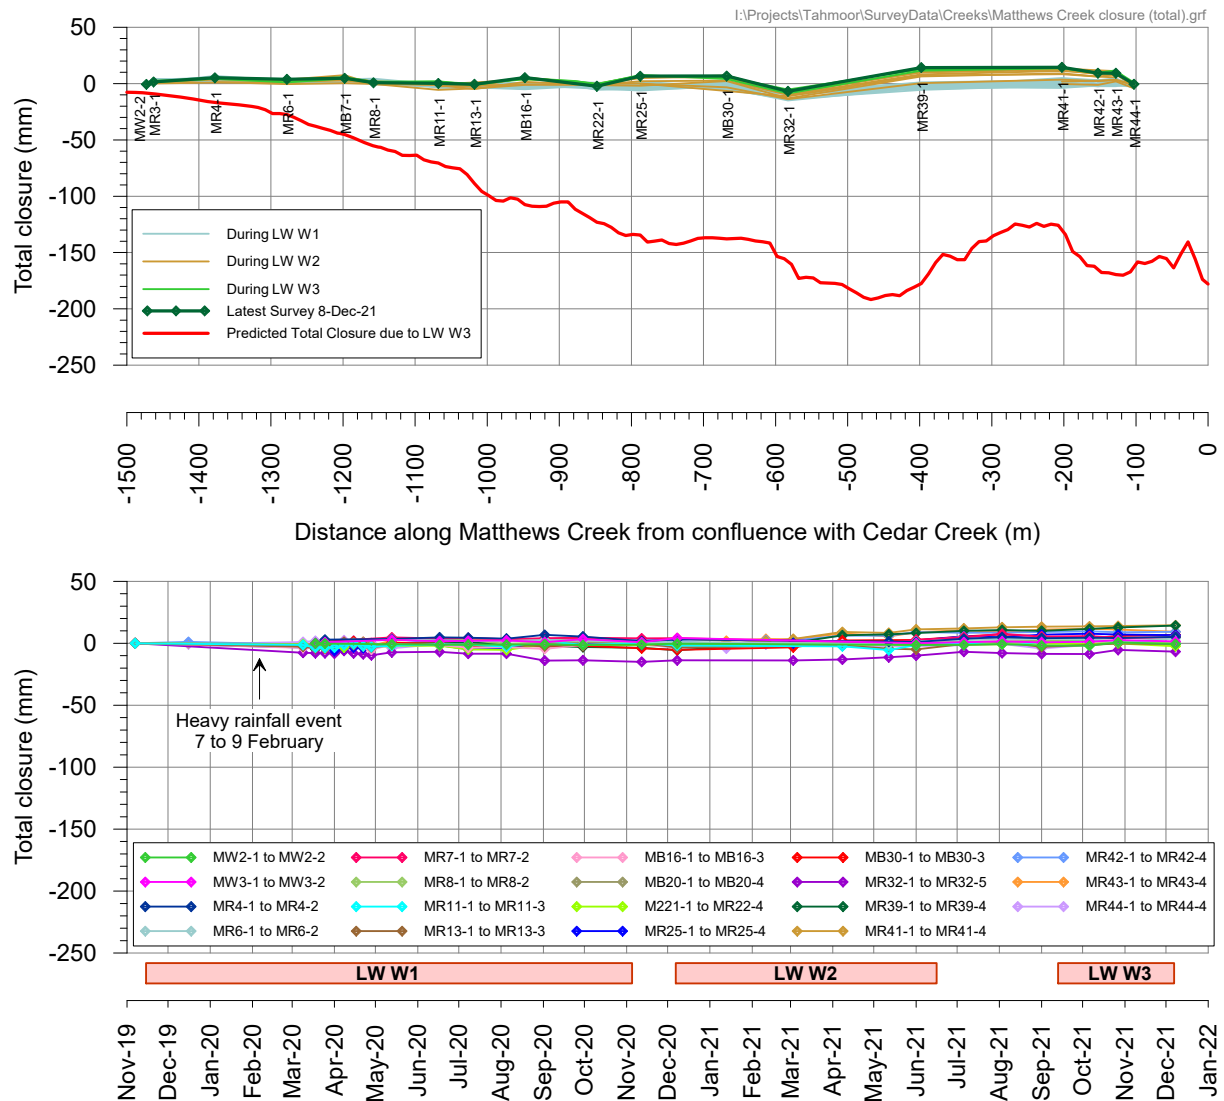
**Figure J Comparison between observed and predicted valley closure along Matthews Creek**

A comparison between observed and predicted valley closure along Matthews Creek is shown in Figure J. The most recent survey was on 8 December, with minor changes observed.

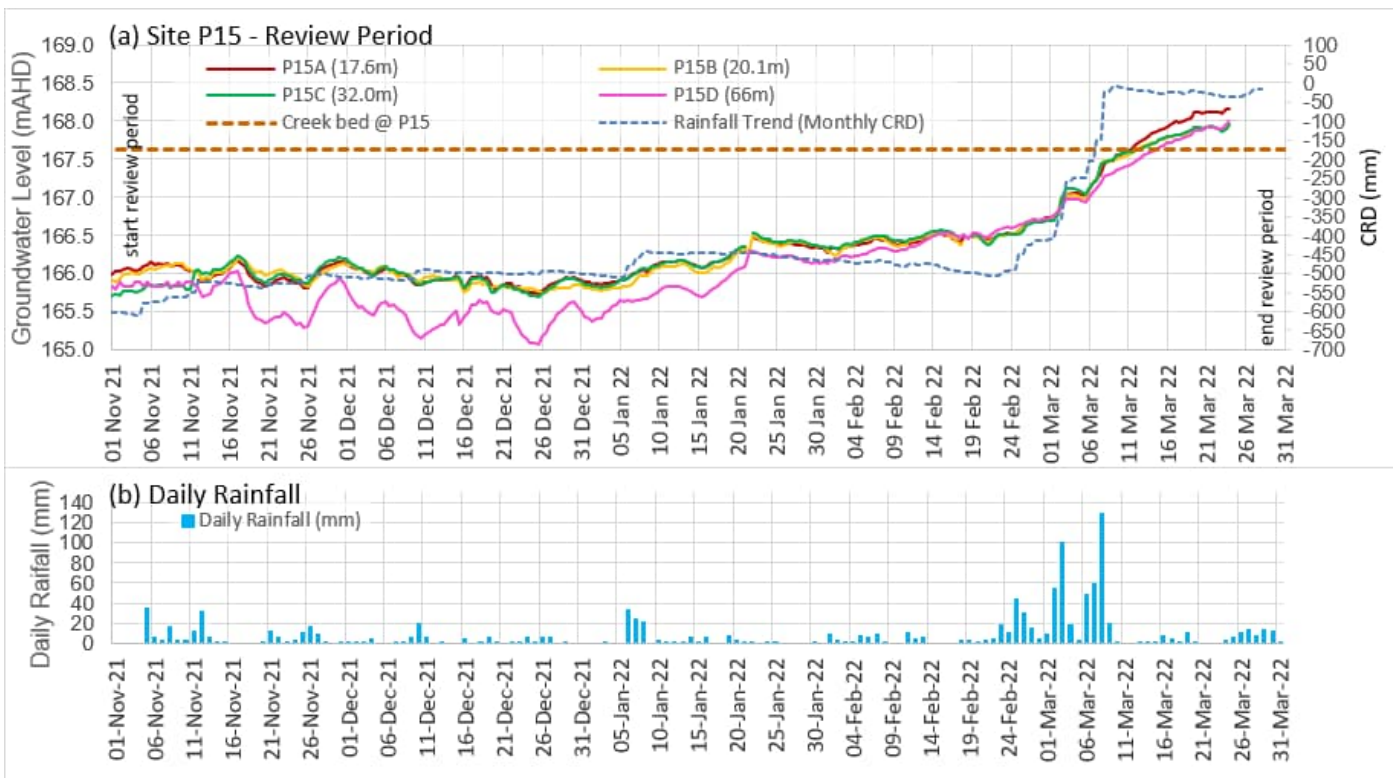
Figure 4 Groundwater levels at P15 during the review period (a); Daily rainfall over the reporting period (b)

A similar trend in groundwater levels to that at P15D is observed in the upper and mid Hawkesbury Sandstone aquifer (bores P15A, B and C), including similar short-term fluctuations, but these short-term fluctuations are in the range of 0.2 m (i.e. smaller than those in P15D). This suggests that if a mining related effect due to LW W3 occurred at P15 (as seems likely), it would have been to a greater magnitude in the deeper strata (P15D) than the shallow strata (e.g. P15A-C) as previously observed in October 2021 (SLR, 2021b)).

From late December 2022, a gradual increase in groundwater levels is observed in all piezometers at P15. The rate of groundwater recovery accelerates in late February 2022 following intense rainfall and flooding in the area. Over the reporting period, groundwater levels in P15D increased by approximately 3 m while groundwater levels in P15A, B and C increased by 2.2 m. At the end of the reporting period, groundwater levels in all piezometers at site P15 are at approximately 168 mAHD which is 0.4 m above the creek bed elevation at P15, suggesting that baseflow conditions (i.e. gaining conditions) to Stonequarry Creek have strengthened.

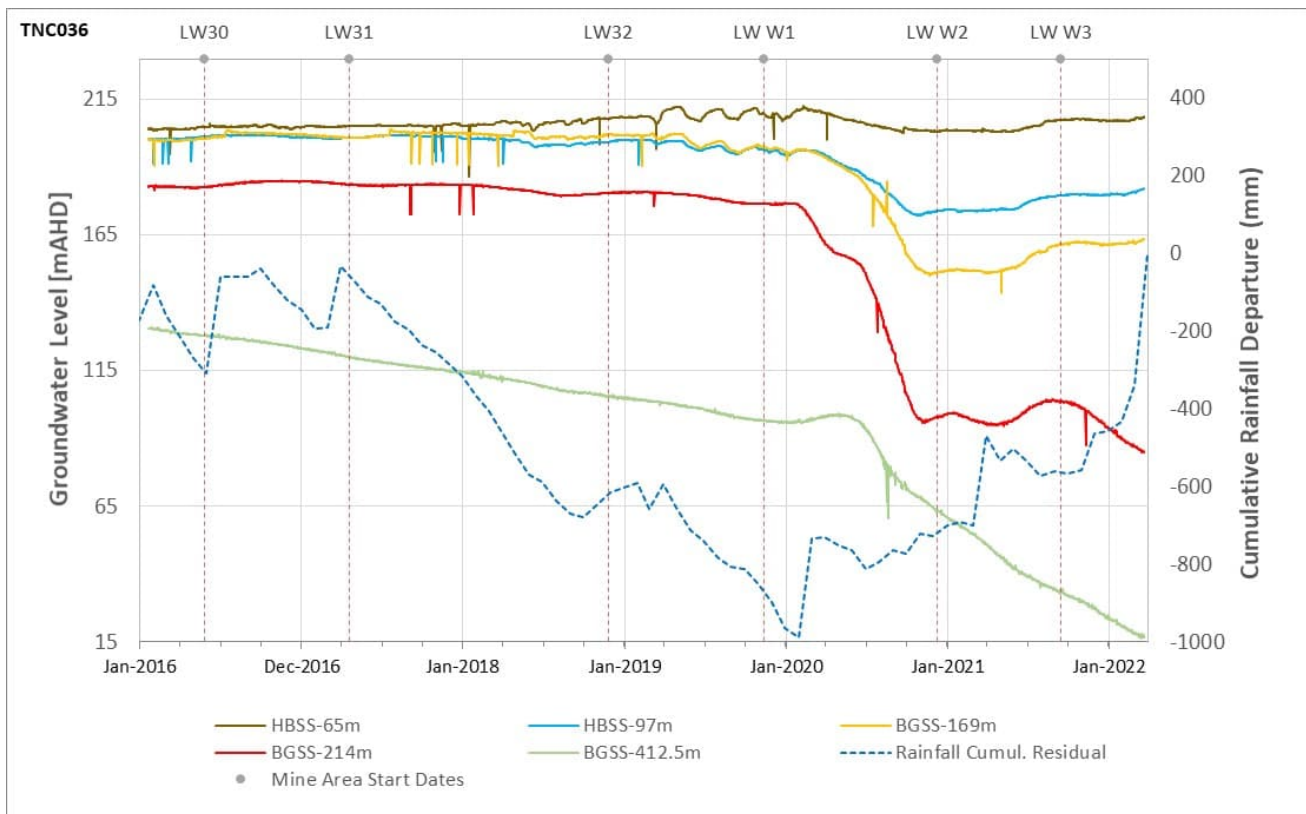
Figure 5 Hydrograph for TNC036

TNC036 is located almost 500 m to the west of the middle of LW W1 and west of Matthews Creek. It has a number of sensors placed in the Hawkesbury and Bulgo Sandstones at various depths, as well as one in the Bulli Coal seam (Table 3). The hydrographs for the VWPs are presented in Figure 5. Groundwater pressures at TNC036 have recently been re-assessed and resulted in the removal of the transducer records at 298 m and 463 m (Groundwater Exploration Services [GES], 2020). Data collected from 2010 to 2011 at TNC036 appears erroneous, likely due to influence from construction. Consistent data that appears representative of local groundwater conditions has been collected from 2016. Further details on reliability of TNC036 data is presented in the Groundwater Technical Report LW W3-W4 (SLR, 2021).

Approximately 60 m of depressurisation is apparent in the lower Bulgo Sandstone (piezometer BGSS-412.5m) for the period from February 2016 to August 2019, with the rate of drawdown increasing in mid-2020 and reducing in late-early 2021. The decline in water levels in the lower Bulgo Sandstone from 2016 (or before) is likely related to regional drawdown of deeper aquifers due to the cumulative effect of Longwalls 29-32 at Tahmoor.

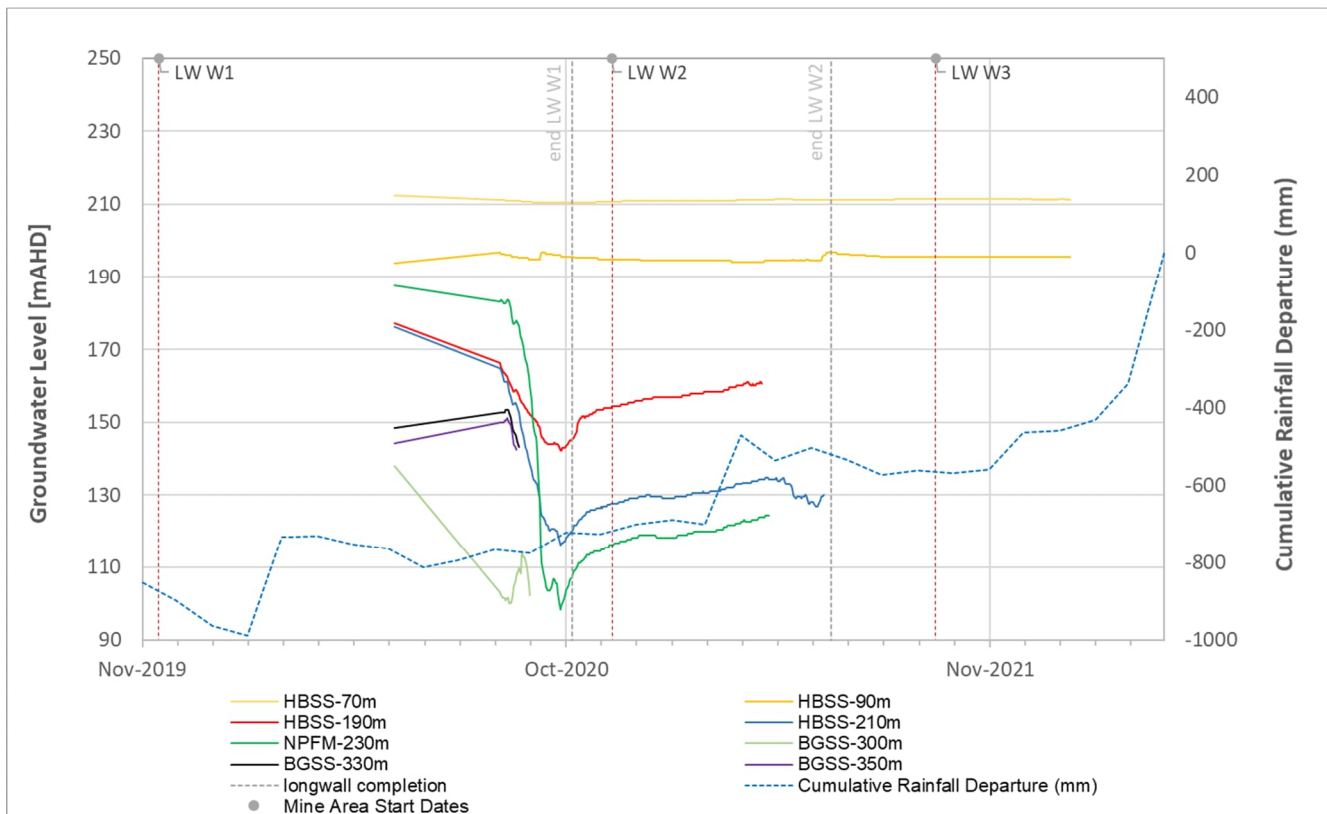
Figure 6 Groundwater Level Trends at WD01

Figure 6 presents a hydrograph of the pre-mining borehole (WD01) located above a chain pillar between the Western Domain LW W1-W2. The bore is 570 m north of the closest Tahmoor North (not Western Domain) goaf (LW 32) and was completed while LW W1 was 400 m to the north (Section 3). WD01 is instrumented with VVPs at multiple depths and has been recording groundwater pressures/heads since June 2020. The latest available groundwater pressure dataset is dated to January 2022. In late April 2021 the sensors HBSS-190m and NPFM-230m both failed due to ground movement therefore no comment on groundwater elevations can be made past this date. The remaining active sensors HBSS-70m and HBSS-90m continue to show stable groundwater levels with no signs of depressurisation as of January 2022. The HBSS-210m sensor failed in late June 2021 due to ground movements caused by the retreating longwall panels. No groundwater level data past January 2022 is available as yet.

The instrument HBSS-70m shows stable groundwater levels at about 211 mAHD. In HBSS-70m, no mining effect is evident as of January 2022, consistent with previous reporting. A small drawdown (1 m) was observed in HBSS-90m late April 2021 caused by the approach of LW W2. In June 2021, water levels in HBSS-90m recovered by approximately 2 m and has since then been stable at 196 mAHD and does not appear to show any discernible effect from mining.

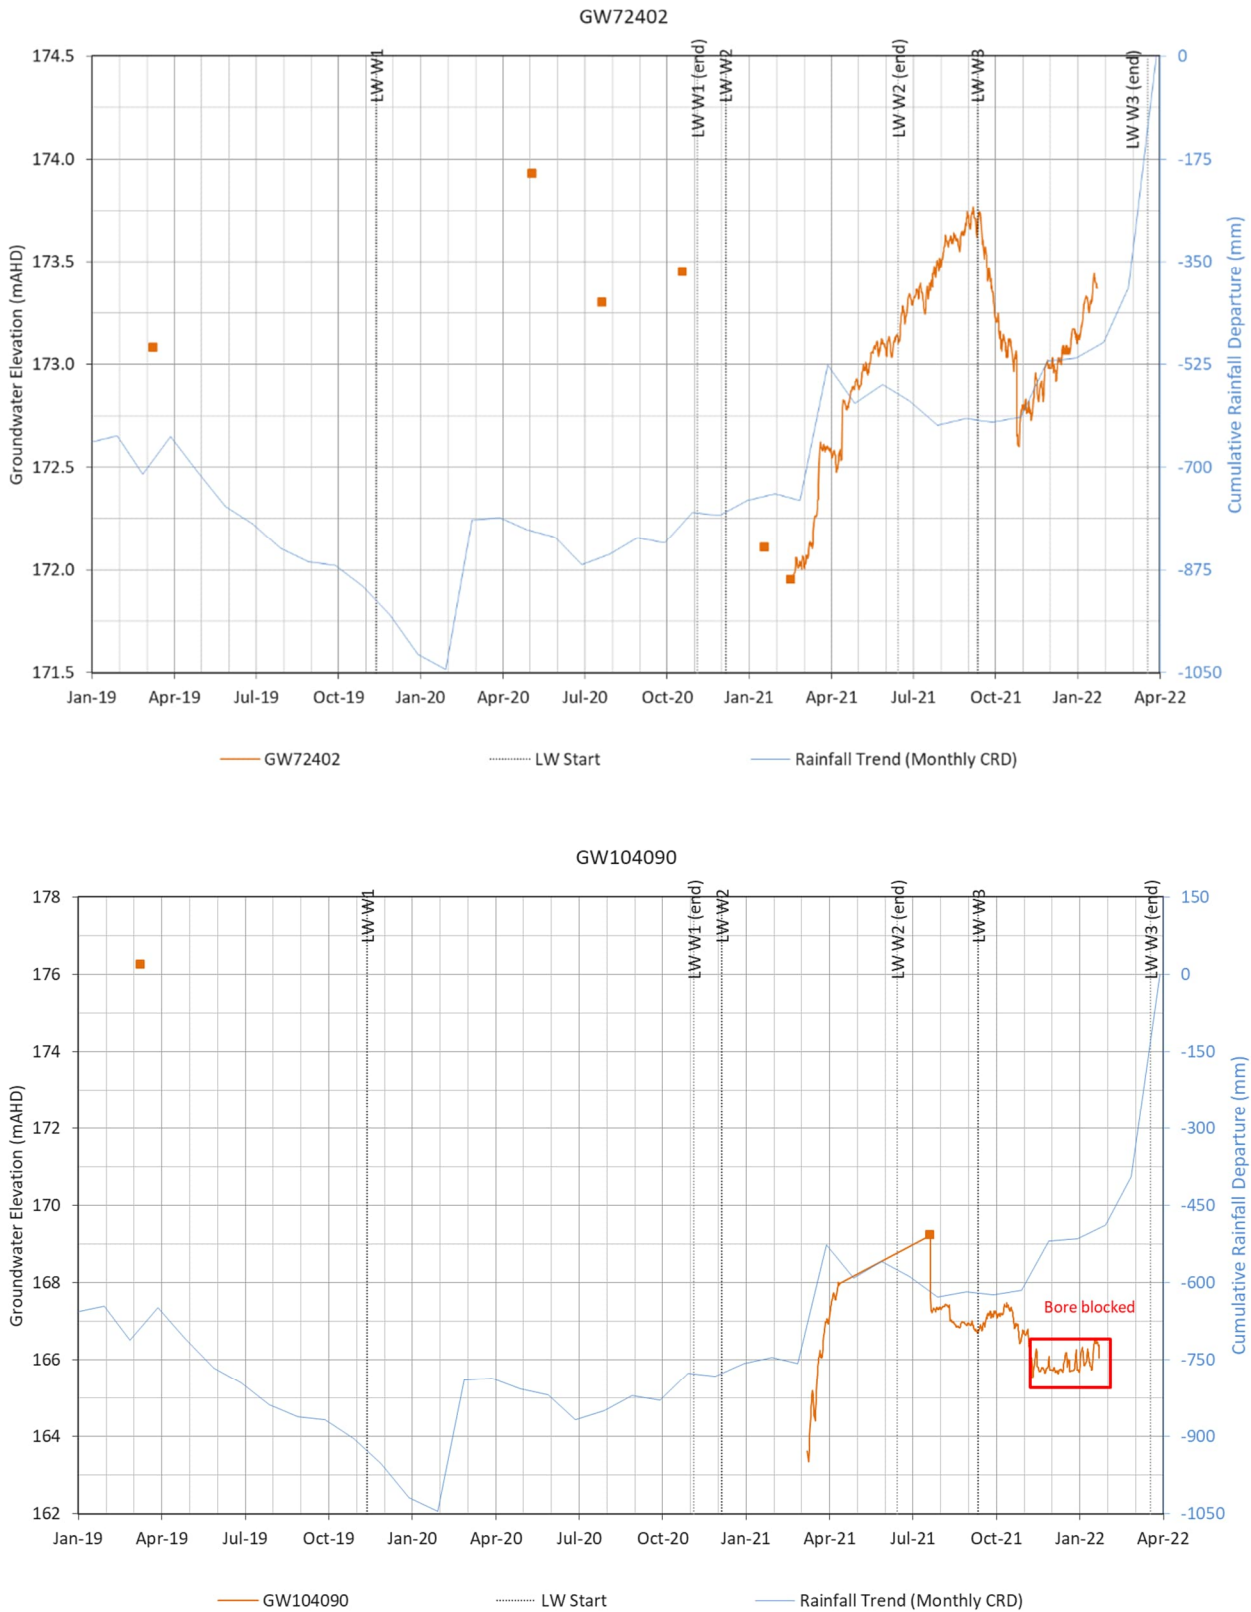
Figure 7 Groundwater level hydrographs for GW72402 and GW10409

From November 2021, groundwater levels start to rise in response to rainfall recharge. By January 2022, groundwater level increased by 0.7 m to 173.4 mAHD, similar to baseline conditions (Figure 7). No yield information is available at this location due to pump malfunction.

Since March 2021 an improved groundwater level dataset has been available. Following the significant rainfall events in February-March 2021, water levels increased by 4.5 m to 167.5 mAHD in April 2021, which is 8.2 m below baseline level (Figure 7). As noted above, groundwater levels at GW104090 experienced some degree of drawdown (>12 m) due to the passage of LW W1 and W2 but still show good responses to rainfall recharge. No groundwater levels were available between late April 2021 and July 2021 due to loss of the datalogger.

A manual measurement of the groundwater level at 169.2 mAHD was made available while replacing the logger in late July 2021 which suggest that water levels continued to recover during the period of missing data. From August 2021, water levels have responded to rainfall and fluctuates by 0.5 m but appear 2m below the water level taken manually in July 2021 which suggest that either the short periods of drier conditions throughout June-July 2021 and/or the completion of LW W2 influenced water levels during this period (or the manual reading in July 2021 was incorrect). In September 2021, an increasing trend in groundwater levels is observed with no mining effect due to the early part of LW W3 extraction identified. In October 2021, groundwater levels decreased by approximately 1.7 m likely due to the progression of LW W3. From November 2021, groundwater levels appeared stable at 165 mAHD. During the month of January 2022, there was a blockage at the private bore GW104090 at a depth of 48.3 m and thus it should be noted the data from January 2021 to the end of the reporting period at this location is not representative of groundwater conditions. A field inspection is planned in the coming months to identify the cause of the blockage and assess if the bore can be unblocked.

No yield information is available at this location due to pump malfunction at these bore locations.

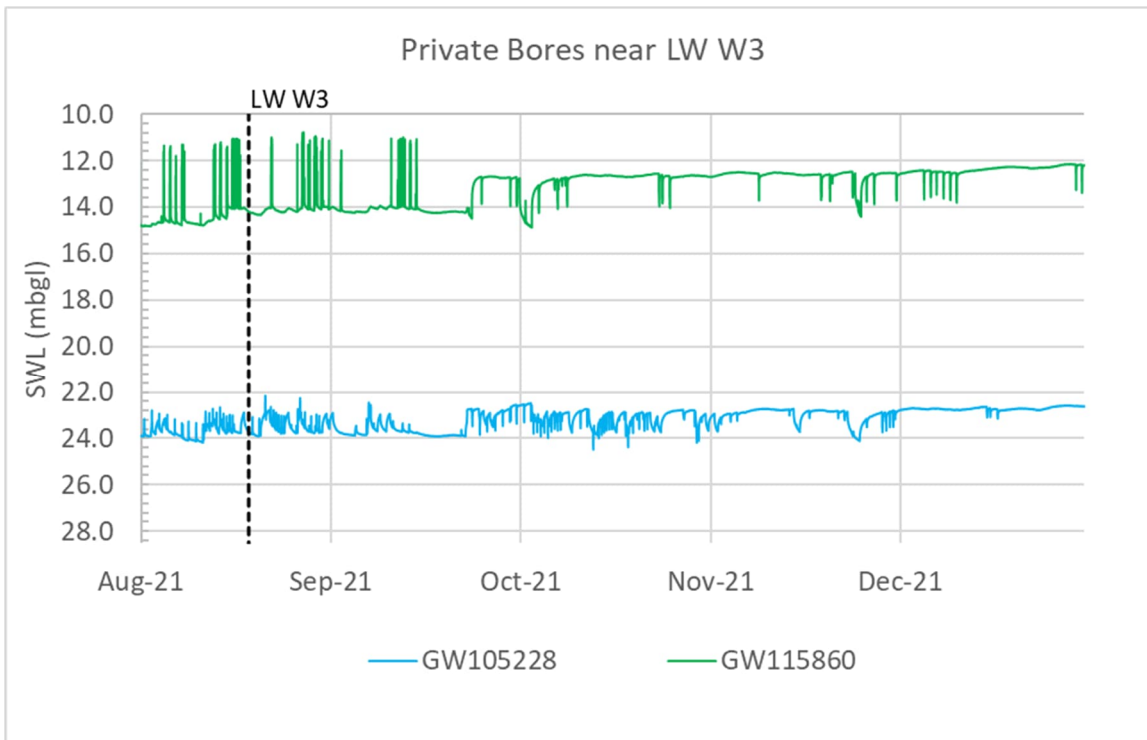
Figure 8 Hydrographs for GW105228 and GW115860

Groundwater level data at private bores GW105228 and GW115860 are recorded every 15 minutes and presented on Figure 8, with the latest available data to 24 January 2022. Groundwater levels for the two private bores show no response in water levels following the commencement of LW W3 compared to GW72402 (Figure 7). As discussed in SLR (2021b) any mining effect on groundwater levels due to the early part of LW W3 extraction is difficult to assess due to alternation between pumping and not pumping at one or both bores for private usage. The timing in groundwater level decline and recovery match between GW105228 and GW115860 (only 110 m apart), suggesting that the drawdown in one bore (i.e. due to pumping) influences water levels in the other bore. On Figure 8, the drawdown observed at GW115860 is consistently greater than the drawdown at GW105228, which suggests that GW115860 is more frequently pumping groundwater and influences water levels in GW105228. During mid-October 2021, at GW115860, pumping seems to have reduced as water level increased by 1.8 m, a period also associated with fewer pumping cycles compared to September 2021. This could be explained by the fact that reliability on groundwater has reduced during a period of above average rainfall conditions throughout October and November 2021 and during the exceptional rainfall in early 2022. However, water levels provided before 19<sup>th</sup> October 2021 seem suspect and any conclusions on pumping effect is difficult to understand prior to this period. No drawdown due to mining of LW W3 is identified during the reporting period at either GW105228 or GW115860.

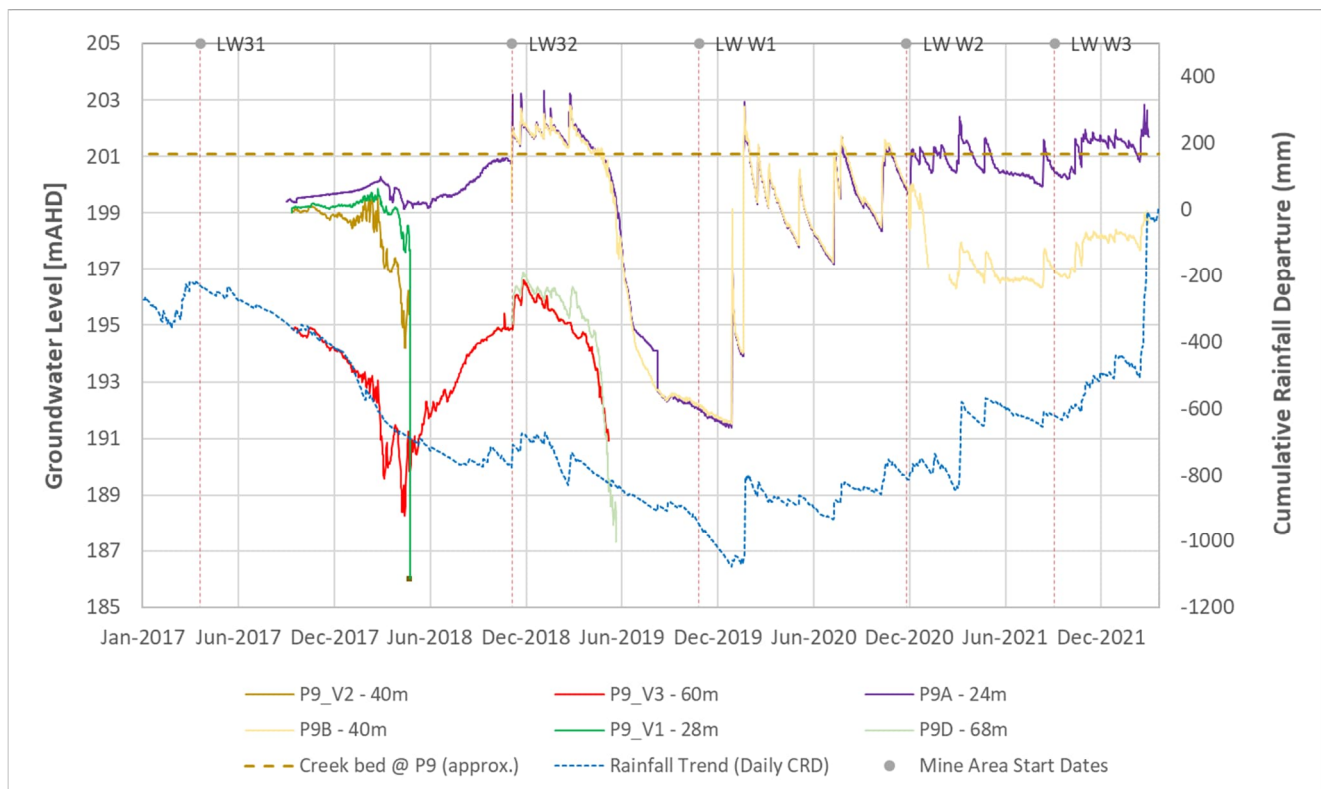
Figure 9 Groundwater Level Hydrographs at P9

One of the standpipe bores P9D (65-68m) and all three VWP sensors at P9 have failed; failures in P9\_V1 in May 2018, P9\_V2 in May 2019 and P9\_V3 in October 2018. This is not surprising given the position between longwall panels and susceptibility to subsidence effects, however measurements of groundwater level are still recorded at P9A (22-24m) and P9C (37-40m) (Figure 9).

Figure 9 presents hydrographs of groundwater levels at P9 VWPs and open standpipes bores. At the commencement of monitoring the water levels in P9\_V1 and P9\_V2 were closely related. Greater head separation exists (approximately 5 m) between the water levels in the two shallower VWPs and the deeper instrument (P9\_V3), however, groundwater levels at all depths show similar peaks and declines in response to rainfall.

During the early extraction of LW W3, responses to rainfall are observed in both P9A-24m and P9B-40m with water levels in December 2021 being 1.5 m and 1.8 m respectively above pre-LW W3 water levels. In early February 2022, a decline of 0.4 m is observed in P9A-24m and P9B-40m during a period of low rainfall (Figure 9). Following the major rainfall in early March 2022, groundwater levels increase by approximately 1 m. We note that water levels at P9A-24m were observed above the creek bed elevation for most of the reporting period which suggests gaining conditions along Redbank Creek in the vicinity of P9, except during the short period of water level decline in February 2022, which would be associated with groundwater in the shallow Hawkesbury Sandstone (P9A-24m) leaking to the underlying aquifer (P9B-40m). No recent mining effect is discernible over the reporting period in the P9A-24m and P9B-40m piezometers.
