**Tahmoor Coal Pty Ltd**

# **SIX MONTHLY SUBSIDENCE IMPACT REPORT**

**Western Domain Longwalls West 1 – West 4**

**Report 5 – June 2022**

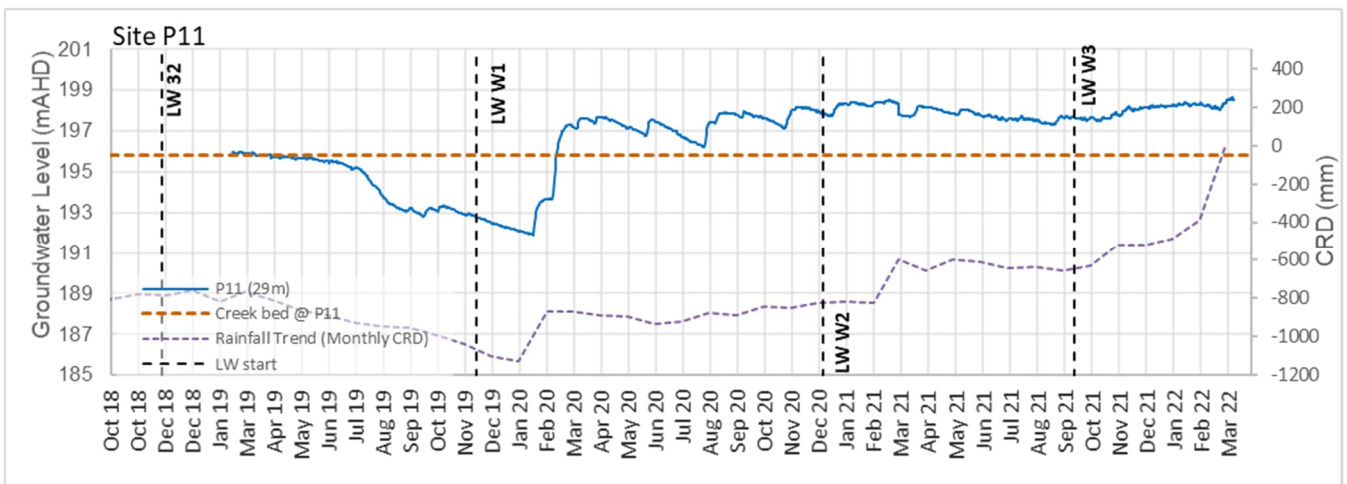
Figure 10 Groundwater Level Hydrograph at P11

Bore P11, located along Redbank Creek and 300 m east of (downstream of) LW 32 shows a mining induced drawdown of approximately 3 m between July 2019 and January 2020 (Figure 10). The groundwater levels along Redbank Creek are correlated to weather patterns or rainfall events. There is a clear response in groundwater levels to the significant rainfall commencing in January 2020. Since March 2020 water levels have recovered above the baseline level (period prior LW W32) and show small responses to rainfall events. Water levels have gradually declined by approximately 0.4 m between March 2021 and August 2021 and have shown a response to rainfall in late August 2021. During the reporting period, groundwater levels at P11 have increased by 0.7 m in response to the above average rainfall conditions. As of March 2022, water levels at P11 are around 2.7 m above the first recorded level in February 2019. No discernible effects on water levels due to LW W3 are identified during the reporting period.

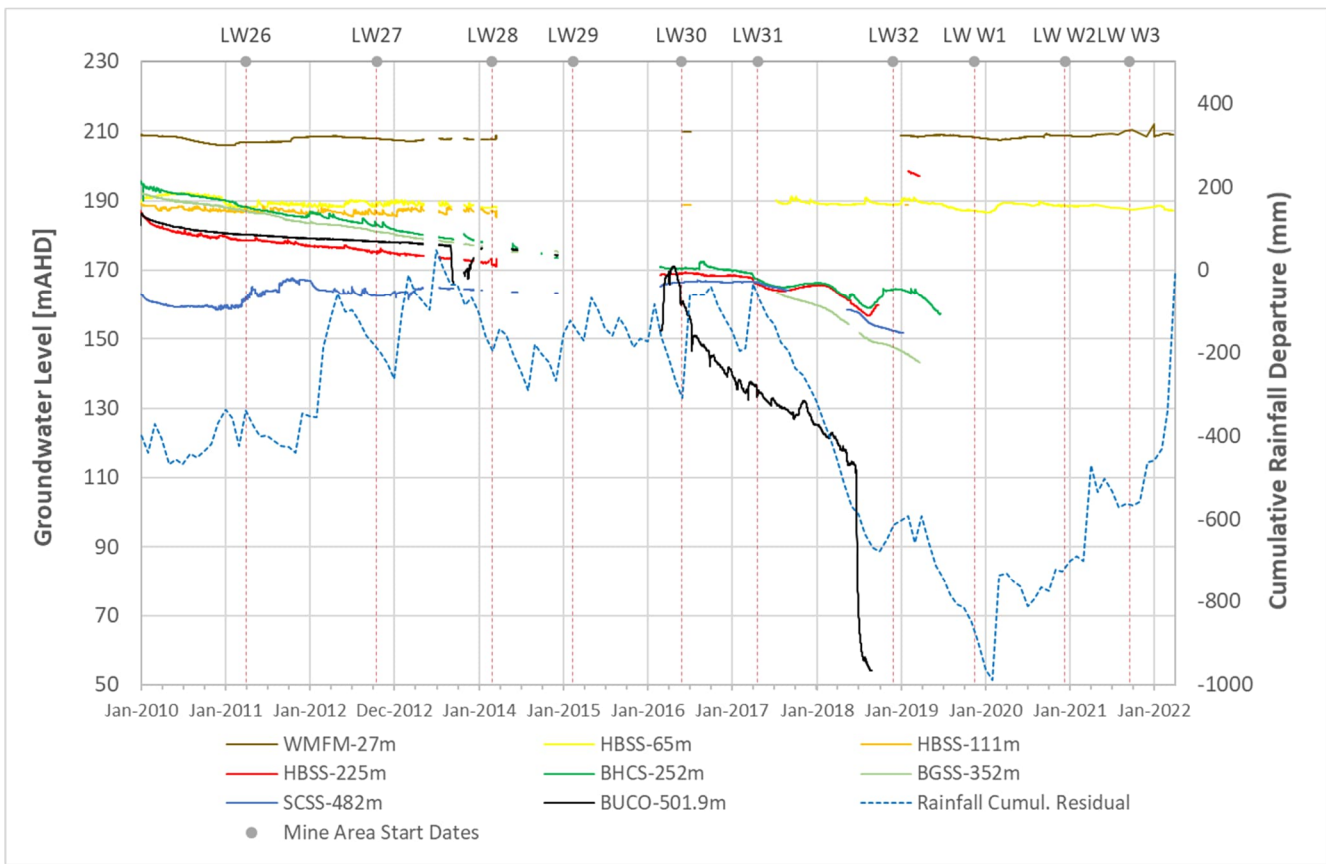
Figure 11 Groundwater Level Trends at TNC040

TNC040 is situated 300 m north of LW32, 650 m south-east of LW W2, and will be 430 m south of LW W4. Eight data sensors installed in TNC040 are positioned within the Wianamatta Group, Hawkesbury Sandstone, Bald Hill Claystone, Bulgo Sandstone, Scarborough Sandstone and Bulli Coal seam (Table 3). As of February 2019, the lower four VWP sensors were no longer active due to subsidence effects (GES, 2019). The decline in water level shown in late 2018 in the lowest sensor in the Bulli Coal seam (BUCO-501.9m) is a result of a nearby road advancement that has caused depressurisation of this seam.

As of March 2022, the upper two sensors (WMFM-27m, HBSS-65m) remain active, with monthly manual measurements taken between June 2021 and December 2021 and do not appear to show an influence from mining (Figure 11). In January 2022 the two loggers WMFM-27m and HBSS-65m were repaired, and continuous data was available from that time. In early February 2022, groundwater levels in HBSS-65m gradually declined by 1 m before stabilising at 187.3 mAHD. Minor fluctuations are observed in WMFM-27m (i.e. 0.2 m water level fluctuations). This water level decline in HBSS-65m could be associated with the progression of LW W3 to the south in the direction of TNC040 (i.e. 450 m from LW W3). No mining effect is discernible in the WMFM-27m piezometer.

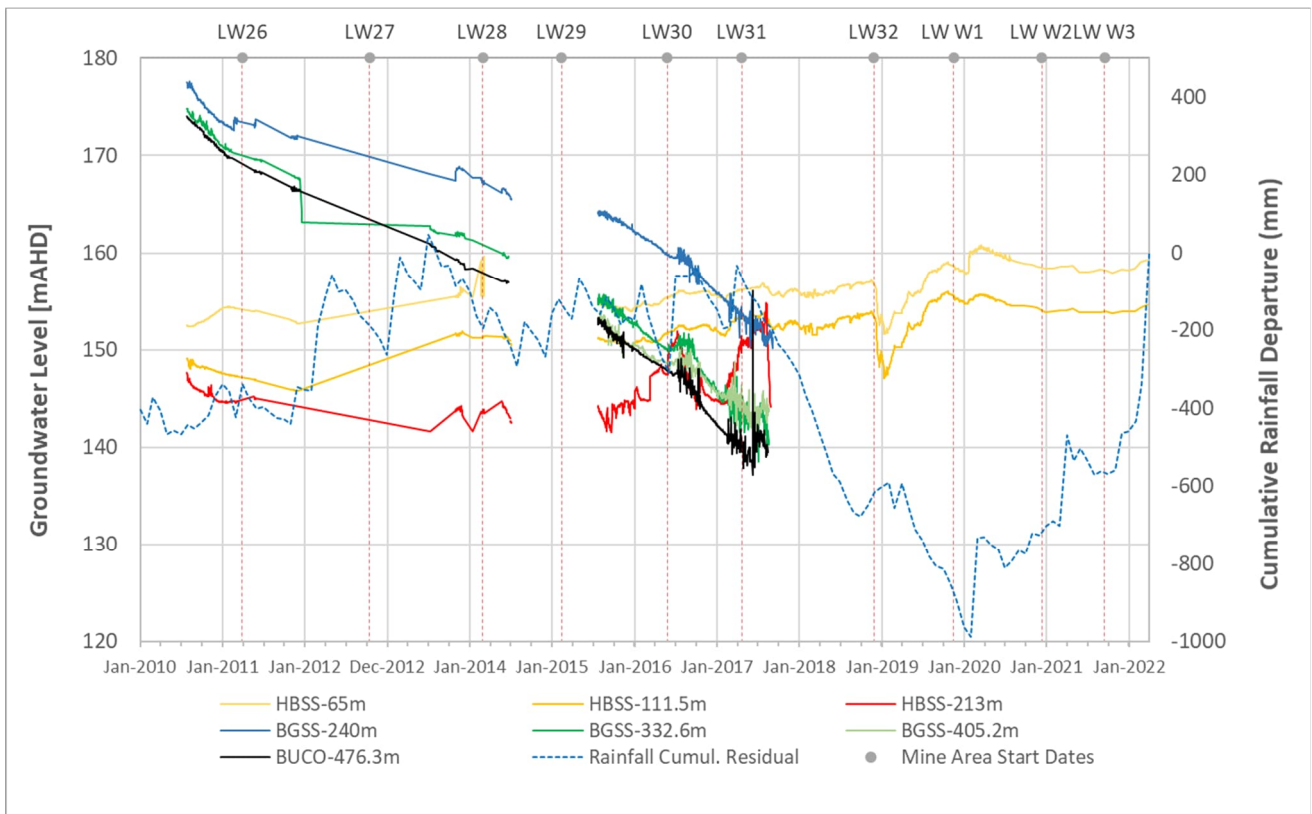
Figure 12 Groundwater Level Hydrographs at TNC043

The water levels at HBSS-65m and HBSS-111.5m present similar trends to one another and both have responded to rainfall since monitoring started (Figure 12).

A gradual decline in water levels is observed throughout 2020 which is likely attributed to mining at LW W1. Water levels at HBSS-65m and HBSS-111.5m stabilised in November 2020 and started to recover respectively at 158.7 mAHD and 154.2 mAHD in April 2021. Since this period, water levels in HBSS-65m and HBSS-111.5m fluctuated by 0.5m and have responded to the early 2022 rainfall in the range 0.7m to 1m.

As of March 2022, water levels in HBSS-65m and HBSS-111.5m are respectively 2.5 m and 1 m above water levels observed during the baseline period (i.e. prior to LW 32).

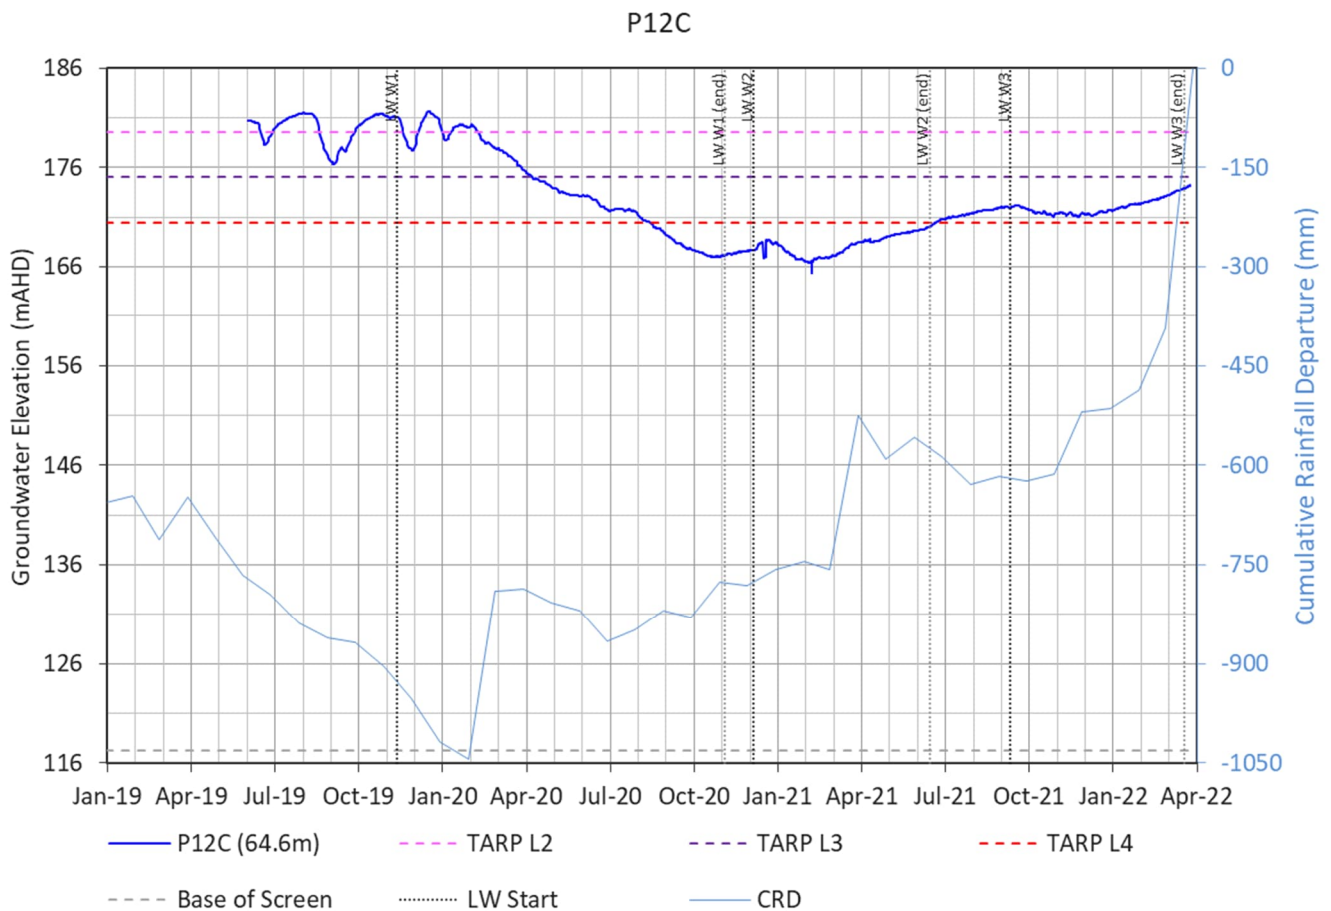
Figure 13 Groundwater Level Exceedance at P12C

During the reporting period, groundwater levels at P12C have increased to a maximum of 174.2 mAHD in March 2022 and are 2.1 m below baseline levels (Table 6). Groundwater levels at P12C have increased by 2.8 m in March 2022 and are approximately 3.1 m above groundwater level observed in the upper piezometer P12A and P12B (Figure A-1). A TARP Level 3 still applies at P12C as the recovered groundwater levels as of March 2022 are below the trigger level 3.

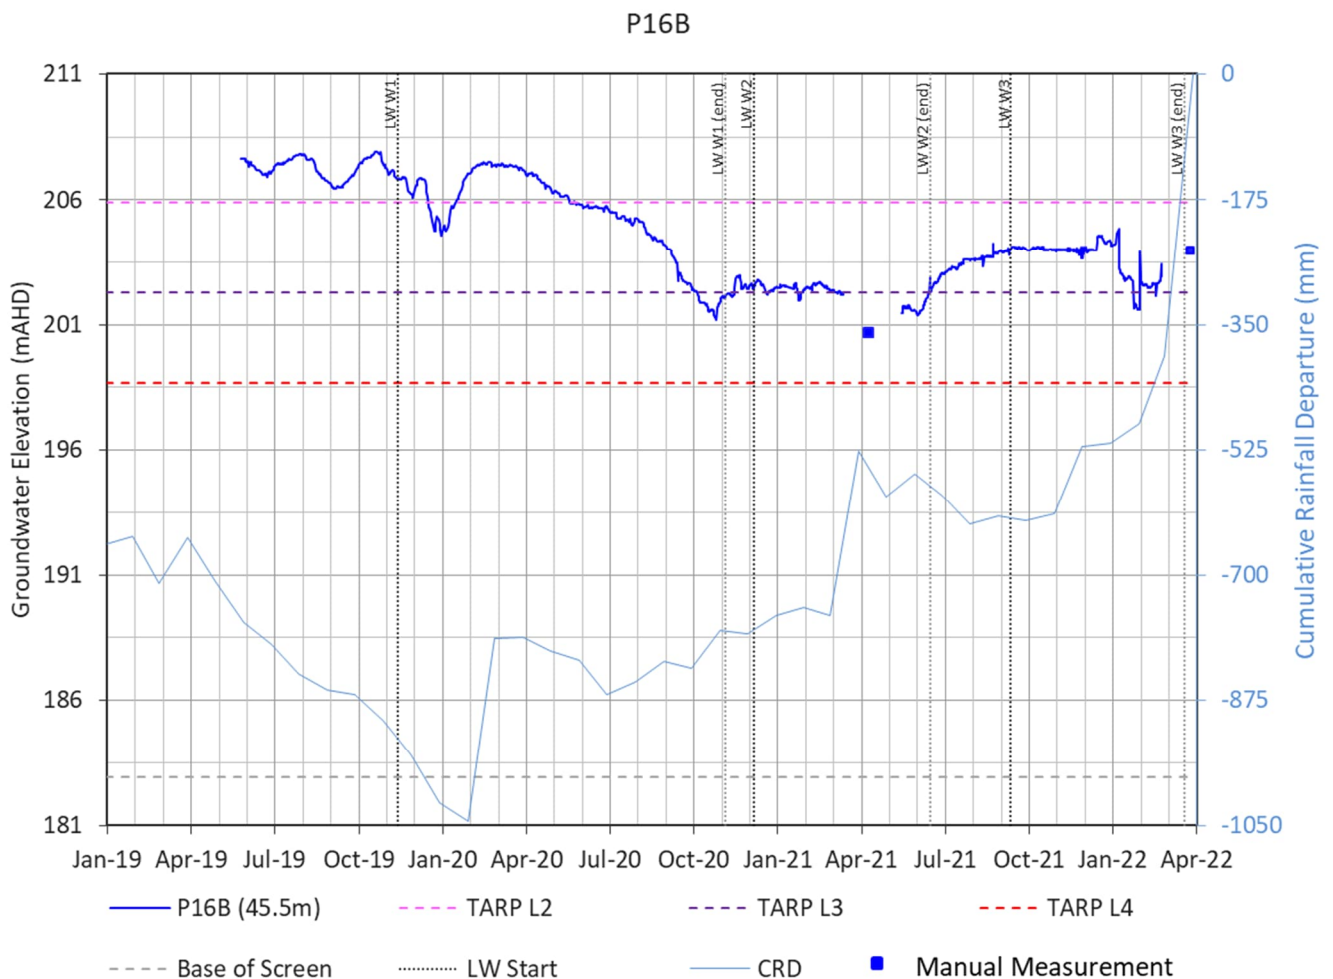
Figure 14 Groundwater Level Exceedance at P16B

Both P16B and P16C have shown a TARP Level 4 exceedance from December 2020 to August 2021 and reduced respectively to Level 2 and Level 3 from September 2021. During the reporting period a TARP Level 2 and Level 3 still apply at P16B and P16C respectively.

At P16B, groundwater levels were observed at 202.8 mAHD in mid-January 2022, below the trigger TARP Level 2 (205.9 mAHD) following a decline of approximately 1.8m (Figure 14). SLR investigated the nature of the sharp decline (SLR, 2022a). The recent decline in groundwater levels could be due to a delayed mining effect from LW W2 and active mining at LW W3. The sudden decline in groundwater levels at P16B could potentially be due to the sudden movement of strata from mining. Similar sudden declines were observed at P15 located adjacent to the northern end of LW W3 after the commencement of that panel (Appendix A, Figure A-3).

During the second half of January 2022, water levels at P16B declined by 1.4 m, dropping below the TARP Level 3 for a short-period of time between 25<sup>th</sup>- 31<sup>st</sup> January 2022 before rising back to approximately 203.4 mAHD from March 2022. As of March 2022, groundwater levels at P16B are within a TARP Level 2 (Figure 14).

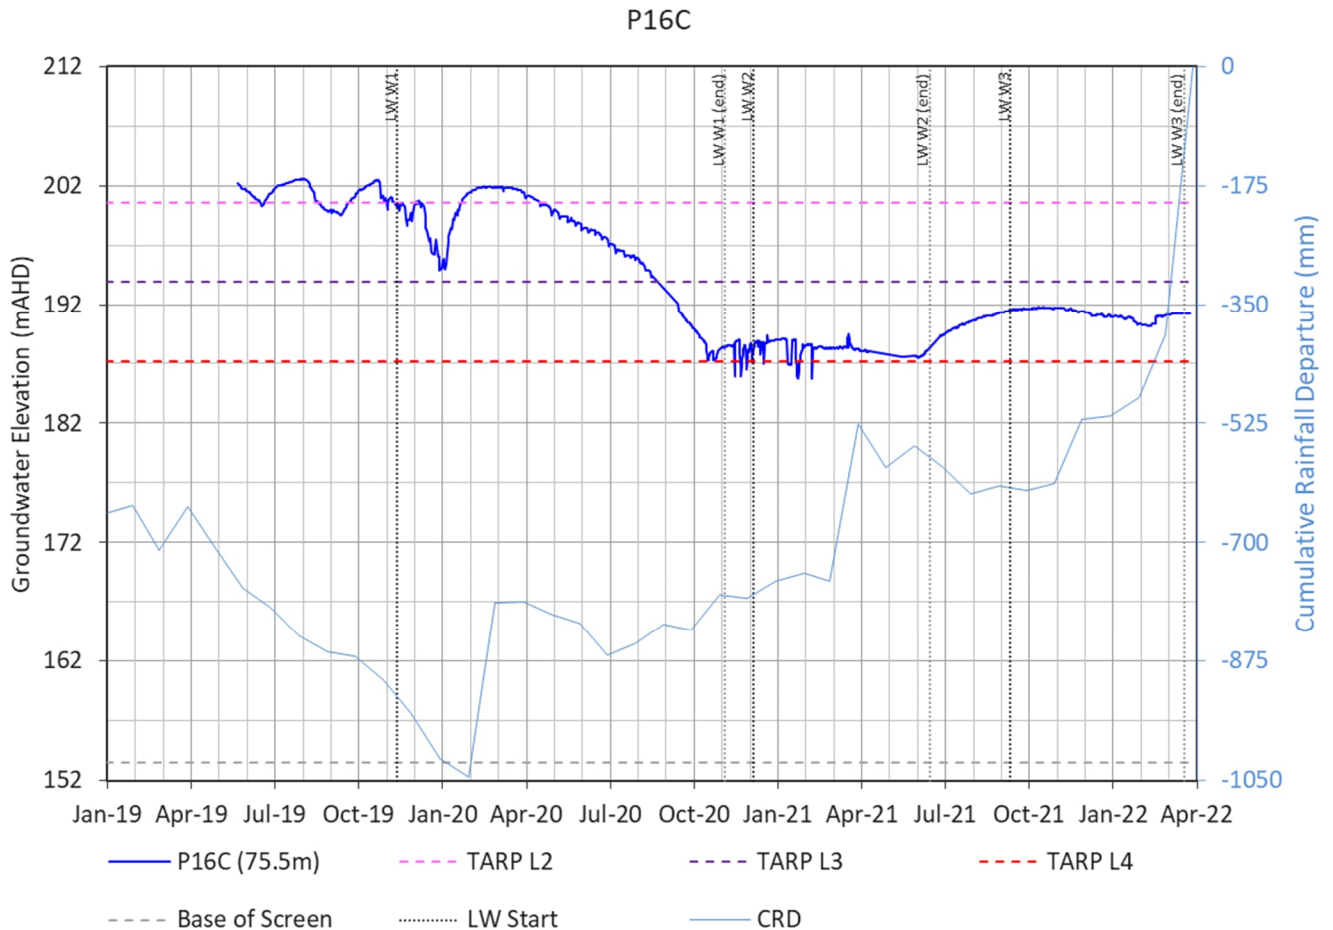
Figure 15 Groundwater Level Exceedance at P16C

During the reporting period, recovery in groundwater at P16C has reduced with water levels at 191.7 mAHD and 7.6 m below baseline levels (Table 6 and Figure 15).

Groundwater levels at P16C gradually declined by approximately 0.4 m throughout the reporting period to 190.2 mAHD and are observed at 191.3 mAHD in March 2022. As of March 2022, groundwater levels remain below the trigger TARP Level 3 (193.9 mAHD), hence a TARP Level 3 still applies (Figure 15).

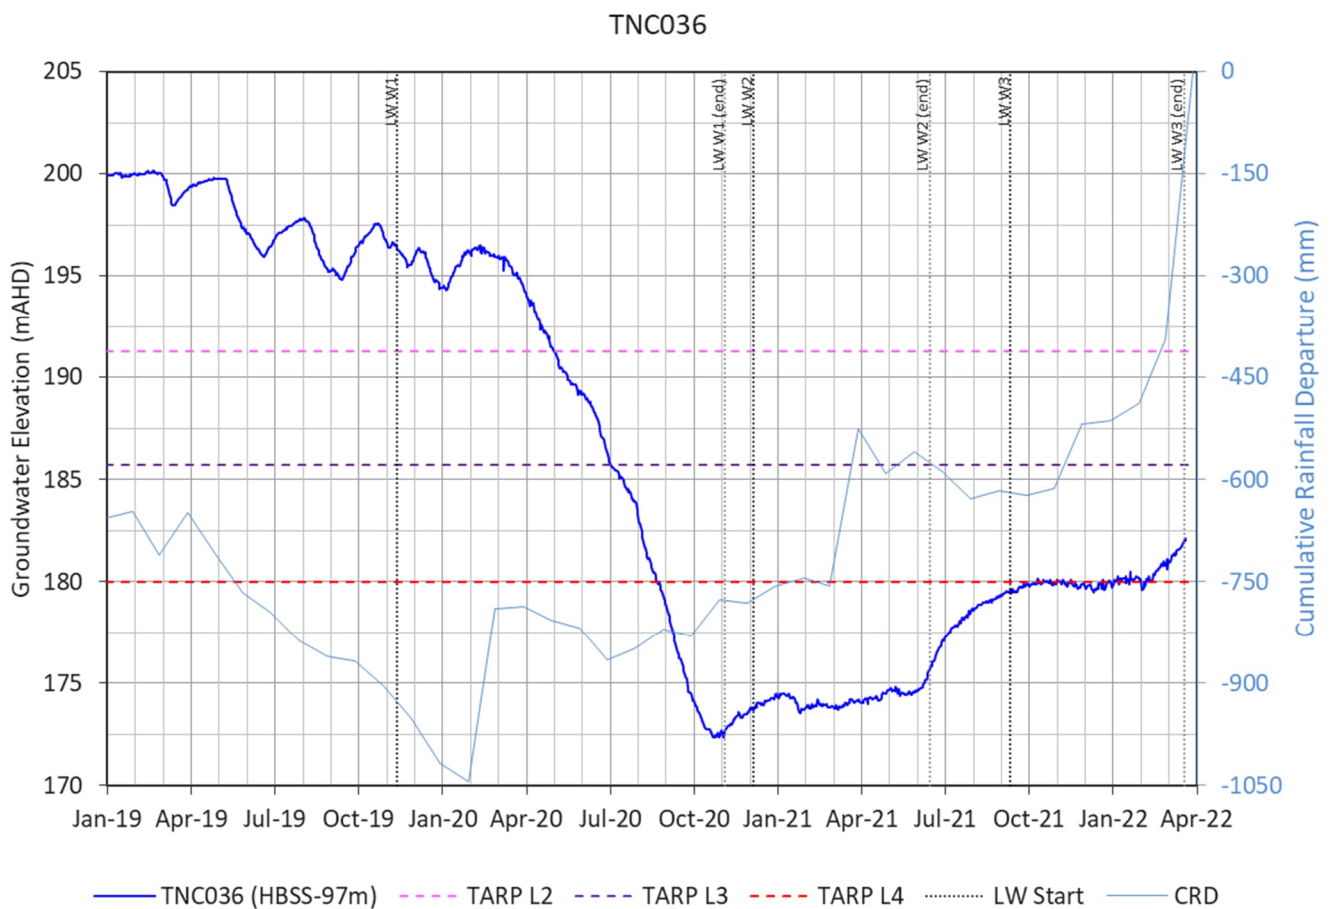
Figure 16 Groundwater Level Exceedance at TNC036-HBSS-97m

At HBSS-97m groundwater levels are observed between 180.7 and 179.6 mAHD between November 2021 and February 2022. Over this period groundwater levels seem to have stabilised with fluctuations up to 1 m. This follows a period of recovery since June 2021 (Figure 16). In February 2022, groundwater levels declined marginally below the trigger TARP Level 4 (180 mAHD) for short periods of time (five days in February 2022). As of March 2022, groundwater levels increased above the trigger TARP Level 4, hence a TARP Level 3 applies.

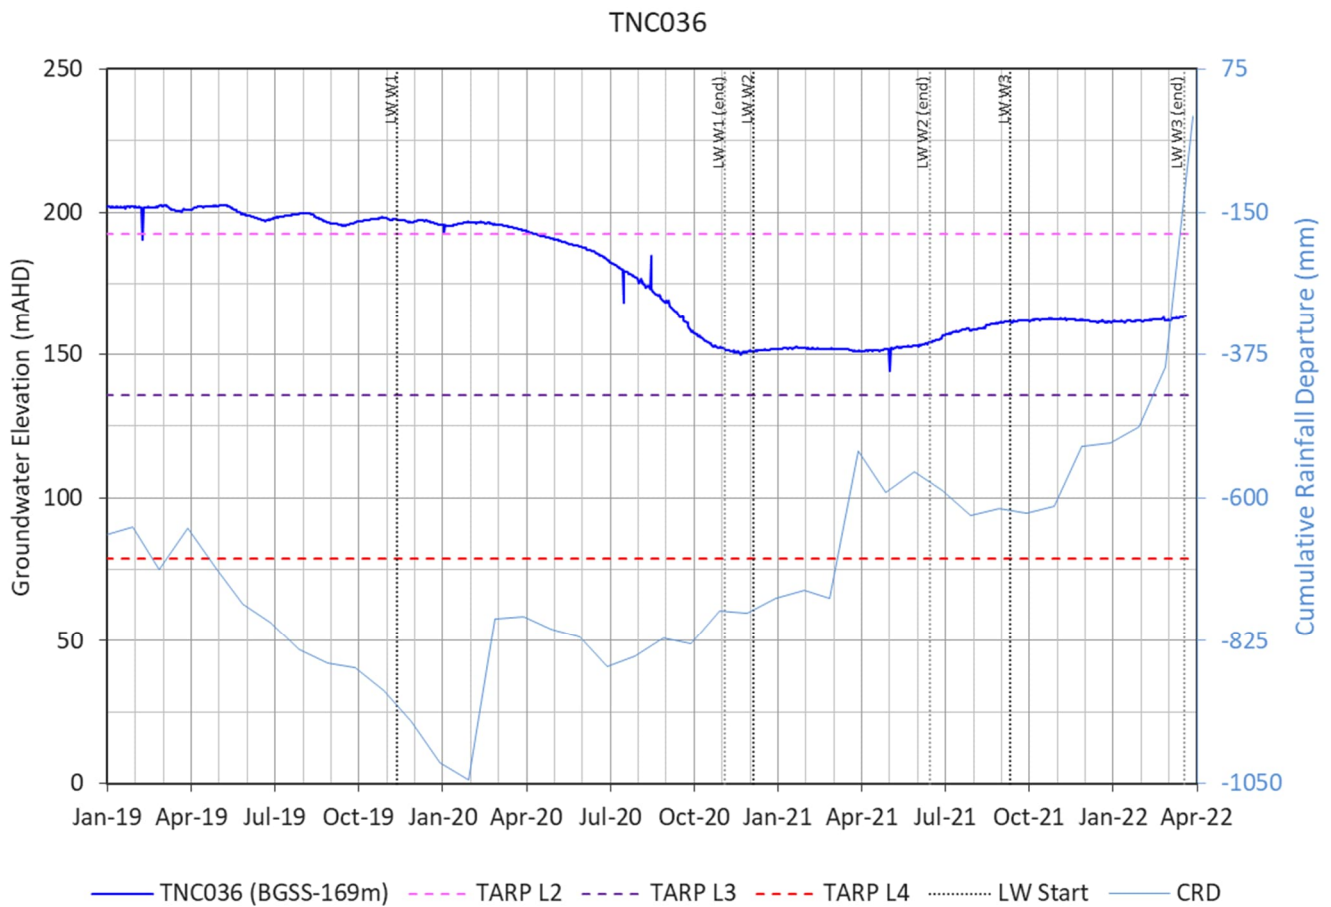
Figure 17 Groundwater Level Exceedance at TNC036-BGSS-169m

In HBSS-169m, the reduction to a TARP Level 2 occurred in September 2021 while groundwater levels continued to recover within the revised TARP Level 2. Groundwater levels are observed between 161.5 and 163.5 mAHD and increase by approximately 2 m during the reporting period (Figure 17). The groundwater trend at TNC36-169m in March 2022 remains consistent with the observations made in the six-monthly review (SLR, 2021a) and previous monthly reporting (SLR, 2022b). As of March 2022, groundwater levels remain below the trigger for TARP Level 2 (192.5 mAHD), hence a TARP Level 2 still applies.

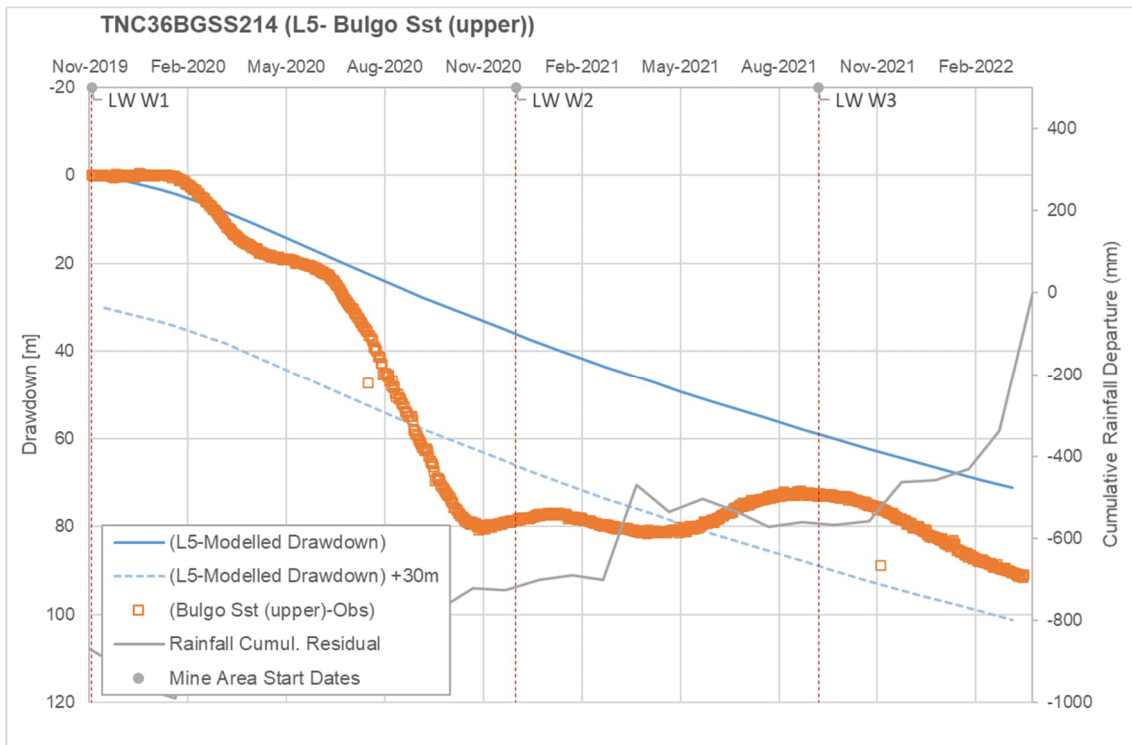
Figure 18 Comparison of Modelled and Observed Drawdown at TNC036 (BGSS-214m) with the +30m Threshold Modelled Drawdown

Figure 18 shows that the observed drawdown at TNC036-BGSS-214m exceeds the modelled drawdown from March 2020 and the 30 m predicted drawdown between September 2020 and April 2021. Since May 2021, a TARP Level 2 applies with observed water levels within the predicted drawdown (+30m) (Table 5).

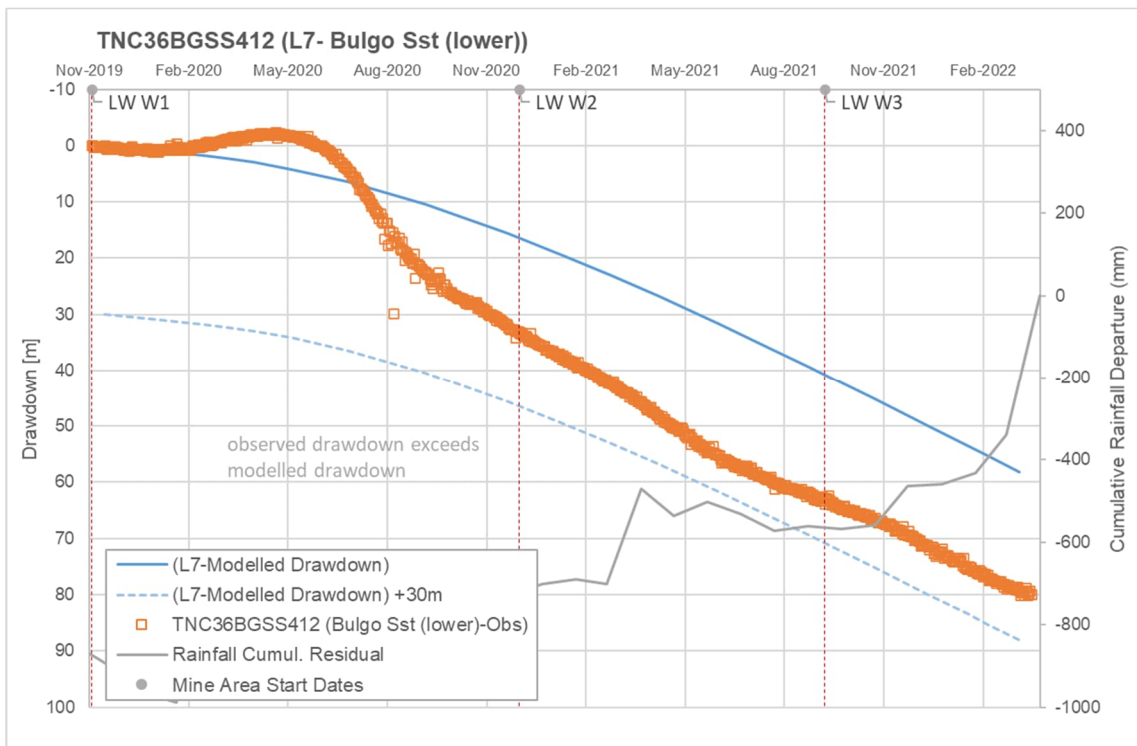
Figure 19 Comparison of Modelled and Observed Drawdown at TNC036 (BGSS-412.5m) with the +30m Threshold Modelled Drawdown

Figure 19 shows that the observed drawdown at TNC036-BGSS-412.5m exceeds the modelled drawdown from August 2020 but remains within the predicted drawdown (+30m) as of March 2022. A Level 2 TARP criteria applies at TNC036-BGSS-412.5m over the reporting period (Table 5).

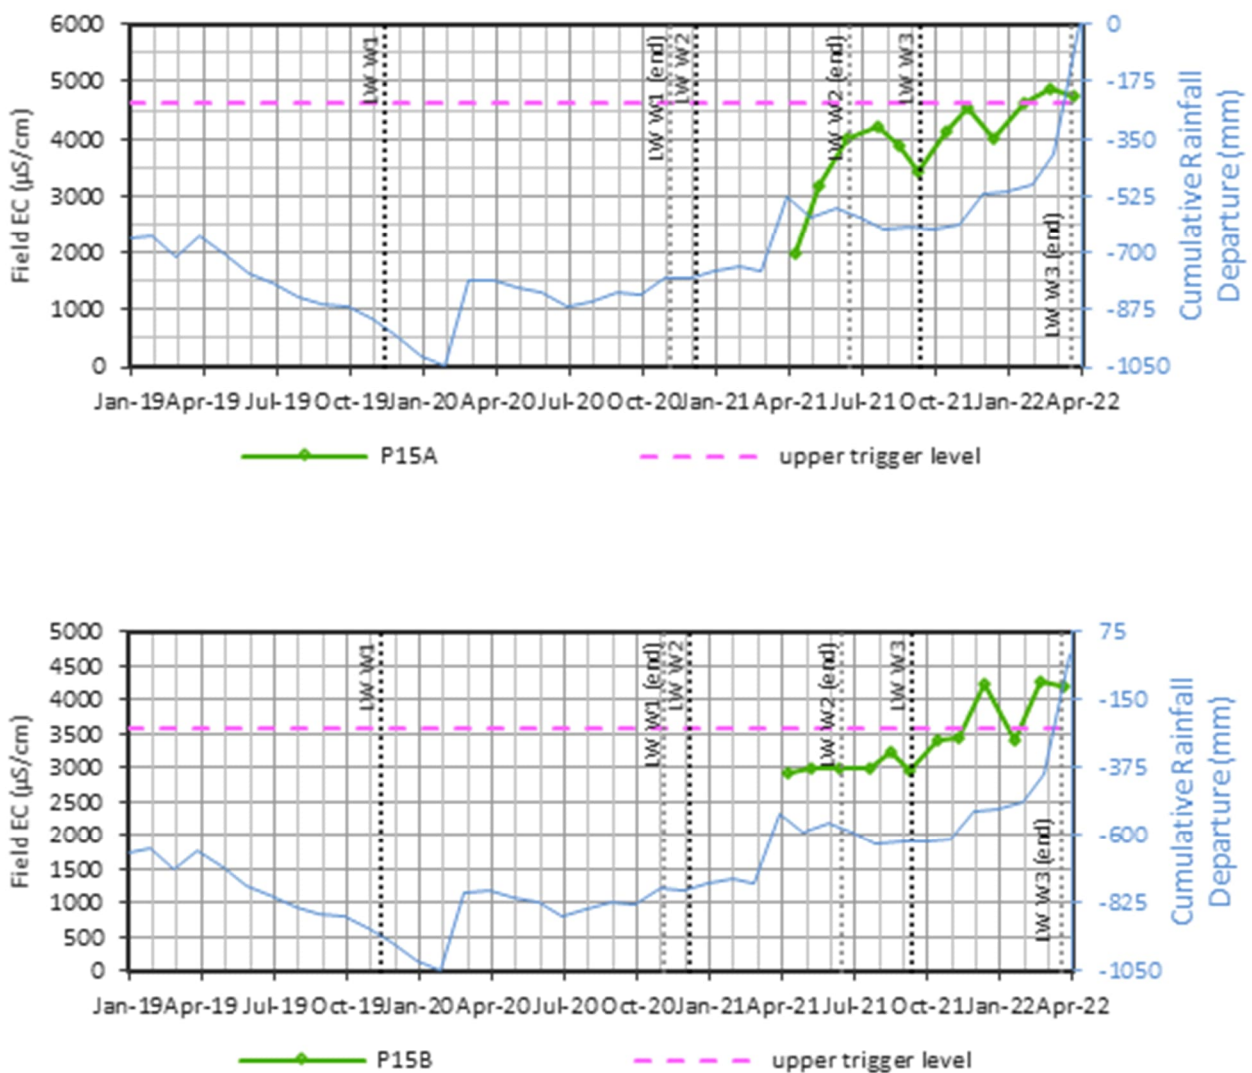
Figure 20 EC Exceedances at P15A and P15B

EC in P15A shows fluctuating behaviour since monitoring started in April 2021. The salinity at P15A has been increasing from 4,010 in December 2021 to 4,860  $\mu\text{S}/\text{cm}$  in February 2022 before reducing to 4,760  $\mu\text{S}/\text{cm}$  in March 2022. Since February 2022, EC has been marginally above the TARP Level 2 of 4,620  $\mu\text{S}/\text{cm}$  (Figure 20).

EC in P15B also shows fluctuating behaviour. At P15B, EC triggered a TARP Level 2 of 3,575  $\mu\text{S}/\text{cm}$  in December 2021 before returning within TARP Level 1 in January 2022. In February 2022, EC increased to 4270  $\mu\text{S}/\text{cm}$  and reduced slightly to 4,210  $\mu\text{S}/\text{cm}$  in March 2022 triggering the TARP Level 2 since February 2022 (Figure 20).

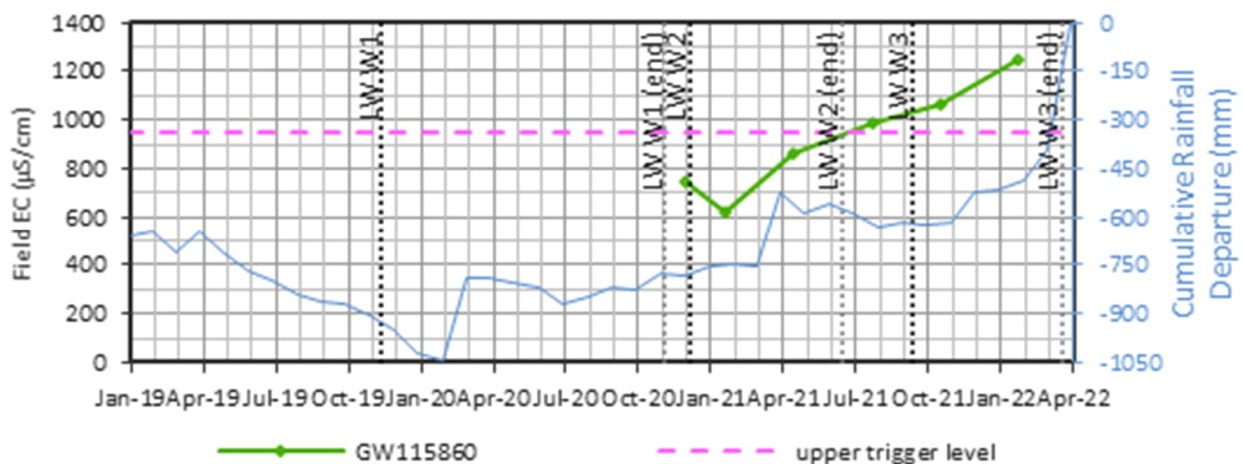
Figure 21 EC Exceedances at GW115860

The salinity at GW115860 has been steadily increasing from 621  $\mu\text{S}/\text{cm}$  in January 2021 to 1,246  $\mu\text{S}/\text{cm}$  in March 2022. Final EC in January 2022 at this bore exceeds the trigger level of 948.2  $\mu\text{S}/\text{cm}$  for three consecutive recordings (greater than 6 months), resulting in a potential TARP Level 4 (Figure 21). Private bore GW115860 is used for domestic purposes. SLR (2022a) investigated the trigger exceedances at GW115860 for EC. The following summarises the findings presented in SLR (2022a):

- The reason for the increased EC at GW115860 is unclear, although it is consistent with the trend observed at nearby bore GW105228. Therefore, this trigger is only 'potential' Level 4 TARP trigger, and it has not been confirmed that the cause is mining.

- No drawdown was observed during the extraction of LW LW3 at GW115860, and hence drawdown does seem to be the cause of the change in EC;
- The increase in EC at GW115860 (to 1,246  $\mu\text{S}/\text{cm}$ ) does not change the beneficial use classification of the groundwater extracted at this site, and therefore the currently observed effects are considered to be immaterial. Indeed, salinity (TDS) at GW115860 remains within the desirable palatability of less than 600 mg/L (class A1 category – DPIE, 2012). Groundwater quality at GW115860 remains suitable for all beneficial uses, including the current purpose.

- Given the low salinity of groundwater at GW115860, and the small incremental change in that salinity in relation to the beneficial use classifications it is recommended to continue observing this bore over the next monitoring period (April 2022) to see if EC decreases, otherwise to revise the trigger. The most reliable method to revise the trigger would be to adopt the EC trigger from GW105228 for use at GW115860 as it has been derived from a longer record period.

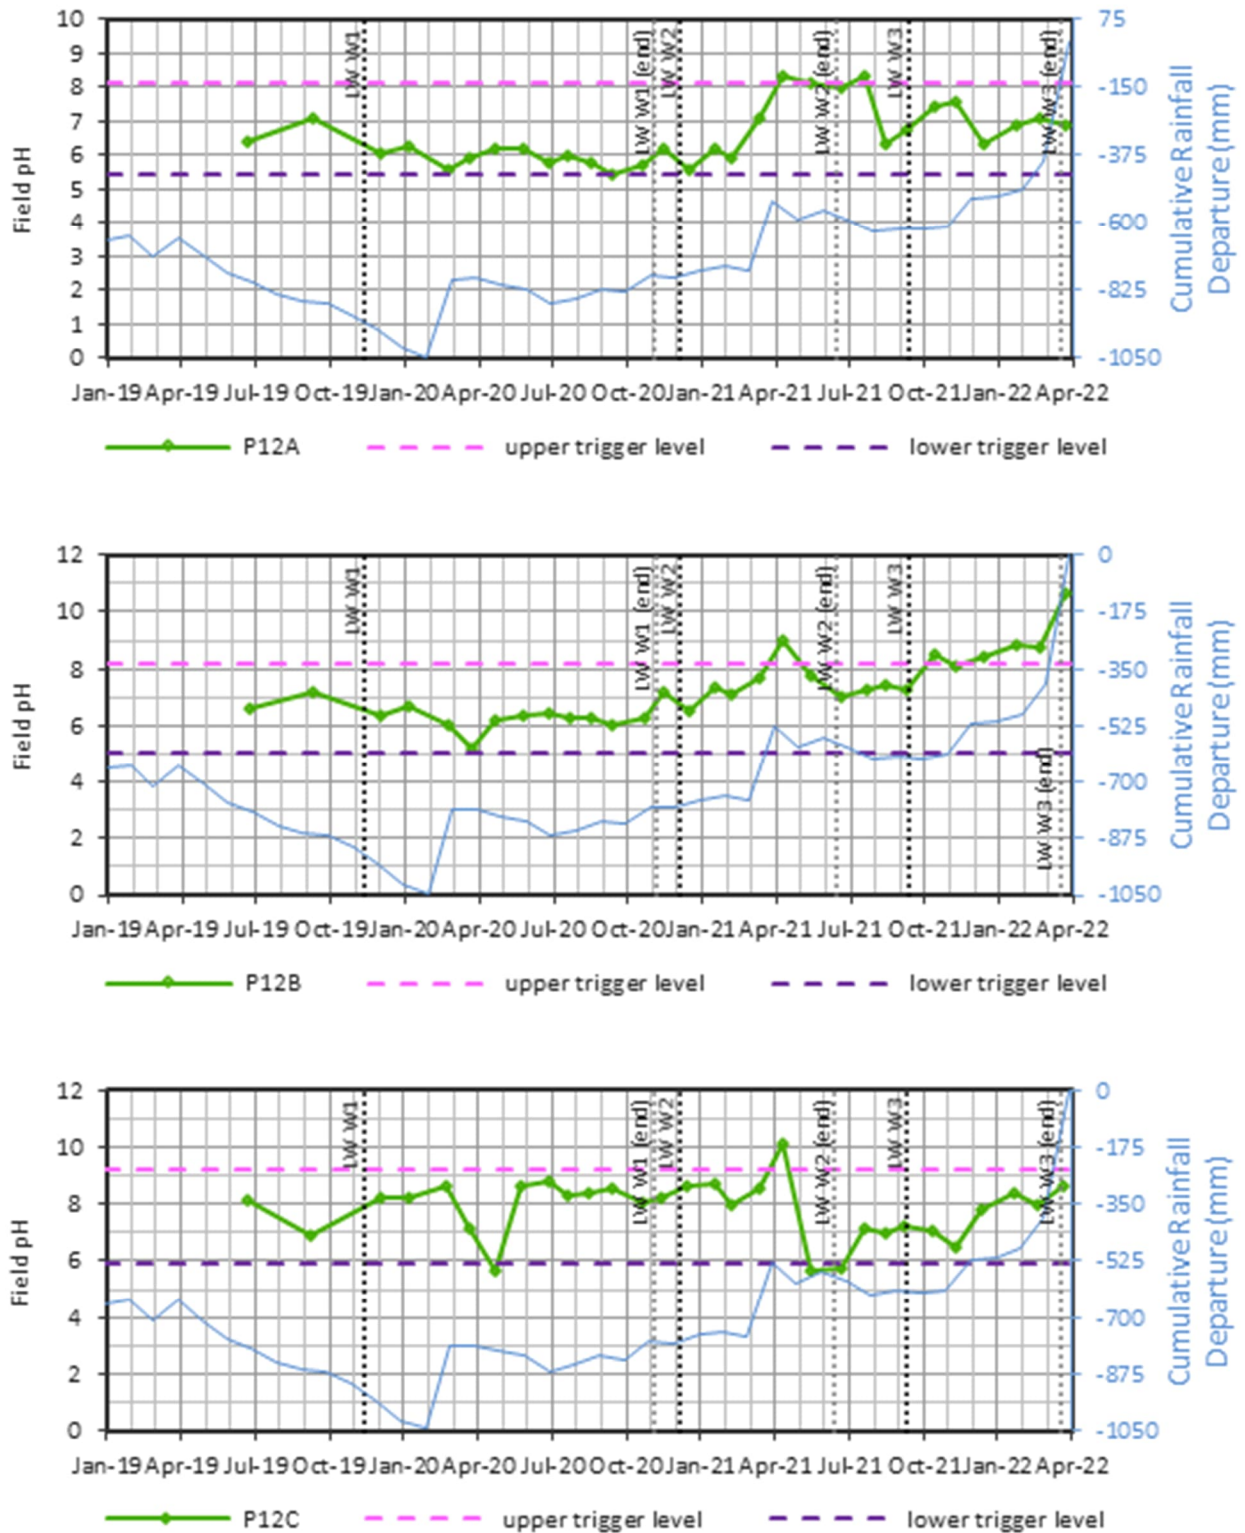
Figure 22 pH at P12A and P12C and pH Exceedances at P12B

P12B triggered the upper trigger level for pH between December 2021 and March 2022 with a pH of 10.65 in March 2022 (trigger level = 8.16) (Figure 22). A potential TARP Level 4 was identified in March 2022 as four consecutive recordings (greater than three months) were recorded during a period of above average rainfalls.

- A rising trend in pH was previously observed at P12A, P12B and P12C around December 2020 to April 2021. It has been previously reported by SLR (2021a), that this could be due to compromised integrity of the monitoring bores combined with high rainfall causing cement to become mobilised into the groundwater.

- The reason for the increase in pH at P12B causing the trigger exceedance is unclear and could potentially be related to compromised bore integrity, however an increasing trend was also observed at GW072402.

At this time, a mining-related effect is plausible, however the consequences of this effect (if it is mining-related) are considered minor.

In addition, in March 2022, pH at nearby bores P12A and P12C is within a TARP Level 1 at 6.9 and 8.61 respectively, both relatively neutral, and well below the pH seen at P12B (Figure 22). It is recommended that pH at P12B remains a potential TARP Level 4.

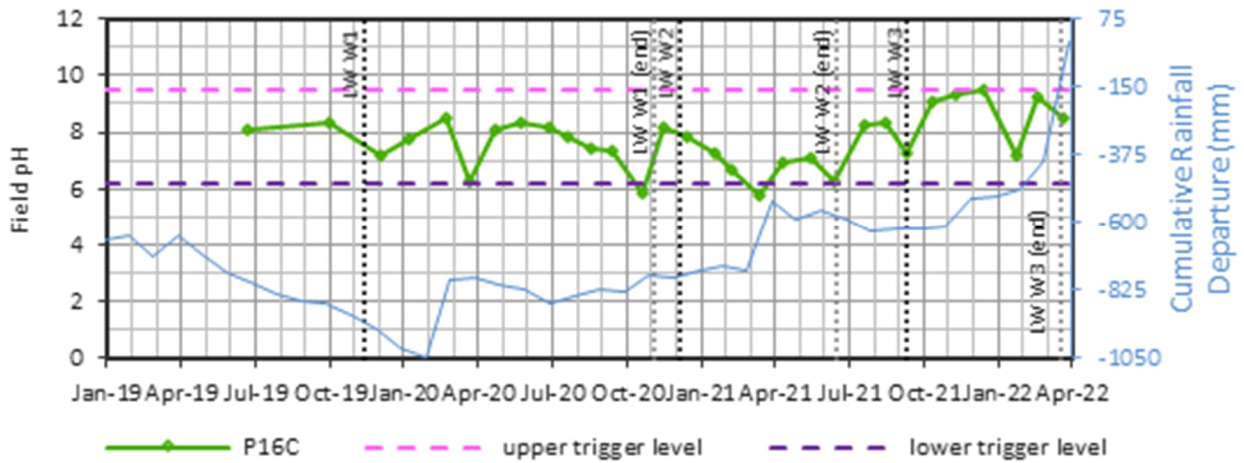
Figure 23 pH Exceedances at P16C

pH at P16C exceeded the TARP Level 2 trigger of 9.49 in December 2021. pH increased from 9.36 to 9.5 in December 2021. Between January 2022 and March 2022, pH at P16C shows a fluctuating behaviour ranging from 7.15 to 9.22. As of March 2022, pH at P16C is within a TARP Level 1.

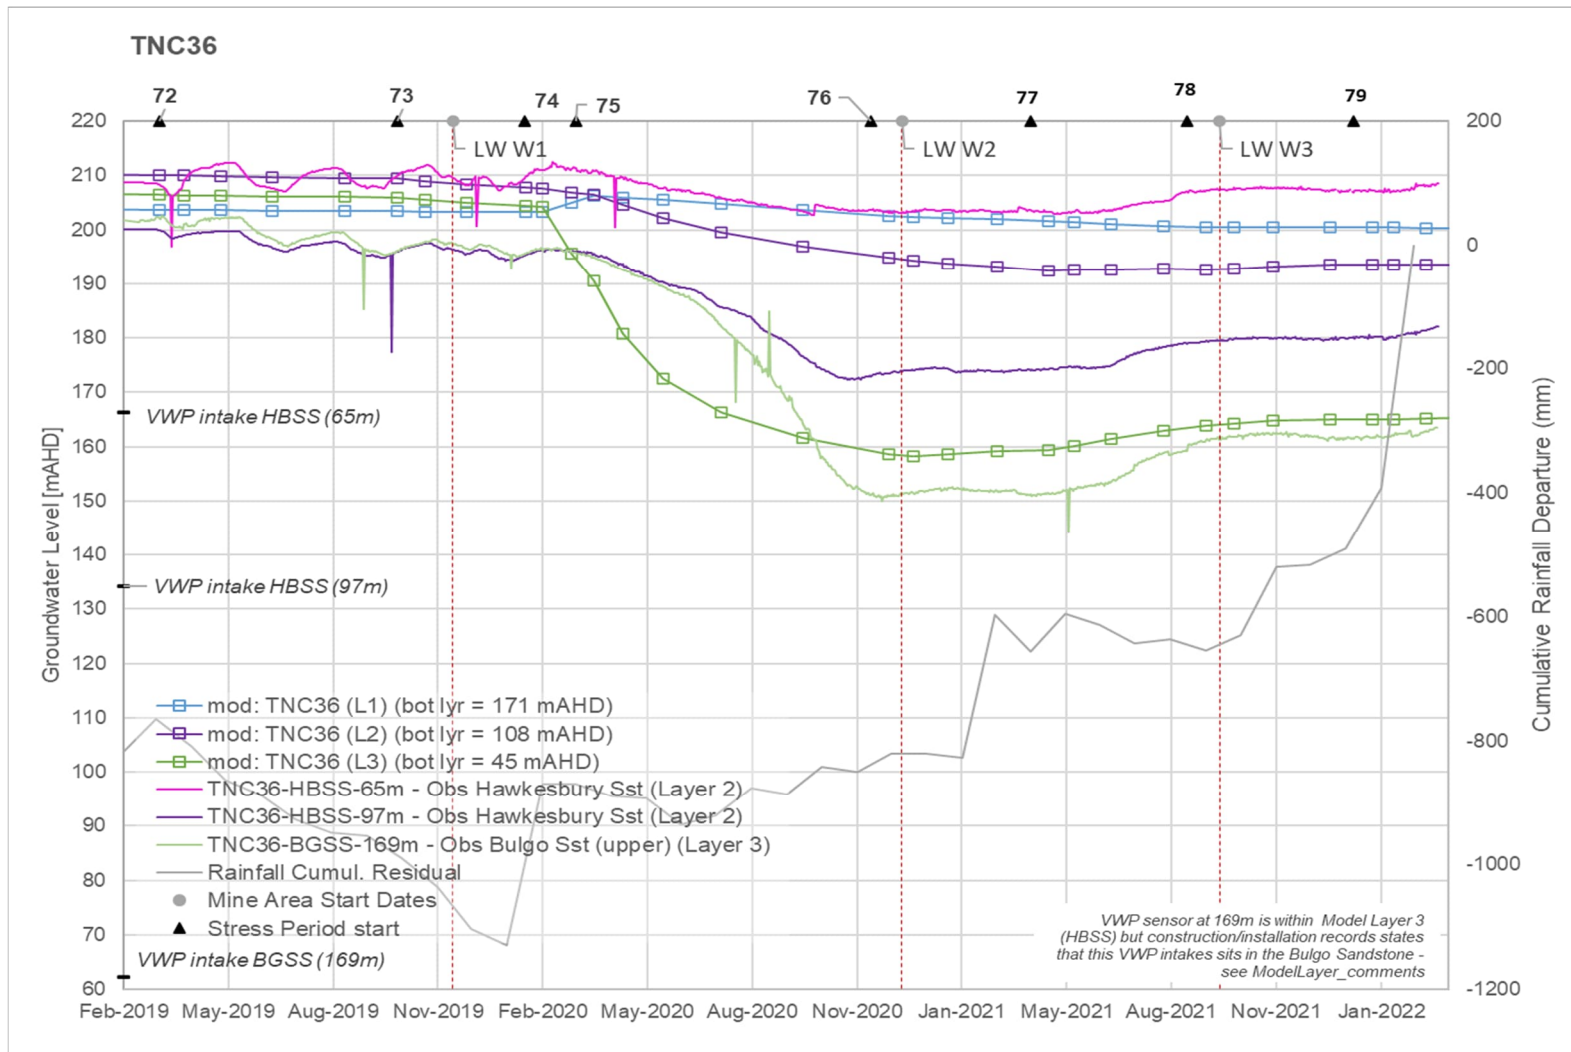
Figure 29 Comparison of Modelled and Observed Groundwater Levels at TNC036

At TNC036 (Figure 29) the simulation of drawdown in model layer 2 is 16 m, which is higher than in the HBSS-65m piezometer (approximately 6 m drawdown), and less than the 24 m recorded against the HBSS-97 m piezometer. The HBSS-65m and HBSS-97 m piezometers are assigned the same model layer, but the model gives a reasonable estimate in the rate and magnitude of drawdown at this location. The model captures the stabilisation in observed water levels between May and June 2021 relatively well. There is a small underestimation in the model to replicate the observed recovery in June 2021 and later in February-March 2022 but modelled groundwater levels are within 10 m observed as of March 2021 (i.e. similar as modelled prior to LW W1).

- The observed stabilisation and recovery in water levels in BGSS-169 m are well replicated by the model, being within 1 m of observed as of March 2022. This suggests that the height and mode of subsidence fracturing in this area is well represented in the model. The issue with comparing the model to these observed drawdowns and recoveries is that the attribution of depths and stratigraphy is not completely reliable (Section 4.1.2.7).

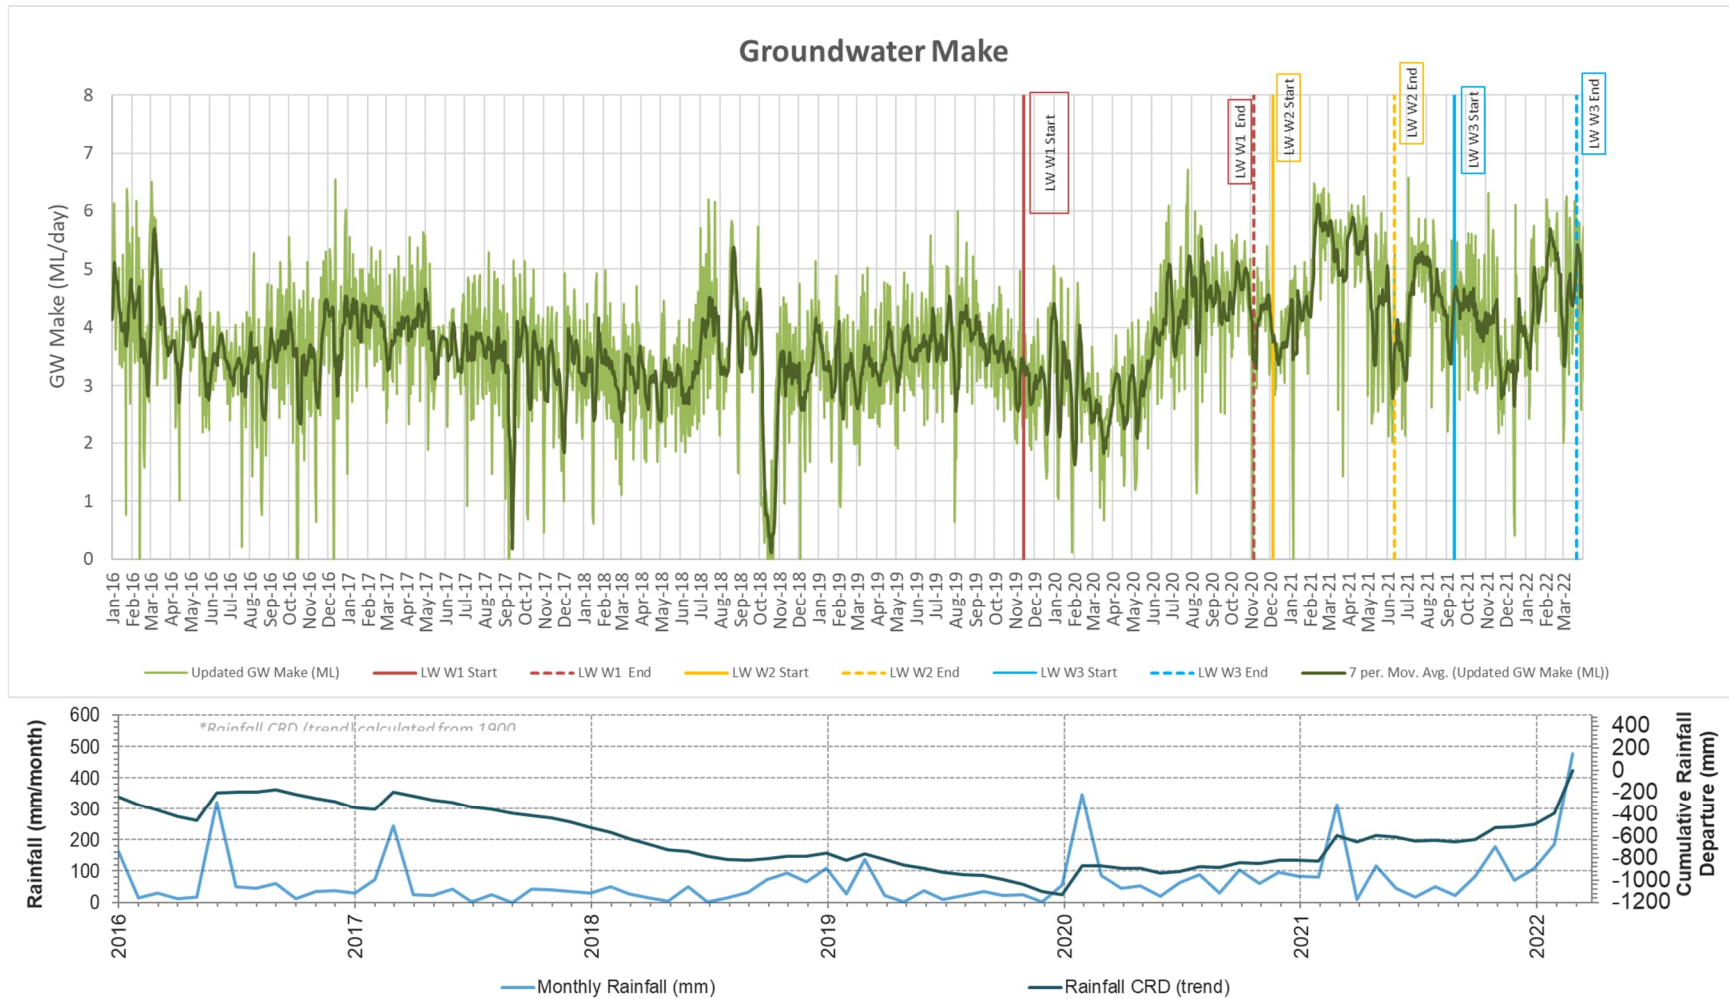
Figure 30 Historical Record of Inflows at Tahmoor North

For the period 2009 to March 2022 (latest reported record is on 31<sup>st</sup> March 2022), inflows to Tahmoor Mine have been within the range of 2 to 6 ML/d. Figure 30 shows net groundwater inflows against daily water pumped from the mine, alongside the historic rainfall (based on records dating back to 1900) and the Western Domain longwall start dates. Inflows to the mine remained relatively steady throughout the extraction of Longwalls 24B to 32 (SLR, 2021a).

A spike in inflows occurred following the cutting of Longwall 27, however, between this time and May 2020 inflow rates have declined (SLR, 2021a). The period between mid-2020 shows an increase in inflows to greater than 5 ML/day at the end of July 2020 likely due to the extraction of LW W1. Inflows declined in late 2020, before rising in February 2021 (early in LW W2), with the recent peak at marginally over 6 ML/d in March and April 2021 (Figure 30). Inflows to the Western Domain are not metered in isolation from other parts of Tahmoor North but were estimated to be greater than 2.5 ML/d in early 2021 (based on advice from Tahmoor Coal staff in early 2021).

Previously, SLR and their subconsultants have advised Tahmoor Coal staff regarding possible options in the event that inflow rates to the workings rise at a similar rate to that of the recent average inflows seen in March-April 2021. Since April 2021, inflow rates to the mine workings have remained below the previous observed peak of 6 ML/d, with a general reduction in the inflow rates. Groundwater entitlement was not exceeded for the 2021-22 water year and as of March 2022 remain just below the limit for the 2021-22 water year (based on a pro-rata calculation).

Tahmoor Coal is currently in the process of obtaining additional groundwater entitlement to meet the likely requirements of the remaining Western Domain and early Tahmoor South mining operations.
