**Tahmoor Coal Pty Ltd**

# **SIX MONTHLY SUBSIDENCE IMPACT REPORT**

**Western Domain Longwalls West 1 – West 4**

**Report 5 – June 2022**

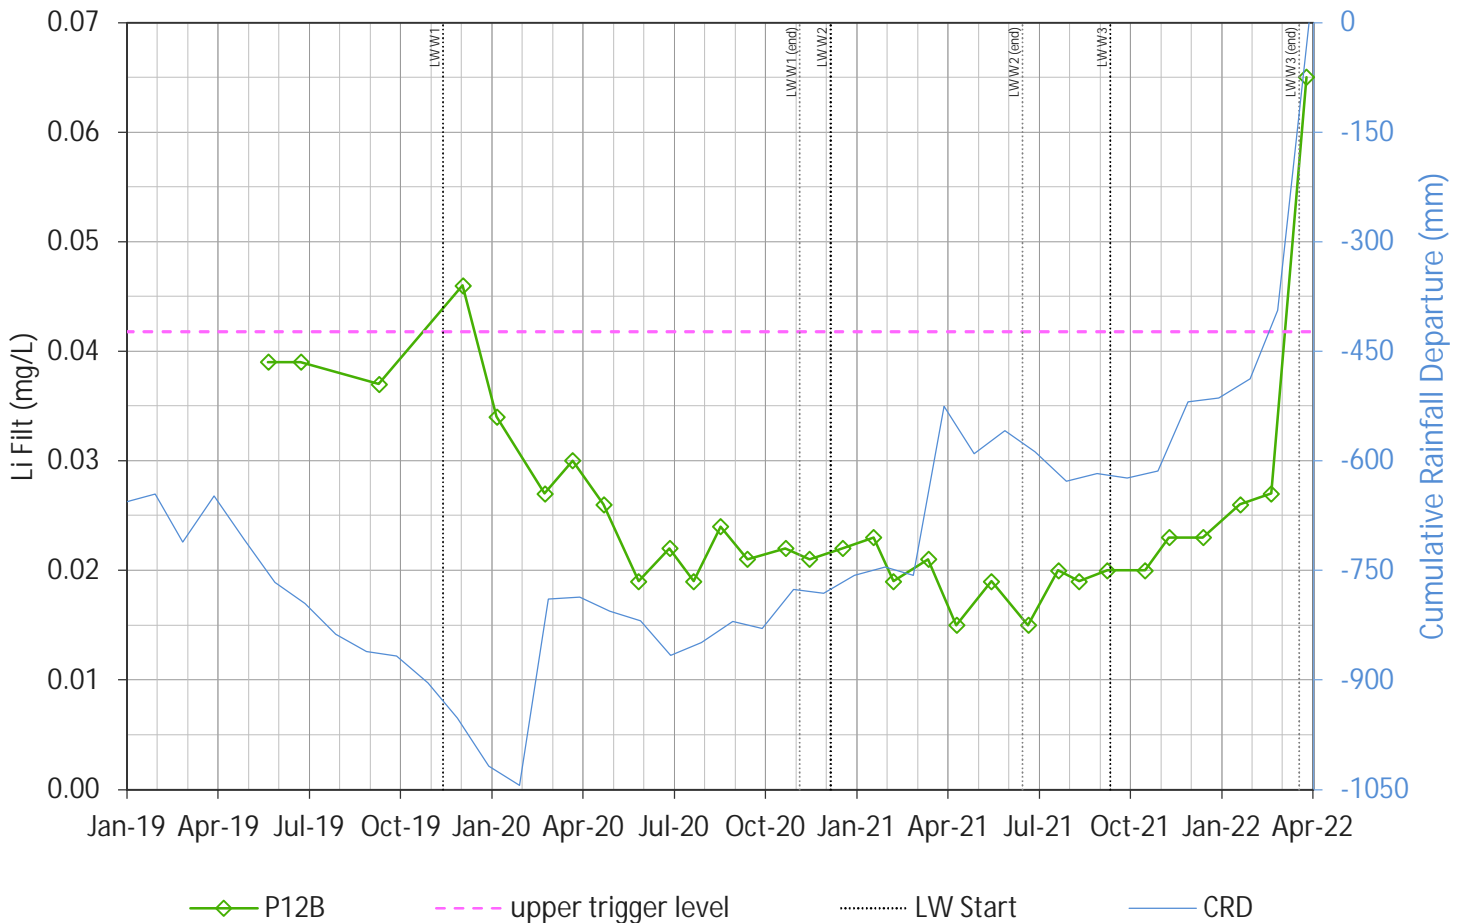
Figure D-4

- A TARP Level 2 for dissolved aluminium (Al) and lithium (Li) was triggered in December and March respectively at P12B. Dissolved (Al) increased from 0.01 mg/L to 0.04 mg/L in December. This aluminium concentration remained close to the trigger level (0.038 mg/L) (Appendix D, Figure D-3). It is noted that aluminium concentrations in all standpipes across the site show fluctuations in the range of 0.01 to 0.06 mg/L, and these are considered representative of the natural groundwater system. Thus, the trigger level for P12B may be too conservative considering the background levels, and therefore occasional exceedances of the trigger limit are expected to occur. Dissolved (Li) increased from 0.027 mg/L to 0.065 mg/L in March marginally above the trigger level of 0.042 mg/L (Appendix D, Figure D-4).

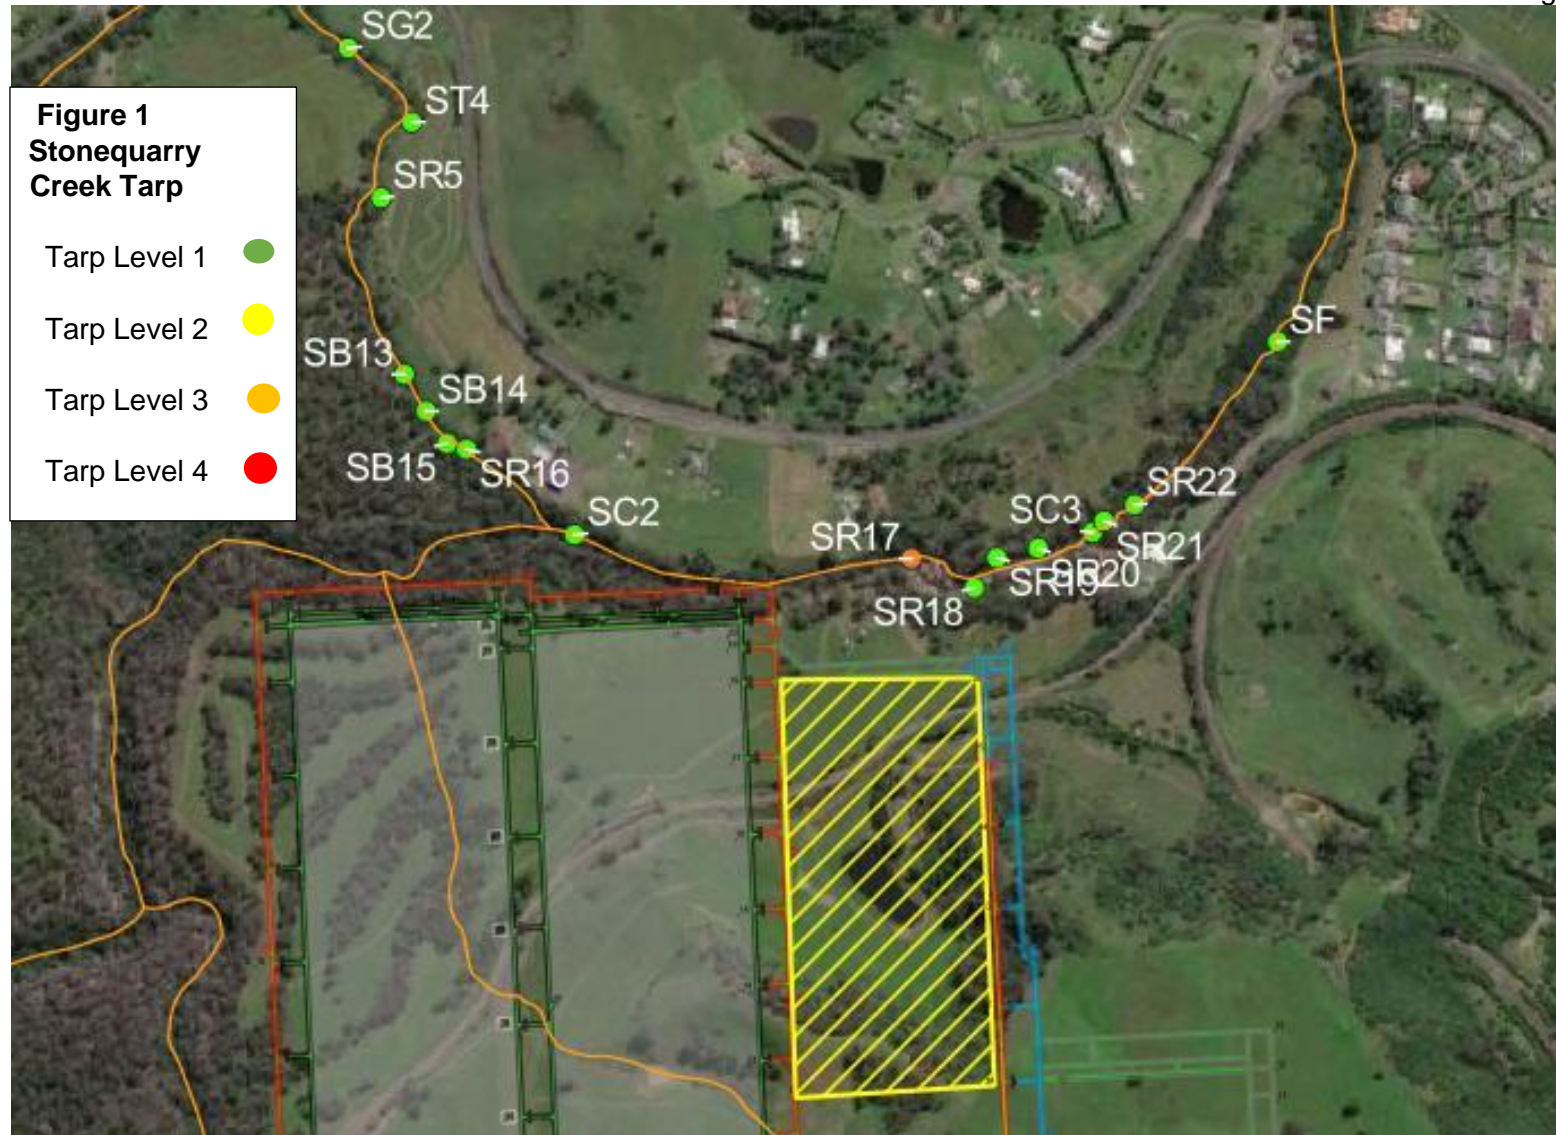
Visual inspections of Stonequarry Creek's pools and associated rock bars within the Longwall West 3 active subsidence reach were conducted on 17 November 2021. The inspections at the sites shown in **Figure 1**, indicated that potential mine-induced surface cracking was observed at SR17 Rockbar. The cracking was observed in an area that vehicles use to access the property on the south side of Stonequarry Creek. No surface cracking, gas release, reduction in pool flow or connective overland flow was observed at any other observed site along Stonequarry Creek. Iron-oxy hydroxide precipitation at site SF was observed however, this had been identified in previous surveys.

Due to the development of laminar cracking and an extension of a natural crack, site SR17 would be at TARP Level 3. All other observed Stonequarry Creek sites were within TARP Level 1 for the observations of individual pool water level and flow, iron oxyhydroxide precipitation and gas releases as compared to previous surveys or the baseline survey conducted in August 2019.

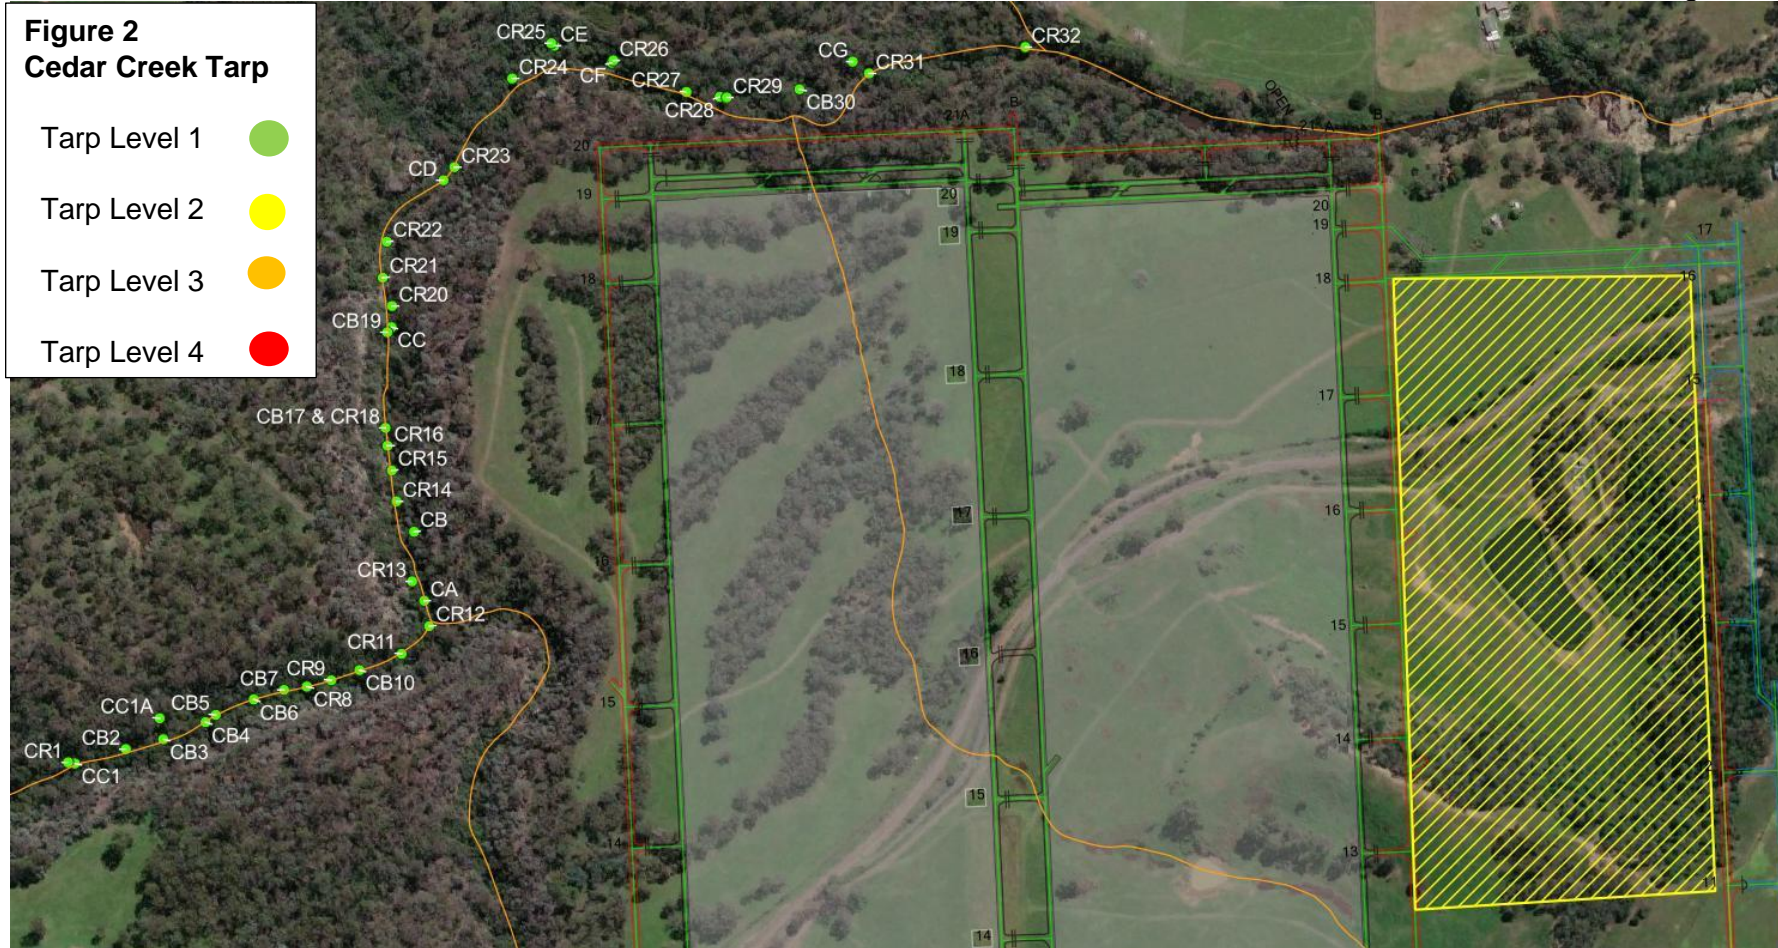
Visual inspections of Cedar Creek's pools and associated rock bars within the Longwall West 3 active subsidence reach were conducted on 17 November 2021. The inspections at the sites shown in **Figure 2**, indicated that no mine-induced surface cracking, gas release, reduction in pool flow or connective overland flow was observed. Iron-oxy hydroxide precipitation at sites CB7, CR11/12, CR14, CR29 and CB30 was observed however, the precipitation was within the degree observed in the pre-Longwall West 1 baseline period.

All observed Cedar Creek sites were therefore within TARP Level 1 for the observations of individual pool water level and flow, iron oxyhydroxide precipitation and gas releases as compared to previous surveys or the baseline survey conducted in August 2019.

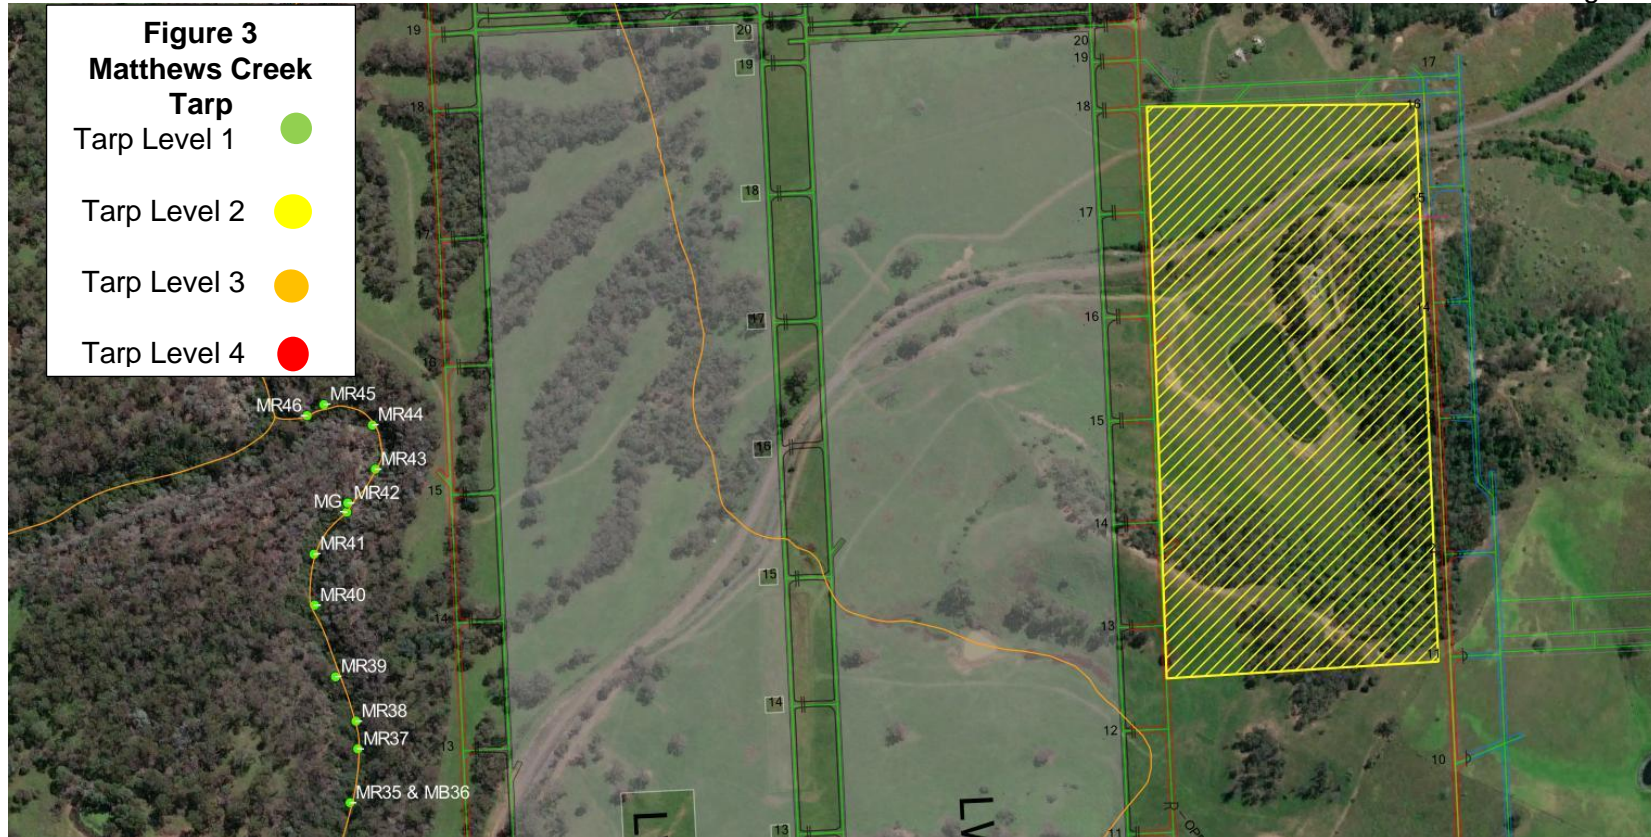
Inspections within the Longwall West 3 reach of Matthews Creek between sites MR35 and MR46 on 27 Oct 2021 as shown in **Figure 3**, identified the presence of minor iron oxy-hydroxide precipitates at site MR35. It should be noted that the iron-oxy hydroxide precipitation was within the degree of precipitates observed in the pre-Longwall West 1 baseline period.

All observed Matthew Creek sites were therefore within TARP Level 1 for the observations of individual pool water level and flow, iron oxyhydroxide precipitation and gas releases as compared to previous surveys or the baseline survey conducted in August 2019.

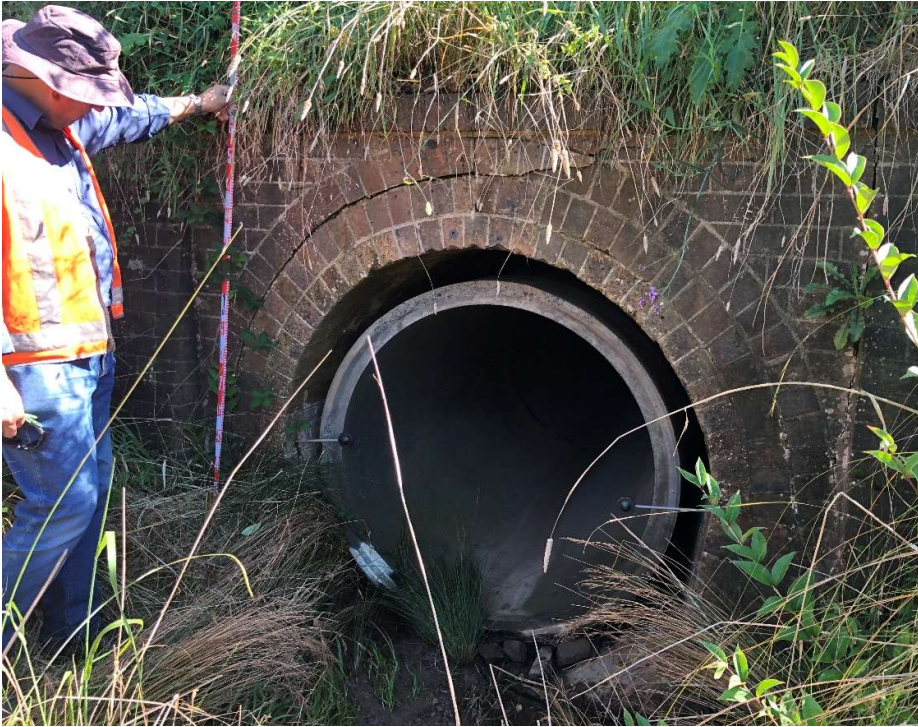
Eastern portal

<b>Site Name</b>	<b>Loop Line culvert 87.850</b>
<b>Heritage listing</b>	Not listed
<b>Site type</b>	Built structure
<b>Location</b>	Above LW W3
<b>Predicted probability of impact during LW W3 – 4</b>	Possible
<b>Item summary</b>	<p>Brick arch culvert</p> <p>When it was initially inspected, this culvert was overgrown with brambles and difficult to assess. Multiple existing cracks were observed during subsequent inspections and supported by photographs.</p>
<b>Monitoring comments</b>	<p>Cracking across and between the bricks is consistent with previous photographs taken during monitoring of the culvert. An inspection by Mark Delaney (engineering geologist) on 3 February 2022 confirmed that the pre-existing cracks on both sides of the culvert have not increased during extraction of LW W3. No changes were noted during the heritage inspection.</p> <p>The inside of the culvert could not be inspected due to the RCP sleeve.</p>

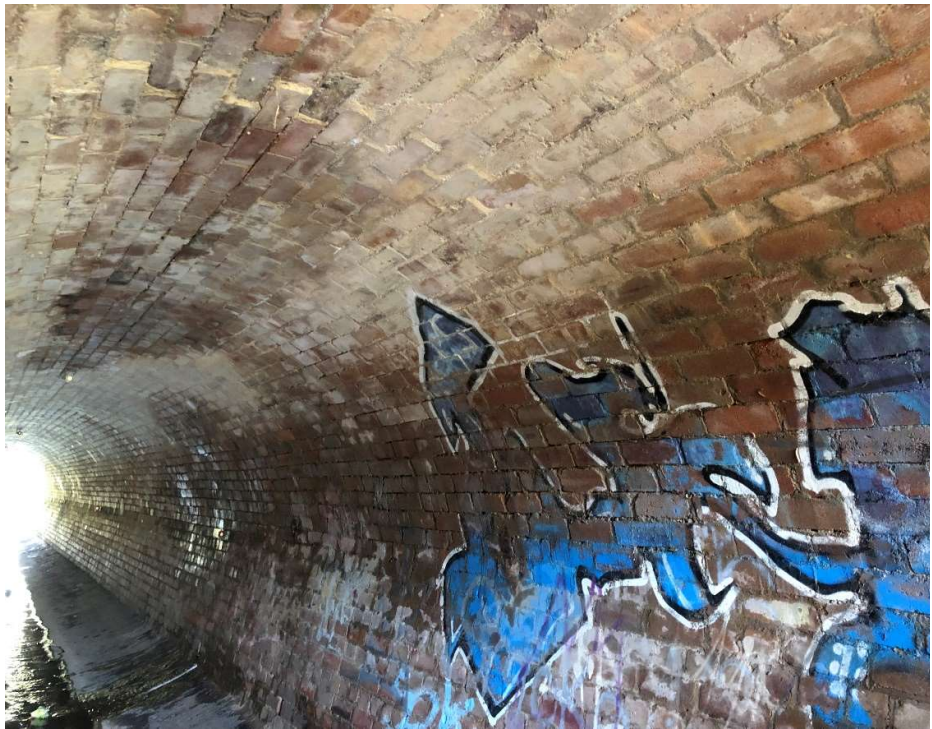
Roof of culvert. View west

Eastern portal. Culvert is in good condition.

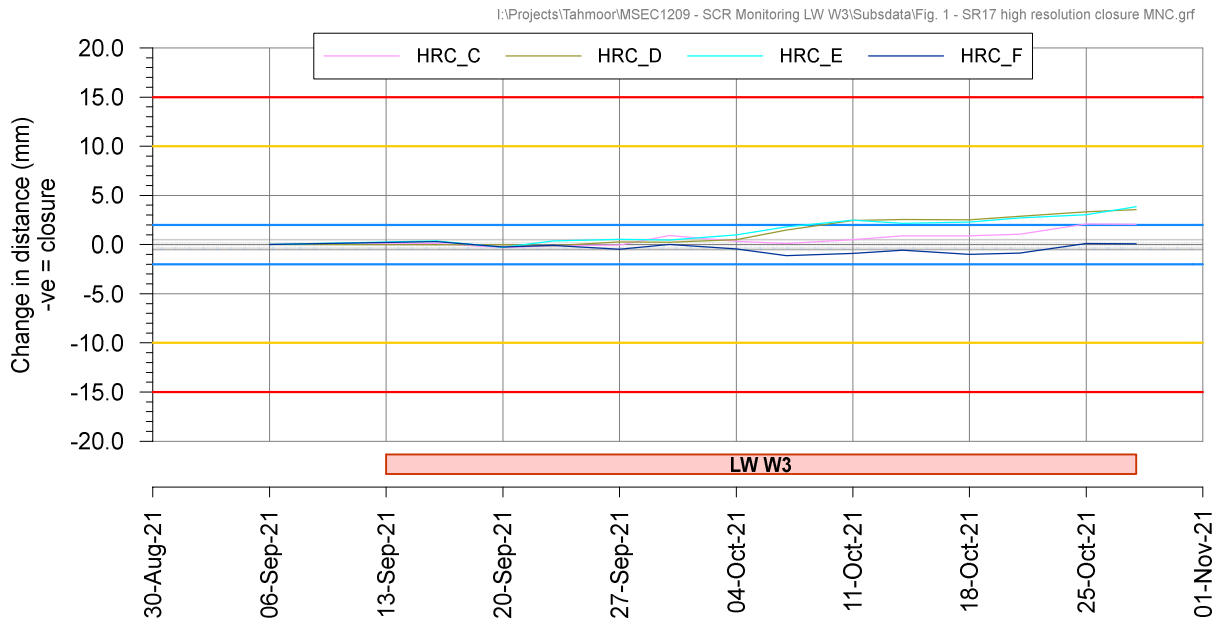
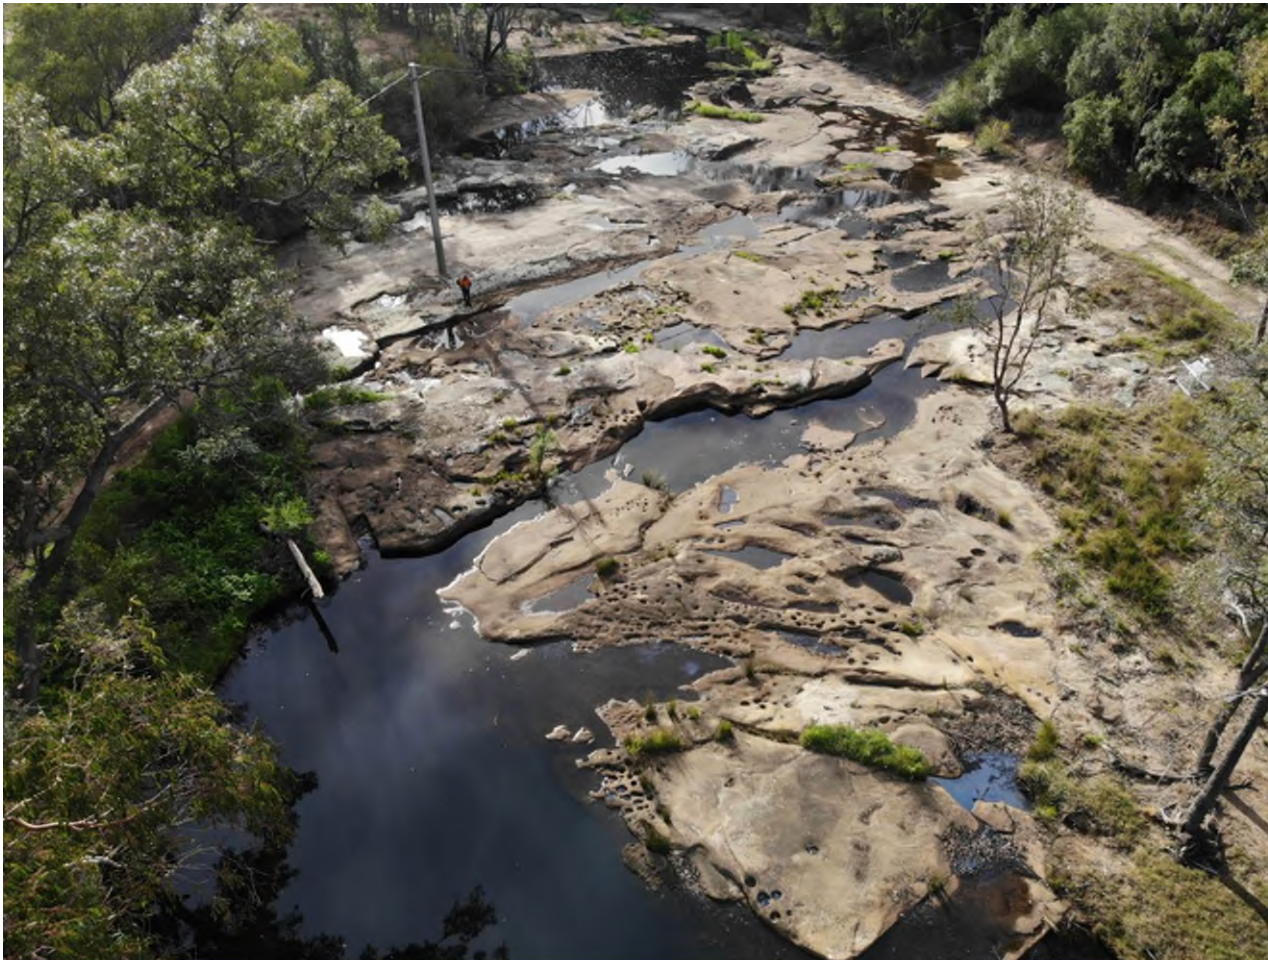
**Rockbar SR17 on 28 October 2021**

Fractures observed in localised area between Marks RBF04 and RBF05, at the end of an existing joint on 28 Oct. Inspection by geotechnical engineers from PSM and SCT on 28 Oct, who confirm fracturing is compressive in nature and appears to be mining-induced. A potential opening of an existing joint has been identified to the east of Mark RBF04 and has been added to the monitoring program. Further geotechnical investigations have been scheduled for 30 Oct. No changes observed across remainder of the rockbar, including across the grinding groove area.

- In light of the observation of fracturing on 28 October, the longwall has been stopped pending further investigations by the Technical Committee.
- The site of fracturing is located downstream of the road crossing, 40 metres south east from the heritage site.
- The visual observations correlate with the survey results, with gradual development of compressive strain prior to fracturing.
- Compressive strain has not been observed across the grinding groove sites.

<ul style="list-style-type: none"> <li>Technical Committee is currently investigating in accordance with the Management Plan. The following actions are recommended at this stage. <ol style="list-style-type: none"> <li>LW to remain stopped until at least 1 Nov until review by Technical Committee has been completed.</li> <li>An inspection by the structural geologist has been scheduled for 30 Oct.</li> <li>Additional HRC-H Line has been installed across the downstream extremity of the rockbar site on 29 Oct. <ol style="list-style-type: none"> <li>Baseline survey will occur on 30 Oct.</li> <li>HRC Lines will be surveyed daily until next scheduled Technical Committee meeting on 1 Nov.</li> </ol> </li> <li>MNC's 3D array will be extended to include the E and F marks. <ol style="list-style-type: none"> <li>Baseline survey will occur on 30 Oct.</li> <li>The 3D array will be surveyed daily until next scheduled Technical Committee meeting on 1 Nov.</li> </ol> </li> <li>Visual inspection will be conducted daily until next scheduled Technical Committee meeting on 1 Nov.</li> <li>Joint monitoring will commence across the identified potentially opened joint to the east of Mark RBF04. <ol style="list-style-type: none"> <li>Changes across the joint will be measured daily.</li> </ol> </li> <li>The Technical Committee will reconvene on 1 Nov to assess the latest observations and make further recommendations.</li> </ol> </li> </ul>

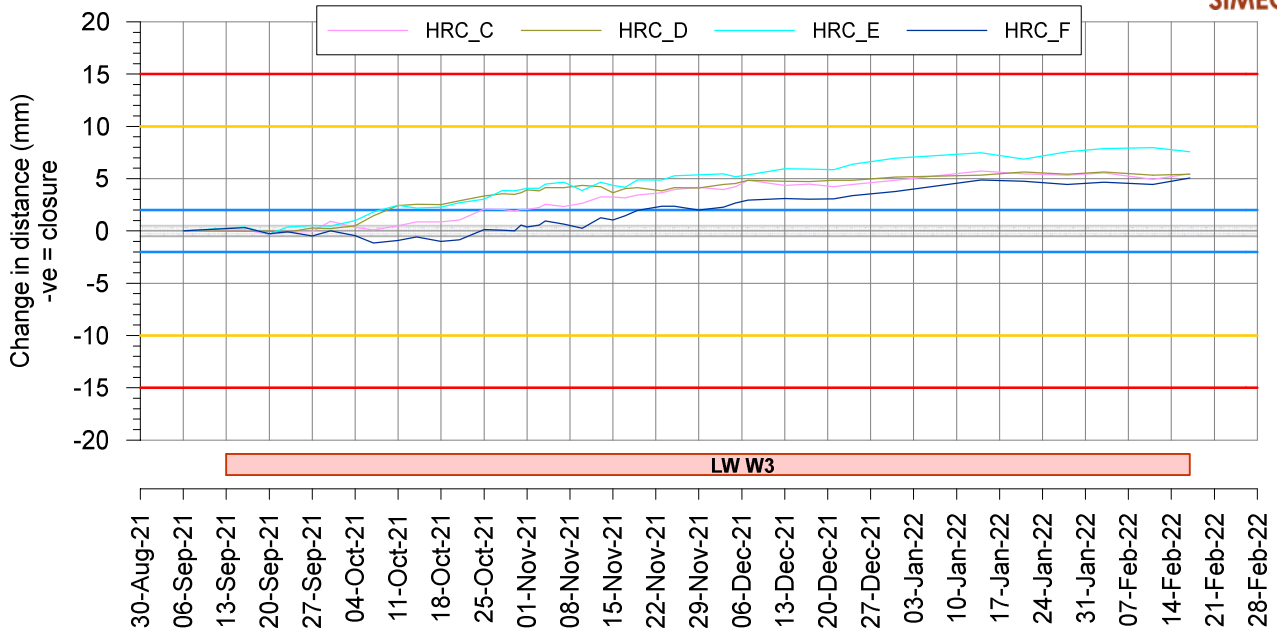
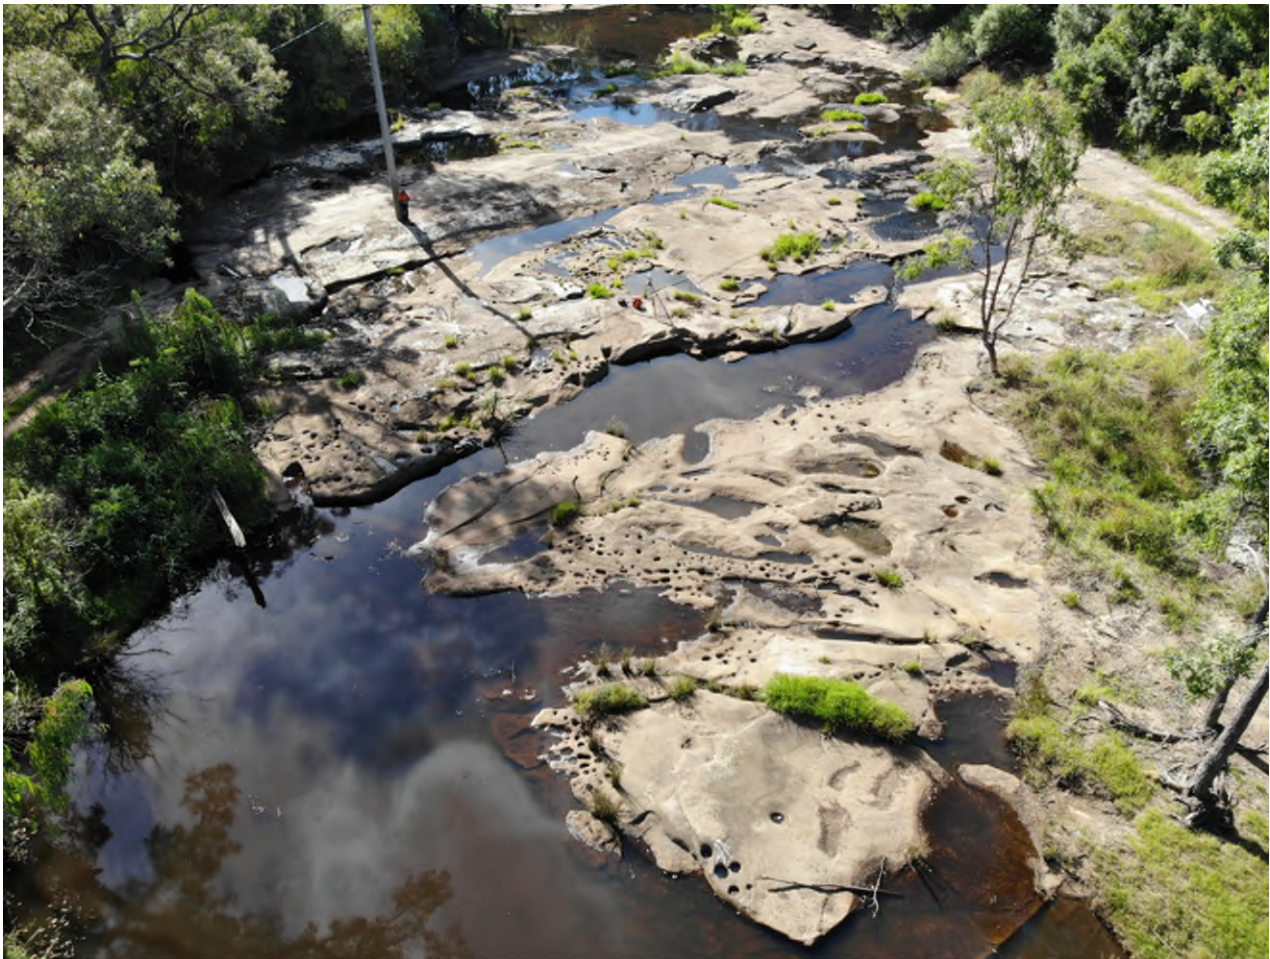
**Rockbar SR17 on 17 February 2022**

No changes observed across the rockbar over the last month, including across the grinding groove area.
