## XSTRATA COAL: **Tahmoor Colliery - Longwall 27**

Management Plan for Potential Impacts to Wollondilly Shire Council Infrastructure

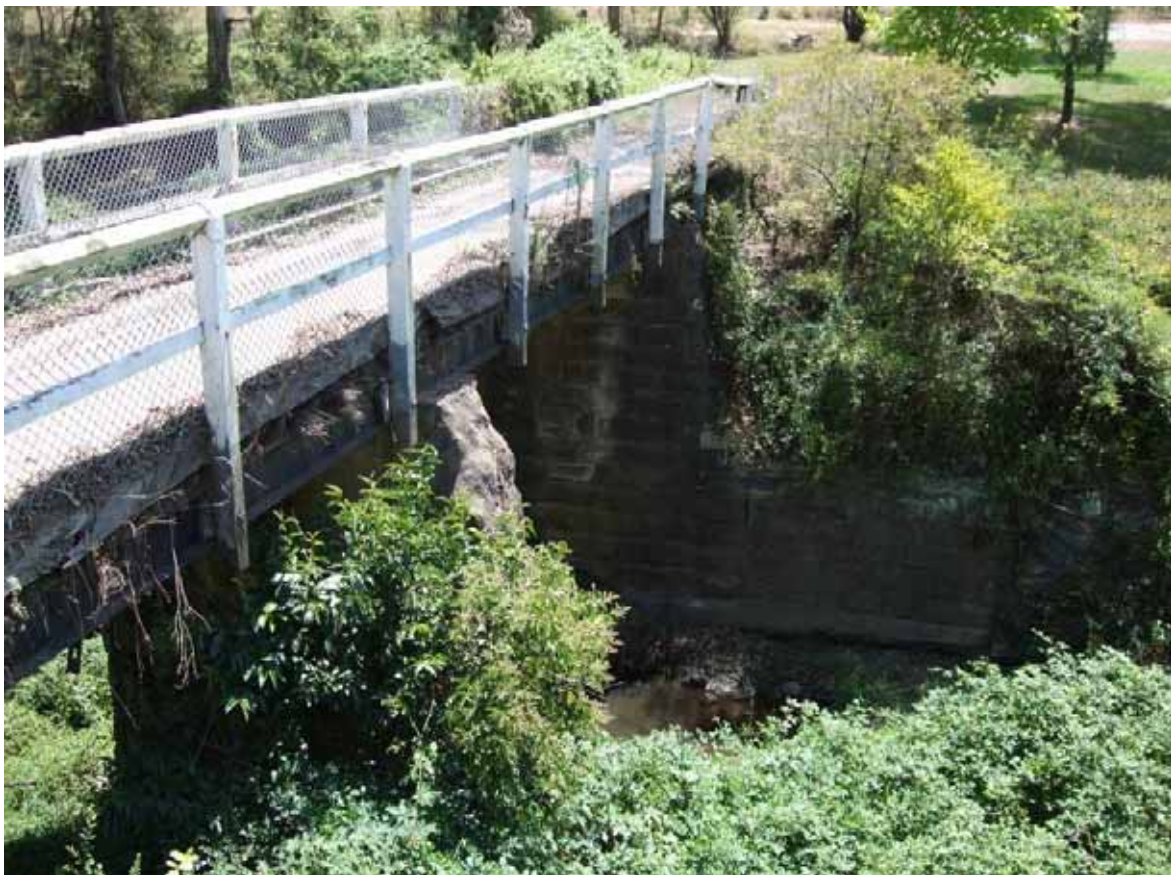
Figure 1

The abutments and central pier have been constructed using sandstone masonry construction with a sand/cement mortar as can be seen in figures 1 and 5. The masonry abutments walls have been constructed with wingwalls returning back into the embankment and the existing drawings indicate that the foundations have been constructed below the riverbed and are likely to have been founded upon rock. The masonry abutment walls and central pier appeared to be in fair condition at the time of the inspection.

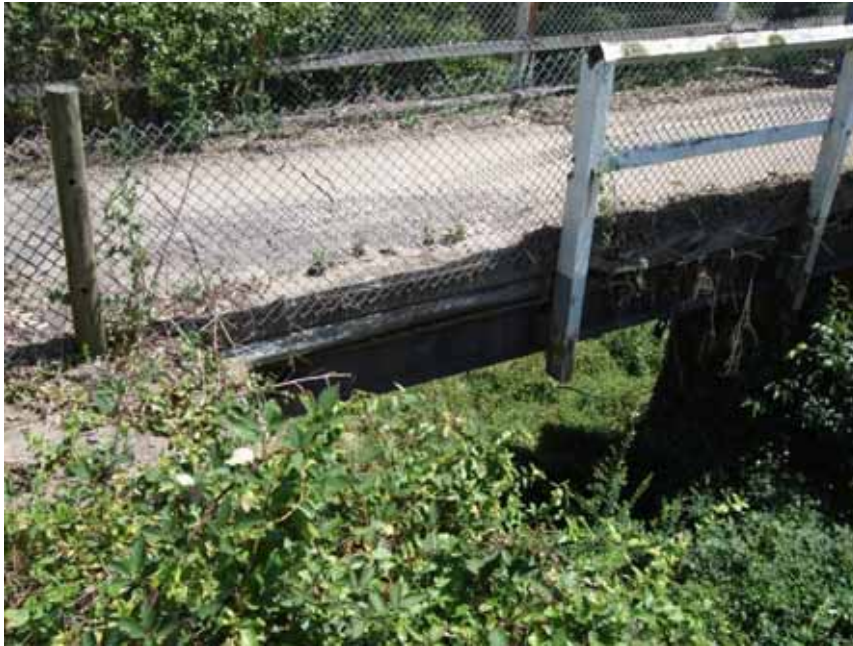
Figure 2

The pedestrian bridge is no longer in use and barriers have been erected across the both ends of the bridge to prevent pedestrian access as the bridge deck is in poor condition and the timber balustrade posts are severely dilapidated due to rot and/or termite damage and the dilapidated state is clearly visible in figures 2, 3, 6 & 7 in particular. The steel buckle plates show evidence of general corrosion; however, it was not possible to carry out an inspection of the tie rods that were embedded within the tar macadam. The edges of the tar macadam pavement have eroded and fretted due to exposure to wind and rain as can be seen in figures 2, 3 & 6.

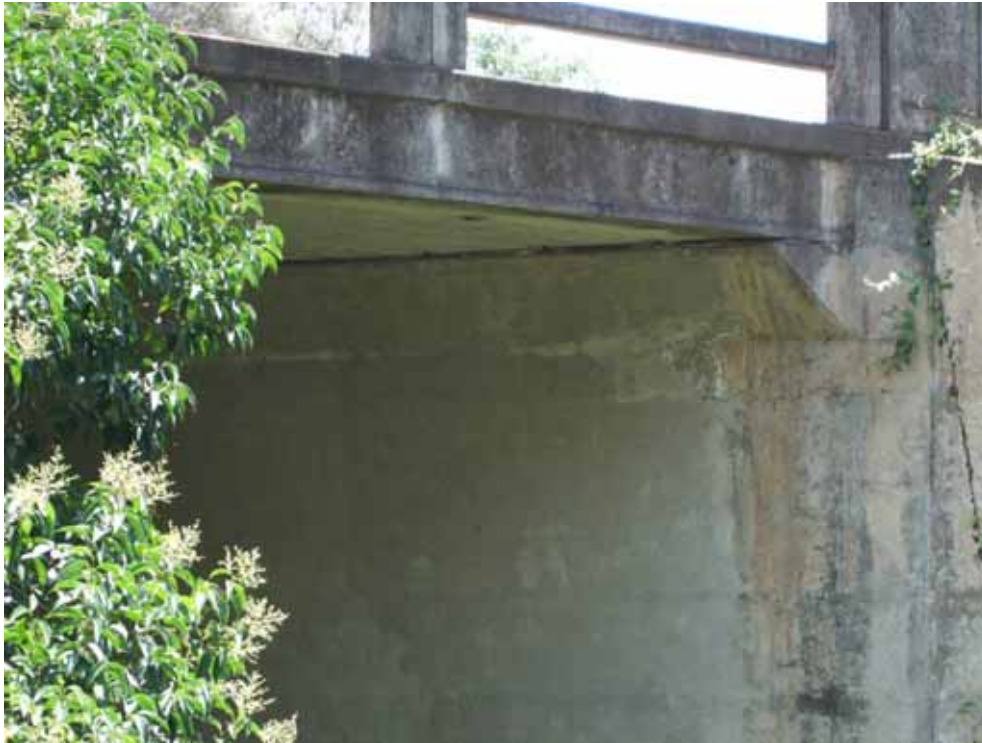
Figure 14

The bridge deck appears to be supported partly upon a reinforced concrete corbel that has been constructed monolithically with the abutment wall and partly upon the abutment wall itself as the barrier post in each corner of the bridge appears to have been constructed upon the bridge deck, refer figure 14. The road surface has cracked behind the abutment wall behind the barrier posts (figure 12), which supports the supposition that the bridge deck continues onto the wall proper. The structural drawings do not show whether or not the deck has been dowelled to both abutment walls. However, experience at the Castlereagh Street Bridge suggests that this is likely.

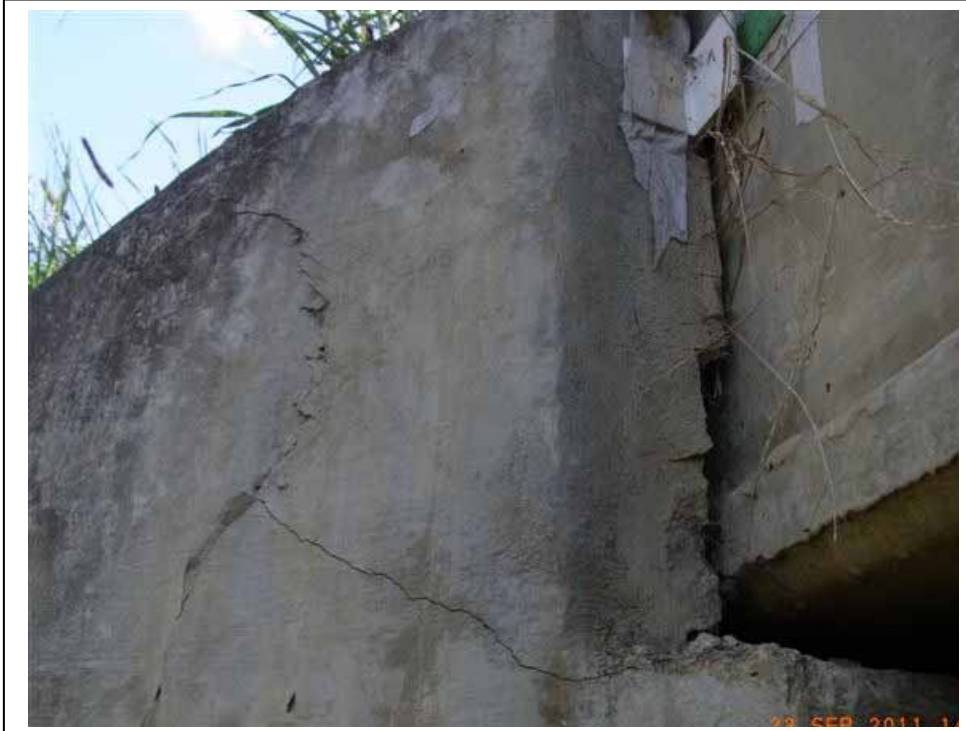
FIGURE 1

The cracks shown in figure 1 were taken of the top of the southeastern wing wall where the wing wall joins the main abutment wall. Figure 2 shows the designated concrete section through the abutment. These cracks appear to reflect a continuation of the joint opening at the rear of the abutment/wing wall with the wing wall above corbel level.

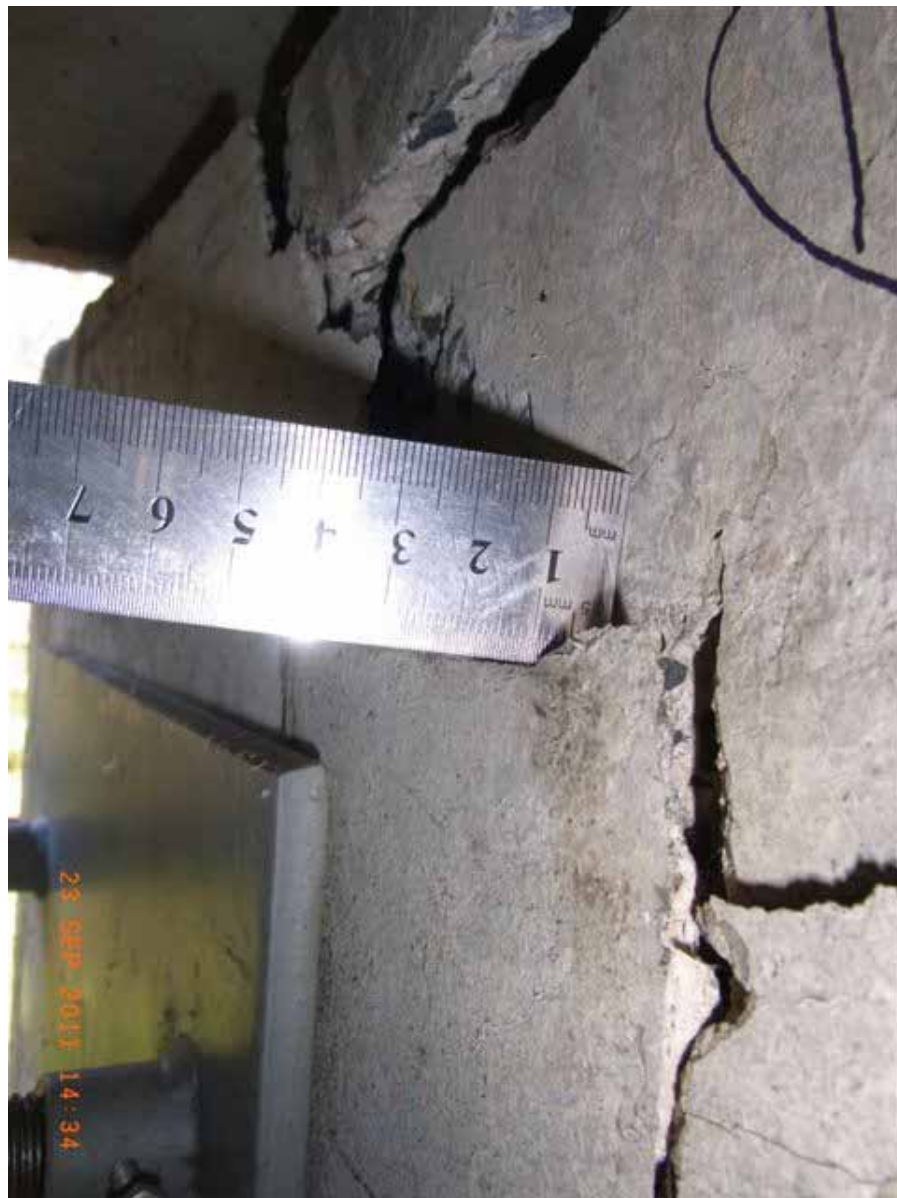
FIGURE 4

The designated wall reinforcement should maintain ductile behaviour up to a point. However, a 10mm horizontal stepped crack is significant given the amount of wall reinforcement shown on the drawings and it should be investigated further. Figure 4, shows the location where the 10mm crack was measured and it appears that the 10mm step in this location may be the result of spalling near the junction with the east wing wall. The crack width is of lesser magnitude elsewhere with 3mm horizontal step being recorded in figure 5.
