## 27 Remembrance Drive, Tahmoor

Structural Inspection Report: R0194-Rev1

Re: 27 Remembrance Drive, Tahmoor

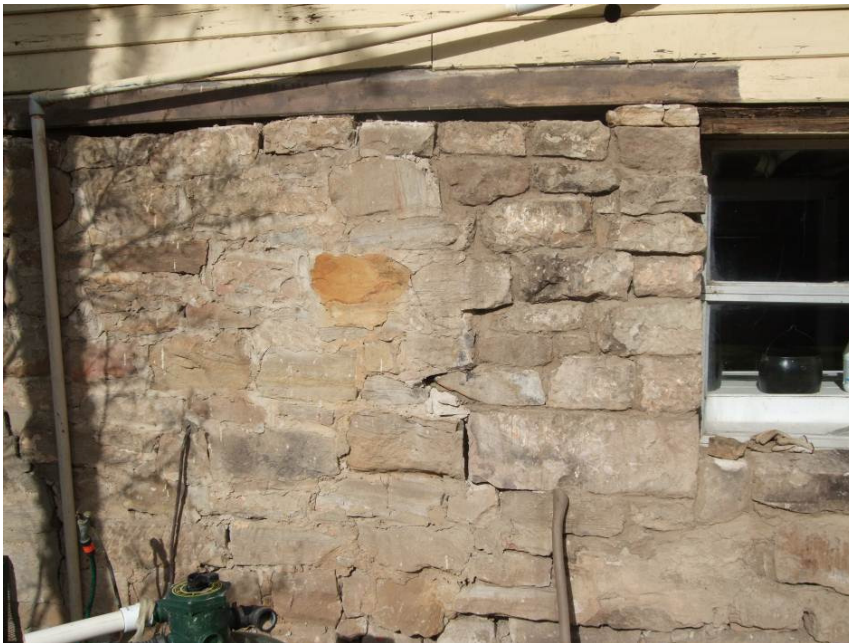
Figure 10

The foundation walls constructed during the 1835 extension using a harder and more durable lime-cement mortar. The exposed masonry is of much fairer face than the original walls, refer to figures 17 and 18 in Appendix A and contrast with figures 9 through 16 in Appendix A. The mortar was largely uncracked with minimal deterioration and the masonry was in serviceable condition.

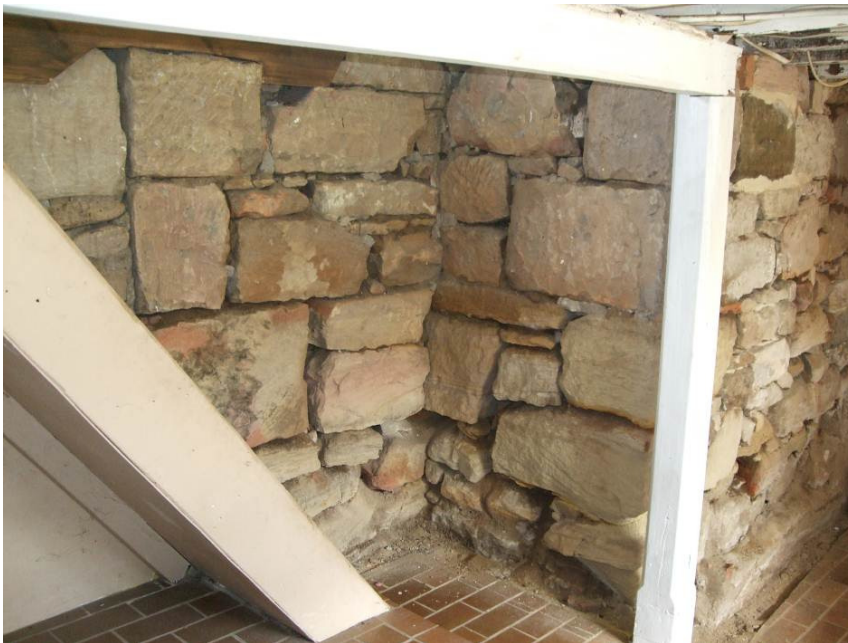
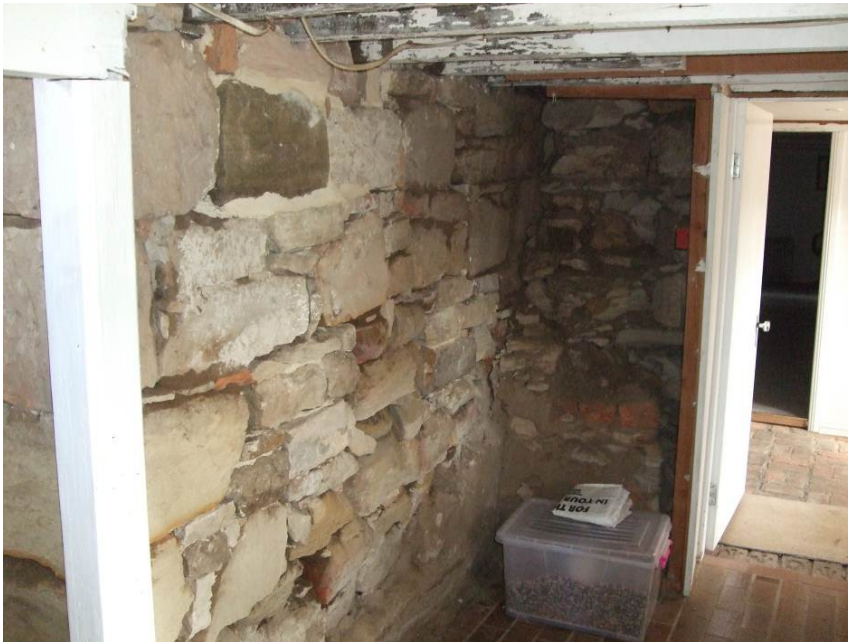
Elsewhere within the lower ground floor area, long stones were laid alternately at external wall corner junctions intended to not only tie the masonry and distribute concentrated loads applied at the wall corners but also to keep the walls true and plumb, refer to figures 20 & 21 in Appendix A and figure 46 in Appendix D. The mortar appeared to be similar throughout the lower ground floor area.

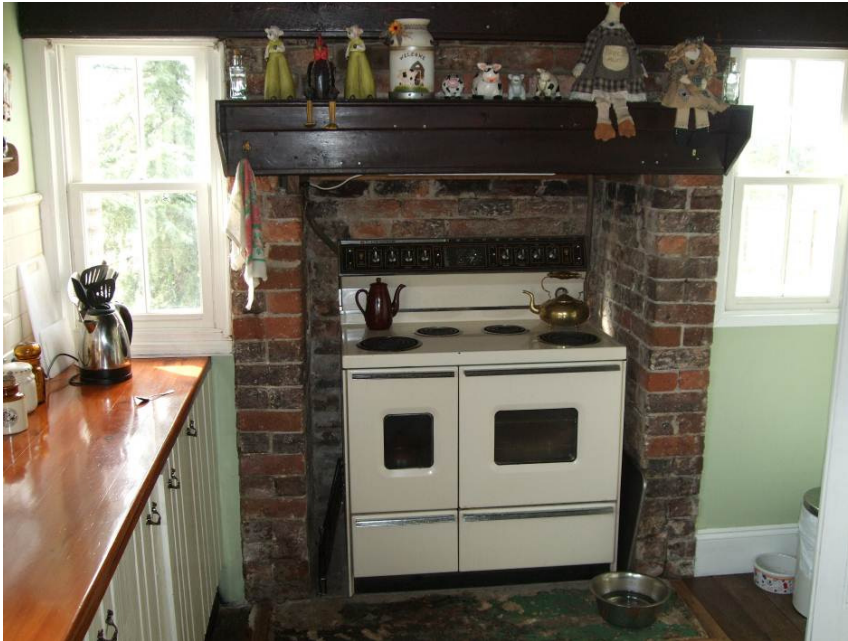
Figure 26

The ground floor wall layout is shown in figure 25 of Appendix B and some internal photographs of the kitchen chimney that is shown in figure 26 and the lounge room chimney and plasterboard walls are shown in figures 27 & 28 of Appendix B.

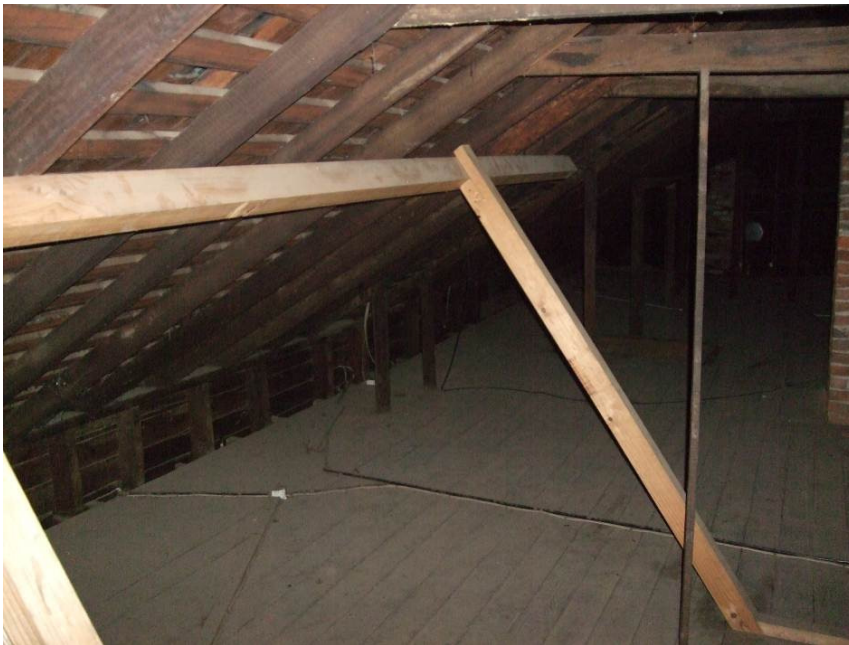
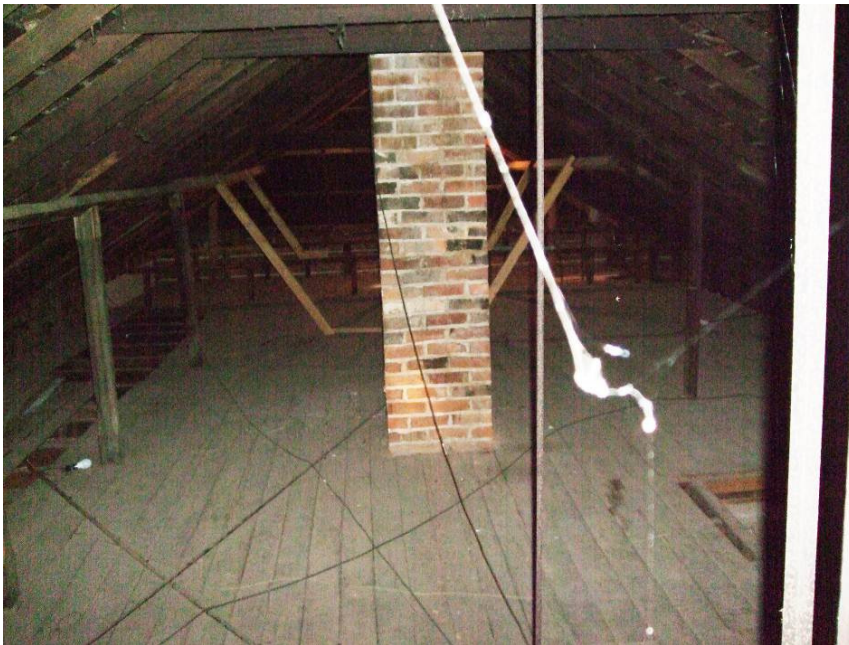
The roof was constructed as a collar tied and pitched timber framed roof with internal under purlins and roof struts carrying roof load down to internal timber framed walls and chimney structures, refer to figures 29, 30, 31, 35, 38, 39, 40, 41, 43 & 45. The ceiling joists were generally concealed by a T&G timber floor that provided access throughout the roof space that appears to be used for storage. Some supplementary repair work was carried out at a time unknown to the original under purlins and timber struts, refer to figures 30, 31, 35, 36, 43 & 45 in Appendix C, which is presumed to be a response to structural damage caused by termite activity.

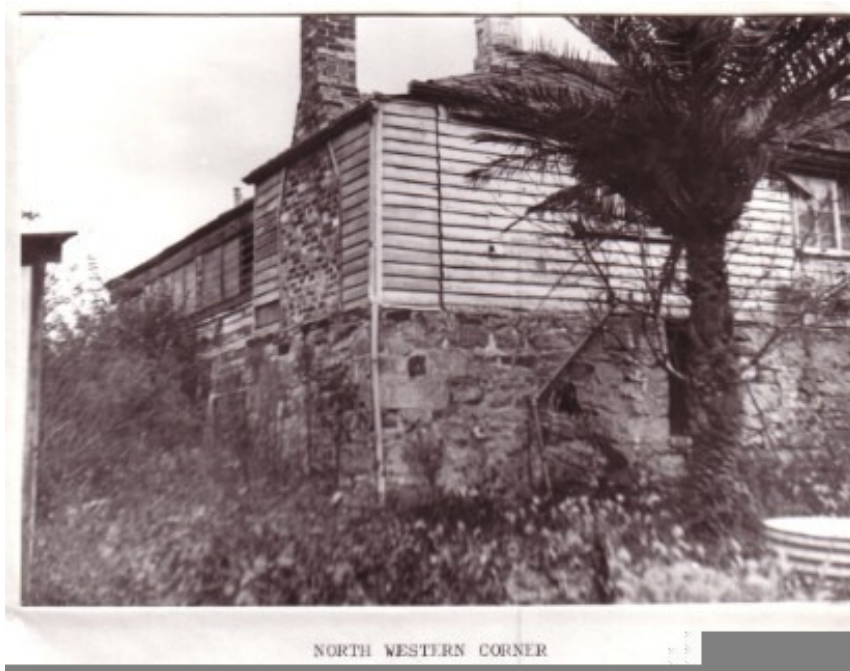
Figure 46 Northwestern corner of dwelling taken prior to 1972

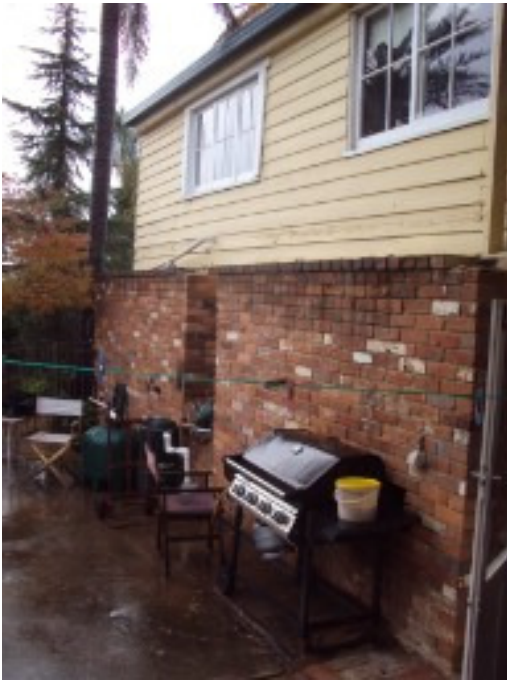
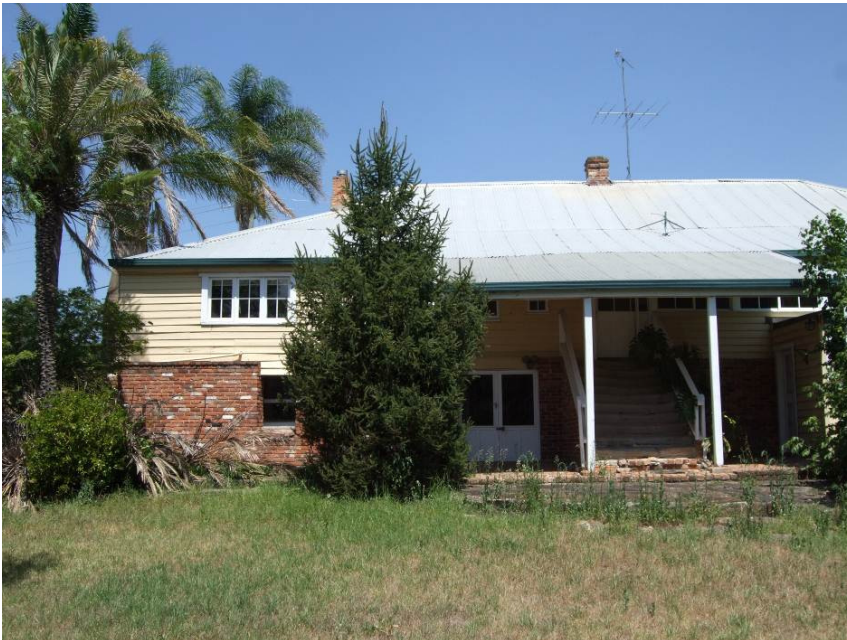
from 1972 onwards, which resulted in the sandstone rubble walls being concealed by a 110mm brick external wall (refer to figures 48 and 49 in Appendix D).
