Tahmoor Coal Pty Ltd

2019 ANNUAL REVIEW AND AEMR

March 2020

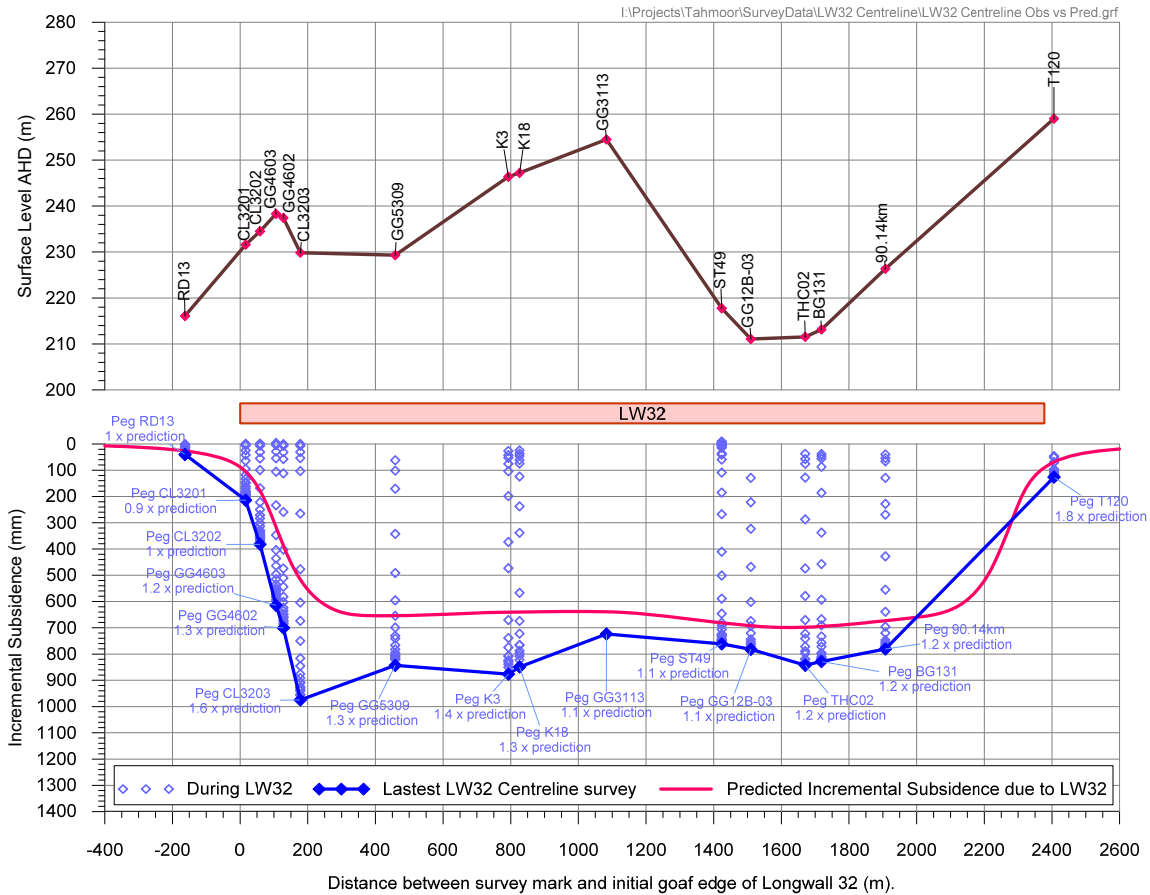
Fig. 2.1 Observed incremental subsidence along centreline of Longwall 32

The monitoring results during the mining of Longwall 32 showed, however, that increased subsidence has developed above the commencing end of Longwall 32 at levels similar to those observed above Longwall 26, as shown in Fig. 2.1. The magnitude of subsidence reduces along the panel as the longwall face progressed to the north, though subsidence was generally at the higher end of the previously observed range.

The observation above the commencing end of Longwall 32 has shown that increased subsidence has developed where mining has occurred close to the mapped first order fault echelon structures. In this case, Peg CL3203 is located approximately 700 metres to the west of the mapped first order fault and the commencing end of the panel is located at the head of a fault ramp, in between two fault echelons. As observed during the mining of Longwalls 24A to 26, the magnitude of subsidence was reduced over the unmined, solid coal side of Longwall 32. Many survey pegs were installed across the mapped first order fault structure and associated second order geological structures to the side of Longwall 32. No increased differential subsidence movements were observed to the side of Longwall 32.

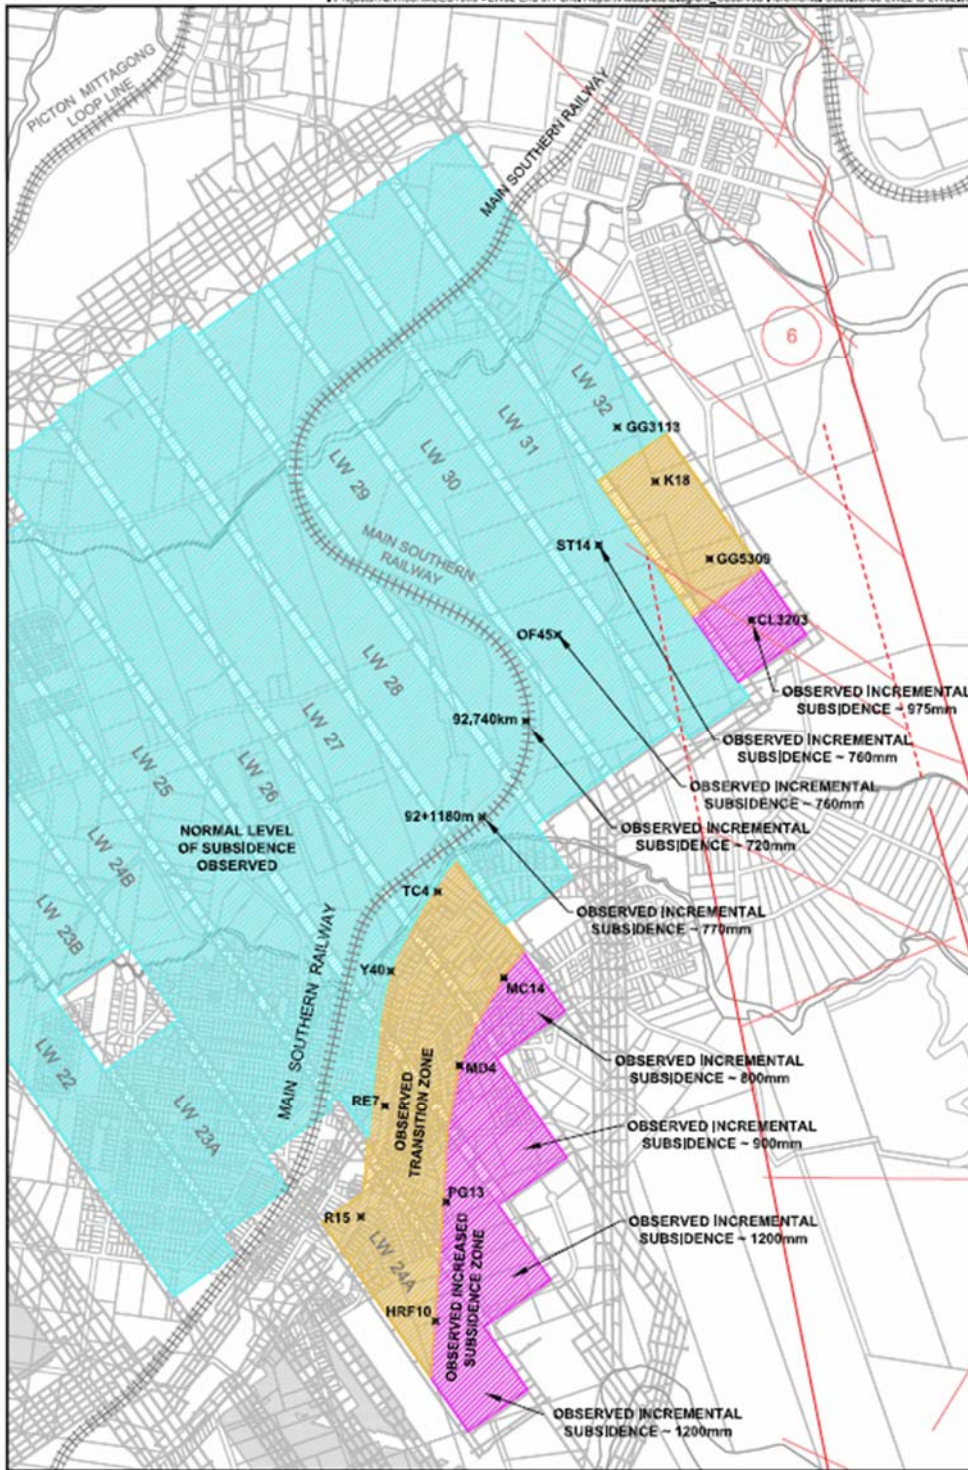
Fig. 2.2 Zones of increased subsidence over Longwalls 22 to 32

Whilst subsidence movements had returned to normal levels, it was considered possible that increased subsidence might return to higher than normal levels during the mining of Longwalls 31 and 32 (Report MSEC969). The potential was discussed in light of revised mapping of the Nepean Fault as comprising a series of en echelon faults, rather than one continuous geological structure. The mapping showed that subsidence may have returned normal levels as the fault echelon structure that is linked to increased subsidence above Longwalls 24A to 27 terminated beyond Longwall 29, as shown in Fig. 2.2.

Prior to the mining of Longwall 32, it was considered possible that subsidence might return to higher than normal levels during the mining of Longwall 32, as it would mine adjacent to another fault echelon structure as shown in Fig. 2.2. It was noted, however, the observations above previously extracted Longwalls 30 and 31 indicated that subsidence has been developing close to normal levels.

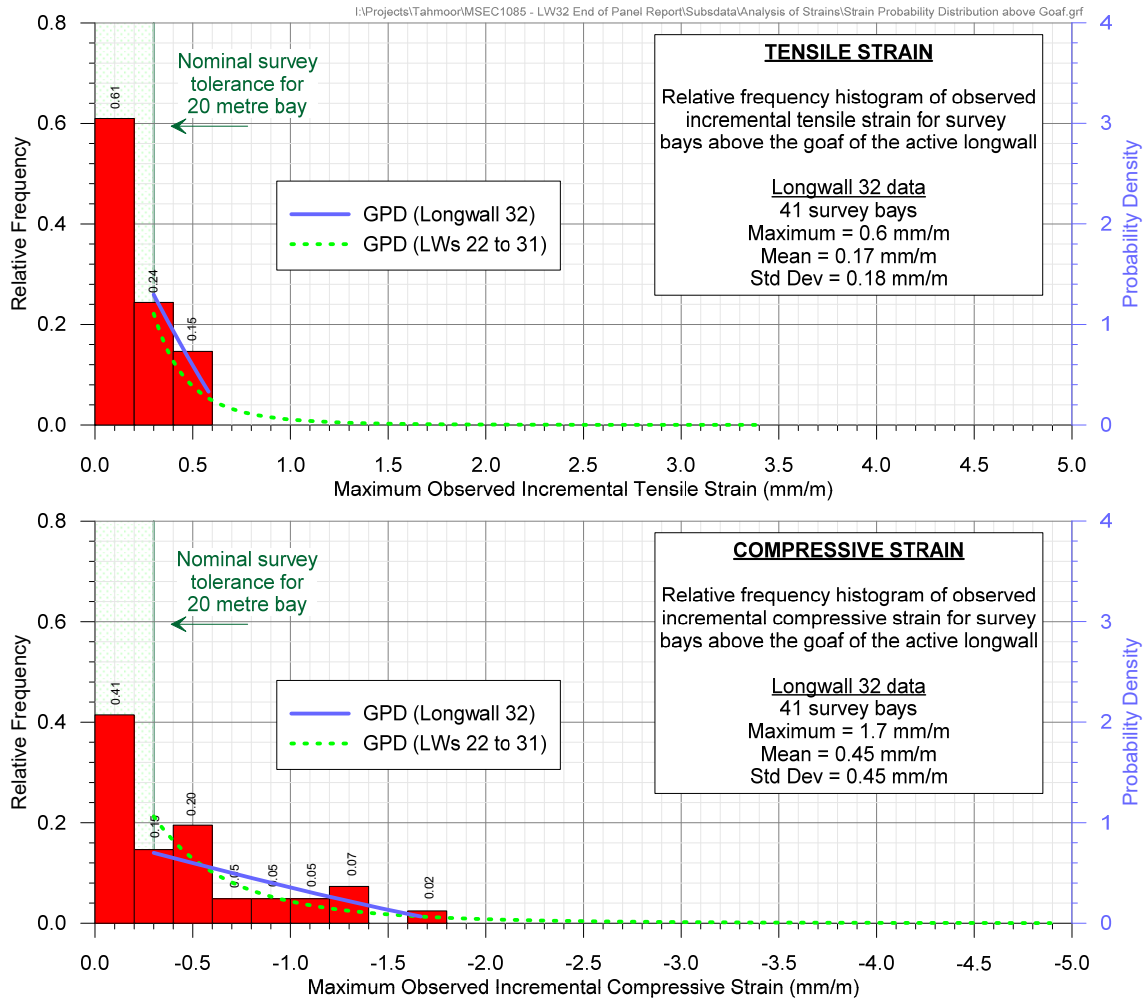
Fig. 2.3 Observed incremental strain for survey bays above goaf resulting from the extraction of Longwall 32

A distribution of the observed incremental tensile and compressive strains along monitoring lines from the extraction of Longwall 32, for survey bays located directly above goaf, is shown in Fig. 2.3. In the cases where the survey bays were measured a number of times during mining, the maximum tensile strain and the maximum compressive strain for each survey bay were used in these distributions.

A *Generalised Pareto Distribution (GPD)* has been fitted to the raw strain data for Longwall 32, as shown in blue. The probability distribution functions for previous monitoring during the mining of Longwalls 22 to 31 are also shown in this figure, as dashed green lines. It can be seen from these comparisons, that the overall distribution of tensile and compressive strain resulting from the extraction of Longwall 32 was similar to that observed during the mining of Longwalls 22 to 31.

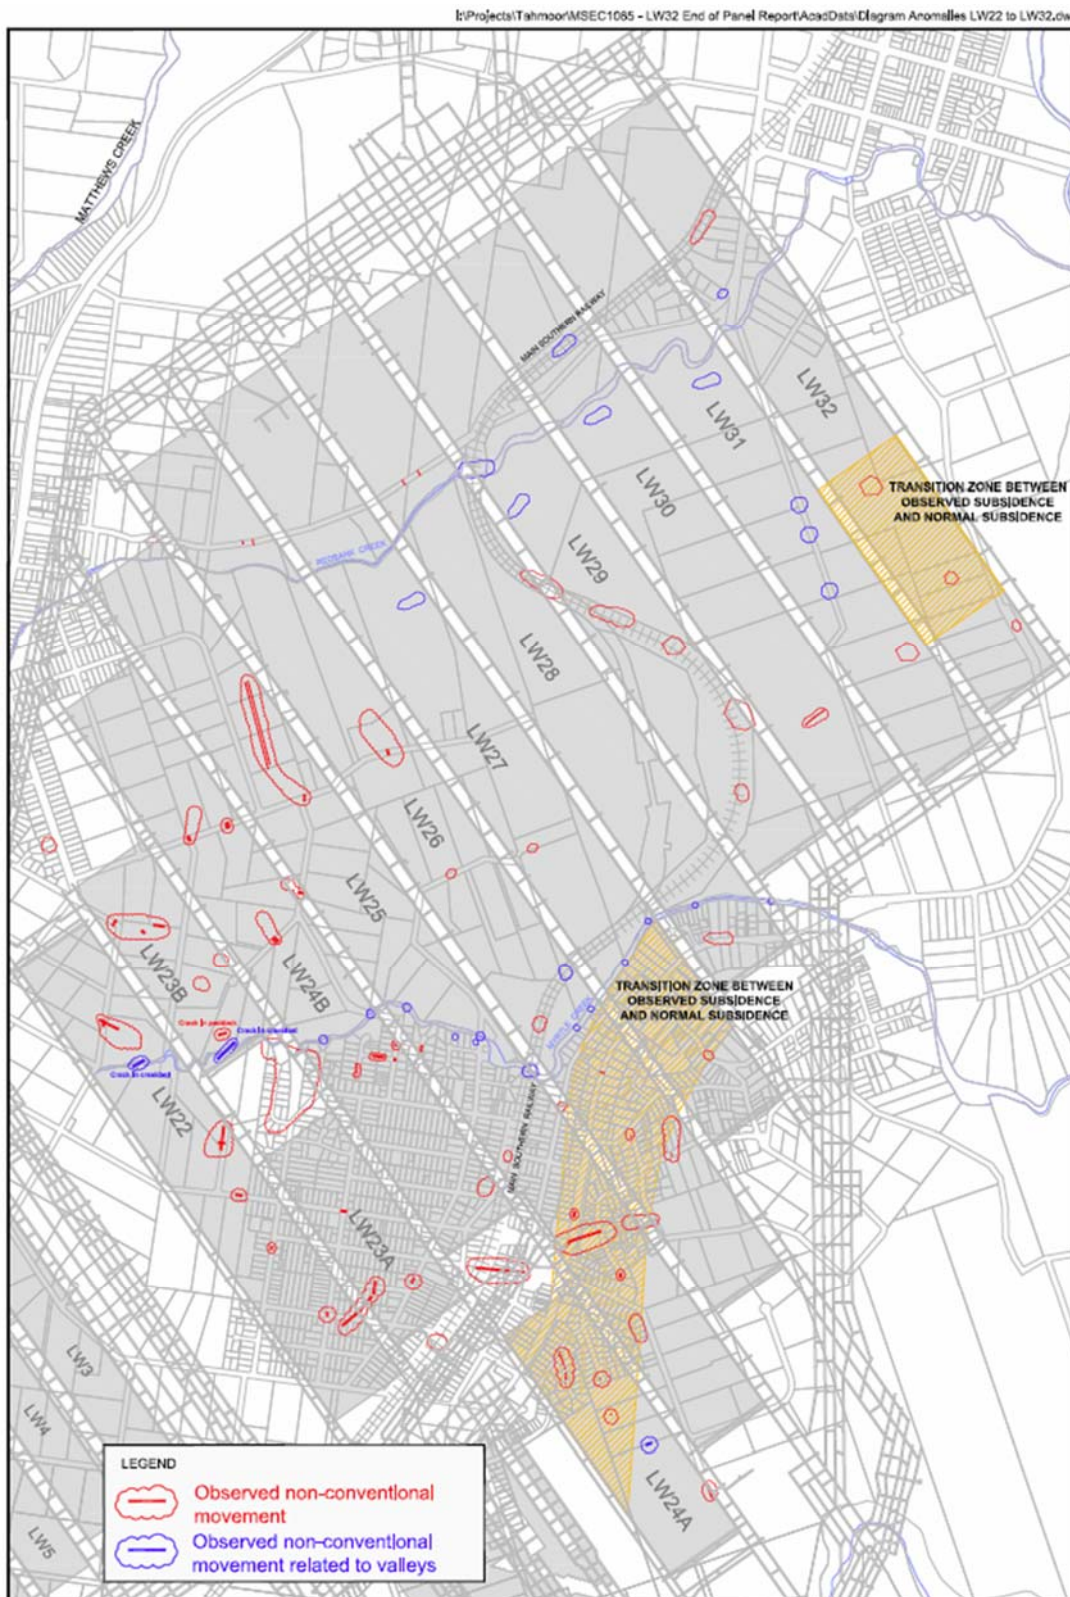
Fig. 2.4 Map of locations of potential non-systematic movements

A plan showing the locations of observed non-systematic movements at Tahmoor is shown in Fig. 2.4. The locations were selected based on ground monitoring results or observed impacts that appear to have been caused by non-systematic movement. A total of approximately 59 locations (not including valleys) have been identified over the extracted Longwalls 22 to 32, of which 4 new locations were observed during the mining of Longwall 32.

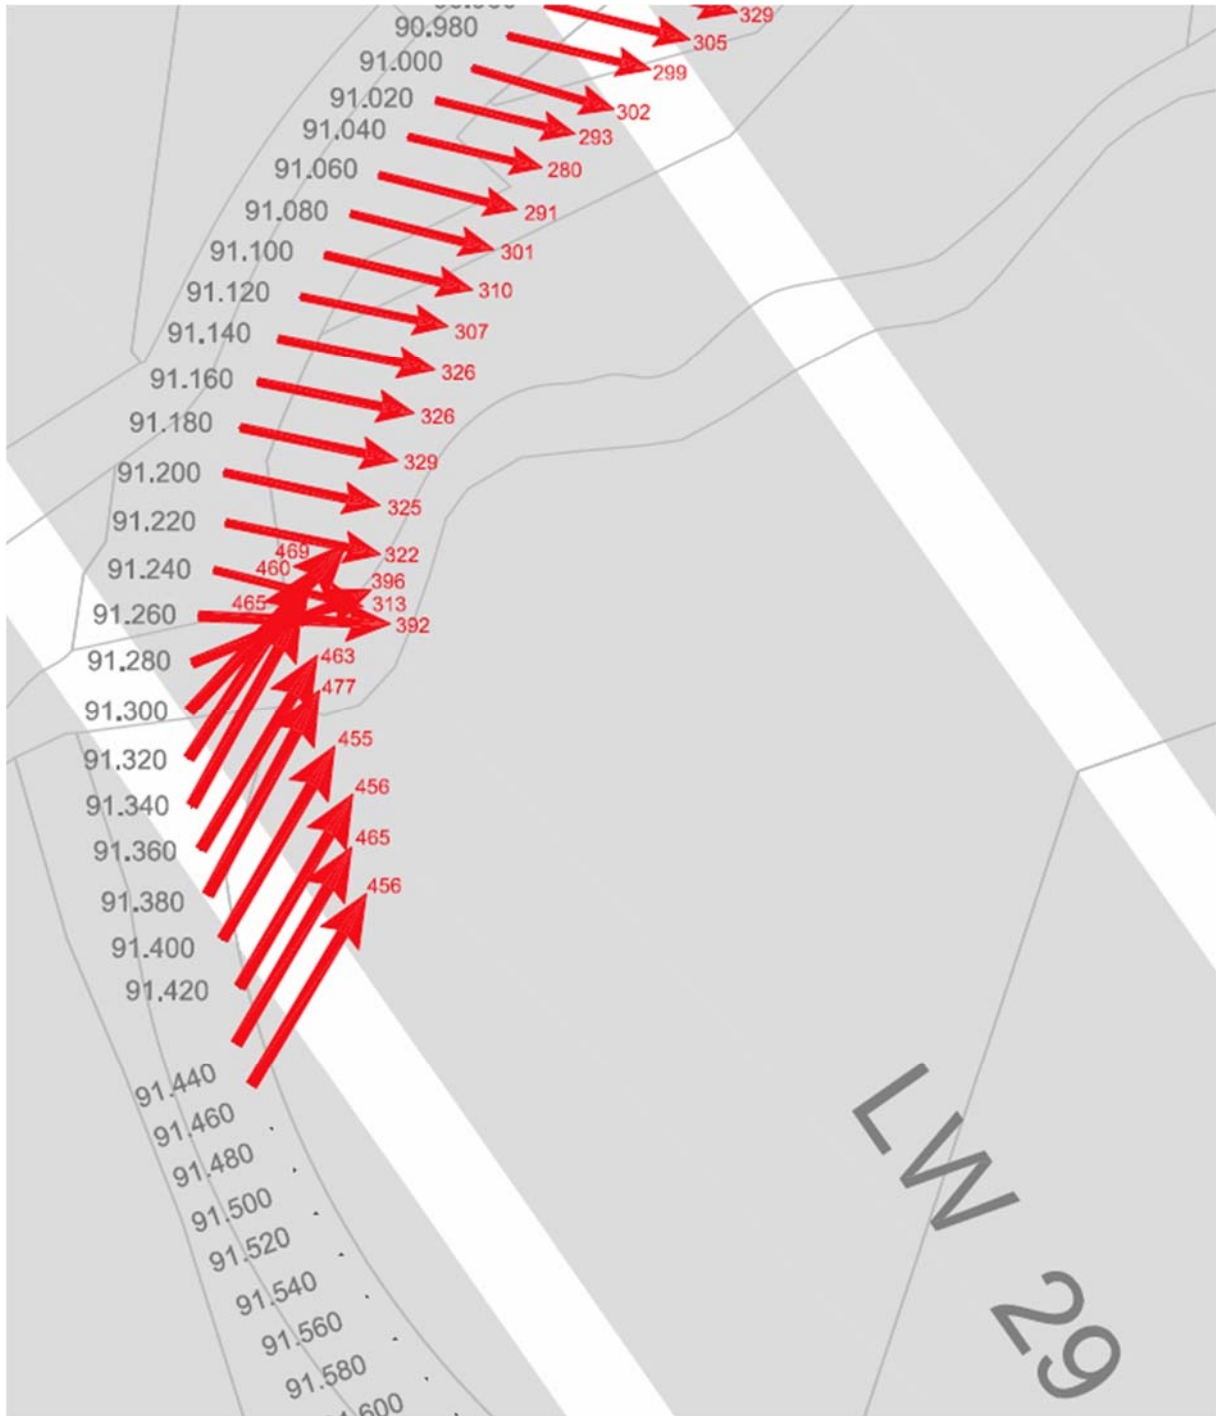
Fig. 2.6 Observed total horizontal movement along Main Southern Railway during the mining of Longwalls 27 to 32

Observed absolute horizontal movements along the Main Southern Railway are shown in Fig. 2.6. It can be seen that the rockmass on the southern of Country side of the Culvert has moved in a different direction to the northern or Sydney side of the Culvert.

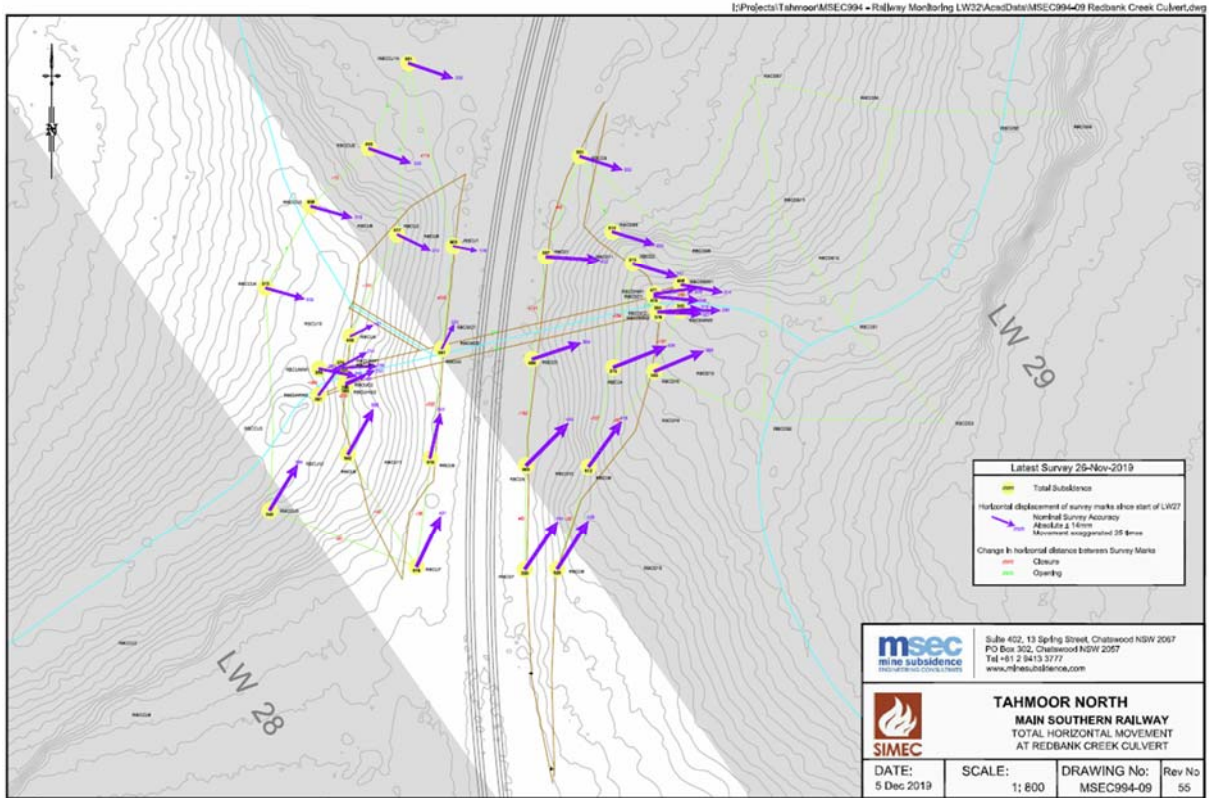
Fig. 2.7 Observed total horizontal movement at Redbank Creek Culvert and embankment during the mining of Longwalls 27 to 32

Observed total subsidence and horizontal movement of survey marks in the immediate of the culvert and embankment are shown in Fig. 2.7. The results show that boundaries of the rockmass in the south-western quadrant intersect with the country side of the culvert. The corner of the rockmass is approximately aligned with midpoint of the culvert, which correlates well with observed detailed closure measurements inside the culvert itself.

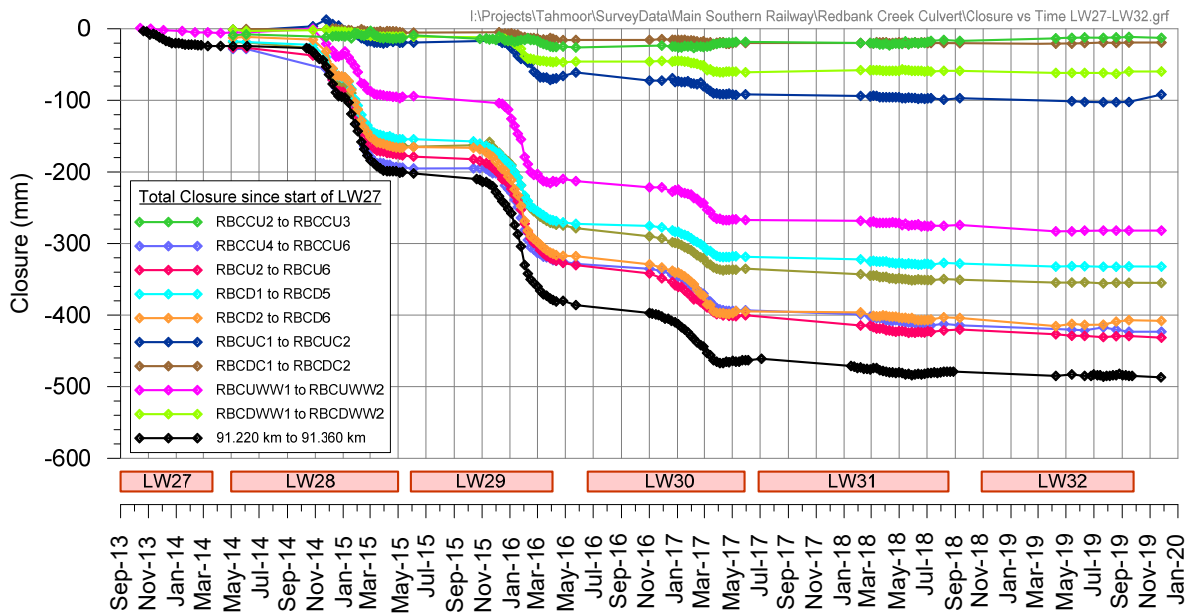
Fig. 2.8 Observed total valley closure over time across Redbank Creek Culvert at Main Southern Railway during the mining of Longwall 32 (includes closure from Longwalls 27 to 31)

The observed gradual development with time of differential horizontal movements between selected pegs at the culvert and embankment are shown in Fig. 2.8. Maximum observed closure was measured between the long bay survey pegs on the track at 91.220 km and 91.360 km, though a similar result was observed between Pegs RBCCU4 and RBCCU6, RBCU4 and RBCU6, and between RBCD2 and RBCD6, which are located in the base of the embankment across the upstream inlet. This suggests that closure across the valley of Redbank Creek and its tributary, were focussed at the culvert. This was confirmed at greater detail from additional detailed surveys in the culvert, which are discussed later.

Whilst the ends of the wingwall on the upstream end have closed by 282 mm, the culvert barrel at the inlet has closed by 92 mm. Measured closure at the ends of the wingwall on the downstream end is 60 mm, and the culvert barrel at the inlet has closed 19 mm.

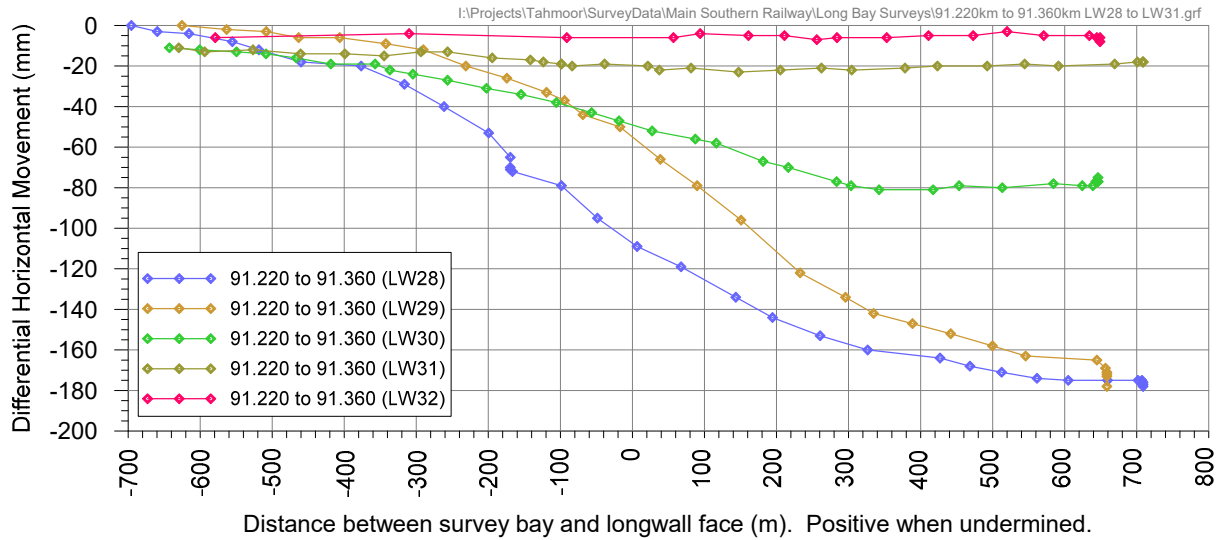
Fig. 2.9 Observed incremental valley closure as measured by long bay survey, relative to face distance, across Redbank Creek Culvert at Main Southern Railway during the mining of Longwalls 28 to 32

It can be seen from Fig. 2.9 that no measurable valley closure movements occurred during Longwall 32.

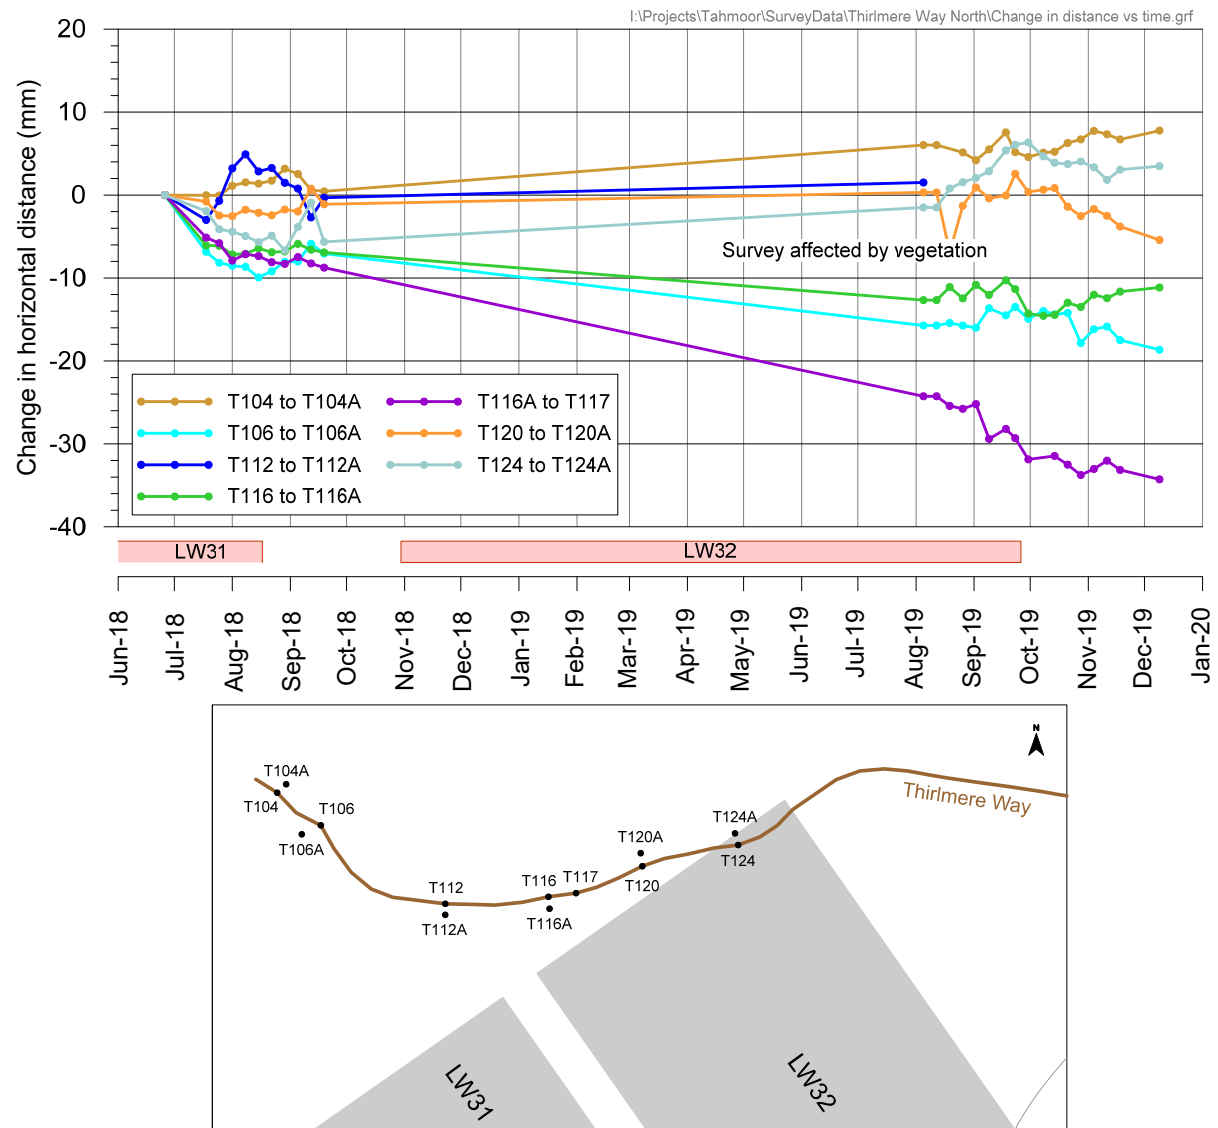
Fig. 2.12 Changes in horizontal distance across Thirlmere Way over time

Measured changes in distance across Thirlmere Way over time are shown in Fig. 2.12. Ongoing small changes are also observed between Pegs T116A and T117, which are oriented along Thirlmere Way on the southern side of the road. No impacts are observed to the pavement or around the pegs. The crash barrier cable on the northern side of the road opposite Peg T118 is slack. An inspection by geotechnical engineer GHD Geotechnics found that one of the support posts had been struck by a vehicle. No issues were identified that were indicative of instability.

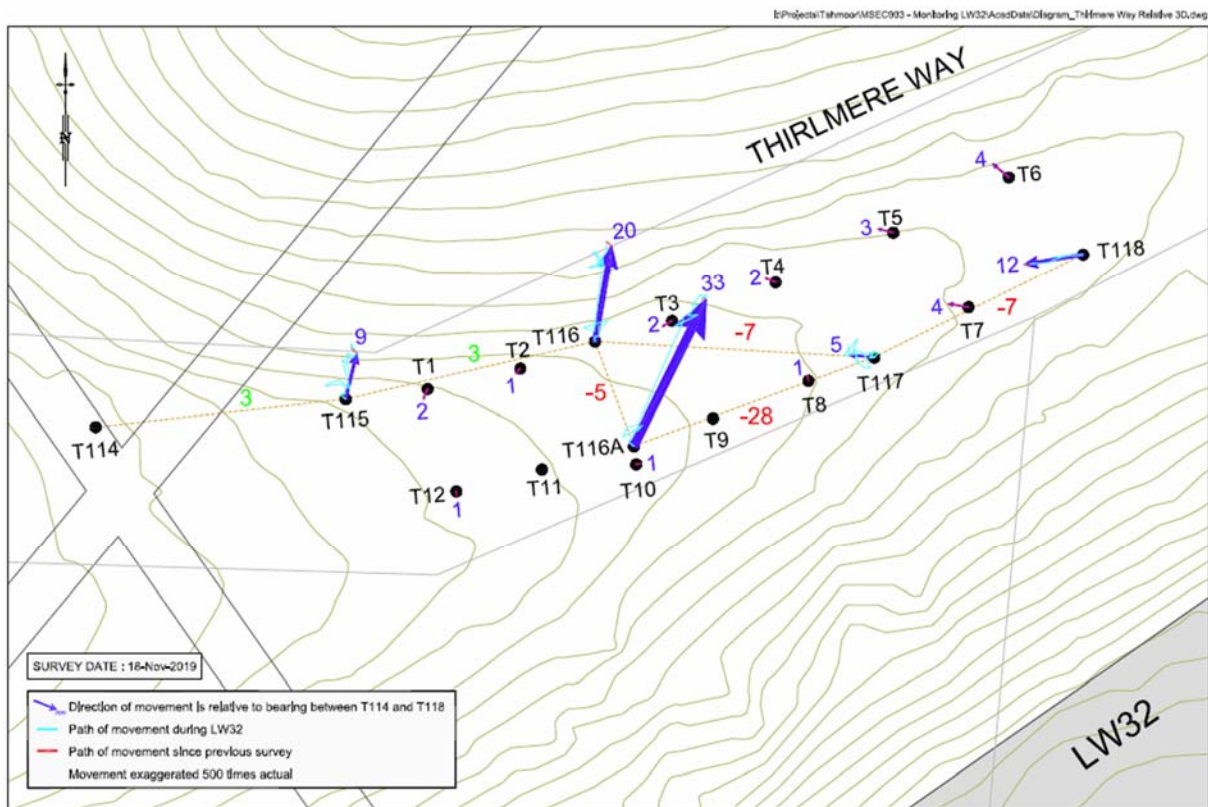
Fig. 2.13 Relative horizontal movements along Thirlmere Way between Pegs T114 and T118

It can be seen from Fig. 2.13 that a lateral rotation and shearing has developed over time at Pegs T116 / T116A, with a clear change in displacements at Peg T117. The movements have, however, developed very gradually over a period of 18 months.

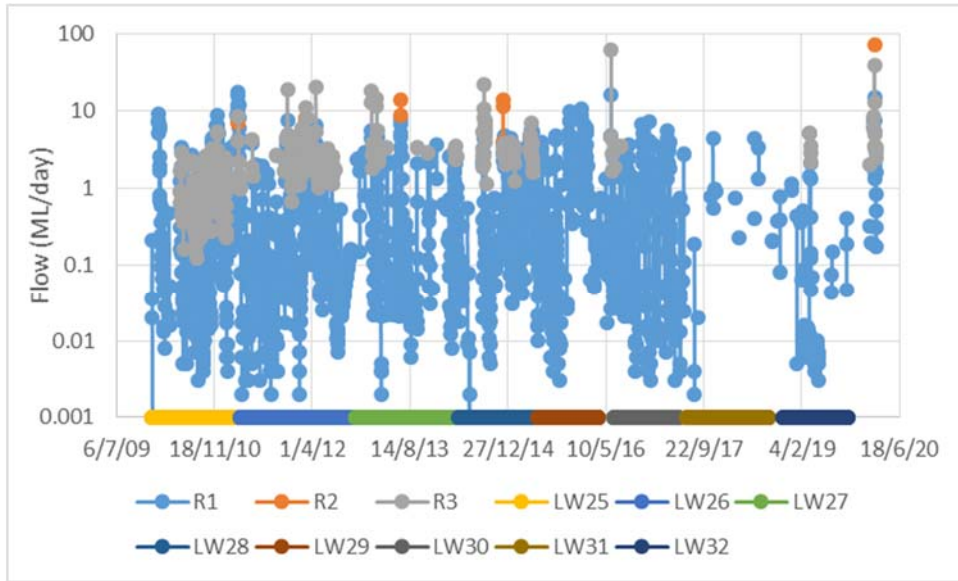
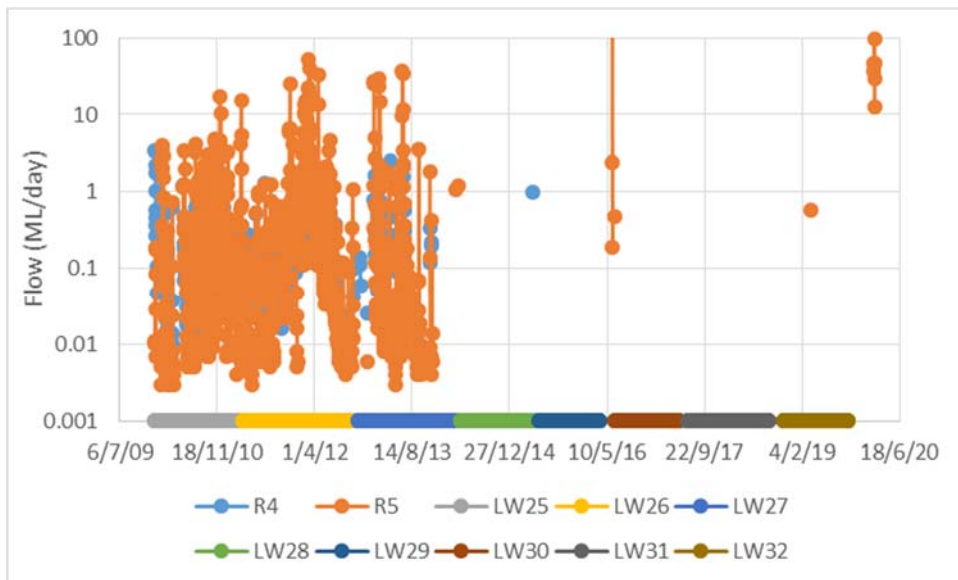
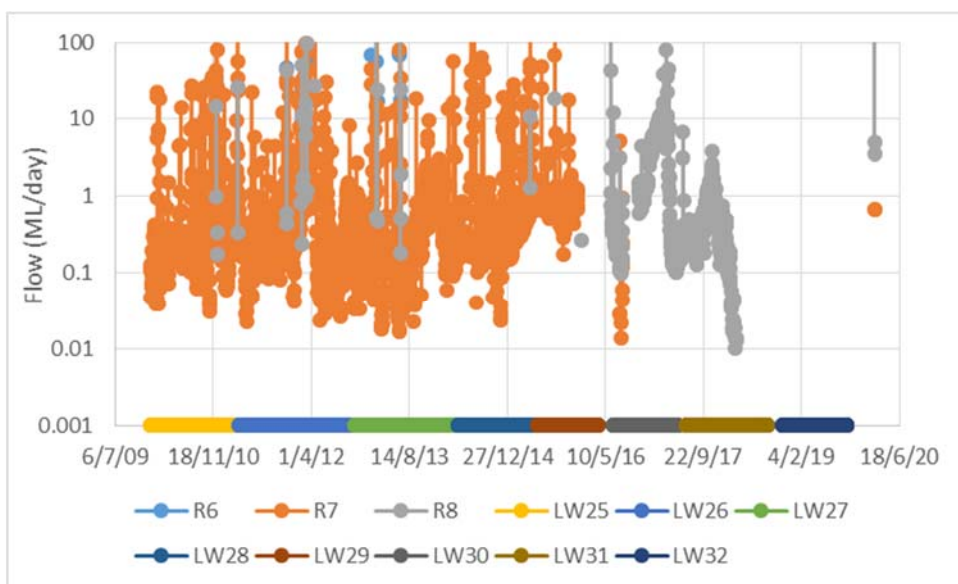
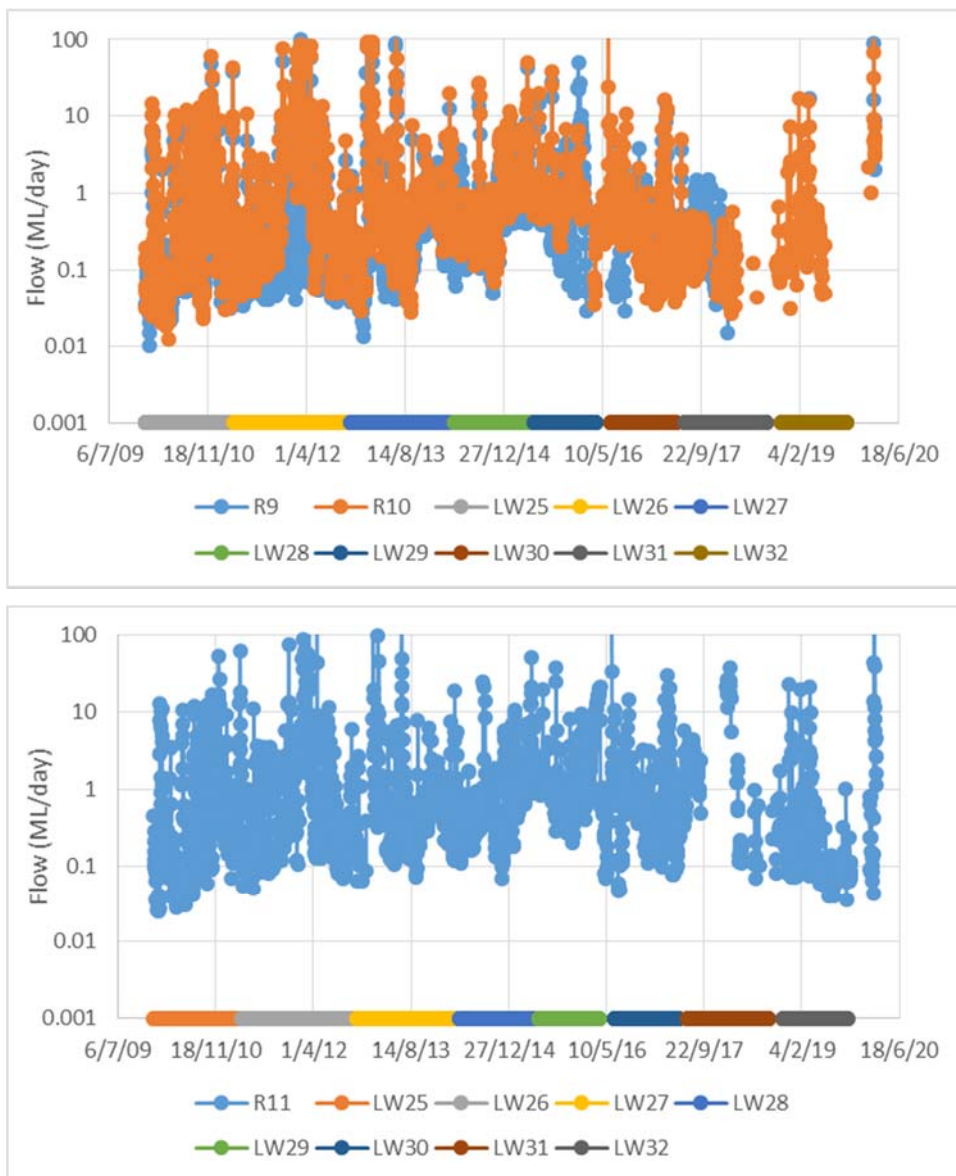
Figure 2 Redbank Creek Flow

The majority of pools over and downstream of Longwalls 25 to 32 showed evidence of subsidence related pool holding capacity impacts. Site R11 also showed drying out of the pool, however this was considered to be primarily due to the extended drought in the catchment, rather than purely subsidence impacts, as shown in **Figure 2**.

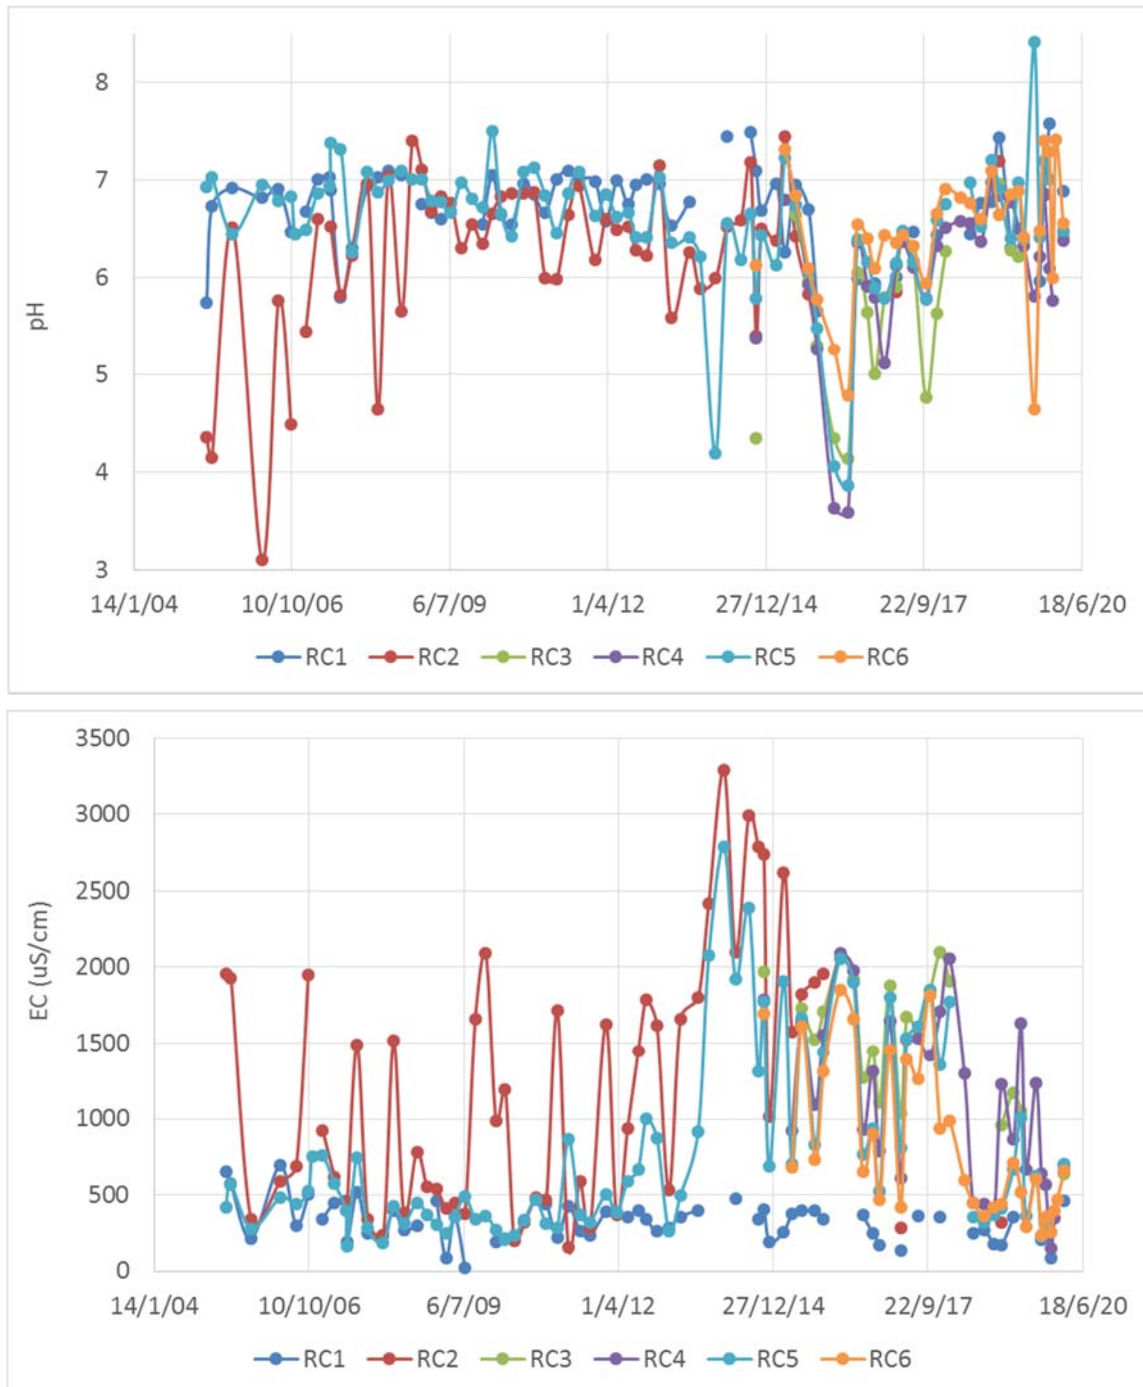
Figure 3 Redbank Creek Field Water Quality

Redbank Creek has had an electrical conductivity (EC) range of 22 – 3,290uS/cm and pH between 3.10 and 7.50, with the creek generally being more acidic and saline at Site RC2 as shown in **Figure 3**.

During extraction of Longwall 32, pH in Redbank Creek distinctly acidified at all monitored sites, whilst salinity did not show a specific trend, except for higher salinity during low flow / drought periods.

Enhanced salinity and lower pH is predominantly associated with the more ferruginous seeps in the stream.

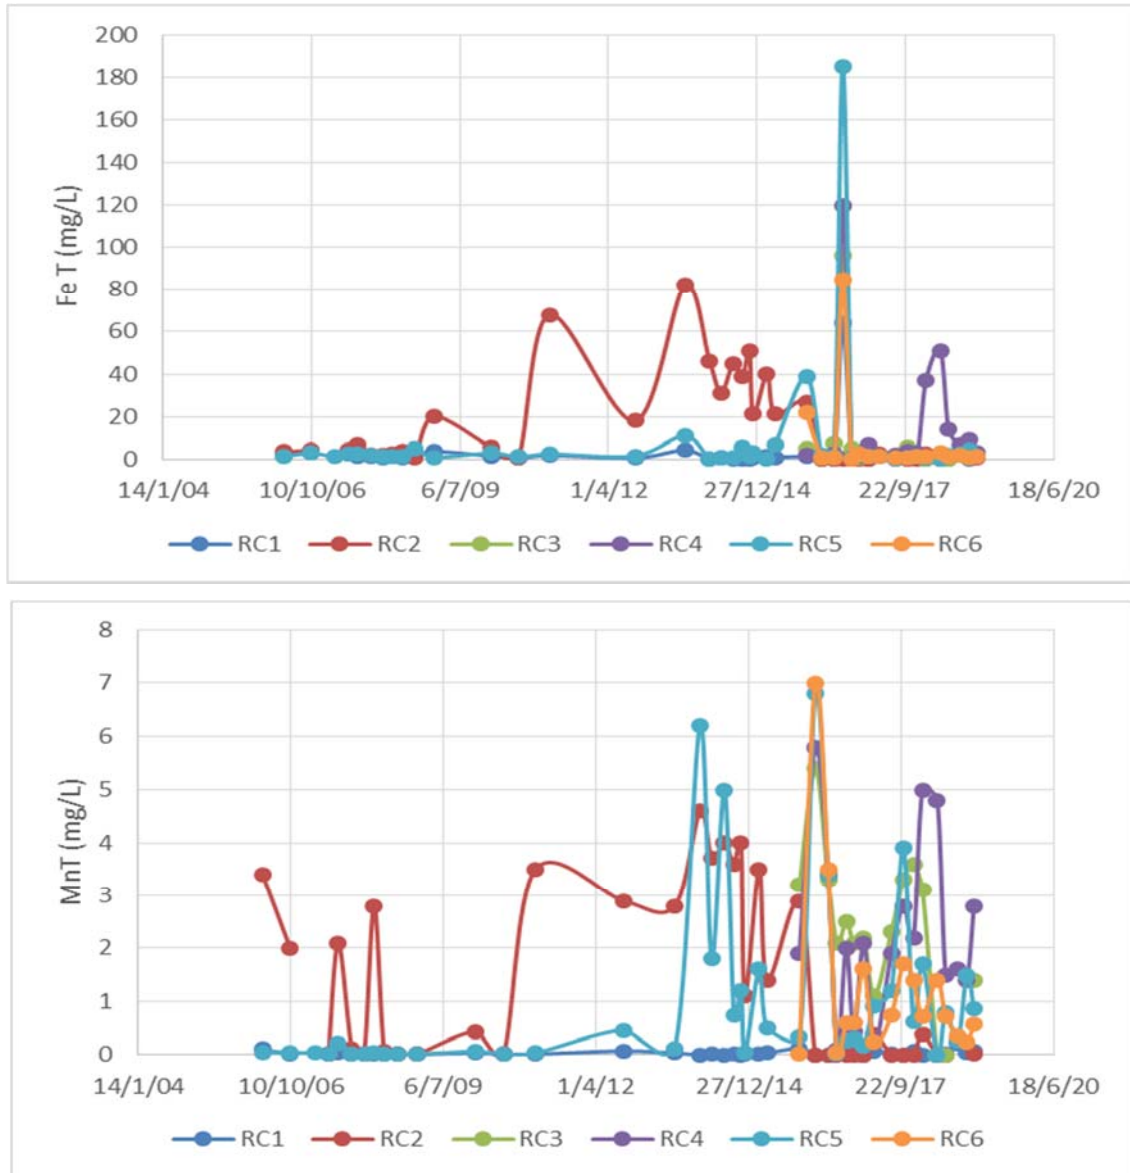
Figure 4 Redbank Creek Iron and Manganese

Redbank Creek generally contained elevated iron and, occasionally, manganese results were above ANZECC 2000 Protection of 95% of Freshwater Aquatic Species trigger level at Site RC2 in association with the upstream tributary seepage as shown in **Figure 4**.

The iron and manganese levels varied with rainfall in the catchment, with lower concentrations noted after wetter periods. However a definitive rise in iron was observed at Site RC2, and a rise in manganese at Sites RC2 and RC5 since Longwalls 27 to 30 undermined Redbank Creek.

Manganese also rose during extraction of Longwall 30 at Sites RC3 to RC6 (at which time Sites RC1 and RC2 were dry).

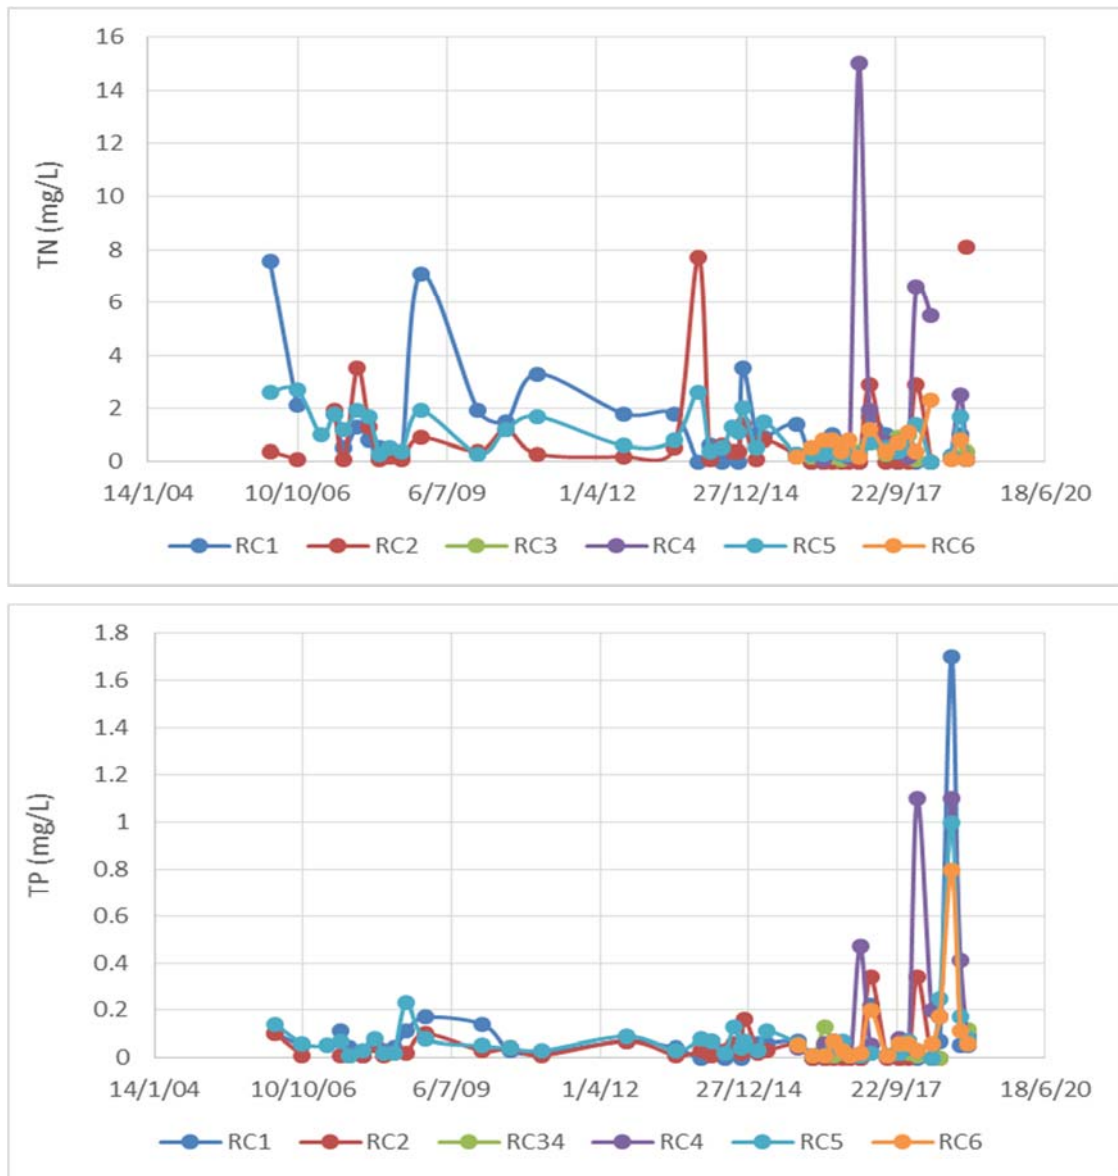
Figure 5 Redbank Creek Nutrients

The creek was recorded to have total nitrogen (TN) up to 15mg/L and total phosphorous (TP) up to 0.47mg/L, and results occasionally exceeded the ANZECC 2000 SE Australian Upland Stream criteria at all monitored sites as shown in **Figure 5**.

The above criteria nutrients were present in the creek due to urban, rural / residential and industrial runoff in the catchment, and were not related to mining influences.
