Tahmoor Coal Pty Ltd

2019 ANNUAL REVIEW AND AEMR

March 2020

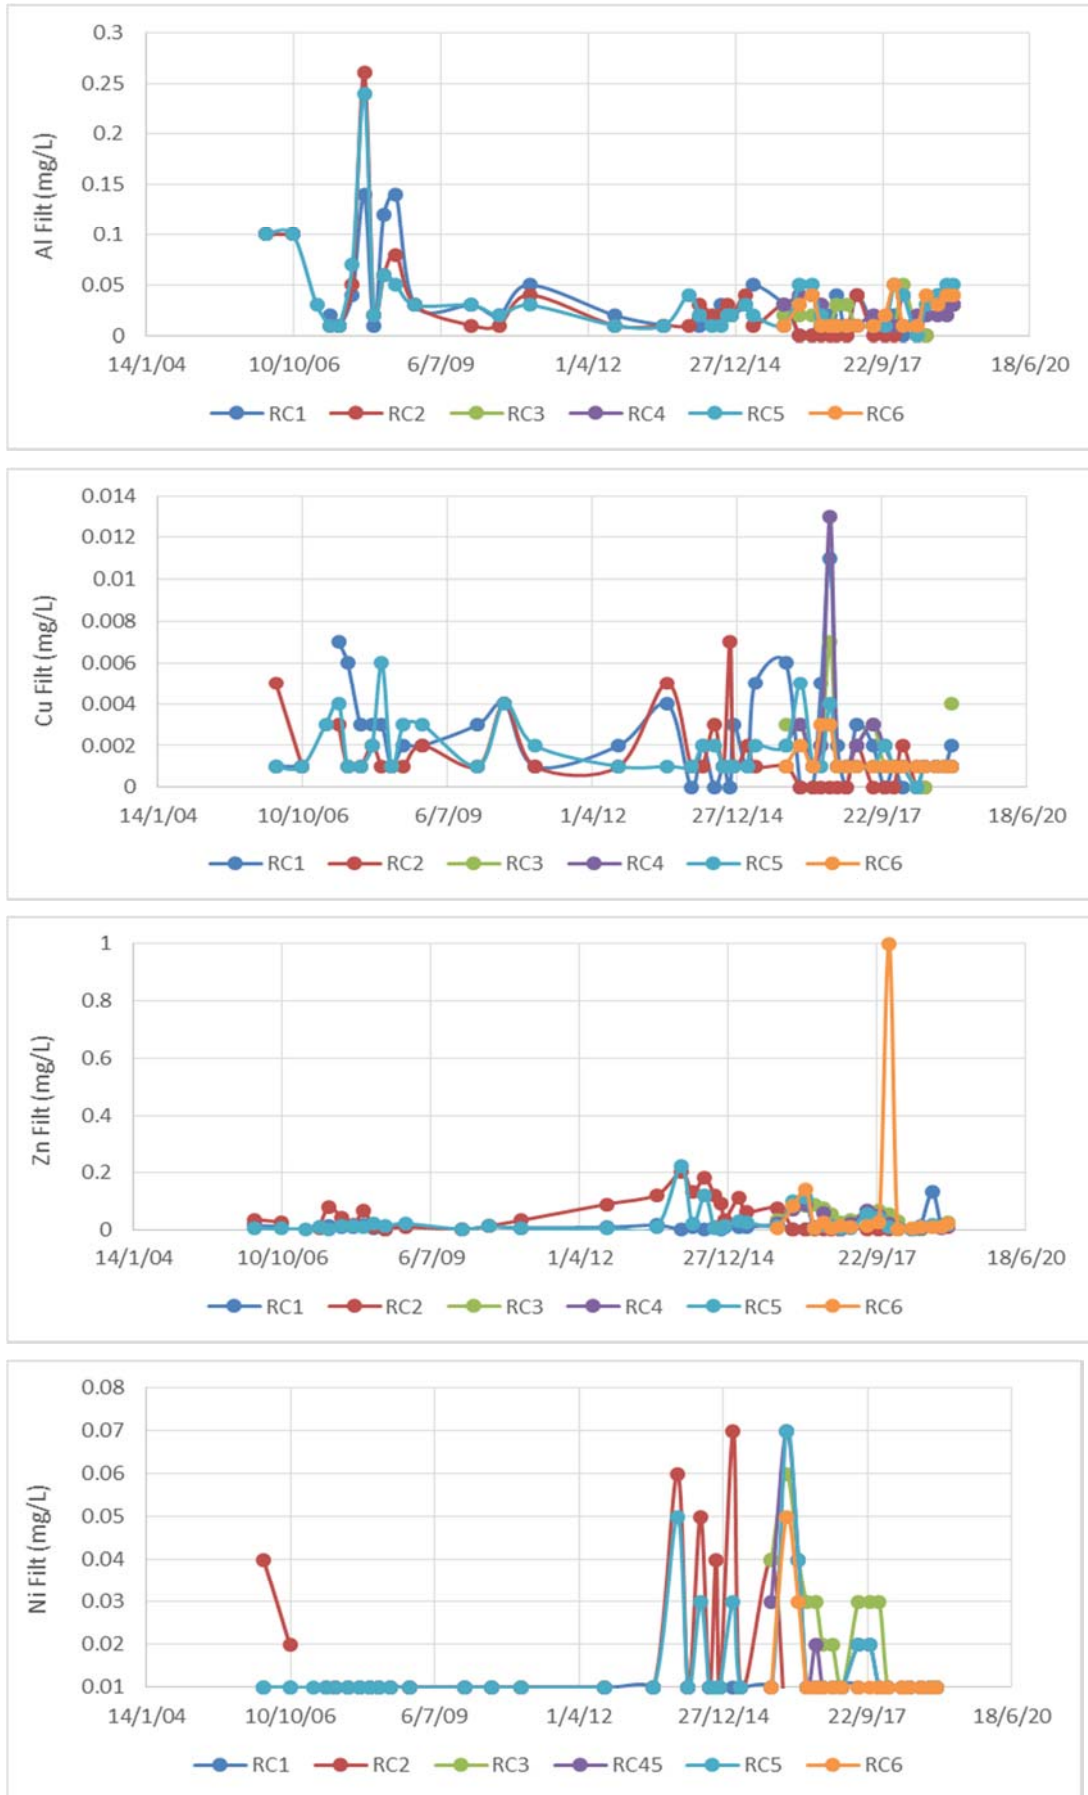
Figure 6 Redbank Creek Metals

Redbank Creek was recorded to exceed the ANZECC 2000 trigger levels for filterable aluminium (<0.26mg/L). Peak levels occurred during late 2007 and early 2008, with no observed increase above background levels during the Longwall 26 to 30 mining period.

Copper concentrations were recorded to reach up to 0.013mg/L, however no sustained increase as a result of Longwalls 28 to 30 was observed as shown in **Figure 6**.

Zinc concentrations were noted to reach up to 1.0mg/L as shown in **Figure 6**, with a rise in concentration observed at Site RC2 since late 2010, and since August 2013 at RC3. An erratic, although generalised reduction, was also observed since February 2014 and subsequent rise after extraction of Longwall 29 and after Longwall 31.

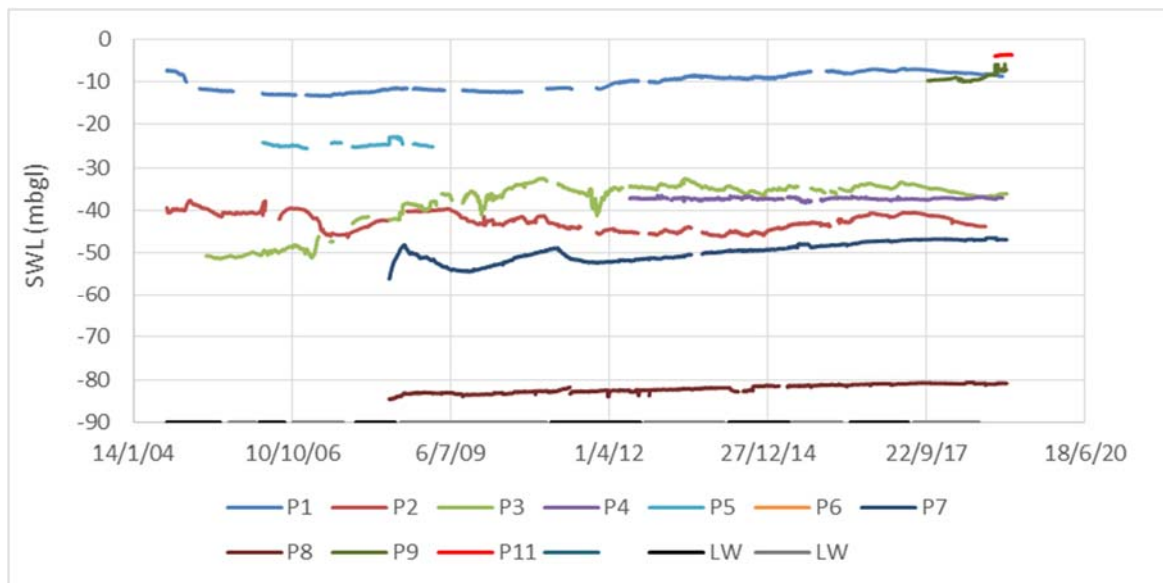
Figure 7 Standing Water Levels and Panel Extraction

No significant open standpipe piezometer water level reduction occurred during the Longwall 31 extraction period (except for the P9 series as discussed further in Section 3.7.5), and no complaints of adverse effects on private bore water levels or yield were received by the Colliery during extraction of Longwall 31.

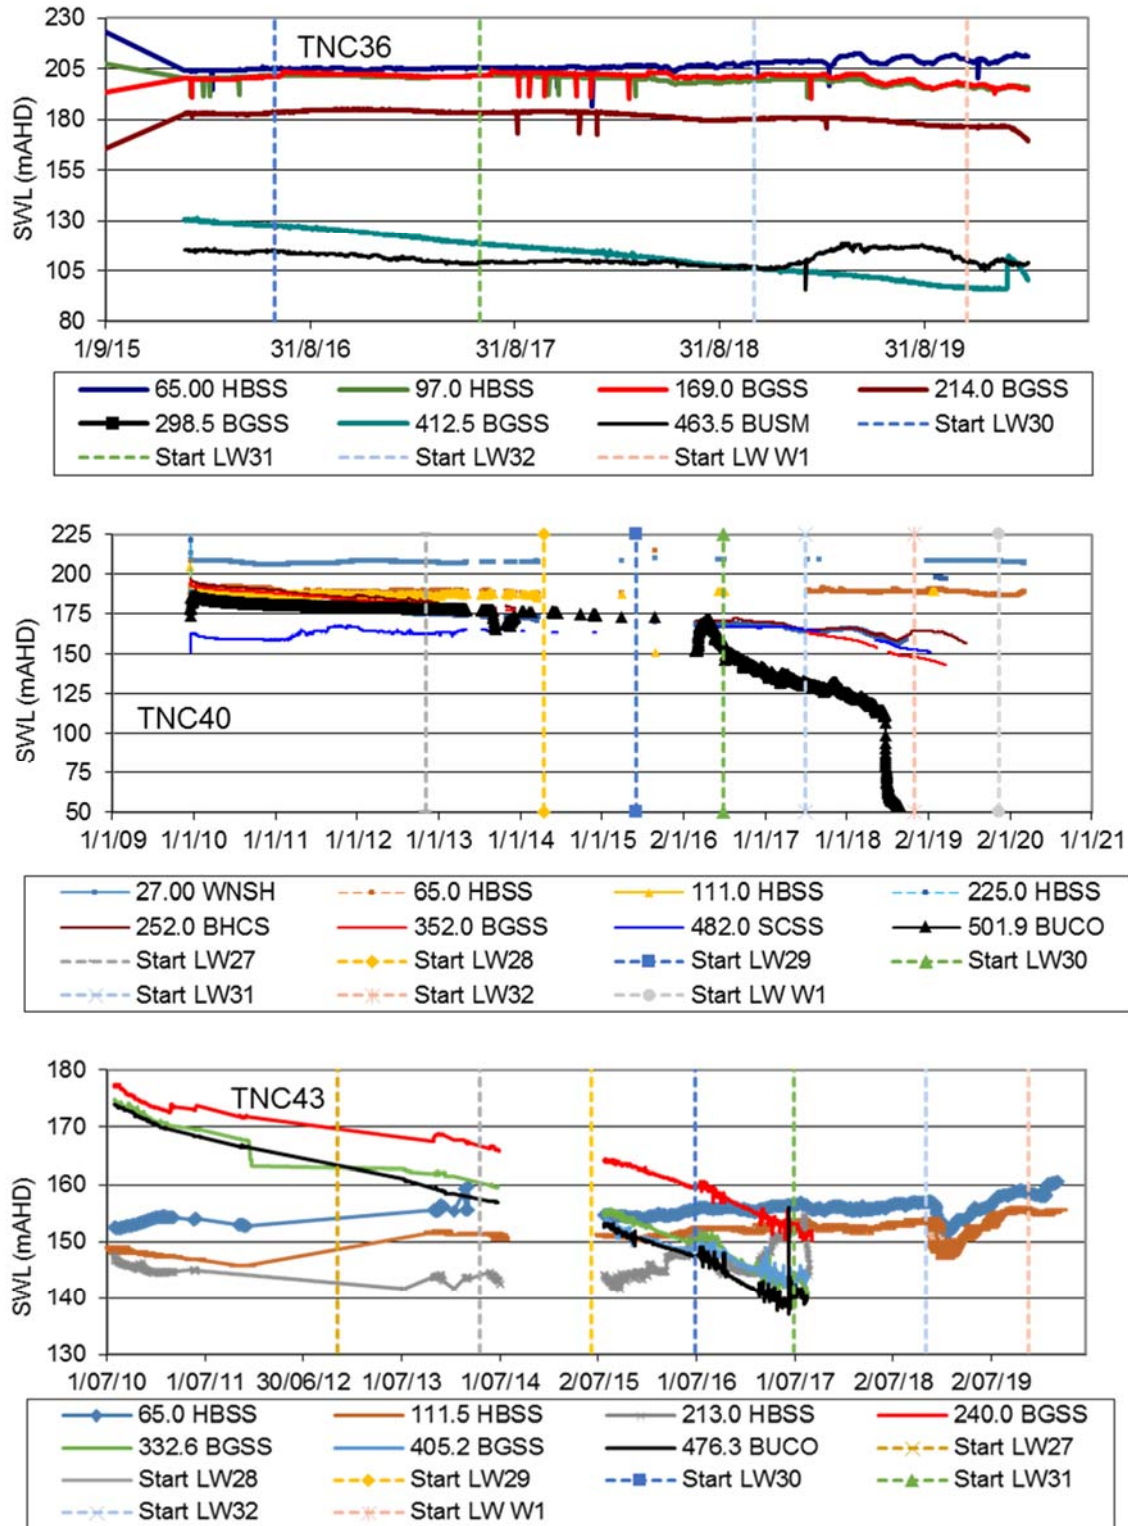
Figure 8 Vibrating Wire Piezometer TNC36, 40 and 43 Groundwater Levels

Partial depressurisation is observed in the Hawkesbury Sandstone at 97mbgl as well as in the Bulgo Sandstone (at 169 / 214 / 299mbgl) and the Bulli Seam in TNC36.

Gradual depressurisation was observed in the Hawkesbury Sandstone (213mbgl) as well as in the Bulgo Sandstone (at 240 / 333 / 425mbgl) and Bulli Seam in TNC43.

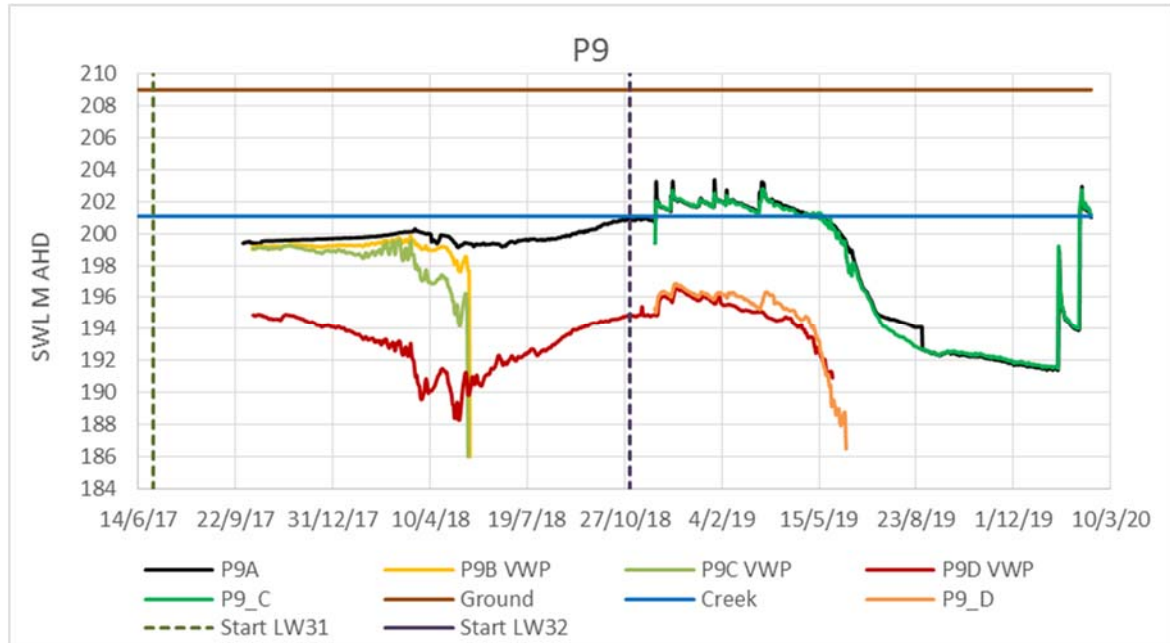
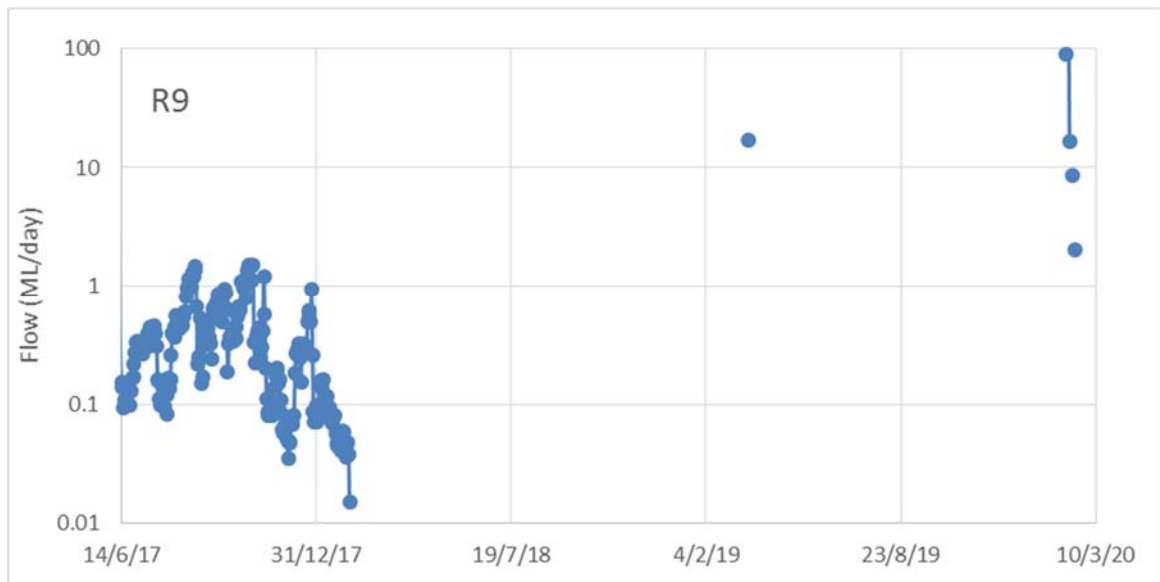
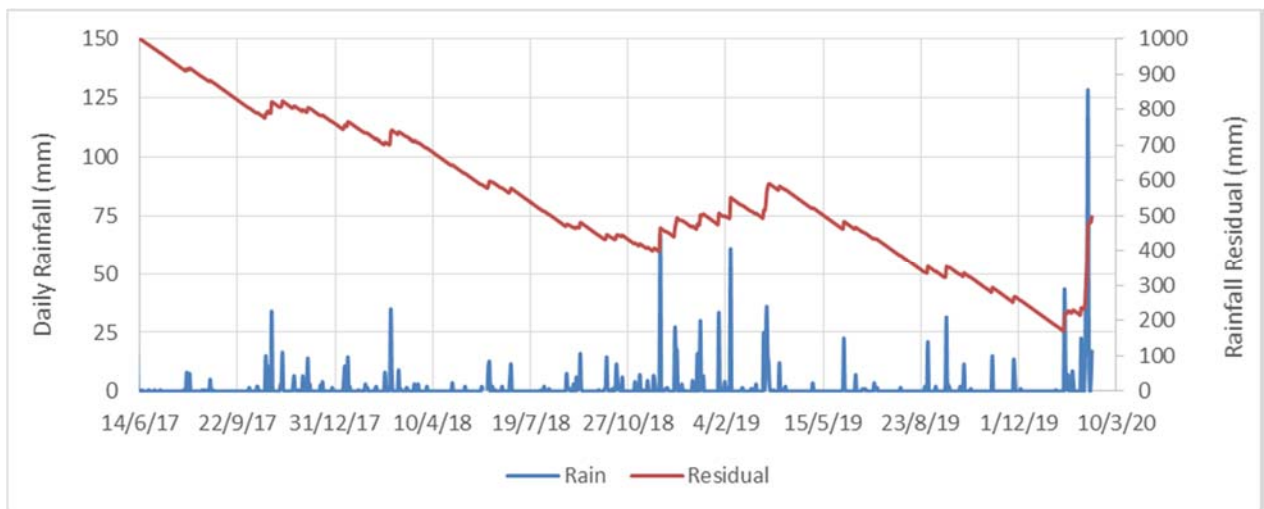
Figure 10 P9 Series Groundwater Levels, Pool R9 Water Level and Rainfall

A definitive reduction in pool depth and downstream overland connective flow occurred within Redbank Creek in the concrete weir based pool (R9 / RC3) on and after 10/3/18 as shown in **Figure 10**, when Longwall 31 was approximately 140m south of the creek bed.

Both VWP intakes at 38mbgl and 48mbgl (P9B and P9C) failed to record any further readings after 19 May 2018, when they sheared off.

Observation of the P9 piezometers, pool levels in Redbank Creek and rainfall indicates undermining of the creek and P9 piezometers by Longwall 31 increased the fracture connection with the creek and enables a heightened recharge / discharge response after rain events within the shallow strata.

P9B and P9C were replaced with open standpipe piezometers on 28/11/2018. After that time they have both shown a heightened response to rainfall in the catchment and recharge of pools in Redbank Creek, compared to before they were undermined.

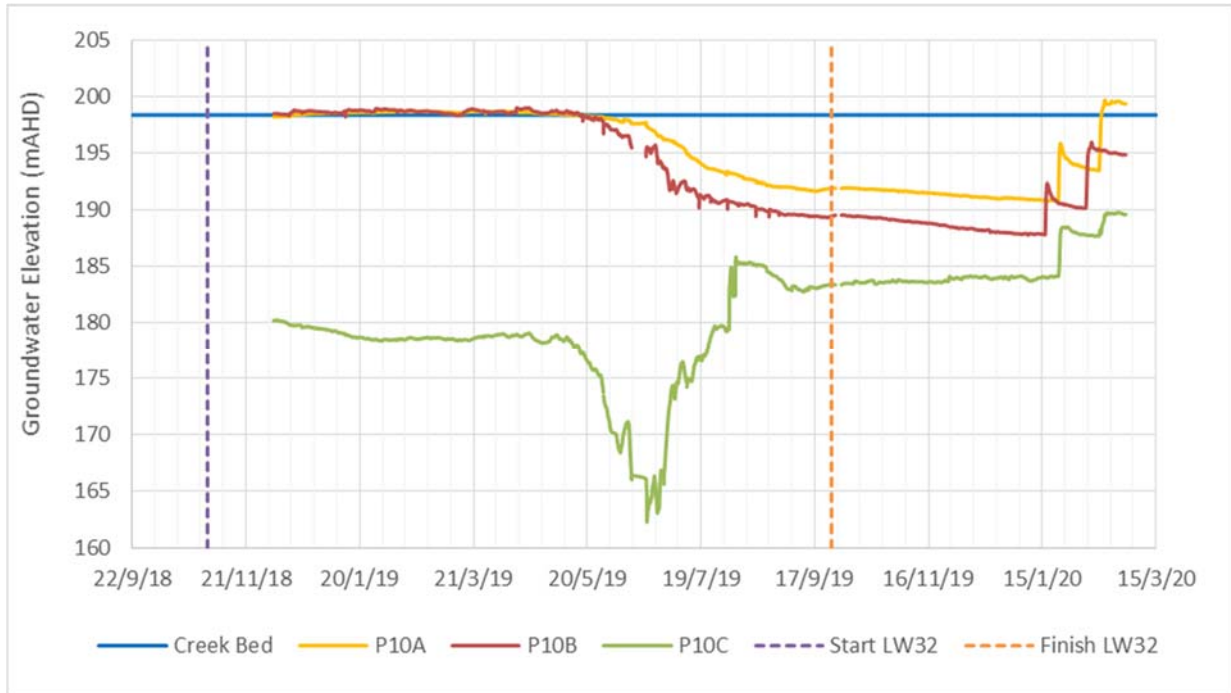
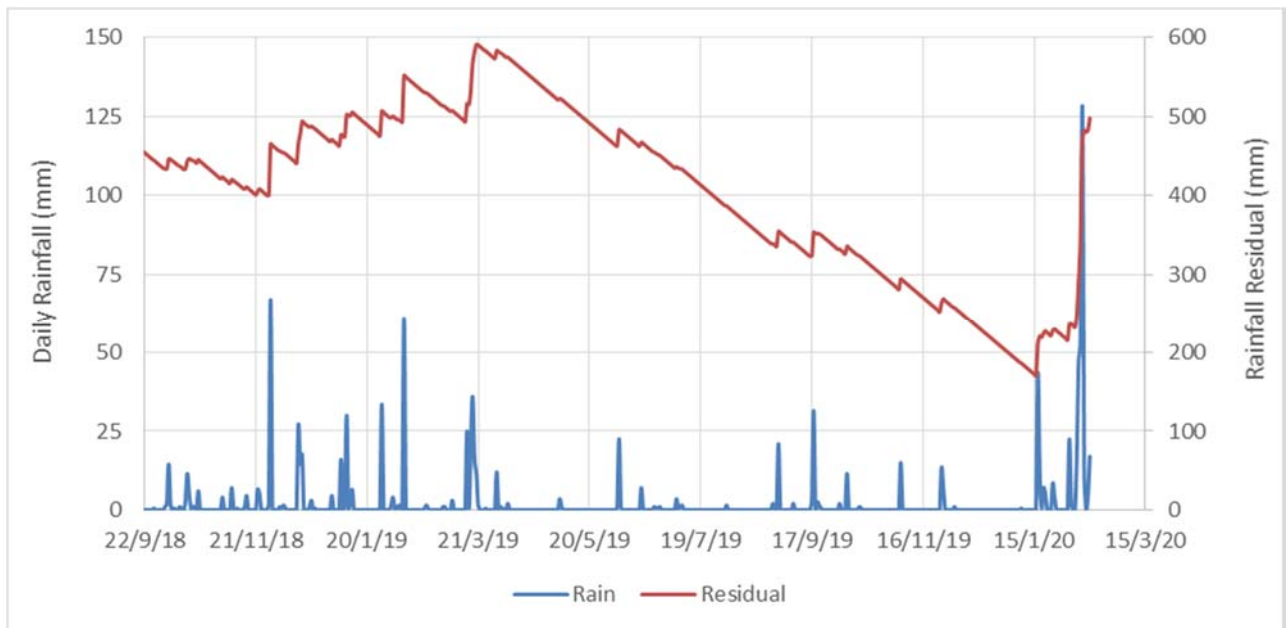
Figure 11 P10 Groundwater Levels and Rainfall

As shown in **Figure 11**, the P10 piezometers showed a definitive water level reduction in all three open standpipe piezometer intakes before the piezometer was undermined in late May 2019.

Observation of the P10 piezometers, pool levels in Redbank Creek and rainfall indicates undermining of the creek and P10 by Longwall 32 increased the fracture connection with the creek and now enables a heightened recharge / discharge response after rain events within the shallow strata.

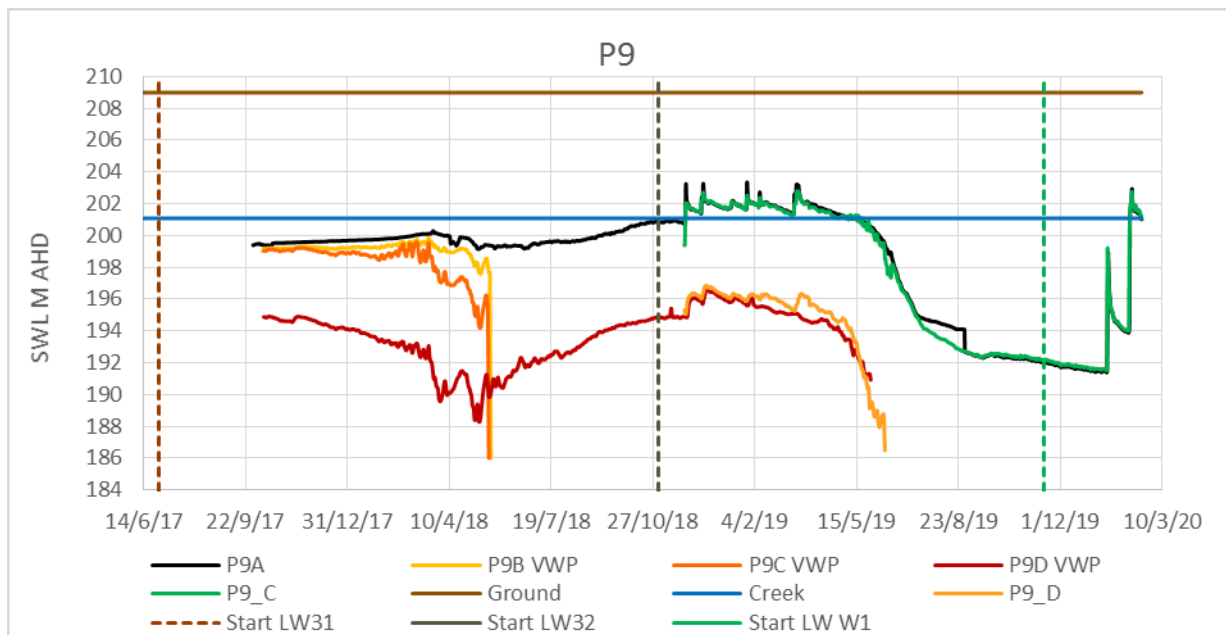
Figure 2: P9 Hydrograph

The upper 2 VWP instruments failed during after undermining by Longwall 31 and were replaced by piezometers P9_C and P9_D.

The lower VWP instrument at 68m failed during progression of LW32 along with P9_D.

The hydrograph for P9 shows groundwater levels within the deeper piezometer falling in the order of 5m during progression of LW31 and then recovering before declining again in association with progression of LW32, prior to failure of the VWP.

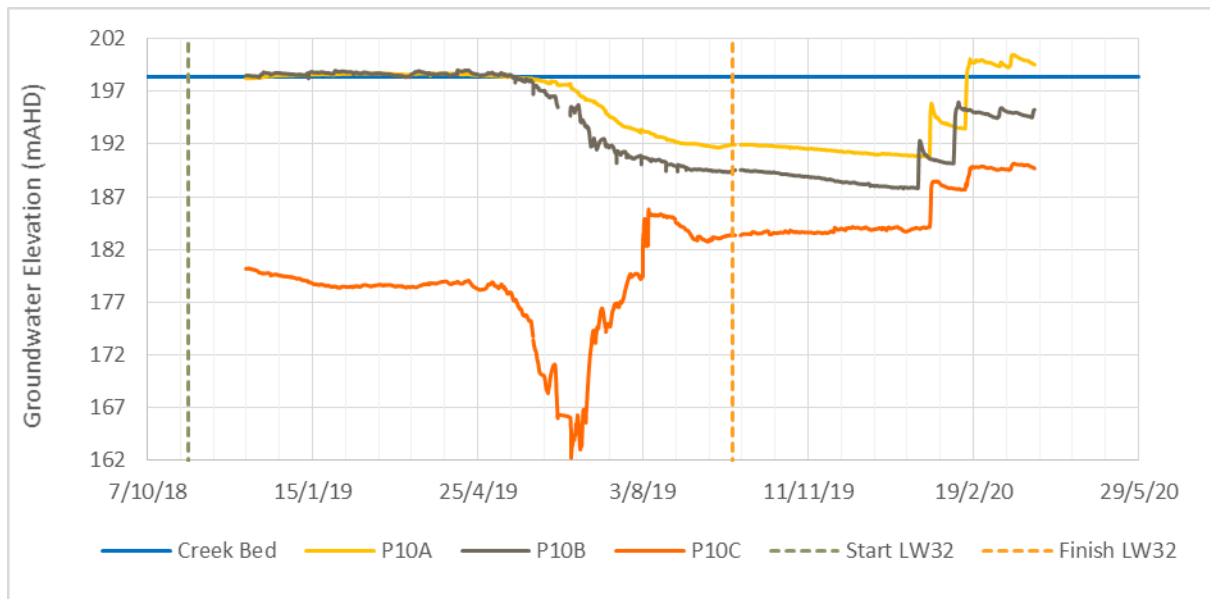
Figure 3: P10 Hydrograph

Figure 3 shows the hydrograph for P10. Similar to P9, the deeper piezometer record shows a subsidence / strata fracturing impact with progression of LW32, although with a greater magnitude of 15m, followed by a recovery to above baseline levels, particularly with the influence of significant rain in January and February 2020.

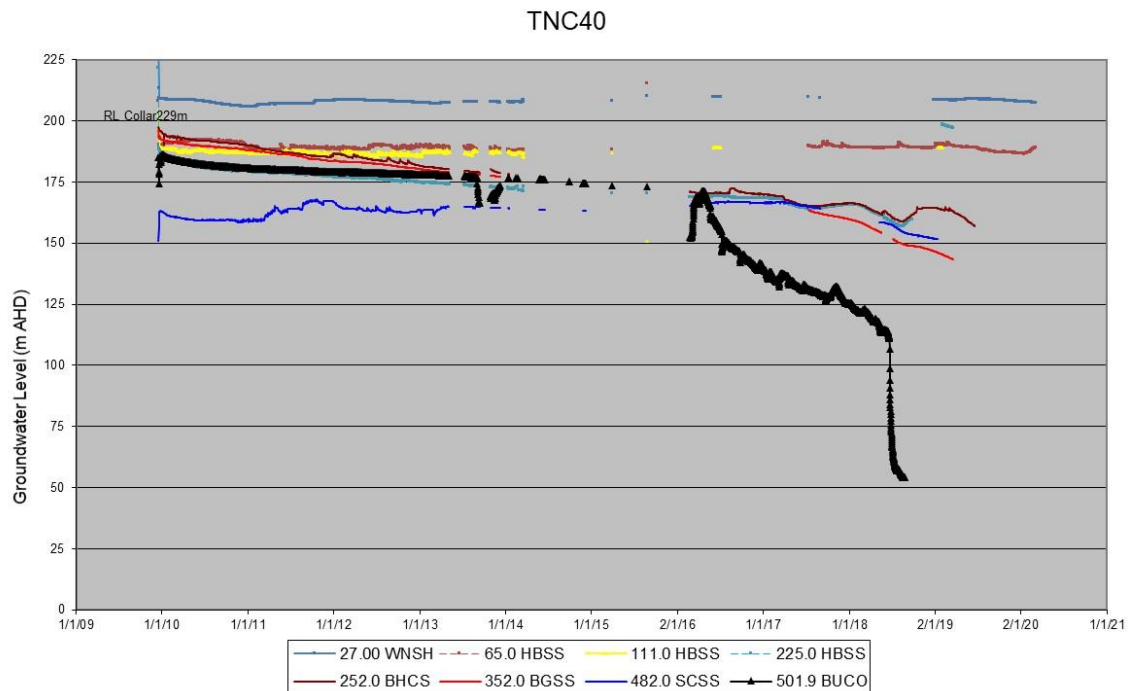
Figure 4: TNC40 Hydrograph

In late September 2018, the signal from the Bald Hill Claystone (225m) was lost and in mid-January 2019 the signal from the transducer now interpreted to be in the Scarborough Sandstone failed.

The Figure 4 TNC40 hydrograph shows relatively static groundwater pressures in the Hawkesbury Sandstone, a punctuated depressurisation in the Bulli Coal Seam and gradual decline of pressures in the overlying Bulgo Sandstone as a result of mining related fracturing and subsidence.

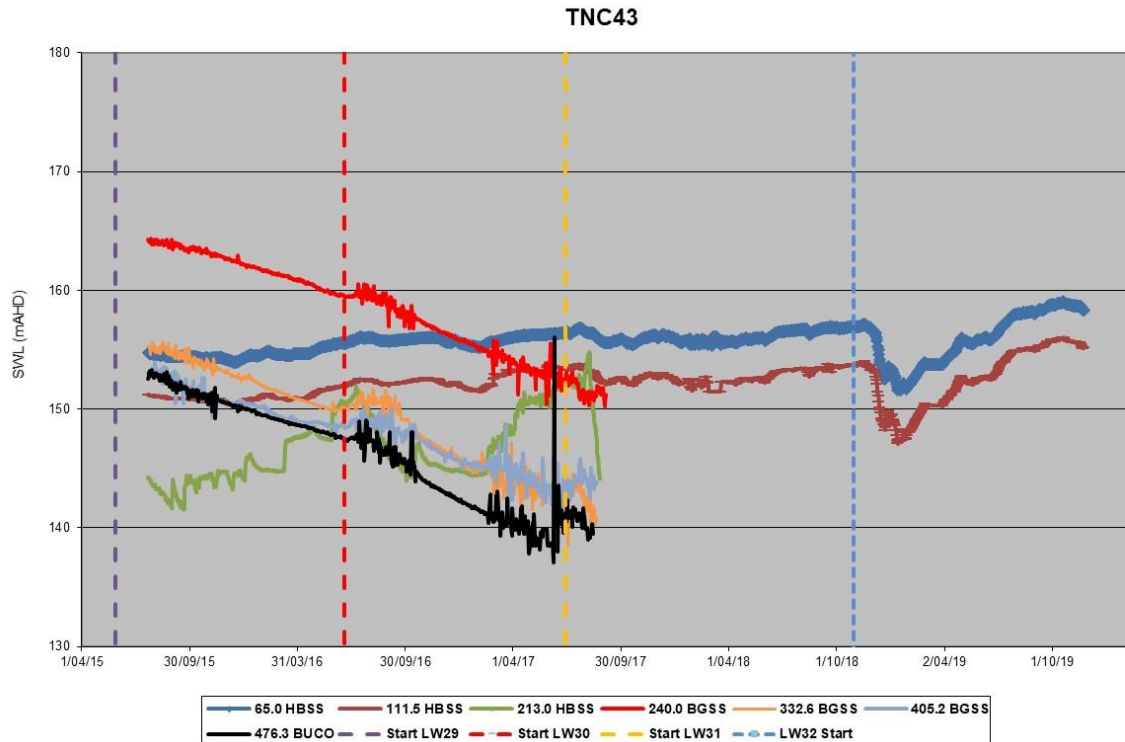
Figure 5: TNC43 Hydrograph

During August and September 2017, signal from deeper instrumentation was lost for unknown reasons. The TNC43 hydrograph in Figure 5 shows relatively static groundwater pressures in the Hawkesbury Sandstone and gradual depressurisation within the Bulli Coal and overlying Bulgo Sandstone as a result of mining related subsidence and strata fracturing.

Figure 5 shows the same hydrograph record for the 2017 calendar year, with a rise in pressure, then punctuated decline for the 213 mbgl intake, before failure at the end of August 2018.

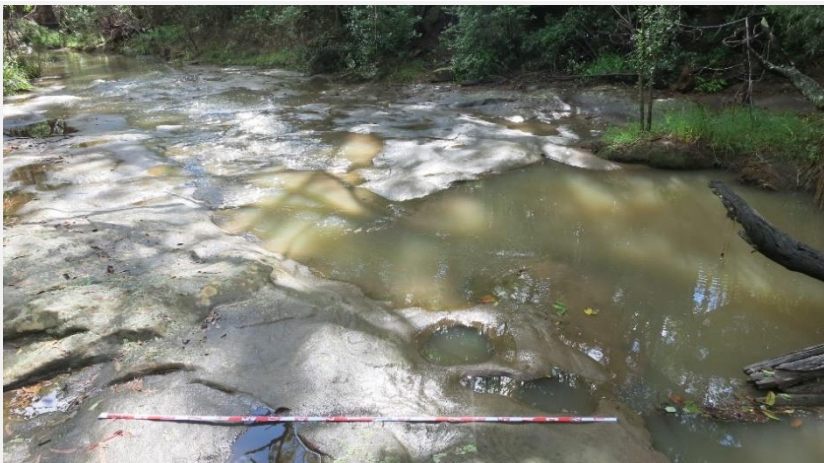
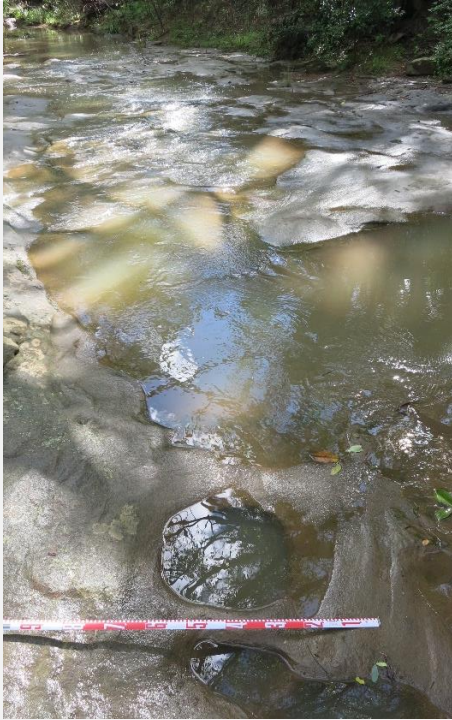
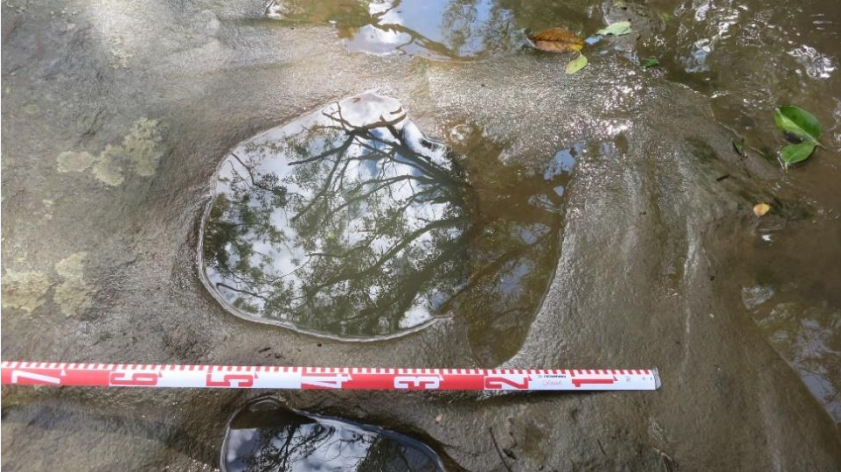
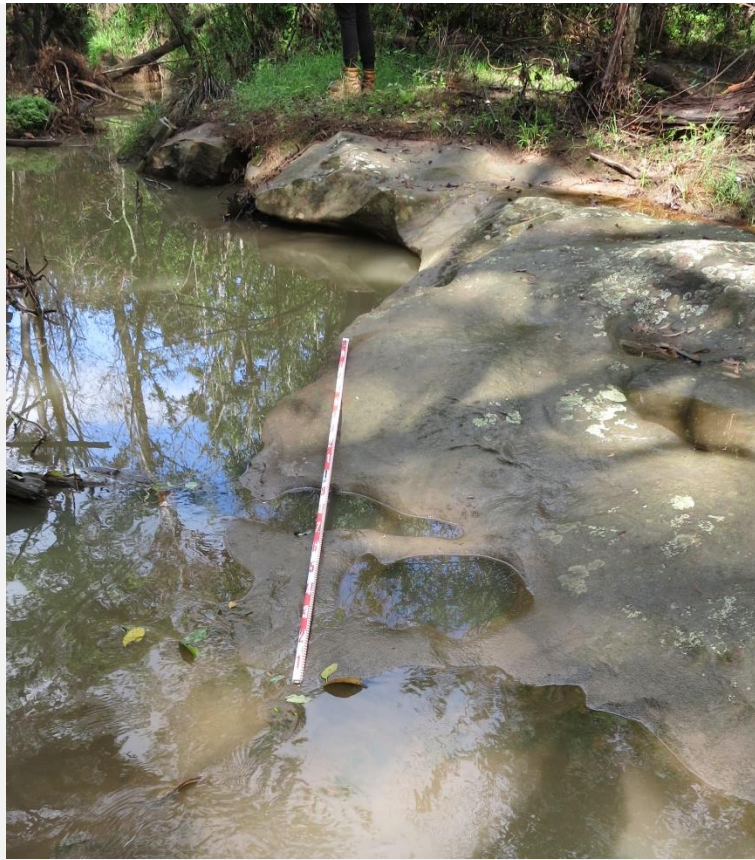
AHIMS Site #	Site Name	Results of Inspection	Photos
52-2-2082	Redbank Creek-4	The condition of the site has not changed due to mining related impacts since the original recording in 1998.

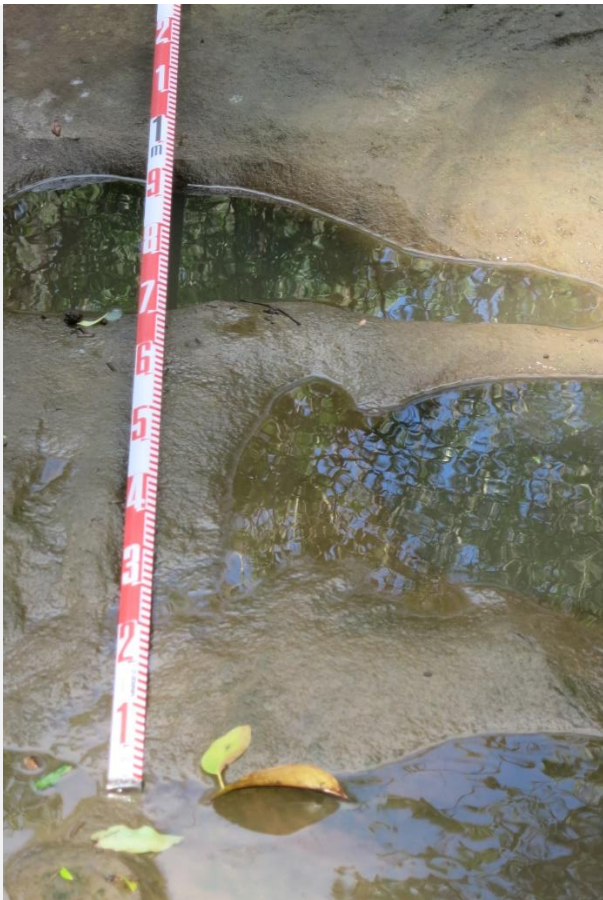
<p data-bbox="580 1263 1390 1294">Plate 7 Close up photo of the grinding groove currently filled with water.</p>
