Tahmoor Coal Pty Ltd

SIX MONTHLY SUBSIDENCE IMPACT

Tahmoor North, Western Domain
Longwalls West 1 and West 2

Report 2 - November 2020

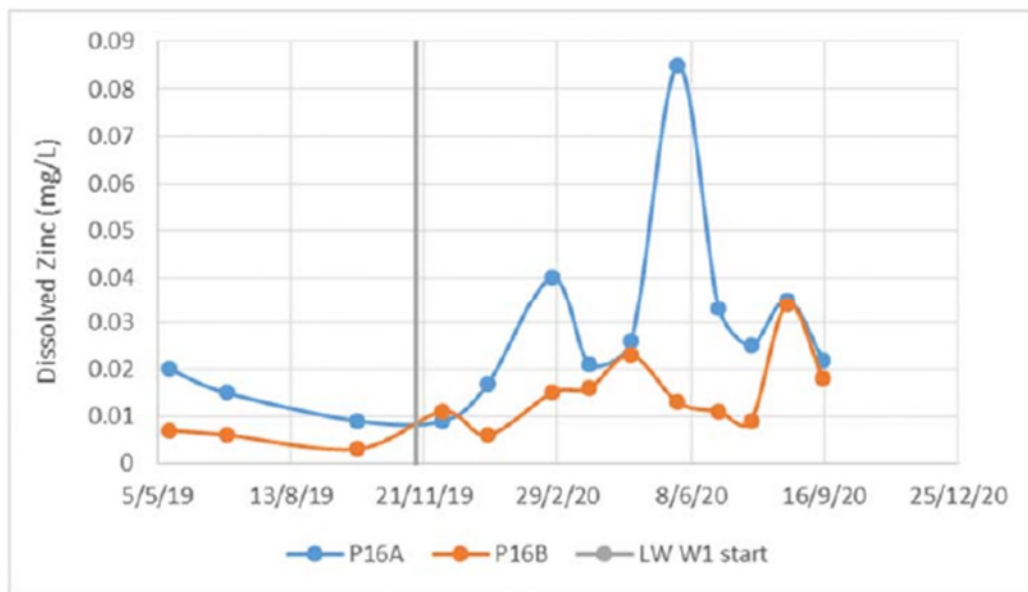
Figure 4-7 Groundwater quality for reporting period – dissolved zinc at P16 (source: GeoTerra, Groundwater Monitoring Report 10, **Appendix D**)

With the exception of October, 2020, there were no observable changes in salinity, pH or metals outside of the baseline variability. During October 2020, groundwater quality results from P12, P13 and P16 resulted in a Level 2 TARP trigger. These results included lower pH in comparison to the baseline variability at P12, P13 and P16, and elevated dissolved zinc levels at P16 (refer to **Figure 4-7** and **Figure 4-8**). These groundwater quality results have been attributed to piezometer casing used.
