Tahmoor Coal Pty Ltd

SIX MONTHLY SUBSIDENCE IMPACT

**Tahmoor North, Western Domain
Longwalls West 1 and West 2**

13 October 2020 – 21 April 2021

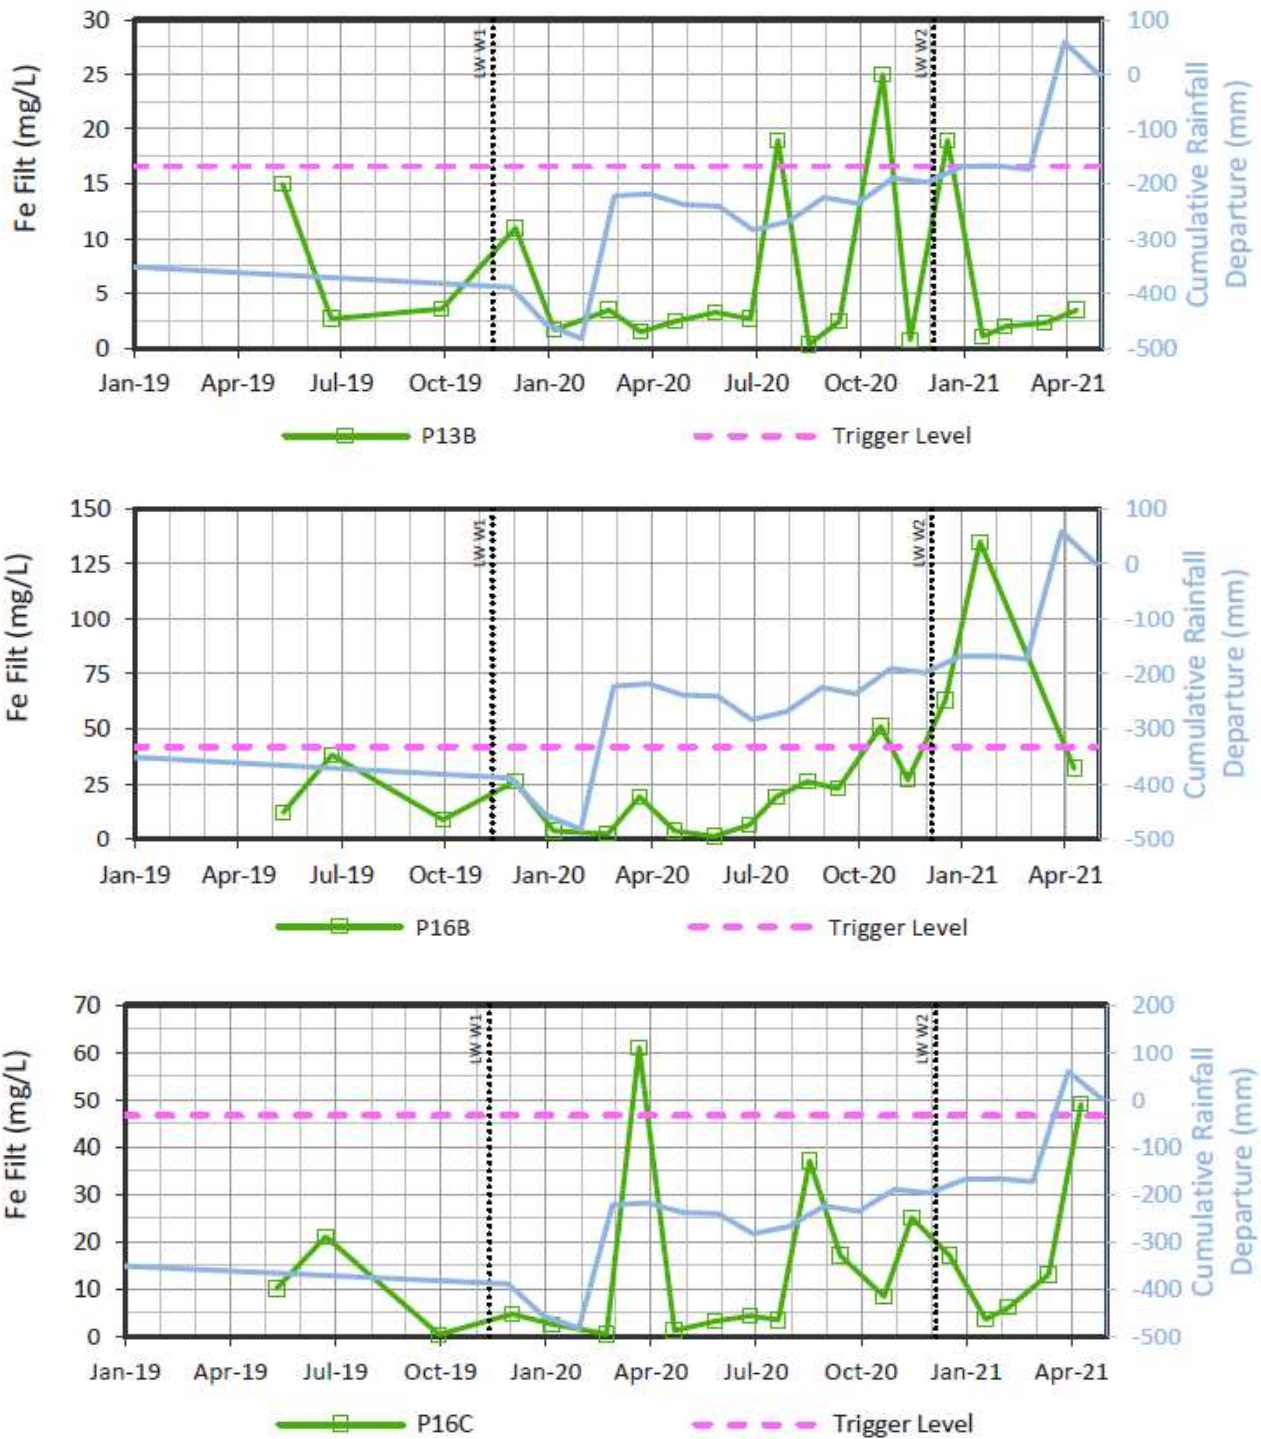
Figure 4-9 Groundwater quality for reporting period – Dissolved Iron at P13 intake B, and P16 intakes B and C (source: SLR, Groundwater Monitoring Report, Appendix D)

All the monitoring bores and private bores at Western Domain triggered the TARP level 2 criteria for specific metals since completion of LW W1 and commencement of LW W2, with the exceptions of P12A, P12B, P12C, P14C, GW115860 and GW104090 that are within the TARP level 1 criteria. Single short-term (<3 months) exceedance in dissolved Iron (Fe) triggered TARP Level 2 at P13B, P16B and P16C in November 2020 and April 2021 and possibly due to natural fluctuations. P13B presents fluctuations in Fe with two exceedances occurring for less than three months in October 2020 and January 2021. Dissolved iron concentrations decline back to baseline levels in April 2021 for locations P13B and P16B but not for P16C where a single exceedance is observed in April 2021 (refer to **Figure 4-9**).

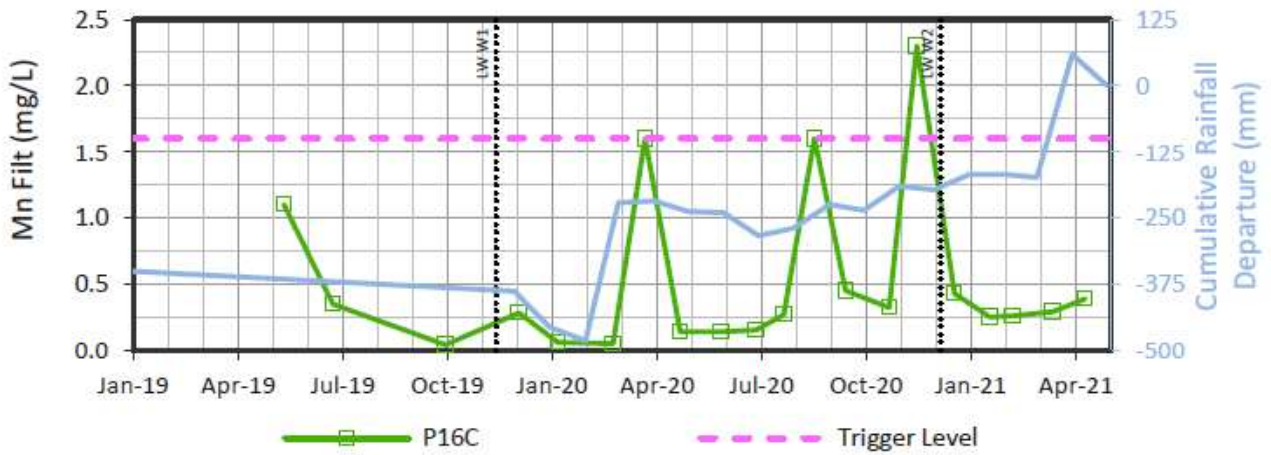
Figure 4-10 Groundwater quality for reporting period – Manganese at P16C (source: SLR, Groundwater Monitoring Report, Appendix D)

A Single short-term (< 3 month) exceedance (TARP Level 2) in Manganese (Mn) was recorded at P16C in November 2020 and reverted to baseline and below the trigger levels in December 2020 further returning to non-exceedance levels in April 2021 (refer to **Figure 4-10**).

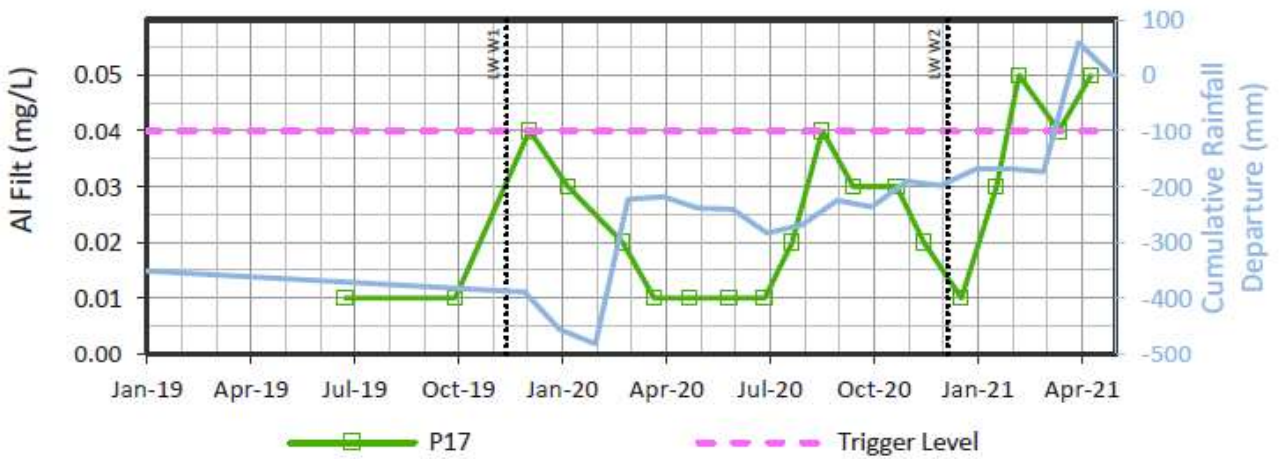
Figure 4-11 Groundwater quality for reporting period – Dissolved Aluminium at P17 (source: SLR, Groundwater Monitoring Report, Appendix D)

In February 2021, Aluminium (Al) concentrations triggered a Level 2 TARP at P17 and during January to March 2021, a Level 2 TARP was triggered for Lithium (Li) at P13 (intakes A and B) and a Level 4 TARP was triggered in April 2021 at P13C for Lithium (Li) concentrations consistently above the proposed trigger level (refer to **Figure 4-11** and **4-12**).

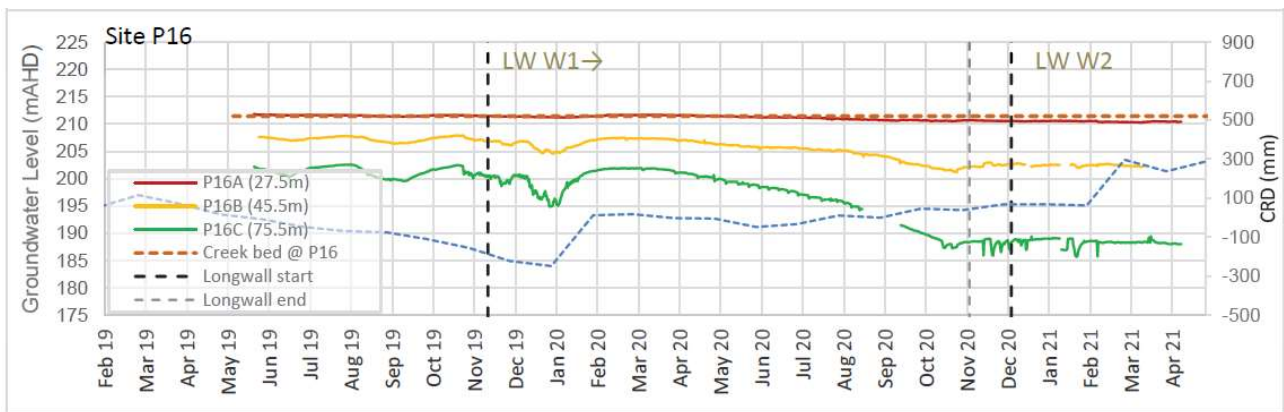
Figure 4-16 Groundwater bore levels during the reporting period – P16 (source: SLR, Groundwater Six-Month Review , Appendix D)

In November 2020, following wetter conditions and cessation of LW W1, groundwater levels at P16B and P16C have stabilised. By December 2020, groundwater levels at P16B and P16C have recovered by 1 m and stand approximately 4 m and 11 m below the minimum baseline water level. A Level 4 TARP trigger at P16B and P16C was notified to DPIE and NRAR on 30th December 2020. P16B and P16C exhibited some mild drawdown in the range of 2 m over short periods after the commencement of LW W2 but stabilised in March 2021 to similar level as December 2020. From 16 March 2020, no groundwater levels are recorded at P16B due to the loss of the logger, it was replaced in late April 2021. As of April 2021, water levels at P16C are observed at 0.7 m above water levels recorded in November 2020 but remain 11.5 m below baseline levels. Actions for the Level 4 TARP level criteria will be on-going at P16B and P16C (refer to Groundwater Six-Month Review in **Appendix D**).

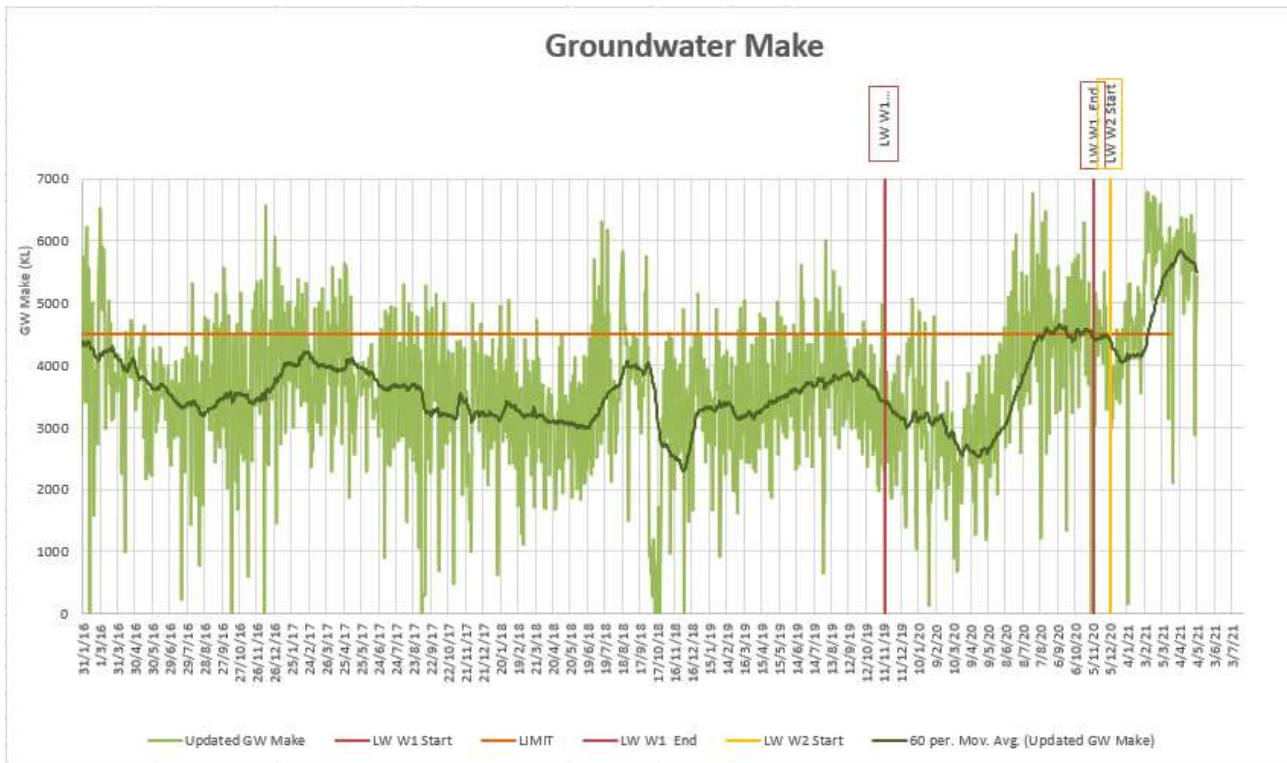
Figure 4-17 Tahmoor Mine daily water make with LW W1 and W2 commencement dates and LW W1 end date (source: courtesy of Tahmoor Coal)

The period between mid-2020 shows an increase in inflows to greater than 5 ML/day at the end of July 2020 likely due to the extraction of LW W1. Inflows declined in late 2020, before rising in February 2021 (early in LW W2), with the recent peak at marginally over 6 ML/d in March/ April 2021 and have recently begun to decline (refer to Groundwater Six-Month Review, **Appendix D**). Analysis of longwall extraction rate (in metres/day) versus inflow rate (ML/d or m³/d) indicates that the consistently higher extraction rates that have been achieved in LW W1 and W2 are at least partly responsible for higher inflows.
