Report on
Geotechnical Assessment
Longwalls S1A to S6A, Bargo

Prepared for
Tahmoor Coal Pty Ltd

Project 210597.00
December 2022

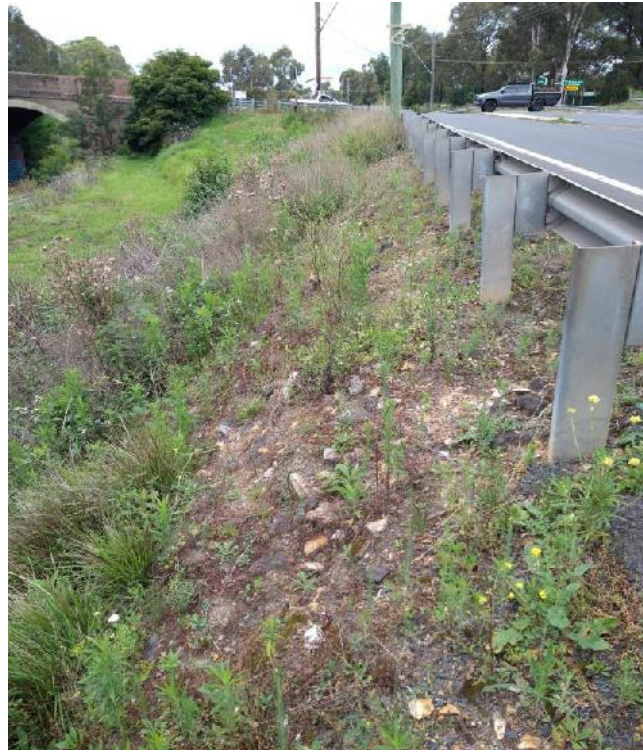
Photo 1: View looking south towards the Wellers Road overpass bridge, along the crest of the downstream face for the RE1 road embankment.

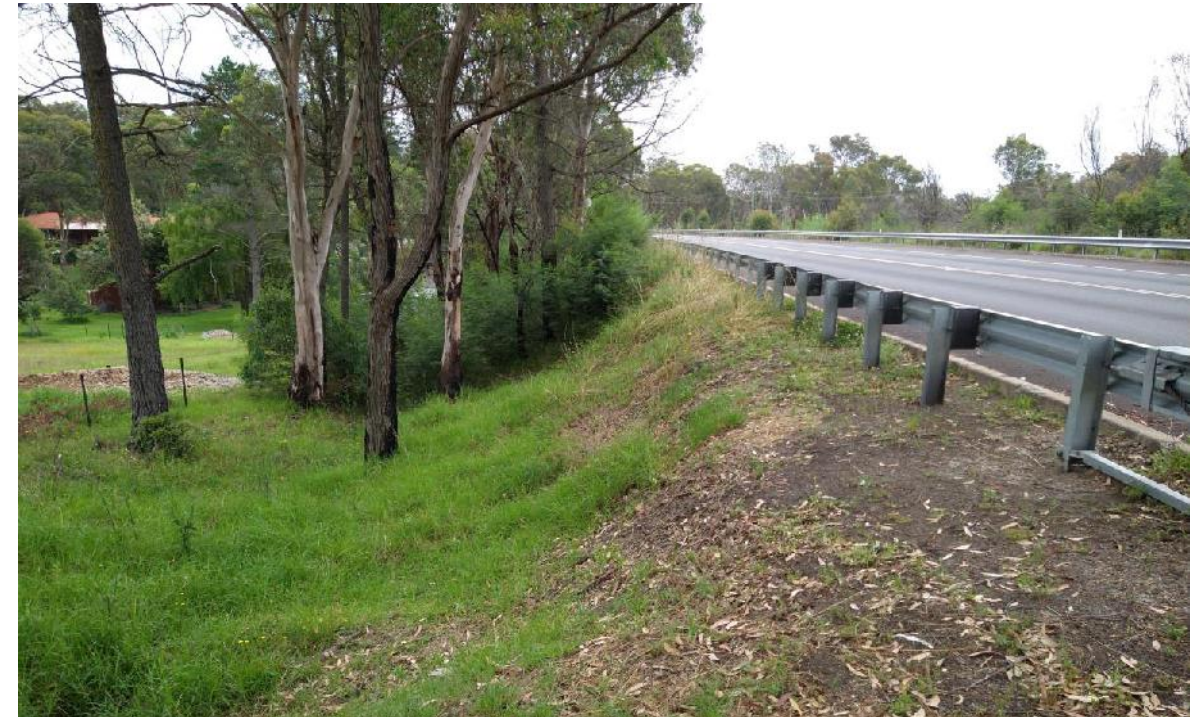
Photo 4: View looking north along the upstream face for RE2.

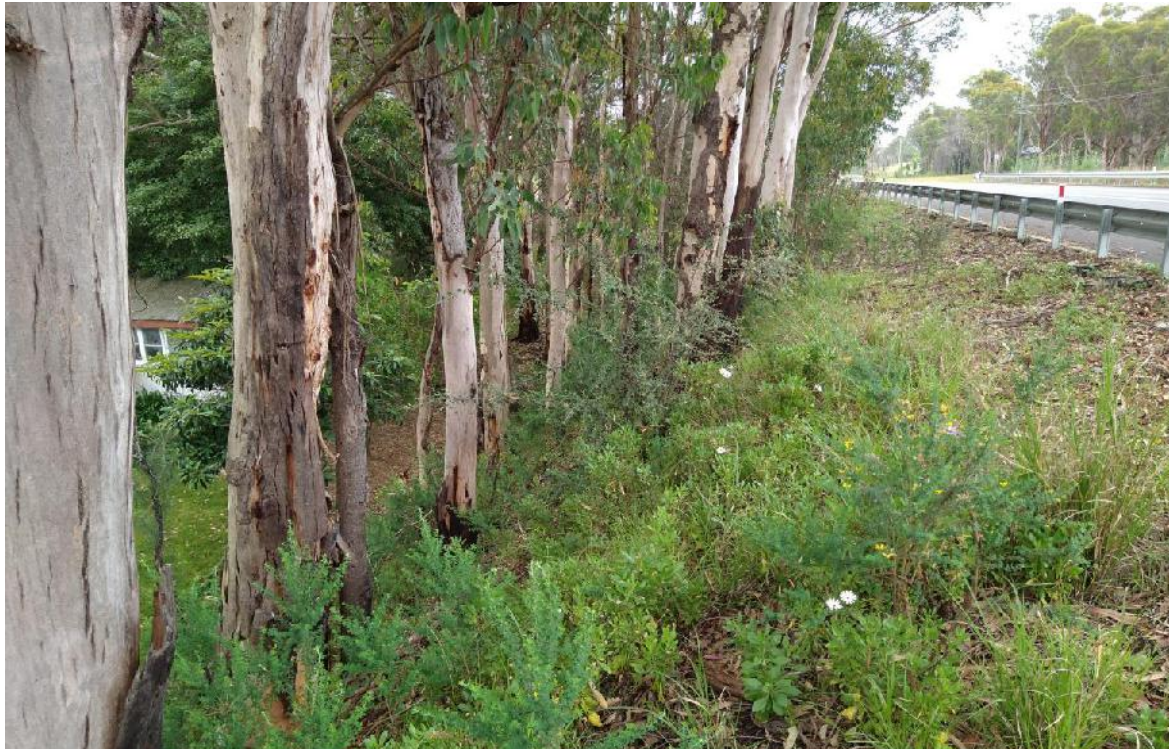
Photo 5: View looking north along the upstream face for RE2. Note: the dwelling at the toe of the embankment, which is downstream from FD51.

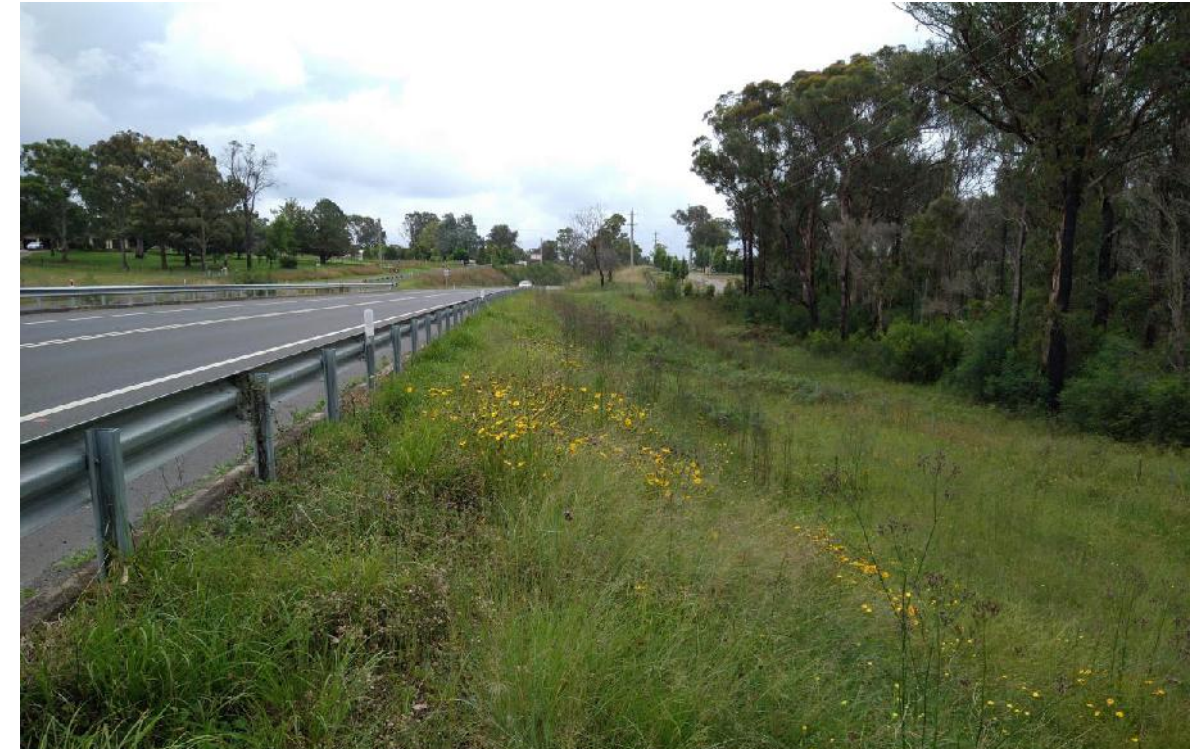
RE3	Remembrance Drive north of Yarran Road	23/12/2021	<ul style="list-style-type: none"> - The upstream face is generally grassed (refer Photos 6 – 8) while the downstream face was obscured with long grass and shrubs. - No signs of deep-seated movement in the pavement. - A high-pressure gas pipeline is located along the eastern side of the embankment.

Photo 6: View looking north along the downstream face for RE3.

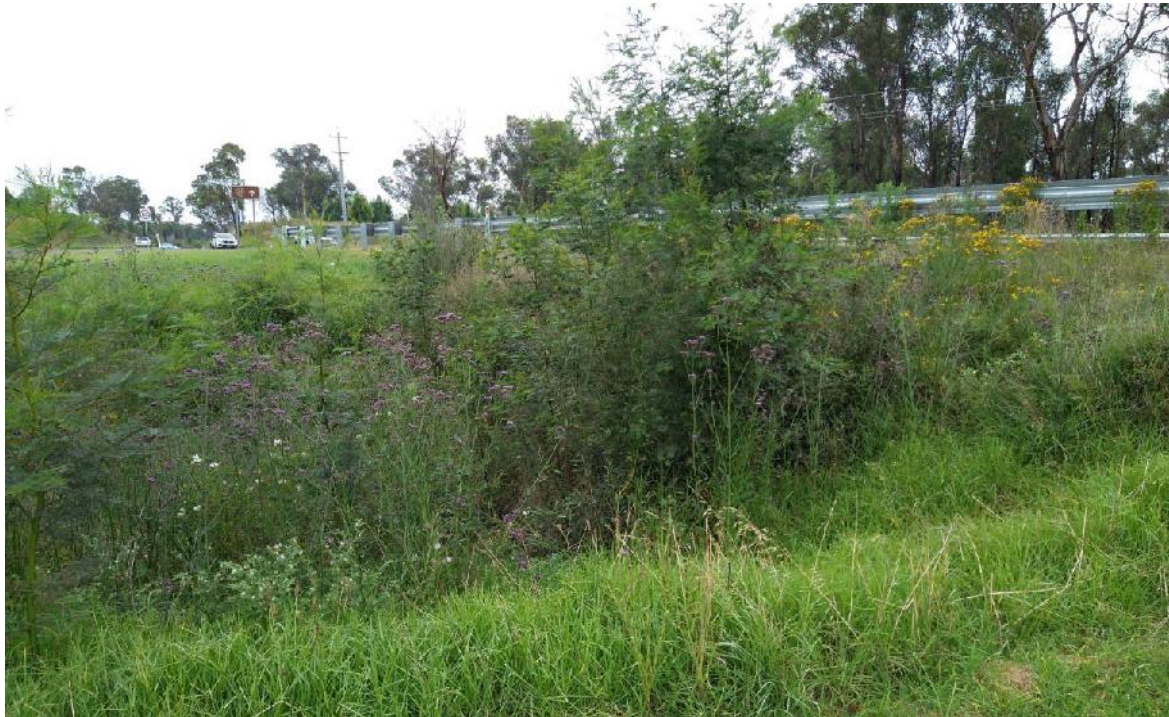
Photo 7: View looking towards the upstream culvert for RE3.

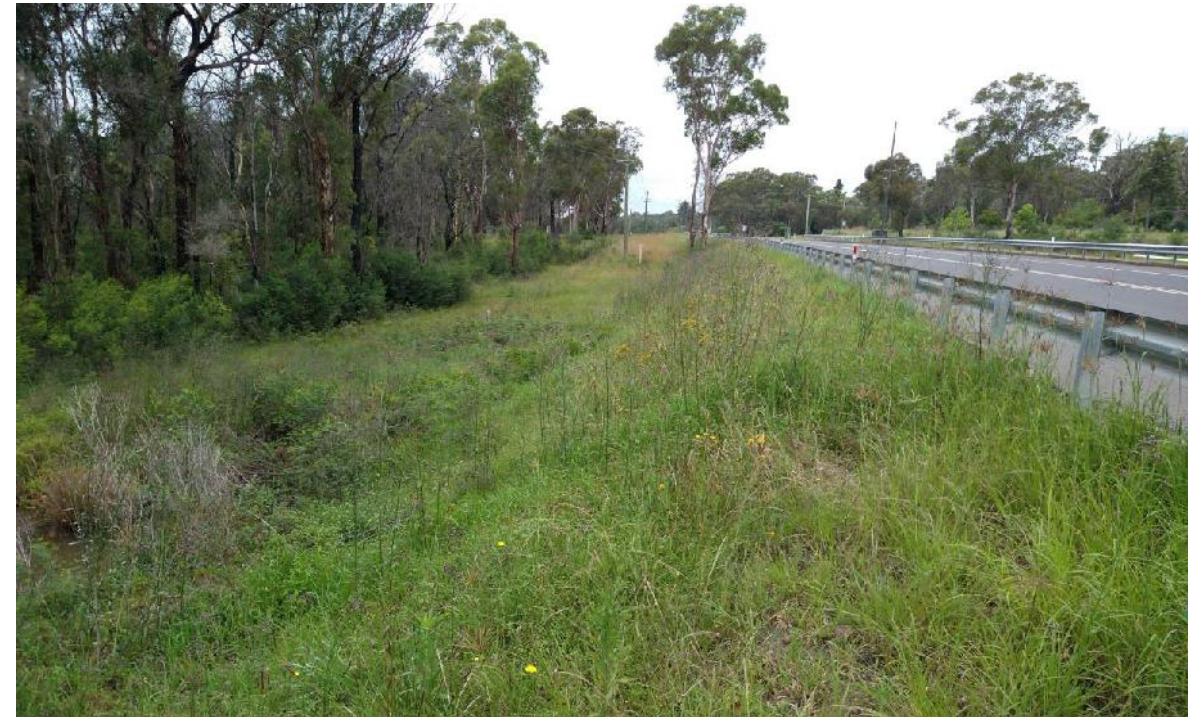
Photo 8: View looking south along the downstream face crest for RE3.

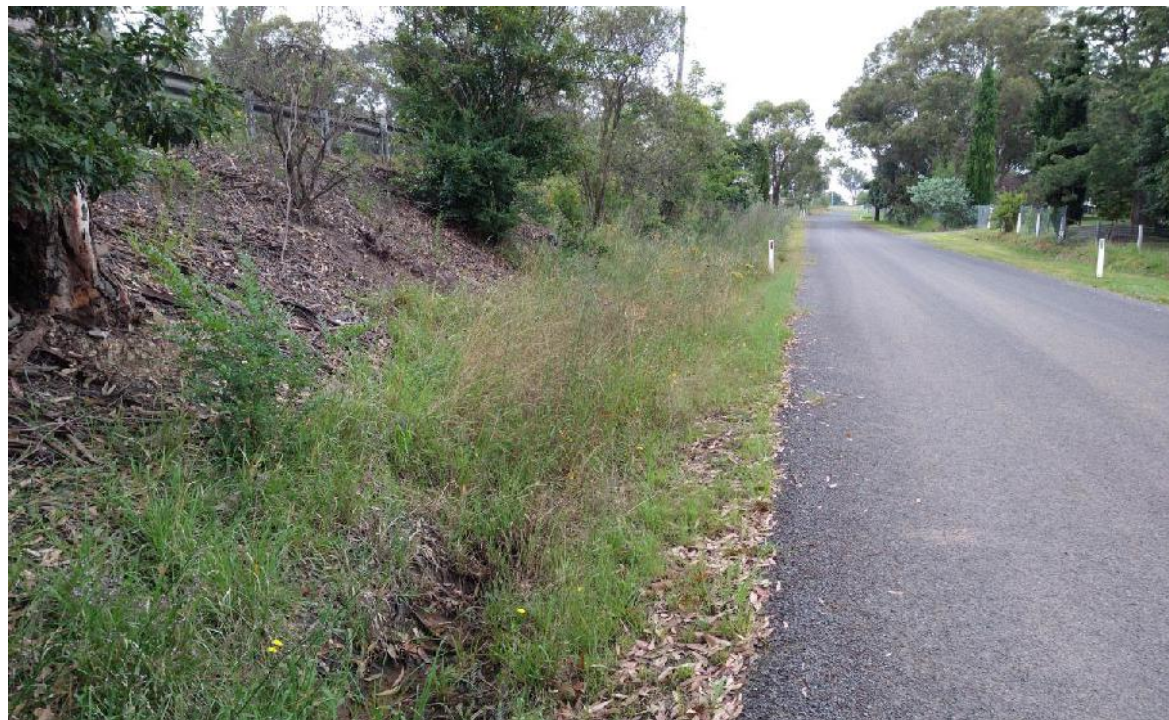
Photo 11: View looking south along the upstream face of RE4 opposite No. 3100 Remembrance Drive. Note: the drain cut into the toe of the embankment.

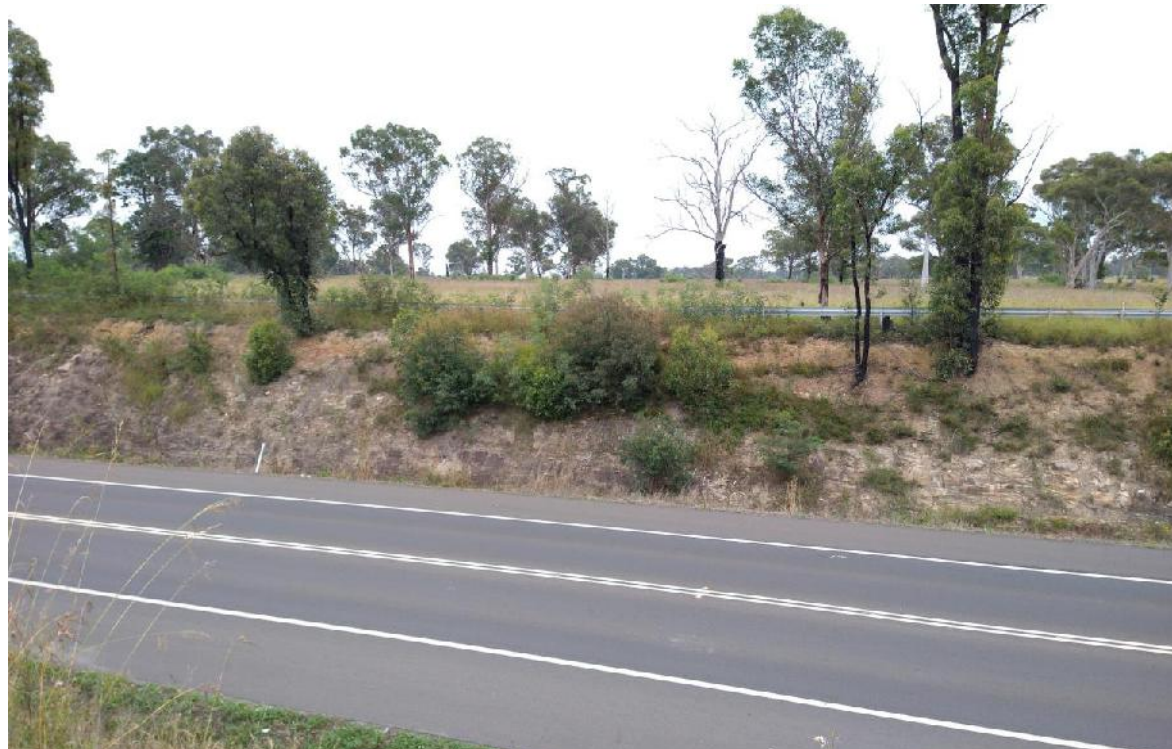
Feature ID/s	Address/Site	Date Inspected	Site Observations
RC1	Remembrance Drive (~No.'s 3116 – 3150 and 3105 – 3165)	23/12/2021	<ul style="list-style-type: none"> - Sandy clay soils up to 1 m deep are located in the upper cut batter. - Average batter slopes measured to be 41° to 45° in the sandstone. - The sandstone in the cut is very low to low strength and highly weathered in the upper cut grading into medium to thickly bedded, medium to high strength, moderately to slightly weathered sandstone in the lower and middle sections of the cut (refer Photos 13 – 15). - A number of burnt tree trunks are located in the cutting (refer Photos 13 and 14). It is understood that the 2020 bushfires affected the area and a number of burnt trees were removed after the fires. - Tension cracking (refer Photo 16) was observed behind the crest above the road cutting opposite No. 3122 Remembrance Drive. - Seepage was observed from the sandstone bedrock adjacent to No. 3150 Remembrance Drive. - A drain is located above the road cutting on the eastern side of the road cutting, adjacent to the central/southern part of No. 3165 Remembrance Drive. - A high-pressure gas pipeline is located above the eastern side of the cutting.

Photo 13: View looking southwest towards the road cutting adjacent to No. 3140 Remembrance Drive. Note: the soil and weathered rock in the upper cut and medium to thickly bedded rock in the

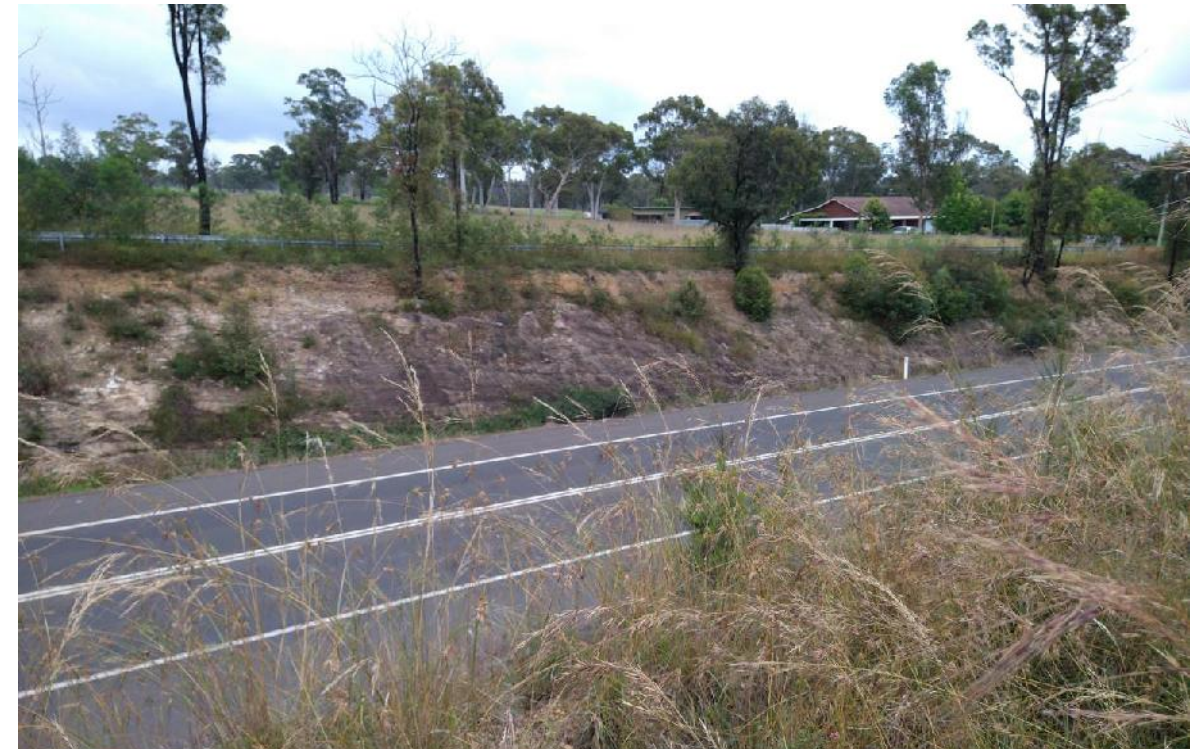
Photo 14: View looking north west towards the road cutting adjacent to No. 3116 Remembrance Drive. Note: the soil and weathered rock in the upper cut and medium to thickly bedded rock in the middle and lower.

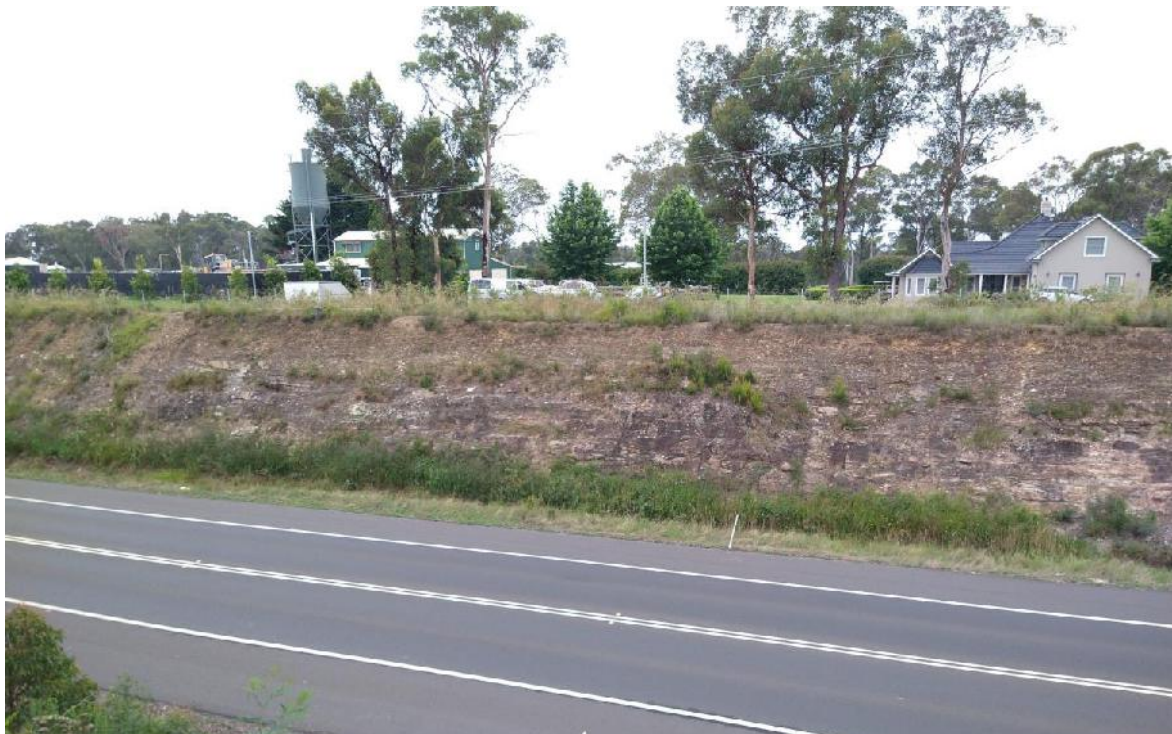
Photo 15: View looking east towards the cutting adjacent to No. 3165 Remembrance Drive. Note: the weathered rock in the upper cut and medium to thickly bedded rock in the middle and lower cut.

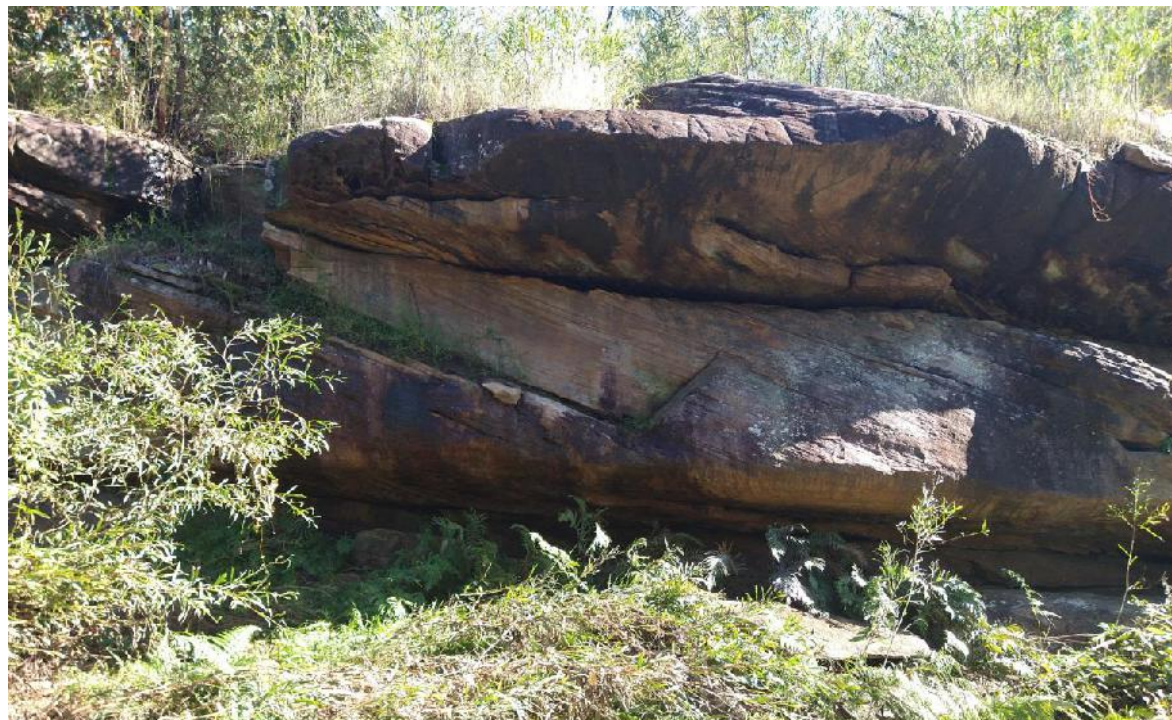
Photo 19: View looking west at rocky outcrop about Dekenden Pool (WC2) in Wirrimbirra Creek.

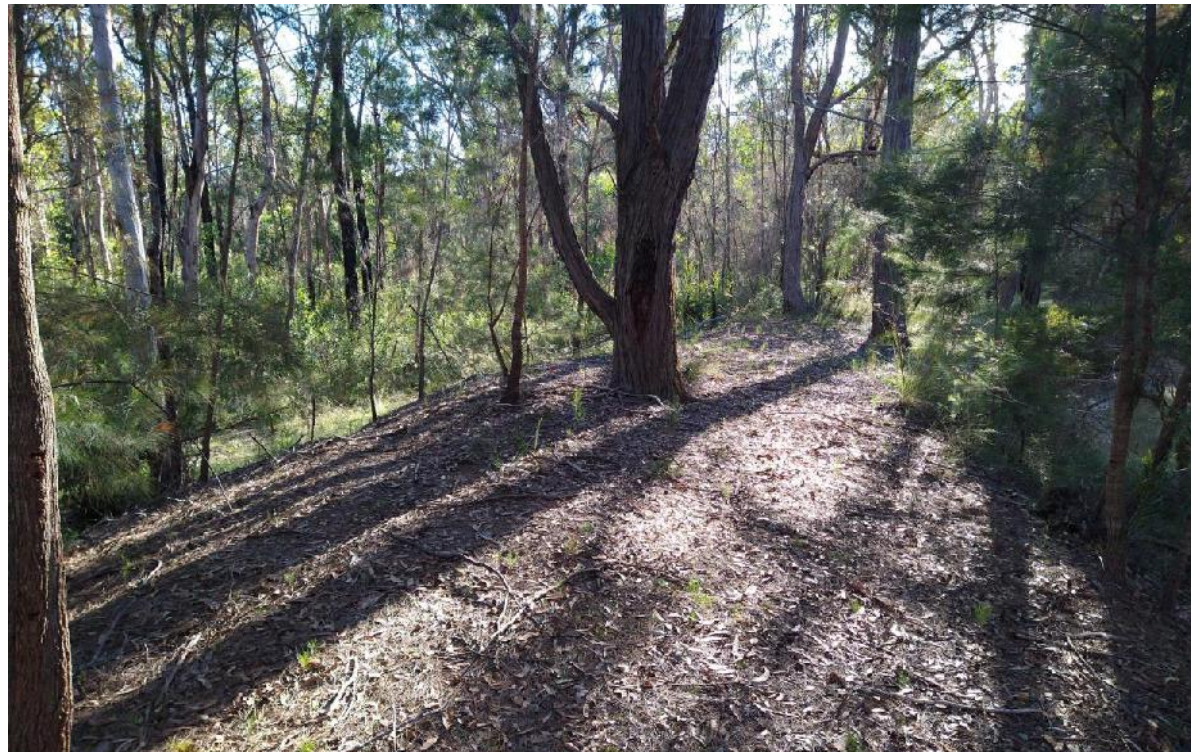
FD5	Lot 20 DP 751250		– The dam has no spillway. The dam (refer Photo 31) is incised into the slope (ie not within a watercourse).
FD6	3105 Remembrance Drive (Australian Wildlife Sanctuary)	10/02/2022	– The dam has a spillway on western side. Trees are growing in the embankment. Uneven surface in downstream embankment face where a tree has been removed. Possible burrows in a section of the embankment.

Photo 31: View looking south along the crest of FD5.

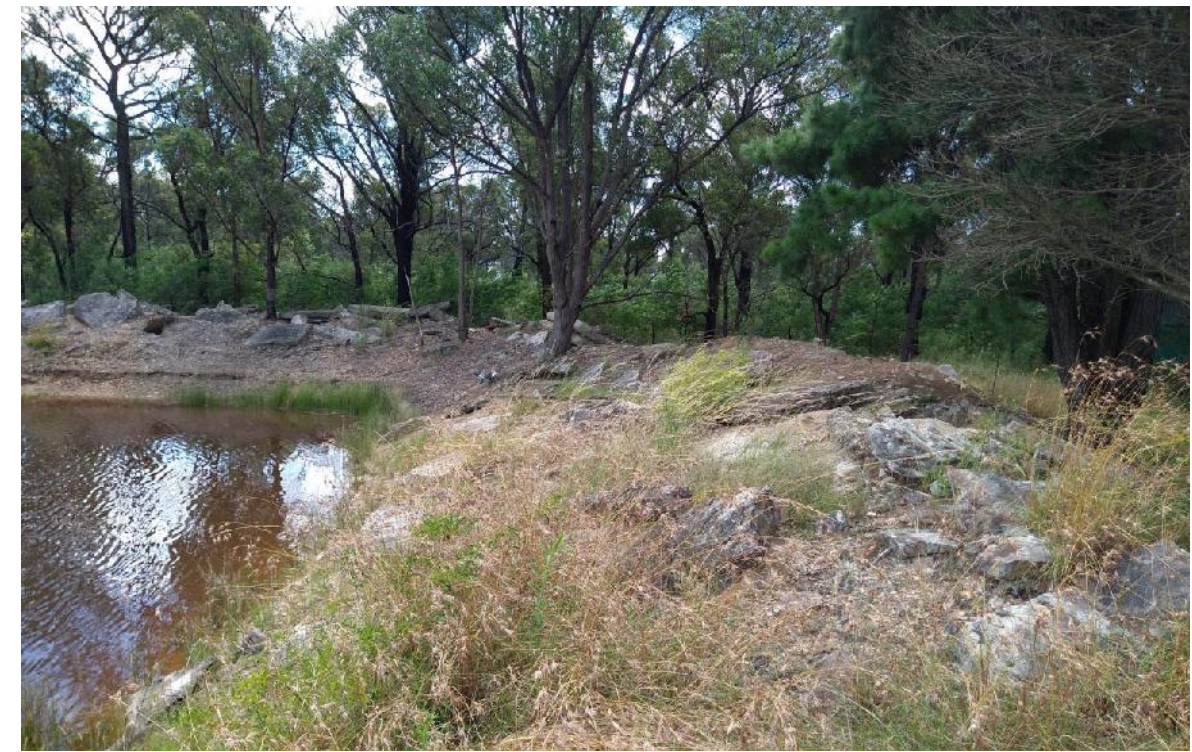
Photo 32: View looking north along the crest and upstream embankment face for FD8. Note: the large sandstone boulders placed over the crest.

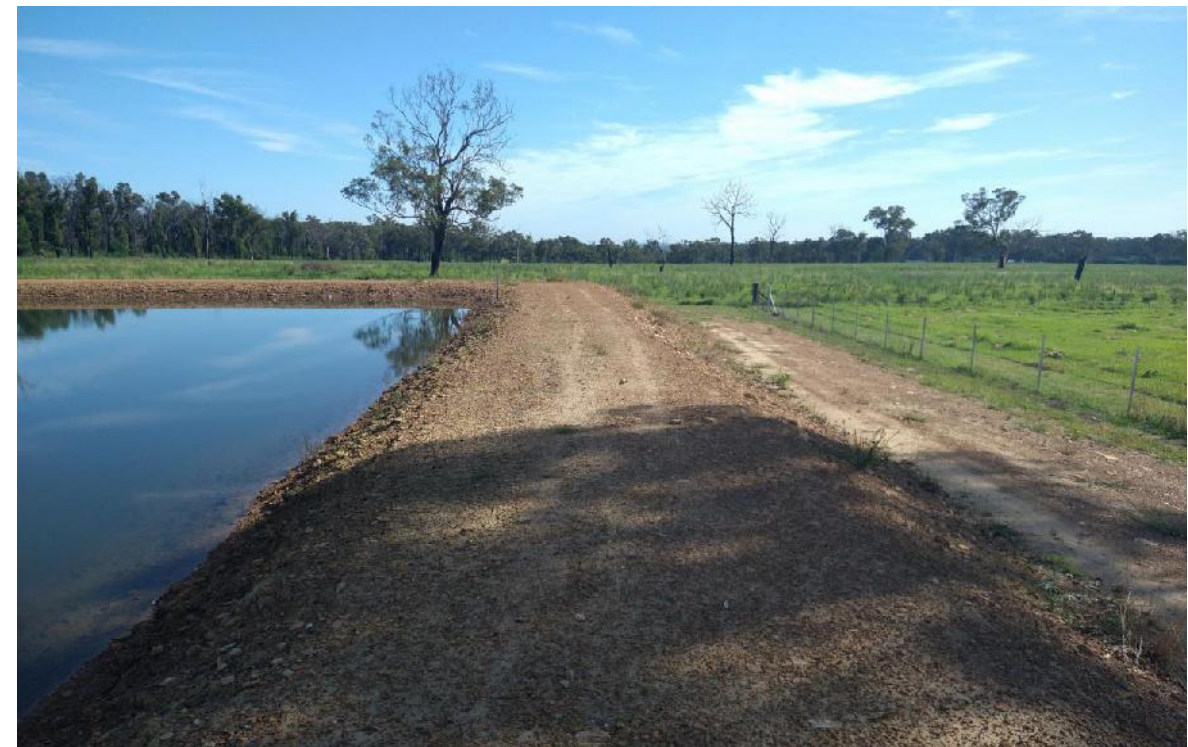
Photo 44: View looking along the eastern wall of FD45.

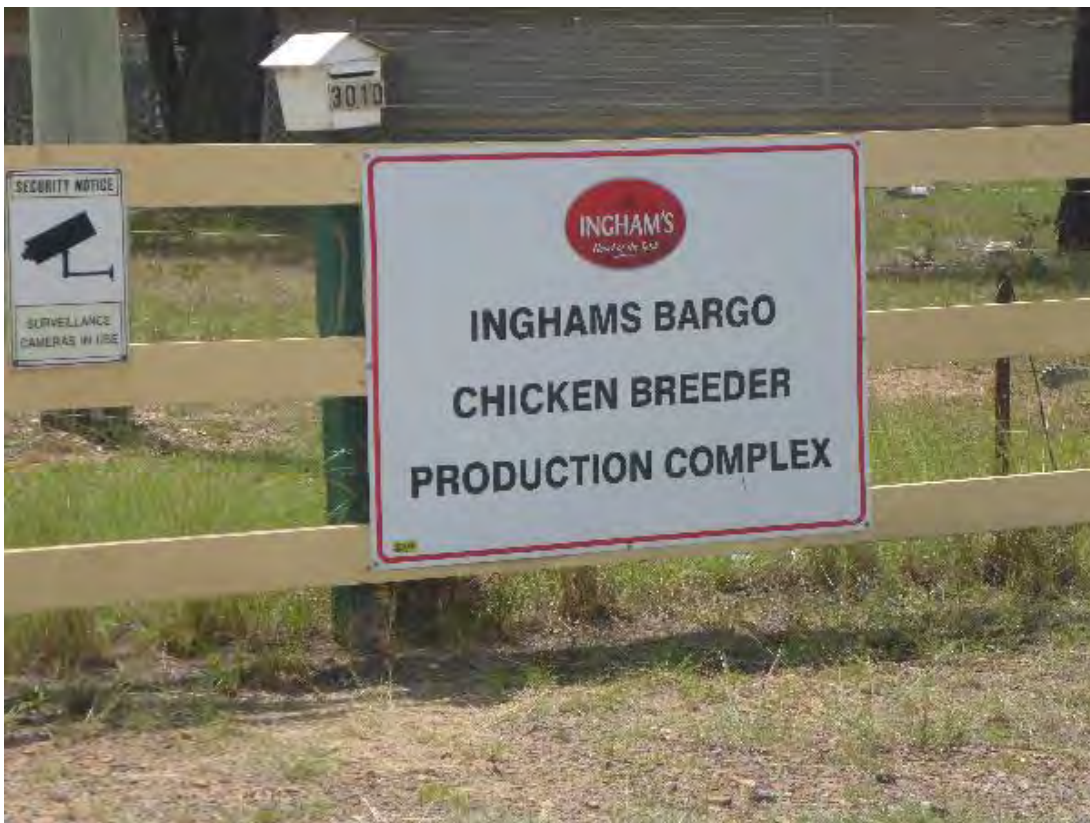
Site 57 – Poultry sheds
