Tahmoor Coal Pty Ltd

SIX MONTHLY SUBSIDENCE IMPACT REPORT

Western Domain Longwalls West 1 – West 4

Report 7 – March 2023

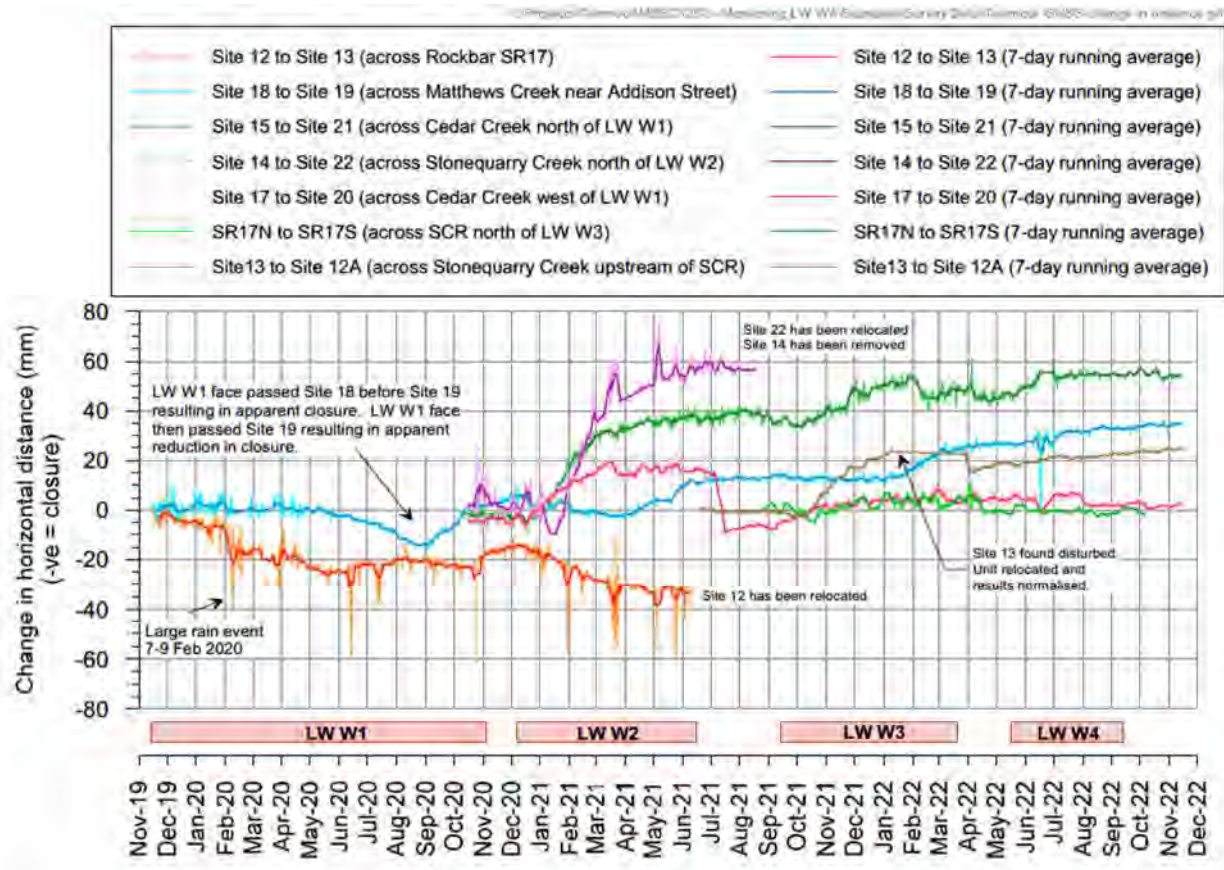
Figure 2-3 Observed changes in horizontal distances between GNSS units during LW W1-W4 extraction (source: MSEC, Subsidence Monitoring Report 20, Appendix A).

Changes in horizontal distances between GNSS units stationed near each other and on opposite sides of a waterway as a result of the extraction of LW W1-W4 are shown in **Figure 2-3**. During LW W4 extraction, only minor changes have been observed between the GNSS units.

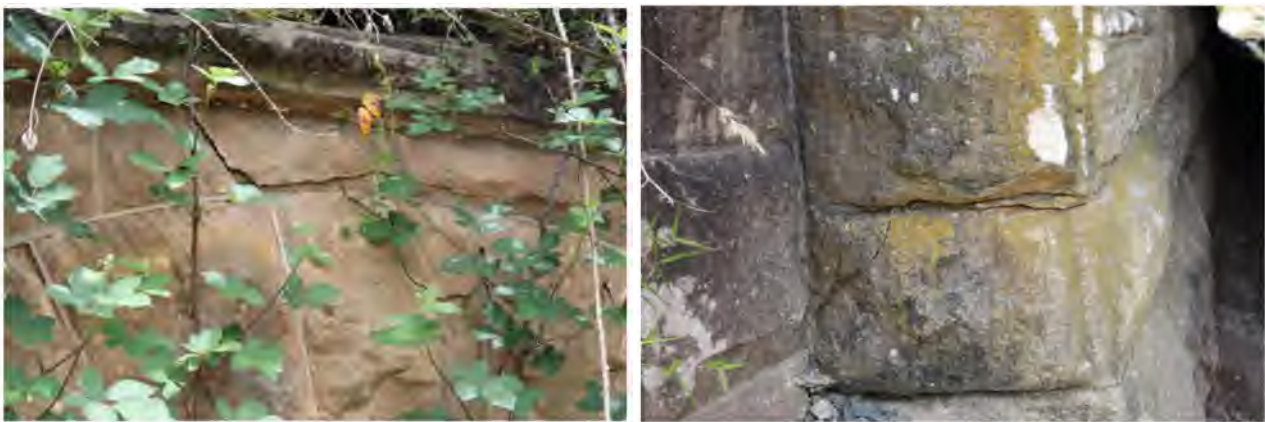
Cracking on the portal ends of the sandstone culverts at 88.980 km and 88.400 km and the barrel of the culvert at 88.400 km results in a Level 3 TARP trigger due to confirmed mining-related impacts.

Figure 3-1 Cracking on the portal ends at culvert 88.400 km. This cracking has not worsened during the mining of LW W4.

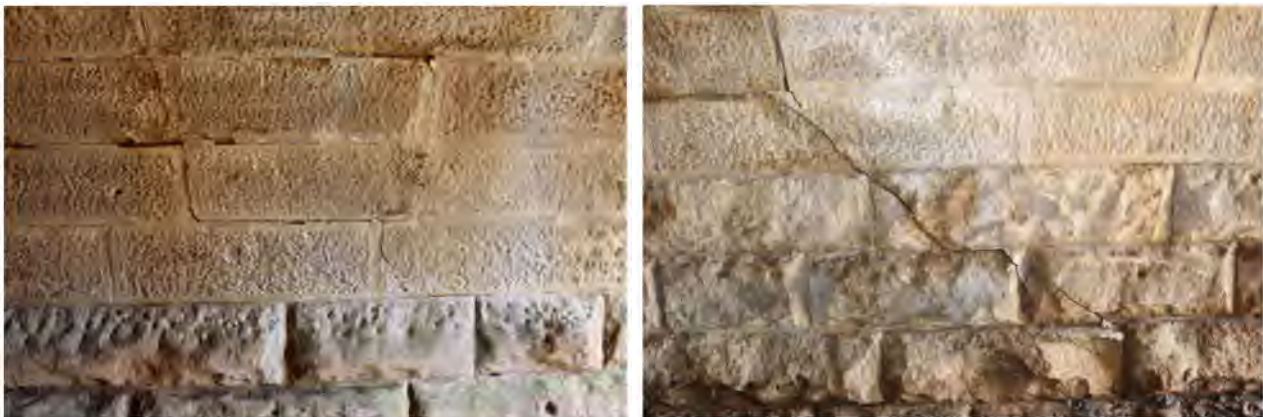
Figure 3-2 Cracking in the barrel of culvert 88.400 km. This cracking has formed during the mining of the Western Domain.

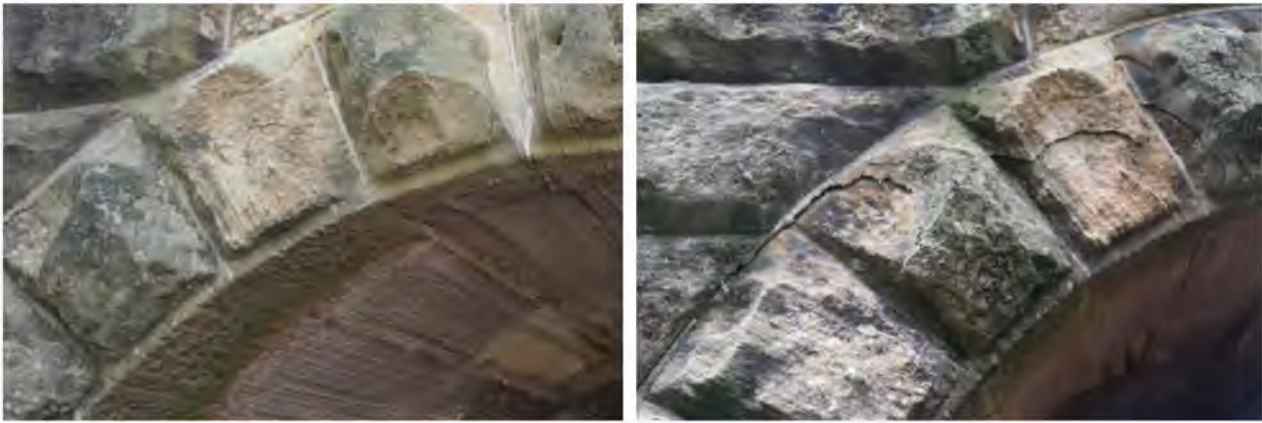
Figure 3-3 Cracking at culvert 88.980 km. Pre-mining (left) and post-mining (right) inspection photographs. Cracking along the mortar and spalling of the arch stones has not worsened significantly during extraction of LW W4.

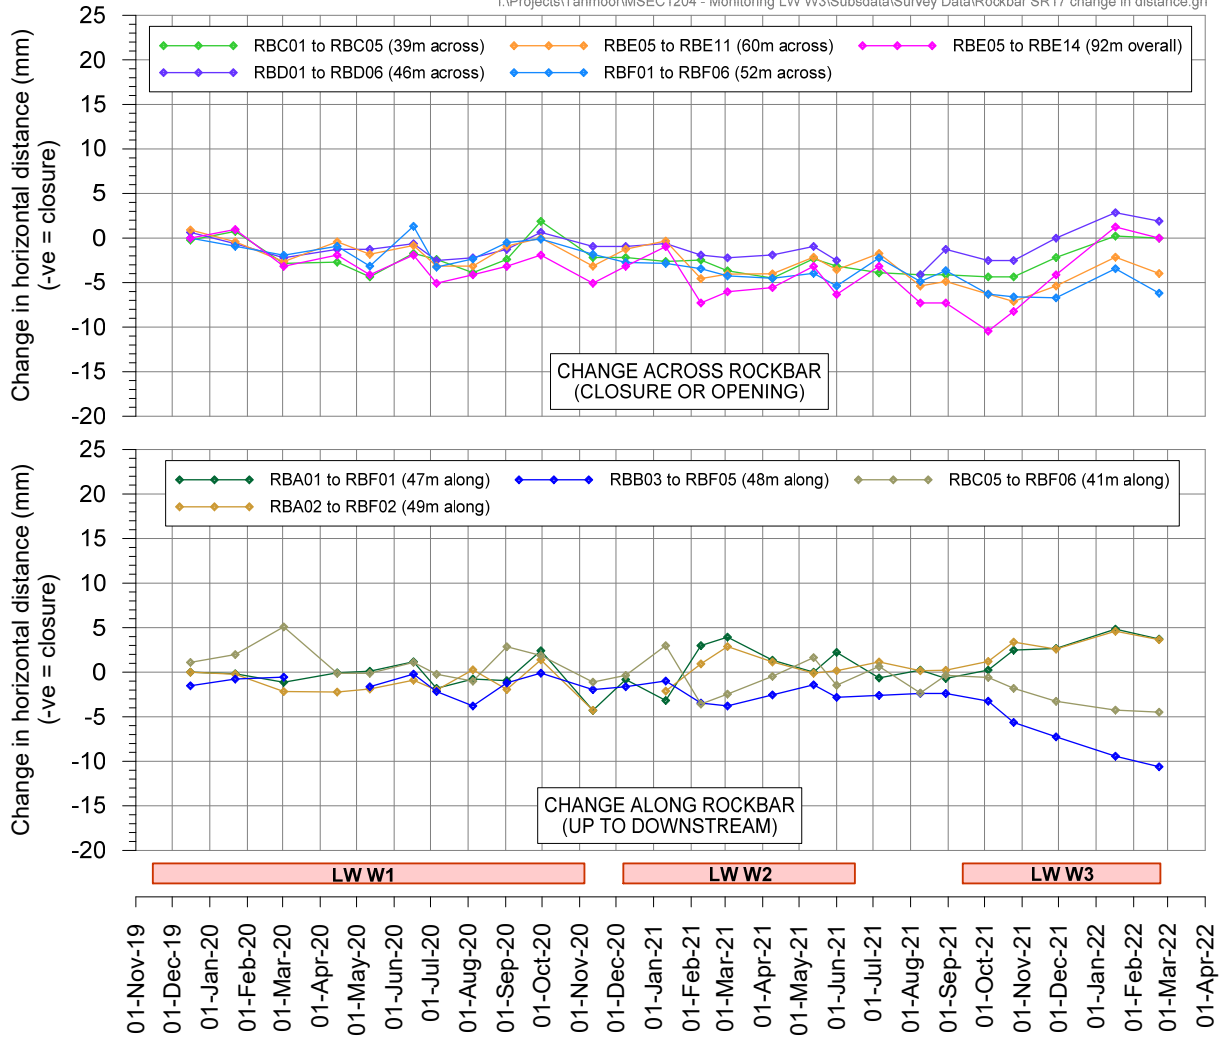
Figure F Changes in distance across and along Rockbar SR17 during LW W1-W3

The most recent monthly survey for Rockbar SR17 was on 22 February. Small changes in horizontal distances were observed both along and across the rockbar, as shown in Figure F. Minor ground shortening is observed in the southeast corner of the rockbar, which is captured by measurements at Marks RBE11, RBF05 and RBF06.

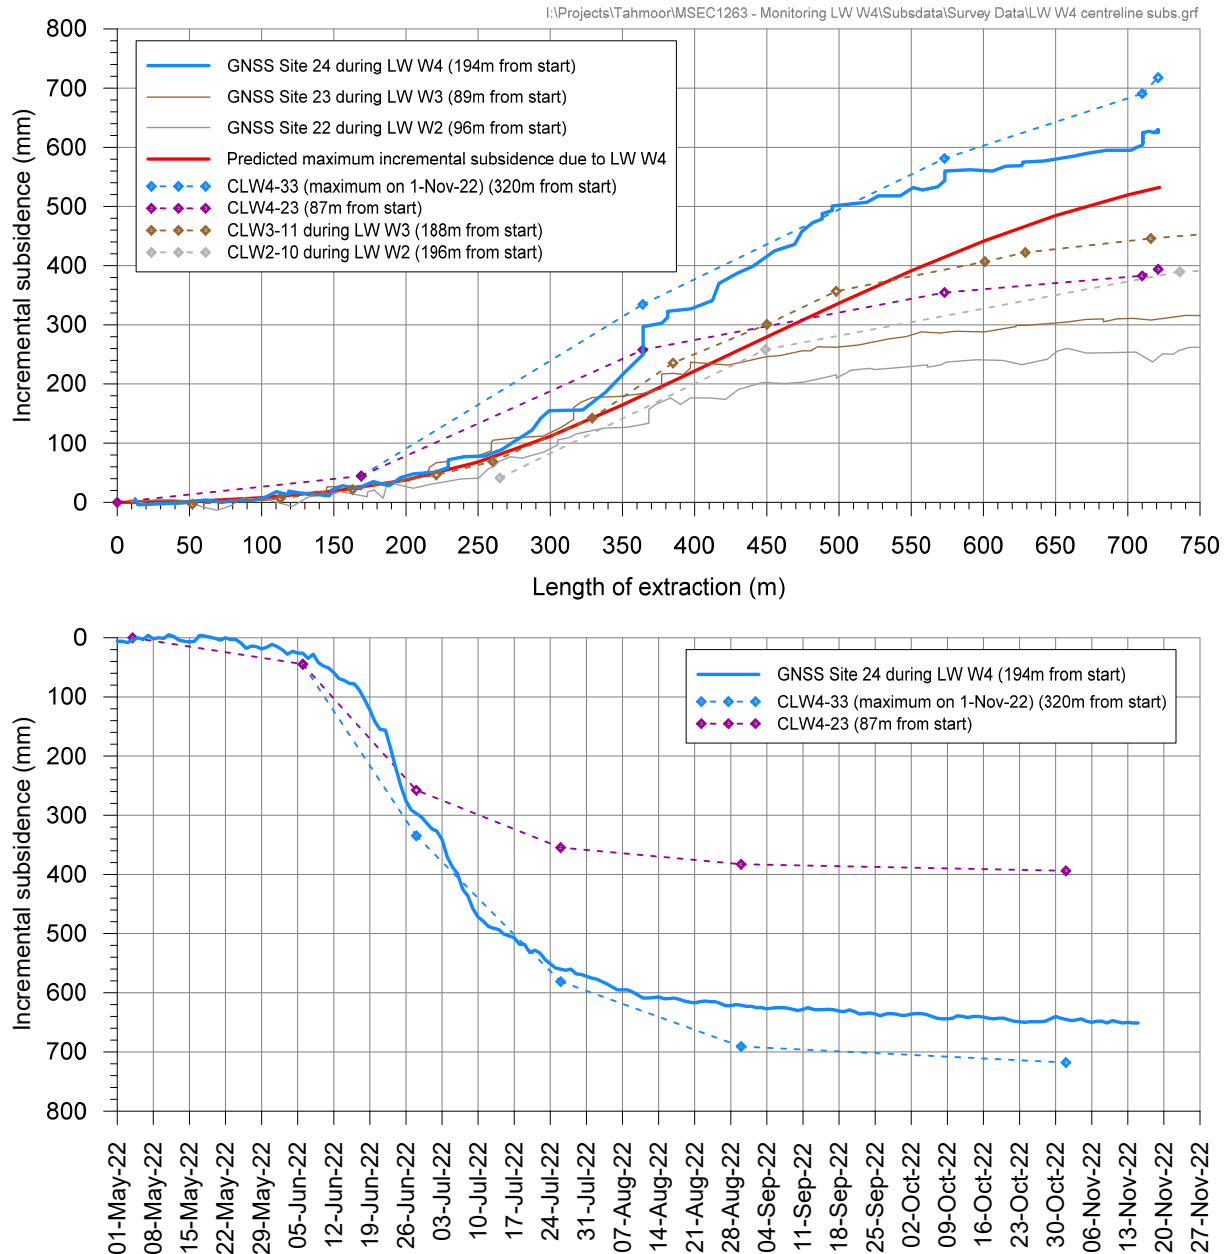
Figure B Development of subsidence along centreline of LW W4

The development of subsidence relative to the length of longwall extraction, and over time, at sites of interest along the centreline is shown in Figure B. GNSS unit 24 has experienced greater subsidence than predicted and greater subsidence than was previously experienced at equivalent locations during the mining of LW W2 and LW W3.

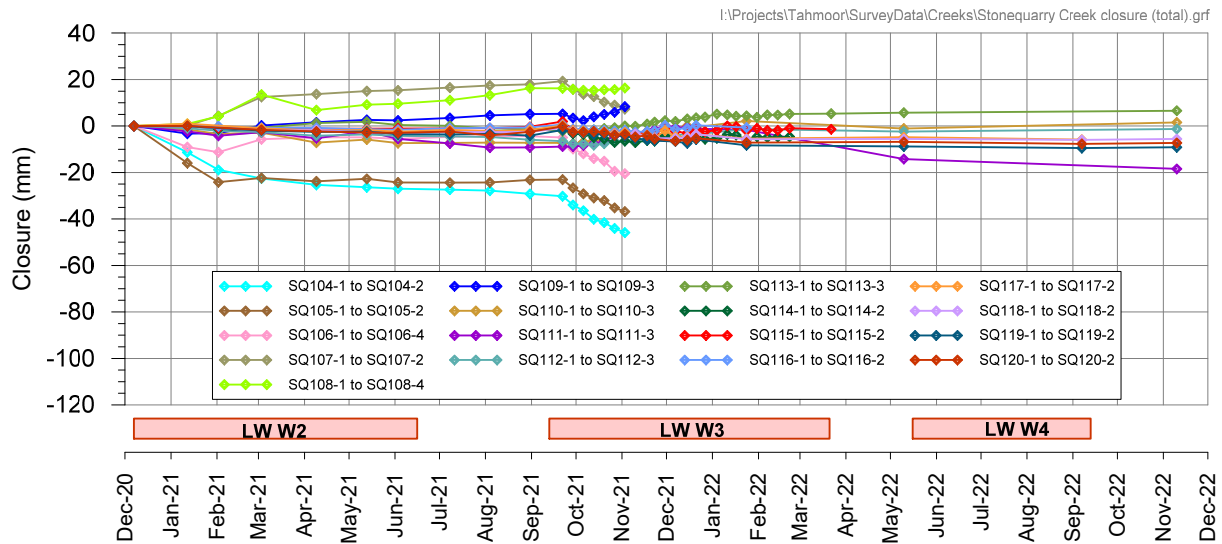
Figure D Development of observed valley closure along Stonequarry Creek (new closure marks)

Results are shown in Figure D. Valley closure has been measured to develop across Stonequarry Creek at SQ104 and SQ105, which are located near the confluence of Stonequarry Creek and Cedar Creek. Minor closure was developing across SQ104, SQ105, SQ106 and SQ107 up to 3 November 2021, when the pegs were removed as requested by the landowner. Survey peg SQ114-1 has been destroyed during flooding. Minor changes have been observed during the mining of LW W4 across SQ113 to SQ120, including where a new fracture was observed near SQ116. Minor additional closure was observed across SQ111.

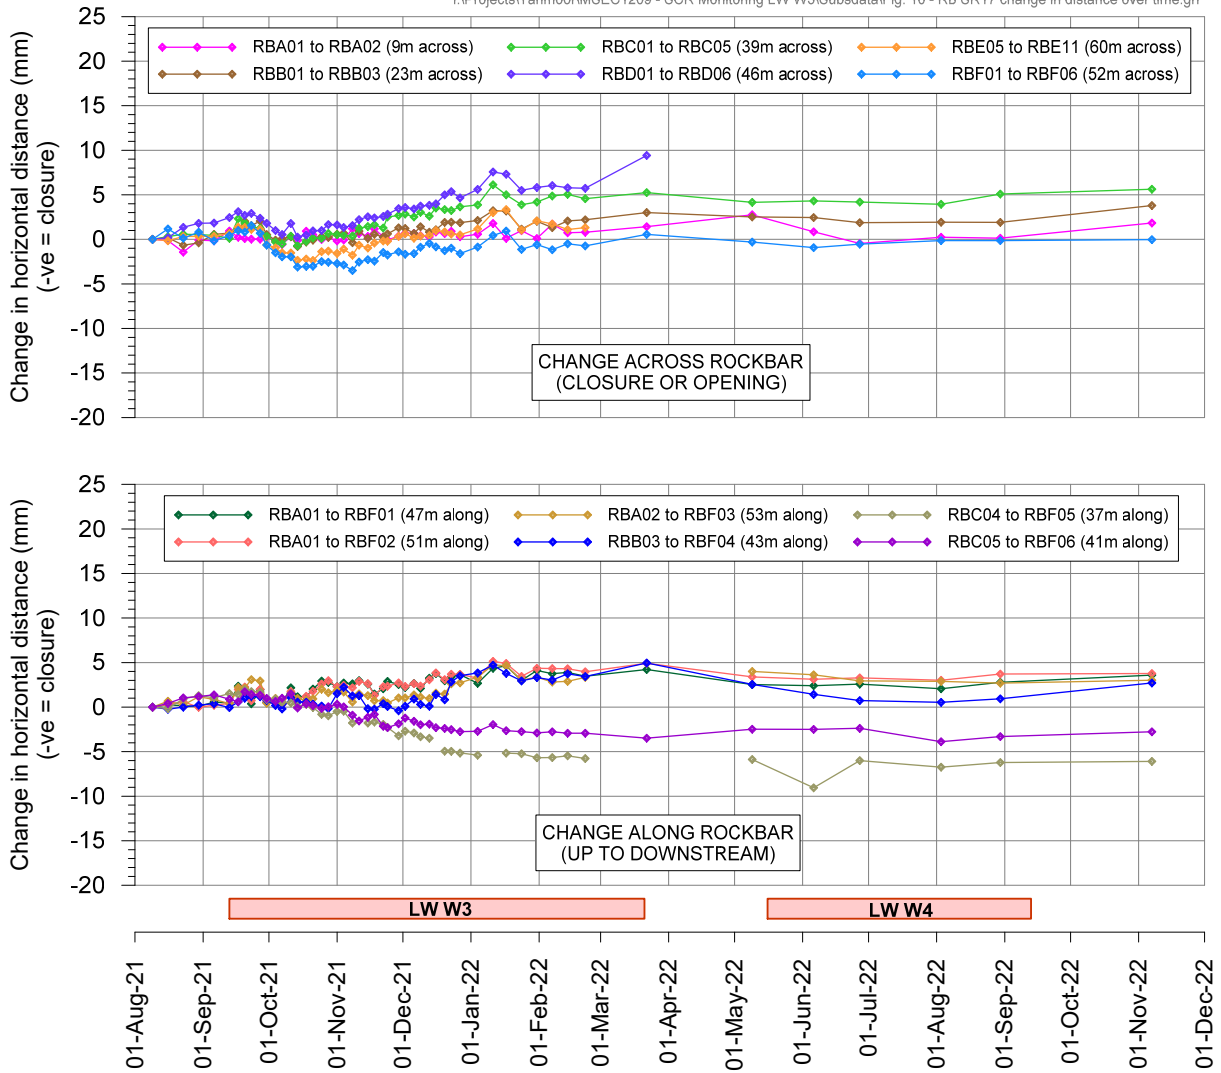
Figure E Changes in distance across and along Rockbar SR17 during LW W3-W4

An end of LW W4 survey for Rockbar SR17 was conducted on 7 November. Minor changes in horizontal distances were observed both along and across the rockbar, as shown in Figure E. Minor ground shortening is observed in the southeast corner of the rockbar, which is captured by measurements at Marks RBE11, RBF05 and RBF06.

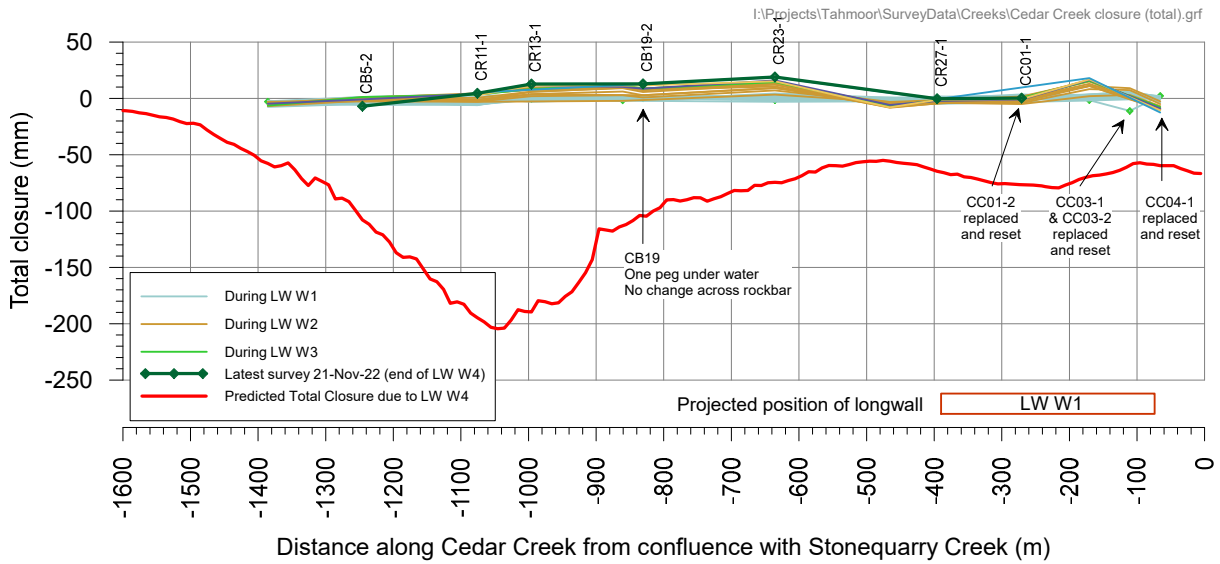
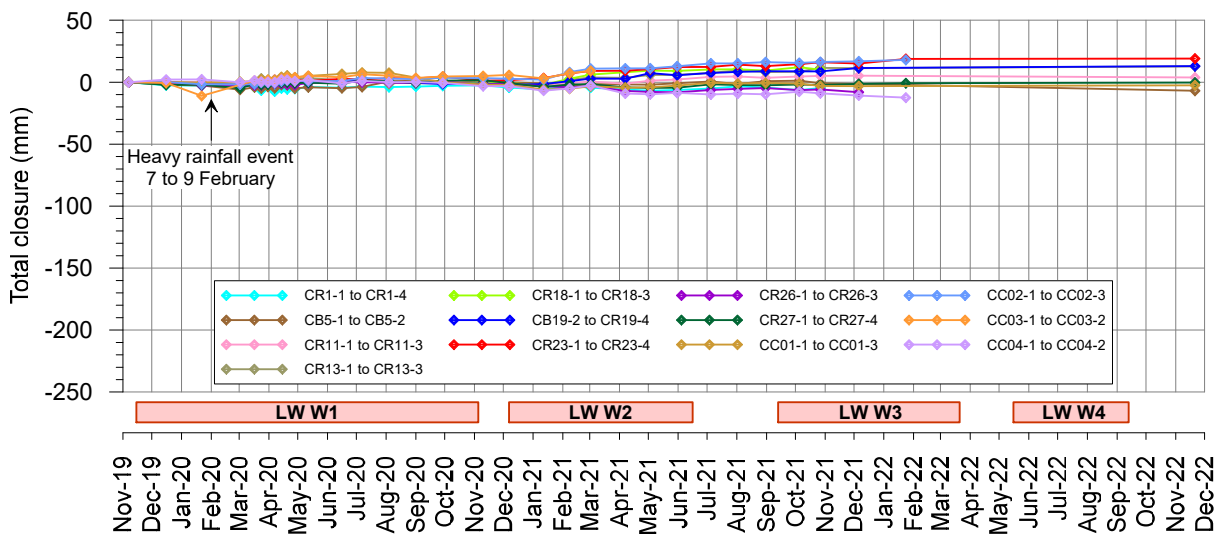
Figure F Comparison between observed and predicted valley closure along Cedar Creek

A comparison between observed and predicted valley closure along Cedar Creek is shown in Figure F. Very little change in closure was observed during the mining of LW W3 and LW W4. The most recent survey was on 21 November 2022 at the end of LW W4, with very minor changes observed.

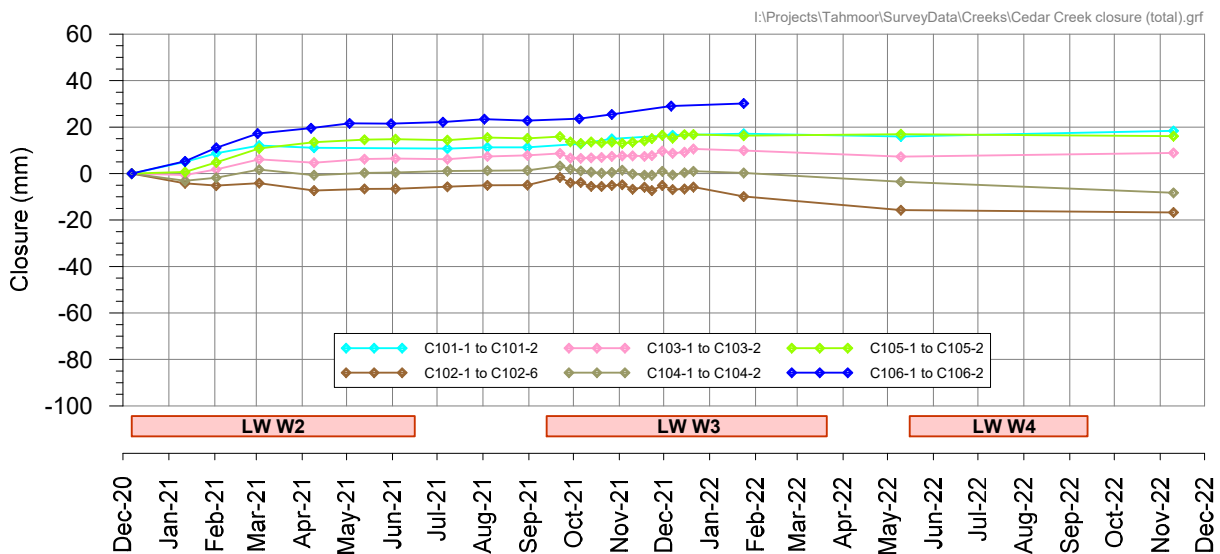
Figure G Development of observed valley closure along Cedar Creek (new closure marks)

Surveys across the newly installed closure marks are shown in Figure G. A final survey was conducted on 10 November 2022 with minor changes observed.

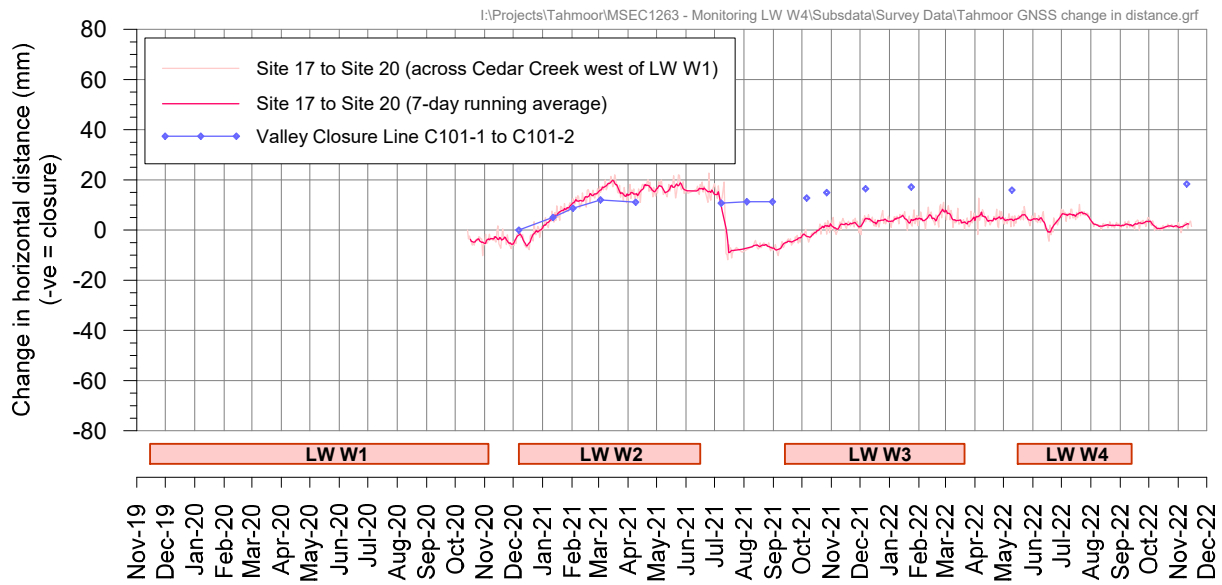
Figure H Development of observed valley closure along and across Cedar Creek

Survey pegs C101-1 and C101-2 are aligned with GNSS sites 17 and 20. A reasonable comparison in measured changes in distance between the two survey sites is shown in Figure H, though one of the GNSS units appears to have been disturbed in July 2021 between the completion of LW W2 and commencement of LW W3.

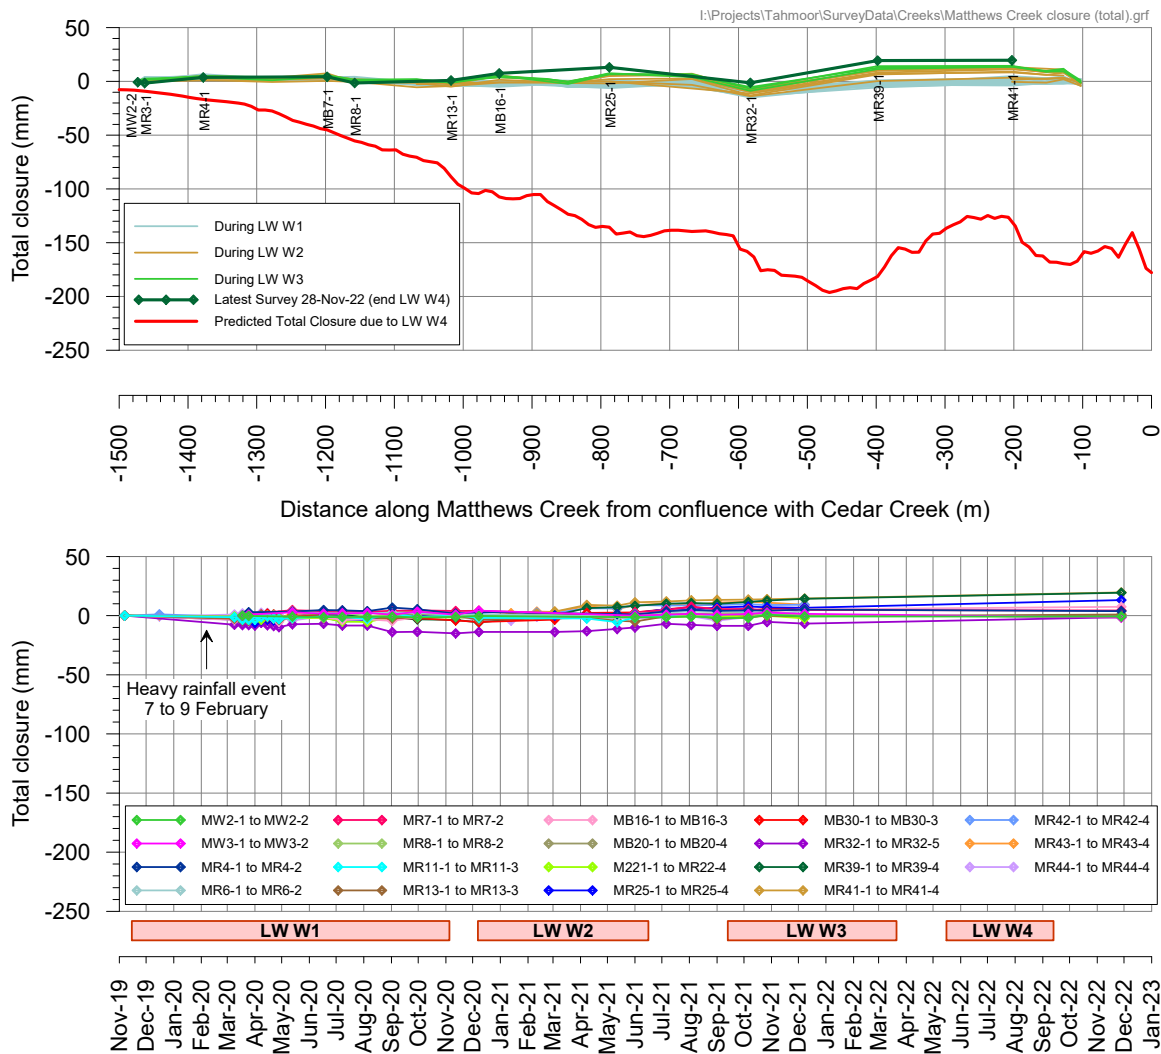
Figure I Comparison between observed and predicted valley closure along Matthews Creek

A comparison between observed and predicted valley closure along Matthews Creek is shown in Figure I. The most recent survey was on 28 November 2022 at the end of LW W4, with very minor changes observed.

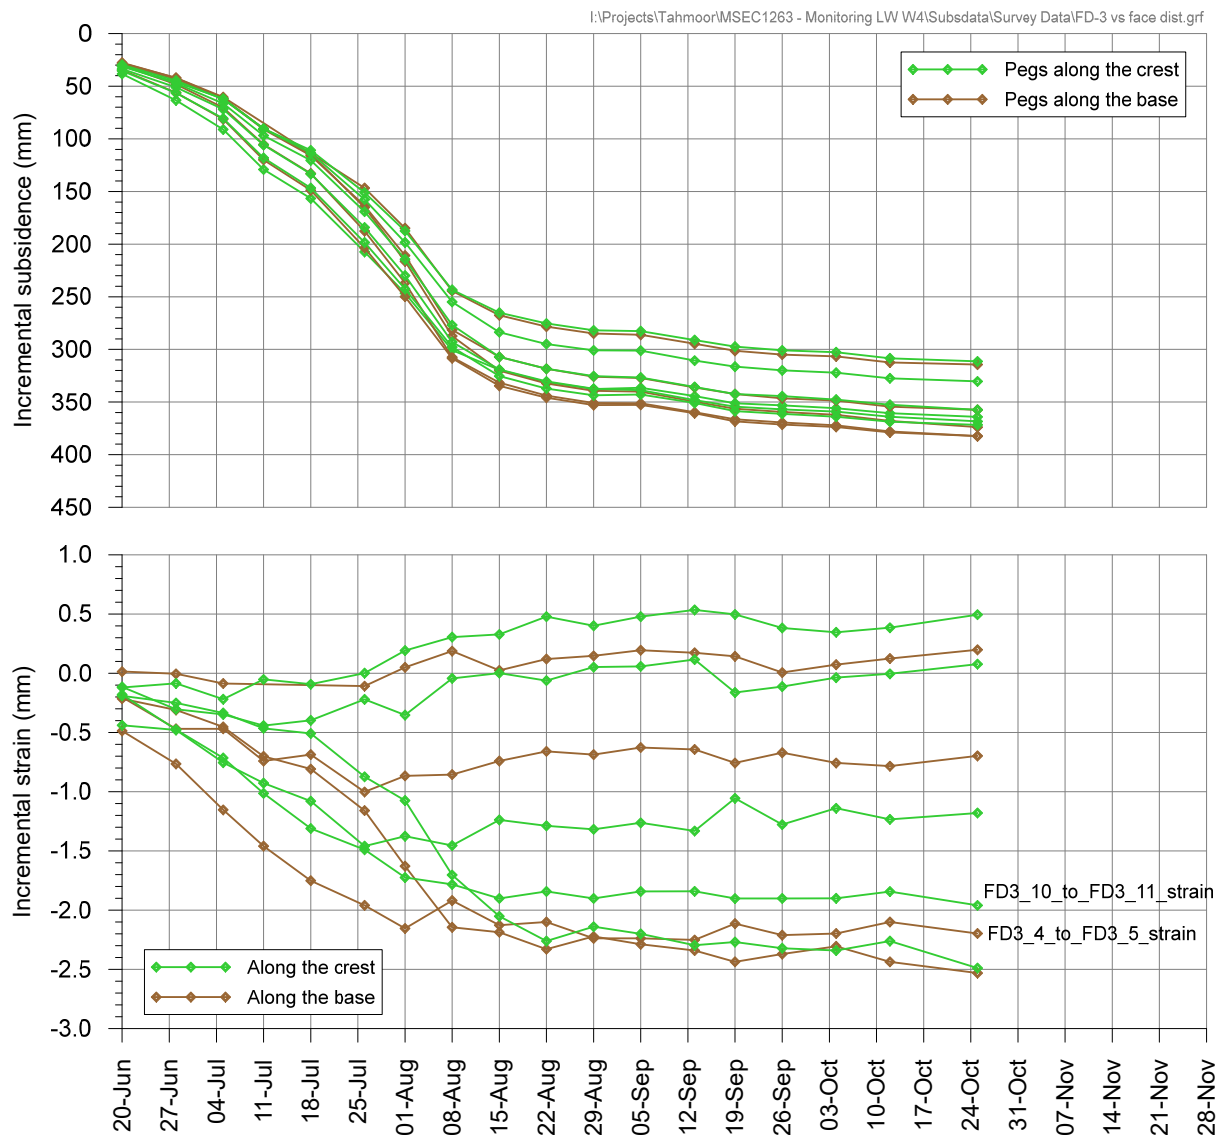
Figure K Development of subsidence and ground strains at Farm Dam FD-3

Visual inspections were conducted at Farm Dam FD-3. Deterioration of the uphill bank resulted from wet weather and cattle movement. The dam was at full capacity on 27 and 29 July and overflowing the northern spillway as intended. No impacts were observed to the dam wall.

A small section of earth had slumped at the southern end of the dam wall (not mining related). A syphon was installed to gradually lower the water level by approximately 400 mm. There was no evidence of the dam wall leaking. A geotechnical inspection was completed with no concerns observed regarding the dam wall.

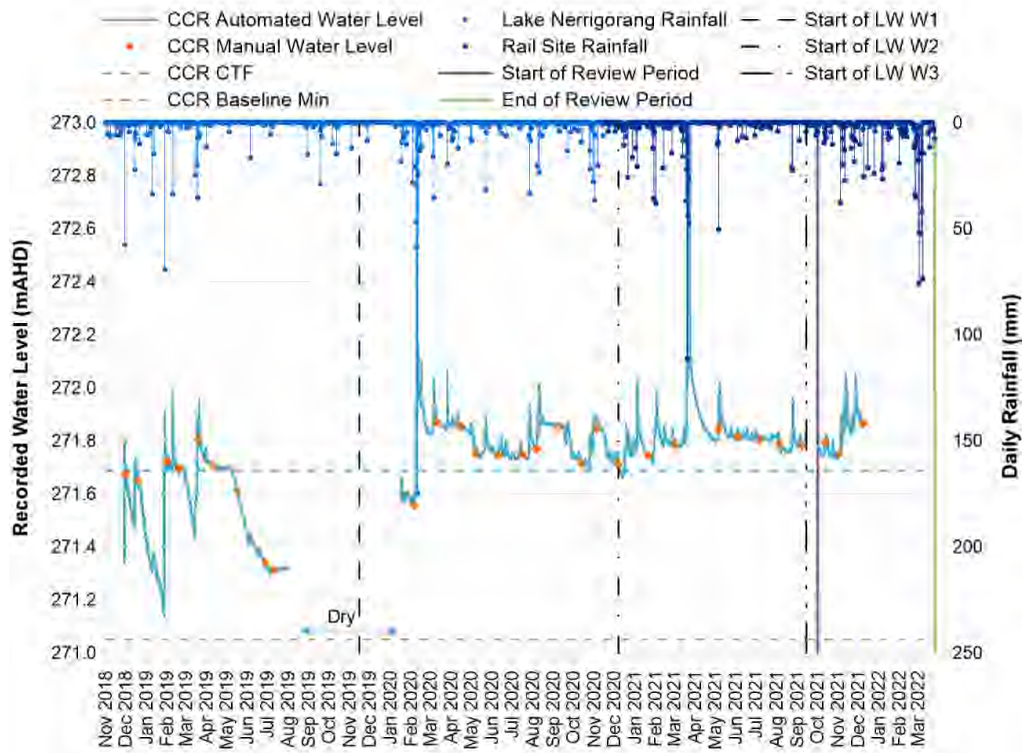
FIGURE A8: MONITORING SITE CCR WATER LEVEL RECORDS³

³ The reference bolts at monitoring sites CCR and SF have not been found and as such the raw data recorded from 7 / 8 December 2021 was unable to be converted to a water level measurement.

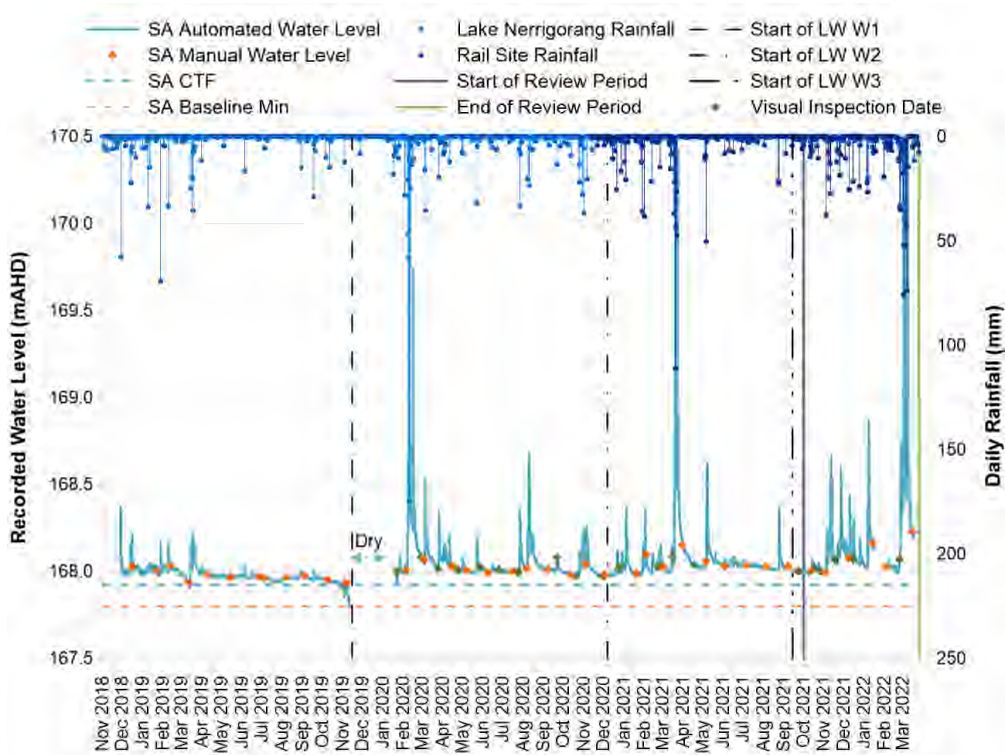
FIGURE A20: MONITORING SITE SA WATER LEVEL RECORDS⁴

⁴ Between 15 January and 5 February 2022, an incomplete data download occurred at monitoring site SA, or the logger was not correctly restarted, and as such no data is available for this period.

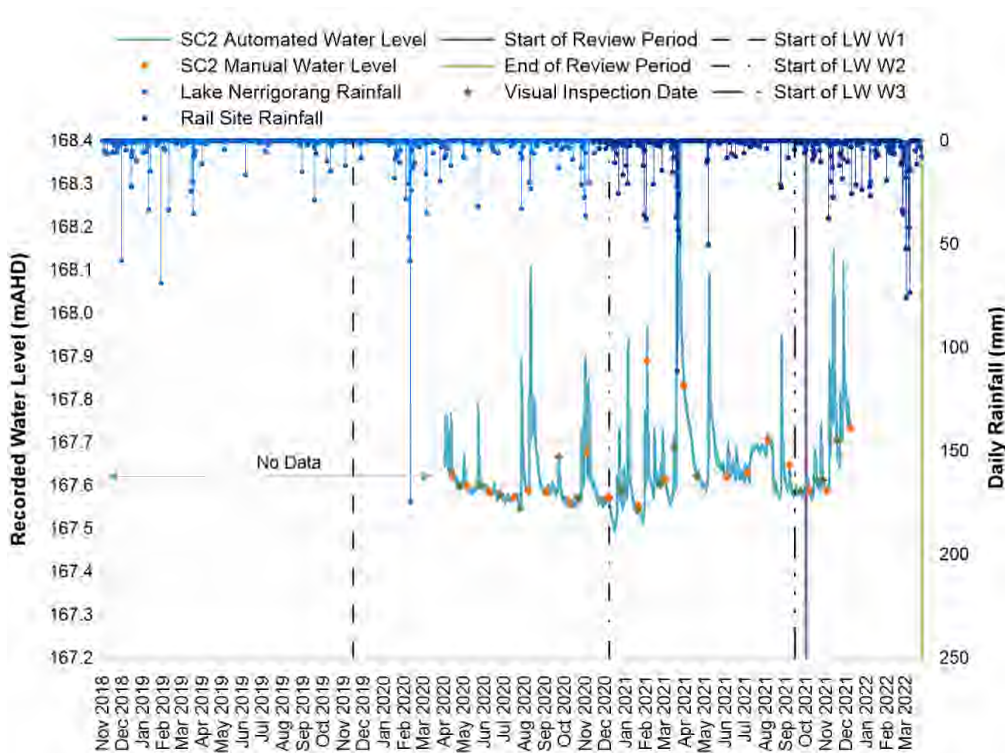
FIGURE A21: MONITORING SITE SC2 WATER LEVEL RECORDS⁵

⁵ The water level sensor has not been located and therefore records are not available from 7 December 2021.

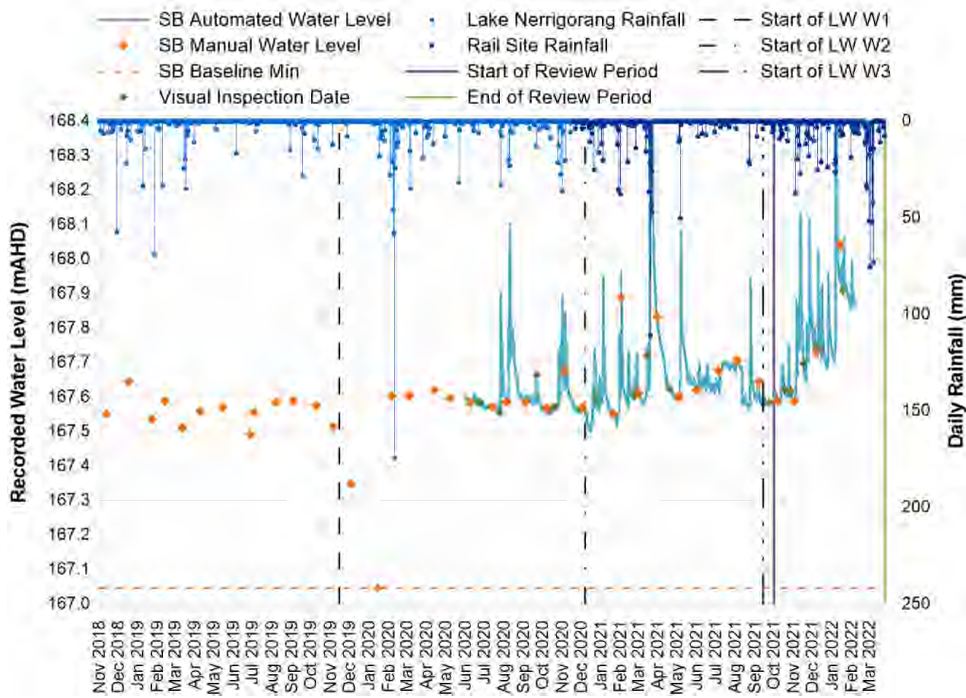
FIGURE A22: MONITORING SITE SB WATER LEVEL RECORDS⁶

⁶ The logger at monitoring site SB was washed away during a major rainfall event from late February to early March 2022 and as such data has not been collected since 5 February 2022.

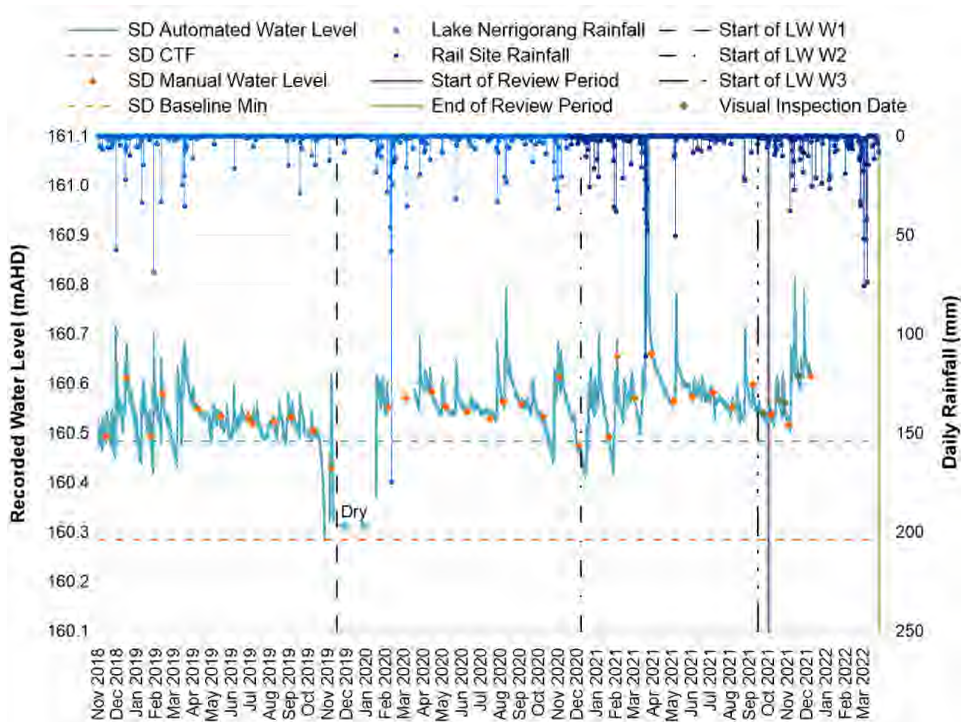
FIGURE A24: MONITORING SITE SD WATER LEVEL RECORDS⁷

⁷ The water level sensor has not been located and therefore records are not available from 7 December 2021.

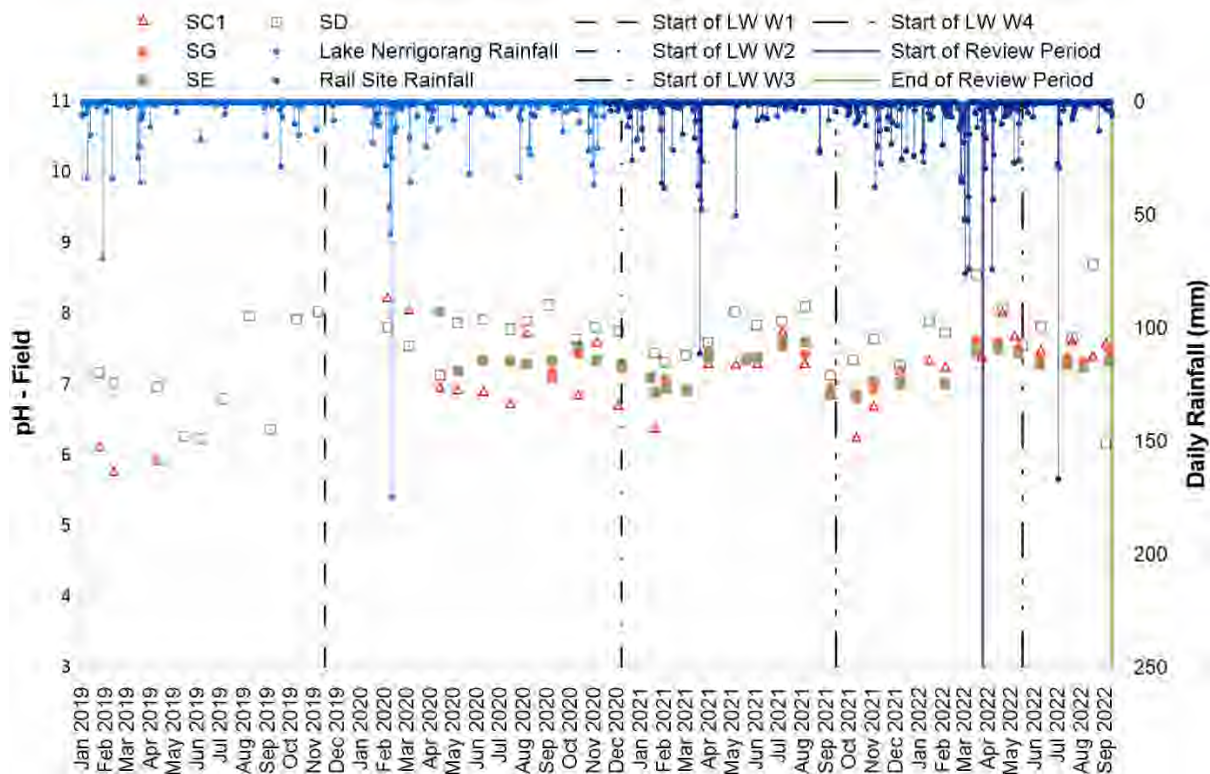
DIAGRAM 1: STONEQUARRY CREEK SITE SD AND REFERENCE SITES - PH RESULTS

- Historically high concentrations of pH were recorded in August 2022 at potential impact site SD. This resulted in a trigger level 2 for the upper pH trigger.
- A historically low concentration for pH was recorded in September. This resulted in a trigger level 2 for the lower pH trigger.

In response to the pH Level 2 trigger exceedances for Stonequarry Creek, the Environmental Response Group convened, and the surface water quality data was reviewed in relation to the prevailing climate and catchment wide water quality trends. Whilst both the upper and low pH trigger levels were exceeded in consecutive months, the recorded values were only slightly above/below the trigger levels. The pH values recorded at monitoring site SD follow a similar trend to the reference sites for the majority of the review period. It is likely that these two consecutive results are an anomaly or a result of field sampling issues including calibration of field instrumentation. Accordingly, re-calibration of field instrumentation has been recommended. Monitoring will continue to be undertaken in accordance with the WMP.

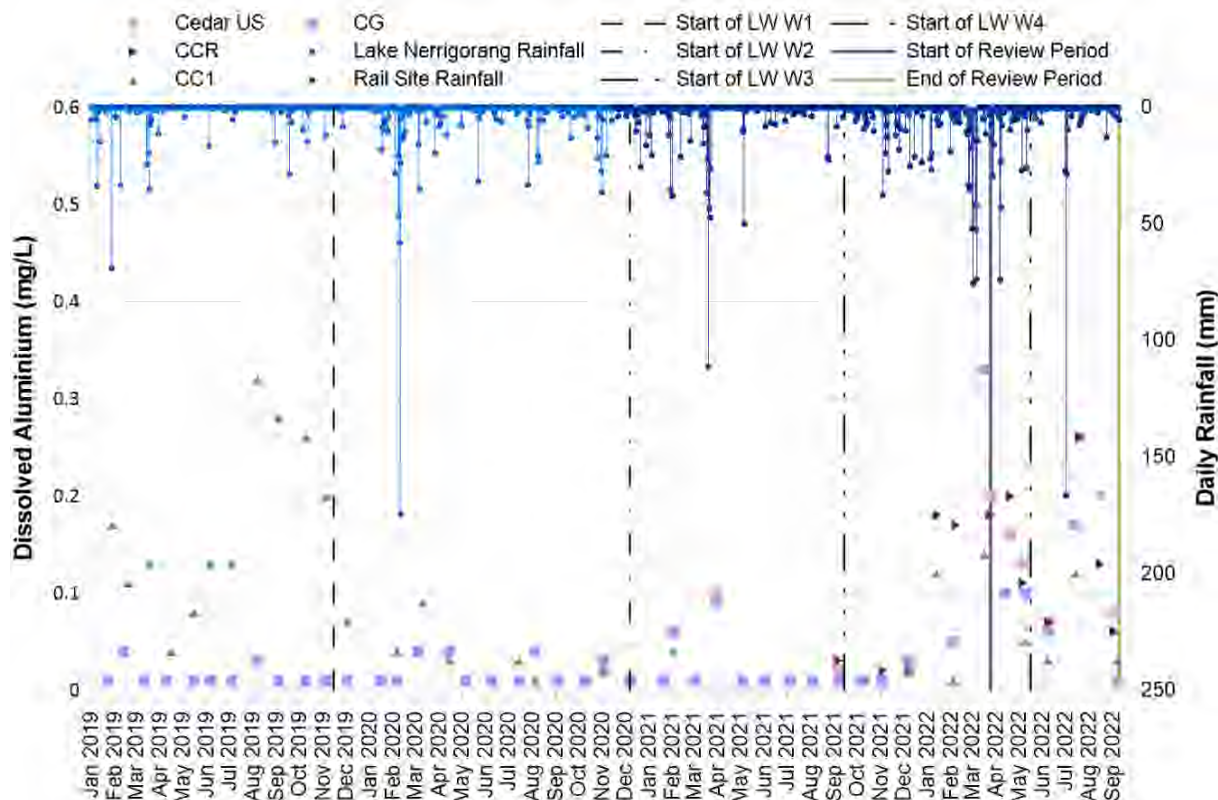
DIAGRAM 2: CEDAR CREEK SITE CG AND REFERENCE SITES – ALUMINUM RESULTS

The dissolved aluminium concentrations recorded at monitoring site CG in April and July 2022 were slightly elevated above baseline concentrations, resulting in an exceedance of the mean plus two standard deviations. As such, a Level 2 TARP significance has been equated. The elevated concentrations of dissolved aluminium did not result in an exceedance of the reference site mean plus two standard deviations during these periods. The aluminium results for monitoring site CG compared to the Cedar Creek reference sites is shown below on **Diagram 2**.

As shown in **Diagram 2**, the dissolved aluminium concentrations recorded at reference sites CCR and Cedar US, which are located at a notable distance upstream of the Western Domain, were higher than that recorded at monitoring site CG for the duration of the review period. As such, this indicates a catchment wide (non-mining related) influence on dissolved aluminium concentrations in Cedar Creek.

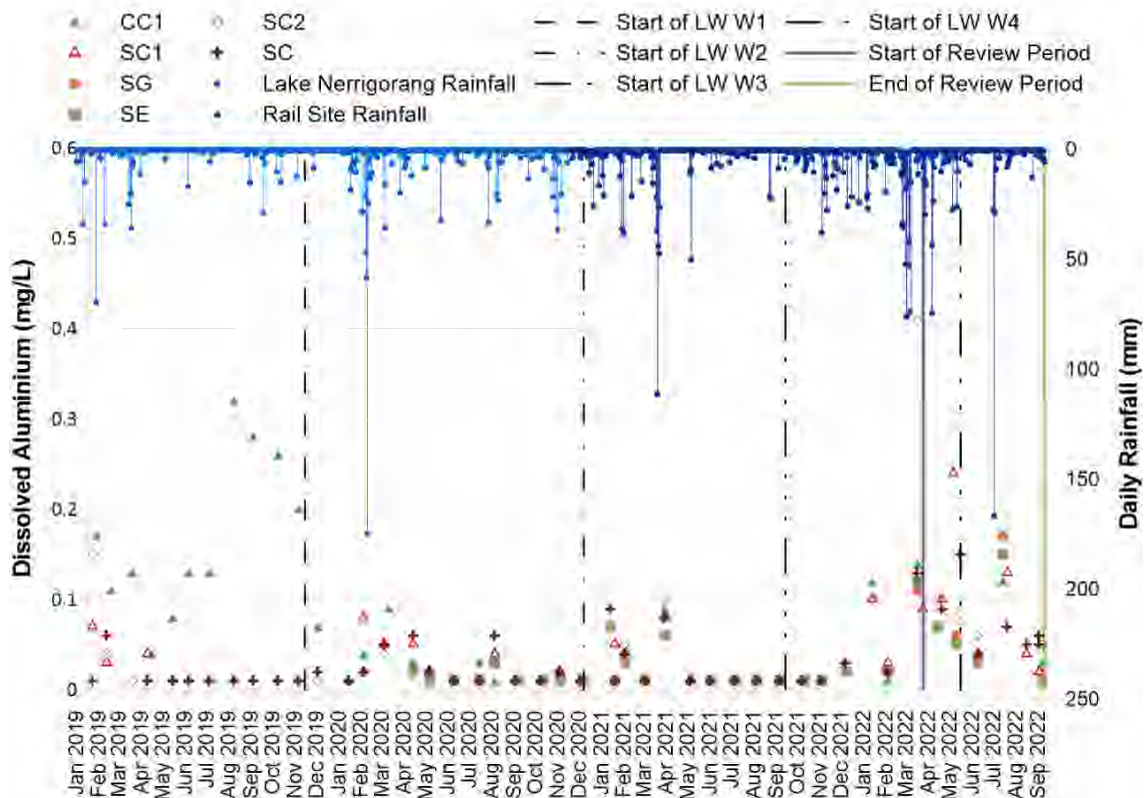
DIAGRAM 3: STONEQUARRY CREEK SITES SC1, SC AND REFERENCE SITES – ALUMINUM RESULTS

Monitoring sites SC2 and SC dissolved aluminium concentrations recorded in April to May and July 2022, resulted in an exceedance of the mean plus two standard deviations, equating to a Level 2 TARP significance at these sites. The elevated concentrations of dissolved aluminium did not result in an exceedance of the reference site mean plus two standard deviations during these periods. The dissolved aluminium results for SC2 and SC compared to the Stonequarry Creek reference sites is shown below on **Diagram 3**.

As shown in **Diagram 3**, the dissolved aluminium concentrations recorded at reference sites SC1, SG and SE, located upstream of potential mining relation influences, were consistent with or higher than that recorded at monitoring sites SC2 and SC for the duration of the review period. As such, this indicates a catchment wide (non-mining related) influence on dissolved aluminium concentrations in Stonequarry Creek.

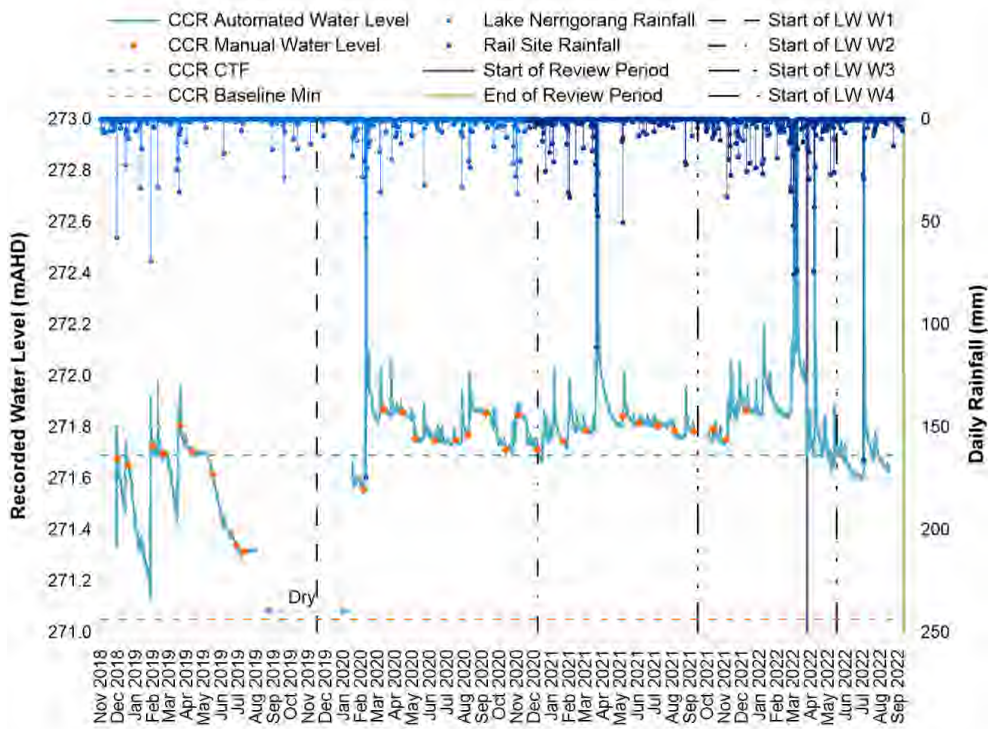
FIGURE B8: MONITORING SITE CCR WATER LEVEL RECORDS³

³ The reference bolts at monitoring sites CCR and SF have not been found and as such the raw data recorded from 7 / 8 December 2021 was unable to be converted to a water level measurement.
