Tahmoor Coal Pty Ltd

SIX MONTHLY SUBSIDENCE IMPACT REPORT

Western Domain Longwalls West 1 – West 4

Report 7 – March 2023

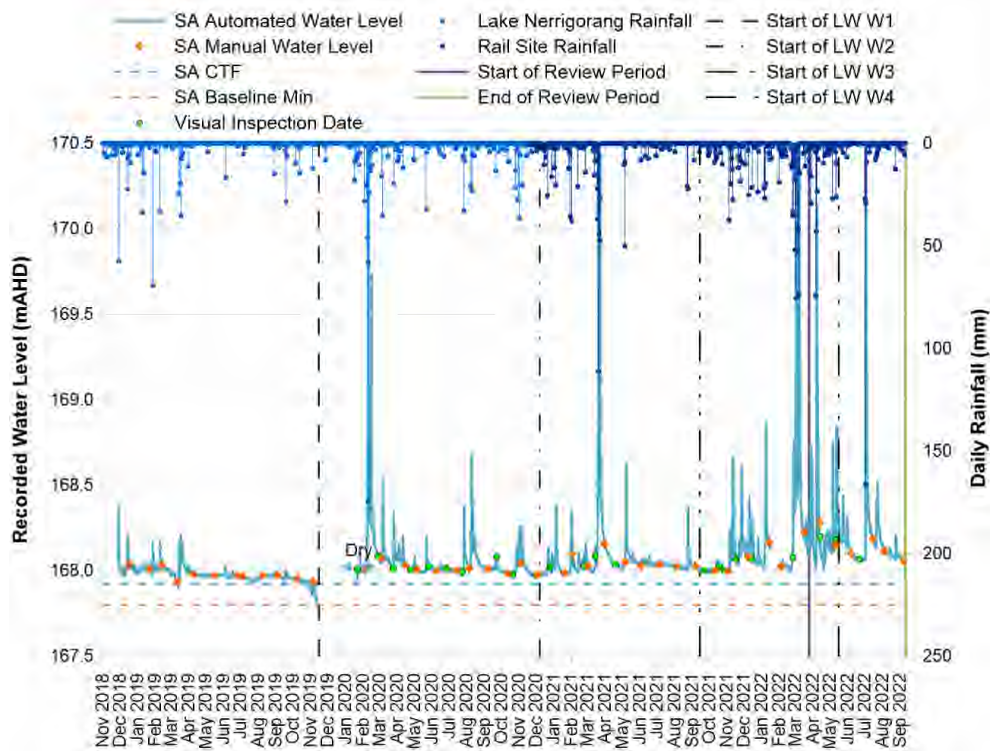
FIGURE B20: MONITORING SITE SA WATER LEVEL RECORDS⁴

⁴ Between 15 January and 5 February 2022, an incomplete data download occurred at monitoring site SA, or the logger was not correctly restarted, and as such no data is available for this period.

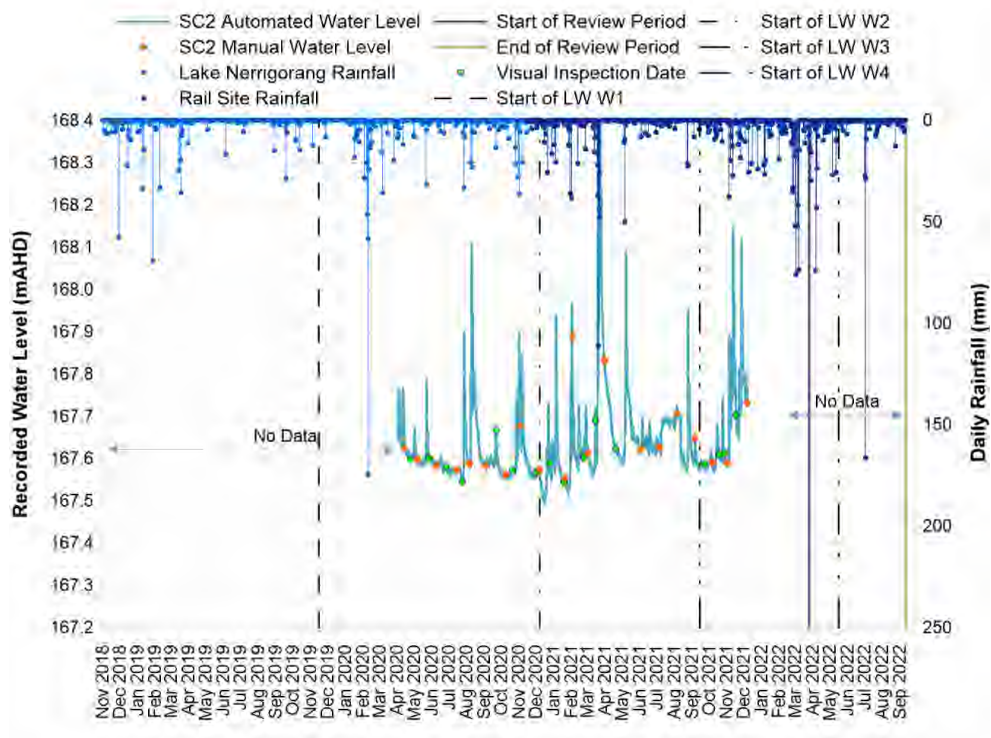
FIGURE B21: MONITORING SITE SC2 WATER LEVEL RECORDS⁵

⁵ The water level sensor has not been located and therefore records are not available from 7 December 2021.

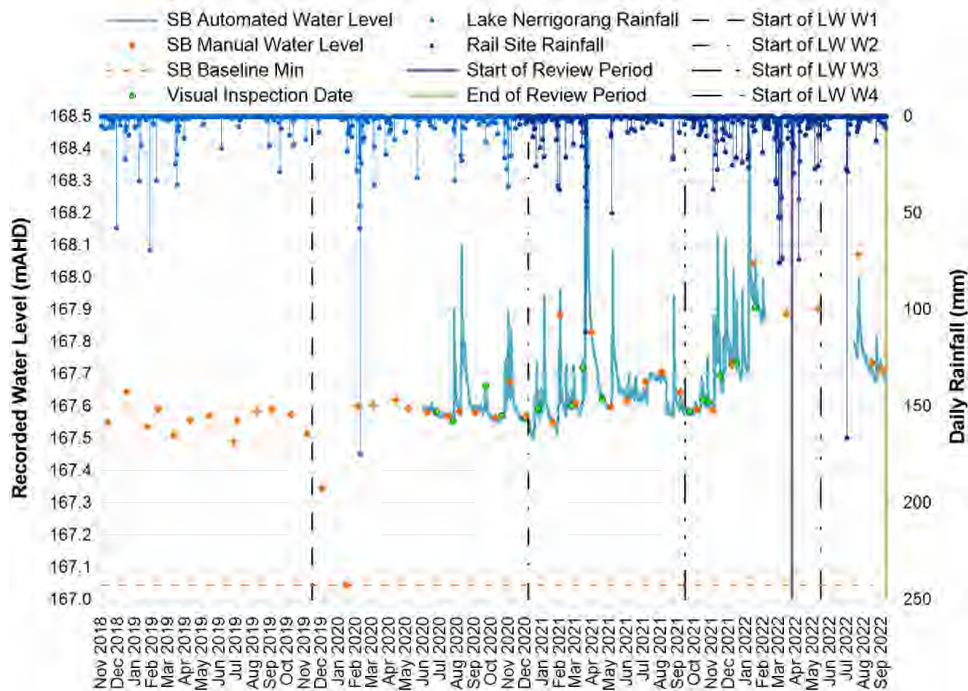
FIGURE B22: MONITORING SITE SB WATER LEVEL RECORDS⁶

⁶ The logger at monitoring site SB was washed away during a major rainfall event from late February to early March 2022 and as such data has not been collected since 5 February 2022.

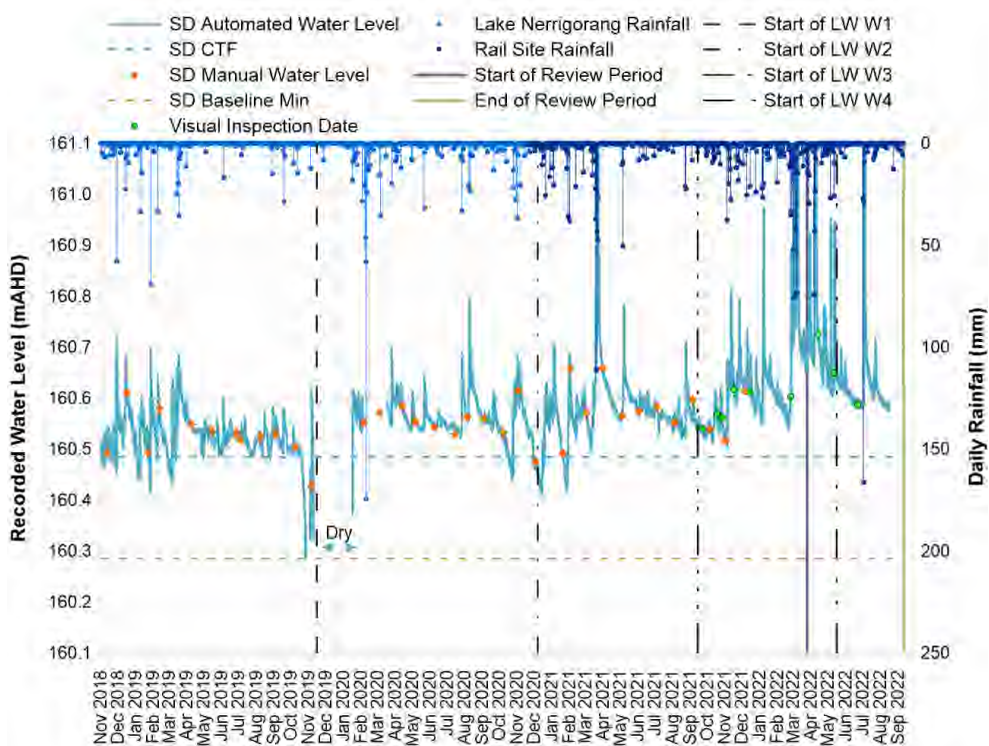
FIGURE B24: MONITORING SITE SD WATER LEVEL RECORDS⁷

⁷ The water level sensor has not been located and therefore records are not available from 7 December 2021.

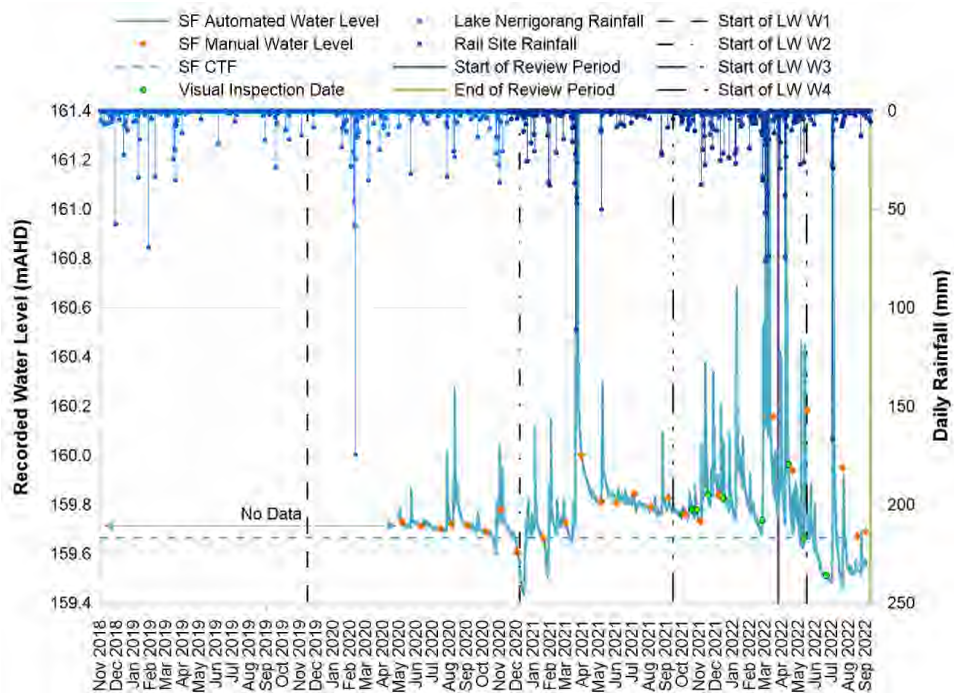
FIGURE B25: MONITORING SITE SF WATER LEVEL RECORDS

- Monitoring site SF - the control at monitoring site SF has been impacted by flood events and, as such, the water level records are not necessarily comparative to pre-flood conditions.

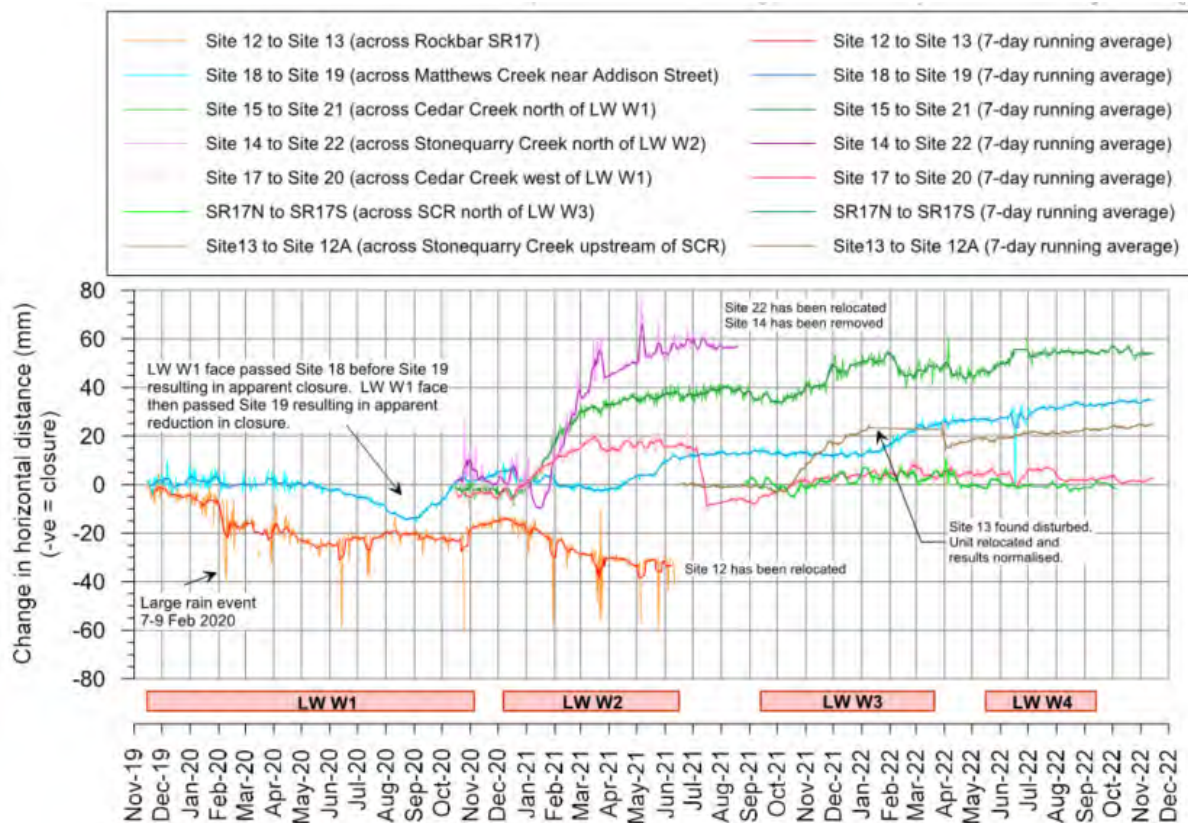
**DIAGRAM 1: OBSERVED CHANGES IN HORIZONTAL DISTANCES BETWEEN GNSS UNITS
(SOURCE: MSEC, 2022)**

Since the completion of LW W4 to 18 November 2022², the following was recorded (MSEC, 2022):

- Small changes in horizontal distance at Site SR17N to Site SR17S across rockbar SR17 (SCR).
- Measurements at Marks RBE11, RBF05 and RBF06 located across rockbar SR17 indicate that minor ground shortening has occurred in the south-east corner of the rockbar (MSEC, 2022).
- Less than 10 mm horizontal distance at Site 13 to Site 12A, located across Stonequarry Creek upstream of rockbar SR17 (SCR).
- Negligible opening at Site 15 to Site 21, located across Cedar Creek upstream of the confluence with Stonequarry Creek.
- Little change in horizontal distance at Site 18 to Site 19, located across Matthews Creek near Addison Street.
- Negligible change in horizontal distance at Site 17 to Site 20, located across Cedar Creek to the west of LW W1.

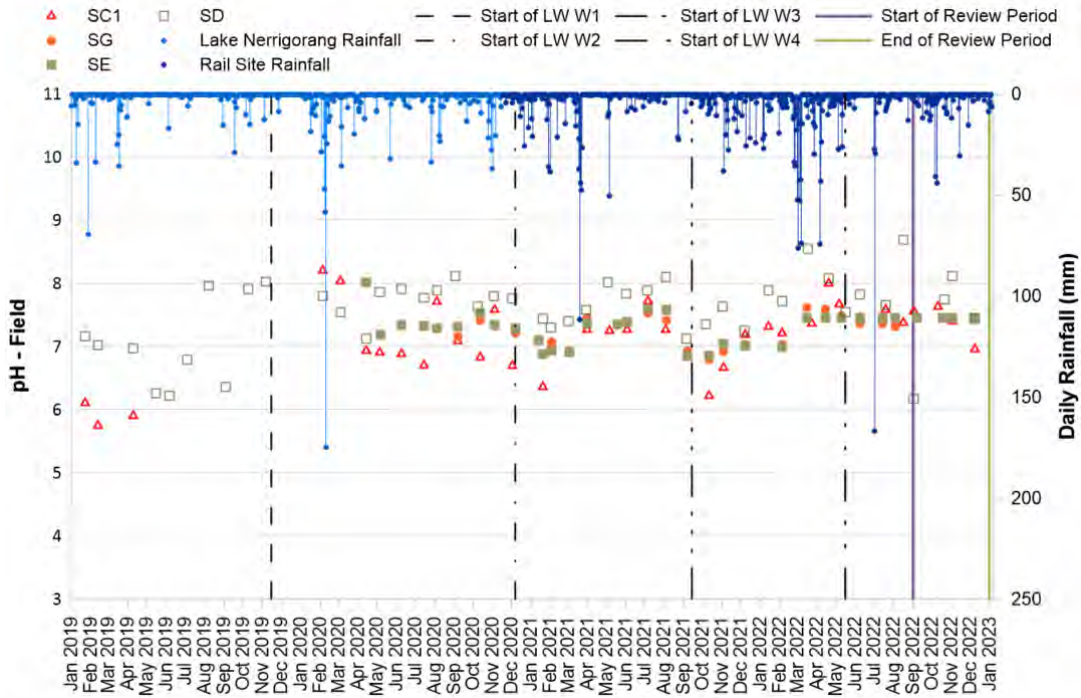
DIAGRAM 2: STONEQUARRY CREEK SITE SD AND REFERENCE SITES – FIELD PH RECORDS

In September 2022, a level 2 trigger exceedance occurred in relation to the field pH measurement recorded at monitoring site SD in Stonequarry Creek (pH 6.2). In response to the trigger exceedance, the Environmental Response Group convened, and the surface water quality data was reviewed in relation to the prevailing climate and catchment wide water quality trends.

The pH value recorded at SD in September 2022 (pH 6.2) was within the range of historical pH values recorded at this site, however, a pH value lower than pH 7 has not been recorded since 2019. It is noted that the pH recorded in October 2022 at monitoring site SD had returned to near neutral (pH 7.7). It is likely that the September record was an anomaly and may be related to instrumentation or field measurement issues. Accordingly, re-calibration of the field instrumentation has been recommended. Monitoring will continue to be undertaken in accordance with the WMP.

As discussed in **Section 5.4.3**, it is recommended that re-calibration of field instrumentation is undertaken due to intermittent records of potentially erroneous field pH values. Progress in relation to this recommendation will be provided in the next quarterly surface water review report for the Western Domain.

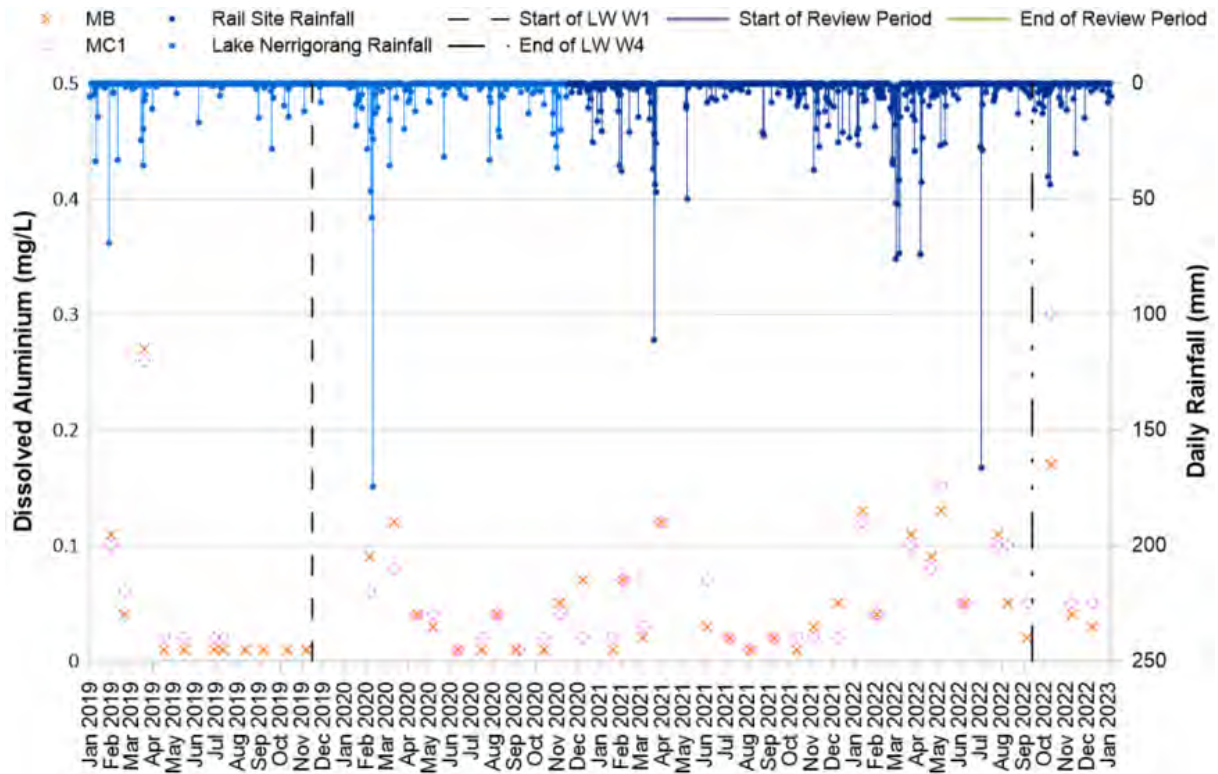
DIAGRAM 3: MATTHEWS CREEK SITE MC1 AND REFERENCE SITES – DISSOLVED ALUMINUM RECORDS

In October 2022, a level 2 trigger exceedance occurred in relation to dissolved aluminium recorded at monitoring site MC1 in Matthews Creek (0.3 mg/L). The elevated dissolved aluminium concentration resulted in an exceedance of the site specific trigger value however did not exceed the reference site trigger level. As shown in **DIAGRAM 3**, the dissolved aluminium concentrations recorded at both MC1 and MB were elevated in October, and may be related to the rainfall event which occurred prior to sampling. The dissolved aluminium concentrations declined in November and December and were within the range of baseline concentrations.

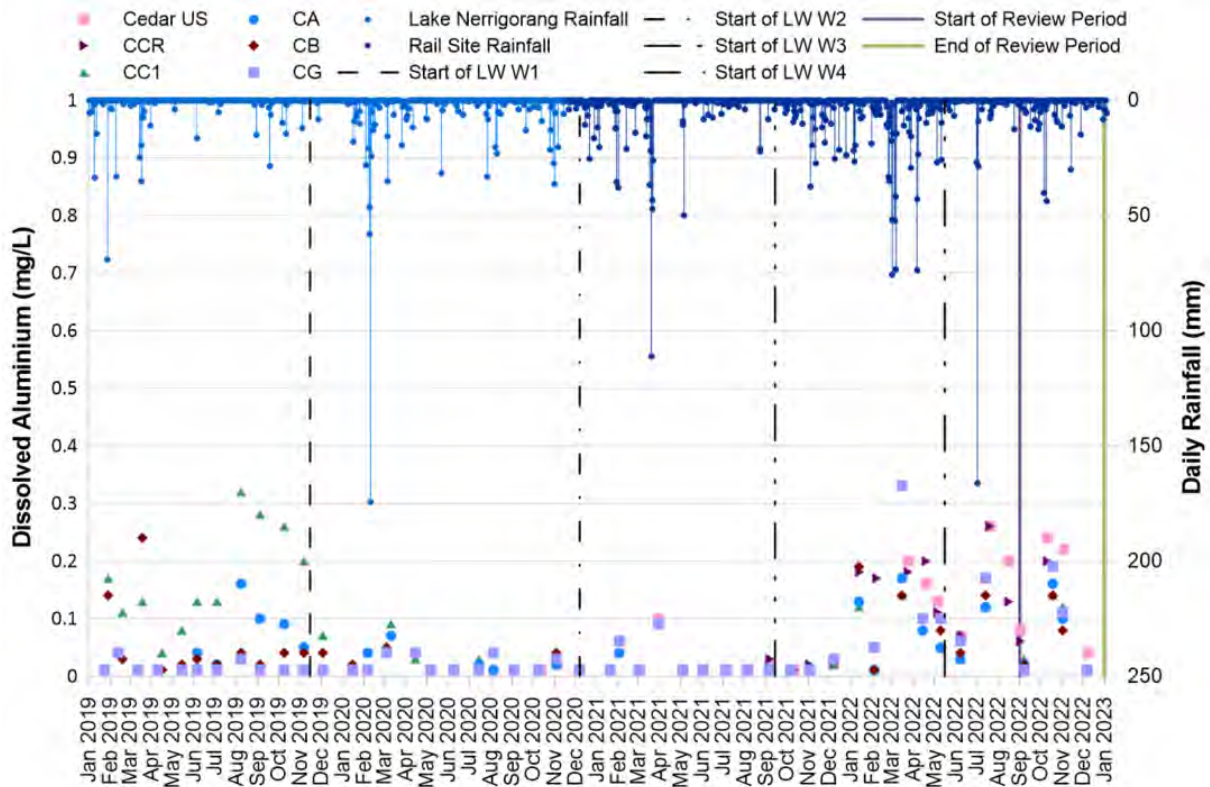
DIAGRAM 4: CEDAR CREEK SITE CG AND REFERENCE SITES – DISSOLVED ALUMINIUM RECORDS

As shown in **DIAGRAM 4**, the dissolved aluminium concentrations recorded at reference sites CCR and Cedar US, which are located at a notable distance upstream of the Western Domain, were higher than that recorded at monitoring sites CA, CB and CG for the duration of the review period. As such, this indicates a catchment wide (non-mining related) influence on dissolved aluminium concentrations in Cedar Creek.

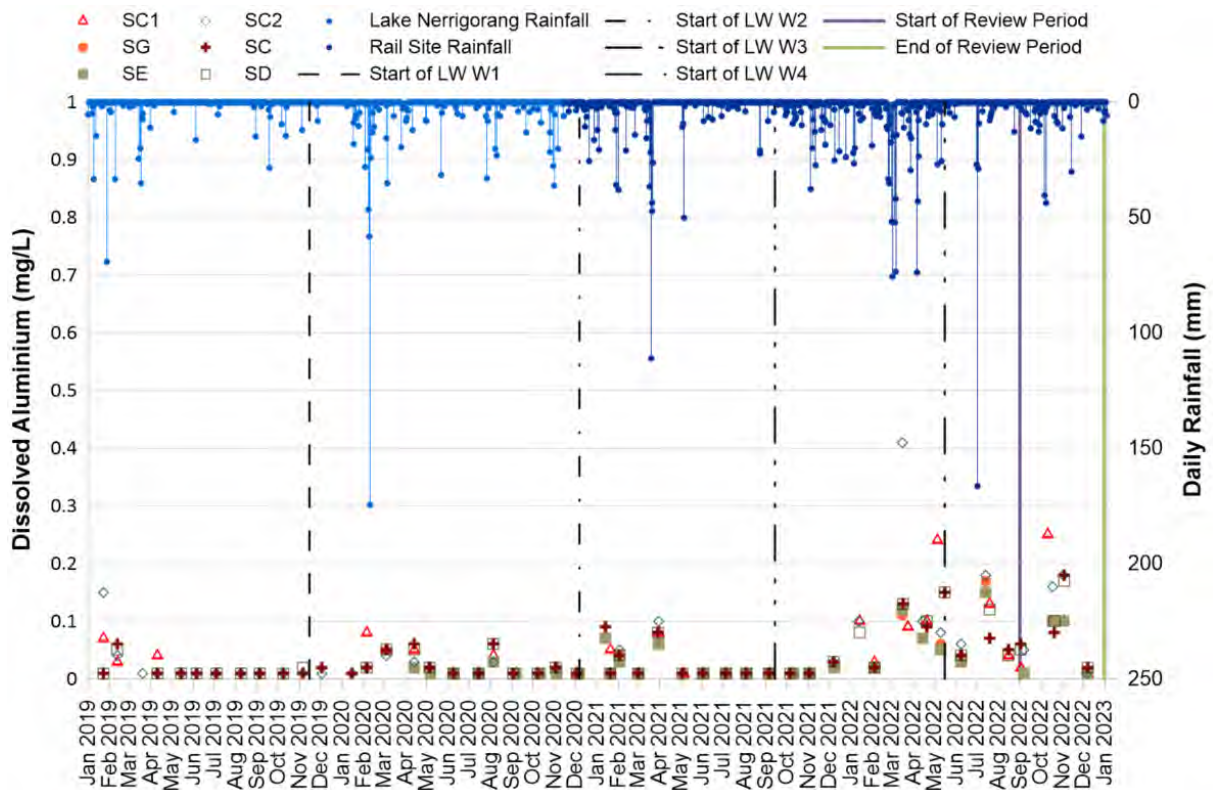
DIAGRAM 5: STONEQUARRY CREEK SITES SC1, SC AND REFERENCE SITES – DISSOLVED ALUMINIUM RECORDS

As shown in **DIAGRAM 5**, the dissolved aluminium concentrations recorded at reference sites SC1 and SE, located upstream of potential mining relation influences, followed a similar trend to that recorded at SC2, SC and SD from September to December 2022. In October 2022, a higher concentration of dissolved aluminium was recorded at reference site SC1 than at other monitoring sites in Stonequarry Creek. As such, this suggests a catchment wide (non-mining related) influence on dissolved aluminium concentrations in Stonequarry Creek.

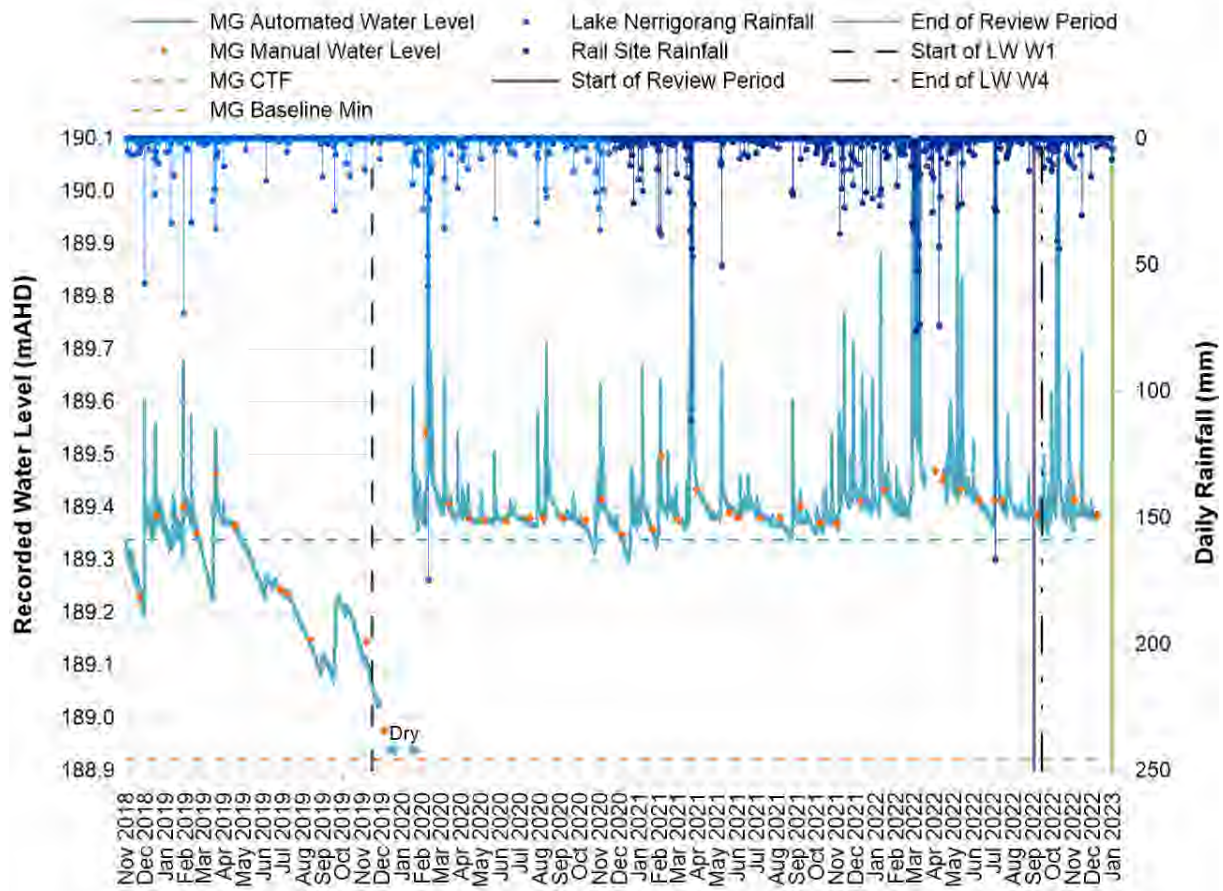
DIAGRAM B7: MONITORING SITE MG WATER LEVEL RECORDS⁵

⁵ No data was recorded between 17 March and 14 April 2022 due to a logger re-start issue.

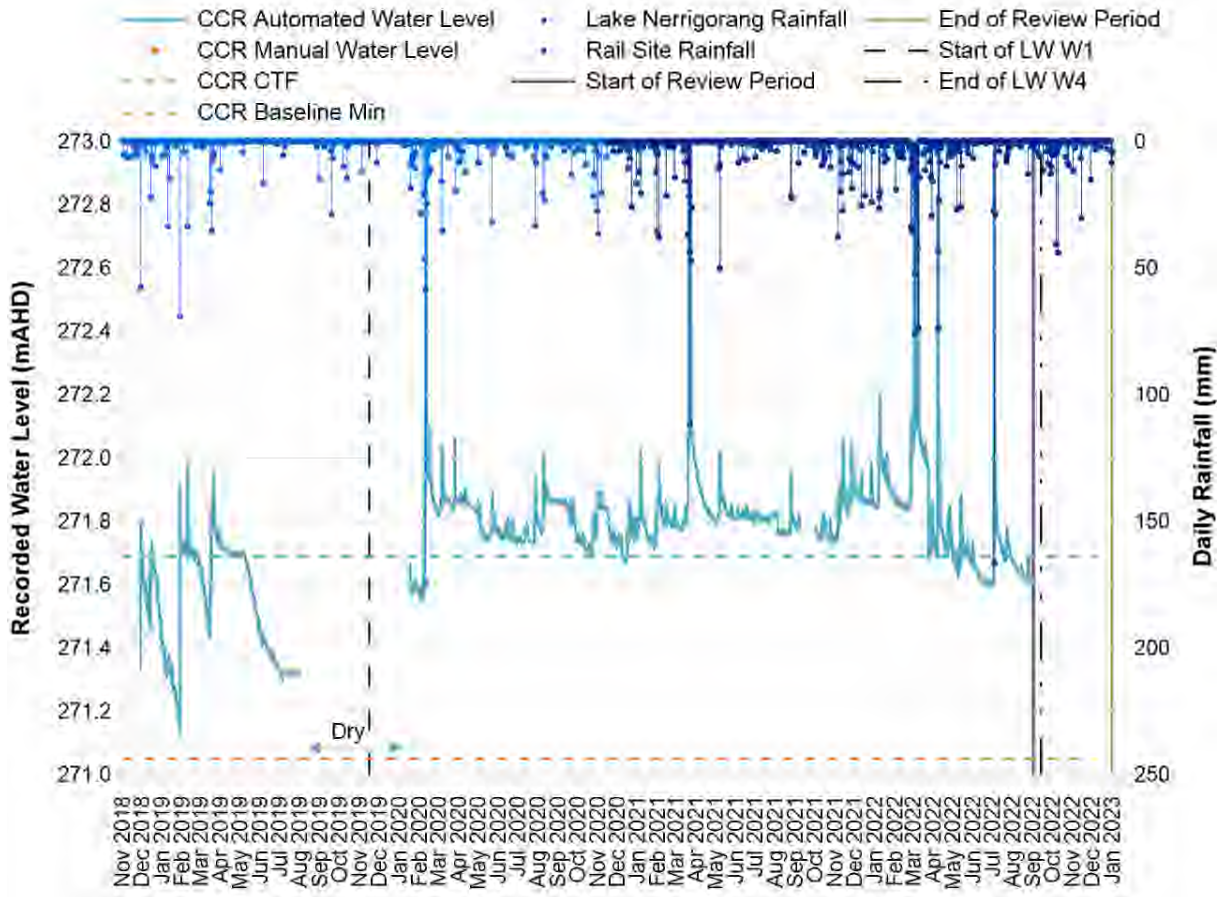
DIAGRAM B8: MONITORING SITE CCR WATER LEVEL RECORDS⁶

⁶ The reference bolts at monitoring sites CCR and SF have not been found and as such the raw data recorded from 7 / 8 December 2021 was unable to be converted to a water level measurement.

Item	Previous Recommendation	Progress of Recommendation
1	Monitoring site CCR: This site is recommended for decommissioning as the reference bolt has not been located and as such the raw data recorded from 8 December 2021 has not been able to be converted to a water level measurements. In addition, this site is influenced by backwater effects from the downstream weir. Cedar US is considered more of a representative reference site for Cedar Creek.	Monitoring site CCR was decommissioned in October 2022.
2	Monitoring site SG: This site is recommended for decommissioning as the flow control at this site, comprised predominantly of sand and rubble, was washed away in recent flood events and is therefore no longer a suitable monitoring site for water level measurements. Two alternative representative reference sites are located on Stonequarry Creek (sites SC1 and SE).	Monitoring site SG was decommissioned in October 2022.

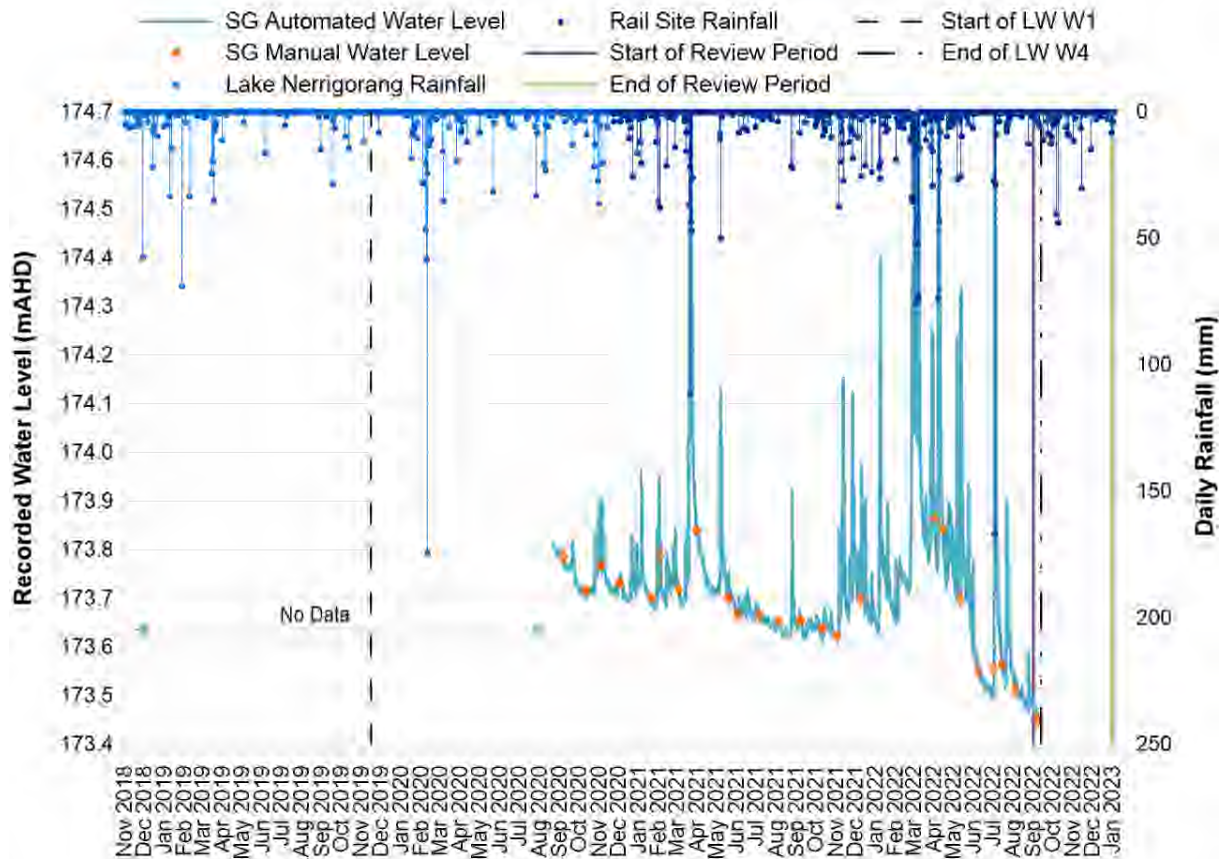
DIAGRAM B18: MONITORING SITE SG WATER LEVEL RECORDS⁷

⁷ The control at monitoring site SG was predominantly comprised of sand and stones and was impacted by high flow events during the review period. Subsequently, the control is no longer functional and the water level recorded from May 2022 is not comparable to previous records.

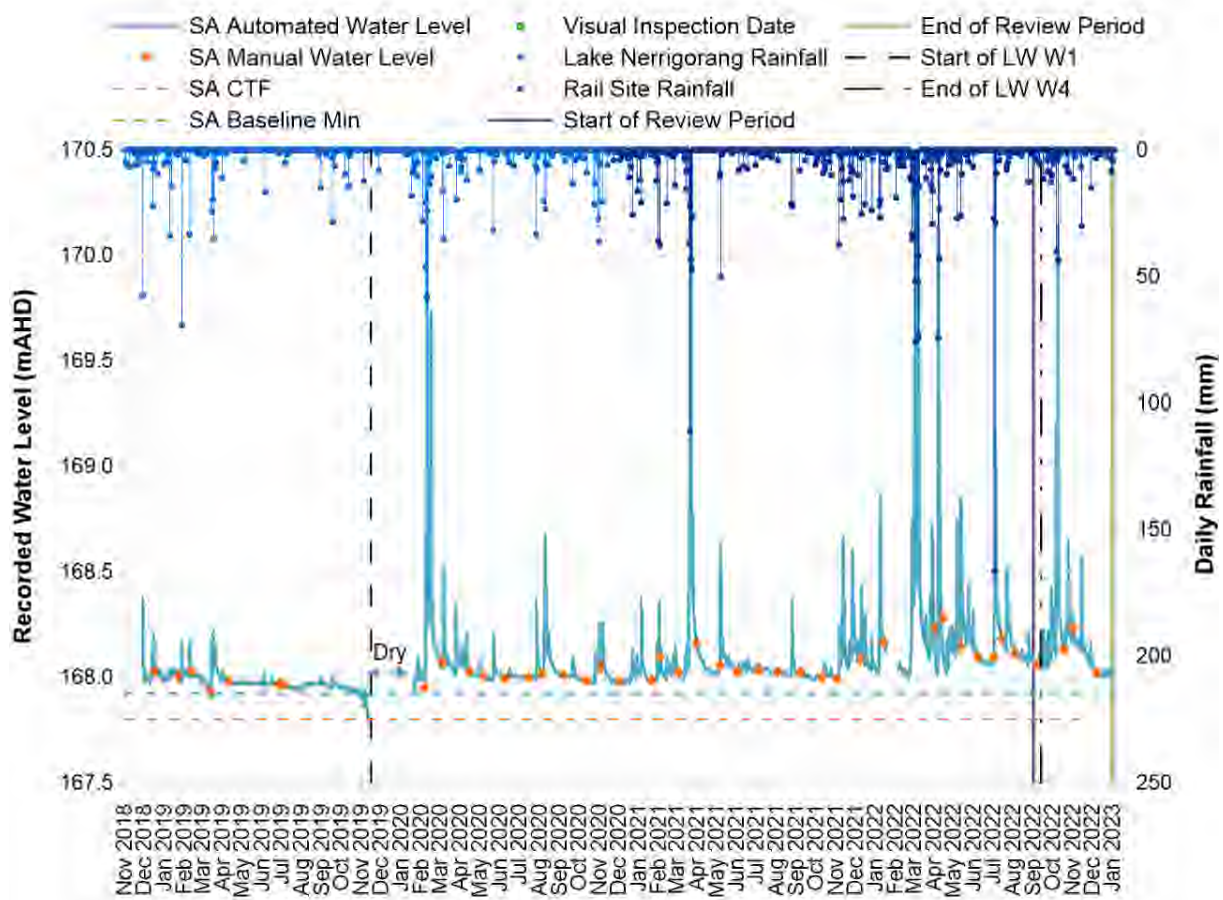
DIAGRAM B20: MONITORING SITE SA WATER LEVEL RECORDS⁸

⁸ Between 15 January and 5 February 2022, an incomplete data download occurred at monitoring site SA, or the logger was not correctly restarted, and as such no data is available for this period.

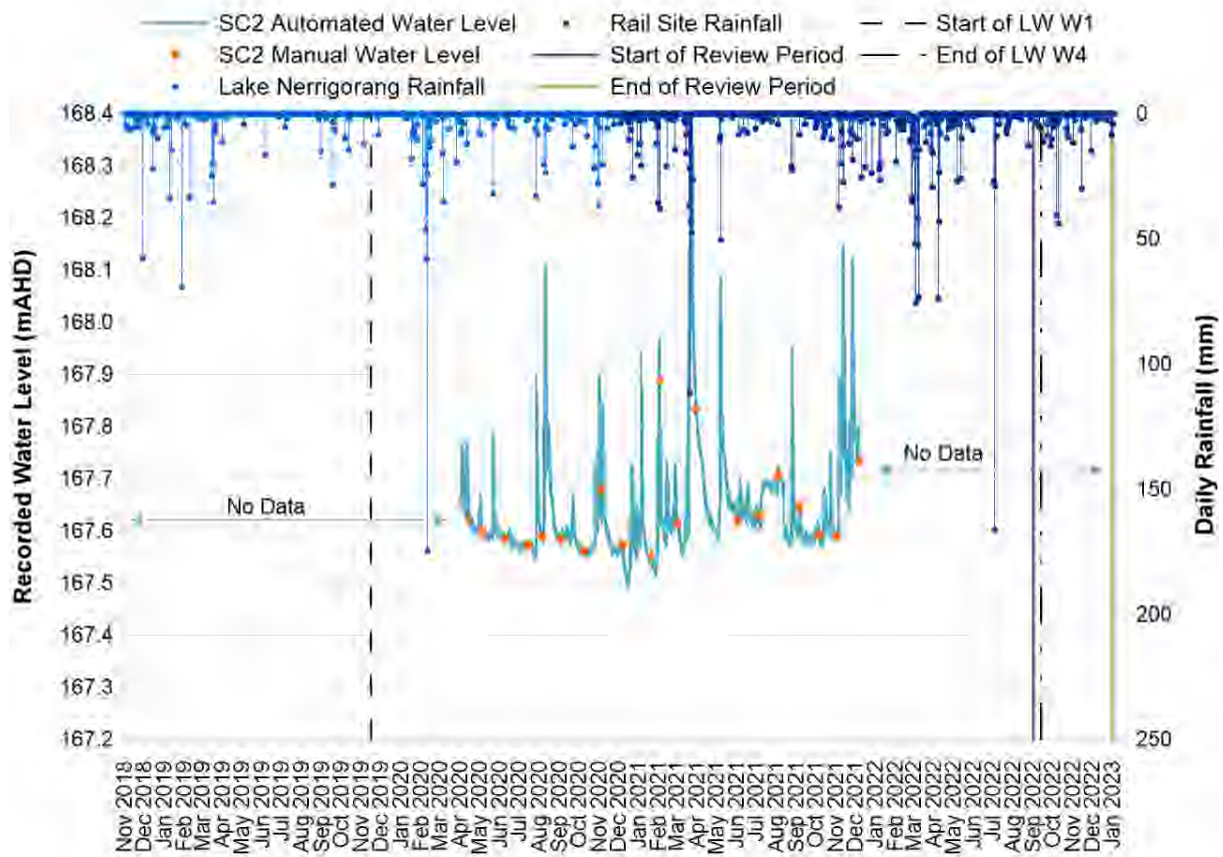
DIAGRAM B21: MONITORING SITE SC2 WATER LEVEL RECORDS⁹

⁹ The water level sensor has not been located and therefore records are not available from 7 December 2021.

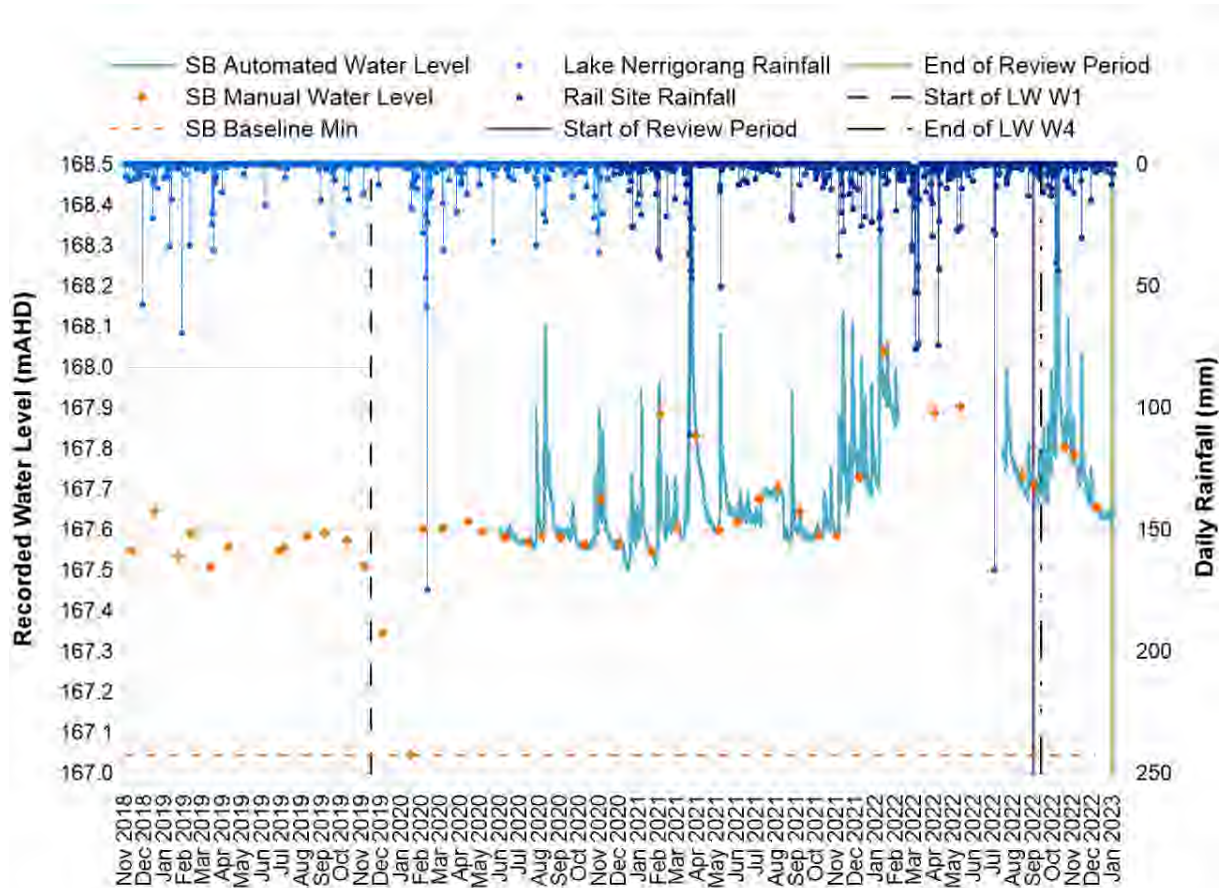
DIAGRAM B22: MONITORING SITE SB WATER LEVEL RECORDS¹⁰

In response to the Level 3 trigger exceedances in relation to physical features at monitoring site SB (pool SR17), the Environmental Response Group convened and the surface water level data was reviewed. The water level records for monitoring site SB (pool SR17) shown in Figure B22, **Appendix B**, indicate that the fracturing of the rockbar has not resulted in an impact to the pool water holding capacity. The water level recorded at monitoring site SB (pool SR17) has not declined below the baseline minimum water level and no atypical water level behaviour has been recorded at this site to date. As such, there is no requirement to increase the frequency of visual inspections and review of data in relation to pool physical features, natural drainage behaviour and pool water level. The physical features and water level records for this site will continue to be monitored in accordance with the WMP.

¹⁰ The logger at monitoring site SB was washed away during a major rainfall event from late February to early March 2022 and as such data has not been collected since 5 February 2022. A manual water level measurement was unable to be recorded in April and June 2022 due to high flow.

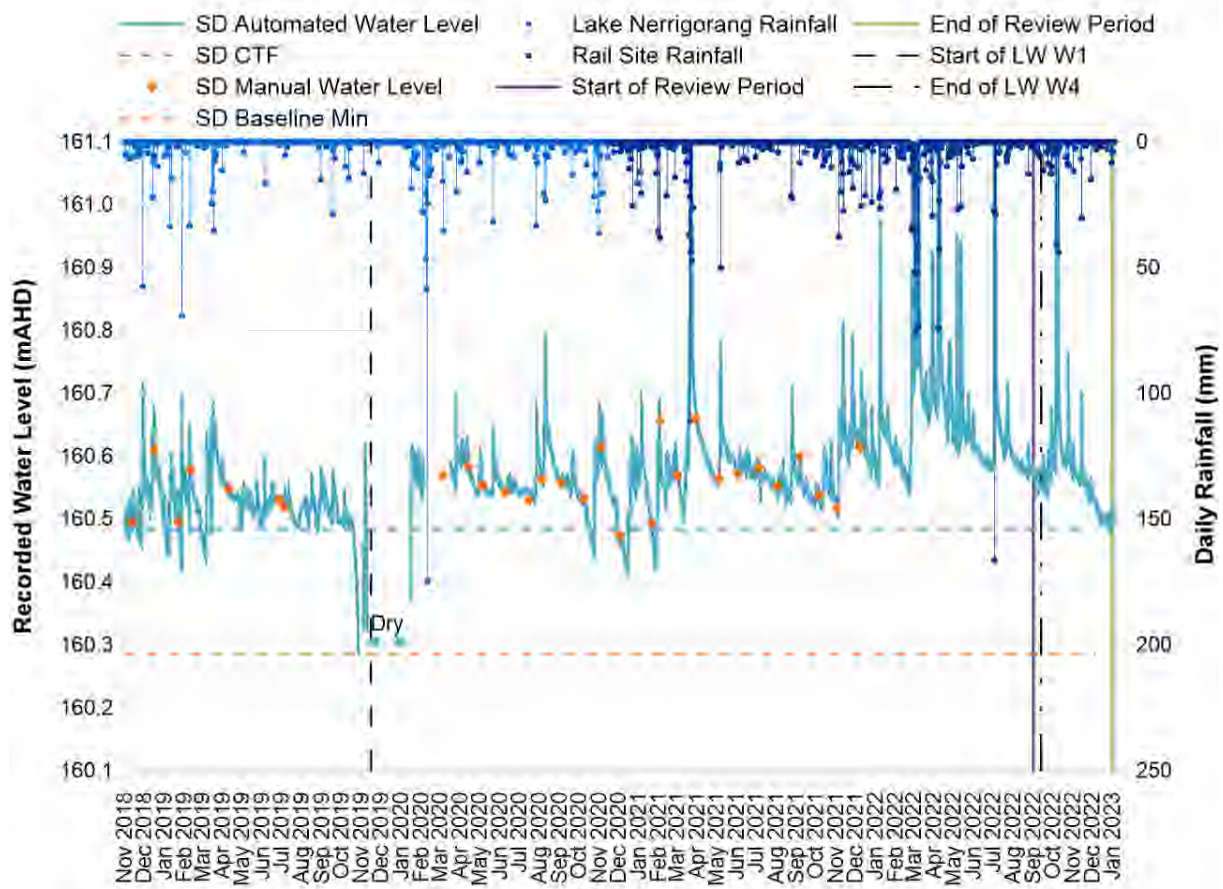
DIAGRAM B24: MONITORING SITE SD WATER LEVEL RECORDS¹¹

¹¹ The water level sensor has not been located and therefore records are not available from 7 December 2021.

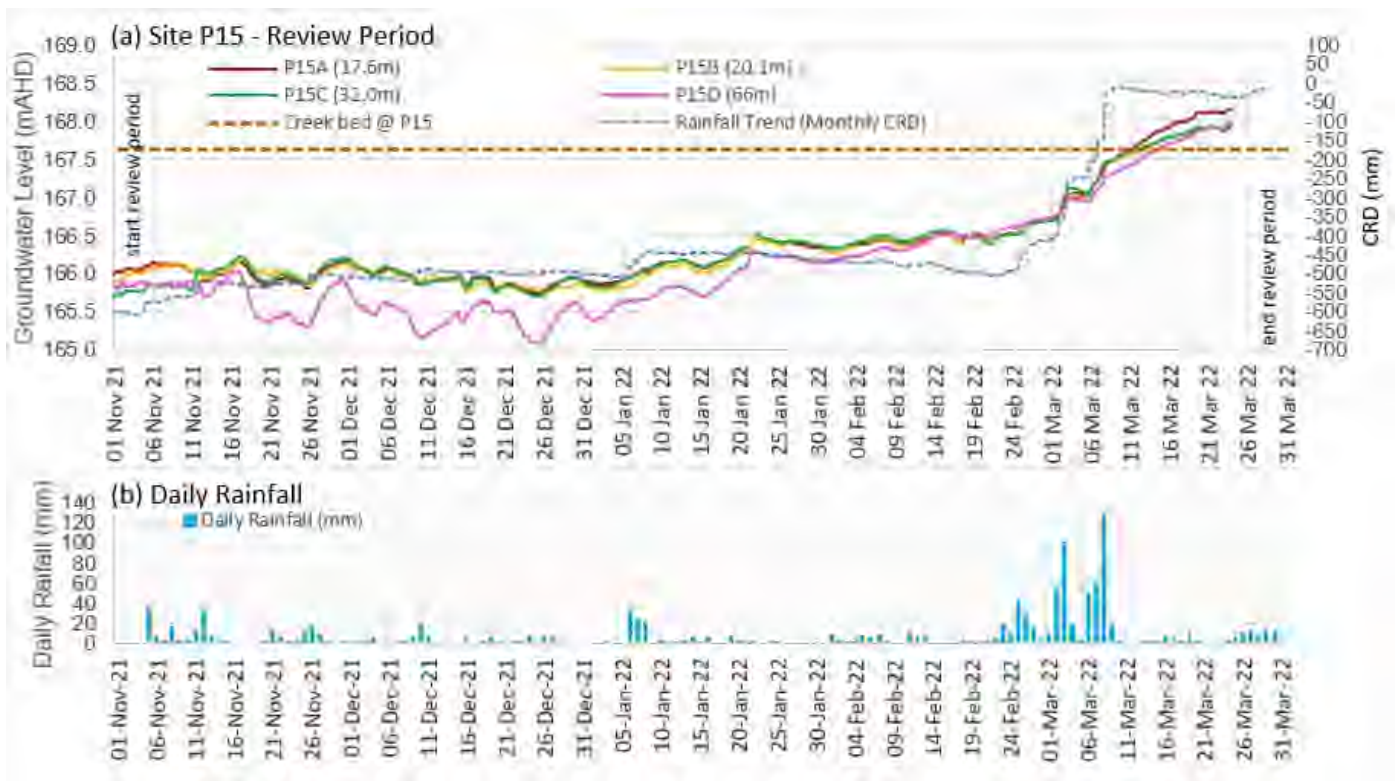
Figure 4 Groundwater levels at P15 during the review period (a); Daily rainfall over the reporting period (b)

Figure 4 (a) presents water levels at site P15 for the length of the review period, with the daily CRD plotted and daily rainfall shown on Figure 4 (b).

A similar trend in groundwater levels to that at P15D is observed in the upper and mid Hawkesbury Sandstone aquifer (bores P15A, B and C), including similar short-term fluctuations, but these short-term fluctuations are in the range of 0.2 m (i.e. smaller than those in P15D). This suggests that if a mining related effect due to LW W3 occurred at P15 (as seems likely), it would have been to a greater magnitude in the deeper strata (P15D) than the shallow strata (e.g. P15A-C) as previously observed in October 2021 (SLR, 2021b)).

From late December 2022, a gradual increase in groundwater levels is observed in all piezometers at P15. The rate of groundwater recovery accelerates in late February 2022 following intense rainfall and flooding in the area. Over the reporting period, groundwater levels in P15D increased by approximately 3 m while groundwater levels in P15A, B and C increased by 2.2 m. At the end of the reporting period, groundwater levels in all piezometers at site P15 are at approximately 168 mAHD which is 0.4 m above the creek bed elevation at P15, suggesting that baseflow conditions (i.e. gaining conditions) to Stonequarry Creek have strengthened.

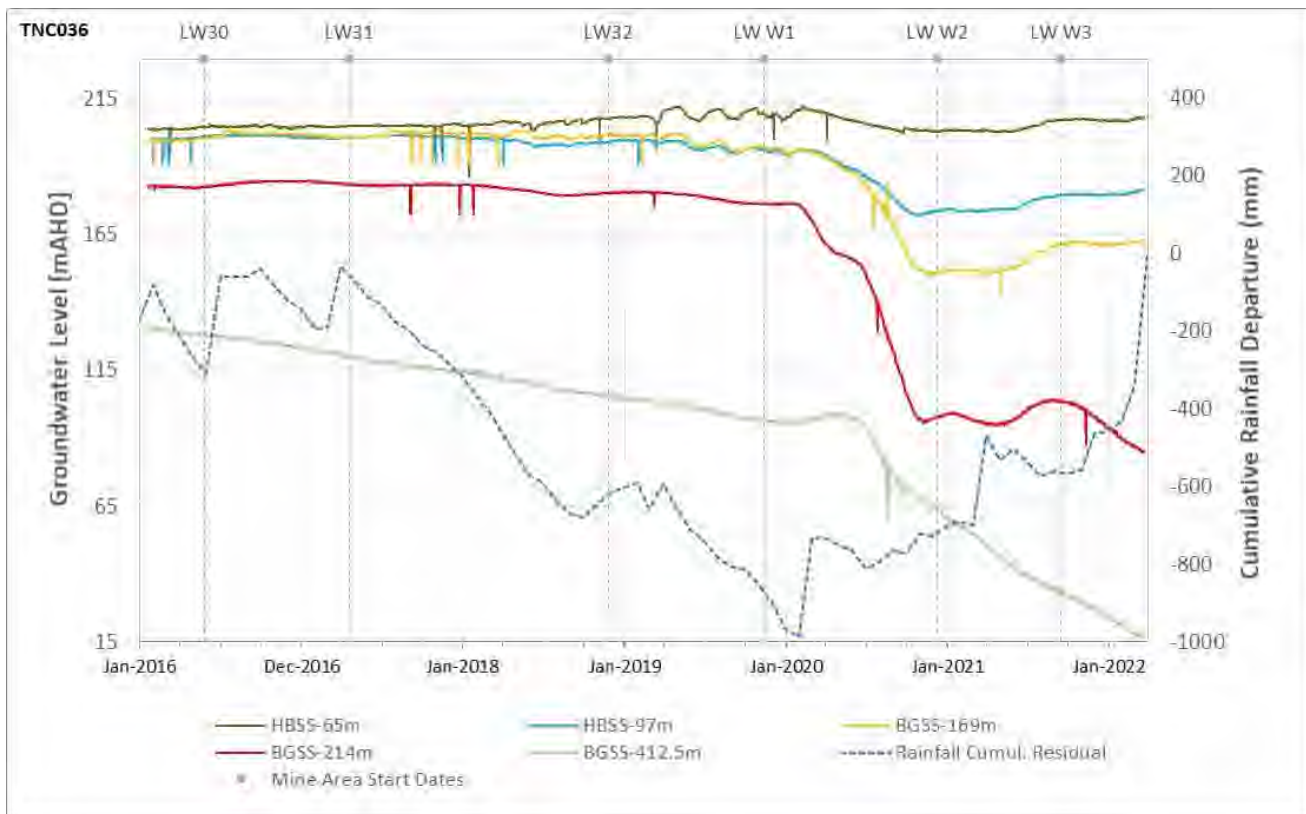
Figure 5 Hydrograph for TNC036

TNC036 is located almost 500 m to the west of the middle of LW W1 and west of Matthews Creek. It has a number of sensors placed in the Hawkesbury and Bulgo Sandstones at various depths, as well as one in the Bulli Coal seam (Table 3). The hydrographs for the VWPs are presented in Figure 5. Groundwater pressures at TNC036 have recently been re-assessed and resulted in the removal of the transducer records at 298 m and 463 m (Groundwater Exploration Services [GES], 2020). Data collected from 2010 to 2011 at TNC036 appears erroneous, likely due to influence from construction. Consistent data that appears representative of local groundwater conditions has been collected from 2016. Further details on reliability of TNC036 data is presented in the Groundwater Technical Report LW W3-W4 (SLR, 2021).

Approximately 60 m of depressurisation is apparent in the lower Bulgo Sandstone (piezometer BGSS-412.5m) for the period from February 2016 to August 2019, with the rate of drawdown increasing in mid-2020 and reducing in late-early 2021. The decline in water levels in the lower Bulgo Sandstone from 2016 (or before) is likely related to regional drawdown of deeper aquifers due to the cumulative effect of Longwalls 29-32 at Tahmoor.

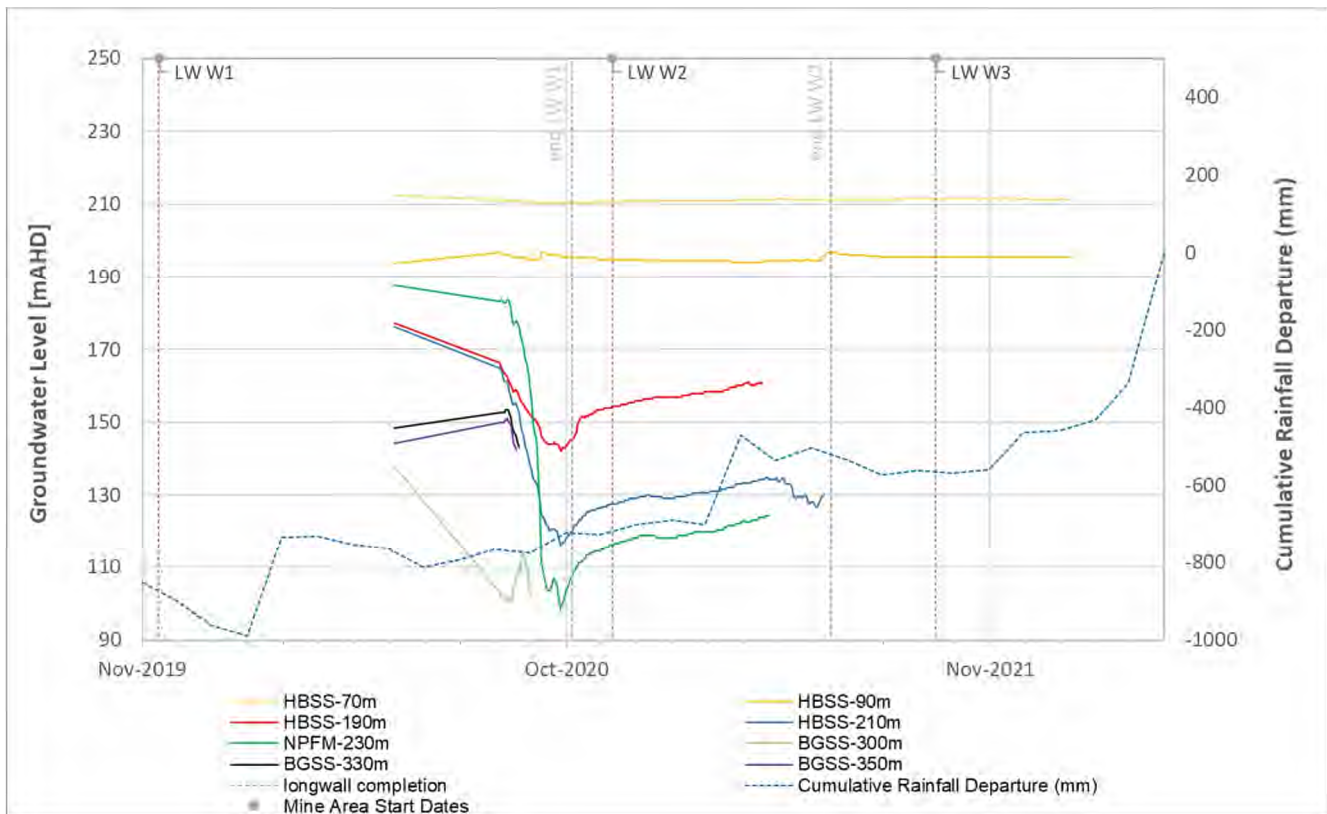
Figure 6 Groundwater Level Trends at WD01

Figure 6 presents a hydrograph of the pre-mining borehole (WD01) located above a chain pillar between the Western Domain LW W1-W2. The bore is 570 m north of the closest Tahmoor North (not Western Domain) goaf (LW 32) and was completed while LW W1 was 400 m to the north (Section 3). WD01 is instrumented with VVPs at multiple depths and has been recording groundwater pressures/heads since June 2020. The latest available groundwater pressure dataset is dated to January 2022. In late April 2021 the sensors HBSS-190m and NPFM-230m both failed due to ground movement therefore no comment on groundwater elevations can be made past this date. The remaining active sensors HBSS-70m and HBSS-90m continue to show stable groundwater levels with no signs of depressurisation as of January 2022. The HBSS-210m sensor failed in late June 2021 due to ground movements caused by the retreating longwall panels. No groundwater level data past January 2022 is available as yet.

The instrument HBSS-70m shows stable groundwater levels at about 211 mAHD. In HBSS-70m, no mining effect is evident as of January 2022, consistent with previous reporting. A small drawdown (1 m) was observed in HBSS-90m late April 2021 caused by the approach of LW W2. In June 2021, water levels in HBSS-90m recovered by approximately 2 m and has since then been stable at 196 mAHD and does not appear to show any discernible effect from mining.
