Tahmoor Coal Pty Ltd

SIX MONTHLY SUBSIDENCE IMPACT REPORT

Western Domain Longwalls West 1 – West 4

Report 7 – March 2023

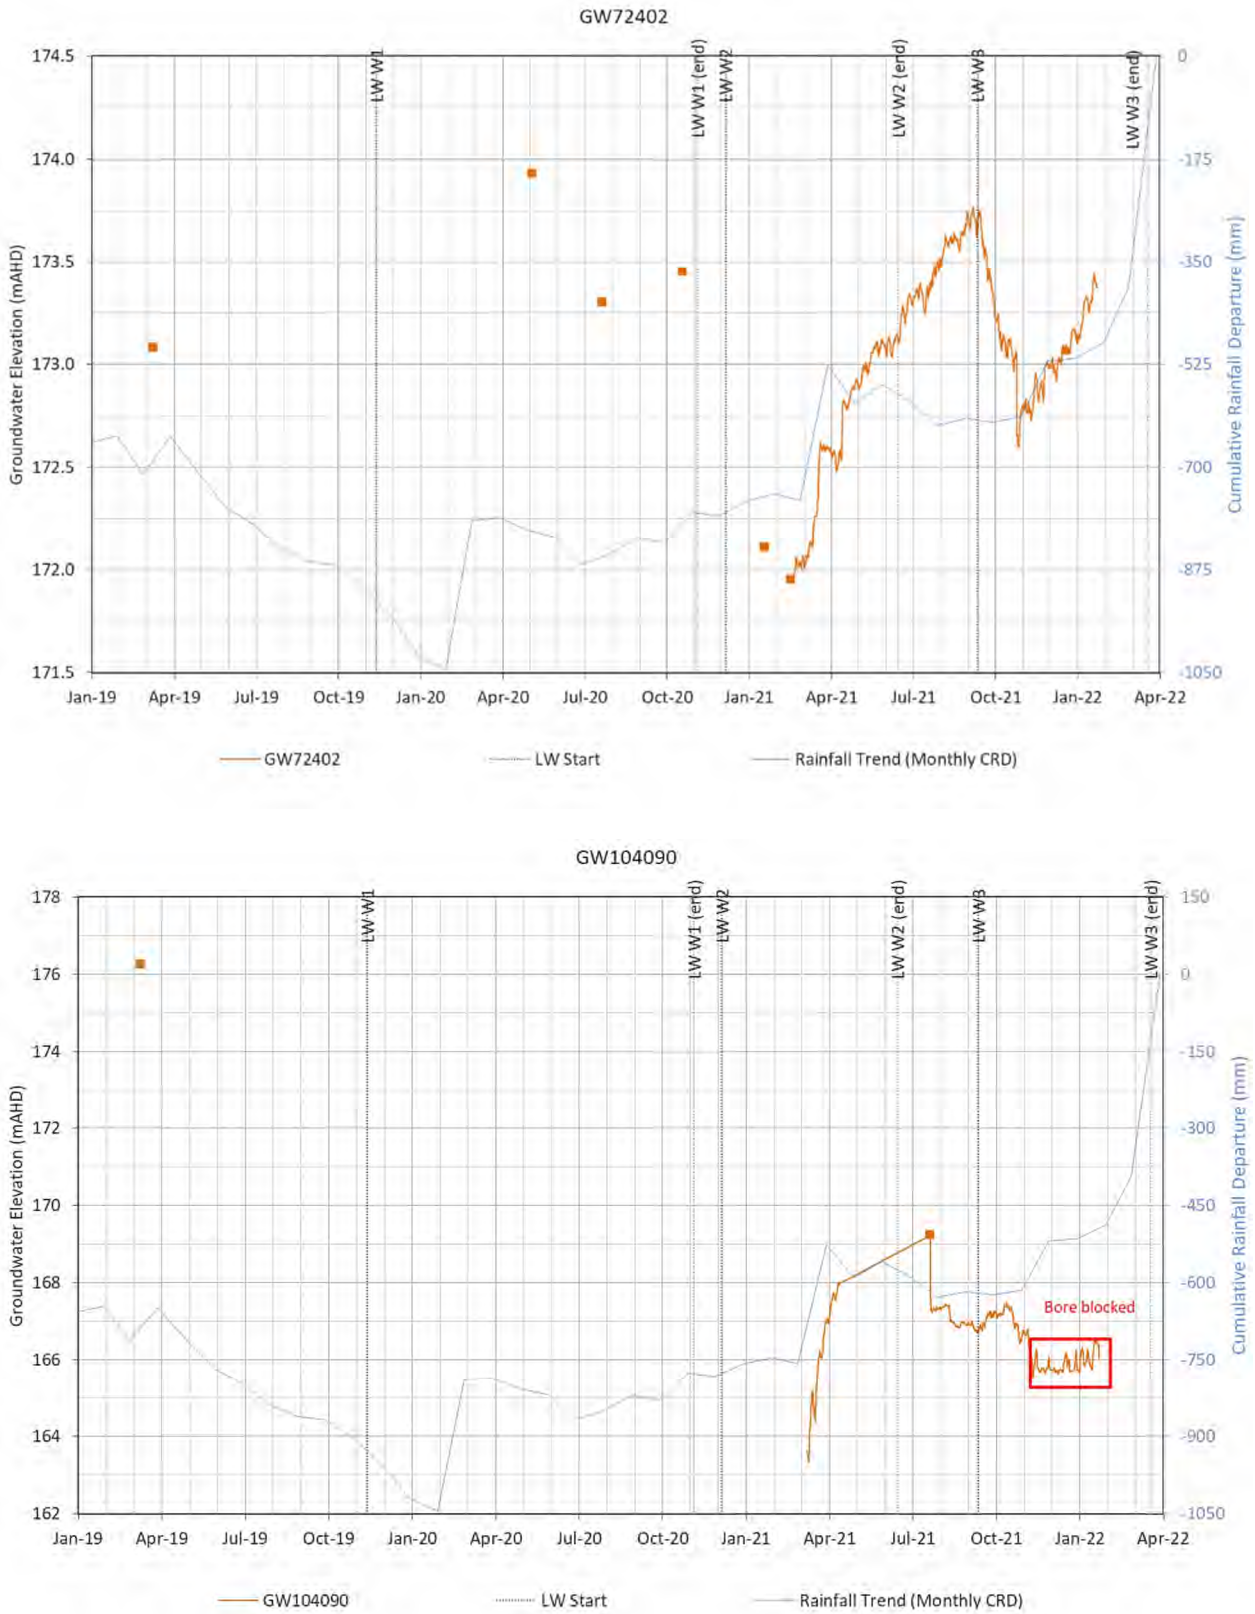
Figure 7 Groundwater level hydrographs for GW72402 and GW10409

From November 2021, groundwater levels start to rise in response to rainfall recharge. By January 2022, groundwater level increased by 0.7 m to 173.4 mAHD, similar to baseline conditions (Figure 7). No yield information is available at this location due to pump malfunction.

Since March 2021 an improved groundwater level dataset has been available. Following the significant rainfall events in February-March 2021, water levels increased by 4.5 m to 167.5 mAHD in April 2021, which is 8.2 m below baseline level (Figure 7). As noted above, groundwater levels at GW104090 experienced some degree of drawdown (>12 m) due to the passage of LW W1 and W2 but still show good responses to rainfall recharge. No groundwater levels were available between late April 2021 and July 2021 due to loss of the datalogger.

A manual measurement of the groundwater level at 169.2 mAHD was made available while replacing the logger in late July 2021 which suggest that water levels continued to recover during the period of missing data. From August 2021, water levels have responded to rainfall and fluctuates by 0.5 m but appear 2m below the water level taken manually in July 2021 which suggest that either the short periods of drier conditions throughout June-July 2021 and/or the completion of LW W2 influenced water levels during this period (or the manual reading in July 2021 was incorrect). In September 2021, an increasing trend in groundwater levels is observed with no mining effect due to the early part of LW W3 extraction identified. In October 2021, groundwater levels decreased by approximately 1.7 m likely due to the progression of LW W3. From November 2021, groundwater levels appeared stable at 165 mAHD. During the month of January 2022, there was a blockage at the private bore GW104090 at a depth of 48.3 m and thus it should be noted the data from January 2021 to the end of the reporting period at this location is not representative of groundwater conditions. A field inspection is planned in the coming months to identify the cause of the blockage and assess if the bore can be unblocked.

No yield information is available at this location due to pump malfunction at these bore locations.

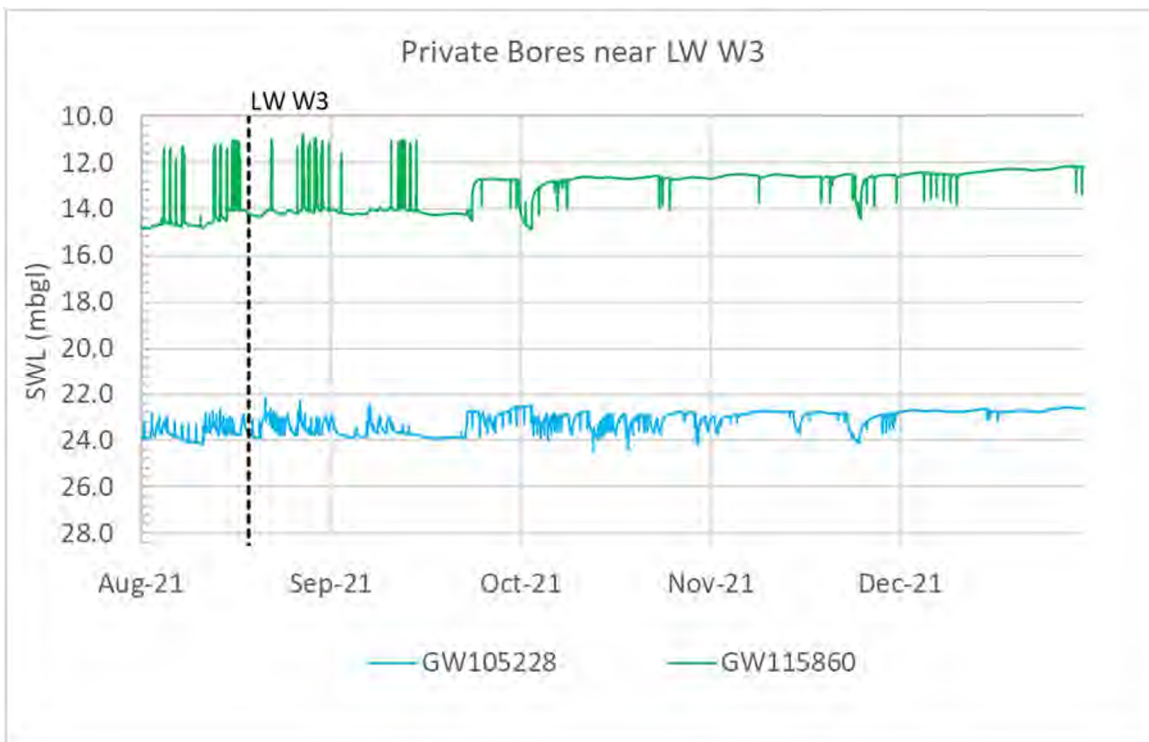
Figure 8 Hydrographs for GW105228 and GW115860

Groundwater level data at private bores GW105228 and GW115860 are recorded every 15 minutes and presented on Figure 8, with the latest available data to 24 January 2022. Groundwater levels for the two private bores show no response in water levels following the commencement of LW W3 compared to GW72402 (Figure 7). As discussed in SLR (2021b) any mining effect on groundwater levels due to the early part of LW W3 extraction is difficult to assess due to alternation between pumping and not pumping at one or both bores for private usage. The timing in groundwater level decline and recovery match between GW105228 and GW115860 (only 110 m apart), suggesting that the drawdown in one bore (i.e. due to pumping) influences water levels in the other bore. On Figure 8, the drawdown observed at GW115860 is consistently greater than the drawdown at GW105228, which suggests that GW115860 is more frequently pumping groundwater and influences water levels in GW105228. During mid-October 2021, at GW115860, pumping seems to have reduced as water level increased by 1.8 m, a period also associated with fewer pumping cycles compared to September 2021. This could be explained by the fact that reliability on groundwater has reduced during a period of above average rainfall conditions throughout October and November 2021 and during the exceptional rainfall in early 2022. However, water levels provided before 19th October 2021 seem suspect and any conclusions on pumping effect is difficult to understand prior to this period. No drawdown due to mining of LW W3 is identified during the reporting period at either GW105228 or GW115860.

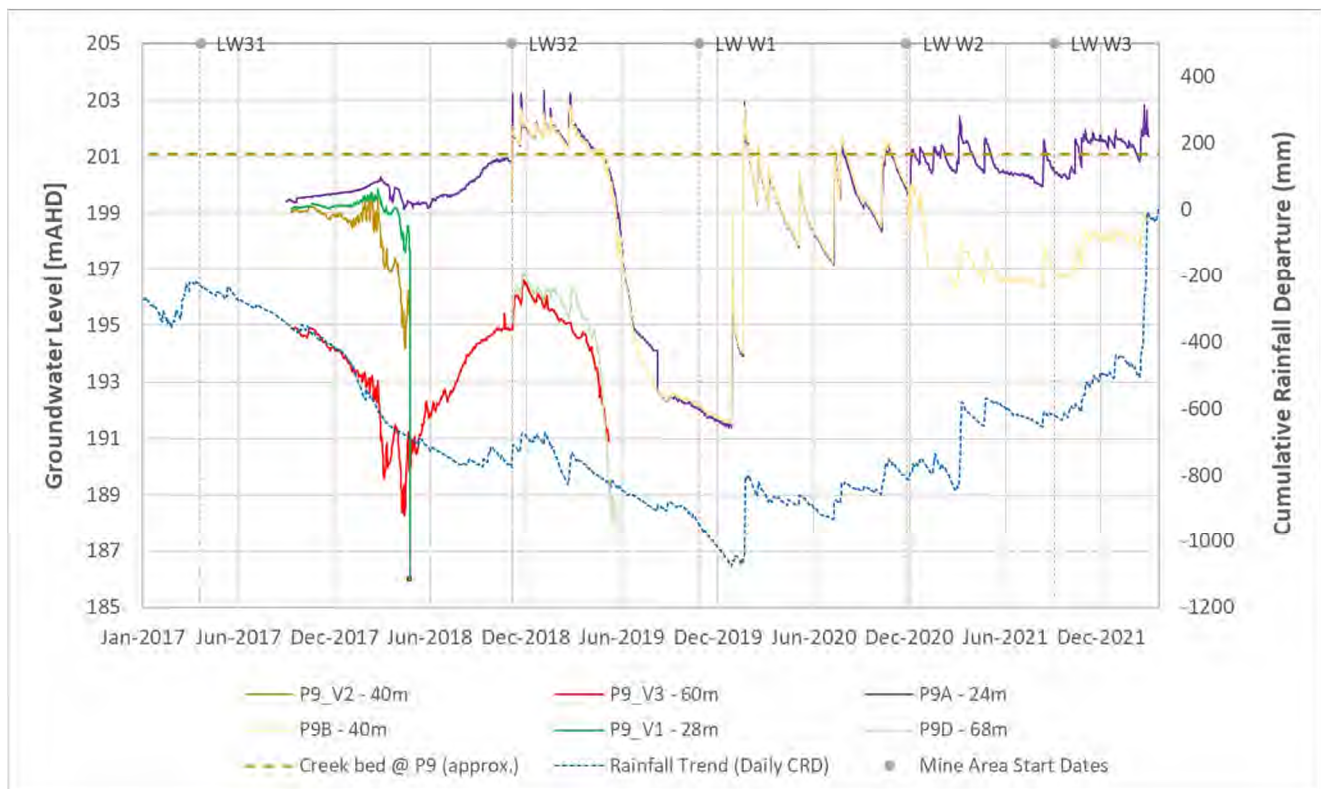
Figure 9 Groundwater Level Hydrographs at P9

One of the standpipe bores P9D (65-68m) and all three VWP sensors at P9 have failed; failures in P9_V1 in May 2018, P9_V2 in May 2019 and P9_V3 in October 2018. This is not surprising given the position between longwall panels and susceptibility to subsidence effects, however measurements of groundwater level are still recorded at P9A (22-24m) and P9C (37-40m) (Figure 9).

Figure 9 presents hydrographs of groundwater levels at P9 VWPs and open standpipes bores. At the commencement of monitoring the water levels in P9_V1 and P9_V2 were closely related. Greater head separation exists (approximately 5 m) between the water levels in the two shallower VWPs and the deeper instrument (P9_V3), however, groundwater levels at all depths show similar peaks and declines in response to rainfall.

Water levels in most of the P9 instruments declined gradually throughout the first half of 2018, following a trend similar to of the rainfall cumulative residual curve. During this period water levels decline by approximately 5 m in each of the VWPs. Following this, groundwater levels decreased to below the groundwater levels at VWPs P9_V1 and P9_V2 and these instruments fail at this point, while pressures at V3 begin to recover. By December 2018, water levels in P9_V3 have fully recovered and are approximately 2 m higher than those first recorded in October 2017. The higher head in P9_V3 at this time may be related to surface fracturing along Redbank Creek. An investigation of shallow groundwater in boreholes (including P9) around Redbank Creek was conducted by SCT in late 2018 (SCT, 2018b). This report identified increases in hydraulic conductivity at bore P9 in the presence of subsidence-induced "surface cracking". This hydrograph indicates that water drains from shallower horizons and recharges deeper horizons.

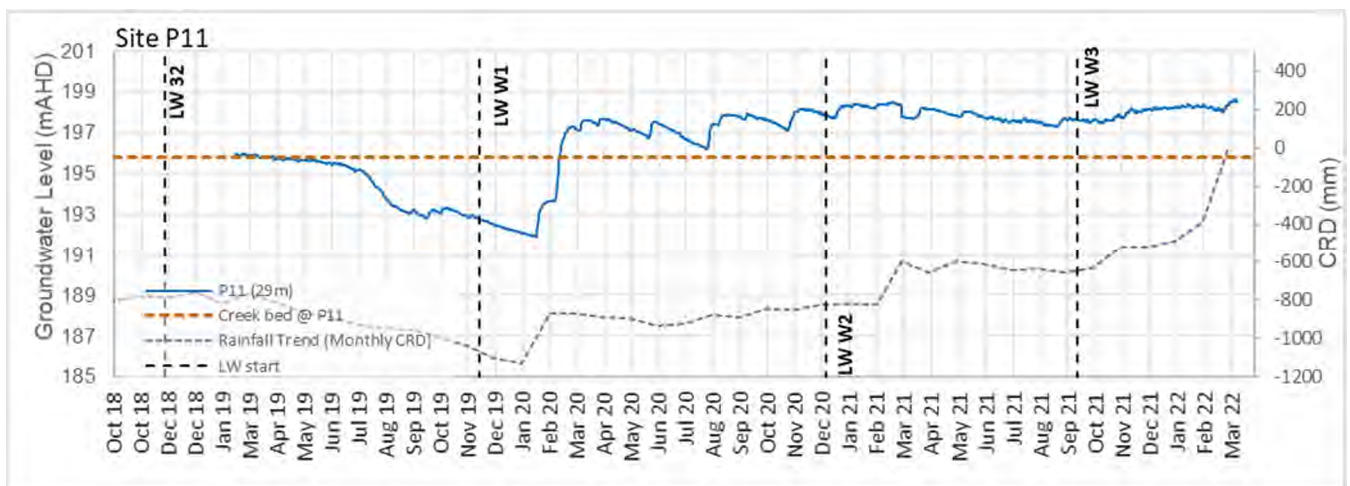
Figure 10 Groundwater Level Hydrograph at P11

Bore P11, located along Redbank Creek and 300 m east of (downstream of) LW 32 shows a mining induced drawdown of approximately 3 m between July 2019 and January 2020 (Figure 10). The groundwater levels along Redbank Creek are correlated to weather patterns or rainfall events. There is a clear response in groundwater levels to the significant rainfall commencing in January 2020. Since March 2020 water levels have recovered above the baseline level (period prior LW W32) and show small responses to rainfall events. Water levels have gradually declined by approximately 0.4 m between March 2021 and August 2021 and have shown a response to rainfall in late August 2021. During the reporting period, groundwater levels at P11 have increased by 0.7 m in response to the above average rainfall conditions. As of March 2022, water levels at P11 are around 2.7 m above the first recorded level in February 2019. No discernible effects on water levels due to LW W3 are identified during the reporting period.

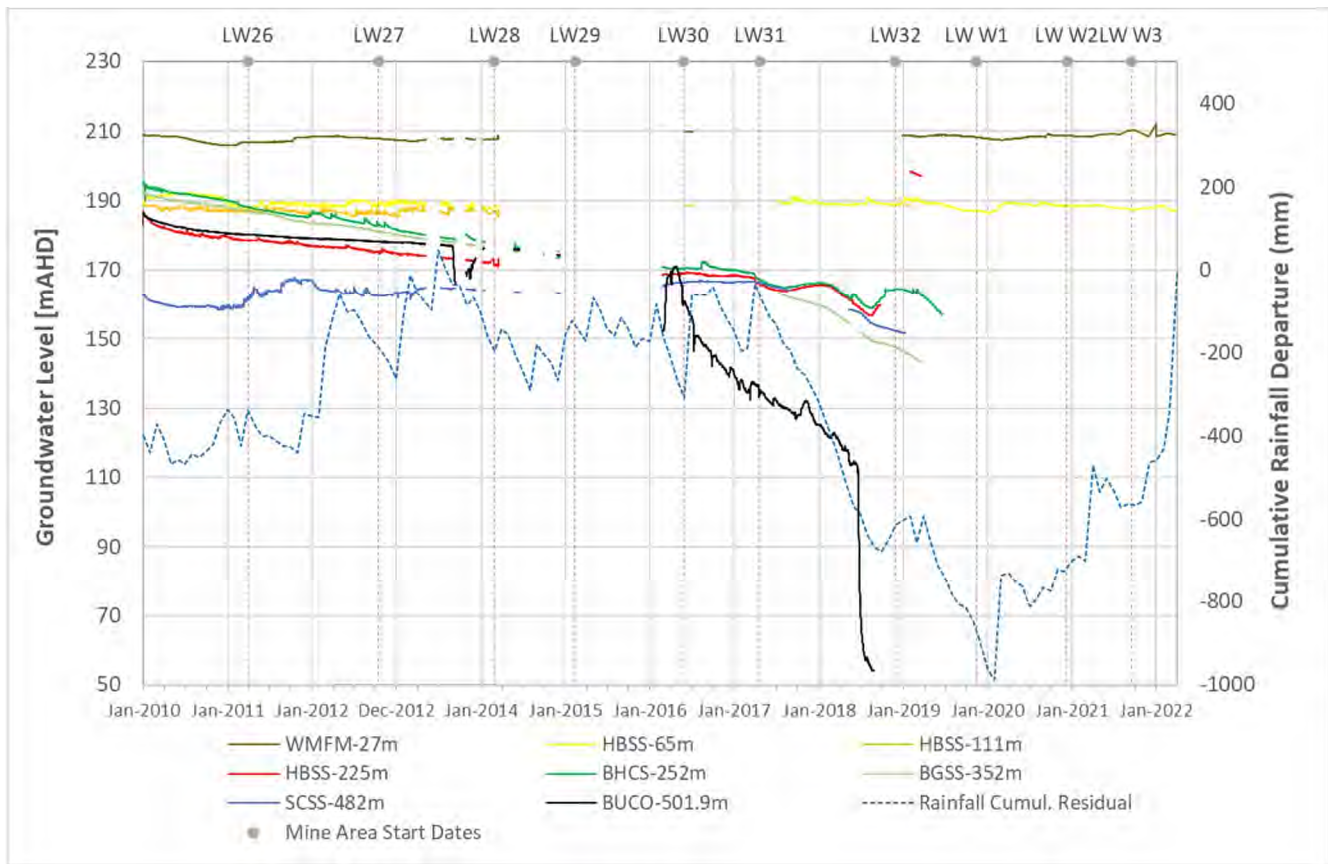
Figure 11 Groundwater Level Trends at TNC040

TNC040 is situated 300 m north of LW32, 650 m south-east of LW W2, and will be 430 m south of LW W4. Eight data sensors installed in TNC040 are positioned within the Wianamatta Group, Hawkesbury Sandstone, Bald Hill Claystone, Bulgo Sandstone, Scarborough Sandstone and Bulli Coal seam (Table 3). As of February 2019, the lower four VWP sensors were no longer active due to subsidence effects (GES, 2019). The decline in water level shown in late 2018 in the lowest sensor in the Bulli Coal seam (BUCO-501.9m) is a result of a nearby road advancement that has caused depressurisation of this seam.

As of March 2022, the upper two sensors (WMFM-27m, HBSS-65m) remain active, with monthly manual measurements taken between June 2021 and December 2021 and do not appear to show an influence from mining (Figure 11). In January 2022 the two loggers WMFM-27m and HBSS-65m were repaired, and continuous data was available from that time. In early February 2022, groundwater levels in HBSS-65m gradually declined by 1 m before stabilising at 187.3 mAHD. Minor fluctuations are observed in WMFM-27m (i.e. 0.2 m water level fluctuations). This water level decline in HBSS-65m could be associated with the progression of LW W3 to the south in the direction of TNC040 (i.e. 450 m from LW W3). No mining effect is discernible in the WMFM-27m piezometer.

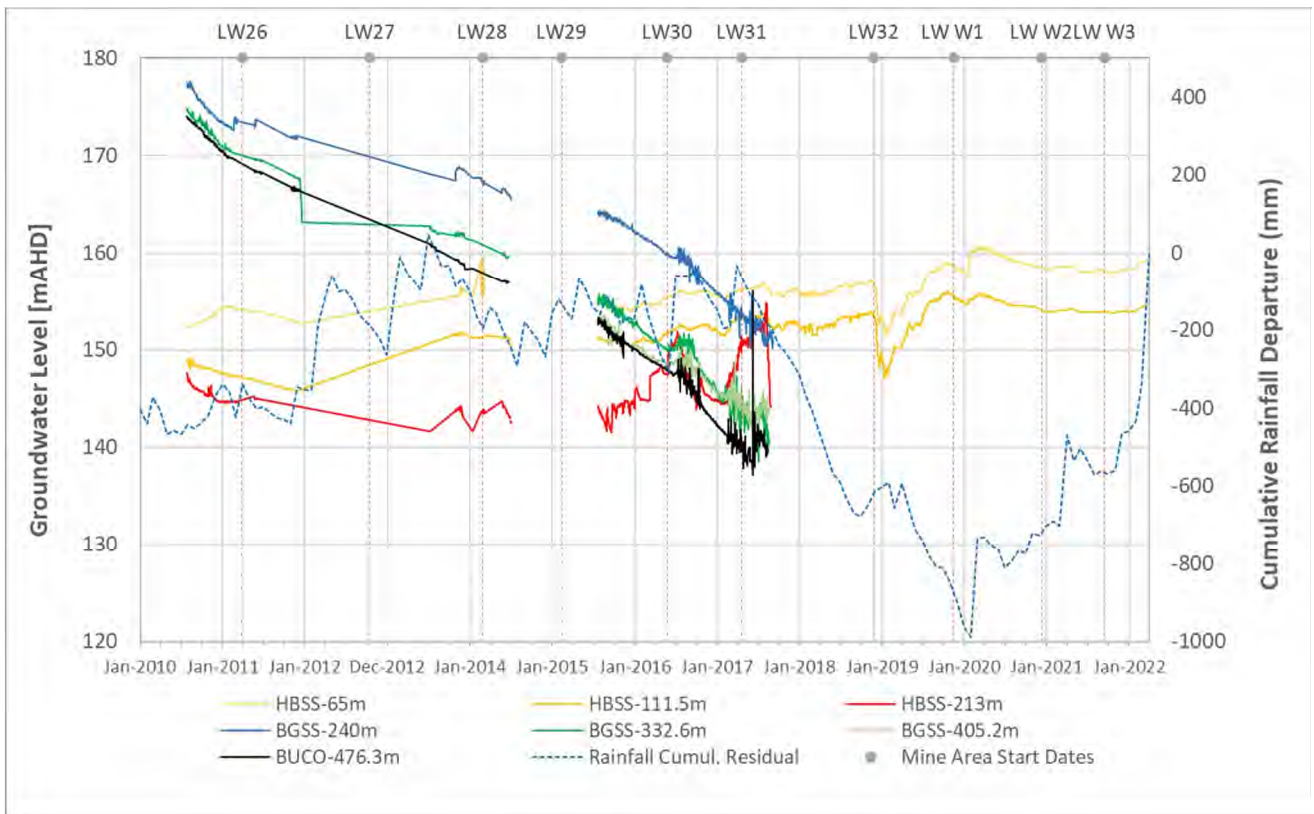
Figure 12 Groundwater Level Hydrographs at TNC043

The water levels at HBSS-65m and HBSS-111.5m present similar trends to one another and both have responded to rainfall since monitoring started (Figure 12).

A gradual decline in water levels is observed throughout 2020 which is likely attributed to mining at LW W1. Water levels at HBSS-65m and HBSS-111.5m stabilised in November 2020 and started to recover respectively at 158.7 mAHD and 154.2 mAHD in April 2021. Since this period, water levels in HBSS-65m and HBSS-111.5m fluctuated by 0.5m and have responded to the early 2022 rainfall in the range 0.7m to 1m.

As of March 2022, water levels in HBSS-65m and HBSS-111.5m are respectively 2.5 m and 1 m above water levels observed during the baseline period (i.e. prior to LW 32).

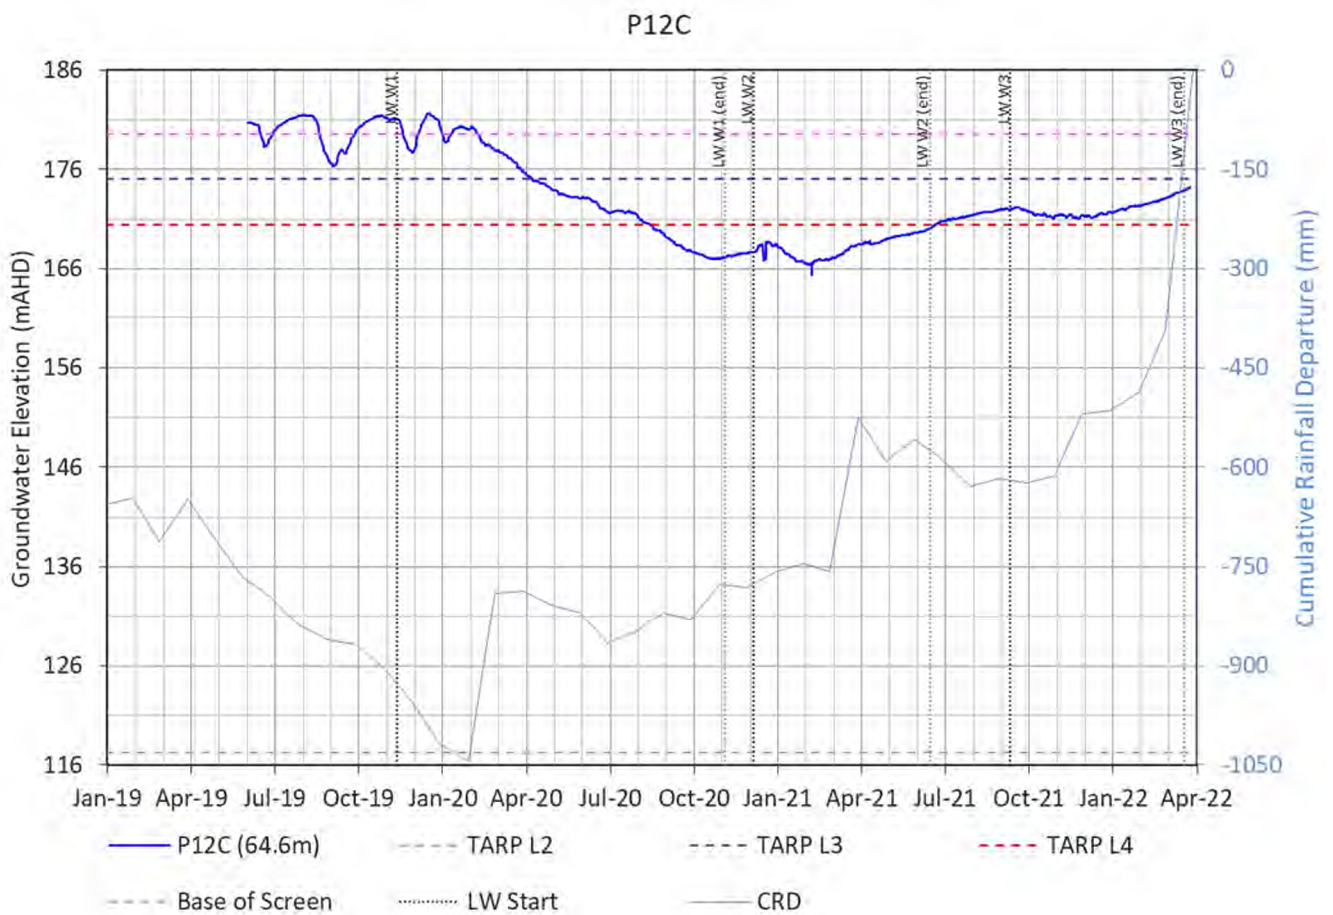
Figure 13 Groundwater Level Exceedance at P12C

During the reporting period, groundwater levels at P12C have increased to a maximum of 174.2 mAHD in March 2022 and are 2.1 m below baseline levels (Table 6). Groundwater levels at P12C have increased by 2.8 m in March 2022 and are approximately 3.1 m above groundwater level observed in the upper piezometer P12A and P12B (Figure A-1). A TARP Level 3 still applies at P12C as the recovered groundwater levels as of March 2022 are below the trigger level 3.

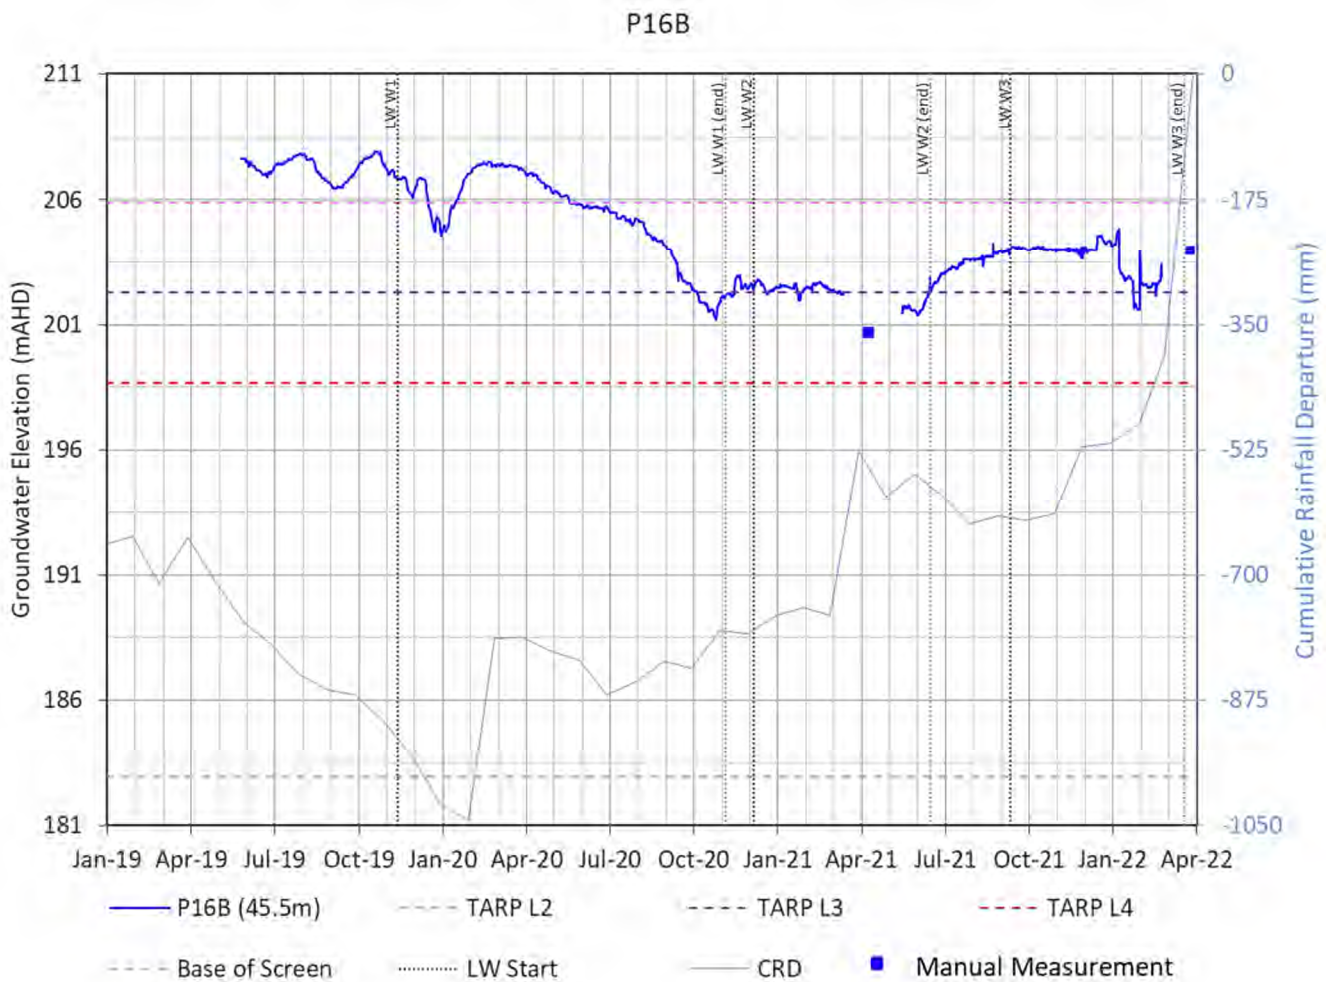
Figure 14 Groundwater Level Exceedance at P16B

At P16B, groundwater levels were observed at 202.8 mAHD in mid-January 2022, below the trigger TARP Level 2 (205.9 mAHD) following a decline of approximately 1.8m (Figure 14). SLR investigated the nature of the sharp decline (SLR, 2022a). The recent decline in groundwater levels could be due to a delayed mining effect from LW W2 and active mining at LW W3. The sudden decline in groundwater levels at P16B could potentially be due to the sudden movement of strata from mining. Similar sudden declines were observed at P15 located adjacent to the northern end of LW W3 after the commencement of that panel (Appendix A, Figure A-3).

During the second half of January 2022, water levels at P16B declined by 1.4 m, dropping below the TARP Level 3 for a short-period of time between 25th- 31st January 2022 before rising back to approximately 203.4 mAHD from March 2022. As of March 2022, groundwater levels at P16B are within a TARP Level 2 (Figure 14).

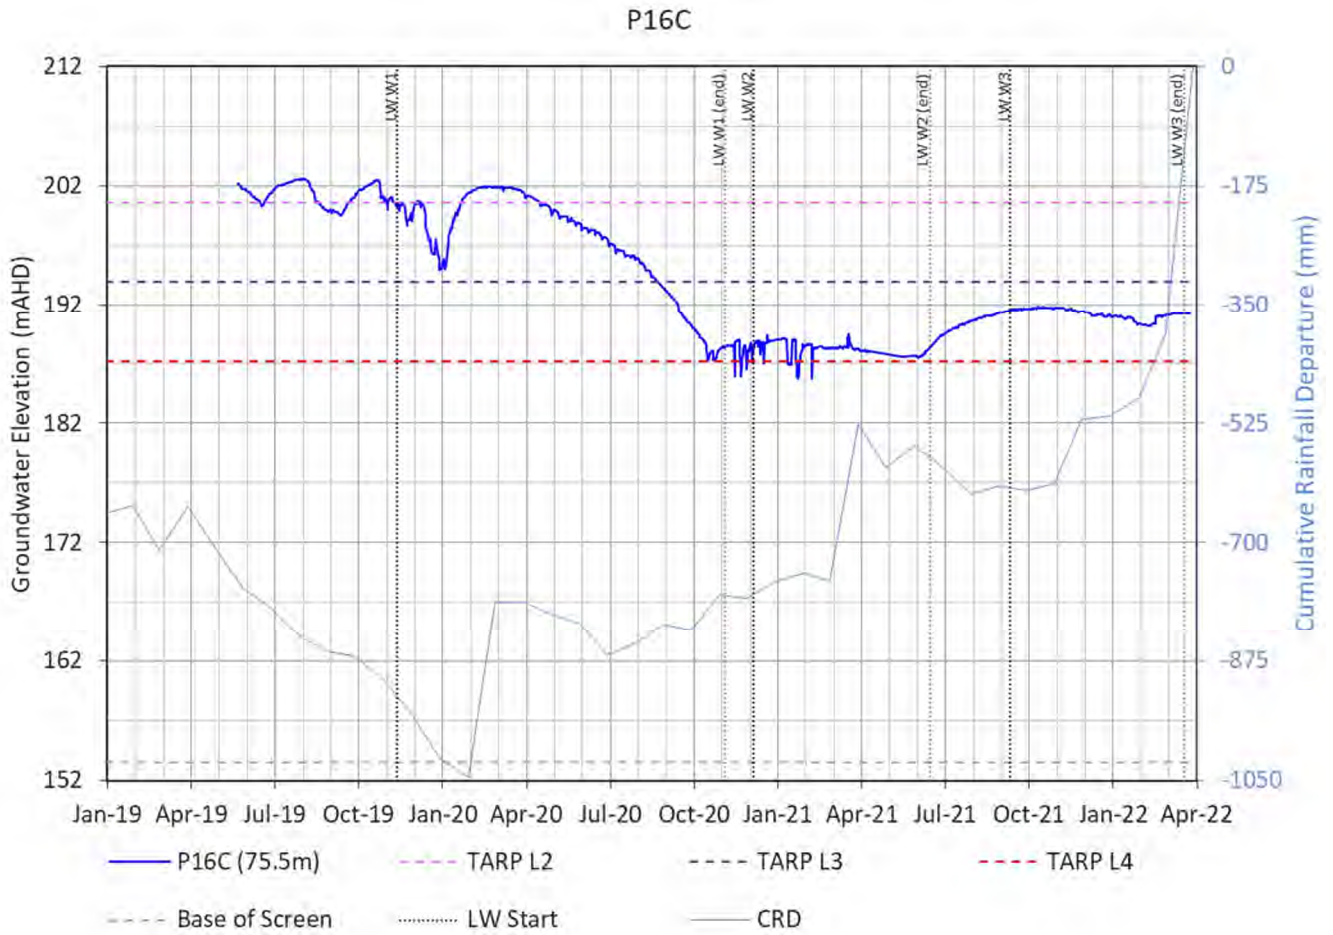
Figure 15 Groundwater Level Exceedance at P16C

During the reporting period, recovery in groundwater at P16C has reduced with water levels at 191.7 mAHD and 7.6 m below baseline levels (Table 6 and Figure 15).

Groundwater levels at P16C gradually declined by approximately 0.4 m throughout the reporting period to 190.2 mAHD and are observed at 191.3 mAHD in March 2022. As of March 2022, groundwater levels remain below the trigger TARP Level 3 (193.9 mAHD), hence a TARP Level 3 still applies (Figure 15).

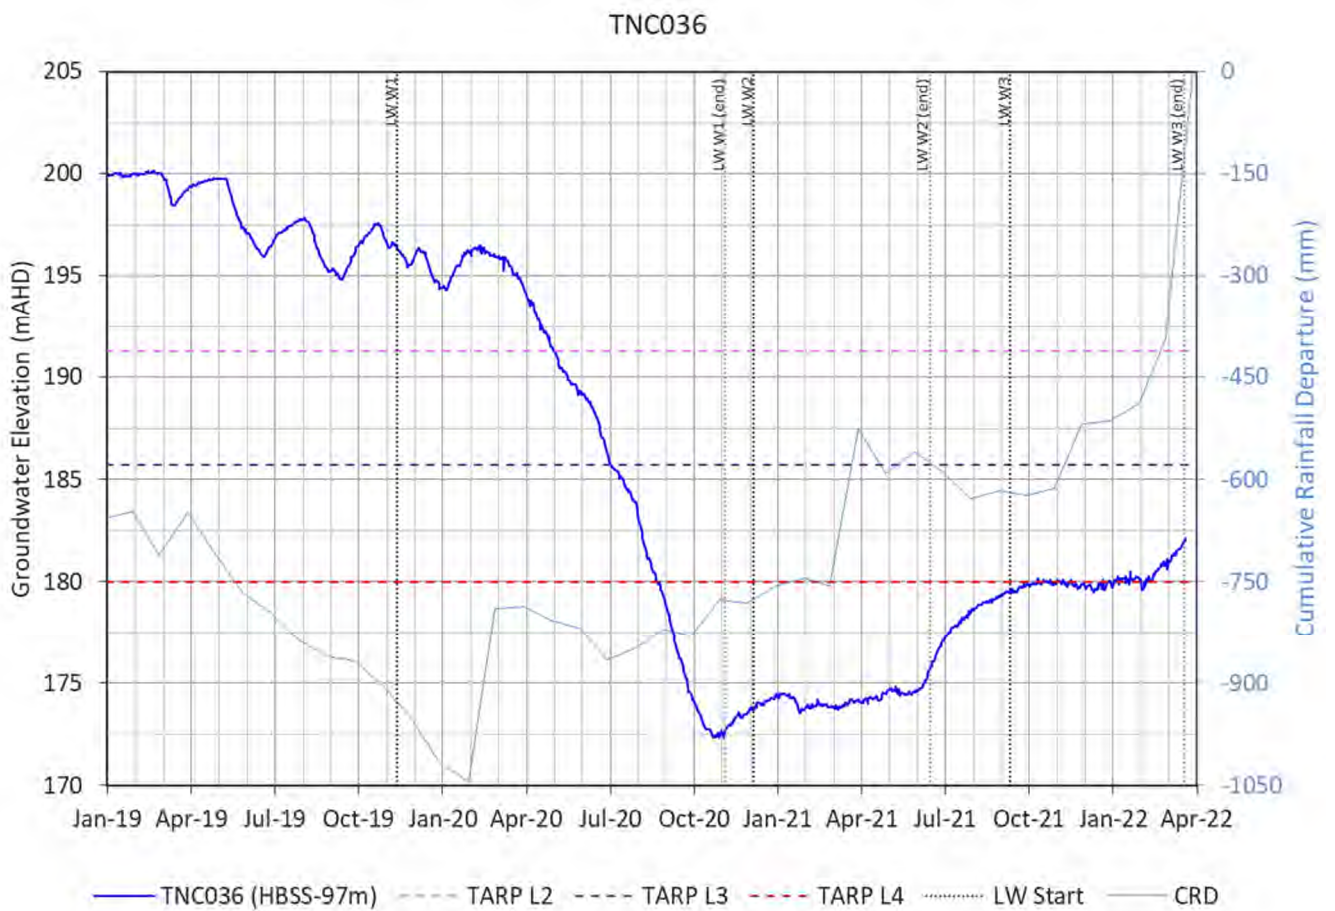
Figure 16 Groundwater Level Exceedance at TNC036-HBSS-97m

At TNC036, the progression of mining at LW W2 induced a minor drawdown in HBSS-65m and HBSS-169m while water levels at HBSS-97m are stable. Between December 2020 and June 2021, water levels in HBSS-65m recorded a reduction greater than 5m due to the passage of both LW W1 and LW W2, being within the Level 4 TARP criteria. Groundwater levels started to recover in June 2021 and by the end of July 2021, water levels in HBSS-65m increased above the TARP level 2 (i.e. 4.2 m below baseline level) and since August 2021 a TARP Level 1 applies (Table 6).

At HBSS-97m groundwater levels are observed between 180.7 and 179.6 mAHD between November 2021 and February 2022. Over this period groundwater levels seem to have stabilised with fluctuations up to 1 m. This follows a period of recovery since June 2021 (Figure 16). In February 2022, groundwater levels declined marginally below the trigger TARP Level 4 (180 mAHD) for short periods of time (five days in February 2022). As of March 2022, groundwater levels increased above the trigger TARP Level 4, hence a TARP Level 3 applies.

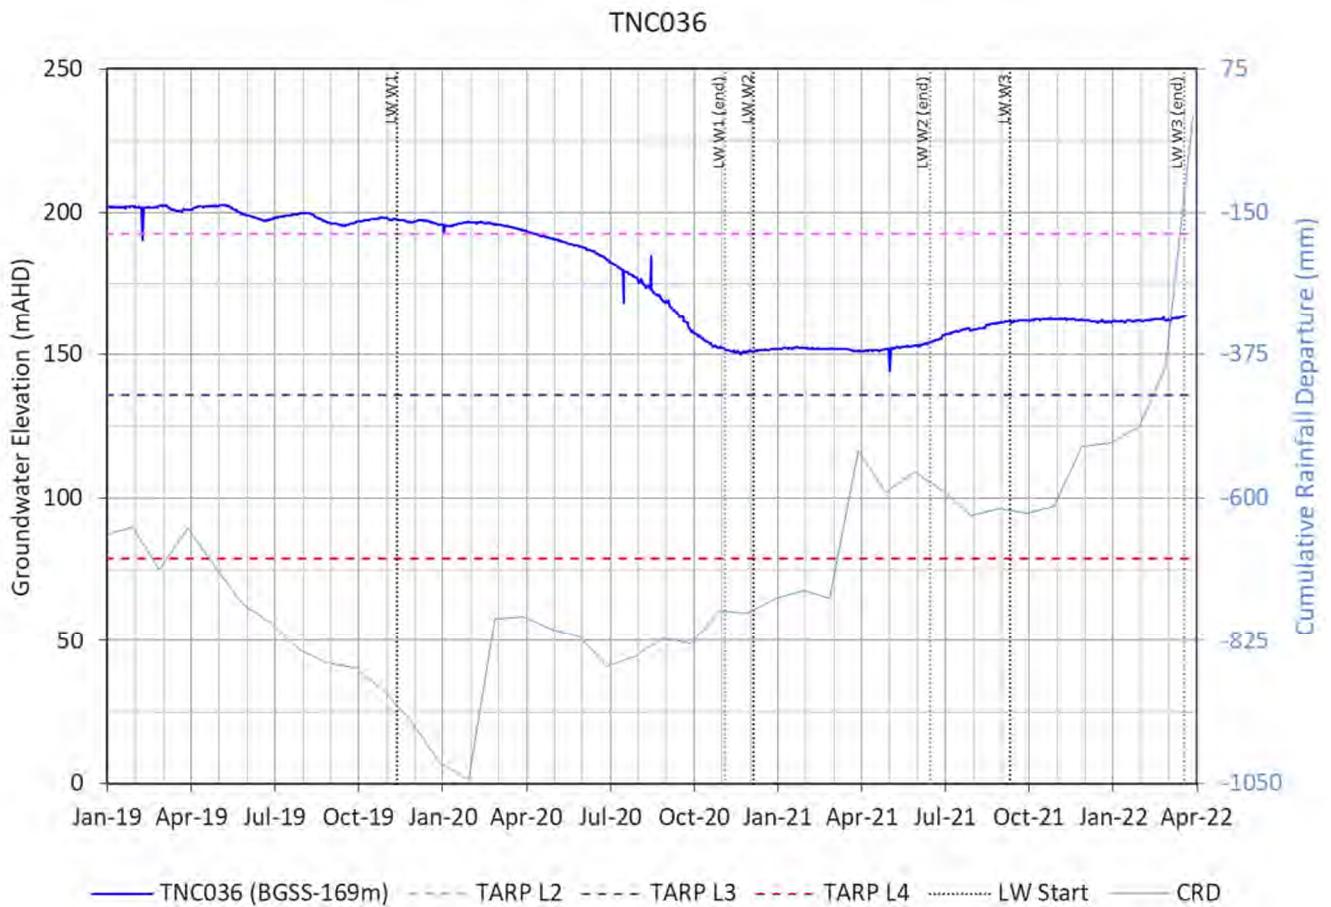
Figure 17 Groundwater Level Exceedance at TNC036-BGSS-169m

In HBSS-169m, the reduction to a TARP Level 2 occurred in September 2021 while groundwater levels continued to recover within the revised TARP Level 2. Groundwater levels are observed between 161.5 and 163.5 mAHD and increase by approximately 2 m during the reporting period (Figure 17). The groundwater trend at TNC36-169m in March 2022 remains consistent with the observations made in the six-monthly review (SLR, 2021a) and previous monthly reporting (SLR, 2022b). As of March 2022, groundwater levels remain below the trigger for TARP Level 2 (192.5 mAHD), hence a TARP Level 2 still applies.

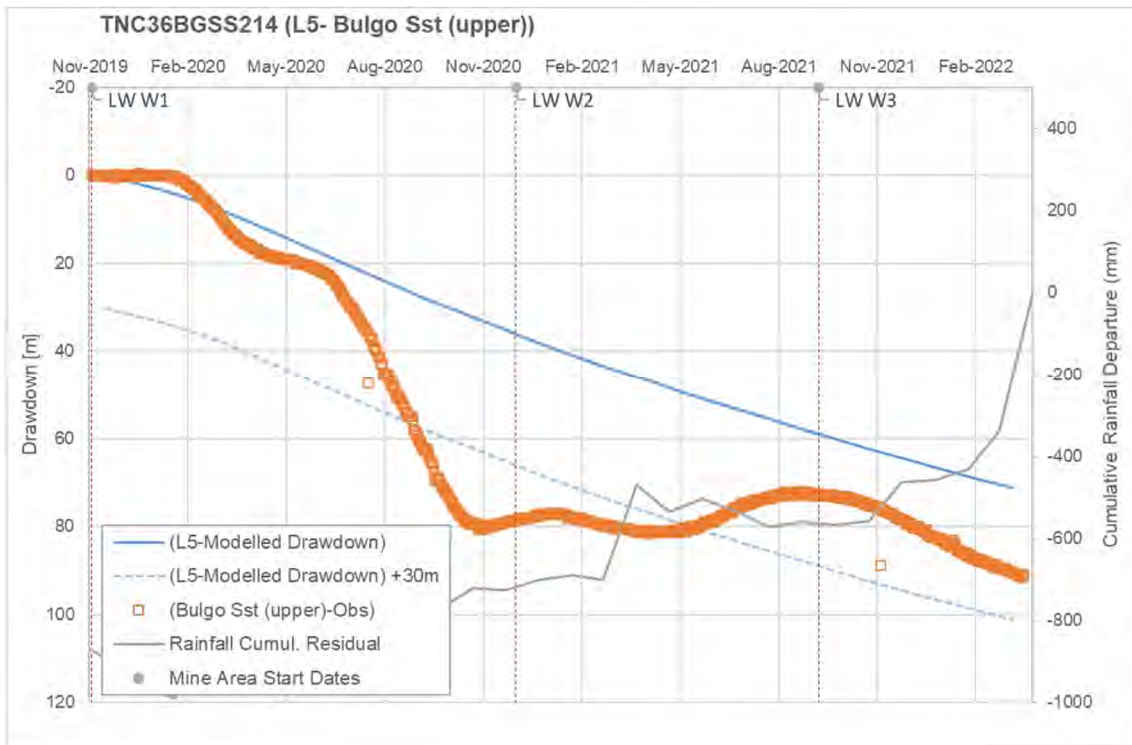
Figure 18 Comparison of Modelled and Observed Drawdown at TNC036 (BGSS-214m) with the +30m Threshold Modelled Drawdown

Figure 18 shows that the observed drawdown at TNC036-BGSS-214m exceeds the modelled drawdown from March 2020 and the 30 m predicted drawdown between September 2020 and April 2021. Since May 2021, a TARP Level 2 applies with observed water levels within the predicted drawdown (+30m) (Table 5).

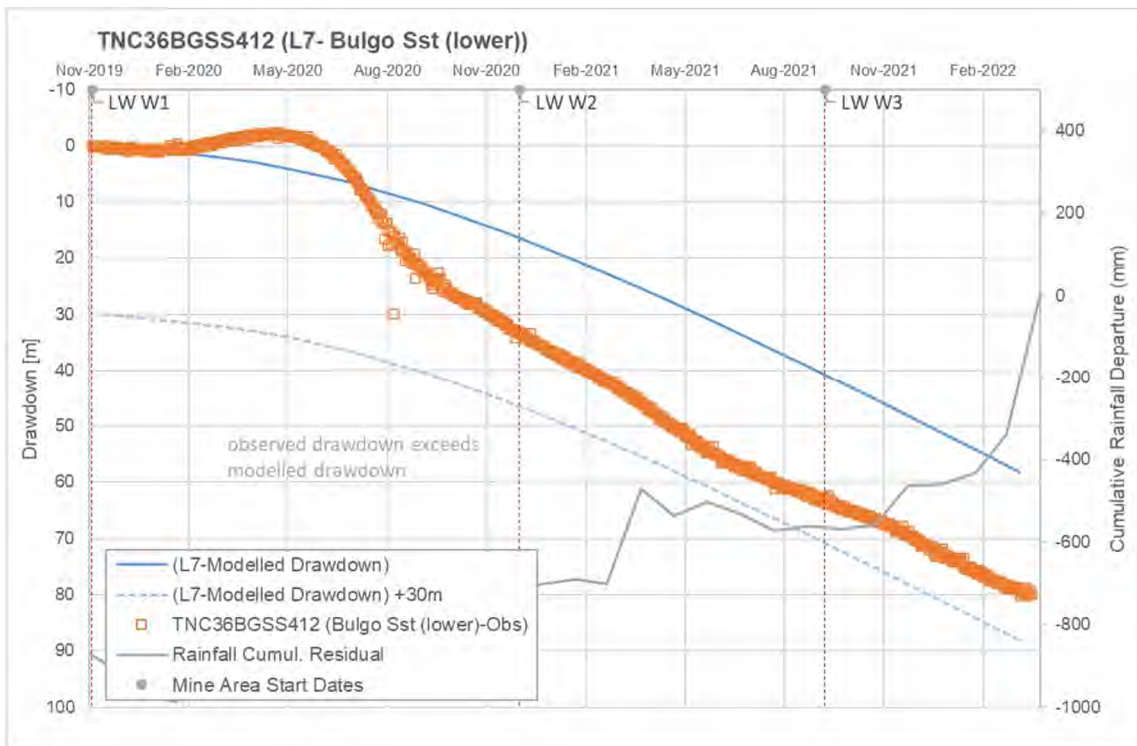
Figure 19 Comparison of Modelled and Observed Drawdown at TNC036 (BGSS-412.5m) with the +30m Threshold Modelled Drawdown

Figure 19 shows that the observed drawdown at TNC036-BGSS-412.5m exceeds the modelled drawdown from August 2020 but remains within the predicted drawdown (+30m) as of March 2022. A Level 2 TARP criteria applies at TNC036-BGSS-412.5m over the reporting period (Table 5).

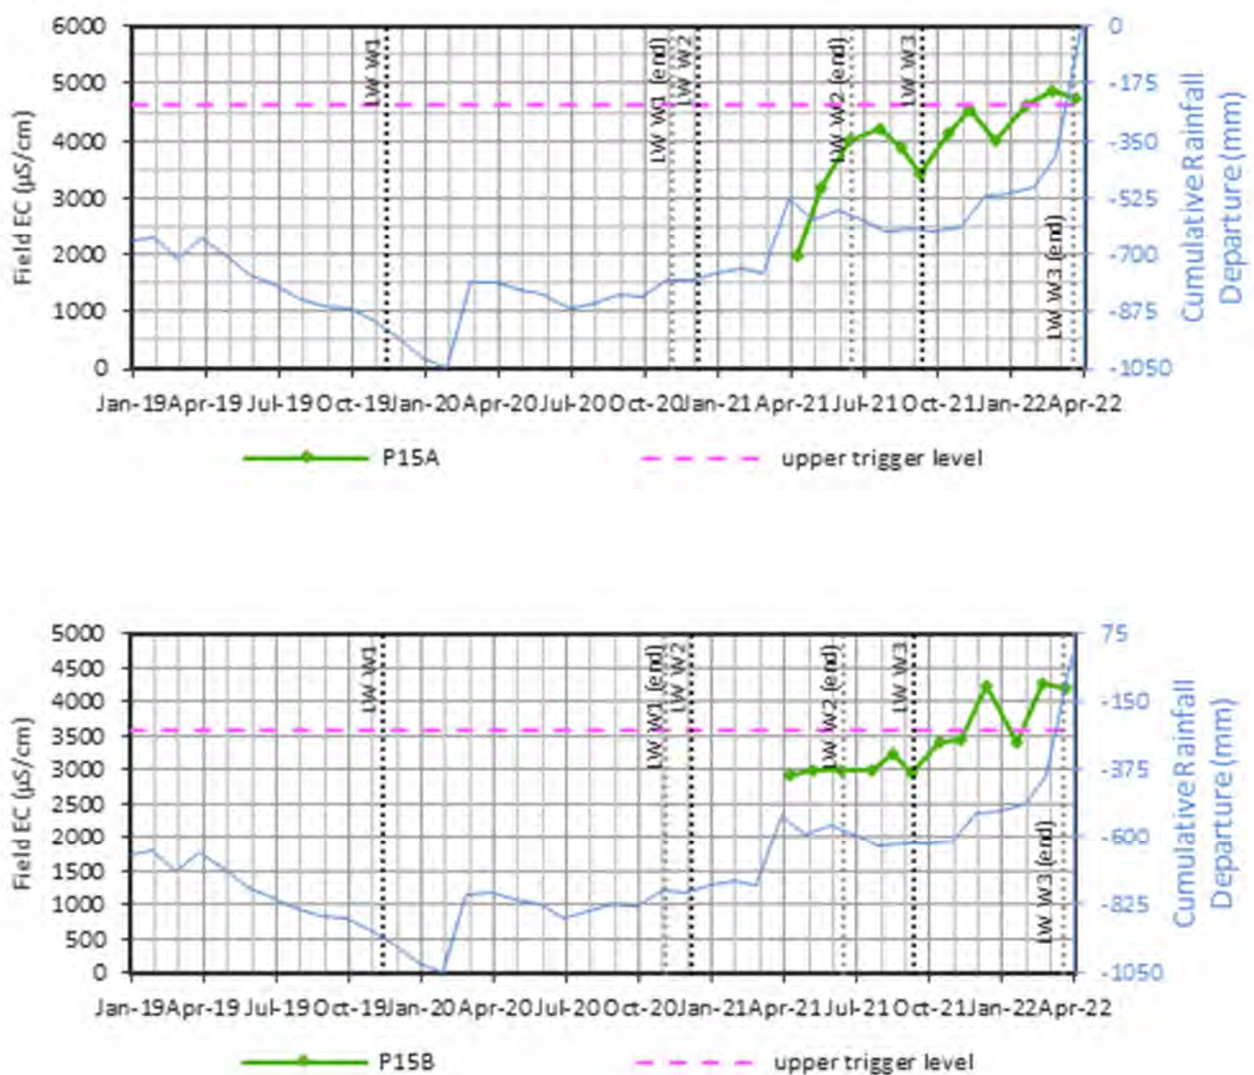
Figure 20 EC Exceedances at P15A and P15B

EC in P15A shows fluctuating behaviour since monitoring started in April 2021. The salinity at P15A has been increasing from 4,010 in December 2021 to 4,860 $\mu\text{S}/\text{cm}$ in February 2022 before reducing to 4,760 $\mu\text{S}/\text{cm}$ in March 2022. Since February 2022, EC has been marginally above the TARP Level 2 of 4,620 $\mu\text{S}/\text{cm}$ (Figure 20).

EC in P15B also shows fluctuating behaviour. At P15B, EC triggered a TARP Level 2 of 3,575 $\mu\text{S}/\text{cm}$ in December 2021 before returning within TARP Level 1 in January 2022. In February 2022, EC increased to 4270 $\mu\text{S}/\text{cm}$ and reduced slightly to 4,210 $\mu\text{S}/\text{cm}$ in March 2022 triggering the TARP Level 2 since February 2022 (Figure 20).

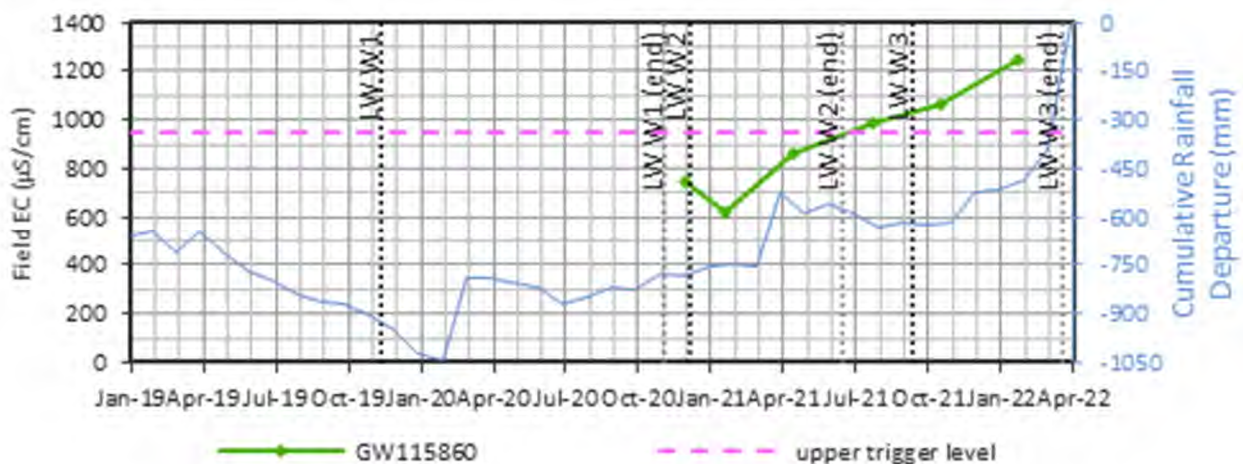
Figure 21 EC Exceedances at GW115860

The salinity at GW115860 has been steadily increasing from 621 $\mu\text{S}/\text{cm}$ in January 2021 to 1,246 $\mu\text{S}/\text{cm}$ in March 2022. Final EC in January 2022 at this bore exceeds the trigger level of 948.2 $\mu\text{S}/\text{cm}$ for three consecutive recordings (greater than 6 months), resulting in a potential TARP Level 4 (Figure 21). Private bore GW115860 is used for domestic purposes. SLR (2022a) investigated the trigger exceedances at GW115860 for EC. The following summarises the findings presented in SLR (2022a):

- The reason for the increased EC at GW115860 is unclear, although it is consistent with the trend observed at nearby bore GW105228. Therefore, this trigger is only 'potential' Level 4 TARP trigger, and it has not been confirmed that the cause is mining.

- No drawdown was observed during the extraction of LW LW3 at GW115860, and hence drawdown does seem to be the cause of the change in EC;
- The increase in EC at GW115860 (to 1,246 $\mu\text{S}/\text{cm}$) does not change the beneficial use classification of the groundwater extracted at this site, and therefore the currently observed effects are considered to be immaterial. Indeed, salinity (TDS) at GW115860 remains within the desirable palatability of less than 600 mg/L (class A1 category – DPIE, 2012). Groundwater quality at GW115860 remains suitable for all beneficial uses, including the current purpose.

- Given the low salinity of groundwater at GW115860, and the small incremental change in that salinity in relation to the beneficial use classifications it is recommended to continue observing this bore over the next monitoring period (April 2022) to see if EC decreases, otherwise to revise the trigger. The most reliable method to revise the trigger would be to adopt the EC trigger from GW105228 for use at GW115860 as it has been derived from a longer record period.
