Tahmoor Coal Pty Ltd

SIX MONTHLY SUBSIDENCE IMPACT REPORT

Western Domain Longwalls West 1 – West 4

Report 7 – March 2023

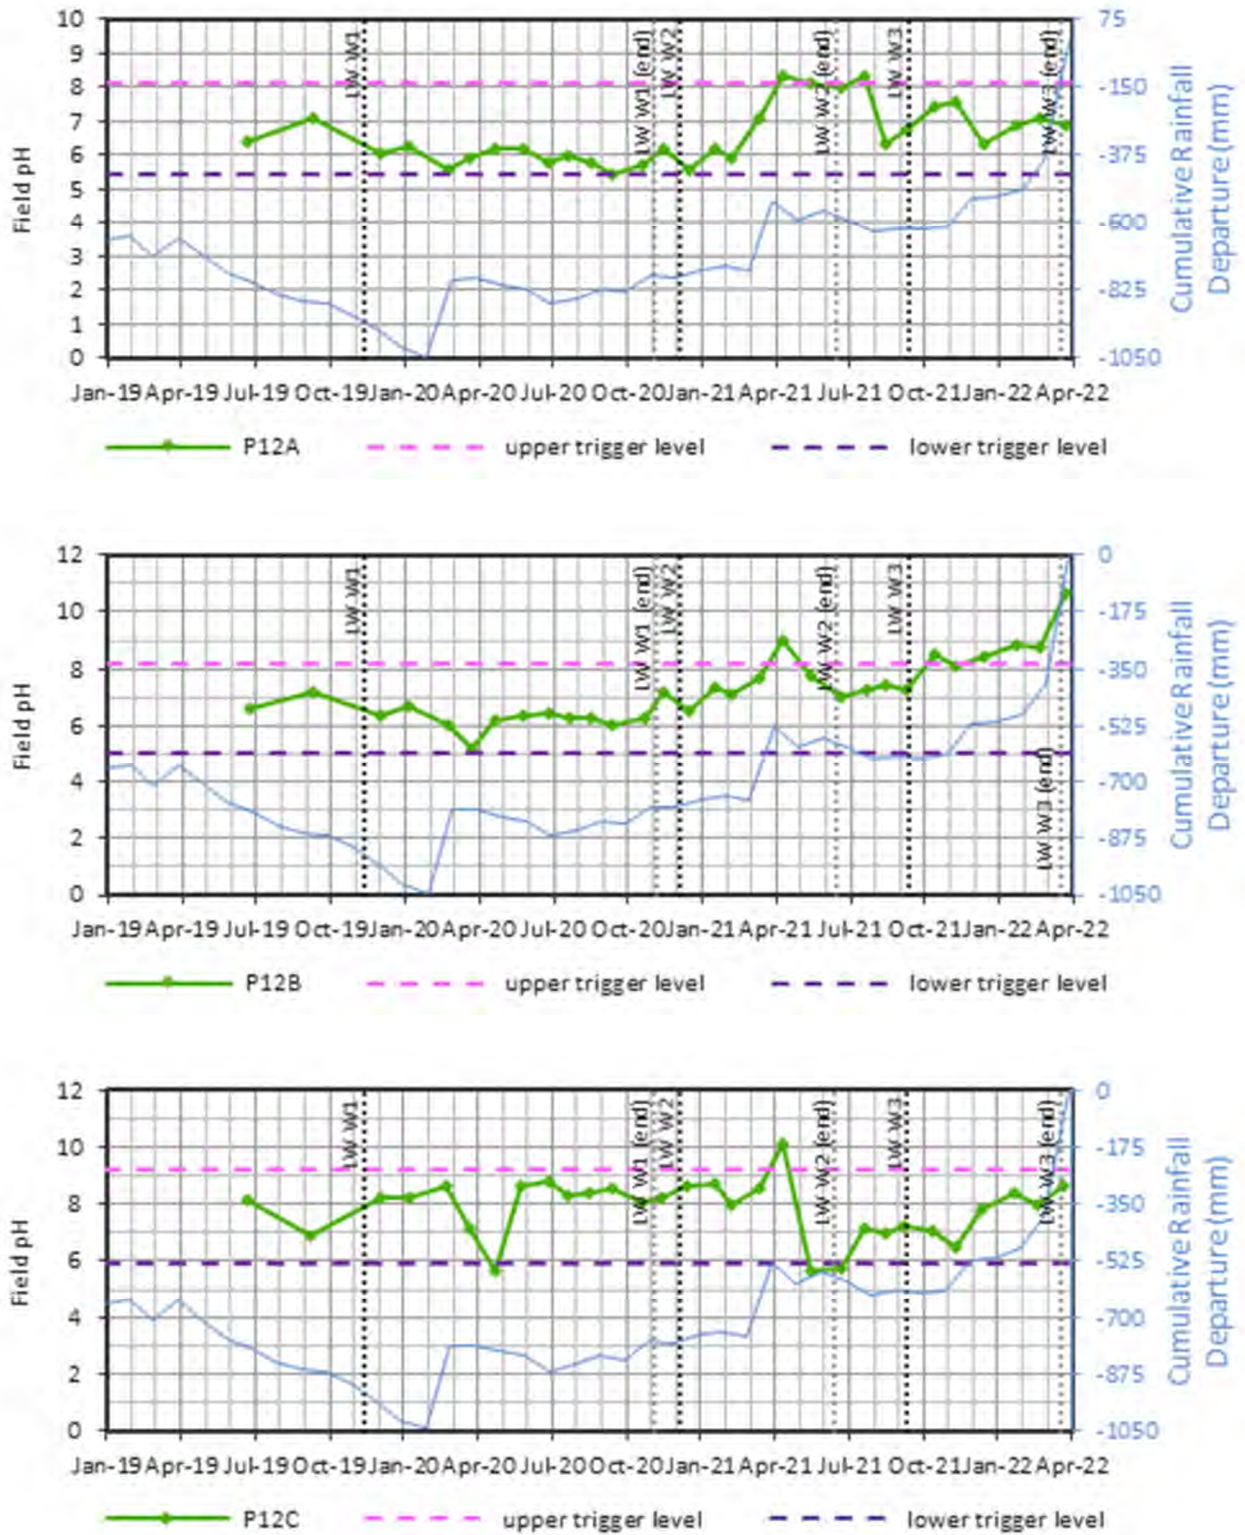
Figure 22 pH at P12A and P12C and pH Exceedances at P12B

P12B triggered the upper trigger level for pH between December 2021 and March 2022 with a pH of 10.65 in March 2022 (trigger level = 8.16) (Figure 22). A potential TARP Level 4 was identified in March 2022 as four consecutive recordings (greater than three months) were recorded during a period of above average rainfalls.

- A rising trend in pH was previously observed at P12A, P12B and P12C around December 2020 to April 2021. It has been previously reported by SLR (2021a), that this could be due to compromised integrity of the monitoring bores combined with high rainfall causing cement to become mobilised into the groundwater.

At this time, a mining-related effect is plausible, however the consequences of this effect (if it is mining-related) are considered minor.

In addition, in March 2022, pH at nearby bores P12A and P12C is within a TARP Level 1 at 6.9 and 8.61 respectively, both relatively neutral, and well below the pH seen at P12B (Figure 22). It is recommended that pH at P12B remains a potential TARP Level 4.

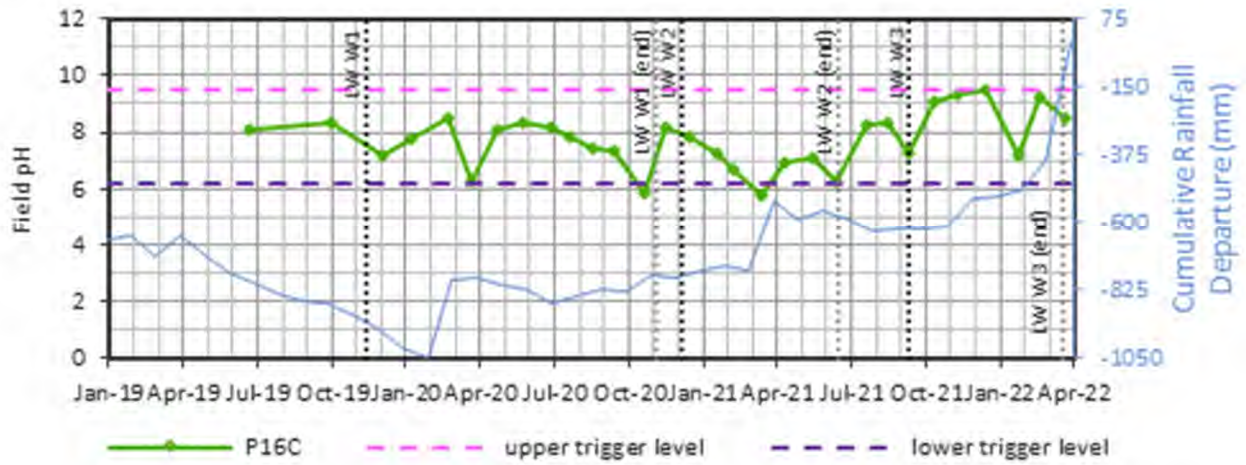
Figure 23 pH Exceedances at P16C

pH at P16C exceeded the TARP Level 2 trigger of 9.49 in December 2021. pH increased from 9.36 to 9.5 in December 2021. Between January 2022 and March 2022, pH at P16C shows a fluctuating behaviour ranging from 7.15 to 9.22. As of March 2022, pH at P16C is within a TARP Level 1.

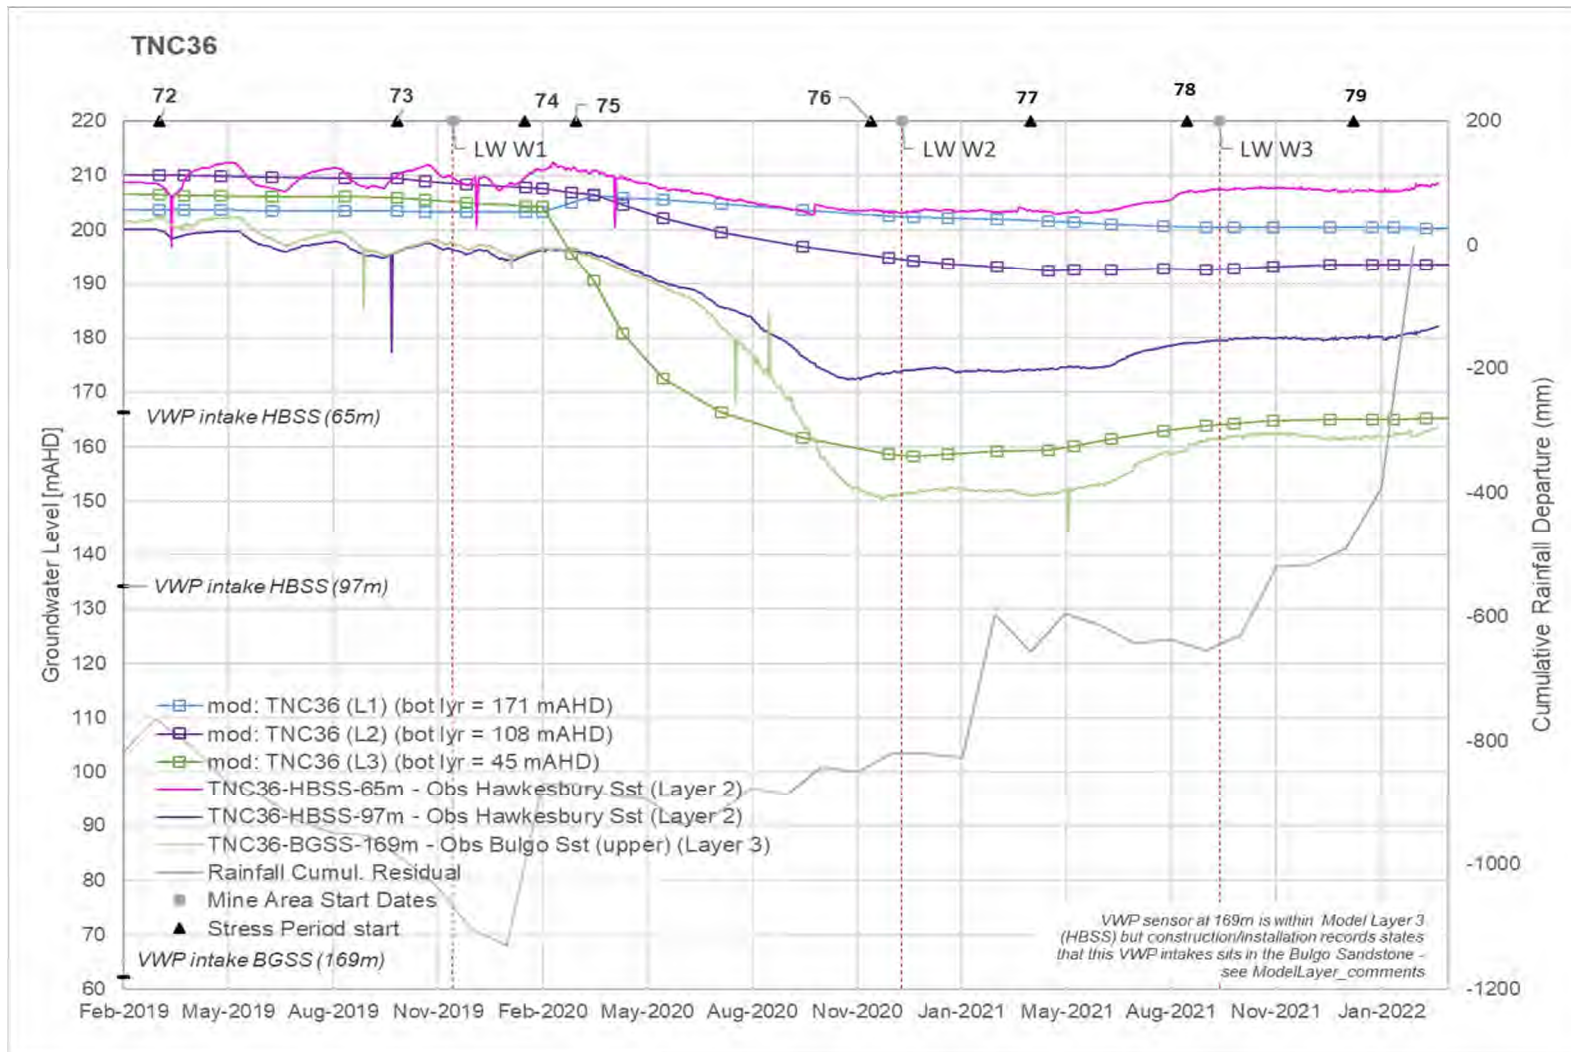
Figure 29 Comparison of Modelled and Observed Groundwater Levels at TNC036

At TNC036 (Figure 29) the simulation of drawdown in model layer 2 is 16 m, which is higher than in the HBSS-65m piezometer (approximately 6 m drawdown), and less than the 24 m recorded against the HBSS-97 m piezometer. The HBSS-65m and HBSS-97 m piezometers are assigned the same model layer, but the model gives a reasonable estimate in the rate and magnitude of drawdown at this location. The model captures the stabilisation in observed water levels between May and June 2021 relatively well. There is a small underestimation in the model to replicate the observed recovery in June 2021 and later in February-March 2022 but modelled groundwater levels are within 10 m observed as of March 2021 (i.e. similar as modelled prior to LW W1).

- The observed stabilisation and recovery in water levels in BGSS-169 m are well replicated by the model, being within 1 m of observed as of March 2022. This suggests that the height and mode of subsidence fracturing in this area is well represented in the model. The issue with comparing the model to these observed drawdowns and recoveries is that the attribution of depths and stratigraphy is not completely reliable (Section 4.1.2.7).

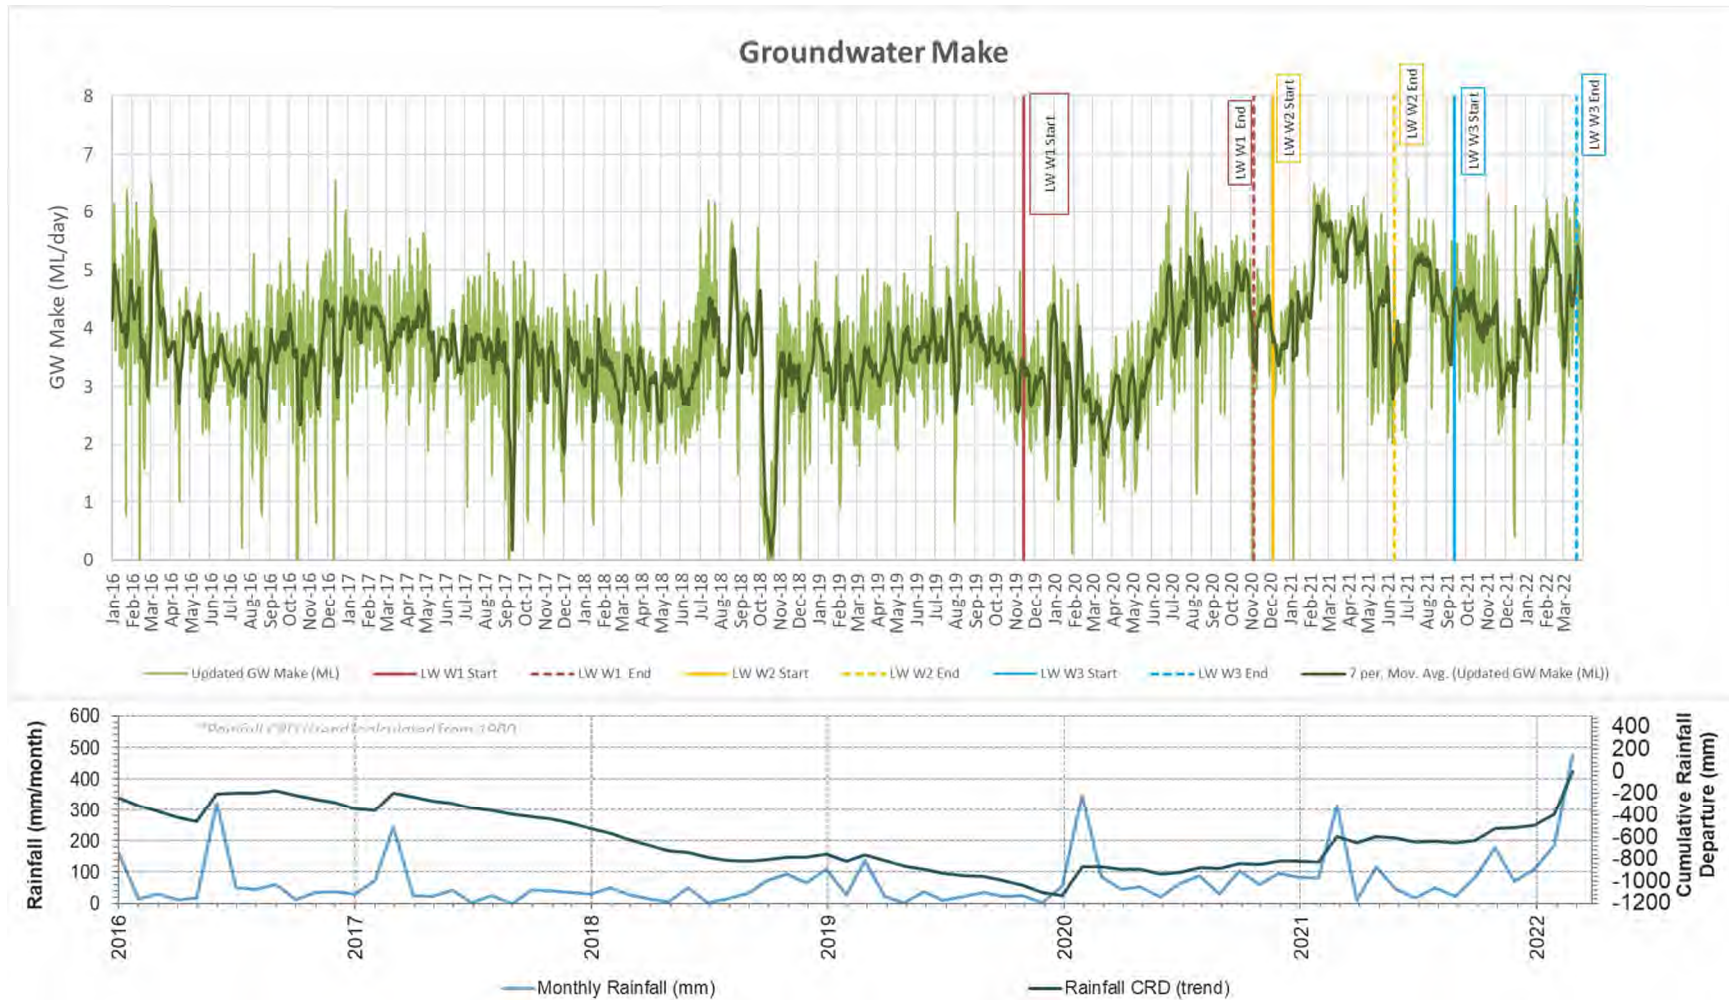
Figure 30 Historical Record of Inflows at Tahmoor North

For the period 2009 to March 2022 (latest reported record is on 31st March 2022), inflows to Tahmoor Mine have been within the range of 2 to 6 ML/d. Figure 30 shows net groundwater inflows against daily water pumped from the mine, alongside the historic rainfall (based on records dating back to 1900) and the Western Domain longwall start dates. Inflows to the mine remained relatively steady throughout the extraction of Longwalls 24B to 32 (SLR, 2021a).

A spike in inflows occurred following the cutting of Longwall 27, however, between this time and May 2020 inflow rates have declined (SLR, 2021a). The period between mid-2020 shows an increase in inflows to greater than 5 ML/day at the end of July 2020 likely due to the extraction of LW W1. Inflows declined in late 2020, before rising in February 2021 (early in LW W2), with the recent peak at marginally over 6 ML/d in March and April 2021 (Figure 30). Inflows to the Western Domain are not metered in isolation from other parts of Tahmoor North but were estimated to be greater than 2.5 ML/d in early 2021 (based on advice from Tahmoor Coal staff in early 2021).

Previously, SLR and their subconsultants have advised Tahmoor Coal staff regarding possible options in the event that inflow rates to the workings rise at a similar rate to that of the recent average inflows seen in March-April 2021. Since April 2021, inflow rates to the mine workings have remained below the previous observed peak of 6 ML/d, with a general reduction in the inflow rates. Groundwater entitlement was not exceeded for the 2021-22 water year and as of March 2022 remain just below the limit for the 2021-22 water year (based on a pro-rata calculation).

Tahmoor Coal is currently in the process of obtaining additional groundwater entitlement to meet the likely requirements of the remaining Western Domain and early Tahmoor South mining operations.

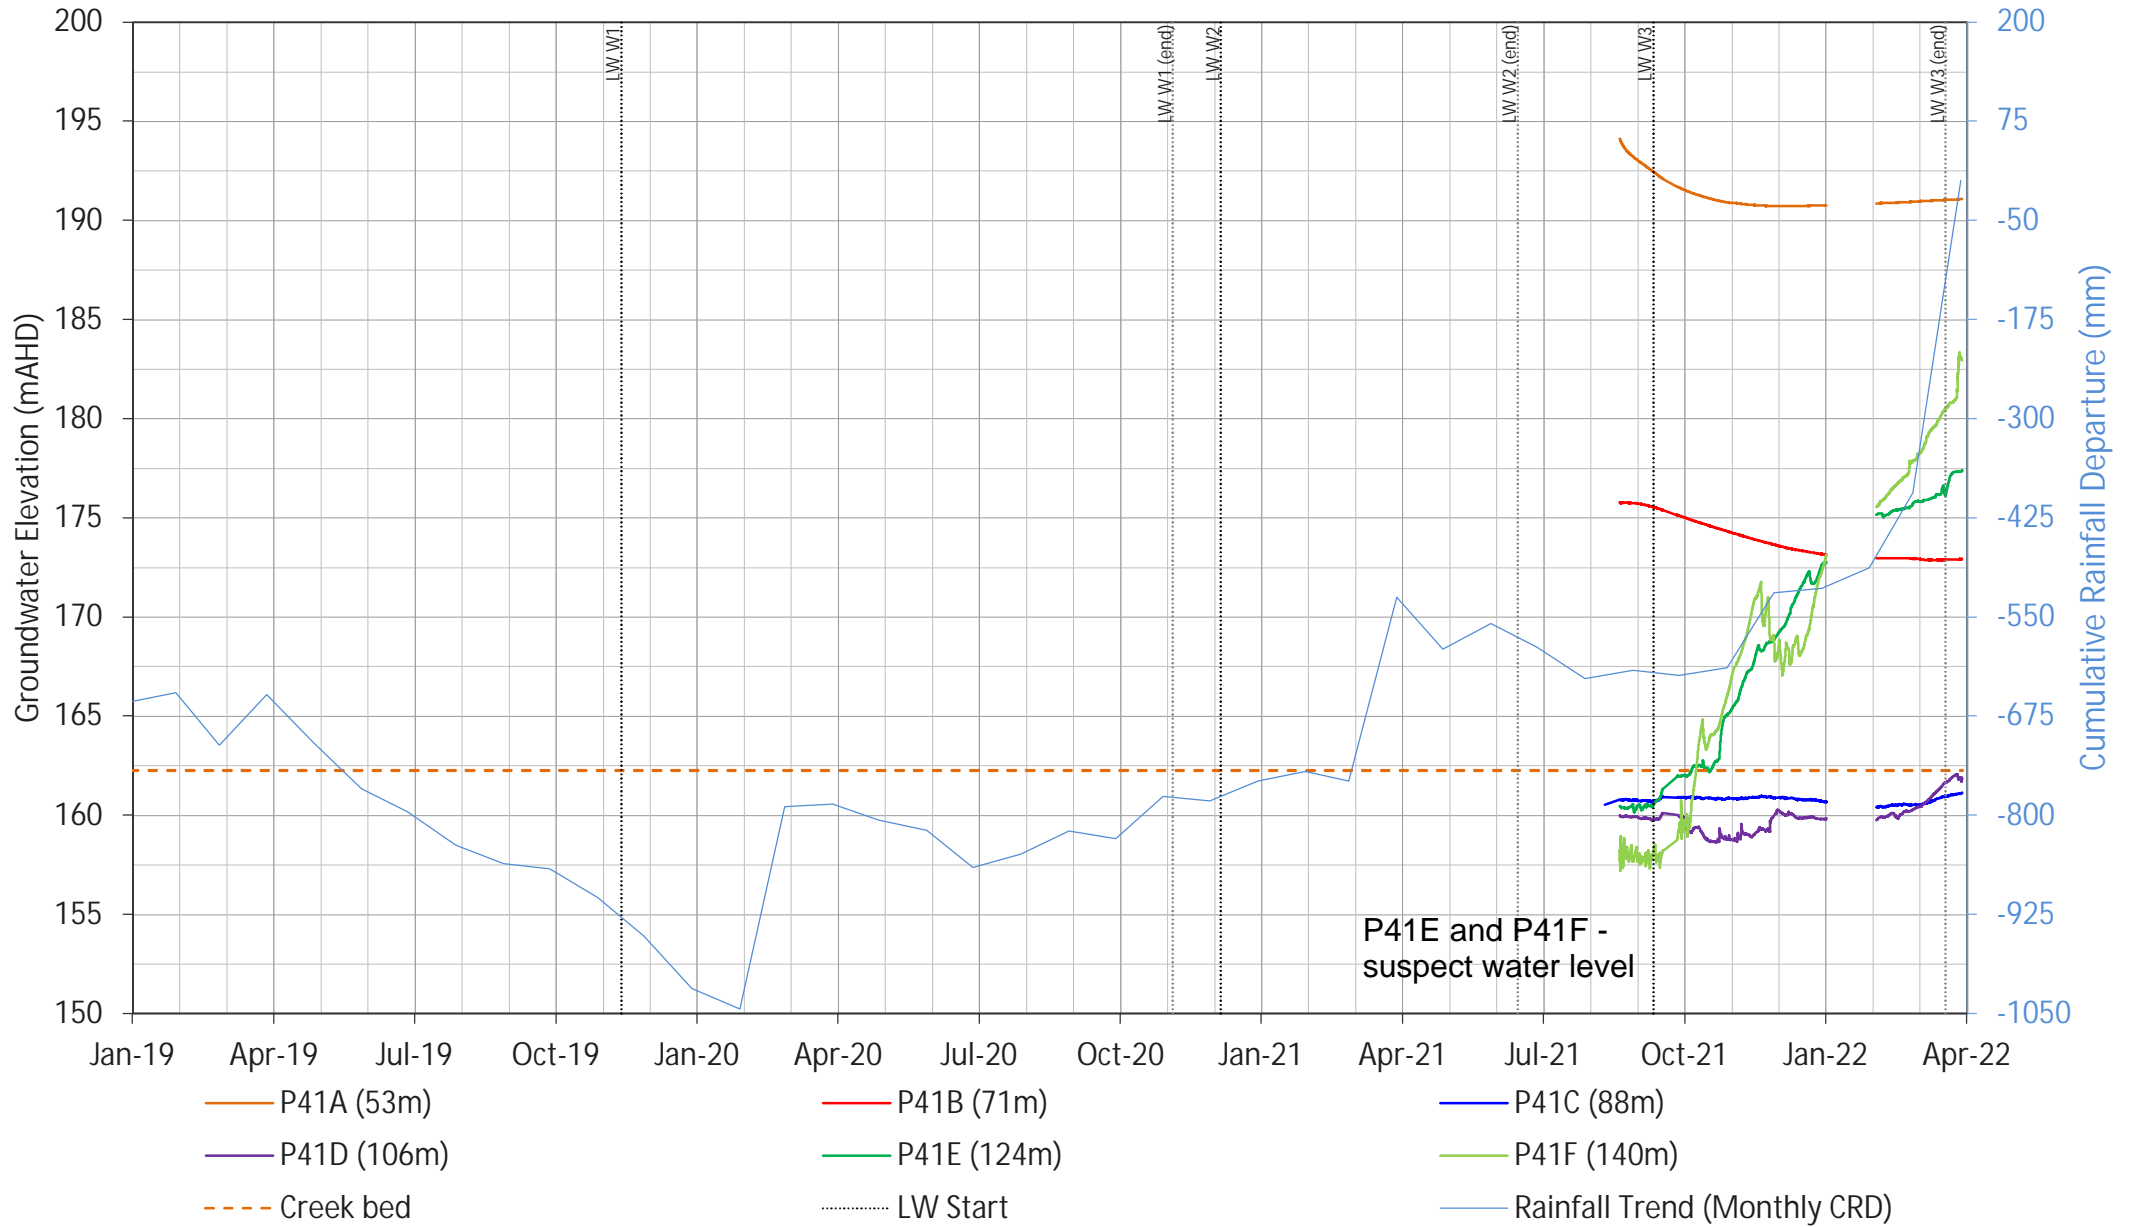
Figure A-6

no groundwater level data available in January 2022 due to downloading issues.

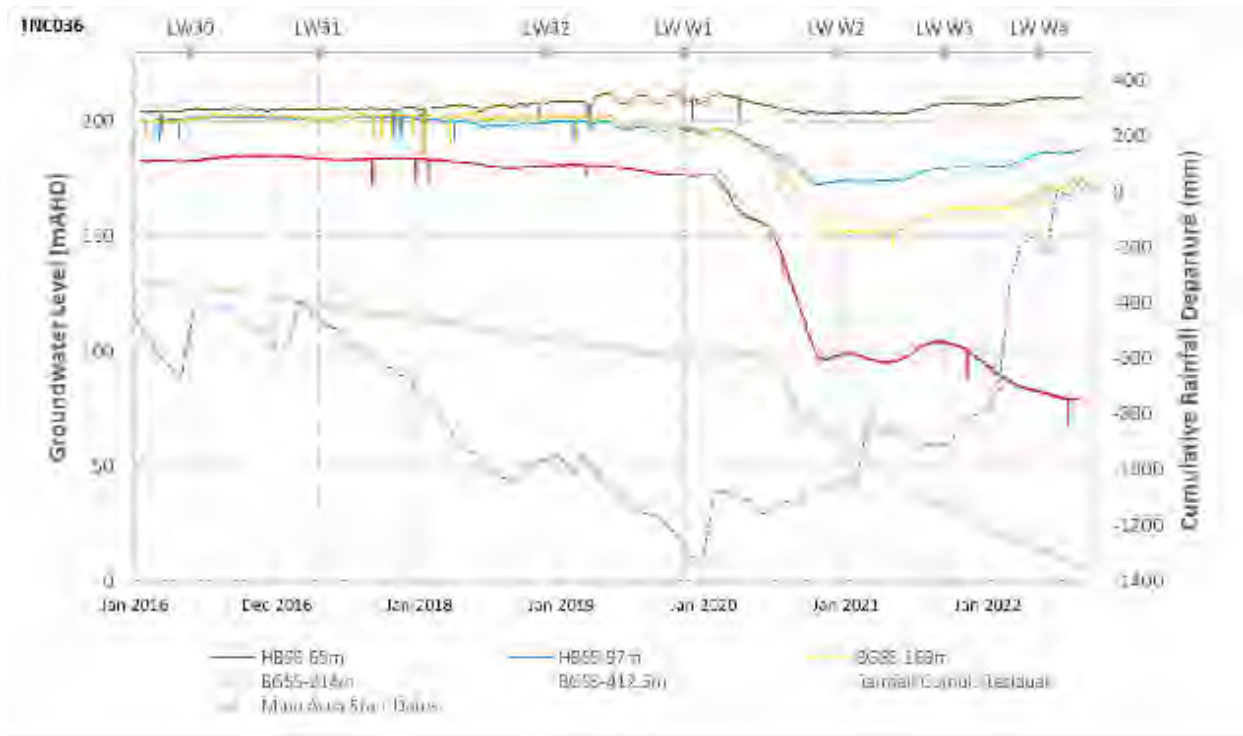
Figure 4 Hydrograph for TNC036

Groundwater levels in HBSS-65m, HBSS-97m and BGSS-169m continued to recover during the reporting period and increased by approximately 1.7 m, 5.3 m and 1 m respectively. Groundwater levels in the mid and lower Bulgo Sandstone BGSS-214m and BGSS-412m decreased by 6 m and 9m respectively during the reporting period. It is expected that the depressurisation in the Bulgo Sandstone to reduce over the next months (or years) and start to recover due to the completion of mining at the Western Domain (**Section 1.3**).

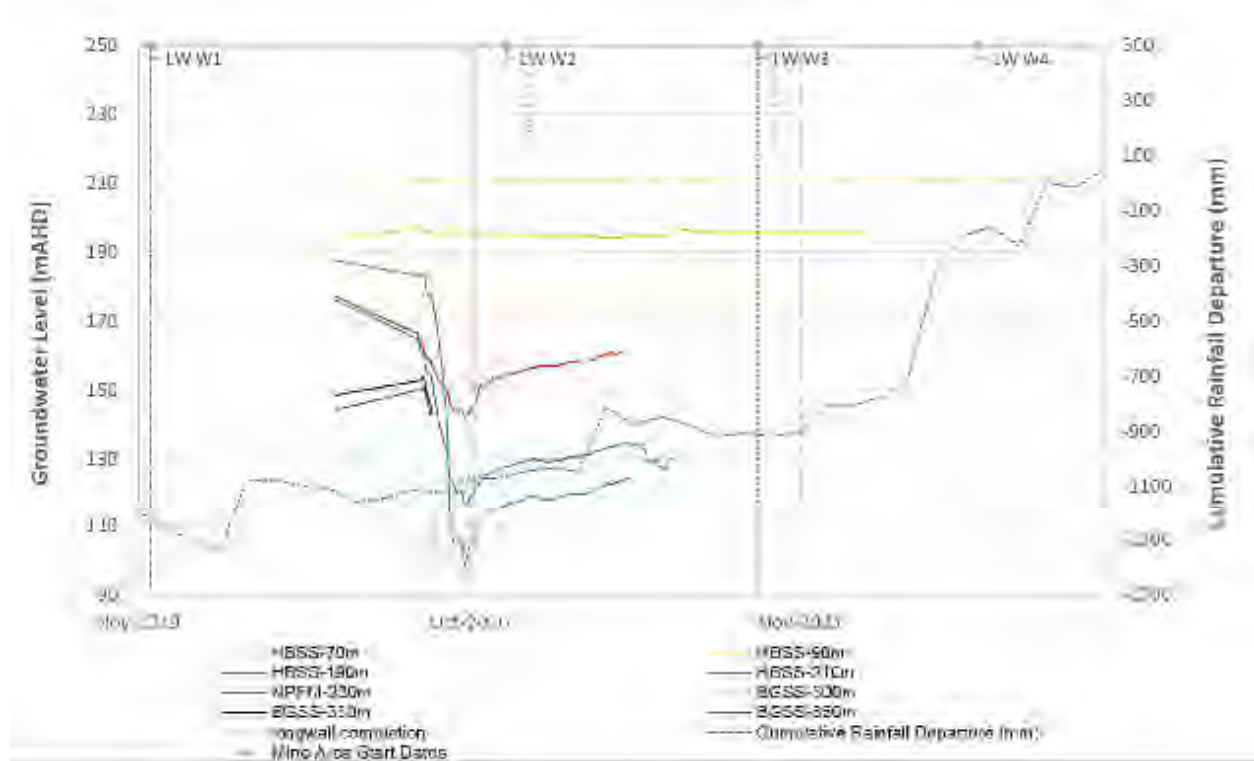
Figure 5 Groundwater Level Trends at WD01

Figure 5 presents a hydrograph of the pre-mining borehole (WD01) located above a chain pillar between the Western Domain LW W1 and W2. The bore is 570 m north of the closest Tahmoor North (not Western Domain) goaf (LW 32) and was completed while LW W1 was 400 m to the north (**Section 3**). WD01 is instrumented with VVPs at multiple depths and has been recording groundwater pressures/heads since June 2020. The latest available groundwater pressure dataset is dated 31st August 2022. The remaining sensor HBSS-70m continues to show stable groundwater levels at 211 mAHD with no signs of depressurization as of August 2022.

The deeper sensors are not recording pressures, likely due to ground movement at this site. This is not unexpected given the bore’s location above LW W1.

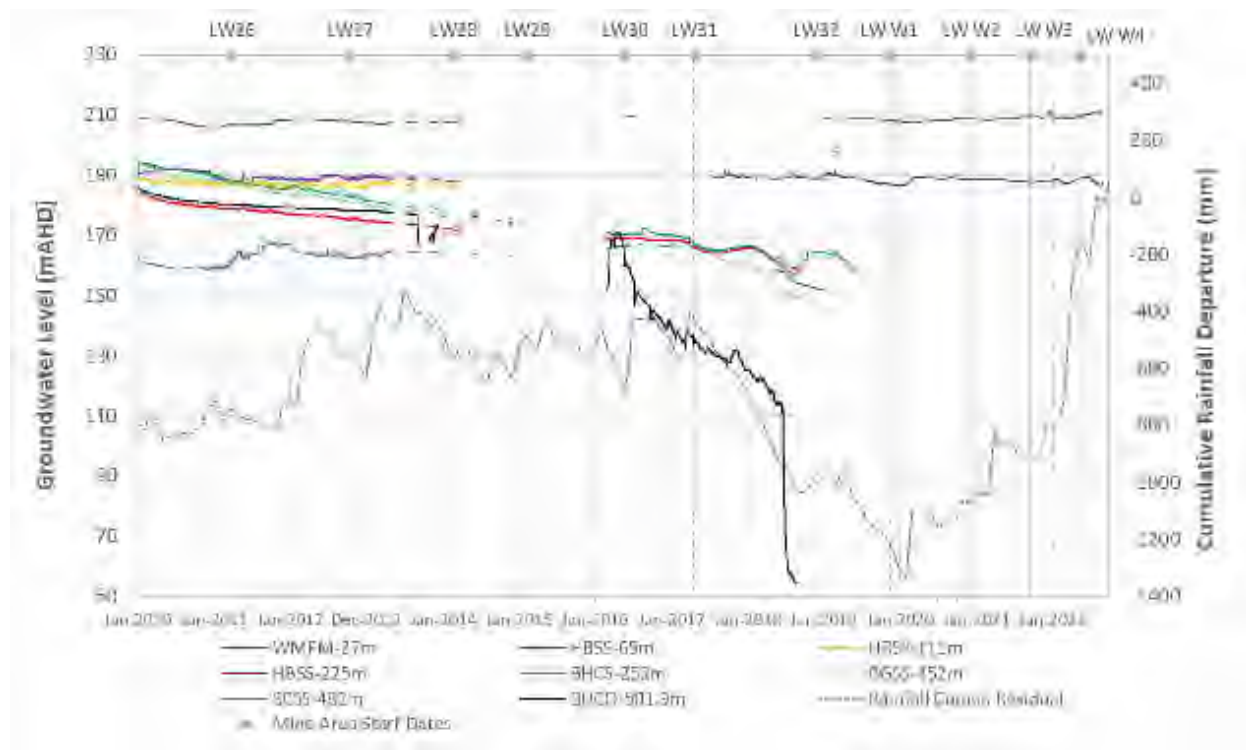
Figure 6 Groundwater Level Trends at TNC040

As of February 2019, the lower four VWP sensors were no longer active due to subsidence effects (GES, 2019). The decline in water level shown in late 2018 in the lowest sensor in the Bulli Coal seam (BUCCO-501.9m) is a result of a nearby road advancement that has caused depressurisation of this seam.

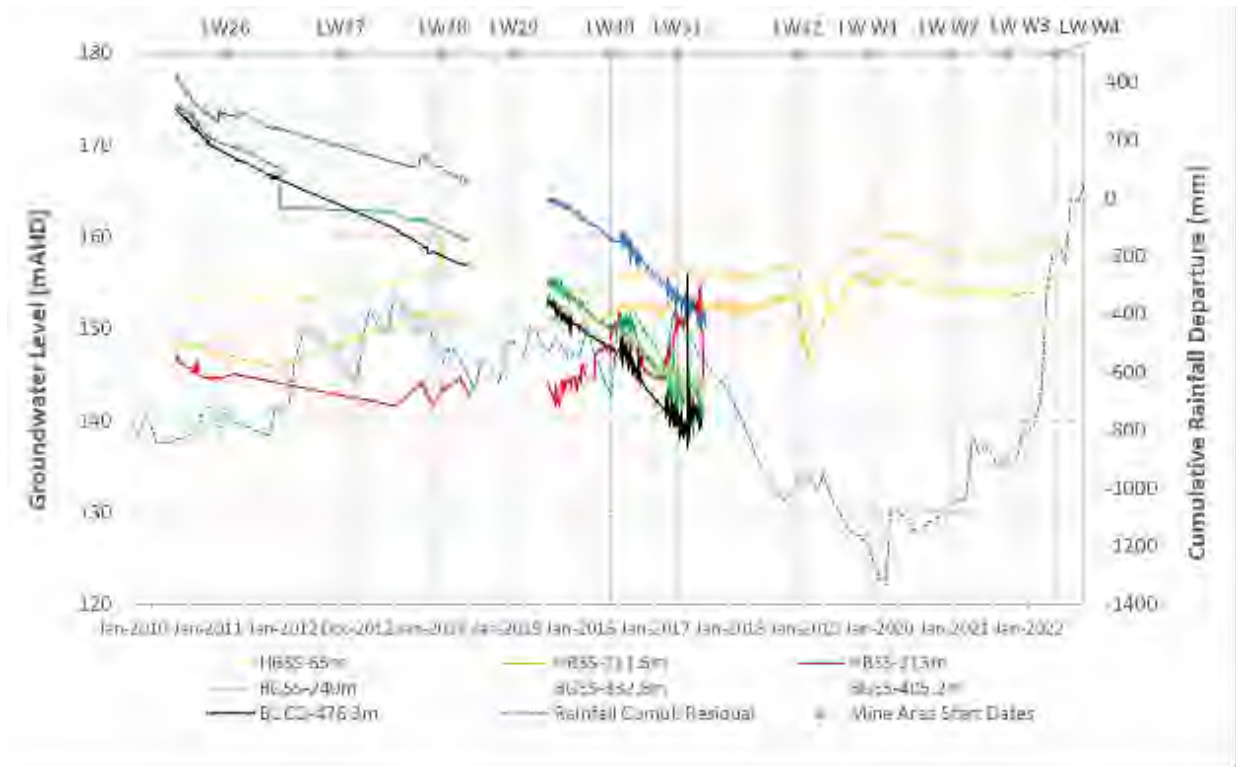
Figure 7 Groundwater Level Hydrographs at TNC043

Until October 2019, the HBSS-65m and HBSS-111.5m piezometers were the only active instruments at this bore, with the remainder failing in 2018 due to subsidence from nearby LW32. The two upper sensors HBSS-65m and HBSS-111.5m at TNC043 remained active until September 2020 before being stolen at the end of 2020 (**Table 4**). Despite the loss of the loggers, manual readings are taken for the upper two sensors approximately monthly.

As of June 2022 (i.e. latest available records) the water levels at HBSS-65m and HBSS-111.5m present similar trends to one another and both have responded to rainfall during the reporting period (**Figure 7**). No mining effect is discernible due to the early part of LW W4 extraction in May and June 2022 in the HBSS-65m and HBSS-111.5m. Groundwater levels in HBSS-65m and HBSS-111.5m were observed at 158.7 mAHD and 154.7 mAHD, respectively 2.1 m and 1.3 m above water levels observed during the baseline period (i.e. prior to LW 32).

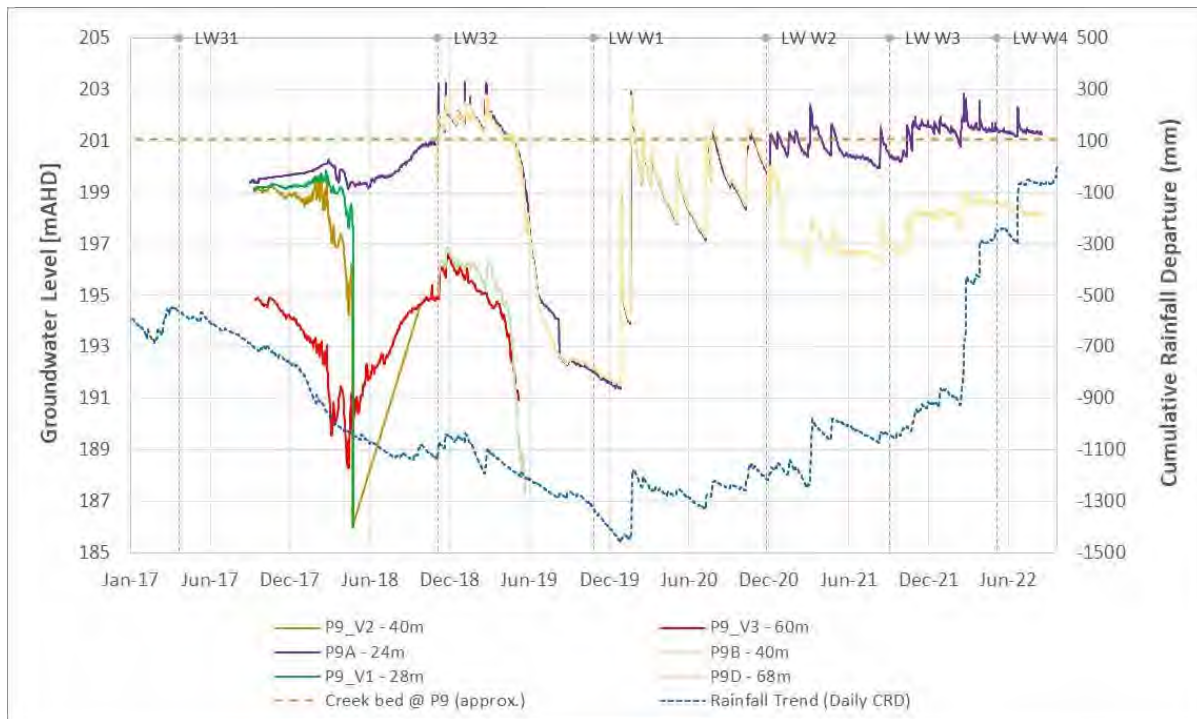
Figure 8 Groundwater Level Hydrographs at P9

Groundwater levels in P9A-24m and P9B-40m show similar trends during the review period, both responding to rainfalls in the range of 1 m in early July 2022 and are stable for the remaining of the monitored period (i.e. latest available data is 26th August 2022). Water levels at P9A-24m were observed above the creek bed elevation during the reporting period which suggests strengthening of gaining conditions along Redbank Creek in the vicinity of P9. No recent mining effect is discernible in the P9A-24m and P9B-40m piezometers.

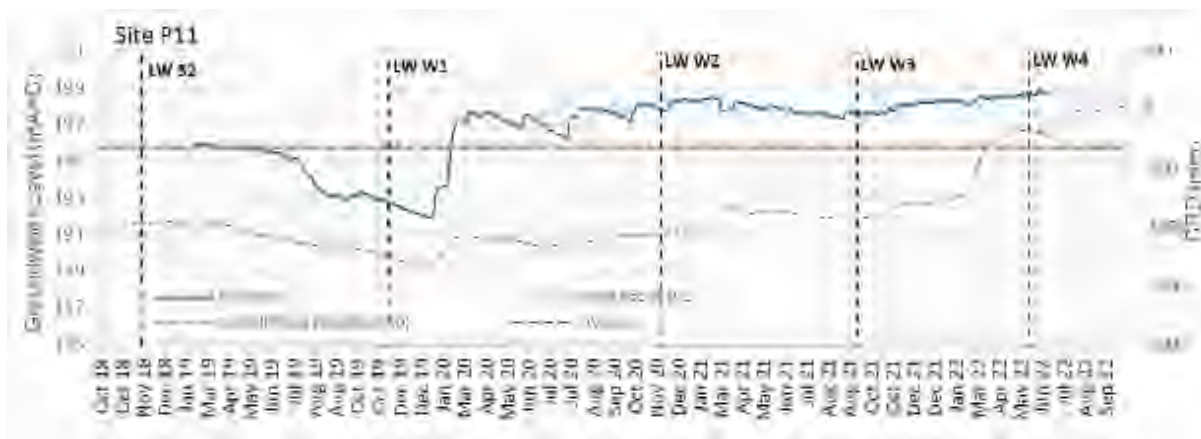
Figure 9 Groundwater Level Hydrograph at P11

As of June 2022, water levels at P11 are around 3 m above the first recorded level in February 2019 (prior to LW 32 passing this site). No discernible effects on water levels due to LW W3 and early parts of LW W4 are identified during the reporting period. Additional groundwater data at P11 will be available and reviewed in November 2022.

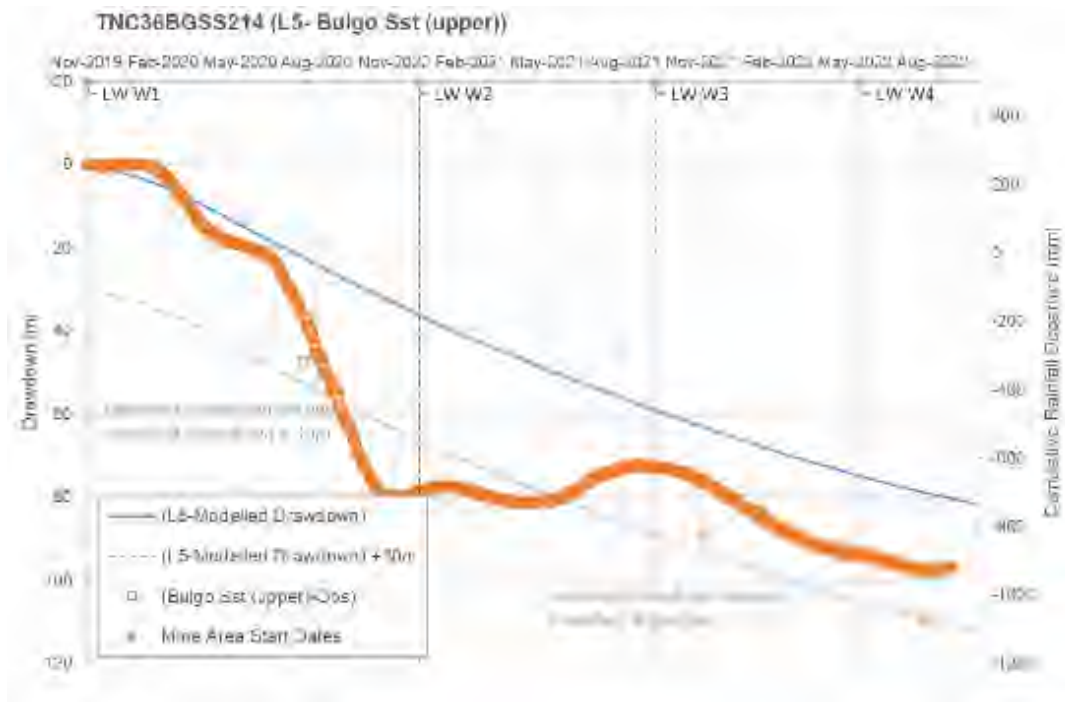
Figure 10 Comparison of Modelled and Observed Drawdown at TNC036 (BGSS-214m) with the +30m Threshold Modelled Drawdown

The groundwater level observed at TNC036-BGSS-214m and TNC036-BGSS-412.5m exceeds the modelled drawdown from mid-2020 but remains within the 30 m predicted drawdown as of August 2022 (**Figure 10** and **Figure 11**). A Level 2 TARP criteria (exceeds modelled drawdown but less than 30 m exceedance) still applies at TNC036-BGSS-214m and TNC036-BGSS-412.5m over the reporting period (**Table 8**).

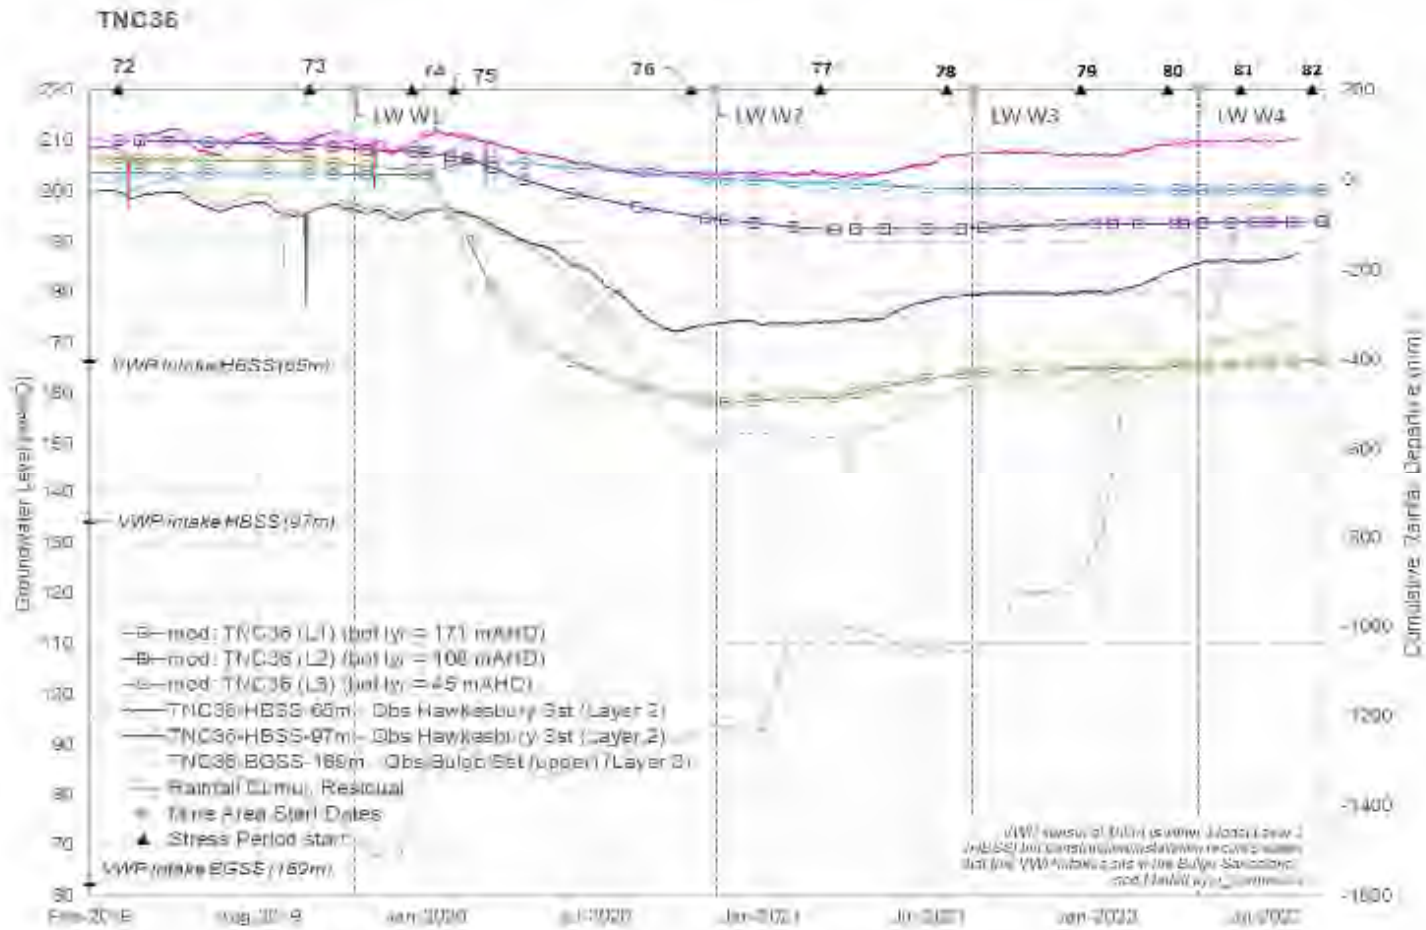
Figure 16 Comparison of Modelled and Observed Groundwater Levels at TNC36

- At TNC036 (Figure 16) there is a small underestimation in the model to replicate the observed recovery during 2022 but modelled groundwater levels are within 5-10 m observed as of August 2022 (i.e. similar as modelled prior to LW W1). The HBSS-65m and HBSS-97 m piezometers are assigned the same model layer, which makes difficult to match the difference in groundwater head between the two shallow piezometers, but previously the model gives a reasonable estimate in the rate and magnitude of drawdown at this location.

- The observed stabilisation and recovery in water levels in BGSS-169 m are well replicated by the model, being within 1 m of observed prior the start of LW W4. This suggests that the height and mode of subsidence fracturing in this area is well represented in the model. The modelled underestimates the groundwater recovery in the upper model layers due to the July rainfall recharge not being captured in the model. This explains why the modelled groundwater levels diverge from observed groundwater levels from July 2021 in TNC36-169m. The model performance at this site remains acceptable.

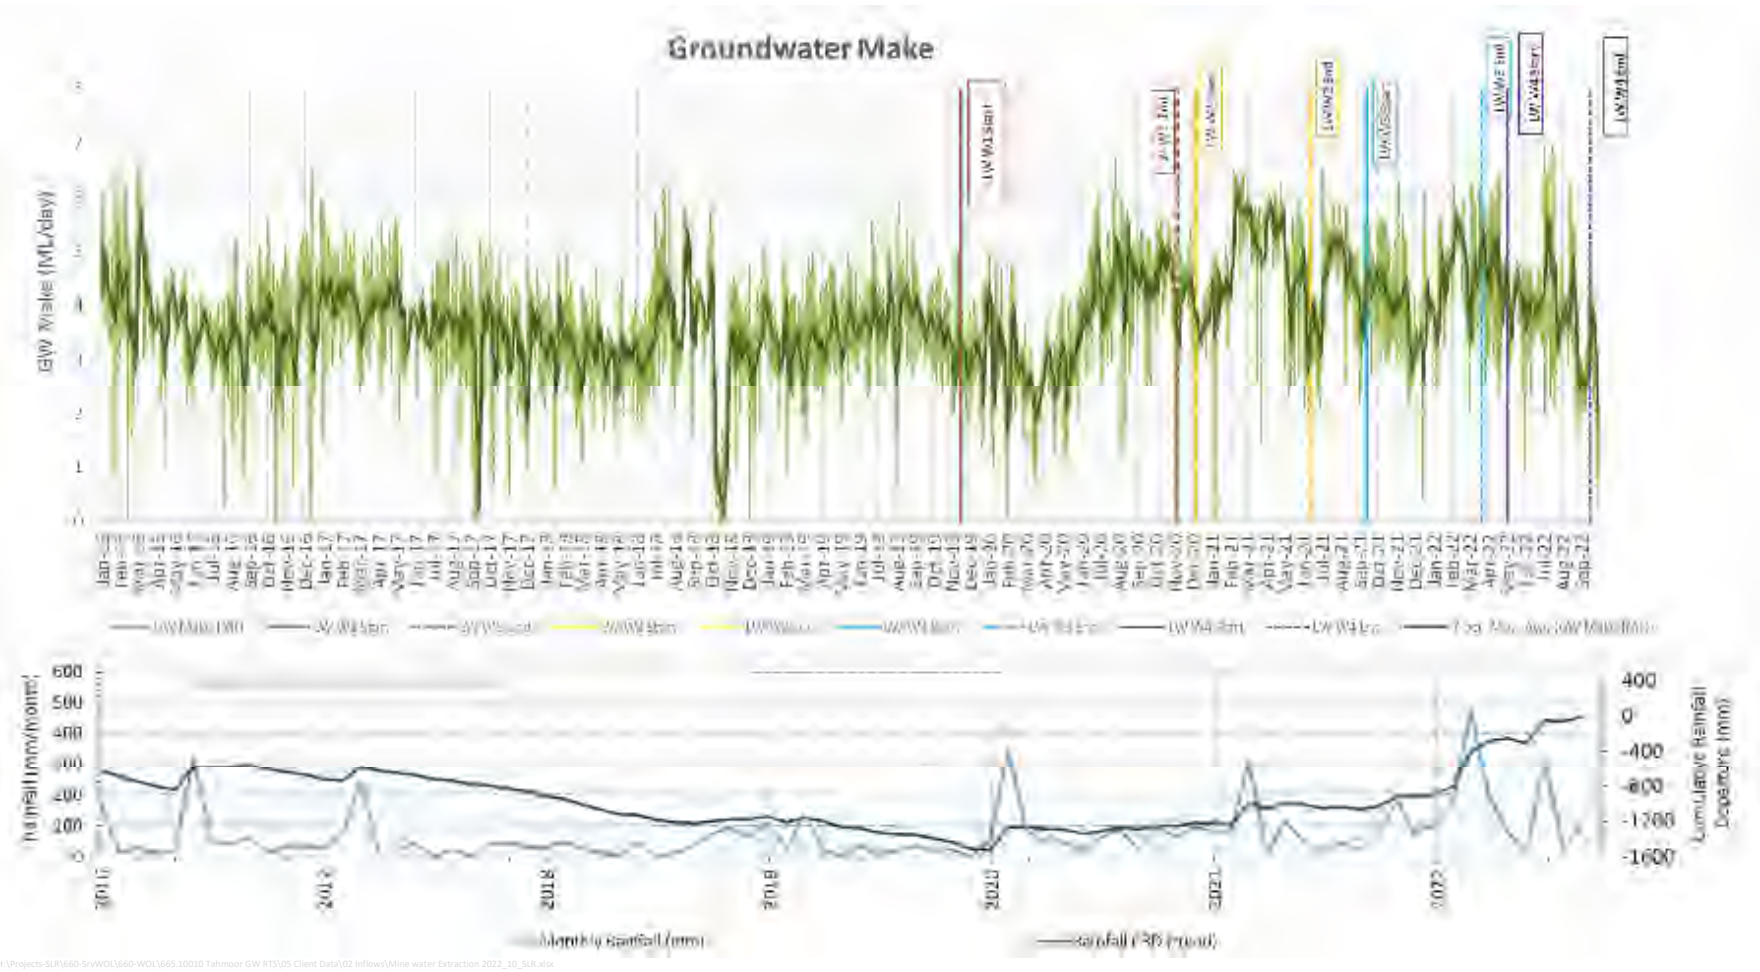
Figure 17 Historical Record of Inflows at Tahmoor North

For the period 2009 to September 2022 (latest reported record is on 30th September 2022), observed inflows to Tahmoor Mine have been within the range of 2 to 6 ML/d. **Figure 17** shows net groundwater inflows (as calculated from the mine water balance and pump-out records), alongside the historic rainfall (based on records dating back to 1900) and the Western Domain longwall start dates. Inflows to the Western Domain are not metered in isolation from other parts of Tahmoor North. For the following analysis we focus on the 7-day moving average on **Figure 17**, as short-term peaks are unlikely to be related to groundwater, but more related to deliberate changes in pumping or water management in the underground mine workings.

Groundwater entitlement was not exceeded for the 2021-22 water year and as of September 2022 remain below the limit for the 2022-23 water year (based on a pro-rata calculation).

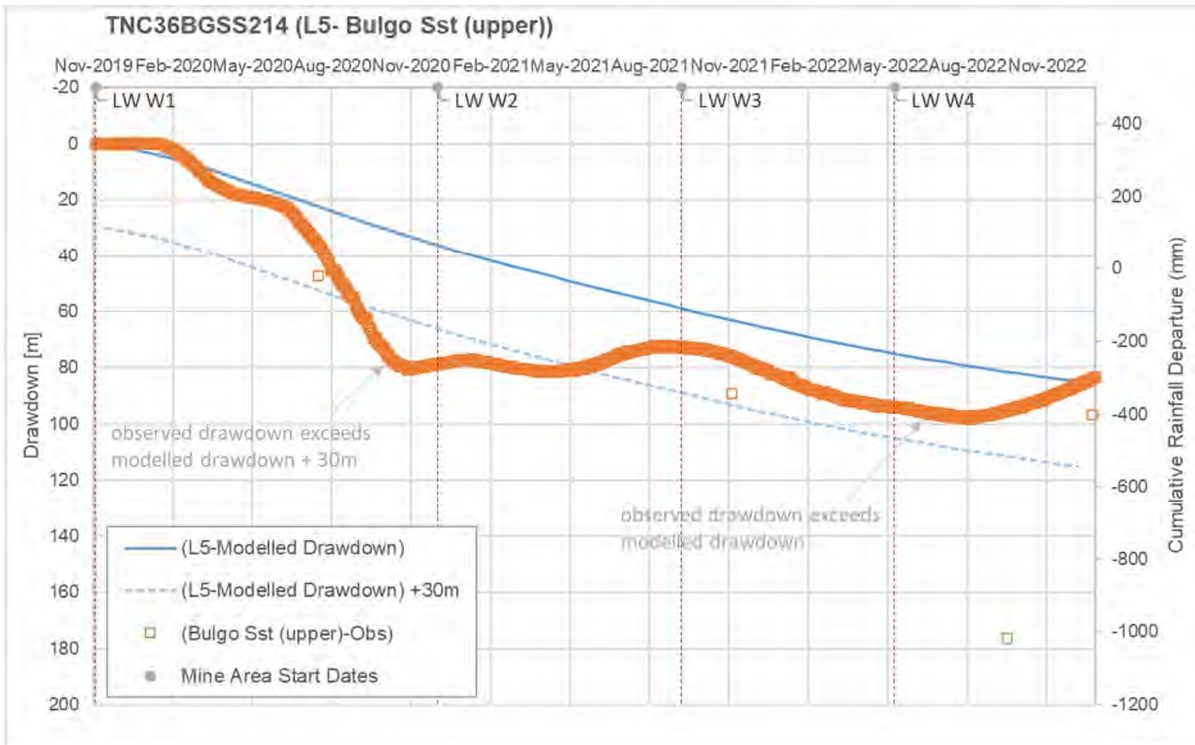
Figure 4 Comparison of Modelled and Observed Drawdown at TNC036 (BGSS-214m) with the +30m Threshold Modelled Drawdown

TNC036 (BGSS - 169m)	TARP Level 2 exceedance was observed from October to December 2022. Groundwater levels are observed at 181.6 mAHD in December 2022 and increased by approximately 8.5 m during the reporting period. As of December 2022, groundwater levels remain below the trigger TARP Level 2 (192.5 mAHD), hence a TARP Level 2 still applies.
TNC036 (BGSS - 214m)	A reduction from TARP Level 2 exceedance to TARP Level 1 was observed during the review period. The groundwater level observed at TNC036-BGSS-214m exceeds the modelled drawdown from mid-2020 but remains within the 30 m predicted drawdown in October and November 2022 (Figure 4). As of December 2022, the observed drawdown does not exceed the modelled drawdown resulting in a TARP Level 1.
TNC036 (BGSS – 412.5m)	TARP Level 2 exceedance was observed during the review period. The groundwater level observed at TNC036-BGSS-412.5m exceeds the modelled drawdown from mid-2020 but remains within the 30 m predicted drawdown as of December 2022 (Figure 5). A Level 2 TARP criteria (exceeds modelled drawdown but less than 30 m exceedance) still applies at TNC036-BGSS-412.5m over the reporting period.
