Tahmoor Coal Pty Ltd

SIX MONTHLY SUBSIDENCE IMPACT REPORT

Western Domain Longwalls West 1 – West 4

Report 7 – March 2023

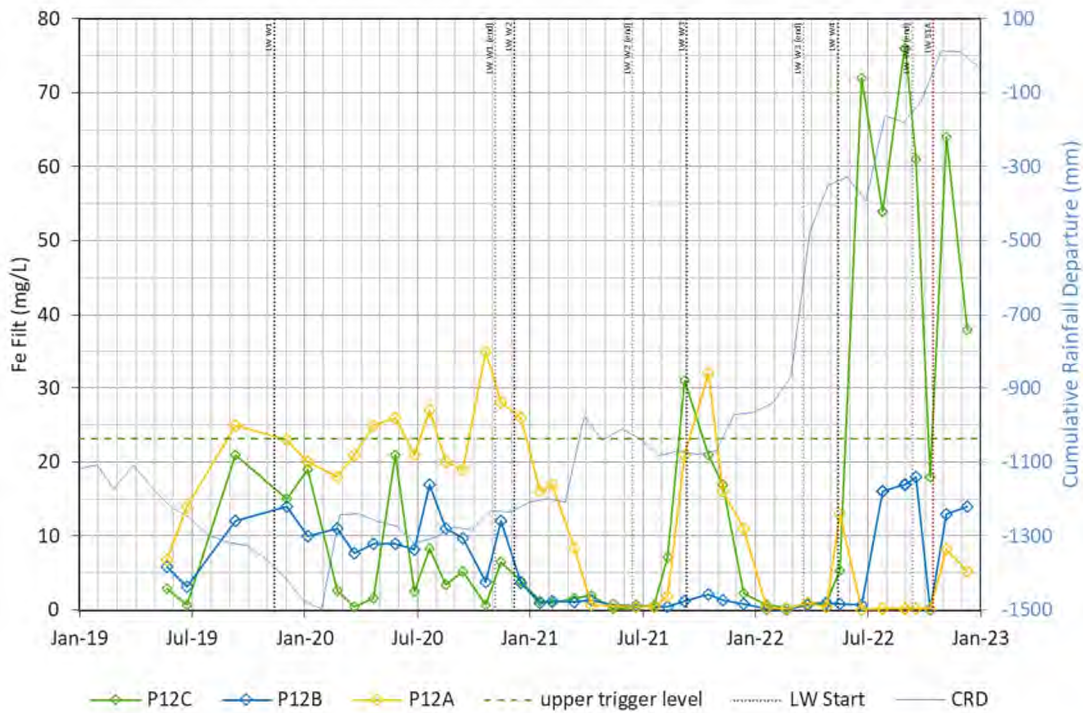
Figure 6 Dissolved Iron (Fe) concentrations at sites P12

Site	Discussion
P12A	Short-term increase in aluminium observed in October 2022 (TARP Level 2) (Figure D13)
P12C	<p>TARP Level 2 metals (iron and manganese) (Figure D1 and Figure D3). Dissolved iron concentrations have shown significant fluctuations in the past six-months with a peak observed in September 2022 to 76 mg/L followed by a sharp decline to 18 mg/L (below the trigger level) in October 2022 (Figure 6). However dissolved iron concentrations fluctuated between 64 and 38 mg/L and above the trigger level in November and December 2022. Dissolved iron concentrations remained below the trigger level at P12A and P12B being recorded at 5.2 mg/L and 14 mg/L respectively which show that dissolved iron concentrations in the shallow Hawkesbury Sandstone aquifer remain within baseline level (Figure 6). The increase in dissolved iron at P12C is suggested to be localised and likely the result of iron being mobilised during the groundwater recovery observed over the past six months. Iron staining may have formed along the steel casing during the period of groundwater depressurisation and is likely mobilised as groundwater levels increased in the bore. It is recommended to purge the bore for a longer period in the next monitoring round to confirm trends in dissolved iron concentrations.</p> <p>The increase of dissolved manganese concentrations above the trigger level during the reporting period (i.e. peak at 1.3. mg/L in October 2022) could also be linked to the staining of the casing. As shown on Figure 6 and Figure 7, dissolved iron and manganese concentrations appear to be correlated. Also, dissolved manganese concentrations at P12A and P12B were recorded between 1 and 1.5 mg/L and are observed within similar level as P12C during the reporting period. This suggests that natural fluctuation in groundwater quality could be associated with the increasing trend at sites P12. As for dissolved iron concentration trigger level, prior to undertake a revision to the dissolved iron trigger level, it is recommended to purge the bore for a longer period in the next monitoring round to confirm trends in dissolved manganese concentrations.</p>

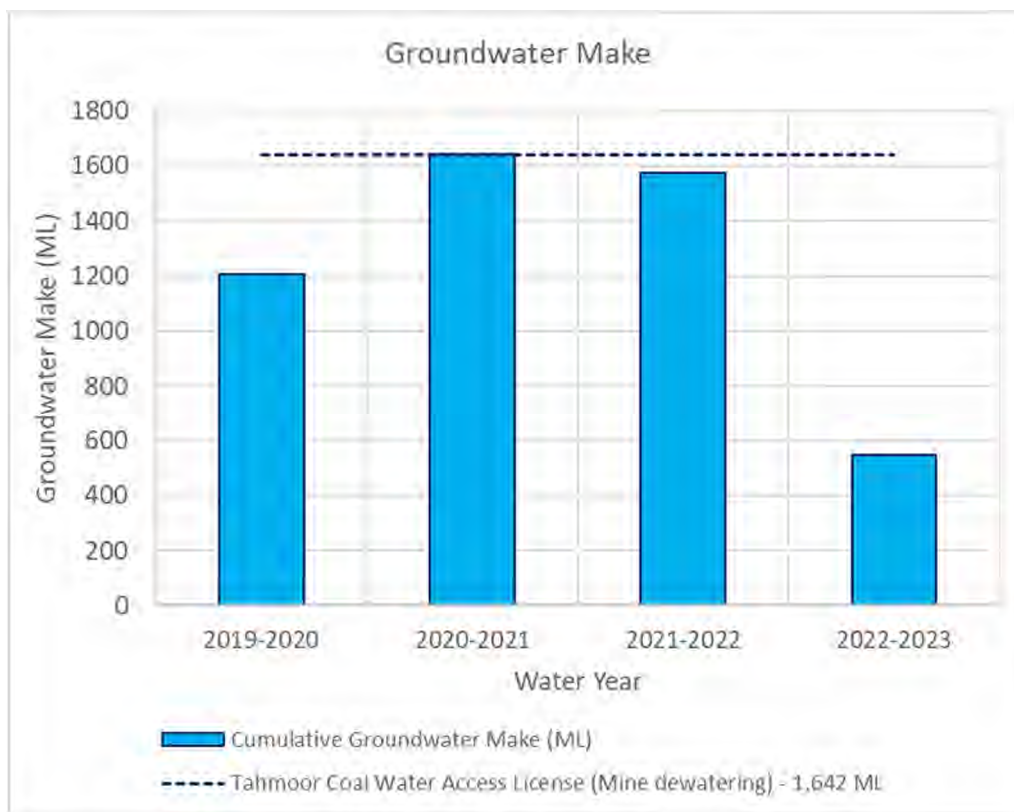
Figure 12 Groundwater Make per Water Year (from 2019-20 to 2022-23)

The reporting period October-December 2022 falls within the water year calendar 2022-23. The observed cumulative groundwater makes for the water 2022-23 is 546 ML and remains below the groundwater entitlement of 1,642 ML per annum (i.e. water year) as of December 2022 (Figure 12).

The Western Domain blocks have been sealed in October 2022 and since then an average groundwater inflow of 2.3 ML/day is reported from the Tahmoor North workings.

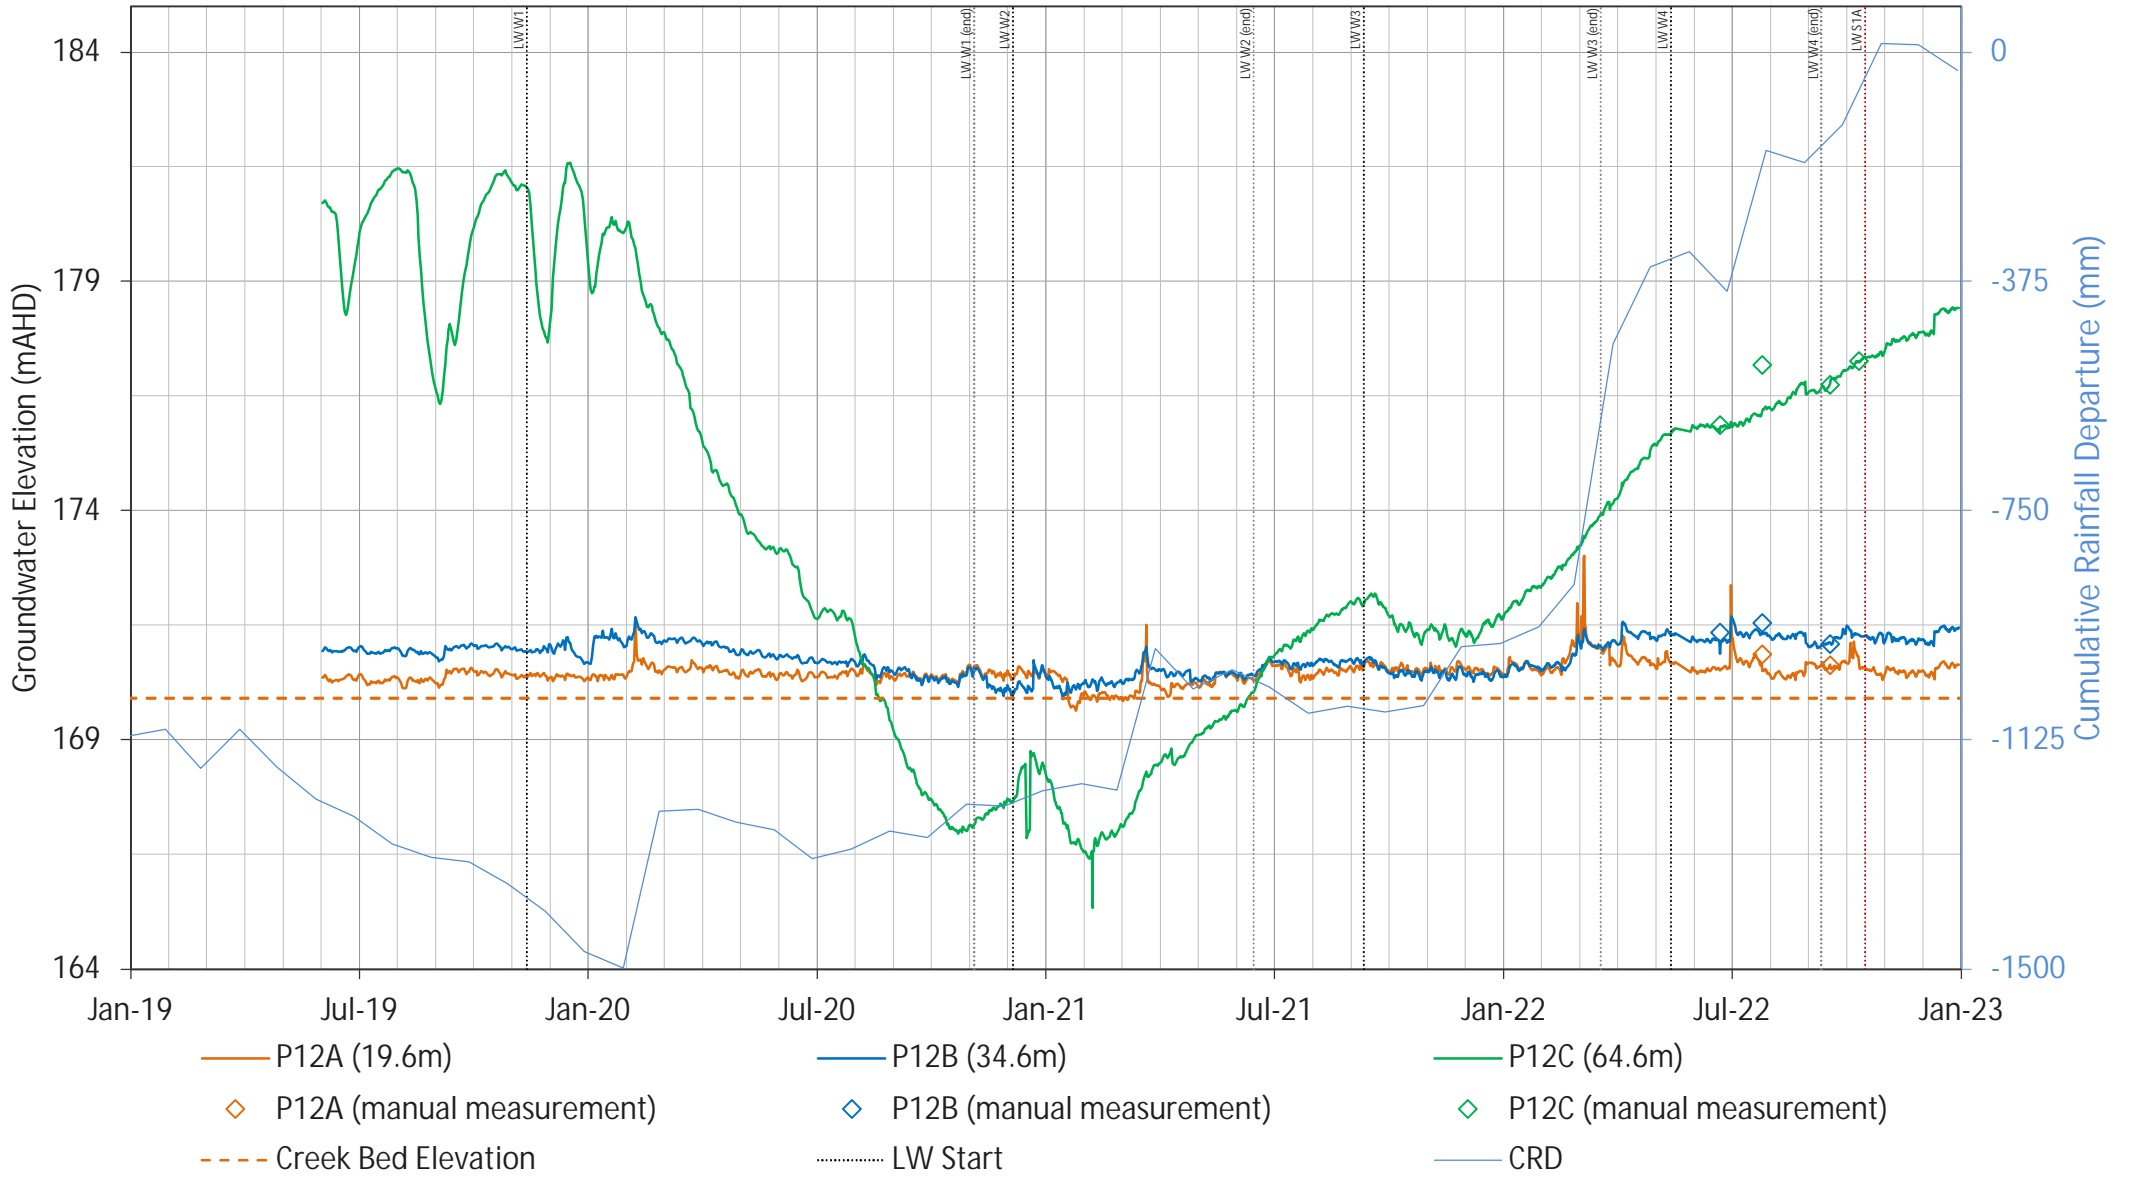
Figure A-1

- Site P12: groundwater levels at P12A and P12B remained relatively stable at 170.4 mAHD and 171 mAHD respectively during the review period (Appendix A, Figure A-1). At P12C, the observed trend of previous months continued with groundwater levels increasing by approximately 1.5 m over the reporting period to 178.4 mAHD in December 2022. As of December 2022, groundwater levels at sites P12 are within baseline level (P12A), 0.5m above baseline level (P12B) and have mostly recovered in P12C as groundwater levels are observed within baseline level. The recovery period at P12C follows a maximum groundwater depressurisation of 11m in February 2021 caused by mining of LW W1-W2.

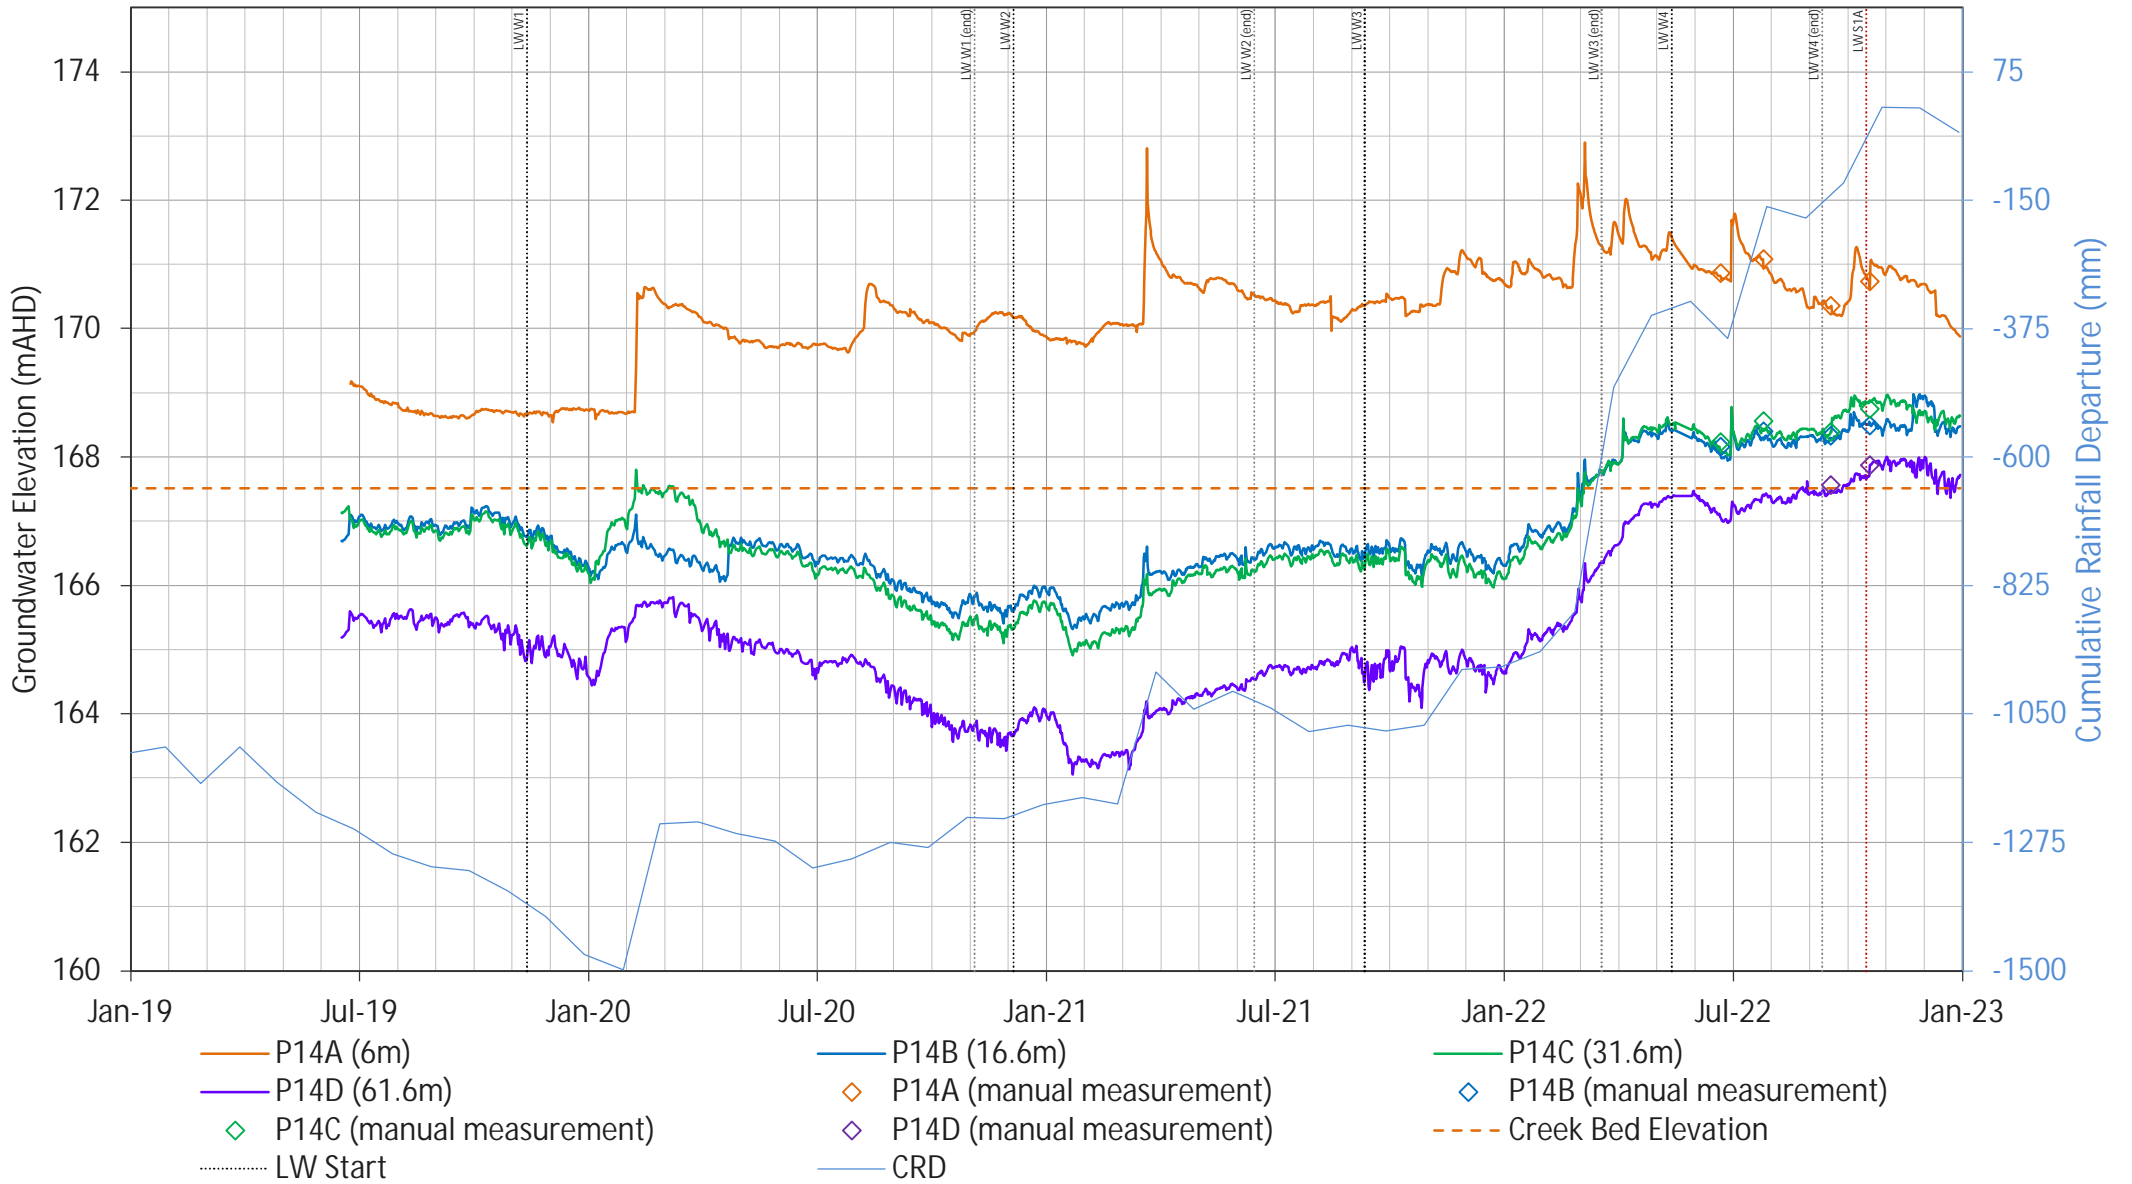
Figure A-2

- Site P14: groundwater levels at P14A decreased by approximately 1.1 m over the reporting period, to 169.9 mAHD in December 2022, which is likely attributable to lower rainfall recharge in November and December 2022 (Figure A-2). As of December 2022, groundwater levels at P14A are observed 1.2m above baseline levels. Overall, groundwater levels fluctuated within 0.5 m, and were observed above the creek bed elevation at P14B, P14C and P14D which suggest strengthening of baseflow conditions along Stonequarry Creek over the reporting period (Figure A-2).

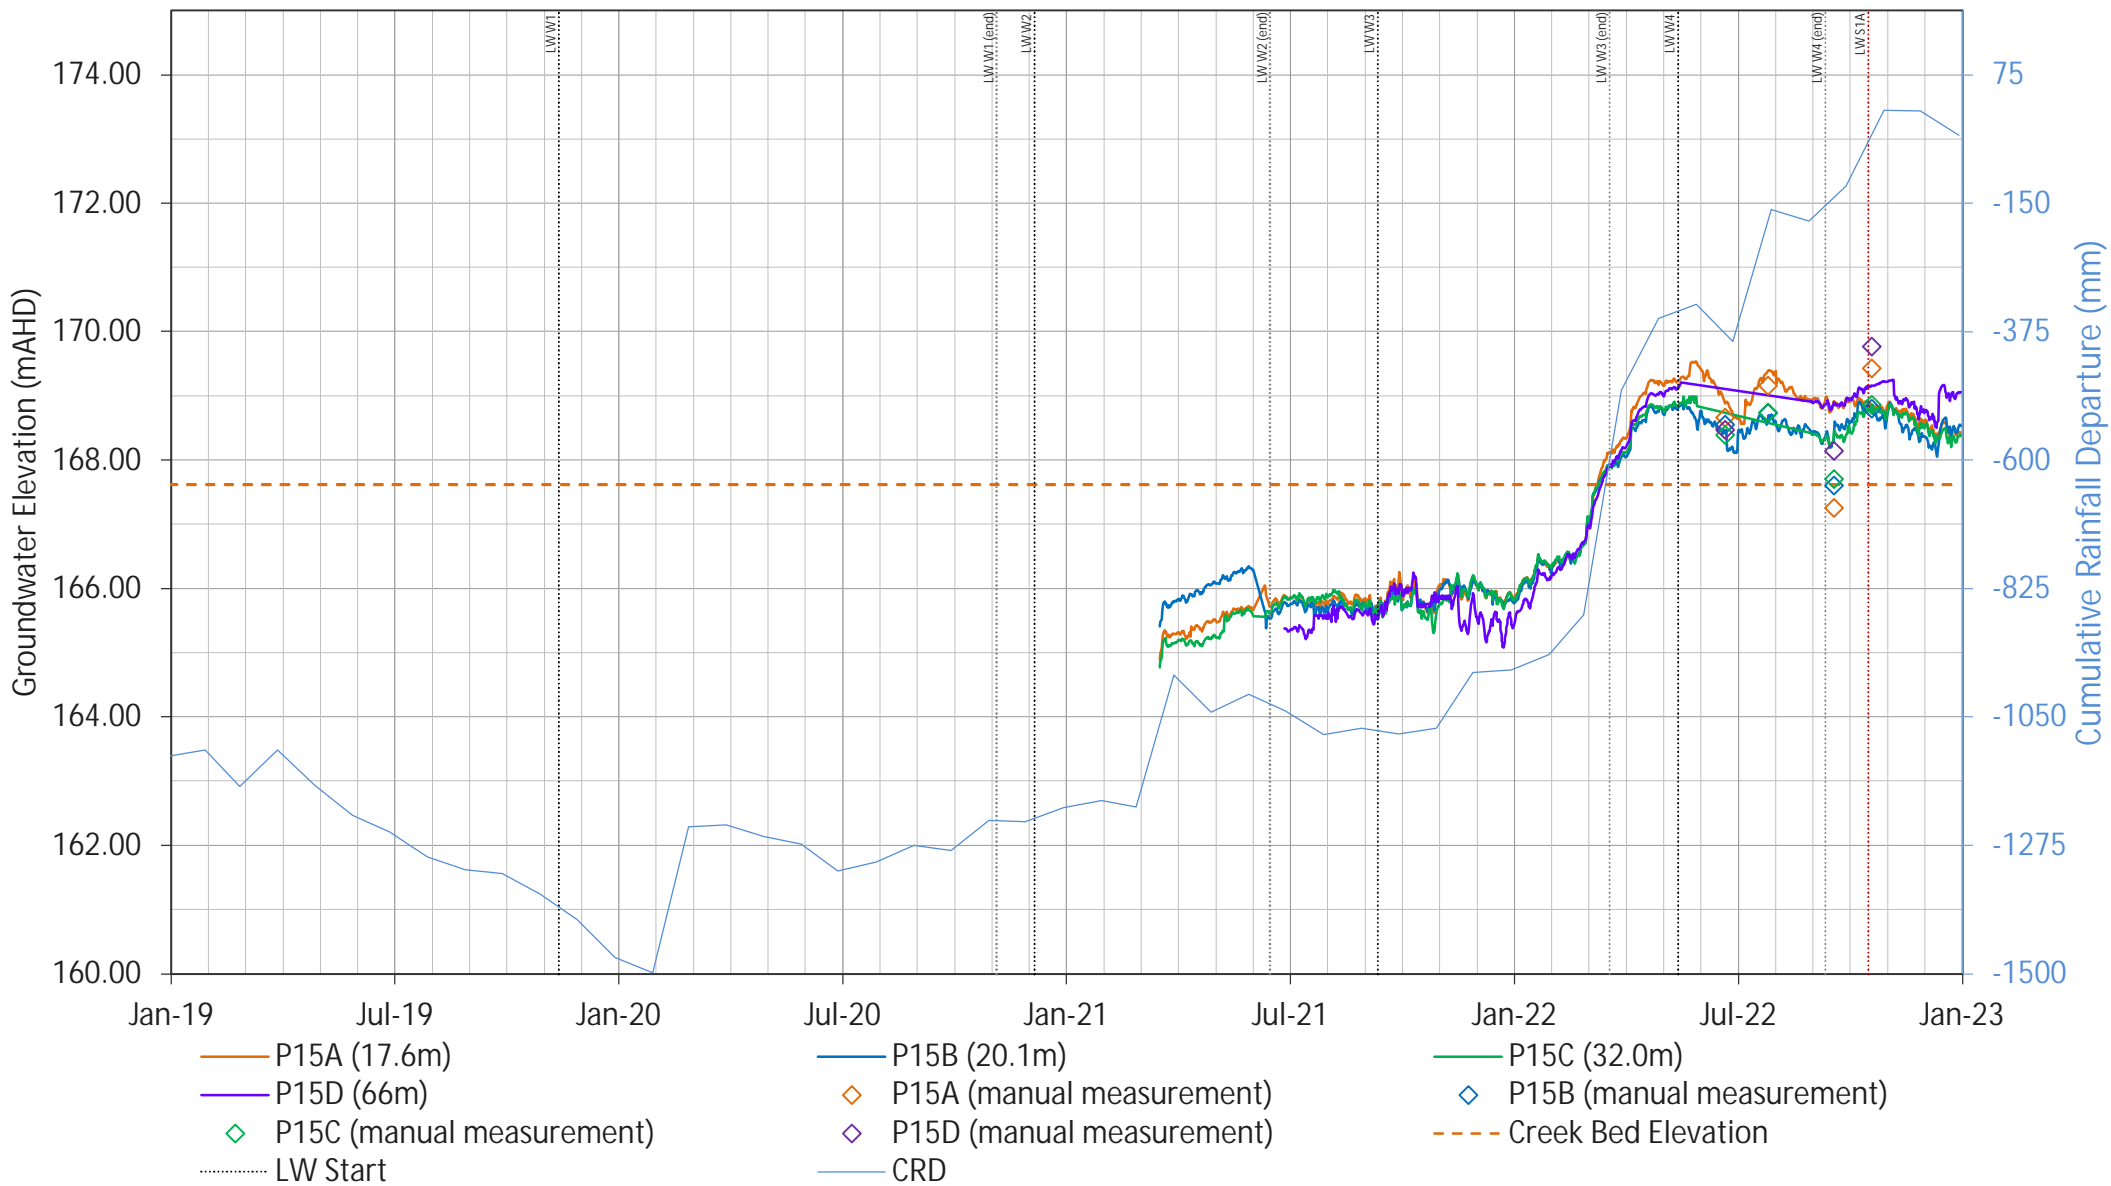
Figure A-3

- Site P15: overall, groundwater levels fluctuated within 0.5-1 m over the reporting period, and decreased in late November 2022, at P15A, P15B, P15C and P15D, which aligned with observed CRD trends (Figure A-3). Similar to the observations for the P14 sites, groundwater levels at P15 sites (P15A, B, C and D) remained above the creek bed elevation favouring baseflow conditions along Stonequarry Creek.

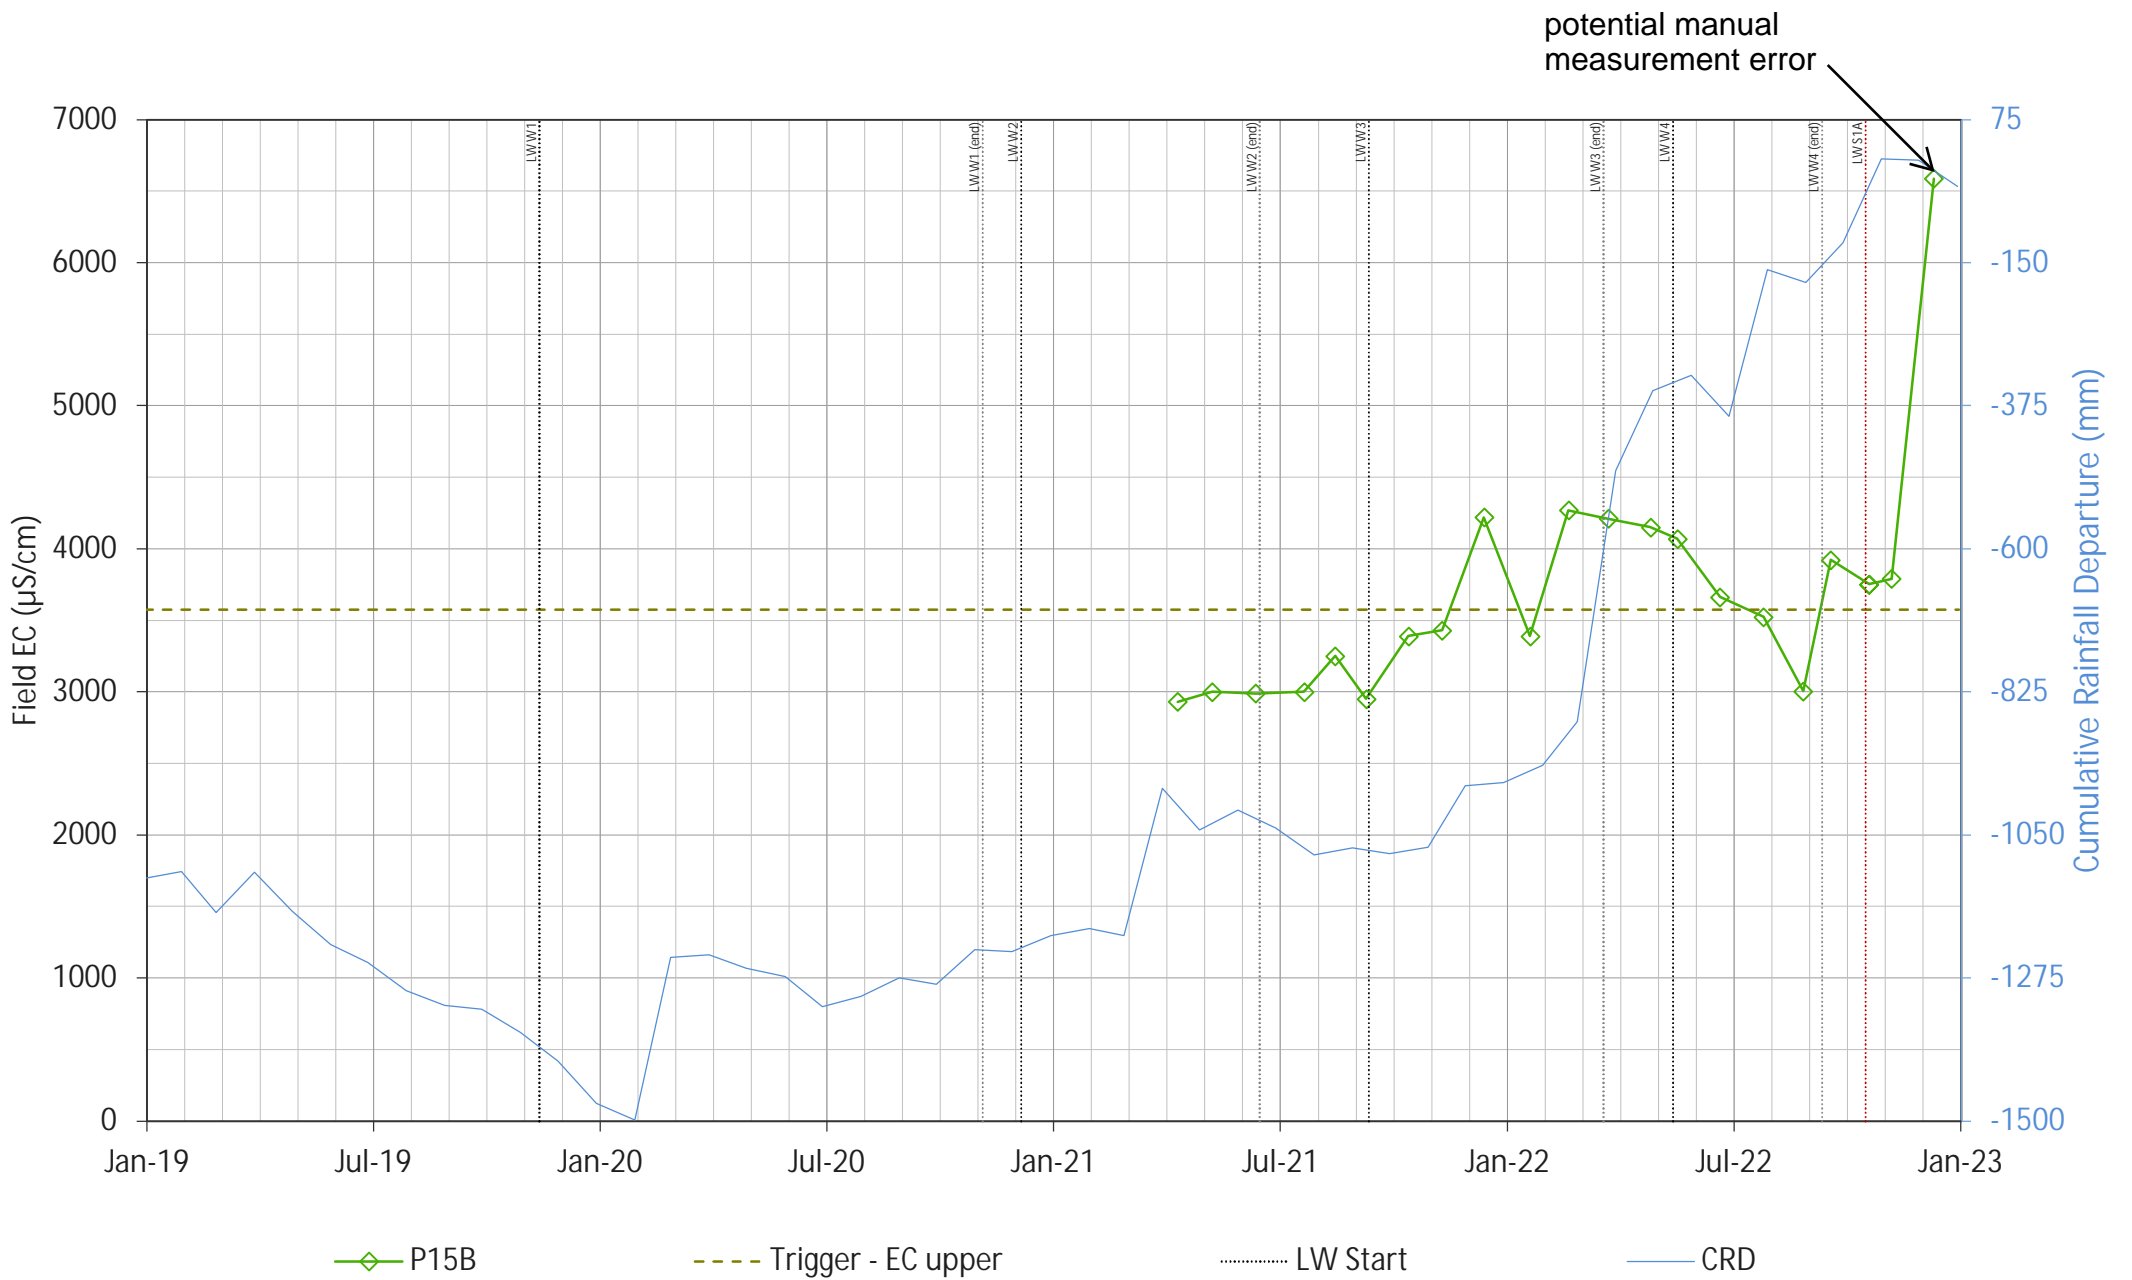
Figure C-2

P15B	<p>Groundwater EC was observed marginally above the trigger level (3,575 uS/cm) in October and November 2022 at 3,741 uS/cm (Figure C2). The groundwater EC data point for December 2022 was removed the datasets as the record appears erroneous (i.e. greater than 6,500uS/cm) while TDS is recorded at 233.5 mg/L. The TDS value suggests that the groundwater EC would be close to 348.5 uS/cm (i.e. EC approximately equals to TDS / 0.67).</p> <p>TARP Level 2 metals (strontium) exceedance observed across the reporting period (Figure D19). Strontium concentrations peaked to 1.5 mg/L in October 2022 and have declined to 1.3 mg/L in December 2022, marginally above the trigger level of 1.21 mg/L (Figure D19). It is recommended to continue closely monitoring strontium concentrations at P15B although the fluctuations in lithium concentrations slightly above the trigger level are likely due to floods events in 2022.</p>

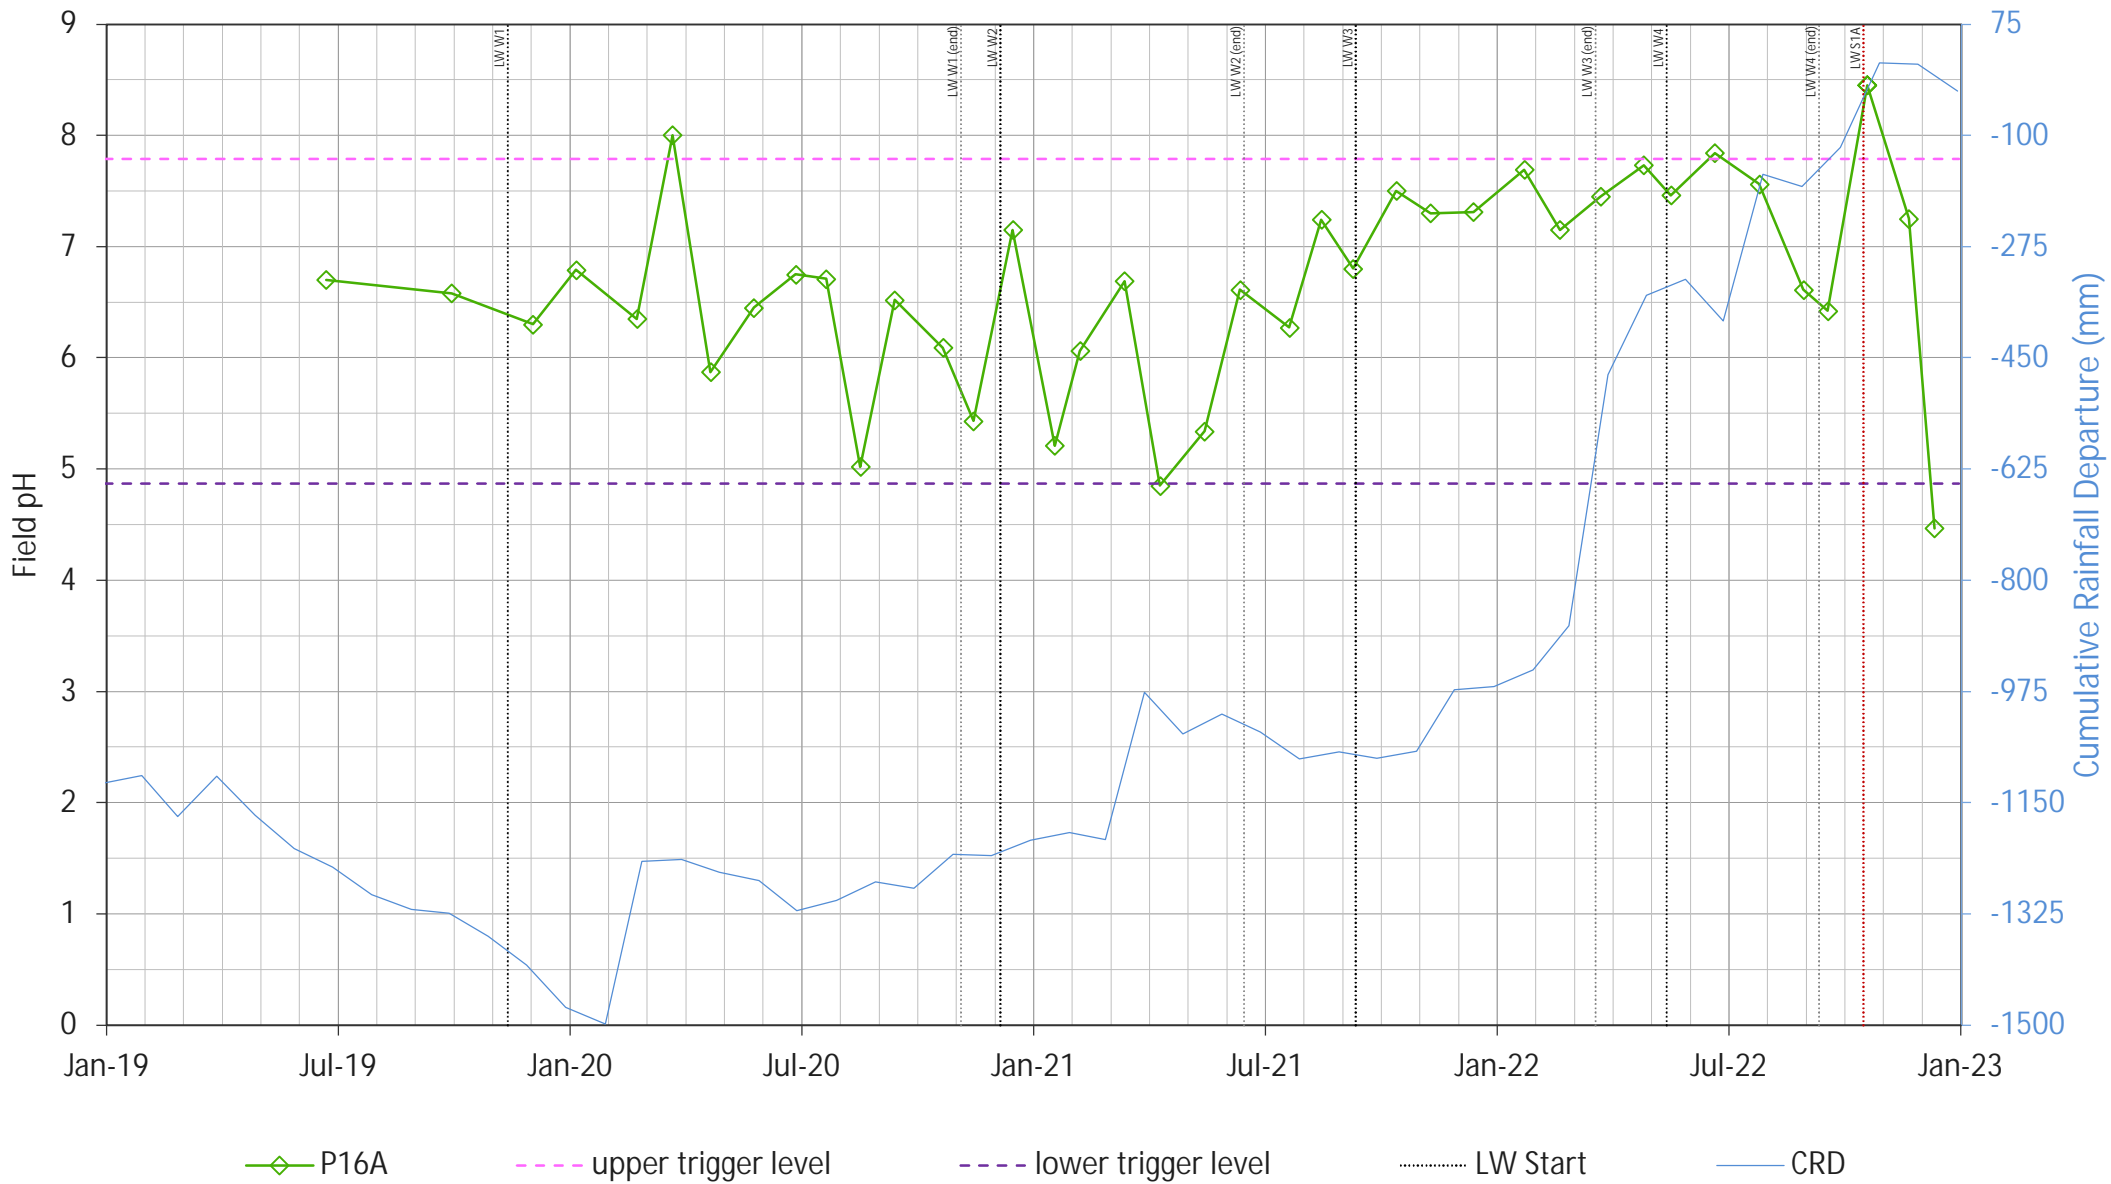
Figure C-4

P16A	<p>pH at P16A has fluctuated significantly as it triggered the upper pH level in October 2022 and lower pH level in December 2022 (Figure C4). pH at P16A has previously shown large fluctuations. Additional monitoring data is required to confirm pH trends. TARP Level 2 applies in October and December 2022.</p>
P16B	<p>Short-term increase in strontium observed in November and December 2022 (TARP Level 2) (Figure D16).</p>
P16C	<p>TARP Level 3 metals (zinc) (Figure D12). Dissolved zinc concentrations have fluctuated above the trigger level (0.021 mg/L) since May 2022 but declined following rainfall events (i.e July and October 2022). In October 2022, dissolved zinc concentrations decreased to 0.034 mg/L (marginally above the trigger level). As of December 2022, zinc concentrations increased to 0.12 mg/L, where a TARP Level 3 applies. For comparisons, P16A and P16B have shown natural fluctuations in zinc concentrations (i.e in the range of 0.1 mg/L) following rainfall events however no increases are observed during the reporting period. This suggest that the increase in zinc in the lower Hawkesbury Sandstone (P16C) is localised (Figure D12). Since early 2022, the sustained increase in groundwater levels seen at P16C could locally mobilised a naturally occurring source of zinc (i.e in the range of 0.10-0.15 mg/L). Also, the mild steel casing at P16C could contribute to a higher zinc concentration. Higher zinc concentrations at P16C could be related to a post mining impact however natural fluctuations in groundwater quality and major flood events in 2022 are likely the reason for higher zinc concentrations.</p> <p>As of December 2022, it is recommended to apply a TARP Level 3 at P16C for dissolved zinc concentrations. A TARP Level 4 should be considered in the next review period if further increase in zinc at P16C is observed and if zinc concentrations increase above the trigger level at P16A and P16B.</p> <p>Short-term increase in aluminium observed in December 2022 (TARP Level 2) (Figure D15)</p> <p>Short-term increase in strontium observed in November and December 2022 (TARP Level 2) – (Figure D17).</p>

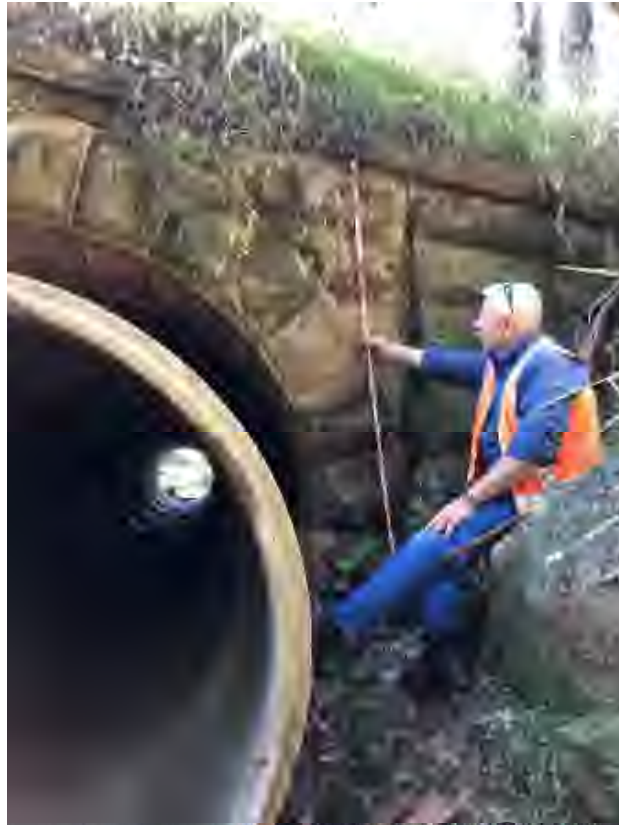
Culvert 88.980 was in poorer condition than the other sandstone culverts prior to the commencement of longwall mining in the Western Domain. Additional cracks through the mortar and sandstone capping as well as some minor spalling of the arch stones of the western portal developed during extraction of LW W2.

Western portal. Cracking around arch stones that was first noted during extraction of LW W2 has not worsened during LW W3.

Level 3 of the TARP was triggered during the extraction of LW W2 and remains at Level 3. While the culvert is currently stable, remediation will be required following the conclusion of subsidence. At this time the RCP sleeve will be removed from the culvert, the barrel will be inspected in detail and Tahmoor will seek further expert advice from a heritage stonemason regarding remediation of the sandstone. Repairs will be undertaken after the full effects of LW W3 – W4 have been completed. To do so earlier may cause greater damage at the new filled joint and then be even harder to repair. The culvert will continue to be monitored and managed in accordance with the HHTR.

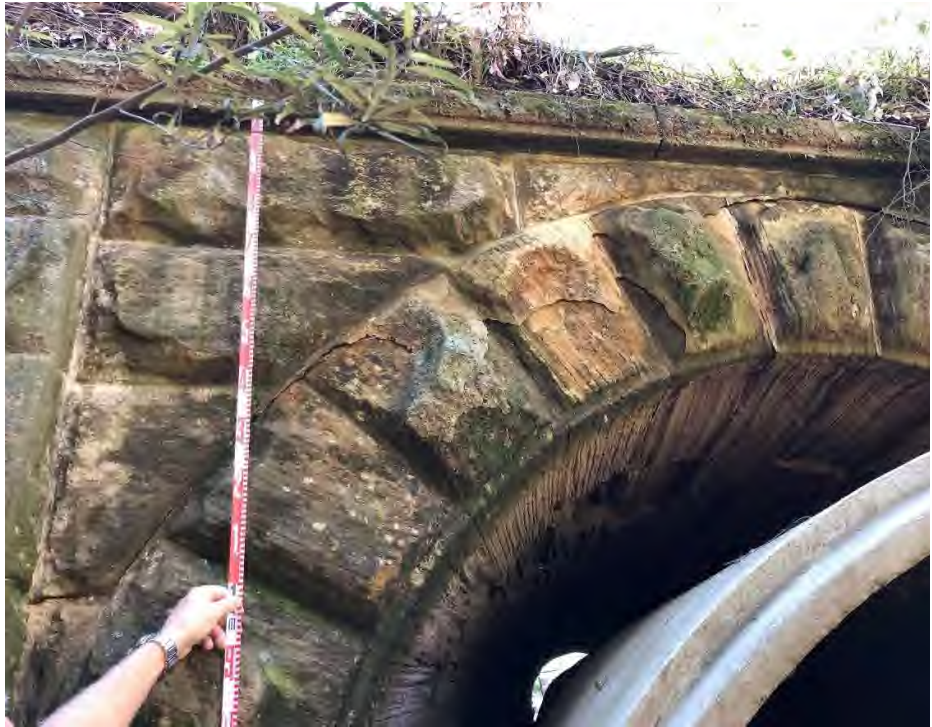
Western portal. Cracking along the mortar and spalling of the arch stones has not worsened significantly during extraction of LW W3.

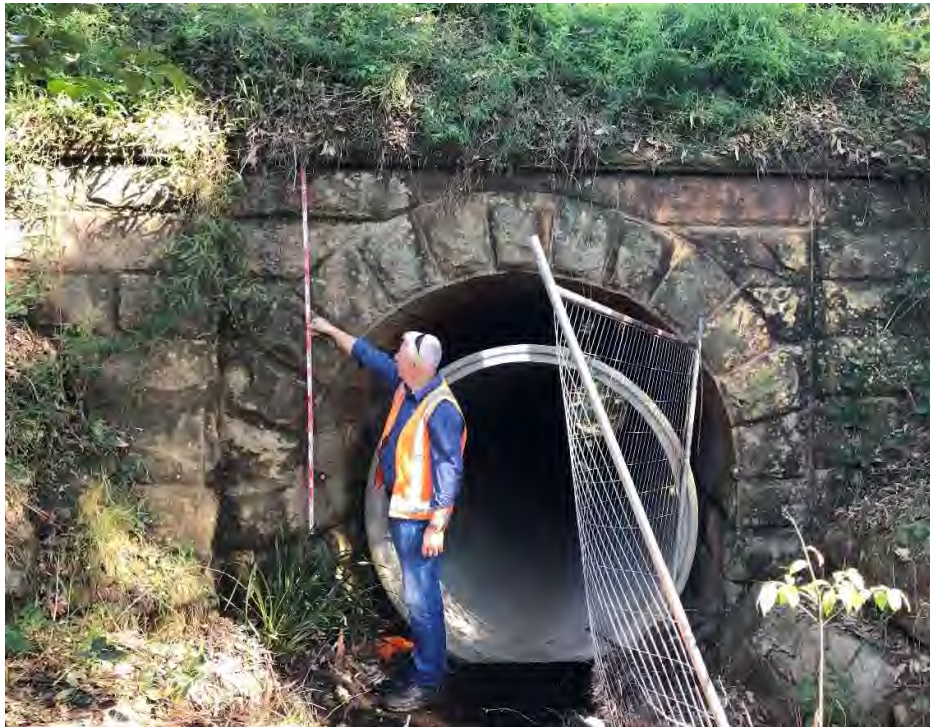
Eastern portal, generally in good condition.

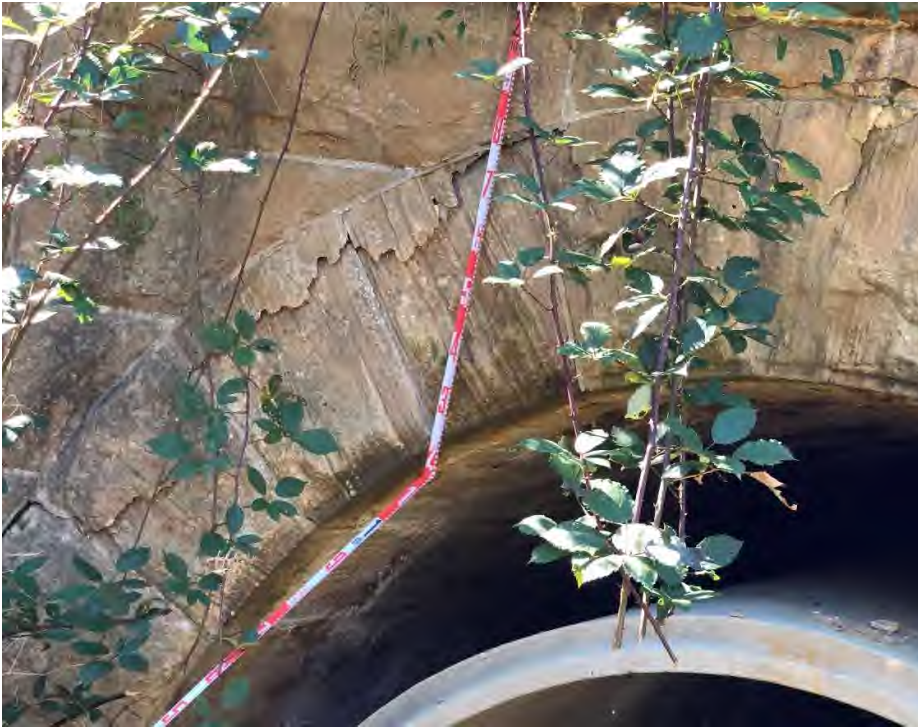
To date, culvert 88.400 has experienced the greatest impacts of the Loop Line culverts within the Study Area. An 8 mm wide crack in the vertical mortar joint and cracked sandstone capping on the downside abutment (eastern side of culvert), as well as a 7 mm wide crack in a mortar joint around the arch stones at the upside (western side of culvert) as well as minor spalling of sandstone on the arch stones were observed during extraction of LW W2. These impacts are a result of the lime grout becoming so strong over time that the weaker sandstone blocks sheer just below the grout bedding plain when under strain.

<p>Western portal. Spalling above the arch that developed during extraction of LW W2 has not worsened significantly during LW W3.</p>

Level 3 of the TARP was triggered during the extraction of LW W2 and remains at Level 3. While the culvert is currently stable, remediation will be required following the conclusion of subsidence. At this time the RCP sleeve will be removed from the culvert, the barrel will be inspected in detail and Tahmoor will seek further expert advice from a heritage stonemason regarding remediation of the sandstone. Repairs will be undertaken after the full effects of LW W3 – W4 have been completed. To do so earlier may cause greater

damage at the new filled joint and then be even harder to repair. The culvert will continue to be monitored and managed in accordance with the HHTR.

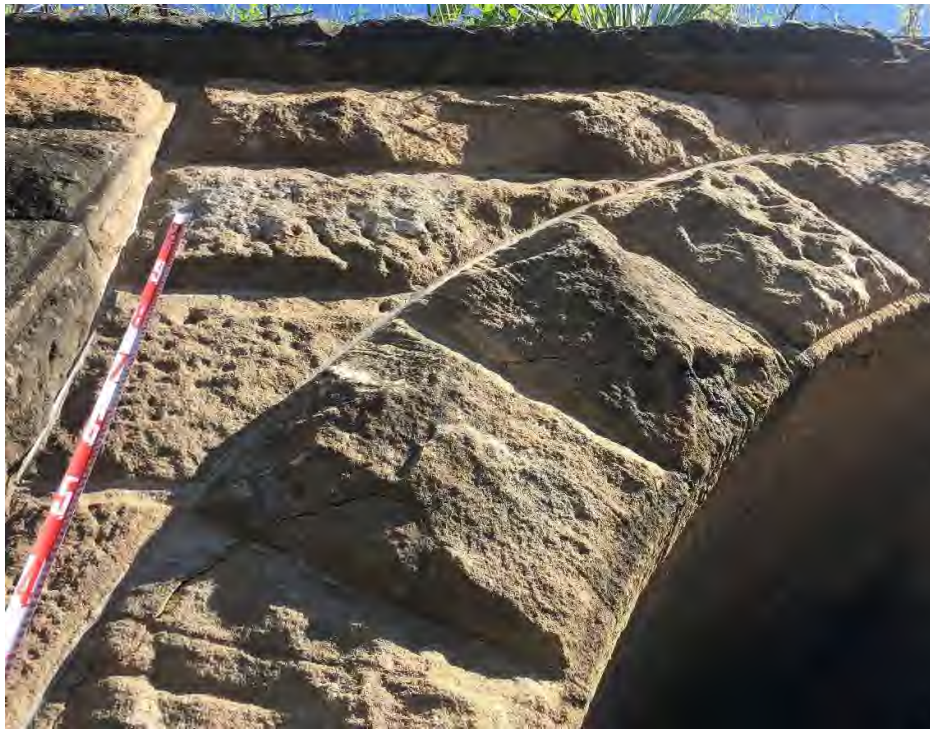
Eastern portal. No worsening of cracking during extraction of LW W3.

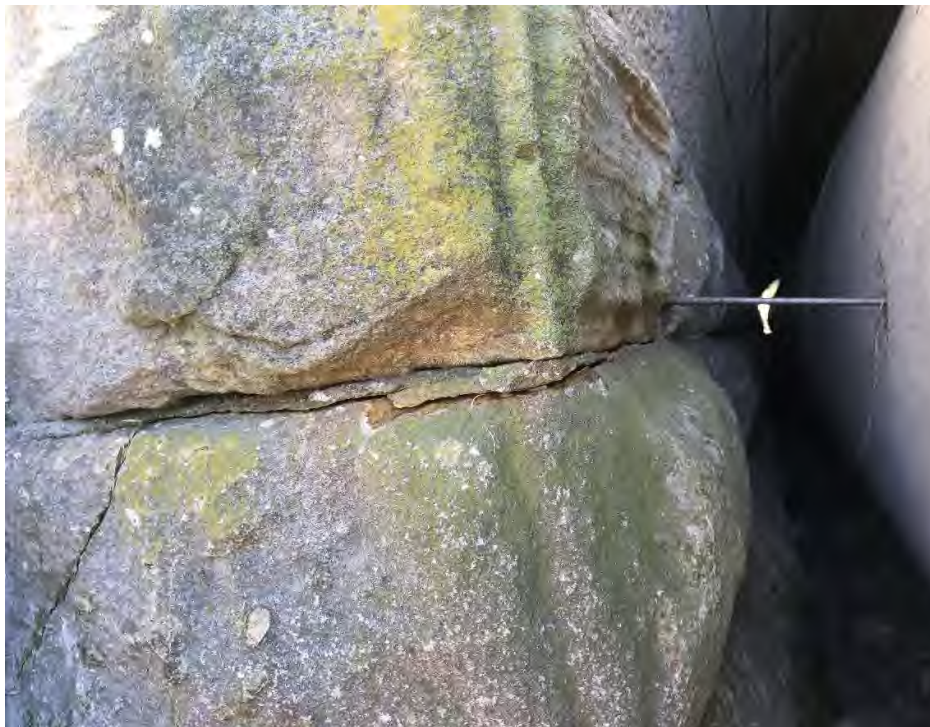
Culvert 88.400 was predicted to experience approximately 75 mm of additional vertical subsidence and 25 mm of valley closure due to the extraction of LW W3. No new impacts to culvert 88.980 were observed during monitoring throughout the extraction of LW W3. The end of panel heritage inspection did not identify any additional cracking or worsening of existing cracks or spalling, apart from cracking mostly along the mortar as a result of a screw on the left side of the eastern portal installed to attach the concrete sleeve to the culvert.

Eastern portal. Screw securing concrete sleeve to the arch of the culvert has resulted in some cracking along the mortar and through the sandstone.

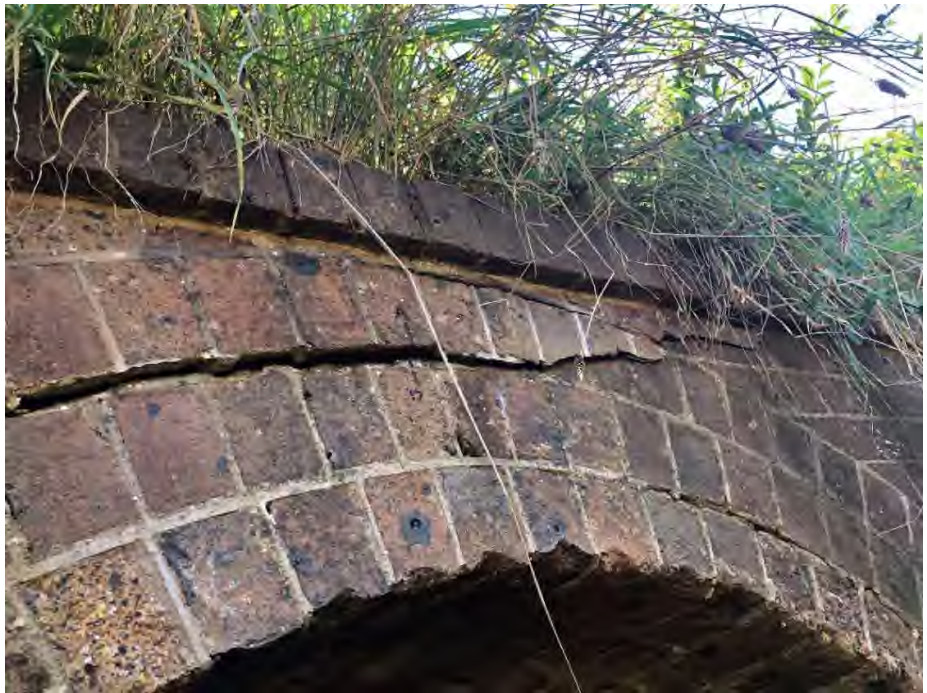
Brick culvert 87.850 has significant cracking across and between the bricks that was identified during pre-extraction inspections. Cracking around the arch is causing the course of bricks to displace. These existing cracks on both sides of the culvert have not increased during extraction of LW W3.

Detail, pre-existing cracking and displacement of bricks around the eastern portal arch that does not appear to have worsened significantly during longwall mining in the Western Domain.

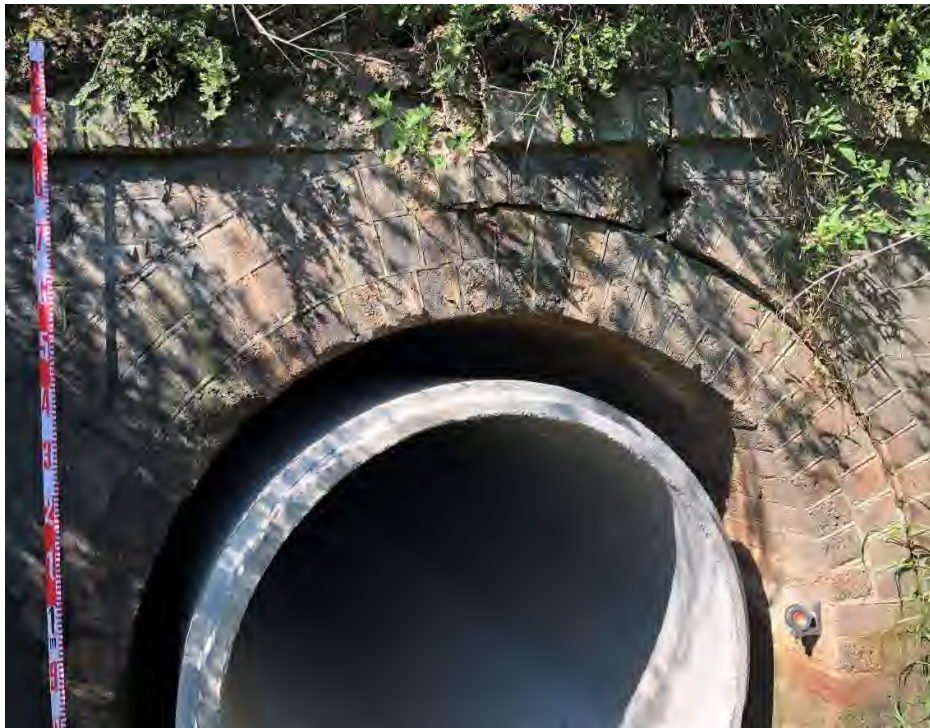
Cracking and displacement of bricks around the western portal arch. Does not appear to have worsened during longwall mining in the Western Domain.
