Tahmoor Coal Pty Ltd

SIX MONTHLY SUBSIDENCE IMPACT REPORT

Western Domain Longwalls West 1 – West 4

Report 7 – March 2023

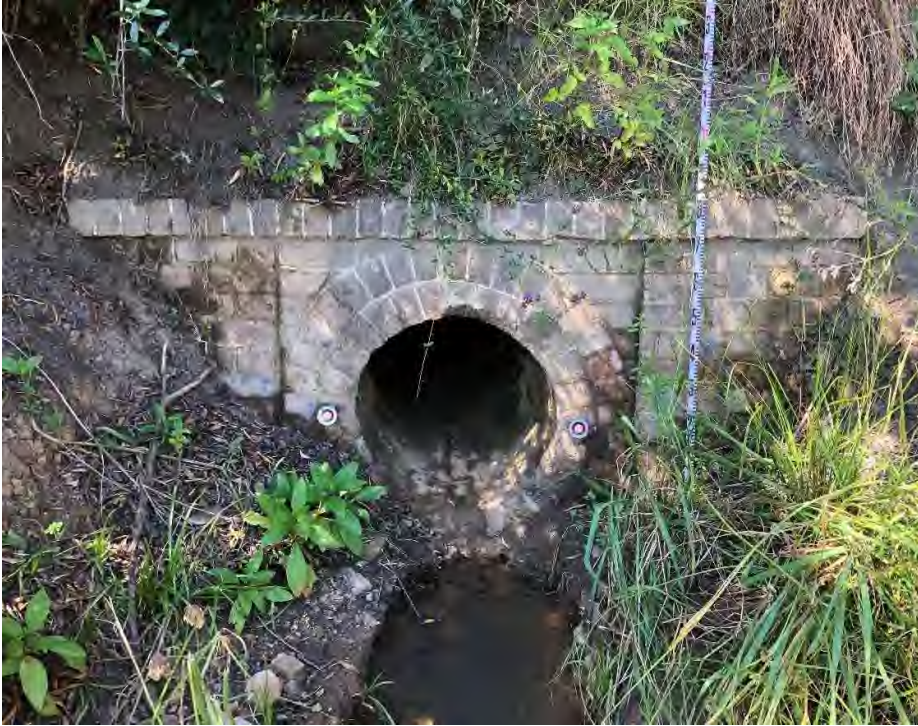
<p>Western portal. In sound condition</p>

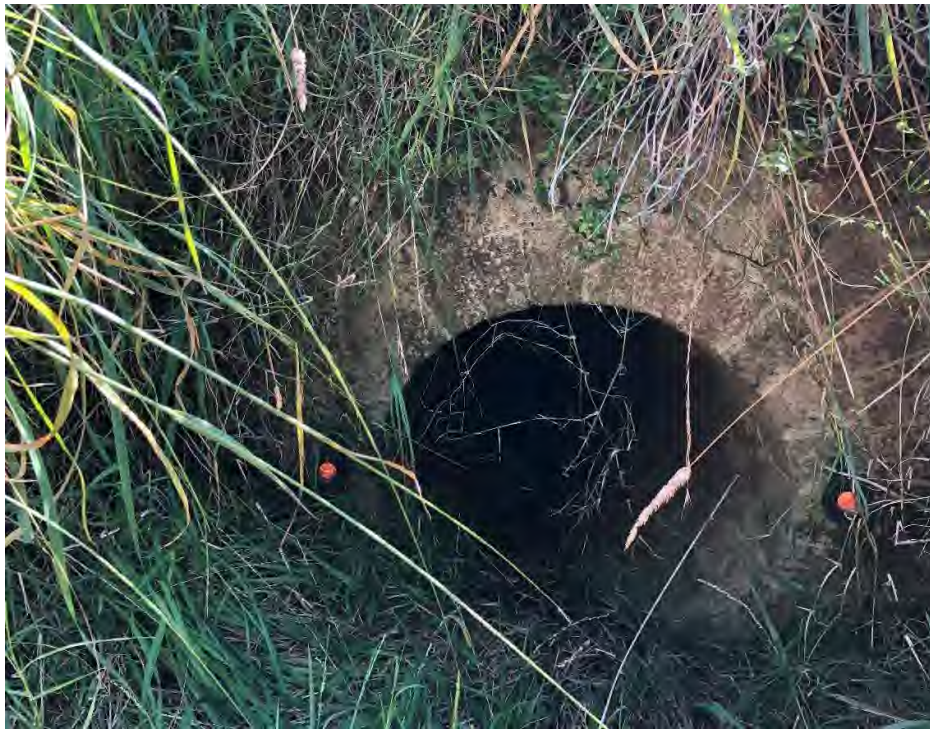
Eastern portal. Overgrown but appears to be in sound condition.

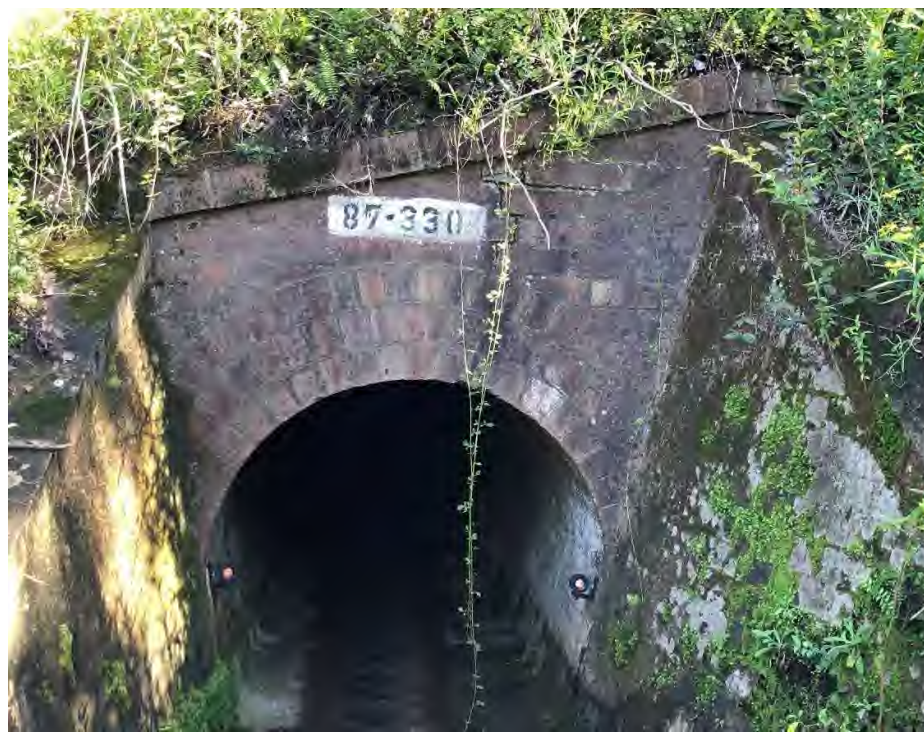
Eastern (downside) portal. In sound condition

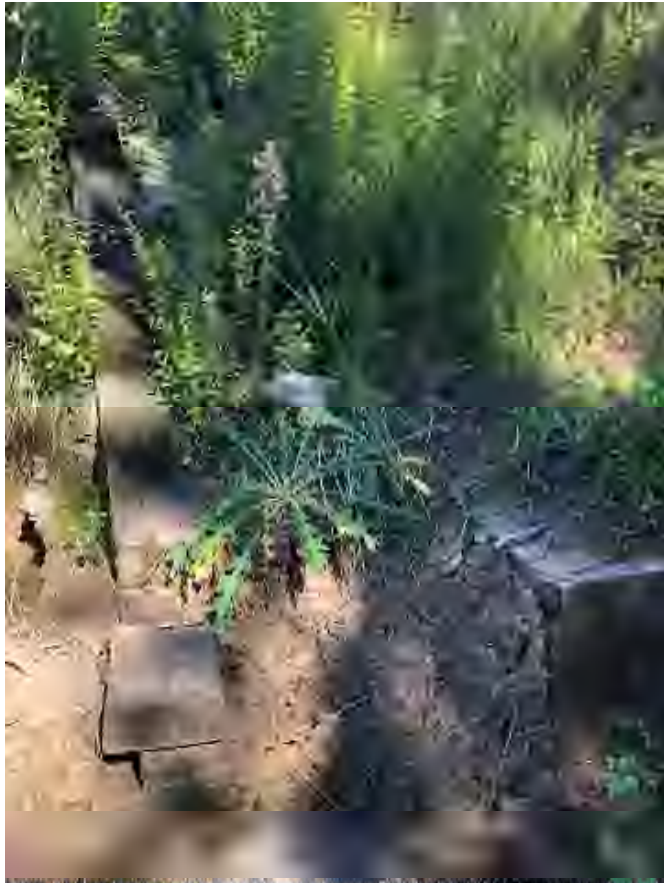
Displaced bricks at the base of the brick chute to the south of the eastern portal.

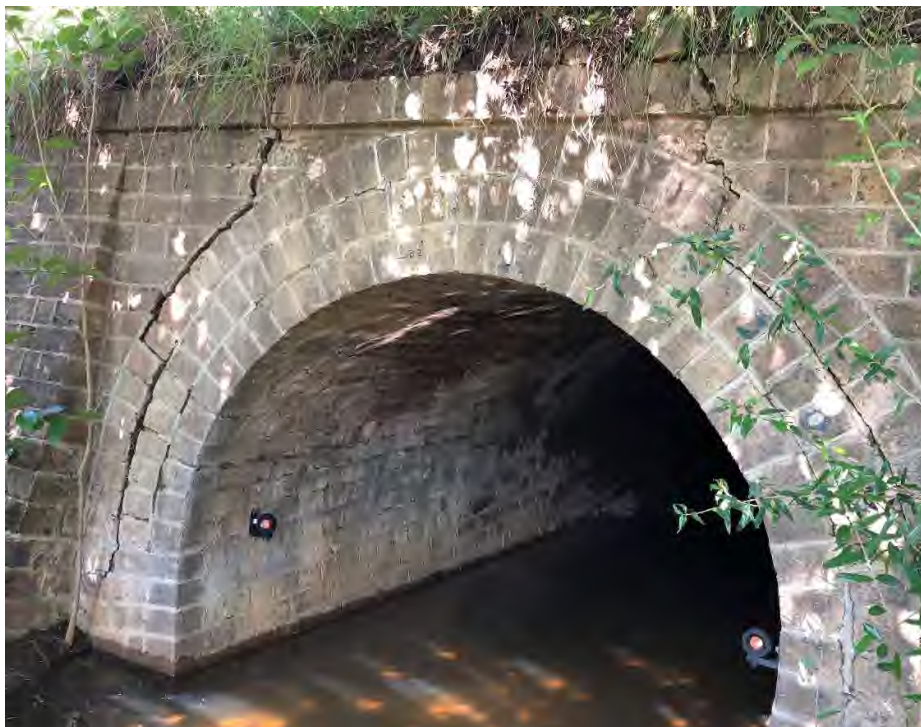
Northern portal. Difficult to access due to water and weeds. Pre-existing cracking around the arch, mostly through mortar.

A review of Mark Delaney's (Engineering Geologist) report assessing the culverts' conditions on 11 October 2022 confirms that the southern (downside) portal contains pre-existing cracking and outward rotation of the headwall which has not worsened during extraction of LW W4. It is recommended that Tahmoor Coal advise the infrastructure owner of the condition of this culvert.

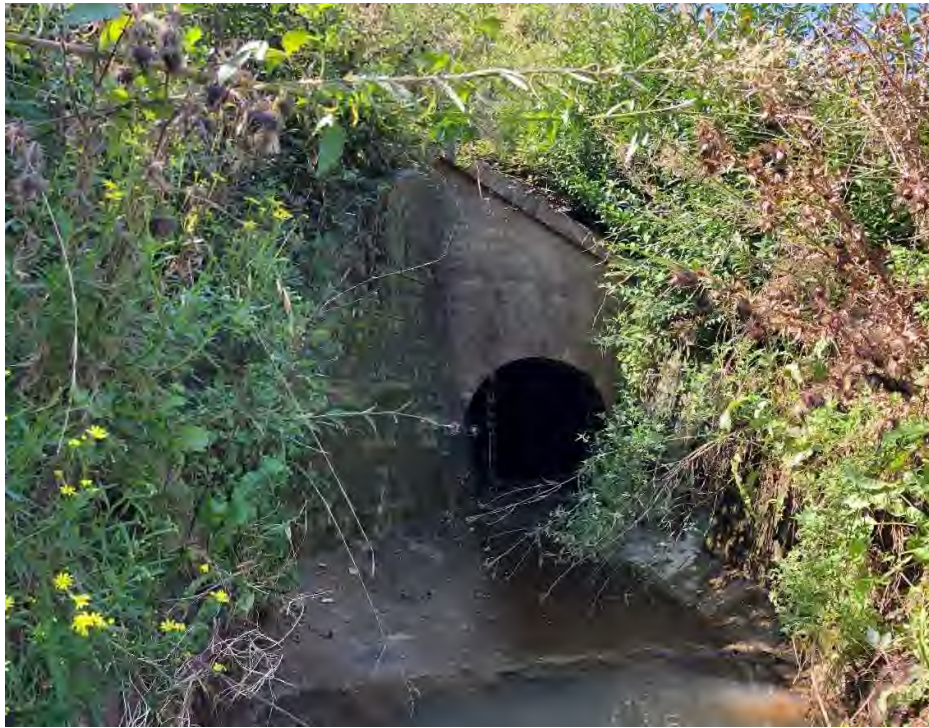
Western portal. In sound condition.

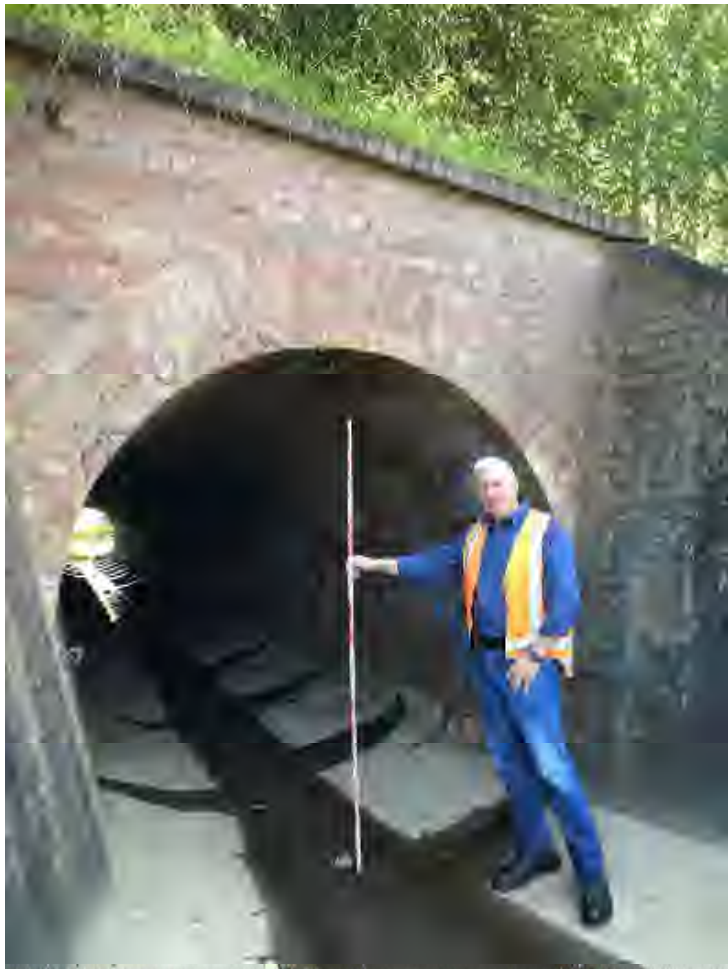
Eastern portal. Culvert is in good condition.

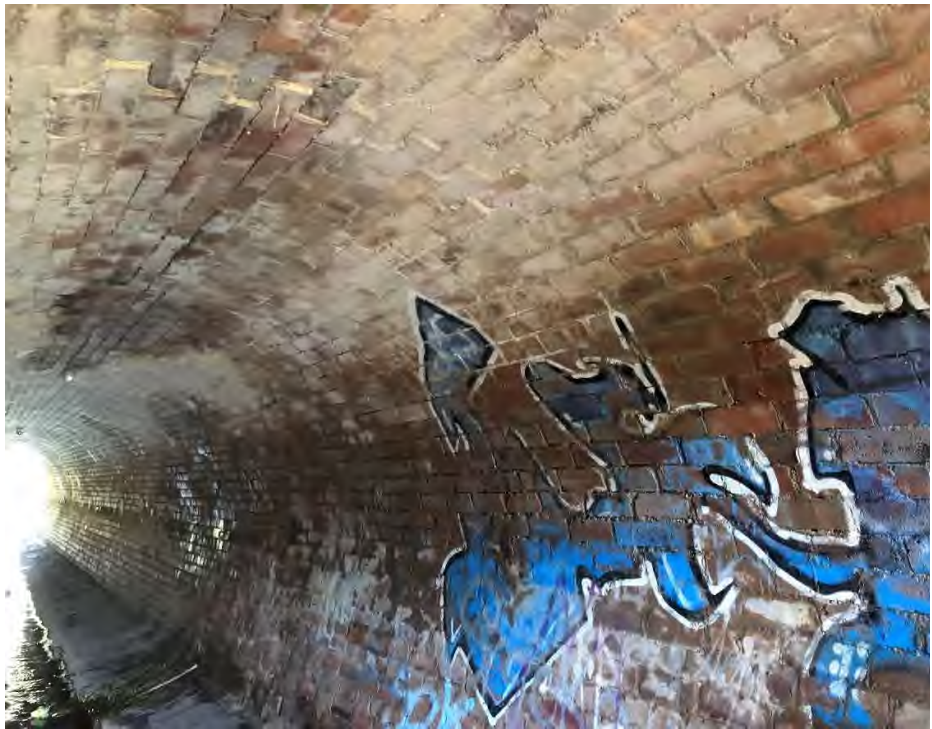
Site Name	MSR culvert 89.216
Heritage listing	Not listed
Site type	Built structure
Location	590 m east of LW W3.
Predicted probability of impact during LW W3 – 4	Very unlikely
Item summary	Brick arch culvert. The brick culvert is in good condition despite a moderate amount of graffiti.
Monitoring comments	The culvert is in good condition and the cracks observed above the western portal arch were checked against the baseline photographs taken prior to longwall mining in the Western Domain and identified as pre-existing. The crack along the centre of the culvert roof may have worsened slightly.

Roof of culvert. View west

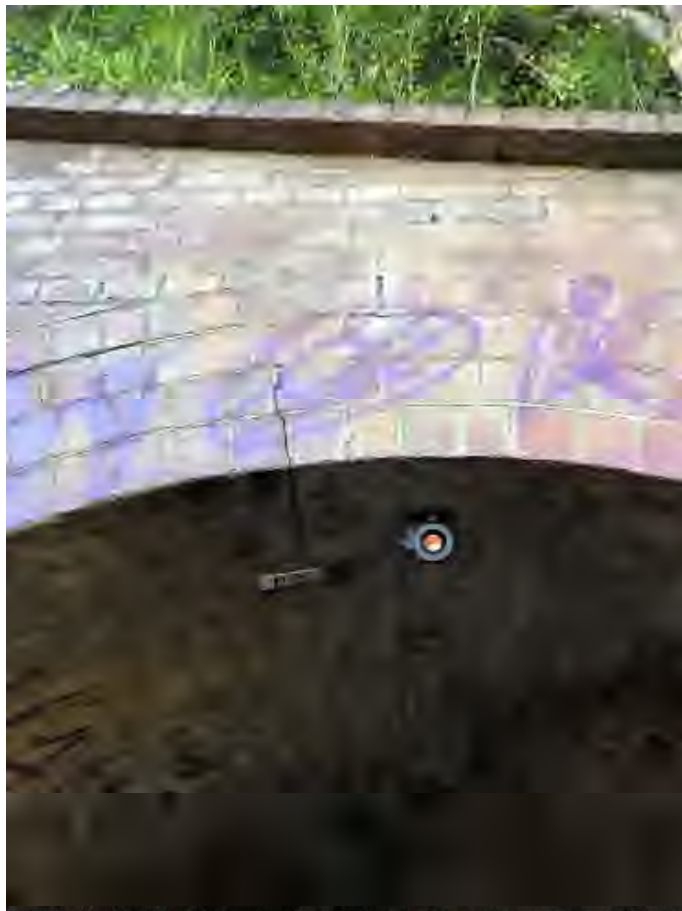
Western portal. Cracking through the mortar above the arch continues along the roof of the culvert.

This culvert has minor cracking and weathering throughout but is in sound condition. Cracking is generally confined to the mortar between the bricks and continues along the centre of the culvert's roof. As no mining-related impacts to this culvert have been noted, no remedial works are required.

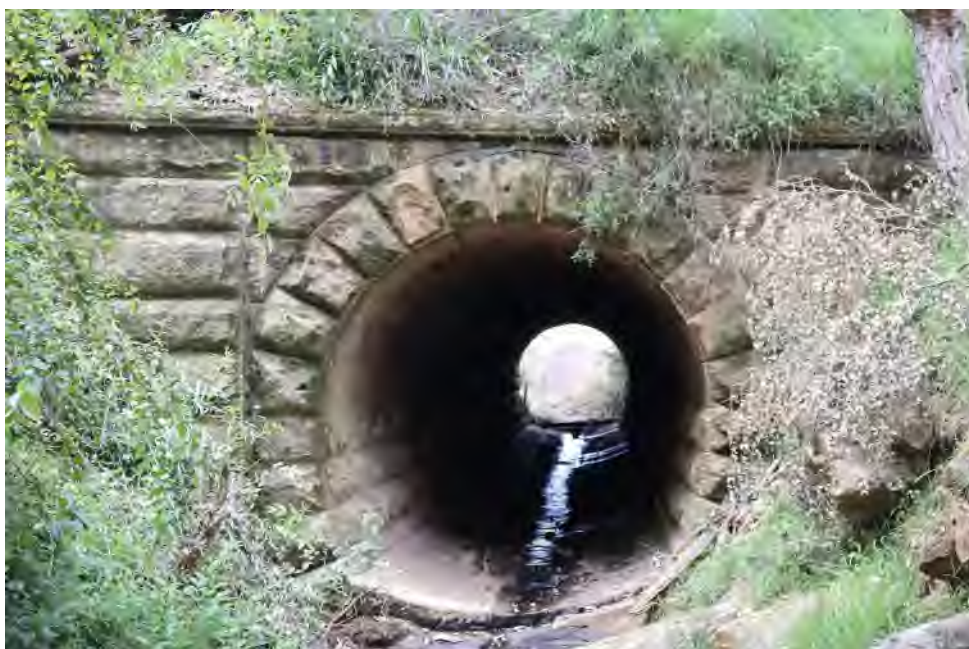
Culvert 88.980 was in poorer condition than the other sandstone culverts prior to the commencement of longwall mining in the Western Domain. Additional cracks through the mortar and sandstone capping as well as some minor spalling of the arch stones of the western portal developed during extraction of LW W2.

No new impacts to culvert 88.980 have been observed during monitoring throughout the extraction of LW W4. The end of panel heritage inspection identified that the eastern (downside) portal is generally in good condition. The western portal, apart from minor flaking, has not developed additional cracking, or worsening of existing cracks or spalling (Appendix A - Photo 88.980-2). All existing cracking observed during LW W2 and LW W3 have been noted by Newcastle Geotech as exhibiting no change, remain largely minor in nature and continue to have no impact on the overall structural integrity of the culvert or to the safety of the track or train operations.

Photo 88.980-1 Western portal. Cracking around arch stones that was first noted during extraction of LW W2 has not worsened during LW W4.

As mining in the Western Domain has been completed, repairs of the sandstone arch stones on the western portal can now be undertaken. These repairs should be completed in accordance with the Transport for NSW Heritage Structures Repair Standard.

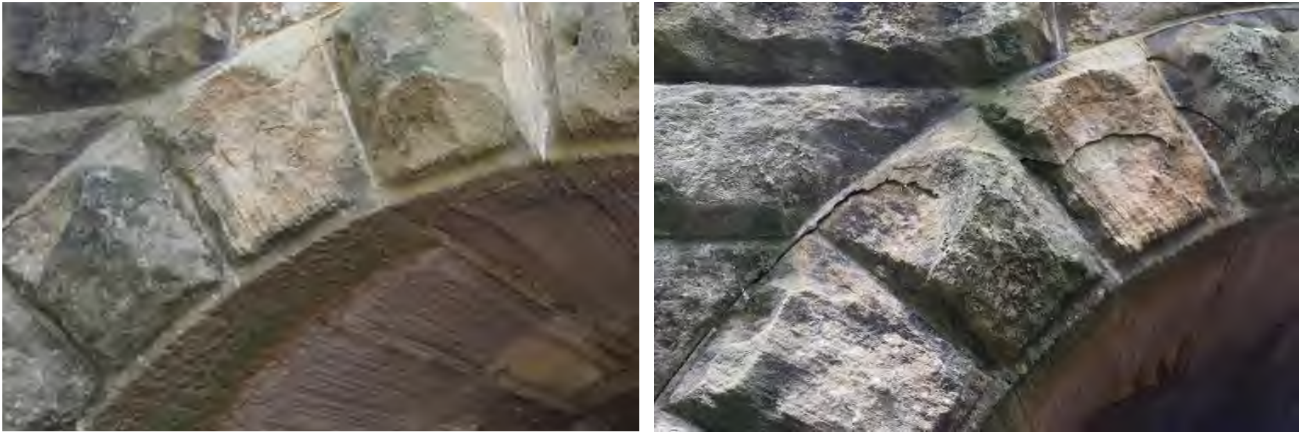
Photo 88.980-2 Western portal. Pre-mining (left) and post-mining (right) inspection photographs. Cracking along the mortar and spalling of the arch stones has not worsened significantly during extraction of LW W4.

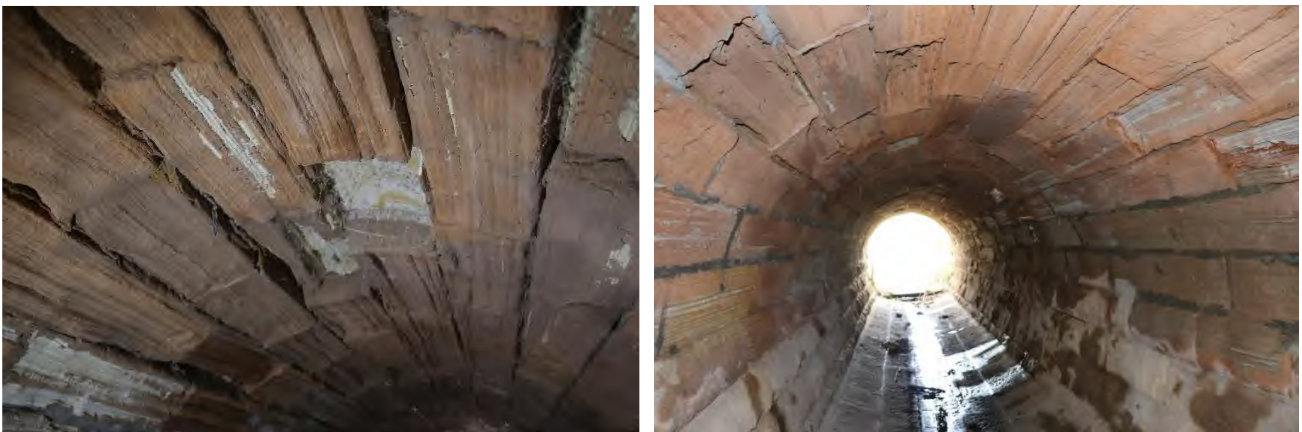
The RCP sleeve within the culvert has been removed and inspected in detail by EMM (refer to Appendix A) noting that the overall structure to culvert 88.980 was in a stable condition, substantiating the above assessments. An inspection of the culvert barrel noted that sandstone surfaces were broadly experiencing significant surface erosion, particularly to the upper sections of the barrel (Appendix A - Photo 88.980-3). This erosion was noted during the pre-mining inspection, and therefore is not likely to be attributed to mining and is likely due to the broad permeation of salt-laden groundwater (Refer to Appendix A.1 and included pre-mining inspection photographs).

Photo 88.980-3 Barrel of culvert. Pre-mining (left) and post-mining (right) inspection photographs. Significant surface erosion and exfoliation throughout the barrel noted in the pre-mining report.

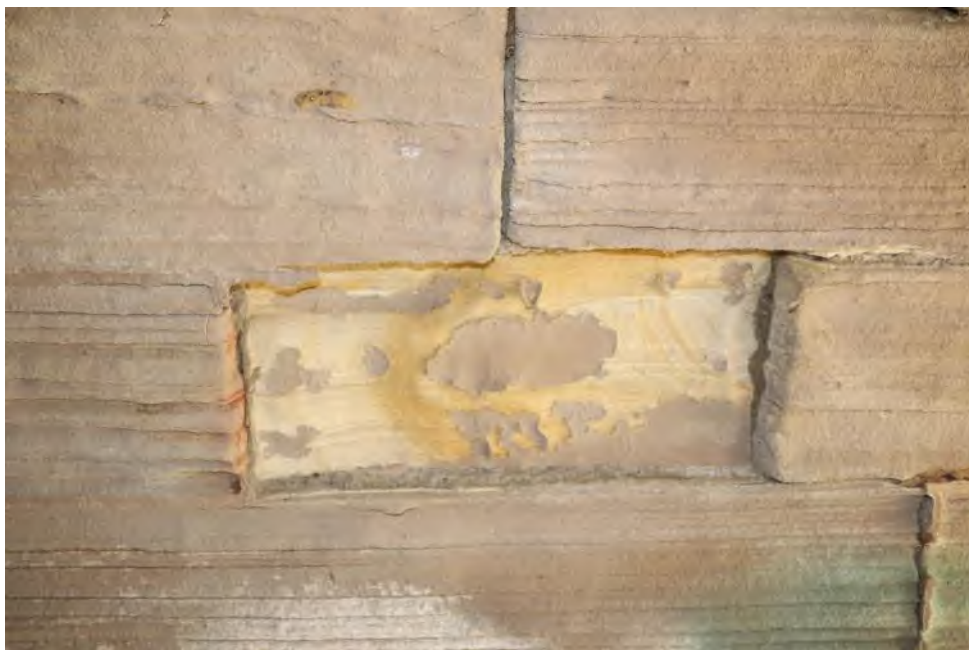
Photo 88.980-4 Example of significantly eroded sandstone block to barrel noted in the pre-mining report.

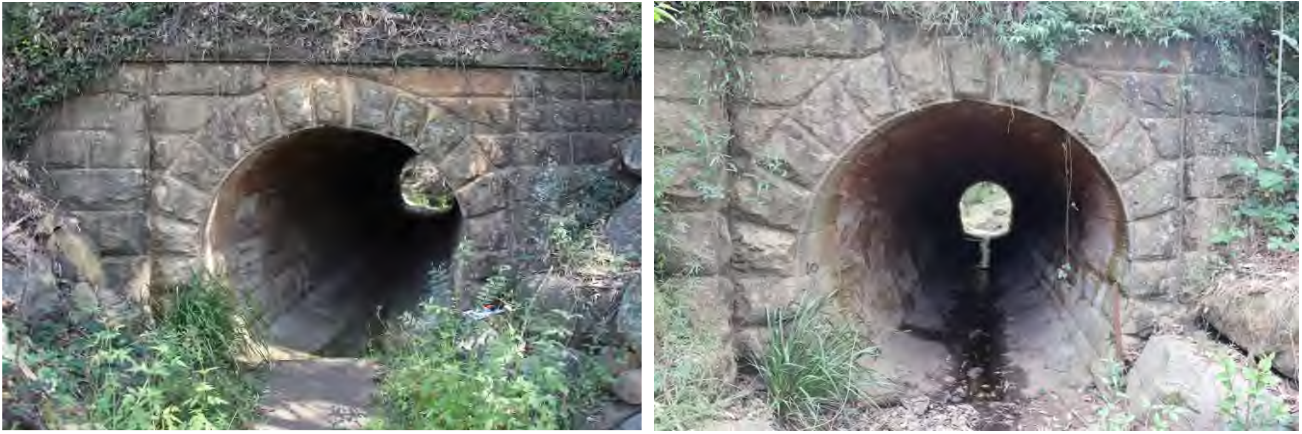
Photo 88.980-5 Eastern portal. Pre-mining (left) and post-mining (right) inspection photographs. Generally in good condition with no new cracking due to extraction of LW W4.

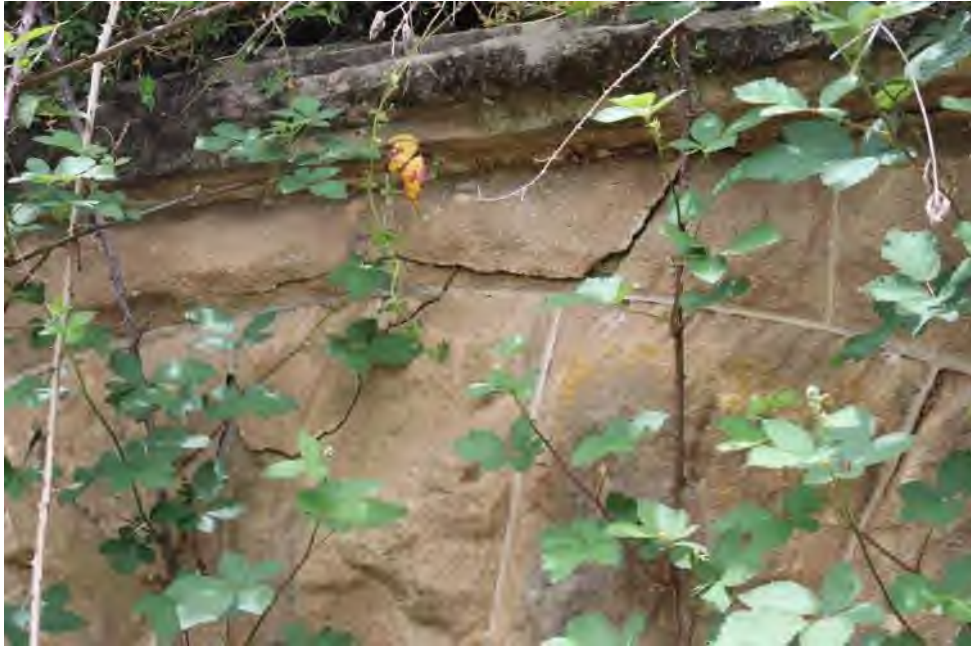
To date, culvert 88.400 has experienced the greatest impacts of the Loop Line culverts within the Study Area. An 8 mm wide crack in the vertical mortar joint and cracked sandstone capping on the downside abutment (eastern side of culvert), as well as a 7 mm wide crack in a mortar joint around the arch stones at the upside (western side of culvert) as well as minor spalling of sandstone on the arch stones were observed during extraction of LW W2. These impacts are a result of the lime grout becoming so strong over time that the weaker sandstone blocks sheer just below the grout bedding plain when under strain.

Photo 88.400-1-Western portal. Spalling above the arch that developed during extraction of LW W2 has not worsened significantly during LW W4.

As mining in the Western Domain has been completed, repairs can now be undertaken on the arch stones on the eastern and western sides of the culvert as well as any additional cracks identified in the culvert barrel that have formed during mining. These repairs should be completed in accordance with the Transport for NSW Heritage Structures Repair Standard.

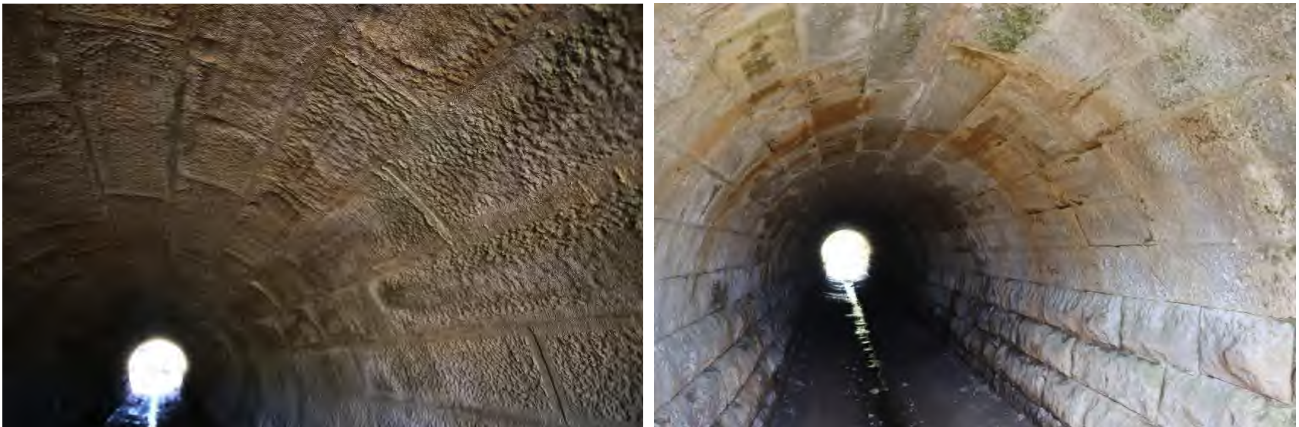
Photo 88.400-2 Barrel of culvert. Pre-mining (left) and post-mining (right) inspection photographs. In generally good condition with only minor cracking to sandstone blocks.

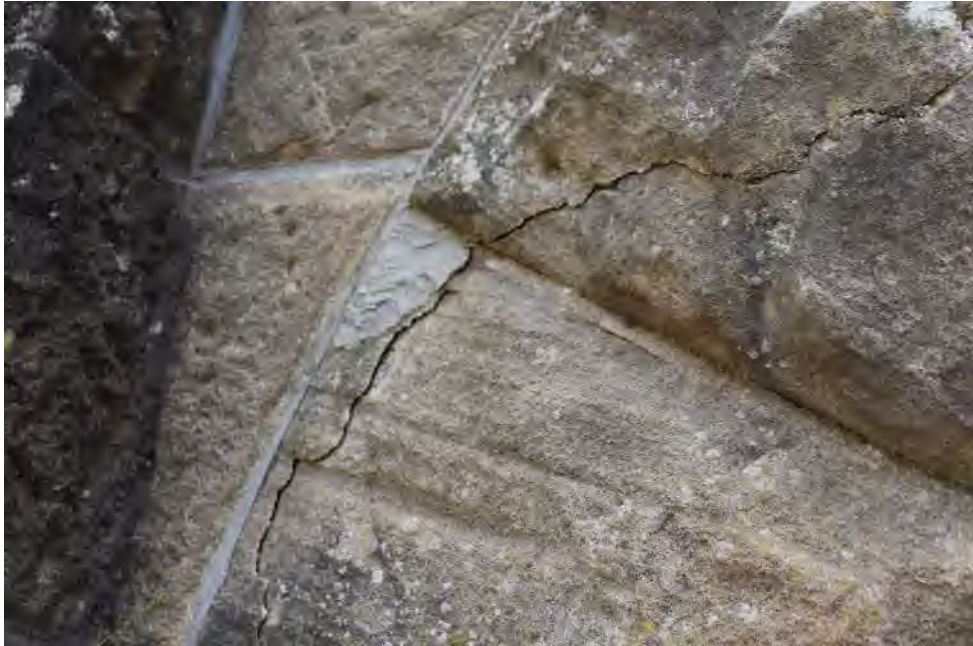
Photo 88.400-3 Eastern portal. No worsening of cracking during extraction of LW W4.

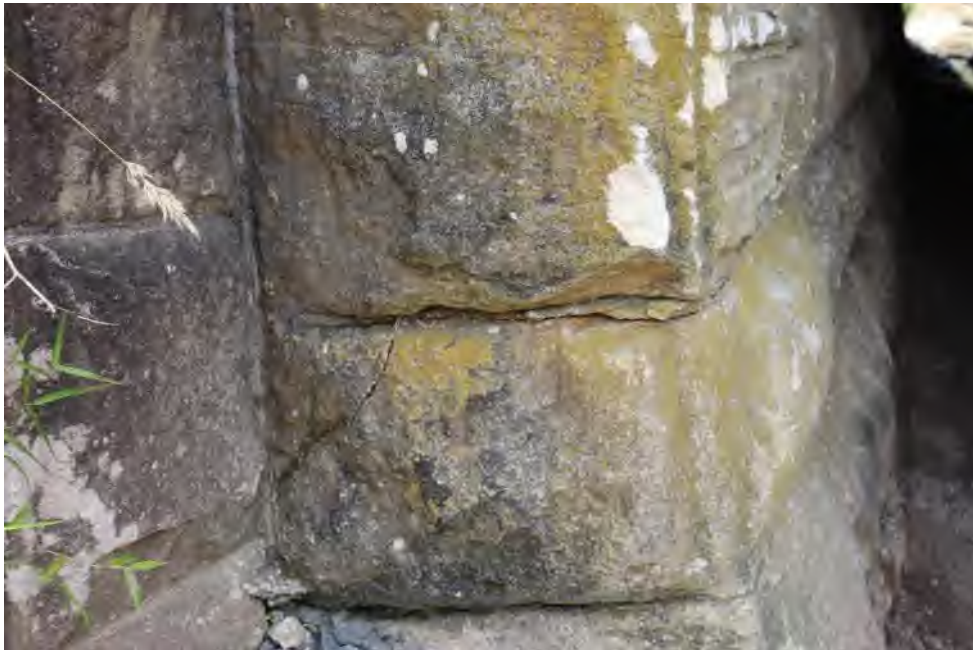
Photo 88.400-4 Eastern portal. Cracking to the arch of the culvert previously identified has not worsened significantly during LW W4.

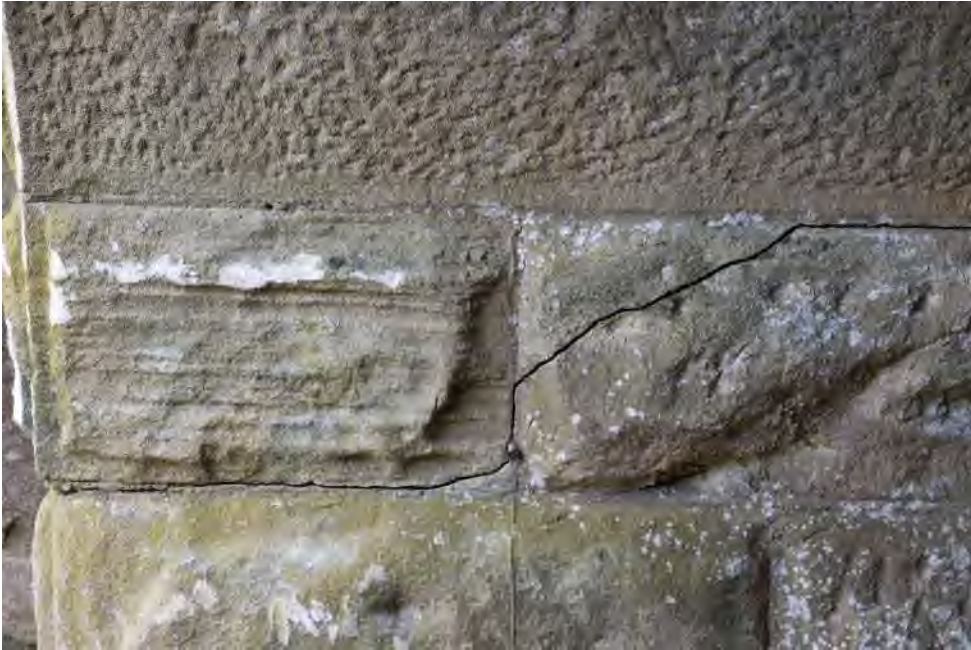
The RCP sleeve within the culvert has been removed and inspected in detail by EMM (refer to Appendix A) noting that the overall structure to culvert 88.400 was in a stable condition, substantiating the above assessments. Several identified cracks that have formed since the commencement of mining in the Western Domain were identified within the culvert barrel described in Appendix A. The inspection found that the cracks are in isolated locations, move through and impact both mortar and blockwork (fractures), and vary from being moderate to significant in size.

The above noted cracks were not identified during the baseline survey by a heritage consultant due to excessive overgrown vegetation obscuring view of the full extent of the culvert. An inspection of the culvert was however conducted in July 2019 by Robinson Rail prior to the introduction of the RCP sleeves and prior to the commencement of extraction in the Western Domain. Inspection findings were detailed in the dilapidation report (Robinson Rail, August 2019, pg. 21-23), noting that the culvert was in good condition. No reference was made in the report to the cracks identified during the post-mining inspection as discussed above. It is therefore likely that these cracks were formed during the extraction of longwalls in the Western Domain.

Photo 88.400-5 Identified crack 1 to culvert barrel. Not noted in the pre-mining report.

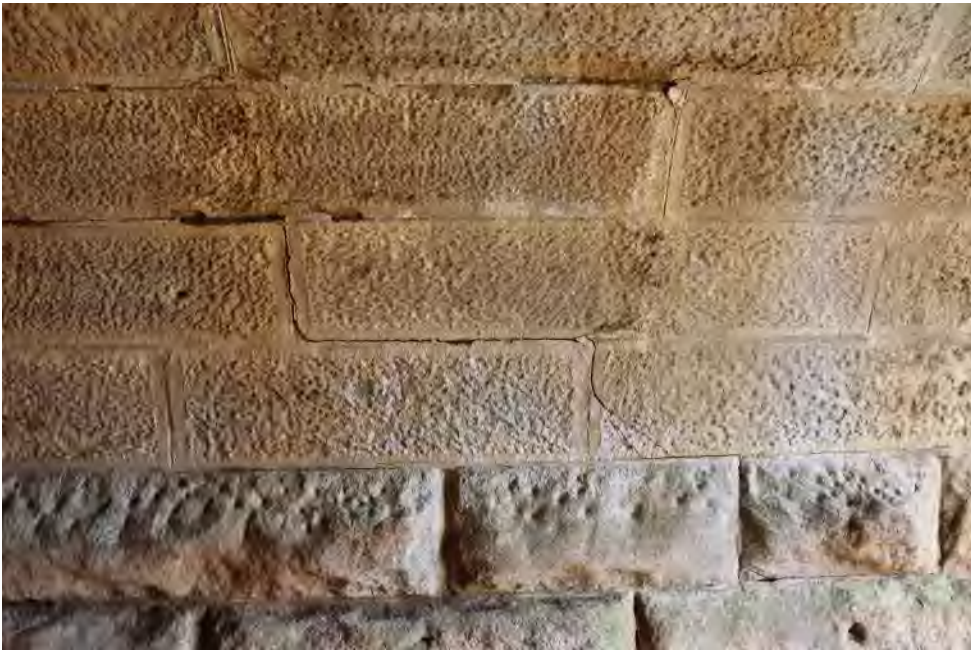
Photo 88.400-6 Identified crack 2 to culvert barrel. Not noted in the pre-mining report.

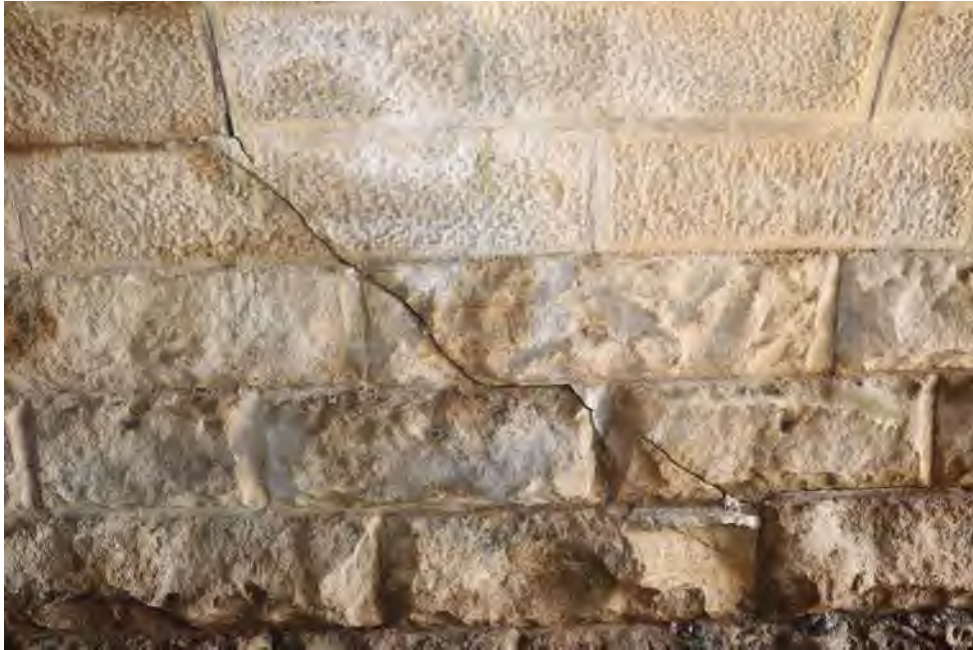
Photo 88.400-7 Identified crack 3 to culvert barrel. Not noted in the pre-mining report.

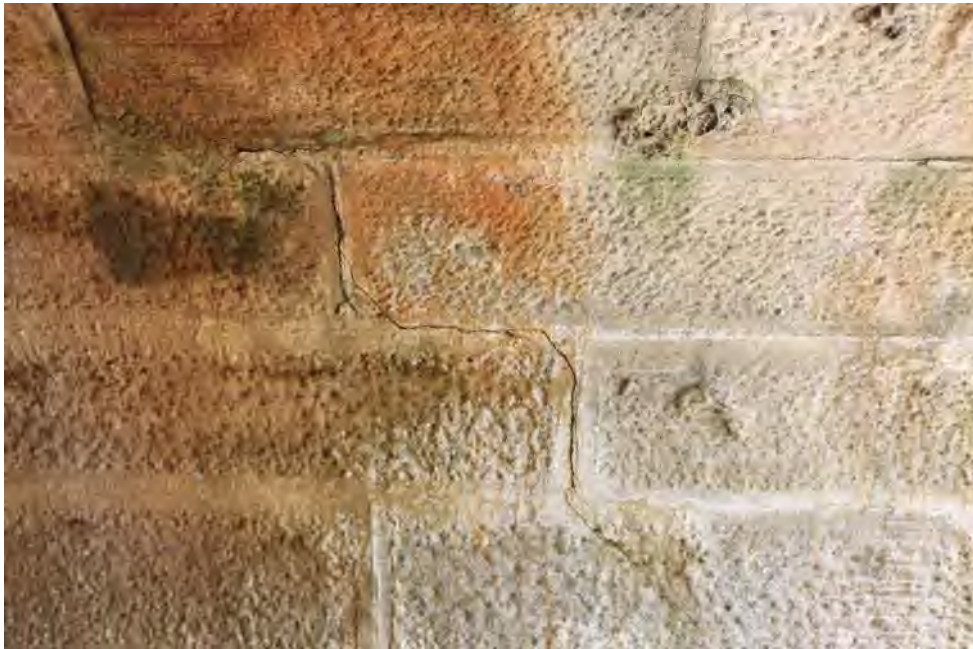
Photo 88.400-8 Identified crack 4 to culvert barrel. Not noted in the pre-mining report.

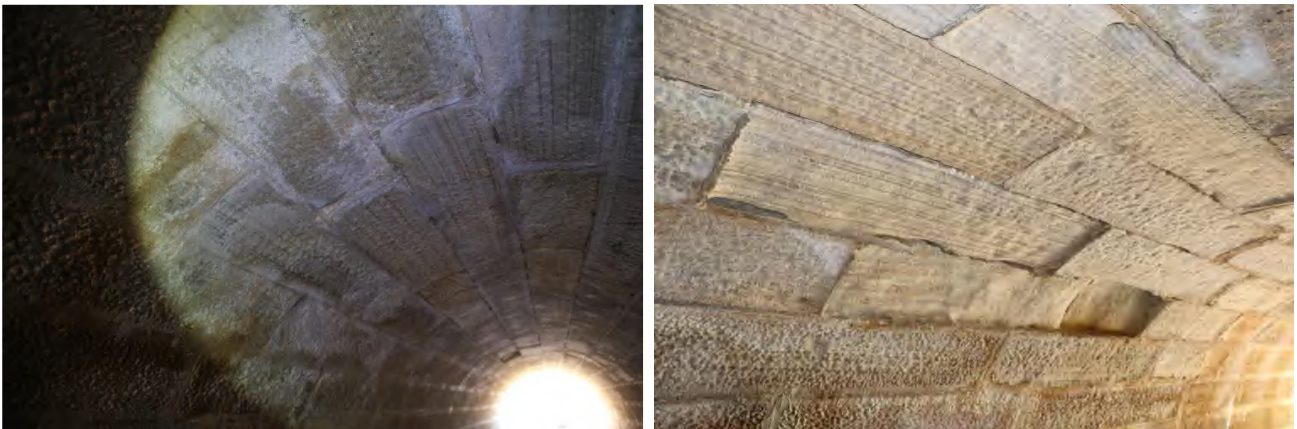
Photo 88.400-9. Pre-mining (left) and post-mining (right) inspection photographs. Isolated section of sandston erosion towards western portal. Not noted in the pre-mining report however no noted increase in surface erosion during LW W4.

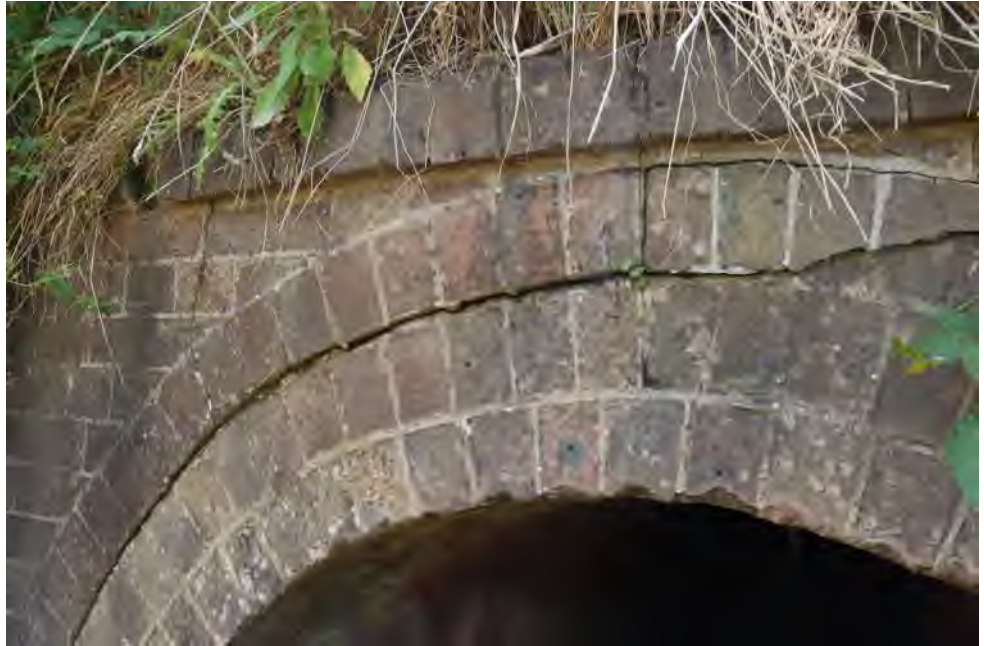
Brick culvert 87.850 has significant cracking across and between the bricks that was identified during pre-extraction inspections. Cracking around the arch is causing the course of bricks to displace. During LW W4, Mark Delaney inspected the culvert on 11 October 2022 and noted that these existing cracks on both sides of the culvert have not increased during extraction of LW W4. As no mining-related impacts to this culvert have been noted, no remedial works are required.

Photo 87.850-2 Detail, pre-existing cracking and displacement of bricks around the eastern portal arch that does not appear to have worsened significantly during longwall mining in the Western Domain.

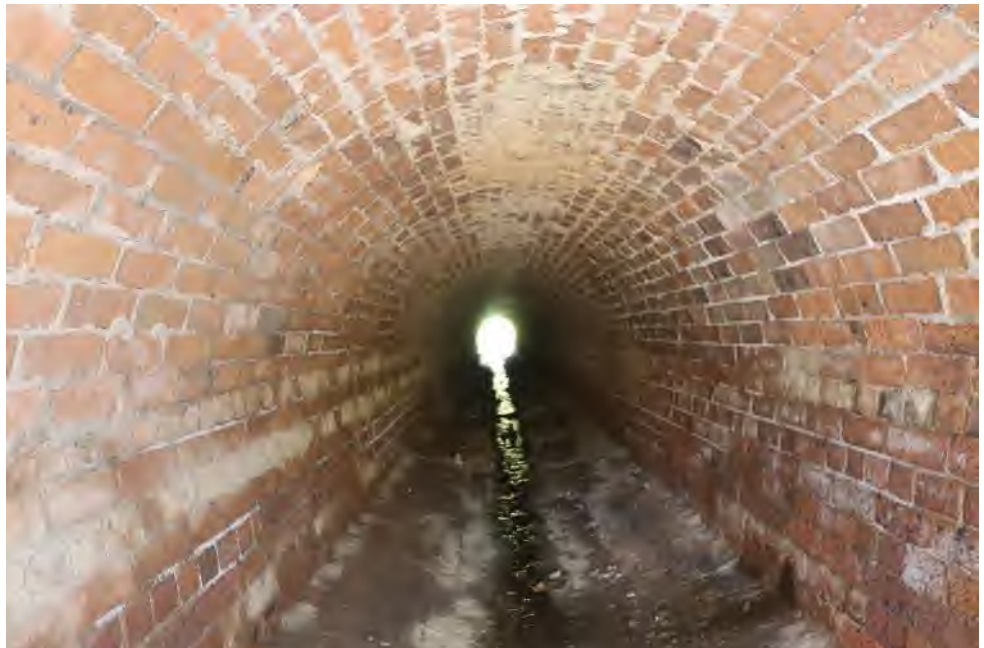
Photo 87.850-3 Masonary culvert barrel.

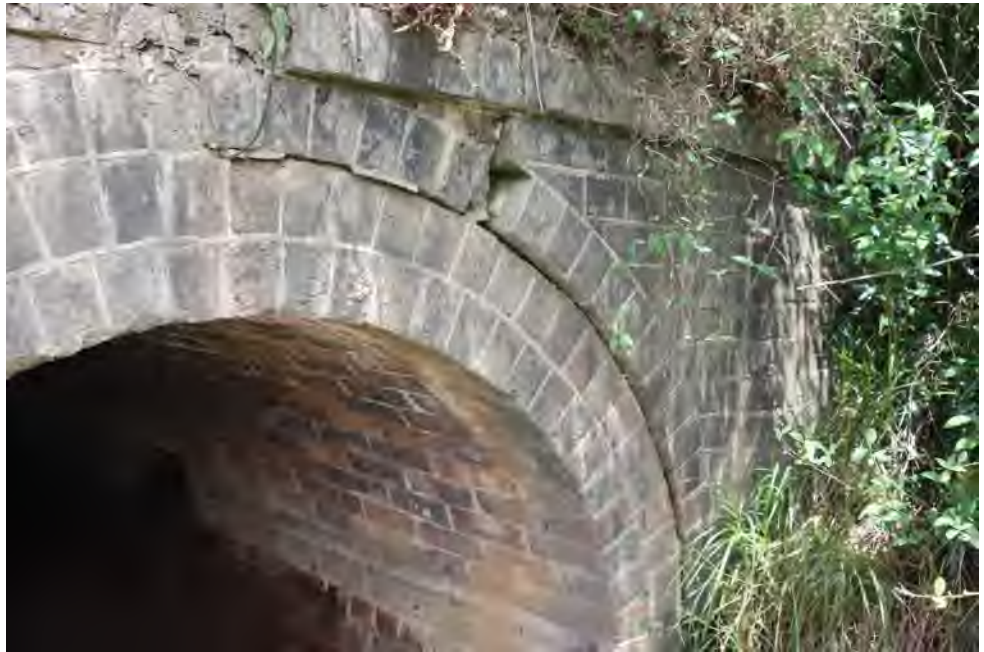
Photo 87.850-4 Cracking and displacement of bricks around the western portal arch. Does not appear to have worsened during longwall mining in the Western Domain.

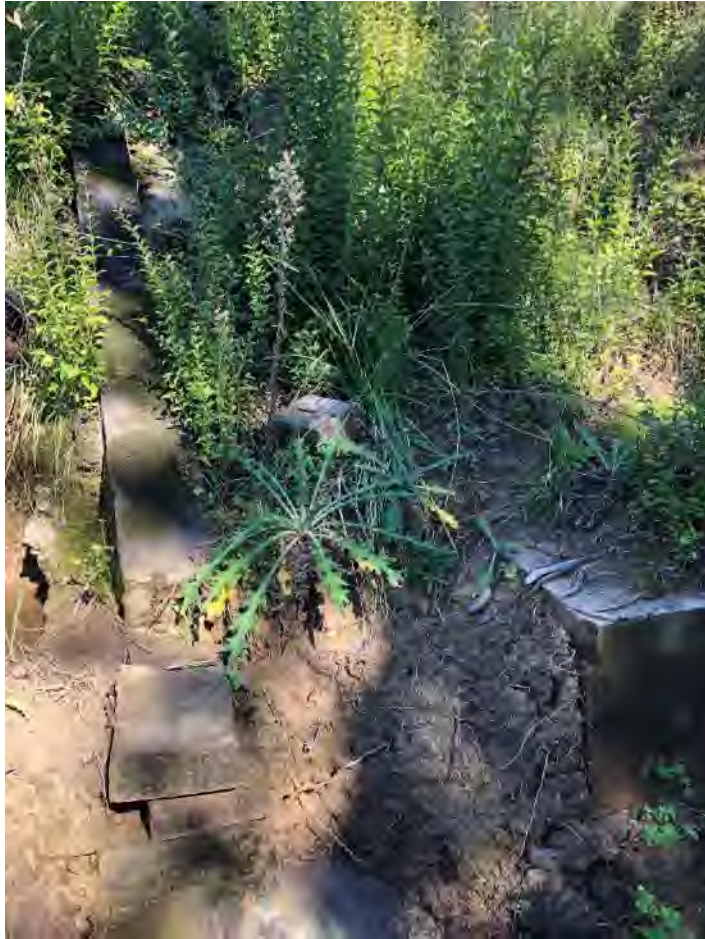
Photo 87.330-2 Displaced bricks at the base of the brick chute to the south of the eastern portal.

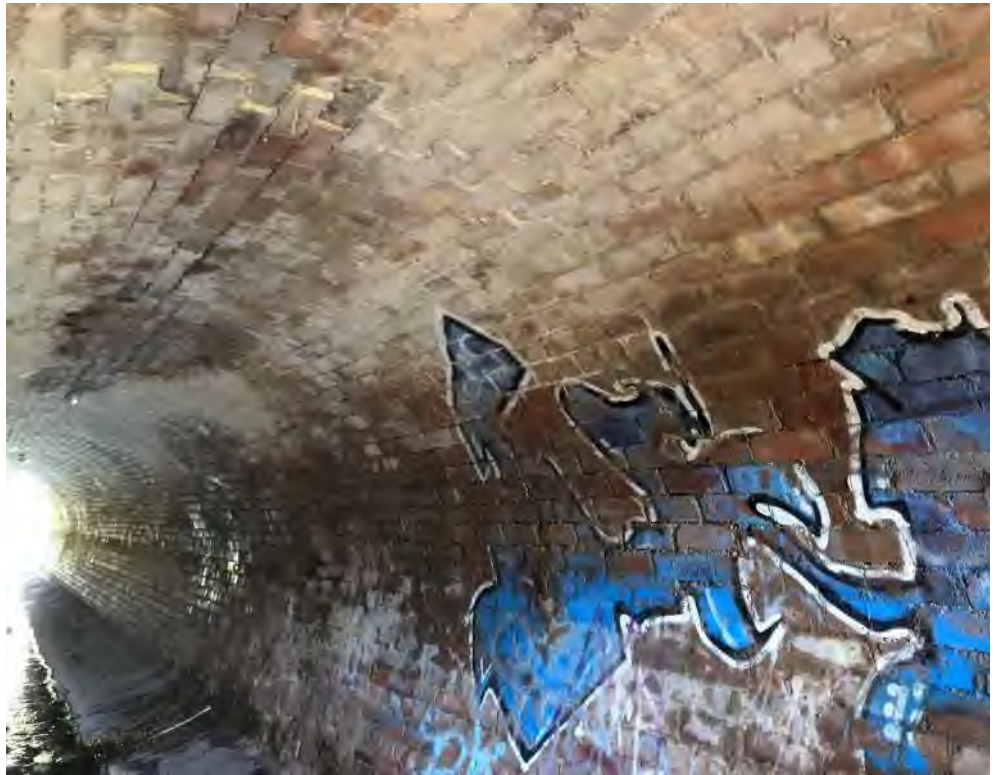
Photo 89.216-2 Roof of culvert. View west

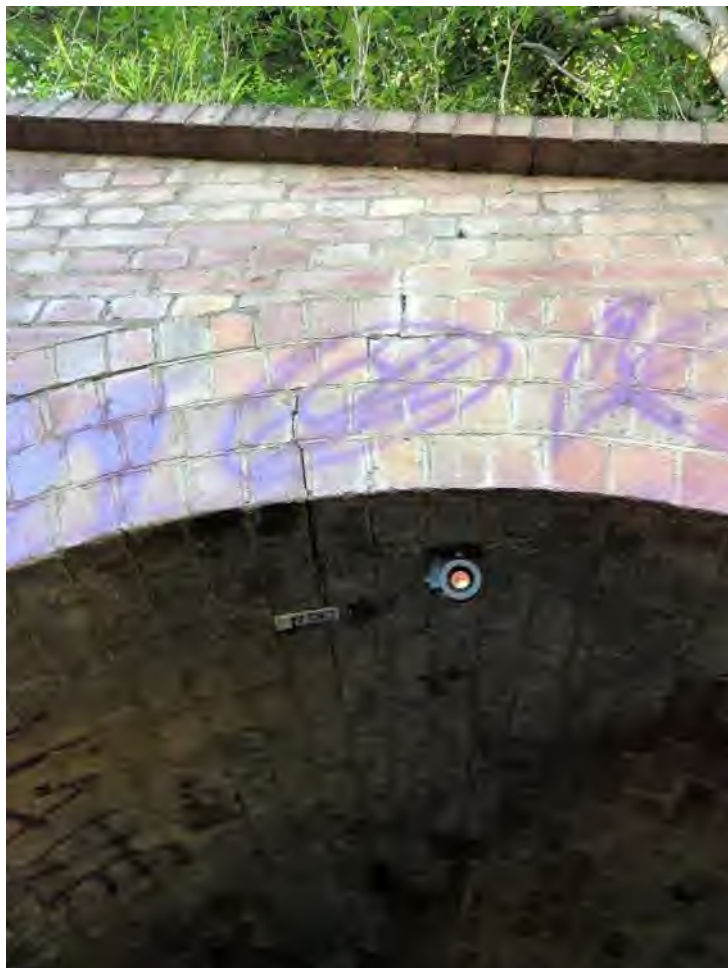
Photo 89.216-3 Western portal. Cracking through the mortar above the arch continues along the roof of the culvert.
