Tahmoor Coal Pty Ltd

SIX MONTHLY SUBSIDENCE IMPACT REPORT

Western Domain Longwalls West 1 – West 4

Report 8 – September 2023

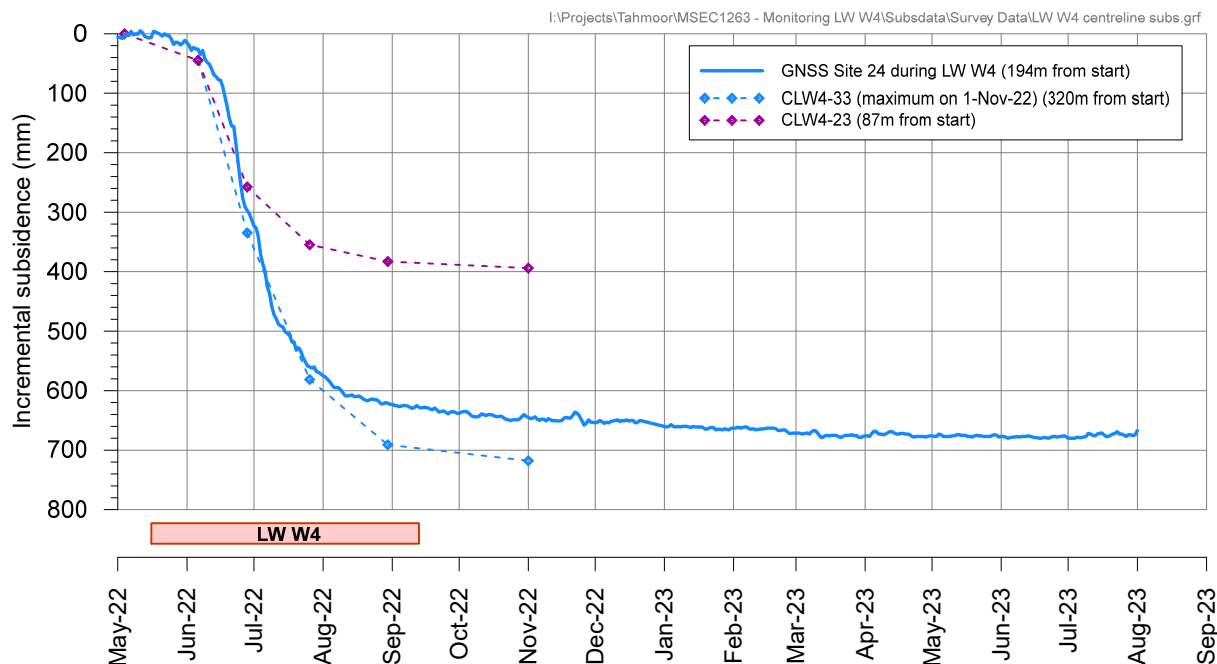
Figure A Development of subsidence along centreline of LW W4

GNSS Site 24 is located directly above the centreline of LW W4, approximately 200 metres from the commencing end. The unit has recorded approximately 660 mm subsidence and has also moved to the east and south. Rates of change have reduced to very low levels.

The development of subsidence over time, at sites of interest along the centreline, is shown in Figure A. GNSS Site 24 recorded an additional 16 mm of vertical subsidence between 1 January 2023 and 30 June 2023.

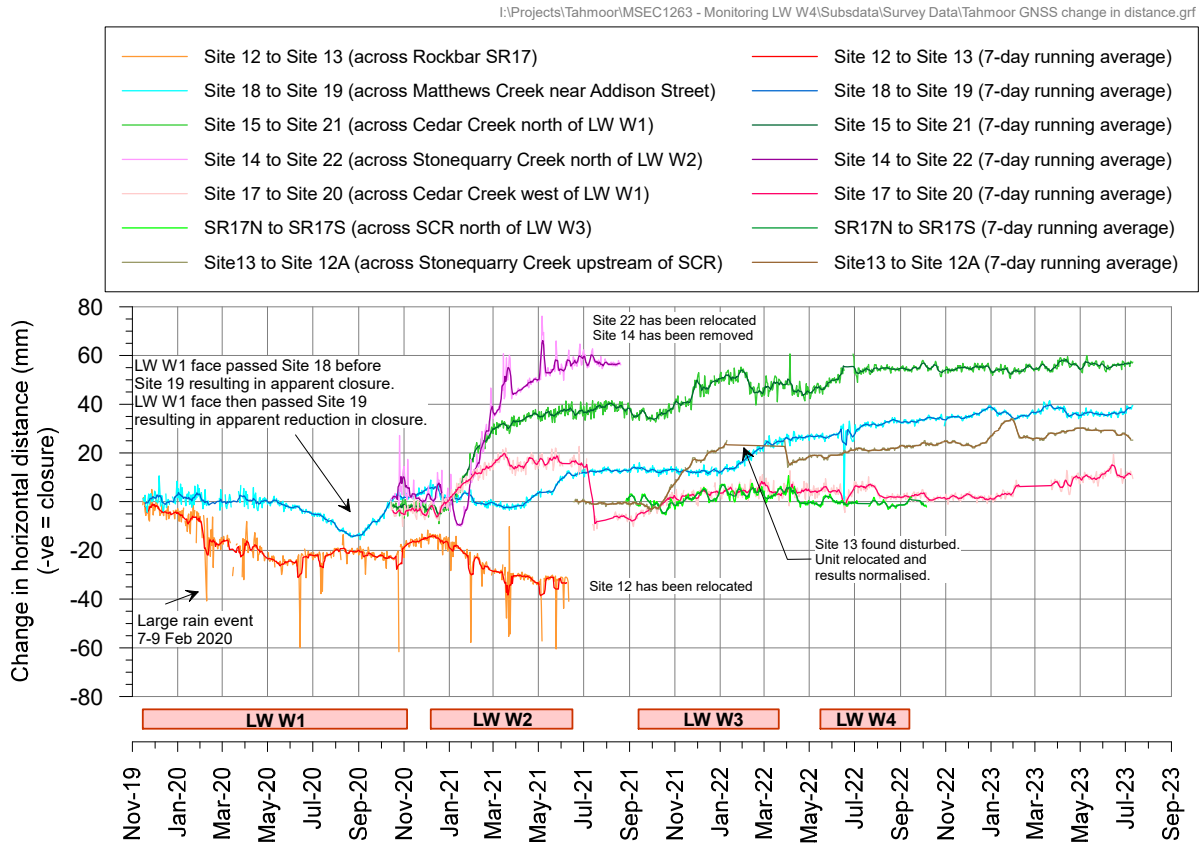
Figure B Observed changes in horizontal distances between GNSS units

It can be seen that the remaining pairs of units have recorded a net ground extension when monitoring ceased in July 2023. Trends of increasing ground extension across Sites 18 and 19 (Matthews Creek) and Sites 15 and 21 (Cedar Creek) ceased in January 2023, with very little change recorded during the reporting period to July 2023.

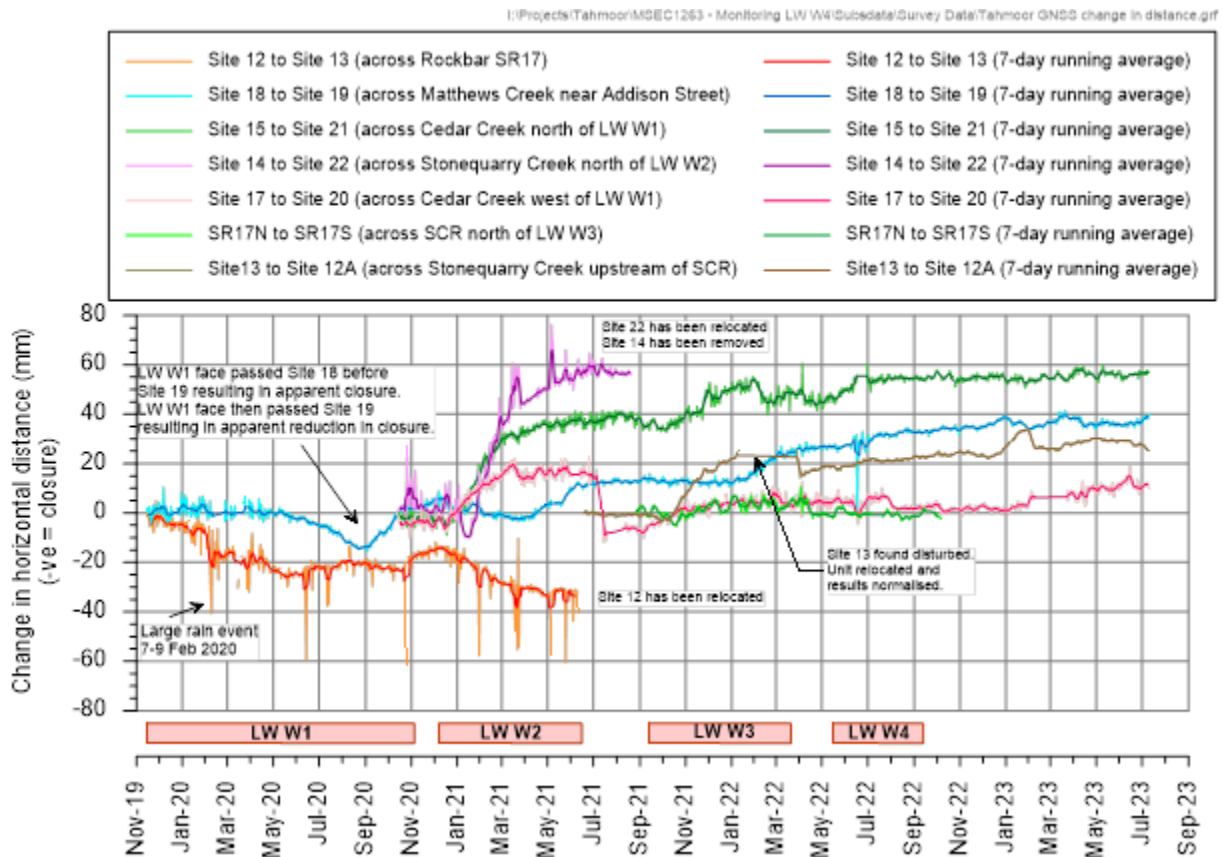
**DIAGRAM 1: OBSERVED CHANGES IN HORIZONTAL DISTANCES BETWEEN GNSS UNITS
(SOURCE: MSEC, 2023)**

From the completion of LW W4 (October 2022) to end of June 2023, the following was recorded (MSEC, 2023):

- Small changes in horizontal distance at Site SR17N to Site SR17S across rockbar SR17 (SCR).
- Less than 10 mm change in horizontal distance at Site 13 to Site 12A, located across Stonequarry Creek upstream of rockbar SR17 (SCR).
- Less than 10 mm change in horizontal distance at Site 18 to Site 19, located across Matthews Creek near Addison Street.
- Less than 20 mm change in horizontal distance at Site 17 to Site 20, located across Cedar Creek to the west of LW W1.

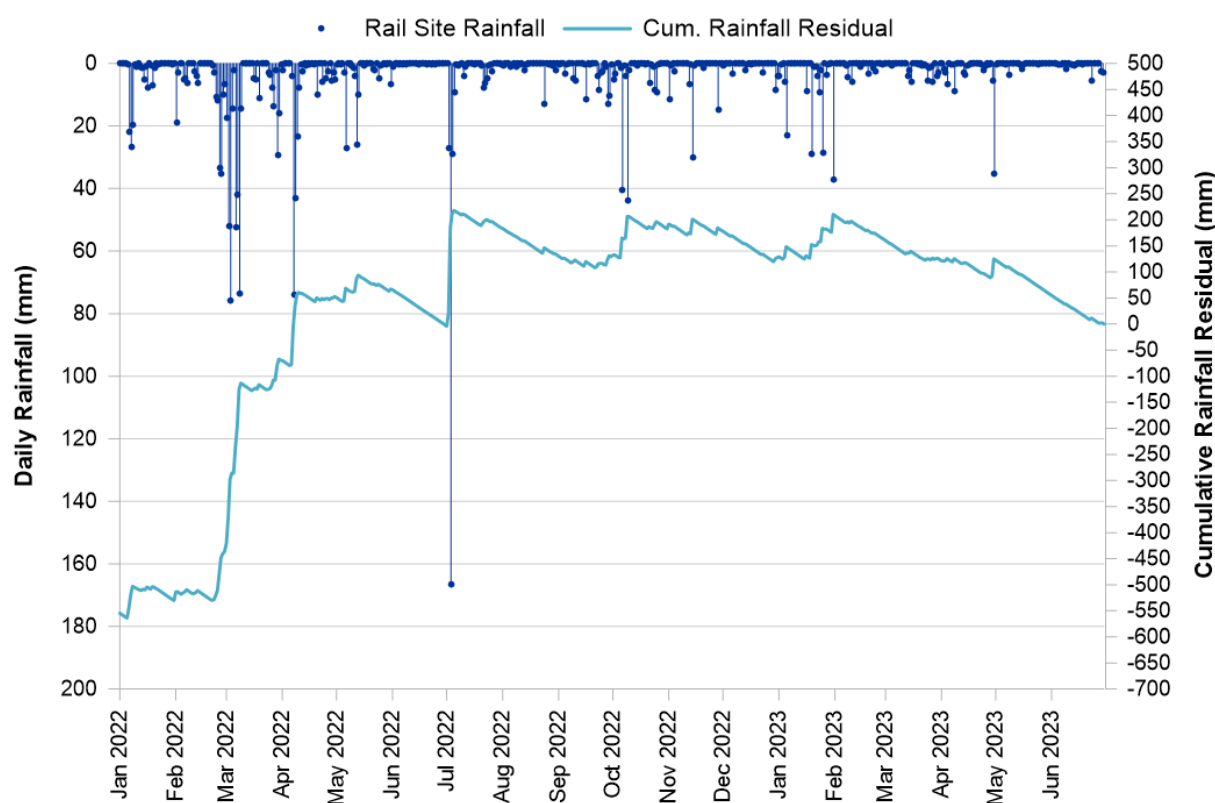
DIAGRAM 2: DAILY RAINFALL AND CUMULATIVE RAINFALL RESIDUAL

The cumulative rainfall residual represents the cumulative deviation from the average daily rainfall where positive (upward) slope in the plot indicates periods of above average rainfall and negative (downward) slope indicates periods of below average rainfall.

The cumulative rainfall residual depicted in **DIAGRAM 2** illustrates a declining trend in rainfall from February to June 2023. This is in comparison to the period of July 2022 to January 2023 where, overall, average rainfall was recorded.

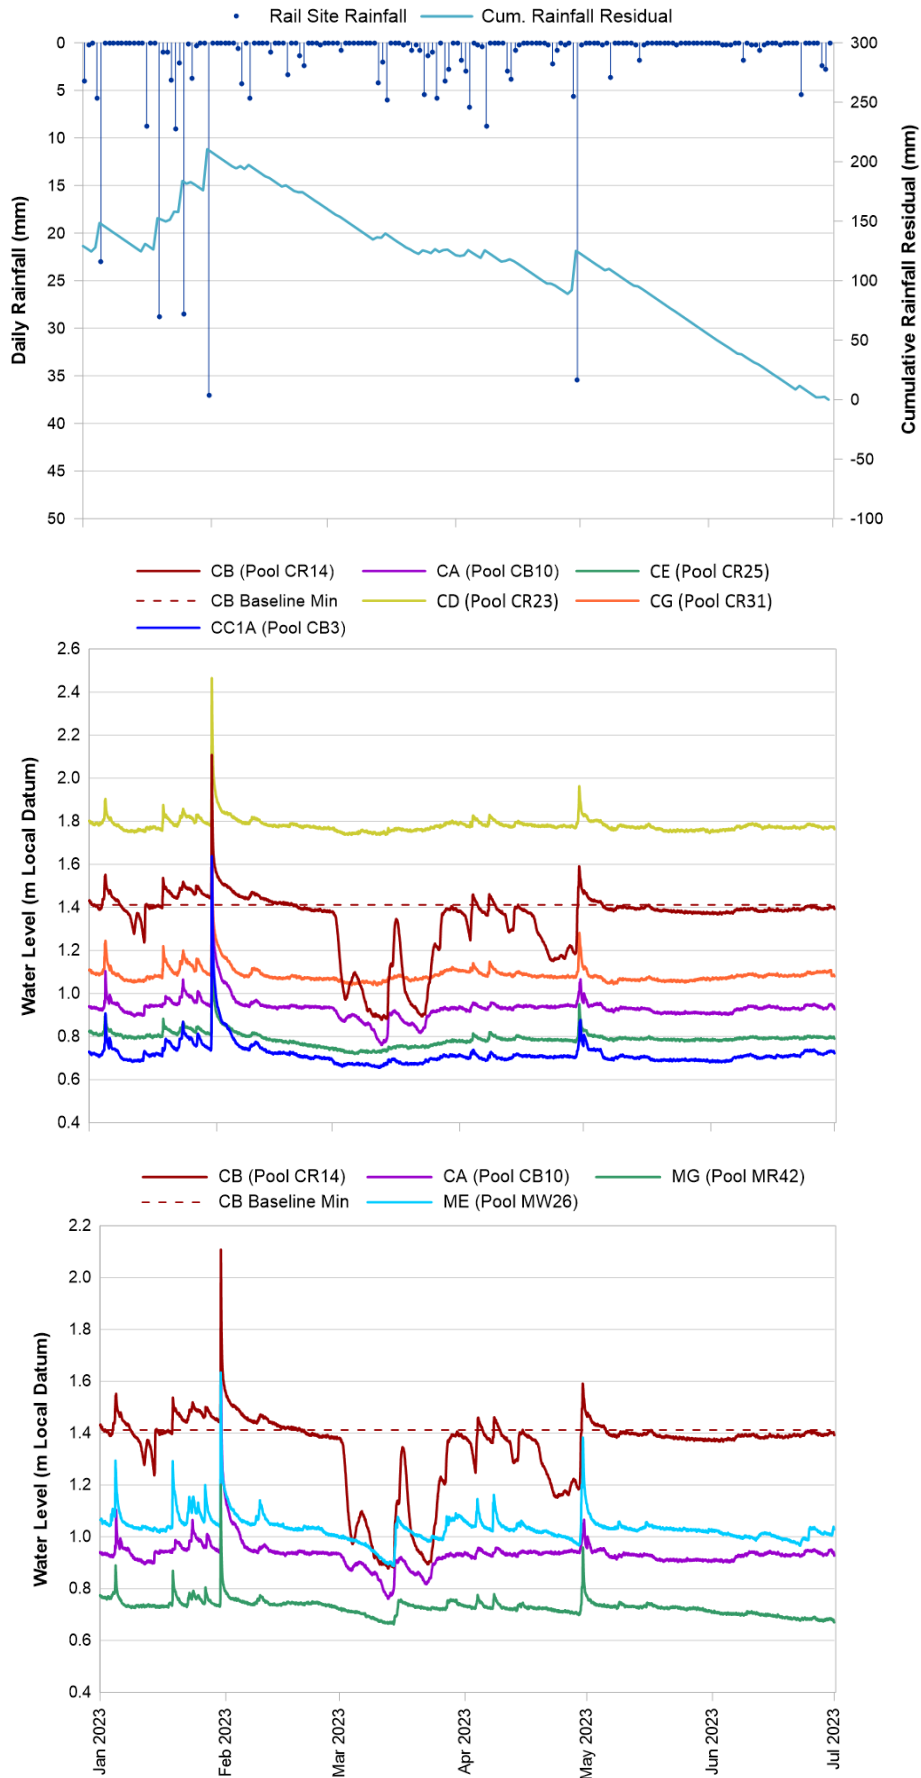
CHART 1: CEDAR CREEK WATER LEVEL AND RAINFALL

The decline in water level recorded intermittently at monitoring site CB during the review period is considered a result of below average rainfall conditions, a reduction in streamflow contribution from upstream sites (including upstream reference sites) and complex groundwater-surface interactions occurring in the vicinity of monitoring site CB which may be exacerbated by the mobilisation of fractures which is considered to have occurred during mining of LW W1-W4.

As illustrated in **Chart 1**, except following high rainfall periods, the water level at monitoring site CB (pool CR14) was recorded below the CTF level and below the baseline minimum for the majority of the review period.

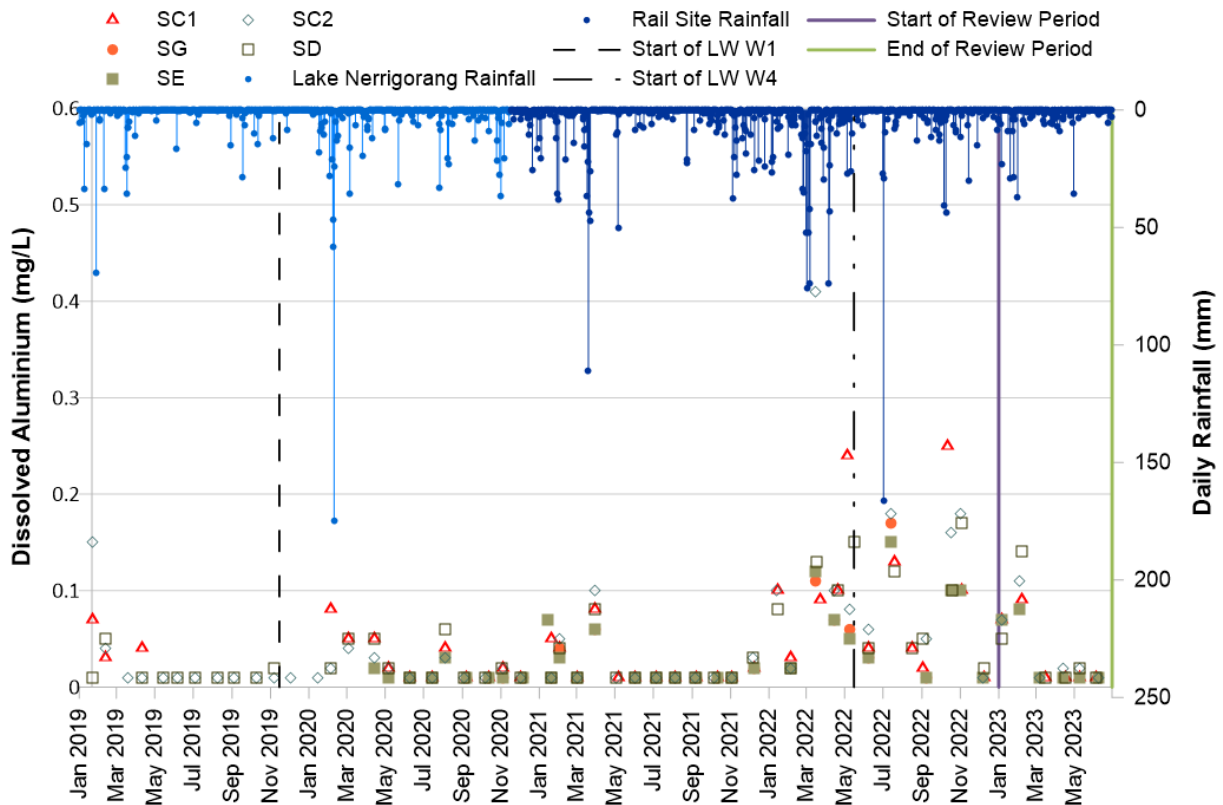
DIAGRAM 4: STONEQUARRY CREEK SITES SC2, SD AND REFERENCE SITES – DISSOLVED ALUMINUM RECORDS

As shown on **DIAGRAM 4**, the dissolved aluminium concentrations recorded at reference sites SC1 and SE, located upstream of potential mining related influences, were similar to the dissolved aluminium concentrations recorded at monitoring sites SC2 and SD in January and February 2023. In March 2023, the dissolved aluminium concentrations recorded at all sites declined to the limit of detection. As such, it is considered that the elevated dissolved aluminium concentrations recorded at monitoring sites SC2 and SD in January and February 2023 were related to the prevailing climatic conditions and indicative of natural variability rather than a residual mining effect. Accordingly, the post-mining monitoring frequency is considered appropriate.

The elevated concentrations of dissolved aluminium recorded during the review period occurred during and following rainfall. Additionally, the elevated concentrations of dissolved aluminium were also recorded at reference sites (located upstream of potential mining influences). Accordingly, the elevated dissolved aluminium concentrations are considered to be catchment wide and related to the prevailing climatic conditions. Additionally, dissolved aluminium concentrations following February 2023 were consistent with baseline concentrations. Thus, no actions are considered required.

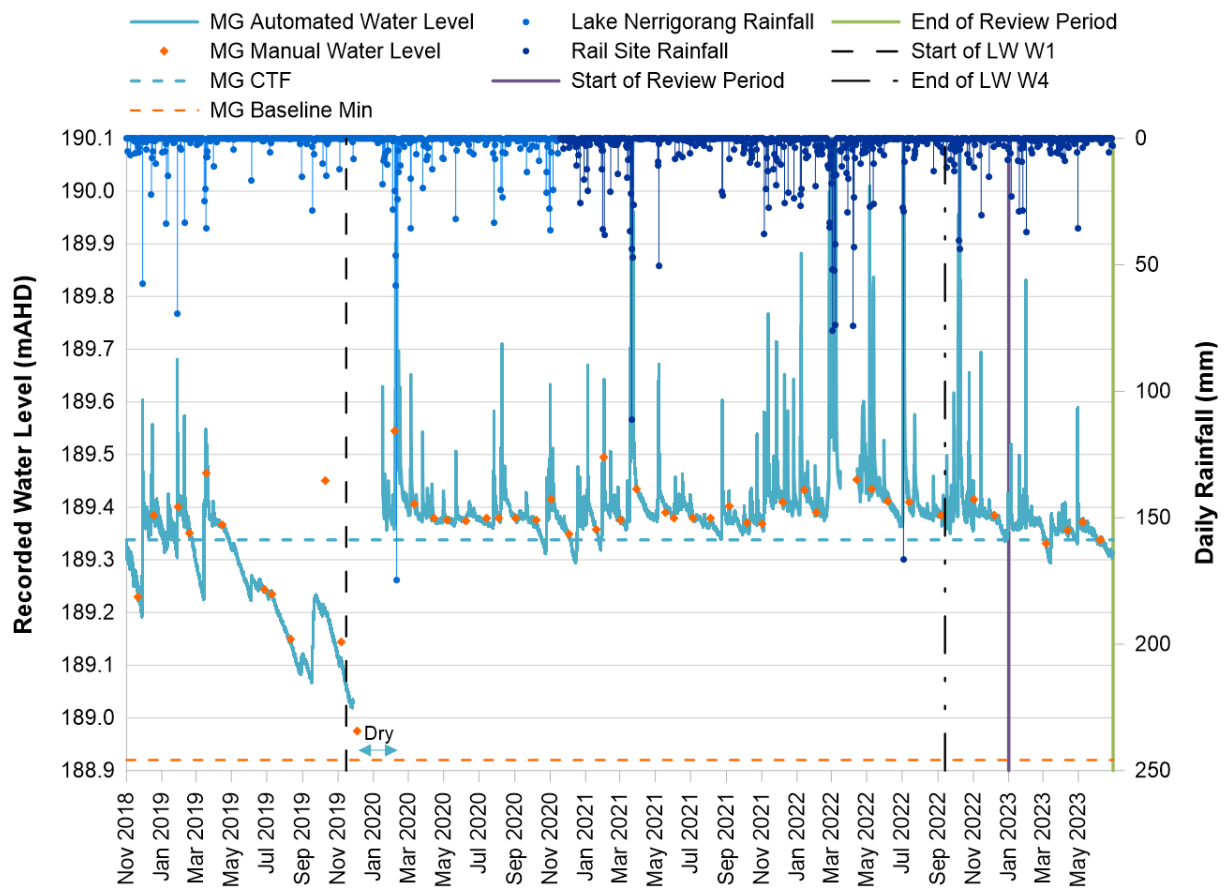
DIAGRAM B7: MONITORING SITE MG WATER LEVEL RECORDS⁵

⁵ No data was recorded between 17 March and 14 April 2022 due to a logger re-start issue.

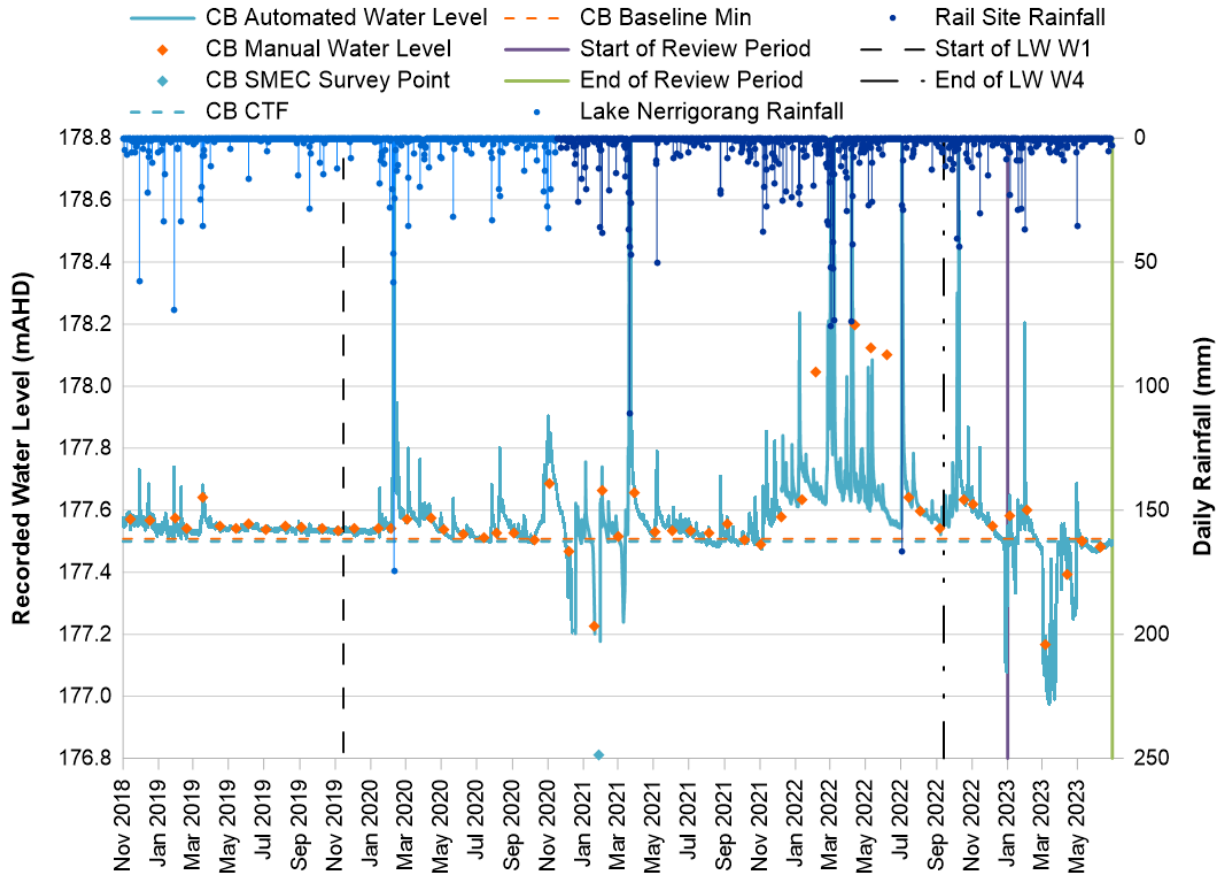
DIAGRAM B11: MONITORING SITE CB WATER LEVEL RECORDS

- The decline in water level recorded intermittently at monitoring site CB during the review period is considered a result of below average rainfall conditions, a reduction in streamflow contribution from upstream sites (including upstream reference sites) and complex groundwater-surface interactions occurring in the vicinity of monitoring site CB which may be exacerbated by the mobilisation of fractures which is considered to have occurred during mining of LW W1-W4.

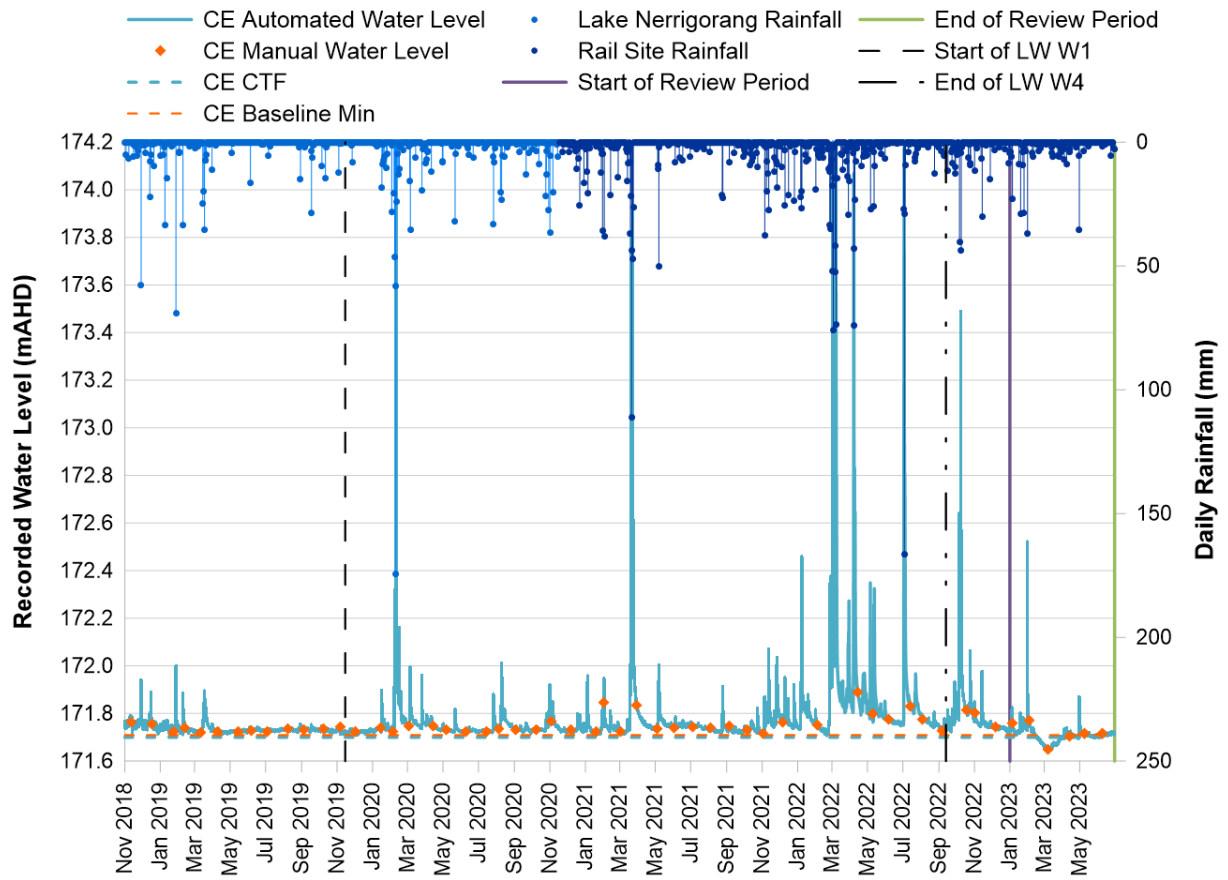
DIAGRAM B14: MONITORING SITE CE WATER LEVEL RECORDS

- The period of slight water level decline recorded at monitoring site CE was consistent with the period of water level decline recorded at monitoring site CB. As such, it is considered that the water level decline recorded at monitoring site CE was related to a decline in surface flow from upstream monitoring site CB in combination with below average rainfall conditions.

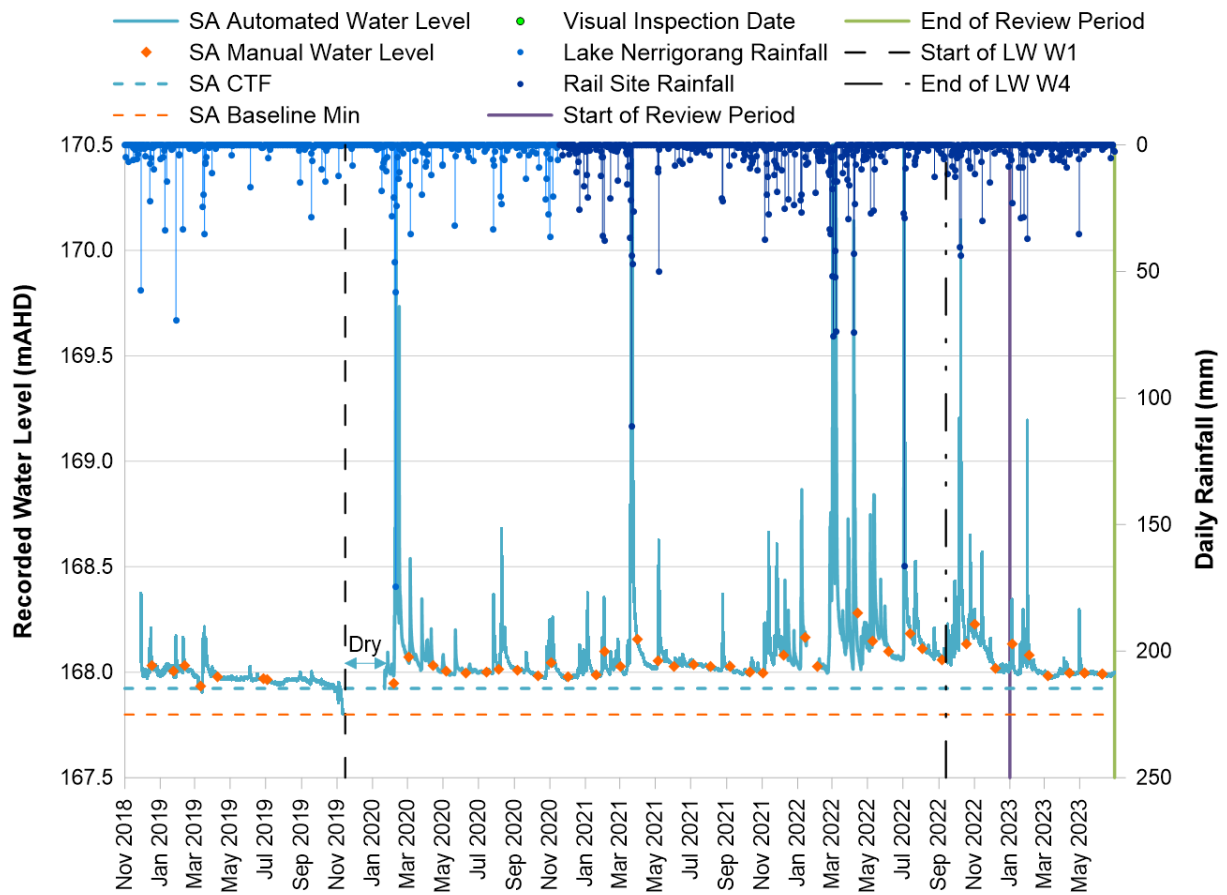
DIAGRAM B18: MONITORING SITE SA WATER LEVEL RECORDS⁶

⁶ Between 15 January and 5 February 2022, an incomplete data download occurred at monitoring site SA, or the logger was not correctly restarted, and as such no data is available for this period.

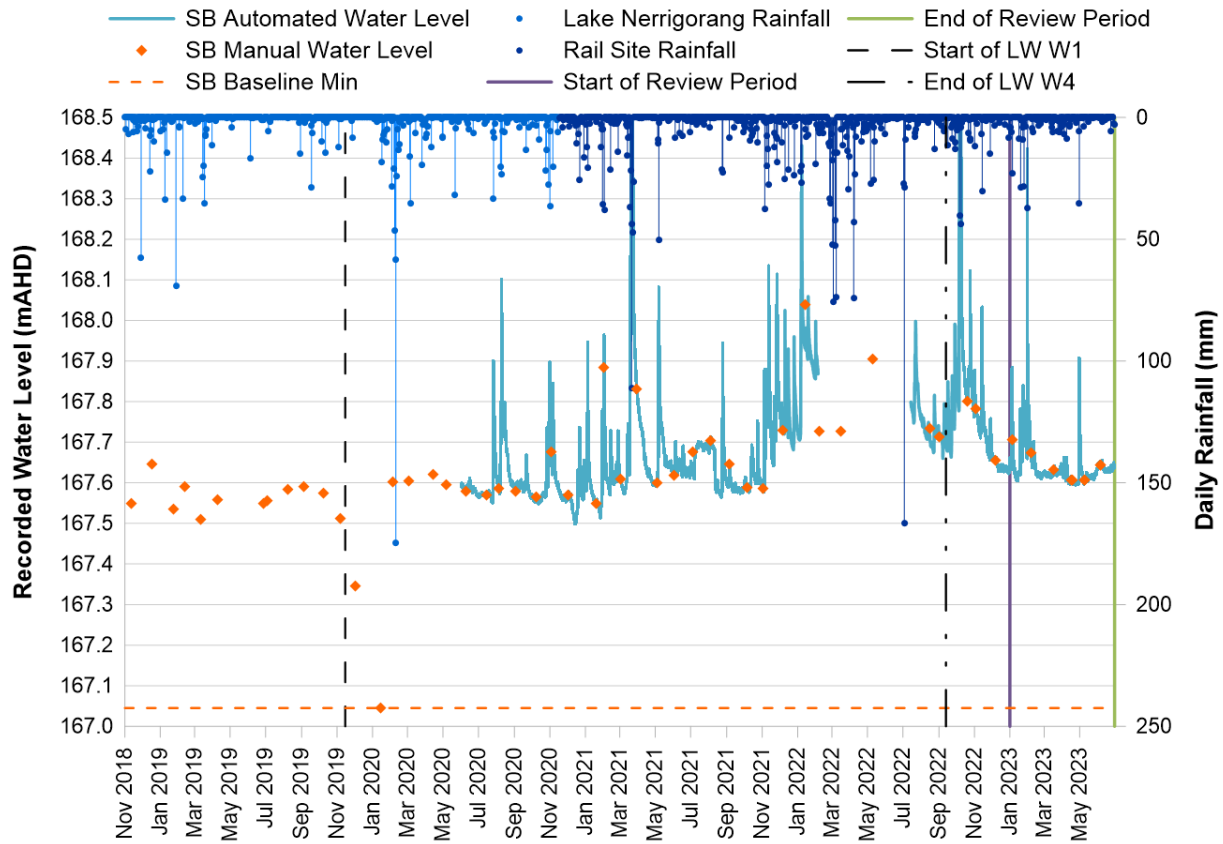
DIAGRAM B19: MONITORING SITE SB WATER LEVEL RECORDS⁷

⁷ The logger at monitoring site SB was washed away during a major rainfall event from late February to early March 2022 and as such data has not been collected since 5 February 2022. A manual water level measurement was unable to be recorded in April and June 2022 due to high flow.

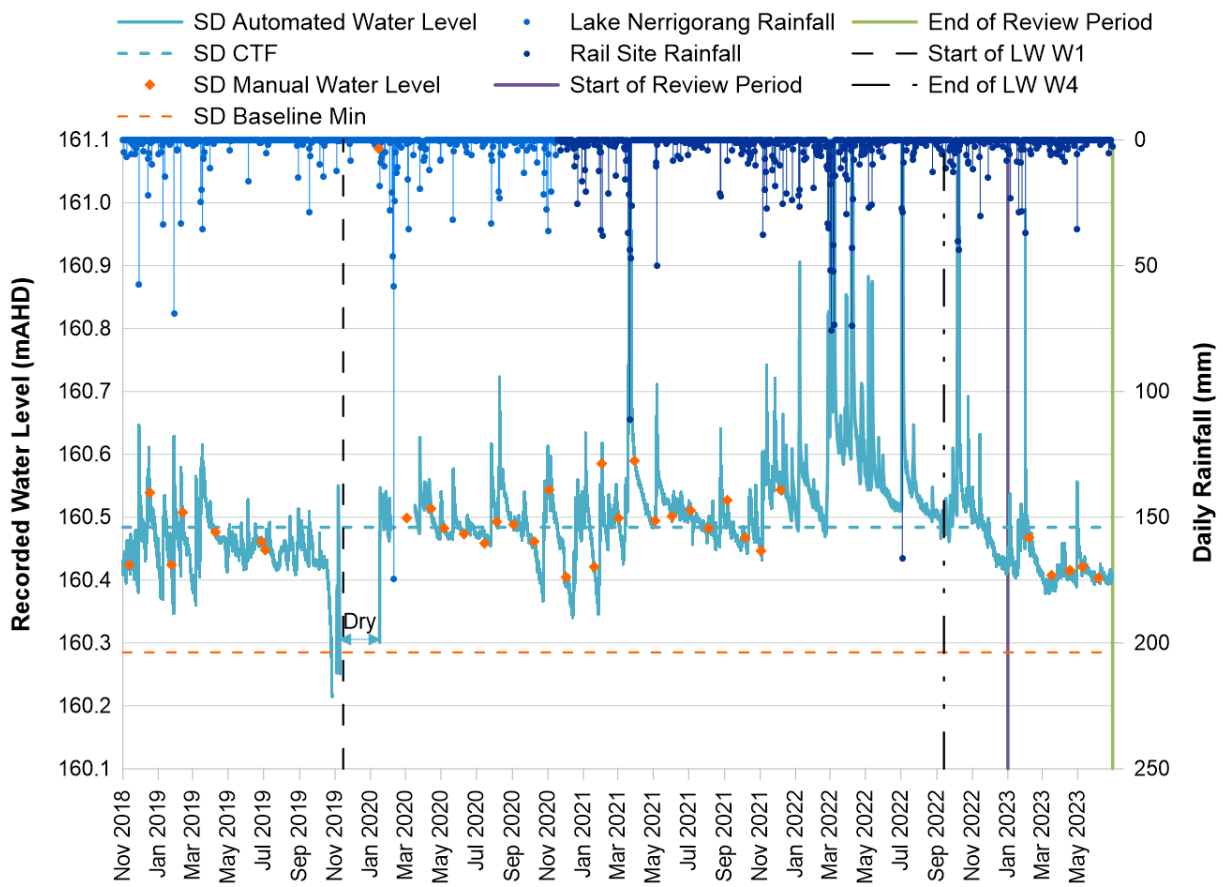
DIAGRAM B21: MONITORING SITE SD WATER LEVEL RECORDS⁸

⁸ The water level sensor has not been located and therefore records are not available from 7 December 2021.

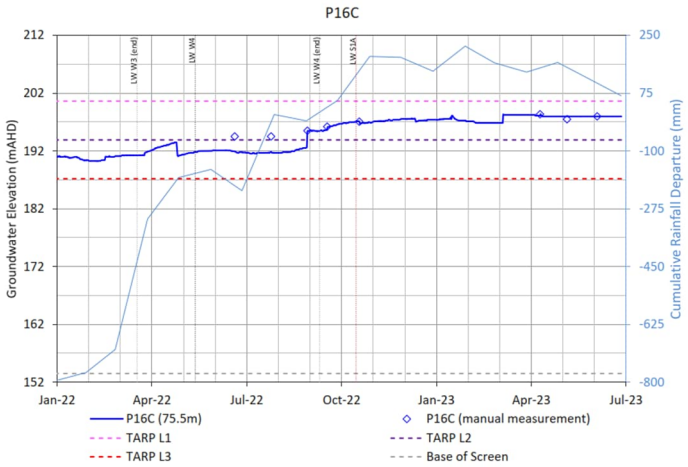
P16C	<p>TARP Level 2 exceedance was observed during the entire reporting period. Groundwater levels continue to remain relatively stable following successive periods of recovery in 2021 and 2022. Upcoming groundwater monitoring data</p>

Site	Discussion
	<p>will inform whether post-mining conditions will allow full groundwater recovery at the P16C site.</p>

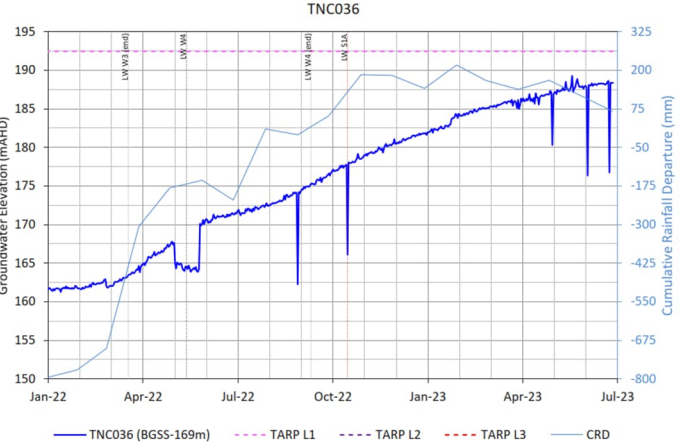
<p>TNC036 (BGSS-169m)</p>	<p>TARP Level 2 exceedance was observed during the full reporting period. Groundwater levels in the Bulgo Sandstone aquifer at 169m started to recover in late September 2022 and whilst showing a significant recovery during the reporting period, the observed groundwater levels remain below baseline levels as of June 2023. Upcoming groundwater monitoring data will inform whether post-mining conditions will allow full groundwater recovery, as indicated by the current trend.</p>

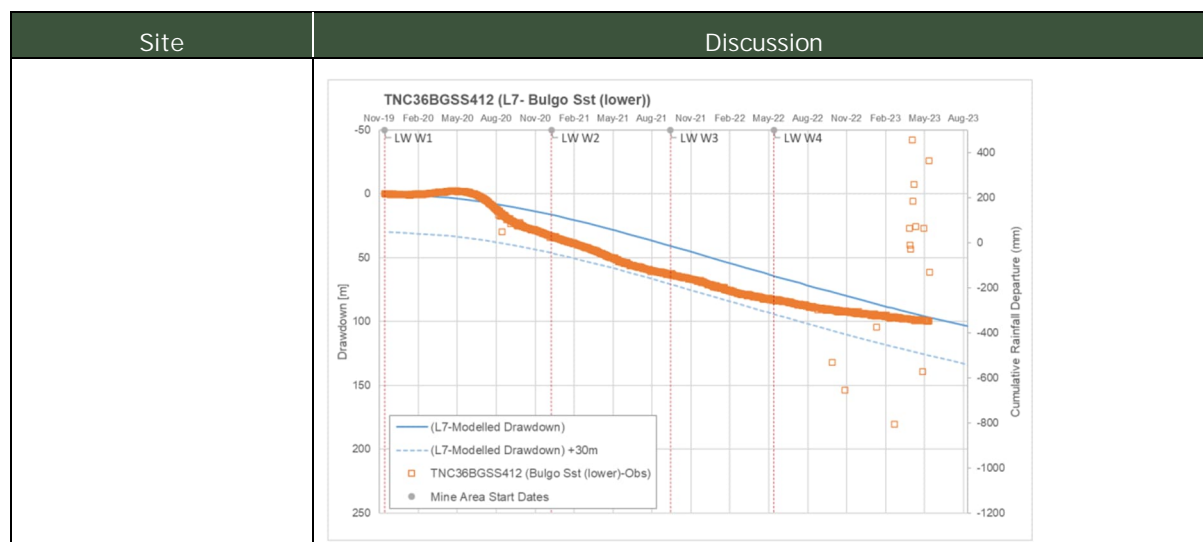
<p>TNC036 (BGSS-412.5m)</p>	<p>TARP Level 2 exceedance was observed during the full reporting period. Observed drawdown at TNC036 (BGSS-412.5m) exceeded predicted (modelled) drawdown but was within 30 m of predicted (modelled) drawdown during the reporting period. Following the commencement of mining at LW W1, observed drawdown has exceeded the predicted (modelled) drawdown at since mid-2020. Over the past 6 months, observed drawdown appears to be trending closer to the predicted (modelled) drawdown. TARP Level 1 is likely to apply in the next reporting period.</p>

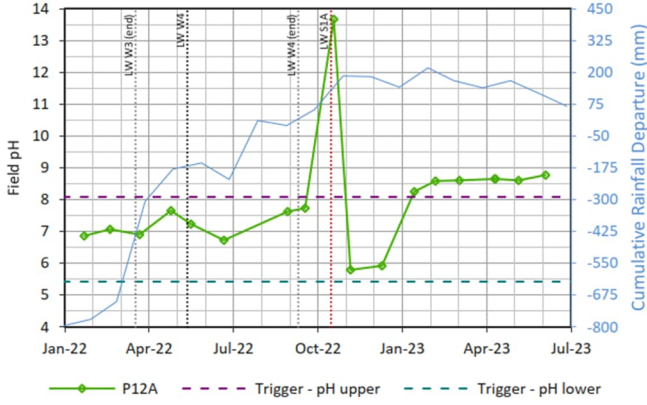
Site	Discussion
P12A	<p>TARP Level 2 exceedance of pH upper observed over the full reporting period. pH levels have generally remained stable, although above the pH upper trigger level, since January 2023. pH levels at P12B and P12C remain within the lower and upper pH trigger levels. Therefore, the exceedance at P12A is likely to be localised and natural, however additional monitoring is required to confirm post-mining pH trends at P12A. The general trend in pH over time in P12A, P12B and P12C is consistent.</p>

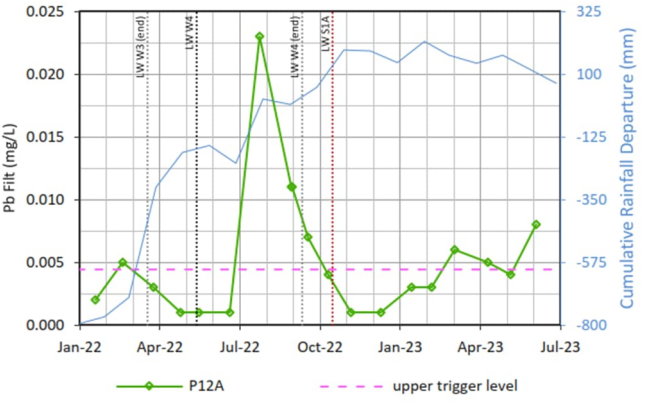
<p>TARP Level 2 exceedance of lead was observed in March, April and June. The concentration of lead returned to within baseline variability in January, February and May 2023. Dissolved lead concentrations have significantly fluctuated over the past 12 months. Continued observation is required however is expected to be localised and within natural fluctuations observed historically.</p>

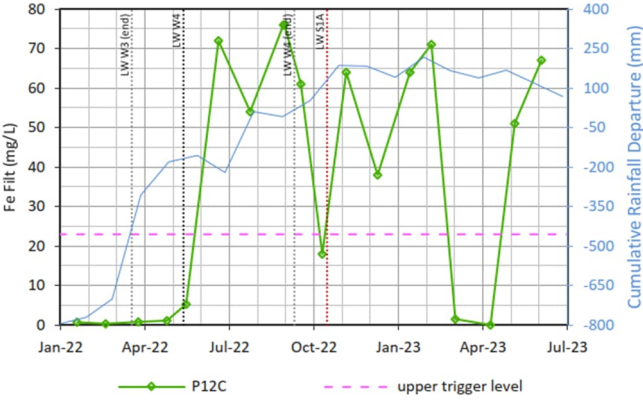
Site	Discussion
P12C	<p>A short-term increase (TARP Level 2 exceedance) in the observed EC (March 2023) was observed before returning to normal conditions.</p> <p>TARP Level 2 exceedance of iron was observed in January and February before returning to within baseline conditions, then noting an exceedance again in May and June 2023. The concentration of iron returned to within baseline variability in March and April 2023. Dissolved iron concentrations have significantly fluctuated over the past 12 months. The increase in dissolved iron concentrations is suggested to be localised and likely to be caused by iron mobilisation during groundwater recovery (SLR, 2023a).</p>

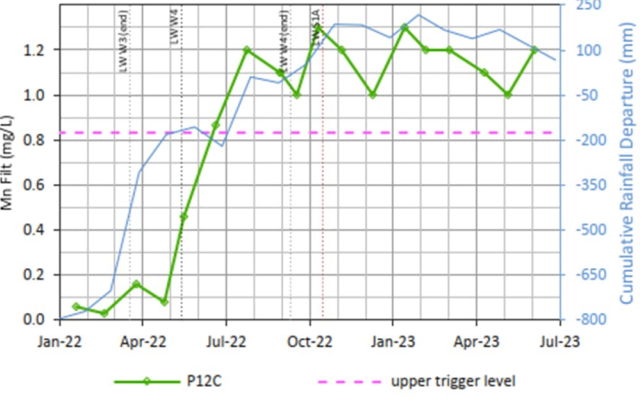
<p>TARP Level 2 exceedance of manganese was observed across the full reporting period. The increase in the dissolved concentrations of iron and manganese appear to be correlated and the natural fluctuation in groundwater quality could be associated with the increasing trend at site P12 (SLR, 2023a). Site P12B follows the same trend, although it was not breaching the trigger.</p>

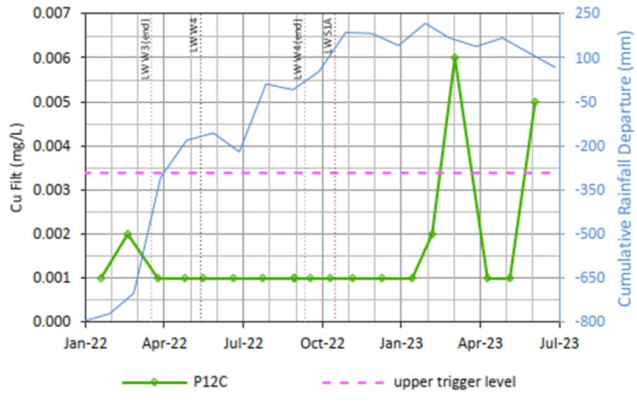
<p>A short-term increase (TARP Level 2 exceedance) in the concentration of copper was observed in March and June 2023. Given the recent high level of fluctuations, the site will continue to be monitored and reviewed.</p>

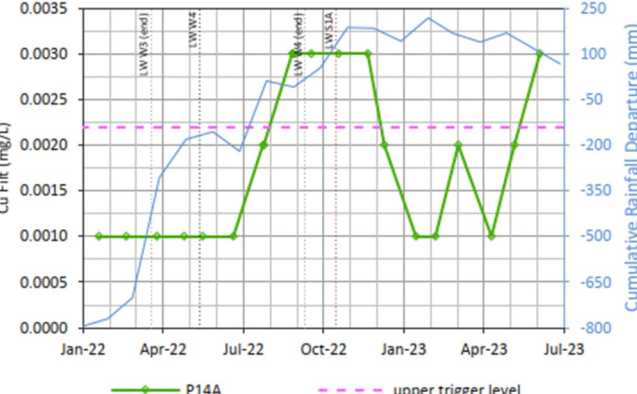
<p>P14A</p>	<p>A short-term increase (TARP Level 2 exceedance) in the concentration of aluminium (March and May 2023) was observed before returning to normal conditions.</p> <p>A short-term increase (TARP Level 2 exceedance) in the concentration of copper (June 2023) was observed. The concentration of Cu in June is not out of line with historical fluctuations and is not considered likely to be a result of historical mining activities.</p>

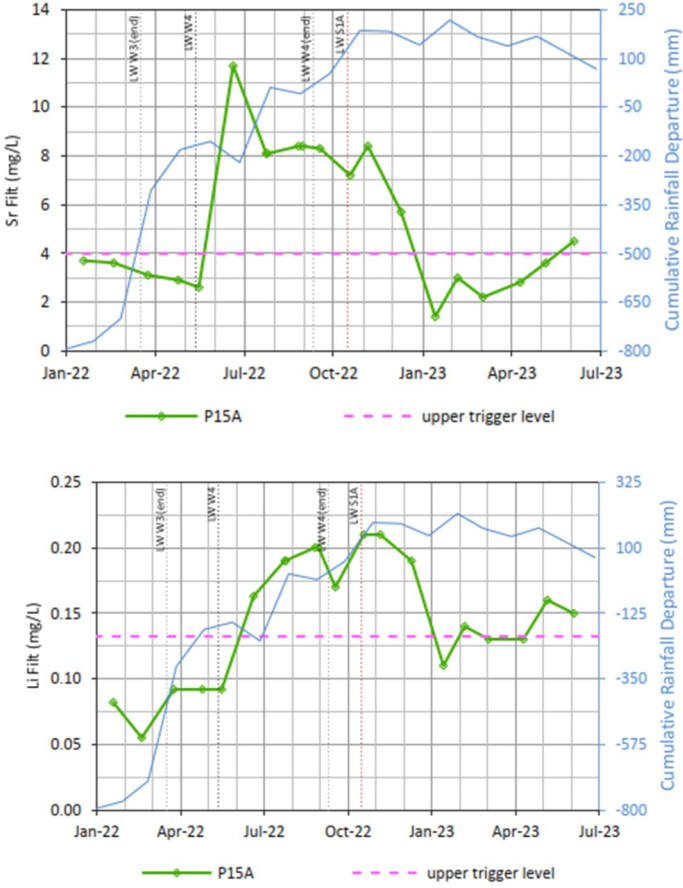
Site	Discussion
	<p>A short-term increase in lithium (May and June 2023), and strontium (June 2023) was observed.</p> <p>These minor breaches of the trigger are in line with historical natural fluctuations and are unlikely to be attributable to mining.</p>

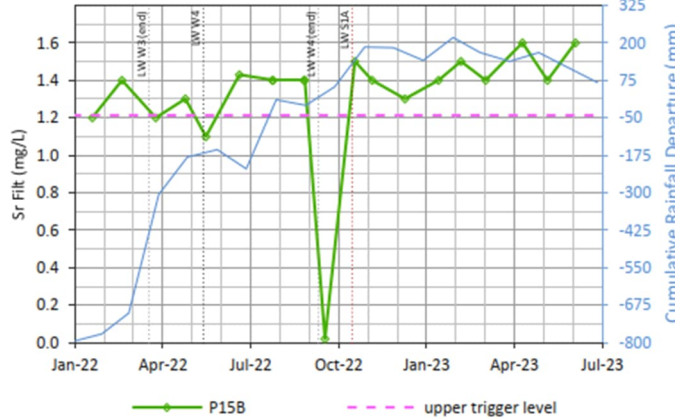
P15B	<p>Short-term increase (TARP Level 2 exceedance) in the concentration of EC, aluminium and lead occurred in February 2023, however was within baseline conditions for the rest of the reporting period.</p> <p>TARP Level 2 exceedance of strontium was observed in April, May and June 2023. The concentration of dissolved strontium has fluctuated over the past 12 months and additional monitoring is required to confirm post-mining strontium trends.</p>

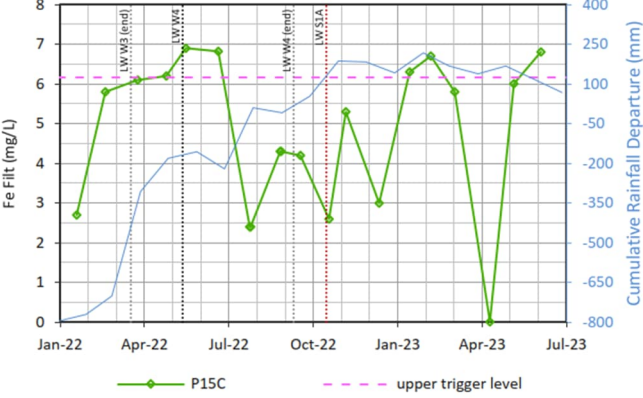
Site	Discussion
P15C	<p>A short-term increase (TARP Level 2 exceedance) in the concentration of aluminium was observed in January 2023 before returning to baseline conditions.</p> <p>A short-term increase (TARP Level 2 exceedance) in the concentration of iron was observed in February and March before returning to baseline conditions, with an exceedance noted again in June 2023. These exceedances appear to be in line with natural fluctuations.</p>

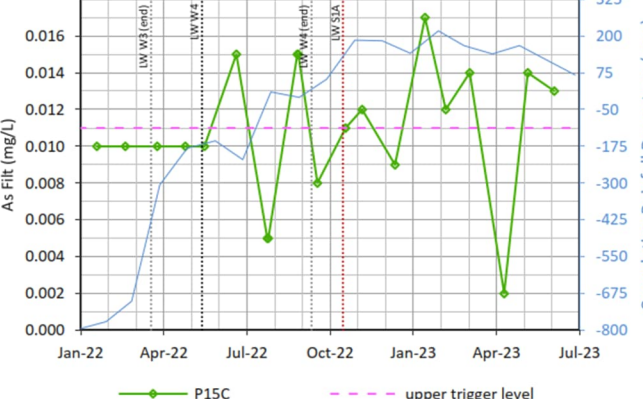
<p>TARP Level 2 exceedance of arsenic was observed in May and June 2023. The concentration of dissolved arsenic has fluctuated over the past 12 months and additional monitoring is required to confirm trends. It is likely the trigger level needs amending to reflect the natural fluctuations observed.</p>

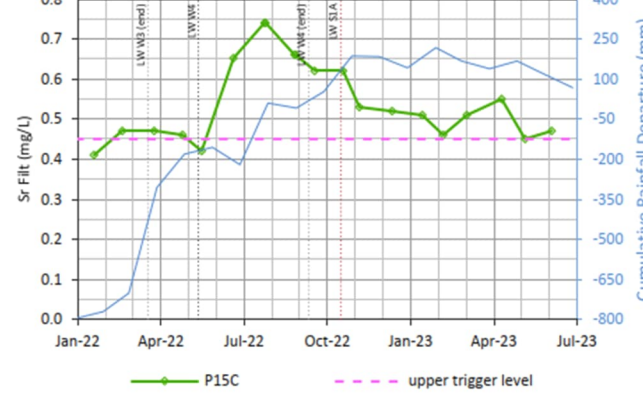
<p>TARP Level 2 exceedance of strontium was observed in April and June 2023. The dissolved strontium concentrations observed at P15B and P15C remain well below the US health-based screening level benchmark of 4 mg/L.</p>

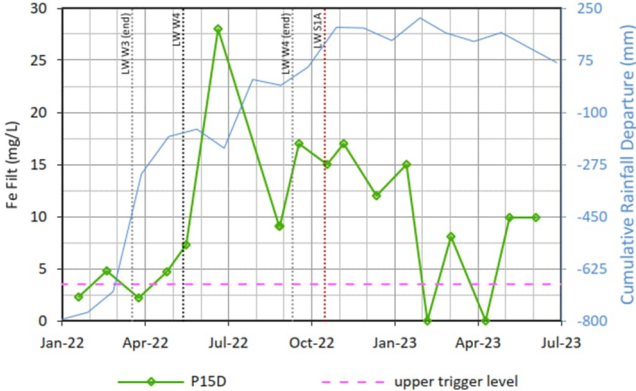
Site	Discussion
P15D	<p>A short-term increase (TARP Level 2 exceedance) in the concentration of aluminium was observed in January 2023 before returning to baseline conditions.</p> <p>TARP Level 2 exceedance of iron was observed in May and June 2023. The trigger level for dissolved iron concentration P15D is considered too conservative, and it is recommended to revise the trigger level for dissolved iron at P15D to 2.5 mg/L (SLR, 2023a). Using the revised trigger level, a TARP Level 1 (normal conditions) applies in the current reporting period.</p>

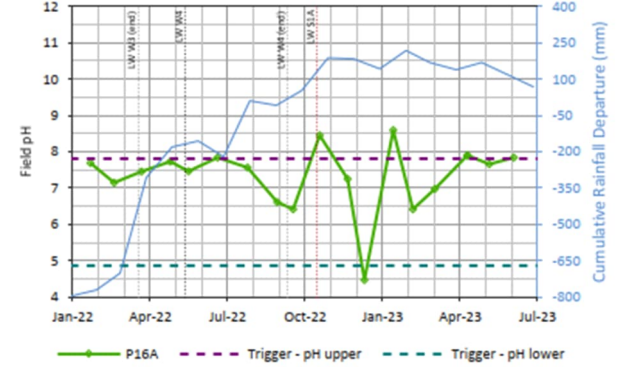
P16A	<p>A short-term increase (TARP Level 2 exceedance) above the pH upper trigger level was observed in January, April and June 2023. The pH level at P16A has previously shown large fluctuations and additional monitoring is required to confirm post-mining pH trends at P16A.</p>

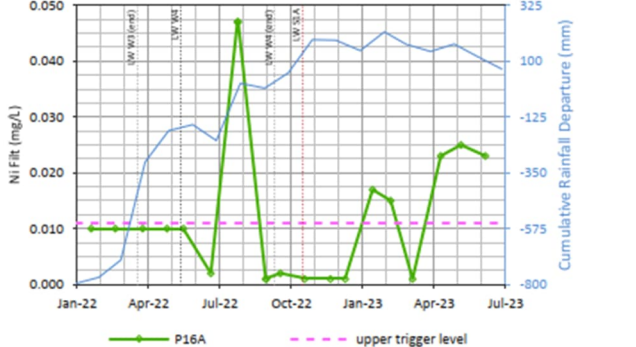
<p>TARP Level 2 exceedance of nickel was observed in January, February, April, May and June 2023. Concentrations of nickel has fluctuated over the past 12 months with periods of high concentration followed by periods of baseline variability. Additional monitoring is required to confirm post-mining nickel trends at P16A.</p>

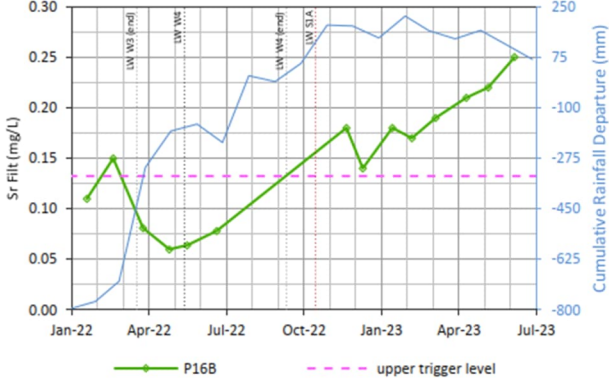
Site	Discussion
P16B	<p>TARP Level 2 exceedance of strontium was observed across the whole reporting period. Elevated strontium concentrations were also observed in January, February and March 2023, and November and December 2022, resulting in six consecutive months of a TARP Level 2 exceedance. No strontium concentration data is available between July and November 2022. Close monitoring of strontium concentrations and rainfall events in the next reporting period is required to confirm post-mining strontium trends and if a TARP Level 3 or 4 applies.</p>

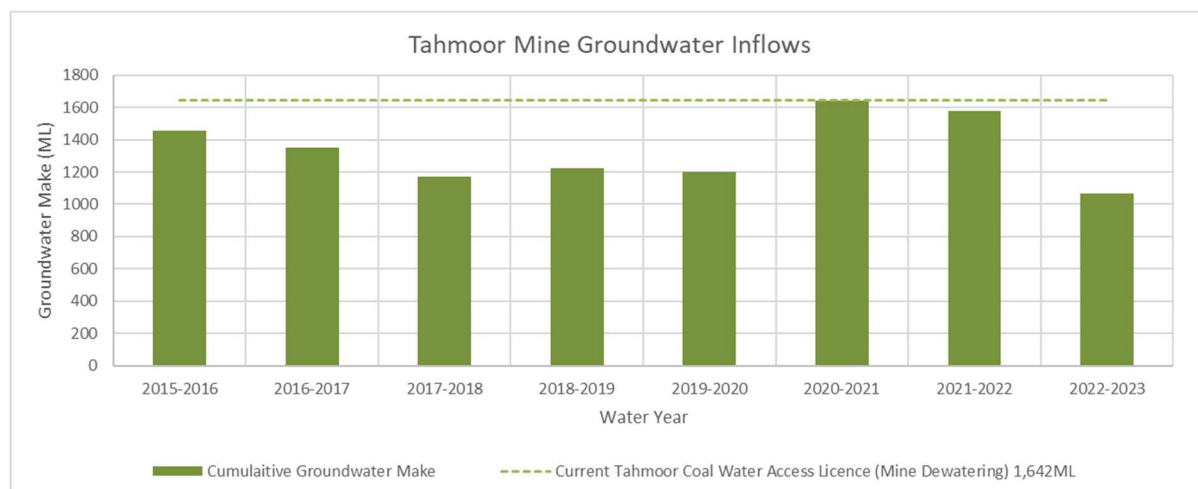
Figure 4 Tahmoor Mine Groundwater Inflows

The reporting period occurs within the water year 2022-23. As of 30 June 2023, the cumulative groundwater make for water year 2022-23 is 1,068 ML, which remains below the groundwater entitlement of 1,642 ML/y (**Figure 4**).
