Tahmoor Coal Pty Ltd

SIX MONTHLY SUBSIDENCE IMPACT REPORT

Western Domain Longwalls West 1 – West 4

Report 8 – September 2023

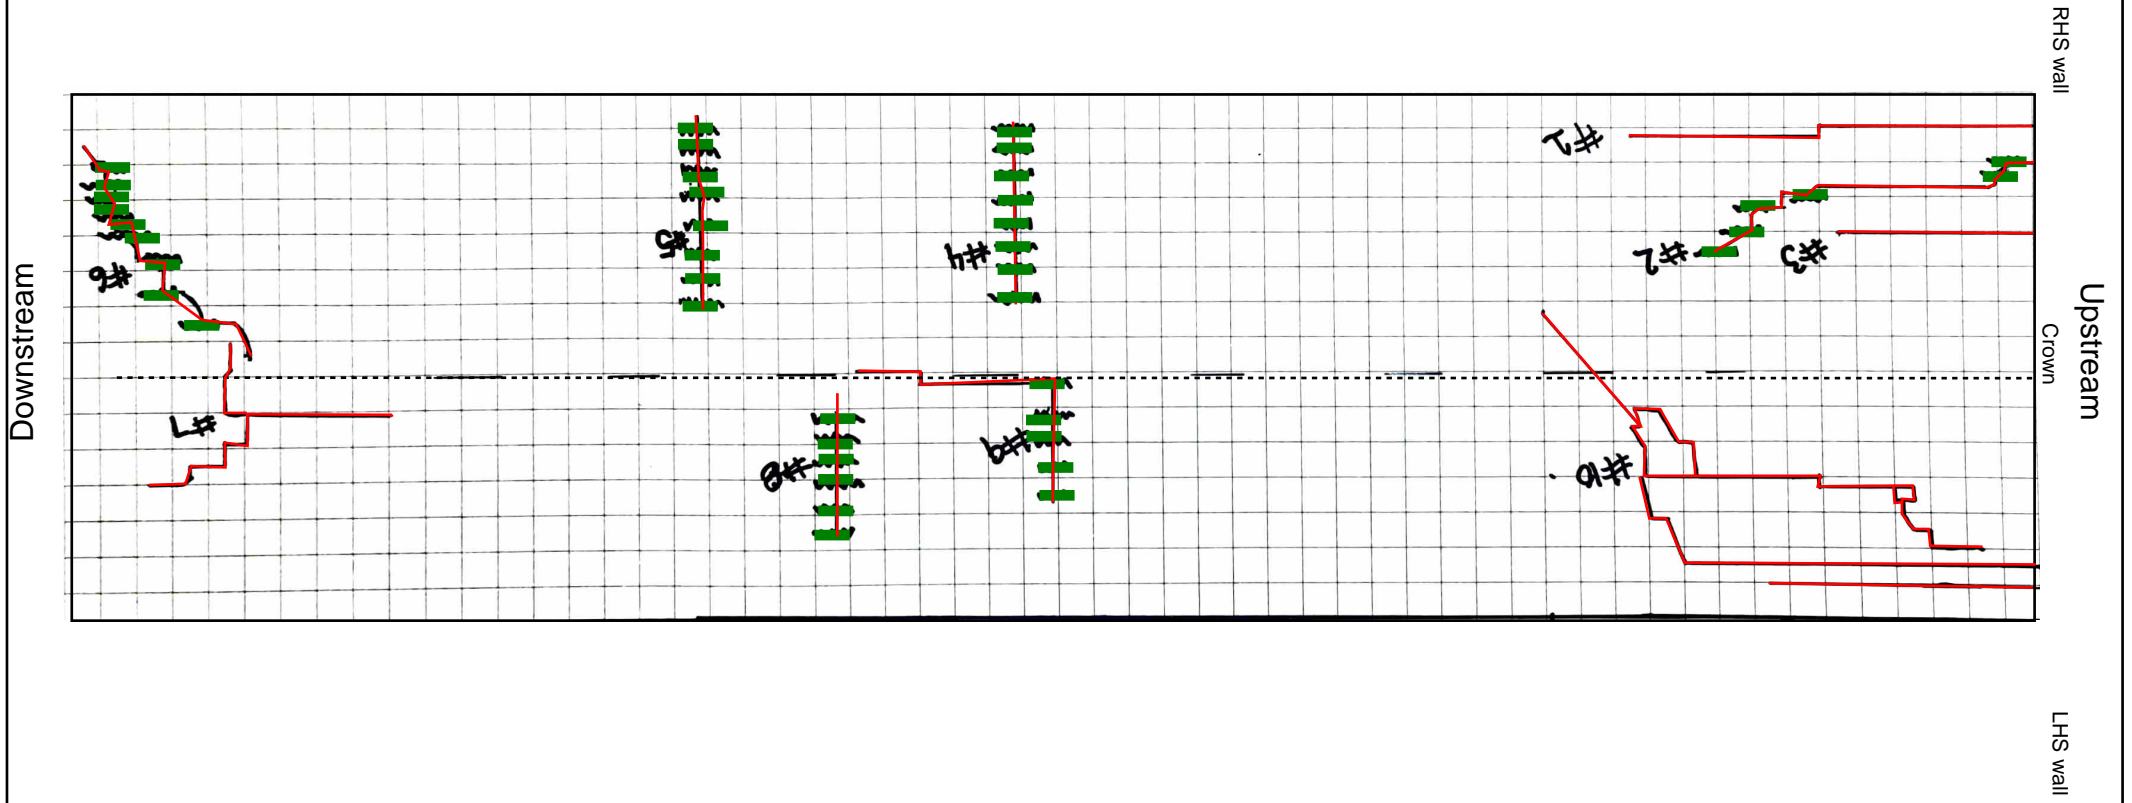
The work crack repair work completed is shown in figures 1 to 3. These detail the locations of crack repairs. Three appendices are attached providing a series of photos from the remediation works:

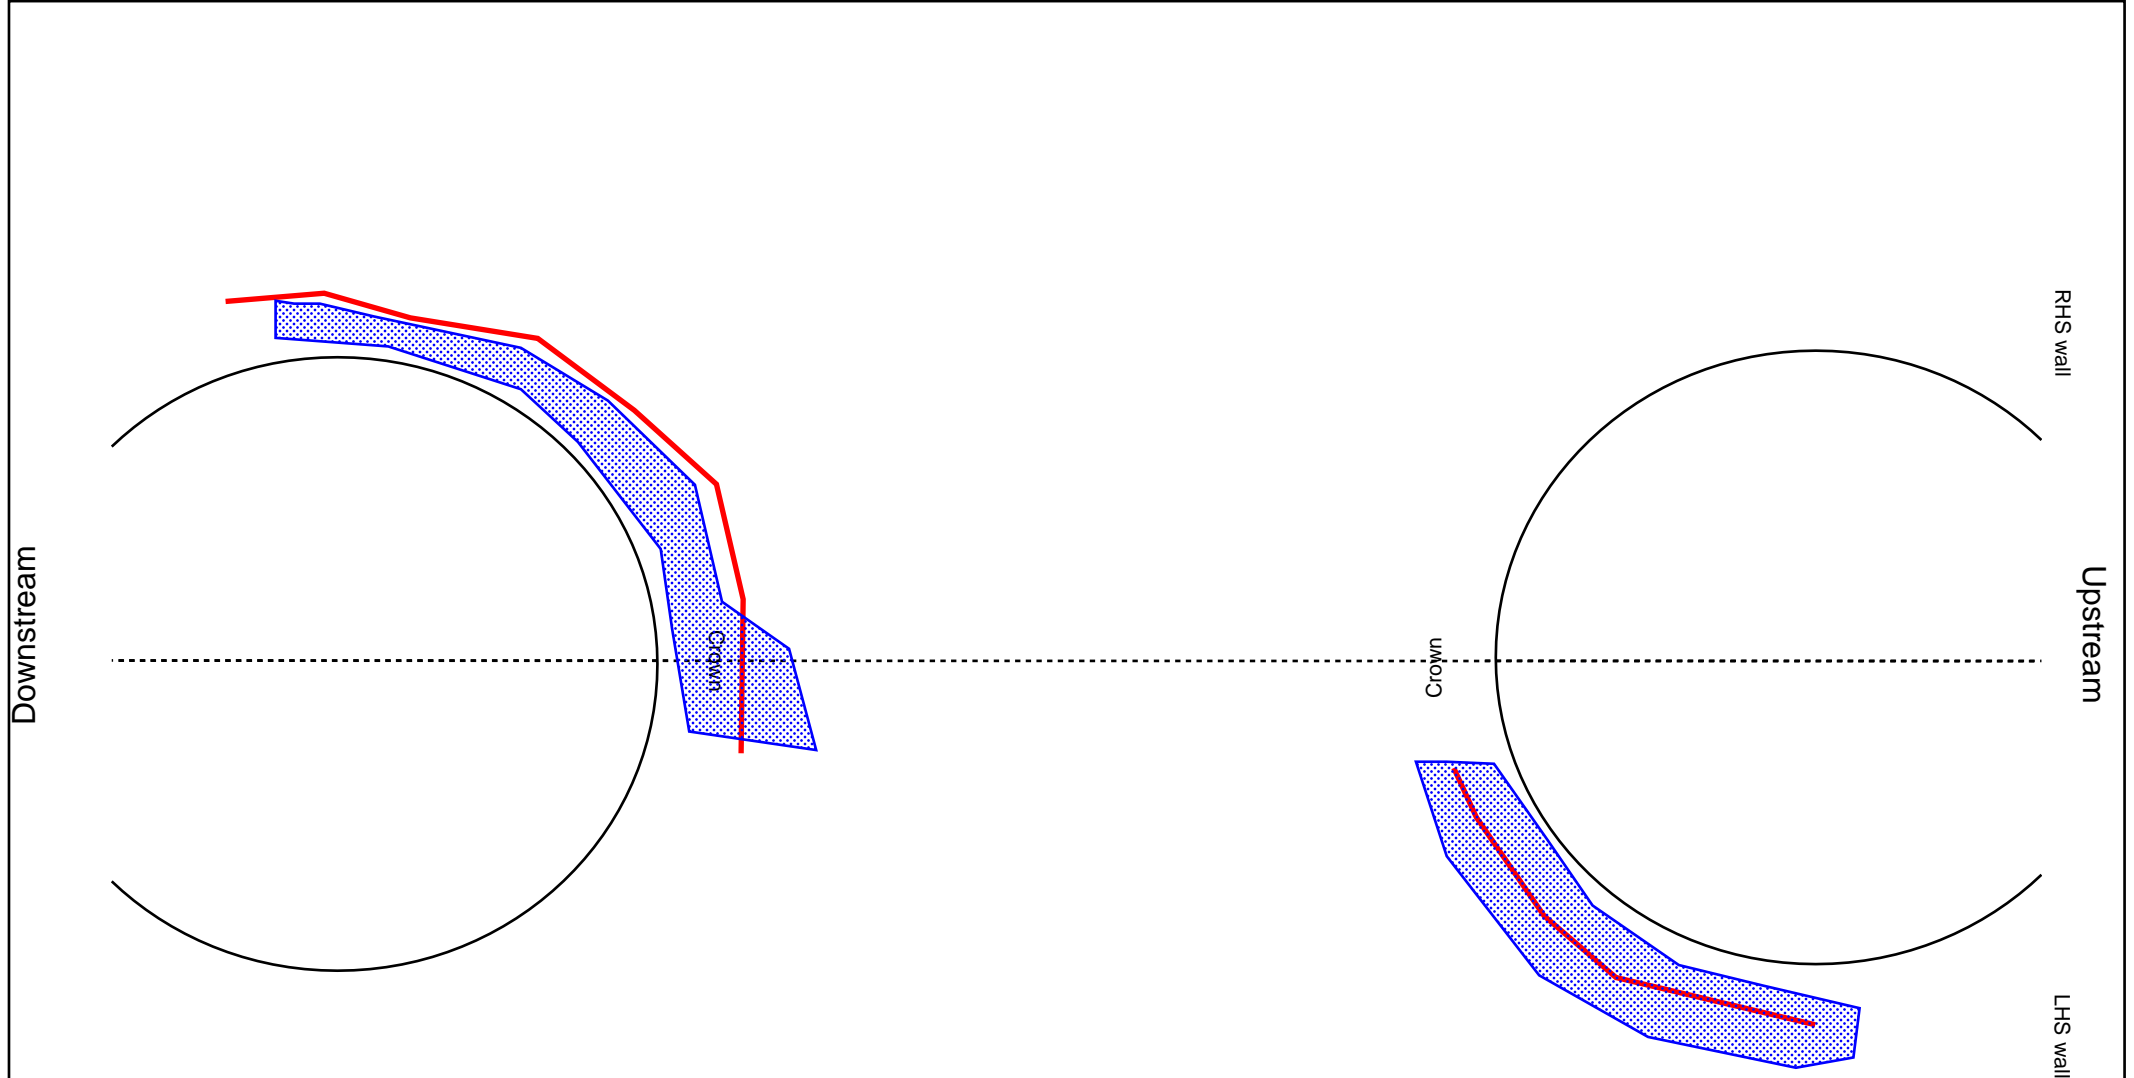
PMLL Culvert Remeadiation	
Culvert 88.400 km Arches	
Figure 2 Rev 1	G.Price

- 88.400 km
 - crack epoxy injection
 - bed joint reinforcement
 - stone voussoir pinning
 - stone voussoir reattachment with epoxy
 - re pointing
- 88.980 km
 - stone voussoir pinning
 - re pointing
- 89.629 km
 - re pointing as per Client request additional monitor repair work completed to pre-existing crack in the headwall to support PMLL asset
 - Removal of the Tahmoor Coal installed plastic shotcrete protection barrier as requested

The repair work included crack epoxy injection, bed joint reinforcement, stone voussoir pinning, stone voussoir reattachment with epoxy and re pointing. This was completed as detailed in J M A Solutions report R0809-R2.

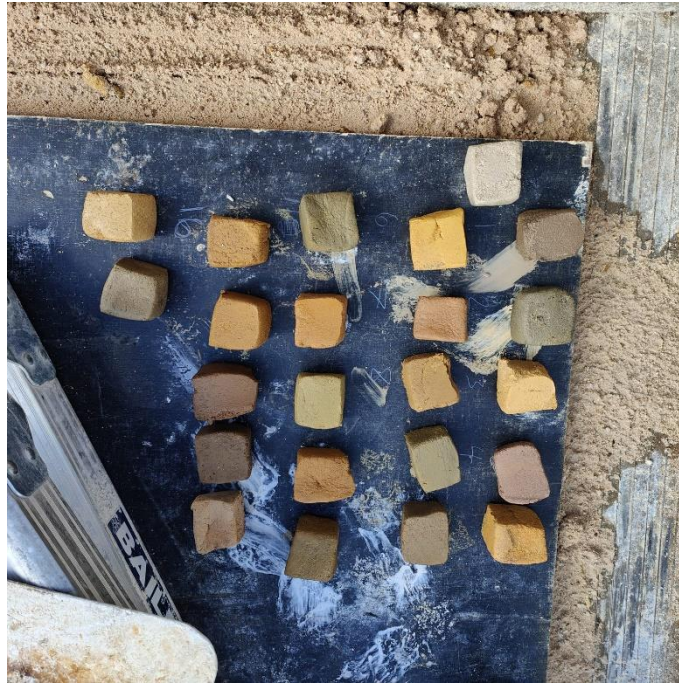
1. Colour Matching

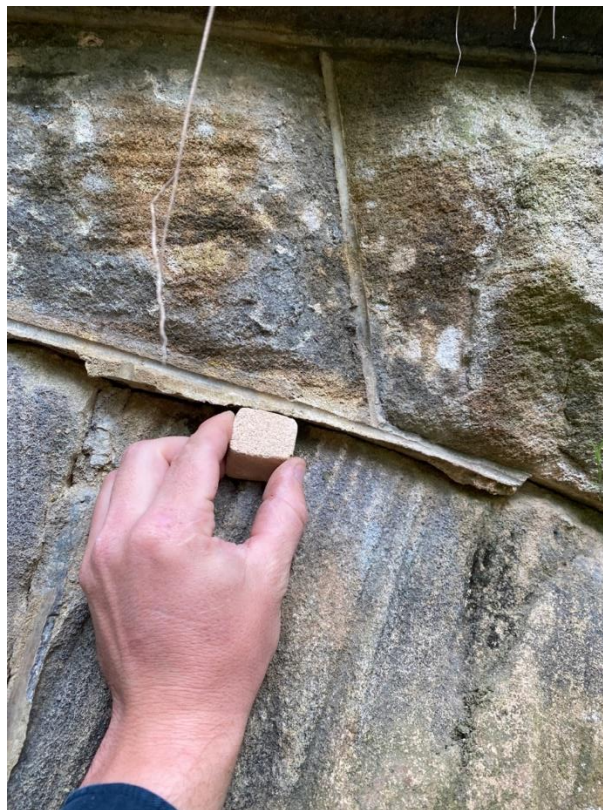
2. Colour Matching

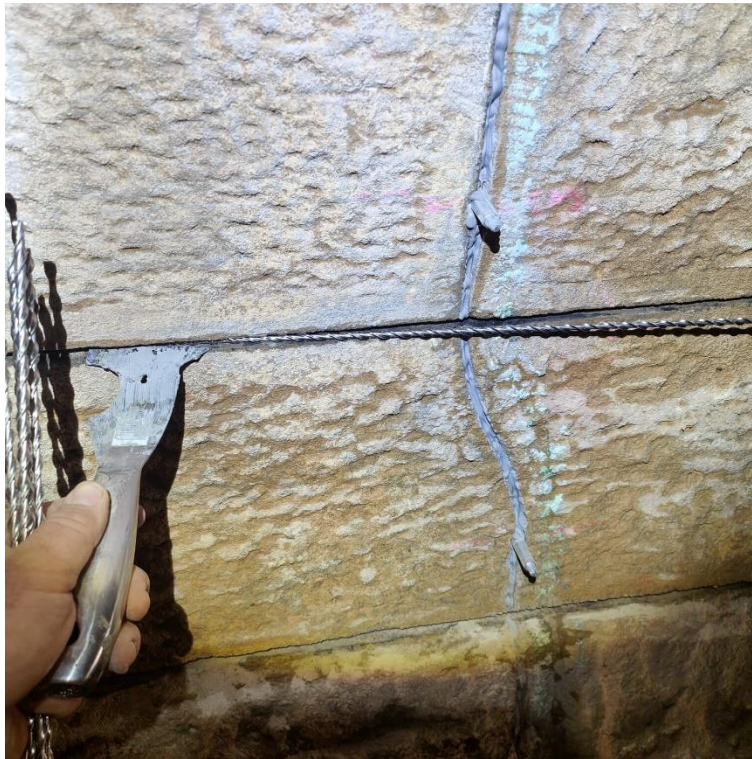
5. Install Helifix HBR60

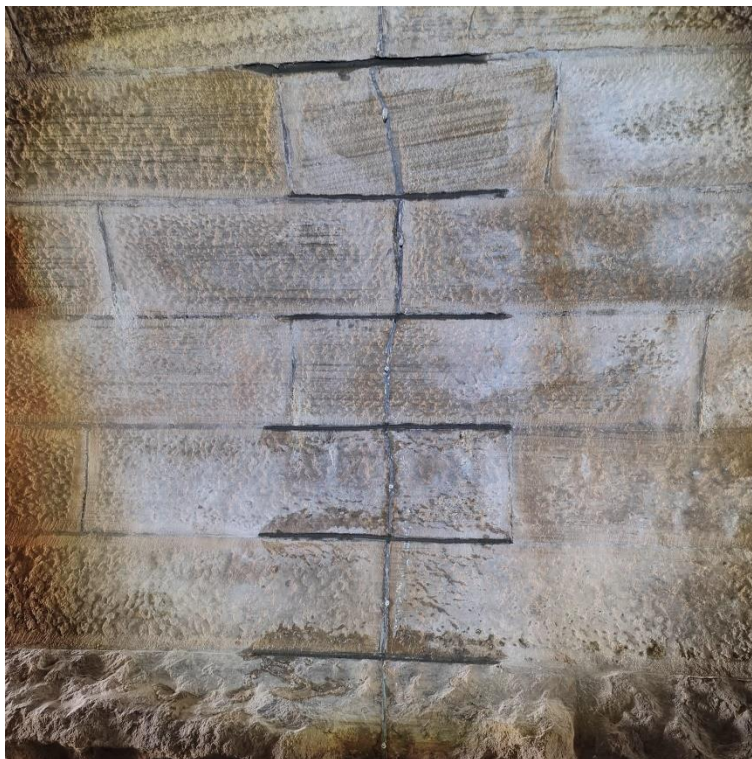
6. Install Helifix HBR60

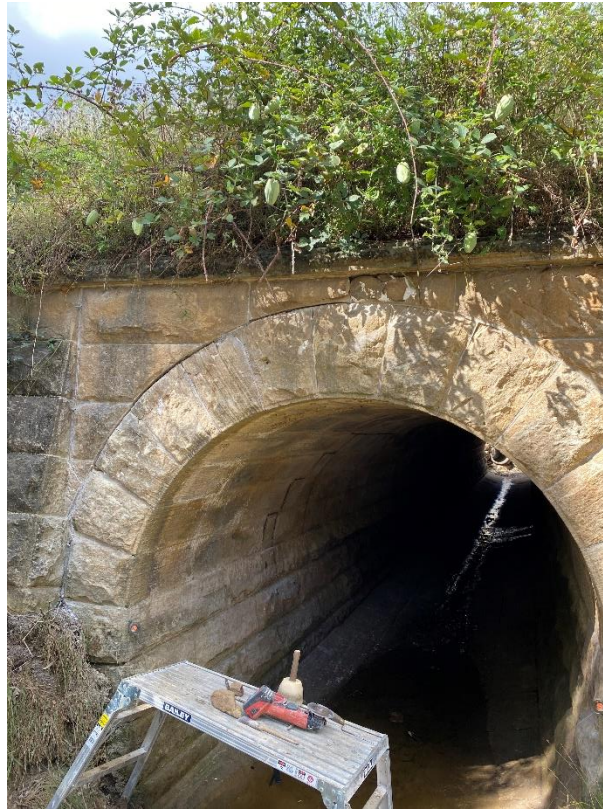
11. Downstream end during the work

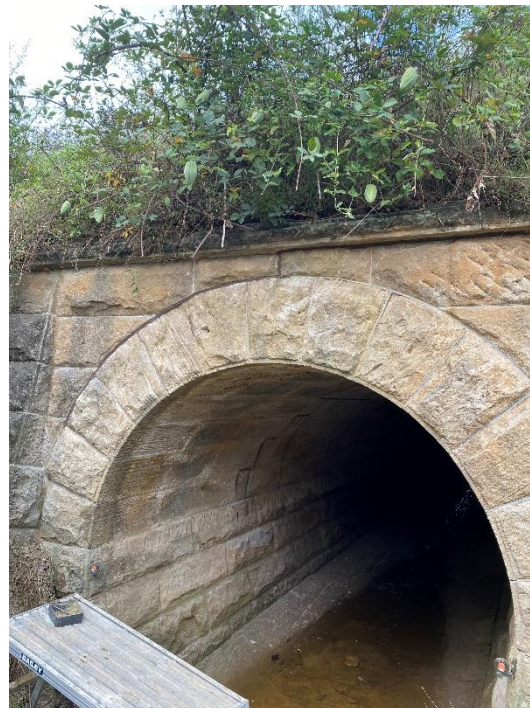
12. Downstream end completed

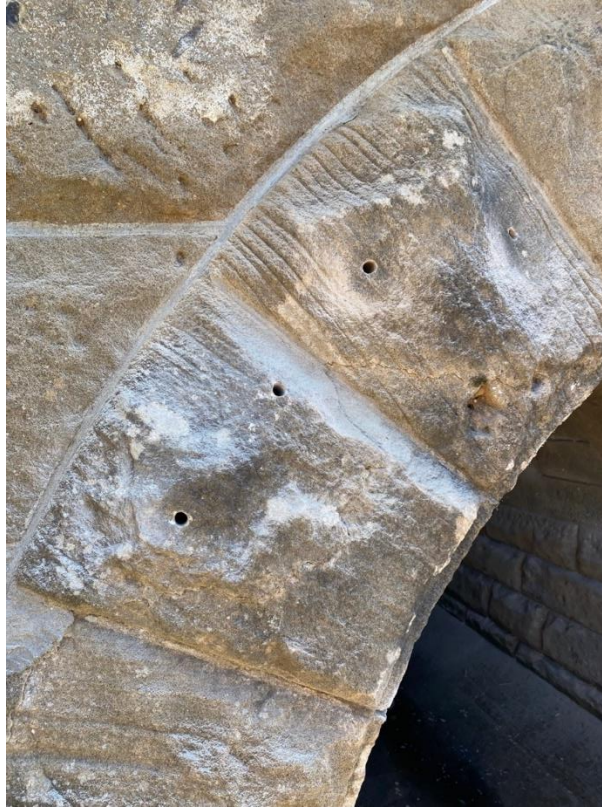
1. Cored holes in stone

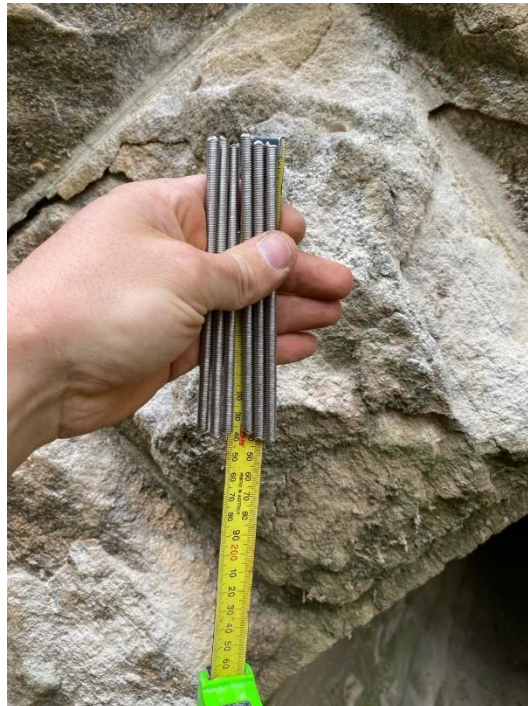
2. 6 mm SS pins

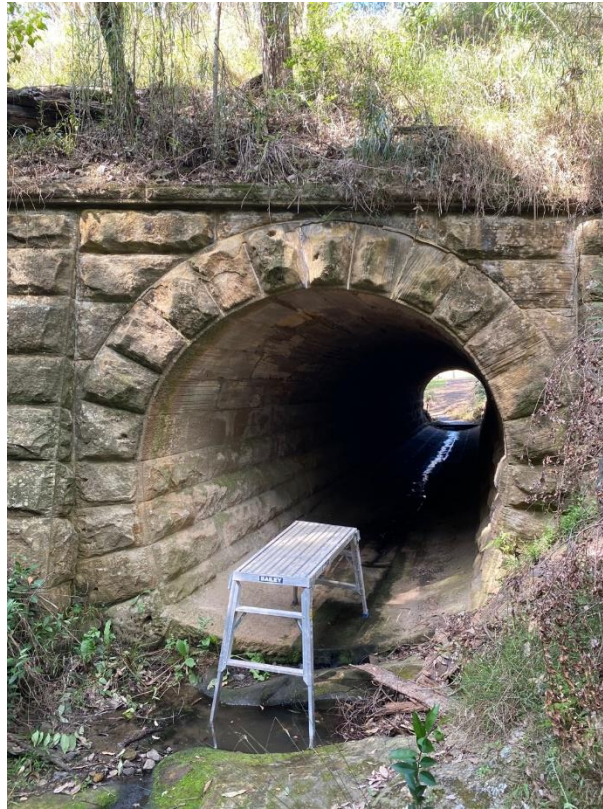
3. Downstream before

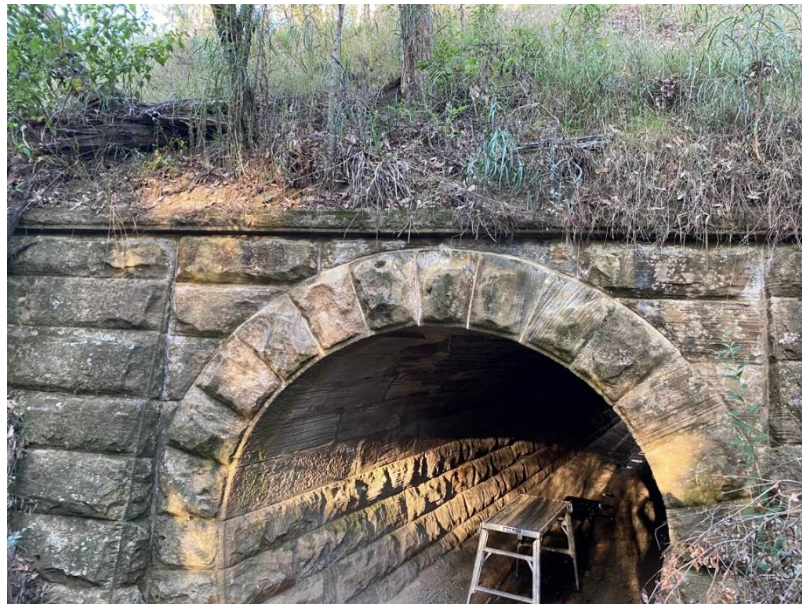
4. Downstream after

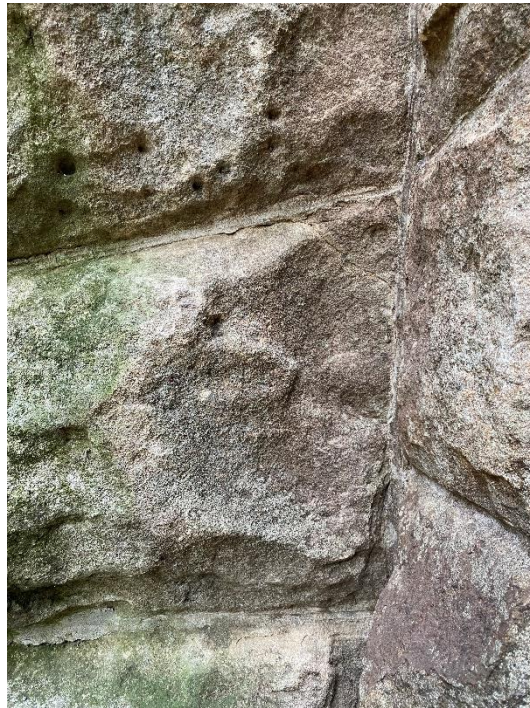
1. Before pointing
