Tahmoor Coal Pty Ltd

SIX MONTHLY SUBSIDENCE IMPACT REPORT

Tahmoor South Domain Longwalls South 1A – South 6A

1 January 2023 – 30 June 2023

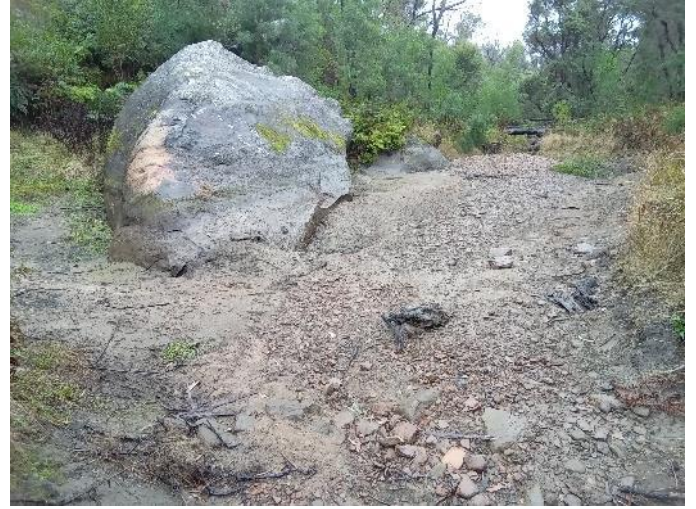
Additional 08/02/2022

Additional Iron Staining 28/06/2023

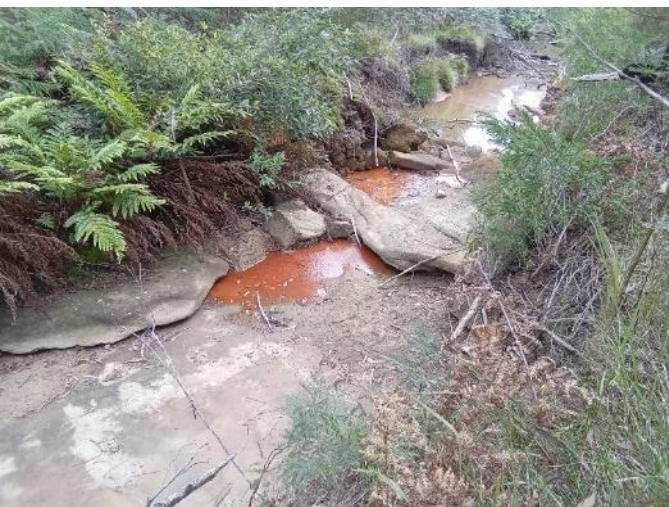
Additional Iron Staining 12/04/2023

Additional Iron Staining 28/06/2023

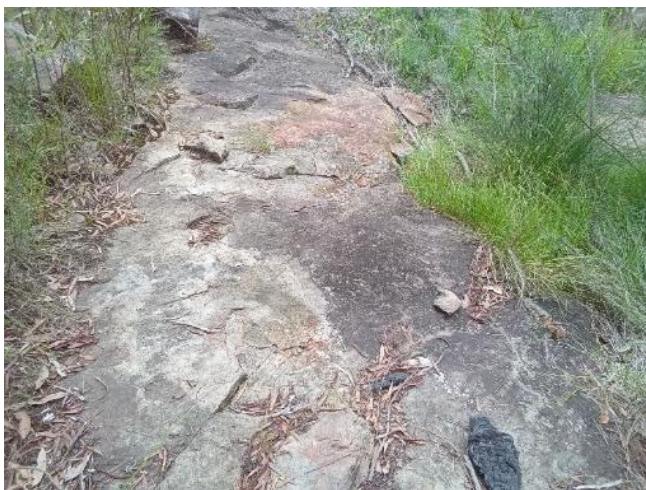
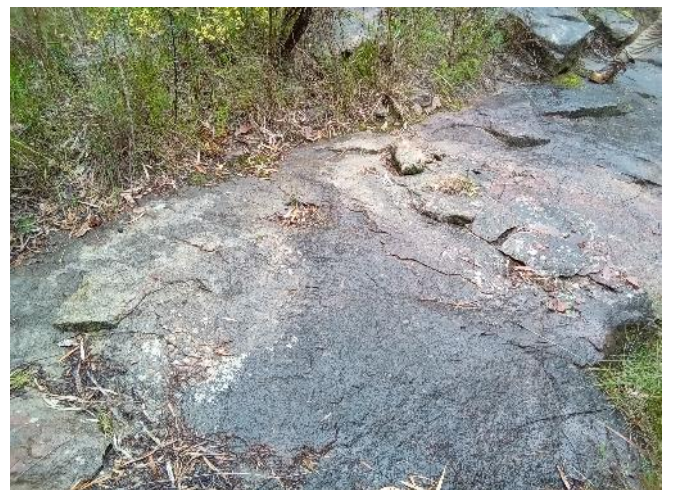
Additional Photo Cracking upstream 08/02/2023

Additional Photo Cracking upstream 28/06/2023

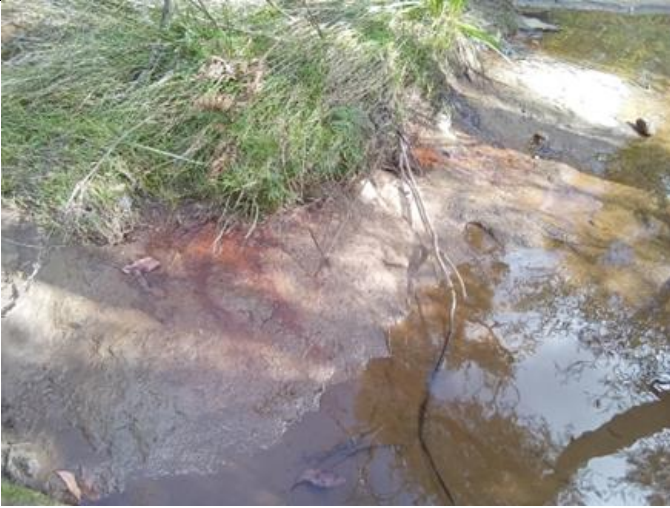
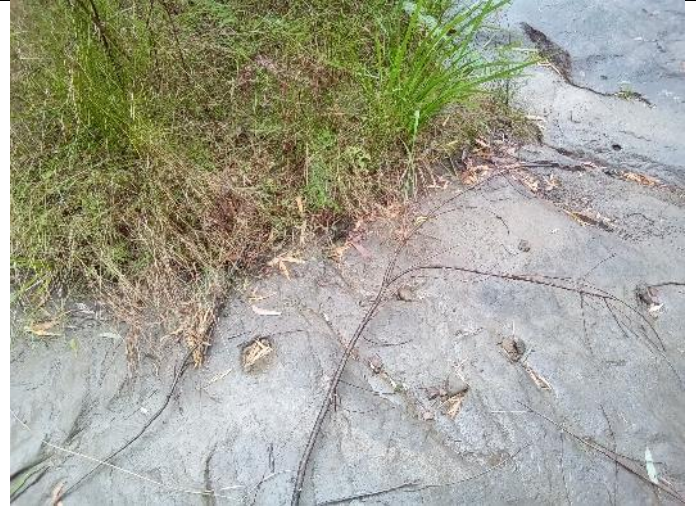
During the inspection, it was observed that the iron staining identified in the 1 March 2023 survey was still evident approximately 50 meters downstream of TT12. The number of cracks in the area has remained steady at 26. During this inspection, it was observed that the length and width of the cracks have increased.

Additional photo Iron Staining 10/08/2022

Additional photo Iron Staining 28/06/2023

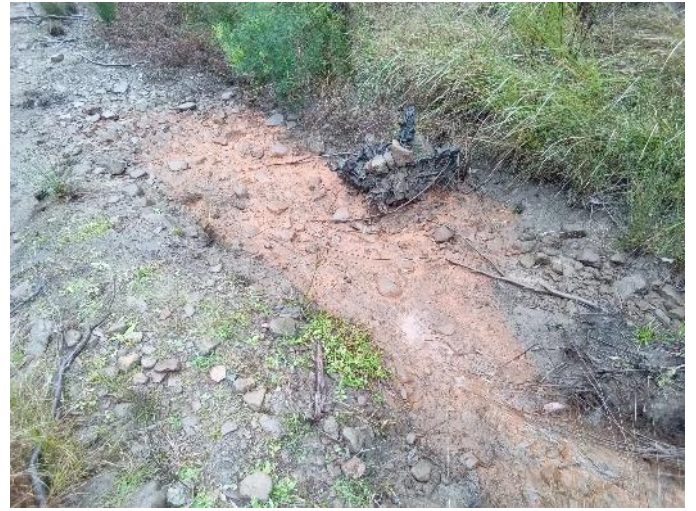
Additional photo 2 Iron Staining 28/06/2023

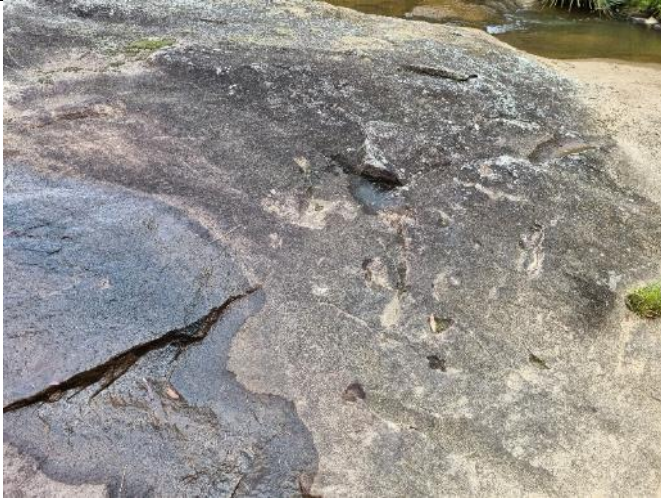
South Rockbank looking south at Depression 7
19/10/2022

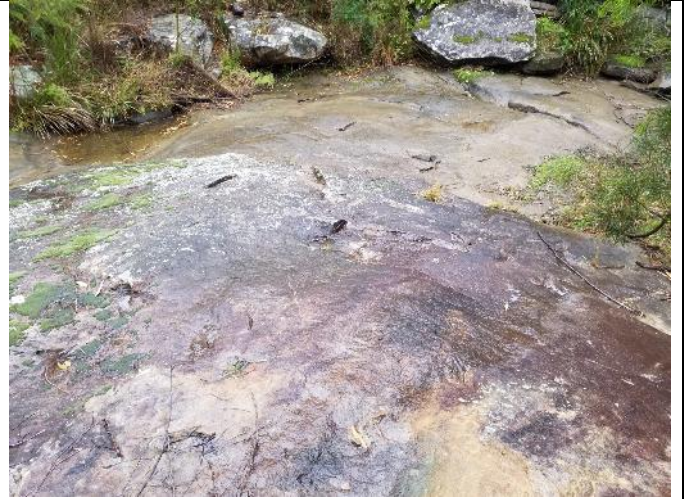
South Rockbank looking south at Depression 7
28/06/2023

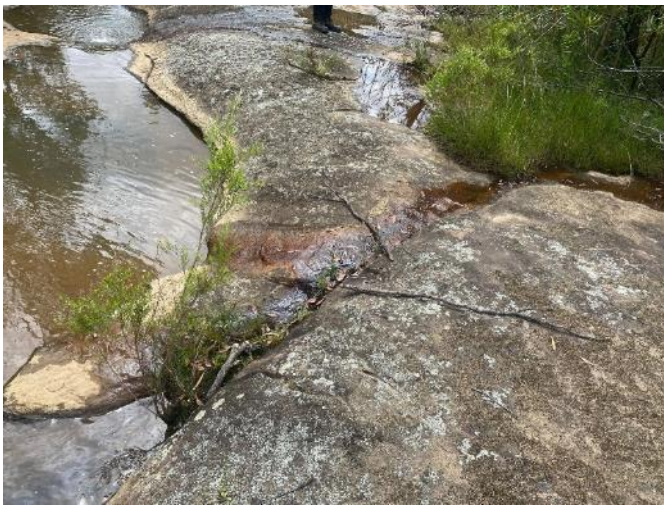
South Rockbank flowing into Depression 5
19/10/2022

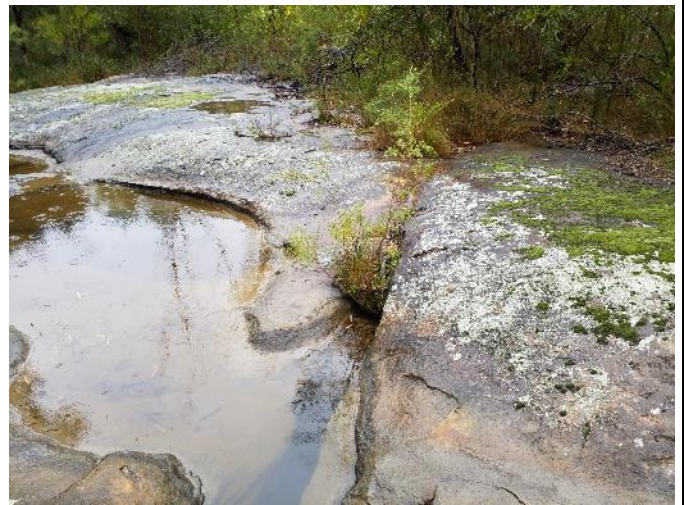
South Rockbank flowing into Depression 5
28/06/2023

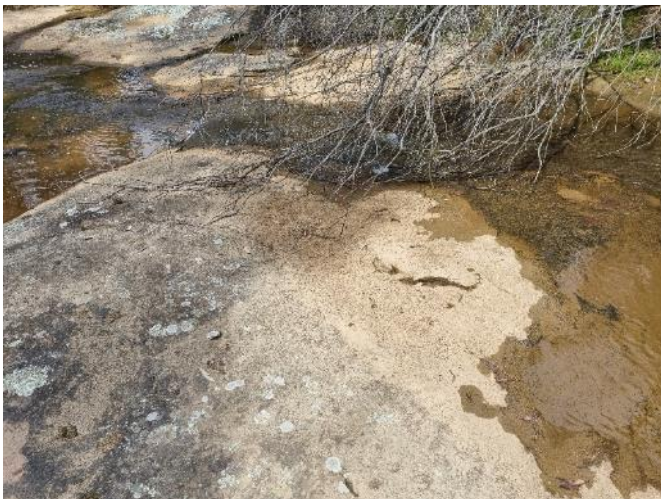
Weathering, cracking on North bank of Rockbar 2
19/10/2022

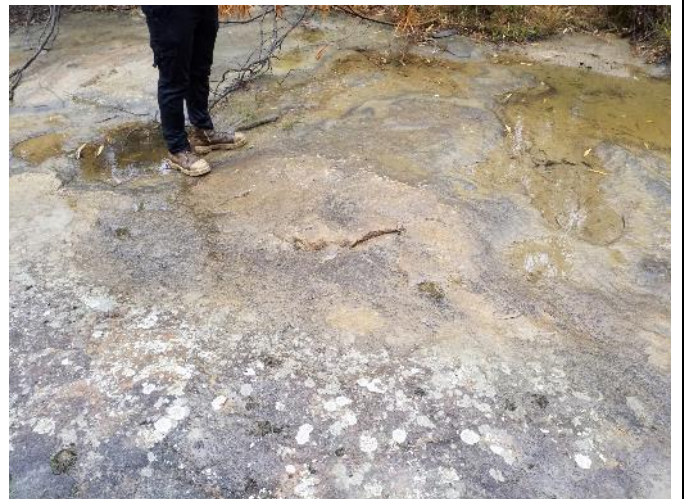
Weathering, cracking on North bank of Rockbar 2
28/06/2023

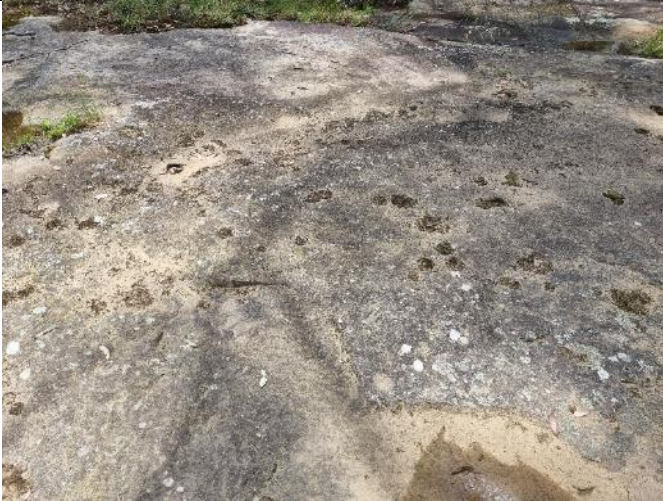
Joint on north rockbank at rockbar 2 Depression 3
Looking north 19/10/2022

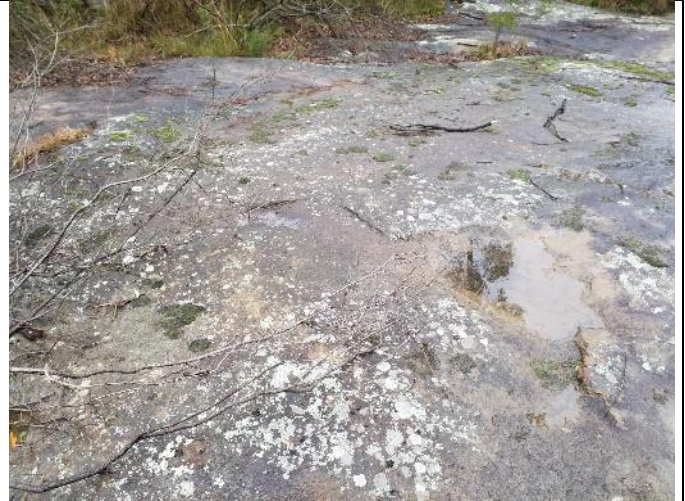
Joint on north rockbank at rockbar 2 Depression 3
Looking north 28/06/2023

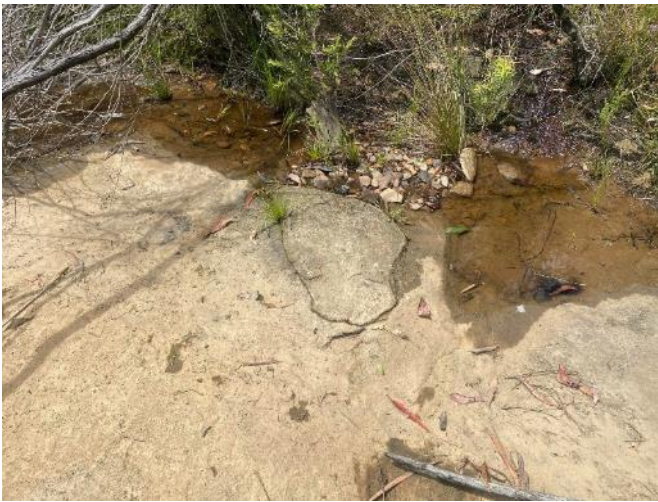
Cracking on South bank of Rockbar 2 15/11/2022

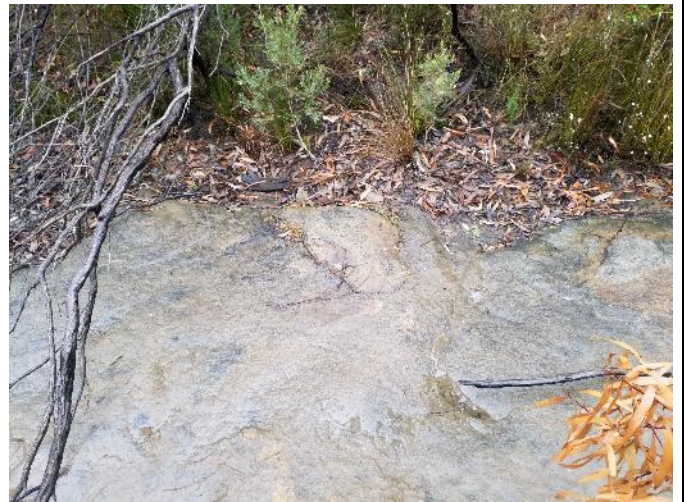
Cracking on South bank of Rockbar 2 28/06/2023

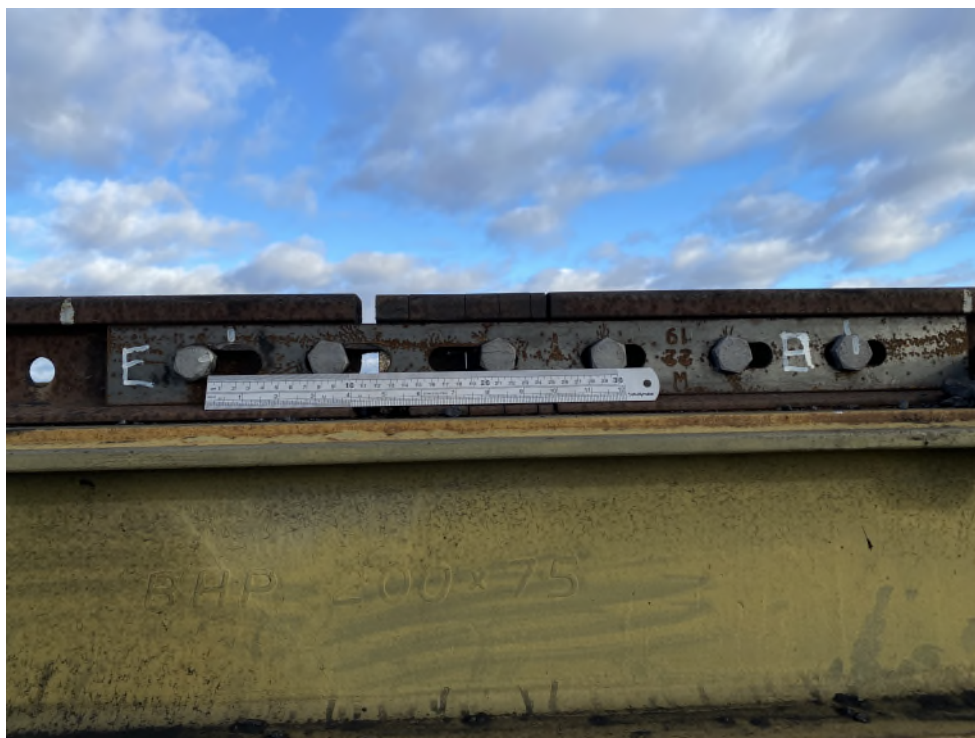
Rail joint gap has remained the same and is likely starting to close.

Figure 1: 5C slide joint East with spacer installed (29/05)

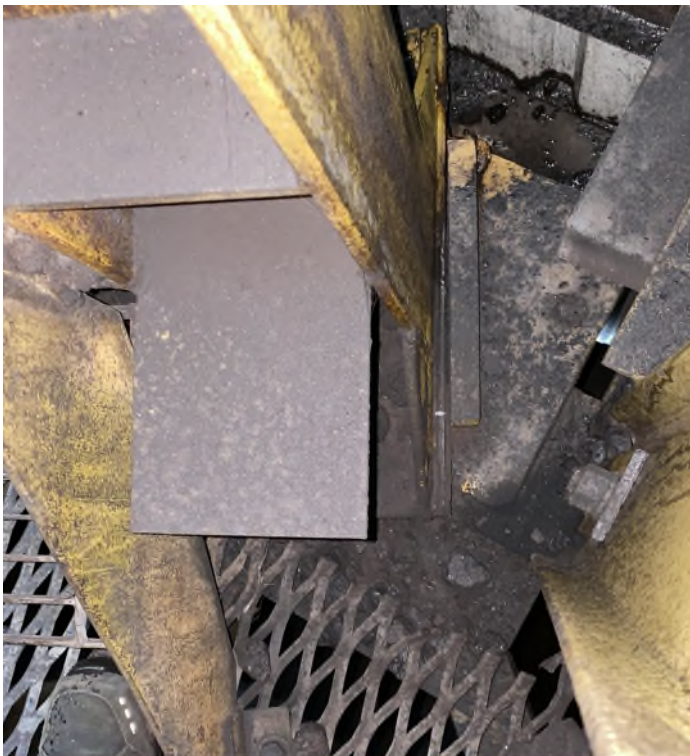
No change this week.

Figure 2: 7C slide joint west (22/05)

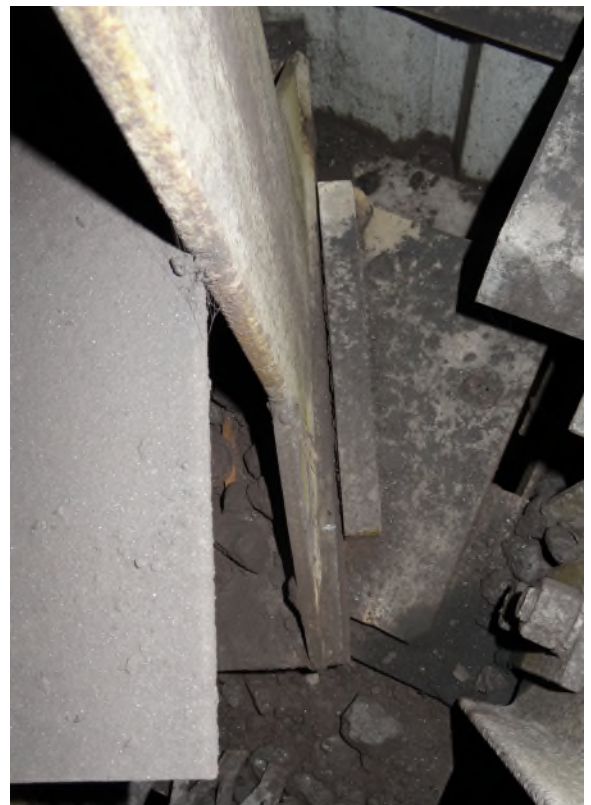
Figure 3: 7C slide joint west (29/05)
