## **Tahmoor South Longwalls S2A to S6A**

Subsidence Management Plan for potential impacts to MKD Machinery,  
3165 Remembrance Drive, Bargo

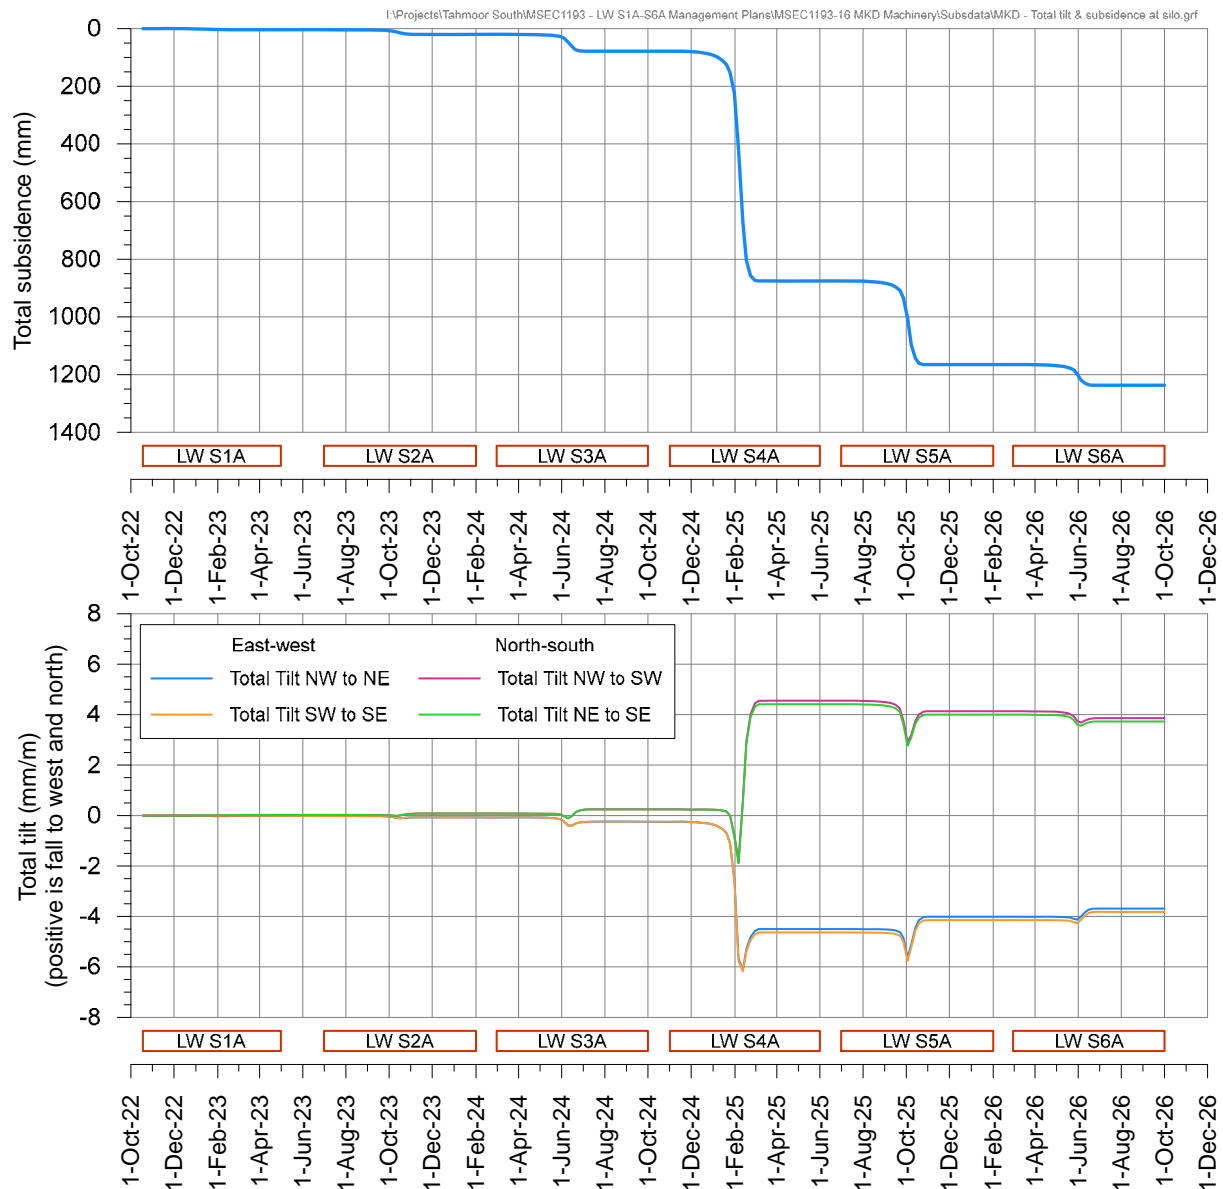
**Fig. 3.3 Predicted development of vertical subsidence and tilt at the silo hopper over time during the mining of LWs S1A to S6A**

It can be seen that the silo hopper is predicted to initially fall slightly to the north east as LWs S2A and S3A are extracted. The predicted tilt then momentarily reverses in direction as LW S4A approaches the structure before increasing in fall towards the north east after the mining of LW S4A. The tilts are then predicted to reduce slightly as LWs S5A and S6A are extracted.

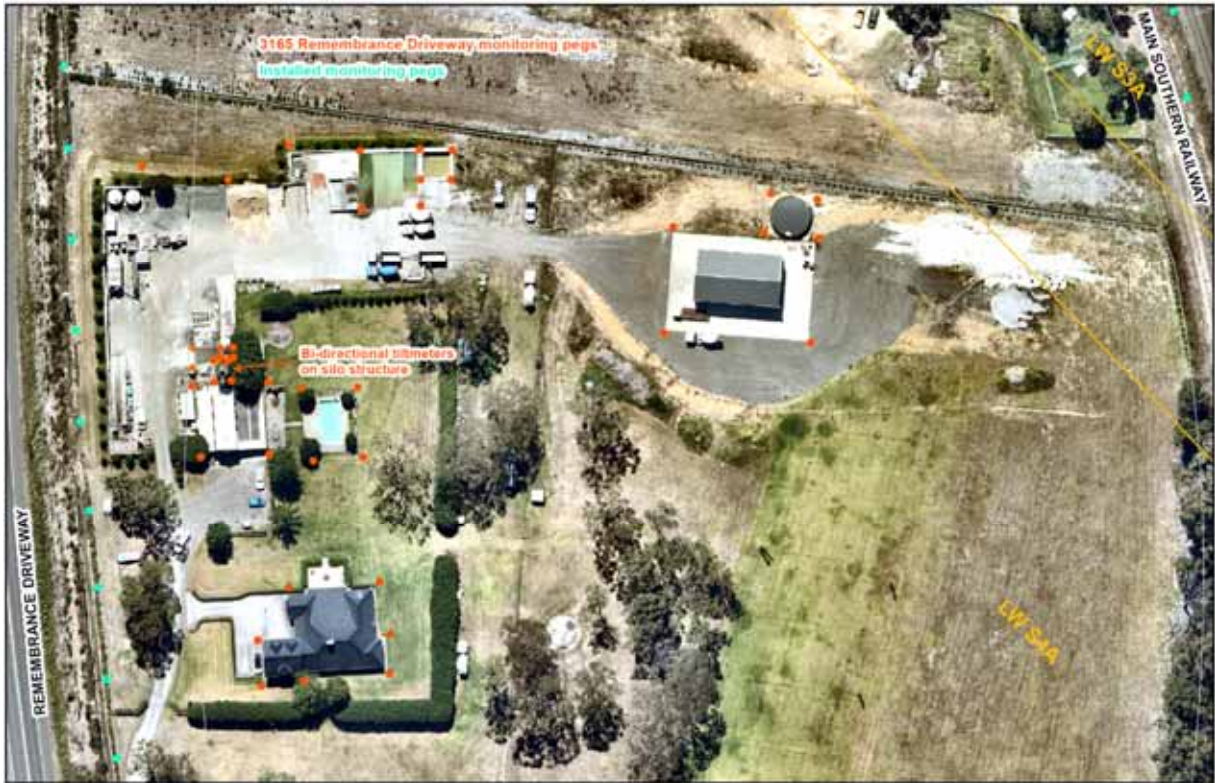
**Fig. 4.1 Survey marks at No. 3165 Remembrance Drive, Bargo**

- Local 3D survey  
Survey marks have been installed around the perimeters of the main structures, concreting yard and sedimentation tanks. Additional survey marks will be installed prior to the influence of LW S2A. The layout of the survey marks is provided in Fig. 4.1. The surveys will measure changes in height and changes in horizontal distances between adjacent pegs in local 3D.

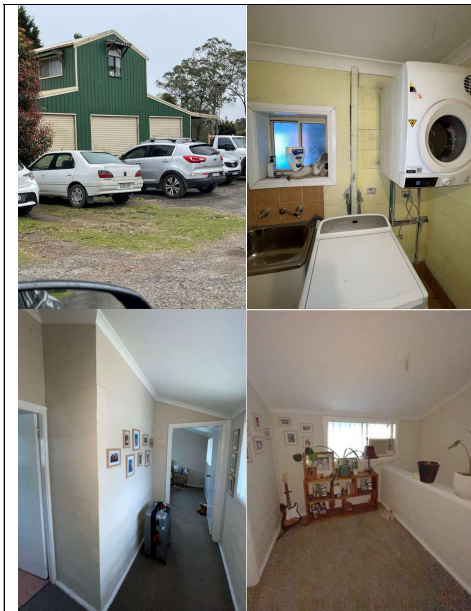
*Figure 2 Cold-formed steel-framed shed, internal ground floor and first floor Hebel block walls and suspended cold-formed steel floor.*

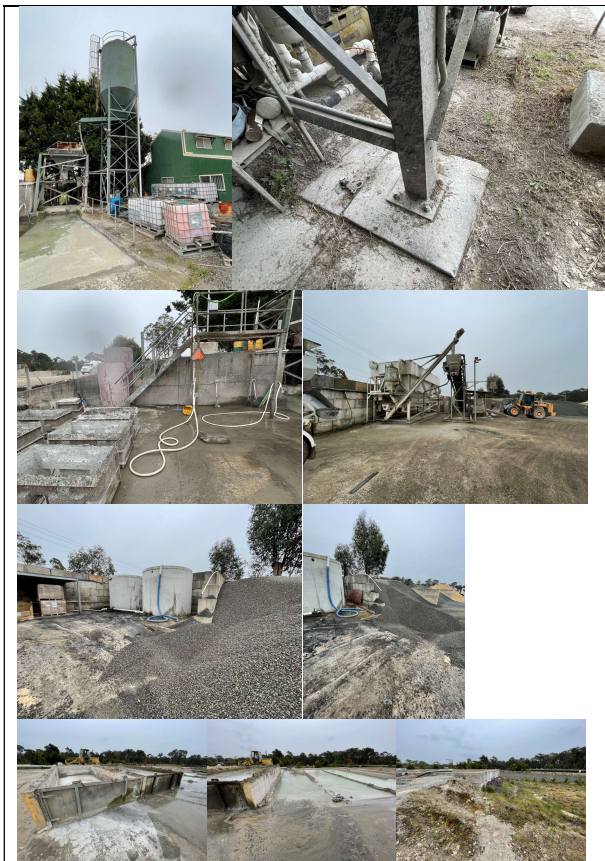
Figure 3 Photographs of possible hazards in the concrete plant

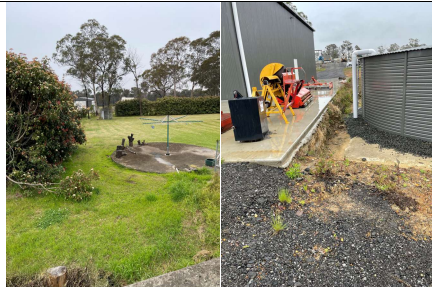
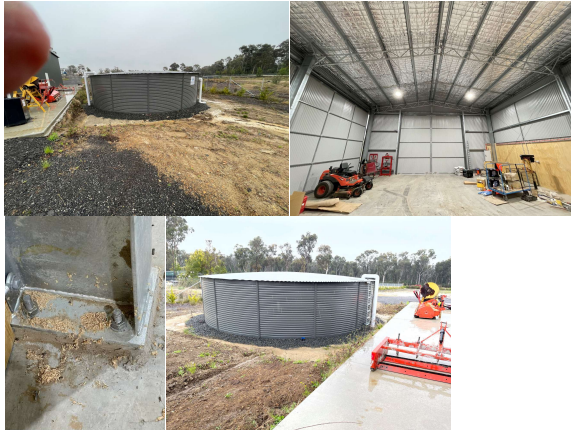
Figure 4 Shed and adjacent rainwater tank structures

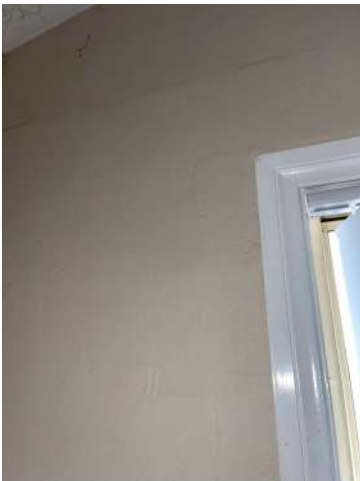
Figure 162: IMG\_3717

| Internal | Element | Pre-existing damage; NVD = No visible damage | Damage Classification to AS2870: 2011 | Camera image |
|---|---|---|---|--|
| | Wall 3 | <ul style="list-style-type: none"> <li>Horizontal crack at top left-hand corner of window, estimated width w≈0.1mm but crack appears to have been previously repaired.</li> </ul> | <ul style="list-style-type: none"> <li>Cat 1</li> </ul> | <ul style="list-style-type: none"> <li>3717</li> </ul> |

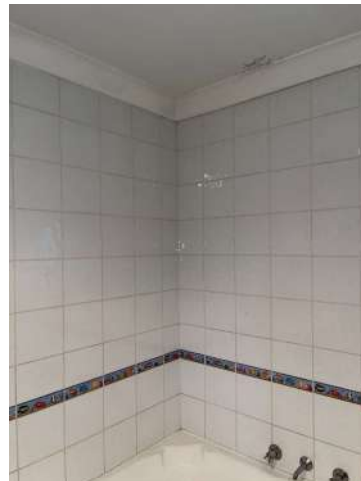
Figure 163: IMG\_3718

| Internal | Element | Pre-existing damage; NVD = No visible damage | Damage Classification to AS2870: 2011 | Camera image |
|---|---|---|---|--|
| Bathroom | Wall 1 | <ul style="list-style-type: none"> <li>Gap between underside of cornice and wall tiles estimated width w≈1-2mm.</li> <li>Corner wall grout crack at wall 2, estimated width w≈1mm.</li> </ul> | <ul style="list-style-type: none"> <li>Cat 2</li> <li>Cat 1</li> </ul> | <ul style="list-style-type: none"> <li>3718</li> <li>3718</li> </ul> |

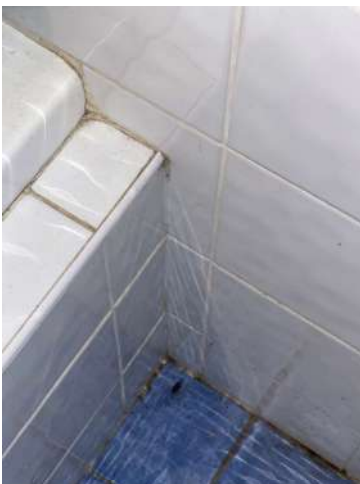
Figure 164: IMG\_3719

| Internal | Element | Pre-existing damage; NVD = No visible damage | Damage Classification to AS2870: 2011 | Camera image |
|---|---|---|---|--|
| | Wall 2 | <ul style="list-style-type: none"> <li>Gap between underside of cornice and wall tiles estimated width w≈1-2mm.</li> <li>Crack between bath and surrounding tile grout.</li> <li>Corner wall crack at wall 2, estimated width w≈1-1.5mm.</li> </ul> | <ul style="list-style-type: none"> <li>Cat 2</li> <li>Cat 1</li> <li>Cat 2</li> </ul> | <ul style="list-style-type: none"> <li>3720</li> <li>3719</li> <li>3721</li> </ul> |

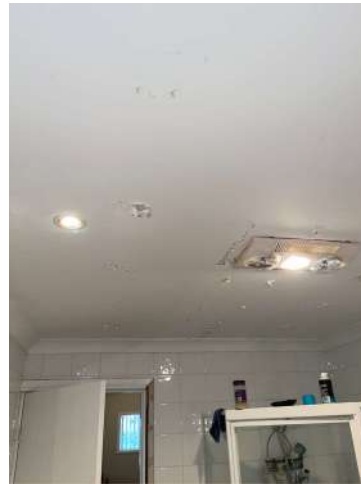
Figure 167: IMG\_3722

| Internal | Element | Pre-existing damage; NVD = No visible damage | Damage Classification to AS2870: 2011 | Camera image |
|---|---|---|--|--|
| | Ceiling | <ul style="list-style-type: none"> <li>Mouldy peeling paint</li> </ul> | <ul style="list-style-type: none"> <li>noted</li> </ul> | <ul style="list-style-type: none"> <li>3722, 3723</li> </ul> |

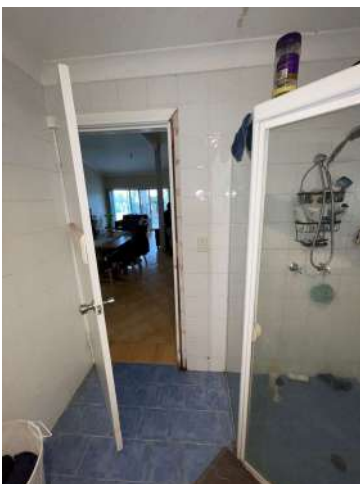
Figure 168: IMG\_3723

| Internal | Element | Pre-existing damage; NVD = No visible damage | Damage Classification to AS2870: 2011 | Camera image |
|---|---|---|--|--|
| | Wall 4 | <ul style="list-style-type: none"> <li>Gap between underside of cornice and wall tiles estimated width w=1-2mm, typical, missing door architrave.</li> </ul> | <ul style="list-style-type: none"> <li></li> </ul> | <ul style="list-style-type: none"> <li>3723</li> </ul> |

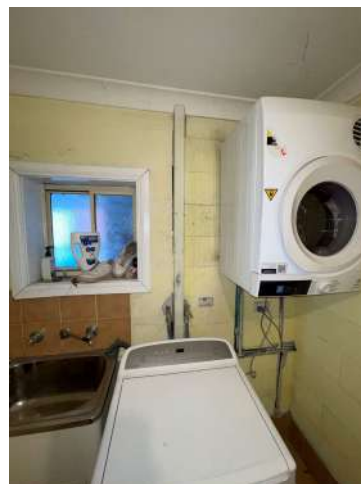
Figure 169: IMG\_3724

| Internal | Element | Pre-existing damage; NVD = No visible damage | Damage Classification to AS2870: 2011 | Camera image |
|---|---|---|--|--|
| | Wall 2 | <ul style="list-style-type: none"> <li>Cracking around back-to-back cold-formed steel columns.</li> </ul> | <ul style="list-style-type: none"> <li></li> </ul> | <ul style="list-style-type: none"> <li>3724</li> </ul> |

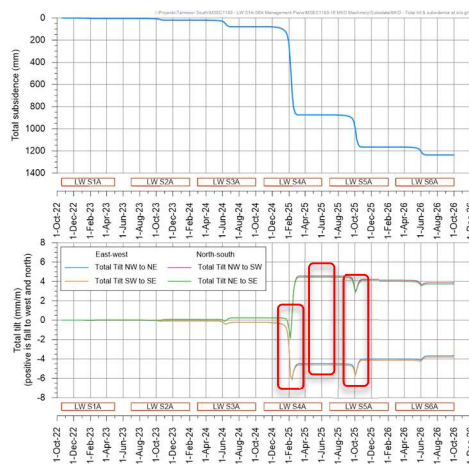
**Figure 2.** Furthermore, in addition to the predicted subsidence-induced ground tilt, a construction tilt of 5mm/m was applied in the same general direction as subsidence-induced tilt.

*Figure 2 Worst-case tilt scenarios that were simulated by the three-dimensional structure model.*

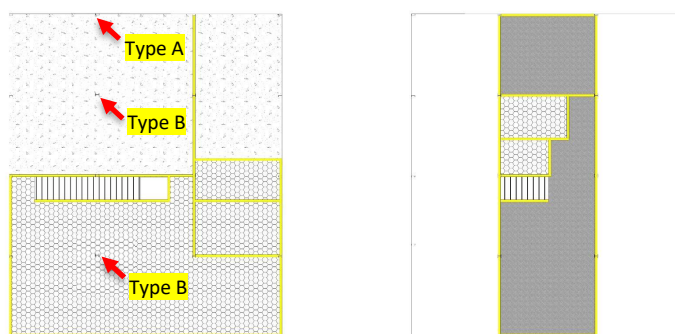
The dwelling has been formed by erecting Hebel walls on the ground floor slab up to the underside of the mezzanine floor structure, see left frame in **Figure 4**. The Hebel walls appear to be tied to the cold-formed steel columns at ground floor level and so the mezzanine floor and roof appear to be effectively braced. Hebel walls have been erected at mezzanine level and again they appear to be tied to the ground floor steel columns that continue up to support the high-bay roof, see **Figure 5**.

*Figure 4 Ground (left) and mezzanine floor (right) internal layout plans showing location of 100mm thick Hebel block walls.*

It is recommended, therefore, that supplementary support should be installed adjacent to the columns that have been identified in **Figure 4**, which are isolated and do not have an alternate load path through adjacent Hebel block walls if an overstress occurred. The props are designated Type A & Type B and could comprise 75x5 SHS posts located adjacent to or sandwiched against and screwed or bolted to the existing columns, with a 10mm baseplate to bear on the ground slab (and 2M12 HD bolts) and a 10mm cap plate to support the timber bearer with 2 M12 coach bolts, see **Figures 6 & 7** for the types of columns where supplementary support is recommended.

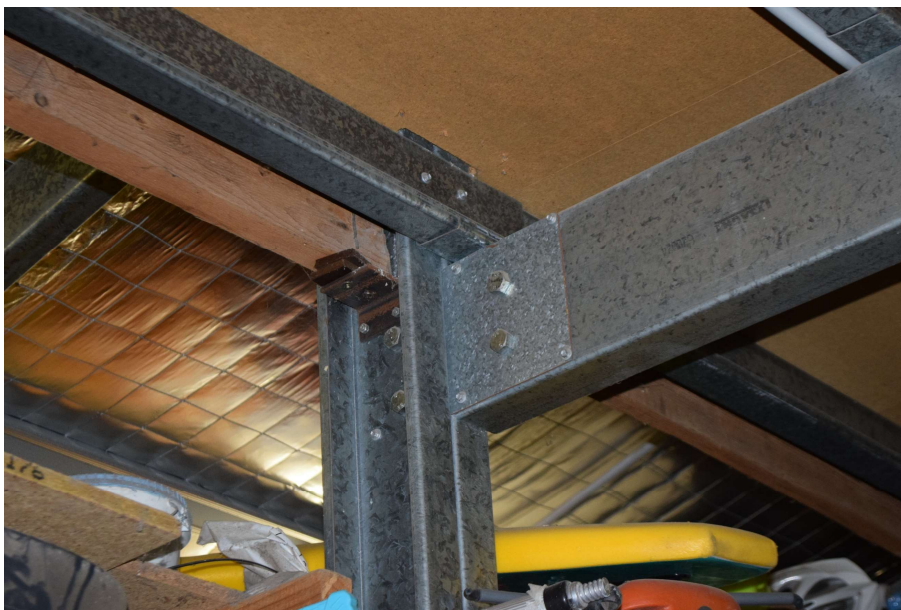
The Hebel block walls at mezzanine level are supported by timber beams, which are in turn supported by the steel columns by angle seats that have been TEK screwed to the webs of the columns. In one case, several packers were installed between the angle seat and timber beam, see **Figure 6**.

However, the columns are currently loaded with major axis eccentricity by way of bracket connections between the beams and columns, see **Figure 5**. Assuming a design eccentricity of 100mm for the beam reactions, the back-to-back columns appear to satisfy the requirements of AS4600 but since they could be supporting more load than for which they were designed, there is a small amount of reserve capacity for the potential impact of ground tilt, differential horizontal movement between the top and bottom of the columns or ground movement anomalies. Furthermore, the support of the Hebel block walls at mezzanine level relies on a pair of TEK screws for vertical support, see **Figure 6**.

*Figure 6 Packing between timber beams and angle seat brackets.*

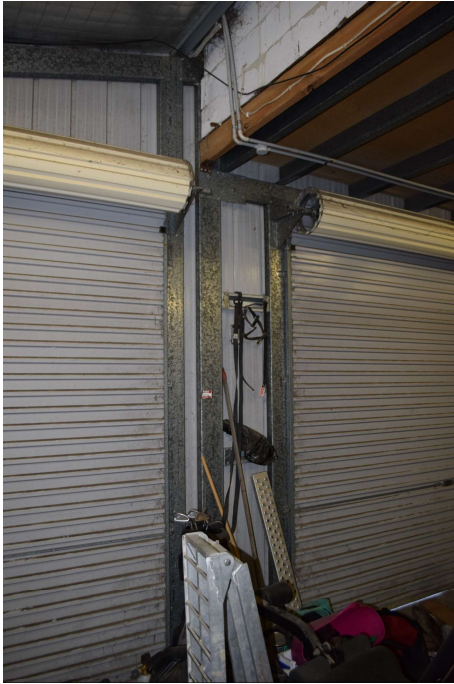
*Figure 7 Single end column*

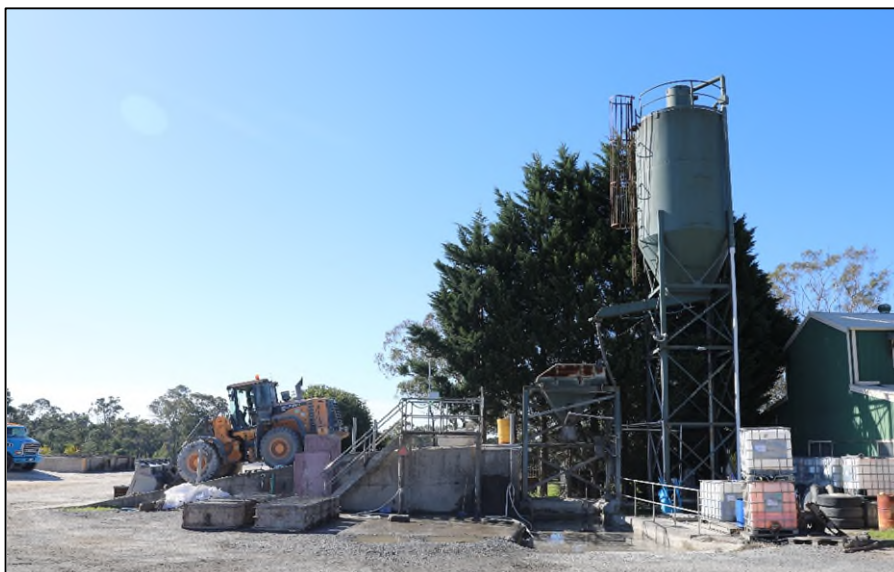
The silo was securely fixed to the foundation.

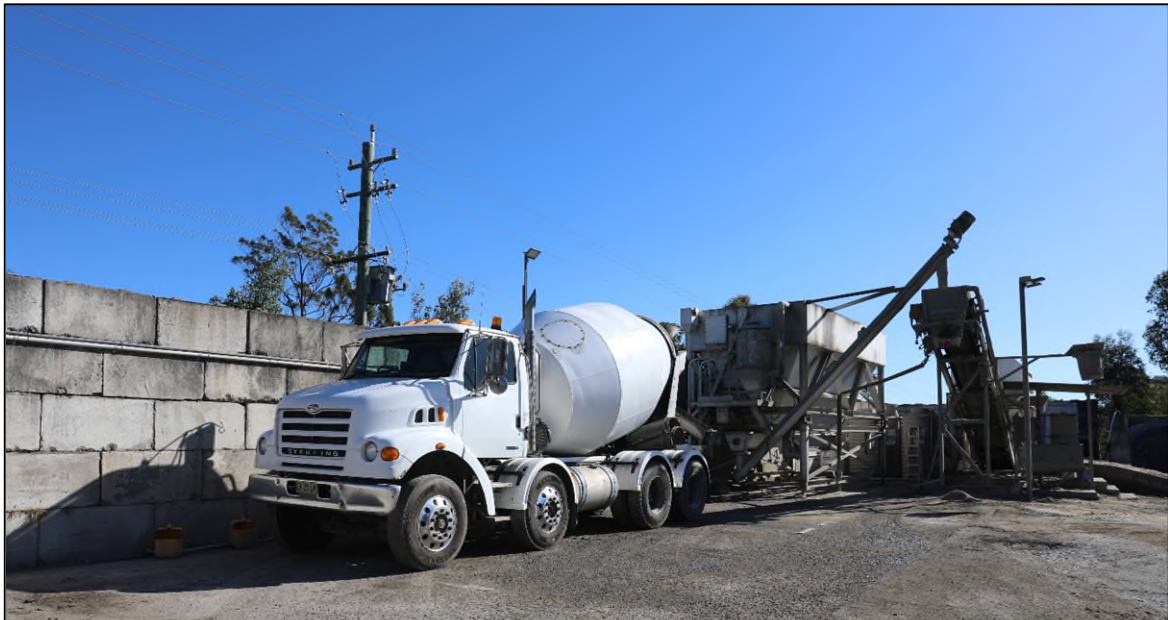
The image below shows the general arrangements at MKD Machinery. No additional risks of serious incidents were identified from the potential impacts of mining induced subsidence. Stability and monitoring of the concrete silos is outside of the scope of this inspection.

General arrangements include a large open area for trucks and loaders to move around the site. Any equipment is free standing and securely fastened. The front barrier wall is made of large concrete blocks, which are flexible but stable.

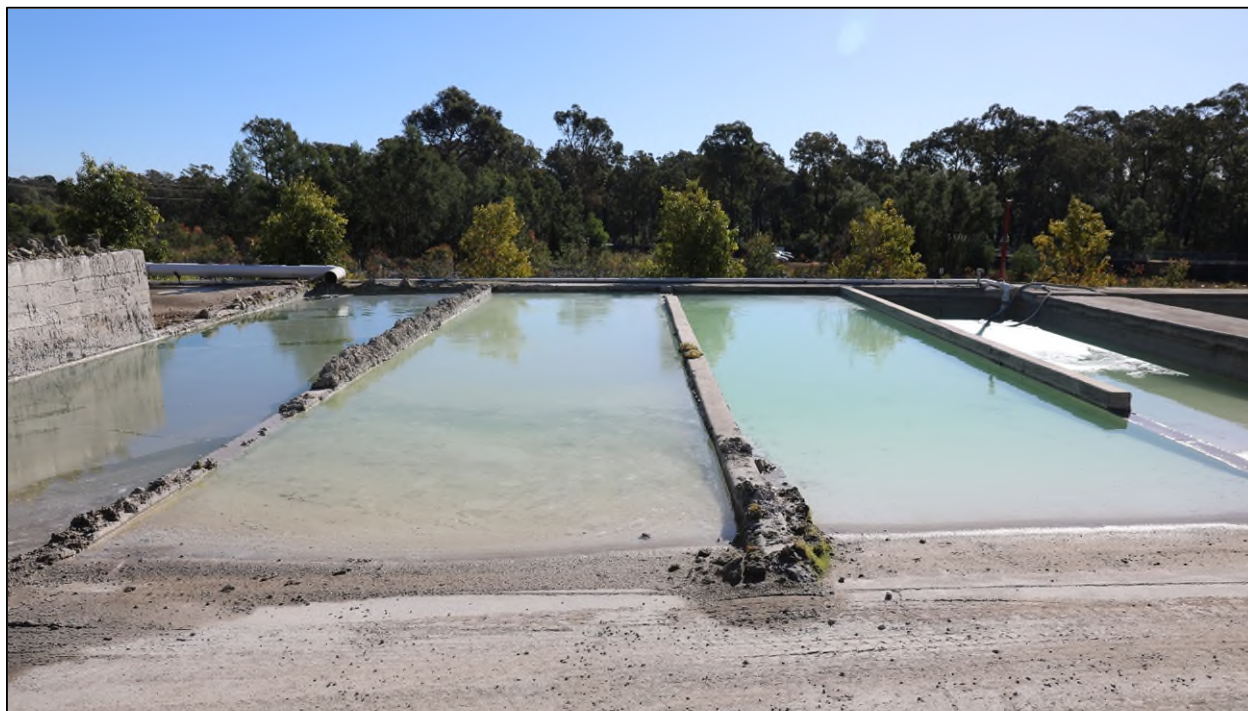
Fuels, chemicals and oils are contained within free standing containers not likely to be affected by mining induced subsidence.

Settling ponds are large concrete structures not likely to result in a catastrophic release of fluid causing a dangerous incident.
