Tahmoor Coal Pty Ltd

SIX MONTHLY SUBSIDENCE IMPACT REPORT

Tahmoor South Domain Longwalls South 1A – South 6A

1 July 2023 – 31 December 2023

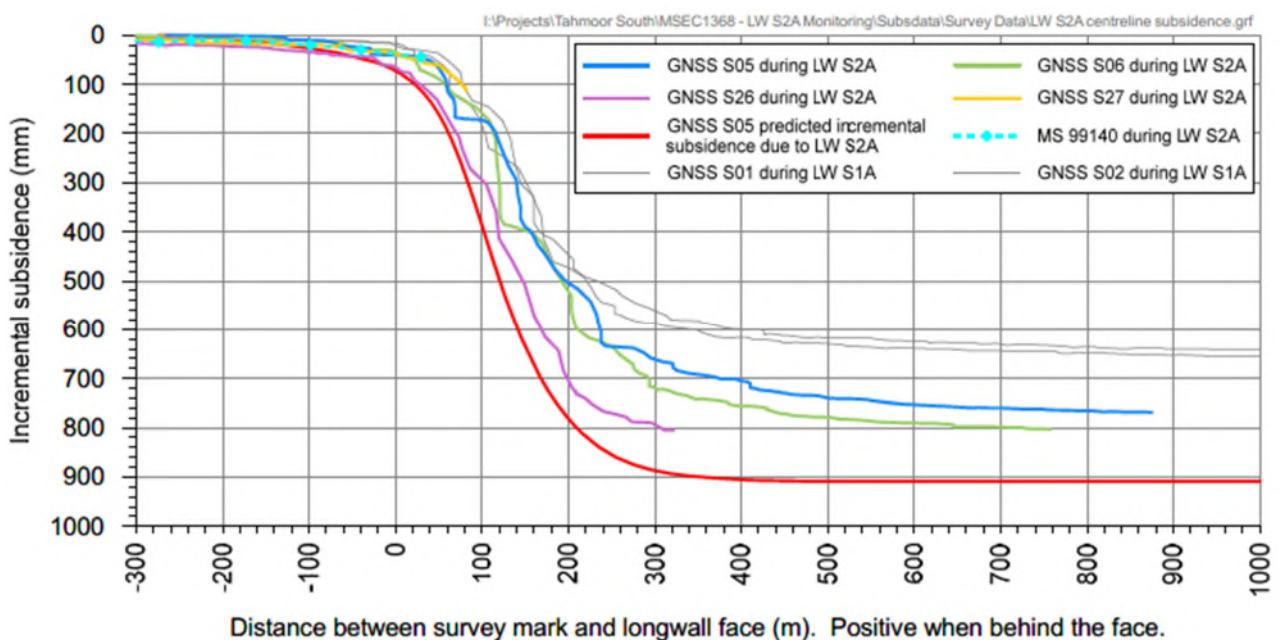
Figure 3-2 Development of observed subsidence above LW S2A (source: MSEC, Subsidence Monitoring Report 19a, Appendix A)

Mining-induced movements are developing at the GNSS units, with maximum incremental subsidence of 805 mm at Site S26 since the commencement of LW S2A. Subsidence is increasing at Site S26 above LW S2A and rates of change are beginning to reduce. Subsidence is also increasing at Site S27 above LW S2A, but at a reduced magnitude at the equivalent stages of mining compared to GNSS S26. Subsidence at Sites S05 and S06 are reducing, as is expected at this stage of extraction (MSEC Subsidence Monitoring Report 19a (**Appendix A**)).

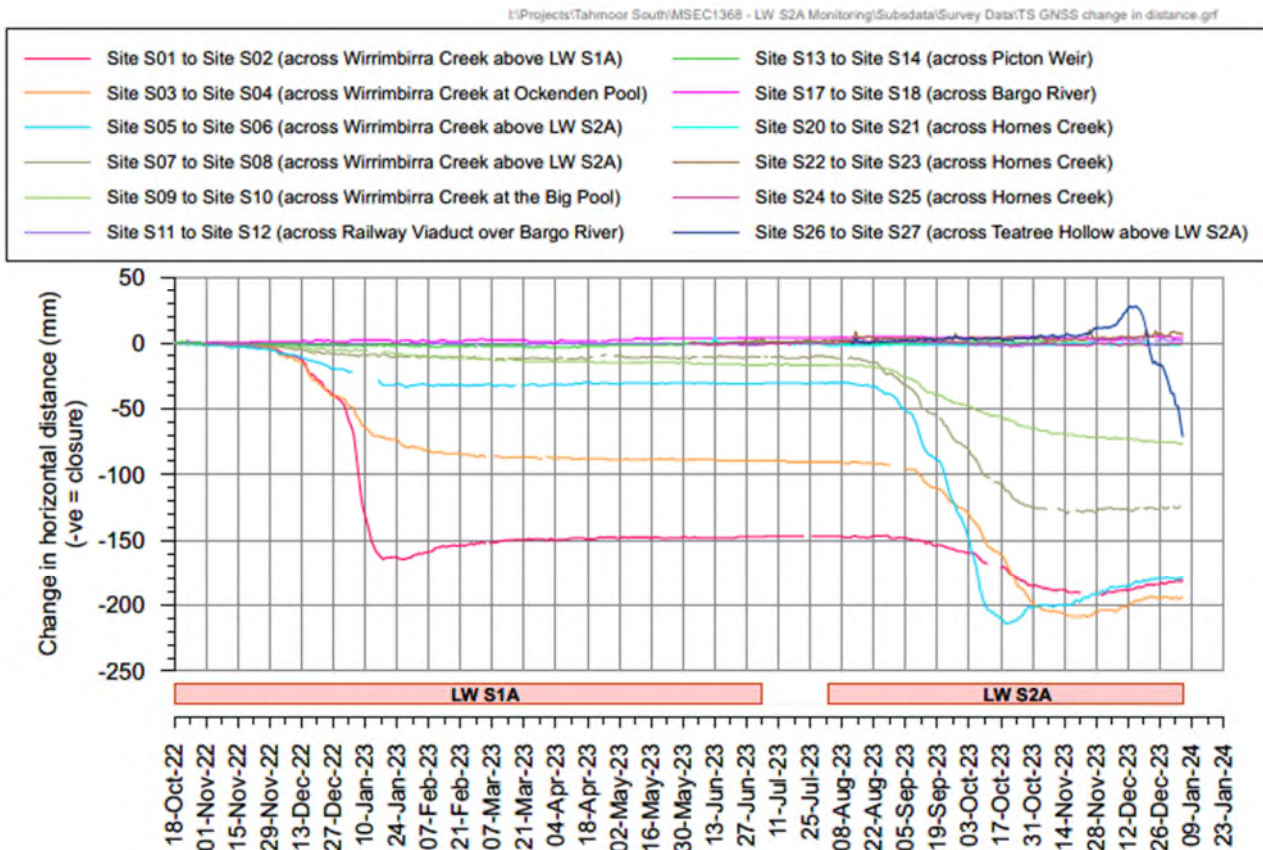
Figure 3-3 Observed changes in horizontal distances between GNSS units during LW S2A extraction (source: MSEC, Subsidence Monitoring Report 19a, Appendix A).

Changes in horizontal distances between paired GNSS units that are stationed close together on opposite sides of Teatree Hollow and Teatree Hollow Tributary (also known as ‘Wirrimbirra Creek’) are illustrated in **Figure 3-3**. The following trends have been observed since the commencement of LW S2A:

- Closure has developed across the Tributary to Teatree Hollow (Wirrimbirra Creek), particularly between Sites S07 and S08 directly above LW S2A. Rates of change between these two locations has not reduced to low levels;
- Closure has reduced between Sites S05 and S06, as previously observed between Sites S01 and S02 during the mining of LW S1A;
- Closure has reduced between Sites S03 and S04; and
- Closure is developing across Teatree Hollow between Sites S26 and S27 directly above LW S2A.

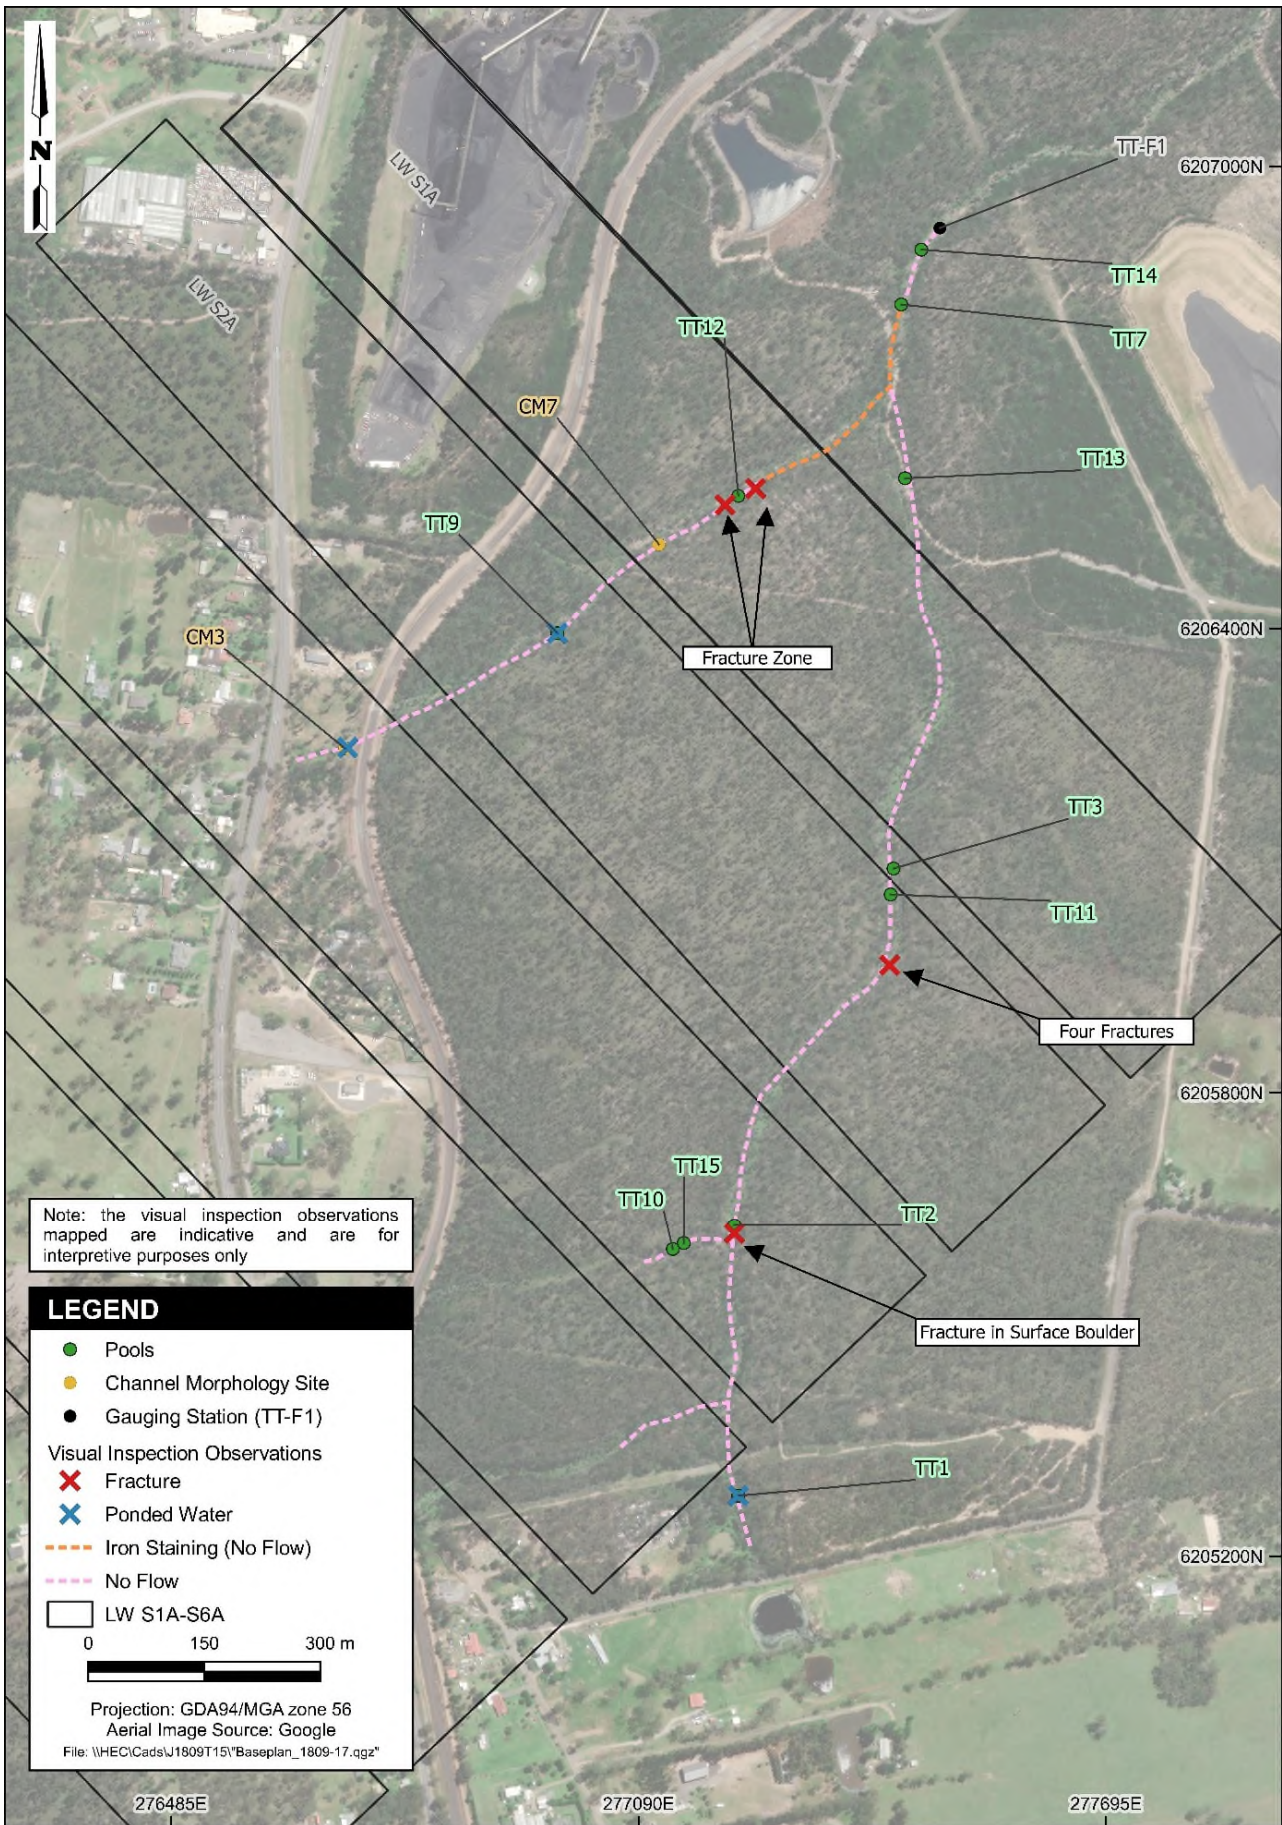
Figure 3-7 Visual depiction of surface water characteristics and physical effects in early November 2023 (source: Appendix B)

Figure 3-7 demonstrates the location of flow re-emergence, fracturing, ponded water, iron staining and overland flow observed towards the end of the reporting period (November 2023) prior to above average rainfall in late November 2023.

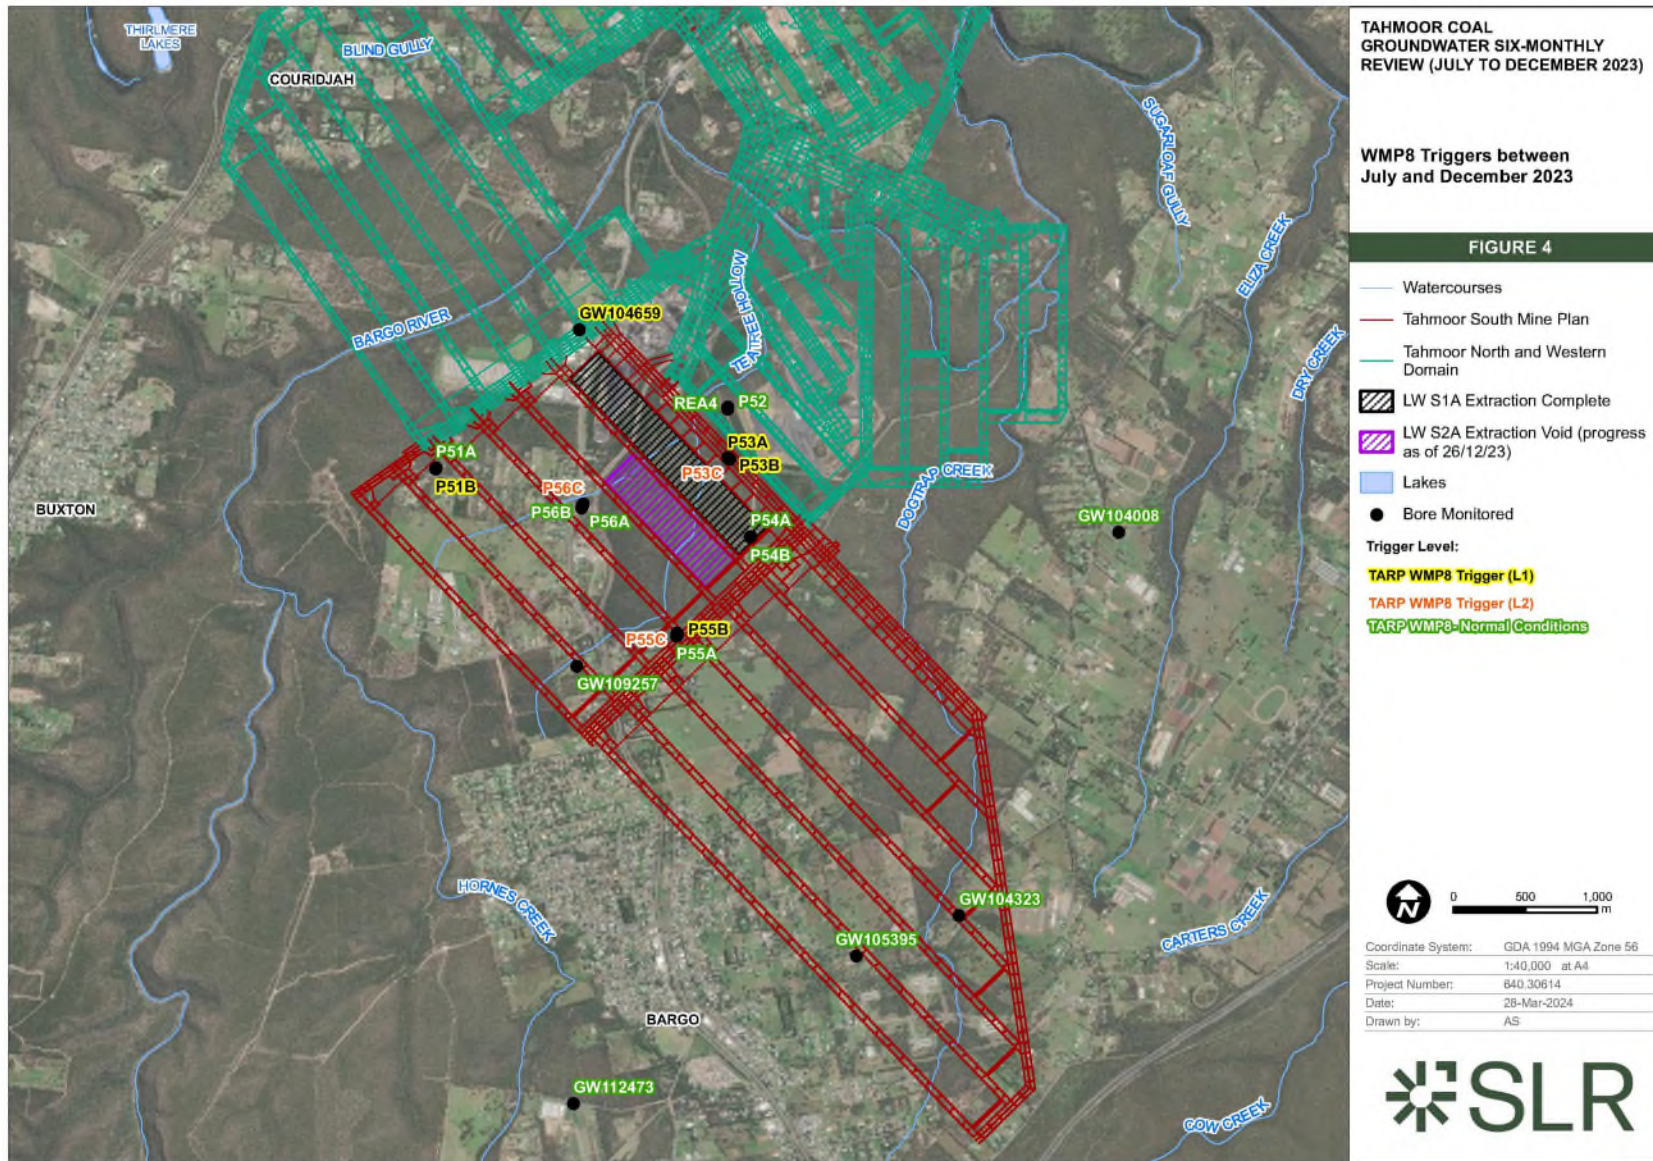
Figure 3-9 Groundwater TARP triggers (source SLR 2023; Groundwater Monitoring Report; Appendix C).

The spatial distribution of these triggers is illustrated in **Figure 3-9**. Further discussion of these triggers is provided in the Groundwater Monitoring Report (refer **Appendix C**).

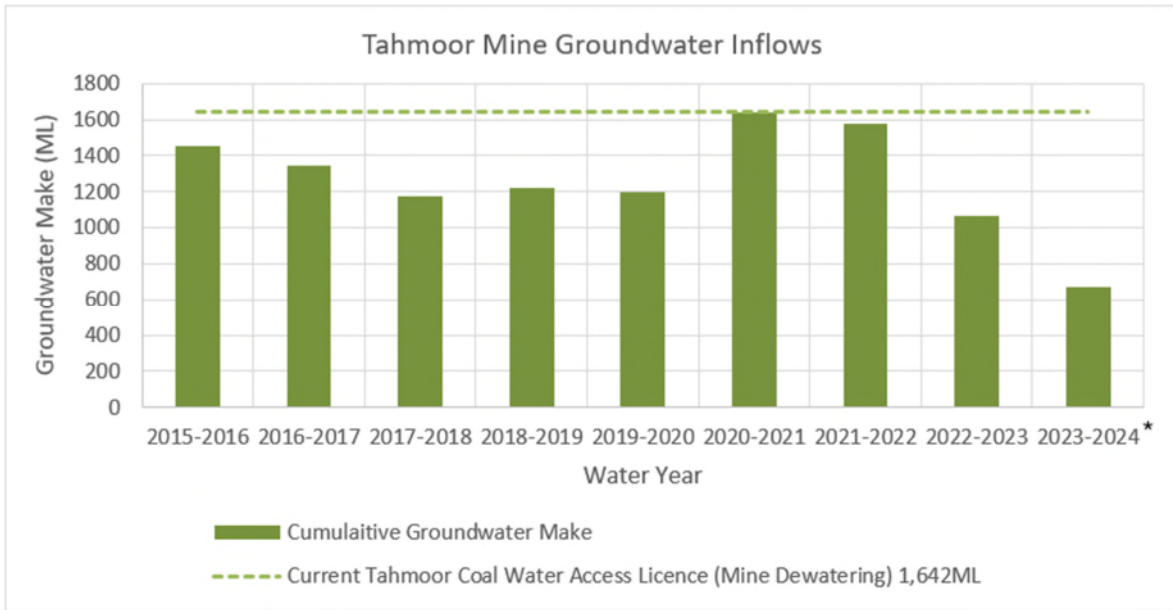
Figure 3-10 Groundwater Make per Water Year (financial year) from 2015/16 to 2023/24 (source SLR 2023; Groundwater Monitoring Report; **Appendix C**).

The reporting period for this report falls within the water year calendar 2023-24. As of 31 December 2023, the cumulative groundwater make for the water year 2023-24 is 673 ML, which remained below the groundwater entitlement of 1,642 ML per annum (i.e. water year) (refer **Figure 3-10**).

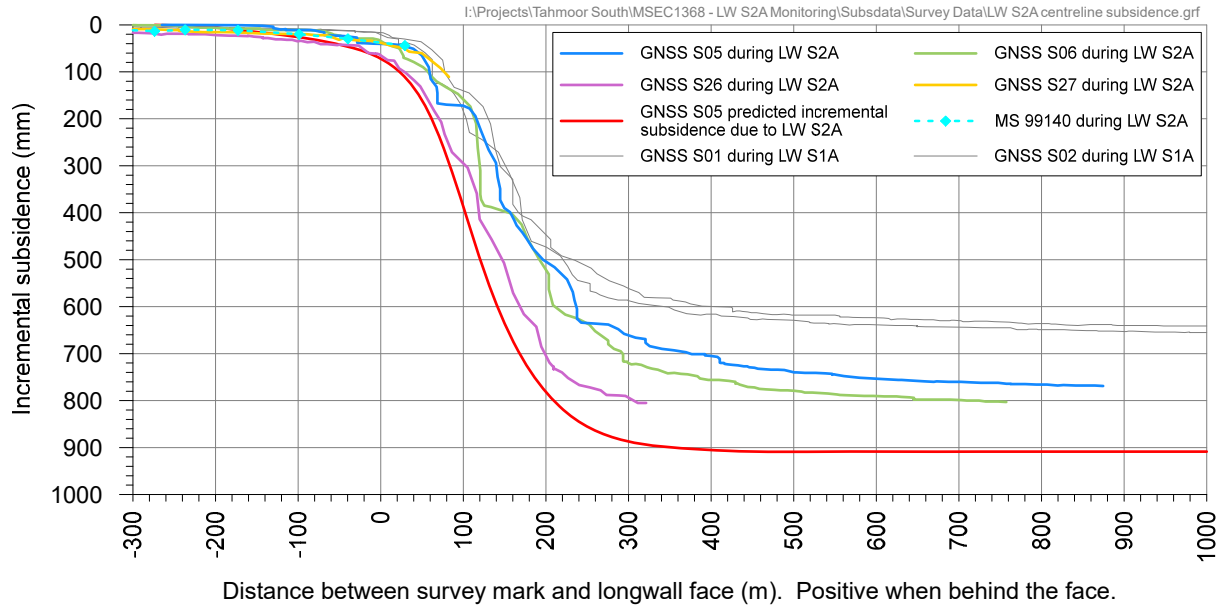
Figure A Observed development of incremental subsidence above LW S2A relative to position of longwall face

Observed development of subsidence above LW S2A relative to face distance is shown in Figure A. Subsidence is increasing at Sites S05 and S06 though rates of change per metre of longwall travel are reducing, as expected at this stage of extraction.

It is predicted that subsidence above LW S2A will be greater than observed above LW S1A because it is the second panel in the longwall series.

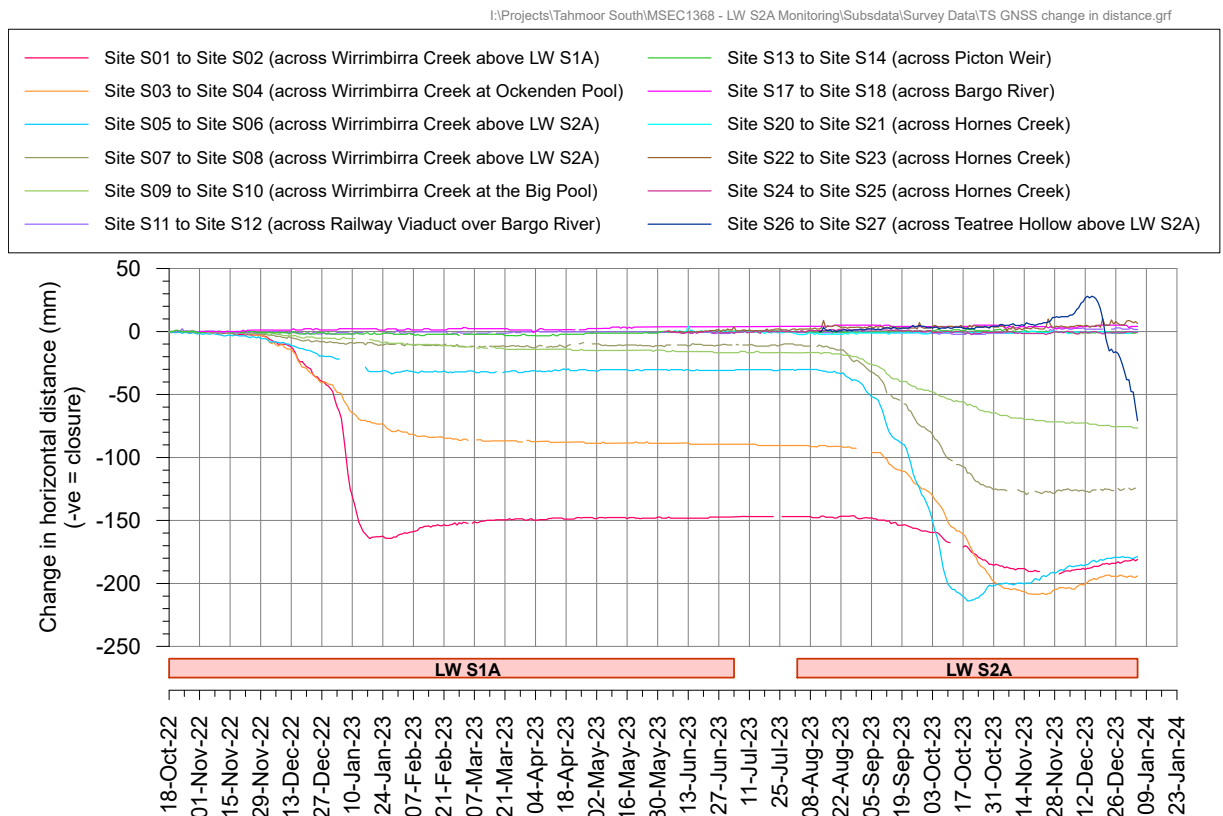
Figure B Observed changes in horizontal distances between GNSS units

Changes in horizontal distances can be calculated between GNSS units that are stationed close together and results are shown in Figure B. Closure has developed across the Tributary to Teatree Hollow (Wirrimbirra Creek), particularly between Sites 07 and 08 directly above LW S2A. Rates of change have reduced to low levels. Closure has reduced between Sites 05 and 06, as previously observed between Sites S01 and S02 during the mining of LW S1A. Closure has also reduced between Sites 03 and 04. Closure is developing across Teatree Hollow between Sites S26 and S27 directly above LW S2A.

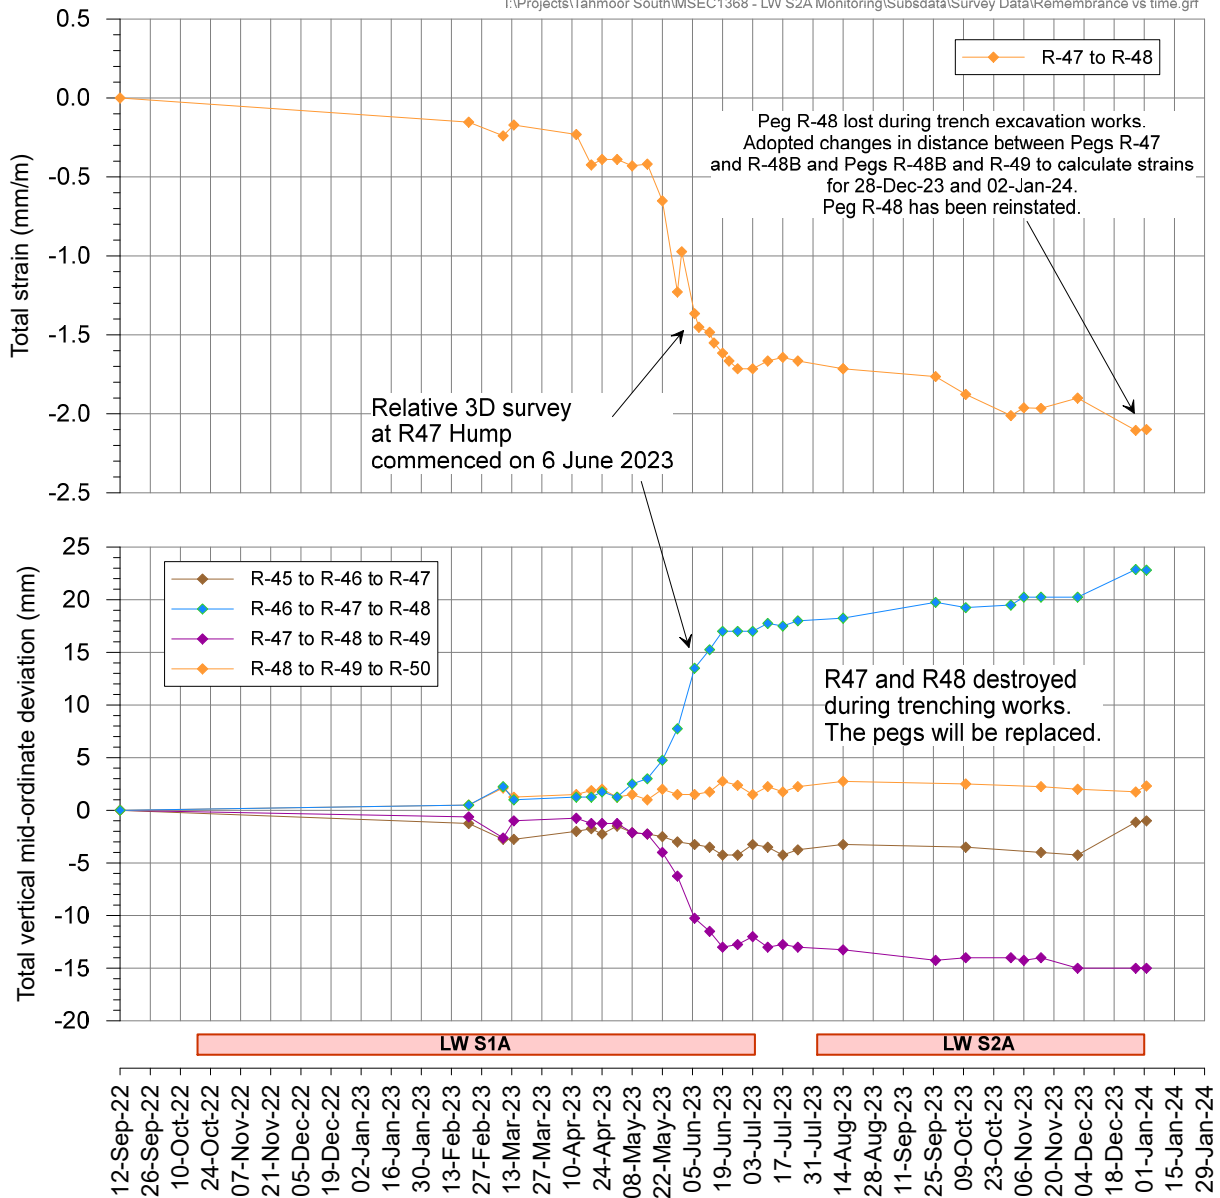
Figure C Observed development of ground strain and changes in vertical alignment at selected pegs along Remembrance Drive

An increase in compressive strain was observed this month, with very minor changes in vertical misalignment. The observation is consistent with measured changes in horizontal distance over a bay length of 40 metres between Pegs R47 and R49.

As shown in Figure C, the observed compressive strain between Pegs R47 and R48 is accompanied by a bump in the observed subsidence profile at Peg R46, and the dip in the observed subsidence profile at Peg R47. The survey on 29 May 2023 found that the bumps in the observed subsidence profile had increased since 22 May 2023. The survey on 6 June 2023 found that the bumps in the observed subsidence profile had increased since 29 May 2023. Minor changes were observed in the survey of 14 August.

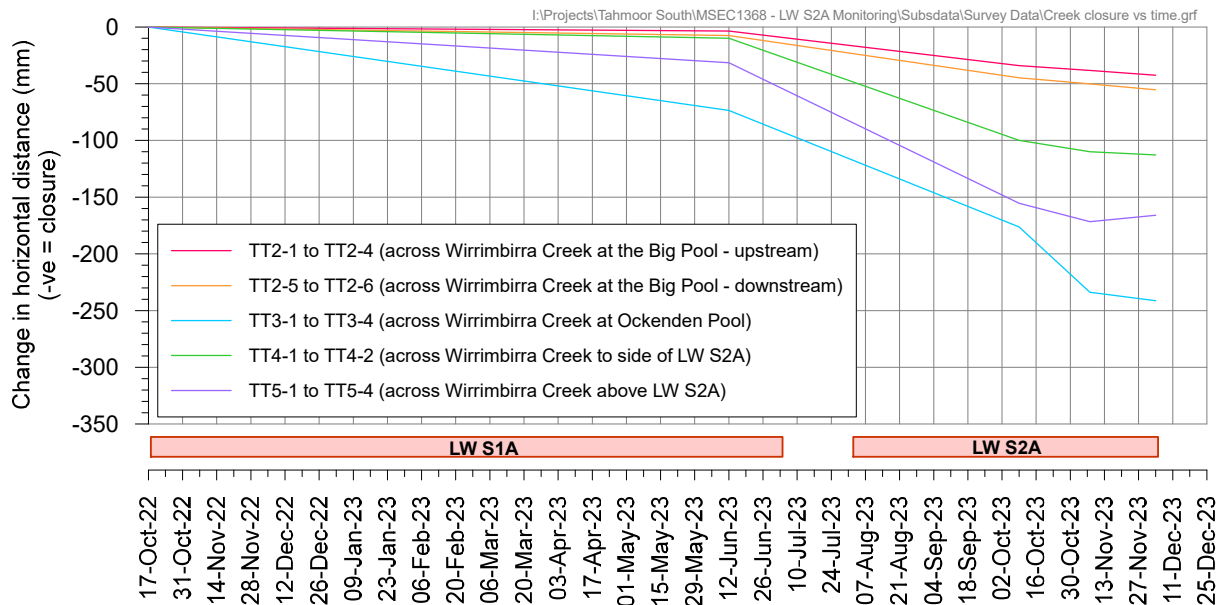
Figure G Observed development of closure across Tributary to Teatree Hollow from ground surveys

A survey was conducted on 4 December along ground survey lines that were installed across the Tributary to Teatree Hollow, and a summary is shown in Figure G. The results correlate reasonably well with the observations from GNSS units, taking into account the shorter lengths of the survey lines, which are based within the floor of the creek valley, compared to the distances between the GNSS units, which are mounted at the tops of the valleys.

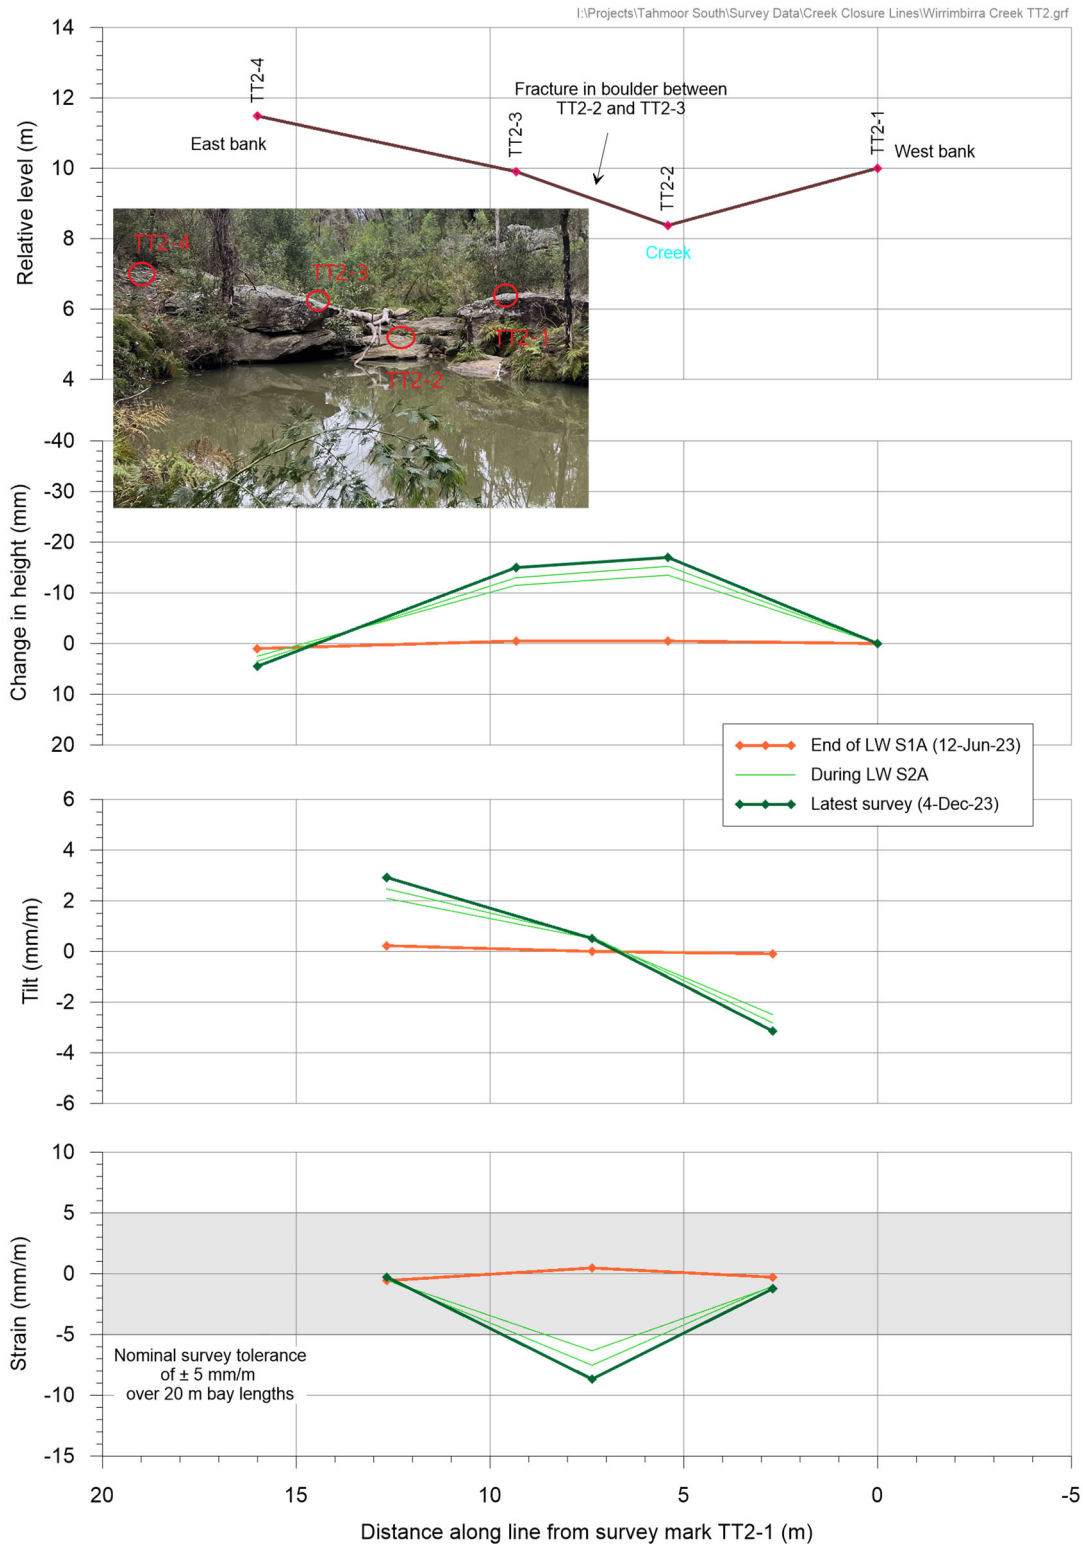
Figure H Observed subsidence, tilt and strain along TT2 line, upstream of Pool TT2

Water levels in Pool TT2 remain low. While the observed rates of water level recession at Pool TT2 are consistent with previously observed rates and consistent with evaporation rates, surface and ground water assessments have found that the low water levels are atypical than what would be considered 'normal' conditions and are likely due to mining-induced reduction in groundwater baseflow into the pool.

An inspection was conducted on 15 November, with similar observations to 25 October though the fracture within the boulder field upstream of Pool TT2 has increased slightly.

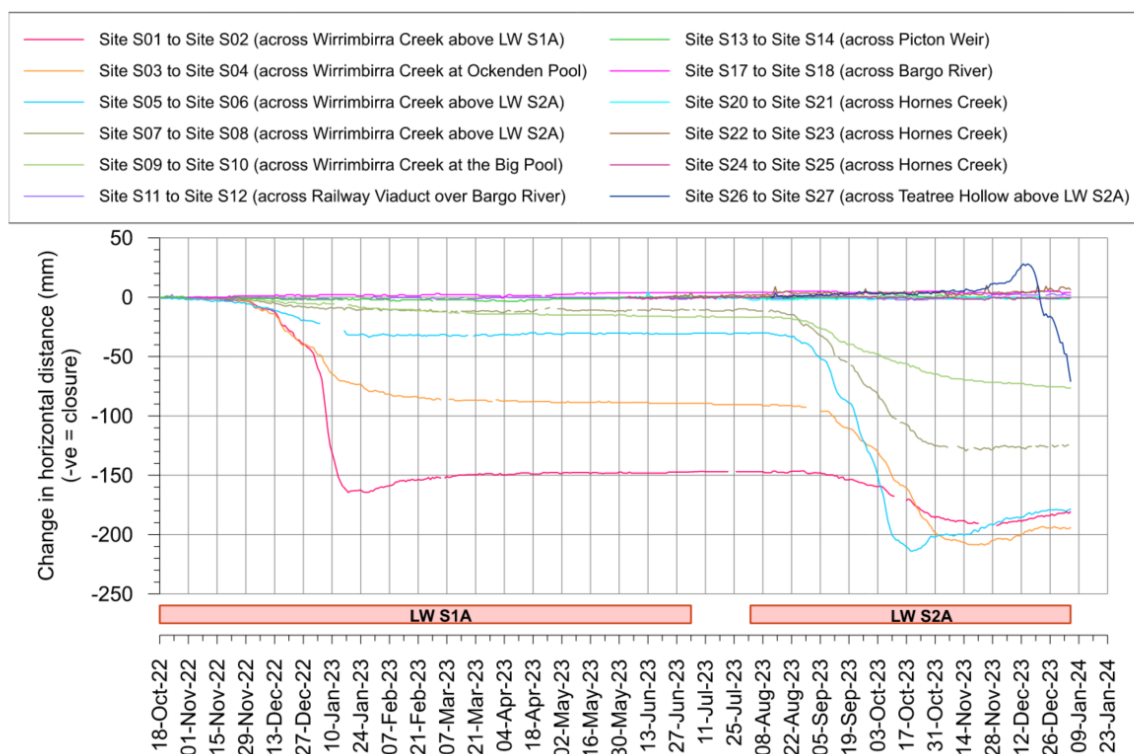
DIAGRAM 1: OBSERVED CHANGES IN HORIZONTAL DISTANCES BETWEEN GNSS UNITS (SOURCE: MSEC, 2023)

From the commencement of LW S1A to December 2023, including completion of LW S1A on 4 July 2023 and commencement of LW S2A on 2 August 2023, the following was recorded (MSEC, 2023):

- Approximately 150 millimetre (mm) of closure developed between Site S01 and Site S02 (across Wurrimbirra Creek² above LW S1A) during mining of LW S1A with a maximum of approximately 190 mm recorded during mining of LW S2A to December 2023.
- Approximately 90 mm of closure developed between Site S03 and Site S04 (across Wurrimbirra Creek at Ockenden Pool³) during mining of LW S1A with a maximum of approximately 210 mm recorded during mining of LW S2A to December 2023.
- Less than 50 mm of closure developed across Wurrimbirra Creek between Site S05 and S06, S07 and S08 and S09 and S10 during mining of LW S1A. Following the commencement of mining of LW S2A, greater than 200 mm closure developed between Site S05 and S06, with less than 130 mm and 80 mm closure recorded between S07 and S08 and S09 and S10 respectively.

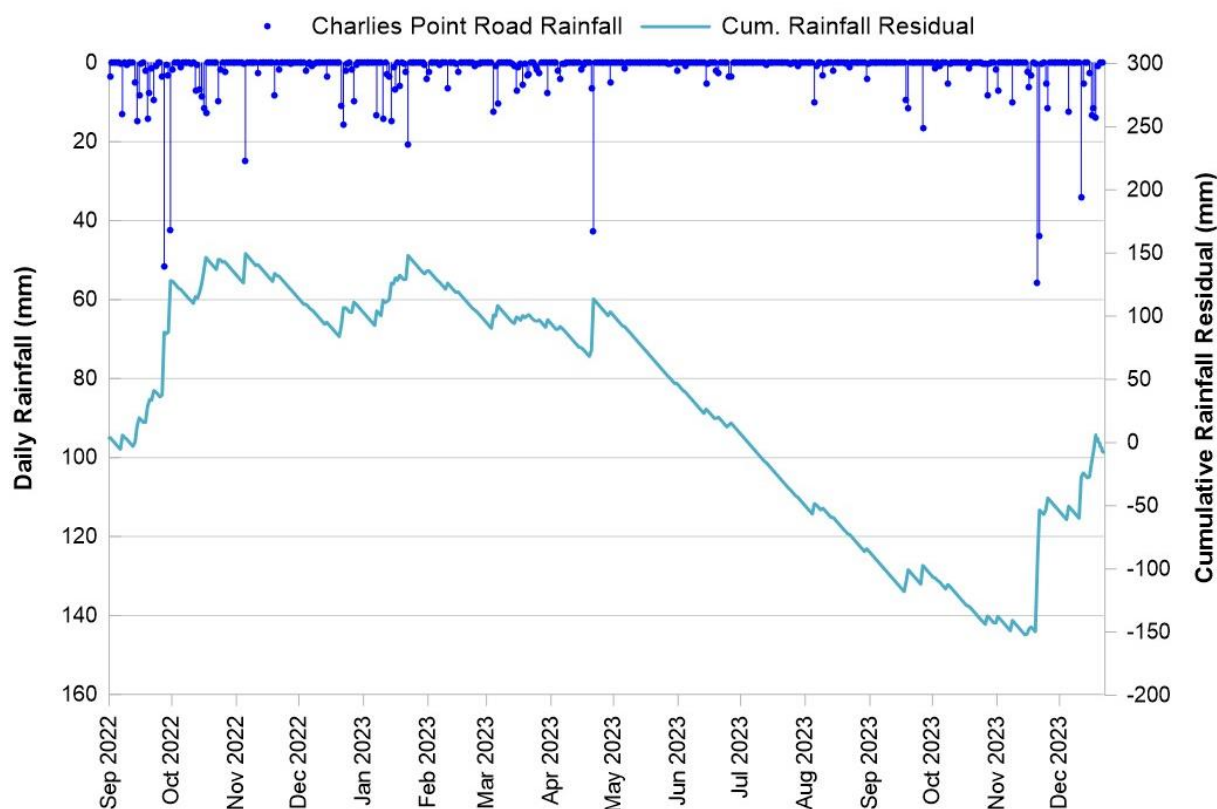
DIAGRAM 2: DAILY RAINFALL AND CUMULATIVE RAINFALL RESIDUAL

The cumulative rainfall residual depicted in **Diagram 2** indicates generally average rainfall conditions from January to April 2023 with an overall declining trend in rainfall from May to November 2023. From late November 2023, generally above average rainfall was recorded.

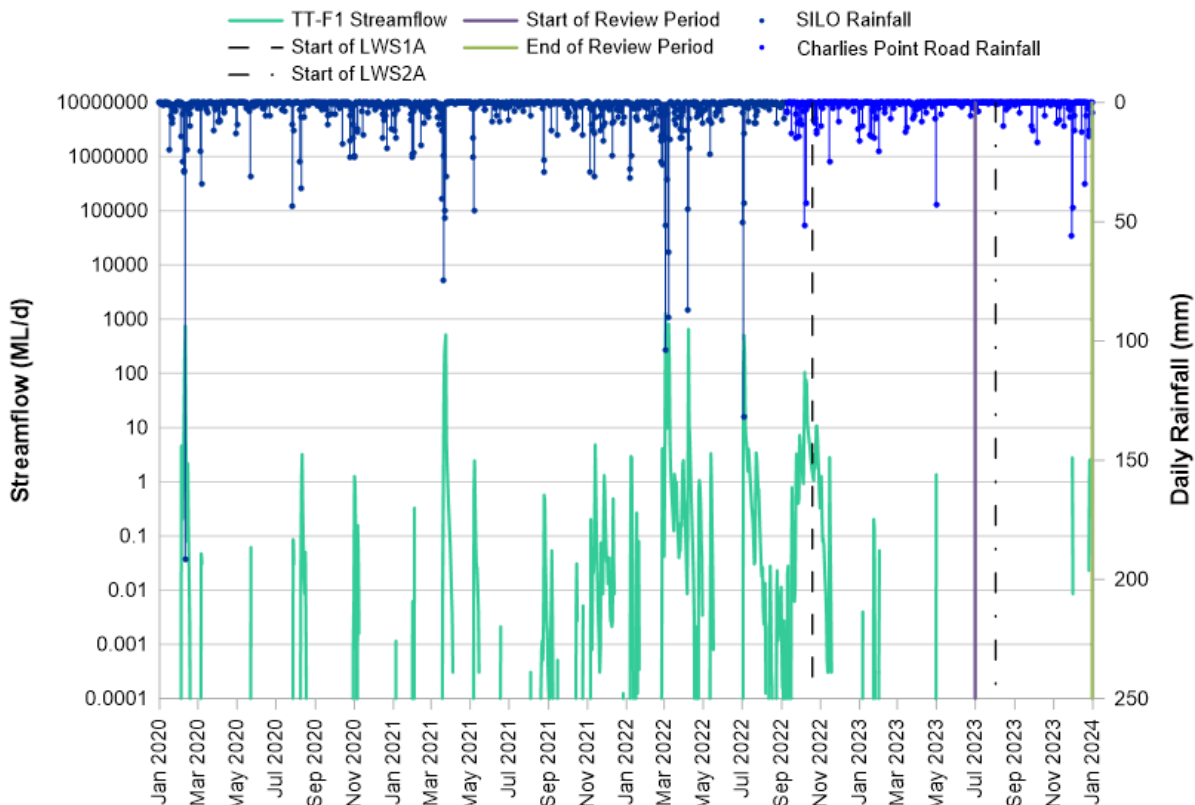
DIAGRAM 3: TEATREE HOLLOW (TT-F1) STREAMFLOW AND RAINFALL

The streamflow records presented in **Diagram 3** indicate that streamflow at TT-F1 in Teatree Hollow is intermittent, with extended periods of no flow recorded prior to the commencement of mining of LW S1A. During the review period, no flow was recorded from July to late November 2023, consistent with below average rainfall conditions. From late November 2023 to the end of the review period, flow events occurred in response to above average rainfall.

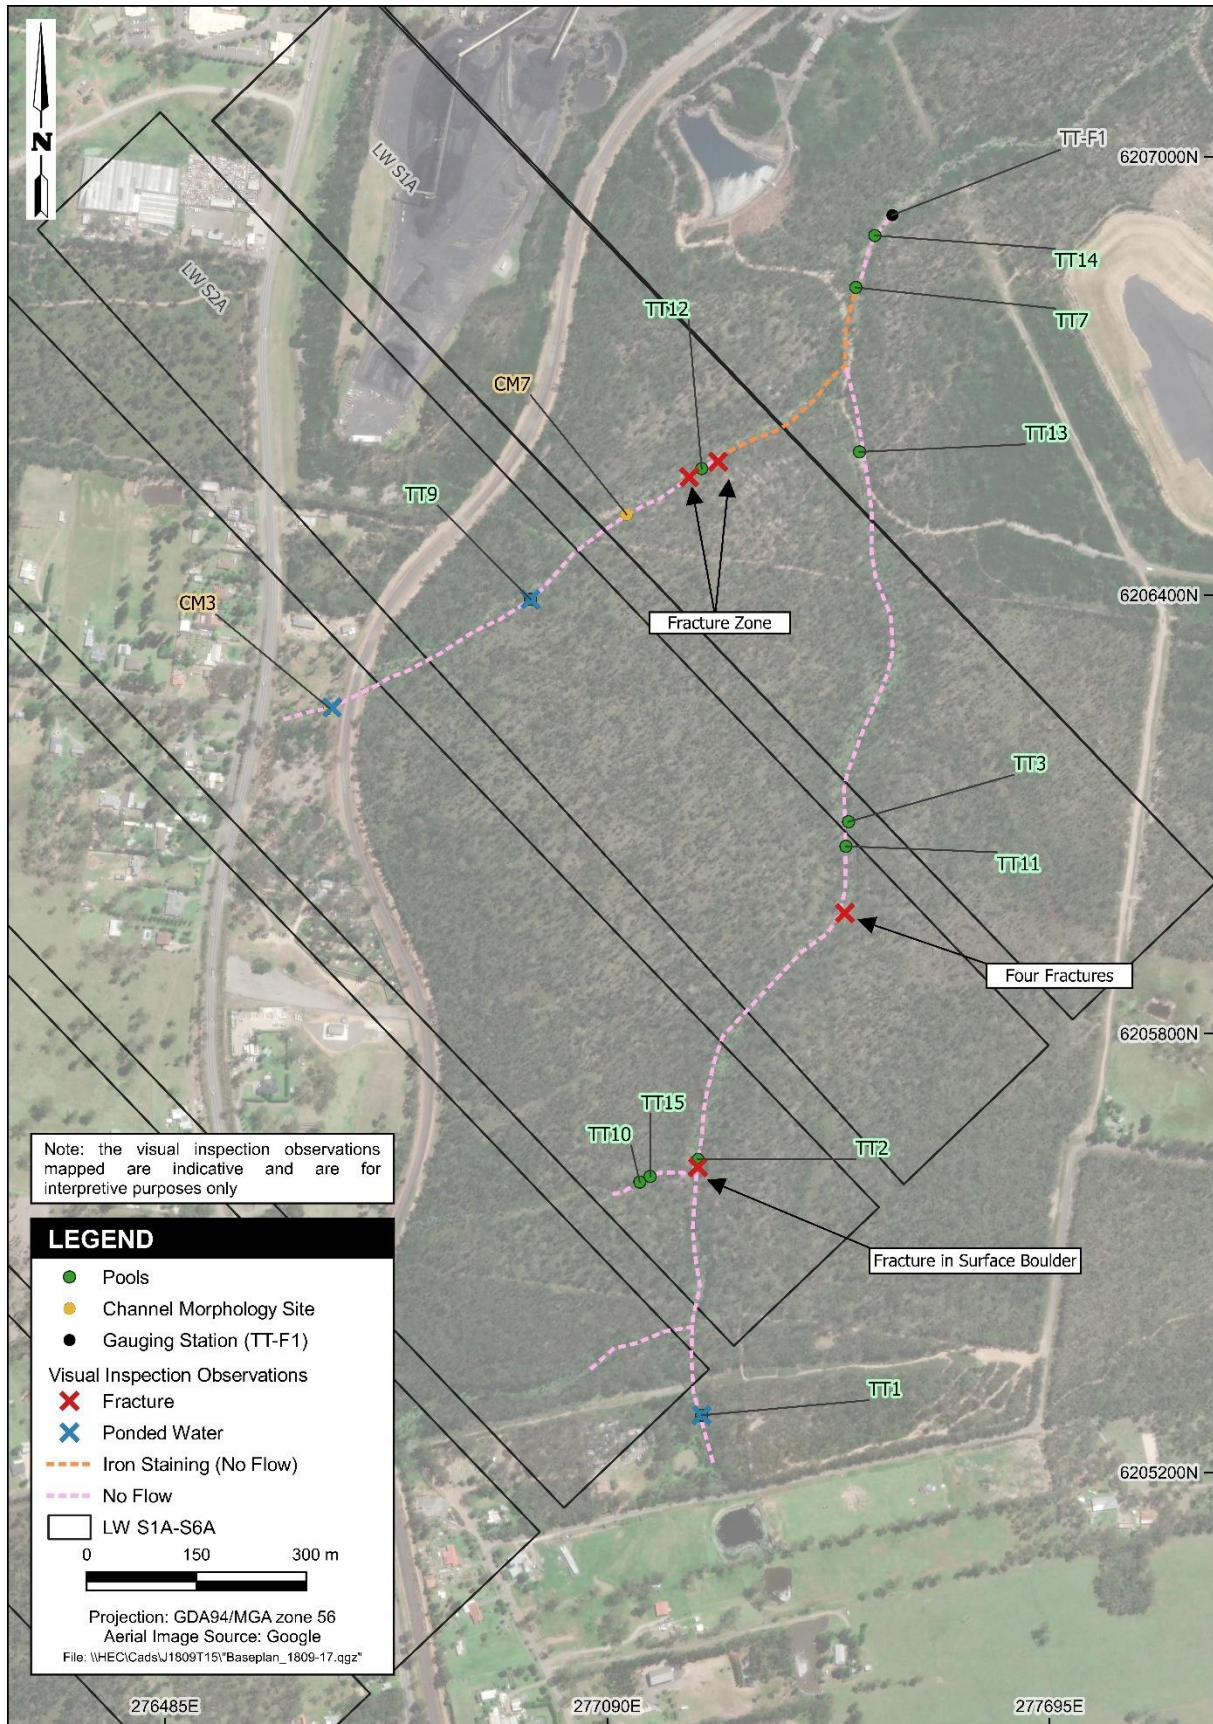
MAP 7: VISUAL DEPICTION OF SURFACE WATER CHARACTERISTICS AND PHYSICAL EFFECTS (EARLY NOVEMBER 2023)

A visual depiction of the Teatree Hollow and Teatree Hollow tributary surface water conditions and physical effects is presented in **Map 7**. The information presented in **Map 7** was predominately collated from the visual inspection records (ENRS, 2023a-f) and represents conditions observed in early November 2023 (below average rainfall period).

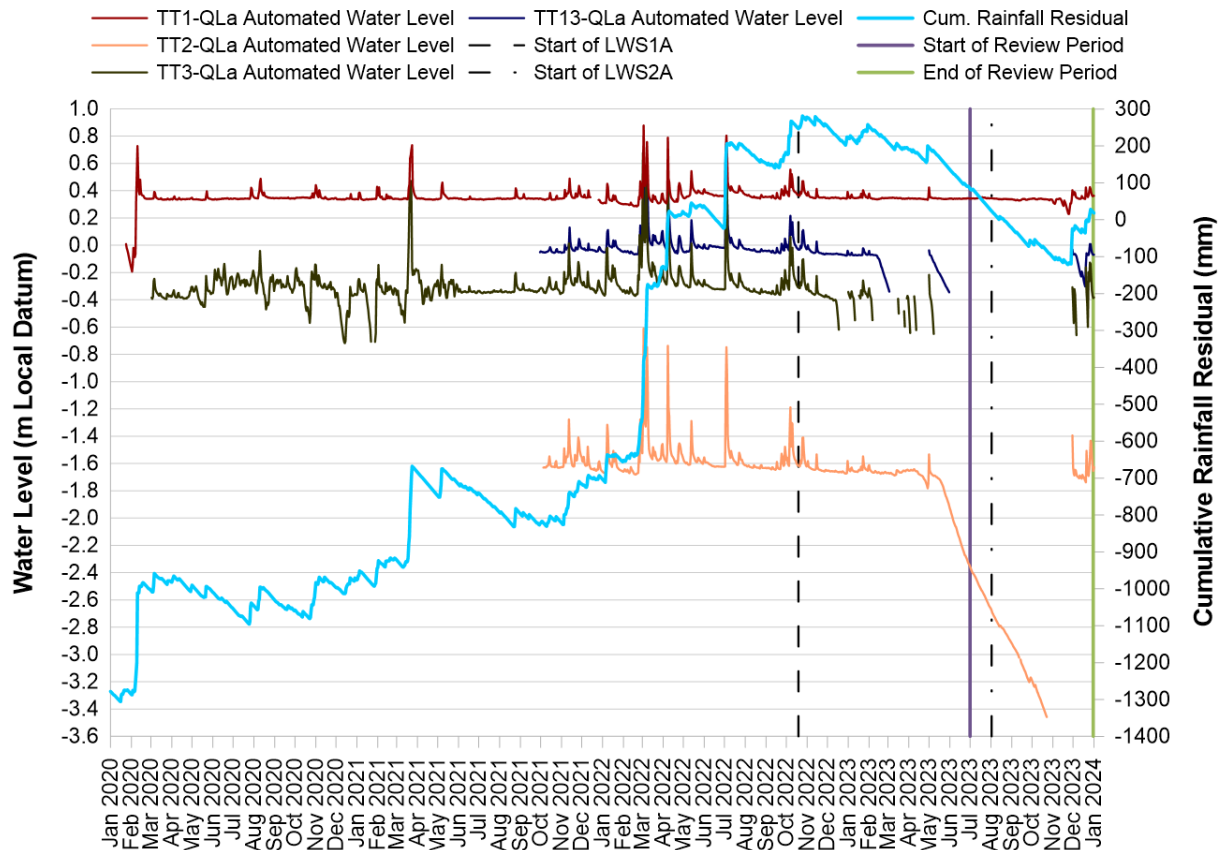
DIAGRAM 5: TEATREE HOLLOW TRIBUTARY WATER LEVEL COMPARISON

As illustrated in **Diagram 5**, the water level at pool TT1 (reference site TT1-QLa) generally remained low to December 2023, consistent with below average rainfall conditions. As stated in **Table 3**, from July to mid-October 2023, surface flow was observed to cease shortly downstream of pool TT1. In late October and November 2023, the water level declined below the CTF level and no surface flow was present downstream of pool TT1 (refer **Map 7**).

It is noted that pool TT1 is located upstream of the zone of active subsidence. Based on the groundwater levels recorded at monitoring bore P55A-C for the period of record, it is inferred that baseflow contribution (groundwater discharge to the surface water system) is likely negligible in the vicinity of TT1-QLa. As such, the decline in water level recorded at pool TT1 during the review period is unlikely related to a decline in baseflow contribution.

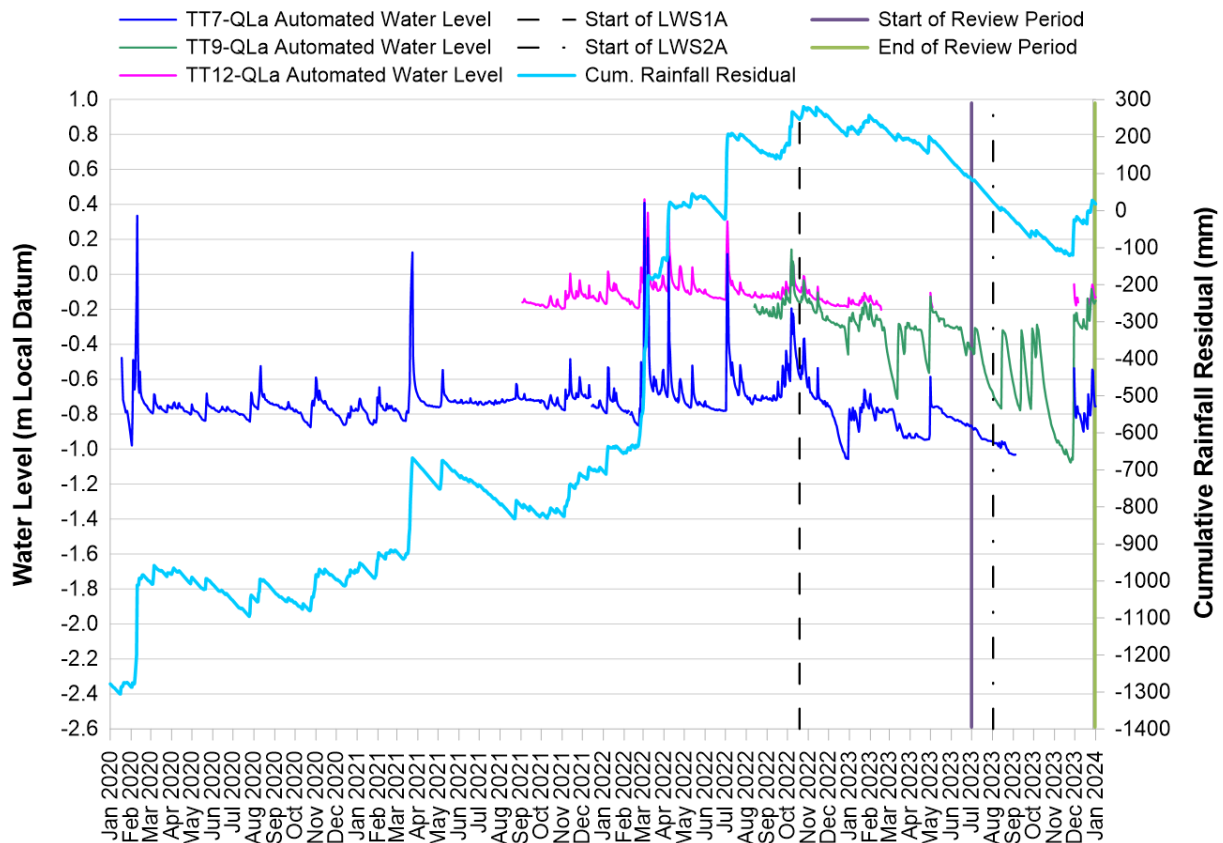
DIAGRAM 6: TEATREE HOLLOW WATER LEVEL COMPARISON

As stated in **Table 1**, pool TT9 water level declined intermittently below the CTF level and the baseline minimum during periods of below average rainfall from July to November 2023. It is noted that only two months of baseline data are available for this site prior to the commencement of mining of LW S1A (refer **Diagram 6**). As such, there is potential that the water level at monitoring site TT9-QLa declined to similar levels historically.

Although the water level declined intermittently during the review period, the water level decline is not considered atypical. It is also noted that:
