Tahmoor Coal Pty Ltd

SIX MONTHLY SUBSIDENCE IMPACT REPORT

Tahmoor South Domain Longwalls South 1A – South 6A

1 July 2023 – 31 December 2023

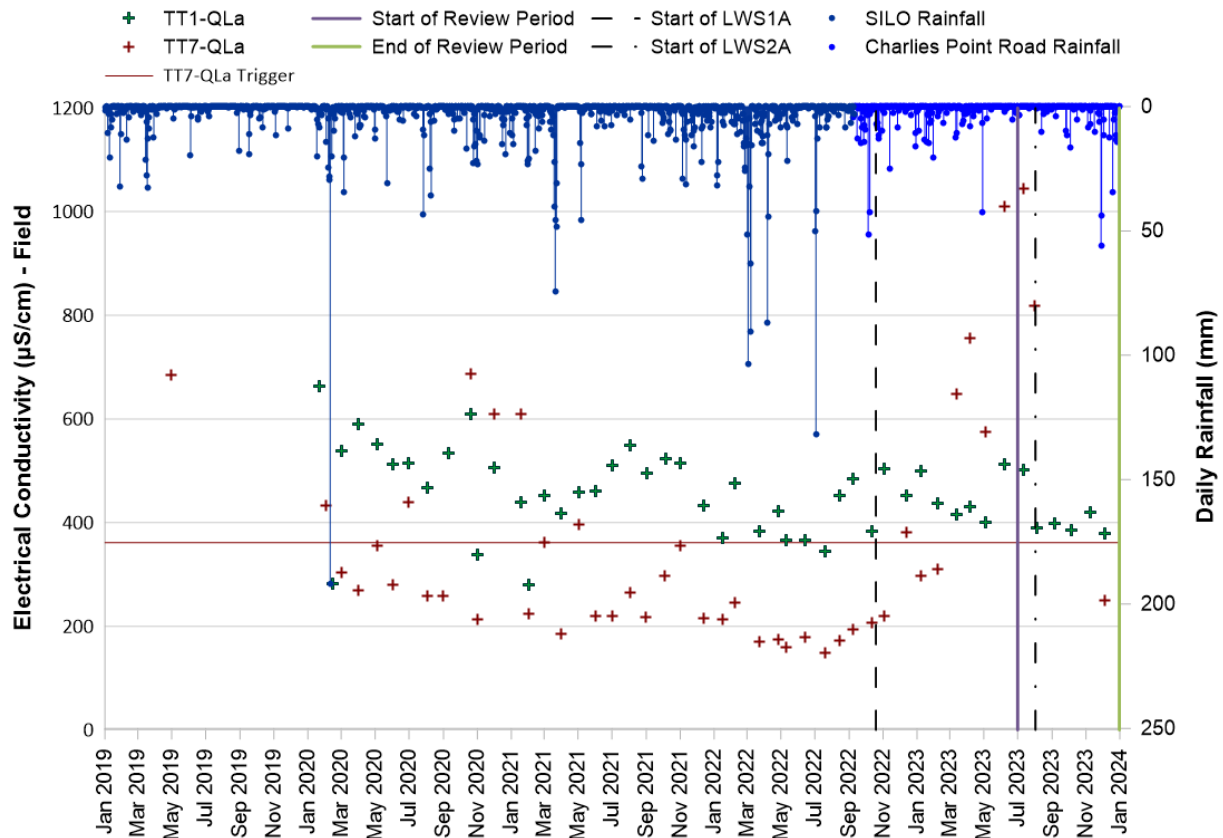
DIAGRAM 7: FIELD ELECTRICAL CONDUCTIVITY

The data presented in **Diagram 7** indicates that:

- TT7-QLa EC SSGV (361 $\mu\text{S}/\text{cm}$) was exceeded for six consecutive months from March to August 2023 (inclusive), equating to a Level 3 trigger.
- Similarly elevated EC values were not recorded at the upstream reference site (TT1-QLa) during the corresponding period.
- Pool TT7 was dry during the September to November sampling events.
- The EC value recorded at TT7-QLa in December 2023 was below the SSGV.
- A Level 1 trigger or above for EC (i.e. an exceedance of the SSGV for three consecutive months or greater) was not recorded at TT7-QLa during the baseline monitoring period prior to commencement of mining.

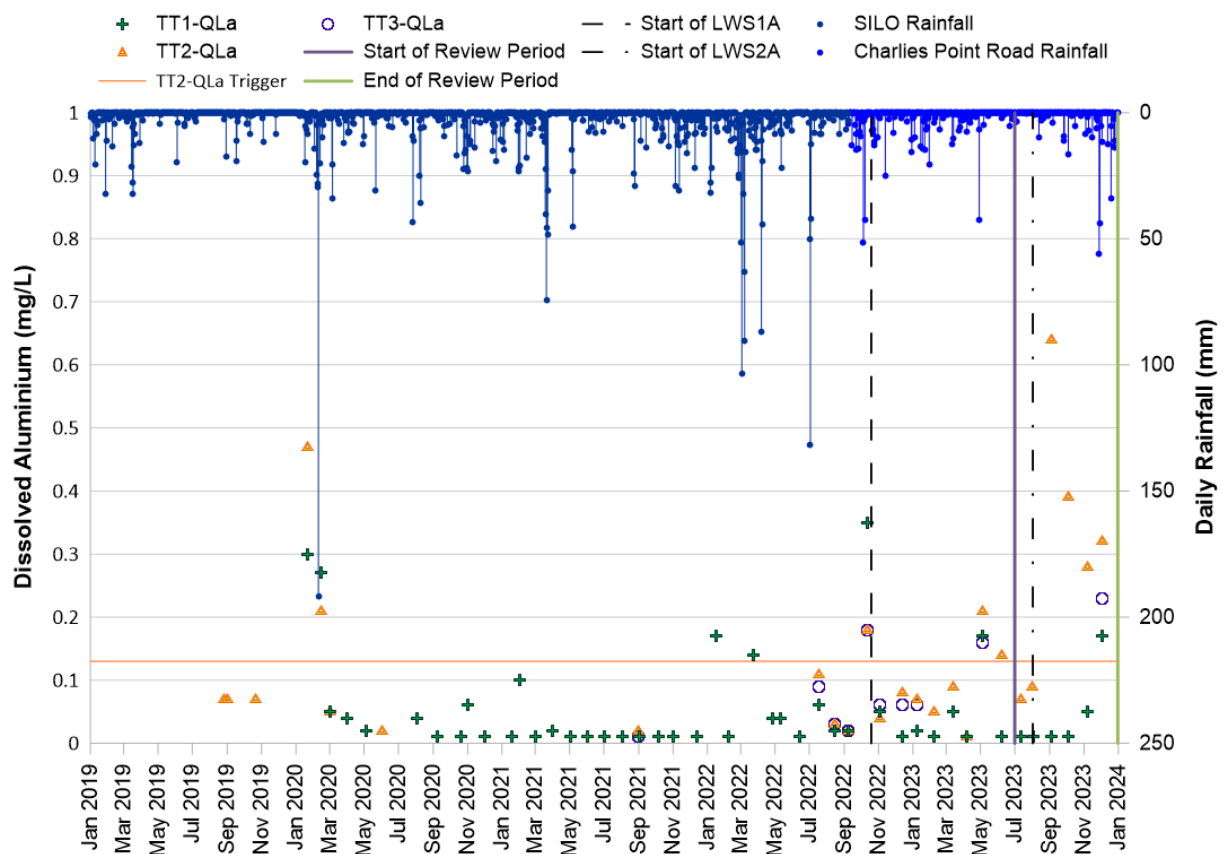
DIAGRAM 8: DISSOLVED ALUMINIUM CONCENTRATIONS

- The TT2-QLa dissolved aluminium SSGV (0.13 mg/L) was exceeded for four consecutive months from September to December 2023 (inclusive). However, in December 2023 the dissolved aluminium concentration recorded at TT1-QLa (upstream reference site) also exceeded the TT1-QLa SSGV. As such, a Level 1 trigger applies for the period of September to November 2023.
- Between September and November 2023, similar elevated dissolved aluminium concentrations were not recorded at the upstream reference site (TT1-QLa).

It is considered that the elevated dissolved aluminium concentrations recorded at pool TT2 from September to December 2023 reflect the low volume of stagnant, ponded water present in the pool at the time of sampling. As such, it is considered that the aluminium concentrations recorded are reflective of a drying phase for pool TT2 rather than typical flow conditions.

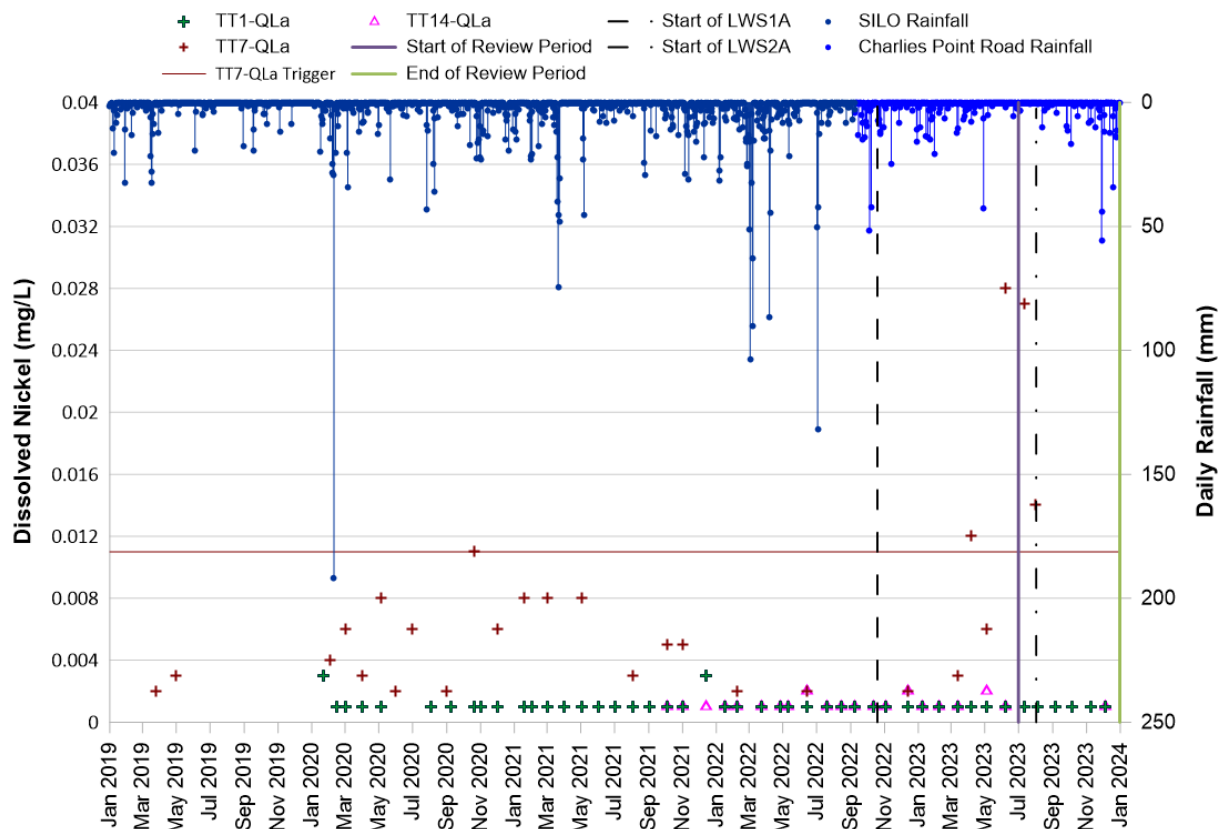
DIAGRAM 9: DISSOLVED NICKEL CONCENTRATIONS

- The TT7-QLa dissolved nickel SSGV (0.011 mg/L) was exceeded for three consecutive months from June to August 2023 (inclusive) i.e., Level 1 trigger for June to August 2023. Following rainfall events in December 2023, the concentration of dissolved nickel returned to historical range below or at LOR.
- Similar elevated dissolved nickel concentrations were not recorded at the upstream reference site (TT1-QLa) during the corresponding period.
- Downstream monitoring site TT14-QLa was dry during the sampling events within the corresponding period, therefore, no comparison can be made. However, in December 2023, the concentration of dissolved nickel was below or at the LOR.

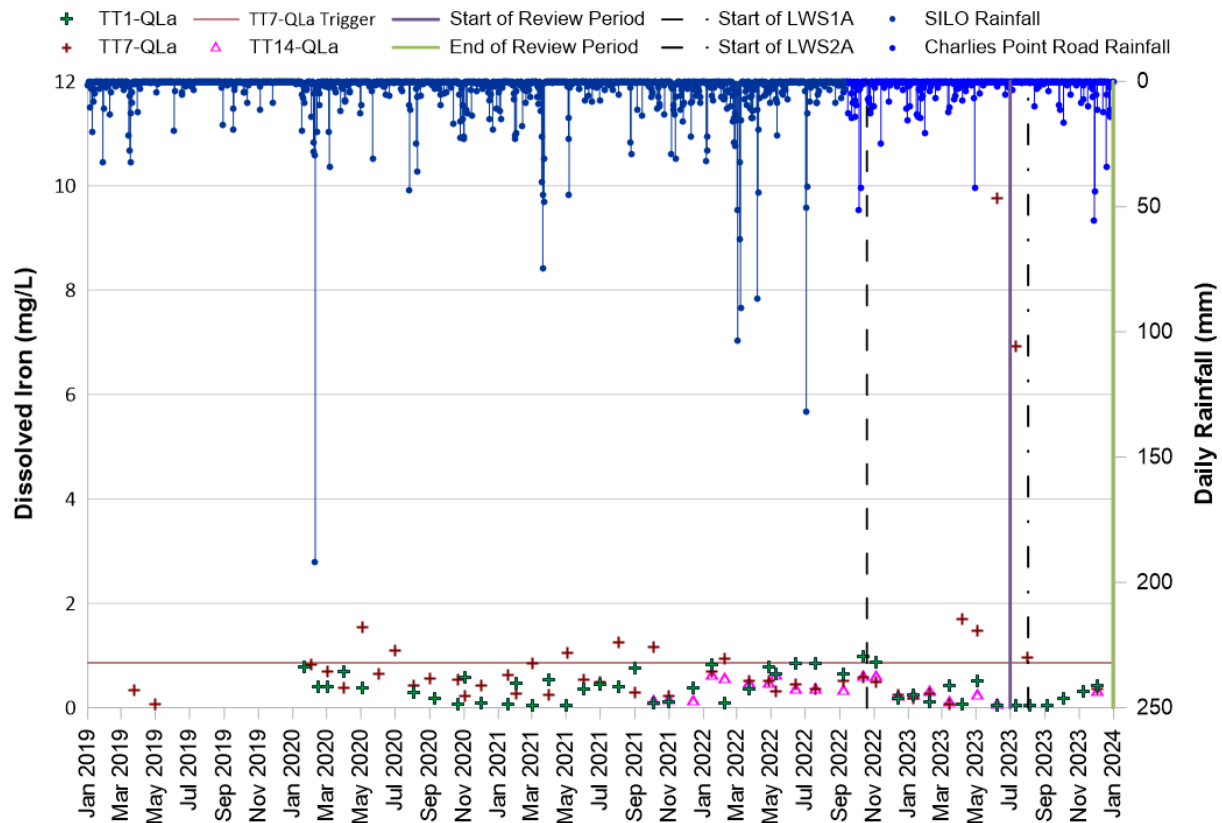
DIAGRAM 10: DISSOLVED IRON CONCENTRATIONS

- The TT7-QLa dissolved iron SSGV (0.86 mg/L) was exceeded for five consecutive months from April to August 2023 (inclusive) as such a Level 2 trigger applies.
- Similar elevated dissolved iron concentrations were not recorded at the upstream reference site (TT1-QLa) during the corresponding period.
- Downstream monitoring site TT14-QLa was dry during April to August 2023 (inclusive).
- Similar elevated dissolved iron concentrations have not been recorded during the baseline period for TT7-QLa at the site.

The elevated dissolved iron concentrations recorded at pool TT7 from April to August 2023 are considered related to the interaction of underflow with subsurface geology and re-emergence of elevated dissolved iron underflow as surface flow in the vicinity of pool TT7. As stated in **Table 3**, iron staining was observed on exposed bedrock at the upstream extent of the pool during the review period.

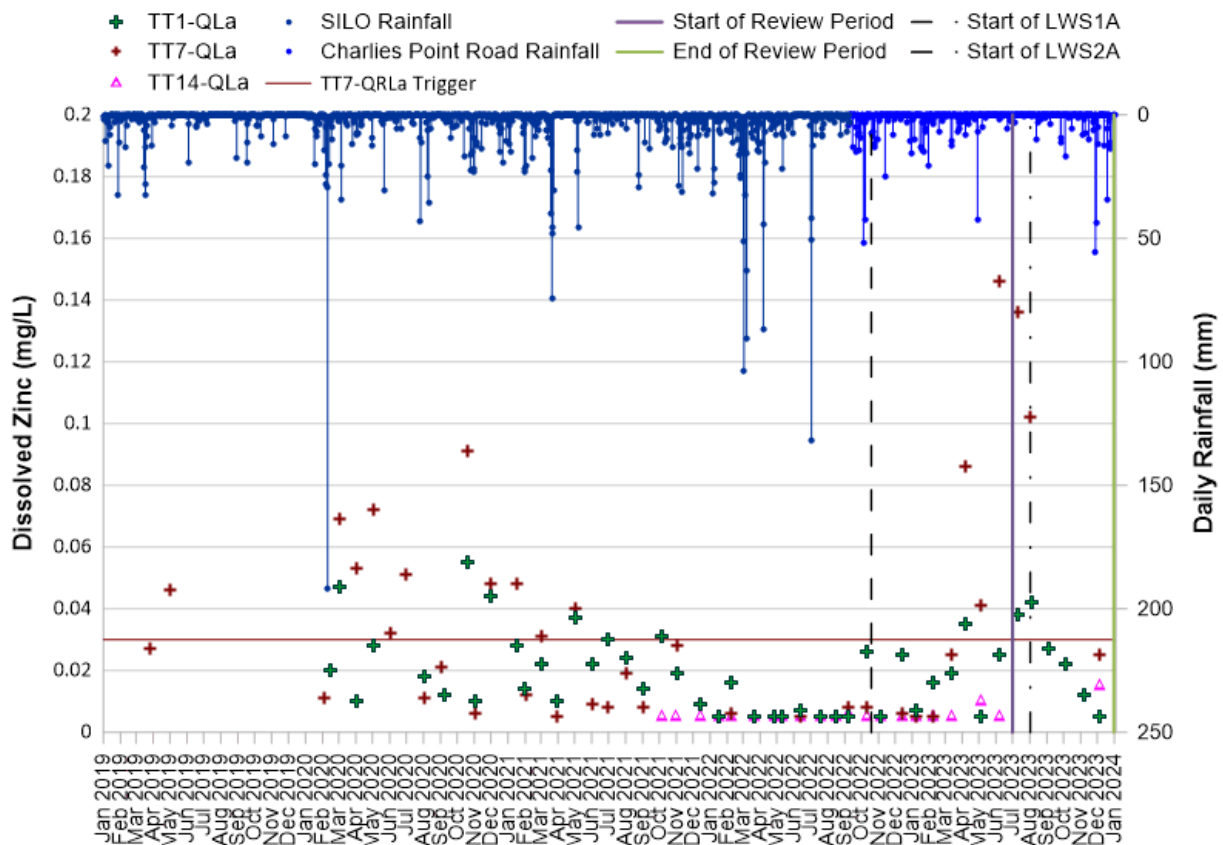
DIAGRAM 11: DISSOLVED ZINC CONCENTRATIONS

- The TT7-QLa dissolved zinc SSGV (0.03 mg/L) was exceeded for five consecutive months from April to August 2023 (inclusive) as such a Level 2 trigger applies.
- Similar elevated dissolved zinc concentrations were not recorded at the upstream reference site (TT1-QLa) during the corresponding period.
- Downstream monitoring site TT14-QLa was dry during April to August 2023 (inclusive).
- Similar elevated dissolved zinc concentrations have been recorded at TT7-QLa during the baseline period prior to commencement of mining.

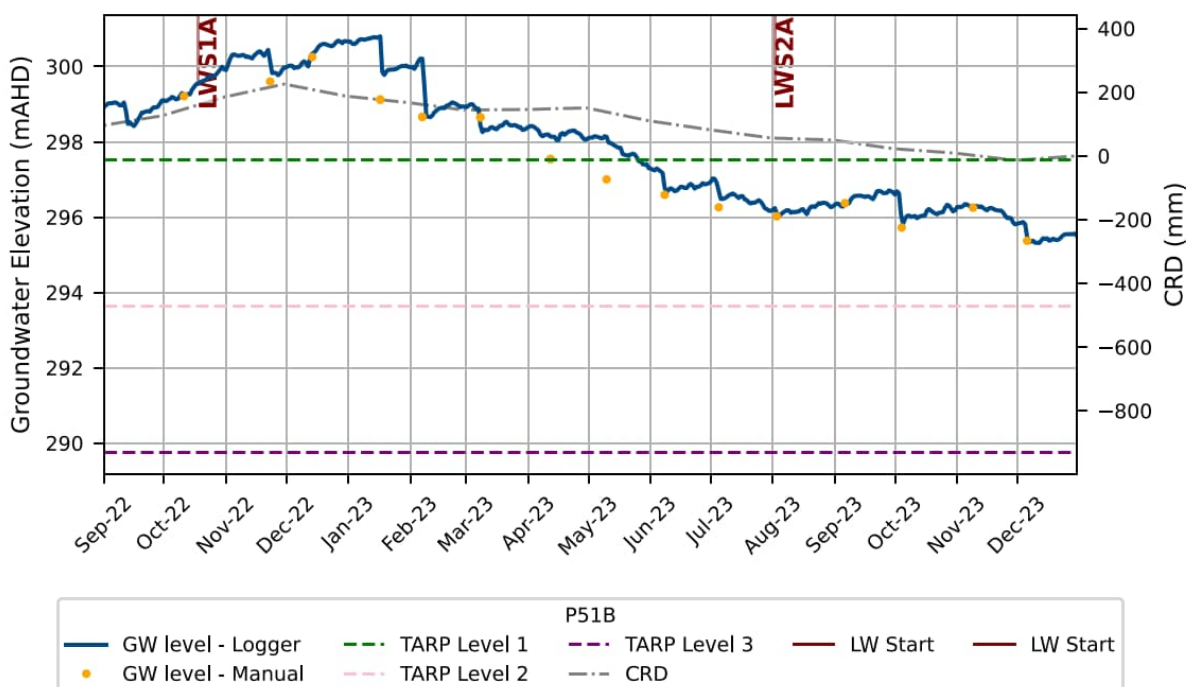
Figure 5: TARP WMP8 Level 1 Exceedance – P51B

As of 31 December 2023, an exceedance of the TARP Level one trigger level occurred at P51B. This observed exceedance is presented in **Figure 5**.

At P51B, the groundwater elevation was lower than the TARP Trigger Level 1 since May 2023. Over the monitoring period between July 2023 and December 2023, the groundwater elevation has fluctuated by approximately 2 m with an overall decreasing groundwater trend since January 2023.

The groundwater elevation at P51A has remained relatively steady throughout the reporting period, with the groundwater elevation above the TARP Level 1 trigger level. Review of the cumulative rainfall departure (CRD) indicates groundwater elevation is potentially reacting to rainfall in the area. Hence, it is uncertain whether groundwater depressurisation is a result of ongoing mining. It is potentially a combination of both factors influencing the groundwater levels.

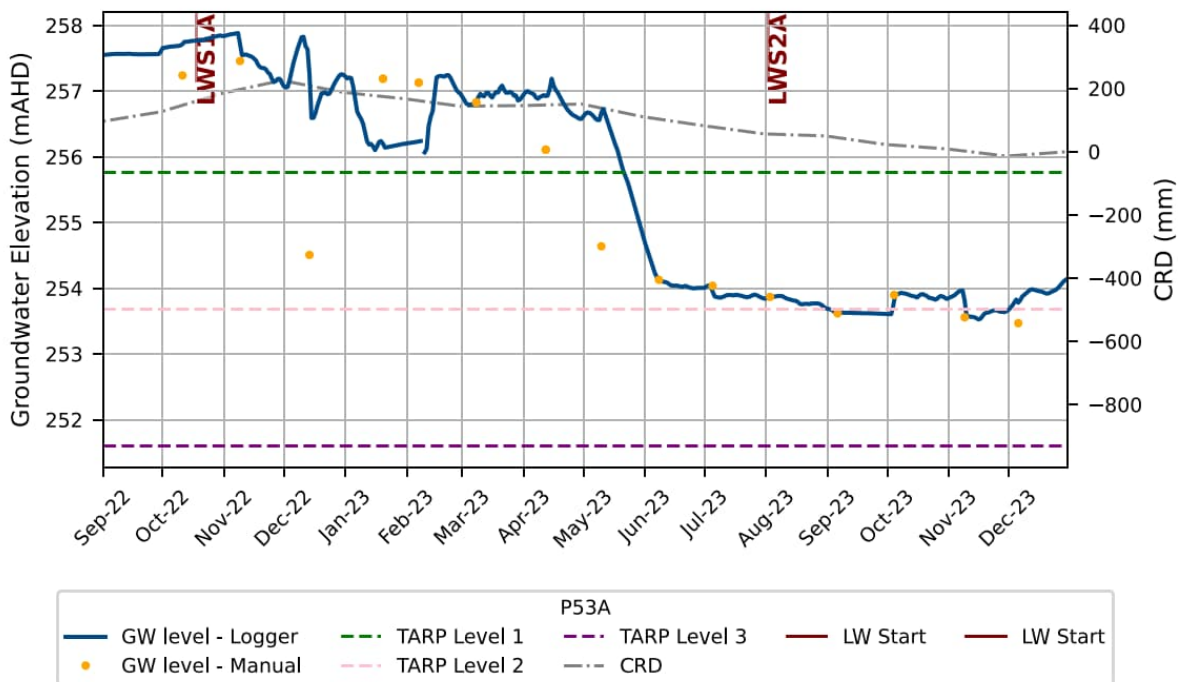
Figure 6: TARP WMP8 Level 1 Exceedance – P53A

As of 31 December 2023, an exceedance of the TARP Level 1 trigger level occurred at P53A. This observed exceedance is presented in **Figure 6**.

At P53A, the groundwater elevation was lower than TARP Level 1 trigger in all monitoring rounds since May 2023 with groundwater elevation fluctuating approximately 4 m between May and June 2023. Over the reporting period between July 2023 and December 2023, the groundwater elevation has remaining relatively stable and only fluctuating by approximately 1 m. Groundwater elevation was noted to temporarily decrease below Level 2 trigger levels in September 2023 and November 2023.

The groundwater elevation at P53A decreased significantly in May 2023 and have remained stable since. The groundwater elevation at P53B has been steadily decreasing since March 2023 and is below TARP Level 1 trigger level. The groundwater elevation at P53C has been decreasing since December 2022 with the groundwater elevation decreasing below TARP Level 2 Trigger level in July 2023.

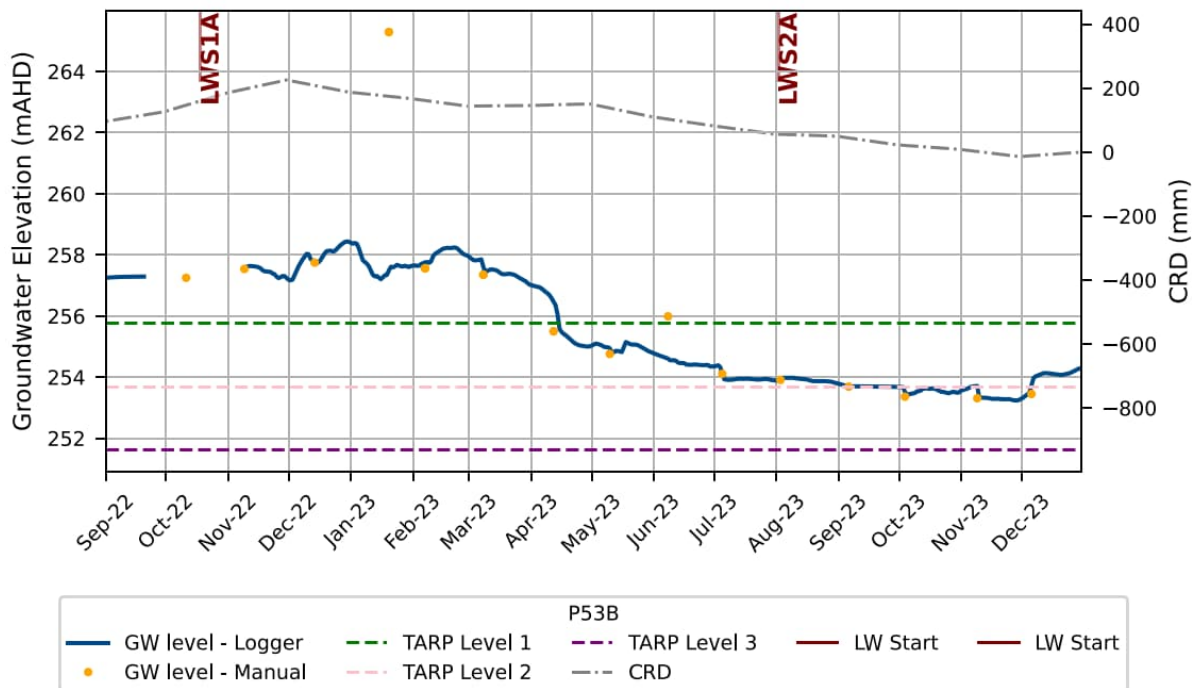
Figure 7: TARP WMP8 Level 1 Exceedance – P53B

As of December 2023, an exceedance of the TARP Level 1 trigger level occurred at P53B. This observed exceedance is presented in Figure 7.

At P53B, the groundwater elevation was lower than the TARP Level 1 since April 2023. Over the monitoring period between July 2023 and December 2023, the groundwater elevation has fluctuated by approximately 1 m with an overall decreasing trend since March 2023.

The groundwater elevation at P53B has remained relatively steady throughout the reporting period, with the groundwater elevation decreasing to below the TARP L1 trigger level since April 2023. The groundwater elevation at P53A decreased significantly in May 2023 and have remained stable since. The groundwater elevation at P53C has been decreasing since December 2022 with the groundwater elevation decreasing below TARP Level 2 Trigger level in July 2023.

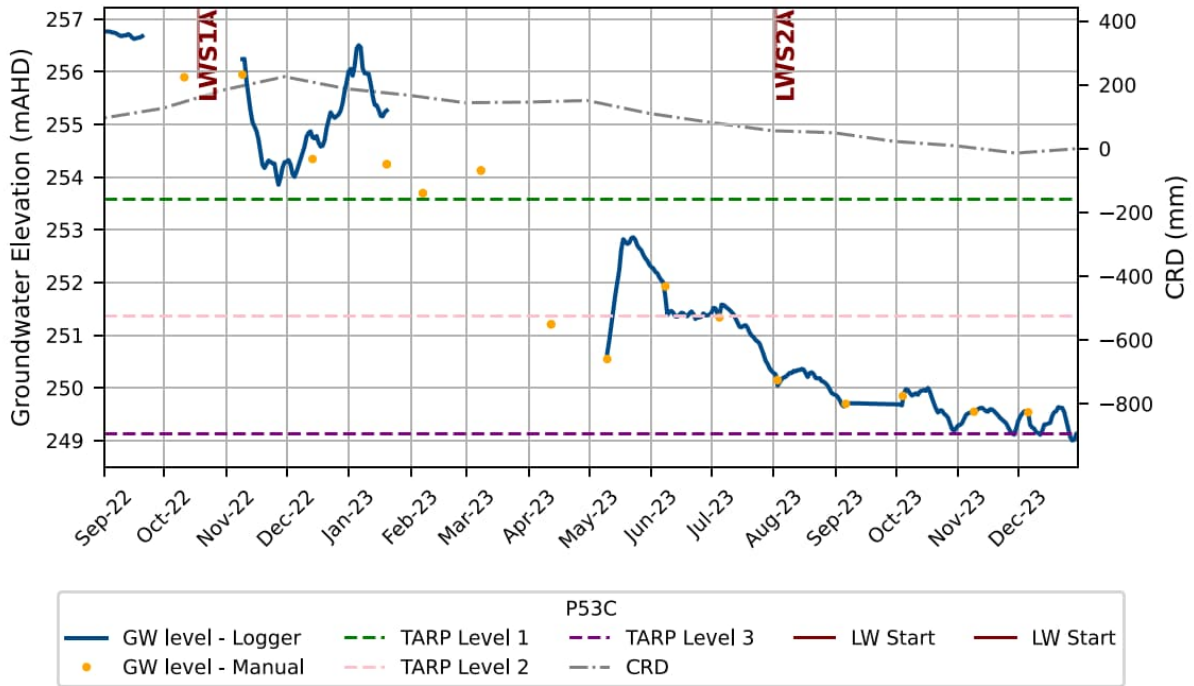
Figure 8: TARP WMP8 Level 2 Exceedance – P53C

As of 31 December 2023, an exceedance of the TARP Level 2 trigger level occurred at P53C. This observed exceedance is presented in **Figure 8**.

At P53C, the groundwater elevation was lower than the TARP Level 2 trigger level in all monitoring rounds since July 2023. Over the reporting period, the groundwater level has fluctuated by approximately 2.5 m with groundwater elevation with groundwater elevation decreasing by approximately 1.5 m between July and August 2023 and steadily stabilising since.

The groundwater elevation at P53C appears to be decreasing since December 2022 with the groundwater elevation decreasing below Level 1 in April 2023 and decreasing below Level 2 in July 2023. This groundwater depressurisation in the deeper bore could be due to an ongoing mining event.

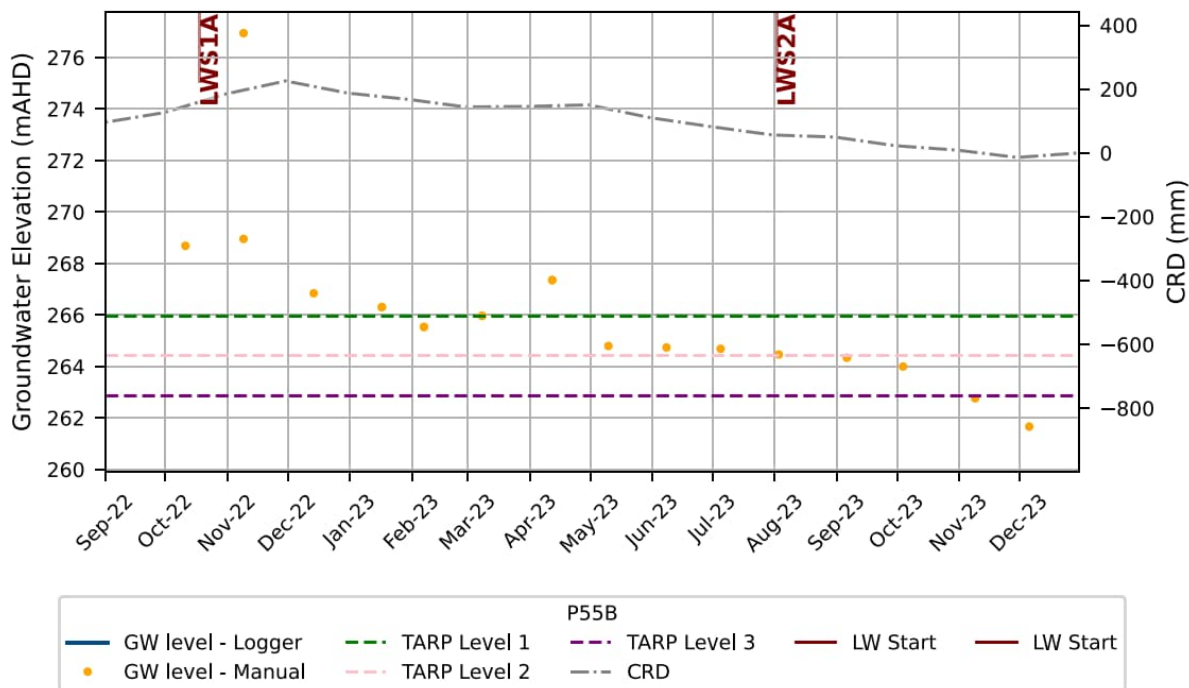
Figure 9: TARP WMP8 Level 2 Exceedance – P55B

As of 31 December 2023, an exceedance of the TARP Level 1 trigger level occurred at P55B. This observed exceedance is presented in **Figure 9**.

At P55B, the groundwater elevation was lower than TARP Level 1 trigger level in all monitoring rounds since May 2023. Over the reporting period between July 2023 and December 2023, the groundwater elevation has overall decreased by approximately 3 m with groundwater levels decreasing to below TARP Level 2 trigger levels in September 2023 and TARP Level 3 trigger levels in November 2023.

The groundwater elevation at P55B has been steadily decreasing since December 2022, and is below the TARP Level 1 trigger level, throughout the reporting period. The groundwater elevation at P55A has remained relatively steady, and above the TARP Level 1 trigger level, throughout the reporting period. The groundwater elevation at P55C is fluctuating below TARP Level 2 trigger level.

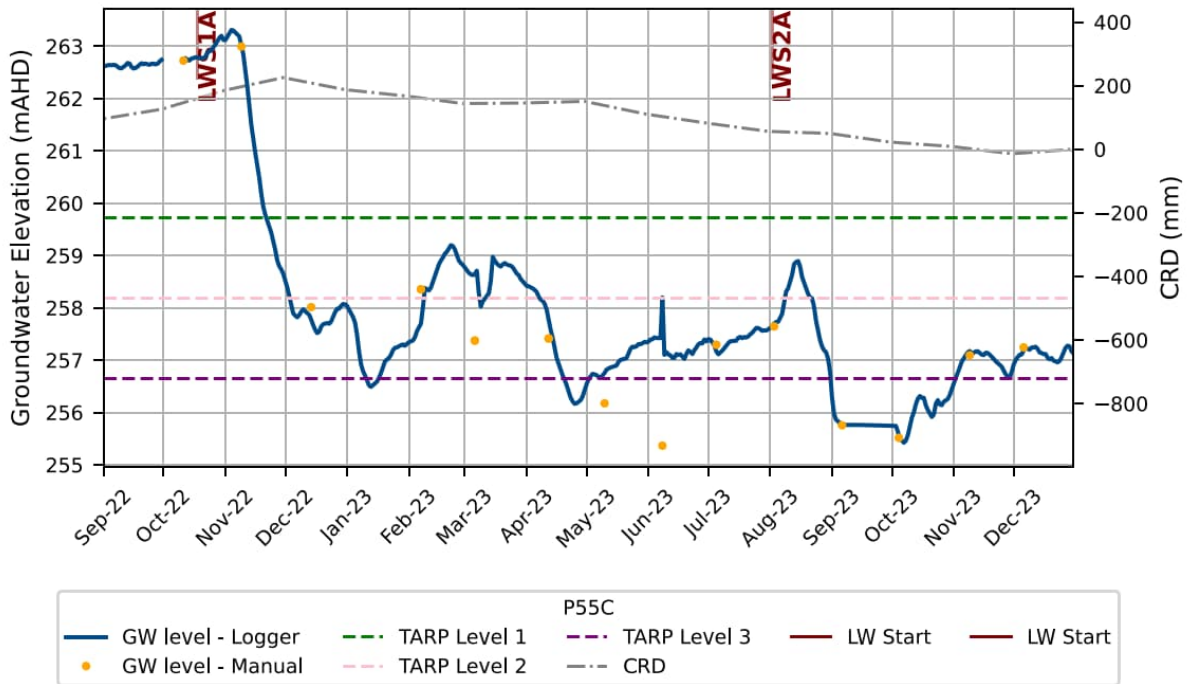
Figure 10: TARP WMP8 Level 2 Exceedance – P55C

As of 31 December 2023, an exceedance of the TARP Level 2 trigger level occurred at P55C. This observed exceedance is presented in **Figure 10**.

At P55C, the groundwater elevation was lower than the TARP Level 1 trigger level in all monitoring rounds since November 2022. Over the reporting period between July 2023 and December 2023, the groundwater elevation has fluctuated by approximately 4.5 m with groundwater levels decreasing to below the TARP Level 3 trigger level in August and September 2023 before slightly increasing to below the TARP Level trigger level in November and December 2023.

The groundwater elevation at P55A has remained relatively steady, and above the TARP Level 1 trigger level, throughout the reporting period. The groundwater elevation at P55B has been steadily decreasing and is below TARP Level 1 trigger level.

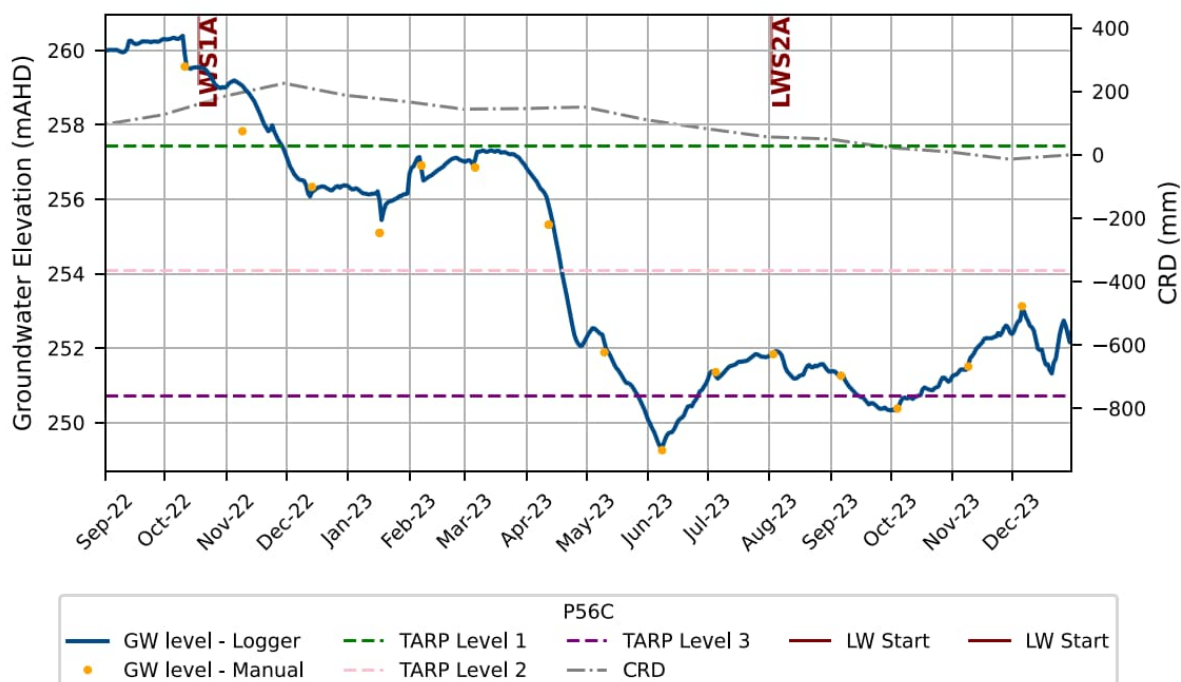
Figure 11: TARP WMP8 Level 2 Exceedance – P56C

As of 31 December 2023, an exceedance of the TARP Level 2 trigger level occurred at P56C. This observed exceedance is presented in **Figure 11**.

At P56C, the groundwater elevation was lower than the TARP Level 1 trigger level since December 2022 and lower than TARP Level 2 trigger level since June 2023. Over the reporting period between July 2023 and December 2023, the groundwater elevation has overall increased by approximately 3 m, however the groundwater are below the TARP Level 2 trigger level.

The groundwater elevation at P56A has remained relatively steady, and above the TARP Level 1 trigger level, throughout the reporting period. The groundwater elevation at P56B has been generally steady, except for short-term spike in early 2023, slowly decreasing since June 2023 below TARP Level 1 between July 2023 to November 2023 and increasing above the TARP L1 trigger level after. Consequently, the exceedance at Site P56 only occurring in the deepest bore (P56C).

The steep decline in April/May 2023 correlates with the similar trend observed at P53, however these are located on opposite sides of LWS2A and there is no obvious link in timing to longwall progression. Since this point, there has been minor fluctuations both up and down, not a typical representative of groundwater depressurisation due to longwall mining. Ongoing monitoring and continued analyse of this trend is required.

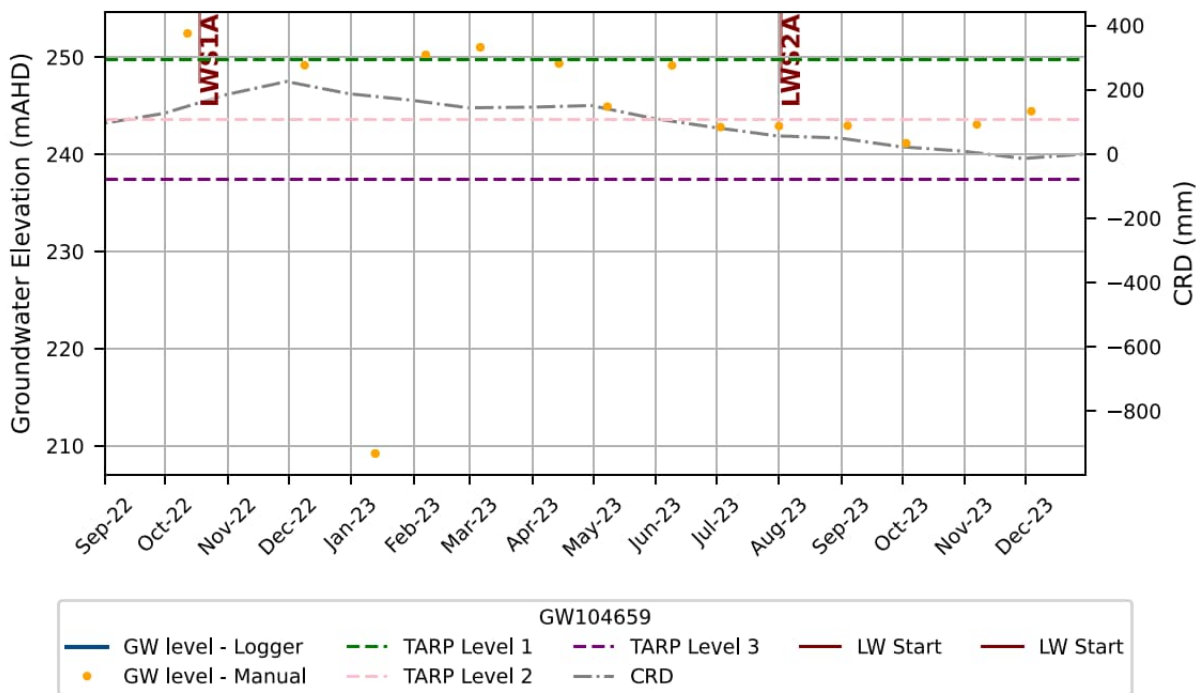
Figure 12: TARP WMP8 Level 1 Exceedance – GW104659

As of 31 December 2023, an exceedance of the TARP Level 1 trigger level occurred at GW104659. This observed exceedance is presented in **Figure 12**.

At GW104659, the groundwater elevation was lower than TARP Level 1 since April 2023. Over the monitoring period between July 2023 and December 2023, the groundwater elevation was relatively steadily decreasing below TARP Level 2 since July 2023, before showing an increase in November 2023 and increasing above TARP Level 2 in December 2023.

The relatively steady decline at this site this groundwater depressurisation in the deeper bore could be due to an ongoing mining effect or in response to overall lower than average rainfall.

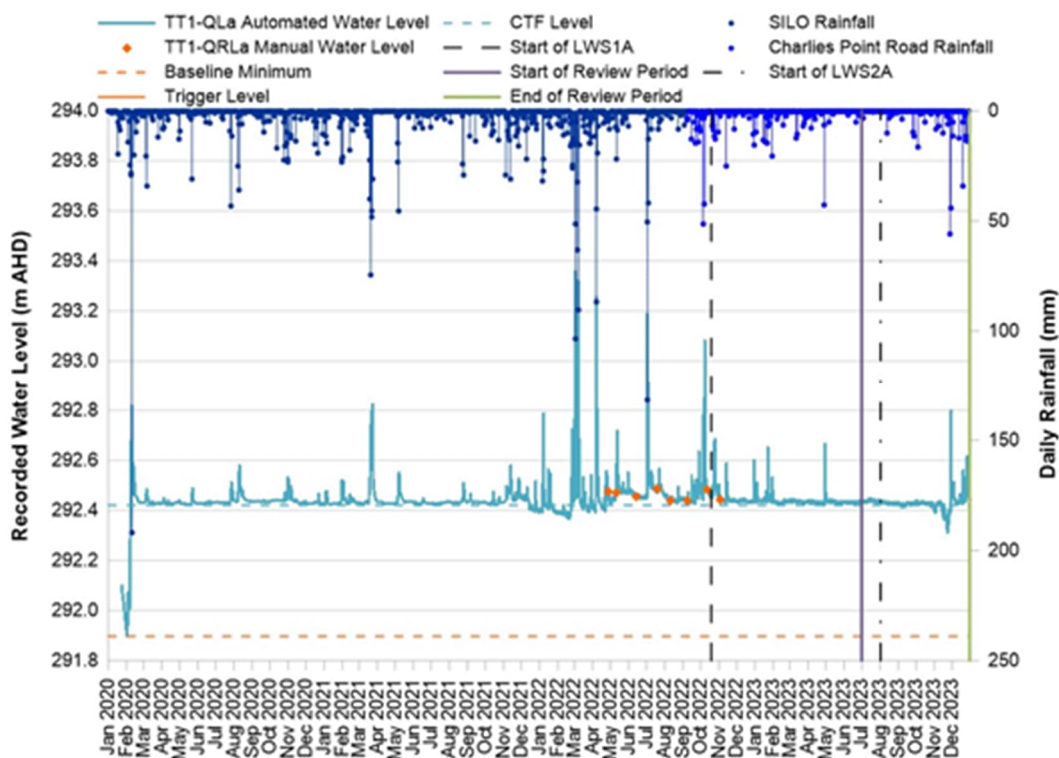
Figure 13: Recorded Water Level and Daily Rainfall for TT1-QRLa

P55C is associated with surface water monitoring site TT1-QRLa and the two can be considered together when reviewing the surface water – groundwater connectivity TARP (WMP12). The water level plot for TT1-QRLa is provided in **Figure 13**, and the groundwater hydrograph reproduced again here for context in **Figure 14**.

There is no apparent correlation at this point in time between the apparent decline in groundwater level and trigger breach at P55C and the nearby surface water gauging station.

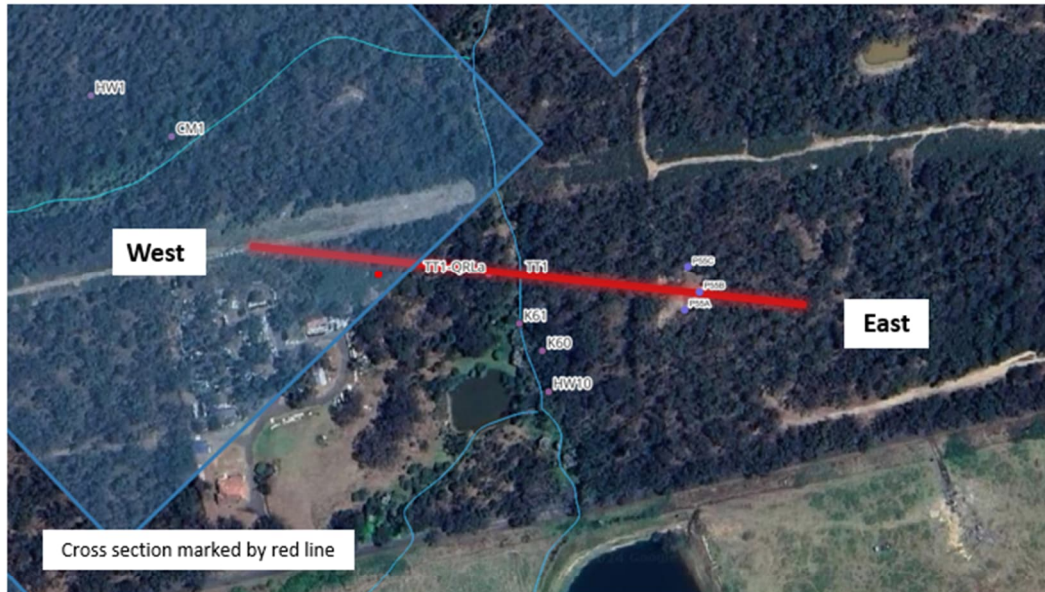
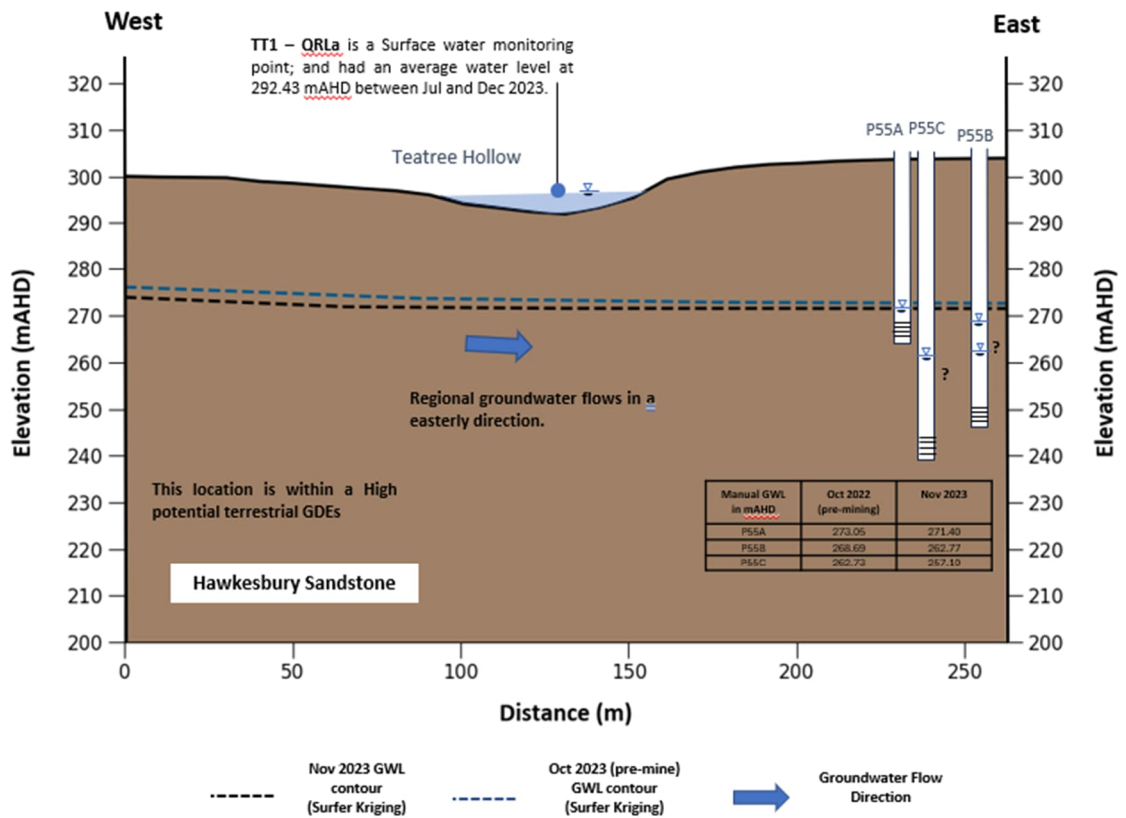
Figure 15: Cross-Sectional Conceptual Model for Groundwater – Surface Water Connectivity at TT1-QRLa and P55.

Groundwater level data for the shallow bores was contoured to create a shallow water table map, used in conjunction with site details and the local LIDAR data, to create a cross section for these sites (**Figure 15**). Conceptually, the groundwater level is notably lower than the base of the Creek, indicating a disconnected system.

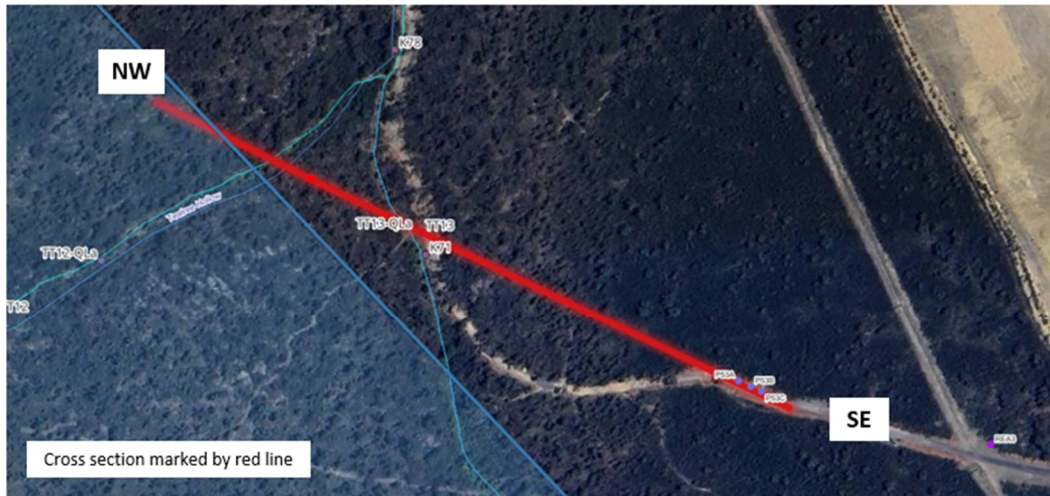
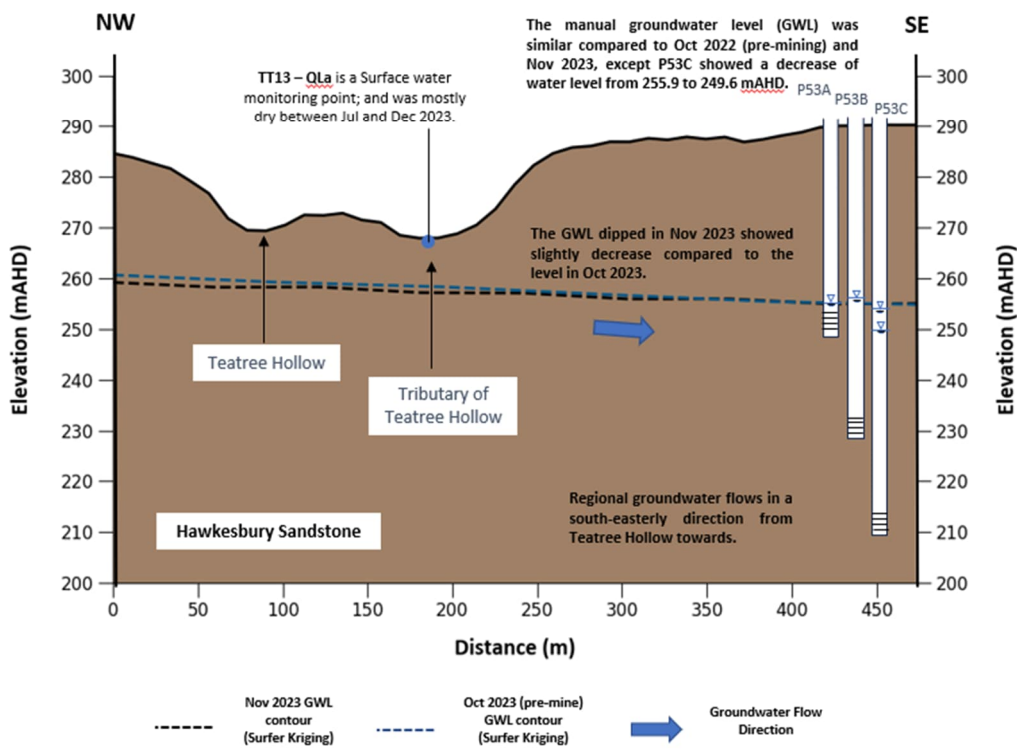
Figure 18: Cross-Sectional Conceptual Model for Groundwater – Surface Water Connectivity at TT1-QRLa and P53.

Groundwater level data for the shallow bores was contoured to create a shallow water table map, used in conjunction with site details and the local LIDAR data, to create a cross section for these sites (**Figure 18**). Conceptually, the groundwater level is notably lower than the base of the Creek, indicating a disconnected system.

There is no apparent correlation at this point in time between the apparent decline in groundwater level and trigger breach at P53C and the nearby surface water gauging station.

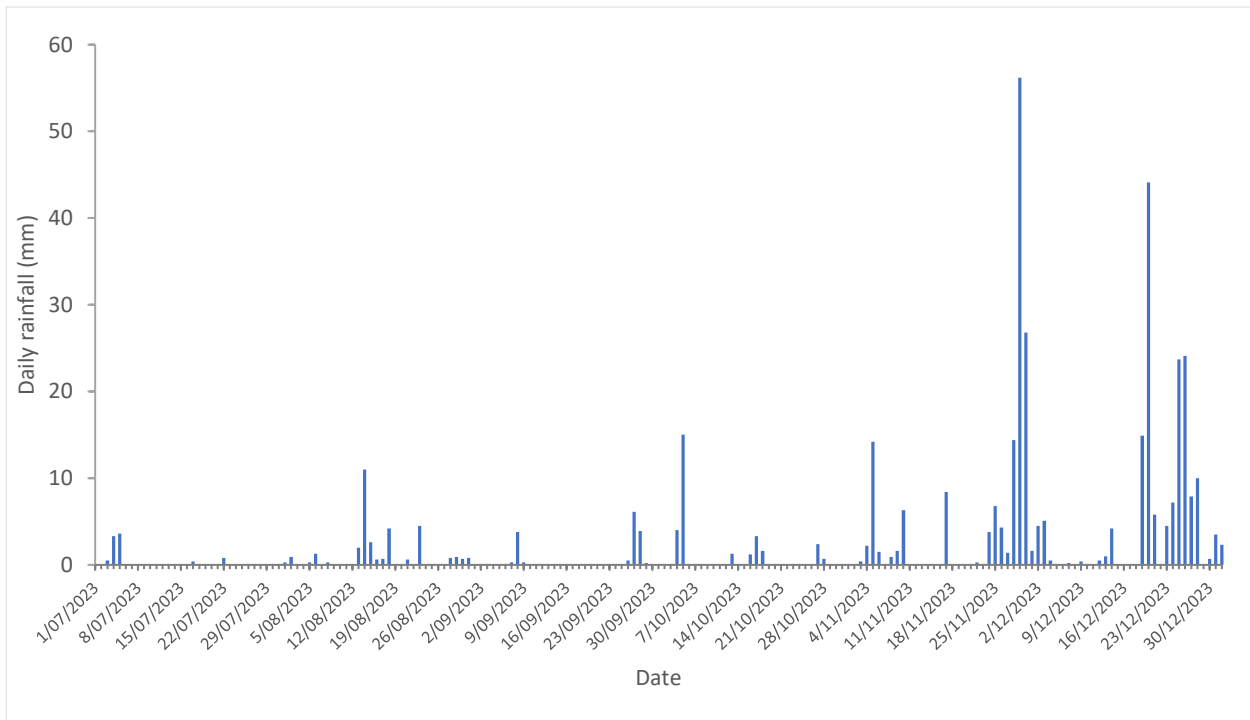
Figure 2: Rainfall Jan 2023 – December 2023 (SILO: -34.25, 150.6)

The winter preceding the spring survey period was relatively dry, with only 41.5 mm of rainfall across all winter months. This contrasts with spring, with 361.4 mm of rainfall over the spring months (Figure 2). In the two weeks immediately preceding the spring survey, 125 mm of rain was recorded including three rain events greater than 10 mm. This high level of rainfall was characteristic of the spring 2023 season, occurring primarily in short events. The biological results must be considered in this context.

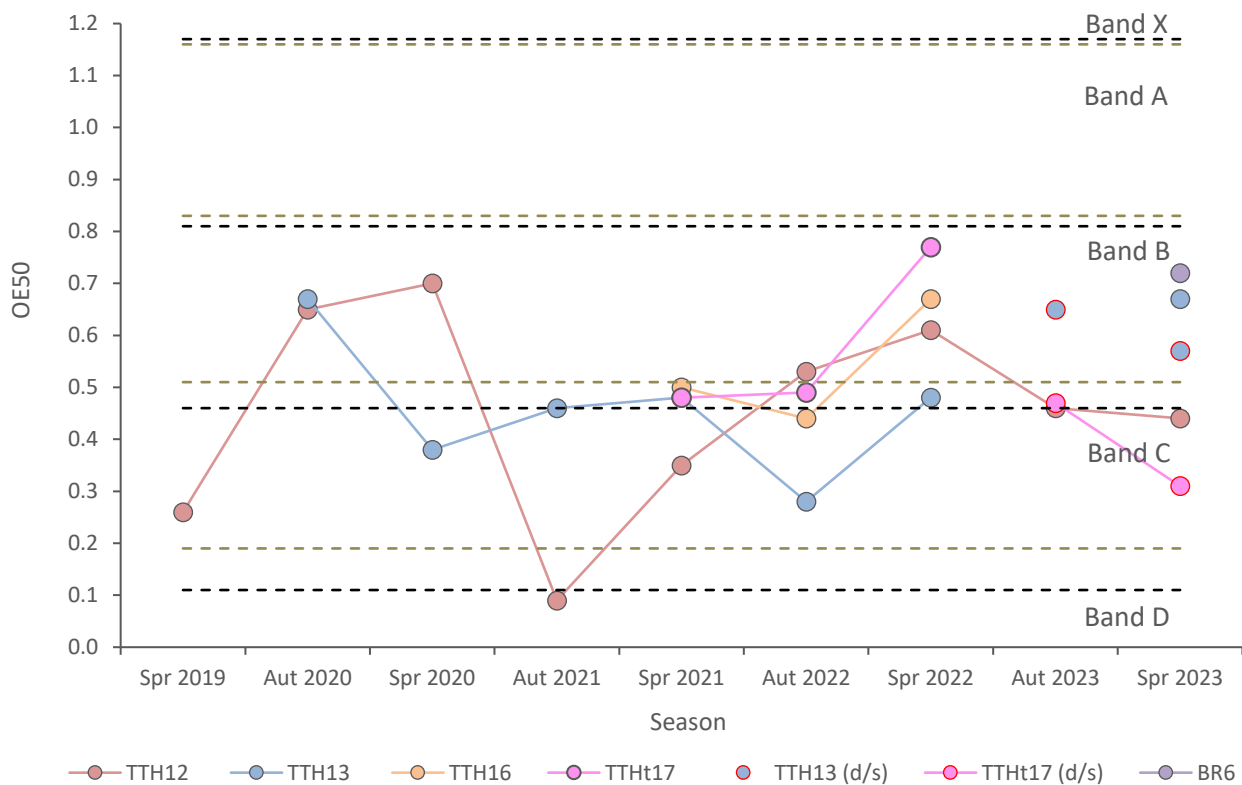
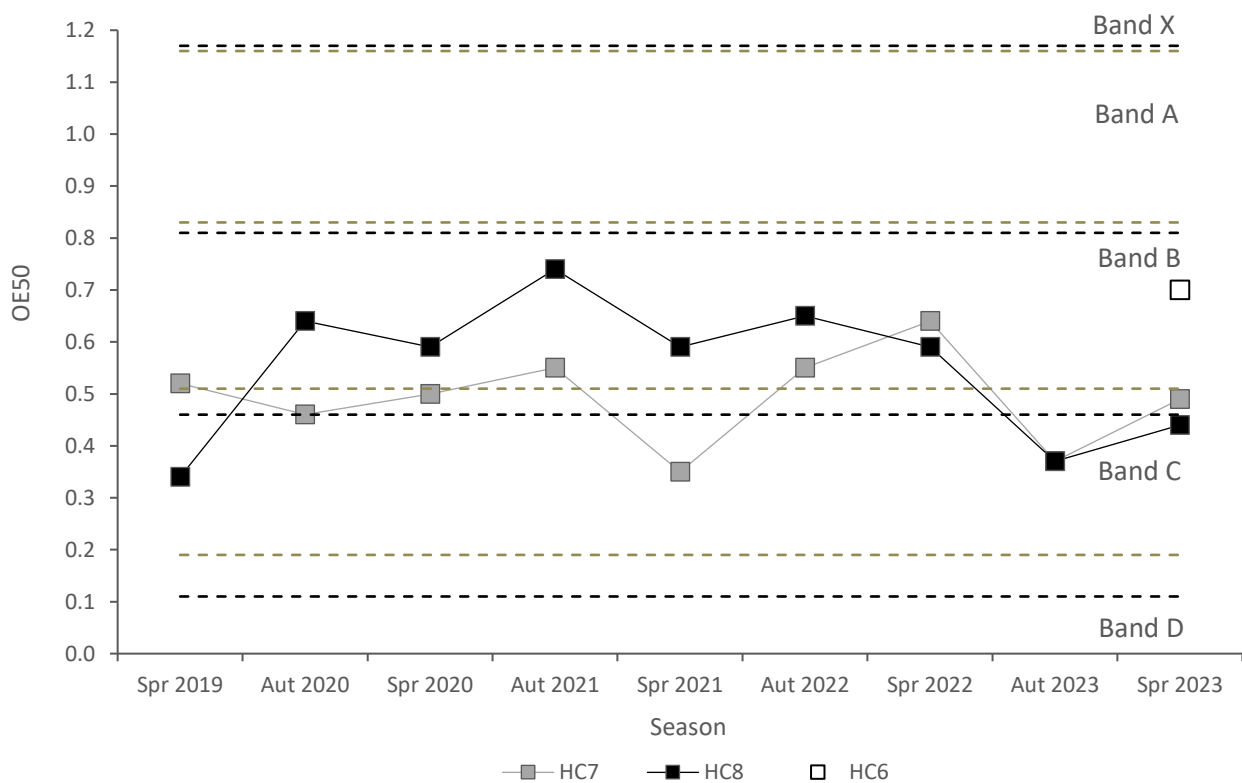
Figure 3: AUSRIVAS OE50 scores recorded at impact sites (above) and control sites (below). Pre-mining: spring 2019 – autumn 2022, post mining: spring 2022 – spring 2023. (NB: The black dashes represent the Band levels in Autumn and the grey dashes Spring)

The AUSRIVAS results showed sites recorded OE50 scores that ranged between Band B to Band C (Table 8), Figure 3) indicating that overall, the macroinvertebrate assemblages present at all sites were impoverished when compared to the reference site data used by the AUSRIVAS predictive models (at both impact and control sites). Generally, the Band scores are comparable between impact monitoring sites that are part of the Tea Tree Hollow stream network (which held water), and the control monitoring sites in Hornes Creek. Impact monitoring site TTHt17 (d/s) is an exception to this, recording somewhat lower scores overall, and in comparison, to pre-mining results from site TTHt17, although no pre-mining data is available specifically for TTHt17 (d/s) itself. This may reflect potentially limited water permanence at this site in spring 2023.
