Tahmoor Coal Pty Ltd

SIX MONTHLY SUBSIDENCE IMPACT REPORT

Tahmoor South Domain Longwalls South 1A – South 6A

1 July 2023 – 31 December 2023

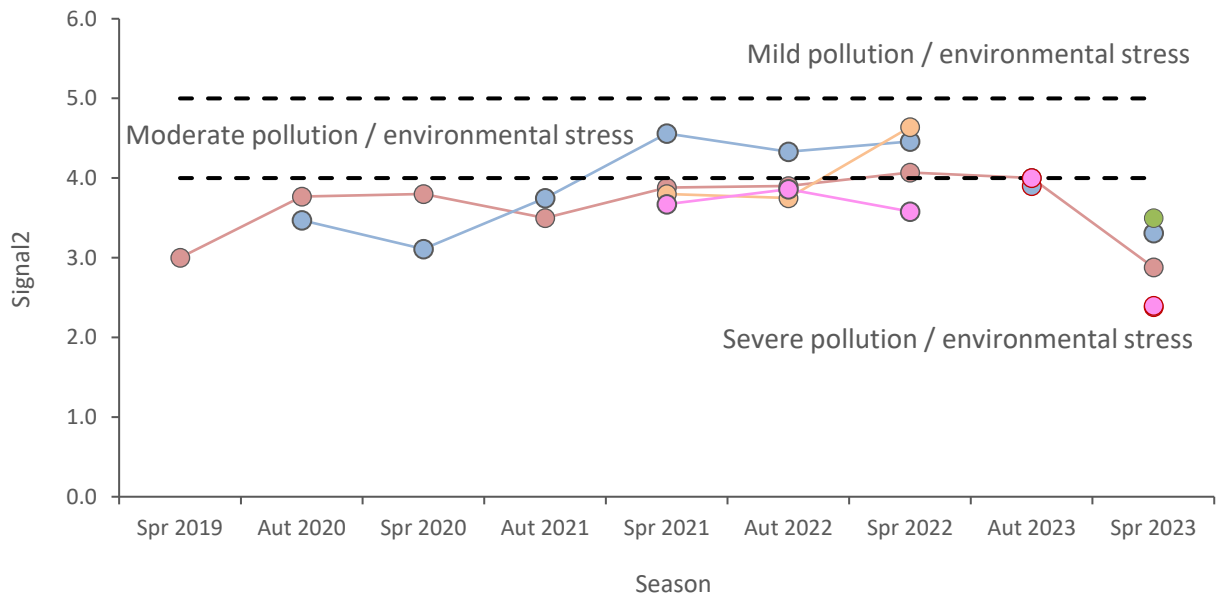
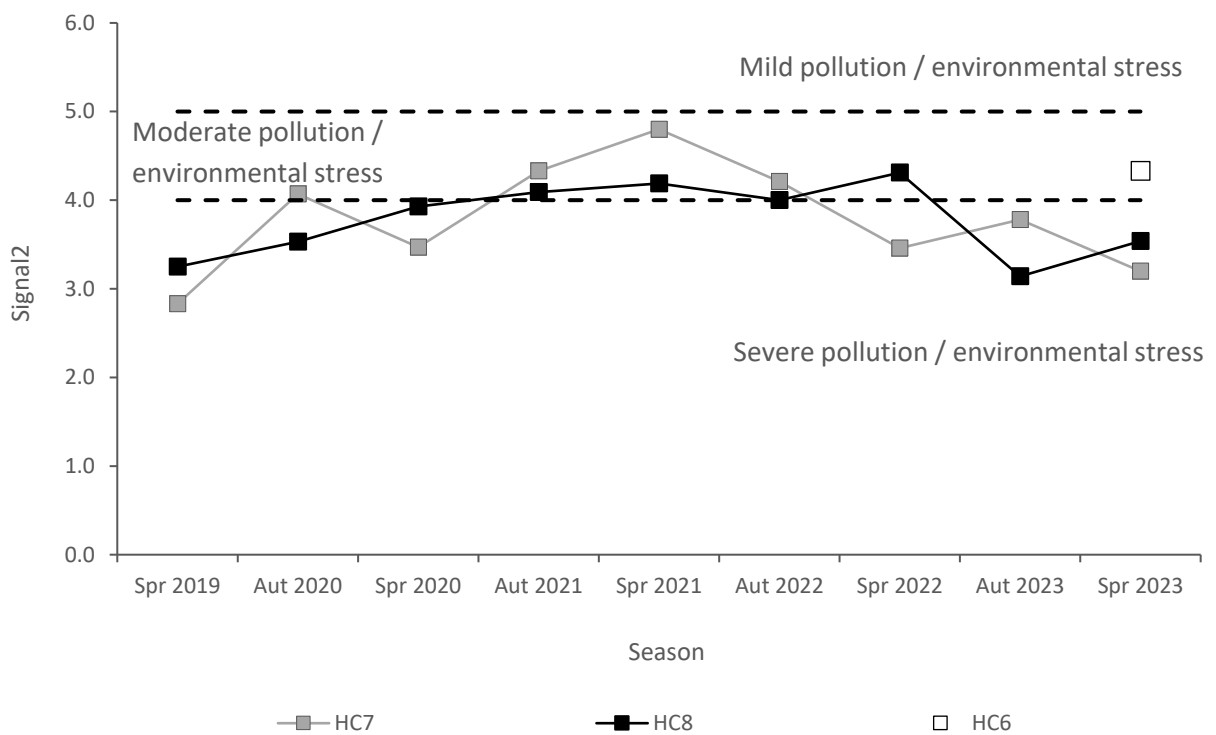
Figure 4: SIGNAL2 scores recorded at impact sites (above) and control sites (below). Pre-mining: spring 2019 – autumn 2022, post mining: spring 2022 – spring 2023.

The Signal2 scores for all sites varied between 2.38 and 3.54, which are considered low, indicating moderate to severe levels of impairment and poor to very poor water quality conditions across the sites (Table 8), including the control monitoring sites. New control monitoring site HC6 recorded the highest SIGNAL2 score (4.33), while impact monitoring site TTHt17 (d/s) recorded the lowest (2.40). When considered as a group, the SIGNAL2 scores were somewhat greater at the control sites when compared to the impact monitoring sites. There is a general trend of overall declining SIGNAL2 scores since Spring 2022, including at the control monitoring sites. This likely reflects the harsher environmental conditions that have occurred during this time, with a transition from elevated rainfall conditions to drier and more sporadic rainfall events. The low scores reflect the dominance of pollution tolerant macroinvertebrates and presence of few pollution-sensitive taxa. However, this is common in low flow pool edge habitat in the area. While the results are somewhat decreased on those of spring 2022, they are comparable between the impact and control groups and within the range of previous results (Figure 3).

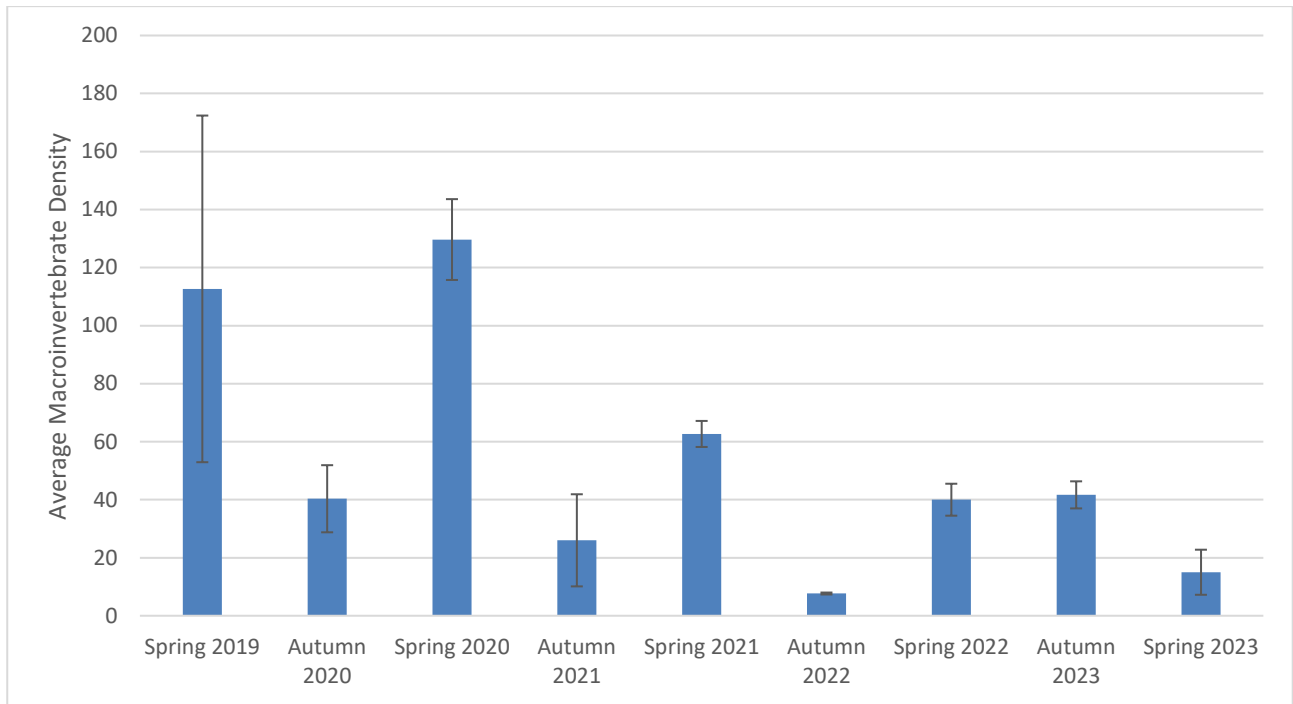
Figure 5: Comparison of average density (\bar{x} , \pm SE) between Surveys for TTH12

Further exploration of data at Site TTH12 (Figure 5 and Figure 6) identifies that macroinvertebrate density and richness in spring 2023 was below that of autumn 2023. Macroinvertebrate density was lower in autumn 2022, however this season was affected by significant flow events, while the richness result in spring 2023 was the lowest to date. Visually however, the results are comparable to pre-mining data at this site.

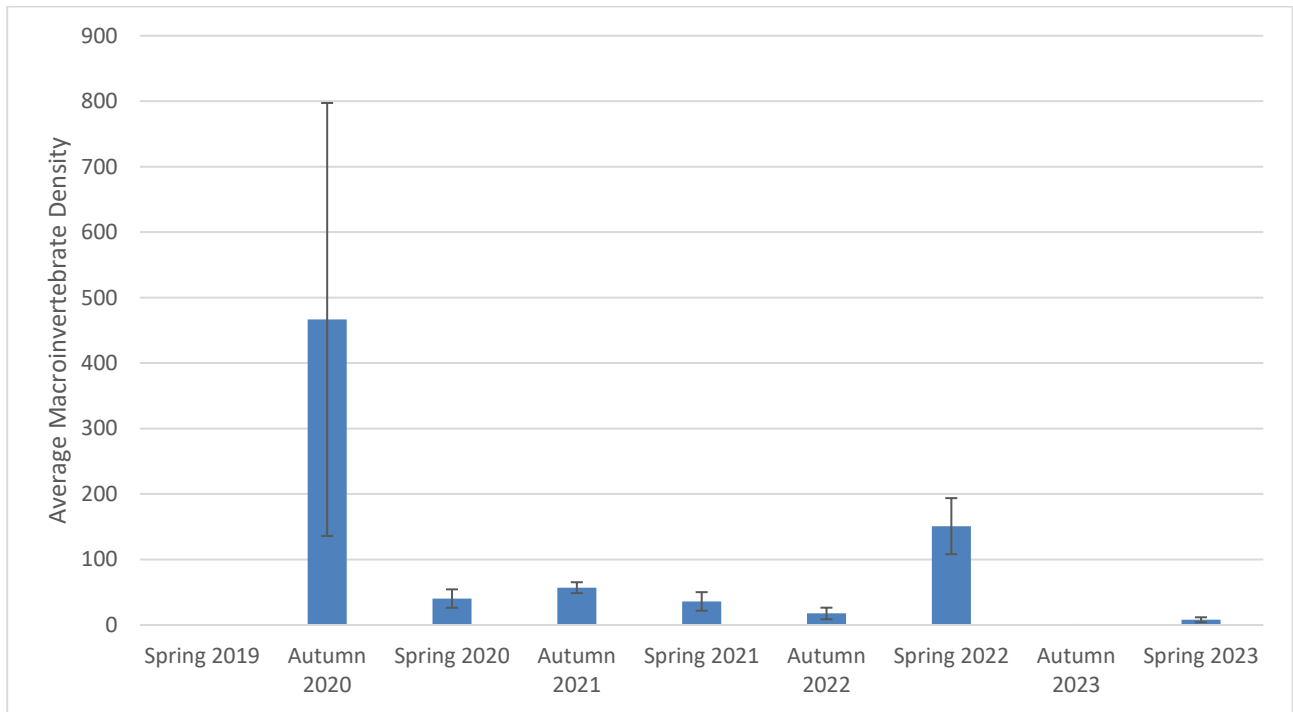
Figure 7: Comparison of average density (\bar{x} , \pm SE) between Surveys for TTH13

Further investigation of data from Site TTH13 identified that both macroinvertebrate richness and density were lower in spring 2023 when compared to spring 2022, in fact these were the lowest totals (outside of dry conditions). With the spring 2022 (first season of monitoring in the ‘during mining’ period) recording higher levels. It is noted that water levels were generally elevated in that season. Visual assessment of the data indicates that the results in spring 2023 are also lower than in the pre-mining period.

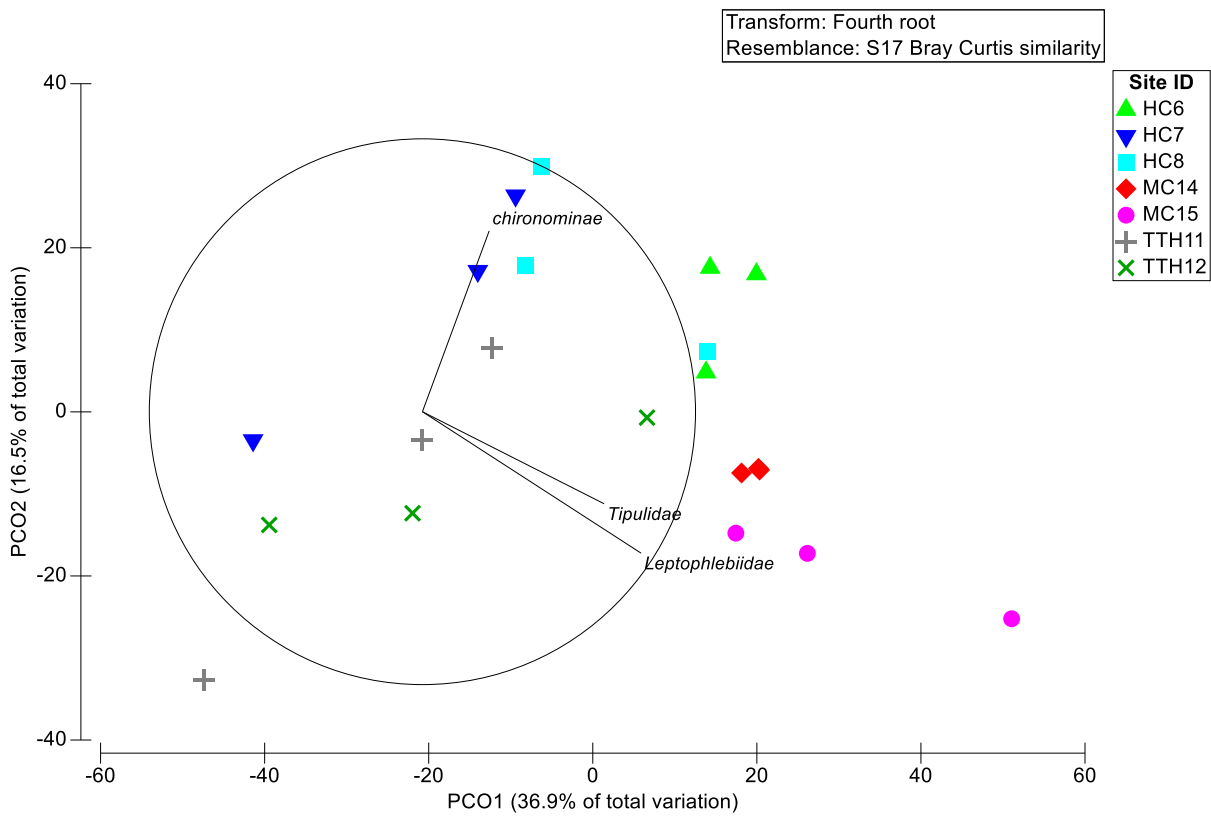
Figure 9: Graph of the two first axis from the PCO analysis for data from the Spring 2023 Survey. Vectors based on Spearman Coefficient >0.7

The PCO analysis found that that the first two axes explain 53.4% of the variation (Figure 9) when Sites are considered. The PCO plot shows that the Tea Tree Hollow sites had greater overlap with Hornes Creek and minimal with Moore Creek in the spring 2023 survey. The strongest driver of the differences in the spring

2023 Survey was a positive relationship of *Chironominae* with the Y Axis and a negative relationship with the Y Axis and a positive relationship with the X Axis of *Tipulidae* and *Leptophlebiidae*.

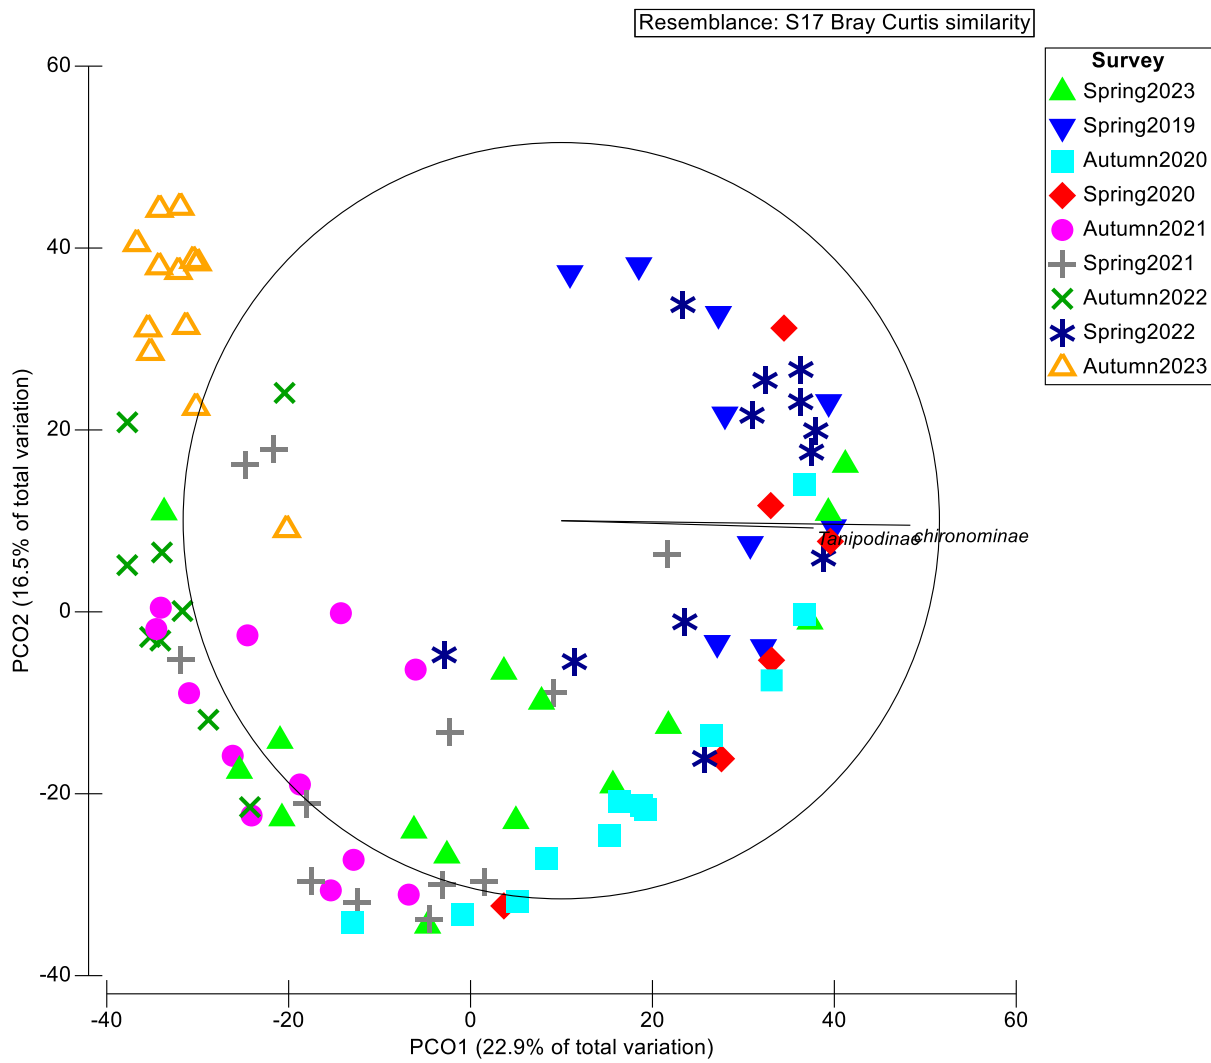
Figure 10: Graph of the two first axis from the PCO analysis for data from Tea Tree Hollow. Vectors based on Spearman Coefficient >0.6

The PCO analysis found that the first two axis explain 39.4% of the variation (Figure 10) when Survey at Tea Tree Hollow is considered. The PCO Plot indicates that for Tea Tree Hollow, the most recent Survey (spring 2023) was much more variable than previous surveys, including the more recent surveys from the During period. The strongest driver of differences in the spring 2023 survey was a positive relationship of *Chironominae* and *Tipulidae* with the X Axis.

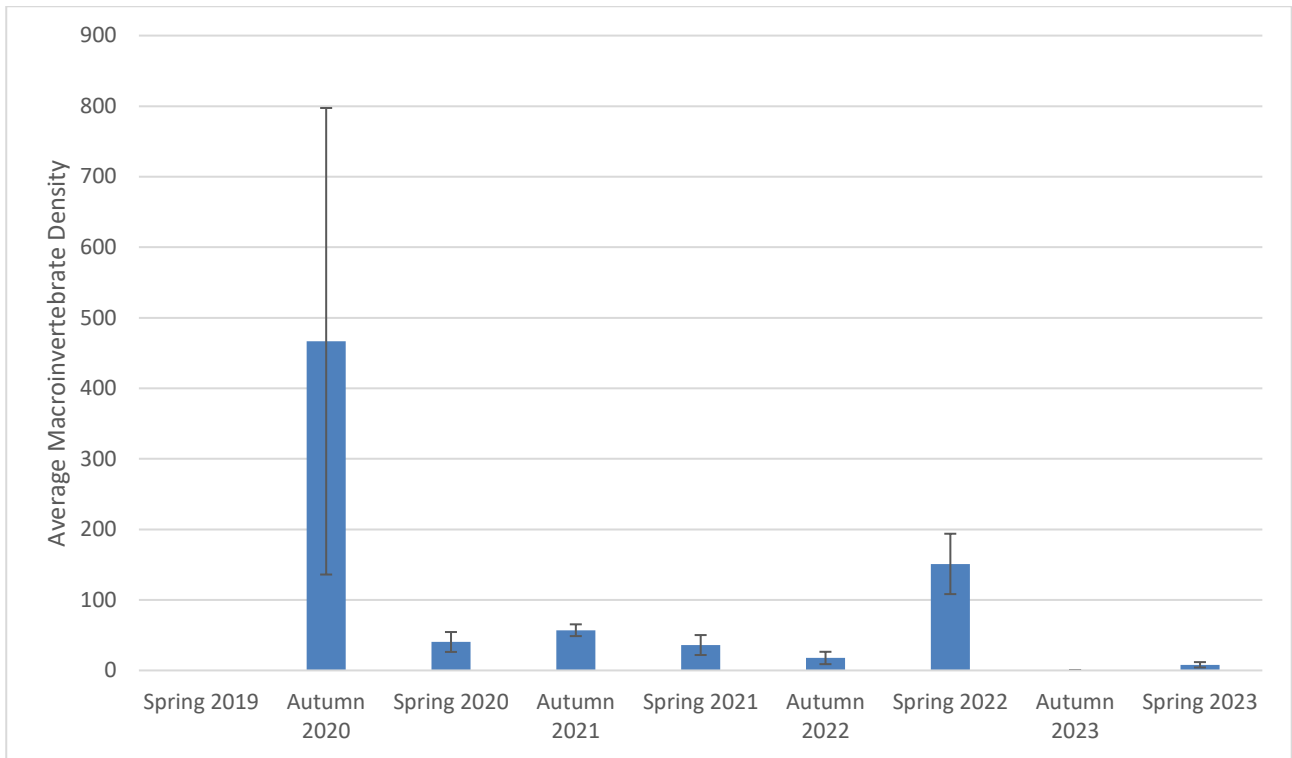
Figure 11: Comparison of average density (\bar{x} , \pm SE) between Surveys for Site TTH13

Investigation of the Pairwise Comparisons between surveys for the Impact sites during the During period found that the spring 2023 Survey was significantly different to both previous surveys at Site TTH13 (Table 12, Figure 11) in the 'during mining' period.

The graph (Figure 11) shows the significant difference between the average density recorded between spring 2023 and spring 2022 (with autumn 2023 being dry and as such being unsamplable) at TTH13. Further assessment of this data identifies that the densities recorded at this site in spring 2023 are also lower than that recorded in the pre-mining dataset. Relatively low results are also recorded at the Control sites (Figure 12), indicating the prevailing environmental conditions are likely to suppress macroinvertebrate results in spring 2023.

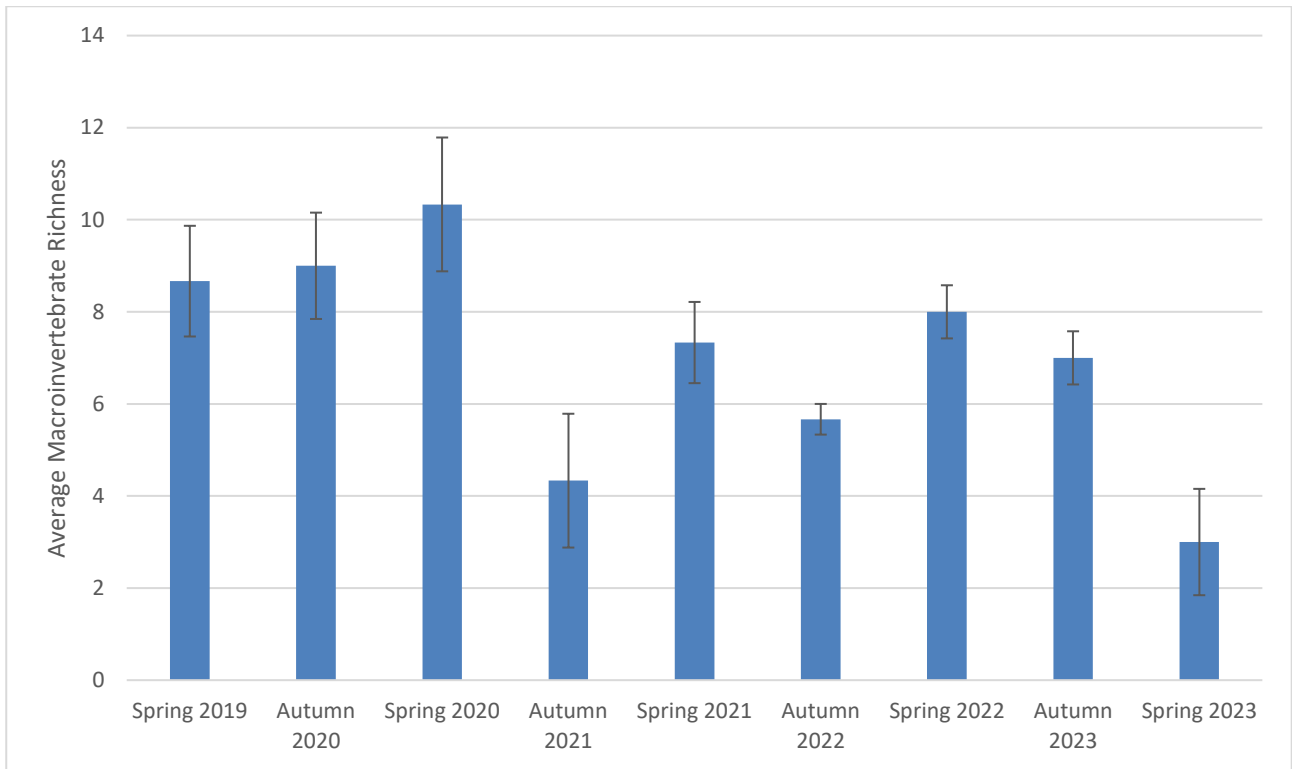
Figure 13: Comparison of average richness (\bar{x} , \pm SE) between Surveys at TTH12

Richness results recorded at TTH12 (Figure 13) and TTH13 (Figure 14) in spring 2023 were the lowest recorded to date, including the pre-mining period. Results at the Control sites in the same period are variable (Figure 15). While the scores are on average lower than spring 2022 and autumn 2023, lower richness results have been recorded at each Control site during the whole monitoring period.

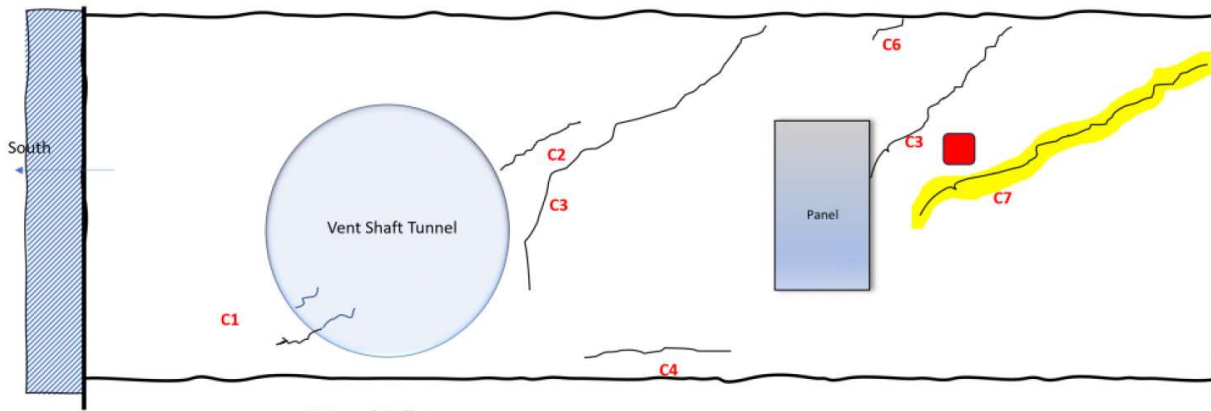
Plate 4.5 Crack C5 (David Talbert, 6 June 2023).

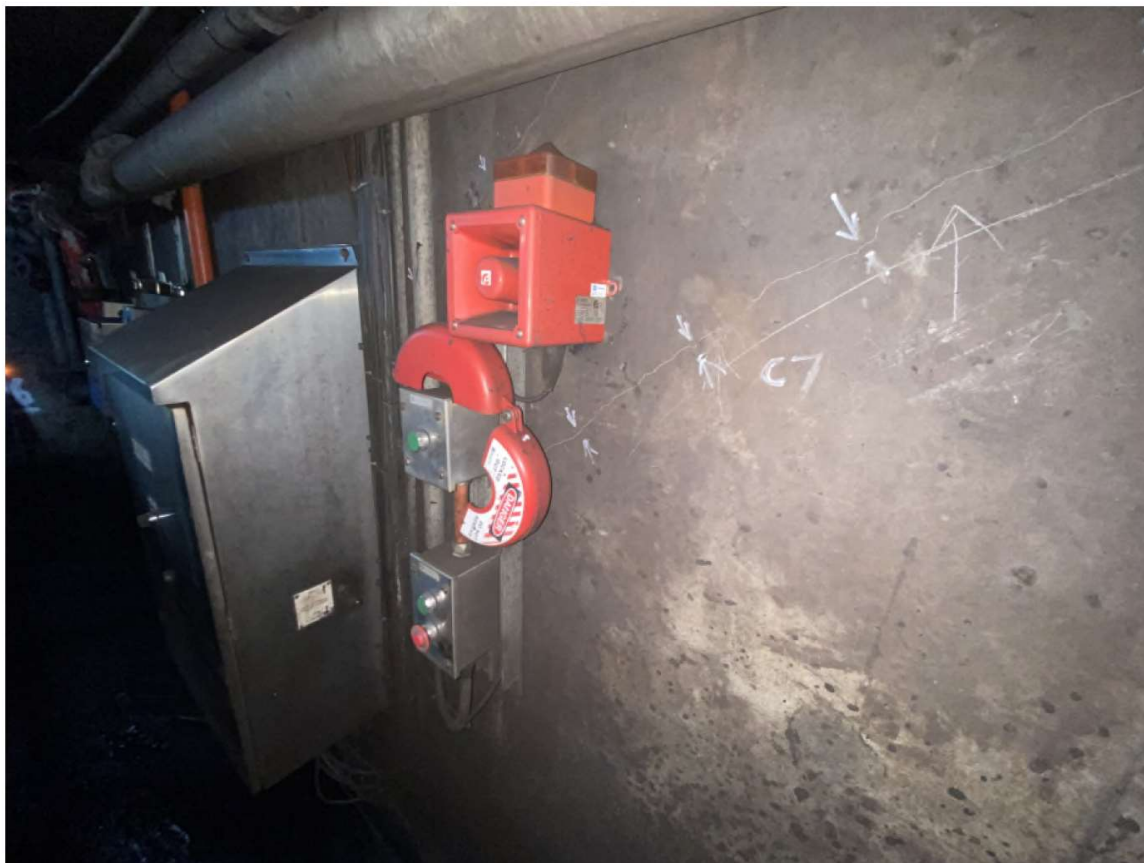
On 29 May 2023, during extraction of LW S1A, two cracks were observed by the structural engineer at the Tahmoor Mine site within the 6C tunnel and vent shaft interface (Plate 4.1 – Plate 4.2). The site continued to be monitored with weekly inspections and on 6 June, four additional cracks were observed (Plate 4.3 - Plate 4.5). An additional crack was detected on 27 June 2023 (Plate 4.6). The site continues to be monitored with weekly inspections.

Plate 4.6 Location of C7 (David Talbert, 27 June 2023)

1. The site should continue to be monitored and the data reviewed as per the Tahmoor Mine Site Management Plan.
2. At the conclusion of mining of LW S1A – S6A, the cracks within Tunnel 6C should be assessed by a suitably qualified heritage advisor to determine whether remediation is required.

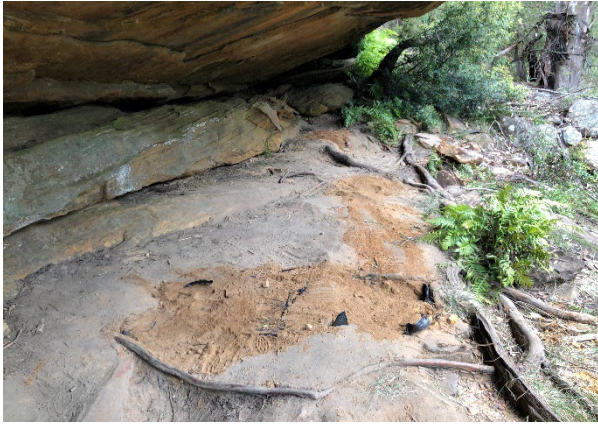
Plate 1 Teatree Hollow rockshelter immediately following archaeological excavations in November 2022, looking south.

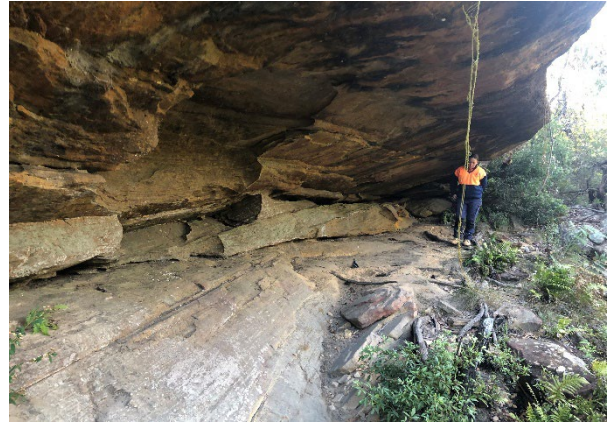
Plate 2 Teatree Hollow rockshelter during site inspection in July 2023, looking south.

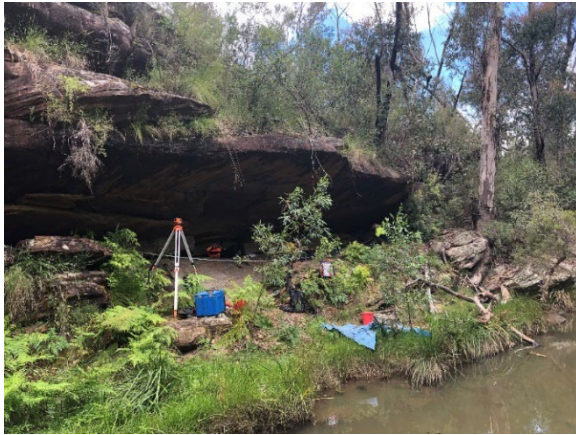
Teatree Hollow Creek that was full at the time of the previous excavations was empty at the time of site inspection (Plates 3 and 4). While not part of the rockshelter site itself, this was noted, since the proximity of the site to the creek provides both a probable reason for its original use in the past, and contributes to its aesthetic significance. SIMEC Mining is currently investigating the changes in creek flow in relation to mining and climatic conditions – the creek being ephemeral and having been subject of several dry months – but is managing this change through Trigger Action Response Plan (TARP) triggers for low flow within the approved LWS1A-S6A Water Management Plan.

Plate 3 Teatree Hollow rockshelter during archaeological excavations in November 2022, looking southwest. Note the water-level of Teatree Hollow Creek in the foreground.

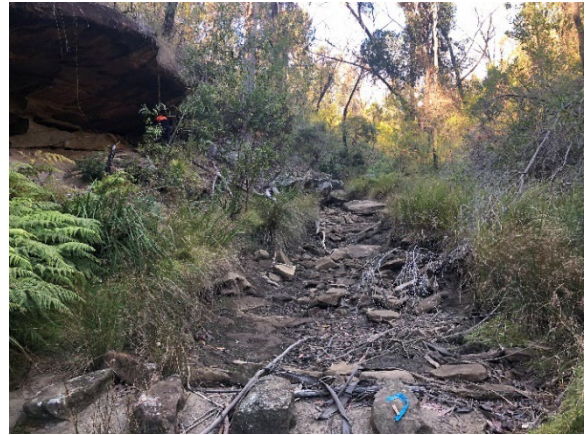
Plate 4 Teatree Hollow creek during the site inspection in July 2023, looking south. The rockshelter is immediately left (east) of photograph.

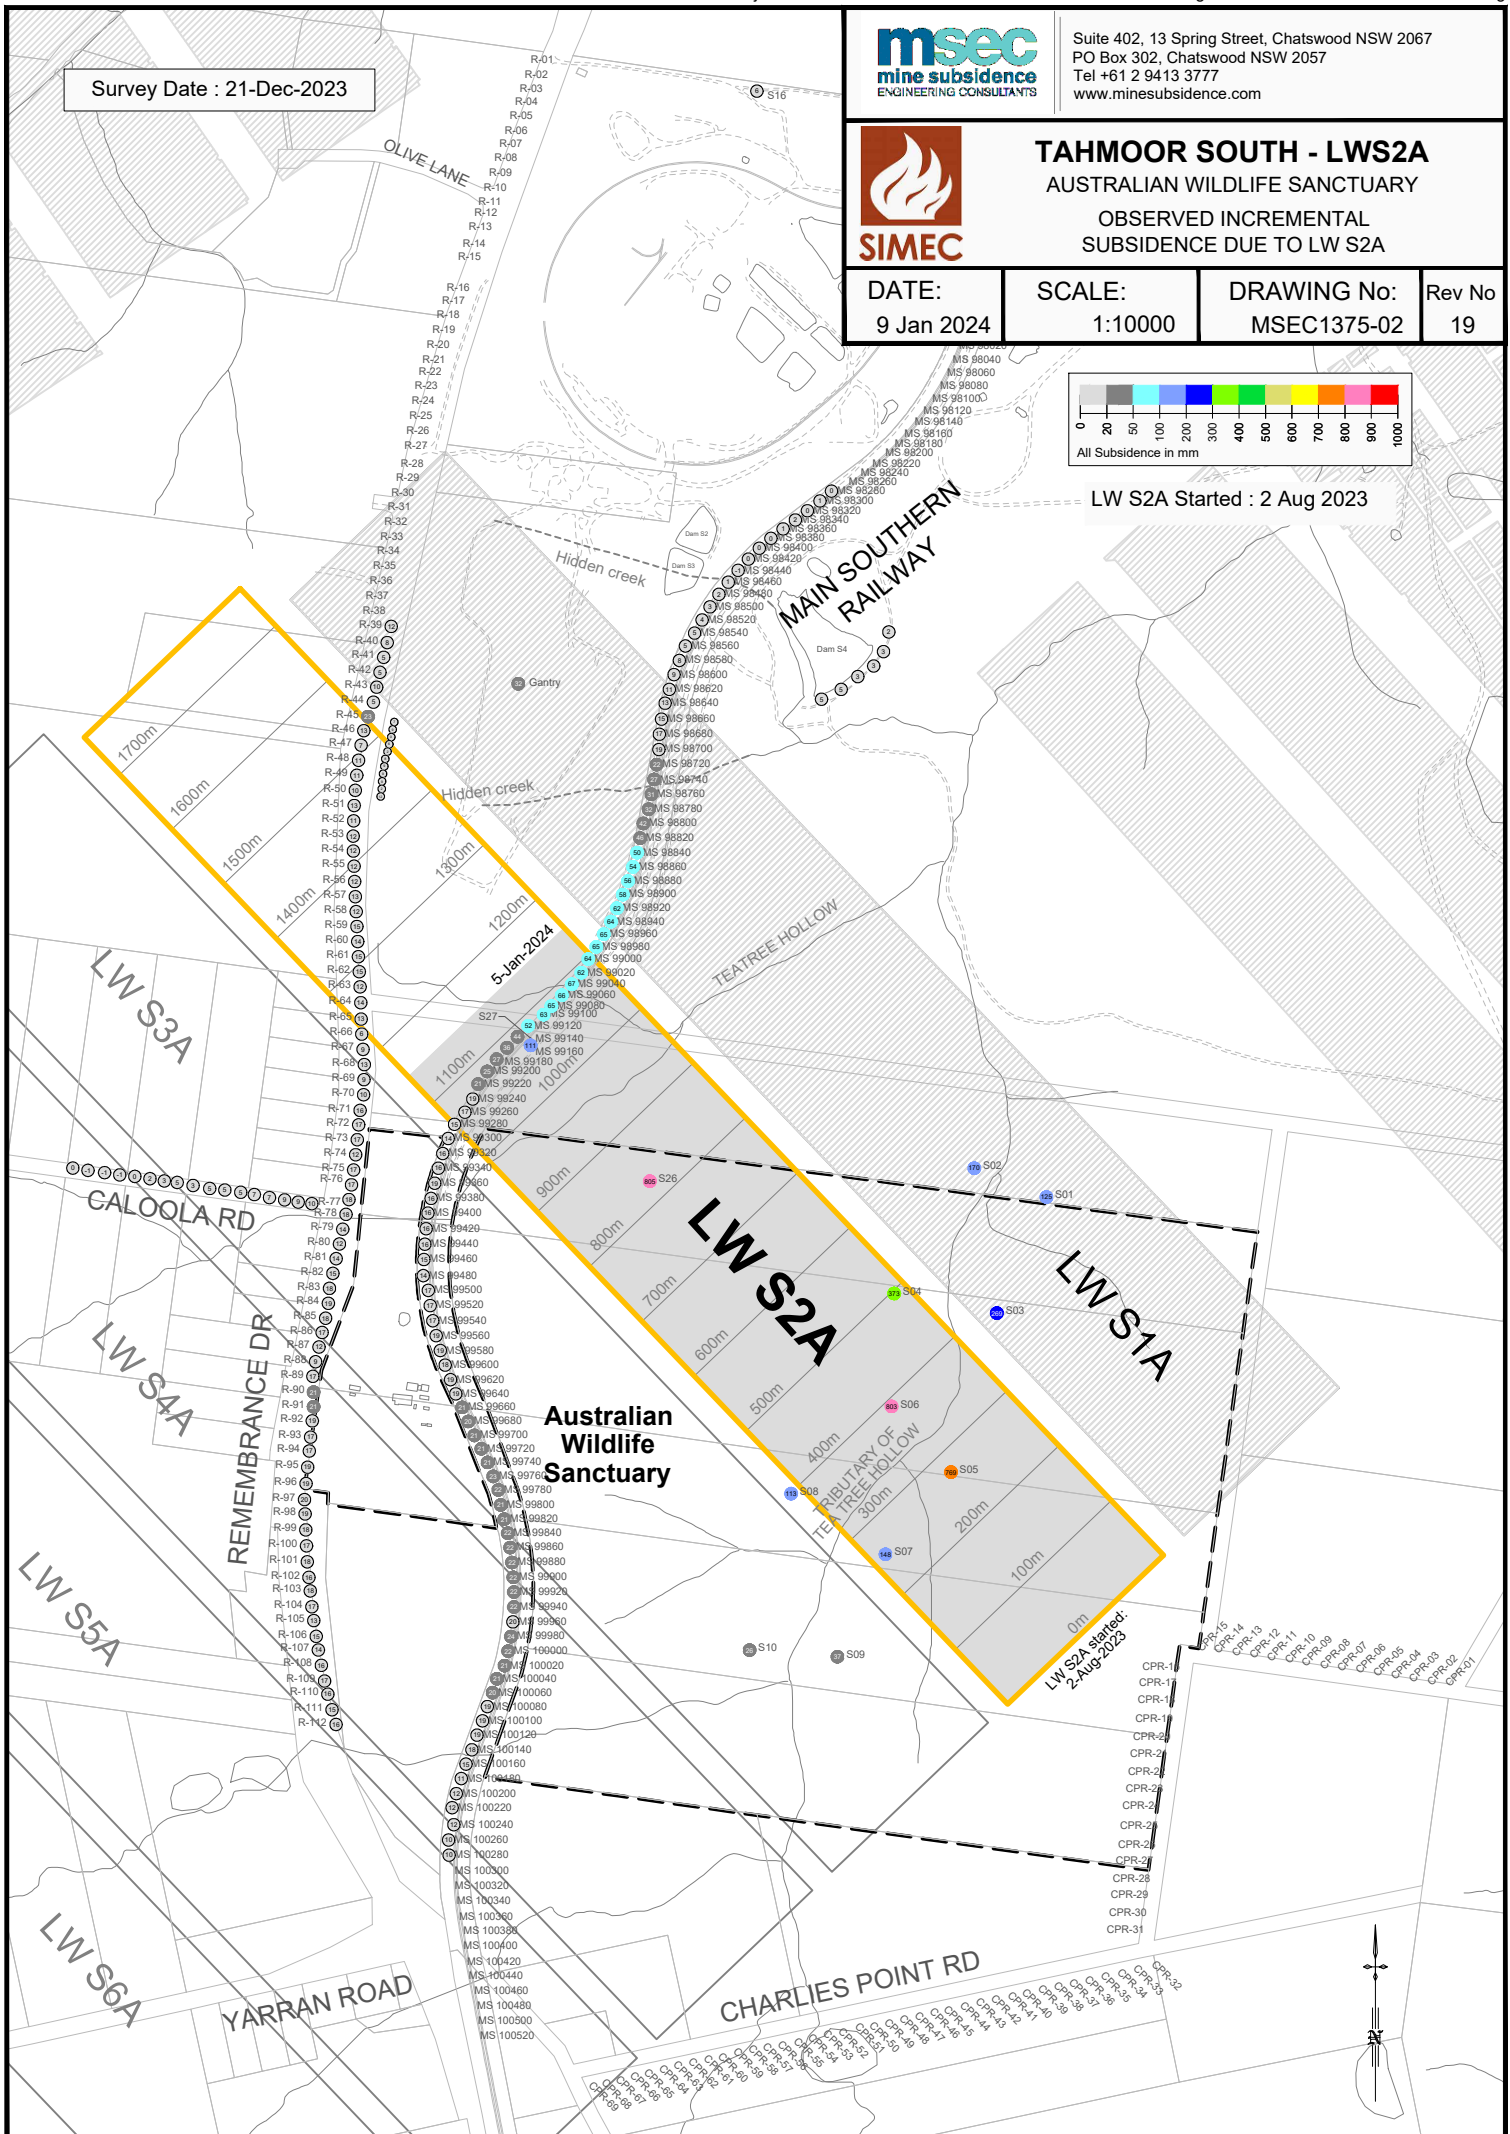
AUSTRALIAN WILDLIFE SANCTUARY
OBSERVED INCREMENTAL
SUBSIDENCE DUE TO LW S2A

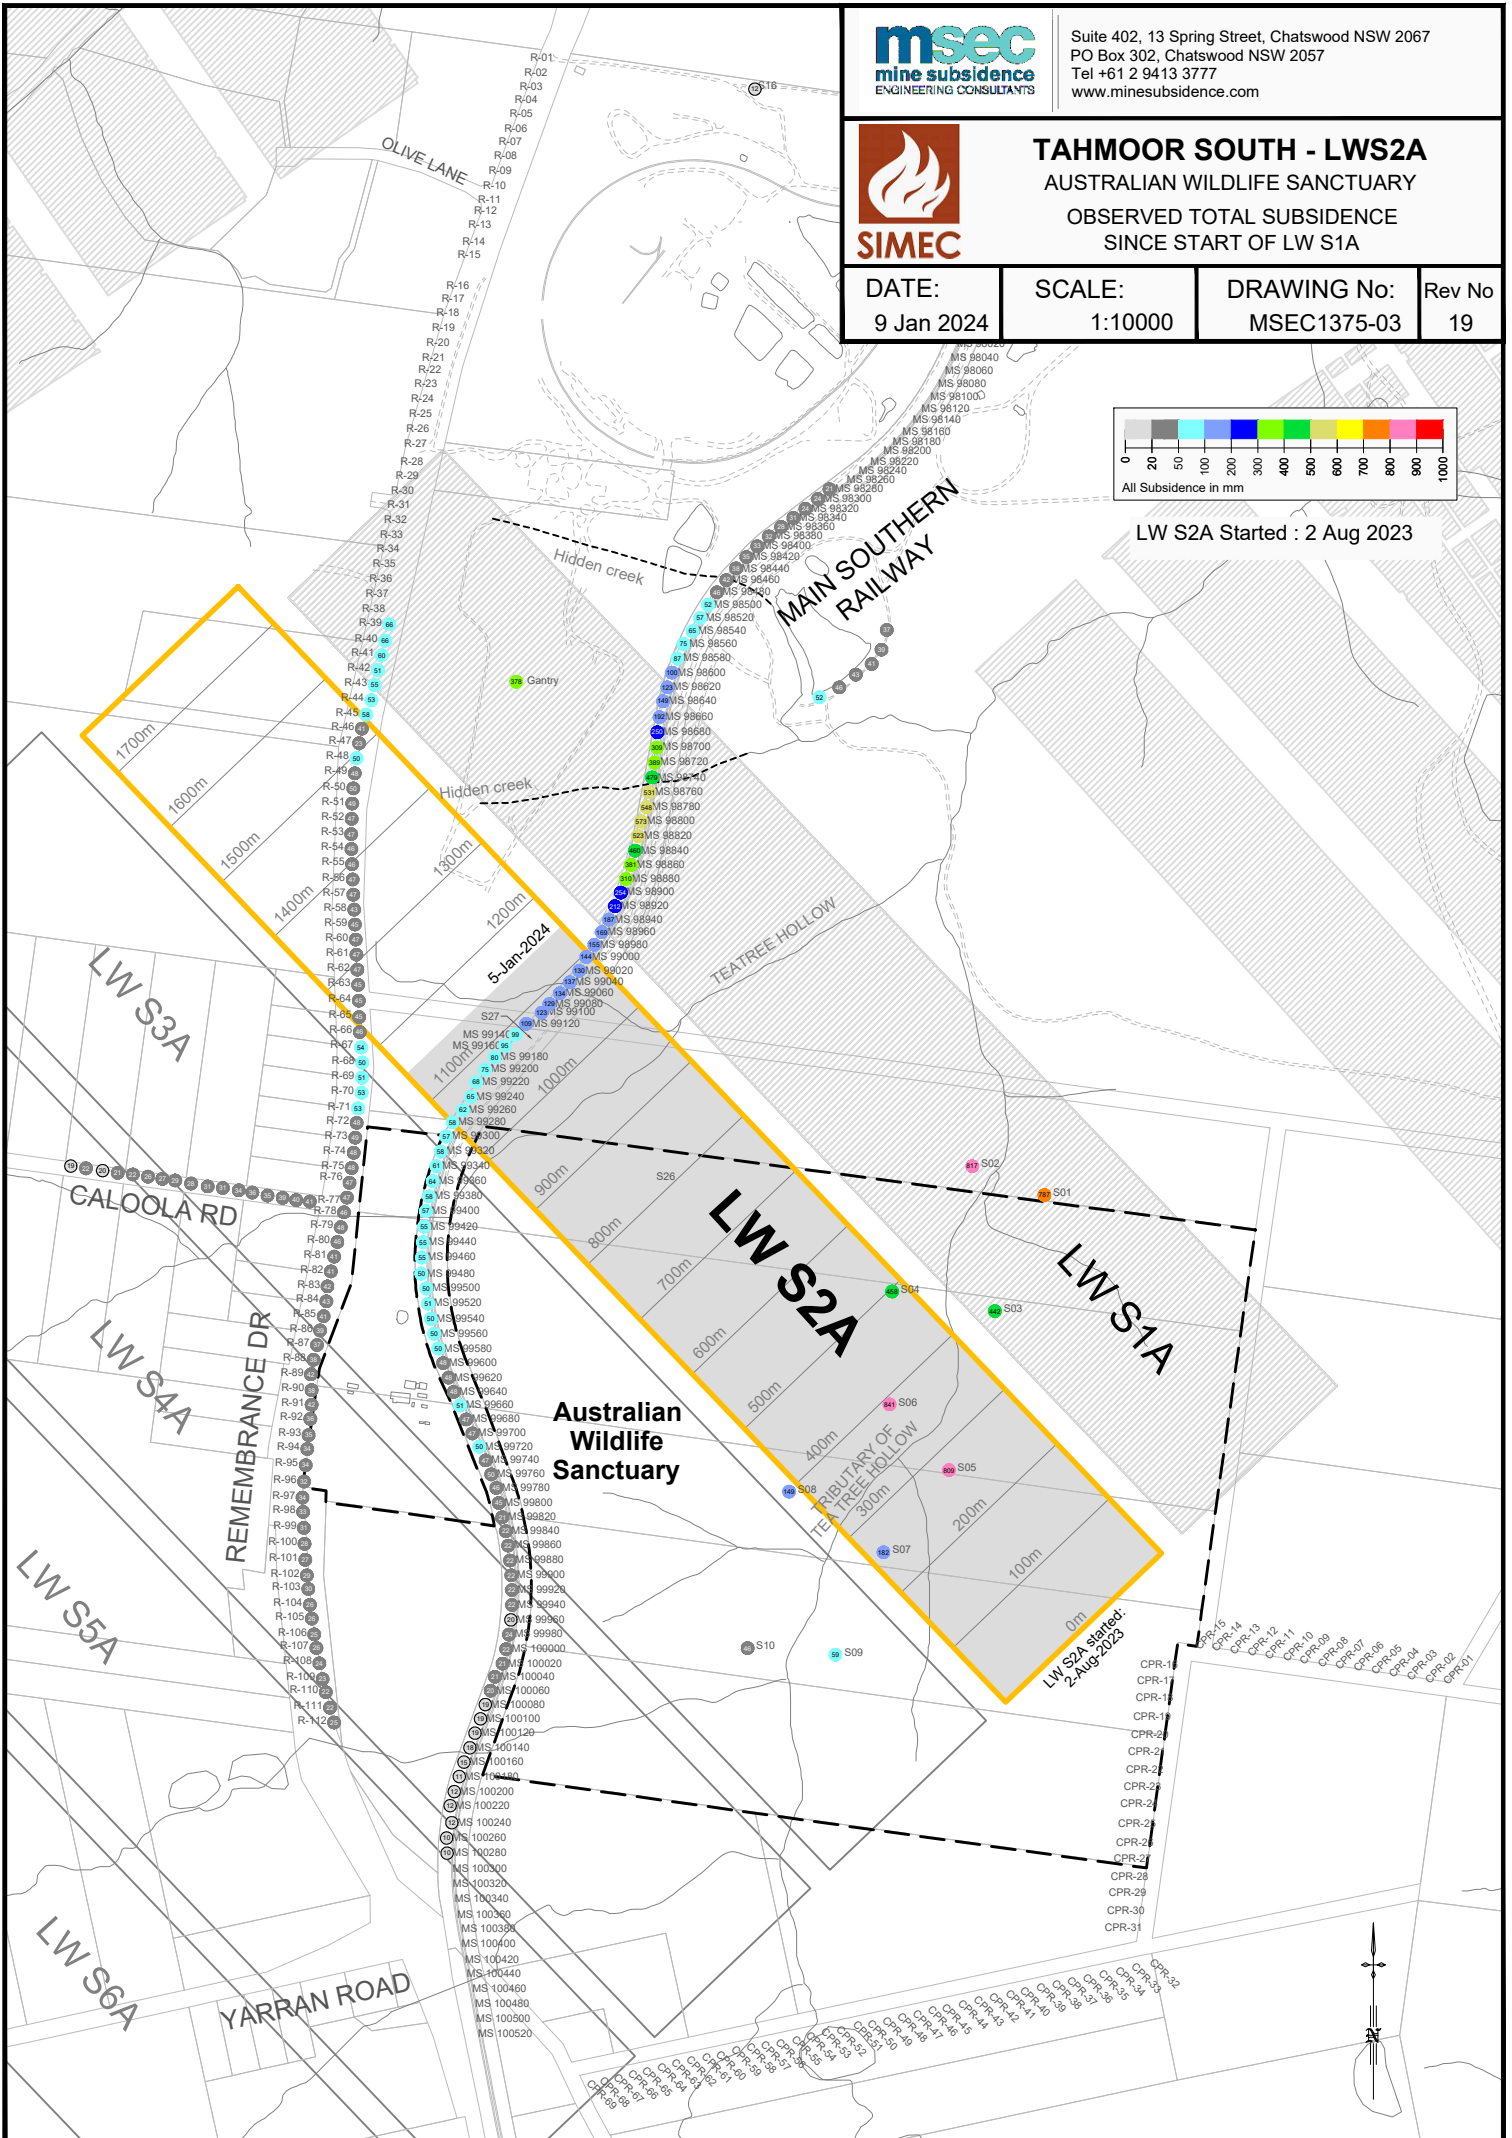
TAHMOOR SOUTH - LWS2A
 AUSTRALIAN WILDLIFE SANCTUARY
 OBSERVED TOTAL SUBSIDENCE
 SINCE START OF LW S1A
