Tahmoor Coal Pty Ltd SIX MONTHLY SUBSIDENCE IMPACT REPORT

Tahmoor South Domain Longwalls South 1A – South 6A

1 January 2024 - 30 June 2024

Report 4 – October 2024

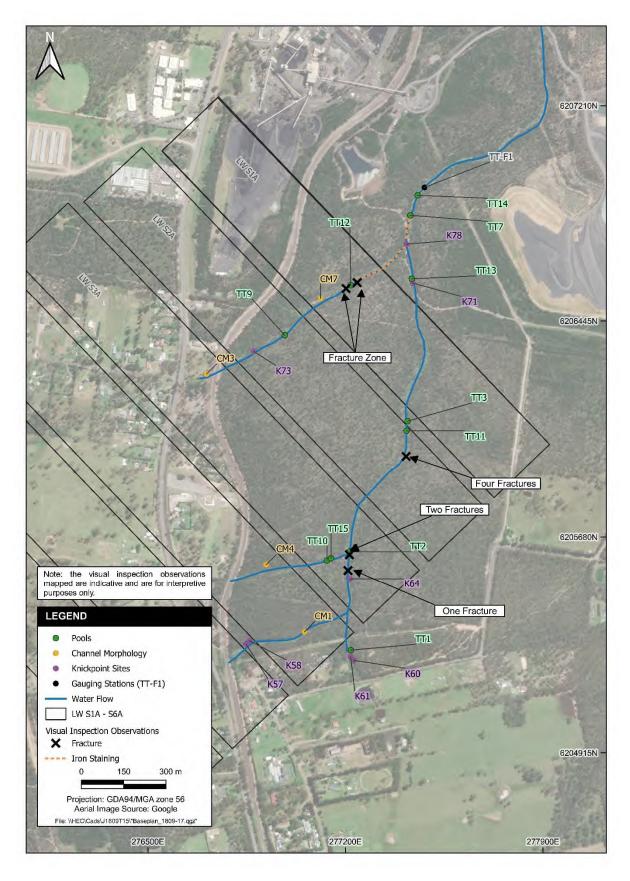
Figure 3-8 demonstrates the location of flow re-emergence, fracturing, ponded water, iron staining and overland flow observed at the end of the reporting period (June 2024).

Figure 3-8 Visual depiction of surface water characteristics and physical effects in June 2024 (source: **Appendix B**)

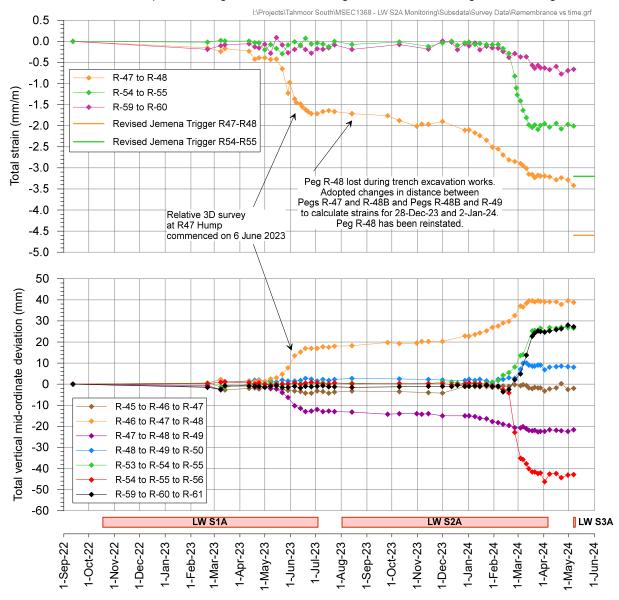
Increased compressive strain is observed between Pegs R54 and R55, accompanied by a small bump in the observed subsidence profile at Peg R54, as shown in Figure C. Rates of change are reducing

Figure C Observed development of ground strain and changes in vertical alignment at selected pegs along Remembrance Drive

In light of the survey results and observations of minor impacts on the pavement, Tahmoor Coal notified potentially affected stakeholders. The gas main pipeline was decoupled from the ground on 11 March. Tahmoor Coal remains on standby with respect to repairing the road pavement and reducing stresses on the direct buried Telstra cable, if required.

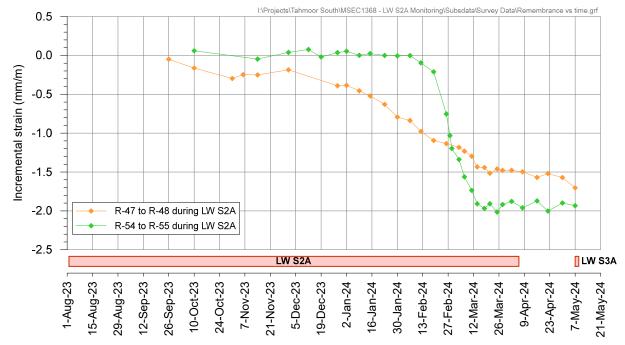
Observed incremental strains between Pegs R47 and R48 due to the mining of LW S2A are plotted in Figure D. Rates of change in compressive ground strain have reduced as expected following the completion of LW S2A, though a minor trend of increasing compressive strain continues.

Figure D Observed development of ground strain between Pegs R47 and R48 and between Pegs R54 and R55 over time

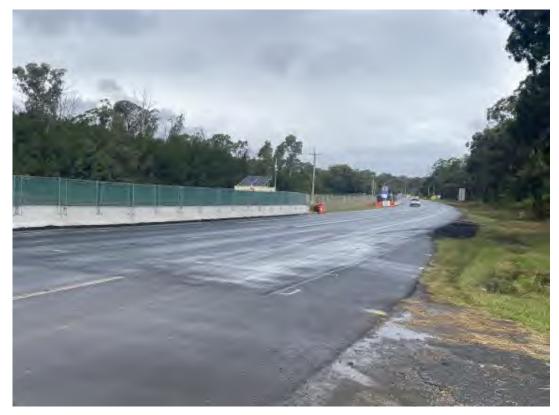
Figure H Resurfaced pavement at location of bump near Peg R47 on 9 April 2024

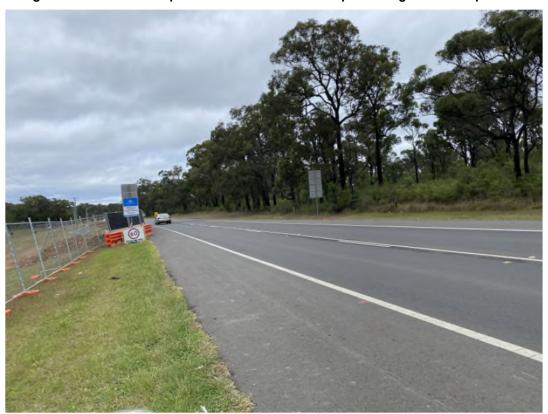
Figure I Remembrance Drive on 30 April 2024

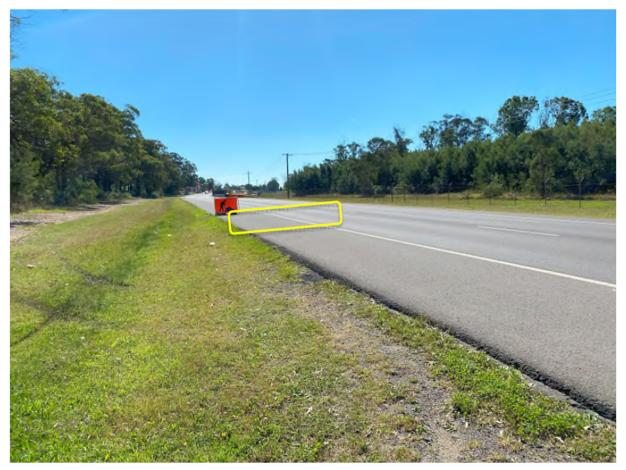
Figure J Remembrance Drive pavement near Peg R61 on 22 April 2024

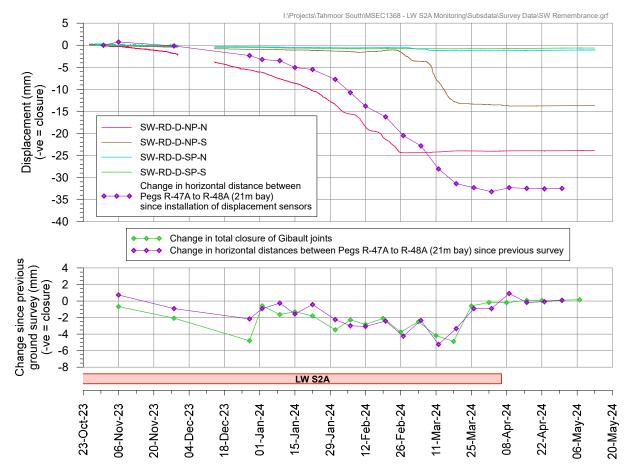
The observed changes are compared with changes in horizontal distance between Pegs R47A and R48A, which are located on either side of the joints. It can be seen from Figure M that the joint displacement is now less than measured between the survey pegs, though there is currently good correlation between the survey methods on weekly changes.

Figure M Observed change in distance across Gibault joints at Remembrance Drive between Pegs R47A and R48A on Sydney Water potable water main

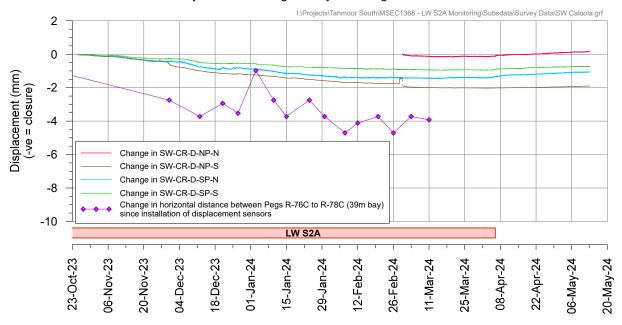
Displacement sensors were also installed on the four Gibault joints of the 100 mm water main on Caloola Road. Minor changes have been observed, as shown in Figure N. The northern displacement sensor across the southern joint has been replaced in late February 2024. The observed changes are compared with changes in horizontal distance between Pegs R76C and R78C, which are located on either side of the joints. It can be seen from Figure N that the measured changes are within survey tolerances. A very small trend of closure observed on the joint sensors is gradually reversing.

Figure N Observed change in distance across Gibault joints at Caloola Road on Sydney Water potable water main

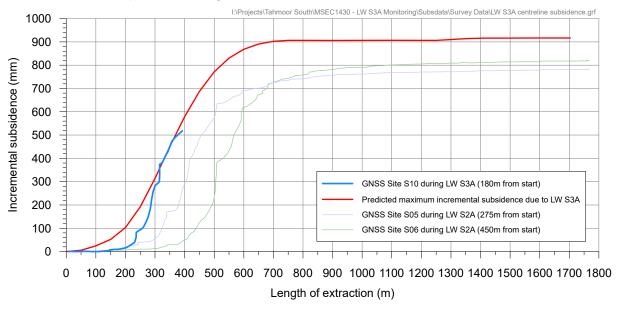
Figure A Observed development of incremental subsidence above LW S3A

Observed development of subsidence above LW S3A relative to the length of extraction is shown in Figure A. It was predicted that subsidence above LW S3A would be greater than observed above LW S2A because it is the third panel in the longwall series.

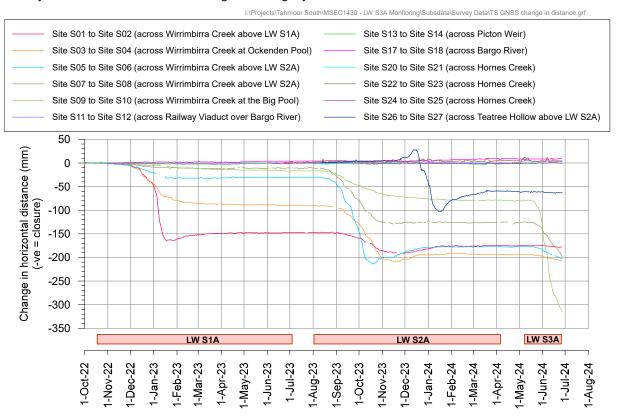
Figure B Observed changes in horizontal distances between GNSS units

Changes in horizontal distances can be calculated between GNSS units that are stationed close together and results are shown in Figure B. Closure has developed across the Tributary to Teatree Hollow (Wirrimbirra Creek). Closure is currently developing across Wirrimbirra Creek between Sites S09 and S10 directly above LW S3A. Rates of change were slightly reduced this week.

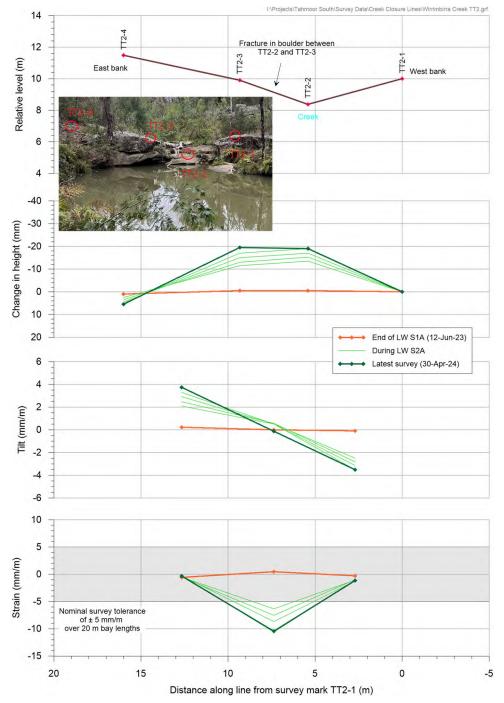
Figure D Observed subsidence, tilt and strain along TT2 line, upstream of Pool TT2

Additional impacts have been observed at TT2 since October 2023. A fracture within a surface boulder upstream of Pool TT2 has been observed to increase in size during the mining of LW S3A. The boulder is wedged between two larger rocks on either side of the creek. Investigations have found that the fracture was present in July 2023, after the mining of LW S1A and prior to the commencement of LW S3A. The fracture contained some debris and some ageing of the exposed rock inside the fracture at this time. While pre-mining photographs and videos identified pre-existing fractures elsewhere within the boulder field upstream of Pool TT2, the fracture was not visible prior to the mining of LW S1A to the scale and extent as observed in July and September. The images, however, were not focussed directly on the boulder in question and could not definitively confirm whether there were any pre-existing hairline or slight fractures in it.

A geotechnical inspection was conducted by Douglas Partners on 9 November 2023. The fractured boulder has been assessed to be a detached sandstone block, which was previously part of the rock strata on either side of the valley prior to mining. The host rock had been naturally eroded and undercut by the weaker underlying strata, resulting in dislocation and fracturing along naturally formed joints at the fracture site. Pre-mining photographs show surface water was flowing underneath the site. While dislocated from the host rock on either side of the valley, the detached sandstone block remained in contact on both sides, such that mining-induced valley closure almost immediately resulted in fracturing. New fractures are developing at the detached sandstone block and within the adjoining rock strata at the contact points due to ongoing closure. The fracture site is situated above Pool TT2 and has no effect on surface water levels in Pool TT2.

A local 3D ground survey was conducted on 9 October 2023 along the TT2 line that is located upstream of Pool TT2 and very close to the fracture in the boulder. The results are shown in Figure D. It can be seen that very little tilt or strain had developed after the mining of LW S1A but valley closure strains and

upsidence have developed since the completion of LW S1A. The fracture in the boulder is located between Pegs TT2-2 and TT2-3. The latest survey on 30 April measured no change in compressive strain.

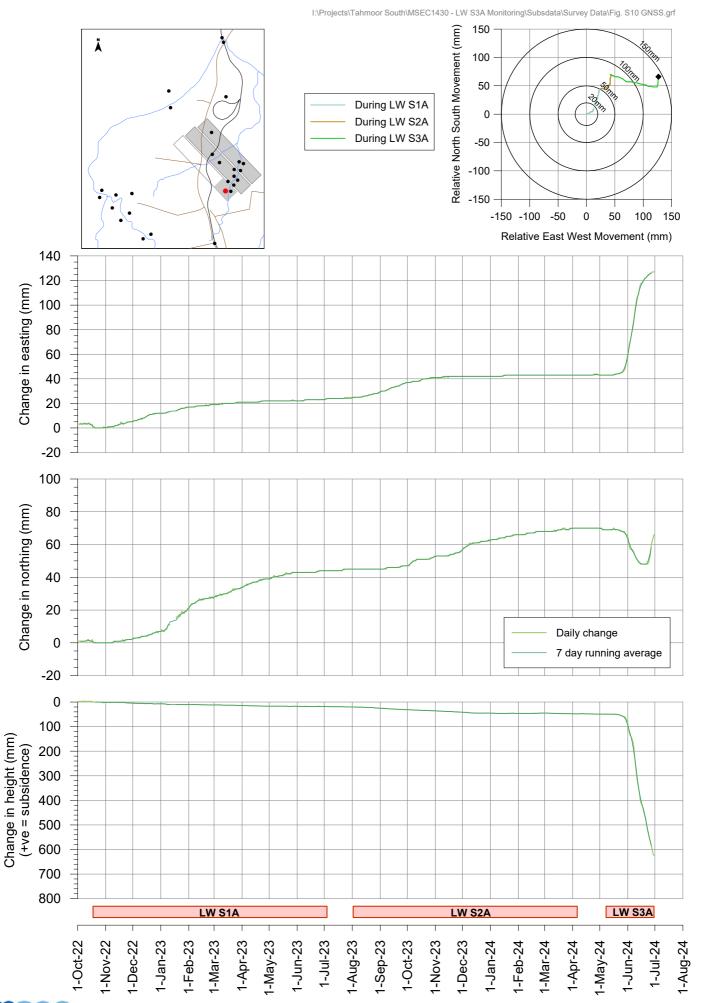
Fig. S10-R05

The results from the GNSS units are shown in Fig. S01 to Fig. S27 and Fig. TM. Mining-induced movements have developed at the GNSS units, with maximum measured incremental subsidence of 533 mm at Site S10 above LW S3A. Rates of change continue at previously observed maximum rates.

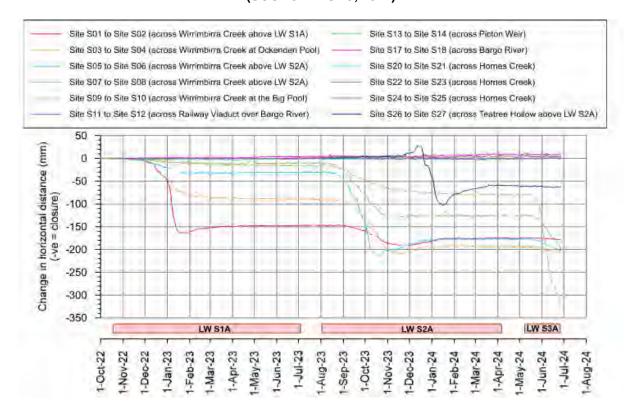
DIAGRAM 1: OBSERVED CHANGES IN HORIZONTAL DISTANCES BETWEEN GNSS UNITS (SOURCE: MSEC, 2024)

- The rate of change of closure recorded between sites S01 to S02 (across Teatree Hollow above LW S1A) was slight during the review period.
- The rate of change of closure recoded between sites S05 to S06 (across Wirrimbirra Creek above LW S2A) was negligible from January to mid-May 2024. Following commencement of mining of LW S3A, a further 20 mm of closure developed with approximately 200 mm of closure recorded in total between sites S05 to S06 as at end of June 2024.

- Approximately 70 mm of closure developed between site S07 and S08 (across Wirrimbirra Creek above LW S2A) in June 2024.
- Negligible change in horizontal distance has been recorded at sites across the Bargo River and Hornes Creek.

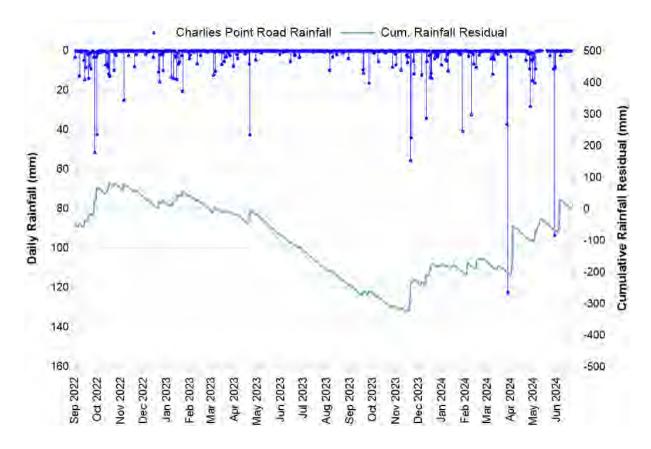
DIAGRAM 2: DAILY RAINFALL AND CUMULATIVE RAINFALL RESIDUAL

The cumulative rainfall residual depicted in **DIAGRAM 2** indicates that during January and early April, near average rainfall conditions were recorded. From middle April to June an increasing trend was recorded.

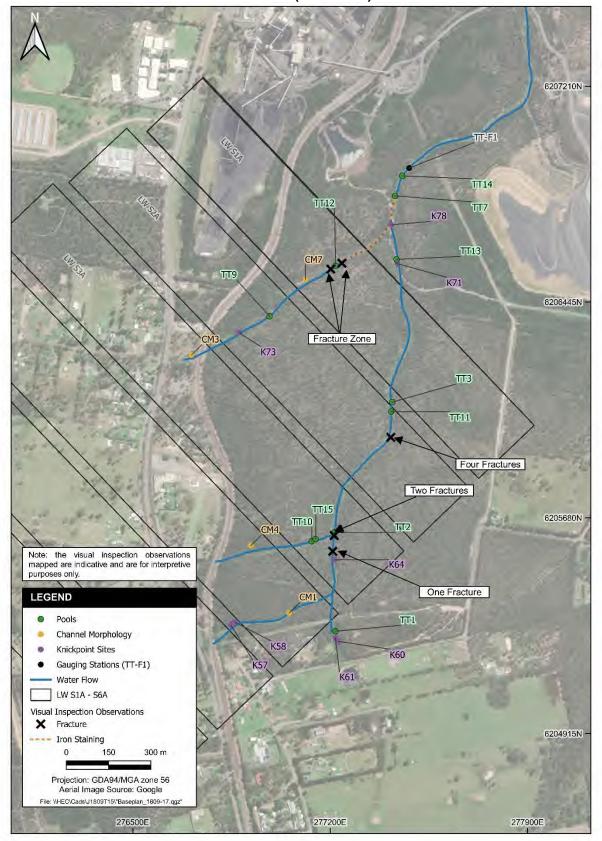
MAP 7: VISUAL DEPICTION OF SURFACE WATER CHARACTERISTICS AND PHYSICAL EFFECTS (JUNE 2024)

A visual depiction of the Teatree Hollow and Teatree Hollow tributary surface water conditions and physical effects is presented in **MAP 7**. The information presented in **MAP 7** was predominately collated from the visual inspection records (ENRS, 2024a-f) and represents conditions observed in June 2024.

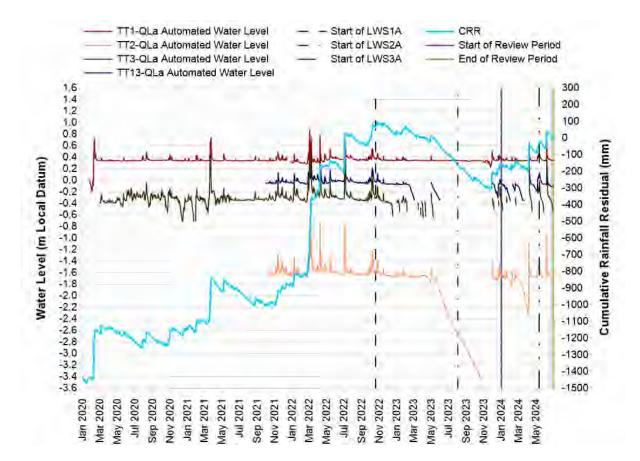
DIAGRAM 5: TEATREE HOLLOW TRIBUTARY WATER LEVEL COMPARISON

DIAGRAM 5 presents a comparison of the water level data recorded at monitoring sites on Teatree Hollow tributary for the full period of record. The cumulative rainfall residual (CRR) is also presented, and it was calculated for the period 1 January 2000 to 30 June 2024 to illustrate long-term trends in rainfall.

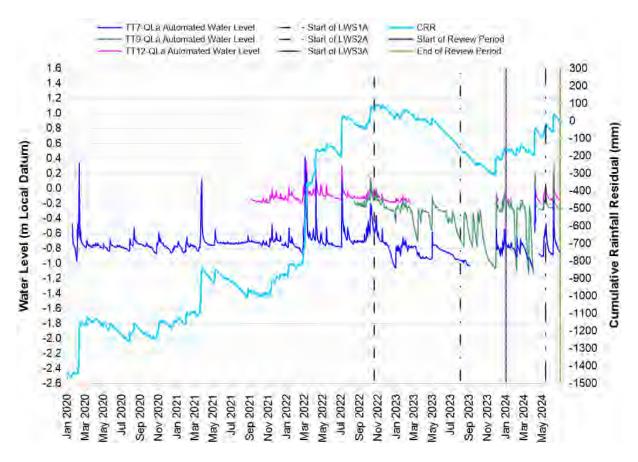
DIAGRAM 6: TEATREE HOLLOW WATER LEVEL COMPARISON

As illustrated in **DIAGRAM 6**, the water level recorded at pool TT7 during the review period was generally consistent with climatic conditions, fluctuating in response to rainfall trends. From late March to early April 2024, a decline in water level was recorded equating to a Level 1 trigger.

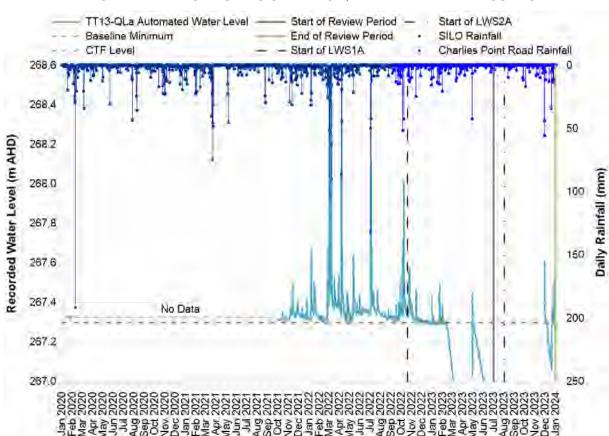
DIAGRAM B1.7: MONITORING SITE TT13-QLA WATER LEVEL RECORDS

Monitoring Site	Classification	Summary of Water Level Trends	Appendix B - Graph Reference
TT13-QLa	Potential Impact Site	Except during rainfall events, the water level was recorded below the baseline minimum during the review period. The water level declined below the trigger level for periods of January, February, March, April and May 2024.	B1.7
Bargo River			
BR16-QLa	Reference Site	The water level trends were consistent with climatic conditions for the duration of the review period. Note that no data was available from mid-January to early March (refer Section 4.2). However, manual measurements recorded during this period indicated that the water level was above the baseline minimum.	B2.1
BR12-QLa	Potential Impact Site	The water level remained above the baseline minimum for the duration of the review period. B2.2	
BR13- QRLa	Potential Impact Site	The water level remained above the baseline minimum for the duration of the review period.	B2.3

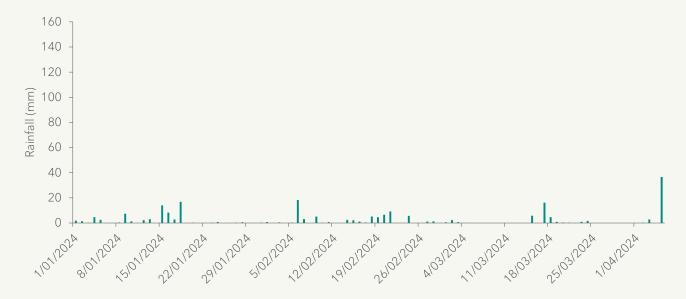
Figure 3 Daily rainfall 2024 (source: SILO: -34.25, 150.60)

The month of March preceding the autumn 2024 survey was characterized by below above average rainfall (Table 8)), which follows below average rainfall in February and January. Although 31 millimetres of rain fell in the two weeks leading up to the surveys (Figure 3). The biological results must be considered in this context.

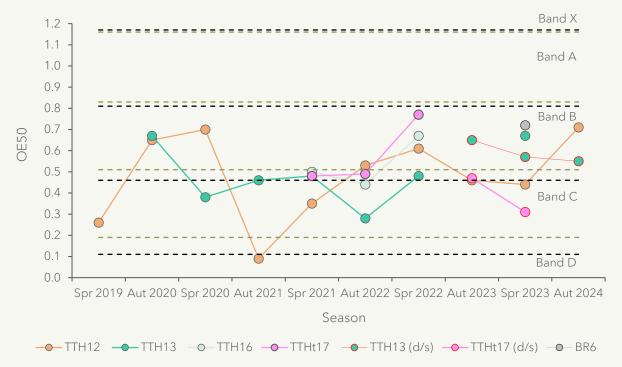
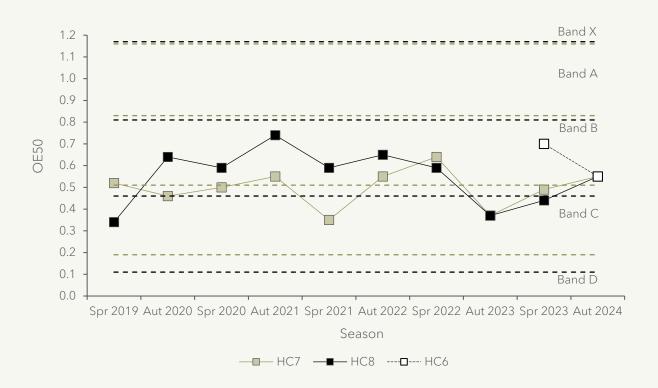
Figure 4 AUSRIVAS OE50 scores recorded at impact sites (above) and control sites (below). Baseline: spring 2019 – autumn 2022, during mining: spring 2022 – autumn 2024.

The AUSRIVAS results showed all sites recorded OE50 scores within Band B (Table 11, Figure 4). This indicates that overall, the macroinvertebrate assemblages present at all sites were impoverished when compared to the reference site data used by the AUSRIVAS predictive models (at both impact and control sites) representing significant levels of impairment. However, the Band scores are comparable between impact monitoring sites that are part of the Tea Tree Hollow stream network (which held water), and the control monitoring sites in Hornes Creek.

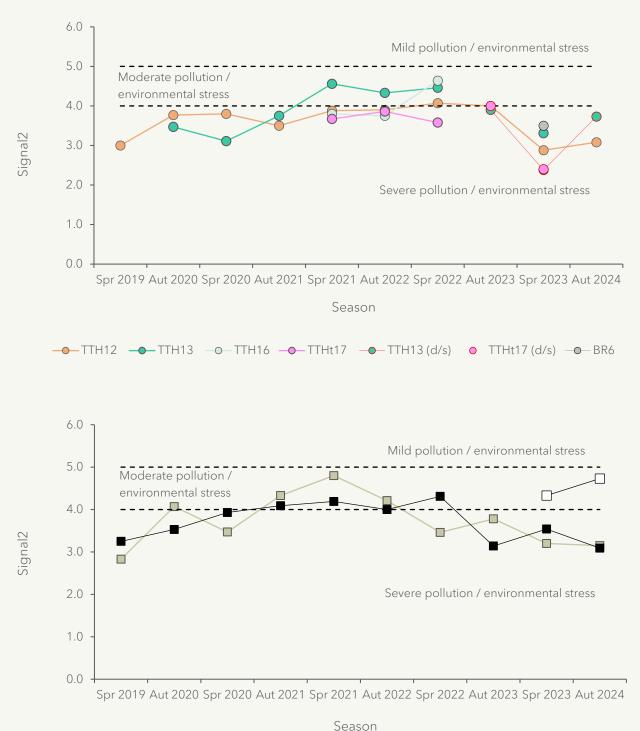
Figure 5 SIGNAL2 scores recorded at impact sites (above) and control sites (below). Baseline: spring 2019 – autumn 2022, during mining: spring 2022 – autumn 2024.

The SIGNAL2 scores for all sites varied between 3.08 and 4.73, which are considered low, indicating moderate to severe levels of impairment and poor to very poor water quality conditions across the sites (Table 11). This includes the control sites. The low scores reflect the dominance of pollution tolerant macroinvertebrates and presence of few pollution-sensitive taxa. This is common in low flow pool edge habitat in the area. Control site HC6 recorded the highest SIGNAL2 score, while impact site TTH12 recorded the lowest. It is noted that the most downstream impact monitoring site that held water, TTH13(d/s), recorded a higher SIGNAL2 score than two of the three controls. The autumn 2024 SIGNAL2 results are generally improved, or consistent with those in spring 2023 (Figure 5). The exception being control monitoring site HC8. There has been a general trend of overall declining SIGNAL2 scores since spring 2022, including at the control sites. This likely reflects the harsher environmental conditions that have occurred during this time, with a transition from consistently elevated rainfall conditions to drier and more sporadic rainfall events.

The autumn 2024 results are generally comparable between the impact and control sites (which held water) and within the range of previous results collected (Figure 5).

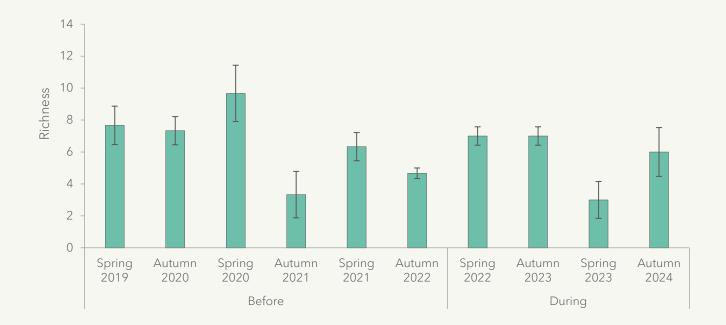
Figure 7 Taxa richness (x̄, ±SE) recorded at TTH12

A significant difference was detected for the survey term, when this factor was considered alone (Table 22). Pairwise comparisons (Table 23)) did not identify any significant differences between autumn 2024 and previous autumn surveys. One autumn-autumn survey comparison (between autumn 2022 and autumn 2023), was significant (p-value = 0.0236). A review of Figure 7 (presented in section (3.6.1)) shows this difference is due to the high richness levels in autumn 2023 and comparatively low levels in autumn 2022 (during baseline monitoring). A number of spring-spring survey comparisons were also significantly different (Table 20). These were between spring 2023 with spring 2019, spring 2020 and spring 2022. A review of Figure 7 shows that taxa richness during the spring 2023 survey was low in contrast to these other seasons.

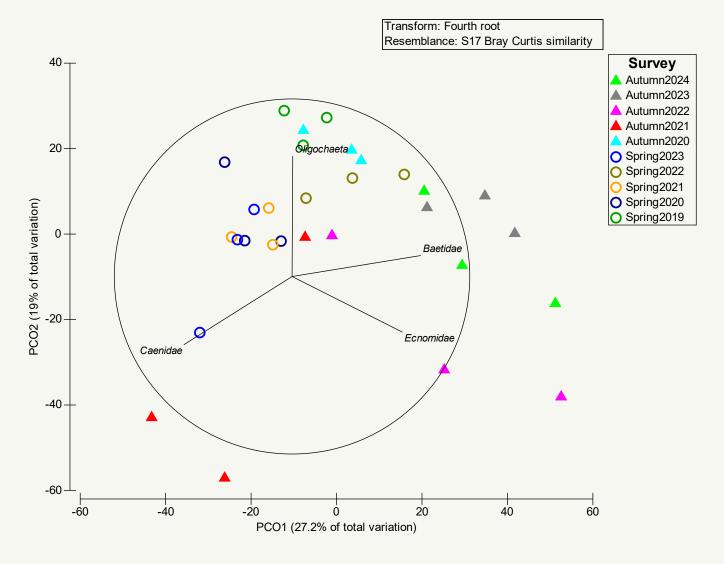
Figure 8 Graph of the two first axis from the PCO analysis for TTH12. Vectors based on Spearman Coefficient> 0.65.

The PCO analysis (Figure 8) found that that the first two axes explain 46.2% of the variation. The PCO plot shows that the autumn 2021 survey is somewhat separated from other surveys. The autumn surveys show a lower degree of overlap with other surveys in contrast to the spring surveys that cluster together to a greater degree. The autumn 2024 survey is shown to overlap to some extent with the autumn 2023 survey. The strongest driver of differences was a negative relationship of Caenidae with both the x and y axis, a positive relationship of Oligochaete with the y axis, a positive relationship of Baetidae with the x axis and negative with the y axis for Ecnomidae. A review of the detection data for these taxa has not identified any significant changes in detection between the baseline and during mining periods, with variability between individual seasons evident.

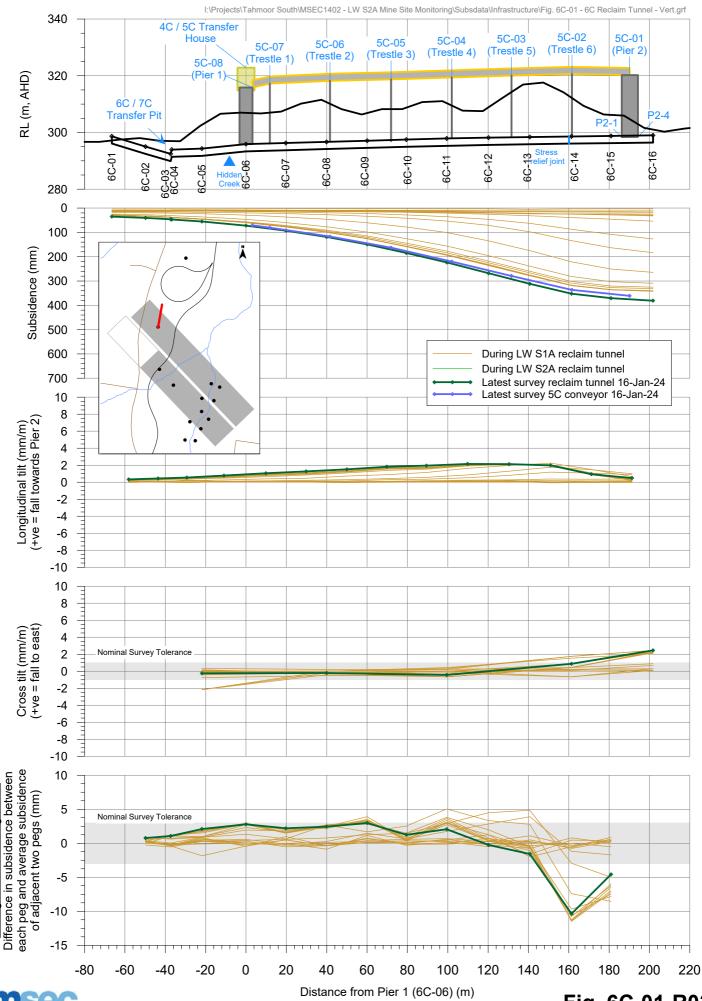
Fig. 6C-01-R03

Tahmoor South LW S2A - Conveyor 6C Reclaim Tunnel Total subsidence, tilt and changes in vertical alignment

Visual inspections	1 Mar	Weekly		No issues reported.	
Stockpile Area: Conveyor 5C and Reclaim Tunnel Conveyor 6C					
Reclaim Tunnel survey	29 Feb	Weekly	0	Gradually increasing extension between Pier 1 and Pier 2 up to 26 mm and spread evenly along Tunnel.	
Conveyor 5C survey	27 Feb	Weekly	N/A	Gradually increasing extension up to 43 mm observed from Pier 1 to Pier 2. NO change measured this week. Very gradual lateral and vertical bending along the conveyor over time	
Inclinometer surveys	26 Feb	Weekly		Minor changes observed since the end of LW S1A.	
Tilt monitoring at Pier 2	Cont	inuous	N/A	Minor changes observed.	
Tilt monitoring at T4	Continuous		N/A	Minor changes observed.	
Displacement monitoring at T4	Continuous			Gradual increase in gap between Trestles 3 and 4.	
Stress monitoring at T4	Cont	inuous	N/A	Minor changes in response to stockpile loading.

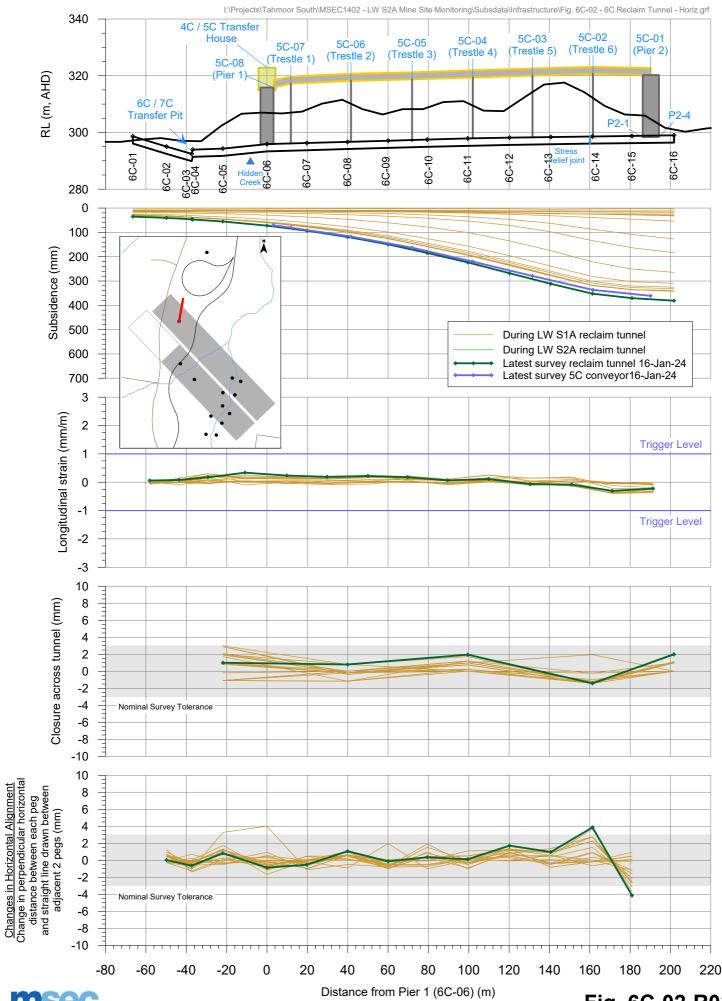
Fig. 6C-02-R03

Tahmoor South LW S2A - Conveyor 6C Reclaim Tunnel Observed Total differential horizontal movements

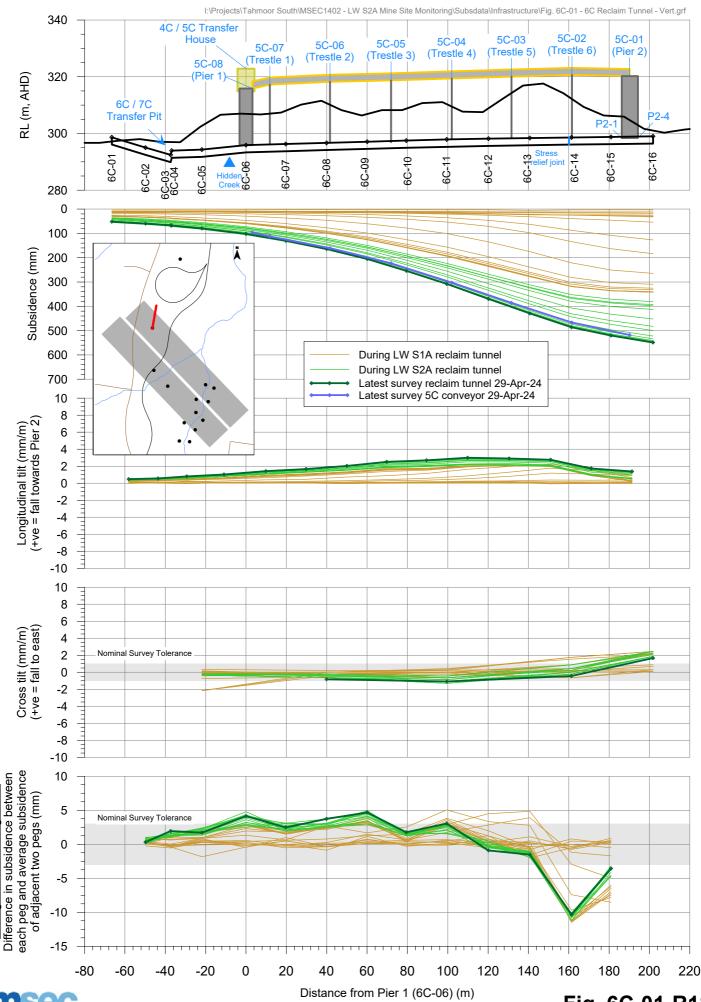
Fig. 6C-01-R18

Visual inspections	29 Apr	Weekly		No issues reported.	
Stockpile Area: Conveyor 5C and Reclaim Tunnel Conveyor 6C					
Reclaim Tunnel survey	29 Apr	Cease	0	Gradually increased extension between Pier 1 and Pier 2 up to 28 mm and spread evenly along Tunnel. A 1 mm increase was measured this week.	
Conveyor 5C survey	29 Apr	Cease	N/A	Gradually increasing extension up to 51 mm observed from Pier 1 to Pier 2. A 2 mm decrease was measured this week. Very gradual lateral and vertical bending along the conveyor over time.	
Inclinometer surveys	30 Apr	Cease	•	Minor changes observed during the mining of LW S2A. Measured reduction of previously measured shear at 37.5m depth in BH1 on 30 Apr that may be due to relaxation of rock mass or due to measuring through previously observed distortion in borehole at that depth. No changes above 37.5m depth and measured change not consistent with GNSS data at nearby Pier 2 or other survey measurements.

Tahmoor South LW S2A - Conveyor 6C Reclaim Tunnel Total subsidence, tilt and changes in vertical alignment

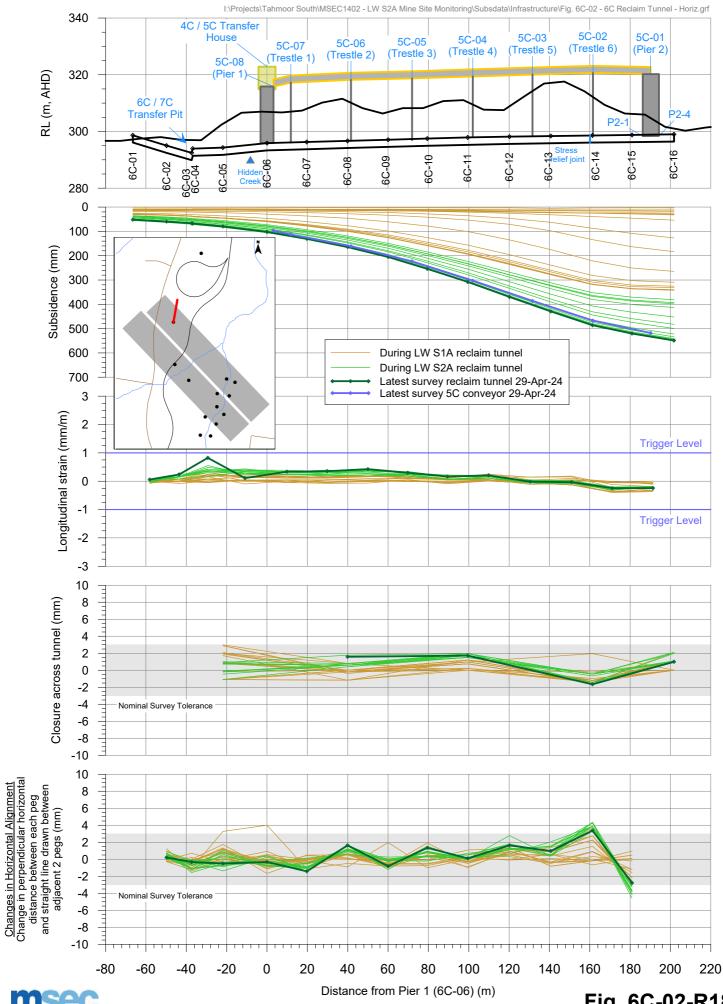
Fig. 6C-02-R18

Tahmoor South LW S2A - Conveyor 6C Reclaim Tunnel **Observed Total differential horizontal movements**

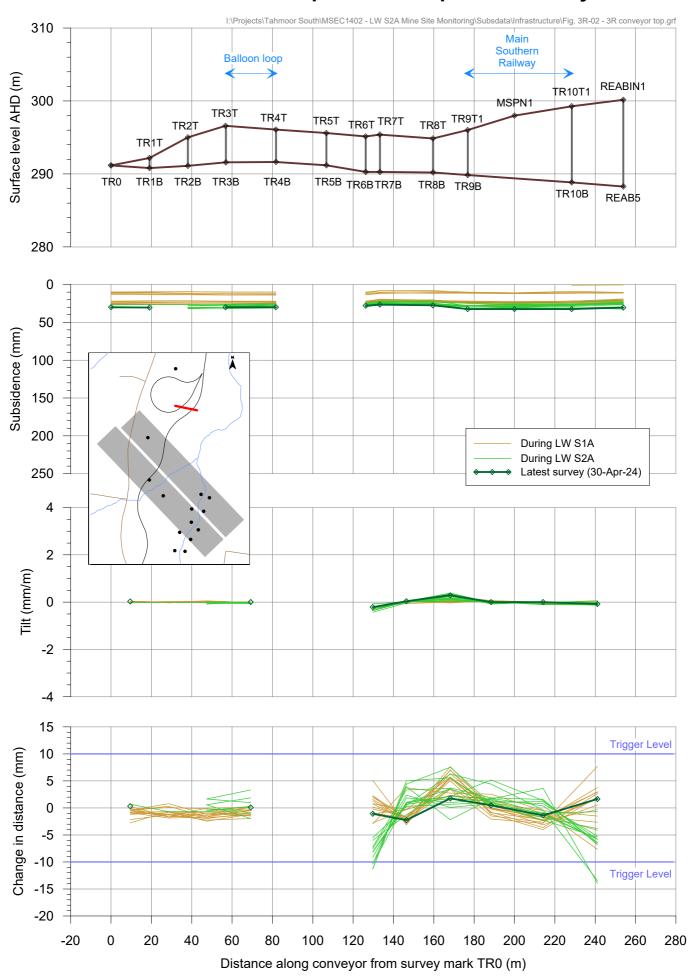
Tahmoor South LW S2A - Tahmoor Mine Site Total subsidence profiles at top of 3R conveyor

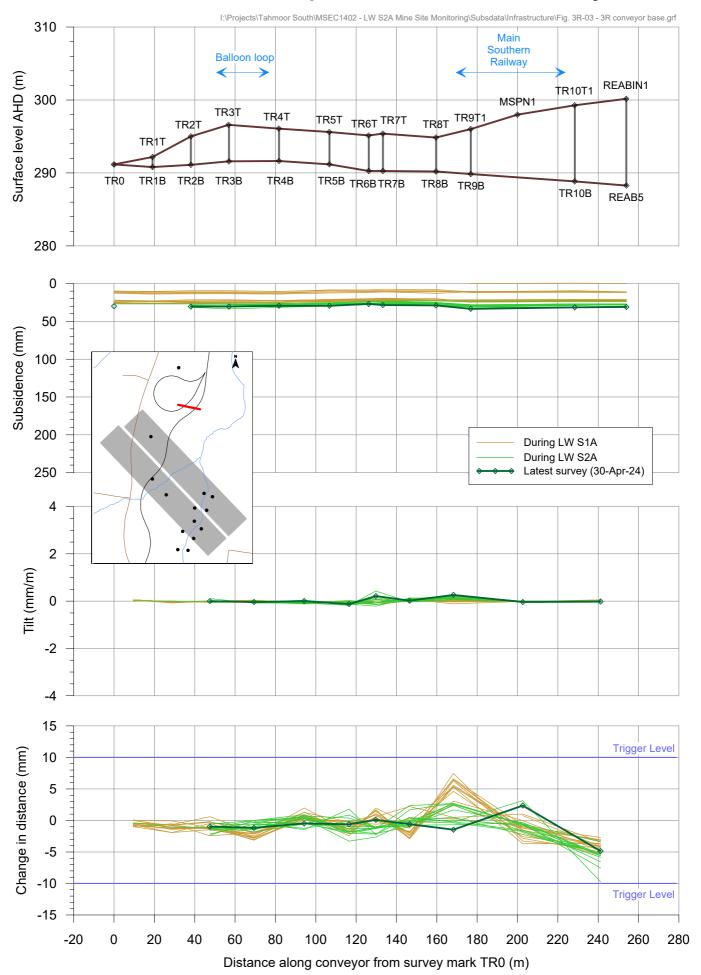
Tahmoor South LW S2A - Tahmoor Mine Site Total subsidence profiles at base of 3R conveyor

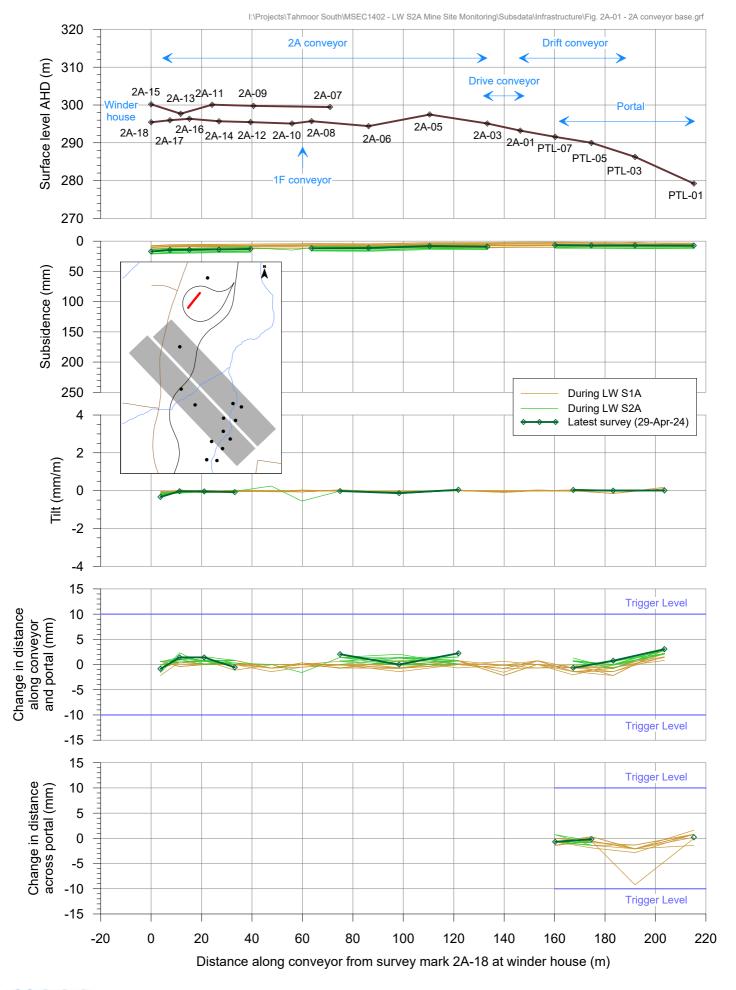
Tahmoor South LW S2A - Tahmoor Mine Site Total subsidence profiles at base of 2A conveyor and drift portal

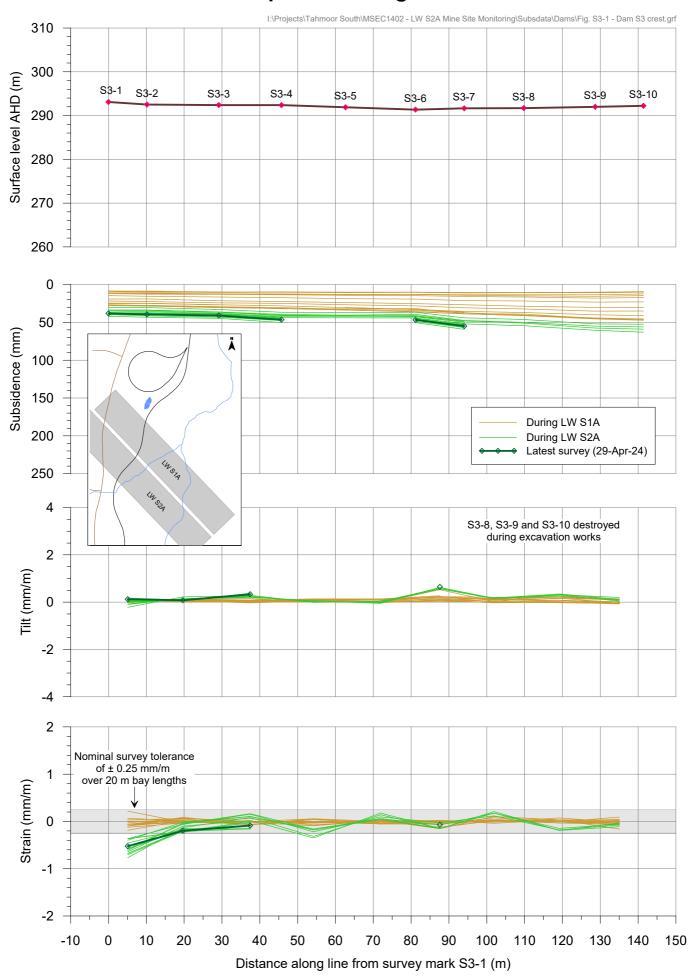
Tahmoor South LW S2A - Tahmoor Mine Site Total subsidence profiles along crest of Dams S2 and S3

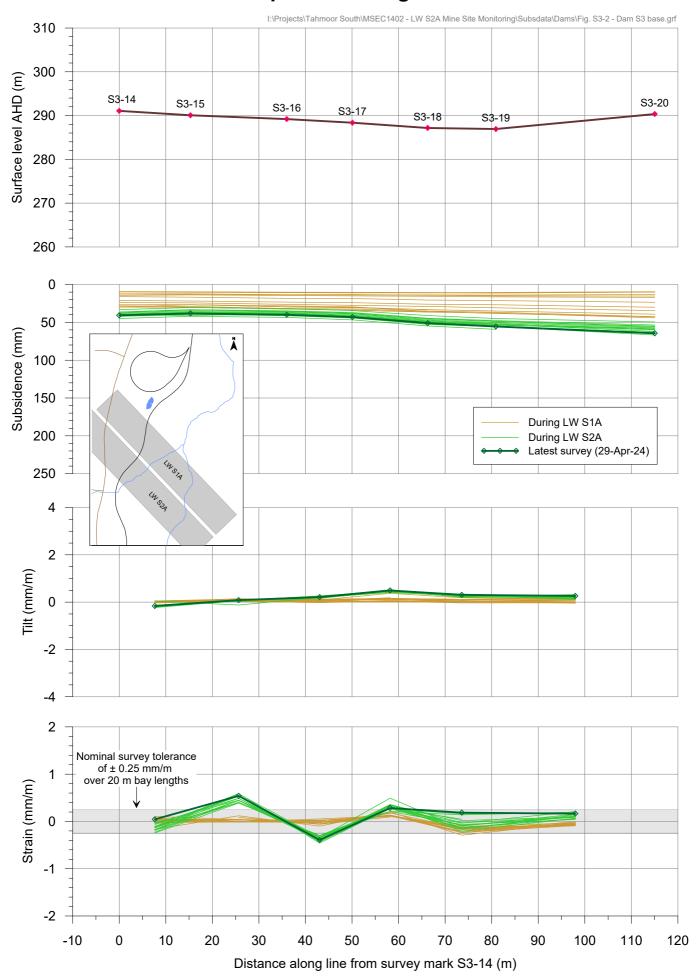
Tahmoor South LW S2A - Tahmoor Mine Site Total subsidence profiles along base of Dams S2 and S3

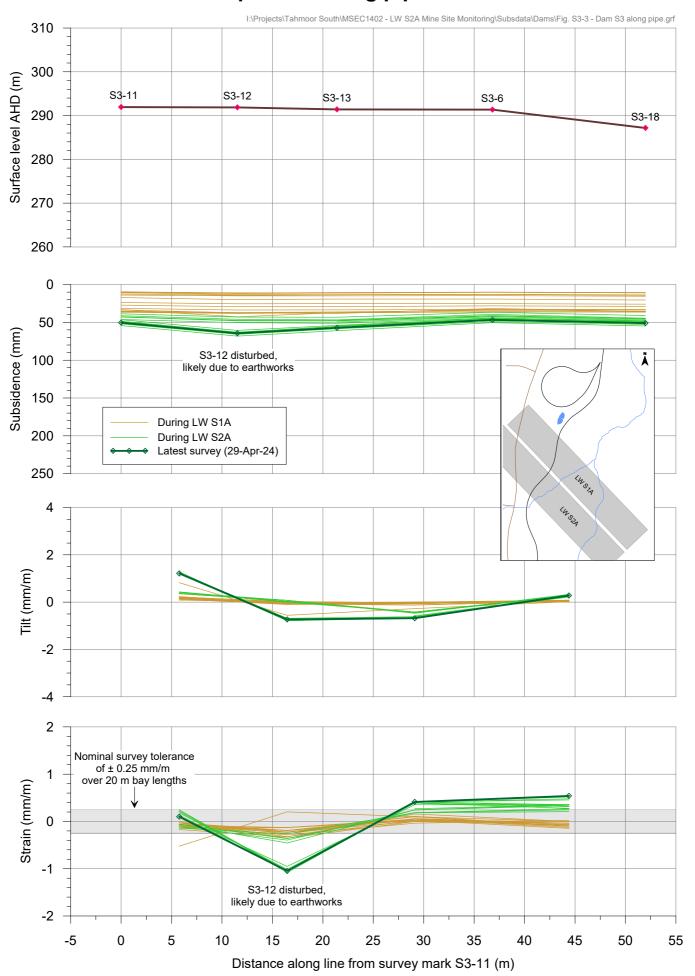
Tahmoor South LW S2A - Tahmoor Mine Site Total subsidence profiles along pipe between Dams S2 and S3

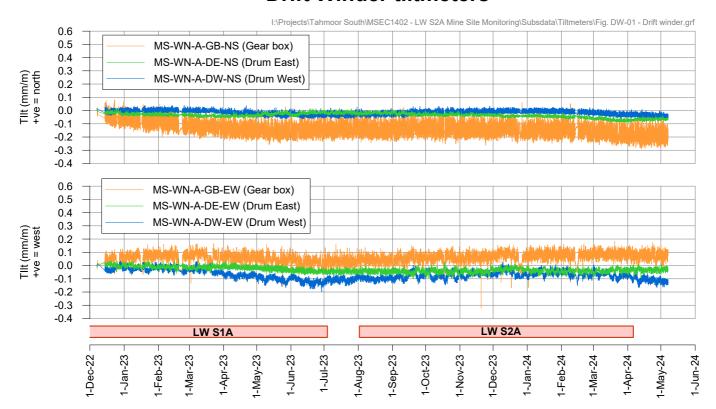
Drift Winder tiltmeters

Overhead conveyors				
Conveyor trestle surveys	29 Apr	Cease	•	Minor changes observed this week. Ino change in closure observed between 8C-11 and RLB-01 at top of 8C conveyor and no measurable change at the base. Minor change measured on 3R conveyor at connection to Reject Bin this week. Both observations are considered to be due to changes in thermal expansion and contraction of the superstructure. Visual inspections have identified changes at slide joints but otherwise no impacts.
Laser distancemeter at Conveyor 3R across Railway	Cont	nuous	<u> </u>	Minor changes observed.
Visual inspection	29 Apr	Cease	0	No issues reported. 7C connection to bins has moved south by 10 mm. No change to 4S slide joint this week.
Drift				
Drift survey	29 Apr	-		Very minor changes since end of LW S1A.
Visual inspection	D	aily	N/A	No issues reported.
Winder				
Tiltmeters on Winder	Cont	nuous	0	Minor changes observed.

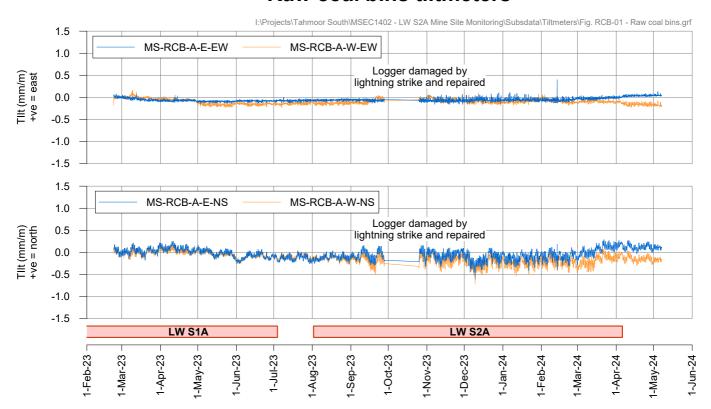
Raw coal bins tiltmeters

Monitoring Activity	Date	Current Frequency	Highest Trigger	Comments	
Mine Site Structures					
Tiltmeters on Raw Coal Bins	Cont	inuous	0	Minor changes observed. Very slight differences between sensors in north-south direction. Slight tilt to the north and west observed in last two months.	
Rail Loader survey	29 Apr	Cease	0	Minor changes observed this week.	
Reject Bin survey	30 Apr	Cease		Very minor changes since end of LW S1A.	
Visual inspections	29 Apr	Cease	•	No issues observed. Drone inspection of raw coal bins showed cracks in connection joint on south side, which are very likely pre-existing. A structural inspection is recommended. Crack gauges installed in 2 locations on 18 April.	
Overhead crane and monorails	S				
Crane rail survey	-	Cease		Last survey 22 April. Very minor changes since end of LW S1A. No access to washery this week.	
Visual inspections	29 Apr	Cease		No impacts observed.

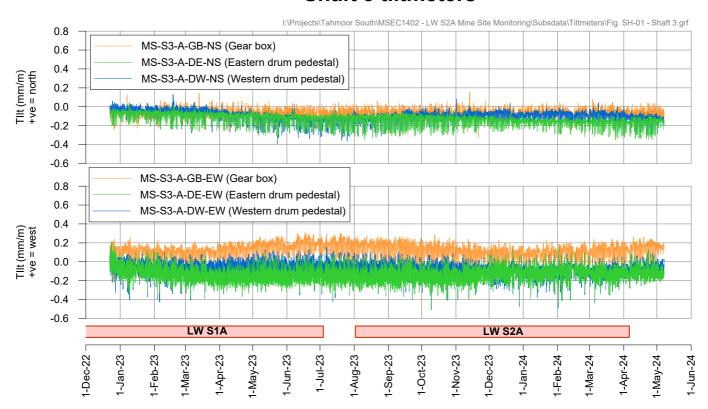
Shaft 3 tiltmeters

Shaft No. 3					
Tiltmeters on shaft winder	Cont	inuous		Minor changes observed.	
Clearance measurements at 135m depth	2 May	Cease	0	Clearances between 260 mm and 300 mm this week, greater than minimum clearance of 180 mm.	
Visual inspection	D	aily	N/A	No issues reported.	
Dams, embankments and site services					
Dam S4 survey	-	Cease	N/A	Minor subsidence and closure observed. Surveys have ceased as the LW face has travelled past the survey line by more than 450 metres.	
Dam S2 and S3 survey	29 Apr	Cease	N/A	Minor changes observed since the end of LW S1A. S3-8, S3-9 and S3-10 destroyed during excavation works. S3-12 likely disturbed by earthworks.	
Visual inspections by building inspector, incl high pressure water pipeline	-	Cease	0	Last inspection 9 April. Stockpile overflowing into Dam S2 following significant rainfall. Scouring observed at toe of the embankment at Dam S3.	
Geotech inspections on mine site	-	Cease	0	Last inspection 8 April. No issues observed by geotechnical engineer.
