TAHMOOR COAL PTY LTD ABN: 97076663968

Tahmoor South LWS1A-S6A Water Management Plan

Myrtle Creek and Redbank Creek Remediation Progress Review

121171.17, R02, Rev D May 2022

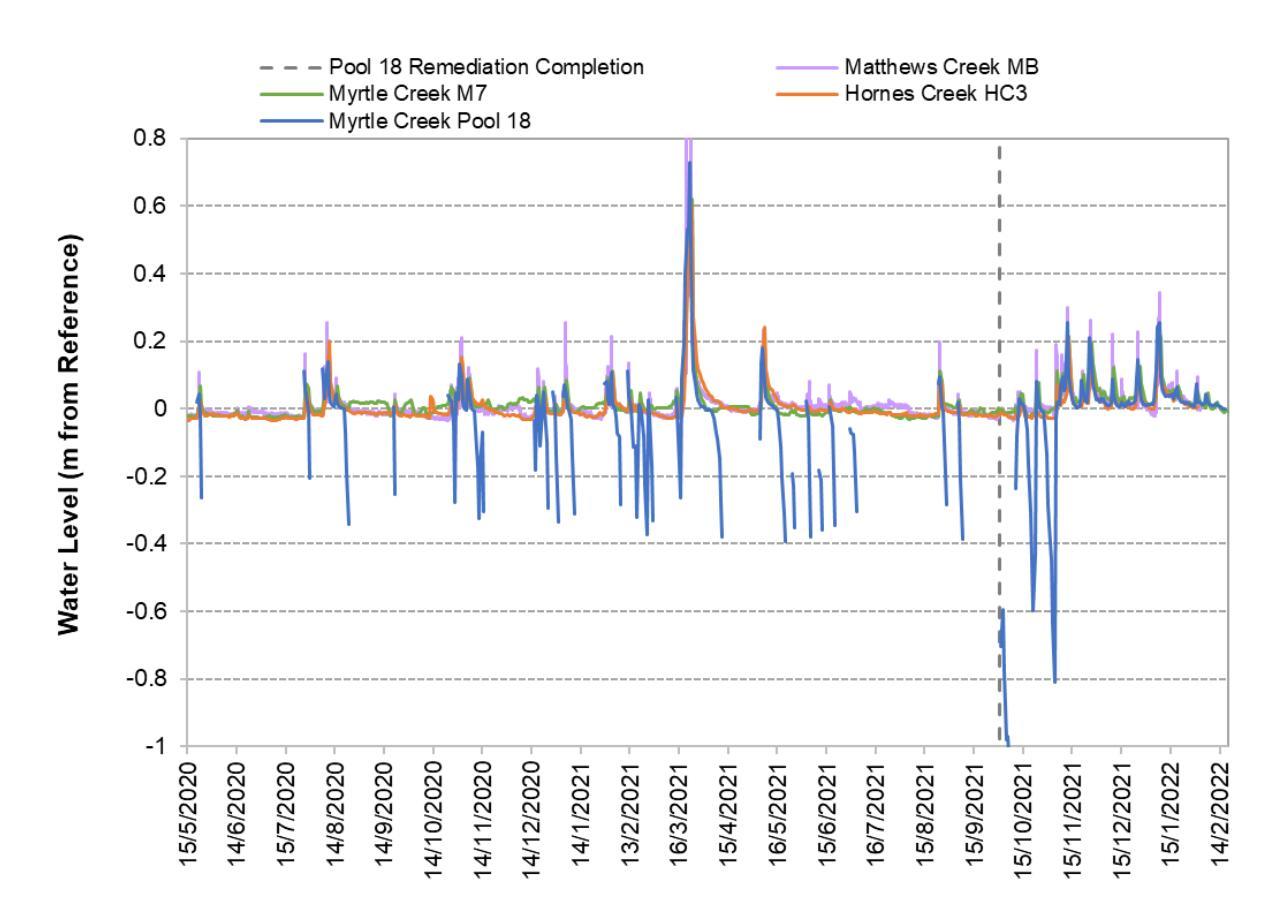
GRAPH 7: MYRTLE CREEK POOL 18 AND REFERENCE SITES - WATER LEVEL COMPARISON

The outcomes of the Method 2 assessment indicate that there has been an improvement in the pool 18 water holding capacity post-remediation, however, the area has experienced above average rainfall during this period. As such, additional post-remediation monitoring data, recorded during periods of below average rainfall, is recommended to provide further confidence in the effectiveness of remediation works at pool 18.

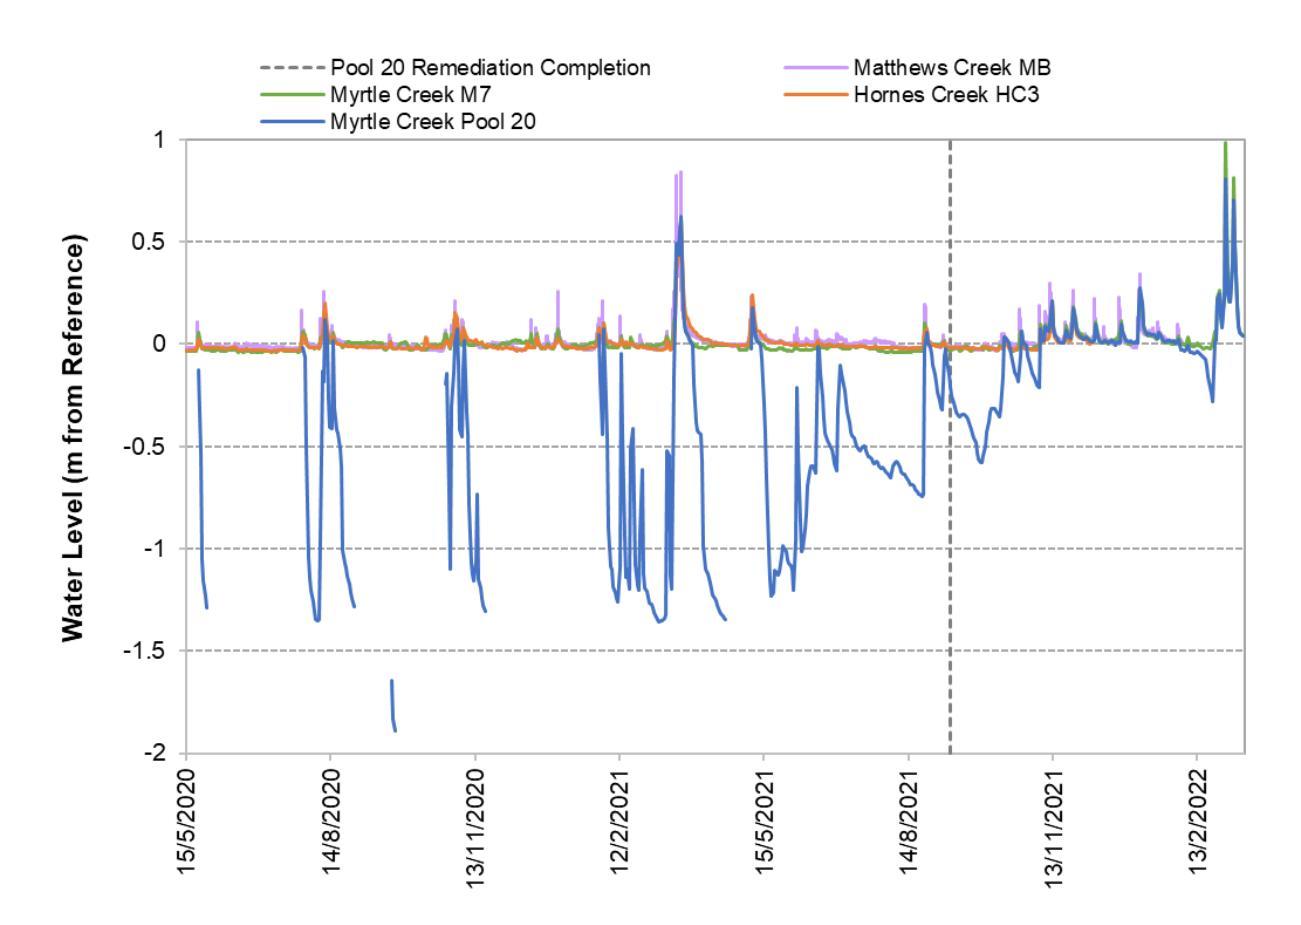
GRAPH 10: MYRTLE CREEK POOL 20 AND REFERENCE SITES - WATER LEVEL COMPARISON

The data presented in Graph 10 shows an evident difference in the hydrological behaviour of pool 20 pre-remediation in comparison to the reference site water level behaviour. From early November 2021 to March 2022, post-remediation and coinciding with a period of above average rainfall, the water level recessionary behaviour of pool 20 was generally consistent with that of the reference sites.

The outcomes of the Method 2 assessment indicate that there has been a notable improvement in the pool 20 water holding capacity post-remediation. As the area experienced above average rainfall during this period, it is recommended that additional post-remediation monitoring data is recorded during periods of below average rainfall to provide further confidence in the effectiveness of remediation works at pool 20.

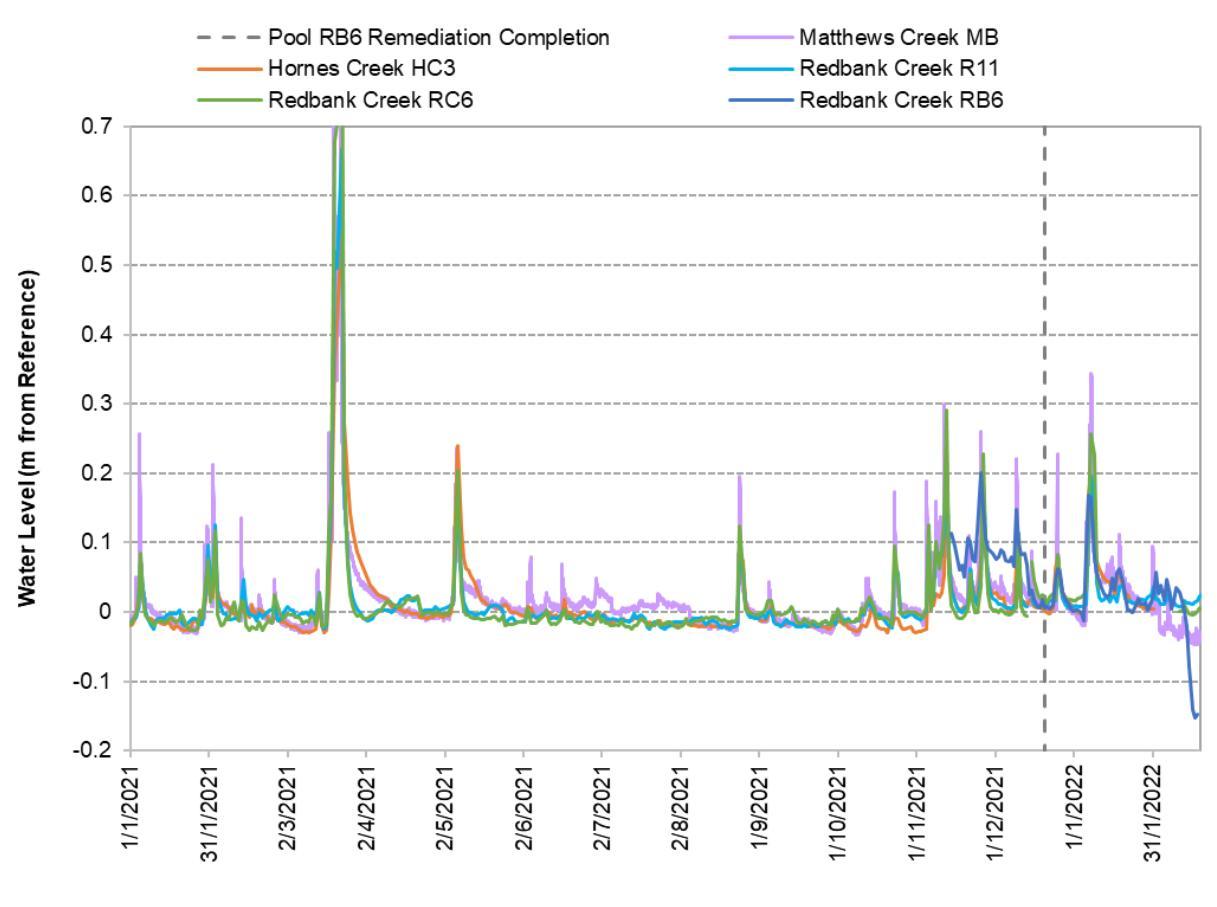
GRAPH 14: REDBANK CREEK POOL RB6 AND REFERENCE SITES - WATER LEVEL COMPARISON

The data presented in Graph 14 shows that the water level recessionary behaviour of pool RB6 was generally consistent with that of the reference sites from mid-December 2021 to early February 2022. In mid-February 2022, a slight decline in water level was recorded at pool RB6 which was inconsistent in extent to that recorded at monitoring sites RC6 and R11 in Redbank Creek and somewhat inconsistent with the decline in water level recorded at Matthews Creek MB.

As only three months of monitoring data has been recorded post-remediation, additional postremediation monitoring data is recommended to enable further assessment of the effectiveness of remediation works at pool RB6 in Redbank Creek.

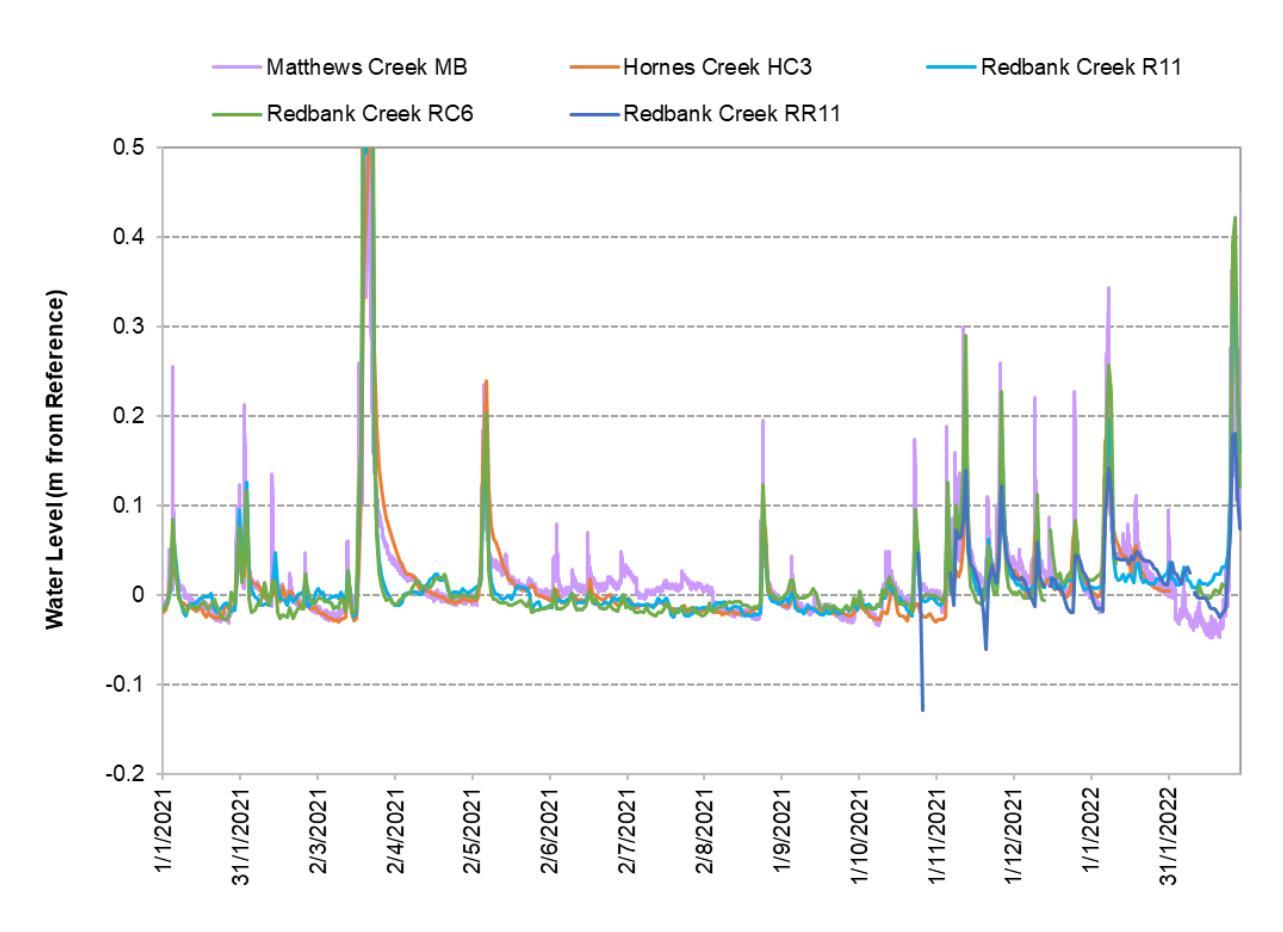
GRAPH 16: REDBANK CREEK POOL RR11 AND REFERENCE SITES - WATER LEVEL COMPARISON

Additional post-remediation monitoring data is recommended to enable further assessment of the effectiveness of remediation works at pool RR11 in Redbank Creek.

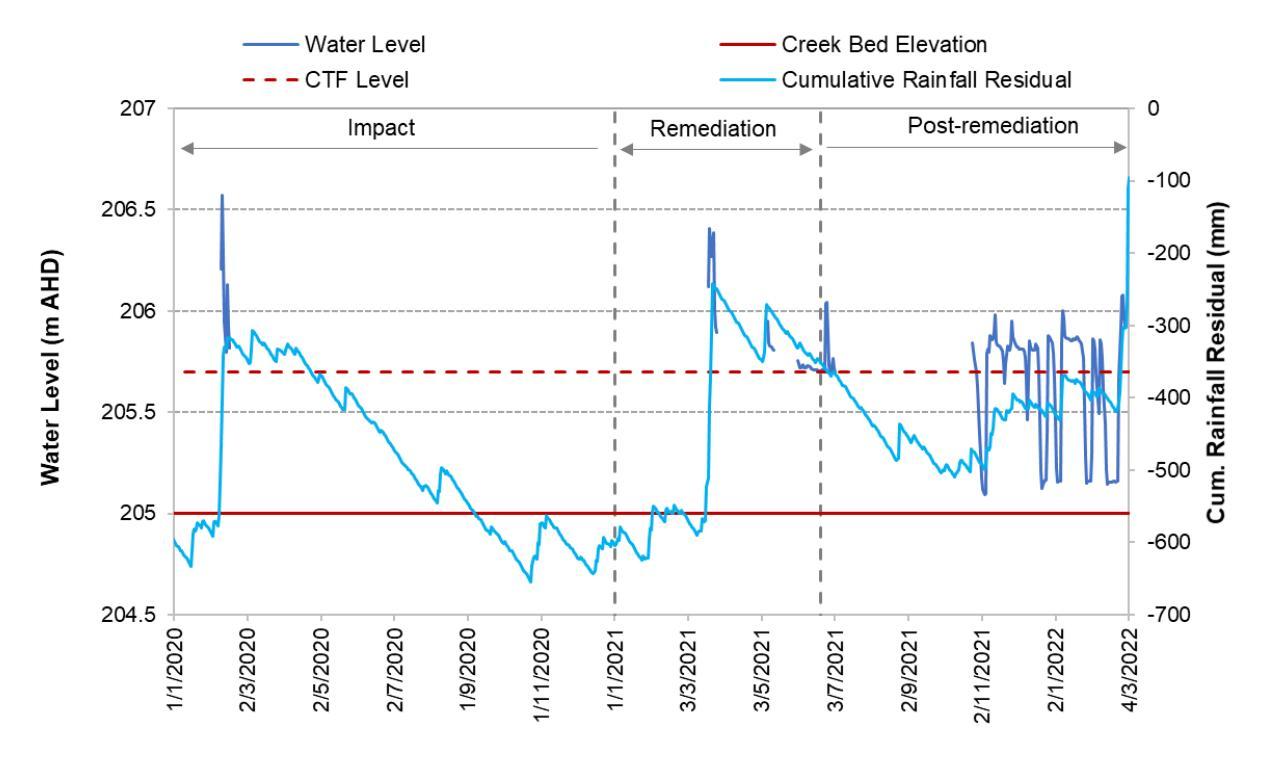
GRAPH 17B: REDBANK CREEK POOL RR19 - WATER LEVEL RECORDS AND RAINFALL RESIDUAL – 2020 TO 2022

Post-remediation, the pool was recorded as dry until late October 2021 during a period of below average rainfall. From late October 2021, as rainfall increased, the water level rose and fell in response to rainfall events.

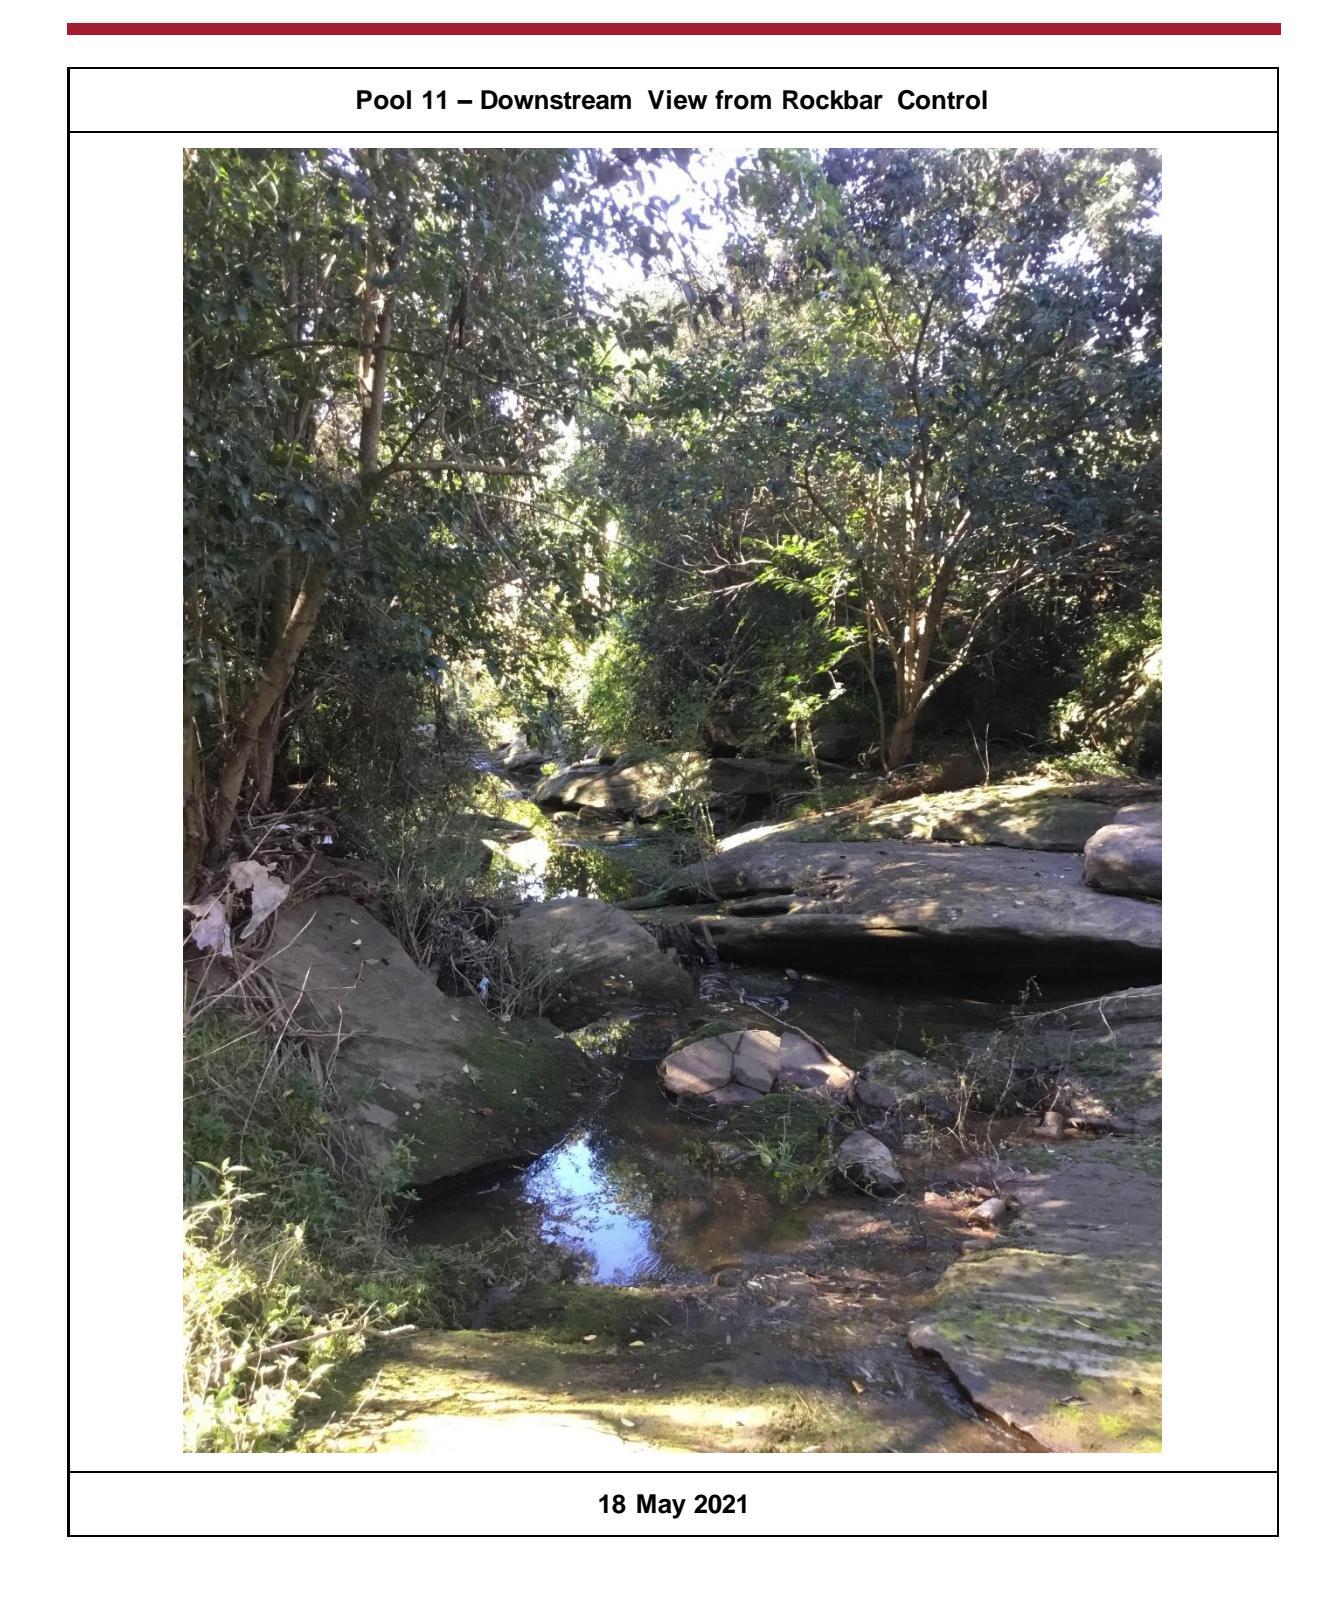
General			
Stream	Myrtle Creek		
ID	Pool 11		
Approximate coordinates	278454 E		
(GDA94) at downstream end of	6211454 N		
Base RL	Approximately 249 m AHD		
	M4 water level sensor		
Longwall	Chain pillar between Longwall 26 a	and Longwall 27	
Geomorphological Variables			
Description	Elongated pool		
Pool dimensions	Approximately 4 m wide x 28 m lo	ng	
Pool depth at overflow point	Approximately 1 m		
Hydraulic control	Rockbar and boulders		
Control features	Raised rockbar extending across width of pool; weathered; horizontal bedding planes; fractures		
Bed forms	Bedrock outcrop		
Bed material	Hawkesbury sandstone outcrop and boulders; bed not visible		
Valley shape	Left bank [*] : Convex upwards: Approx. 1.0 m high silty/clay banks extending to gently inclined, approx. 5 m heavily vegetated outcrop	Right bank [^] : Irregular outcrop: Approx. 8 m high, steeply inclined, irregular outcrop. Some shallow soil and vegetation coverage. Residential property on overbank.

Bank vegetation type and cover	Left bank^: Grass, wandering jew, vines privet, trees	Right bank^: Grass, scattered trees	
Bed vegetation including debris	Leaf litter		
Pool tree canopy	Moderate canopy coverage		
Channel width	> 15 m		
Uniformity of bed profile	Non-uniform		
Bed scour features	Some scouring of shallow soil banks		
Bed eroding or accreting	accreting Variably eroding and accreting		
Catchment landform	Partly confined valley		
Catchment Influences			
Catchment landuse	Predominately farmland to the north and residential development to the south		
Structures	N/A		
Mining related impacts	Fracturing and reduced pool water holding capacity

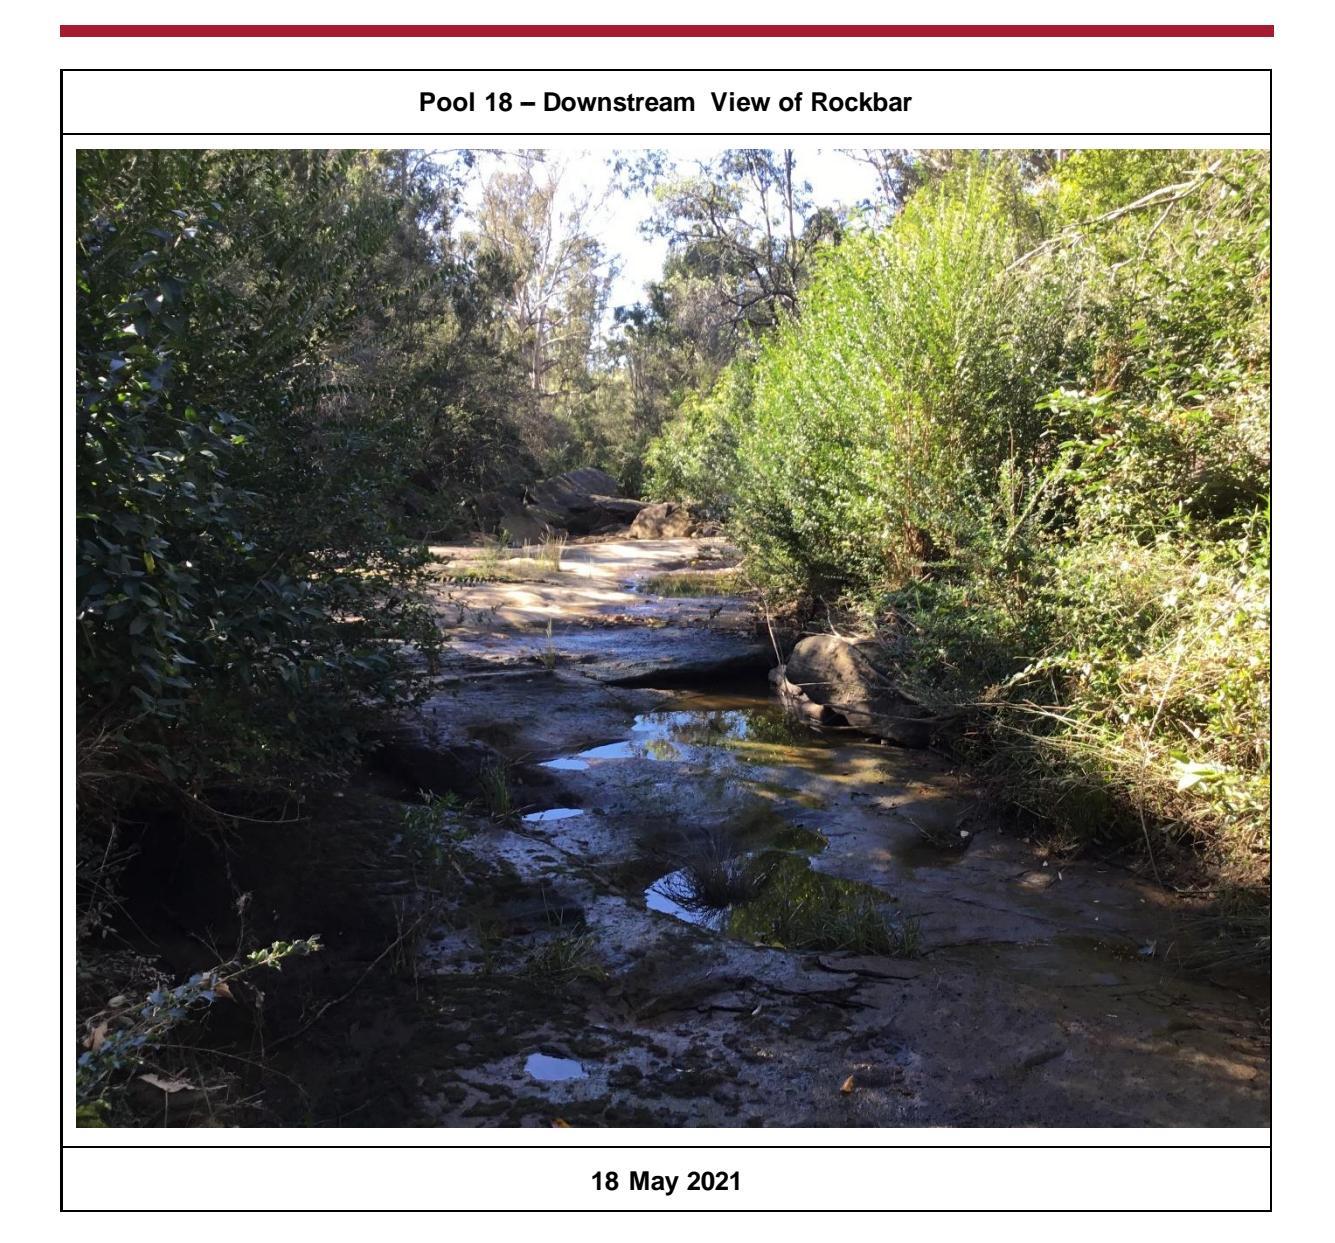
General				
Stream	Myrtle Creek			
ID	Pool 18			
Approximate coordinates	2788615 E			
(GDA94) at downstream end of	6211693 N			
Base RL	Approximately 243 m AHD			
Notable reference points	Water level sensor			
Longwan	Eastern edge of LW27			
Geomorphological variables				
Description	Shallow, elongated pool			
Pool dimensions	Approximately 4 m wide x 30 m lo	ng		
Pool depth at overflow point	Approximately 1 m (pool base not	visible)		
Hydraulic control	Rockshelf			
Control features	Elongated rockshelf extending acr depressions and fracturing	oss width of pool; some		
Bed forms	Bedrock outcrop			
Bed material	Hawkesbury sandstone outcrop; notable sediment, gravel and boulder deposition			
Valley shape	Left bank ^A : Compound stepped depositional: Approx. 1.5 m high clay/silt banks, densely vegetated; extending to inclining open grassland	Right bank [^] : Compound stepped depositional: Approx. 1.5 m high clay/silt banks, densely vegetated; inclining to residential property

Bank vegetation type and cover	Left bank^: Grass, wandering jew, privet, gum trees	Right bank^: Grass, wandering jew, privet, willow and gum trees		
Bed vegetation including debris	Pool base not visible			
Pool tree canopy	Substantial canopy coverage			
Channel width	> 10 m			
Uniformity of bed profile	Non-uniform			
Bed scour features	Bank toe undercutting and exposed roots			
Bed eroding or accreting	Eroding			
Catchment landform	Partly confined valley			
Catchment Influences				
Catchment landuse	Predominately farmland to the north and residential development to the south			
Structures	N/A			
Mining related impacts	Fracturing and reduced pool water holding capacity

Surface Water Flow (18 May 2021)			
Pool water depth	Approximately 700 mm		
Connective surface flow	No connective surface flow		
Other observations	N/A

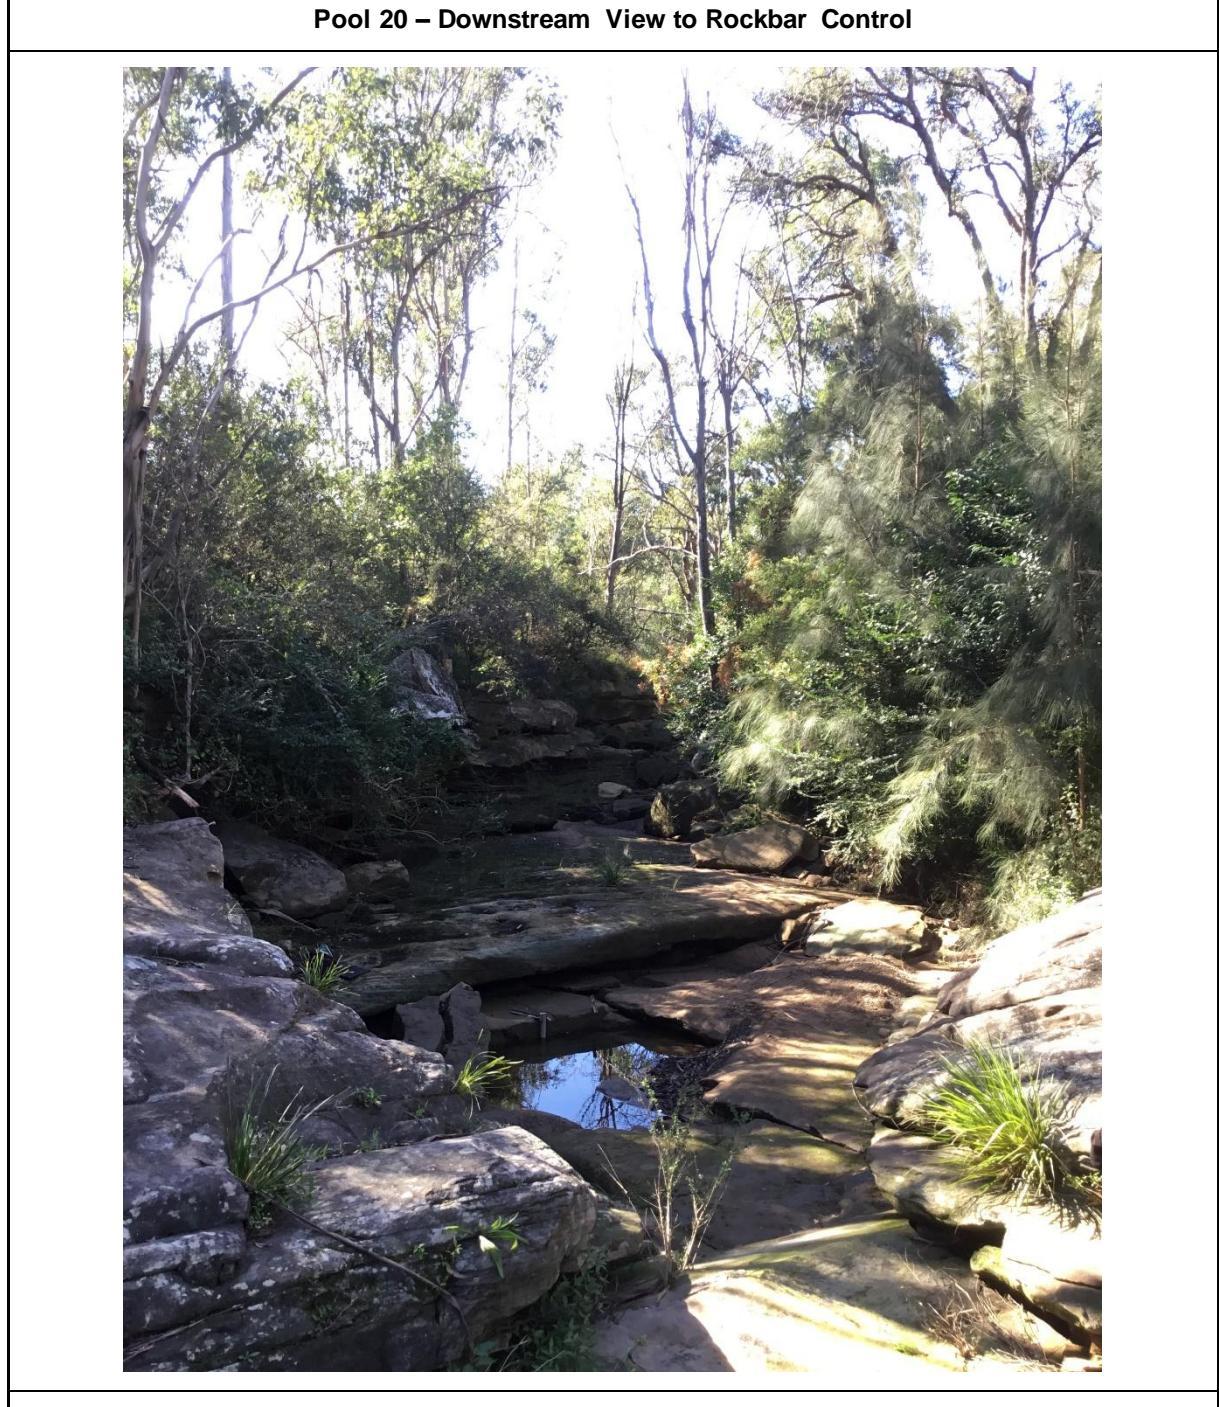
Ormanal			
General			
Stream	Myrtle Creek		
ID	Pool 20		
Approximate coordinates	278714 E		
(GDA94) at downstream end of	6211736 N		
	Approximately 220 m AHD		
Notable reference points	Water level sensor		
Longwall	Western edge of LW28		
Geomorphological Variables			
Description	Large, elongated pool in sandstone race with plunge pool		
Pool dimensions	Approximately 9 m wide x 50 m lo	ng	
Pool depth at overflow point	Approximately 1.5 m (plunge pool rockbar); approx. 3.5 m total depth at	
Hydraulic control	Rockbar		
Control features	Raised rockbar extending across width of pool; approximately 2 m high, 5 m wide; open horizontal bedding planes; some lateral accretion		
Bed forms	Bedrock outcrop		
Bed material	Hawkesbury sandstone outcrop; weathered; flute holes; some gravel and sand		
Valley shape	Left bank [^] : Irregular bedrock: Approx. 5 m high irregular outcrop, horizontal bedding; extending to vegetated incline with large boulders	Right bank ^A : Compound stepped depositional: Approx. 2 m high stepped outcrop extending to inclined vegetated outcrop with boulders. Residential property on overbank.

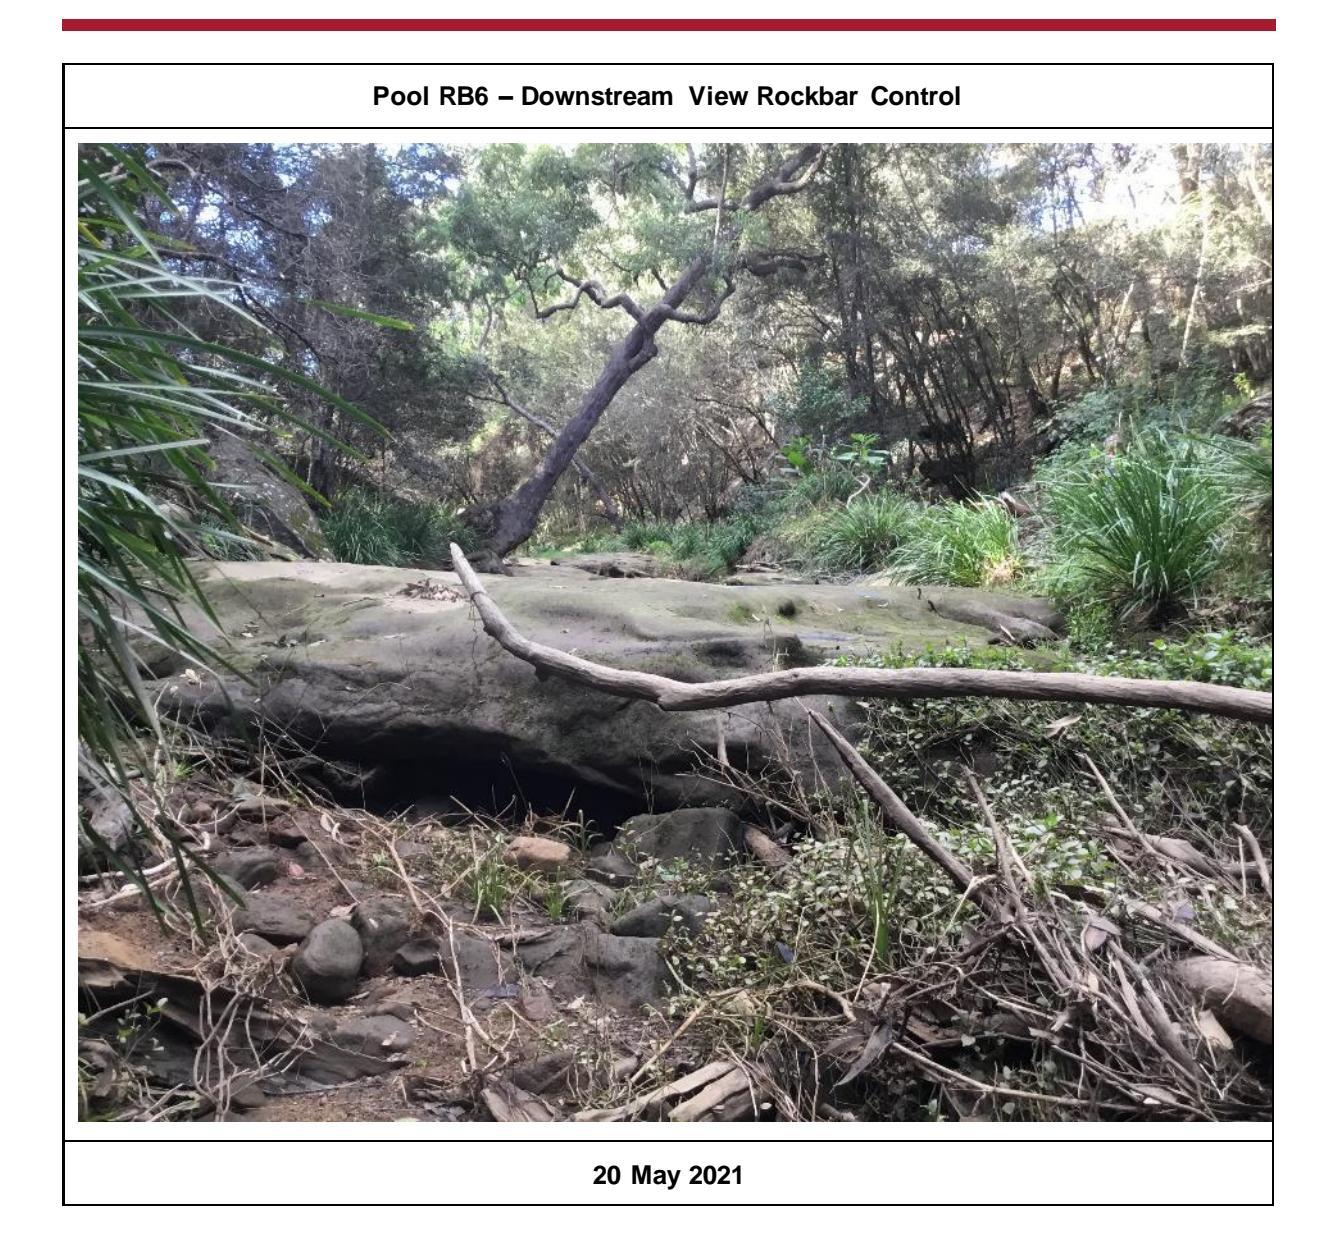
General		
Stroom	Bodhank Crook	
	Redbank Creek	
Approximate coordinates		
(GDA94) of pool (DS)	6213382 N	
Pool base RL	Approximately 214 m AHD	
Notable reference points	Rockbar characterization bore	
Longwall	Far east edge of LW29	
Geomorphological Variables		
Description	Series of pools in elongated reach	
Pool dimensions	Variable; < 6 m wide x < 10 m long; full reach approximately 80 m long	
Pool depth at overflow point	Approximately 1 m	
Pool hydraulic control	Rockbar	
Control features	Extends across width of pool; triangular in shape; approximately 7 m wide x 15 m long; semi-regular; one large fracture, other minor fractures; small to moderate flute holes	
Bed forms	Bedrock outcrop with substantial deposition; notable fractures	
Bed material	Hawkesbury Sandstone outcrop Upper reach – bedrock overlain with delaminated sandstone, boulders, sediment and gravel Upstream pool – bedrock overlain with soil/sediment (silty/clay) – tannic Mid to lower reach – bedrock overlain with sand/silt, some gravel – iron staining; horizontal bedding planes in outcrop; interspersed with boulders
