# 2024 Annual Rehabilitation Walkover

Refuse Emplacement Area

| Project Name | Tahmoor Coal Pty Ltd Rehabilitation Monitoring 2024 |

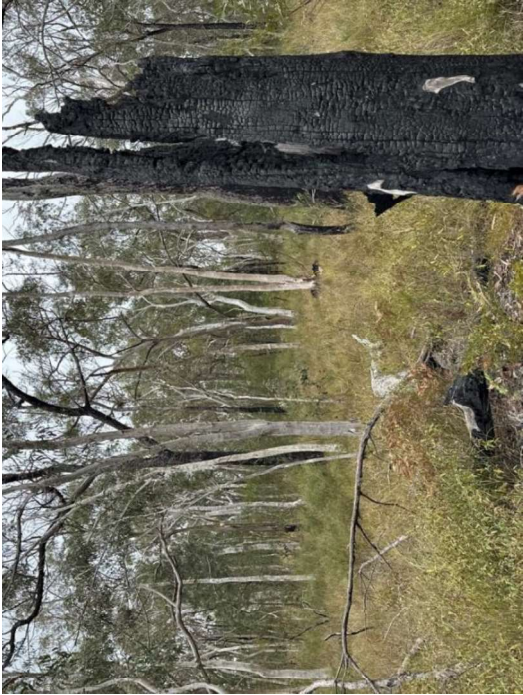
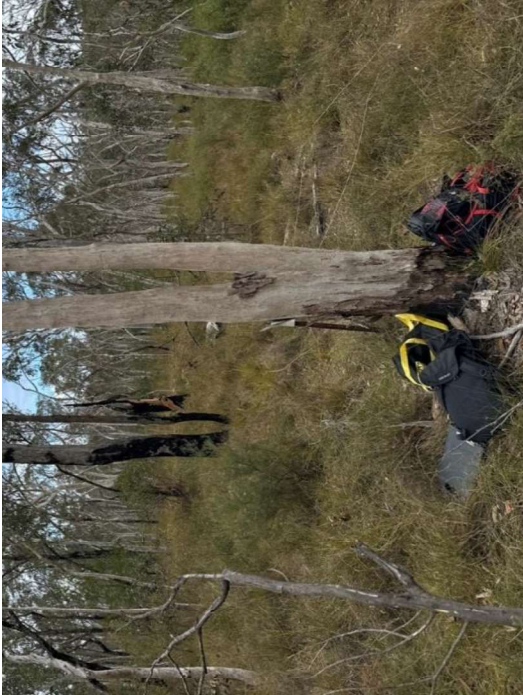
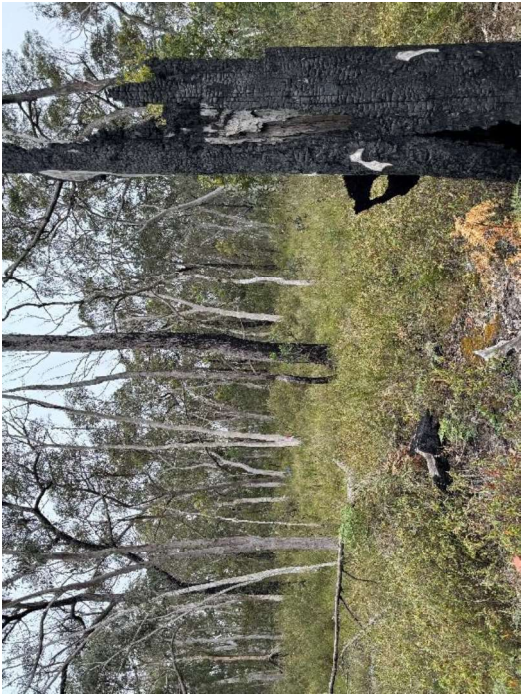
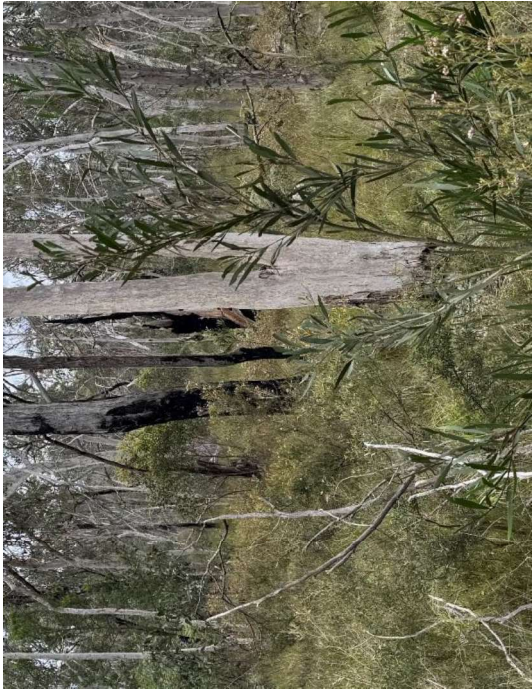
Figure 3: Reference plot 001 in 2023 and 2024

The reference plots and permanent monitoring plots which were burnt by fire in 2019 have recovered well and have a diversity and abundance of species similar to those species within the REA. There is continued evidence of nutrient recycling with termite mounds, ants and scats noted in those burnt plots. Litter cover has stabilised in these plots with grass, leaf litter and twigs recorded in all plots. Plot monitoring data is available in Appendix A.

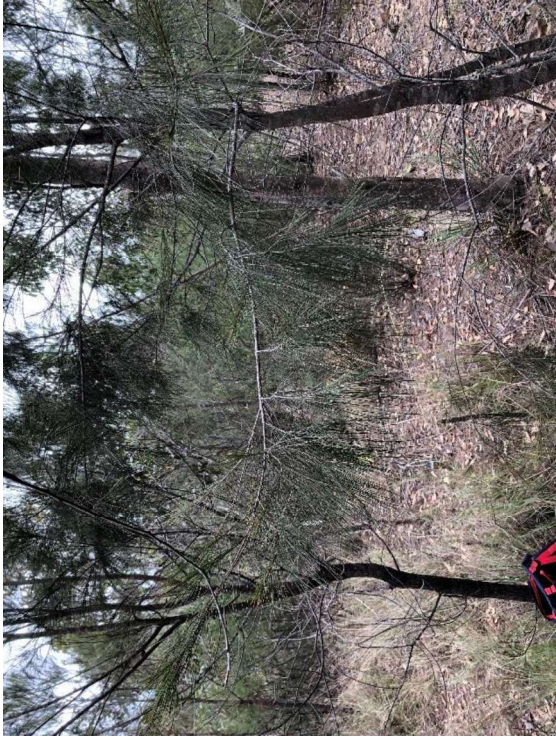
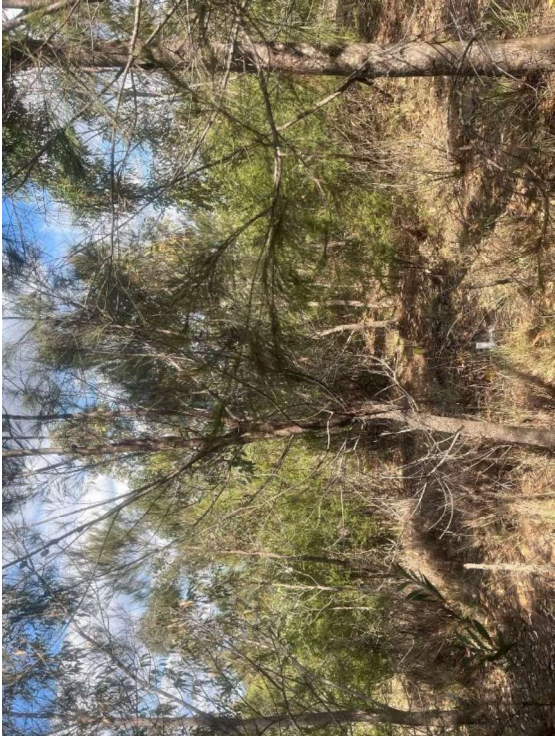
Figure 13: Stage 12A plot F1 in 2023 and 2024

| Characteristic | Plot number | | Comment<br>(including comparison with 2023 results) |
|---|---|---|---|
| Tree health | Good | Moderate-Good | Overall good condition across both plots, aside<br>from a few poor <i>Acacia decurrens</i> and <i>Acacia</i> sp.<br>in both plots.<br><br><i>Eucalyptus</i> spp. in good condition across both<br>plots, especially <i>Eucalyptus punctata</i> in F2. |

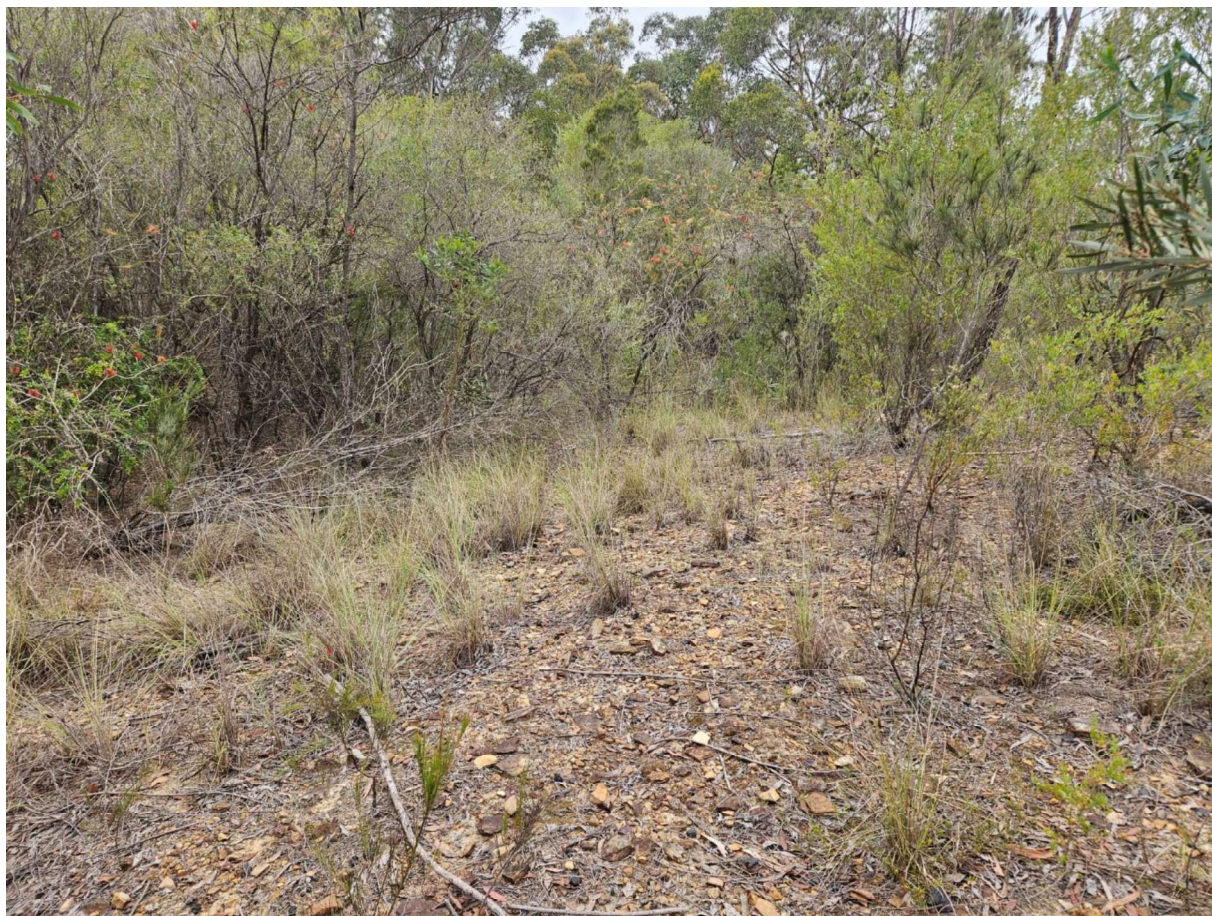
Figure 4: Trial A in Stage 2

A brief visual assessment of native grass and exotic cover was carried out within each trial area during the rehabilitation monitoring in November 2024. Photos of trials A, B, C, E, F and H are provided below.
