Tahmoor Coal Pty Ltd

BUILT FEATURES MANAGEMENT PLAN

**Tahmoor North - Western Domain
Longwalls West 3 and West 4**

May 2021

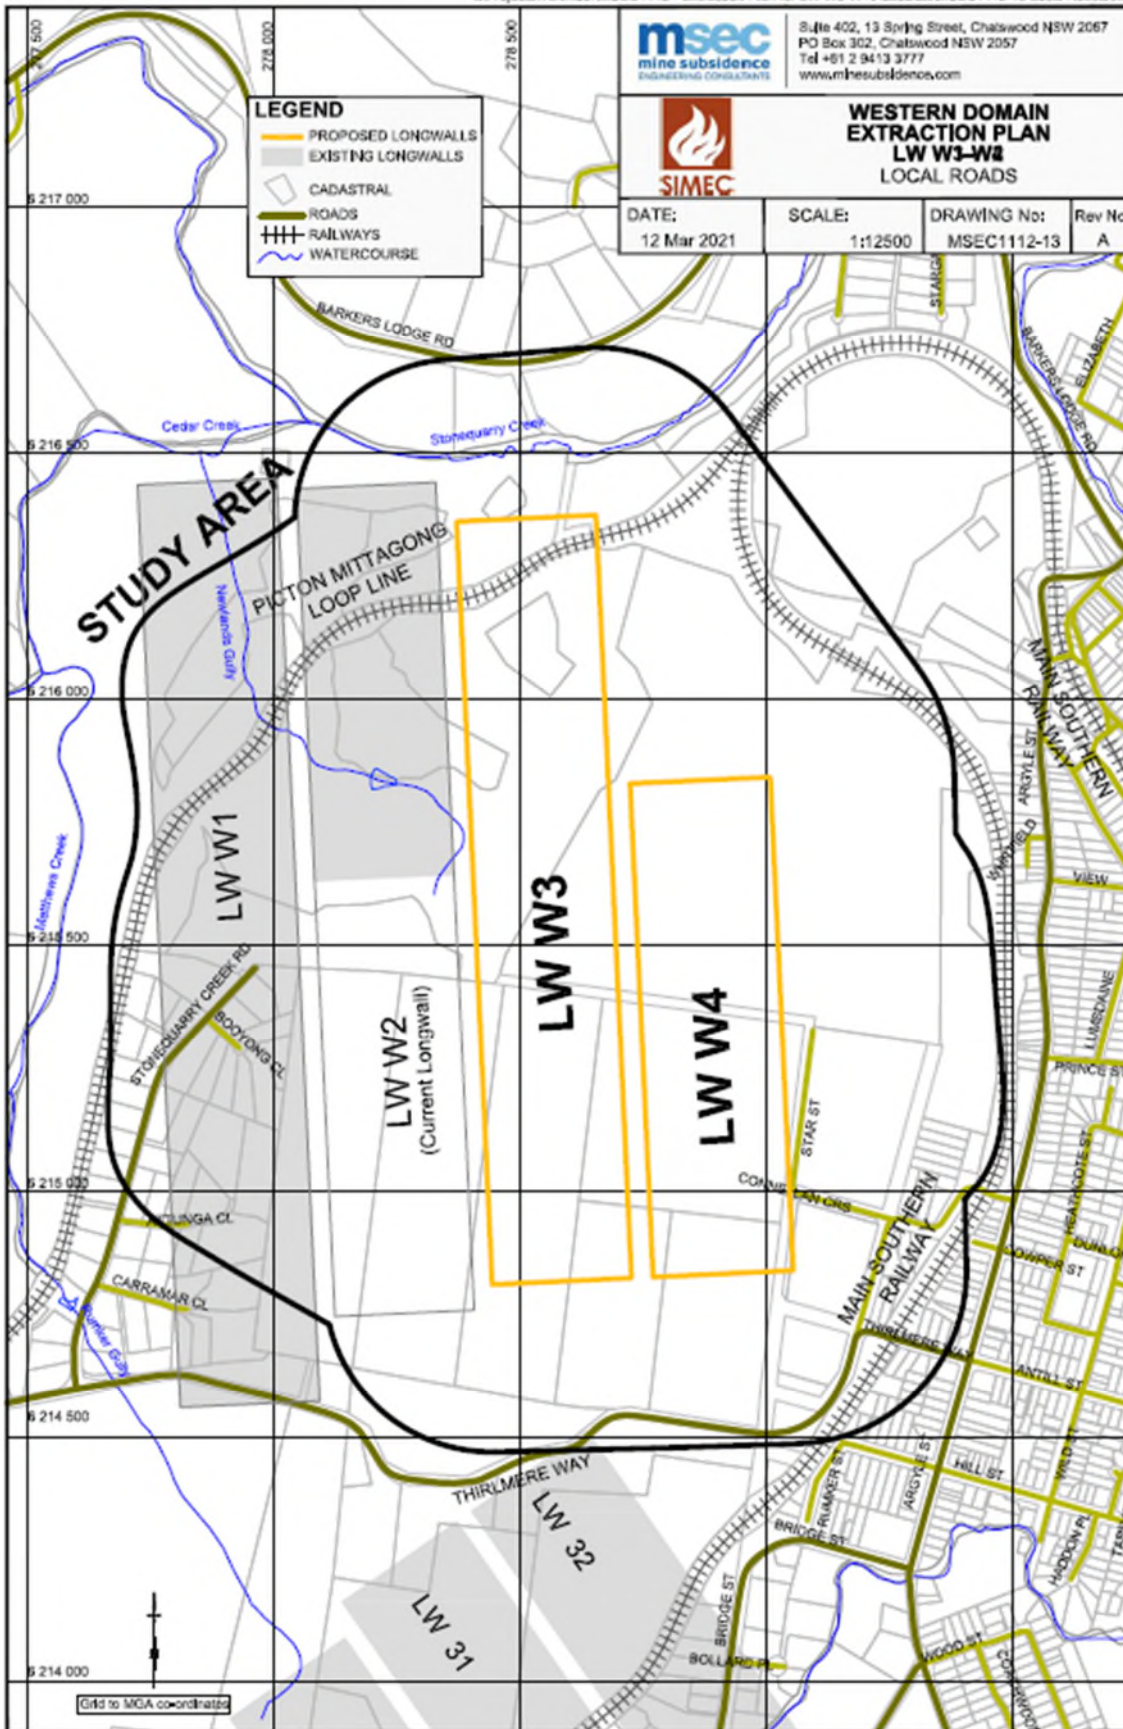
Figure 3-2 Public Roads and LW W3-W4 Extraction Plan Study Area (MSEC, 2021)

The local roads are maintained by WSC. The locations of public roads within the Study Area are shown in **Figure 3-2**.
