**SIMEC Mining – Tahmoor Coal**  
**Tahmoor North Western Domain**  
**Longwalls West 1 and West 2**

Management Plan for Potential Impacts to Roads and Maritime Services Infrastructure

**Prepared by Mine Subsidence Engineering Consultants**  
**on behalf of**  
**the Technical Committee**

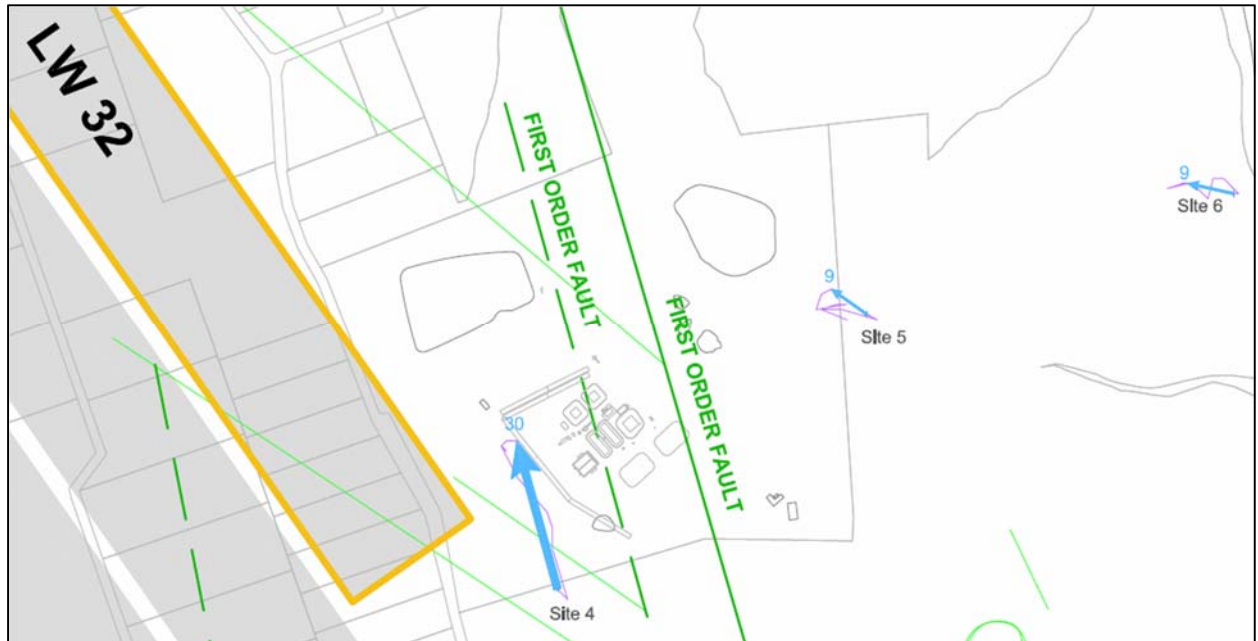
**Fig. 2.16** Observed horizontal movements at the PWRP GNSS units during the mining of LW 32

Three GNSS units continuously recorded their position during the mining of Longwall 32 within the PWRP property. Site 4 is located near the commencing end of Longwall 32. Site 5 is located on the other side of the surface expression of the Nepean Fault and Site 6 is located 1.6 km to the east of Longwall 32, away from the Nepean Fault. A map showing observed absolute horizontal movements are shown Fig. 2.16, where it can be seen that all three units have moved to the north and west at magnitudes and directions that are consistent with the ground surveys.

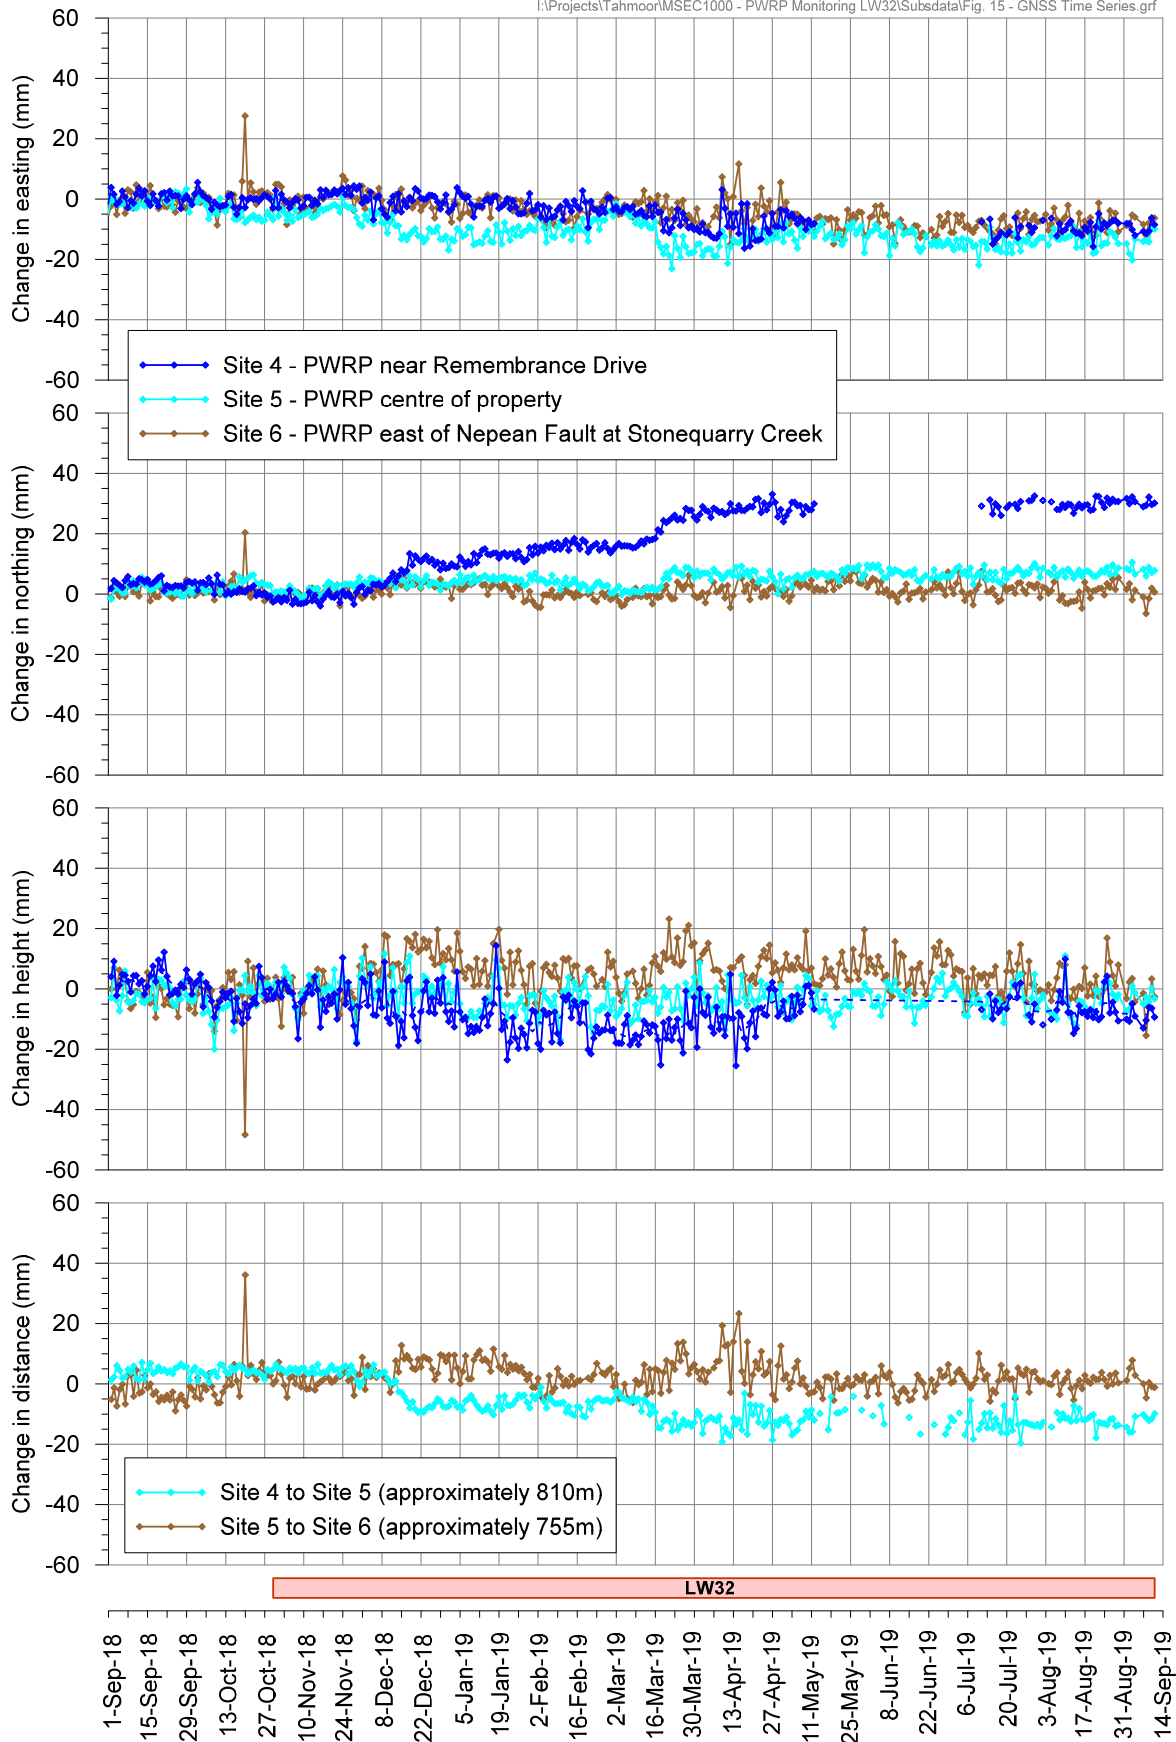
**Fig. 2.17** Observed development of horizontal movements with time at the PWRP GNSS Units during the mining of LW 32

The GNSS units also demonstrated that horizontal movements developed gradually over time, as shown in Fig. 2.17.

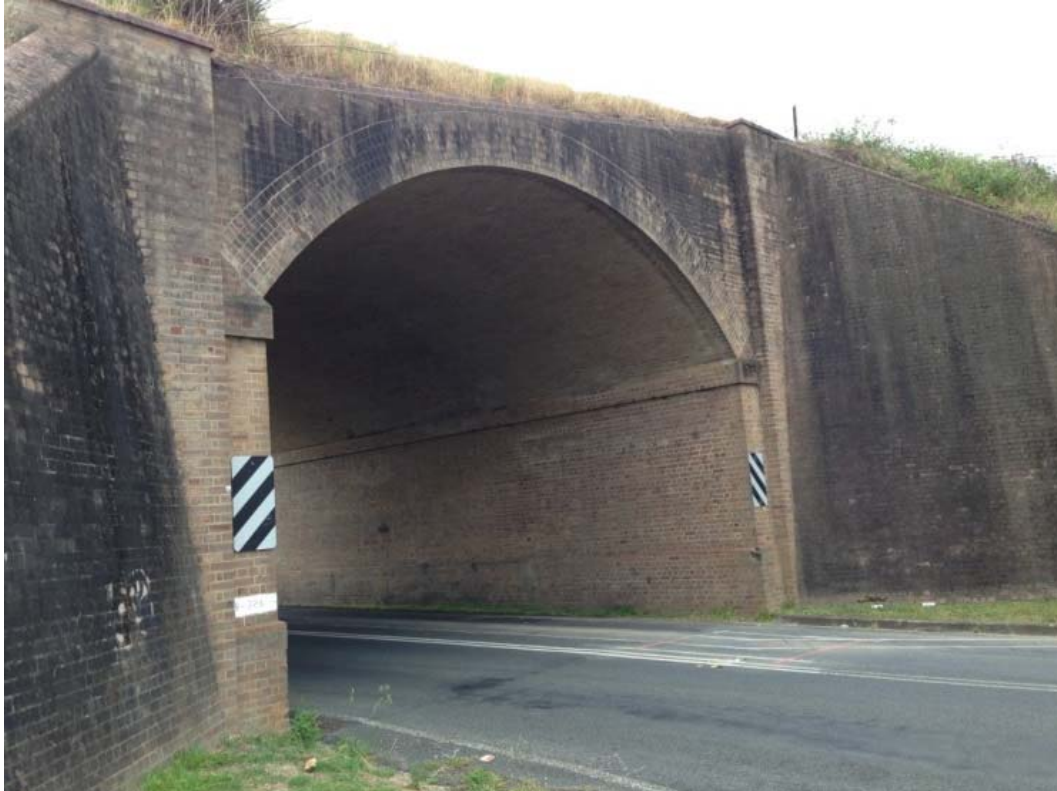
**Fig. 2.21 Thirlmere Way Rail Underbridge at 89.326 km**

The Thirlmere Way Rail Underbridge (89.326 km) is located 630 metres from Longwall 32. The bridge is a single span brick arch structure with brick spandrel walls, as shown in Fig. 2.21.

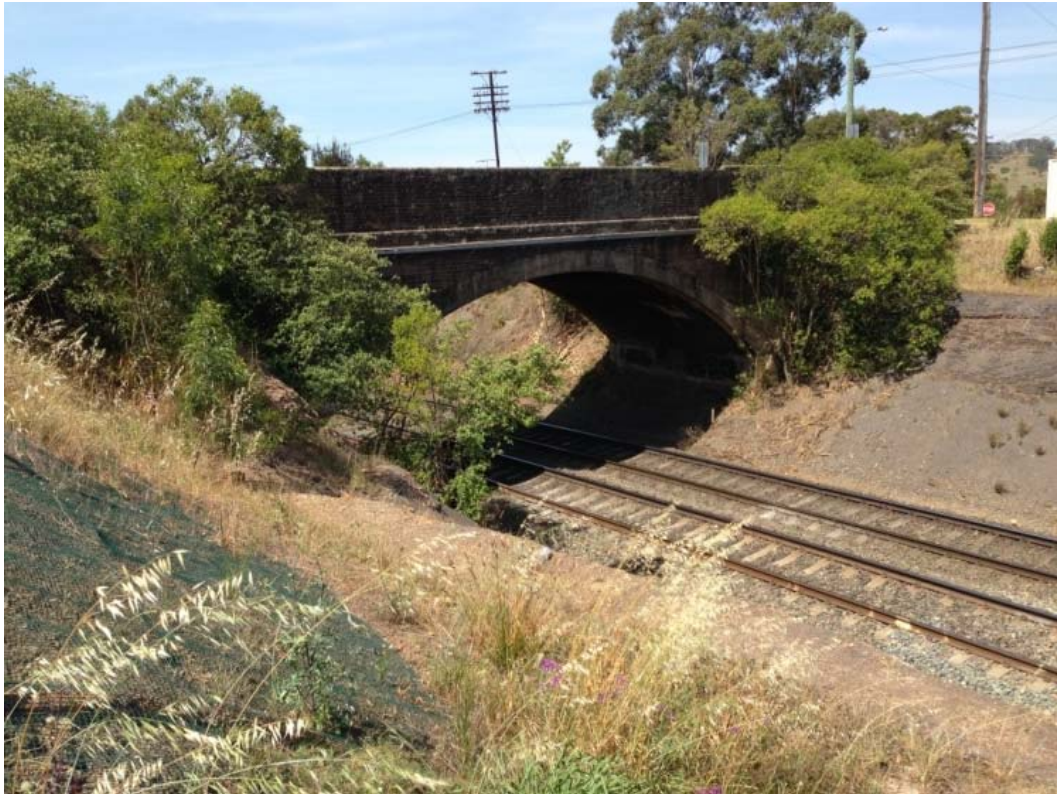
**Fig. 2.23 Connellan Crescent Railway Overbridge at 89.080 km**

The Connellan Crescent Railway Overbridge (89.080 km) is located 940 metres from Longwall 32. The bridge is constructed with masonry abutments and the deck is supported by a reinforced concrete arch, as shown in Fig. 2.23.

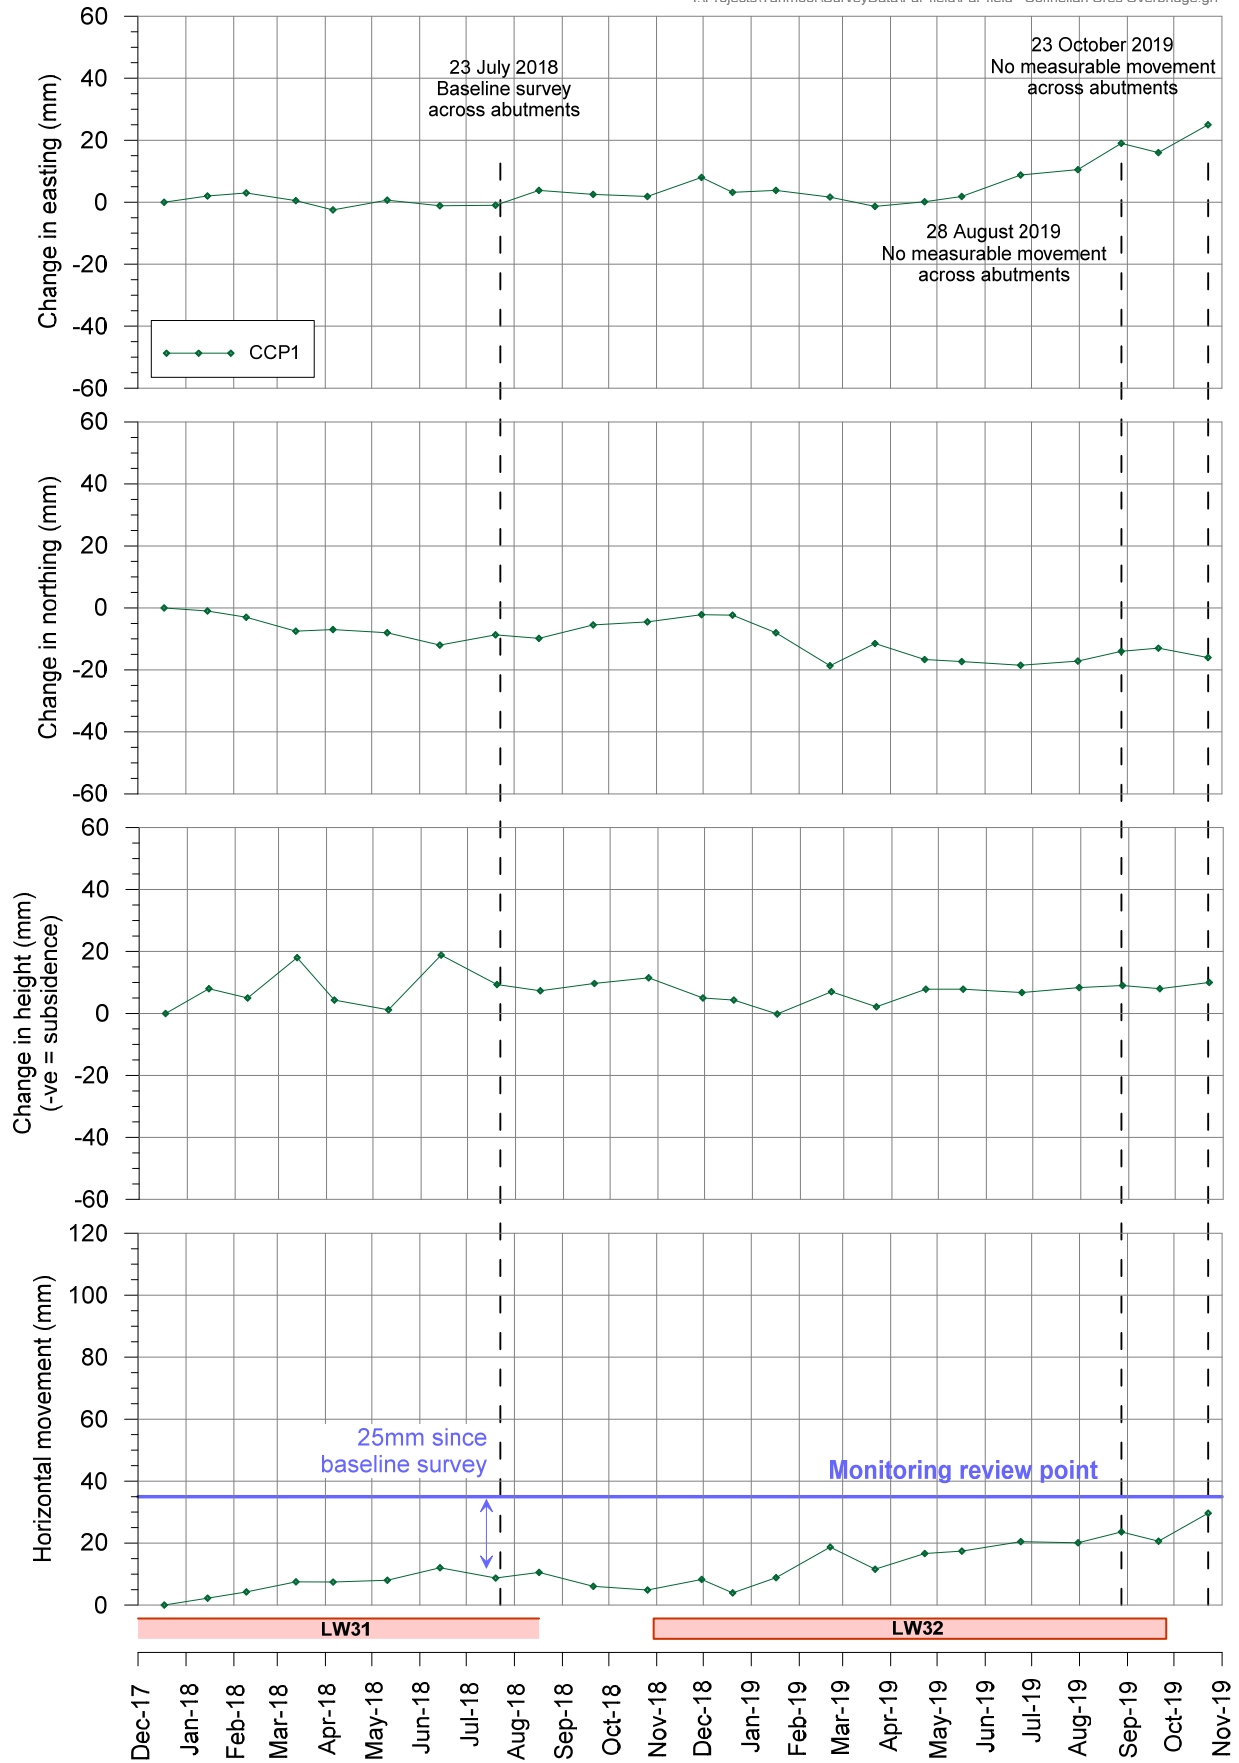
Fig. 2.24 Far-field movements at Connellan Crescent Rail Overbridge

Absolute 3D surveys have been conducted on a monthly basis at the Connellan Crescent Overbridge since December 2017 when the length of extraction of LW31 was approximately 900 metres. The observed changes in easting, northing and height are shown in Fig. 2.23, where it can be seen that the Overbridge has moved to the east during the last 3 months as LW32 approached the Overbridge. The Overbridge may also have moved slightly to the south. A minor continued easterly movement was measured in the last month after mining had ceased.

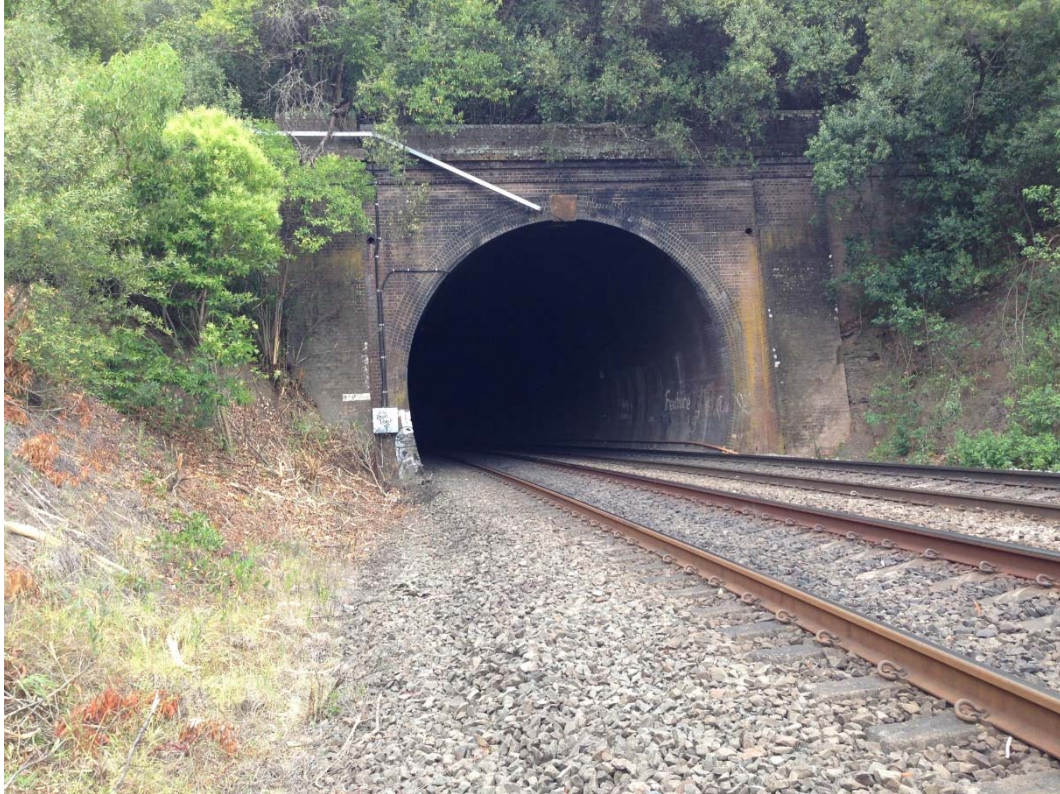
**Fig. 2.25 Picton Railway Tunnel – Southern Portal**

The Picton Tunnel (87.850 km) is located 1.6 km from Longwall 32. The Tunnel is constructed with masonry arches as shown in Fig. 2.25.

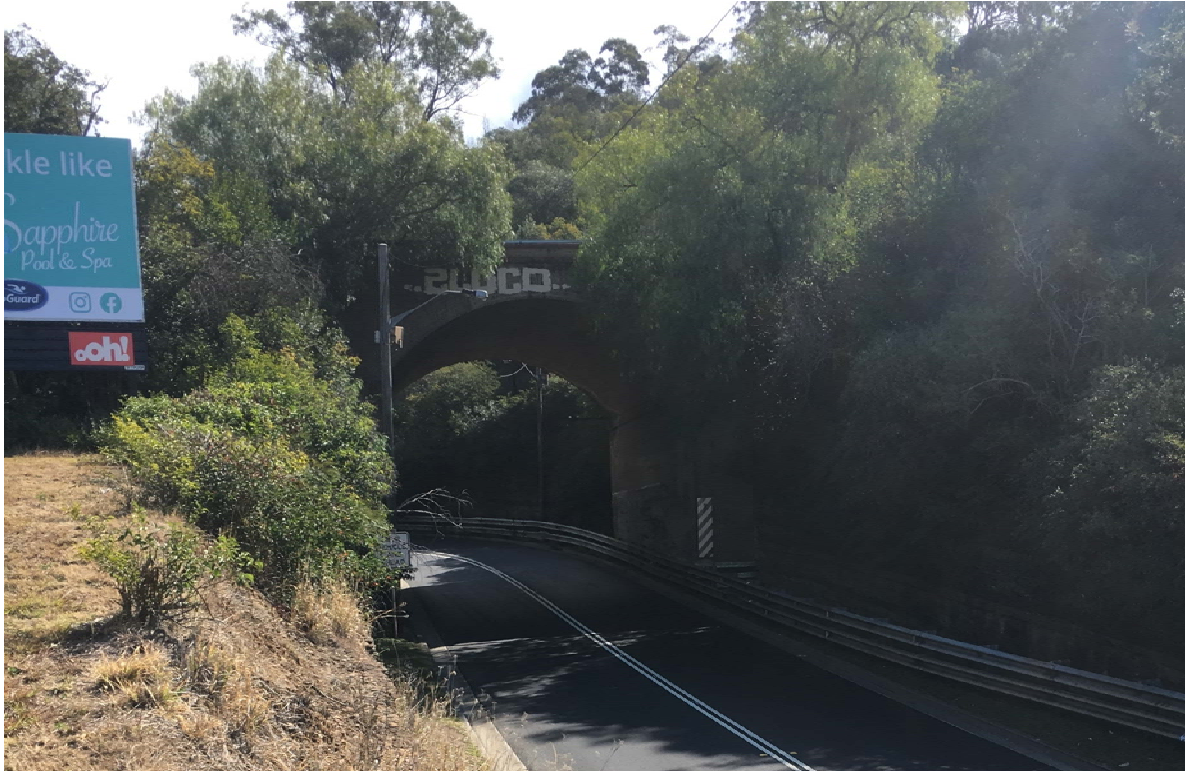
**Fig. 2.27 Argyle Street Rail Underbridge at 86.160 km**

The Argyle Street Rail Underbridge (86.160 km) is located 2 kilometres north-east of Longwall 32. The bridge is a single span masonry brick arch structure with brick spandrel walls, as shown in Fig. 2.27.

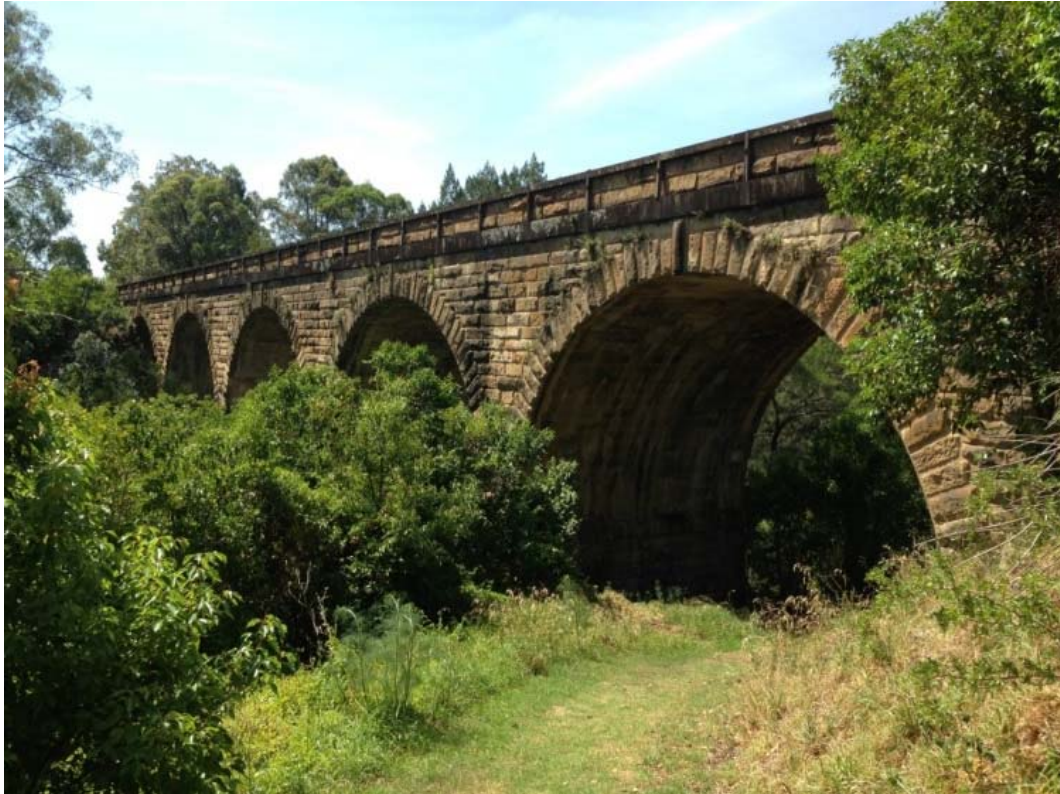
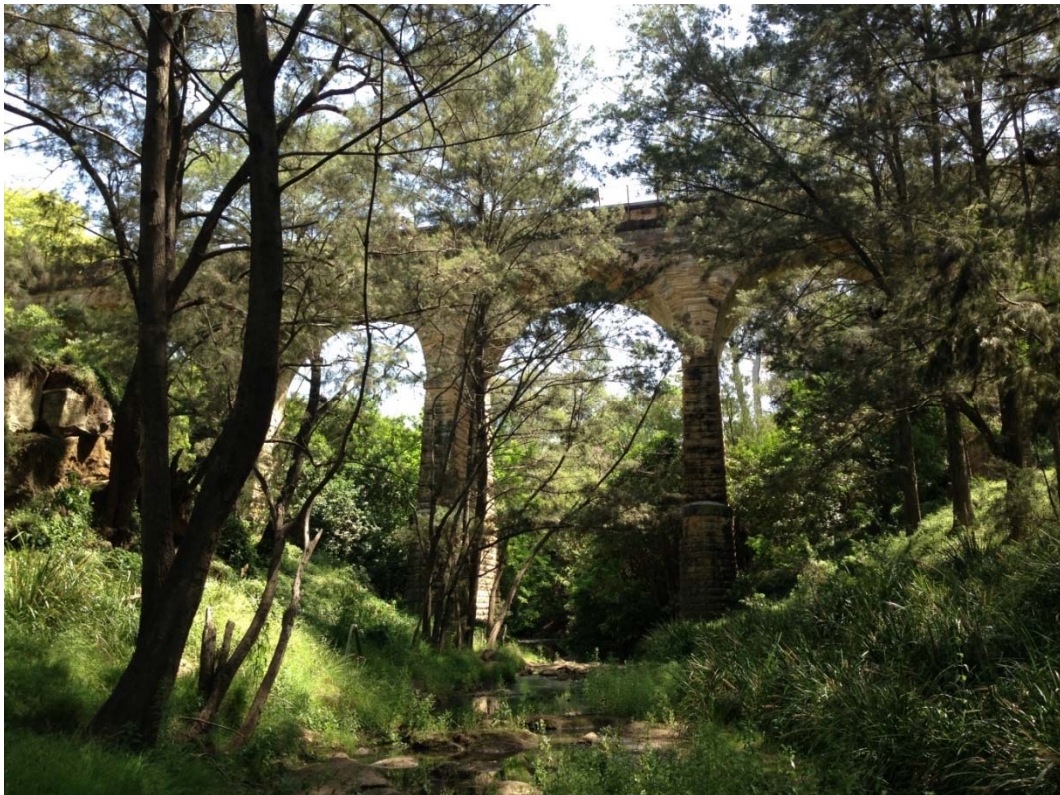
**Fig. 2.29 Picton Viaduct at 85.42 km over Stonequarry Creek**

The Picton Viaduct (85.42 km) is located 1.6 km north-east of Longwall 32. The viaduct is a five-span stone arch structure across Stonequarry Creek, as shown in Fig. 2.29.

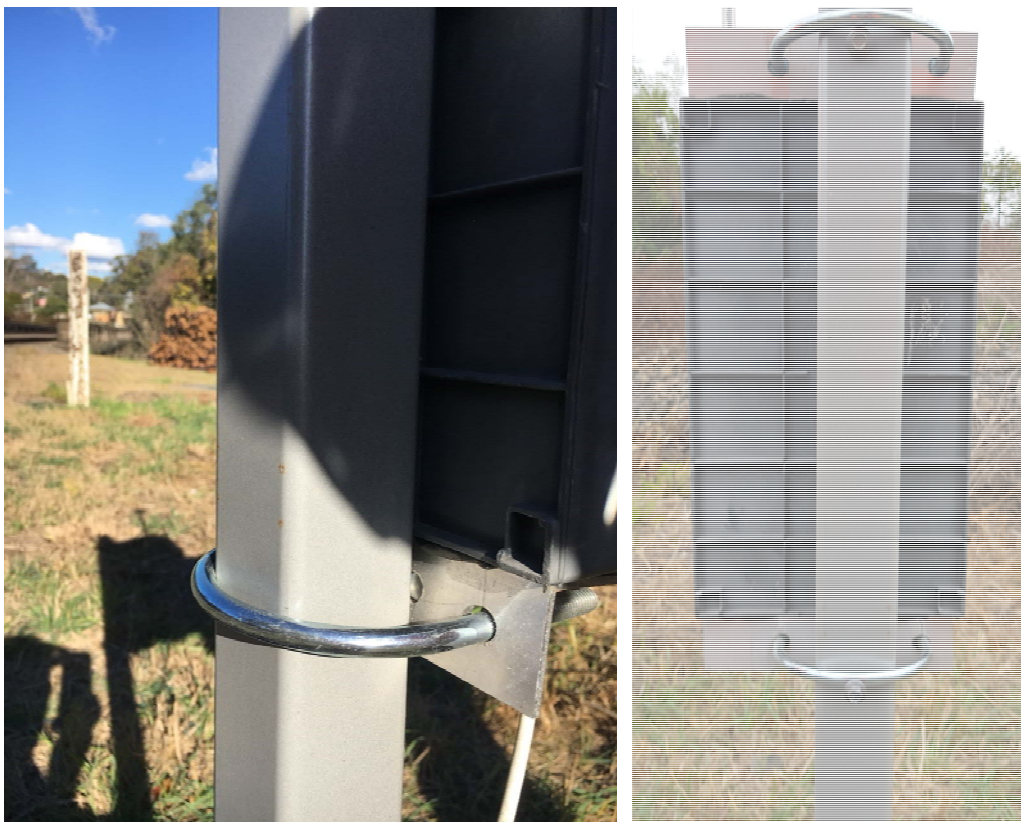
**Fig. 2.30 Observed slippage of U-bolt down the post at northern GNSS unit**

A site inspection of the GNSS unit found that it had been fixed to the post via U-bolts and the U-bolts had gradually slipped down the post due to vibration from passing trains, as evidenced by rust marks on the post approximately 40 mm above the U-bolt, as shown in Fig. 2.30. Screws have since been installed and no further has been observed.

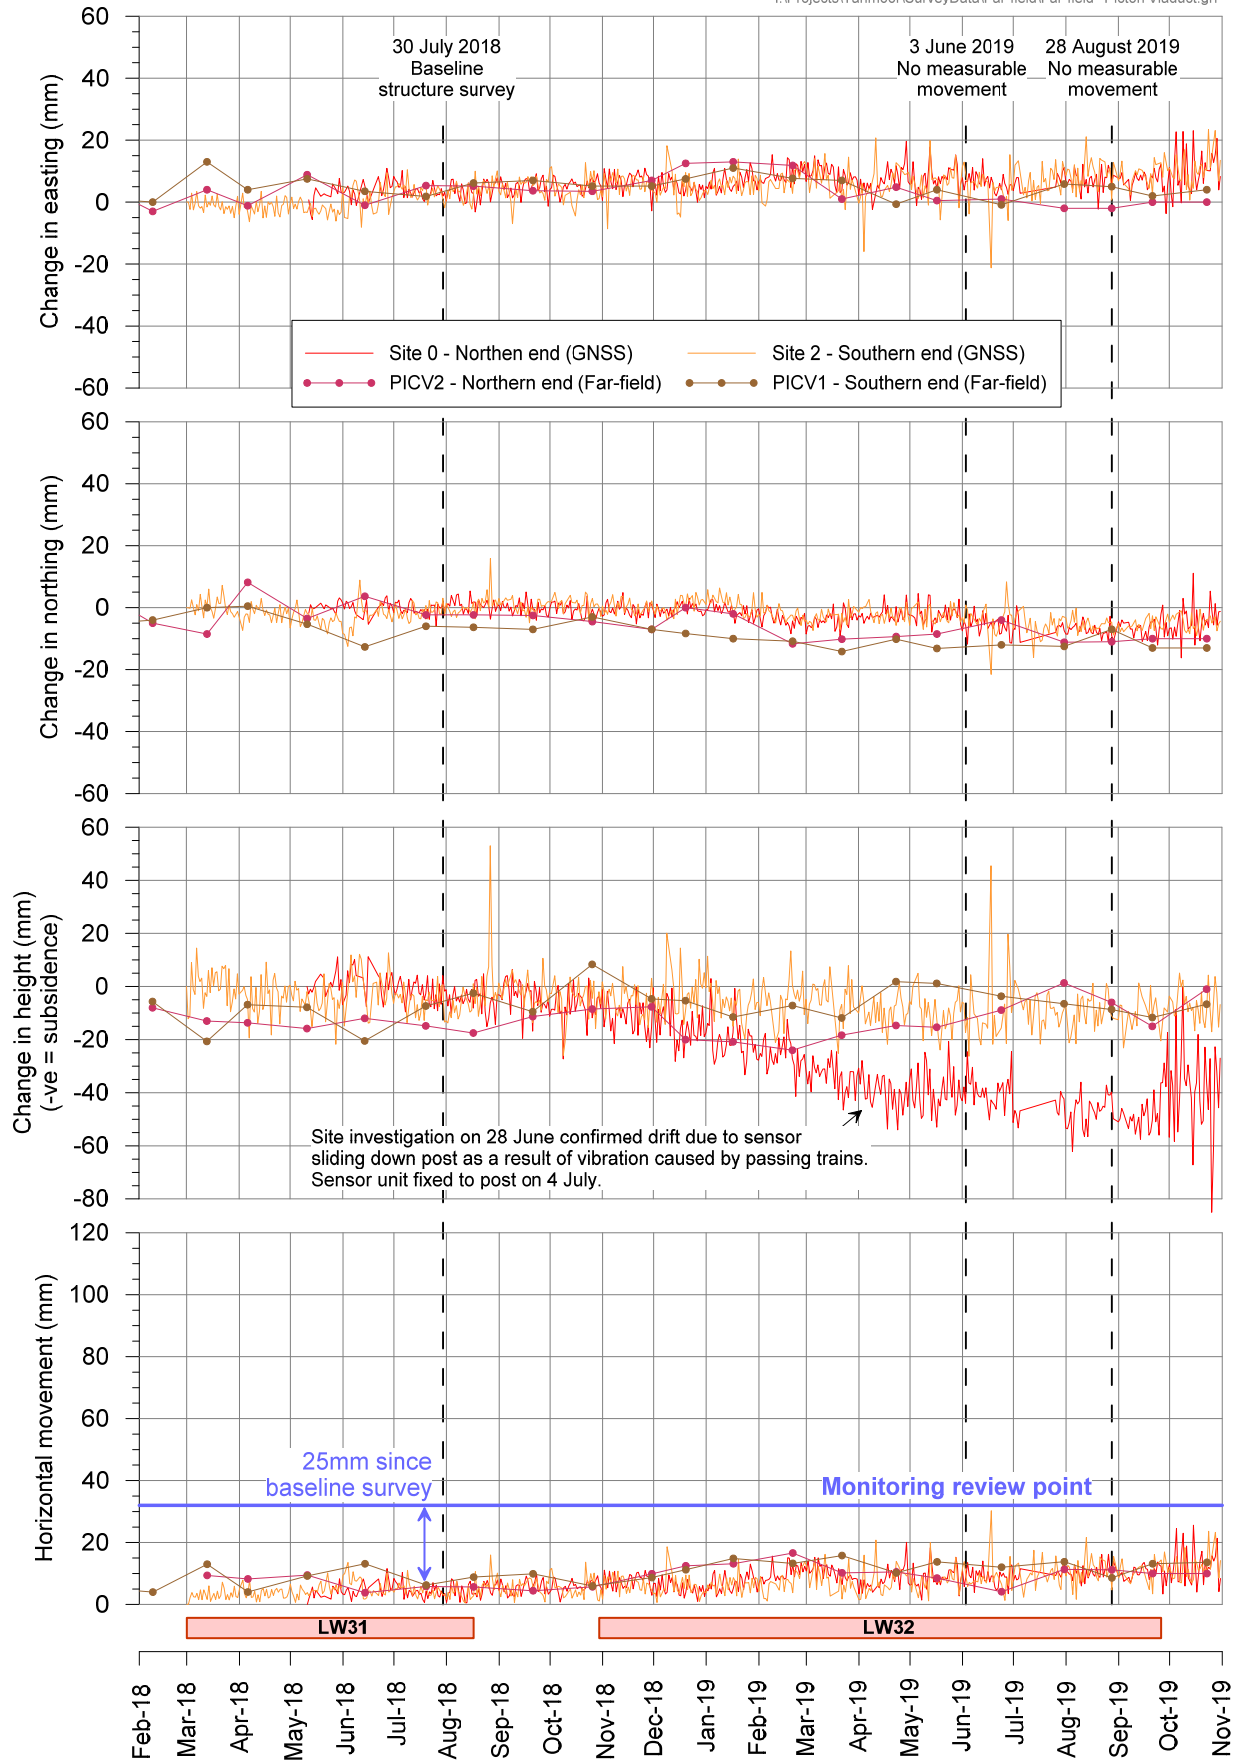
Fig. 2.31 Far-field movements at Picton Viaduct

The observed changes in easting, northing and height of the ground marks and the GNSS units are shown in Fig. 2.31. It can be seen that measured changes in eastings and northings are within survey tolerance.

A gradual fall in height was measured by the GNSS unit at the northern end of the Viaduct during the warmer months, which was inconsistent with the survey results at the ground mark. As a precautionary measure, the structure surveys were re-measured and the results confirmed that the Viaduct had not experienced any measurable differential vertical movements.

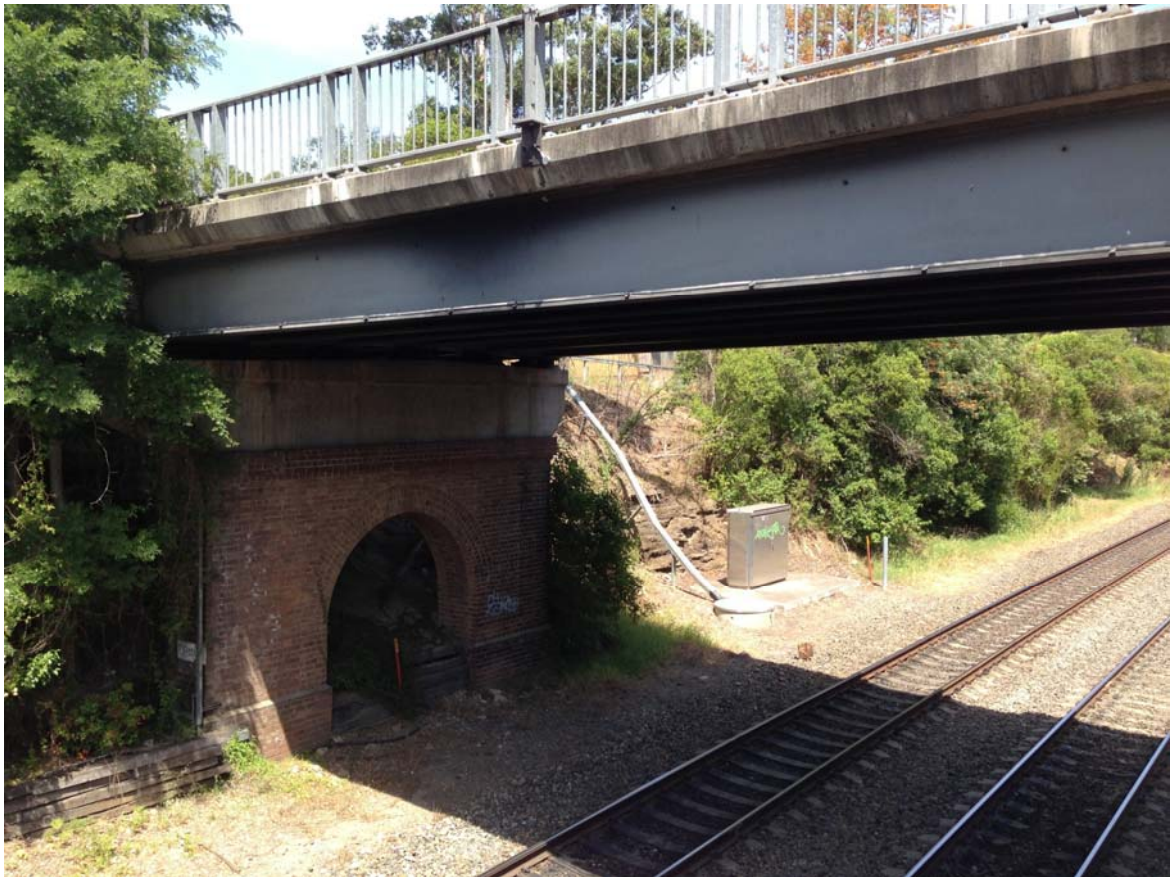
**Fig. 2.33 Prince Street Overbridge at 85.17 km**

The Prince Street Overbridge (85.17 km) is located 1.6 kilometres north-east of LW 32. The bridge is a steel framed overbridge with steel handrails with the deck supported by bearings on concrete headstocks and brickwork piers, as shown in Fig. 2.33.

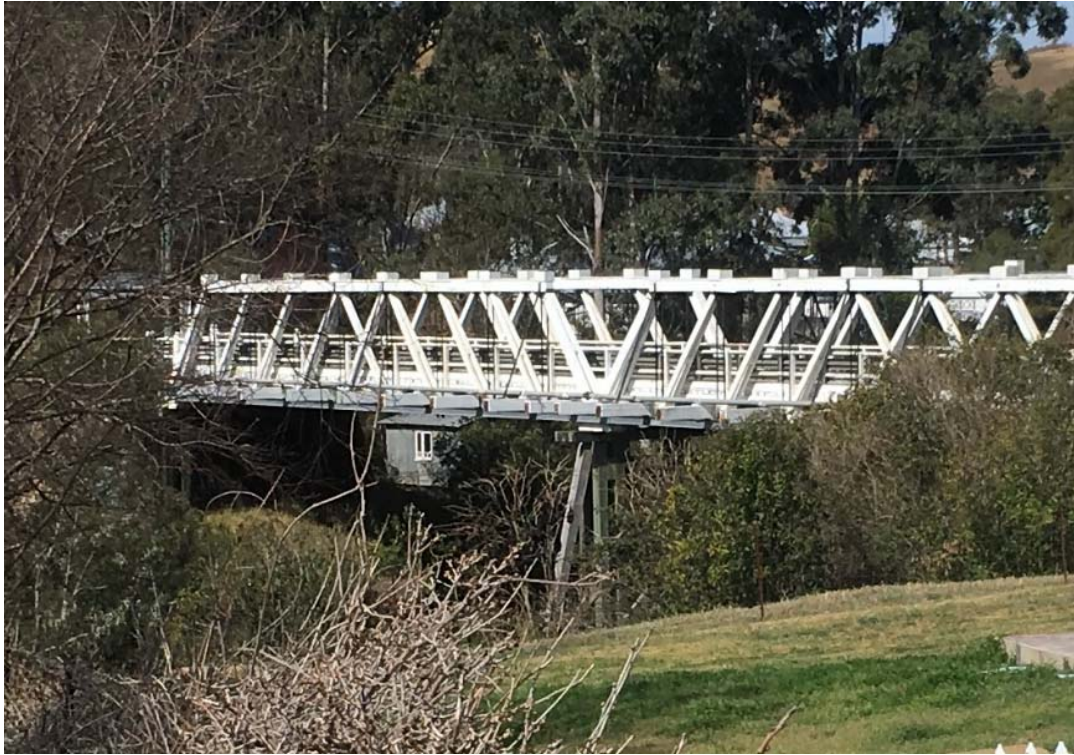
Fig. 2.35 Victoria Bridge

The Victoria Bridge over Stonequarry Creek at Picton consists of three Allan type timber truss spans over 19.5 metre high timber trestles or piers (Cardno, 2019). The Bridge has no approach spans and each of the main spans is 24.7 metres in length. The Bridge can accommodate a single lane of traffic, with a signposted load limit of 5 tonnes. Photographs of Victoria Bridge are provided in Fig. 2.35 to Fig. 2.37.

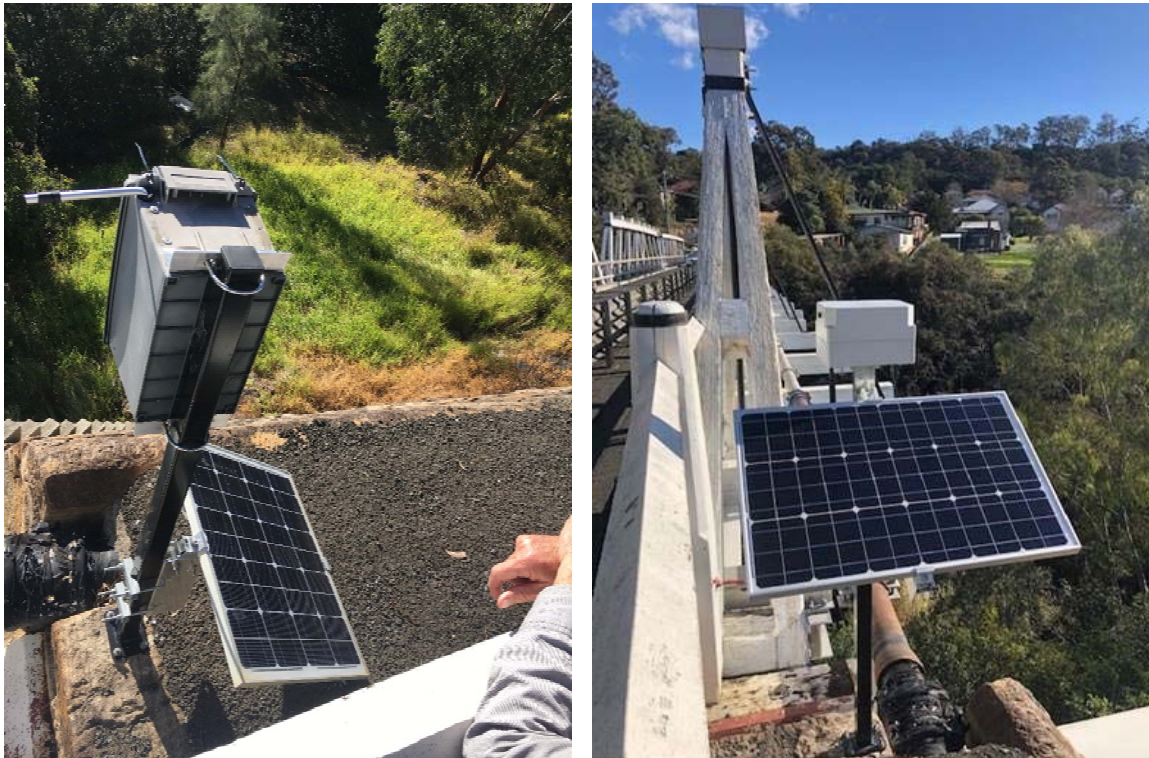
Absolute 3D surveys have been conducted at both ends of the Victoria Bridge on a monthly basis since December 2017 when the length of extraction of LW31 was approximately 900 metres. A GNSS unit was mounted on the eastern Abutment B to continuously measure its absolute horizontal and vertical position in real time. The original GNSS unit was vandalised in May 2019 and was replaced in July 2019. Photographs of the damaged original unit and the new unit are shown in Fig. 2.40.

**Fig. 2.40** Damaged old and new GNSS Unit 3 at Victoria Bridge on Eastern Abutment B

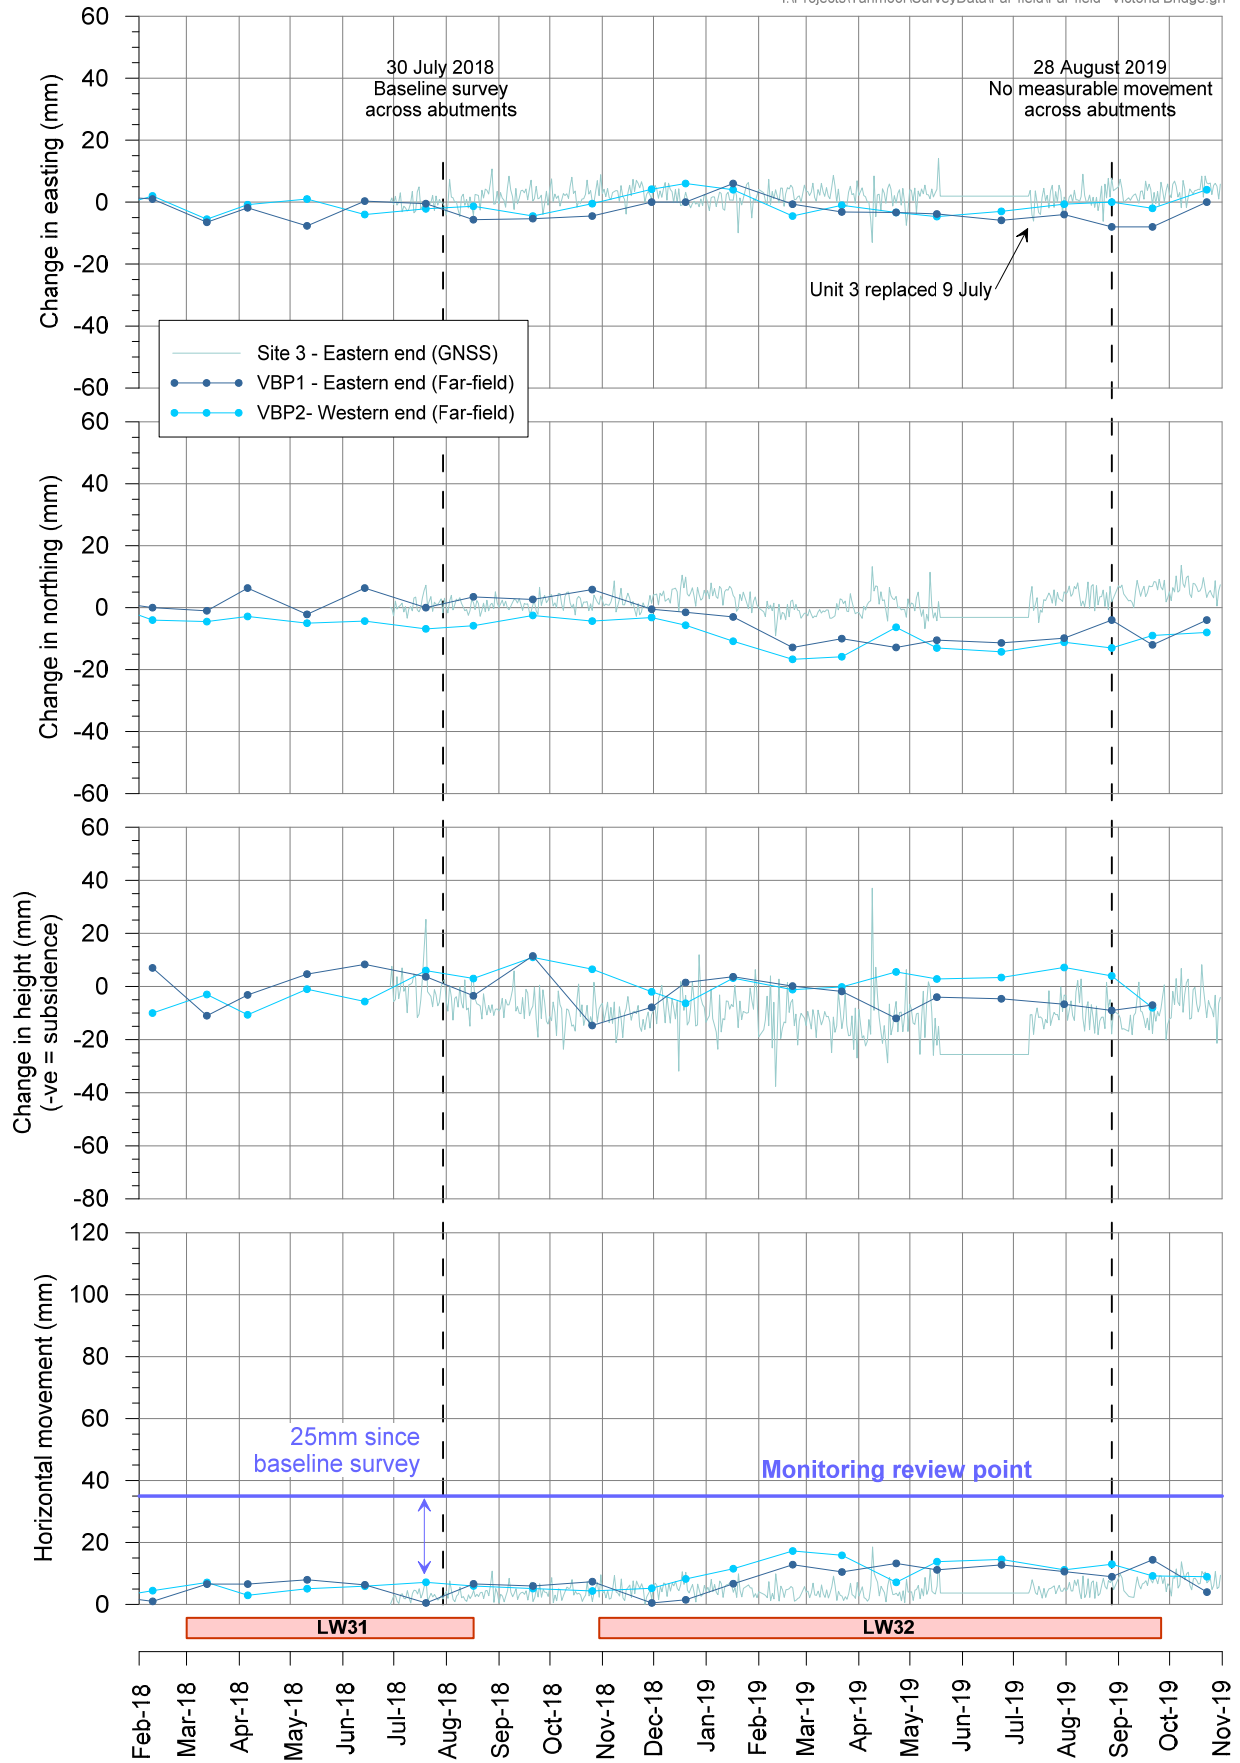
Fig. 2.42 Far-field movements at Victoria Bridge

The observed changes in easting, northing and height of the ground marks and the GNSS unit are shown in Fig. 2.42. It can be seen that measured changes in eastings and northings are within survey tolerance.

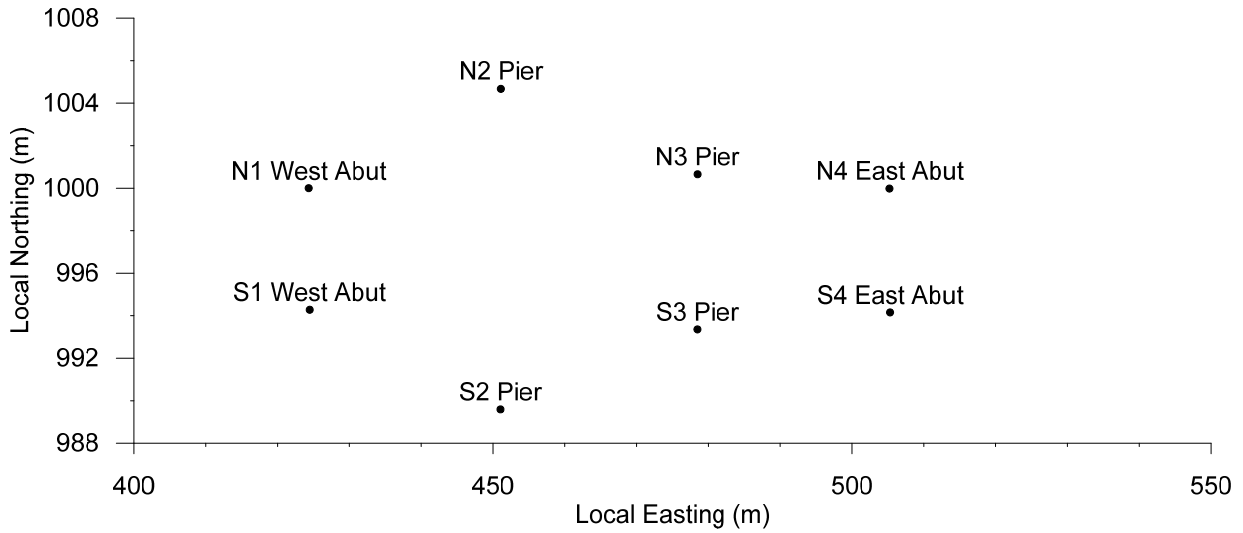
Eight prisms were installed and surveyed on 30 July 2018 at each end of the Bridge and at the base of the timber trestles, on both sides. A plan view layout of the marks is shown in Fig. 2.43. The marks were measured in local 3D coordinates.

**Fig. 2.43** Layout of survey marks in Plan View at Victoria Bridge

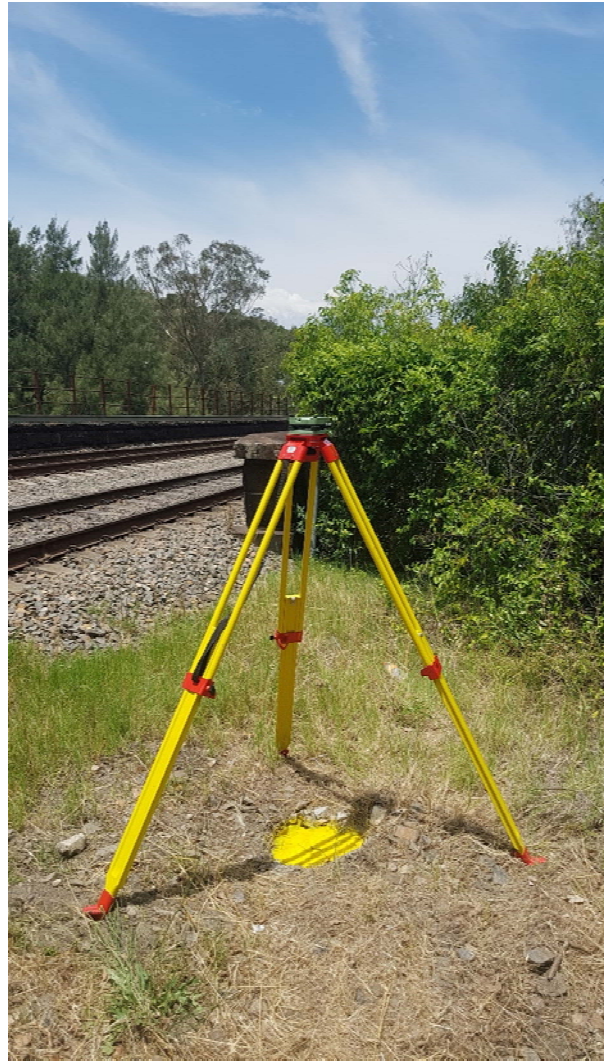
Ground pegs have been installed or will be installed at the above locations prior to the start of LW W1. Photographs of the survey pegs installed above the Picton Tunnel and Picton Viaduct are shown in Fig. 4.1.

**Fig. 4.1** Ground survey peg installed above Picton Tunnel (left) and Picton Viaduct (right)
