SIMEC Mining:

**Tahmoor North Western Domain
Longwalls West 3 and West 4**

Management Plan for Potential Impacts to Built Structures

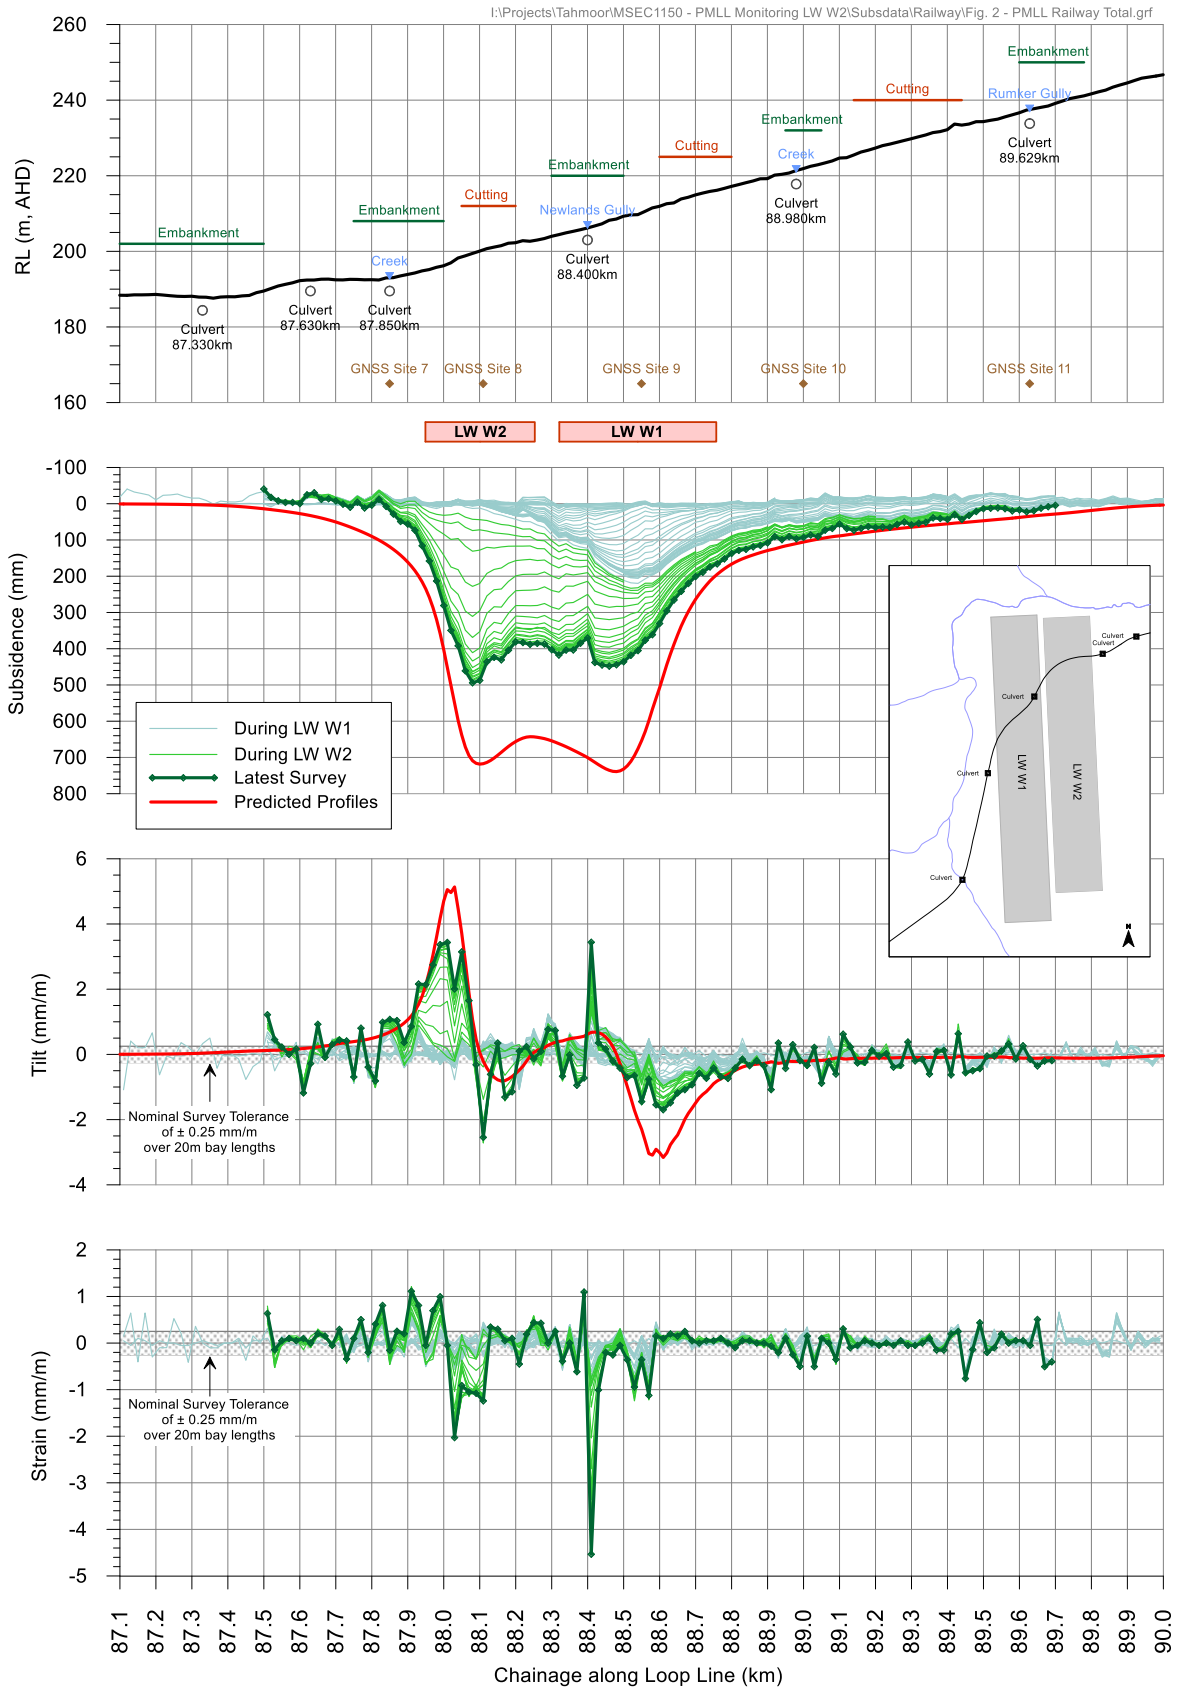
As of 1 June 2021, subsidence surveys above LW W2 have measured less subsidence than predicted. Observed subsidence along the Picton-Mittagong Loop Line after the extraction of LW W2 is shown in Fig. 2.2. Observed subsidence along the LW W1 W2 crossline after the extraction of LW W2 is shown in Fig. 2.3.

Fig. 2.2 Observed subsidence along Picton-Mittagong Loop Line during the mining of LW W1-W2

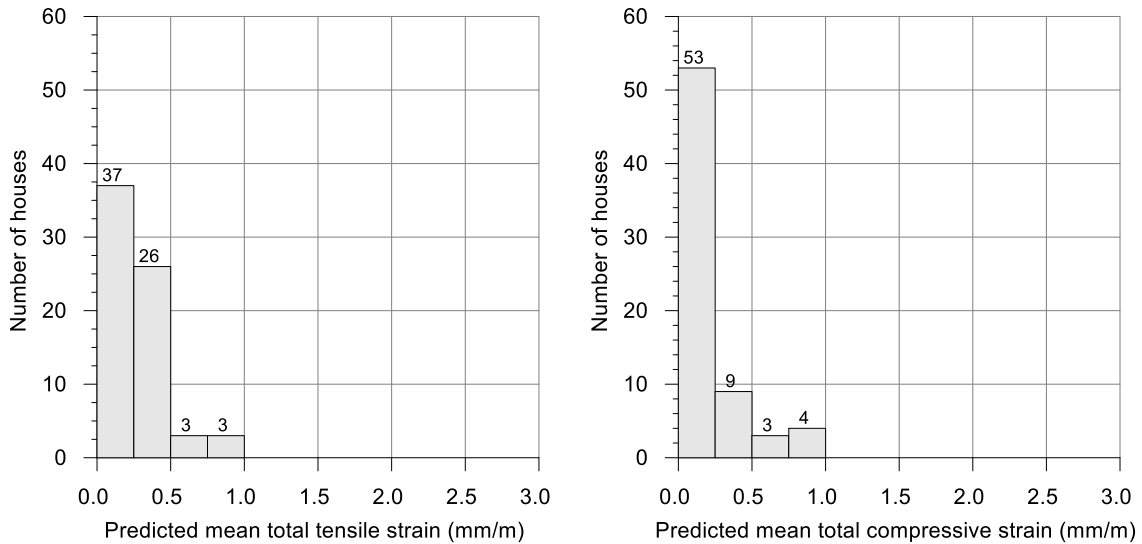
The predicted total strains for each of the houses within the Study Area are provided in Report No. MSEC1112. Distributions of the predicted total strains based on the mean and on the 95 % confidence levels are provided in Fig. 4.6 and Fig. 4.7, respectively.

Fig. 4.6 Predicted total tensile strain (left-side) and total compressive strain (right-side) for the houses based on the mean

The houses within the Study Area are predicted to experience total tensile strains between 0.3 mm/m and 1.7 mm/m and total compressive strains between 0.2 mm/m and 2.4 mm/m based on the 95 % confidence levels. The predicted mean values range between 0.2 mm/m and 0.7 mm/m tensile and compressive.

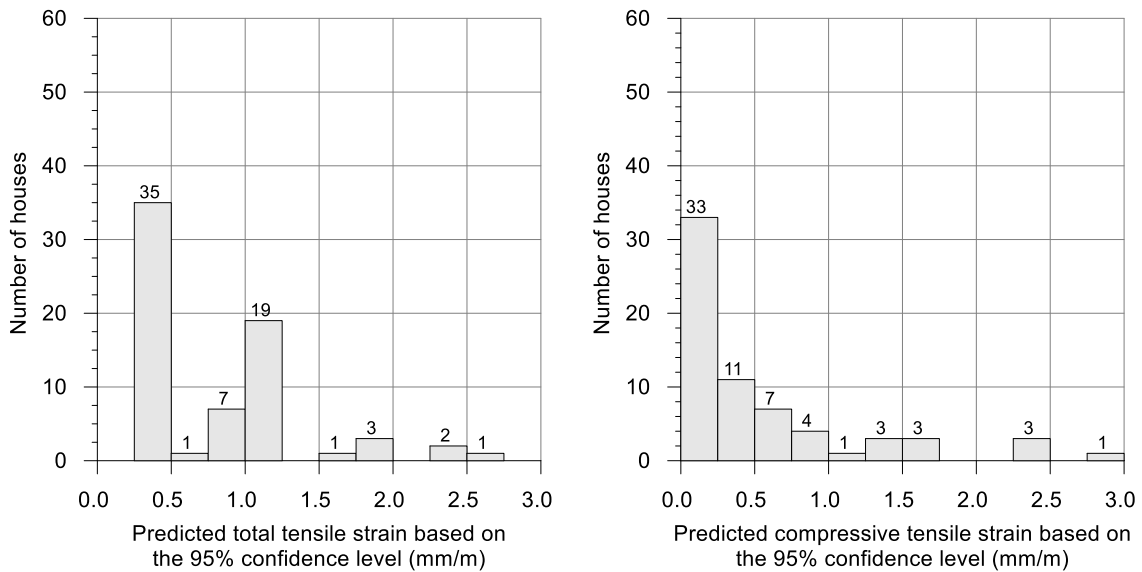
Fig. 4.7 Predicted total tensile strain (left-side) and total compressive strain (right-side) for the houses based on the 95 % confidence level

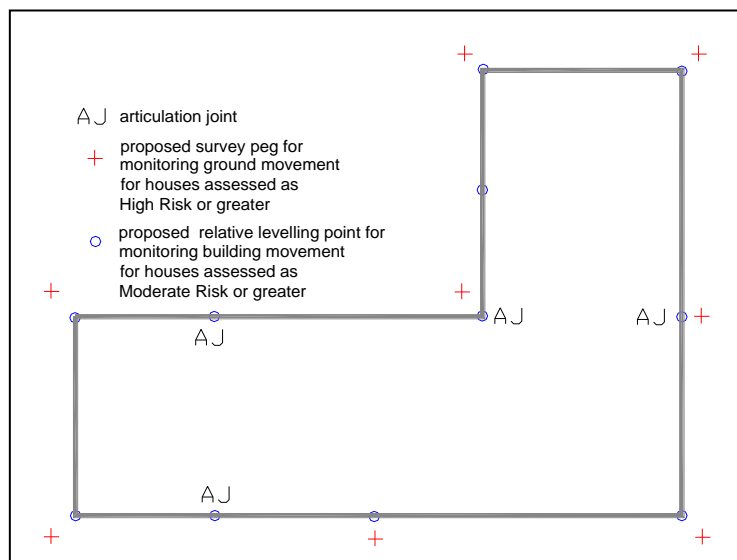
Fig. 6.5 Schematic layout for ground movement and building level surveys around a typical building

Ground surveys around structures are used as a baseline monitoring tool. Surveys are undertaken following completion of each longwall unless impacts or high tilts are observed. Tahmoor Coal will place permanent ground survey marks around each subject building. Tahmoor Coal will endeavour to place marks at each external and internal corner of the building, and one mark at the centre of each external side of reasonable length (this will depend on the overall size of the building, but is approximately 10 m).

Tahmoor Coal will record the reduced levels of each mark, as well as the relative horizontal position between each mark around the perimeter of the building (local 3D survey). The survey information will provide subsidence, tilt, curvature and strain information on the ground around the building. This general surveying scheme is illustrated in Fig. 6.5. It is recognised that in some cases, it will not be possible to gain access and suitable lines of sight to the entire perimeter of the building, and in some cases, the number of survey pegs may be reduced. However, as a minimum, survey marks will be placed at every corner of the building.
