GLENCORE:
Tahmoor Colliery – Longwall 31

Management Plan for Potential Impacts to Built Structures

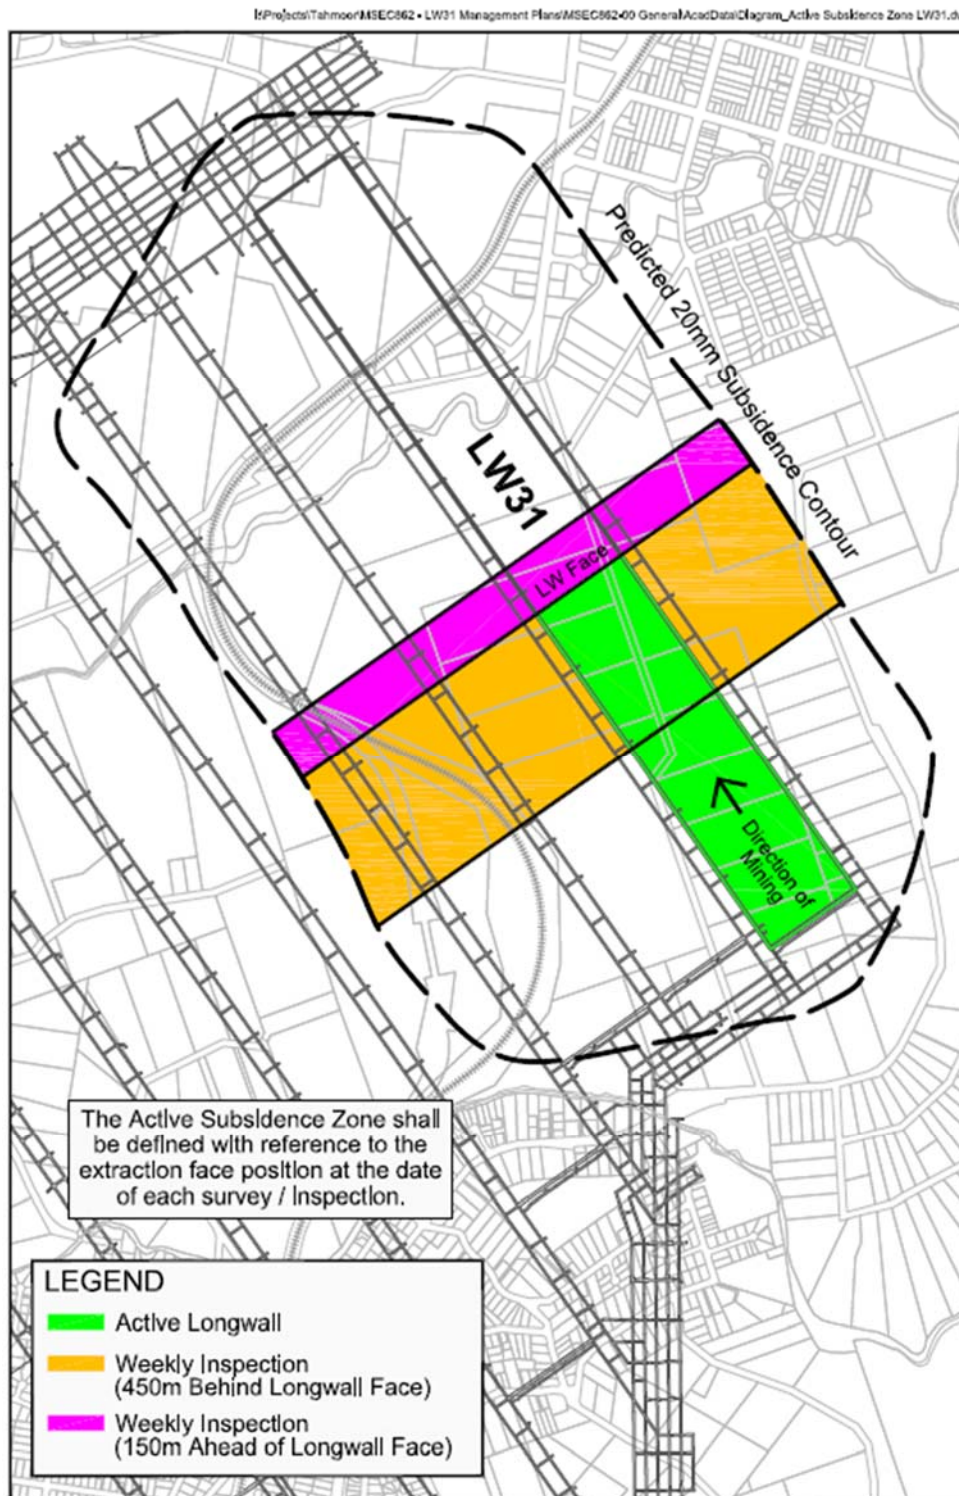
Fig. 1.1 Diagrammatic Representation of Active Subsidence Zone

This is termed the “active subsidence zone” for the purposes of this Management Plan, where surface monitoring is generally conducted. The active subsidence zone for each longwall is defined by the area bounded by the predicted 20 mm subsidence contour for the active longwall and a distance of 150 metres in front and 450 metres behind the active longwall face, as shown by Fig. 1.1.

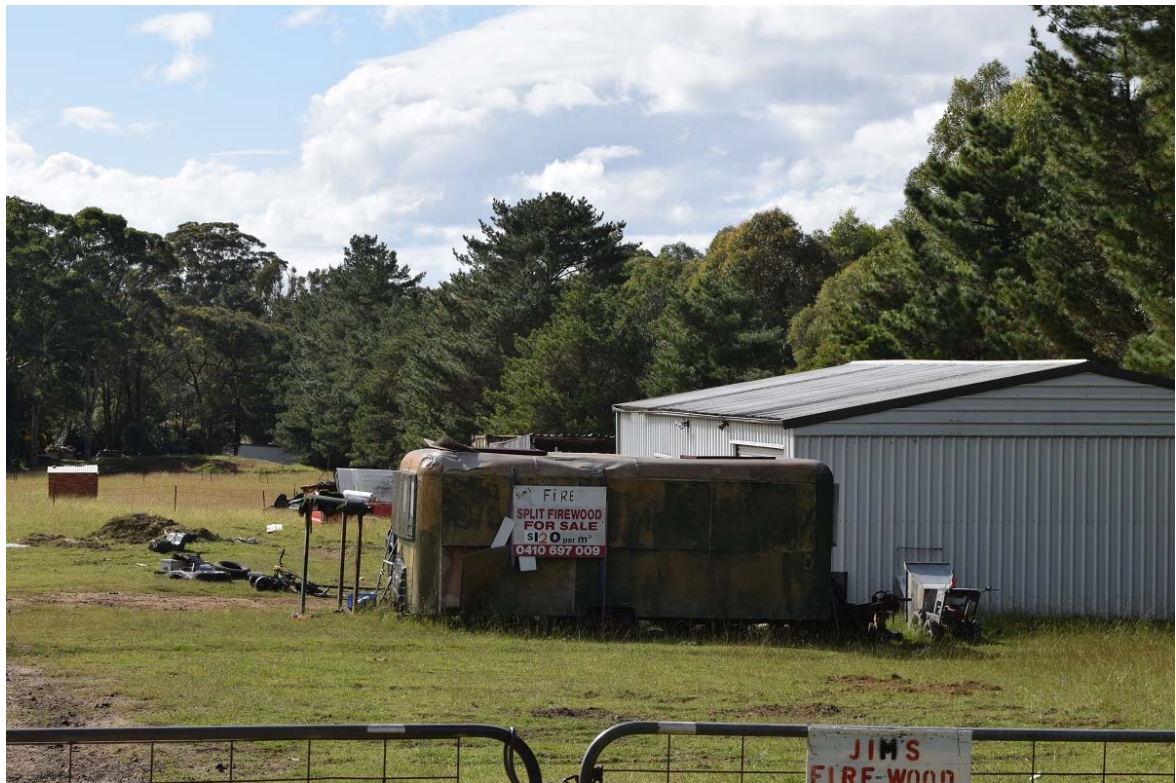
Image 5450:

Image 5450 depicts single storey shed with metal roof, steel roof framing, metal clad walls on a concrete raft slab.

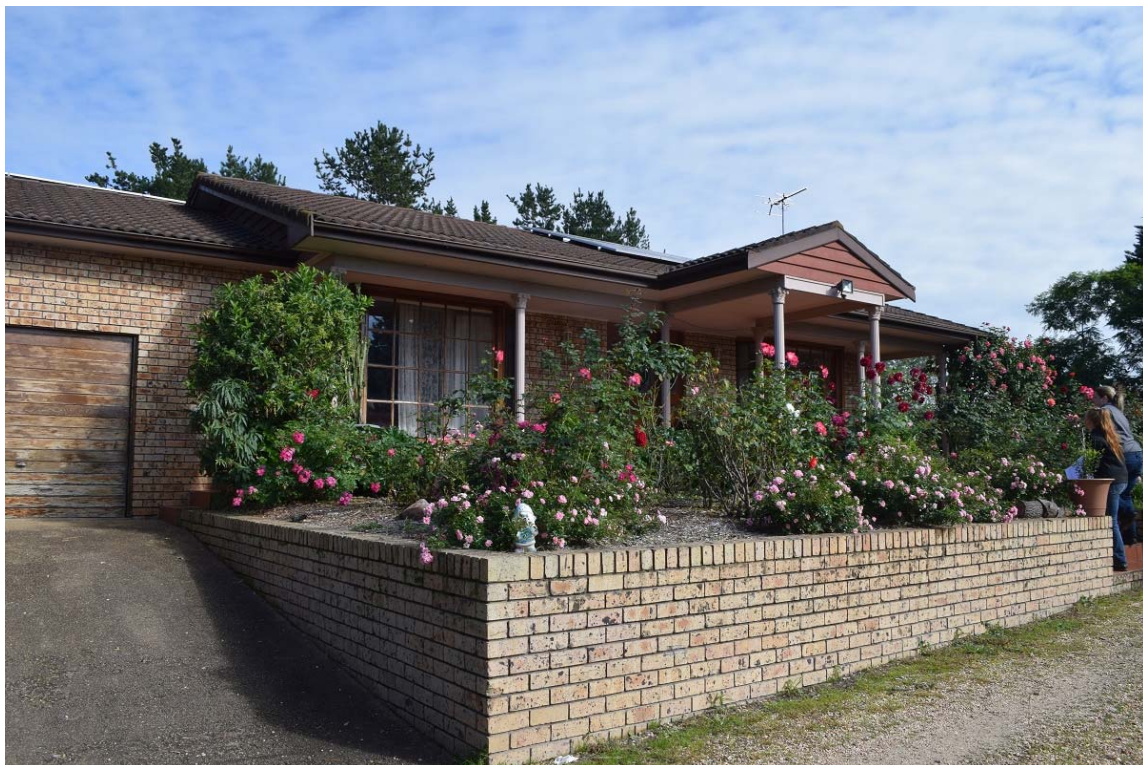
Image 5443:

Image 5443 depicts single storey house with tiled roof. Timber roof framing with brick veneer walls on a suspended timber floor.

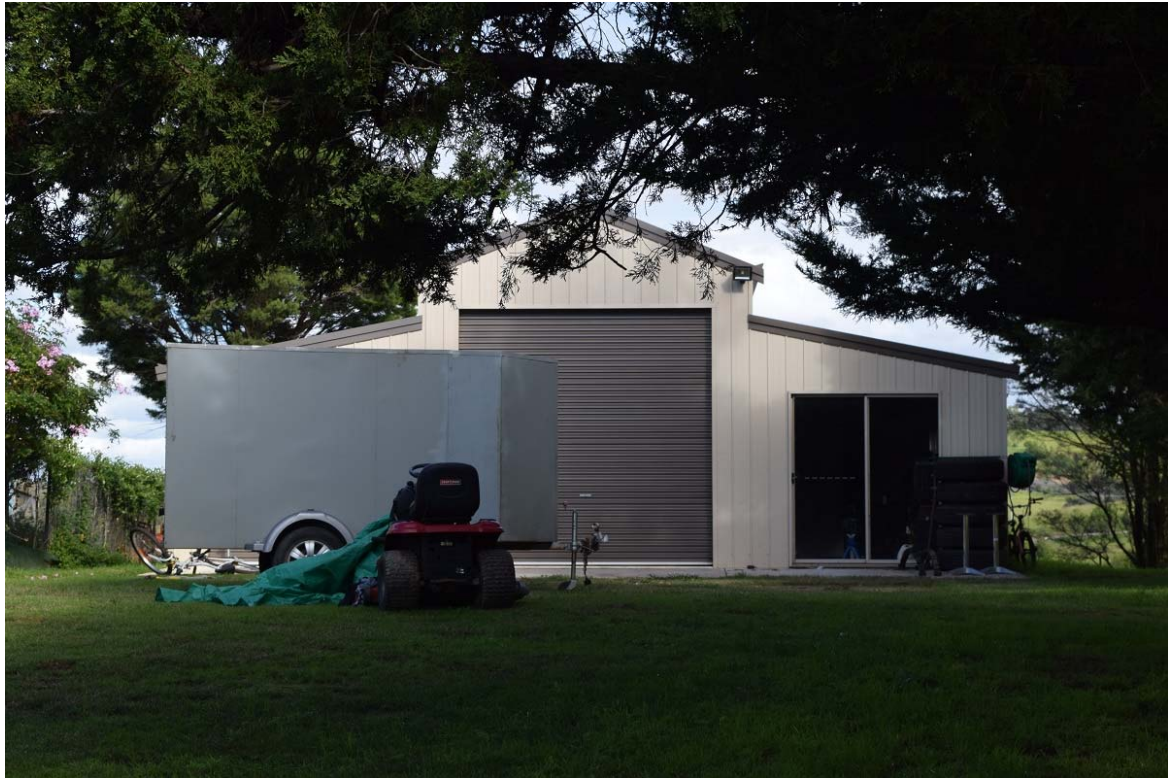
Image 5444:

Image 5444 depicts single storey shed with metal roofing. Steel roof framing, metal clad walls on a concrete raft slab

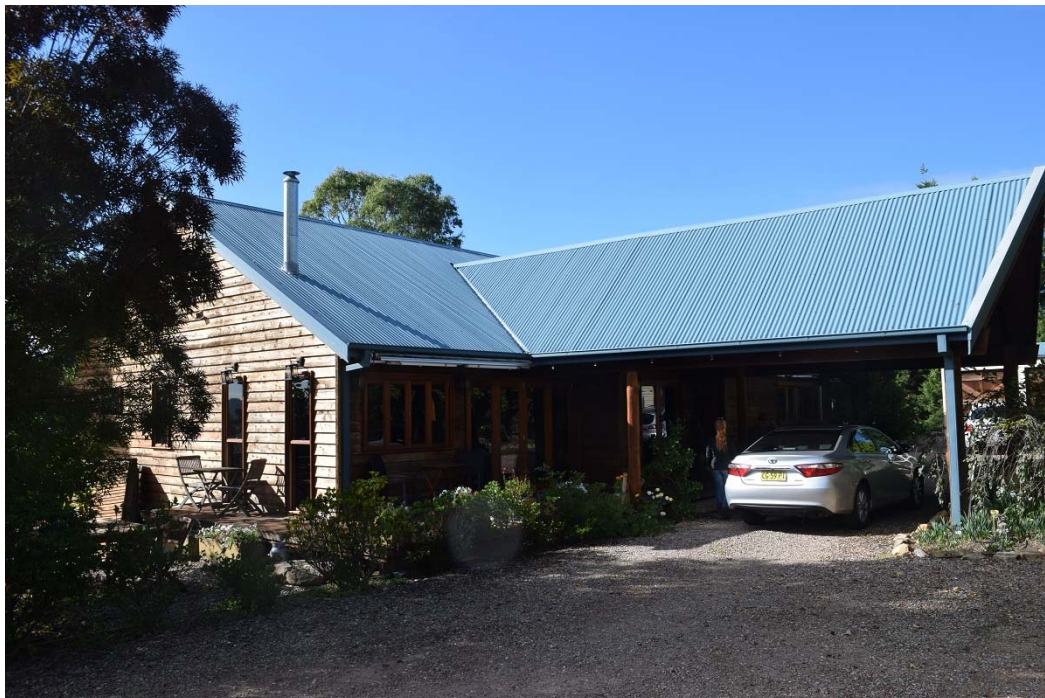
Image 5435:

Image 5435 depicts a single storey house with metal roof. Timber roof framing with clad timber walls on a suspended timber floor.

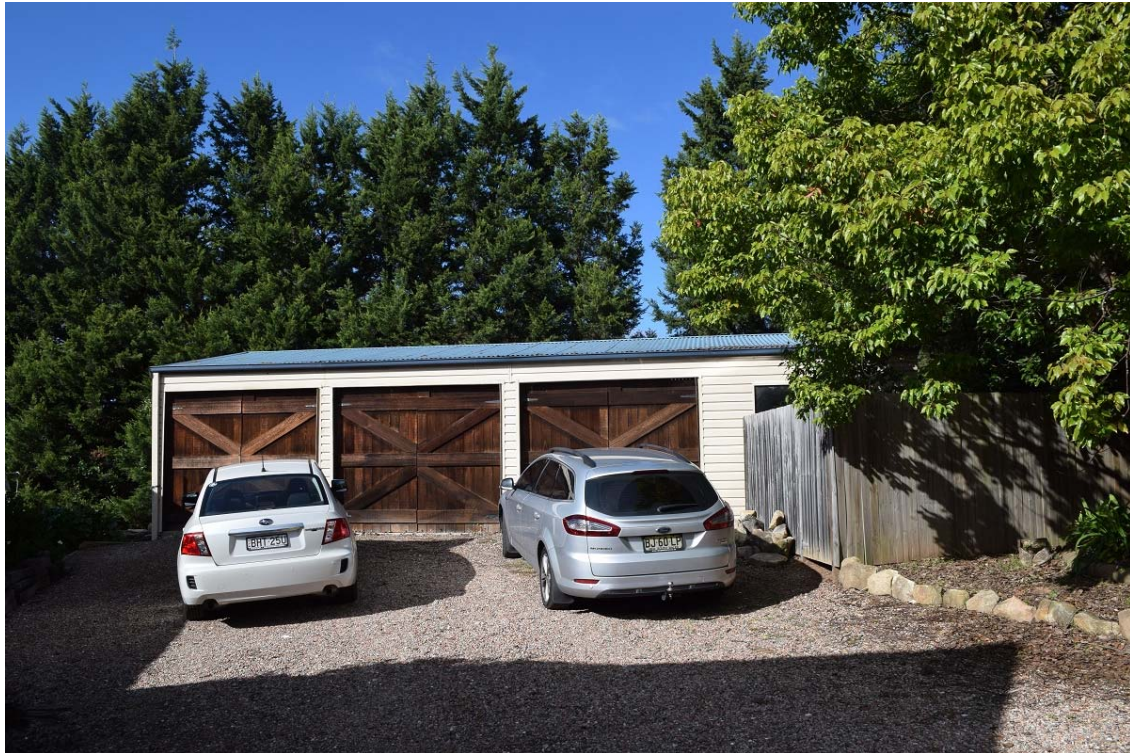
Image 5436:

Image 5436 depicts a single storey stables with metal roofing. Timber roof framing with timber clad walls on a concrete raft slab.

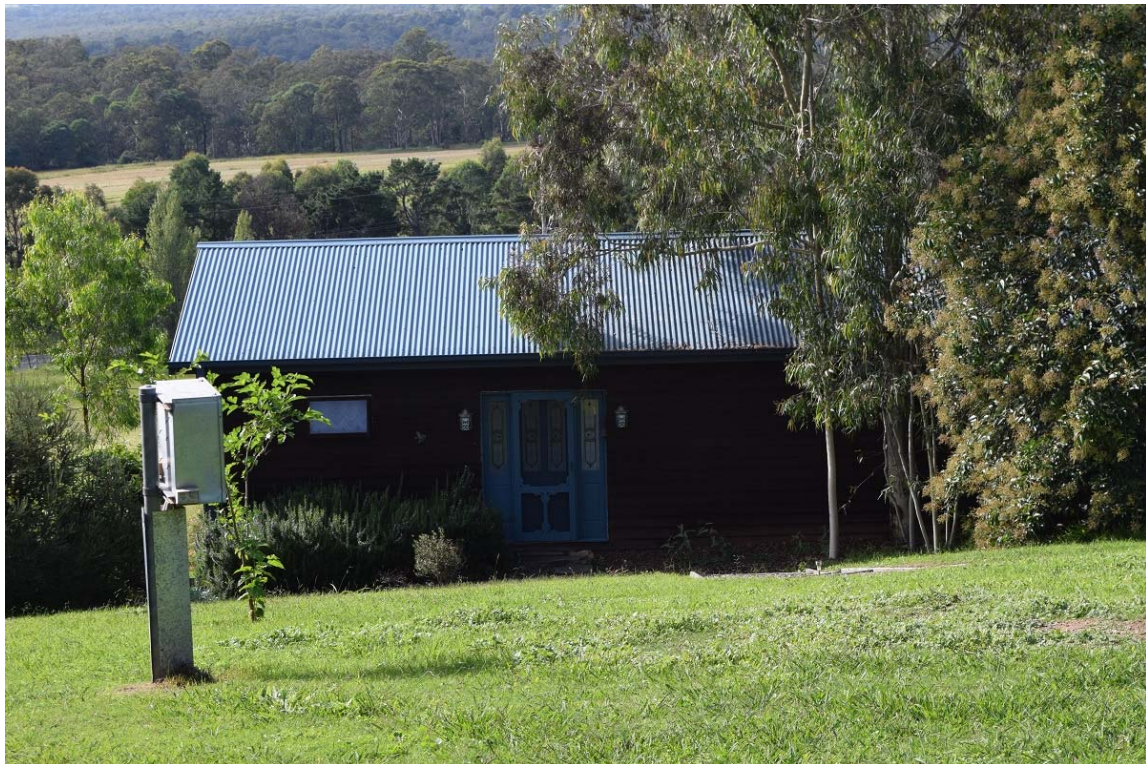
Image 5442:

Image 5442 same as main house.
