# **Tahmoor Colliery Longwalls 25 to 26**

## **INTEGRAL ENERGY**

# **SURFACE SAFETY AND SERVICEABILITY MANAGEMENT PLAN**

**REVISION D**

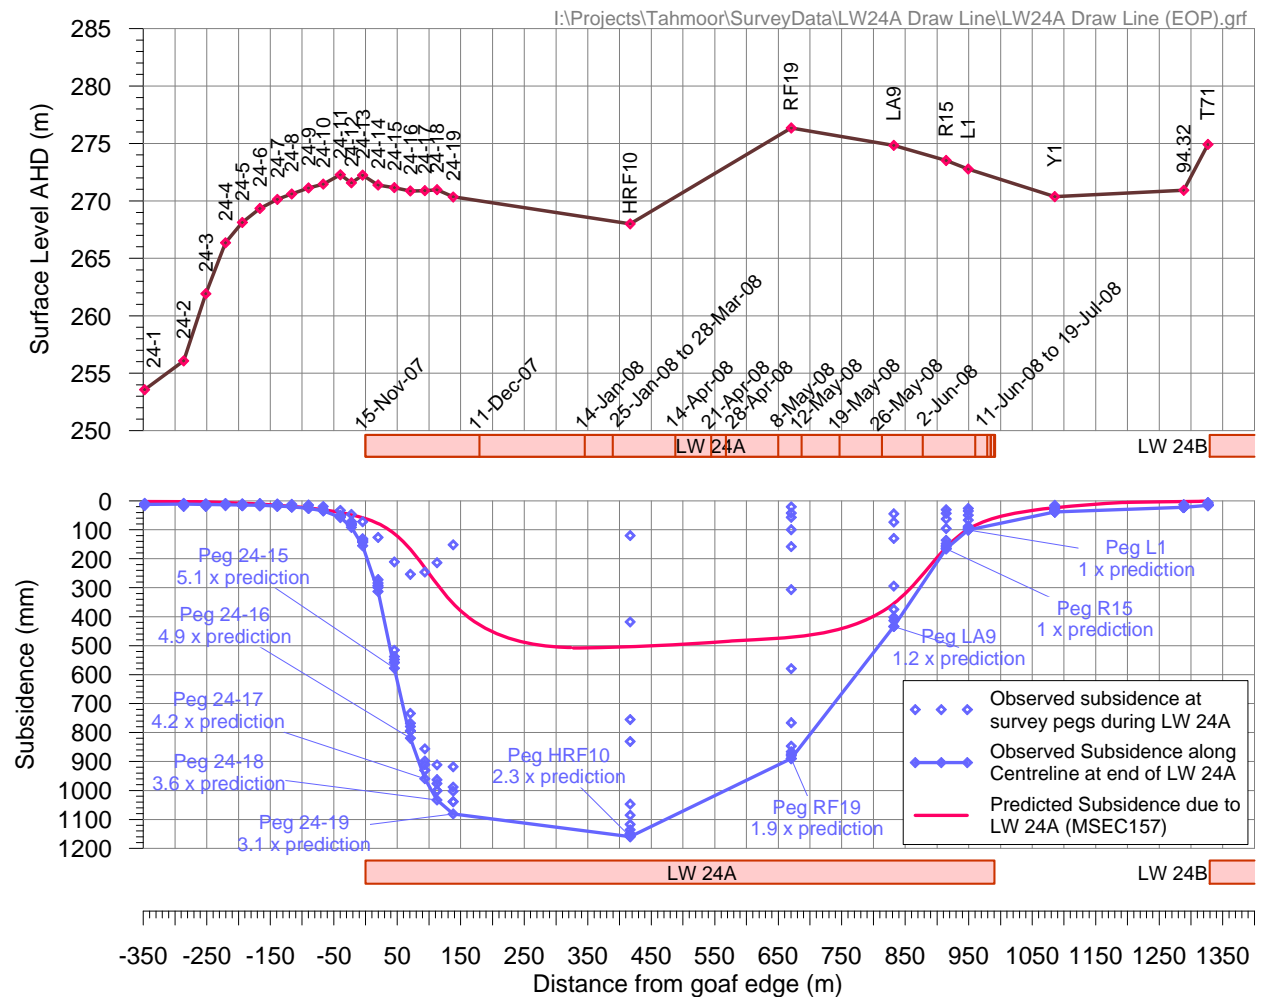
**Fig. 2.1 Observed Subsidence along Centreline of Longwall 24A**

Increased subsidence has been observed above Longwall 24A with no reported impacts to electrical infrastructure. Subsidence monitoring and daily visual inspections were undertaken along the streets during mining. Observed subsidence was greatest above the southern half of Longwall 24A, and gradually reducing in magnitude towards the northern half of the longwall, which was directly beneath the urban area of Tahmoor. These observations are shown graphically in Fig. 2.1, which shows observed subsidence at survey pegs located along the centreline of Longwall 24A.

It can be seen from Fig. 2.1 that while observed subsidence was substantially greater than predicted above the commencing end of the longwalls, observed subsidence compared reasonably well with predictions towards the finishing end of Longwall 24A. It is noted that the extent of the urban area of Tahmoor above Longwall 25 is located near Remembrance Drive (refer Peg R15 in Fig. 2.1).

Given the experience above Longwall 24A, it is considered possible that increased subsidence could be observed above Longwall 25, particularly near the commencing (southern) end of the longwall.
