Tahmoor Colliery Longwalls 24 to 26

NATURAL FEATURES

SURFACE SAFETY AND SERVICEABILITY MANAGEMENT PLAN

REVISION H

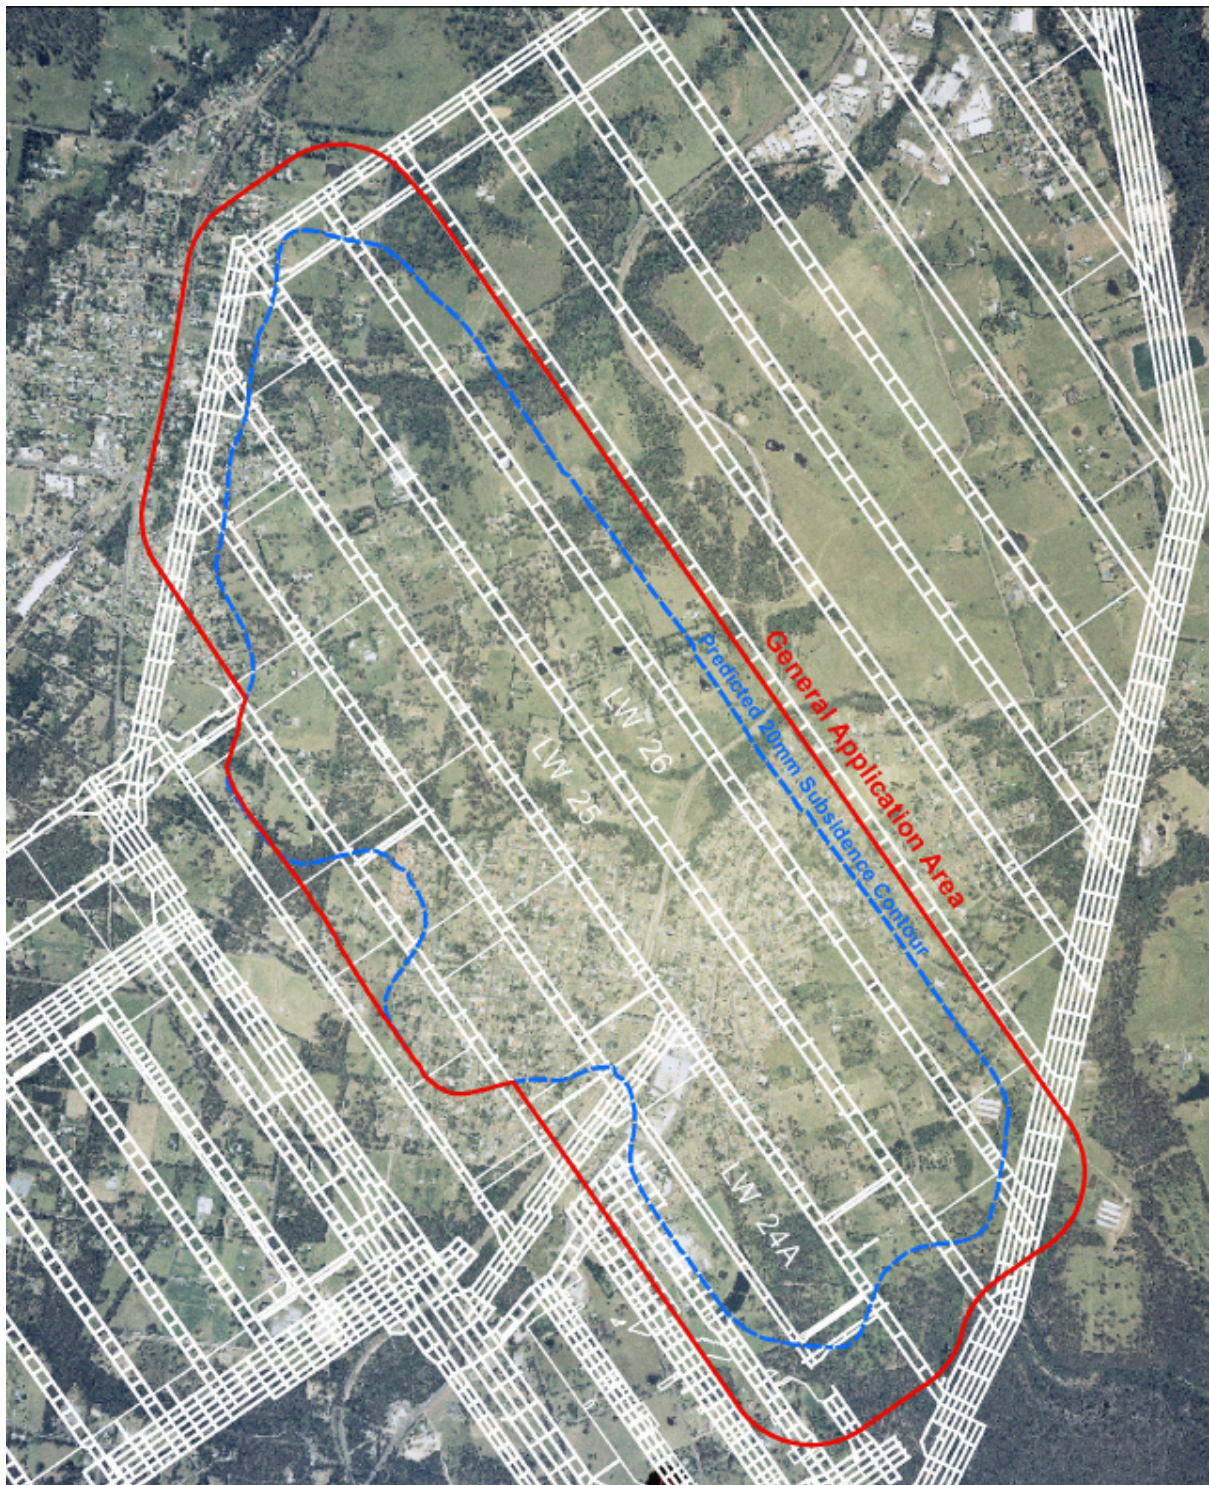
Fig. 1.1 Aerial Photograph overlaid with Mine Plan

This Surface Safety and Serviceability Management Plan (SSSMP) is based on the predictions of the effects of mining on the surface as provided in Report No. MSEC157 by Mine Subsidence Engineering Consultants. Predictions are based on the planned configuration of longwalls at Tahmoor Colliery (refer Fig. 1.1), along with available geological information and data from numerous subsidence studies for longwalls previously mined in the area.

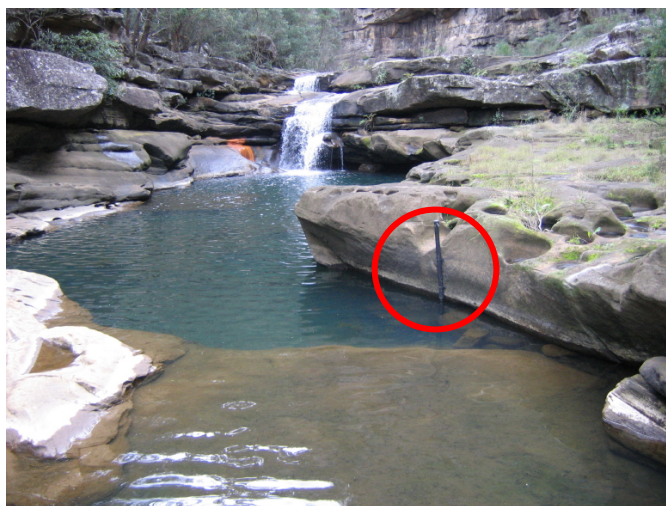
Fig. 3.1 Automated Water Level Logger at Pool H

Five (5) automated pressure transducer loggers (Fig. 3.1) record water levels on a daily basis and are downloaded monthly by Hydrometric Consulting Services (HCS). Bolts have been placed in other pools and the vertical distance between the bolt and the water level is measured by HCS on a monthly basis. The locations of all loggers and bolts are shown in Fig. 3.2. Results will be compared against trigger levels described in **Section 3.11**.

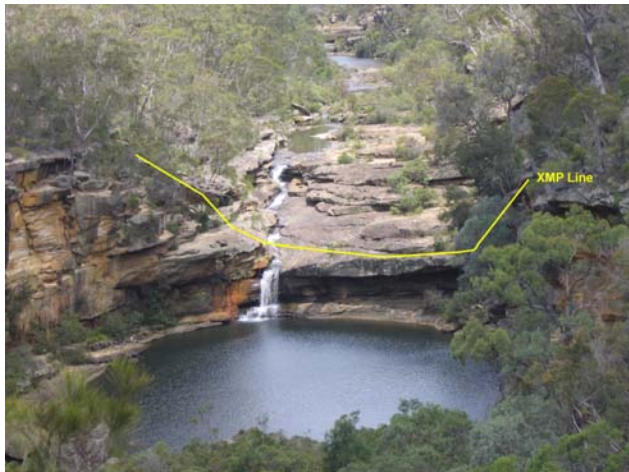
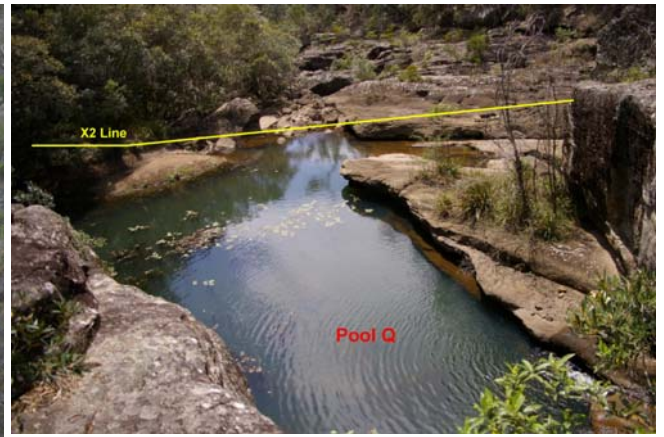
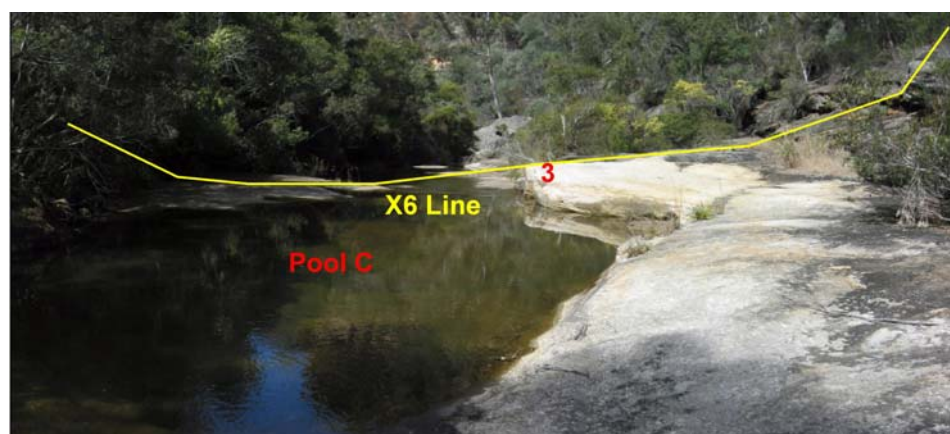
Note: Red numbers refer to MSEC photographic survey stations.

Fig. 3.3 XMP, X2, X3, X3a and X6 Rockbar Monitoring Lines
